NONDESTRUCTIVE EVALUATION AND ASSESSMENT OF CONCRETE BARRIERS FOR DEFECTS AND CORROSION

Final Report

November 15, 2013

WJE No. 2006.5773 (Iowa DOT, Project Number BARR-010)

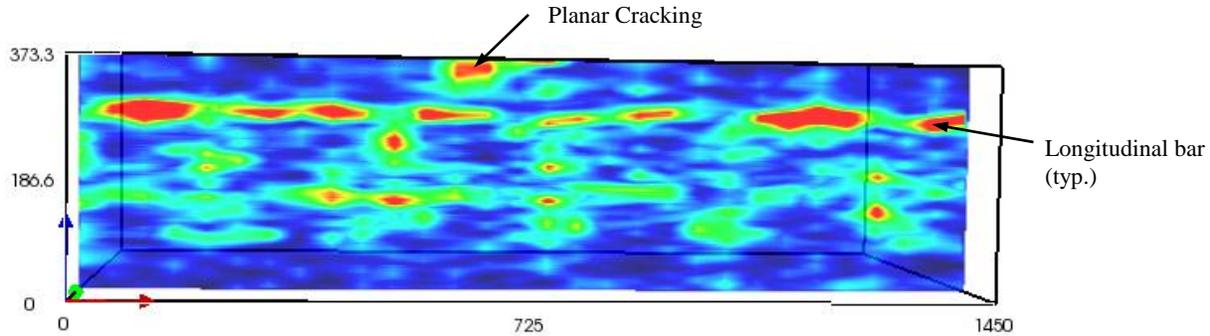
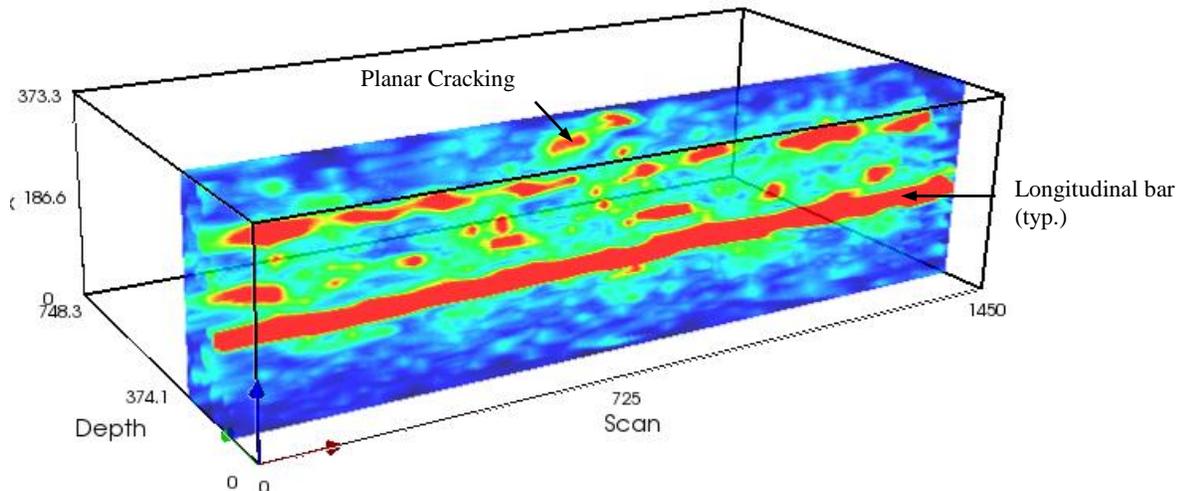
Figure 64 shows the top of the barrier at MIRA testing grid H-3 on the east barrier of the Kickapoo Creek Bridge [IDOT Str. No. 054-0505]. A horizontal crack measuring approximately 10 inches long was observed near the middle of the top surface of the wall. MIRA testing at this location identified signal reflections from the planar separation extending from the top of the wall to the top layer of longitudinal bars (Figure 65). The planar separation did not appear to extend beneath the reinforcing at this location.

Figure 65. Grid H-3 MIRA Result: interior elevation, isometric images. Grid Location: Kickapoo Creek, east barrier, 214' - 220' from N end. MIRA Analysis Results: Interior and exterior reinforcing identifiable, good reflection from back surface, planar separations above longitudinal bars at top of barrier.

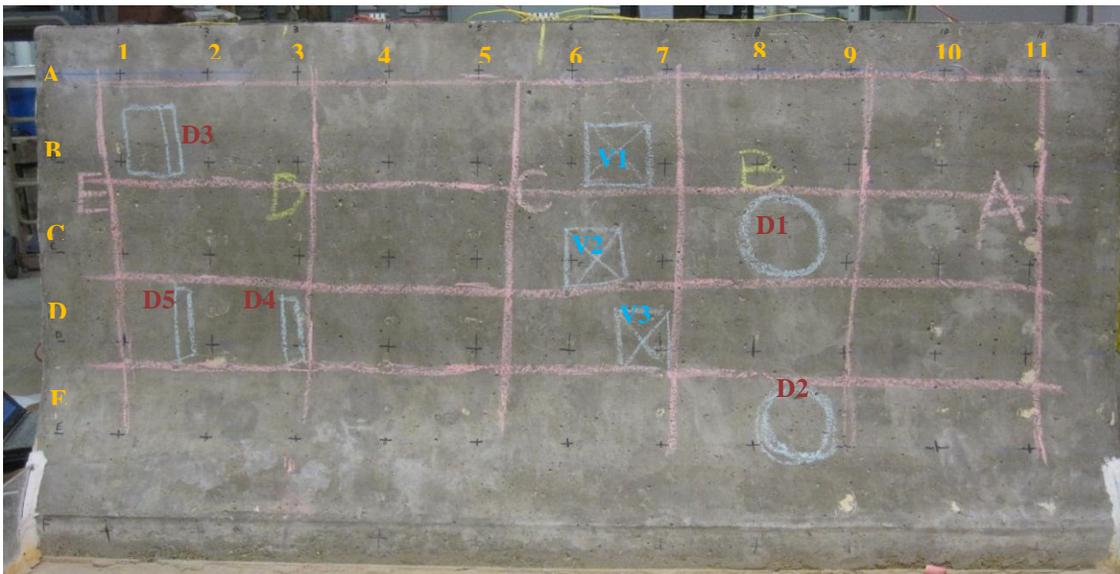
Figure 66. View of interior face of the mock-up barrier wall indicating locations of embedded voids (V1-V3) and honeycomb defects (D1-D5) and UPV testing grid labels (corresponding grid on opposite face).

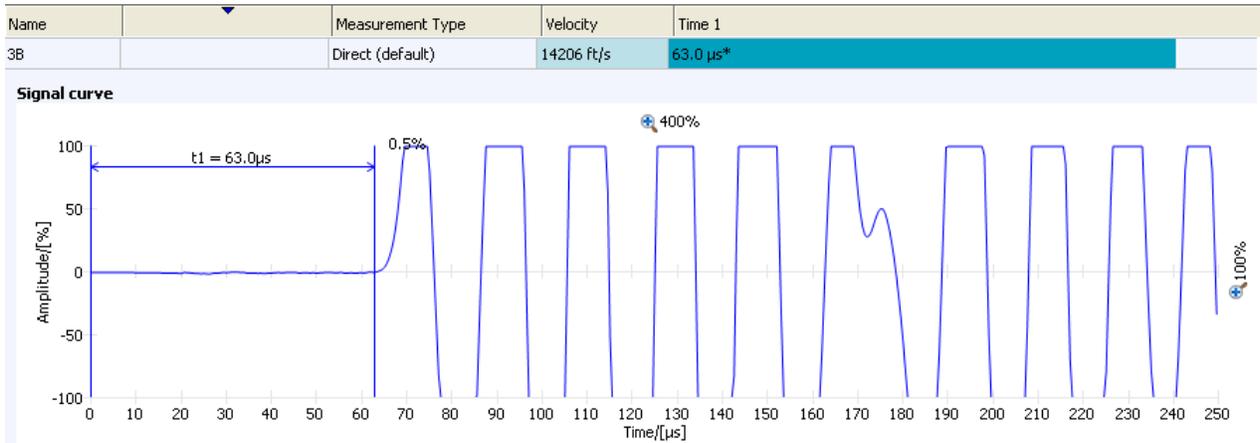
Figure 67 provides the UPV test result at a location on the mock-up barrier at which no internal flaws were present through the thickness of the wall (UPV Test Location B-3). The plot displays the time domain waveform of the stress wave collected at the receiving transducer. The test result shows a time delay of 63.0 μ s, corresponding to a measured ultrasonic pulse velocity of 14,206 feet per second, at which time an unimpeded, high amplitude signal is received. Figure 68 provides the UPV test result at embedded void V2. The embedded void results in an increase in the transit time of the stress wave and reduction in the measured ultrasonic pulse velocity to 12,590 feet per second. The amplitude of the received waveform is also severely affected by the presence of the flaw. The difference between the acoustic impedance of the embedded foam and the concrete at this location results in reflection of a majority of the propagating stress wave at the surface of the void. Therefore, the stress wave collected at the receiving transducer likely represents waves which have traveled around the embedded void panel, resulting in an increased path length. Similarly, testing at the embedded honeycomb panels D1 and D3, as shown in Figure 69 and Figure 70, respectively, resulted in a reduction in the measured pulse velocity and a notable effect on the amplitude of the received signal. The stress waves at these test locations, however, likely propagate directly through the honeycomb concrete, directly reducing the pulse velocity.

Figure 67. UPV test result at Test Location B-3; no flaw. Measured UPV velocity of 14206 ft/s.

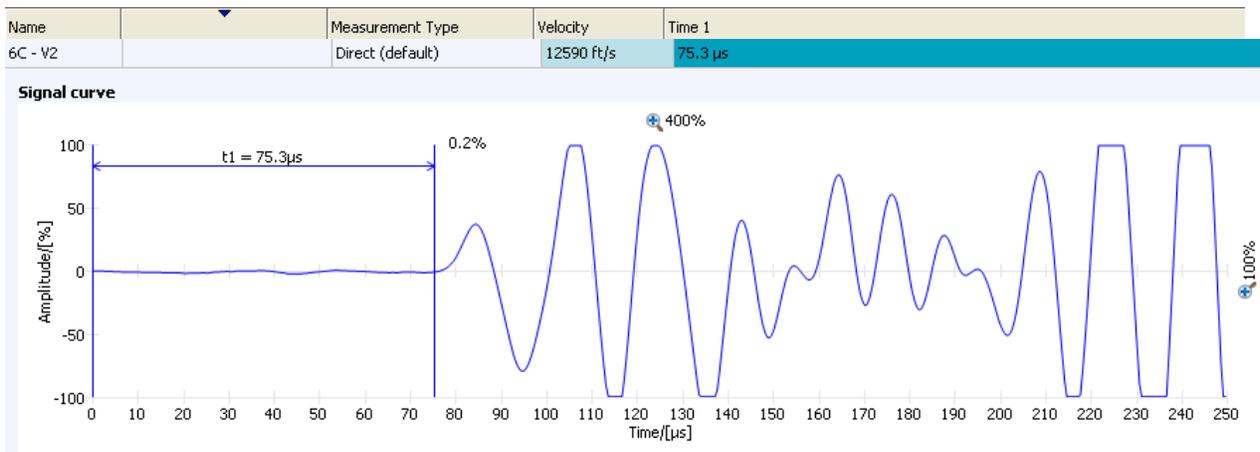
Figure 68. UPV test result at Test Location C-6; embedded void panel V2. Measured UPV velocity of 12590 ft/s.

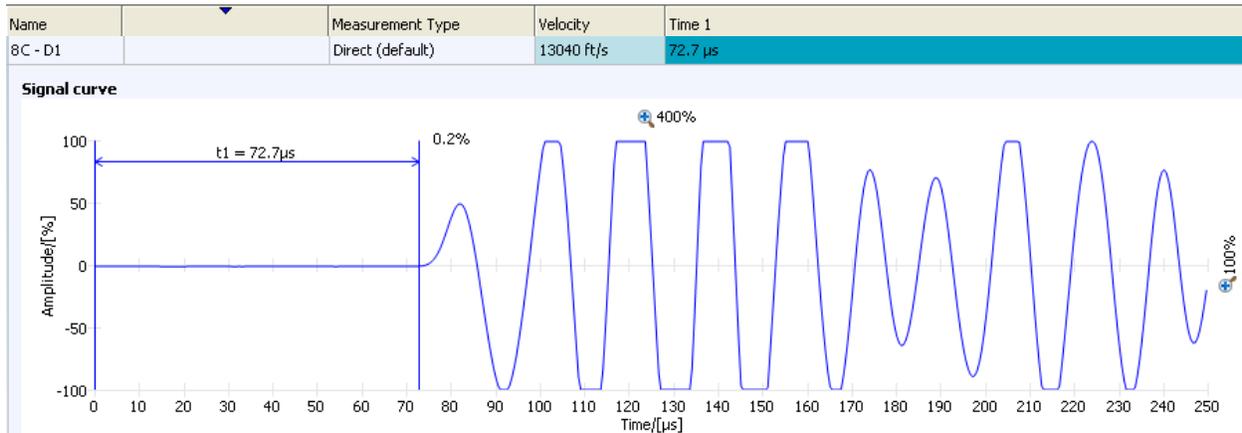
Figure 69. UPV test result at Test Location C-8; embedded honeycomb panel D1. Measured UPV velocity of 13040 ft/s.

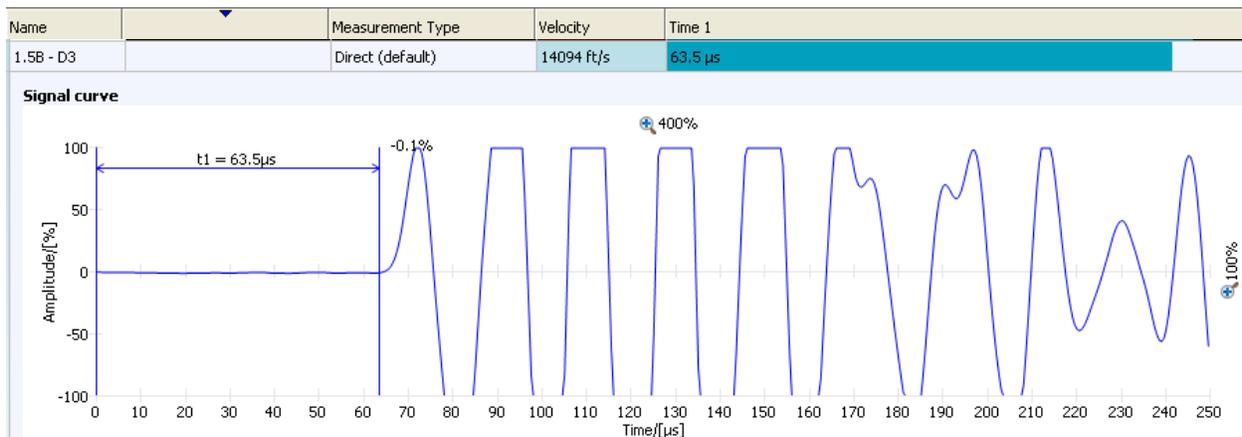
Figure 70. UPV test result at Test Location B-1.5; embedded honeycomb panel D3. Measured UPV velocity of 14094 ft/s.

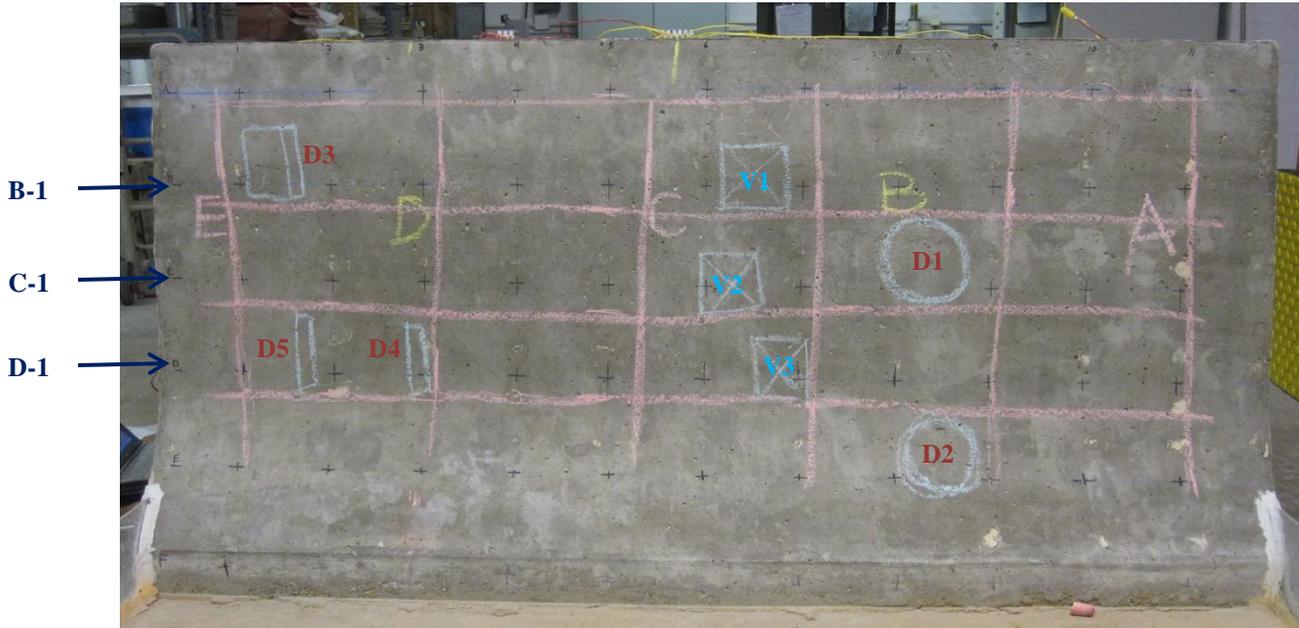
Figure 71 through Figure 74 provide examples of the GPR trial testing performed on the mock-up barrier wall sample. An elevation view of the interior face of the mock-up barrier wall indicating the locations of selected horizontal scans in relation to the embedded flaws is provided in Figure 71. Selected horizontal scans after signal filtering and post-processing are shown along with an indication of the locations of the embedded voids or honeycomb defect panels along the scans.

Figure 71. View of interior face of the mock-up barrier wall indicating locations of embedded voids (V1-V3) and honeycomb defects (D1-D5) and locations of selected horizontal GPR scans (B1, C1, D1).

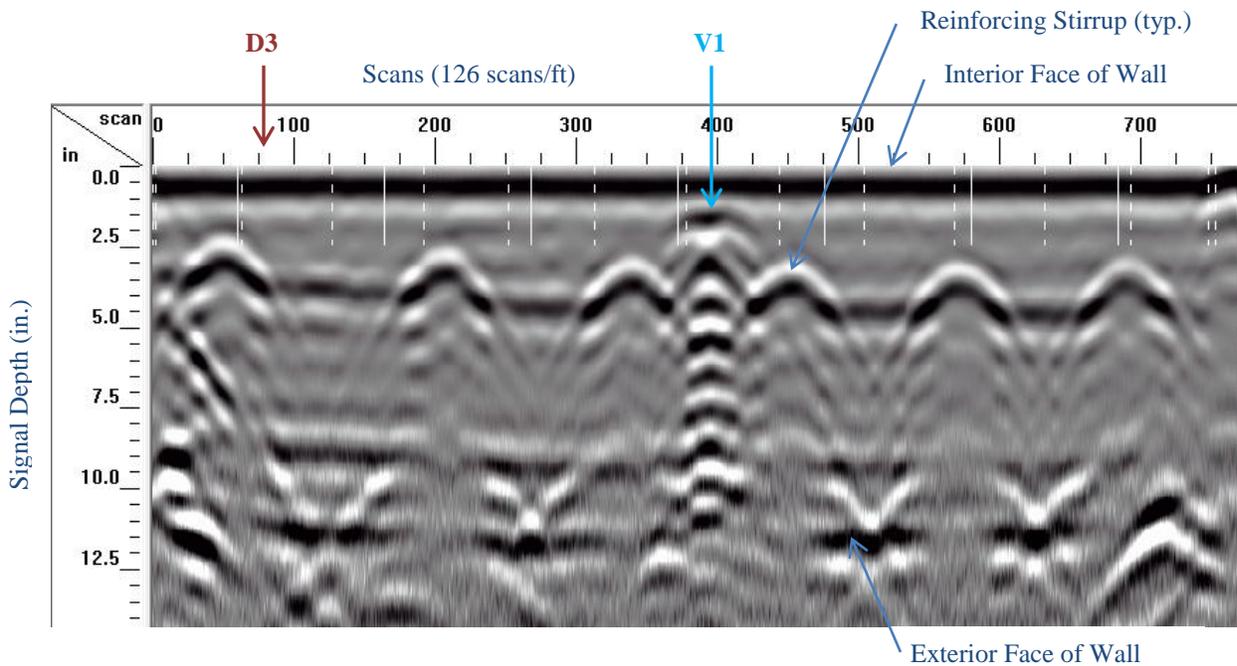
Figure 72. Sample GPR scan B-1 collected horizontally along gridline B of the mock-up barrier wall.

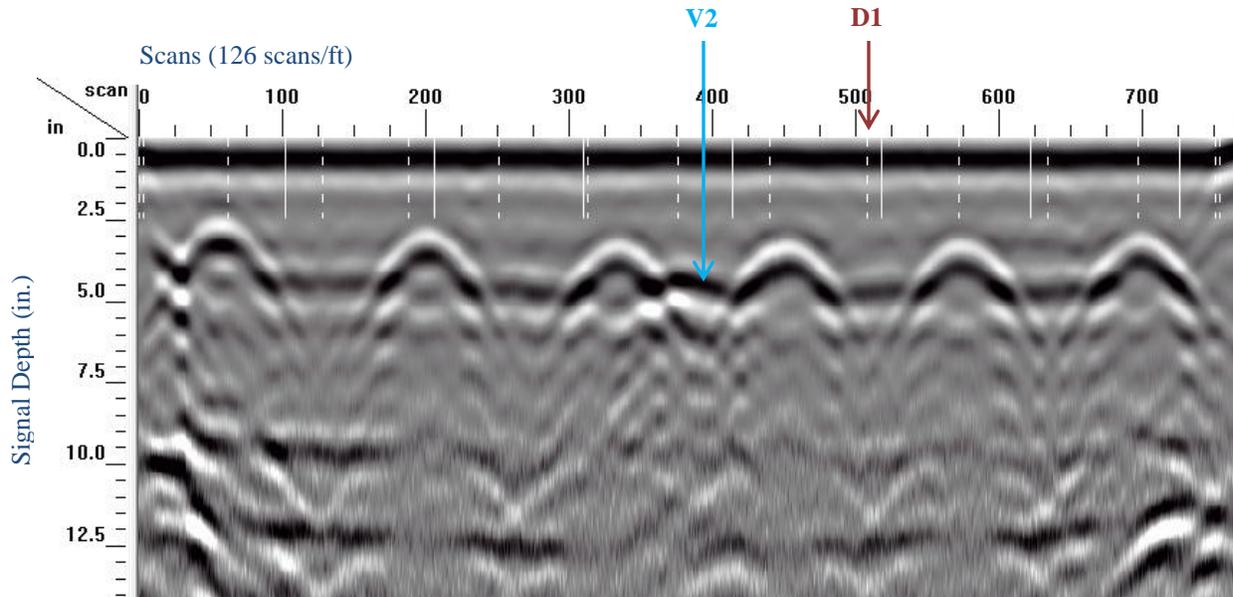
Figure 73. Sample GPR scan C-1 collected horizontally along gridline C of the mock-up barrier wall.

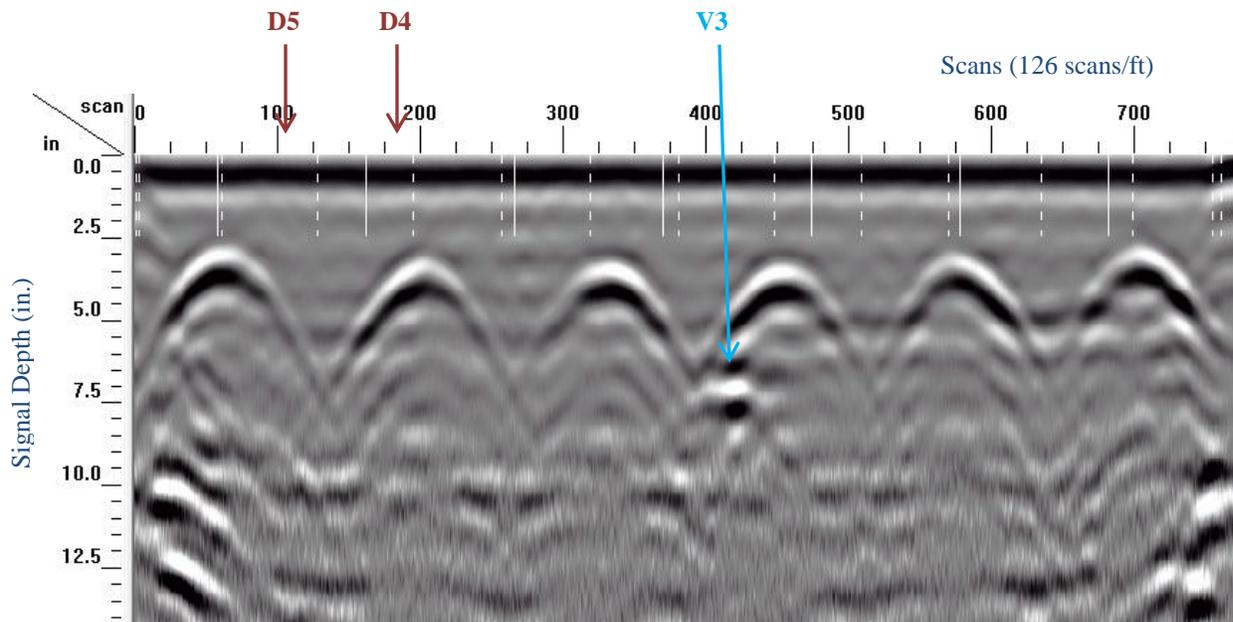
Figure 74. Sample GPR scan D-1 collected horizontally along gridline D of the mock-up barrier wall.

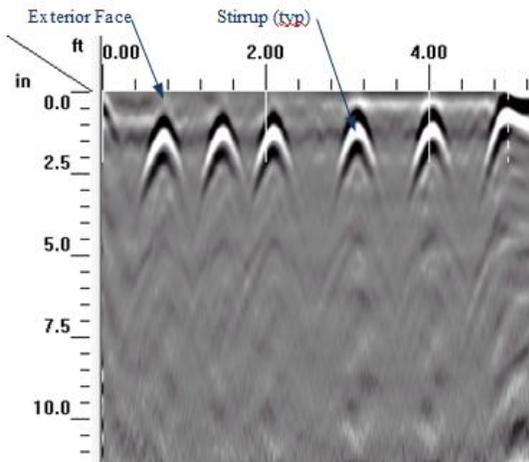
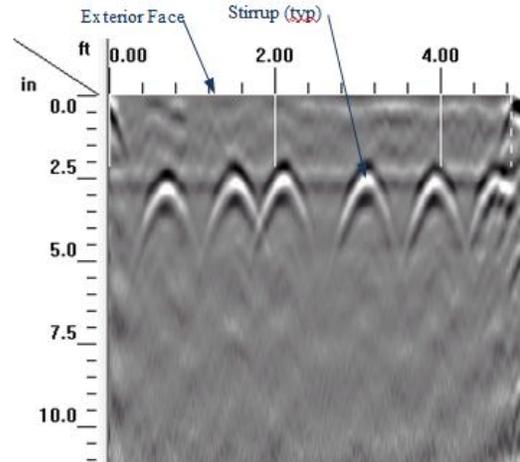
In addition to the laboratory mock-up testing, GPR testing was performed on the Killian trial barrier segments. Results of the testing indicated that GPR testing of early-age slip formed barrier walls (48 hour after construction) was feasible. However signal resolution was adversely affected by the concrete age (Figure 75). Early-age concrete contains higher free moisture levels, resulting in higher signal attenuation through the thickness of the wall. Detection of internal conditions beyond the nearest reinforcing layer was limited in these test samples.

Figure 75. Sample GPR scans collected horizontally on the exterior face of the Killian Test Sample 2. GPR Result: Signal penetration limited, not able to resolve interior reinforcing from exterior face.

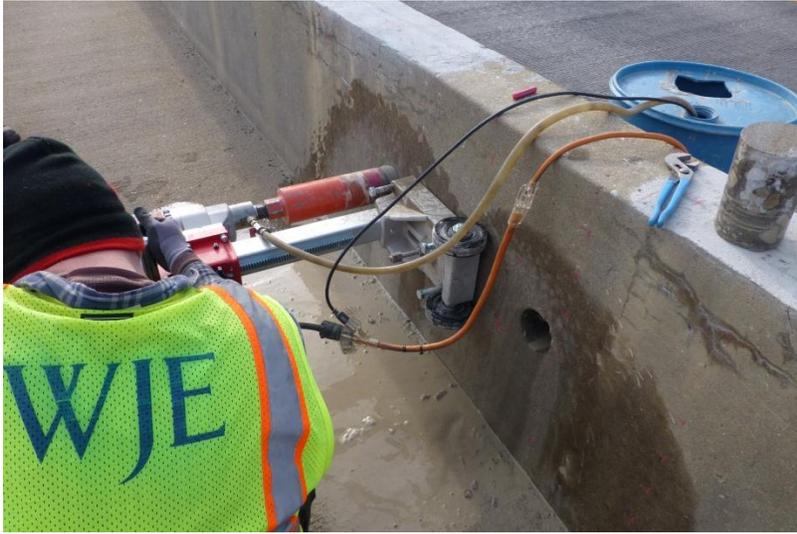
Figure 76. Exploratory coring in progress on the exterior face of the northbound barrier of Iowa 150.

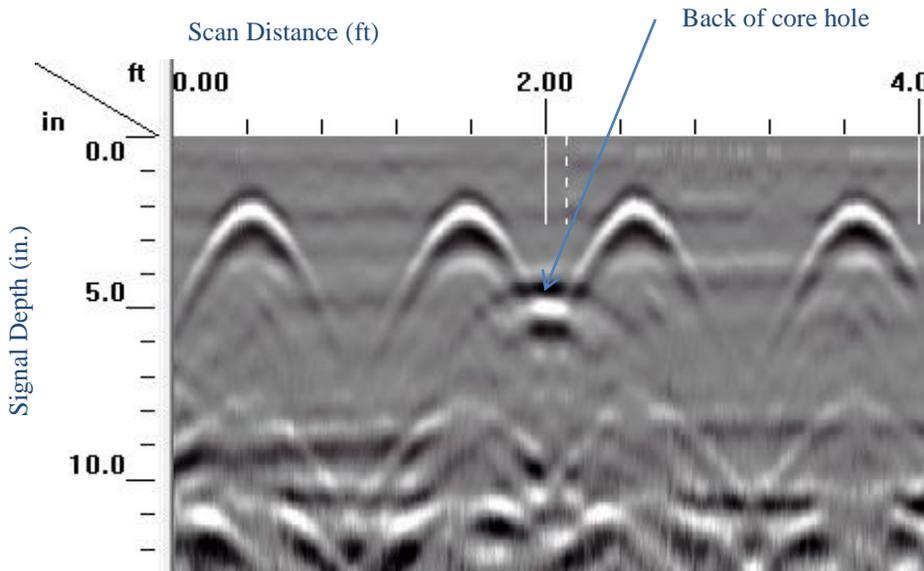
Phase A field testing of GPR provided general conclusions about the feasibility and capabilities of using the test method for barrier assessment; more specific flaw detection studies were completed during Phase B field testing. It was determined that the higher frequency 2.6 GHz antenna provided optimum signal resolution through the thickness of the barrier wall. GPR testing at the Iowa 150 bridge did not identify any internal reflections indicating potential internal flaws or voids. Several partial-depth exploratory cores were collected from the exterior face of the barrier at selected locations to confirm the unflawed condition (Figure 76). Subsequently, GPR scanning of the barrier wall on the interior face at each core location confirmed that GPR was capable of detecting the drilled core holes (Figure 77).

Figure 77. Horizontal GPR collected on the interior face of the barrier at typical exploratory core location at northbound barrier of Iowa 150.

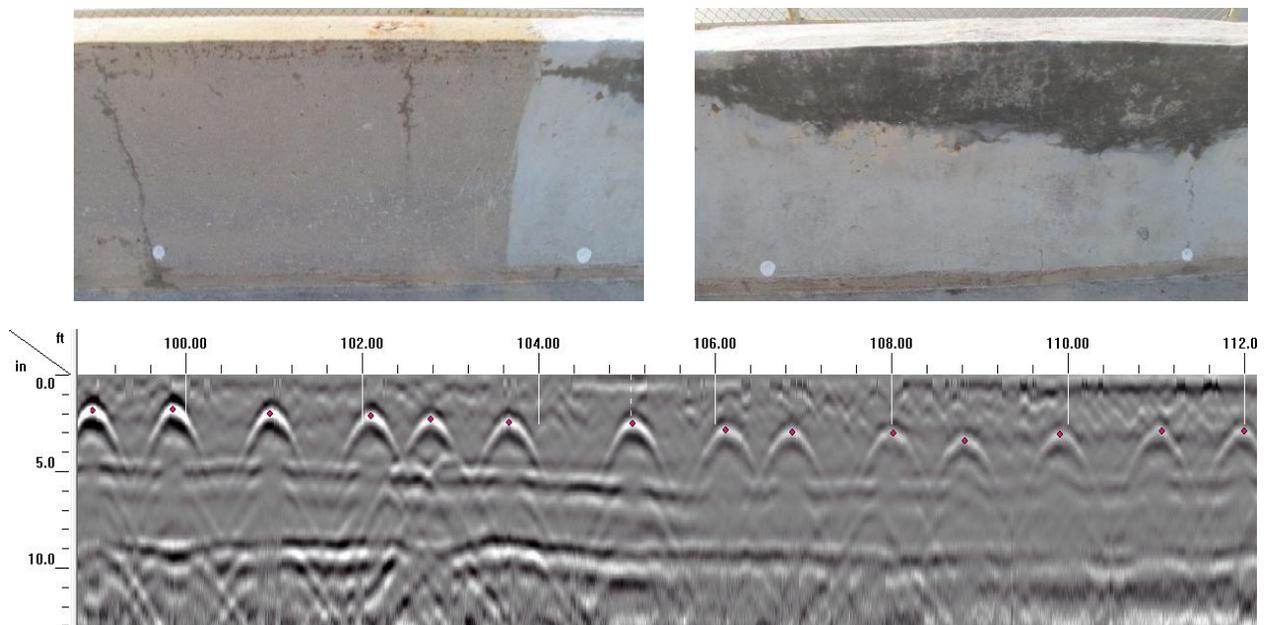
the distress. A specific method, analogous to methods used to detect delamination of concrete bridge decks, was explored during which the amplitude of the signal reflection from the vertical reinforcing bars within the barrier was analyzed along with cover depth data. Signal amplitude and cover depth were plotted, and the results were compared with photographs and condition assessment notes along the length of the scans. Figure 78 provides an excerpt of a GPR scan collected on the west face of the southbound barrier at station 2+45 to 2+57 along with selected photographs showing the surface condition of the area. Note the presence of a cracking and moisture staining around a repair patch reduces signal velocity, signal reflection amplitude from the embedded vertical reinforcing bars, and signal reflection amplitude from the back surface of the barrier. Figure 79 shows a plot of signal amplitude and cover depth from a full sample horizontal GPR scan relative to areas that were visibly distressed. Some correlation between the observed distress and signal velocity and reflection amplitude values was observed. However, this correlation requires additional study.

Figure 78. Sample GPR scan D-1 collected horizontally along gridline D of the west face of the southbound barrier at station 2+45 to 2+57 for Iowa 150.

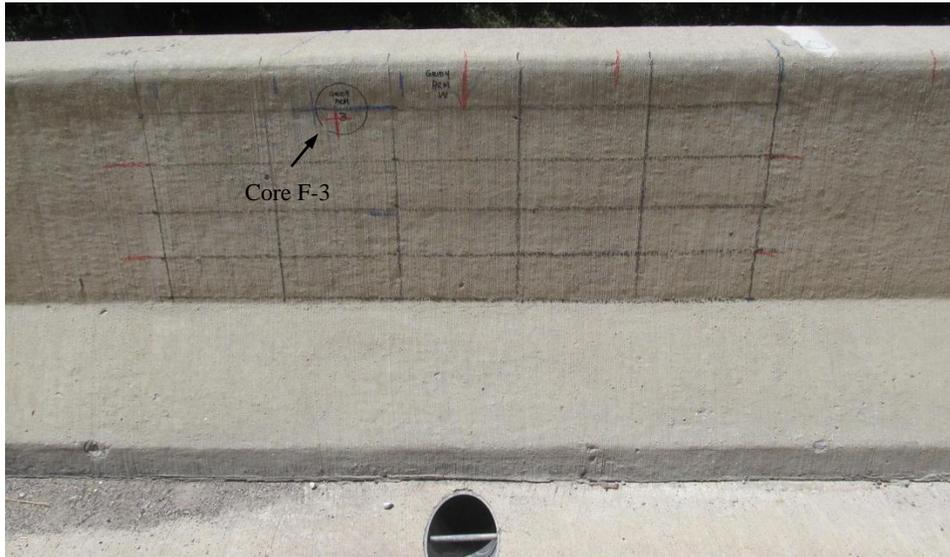
Figure 80 shows the interior face of the west barrier of the Armitage Spur Bridge [IDOT Str. No. 054-0503]. Results of a GPR scan collected on the exterior face approximately 8 inches from the top of the barrier are provided in an excerpt of the processed GPR scan shown in Figure 81. The interior and exterior layer of reinforcing stirrups and the opposing interior surface of the barrier wall are identifiable in the horizontally oriented scan. The scan shows a negative signal reflection indicative of possible internal voiding near the exterior face stirrup at 42 feet-6 inches from north end of barrier. Core F-3, shown in Figure 82, indicated a void measuring 1-1/4 inch diameter located adjacent to the stirrup and longitudinal bar at this location.

Figure 80. Photograph of interior face of west barrier of Armitage Spur. Core F-3 located 42'-10" from N end.

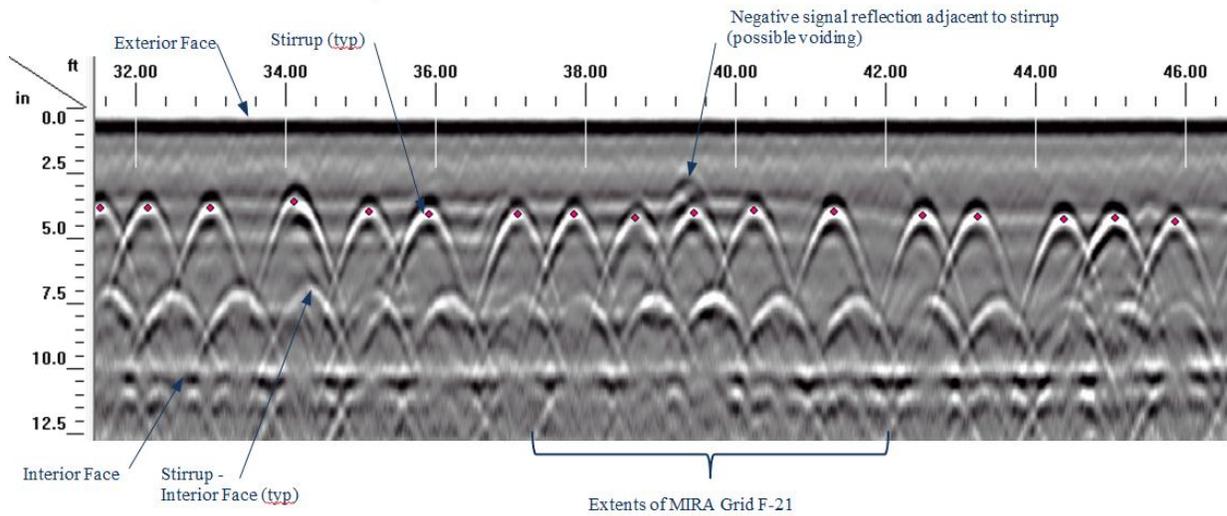
Scan 071 - Exterior Face, 8" from Top of Barrier

Figure 81. GPR Scan Excerpt: Scan 071 collected on Armitage Spur, west barrier, exterior face, 8" from top of barrier. GPR Analysis Results: Negative signal reflection near exterior face stirrup at 42'-6" from north end of barrier.

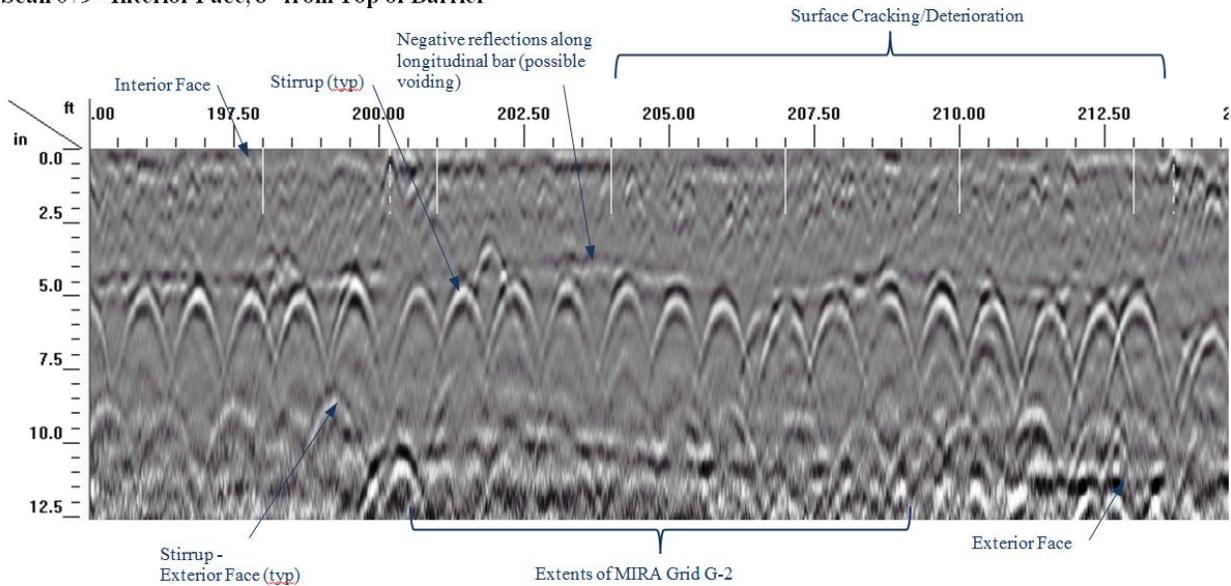
Scan 079 - Interior Face, 8" from Top of Barrier

In contrast to ultrasonic testing methods, the GPR test method is capable of penetrating visibly deteriorated areas, including those areas with moderate to severe cracking and freeze-thaw deterioration. An excerpt of the GPR scan collected on the interior face of the south barrier at the Emden Road Bridge [IDOT Str. No. 054-0078] shows that the interior and exterior reinforcing stirrups and the exterior surface of the barrier can be identified in the scan. However, signal wave speed (depth measurement) and signal amplitude are affected by the presence of the deterioration (Figure 83). Additionally, minor negative reflections observed near the longitudinal reinforcing bars in the scan indicated possible voiding along the bar. Note that this test location coincides with the MIRA test location G-2 shown in Figure 58. As noted earlier, Core G-3 indicated moderate voiding (3/8 to 1/2 inch diameter) behind reinforcing and around aggregate (Figure 60).

Figure 83. GPR Scan Excerpt: Scan 079 collected on Emden Road, south barrier, interior face, 8" from top of barrier. GPR Analysis Results: Overall signal disturbance near-surface, wave speed affected by deterioration/cracking, negative reflections along longitudinal bar indicates possible voiding along bar

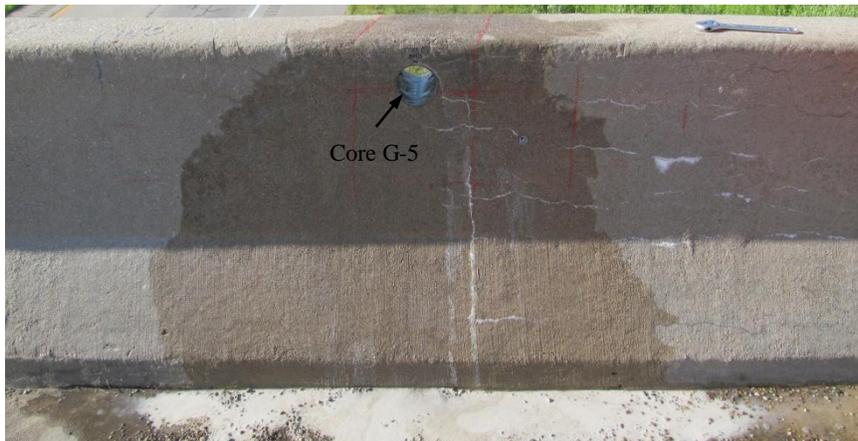
More severe voiding around the reinforcing bars was identified by GPR at a test location at 150 feet to 170 feet from the north end of the north barrier of the Emden Road Bridge (Figure 84). An excerpt of the GPR scan collected on the exterior face of the barrier identifies severe voiding along the exterior longitudinal bar (Figure 85). Core G-5, shown in Figure 86, indicated severe voiding at the interior and exterior reinforcing. Based on the appearance of the voids, the separation was caused by a vertical shift, or sag, in the concrete during slip forming while the material was still in a plastic state.

Figure 84. Photograph of interior face of the north barrier of Emden Road. Core F-5 located 162'-7" from N end.

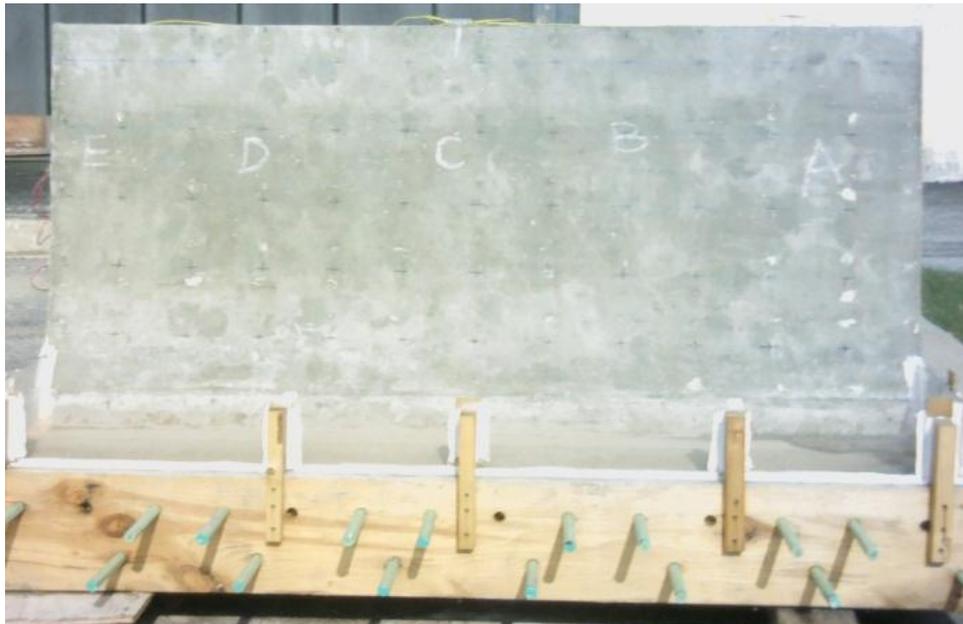
Optical and thermogram images of the mock-up barrier wall and the barriers tested in the field were analyzed to determine whether known internal defects could be detected using infrared thermography. An optical image of the interior face of the mock-up barrier wall is shown in Figure 88. Figure 89 provides a corresponding infrared thermogram during an ambient heating cycle in an exterior environment. In this example, a wide temperature range was selected and the resultant thermogram clearly indicates the presence of embedded void panel V1, which is positioned approximately 1-1/8 inches from the front face of the barrier. Post-processing of the collected images, including attempts to enhance the images at other areas with known internal defects, showed only near surface defects were detected. Similar testing at various times during the ambient heating cycle and using various temperature range settings had similar results. Embedded void panels positioned at 4 inches and 6-3/16 inches and embedded honeycomb defects D1 through D3 were undetectable using infrared thermography.

Figure 88. View of interior face of the mock-up barrier wall prior to exterior infrared thermography testing.

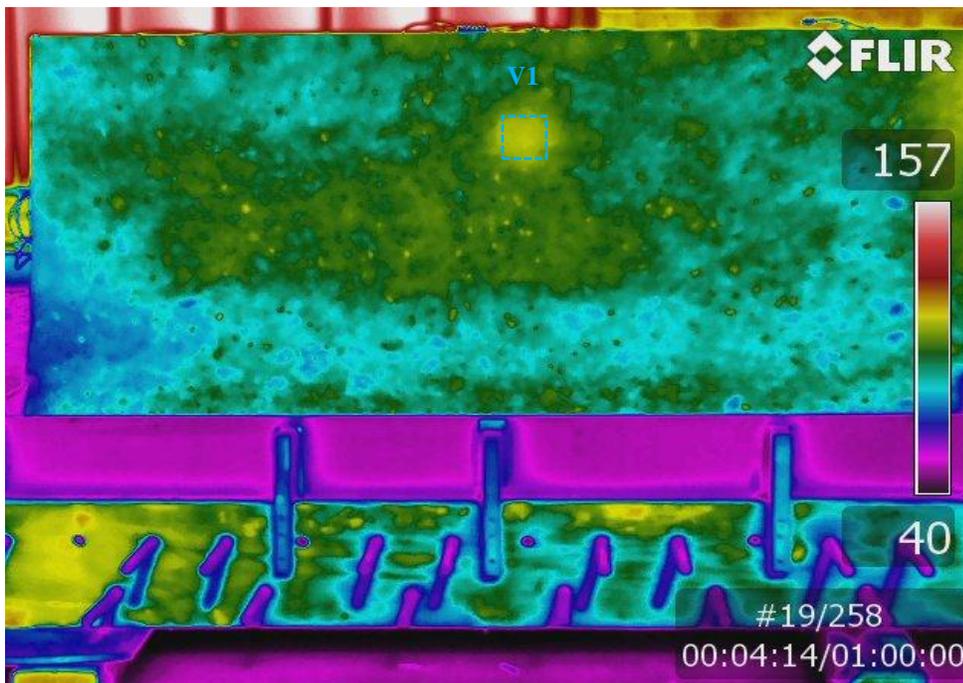
Figure 89. Sample IR thermogram image collected during an ambient heating cycle.

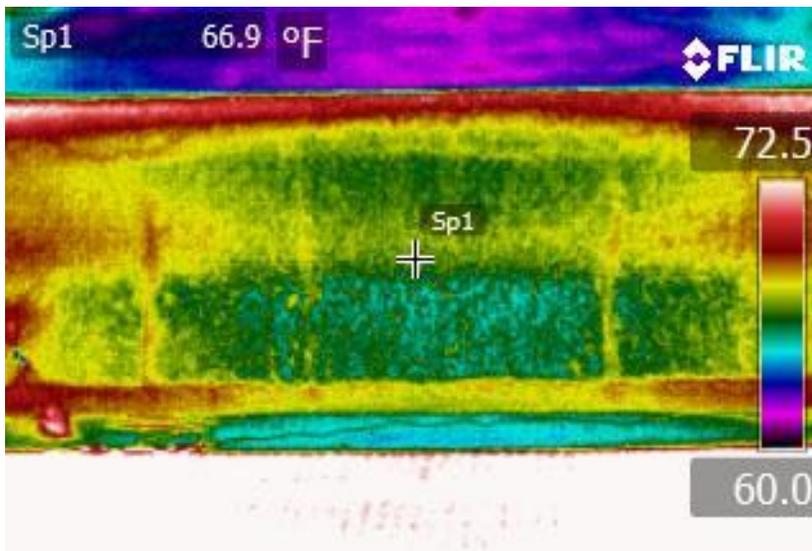
Phase A field testing of the IR method performed at each of the three selected bridges provided some information regarding the feasibility of testing in-situ barrier walls. Figure 90 and Figure 91 provide sample thermogram images collected on the eastbound barrier of Blair Bridge (US30 over the Missouri River) and the northbound barrier wall of Iowa 150 over the Cedar River during an ambient heating cycle, respectively. The images indicate that natural variation in the surface temperatures over the height of the wall due to varying exposure to sunlight is significant and must be accounted for during data collection and analysis. Vertical cracking in the barrier wall can be identified using the IR method. Although the cracking was apparent on the barrier wall surface, the distress was more easily identified in thermogram images compared with optical images of the barrier walls, especially when moisture was present within the cracks. Areas of moisture staining and repair patches at the barrier surfaces were identifiable in the thermogram images due to differences in surface emissivity, which detracted from the ability to identify internal defects at these locations. Figure 92 provides a close-up thermogram image of cracking and freeze-thaw damage at a selected location along the top of the northbound barrier wall of Iowa 150 over the Cedar River. This distress, observed at locations coinciding with previously installed light pole or railing bases, was found to result in higher thermal gradients during the ambient heating cycles and was therefore identifiable using the IR method.

Figure 90. Sample IR thermogram image collected on the eastbound barrier of Blair Bridge (US30 over Missouri River) during an ambient heating cycle.

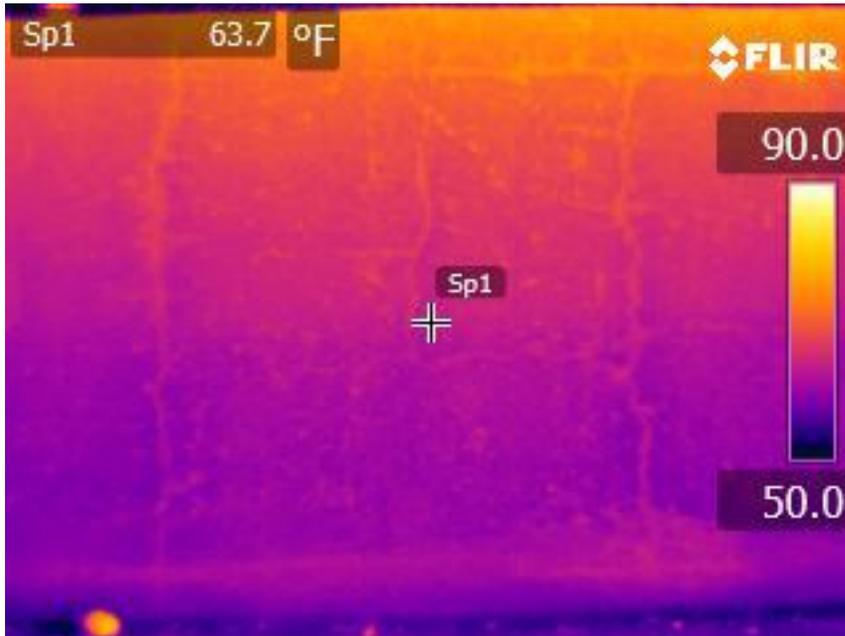
Figure 91. Sample IR thermogram image collected on the northbound barrier of Iowa 150 over the Cedar River during an ambient heating cycle.

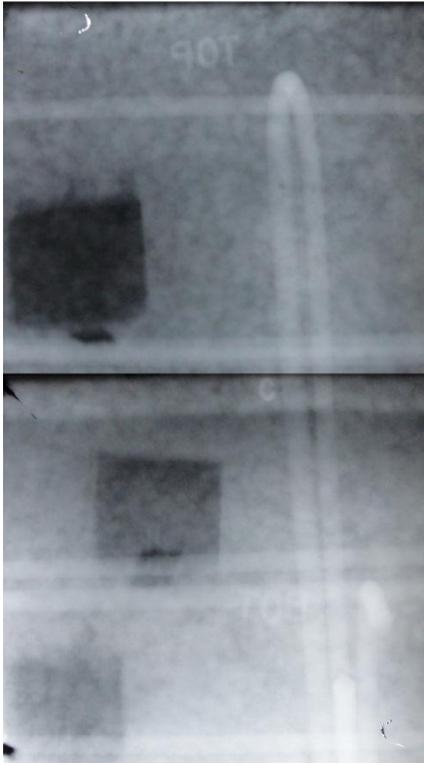
The images obtained from the developed radiographic screens, a sample of which is provided in Figure 93, clearly showed the location of reinforcing bars and the void panels within the tested portions of the barrier wall. The darkness of a radiographic image relates directly to the number of photons that are able to pass through the barrier wall and reach the collection screen. Correspondingly, paths that are relatively denser than surrounding paths (i.e. paths that travel through reinforcing bars) appear lighter in comparison. The transmitted intensity received by the collection screen is inversely proportional to the attenuation coefficient. This coefficient is dependent on an object's density, with values of 1 for steel, 0.3 for concrete, and 0 for air.

Figure 93. Developed screens from radiographic testing of the mock-up barrier wall showing reinforcing (lightly shaded lines) and void panels (dark areas) in a fairly consistent concrete matrix.

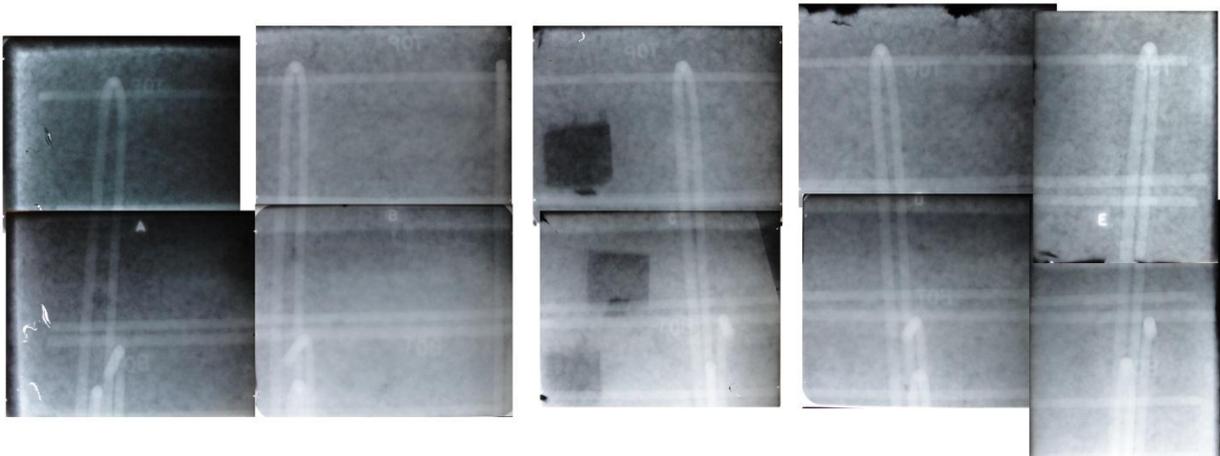
An image created by stitching the radiograph images of multiple screens along the length of the barrier wall (as seen from the outside face) is shown in Figure 94. It is clear from this figure that the reinforcing steel and void panels are discernible. The embedded honeycomb panels positioned within the tested areas, were not identifiable in the radiographic images. The relative high density of the honeycomb panels likely contributed to the difficulty in identifying them using radiography.

Figure 94. Stitched screens from radiographic testing of the mock-up barrier wall.

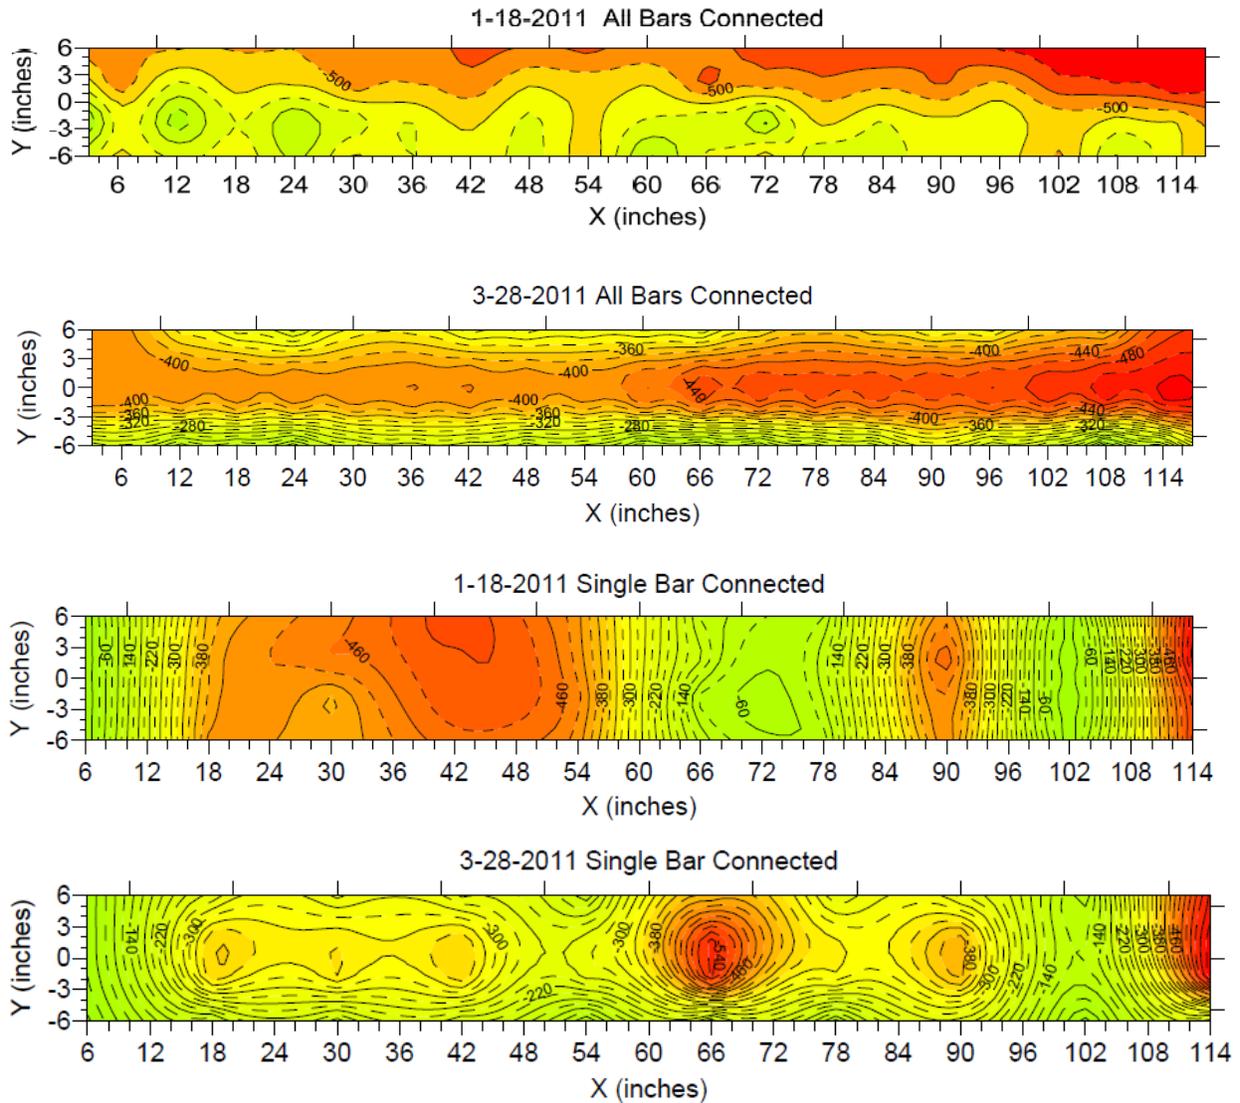
Half-cell potential contours for the mock-up flat-slab sample at the initiation and conclusion of the 12-week chloride exposure period are shown in Figure 95. Different results were obtained when all bars were electrically connected compared to when the half-cell was connected to individual bars. In January 2011, corrosion of individual bars was not clearly indicated by HCP testing except for a couple of locations when connections were made to individual bars. In March 2011 after continued cycling with salt water, the half-cells indicated general corrosion along the construction joint, but individual bar corrosion could not be well distinguished. When connected to an individual bar, corrosion of the individual bars could be better assessed as shown in the 3-18-2011 Single Bar Connected plot. These results indicate that it may be difficult to test barriers having epoxy-coated reinforcing since the results are affected by the electrical

continuity to the bar being tested. Testing using two half-cells placed on two different areas of the slab and without making an electrical ground to the bars was inconclusive. Little variation was noted between test areas.

The mock-up slab sample was stored in the laboratory and periodically wetted over a period of 2-1/2 years. Additional half-cell potential testing and corrosion rate testing remained inconclusive in identifying individually corroding bars. Half-cell potential measurements were not able to clearly differentiate corrosion magnitudes of adjacent epoxy-coated bars; however, values did indicate that corrosion was occurring at the joint location. Potentials near the joint became more negative and ranged between -100 mV and -400 mV CSE (June 2013) and -200 mV to -440 mV CSE (October 2013). Measurements directly over bars having active corrosion did not always have more negative potentials than non-corroding bars.

Figure 95. Half-cell potential plots of the flat slab mock-up, at the initiation and conclusion of 12 weeks of ponding.

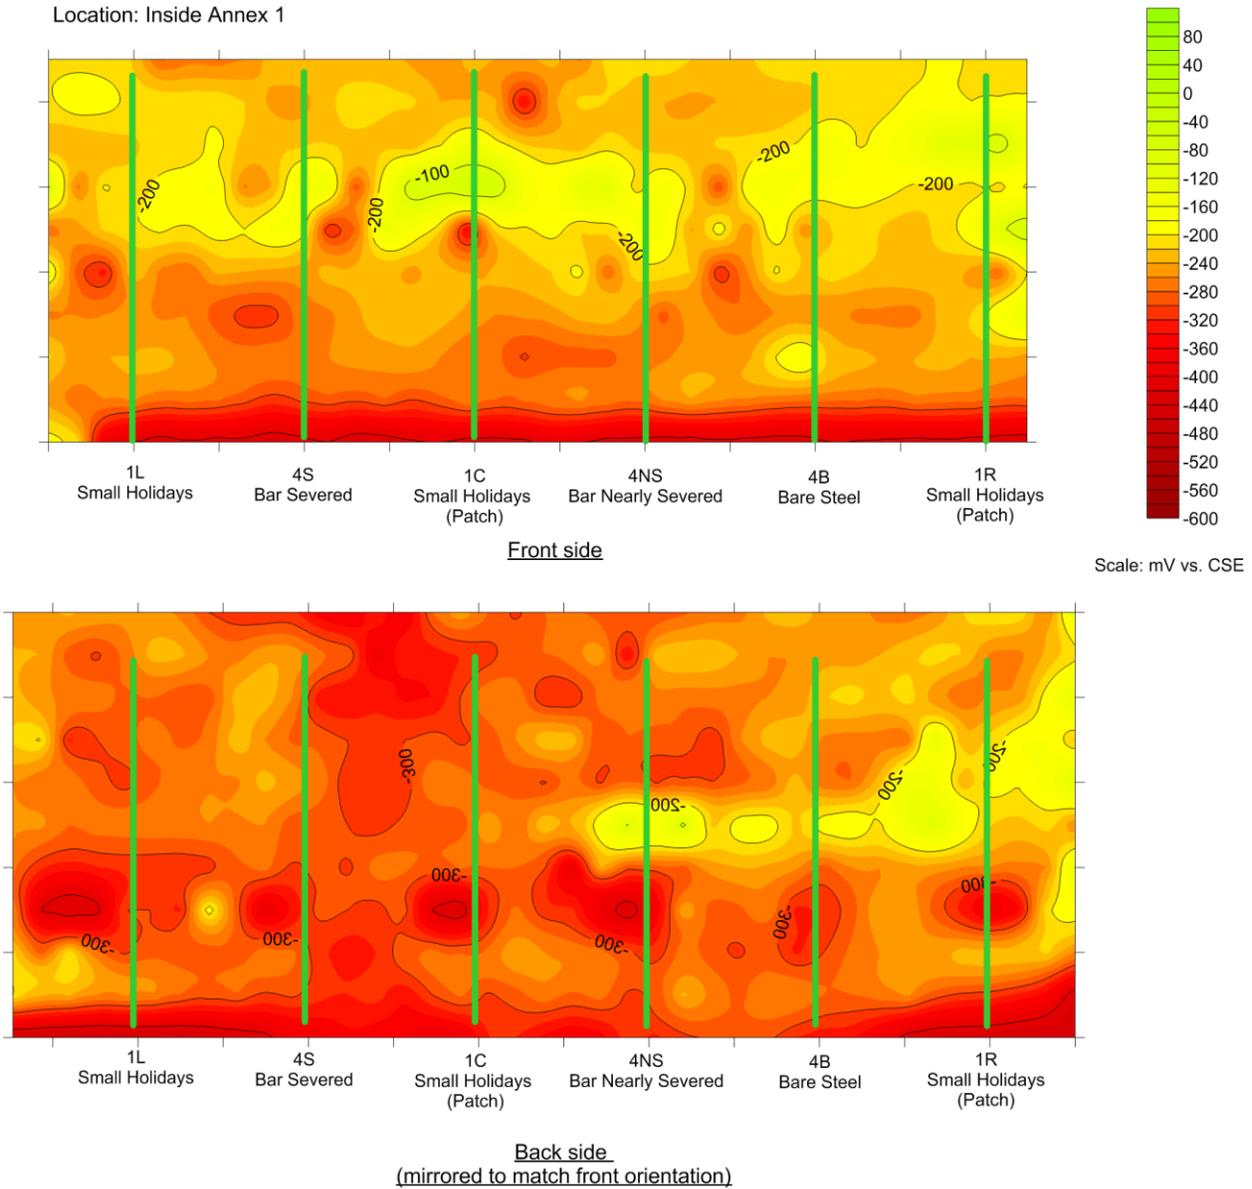
For the mock-up barrier wall sample, half-cell potentials contours of the front and back sides are shown in Figure 96 with all bars being electrically connected to the half-cell. At the time measurements were taken, the concrete had been allowed to dry in ambient indoor conditions for a number of months. Overall, the plots show electronegative areas near the base of the wall (along the construction joint) where saltwater was ponded. These negative potentials may be indicative of corrosion occurring in the bars along that zone. No distinction could be identified between the different types of damage of the bars in the contour maps.

Figure 96. Half-cell potential contours of the barrier wall mock-up. Locations of embedded bars and their intentional defects are overlaid on the plots.
