NONDESTRUCTIVE EVALUATION AND ASSESSMENT OF CONCRETE BARRIERS FOR DEFECTS AND CORROSION

Final Report

November 15, 2013

WJE No. 2006.5773 (Iowa DOT, Project Number BARR-010)

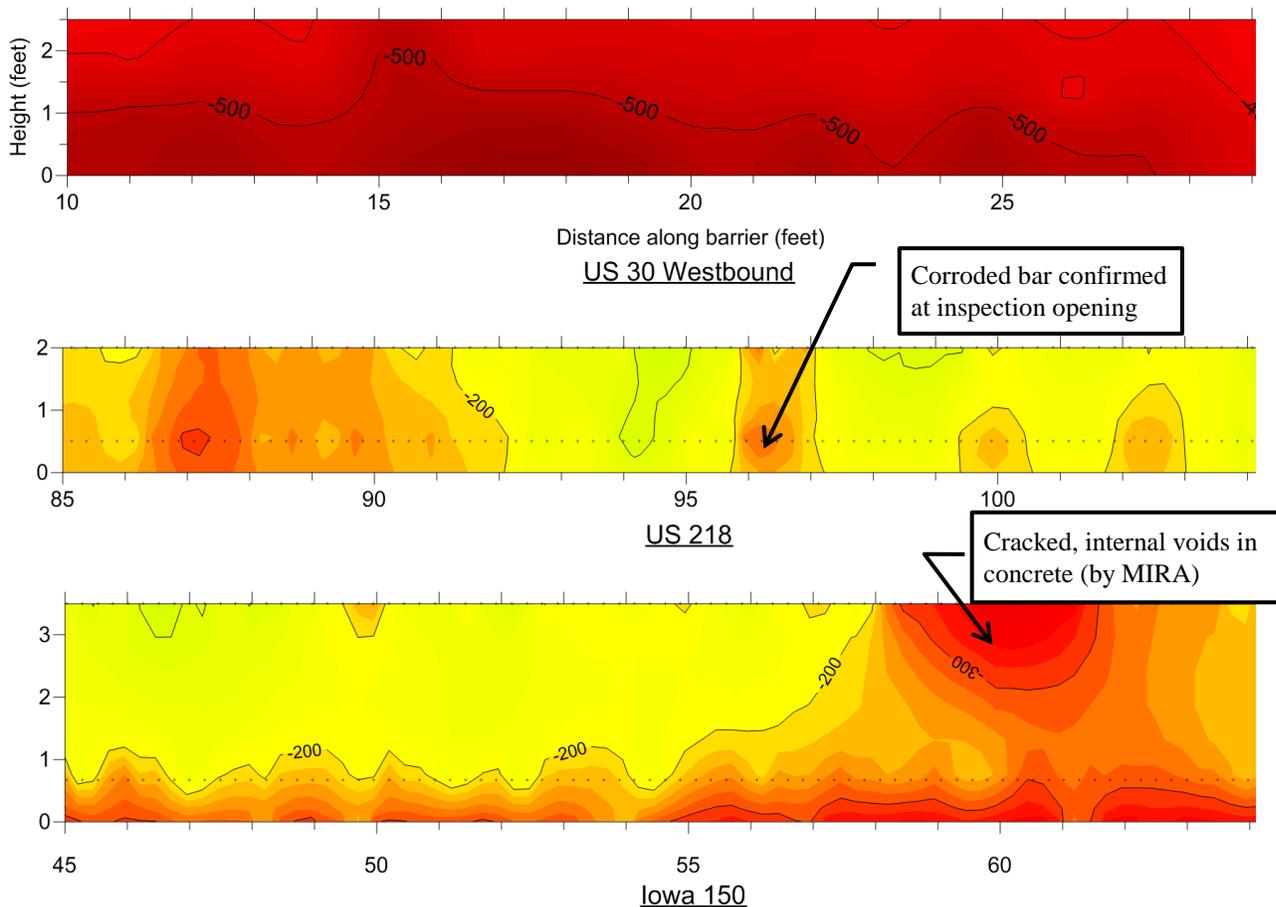
Results of the field testing, as shown in Figure 97, varied widely between the three bridges. For US 30, the epoxy-coating on the bars appeared to result in more negative potentials. This may reflect that the bars in the barrier wall were not well electrically connected. For the two bridges with uncoated bars (US 218 and Iowa 150), the contour plots show both anodic (more negative) and cathodic (more positive) zones along the length of the wall. The concrete electrical resistivity varied along the length of the barriers and ranged from about 45 k-ohms to 445 k-ohms. Areas of low resistivity are indicative of water or deicer saturated areas that would be more prone to corrosive conditions. As indicated in the figure, an inspection opening performed on US 218 located a corroding bar at one of the anodic zones on the plot. The half-cell survey results shown for Iowa 150 were collected at the same location as the shear wave tomography scan shown in Figure 54. The location of internal flaws identified by shear wave tomography correlated with an anodic region. This may indicate that the internal flaws have resulted in faster penetration of chloride and subsequent reinforcing steel corrosion. The half-cell potential technique was able to identify active corrosion of dowel bars in barriers having black reinforcing steel. However, barriers having epoxy-coated reinforcing did not show significant distinctions in corrosion activity.

Figure 97. Selected portions of half-cell potential contour plots from field trials at three bridge barrier walls. All plots are from the front side of the barriers. Note that US 30 had epoxy-coated bars, but US 218 and Iowa 150 had uncoated bars. All maps are plotted with the same scale. The location selected for Iowa 150 is the same section shown for the MIRA results in Figure 54.

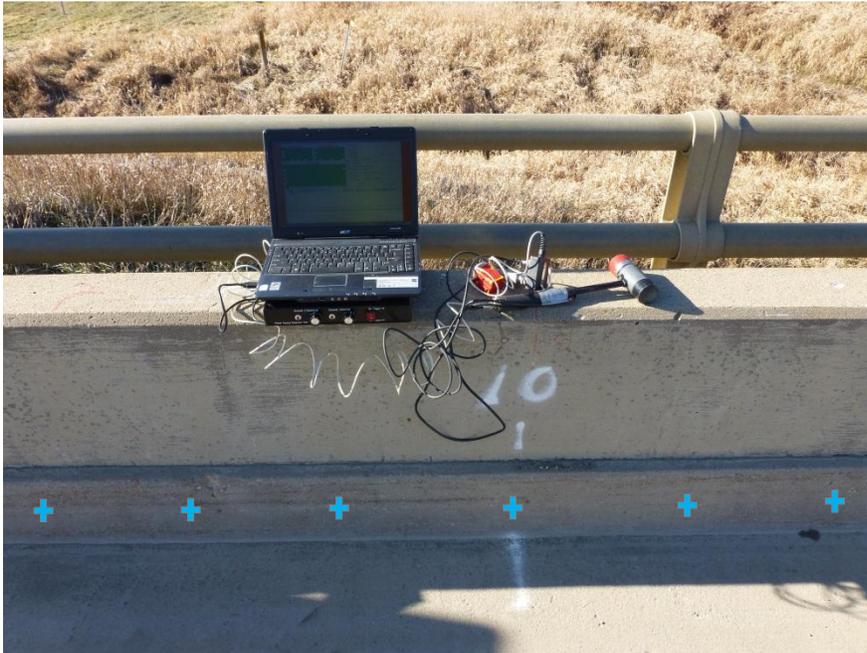
Impulse-response testing performed on the southbound barrier of US 218 provided a more useful assessment of the testing method. Testing was performed laterally at 131 test locations along the base of the barrier wall. Although testing requires individual tests to be performed at each location, data collection was relatively fast and the entire length of the barrier was evaluated in less than 1 hour. Average mobility was found to be the most appropriate component calculation for evaluation of corrosion-related dowel deterioration. A plot of average mobility along the length of the barrier wall is shown in Figure 99. There were several locations where average mobility readings were elevated, indicating that the lateral response of the barrier wall from the imparted impact was higher and may indicate damaged or severed dowels. An inspection opening was made at the peak measured response at test location 75. The dowel exposed at this location was moderately corroded with some section loss observed. Note that surface conditions at the joint were not visible, and additional inspection openings were difficult at this barrier due to the recessed joint design and presence of a deck overlay. More testing and correlation is required to determine the extent and severity of corrosion-related damage in the dowels necessary to be detectable by the impulse-response method for various barrier wall designs.

Figure 98. View of the interior face of the southbound barrier wall of US 218, the s'MASH impulse response system, and the approximate impulse-response test locations.

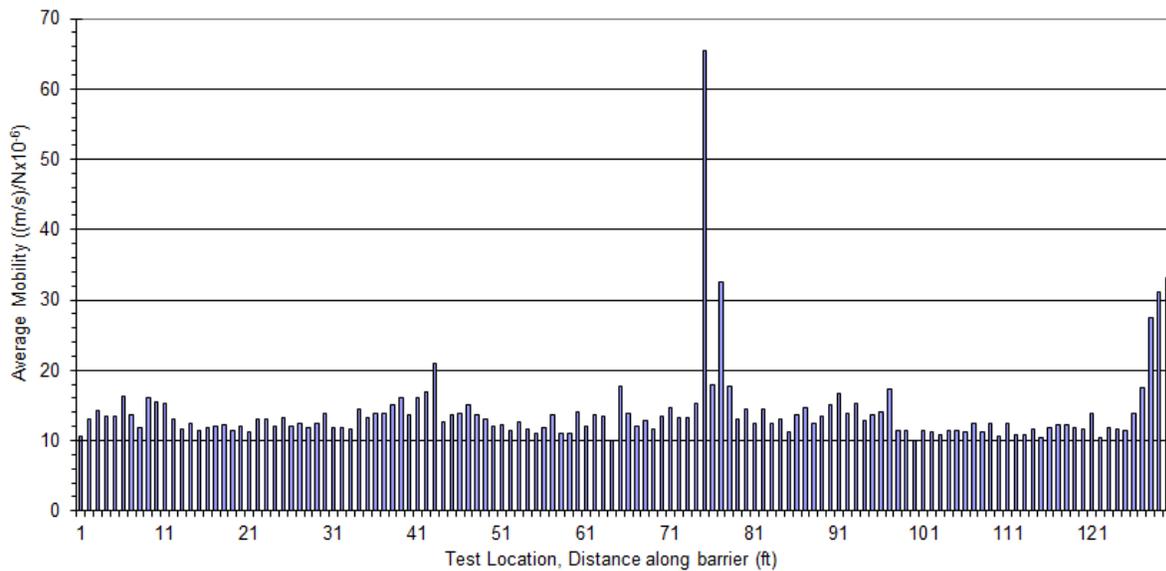
Figure 99. Plot of average mobility obtained from impulse-response testing along the length of the southbound barrier wall of US 218.
