# Evaluation of Unbonded Ultrathin Whitetopping of Brick Streets

Construction Report  
August 2002

Iowa DOT Project TR-466  
CTRE Project 01-91

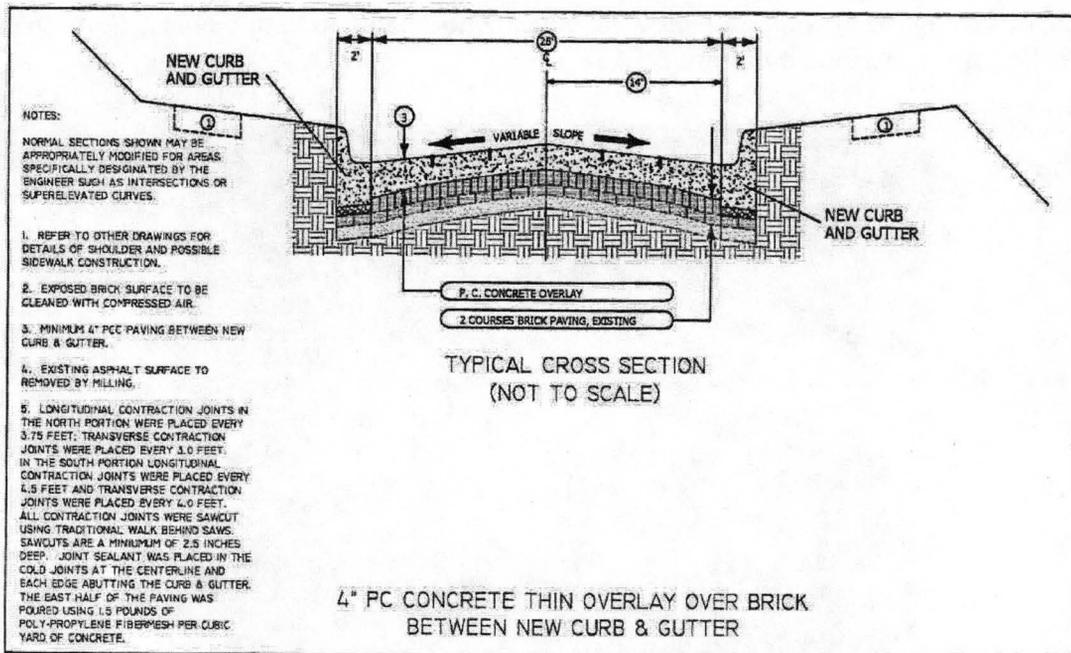
Figure 4. Design Cross Section

The original pavement construction cross section and the overlay cross section are shown in Figure 4. This figure, from the construction plans, illustrates the various layers of sand, brick, and portland cement concrete overlay.
