A CONTINUOUS SPAN ALUMINUM GIRDER CONCRETE DECK BRIDGE

PART 2 OF 2:
FATIGUE TESTS OF ALUMINUM GIRDERS

FATIGUE TESTS OF ALUMINUM GIRDERS

May 1997

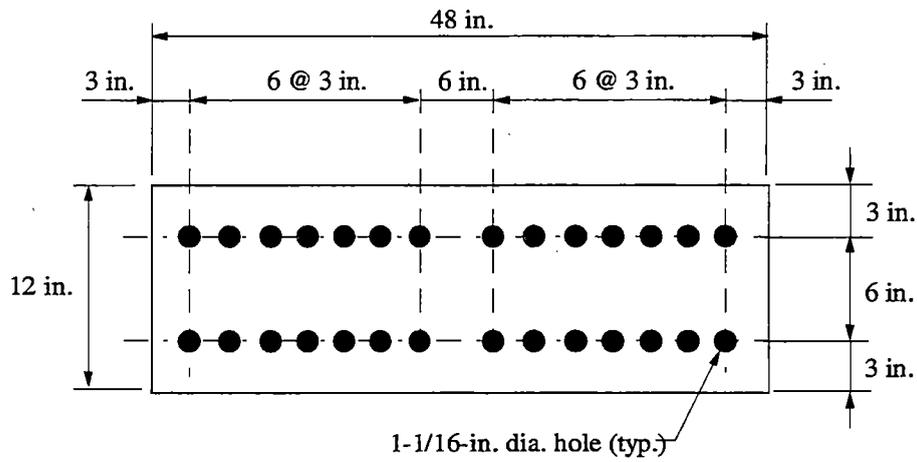
Figure 2.15. Cover-plate repair detail no. 1

Figures 2.15 and 2.16 show the structural steel plates that were used to reinforce a specimen that experienced a fatigue fracture at a new, bottom flange, cover plate and/or at the original, midspan bottom flange splice in a long girder specimen. The cover-plate, repair detail no. 2 shown in Fig. 2.16 was used only once, as a bottom flange reinforcing plate, after fatigue fractures at both the new, bottom flange cover plate no. 2 and original, midspan, bottom flange splice had occurred in the long, exterior girder specimen no. 1. This long repair plate was used in an attempt to reinforce this girder specimen at both locations, so that a fatigue fracture at the new, bottom flange, cover plate no. 1 might be developed. However, due to the high-load magnitudes and the length of this repair detail, the original fatigue fractures continued to propagate. Therefore, this long reinforcing plate was not an effective strengthening method. Figure 2.17 shows a double-angle, web plate reinforcement that was placed horizontally on the web plate of a specimen to prevent a web plate, fatigue crack from occurring or to stop the propagation of an existing, web plate, fatigue crack. The bolts used for these repair details were 1-in. diameter, A325 bolts with hardened nuts and washers. The turn-of-the-nut method was implemented to properly tension the bolts.

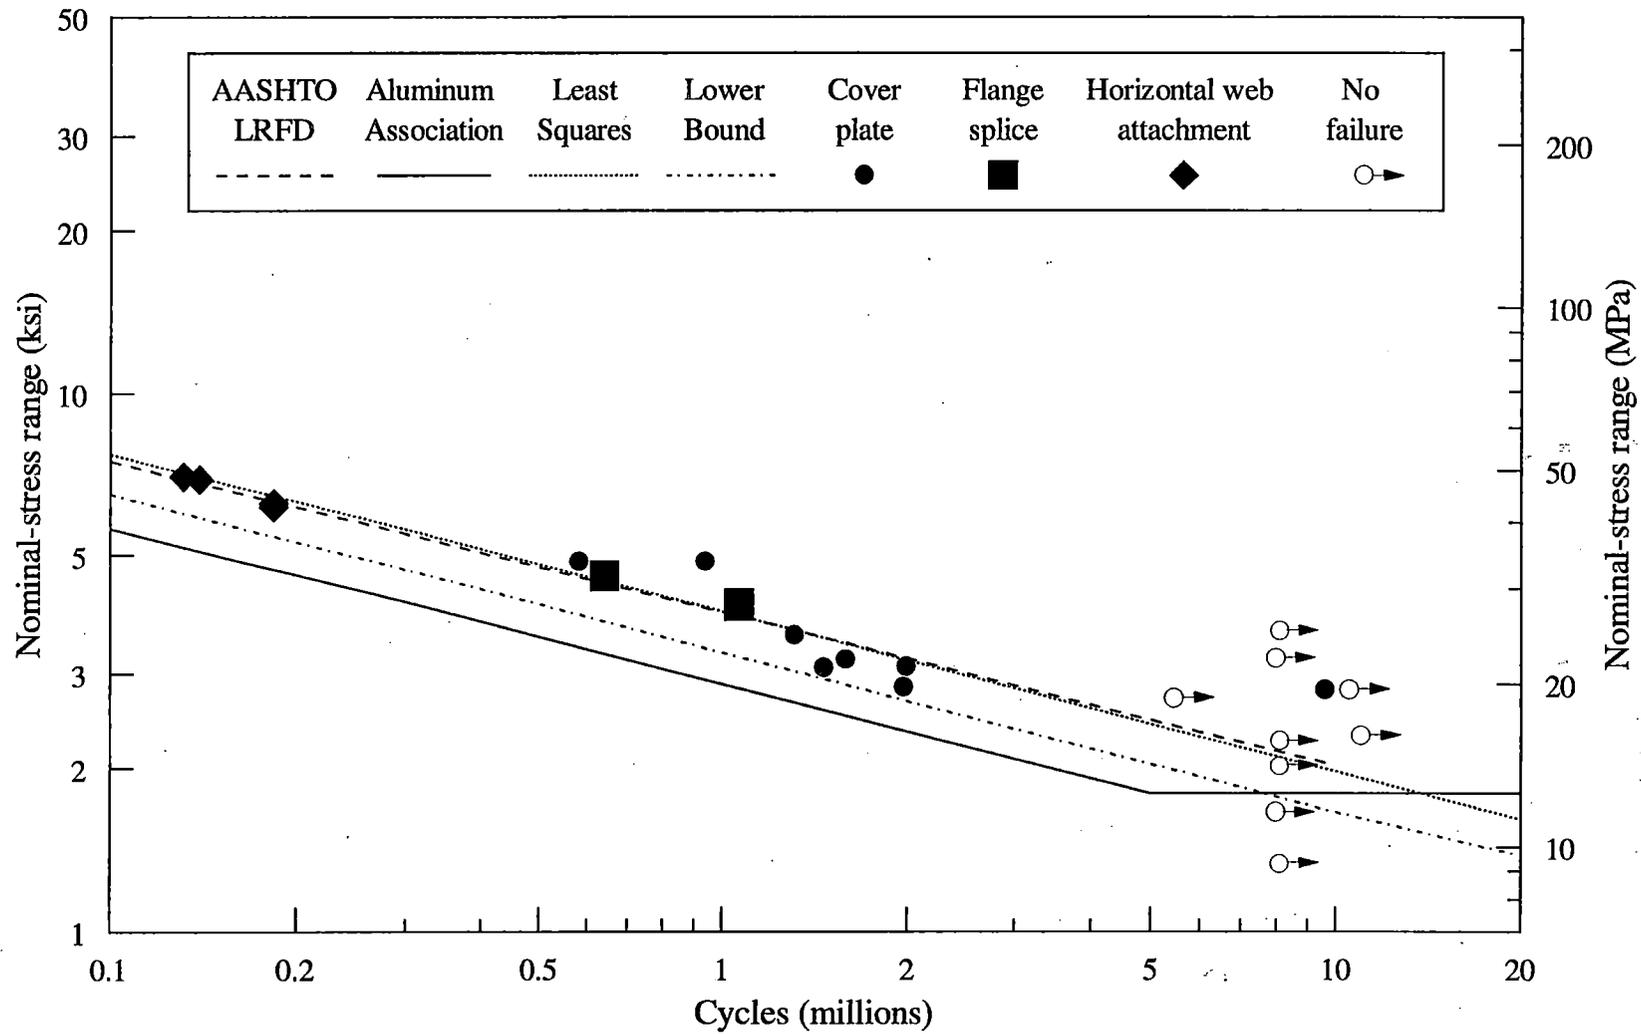
Figure 3.14. Nominal SN-curves for Category E details

The information given in Tables 3.7 and 3.8 was used to develop two stress-range versus load-cycle relationships (SN-relationships) for the girder specimens. The first SN-relationship that involved the nominal-stress ranges is shown in Fig. 3.14, and the second SN-relationship that involved the experimental-stress ranges is shown in Fig. 3.15. As discussed in Chapter 2, nominal SN-curves are normally used to present fatigue strength relationships. The stress-range and load-cycle data points were plotted on graphs that have logarithmic scales for both axes. The original, bottom flange, splice fractures are shown as solid squares; the new, bottom flange, cover plate fractures are shown as solid circles; and the new, horizontal, web plate fractures are shown as solid diamonds in these figures. The Category E weld details that did not experience a fatigue fracture are shown in Figs. 3.14 and 3.15 as hollow circles with an arrow pointing towards the right, indicating that any potential fatigue fracture for these weld details may occur at a number of load cycles greater than that shown by the data point.

The data for the specimens that experienced a constant-amplitude, cyclic-load, fatigue fracture were statistically analyzed to establish the least-squares-regression line and the lower-bound-strength line shown in Figs. 3.14 and 3.15. A least-squares-regression line, which represents a 50% chance of survival against a fatigue fracture, was obtained by applying a least-squares-linear regression analysis using the Power Regression Method [13] to the fracture data points. A lower-bound-strength line, which is two standard deviations below the least-squares regression line, represents a 95% confidence that 97.5% of the fatigue fractures will occur at stress ranges equal to

or greater than the stress-range levels associated with this line. None of the SN-data points for the fatigue fractures experienced by the test specimens in this research occurred beneath the lower-bound-strength line.

where, $(\Delta F)_n$ = nominal-stress-range fatigue resistance, C_1 and C_2 are linear-regression-analysis constants associated with a particular weld detail category (for Category E detail weldments: $C_1 = 36.0 \times 10^8$ and $C_2 = 0.237$), N = number of constant-amplitude load-cycles, and $(\Delta F)_{th}$ = constant-amplitude fatigue threshold. For Category E detail weldments, $(\Delta F)_{th} = 2.0$ ksi at 10-million load cycles. Figure 3.14 shows that the least-squares-regression line nearly coincides with the AASHTO-LRFD specification line. The experimental-stress-range, least-squares-regression line shown in Fig. 3.15 is lower than the AASHTO-LRFD specification line.

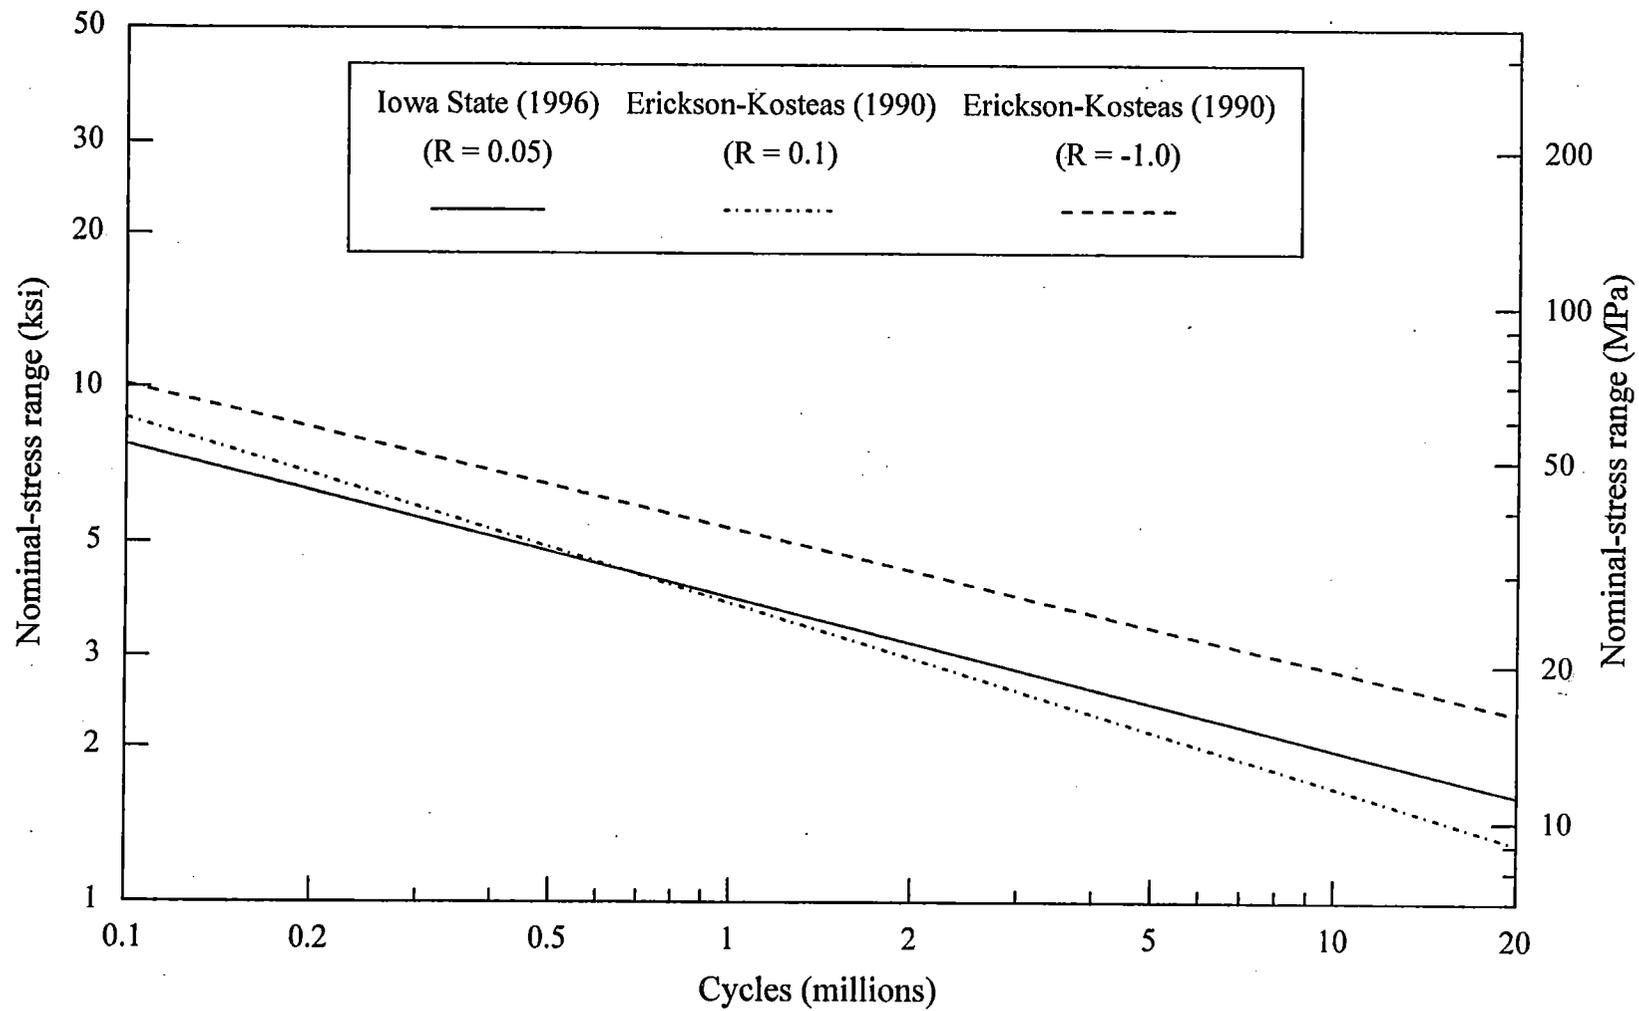
Figure 3.16. SN-curves for transverse-fillet welds on full-size specimens

The least-squares, linear-regression lines that were developed from this study and from an investigation of only large-size, Category E weld details (cover-plate fatigue fractures) by Erickson and Kosteas [19] are shown in Fig. 3.16. In their comparison of large and small-size specimens involving transverse, fillet-welds, Erickson and Kosteas noticed a significant reduction in the fatigue strength as the size of the weldment increased. Each linear-regression line corresponds to fatigue tests that were conducted at a specific stress ratio, R . Although some researchers [21,24,34] note that the stress ratio does not have a significant influence on the fatigue life of a structural steel weldment, Erickson and Kosteas [19] and Tomlinson and Wood [55] have stated that the stress ratio affects fatigue life of aluminum weldments. The influence of the stress ratio on fatigue life has not been included in 1994 edition of the Aluminum Association [8] fatigue provisions.

Figure 3.16 shows that the linear-regression line for $R = -1.0$ (full-strain reversal) is significantly higher than the linear-regression lines for $R = 0.05$ and $R = 0.1$. When a full-strain reversal exists, the stress range required to induce a fatigue fracture at a weldment for a specific number of load cycles is larger than that for any other stress ratio. This fact can be explained by realizing that fatigue damage occurs from repetitive tensile strains and that for a full-stress reversal,

the compressive portion of the stress range is the same as that for the tensile portion. Therefore, the peak-tensile strain for a negative stress-ratio condition is lower than that for a positive stress-ratio condition. Figure 3.16 shows that the least-squares, linear-regression line for this study, in which $R = 0.05$, is close to the least-squares, linear-regression line by Erickson and Kosteas [19] with $R = 0.1$. The use of similar specimens, weld details, and loading methods attributed to the development of similar SN-curves. The small difference in the two positive stress ratios that existed between the two test programs should not have significantly alter the fatigue behavior of a specimen.

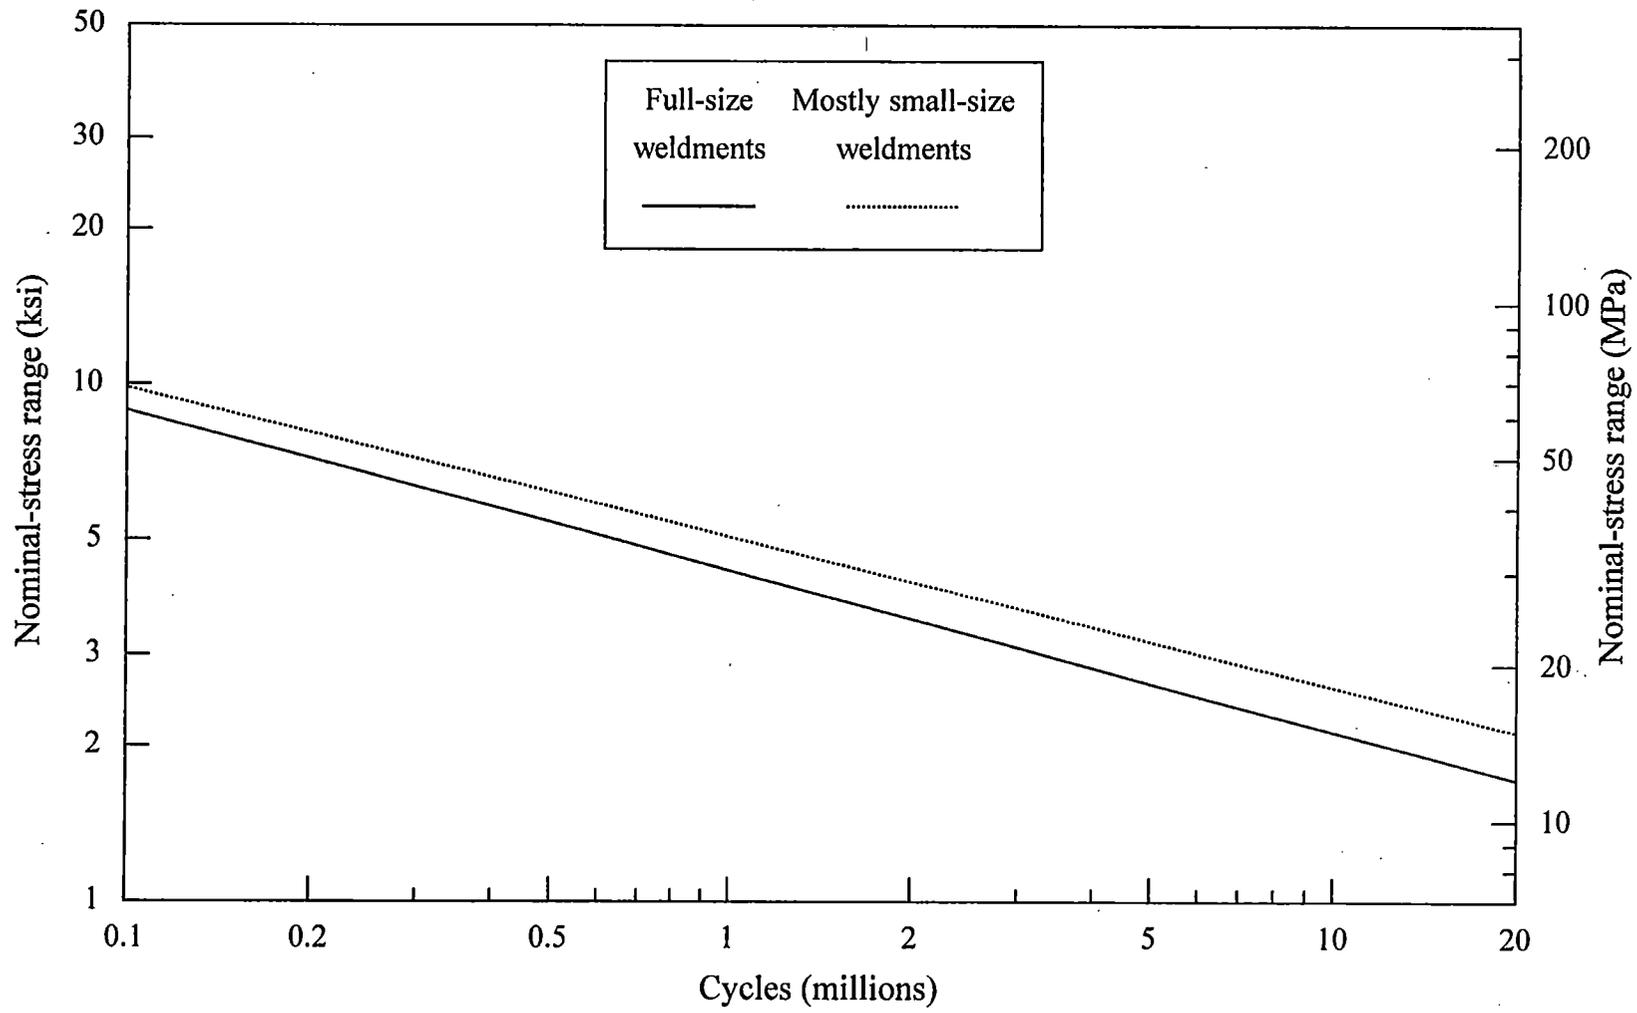
Figure 3.17. SN-curves for small and full-size Category E weldments (R varies)

In an attempt to investigate the effects of the size of Category E weld details on their fatigue fracture strength, the fracture results from the ISU, full-size specimens with $R = 0.05$ were combined with the fracture results from the tests by Erickson and Kosteas for their full-size weldments with $R = 0.1$ and -1.0 . These data points were statistically analyzed through a least-squares, linear-regression analysis to obtain a single, linear-regression line for full-size weldments that does not consider the influence of the stress-ratio on the fatigue strength of a specimen. This regression line is shown as the solid line in Fig. 3.17. A data set of fatigue fractures for mostly small-sized, Category E weld details was gathered by representatives of the Aluminum Association from the fatigue test programs of other researchers. These fatigue fractures involved both small-size and full-size weldments; however, the vast majority of those previous tests were conducted using small-size specimens. A linear-regression analysis of these fatigue fracture, SN-data points produced the linear-regression line that is shown as the dotted line in Fig. 3.17. The regression line for the mostly small-size weldments was above the regression line for the full-size weldments; therefore, the scale of an aluminum weldment initially appears to have an influence on the fatigue strength of a structural member. However, these results are not conclusive because the effect of different stress ratios on fatigue strength has not been eliminated. Both regression lines shown in Fig. 3.17 involved a

mixture of test specimens with different stress ratios. One conclusion can be made from an observation of Fig. 3.17. The slopes of the two linear-regression lines are essentially equal. Additional research involving the fatigue strength of Category E weld details should be conducted to isolate the independent effects of the size of a weldment and the stress ratio.

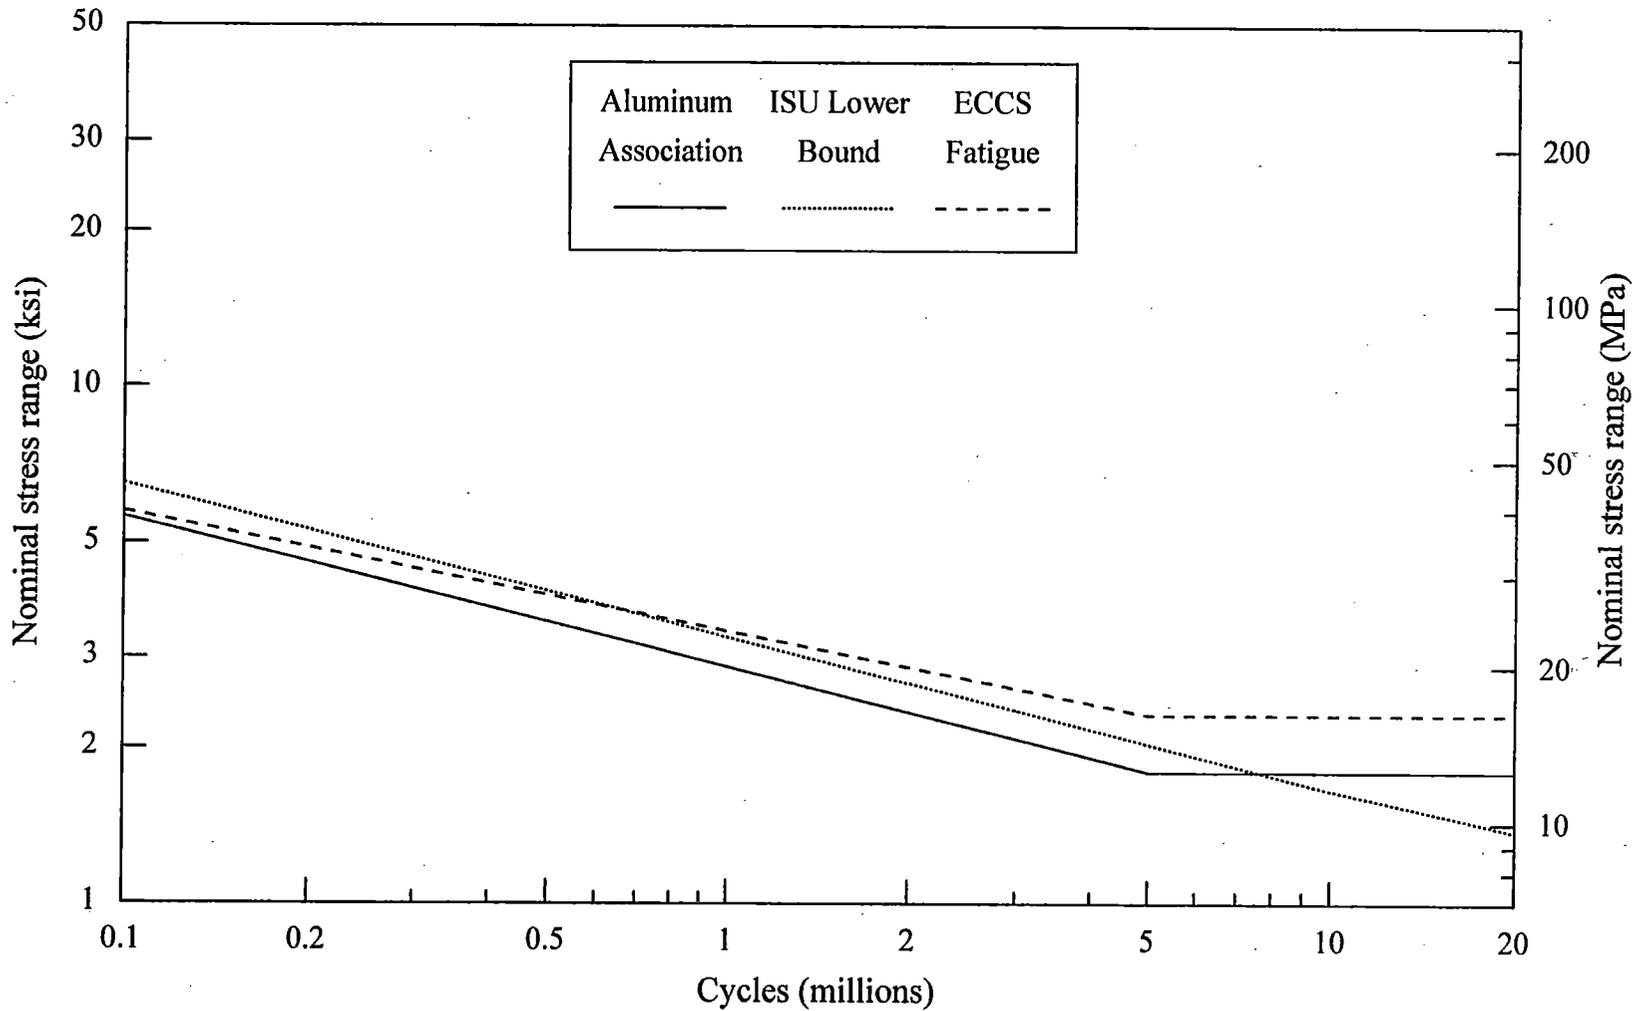
Figure 3.18. Aluminum Association and ECCS SN-Curves for Category E details

The European Recommendations for Aluminum Alloy Structures (ERAAS) Fatigue Design [20] developed by the European Convention for Constructional Steelwork (ECCS) are similar to the most recent Aluminum Association fatigue provisions [8]. The ECCS structural detail with an F3-Classification is designated as a Category E weld detail by the Aluminum Association. The SN-curve for the ECCS-F3-Classification is also defined by Eq. (3.4), where for an F3-Classification, $A = 574.9$ MPa (83.4 ksi) and $m = 4.32$ MPa (also 4.32 ksi). A constant-amplitude, nominal-stress-range threshold of 16.2 MPa (2.35 ksi) is assumed to exist at 5-million load cycles. Figure 3.18 shows that the SN-curves for ECCS and the Aluminum Association are similar. The database that was used to generate the ERAAS fatigue design curve was not the same as that used to produce the Aluminum Association fatigue provisions, although there is some test data that was included in both databases. The Aluminum Association SN-curve is more conservative than the ECCS SN-curve.

Figure 3.18 also shows the linear-regression, lower-bound, strength line that was established at two standard deviations below the least-squares, linear-regression line for the Category E weld details tested in the ISU research. This lower-bound, strength line is slightly above and nearly parallel to the sloping portion of the Aluminum Association SN-curve, and it crosses the ECCS SN-curve at approximately 700,000 cycles. The fatigue testing conducted during this ISU study did not establish an endurance limit due to the lack of a sufficient number of weld fractures beyond 5-million load cycles. Although slight differences occurred between the lower-bound strength line

generated from this ISU study and the Aluminum Association and ECCS SN-curves, the differences are believed to be attributed to the different fatigue-strength data sets that were used to establish the individual SN-curves.
