Development of In-Situ Detection Methods for Materials-Related Distress (MRD) in Concrete Pavements

Phase 1 Report
July 2003

CTRE Project 00-96

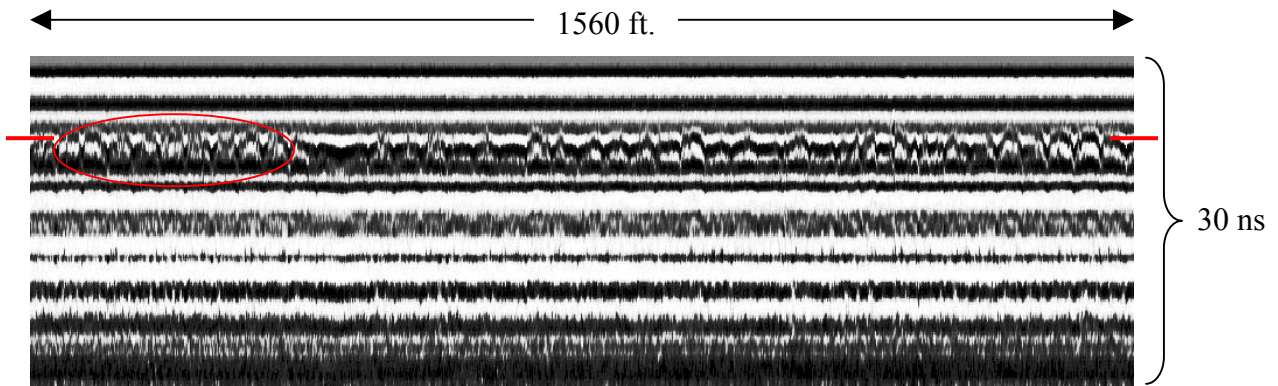
Figure 15. GPR Data from US 63 Southbound (900 MHz antenna)

The GPR survey conducted by MGPS, Inc., was about a half-mile in length. The data were collected while moving at about 50 mph. Several interesting response characteristics were noted in the GPR data that were collected from US 63 southbound. The most interesting was the phase change that alternates with a varying response magnitude at the expected location of the concrete-subgrade interface (see Figures 15 and 16). A red hash mark indicates the time that corresponds to the expected depth of the concrete-subgrade interface in the Figure 15 response. The red oval that is located at the corresponding depth highlights a response to the boundary between the concrete and subgrade that alternates phase very frequently in the direction of the data collection. This appears to be indicative of moisture gradients and/or variable support beneath the pavement. These anomaly responses are likely to be a result of either deteriorated concrete or poor support at the subgrade-concrete interface. Similar, less pronounced features are found along the length of the data presented in Figure 15. Figure 16 simply enlarges the scale of the horizontal axis and gives a better view of the region where distress was expected.

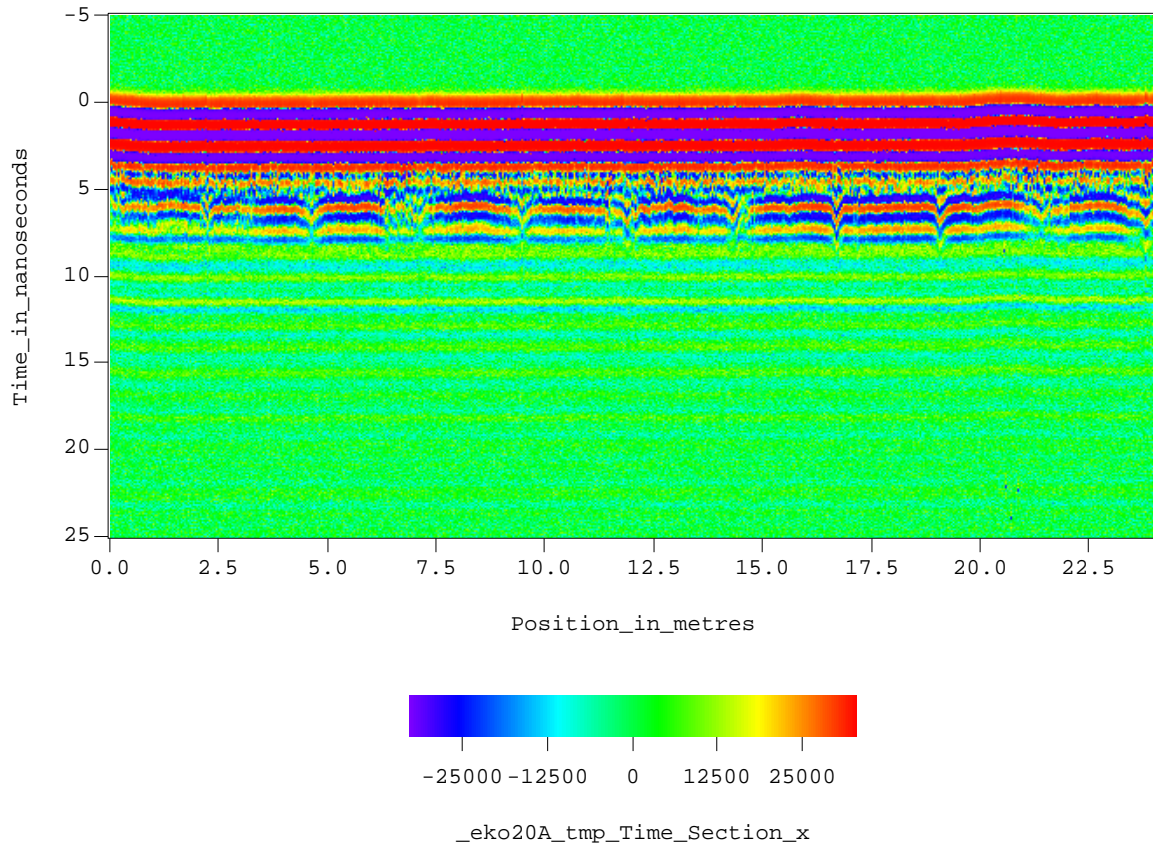
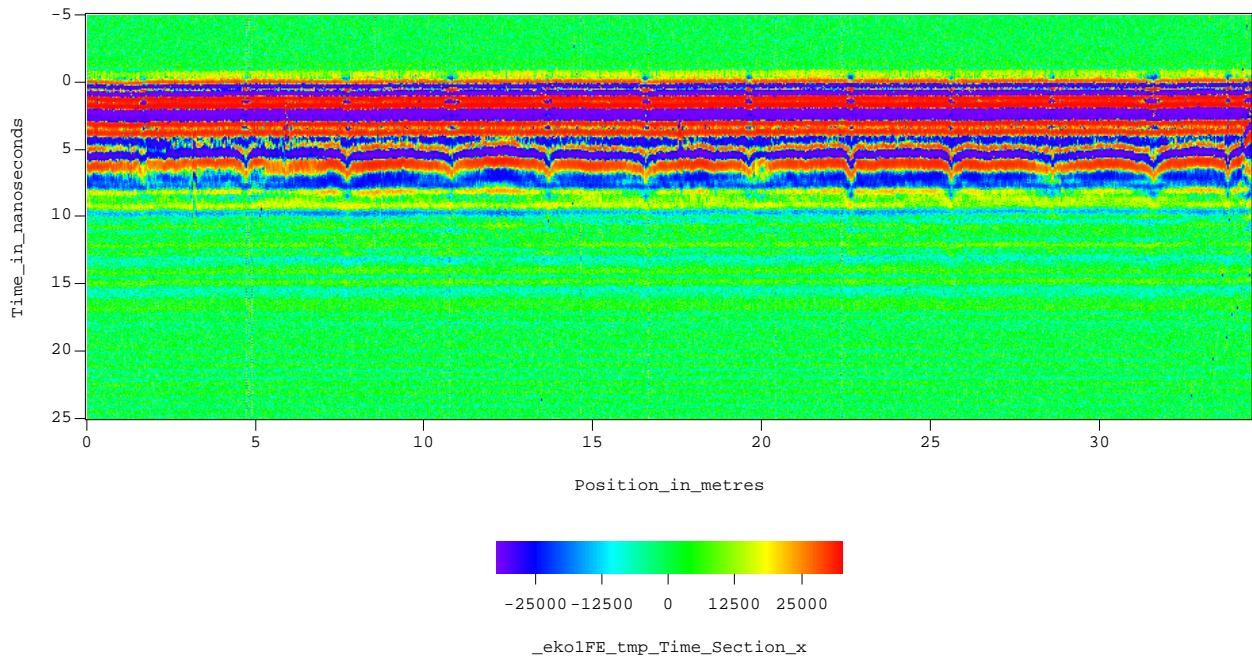
Figure 17. High-Resolution GPR Illustrating the Periodic Signal from the Base of US 63

The GPR survey conducted by ISU personnel produced information similar to that obtained from the MGPS, Inc. survey. However, the ISU survey had a length of about 100 feet (30 meters) and was collected at a maximum speed of 5 mph. The main feature noted was the periodic signal at the boundary between the subgrade and the concrete slab (see Figure 17). Previous research has indicated that this GPR signal has been observed in pavements that exhibited d-cracking at the pavement joints (41). More work is needed to see if the extent of the distress can be accurately mapped using the GPR results.

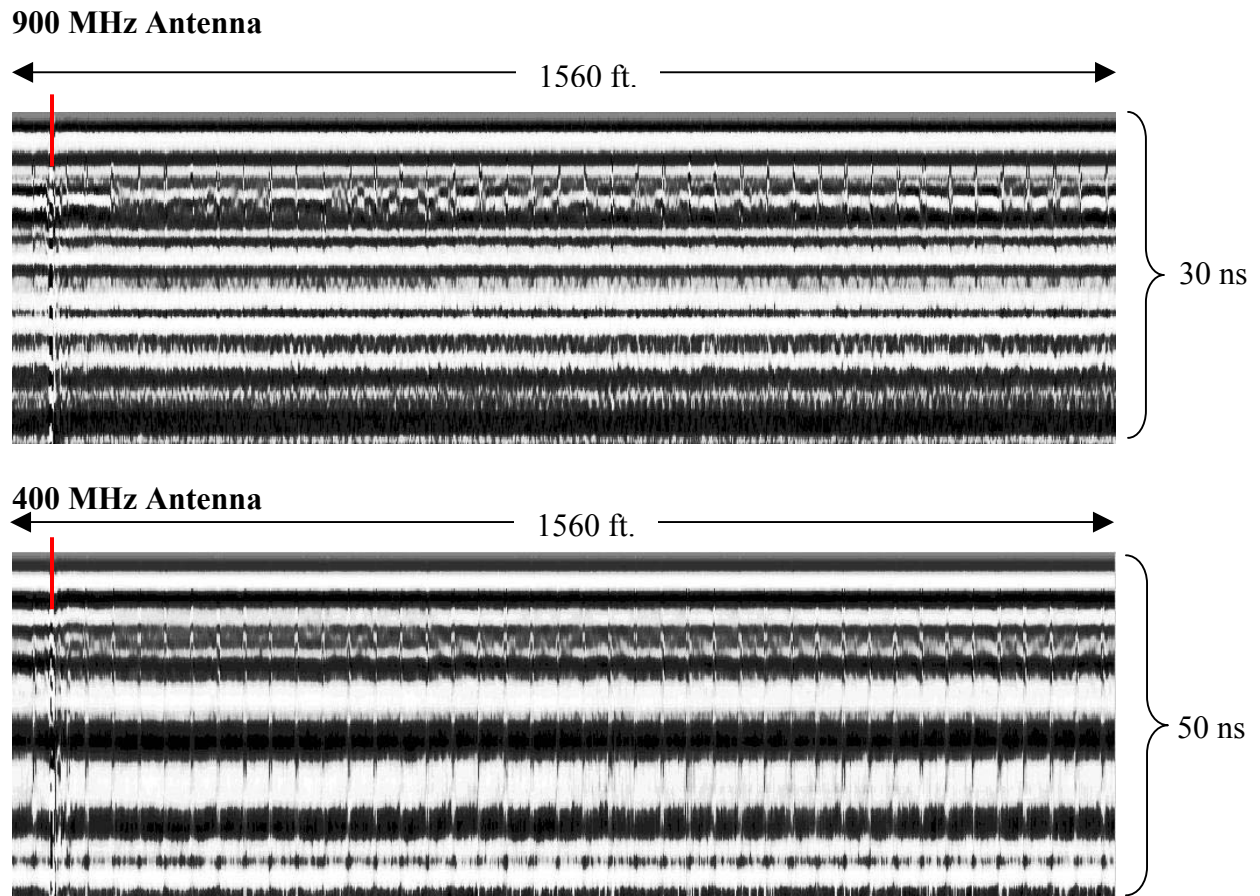
Figure 21. GPR Data from Hwy 146 Northbound

The GPR survey conducted by MGPS, Inc., was about four-tenths of a mile in length. The data was collected while moving with traffic (speed varied from about 15 to 40 mph). The responses observed in the Highway 146 data are very similar to those in the US 63 southbound data that were presented earlier. However, there are fewer observable anomalies. This is in good agreement with the distress noted in the cores. The response that appears to come from dowel chairs is found in both the 900 and 400 MHz data (see Figure 21). The vertical red hash mark denotes the beginning of the data collection; this corresponds to the location of a manhole at mile marker 20 on Highway 146.

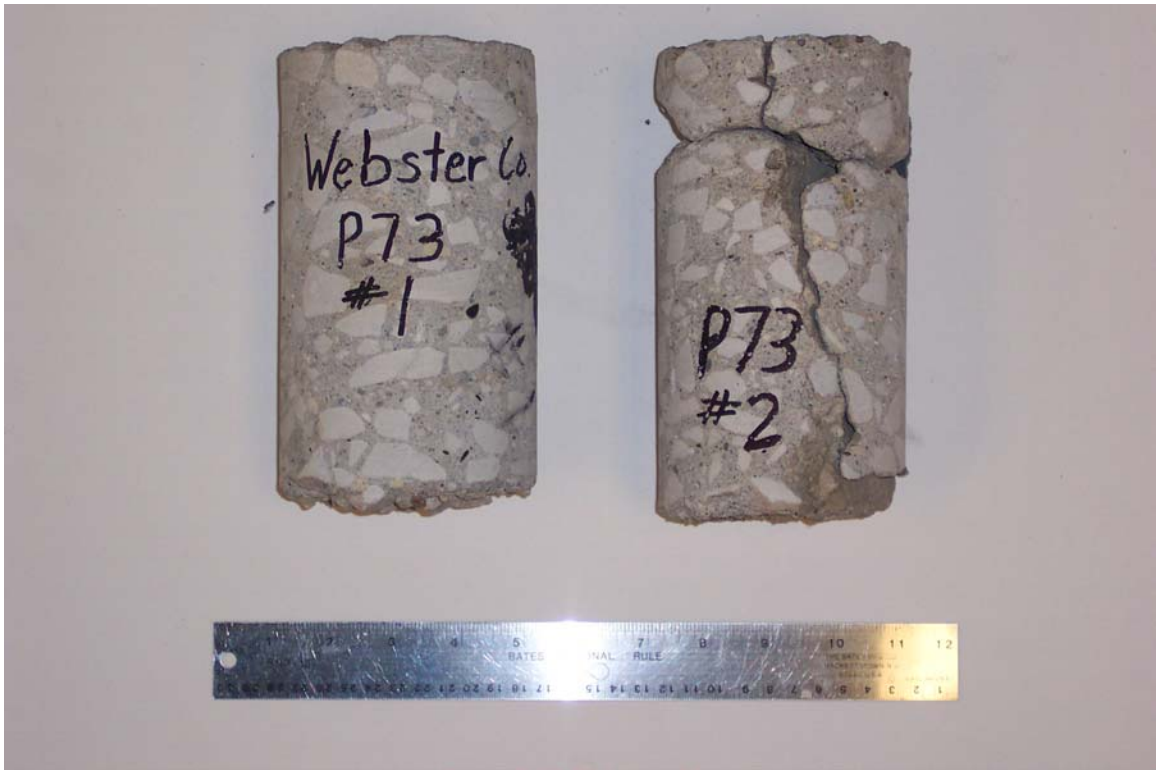
Figure 24. Cores Extracted from the P 73 Pavement

P 73 exhibits extensive cracking over most of the pavement slab. Typical cracking patterns that were observed are shown Figure 23. Cores extracted from the pavement exhibited significant cracking (see Figure 24). The core extracted from the pavement joint split into pieces during extraction. Petrographic examination of the cores indicated that the cracking was not related to the coarse or fine aggregate used in the mix (see Appendix C). Instead, the distress appeared to be concentrated in the paste fraction of the concrete.

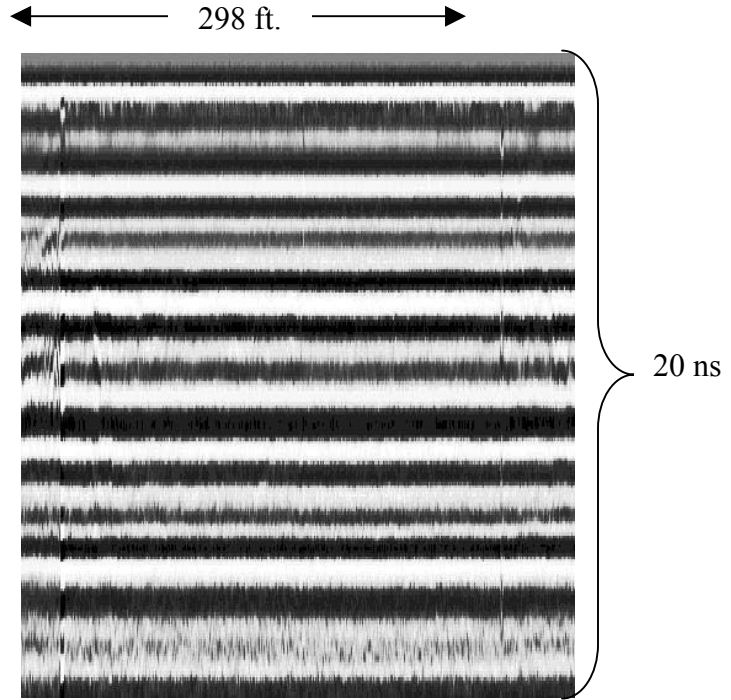
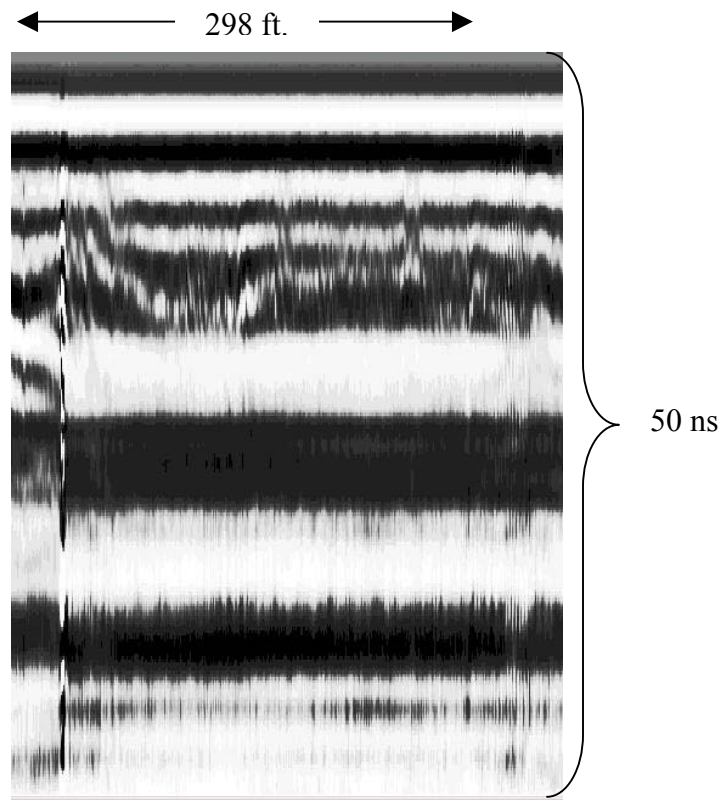
Figure 25. GPR Data from P 73, Southbound

GPR testing conducted by MGPS, Inc., traversed a short section of pavement that was 298 feet long. The data were collected while moving slowly (about 10 to 20mph). Significant cracking and subsurface distress dominates the P 73 pavement section that was surveyed. It is interesting that the response from the high frequency 1.5 GHz antenna does not appear to image this distress (since this response is flat and consistent along the length of the site, see Figure 25). However, the irregular features in the 400 MHz response indicate that the pavement subgrade may not be providing continuous support or that there may be moisture gradients beneath the surface of the pavement. The unusual radar response this concrete produced, in light of the known distress modes, indicated that the radar response may have been masked by excessive moisture in the pavement or subgrade. It is also possible that the radar equipment did not perform optimally at this site. Whatever the reason, it appears that a more thorough survey of this site will be required to properly identify the problems that exist here using GPR.

The GPR survey conducted by ISU personnel produced information in good agreement with that obtained from the MGPS, Inc., survey. The ISU survey had a length of about 75 to 150 feet (25 to 45 meters, depending on the antenna that was used) and was collected at a maximum speed of 5 mph. The typical feature noted in the test results was a flat and consistent response along the length of the survey (see Figure 26). Hence, it seems unlikely that the radar equipment did not perform adequately on two separate studies. Rather, it may not be possible to image this type of materials-related distress using GPR. Additional work will be needed to clarify why GPR does not work at this site.

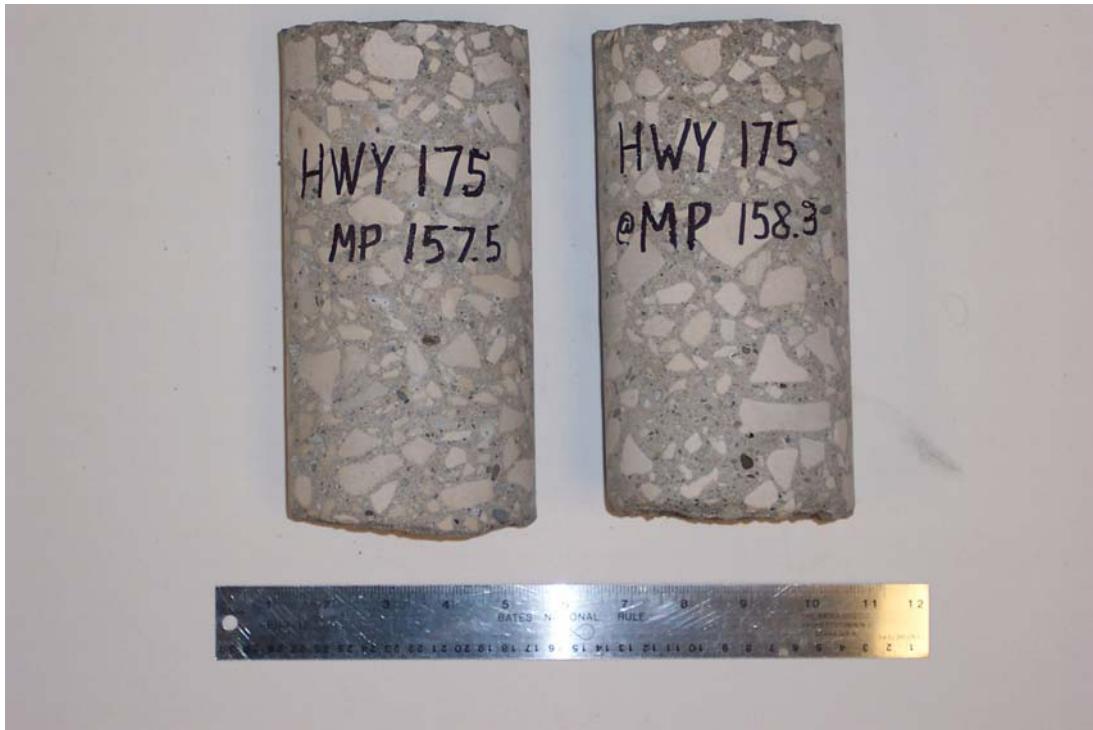
Figure 28. Typical Cores Extracted from Hwy 175 (eight cores were taken from the site)

Very few cracks were noted on the section of Highway 175 that was evaluated for this study. Some aggregates were exposed on the pavement surface due to wear; however, the depth of abrasion did not appear excessive for a road with nearly 25 years of service. Cores extracted from the pavement were intact and sound (see Figure 28). Petrographic examination of the cores indicated that some particles of fine aggregate (shale and occasionally chert) exhibited minor cracking. Also, the core from the transverse joint from the first test section (near milepost 156.2) did contain some cracked coarse aggregate particles (see Appendix D).

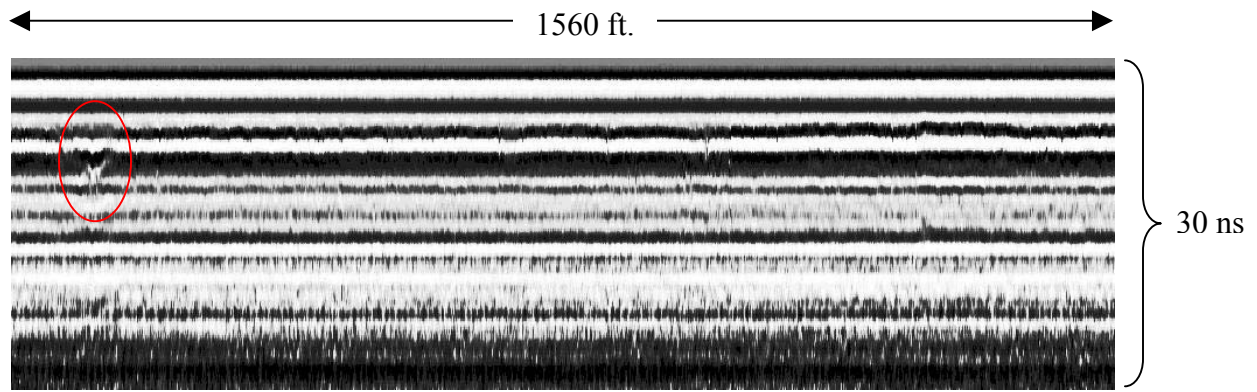
Figure 29. GPR Data from Hwy 175 Eastbound (900 MHz antenna)

GPR testing conducted over this roadway traversed nearly two miles of pavement, including three contiguous test sites. These sites were used in the study as control sections. The data were collected while moving at highway speed (about 55 mph). The radar response from all three of the antennas that were used for the GPR survey produced a flat, consistent response throughout the majority of the survey. An exception to this characteristic response occurred at the location of a drainage culvert that passes underneath the road near the western end of the site. The red encircled locations in the data presented in Figure 29 indicate the response to the drainage culvert based on the expected site location for this feature. The remaining data are essentially free from anomalies, which are representative of this site.

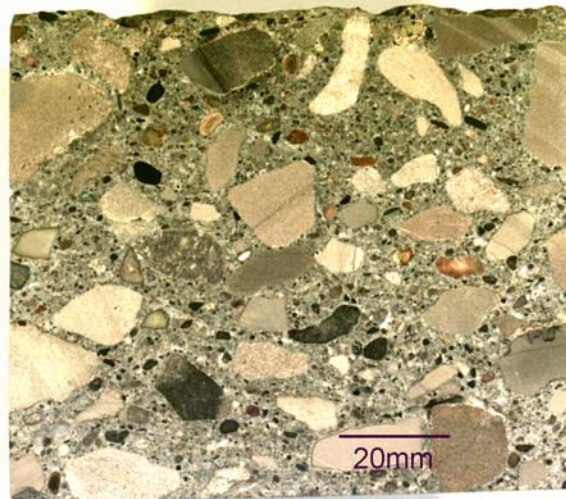
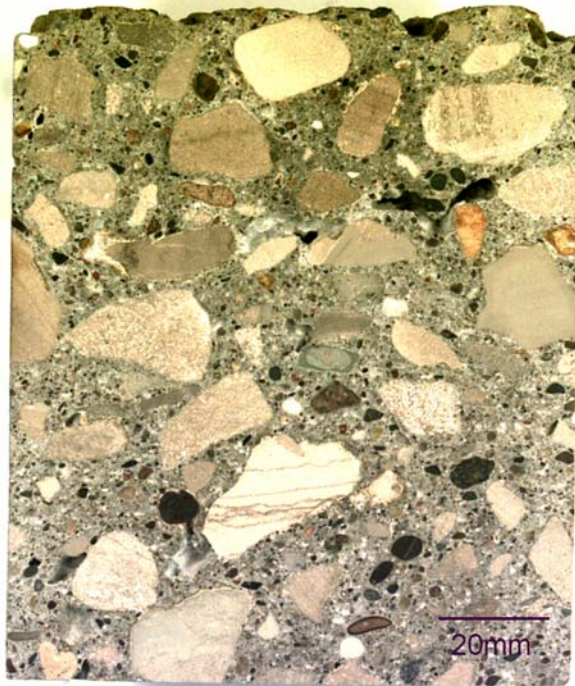
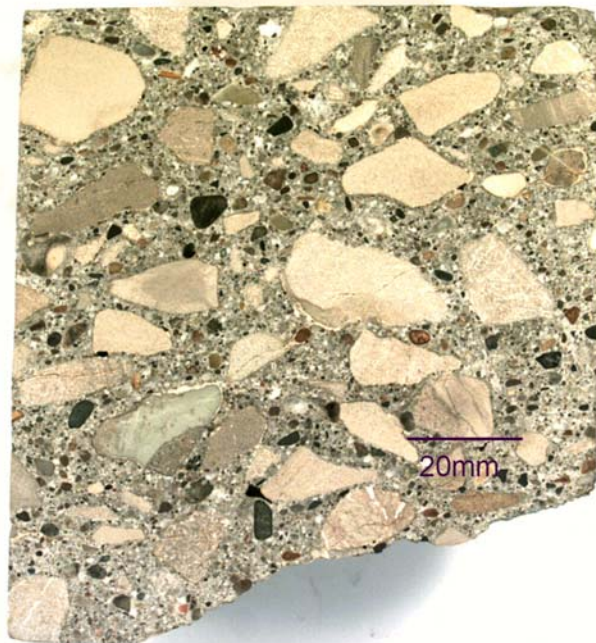
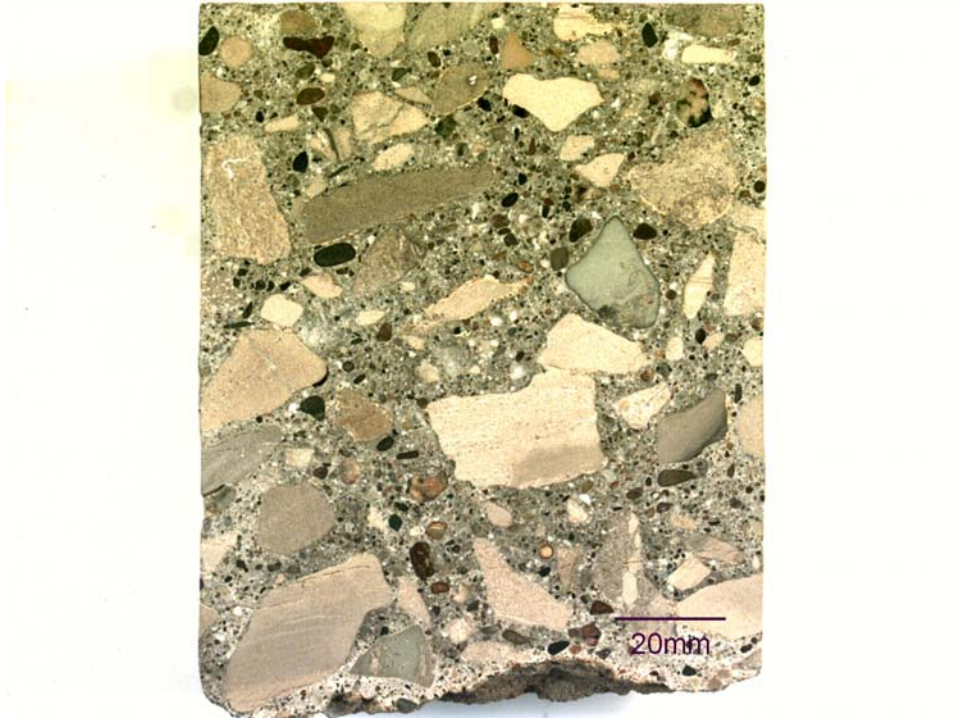
Distress was the results of fractures occurring at the base of the slab. The fractures were sub-parallel to the base. Distress was worse at the joints than the mid-panel, although the core from the mid-panel showed some distress in the form of fractured coarse aggregate particles. Fractures were seen at the paste/aggregate interface and in the interior of the aggregate particles. Some of the fractures terminated in the paste. The paste was discolored around some of the coarse aggregate particles. In the coarse aggregate particles, both coarse and fine-grained particles contained fractures. There was no indication of alkali silica reactions (ASR) or alkali carbonate reactions. The most likely cause for the distress was failure of the coarse aggregate particles, possibly due to the capillary pore system. The distress may have been magnified due to poor drainability of the subbase and possibly due to anti-icing brines leaking through the joints.

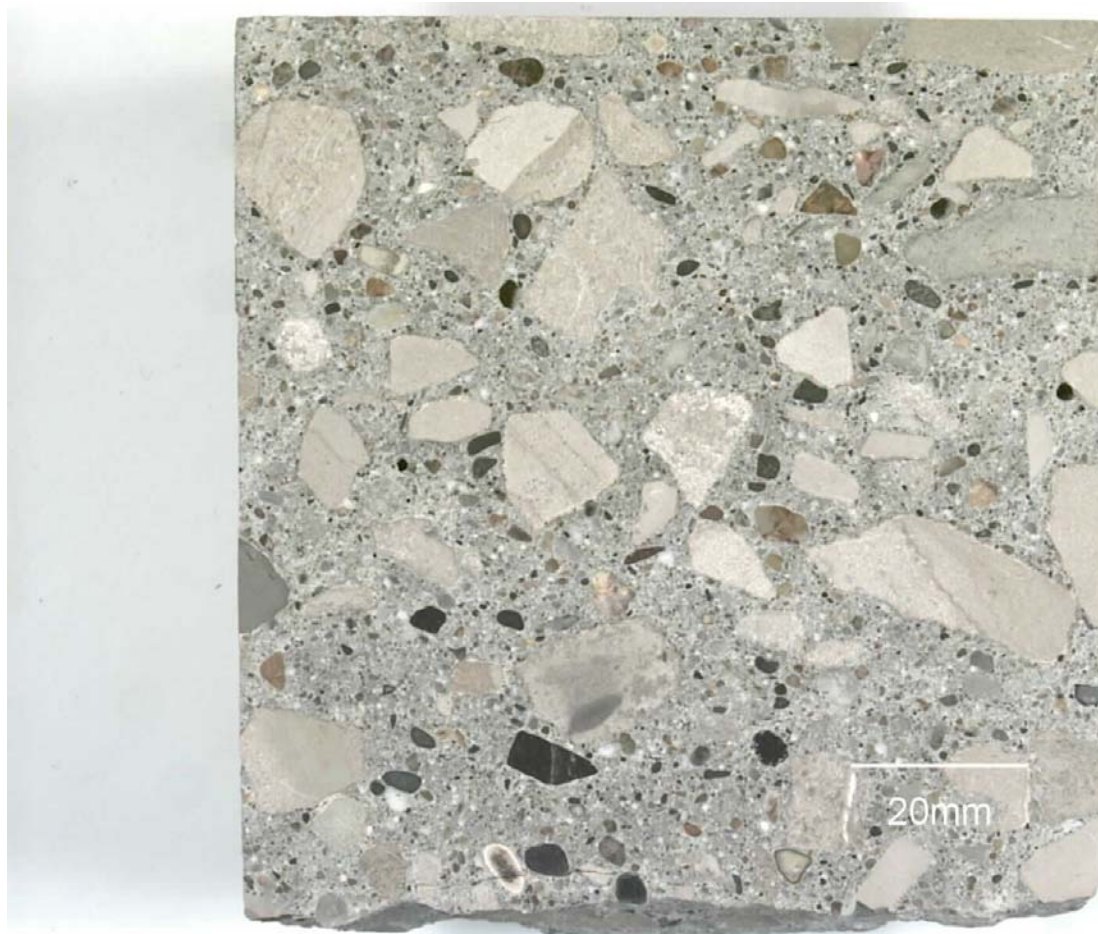
Figure B.1. Bottom of Core 3 (joint)

Distress was the result of fractures occurring at the base of the slab. The distress was very similar to that observed in US 63. The paste was discolored around some of the coarse aggregate particles. In the coarse aggregate particles, both coarse and fine-grained particles contained fractures. The most likely cause for the distress was failure of the coarse aggregate particles, possibly due to the capillary pore system.

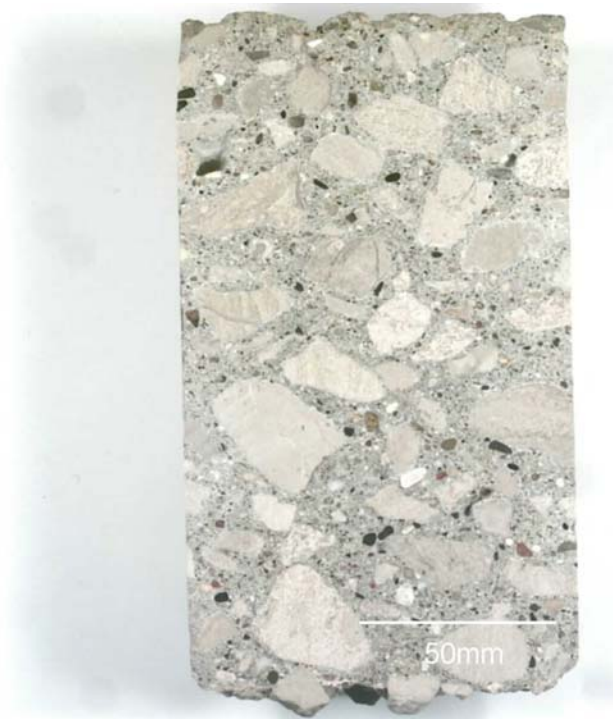
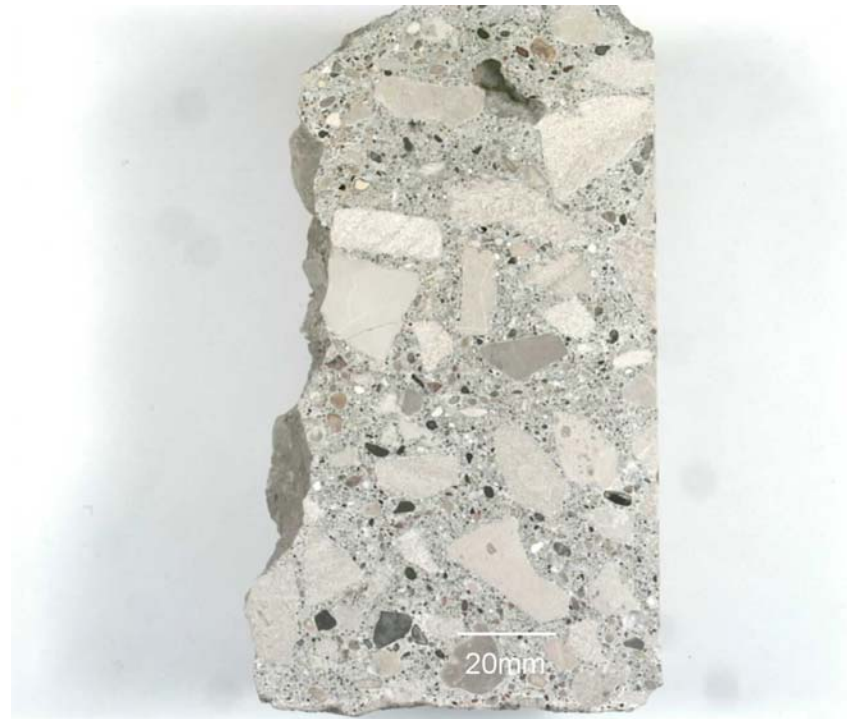
County road P73 (just north of US 20) in Webster County is badly map-cracked. Two cores were taken by Iowa DOT personal for petrographic examination. Figures C.1 and C.2 show polished cross sections of the cores. Figures C.3 through C.9 are photomicrographs showing details of fractures in both the aggregate and the paste. Several general observations can be made about the aggregate particles and fractures seen in these two cores. (1) The coarse aggregate is clastic carbonate limestone containing fossil fragments, peloids, and oolites. This is consistent with aggregate from the Gilmore City Formation (probably Fort Dodge Mine). (2) The fractures tended to be at the coarse aggregate/paste boundary (e.g., Figures C.3, C.7, C.8, and C.9). Some of these fractures may have occurred while the paste was still plastic. (3) Some of the fractures extent from the aggregate/paste interface into the paste (e.g., Figures C.4, C.7, C.8, and C.9). (4) Fractures in the aggregate tended to terminate at the aggregate paste interface and not propagate into the paste (e.g., Figures C.6, C.8, and C.9). These observations are consistent with the premature distress being related to construction problems and not aggregate or materials.

Figure C.1. Polished Cross Section of Core 1 from County Road P 73, Webster County

Figure C.2. Polished Cross Section of Core 2 from County Road P 73, Webster County

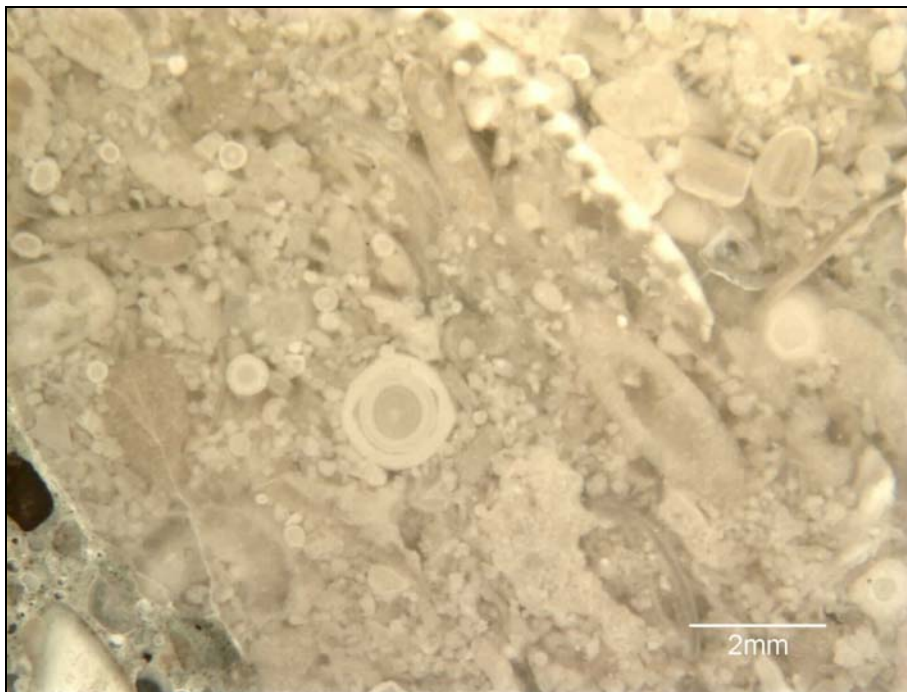
Figure C.5. Optical photomicrograph showing the clastic components found in the coarse aggregate particles (core 2).
