Performance Evaluation of Recent Improvements of Bridge Abutments and Approach Backfill

Tech Transfer Summary

November 2018

TR-736

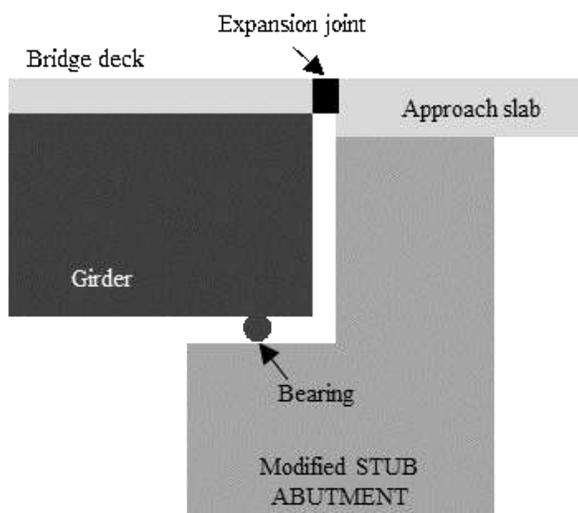
Schematic of a proposed detail for 'modified stub abutment'.

5. A comparative study of the advantages and disadvantages of the different types of abutments across their life cycle should be conducted.
6. A possible new design detail for a modified stub abutment is shown below. This will eliminate the joint between the approach slab and abutment and will eliminate the paving notch. New designs addressing the failure of the joint between the barrier and the approach slab, the differences between measured and designed expansion joint widths, and other challenges should be considered.
