# Low-Cost Rural Surface Alternatives Phase III: Demonstration Project

Final Report April 2022

**Sponsored by** Iowa Highway Research Board (IHRB Project TR-721) Iowa Department of Transportation (InTrans Project 17-604)

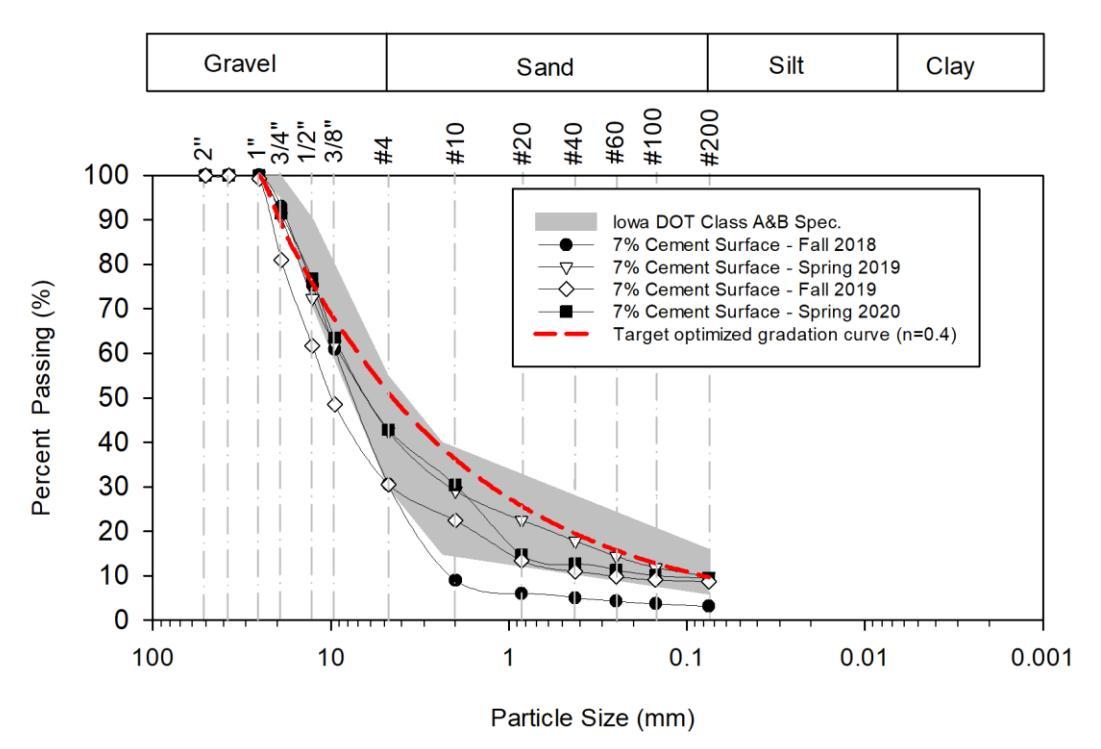
Figure 114. Particle size distribution curves for Howard County RAP section
In Washington County, the 4 in. cement-treated surface section initially had a coarser gradation curve below the Iowa DOT Class A and B specification; but with compaction and abrasion from traffic breaking up the aggregate over time, the gradation became finer and remained almost within the specification band from spring 2019 to spring 2020 (Figure 115).

Figure 115. Particle size distribution curves for Washington County 4 in. cement-treated surface section

In spring 2020, an additional 26 tons of fresh aggregate were spread to cover potholes. In contrast, the initial gradation of the 12 in. cement-treated subgrade section in 2018 was almost entirely within the specification band, but migrated above the band in fall 2019 before decreasing by spring 2020 despite no fresh aggregate being placed on the section (Figure 116).

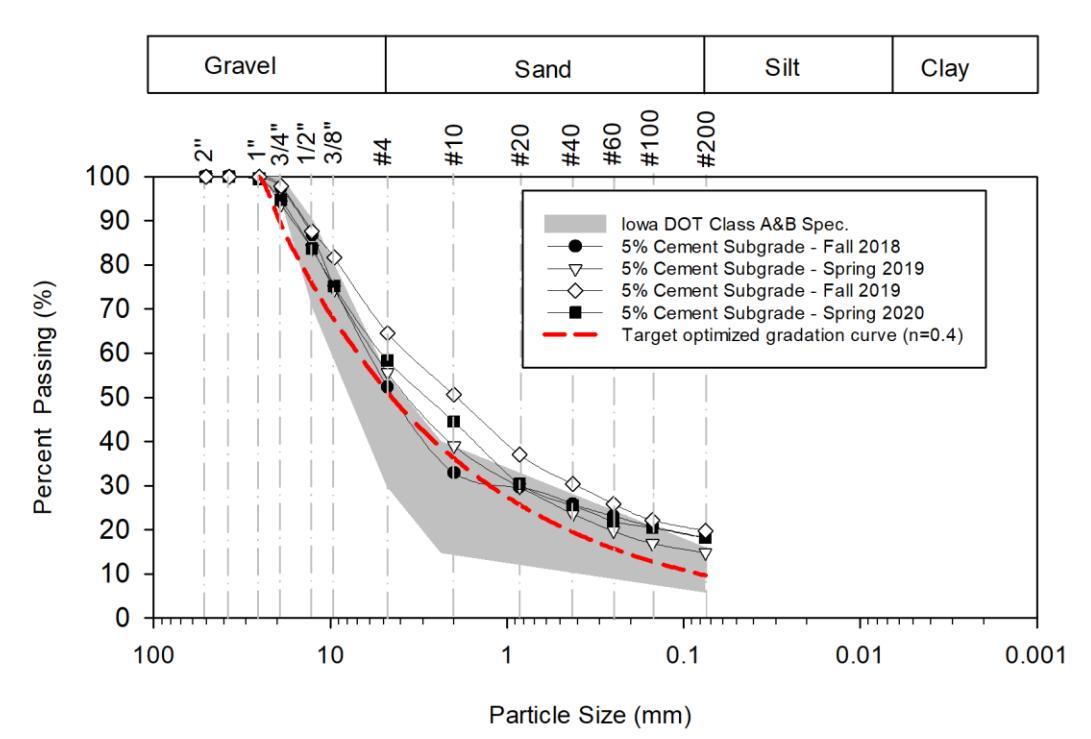
Figure 116. Particle size distribution curves for Washington County 12 in. cement-treated subgrade section

The decrease in the sand and fines fractions for this section in spring 2020 may be a result of dust generation in addition to abrasion from traffic loads creating sand-sized particles, which are then blown or washed off the relatively stiff surface by traffic and water.

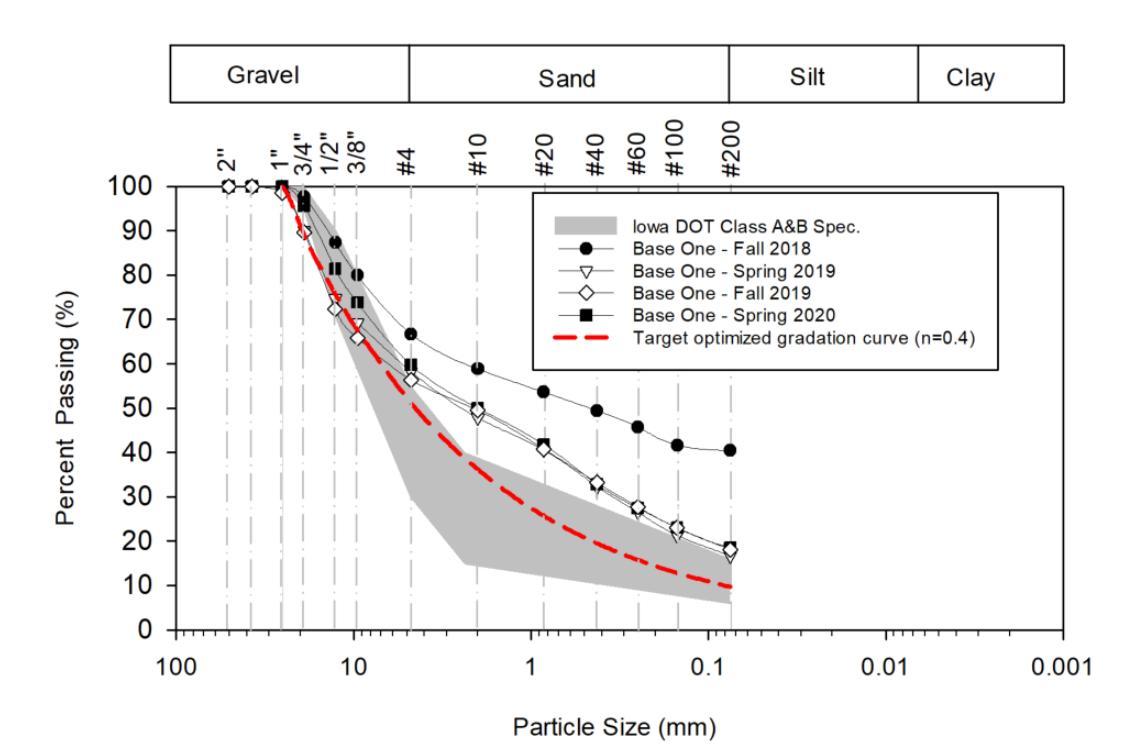
Figure 117. Particle size distribution curves for Washington County BASE ONE section

The BASE ONE section in Hamilton County (see Figure 120) exhibited a smaller overall change in gradation than the one in Washington County (Figure 117), but the latter changed very little over the last three testing periods and retained more gravel-sized particles within the gradation band. Interestingly, the BASE ONE sections in both counties ended up with gradations very similar to their respective control sections in spring 2020.

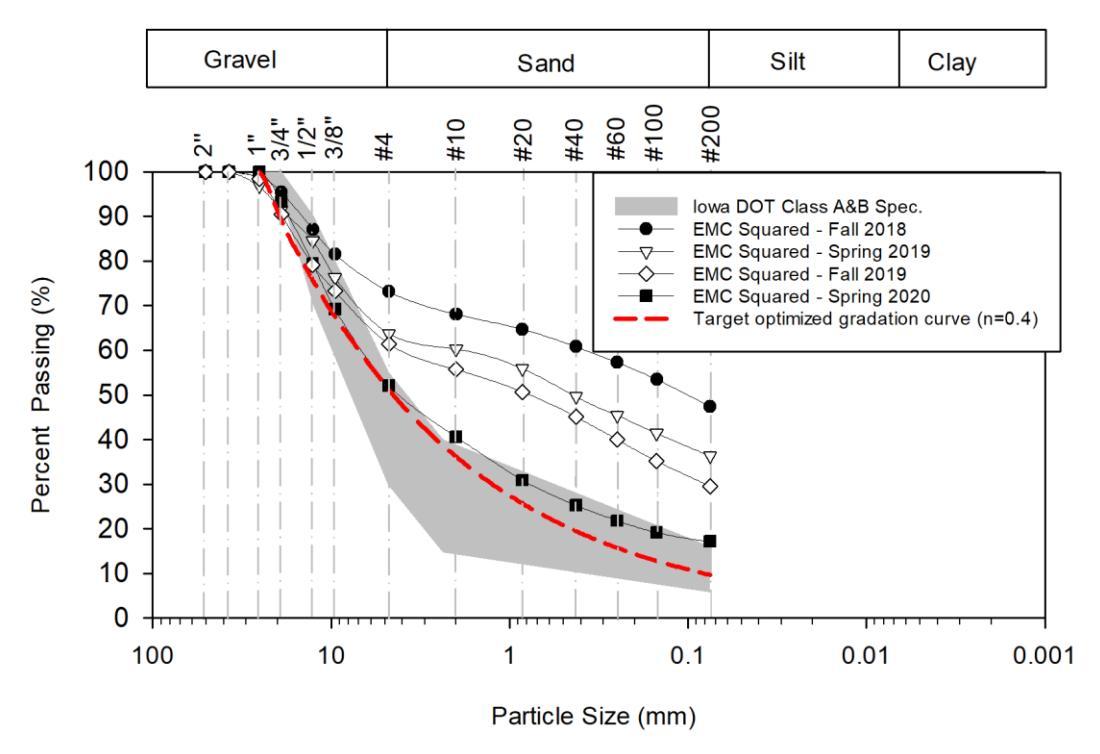
Figure 118. Particle size distribution curves for Washington County EMC SQUARED section

The EMC SQUARED section in Washington County (Figure 118) started out in fall 2018 with a very fine gradation but continually became coarser over time, with its gradation curve ending up almost entirely inside the specification band after maintenance aggregate was added in spring 2020. In Hamilton County where no maintenance aggregate was added, the EMC SQUARED section showed the opposite trend (Figure 121), starting out with its coarsest gradation close to the top of the specification band in fall 2018 and ending with its finest gradation far above the band in spring 2020. Even before the maintenance aggregate was added in Washington County, the gravel-sized portion of the EMC SQUARED section's gradation stayed much closer to the specification band in Washington County than in Hamilton County.

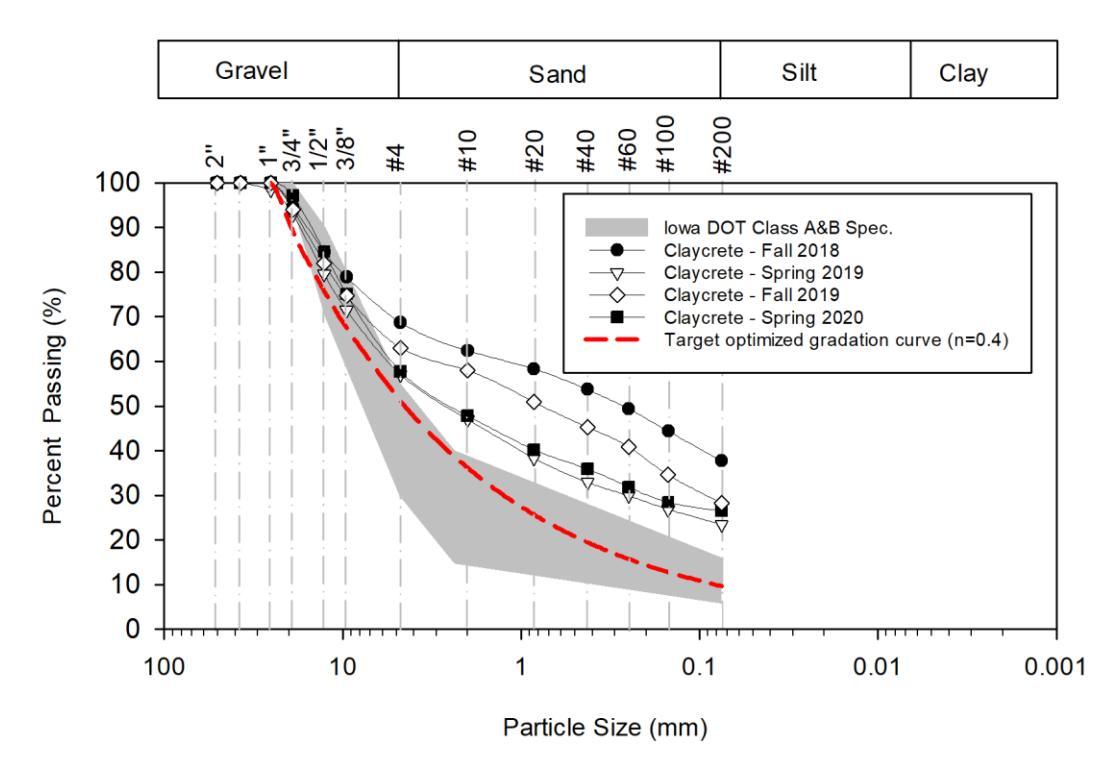
Figure 119. Particle size distribution curves for Washington County Claycrete section

The Claycrete section in Washington County (Figure 119) started out with its finest gradation in fall 2018 and generally moved toward a coarser one with time but remained above the specification band in the sand-sized range even after fresh aggregate was added in spring 2020.

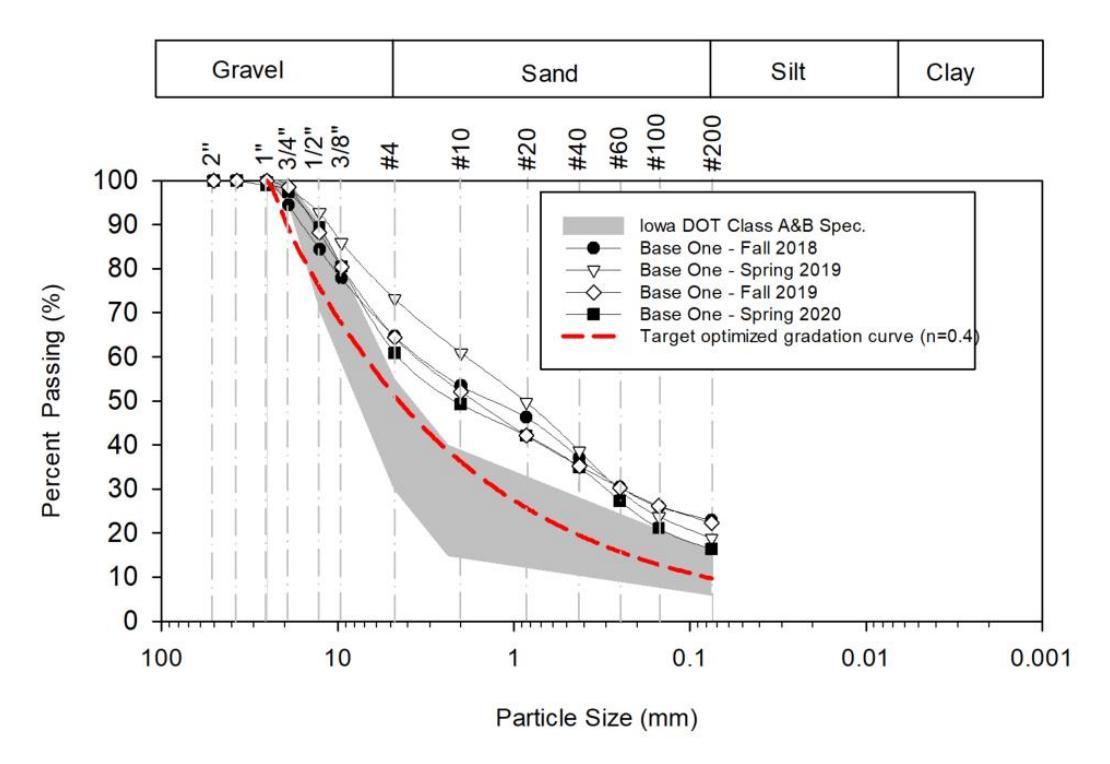
Figure 120. Particle size distribution curves for Hamilton County BASE ONE section

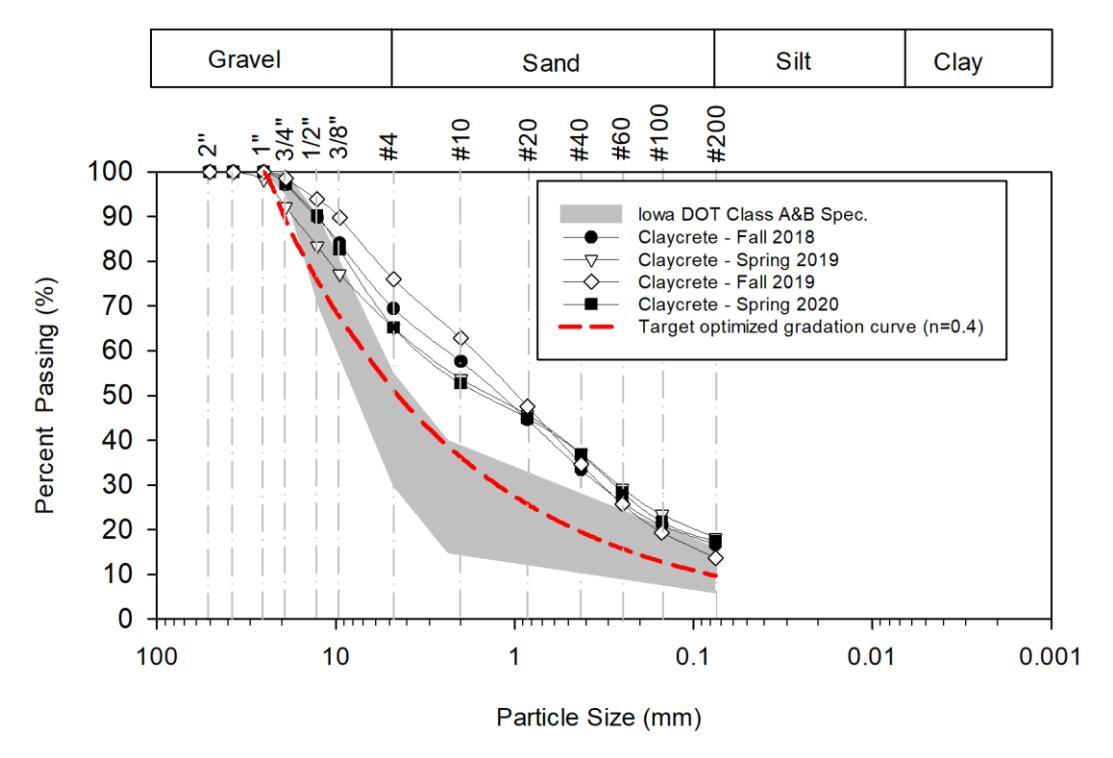
Figure 122. Particle size distribution curves for Hamilton County Claycrete section

In contrast, the gradation of the Hamilton County Claycrete section changed less over time but was further from the gravel-sized portion of the specification band than the Washington County gradation (Figure 122).

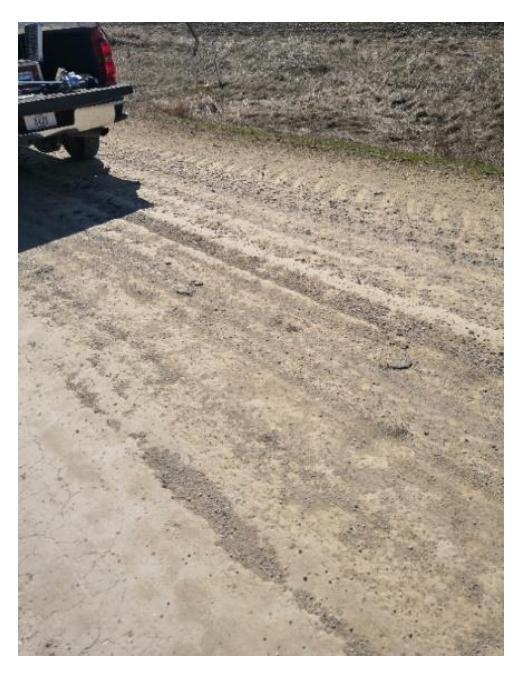
Throughout the study, the most common surface distress issues observed were rutting and potholes, with rutting caused by agricultural machinery on the road surface and shoulder being the most common issue in all counties. Examples of these conditions are shown in Figure 127 and Figure 128.

Figure 128. Rutting in Howard County OGCS section during spring 2020

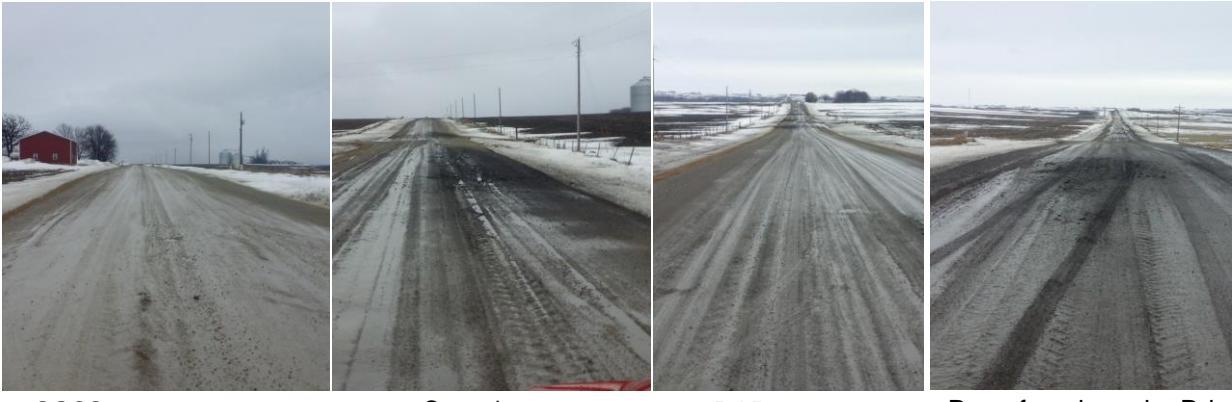
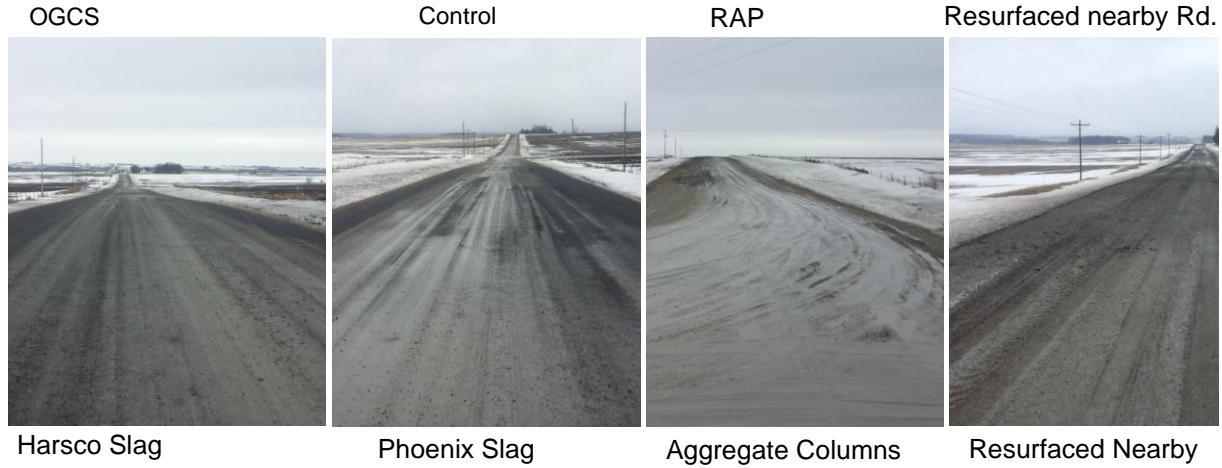
The stabilized Howard County sections also held up remarkably well in spring 2019 compared to both the control section and nearby roads that were recently resurfaced. At the time, some of the surrounding untreated roads were nearly impassable or closed due to significant damage and flooding from melting of snow followed by significant precipitation resulting in the worst road conditions seen in decades, while the test sections were in relatively good condition (see Figure 131).

Figure 131. Test sections and recently resurfaced nearby roads in Howard County March 14, 2019
