Evaluation of Microcracking and Chemical
Deterioration in Concrete Pavements

Final Report

Iowa DOT PROJECT HR-358

Sponsored by the Highway Division of the Iowa Department of
Transportation and the Iowa Highway Research Board

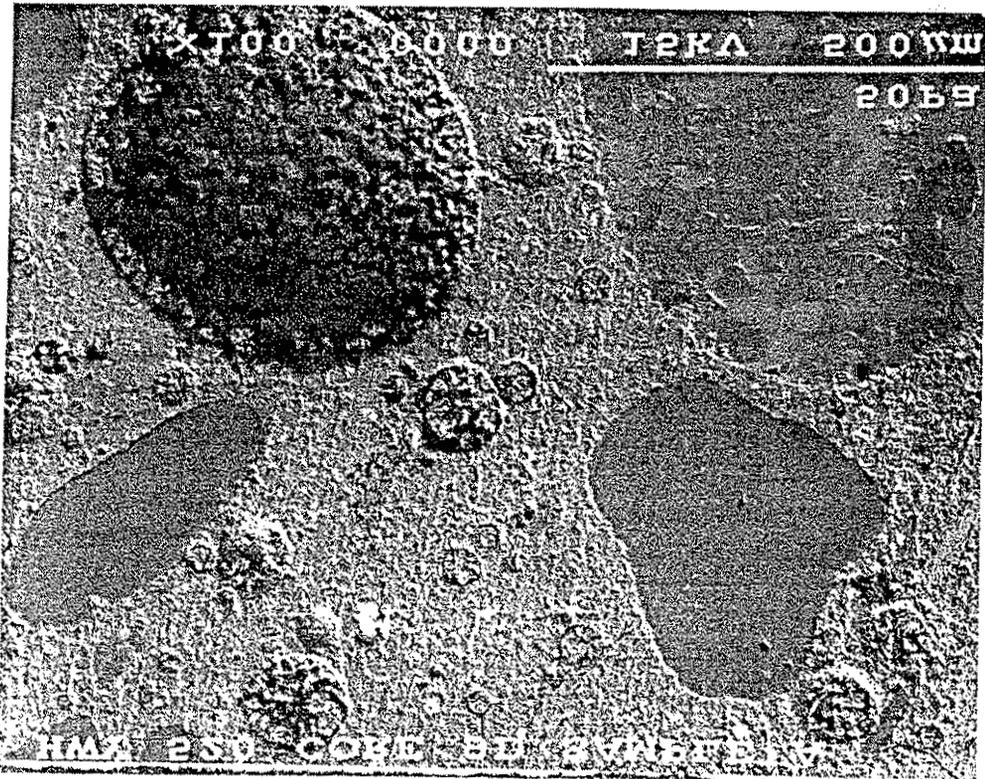
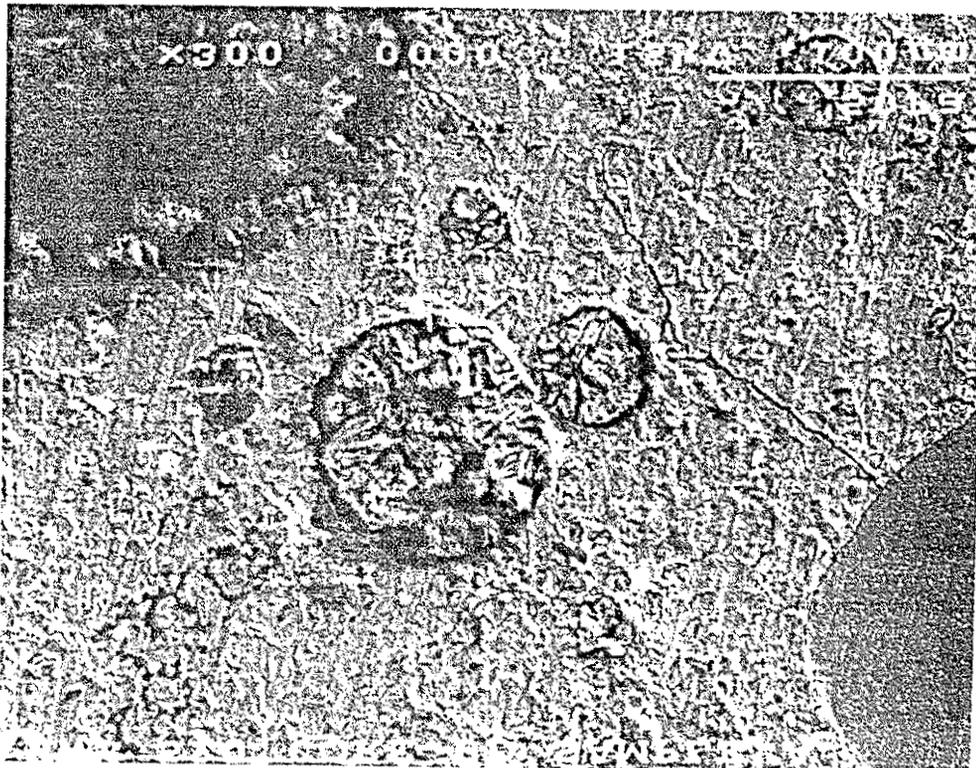
Figure 8. US 20, polished specimen, normal preparation technique.

Backscattered electron images obtained from the normal sample preparation method used in this study (ground and polished surfaces), which was described earlier in this report, are shown in Figure 8. The images have been oriented so that the area shown in Figure 7 corresponds closely to the area shown in Figure 8. The images shown in Figure 8 were obtained before the samples were sent to be made into thin sections. This allowed the laboratory that made the thin sections to prepare a specimen of nearly the same area that had been viewed on the bulk specimen (except for the 30 micron thickness of the thin section).

Overall, Figures 7 and 8 contain essentially the same information. The surface polish is a little better in Figure 8 than in Figure 7, but the major features, particularly the filled voids, have been preserved in both sample preparation techniques. The voids are filled with a sulfate bearing mineral (see Fig. 9). The X-ray map indicates that only a small amount of aluminum is present in the material in the voids, this suggests that the material's composition has been altered to some extent by the sample preparation process because the material started out as ettringite. If the thin section is viewed in transmitted light using a petrographic microscope the voids appear to be nearly empty. This may help to explain why these features were not mentioned in previous studies of similar cores [2,17]. The distinct morphology of the ettringite is easily recognized when using a scanning electron microscope. In addition, the visual information can easily be supplemented with chemical information (via an X-ray spectrum or an X-ray map). This allows one to better estimate the identity of the object that is being observed.

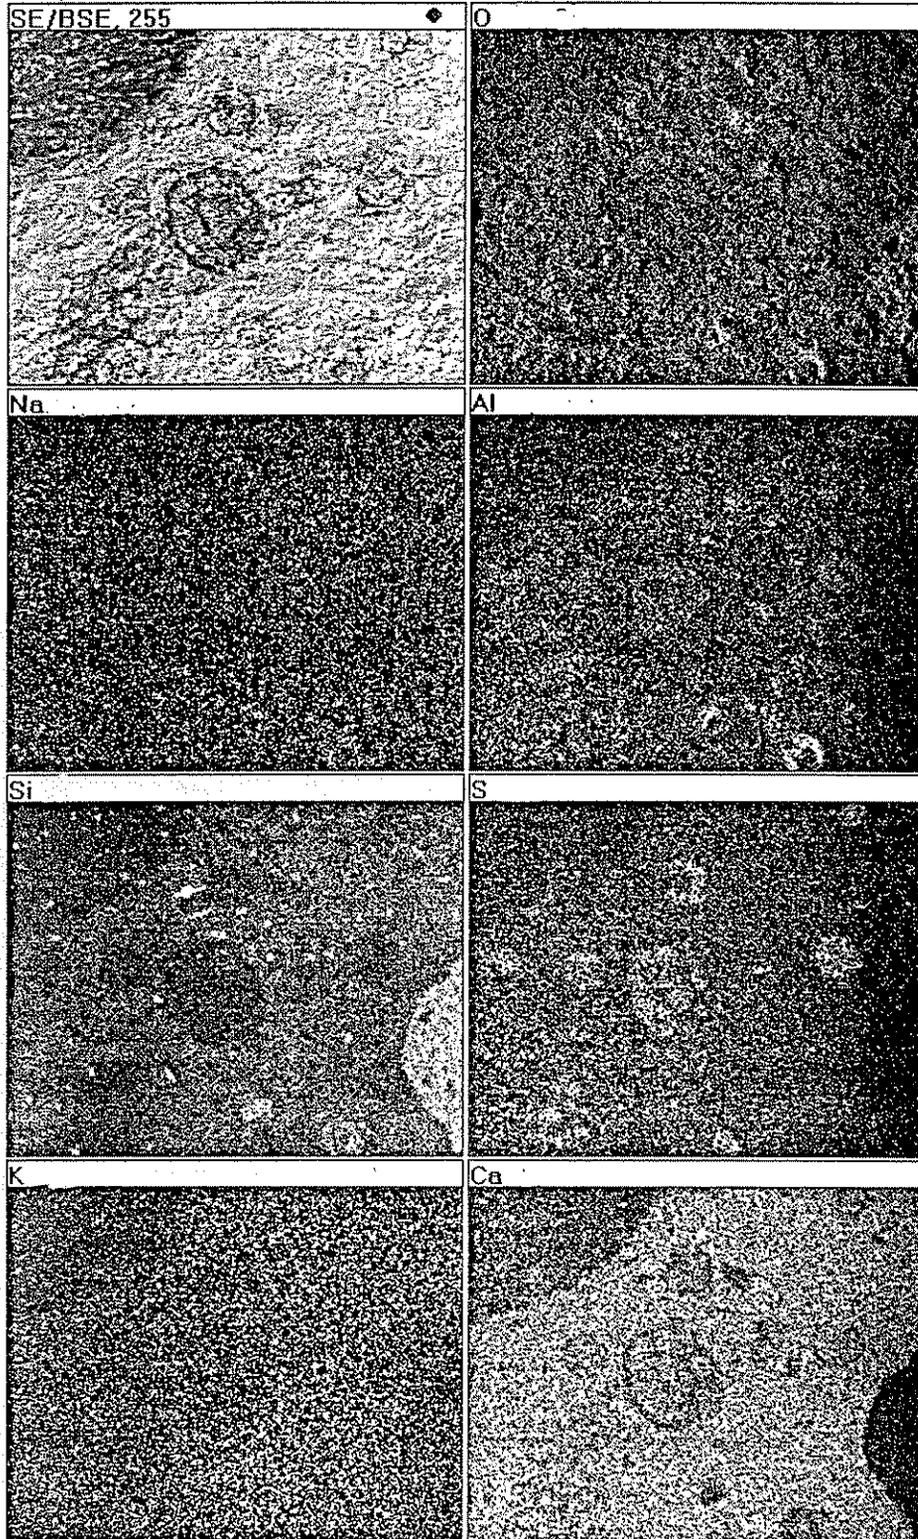
Figure 9. X-ray map of the region shown in Fig. 7B, 300X magnification.

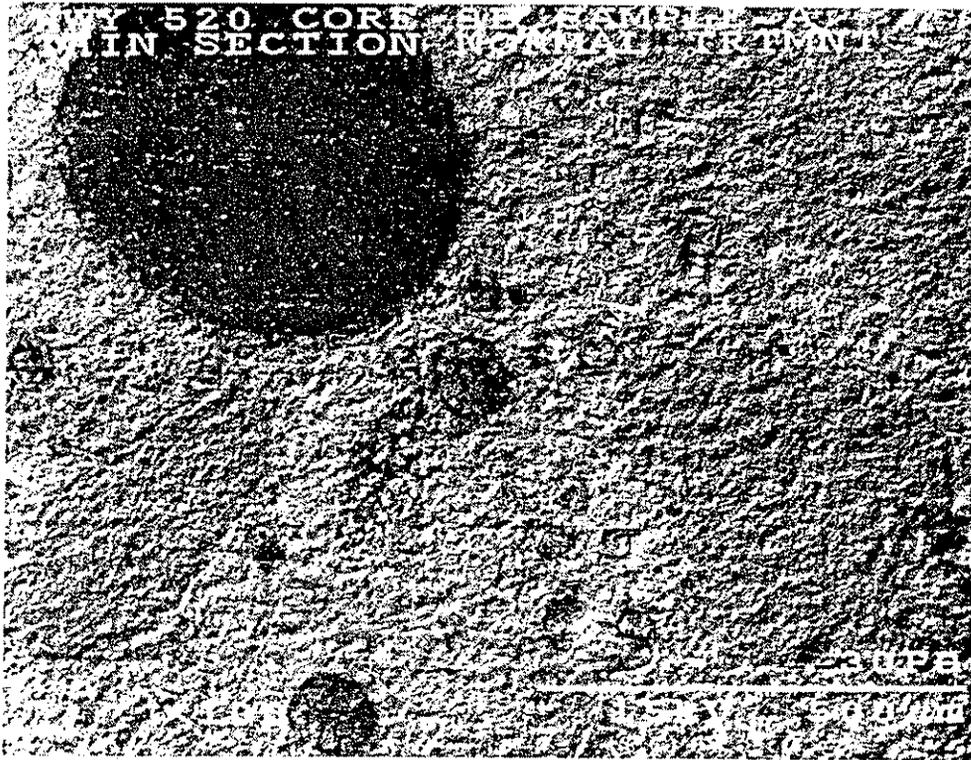
Figure 7. US 20, thin section specimen, normal preparation technique.

image clearly indicates the presence of material in the air voids. In fact, many of the smaller voids have been completely filled. Fine hair line cracks were also evident in the paste portion of the specimen. Most of the features remained intact during the preparation of the thin section; however, some of the shale particles were destroyed by the process.

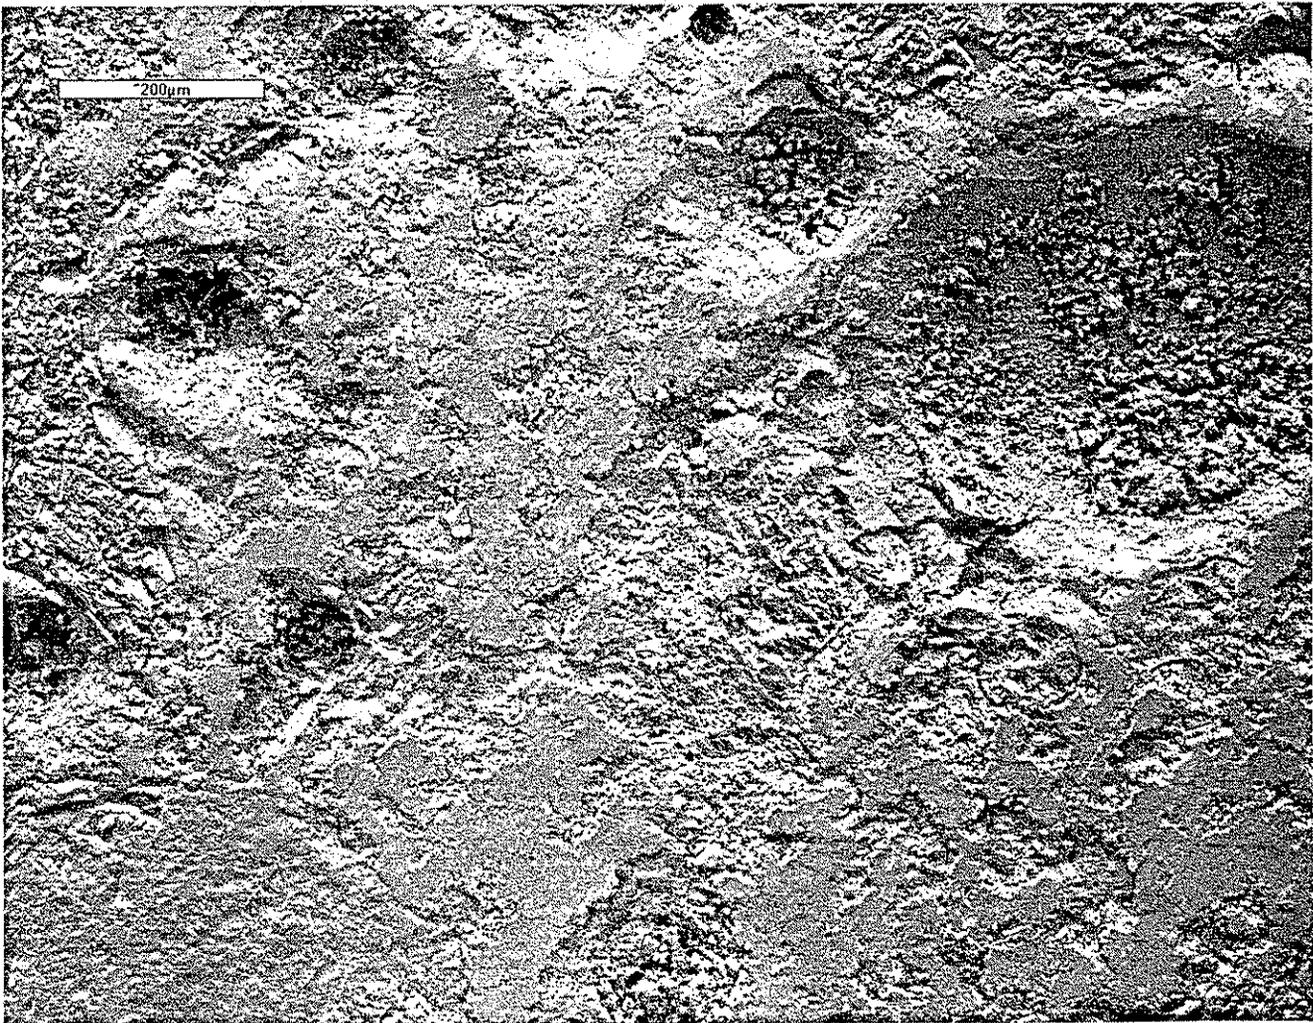
Images obtained from the sawn surface of the specimen are shown in Figures 10 and 11. Note the poor contrast between adjacent minerals in Figure 10. The sawing process has smeared debris over the surface of the specimen, this has distorted the information in both the backscattered electron image and the X-ray map. This also makes it difficult to identify microcracks in the specimen. However, both figures still indicate the presence of filled air voids. Higher magnification (see Fig. 12) helps to discern features but it also indicates that specimen topography will interfere with accurate X-ray mapping.

Figure 10. US 20, sawn surface, magnification =100X..

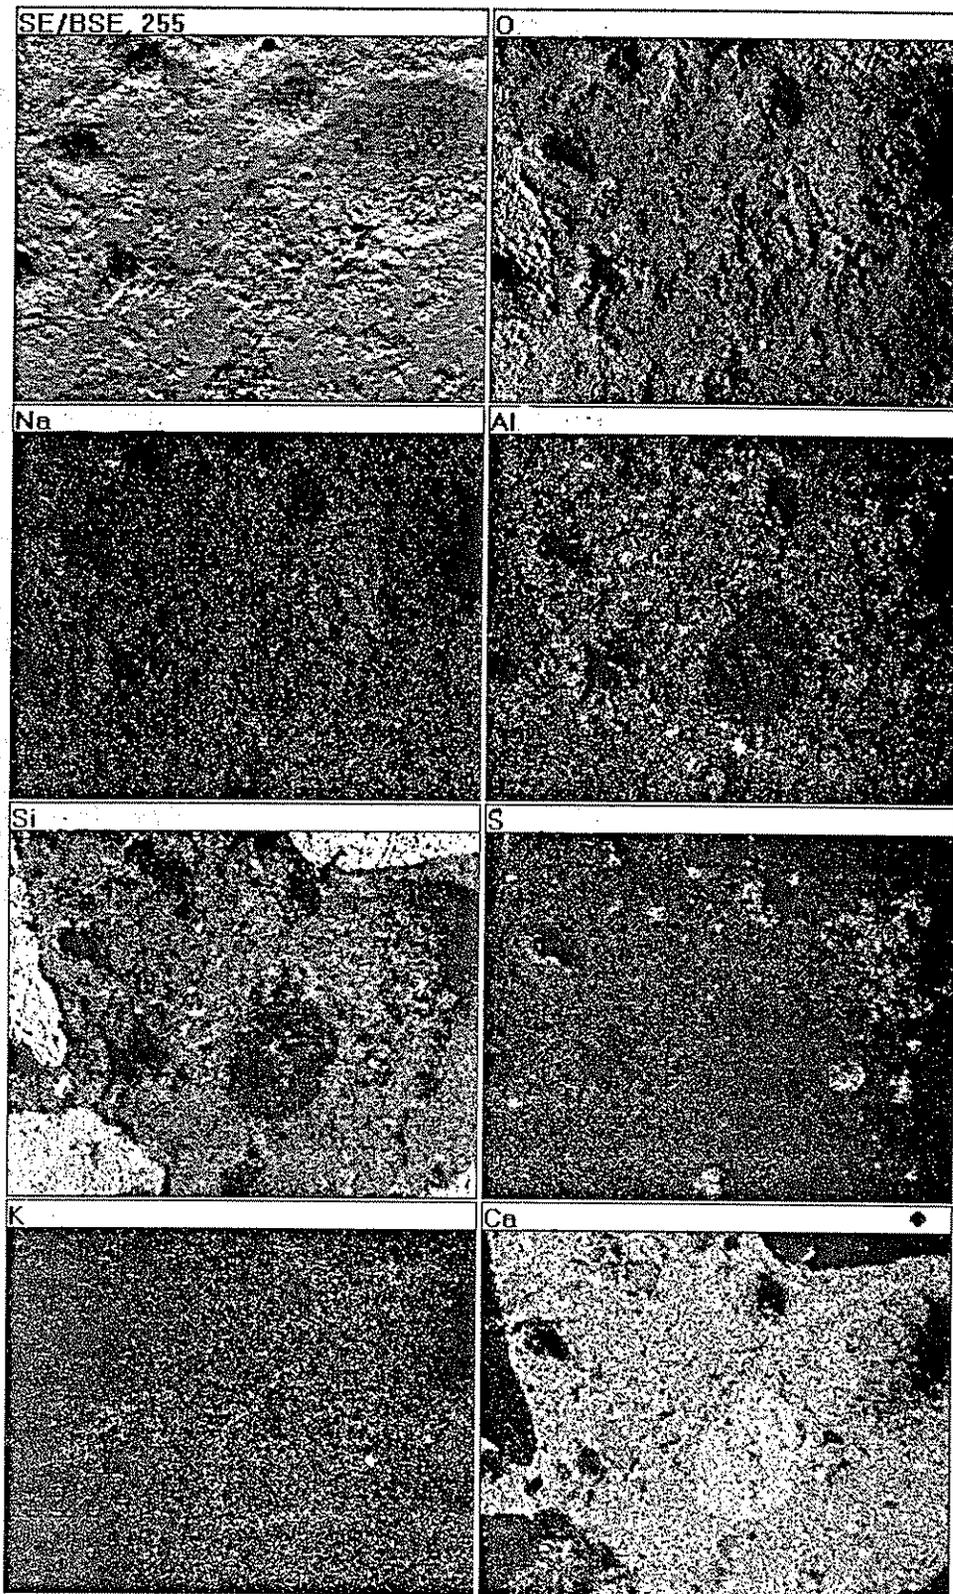
Figure 11. X-ray map of the region shown in Fig. 10; 100X magnification.

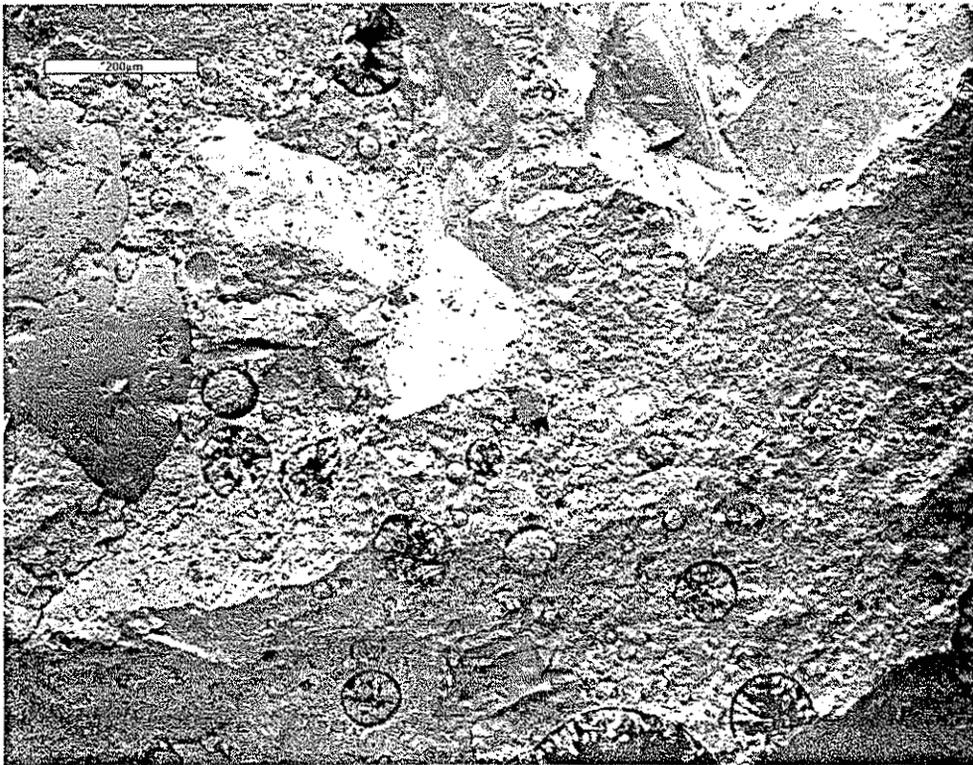
Images from a freshly fractured specimen surface are shown in Figures 13 through 17. The first two figures clearly illustrate the presence of filled air voids. In fact, the images give a better illustration of the three dimensional nature of the air voids. The X-ray map (see Fig. 15) contains many shadows (due to topography) which make interpretation difficult. Figures 16 and 17 show a large shale particle that was uncovered during the fracturing process. The shale particle is surrounded by voids that have been filled with ettringite. None of the voids give any evidence of being filled with alkali-silica gel. However, this statement must be tempered by the fact that surface topography has distorted both the image (this is why the lower-right half of the image is poorly focused) and the elemental map.

Figure 14. US 20, fractured surface, 100X magnification.

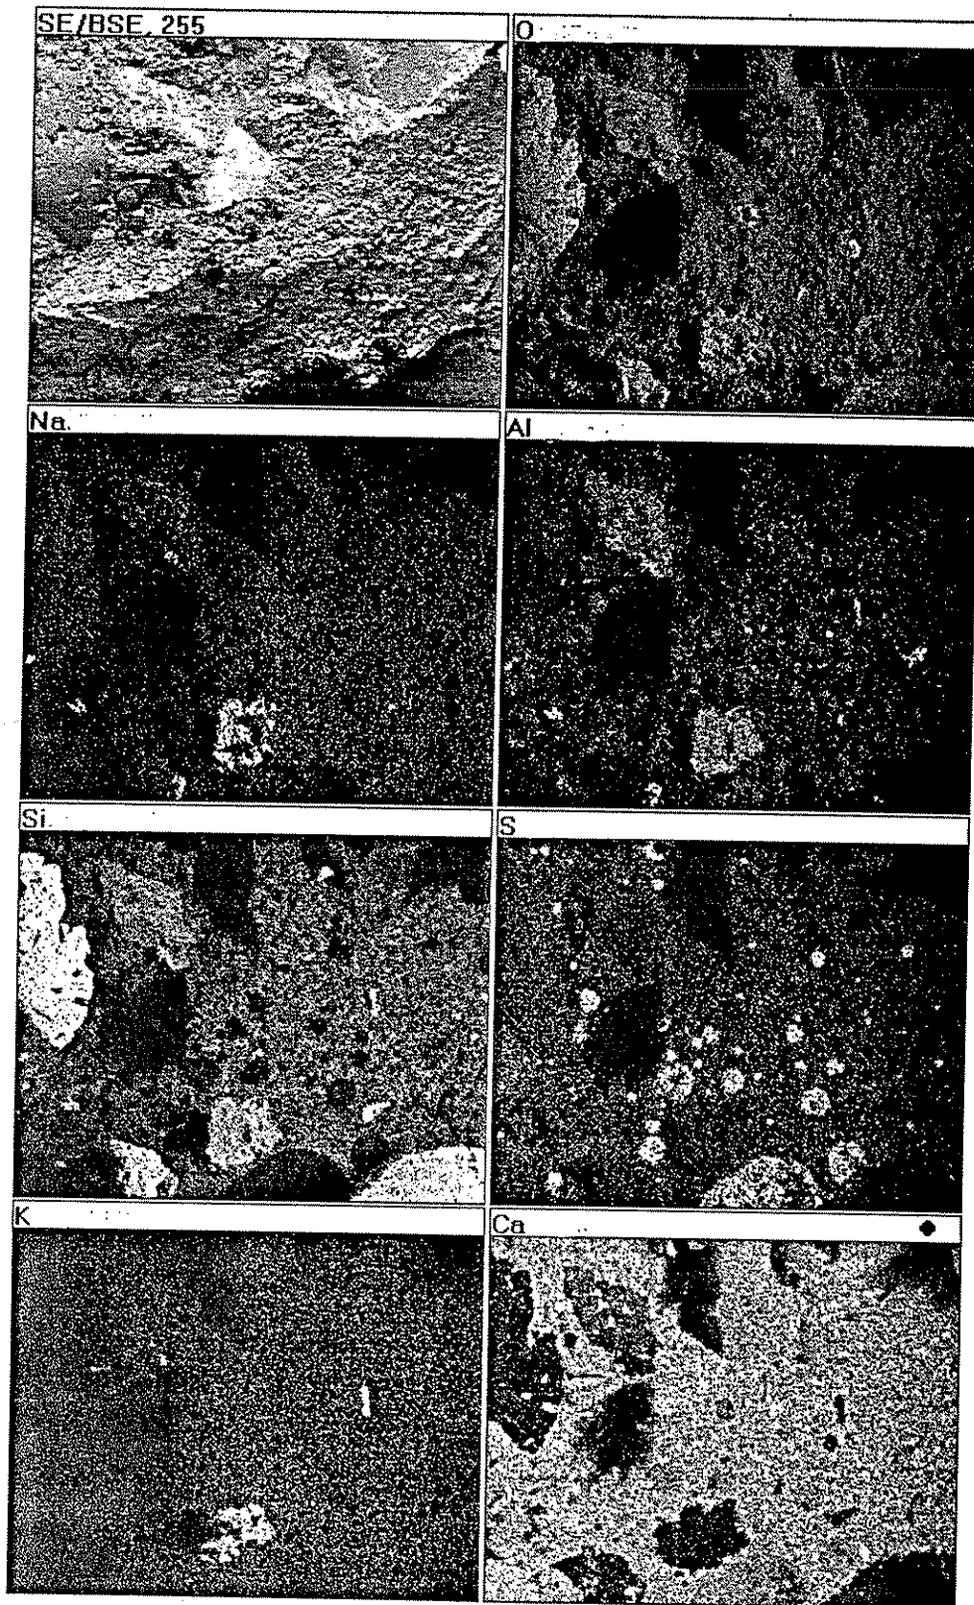
Figure 15. X-ray map of the region shown in Fig. 14; 100X magnification.

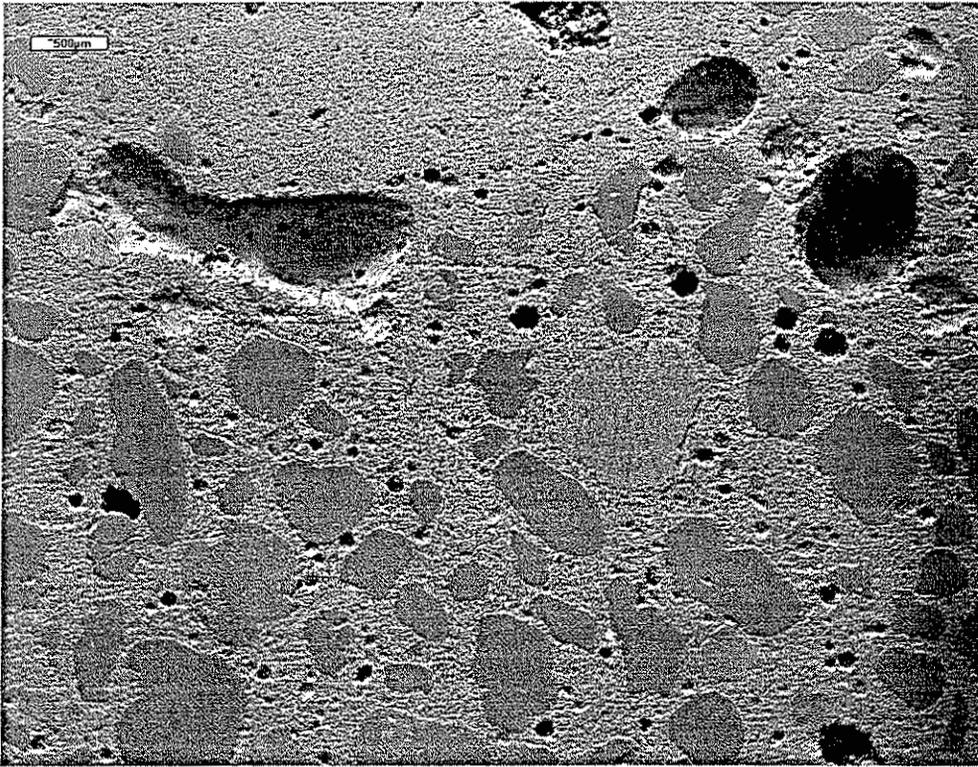
Figure 18. Fast track, Benton County (CMI-11), 20X magnification.

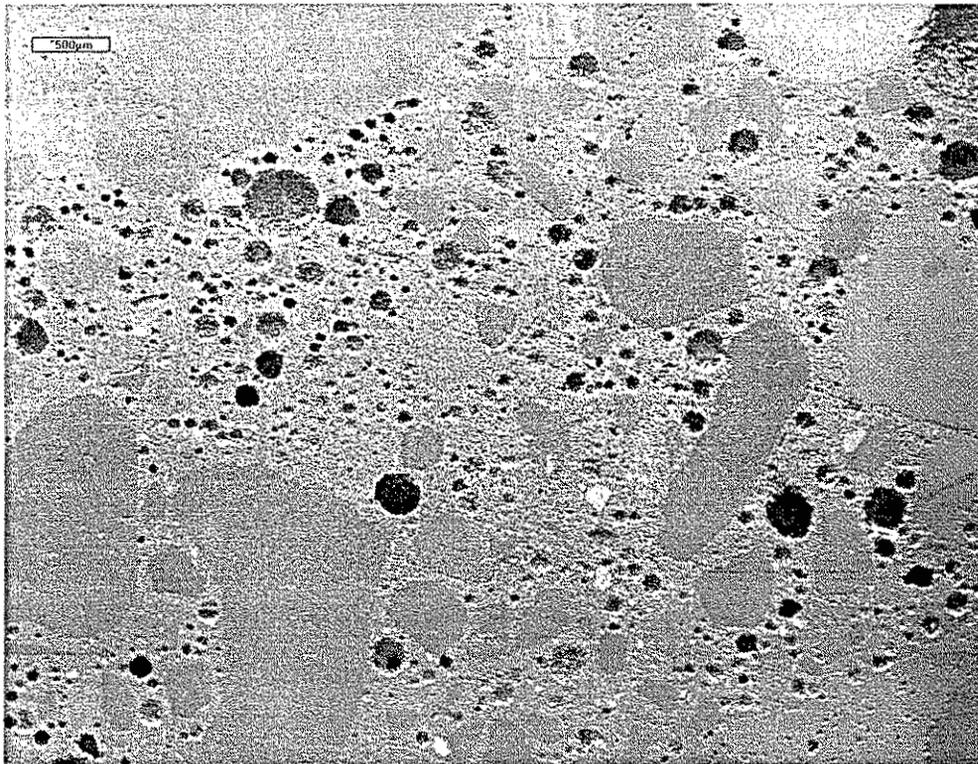
Figure 19. County Road B, Hancock Co. (CMI-12), 20X magnification.

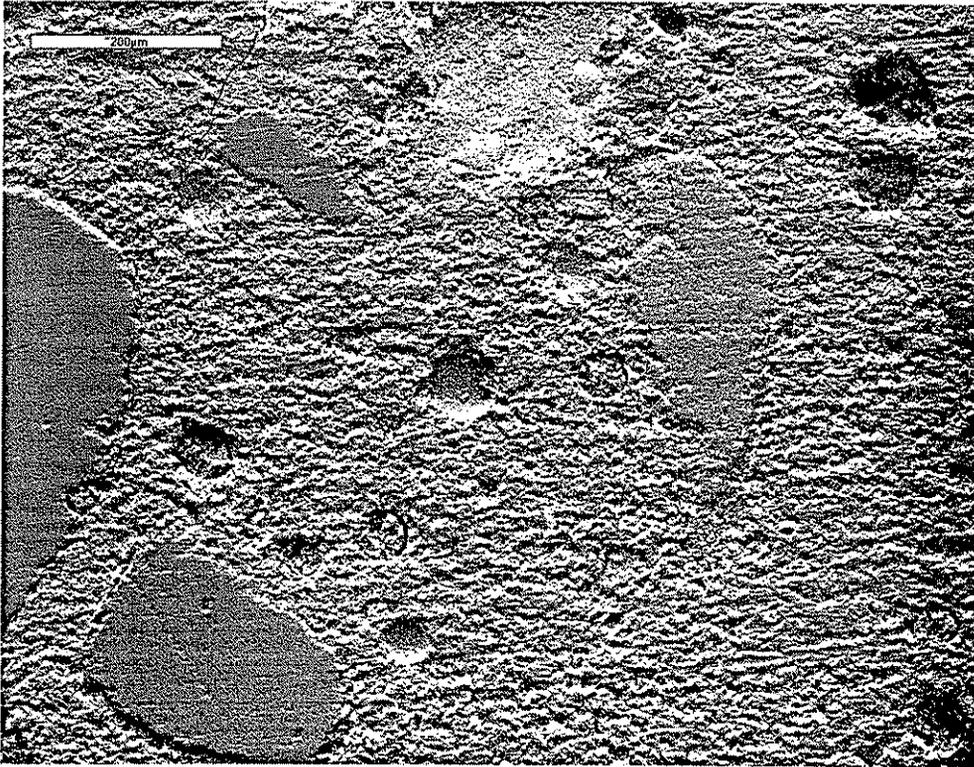
The samples denoted as CMI-11 and CMI-12 both exhibited very little cracking; however, they did contain features that help to illustrate points that will be mentioned later in this report. The CMI report [17] indicated that the two specimens contained similar amounts of entrained air (7.9% and 7.5%, respectively), and that the air voids were only thinly lined with ettringite. This investigation revealed major differences in the distribution of air voids (compare Figures 18 and 19), and it also indicated that many of the small air voids in the CMI-11 sample had been filled with ettringite (compare Figures 20 and 21).

Figure 20. Fast track, Benton County (CMI-11), 125X magnification.

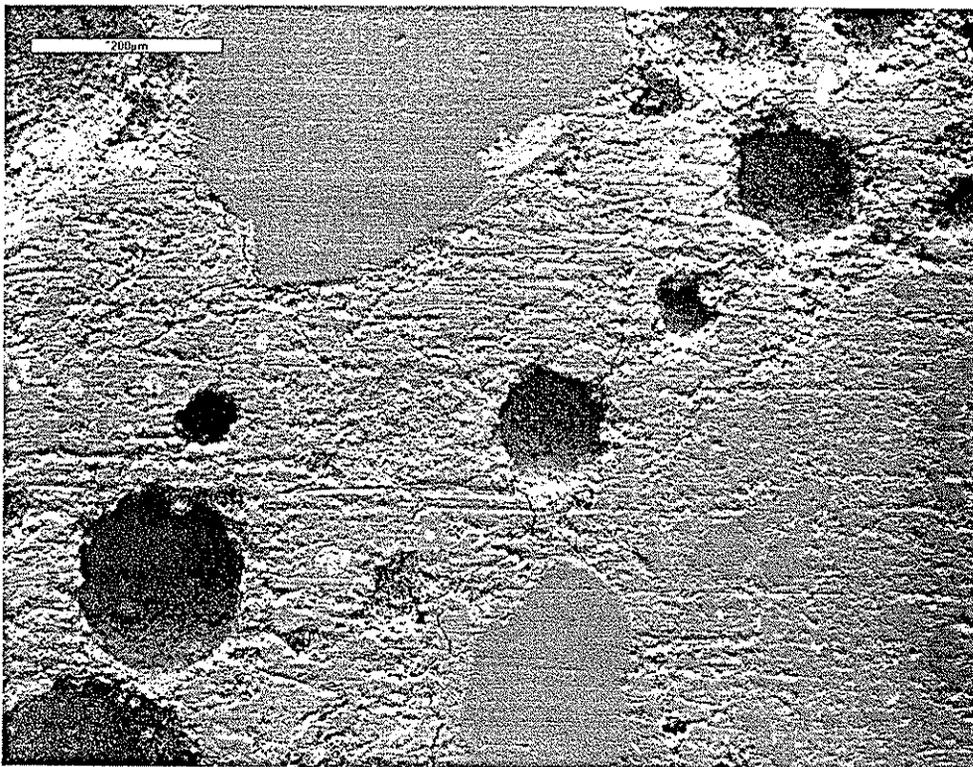
Figure 21. County Road B, Hancock Co. (CMI-12), 125X magnification..

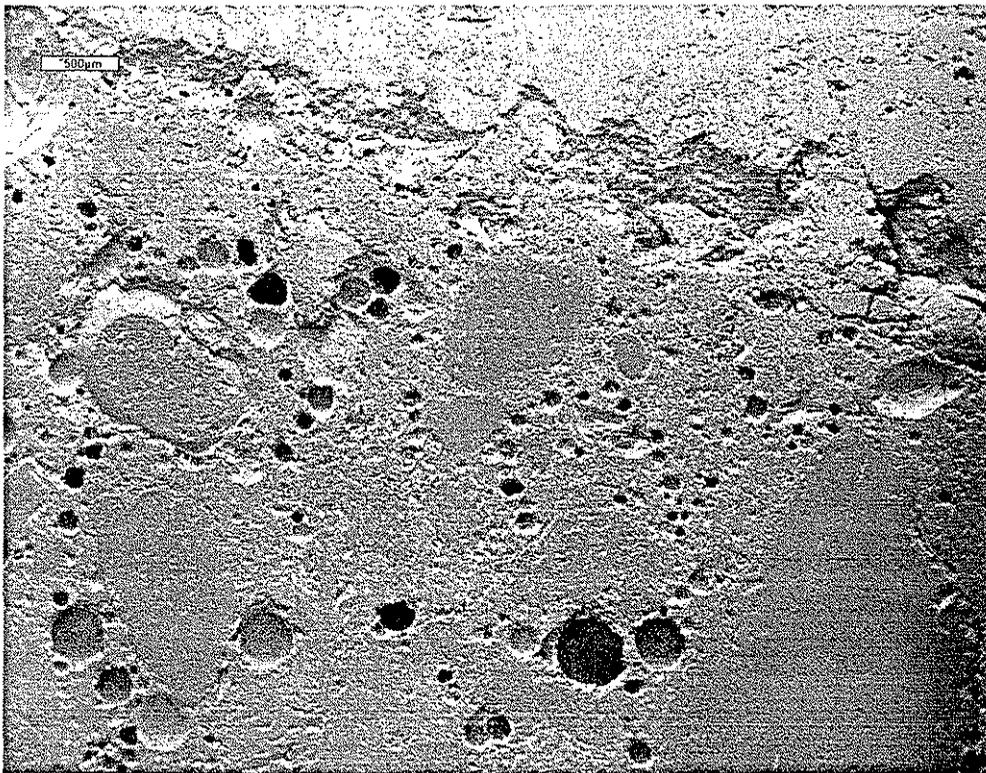
specimen containing Class C fly ash. However, the specimen containing only Type I cement appeared to exhibit more internal distress, this distress was particularly evident at the paste-aggregate interface (see Figure 23). This observation was consistent with the results of the expansion tests that had been conducted on the specimens during research project HR-327 (see Figure 24).

Figure 23. Lab concrete exposed to sulfate solution, 20X magnification;
(Beam 53 from HR-327, Type I cement, no fly ash).

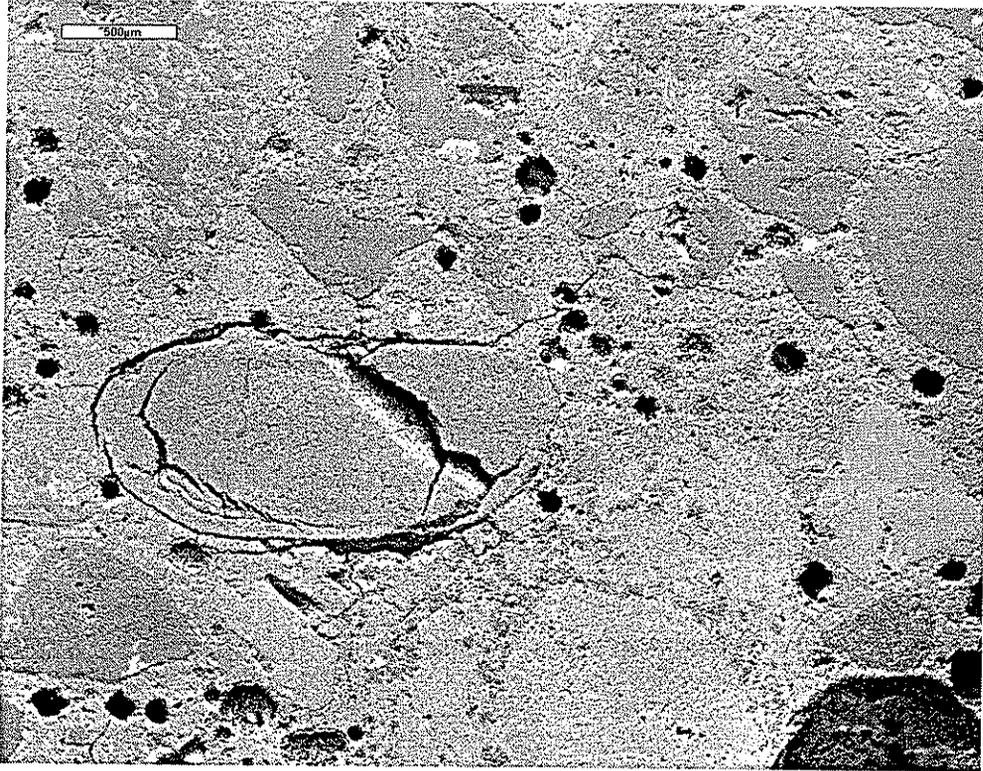
Figure 26. US 20, core 15B, 30X magnification (mix#2, no fly ash).

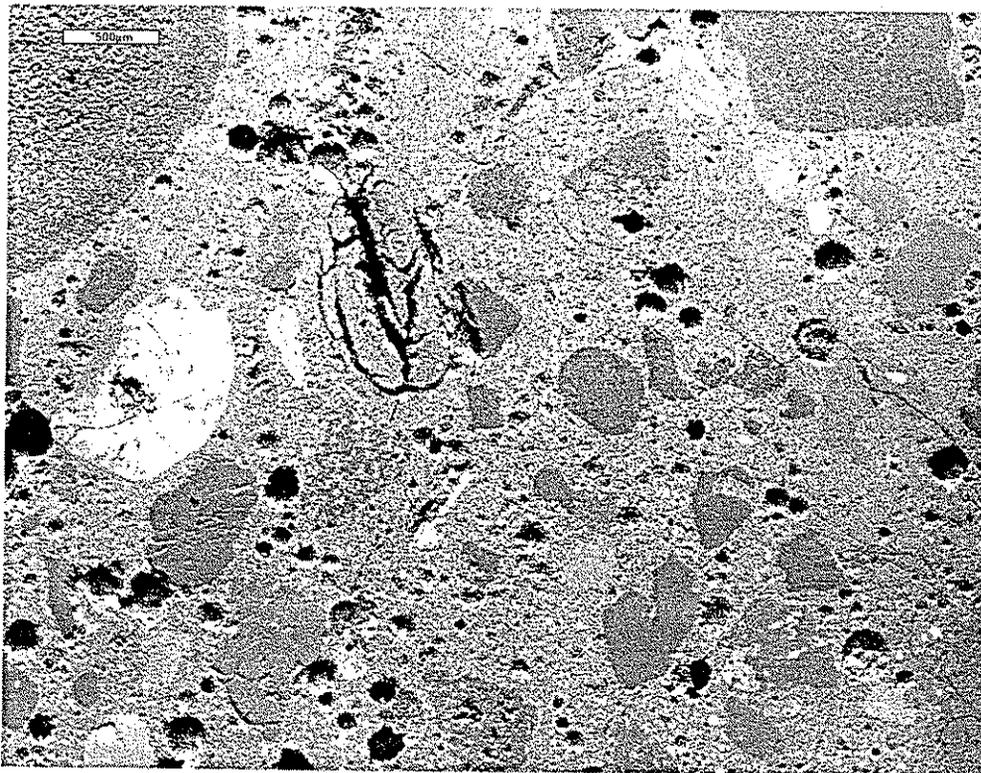
Figure 27. US 20, core 12B, 25X magnification (mix#1, 15% fly ash)

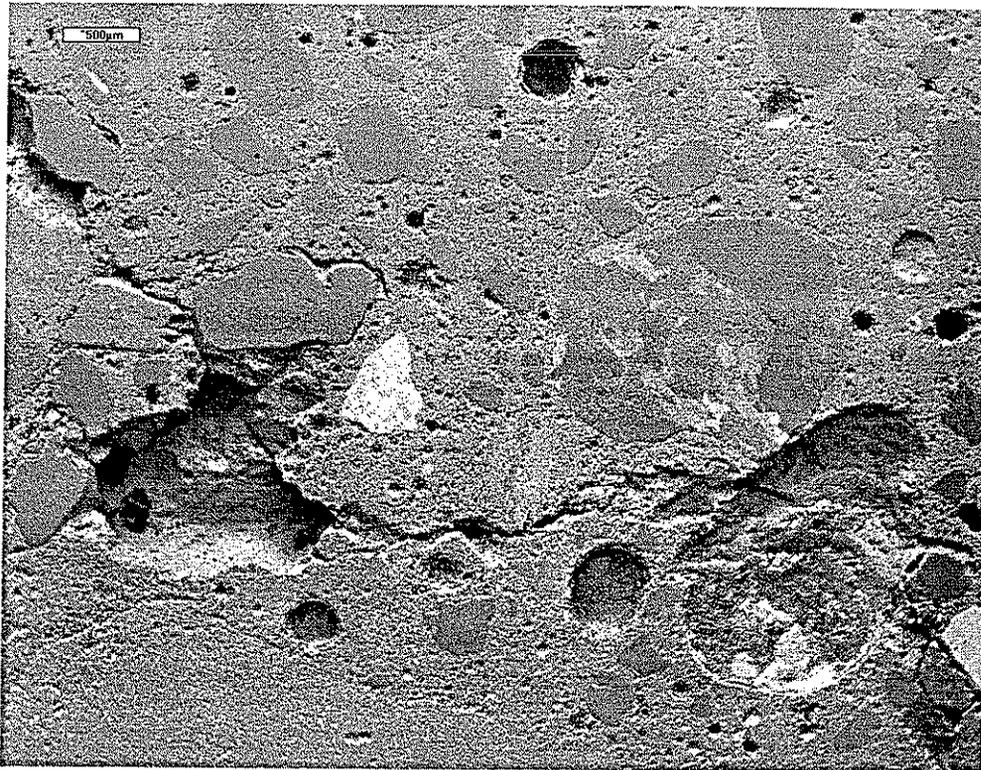
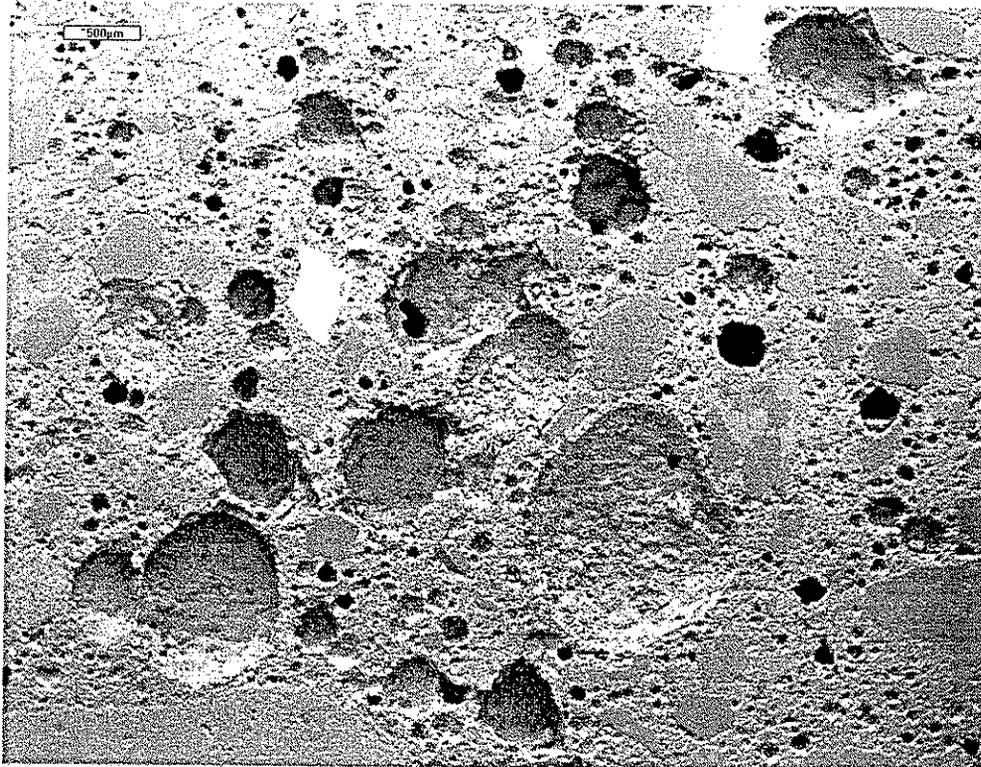
The entrained-air void system varied considerably from core to core. It also varied from the top to the bottom of the core in many instances (see Figure 30 for an example). Again, the discussion that follows will hinge on qualitative

Figure 30. US 20, core 20, 20X magnification; note difference in air voids.

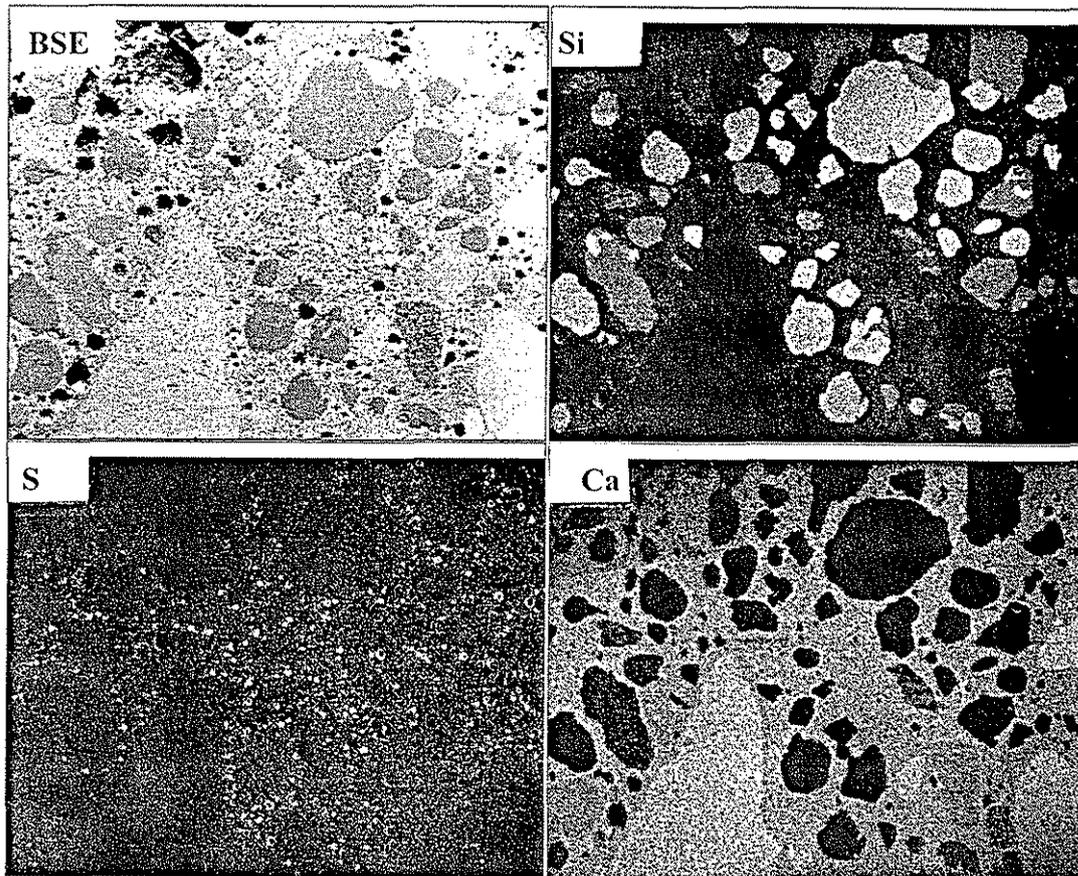
comparisons rather than strict quantitative comparisons. The distribution of air voids throughout the paste often appeared to be very poor when compared to laboratory concrete specimens. However, a closer inspection of the paste generally indicated that ettringite had filled many of the small (<100 microns) air voids (see Fig. 31). Even closer inspection (see Fig. 32) appeared to indicate that the air voids had been filled from smallest to largest (note the linings on the larger voids while the small voids have been filled). Often the air voids that had been filled were difficult to see without careful inspection (even though ettringite has a very unique morphology in the scanning electron microscope). X-ray maps, particularly the sulfur and silicon maps, were useful for detecting the ettringite filled voids (see Fig. 31). Sometimes very fine cracks were observed to pass through the filled air voids into the adjacent paste (or perhaps to another filled air void).

Figure 31. X-ray map of US 20, core 10B, note filled voids; 20X magnification.

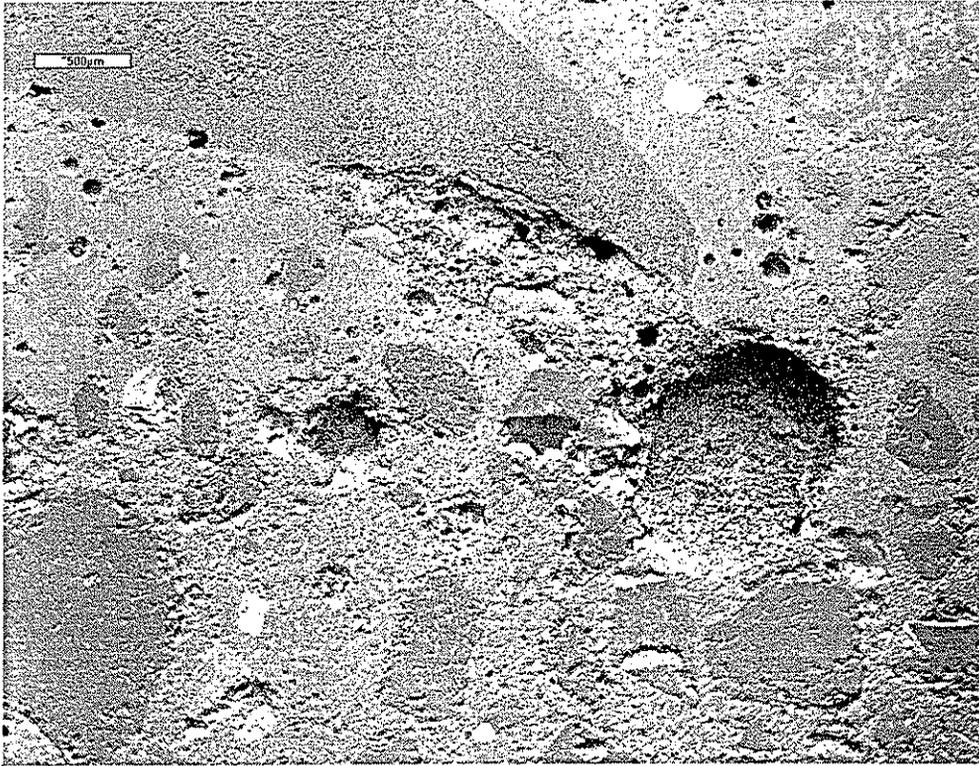
The paste fraction of the concrete cores often looked poor. The paste contained many entrapped voids (especially in the cores obtained from the pavement joints), and often the entrained air content varied considerably from the top to the bottom of the cores (see Figures 36 and 37). Again, the joints appeared to look the worst. The air content often appeared to be low in both the top and bottom of some cores. Occasionally, clumps of what appeared to be fly ash were observed in the paste (see Fig. 38). The significance of such features is difficult to ascertain; however, such features would typically suggest problems in the mixing cycle of the concrete.

Figure 36. I-35, core 2B, 25X magnification.

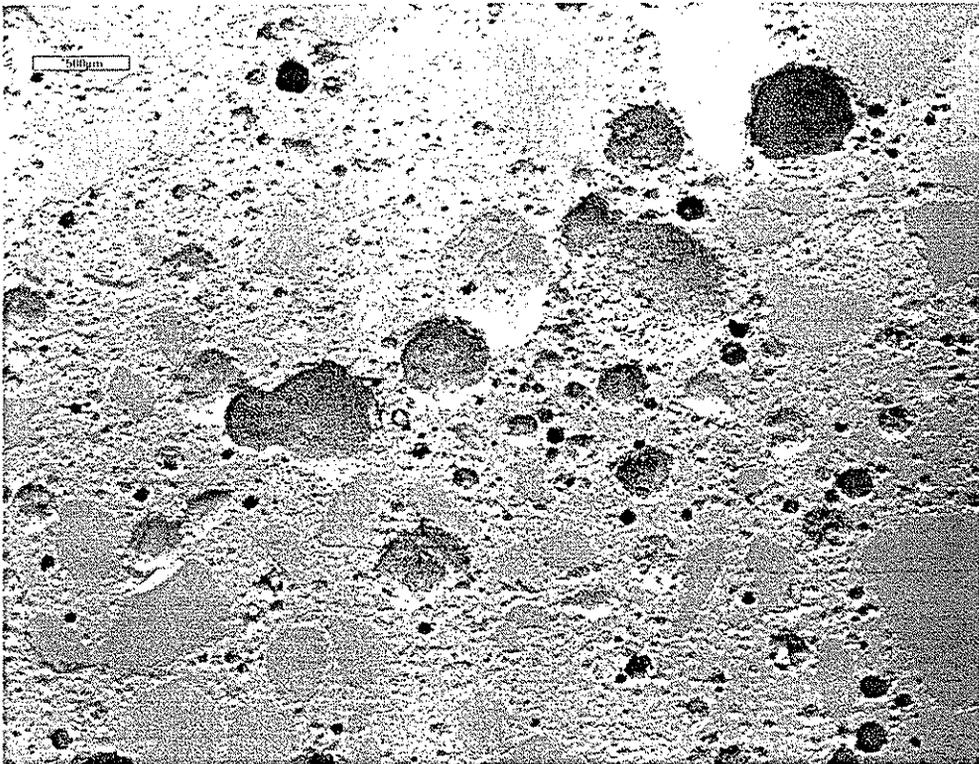
Figure 37. I-35, core 2C, 25X magnification; compare air voids to Fig. 36.

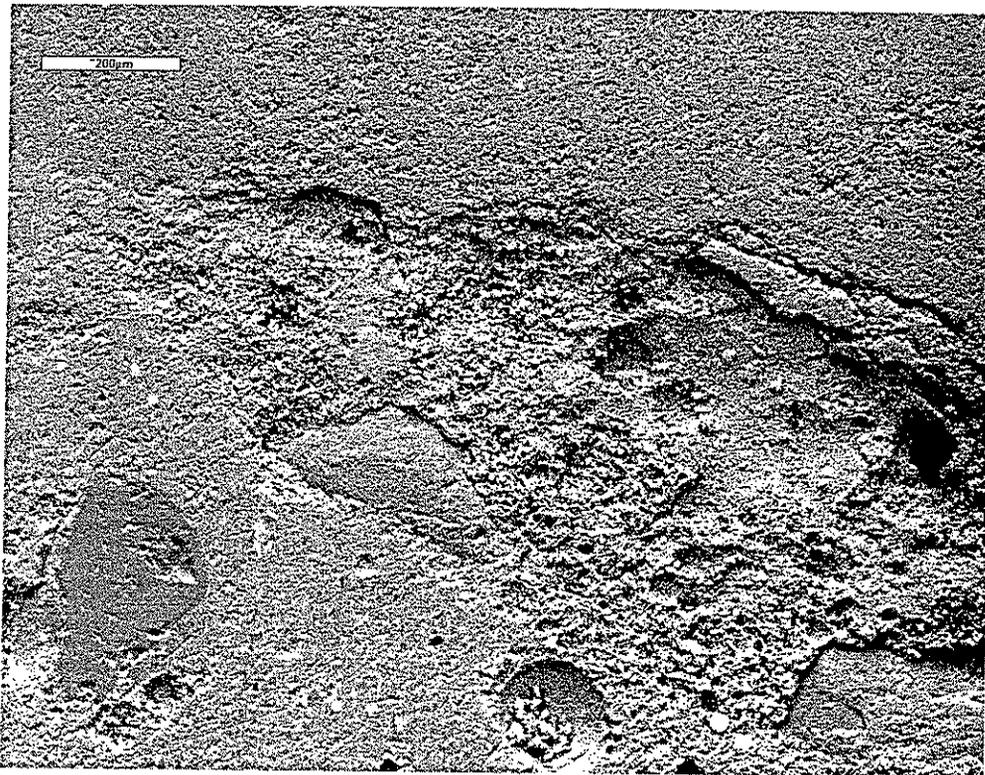
Figure 38. I-35, core 2B, 90X magnification; note clump of fly ash.

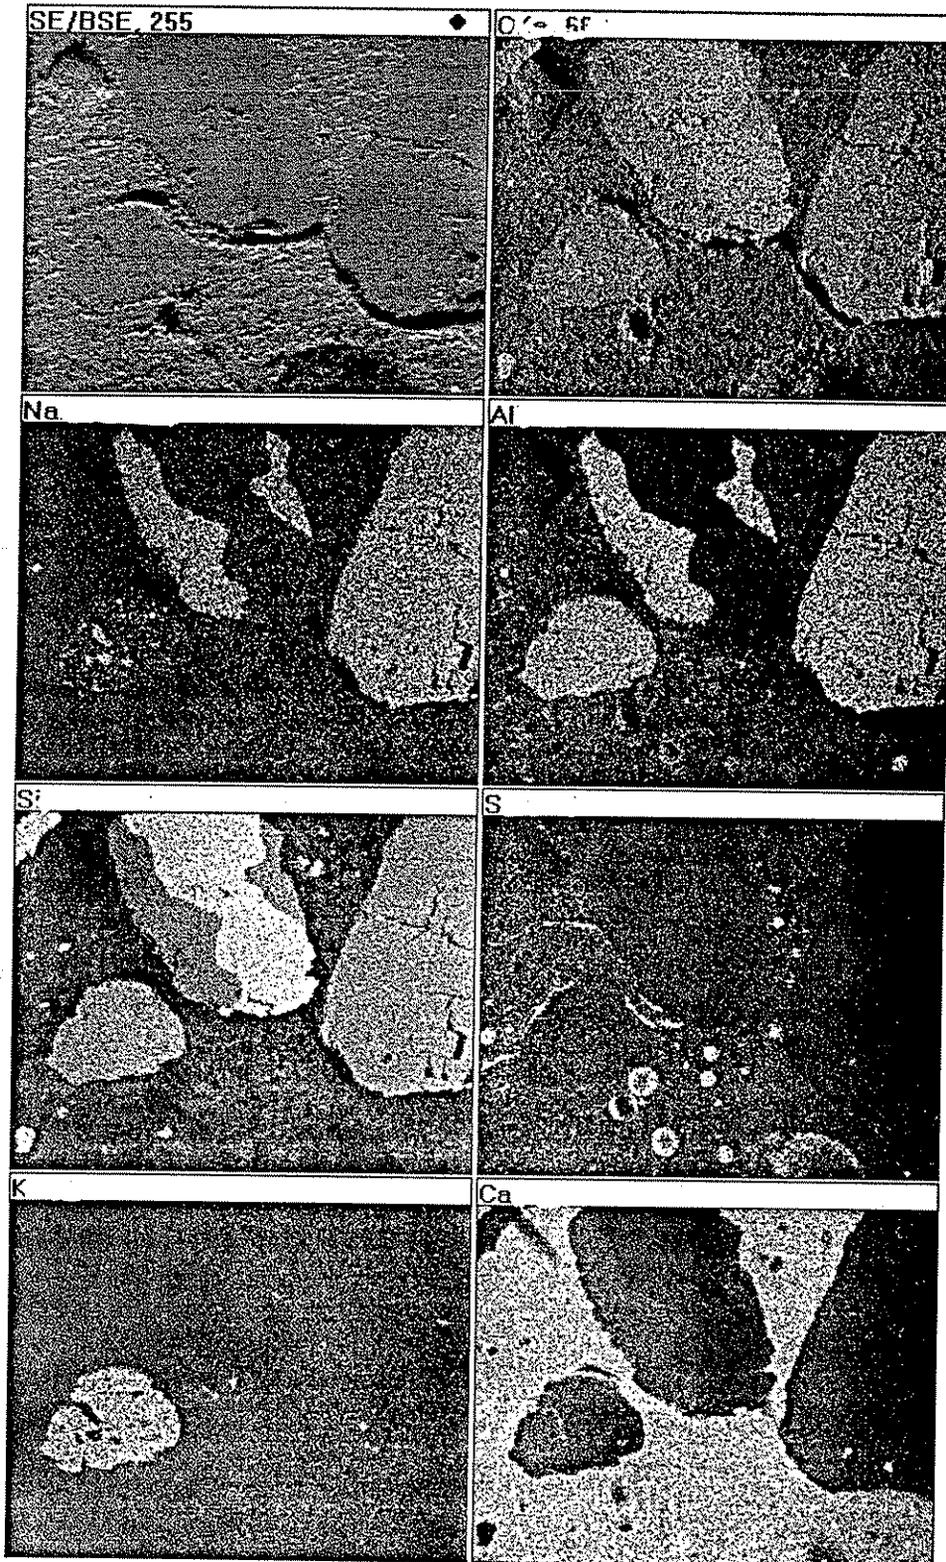
Figure 40. I-35, core 7B, 125X magnification; note gaps around aggregate particles that have been filled with ettringite.

Figure 41. X-ray map of the region shown in Fig. 40; 125X magnification.
