Evaluation of Microcracking and Chemical
Deterioration in Concrete Pavements

Final Report

Iowa DOT PROJECT HR-358

Sponsored by the Highway Division of the Iowa Department of
Transportation and the Iowa Highway Research Board

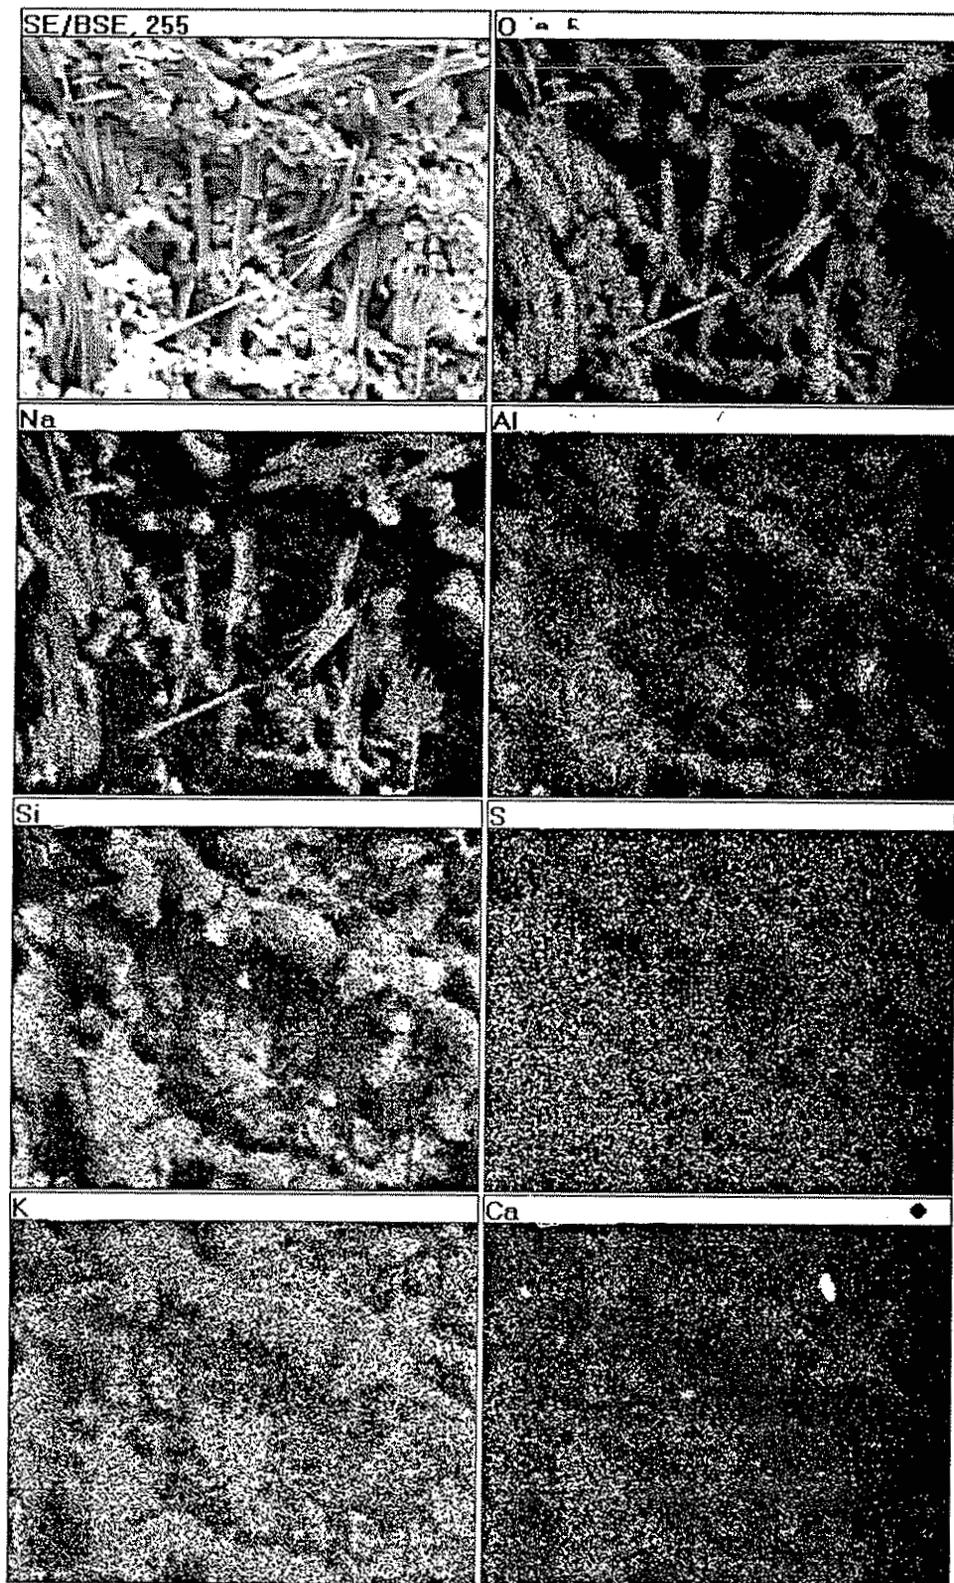
The coarse aggregate appeared to be sound. The fine aggregate contained shale particles that were causing popouts, this was due to the formation of alkali-silica gel (see Figure 42). Needle-like crystals, which were primarily composed of sodium and oxygen (perhaps sodium hydroxide?), were observed during detailed investigation of the popout region (see Figure 43). The exact significance of these crystals is not clear; however, it was noted that the composition of the alkali-silica gel tended to be enriched in potassium and low in sodium.

Figure 43 X-ray map of shale pop-out from I-80, core 24; 2000X magnification.

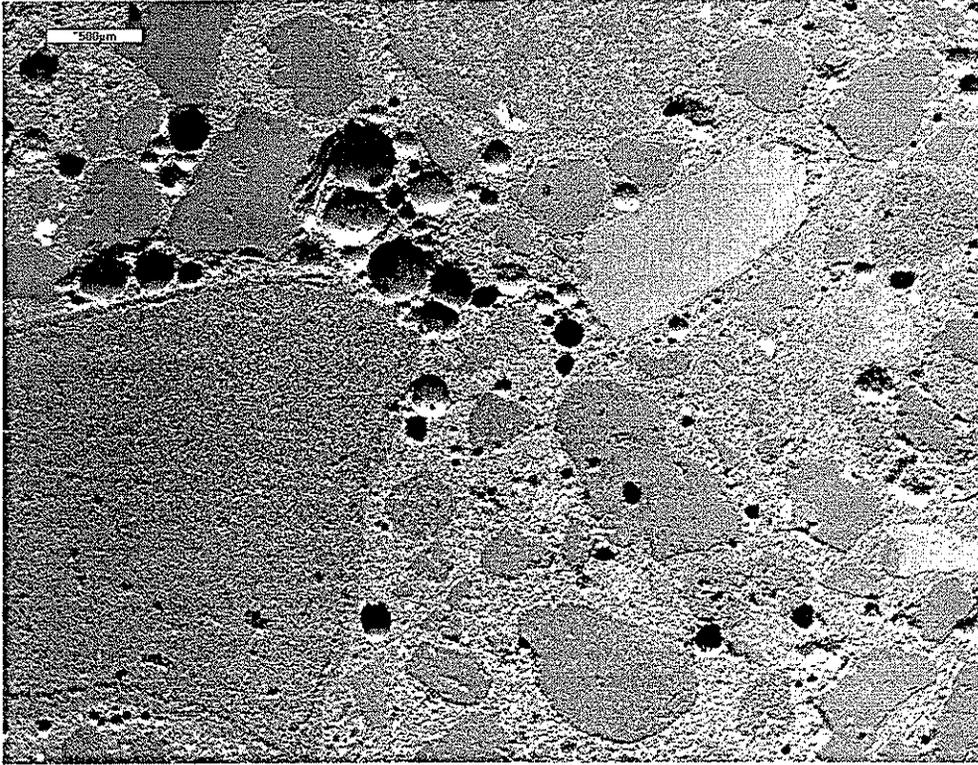
The paste fraction of the concrete was highly variable. Both entrapped and entrained air voids tended to be poorly dispersed throughout the paste. Some regions had virtually no air voids (see Figure 44), while other regions contained many air voids but they were not dispersed uniformly (see Figure 45). Also, it appeared that the tops of the cores from pavement sections containing vibrator trails contained less entrained air than similar cores without vibrator trails (compare Figures 44 and 45 with Figures 46 and 47, note the small change in

Figure 44. I-80, core 21B, 25X magnification.

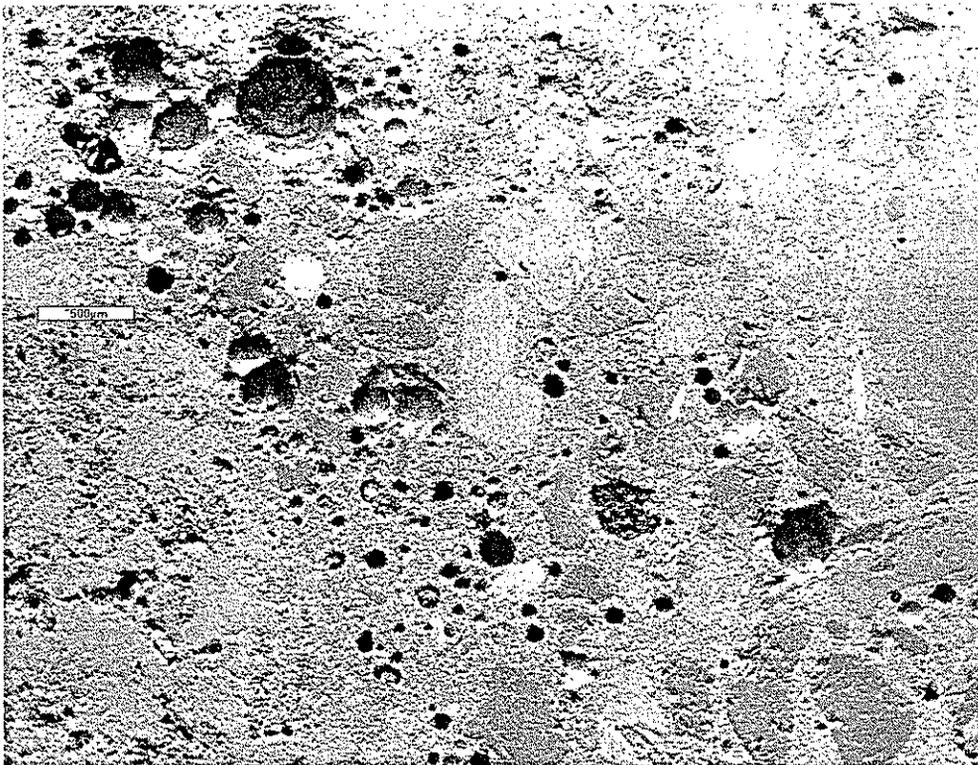
Figure 45. I-80, core 22B, 25X magnification.

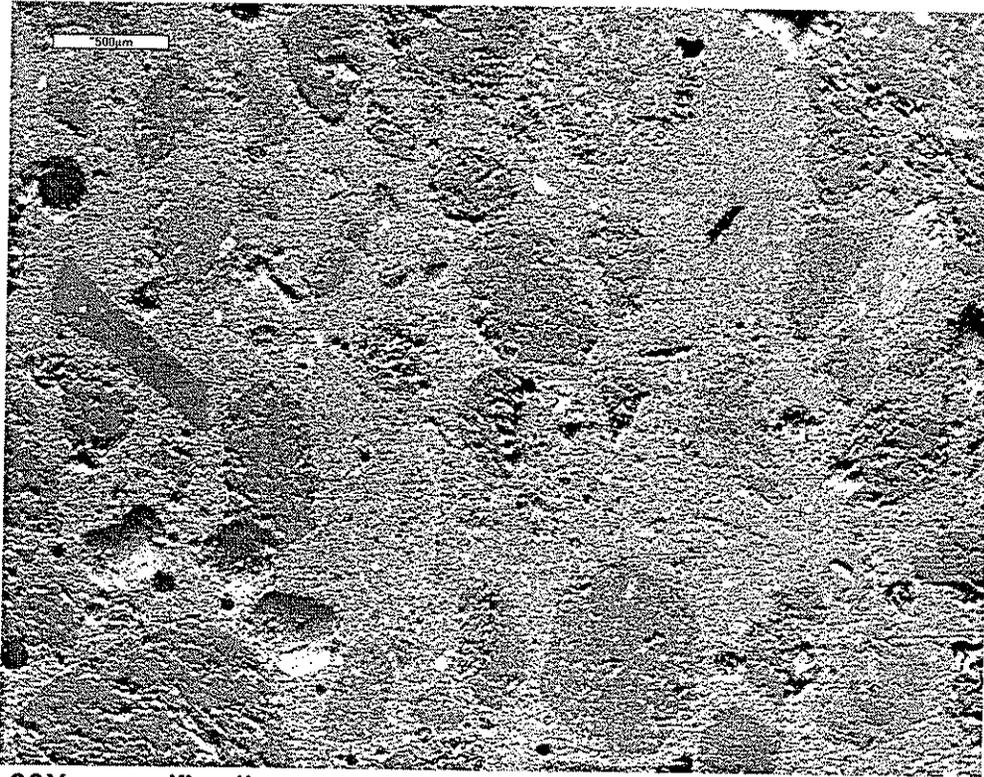
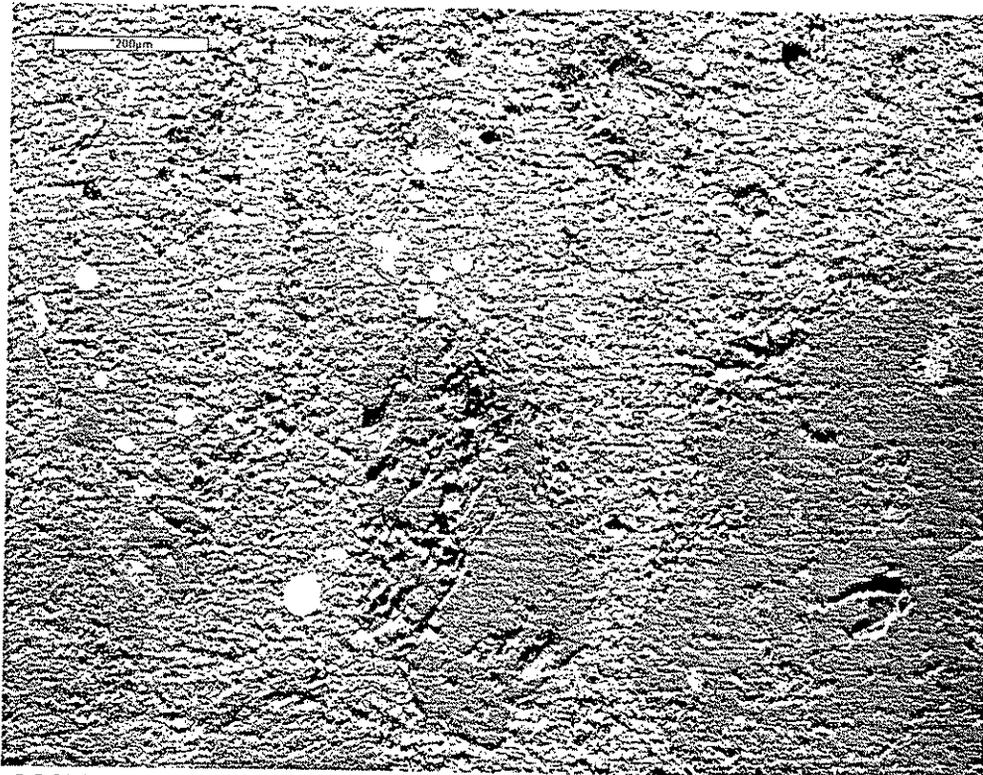
Fly ash also appeared to be poorly distributed in the paste (see Fig. 48). An alternative explanation for the number of fly ash spheres that were observed would be that too much fly ash was batched into the concrete. However, this explanation does not seem as plausible as poor mixing because other paste regions appear to contain virtually no fly ash.

Figure 48. 180, core 22B; note excess fly ash.

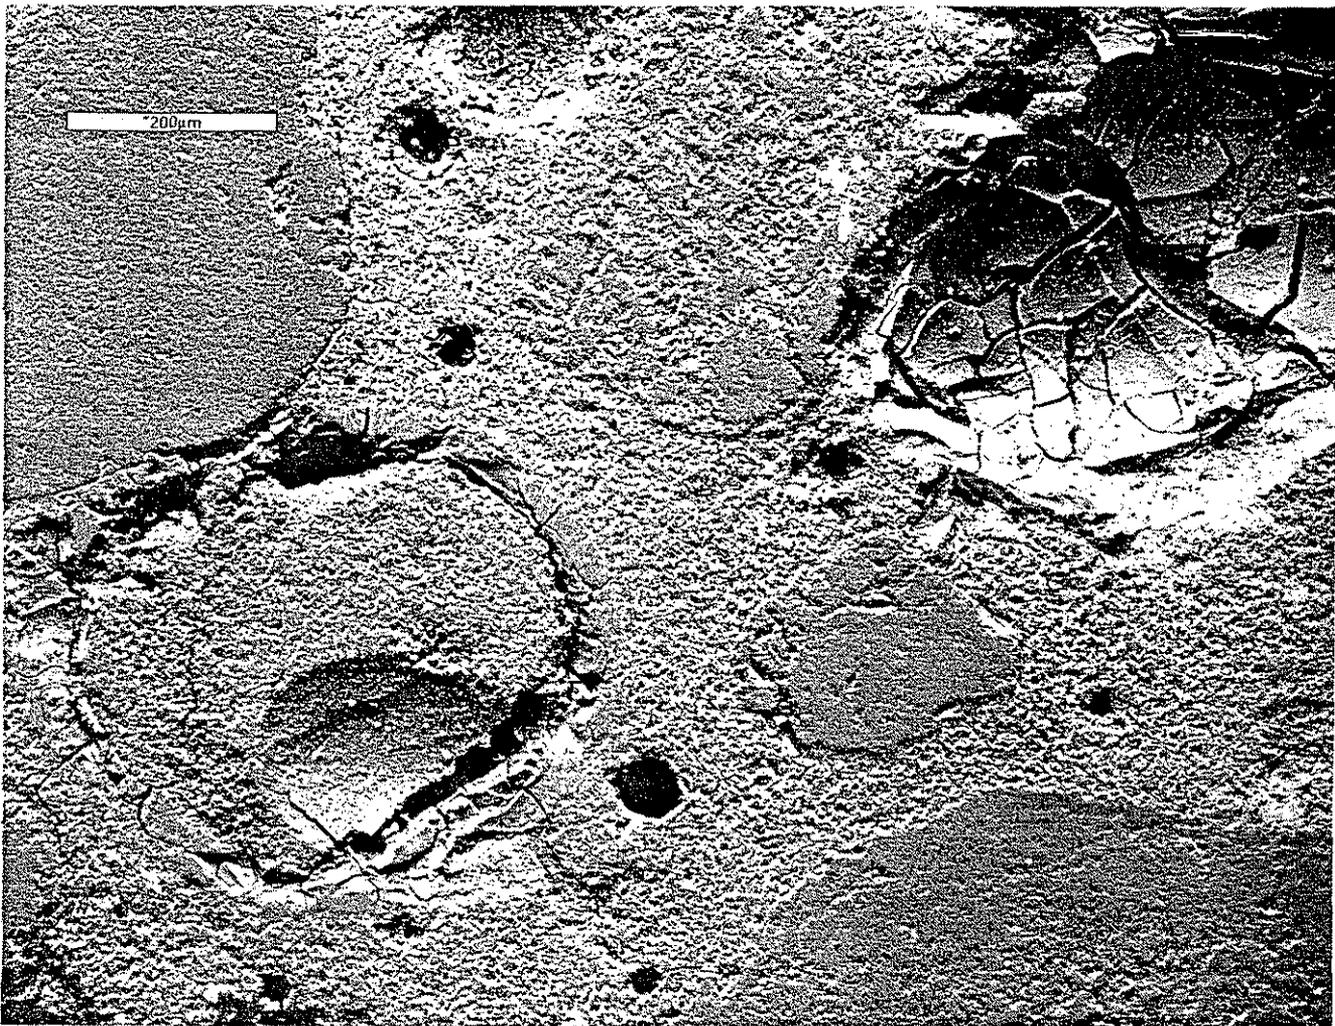
Figure 49. Bettendorf fast track, core 25B, 100X magnification.

The coarse aggregate appeared to be sound. The fine aggregate contained some reactive particles that were in the early stages of alkali-silica related deterioration (see Figures 49 and 50). Cracking related to the formation of alkali-silica gel was minimal; however, some voids lined with gel were observed. Sand-sized dolomite particles were observed in all of the cores.

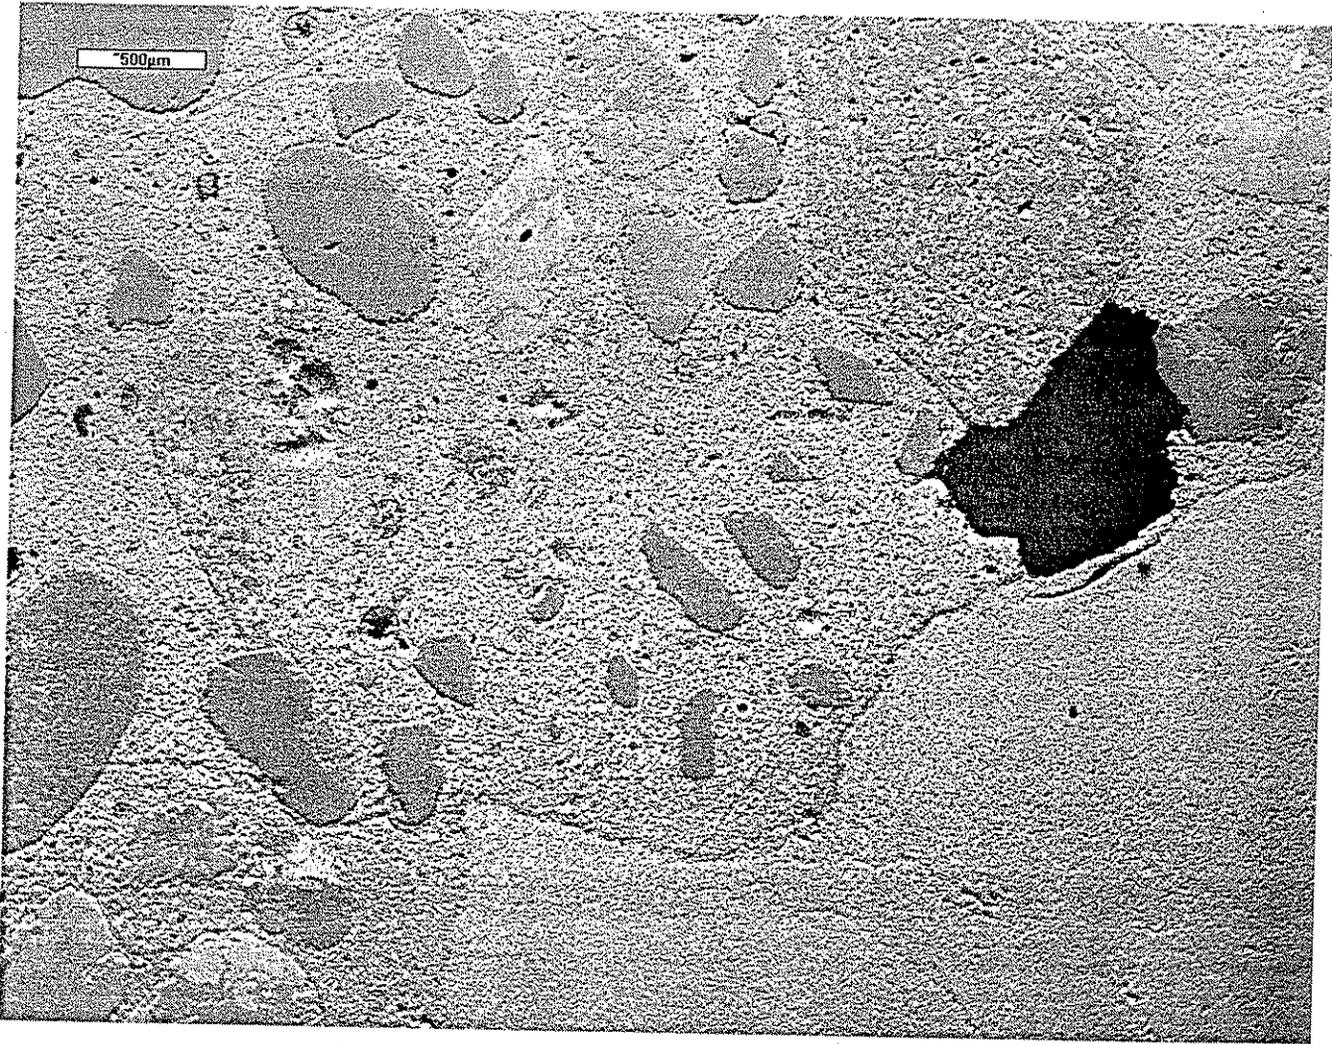
Figure 51. Bettendorf fast track, core 27B, 25X magnification.

to the fact that many of the entrained air voids had been filled with ettringite (see Figures 51 and 52). Also, cracks were often filled with ettringite (note the bright lines in the sulfur and aluminum maps in Fig. 52). Sometimes the air voids even appeared as if they had been distorted during the placement process (note the asymmetric voids in Figure 53). Microcracking was common in the paste and typically went around aggregates and through air voids. Again, in a manner very similar to that which was observed in the cores from I-35, the ettringite-filled cracks tended to propagate several millimeters through the cement paste.

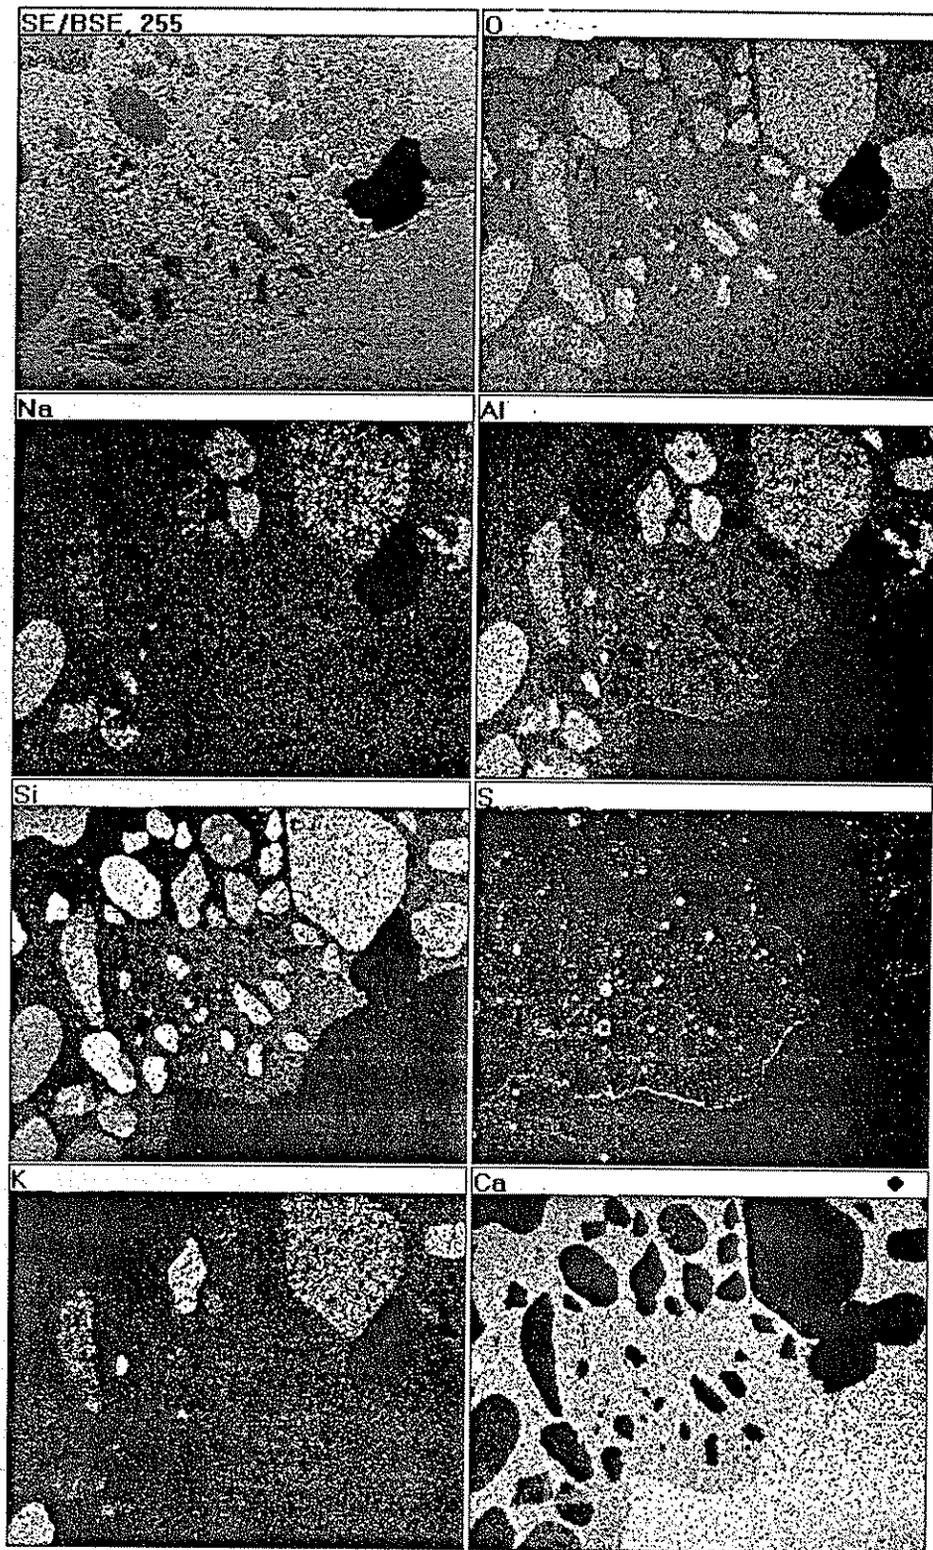
Figure 52. X-ray map of the region shown in Fig. 51; 25X magnification.

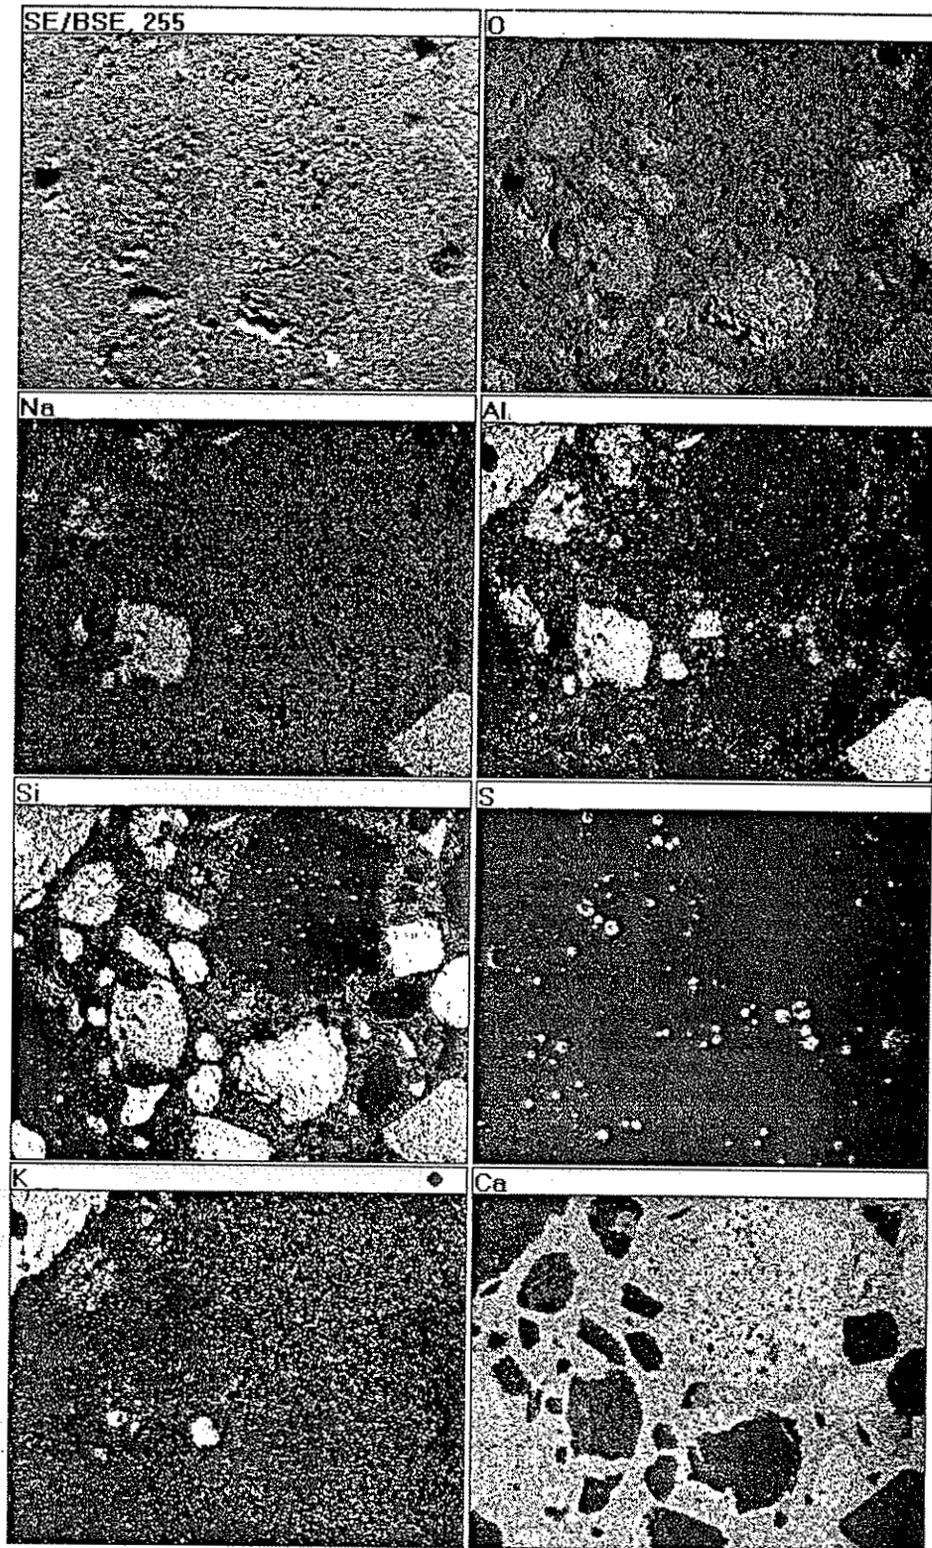
Figure 56. X-ray map from US 169, core 37B; 30X magnification.

Distress was observed in all of the cores taken from the two pavements. Cracking was nearly always oriented subparallel to the top of the pavement. The cracks tended to pass through coarse aggregate particles as they traversed across the samples. Cracking was always severe (this was the most deteriorated concrete that was studied in this project) handling during viewing in a stereo microscope often resulted in specimen breakage.

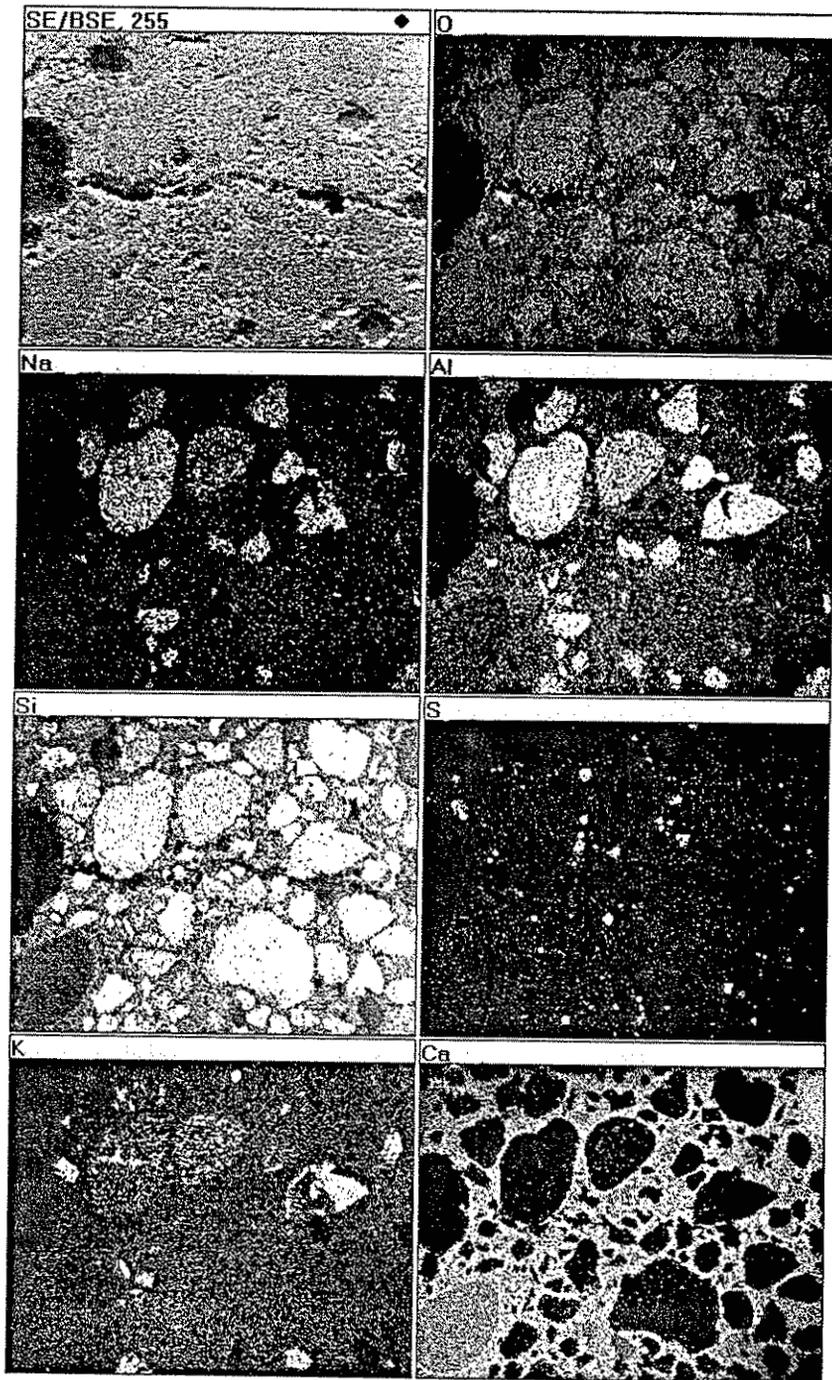
Figure 57. X-ray map from IA 25, core 45B; 20X magnification.

The coarse aggregate was extensively cracked in both sets of cores. This was most frequent in the cores from Highway 25, where over 50% of the coarse aggregate particles exhibited cracks. The cracks in the coarse aggregate particles were not filled (i.e., little evidence of ettringite or gel products). The fine aggregate looked sound and very few shale particles were observed. Sand-sized dolomite particles were observed in all the cores from IA 25, and core number 40 from US 169.

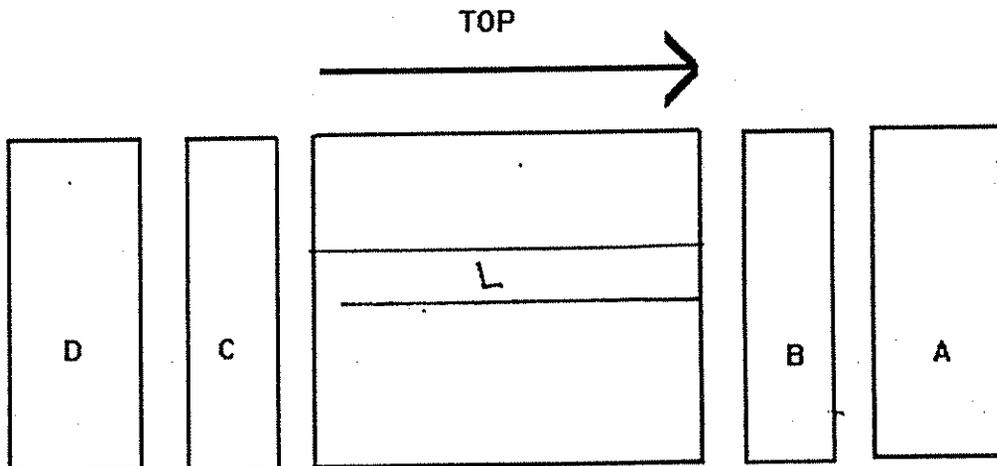
SAMPLE IDENTIFICATION: # 21, DALLAS Co., I-80, STA 726+60 EB LANE

CRACKED THROUGH CENTER OF
TOP SURFACE EXTENDING $\hat{=}$ 3cm INTO SAMPLE.

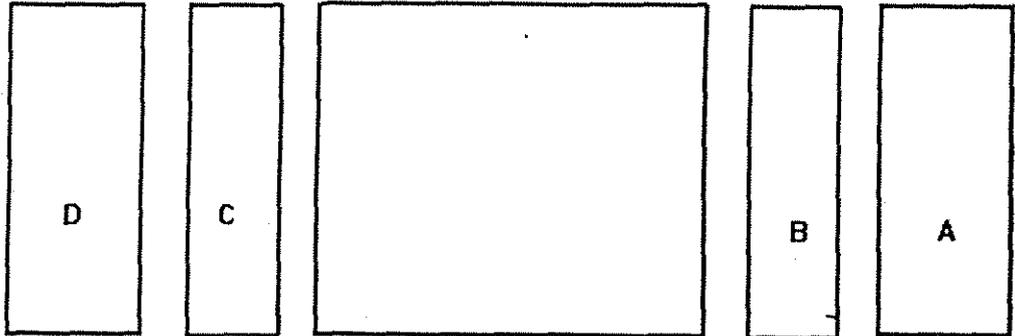
NO CRACKS NOTED

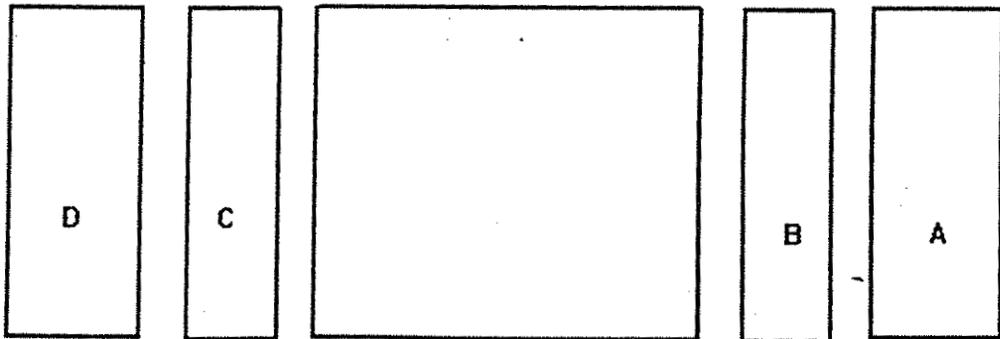
NO CRACKS NOTED

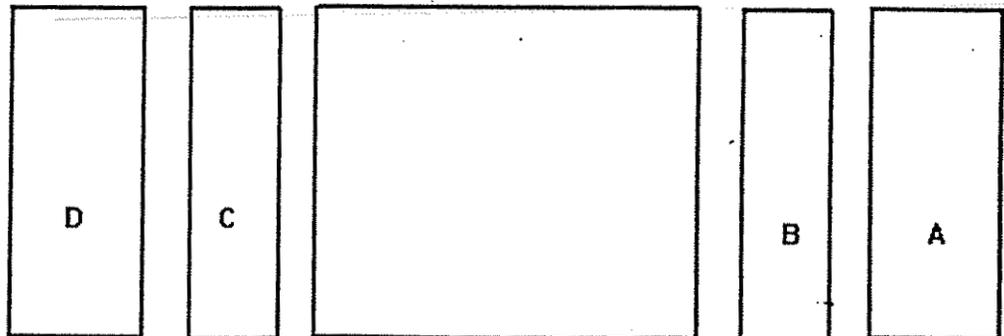
Distinctive Features: CRACKED ON TOP SURFACE

APPRECIABLY INTO SAMPLE.

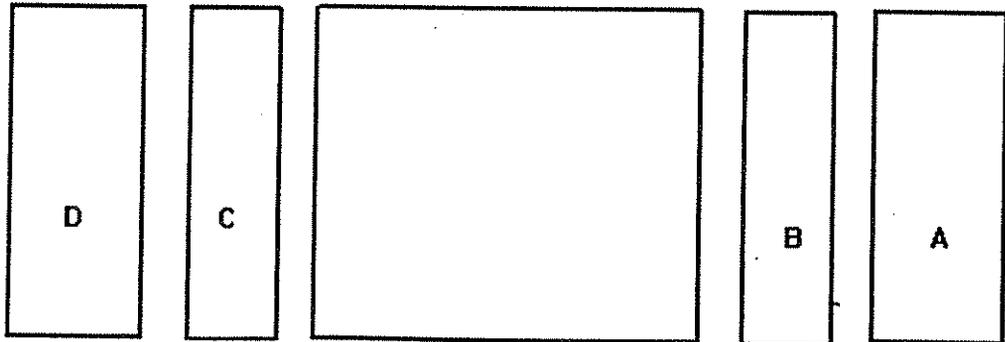
NO CRACKS NOTED

THOUGH NOT VERY LARGE (1/2 cm diameter).

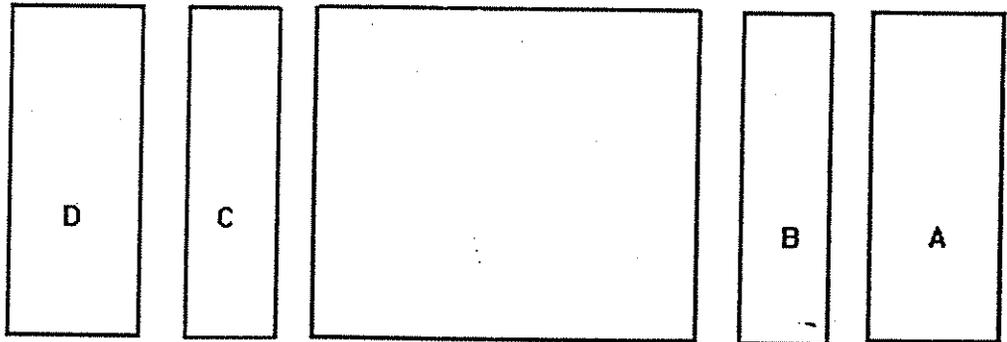
Cracks and Other Distinctive Features: NO CRACKING NOTED.

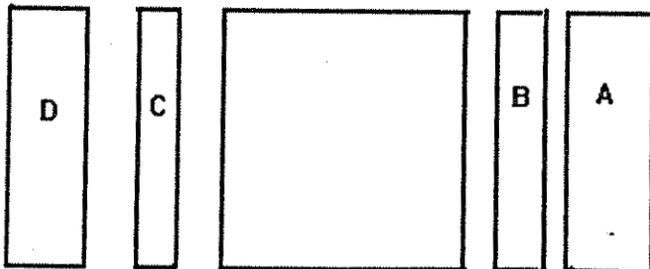
Cracks and Other Distinctive Features: NO CRACKS PRESENT

Note rims on aggregates

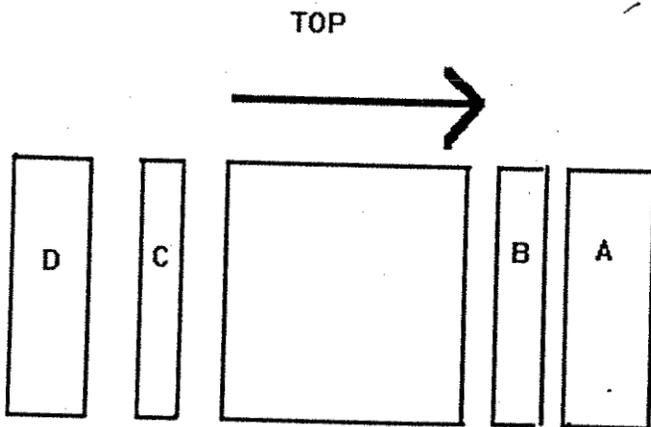
Distinctive Features: NO CRACKS NOTED, CHIP TAKEN OUT OF TOP (MAY HAVE OCCURRED WHILE DRILLING)

Note discoloration around course agg.

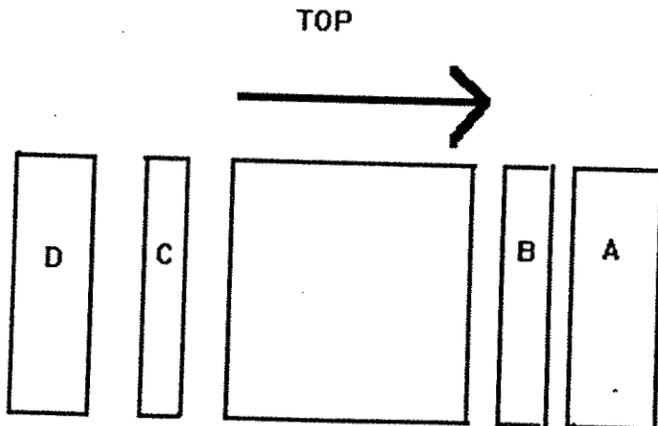
Distinctive Features: NO CRACKS NOTED

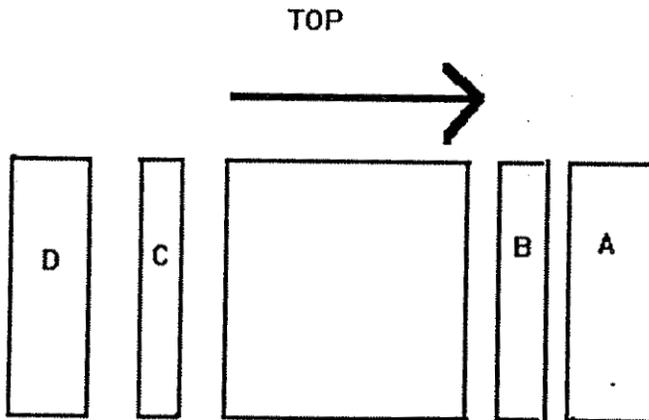
Top- TILES, BADLY WORN SURFACE.

Distinctive Features: NO CRACKS NOTED, MANY

SMALL VOIDS AROUND AGGREGATE

Extremely soft!! - simple sawing plucked out
Note rims around aggregates; *material*

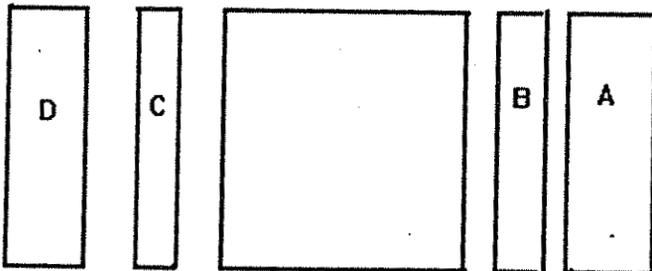
Top- TINES, BADLY WORN SURFACE

Distinctive Features: NO CRACKS NOTED, NUMEROUS SMALL HOLES

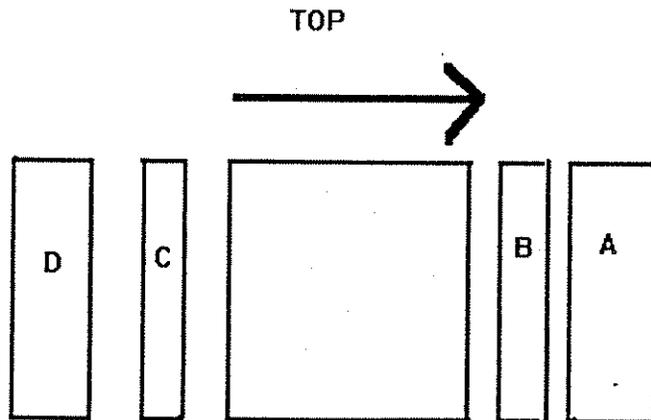
Top- TINES, BADLY WORN, LARGE PITS DEVELOPED

Distinctive Features: NO CRACKS NOTED, NUMEROUS SMALL VORES

OK Check mix design on these cores

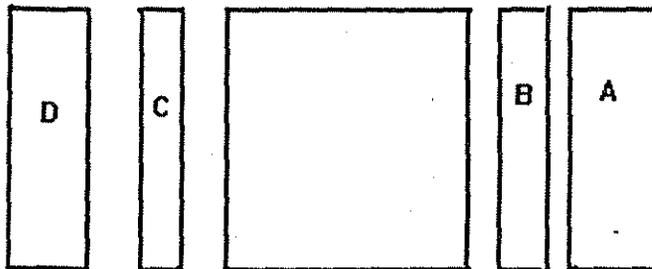
Top- TINES BADLY WORN, PITTING \approx 2CM X 2CM

Distinctive Features: NO CRACKS, NUMEROUS SMALL PITS

NEARLY ALL IN TOP 1/3 OF SAMPLE.

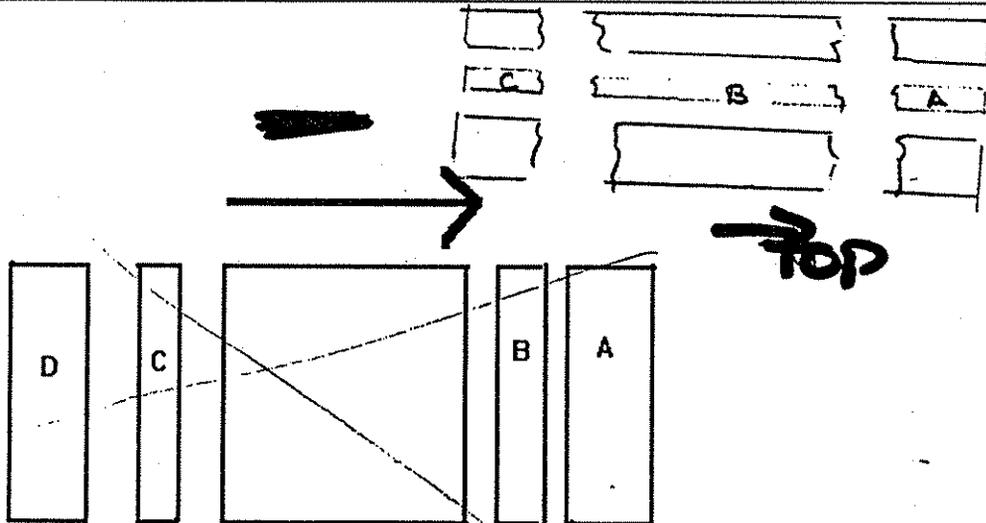
Distinctive Features: COMPLETELY BROKEN INTO THREE PIECES

NUMEROUS OTHER CRACKS, ALL PARALLEL TO TOP SURFACE.

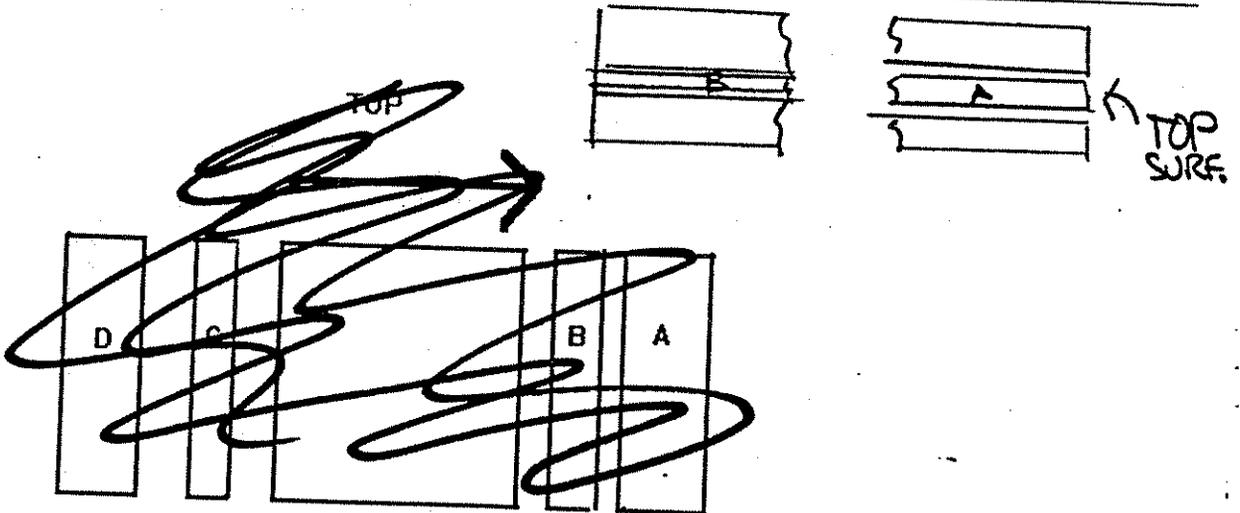
Distinctive Features: BROKEN @ 29.5 cm FROM TOP SURFACE.

OTHER CRACKS NOTED THROUGHOUT SAMPLE

CRACK IN TOP SURFACE PERPENDICULAR TO

TINES, NOT EXTENDING DOWN INTO SAMPLE.

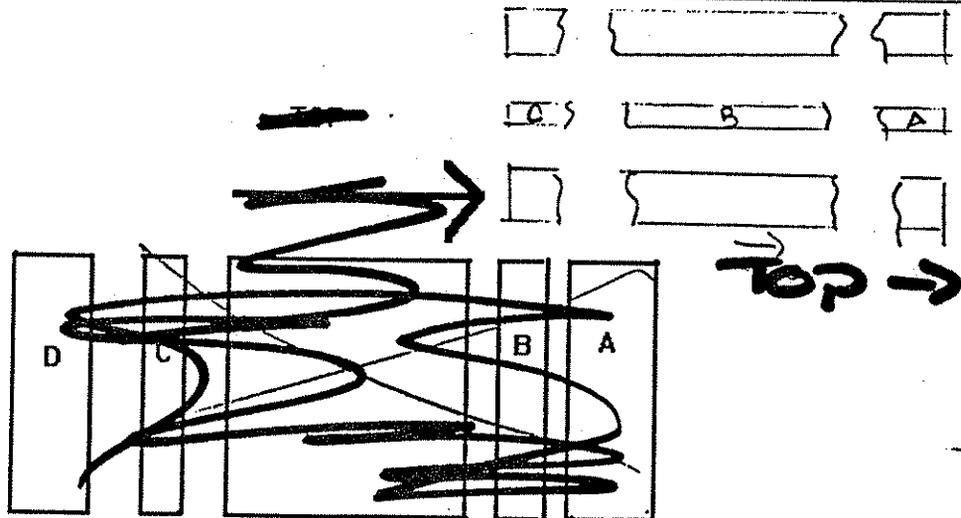
Distinctive Features: CRACKS PARALLEL TO TOP SURFACE

THROUGHOUT SAMPLE. BROKEN @ APPROX 5 + 13 CM FROM TOP SURFACE. A SMALL CRACK IN TOP SURFACE PERPENDICULAR TO TINES.

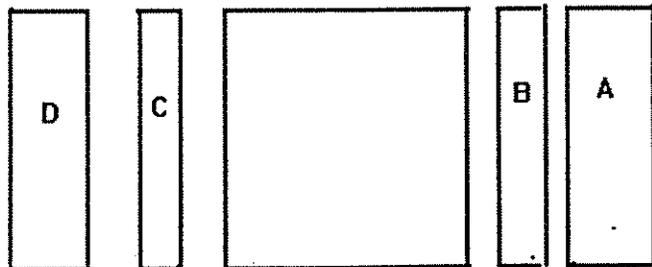
Distinctive Features: NO CRACKS NOTED. LARGE VOIDS

(2cm x 7mm, 5mm x 5mm) NOTED. SHALE CONTENT
SEEMED HIGH.

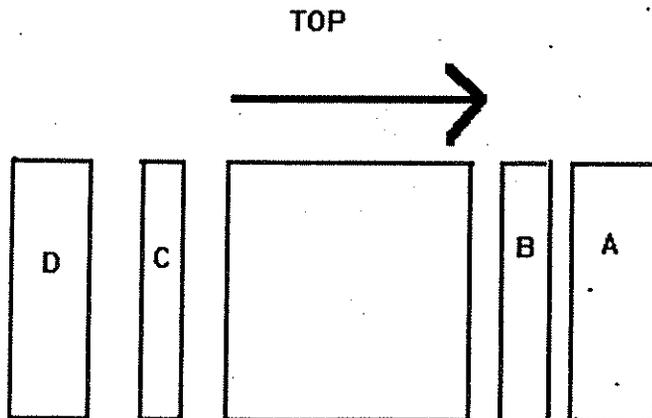
Distinctive Features: NO CRACKS NOTED. NUMEROUS VOIDS

approx 1cm diameter AVERAGE. SHALE CONTENT
NDA.

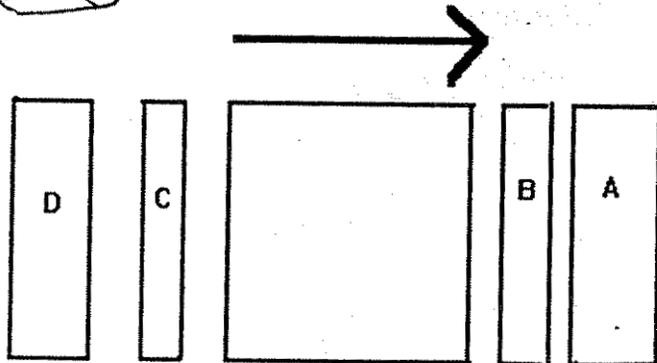
Distinctive Features: NO CRACKS PRESENT, NUMEROUS

SMALL HOLES (0.5cm) ESPECIALLY NOTED AROUND
LARGE AGGREGATE,

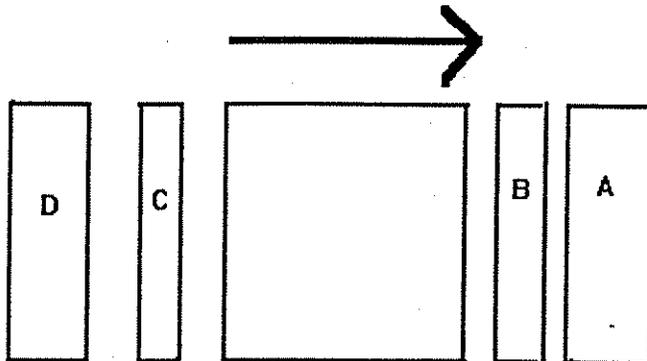
Distinctive Features: CRACKED @ 0.5cm FROM BASE, VOIDS CONCENTRATED

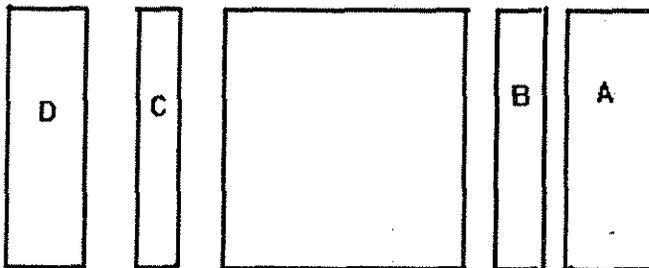
Distinctive Features: NO CRACKS NOTED, A LARGE NUMBER

OF VOIDS CONCENTRATED AROUND LARGE
AGGREGATE.

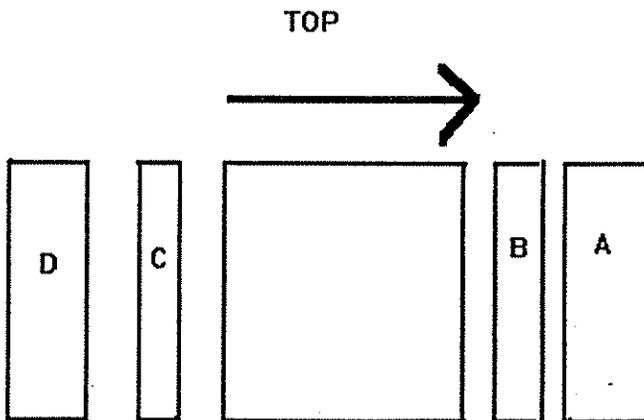
Distinctive Features: NO CRACKS NOTED. VOIDS CONCENTRATED

AROUND AGGREGATE.

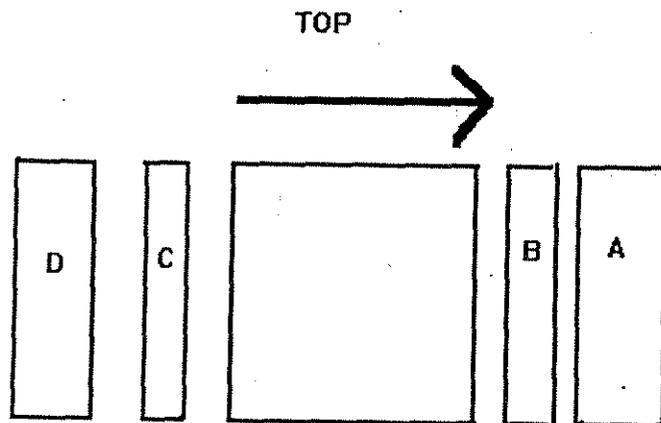
Distinctive Features: CRACK @ 19 cm FROM TOP (MAY HAVE

AROUND AGGREGATE. MANY VOIDS IN AGGREGATE

THROUGHOUT ENTIRE SAMPLE.

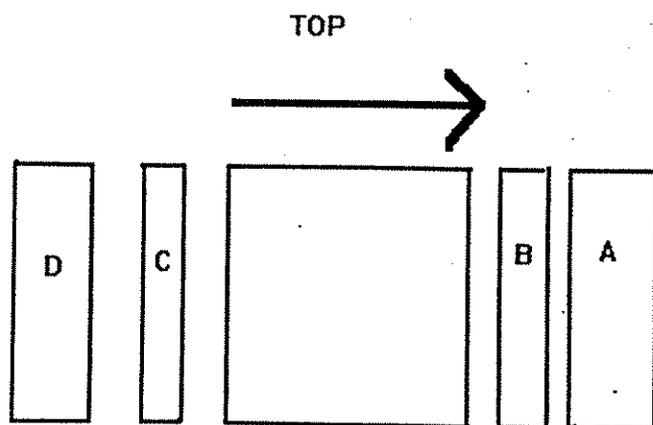
Distinctive Features: NO CRACKS NOTED, APPROXIMATELY1 cm OF SPALLING OCCURED ON PART OFTHE SAMPLE BOTTOM. APPEARS TO HAVEAGGREGATE RXNS. VOIDS IN MAN? OF AGGREGATE;VOIDS IN PASTE CONCENTRATE AROUND AGGREGATE.

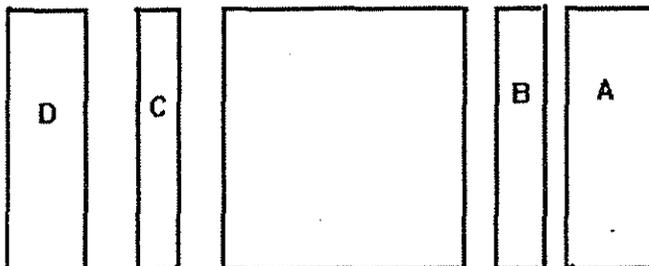
Distinctive Features: CRACKED 0.5 cm FROM BOTTOM OF SAMPLE

W/ SOME SPALL OFF. VOIDS CONCENTRATED AROUND

AGGREGATE. ALSO, VOIDS IN MUCH OF AGGREGATE.

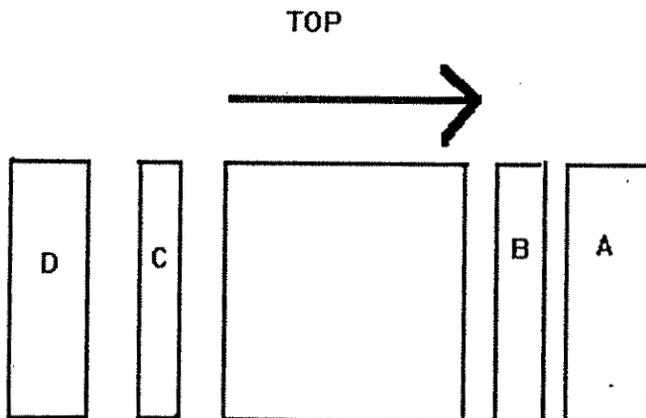
SAMPLE IDENTIFICATION: 53, BUCHANAN Co., U.S. 20, STA 385+64, EB LANE
(JOINT, NO VIB TRAIL)

Distinctive Features: NO CRACKS NOTED. VOIDS CONCENTRATED

AROUND AGGREGATE. ALSO, VOIDS IN MUCH
OF AGGREGATE. LARGE VOIDS CONCENTRATED
IN TOP 1/3 OF PASTE.
