# Flame Hardened Snow Plow Blades

Final Report

RB13-012

## **SPR Equipment Purchase Final Report Flame Hardened Underbody Plow Blades**

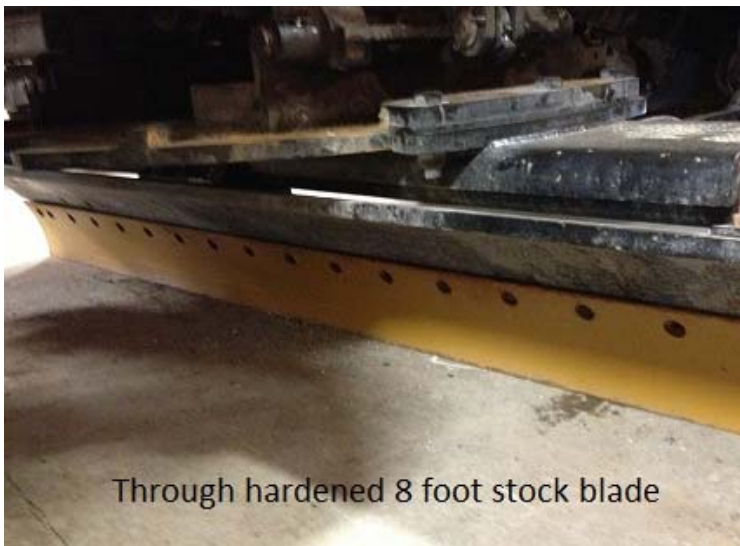
Seventy-five percent of the flame hardened blades were found to have vertically broken into two or more pieces causing one garage to remove the blade with usable life remaining due to safety concerns. The testing garages indicated that this is not typical with our current blades.

Of the garages that reported the type of road surface the blades were used on, an equal amount reported plowing on Portland cement and Asphaltic concrete, with the remaining reporting they plowed on Portland cement that has been resurfaced with Asphaltic Cement concrete. Cracked or broken flame-hardened blades were reported on all three surfaces.

Broken Flame Hardened 8 foot test blade

It is not recommended that the DOT pursue the purchase of these blades at this time due to the increased cost without seeing significantly increased lifespan and the safety concerns associated with broken blades.
