# Laboratory and Field Testing of an Accelerated Bridge Construction Demonstration Bridge: US Highway 6 Bridge over Keg Creek

**Final Report**  
**April 2013**

**Sponsored by**  
Federal Highway Administration  
Iowa Department of Transportation  
(InTrans Project 11-411)

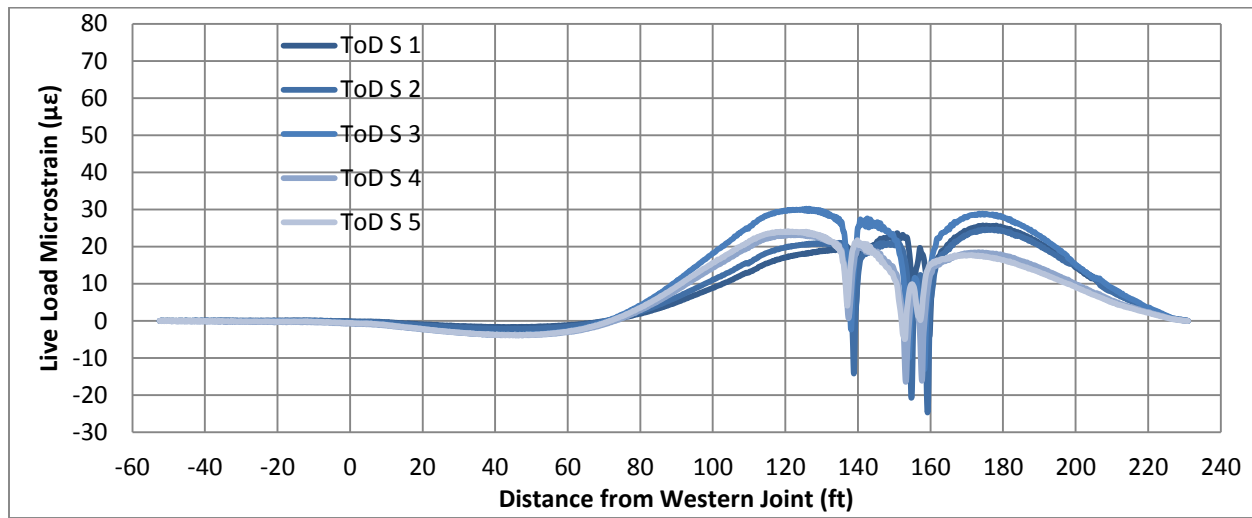
**Figure 4.7. Representative data from load path 3 of 2011 live load strains of top of deck gauges south line**

There is a distinct difference in the behavior between the north and south lines of the surface-mounted gauges. Reviewing the results from the gauges mounted on the top of the deck along the south instrumentation line, all recorded strain values were very similar throughout the test with maximum strain values being recorded by the transducer located at the centerline of the UHPC joint, which is to be expected. This can be seen in Figure 4.7.

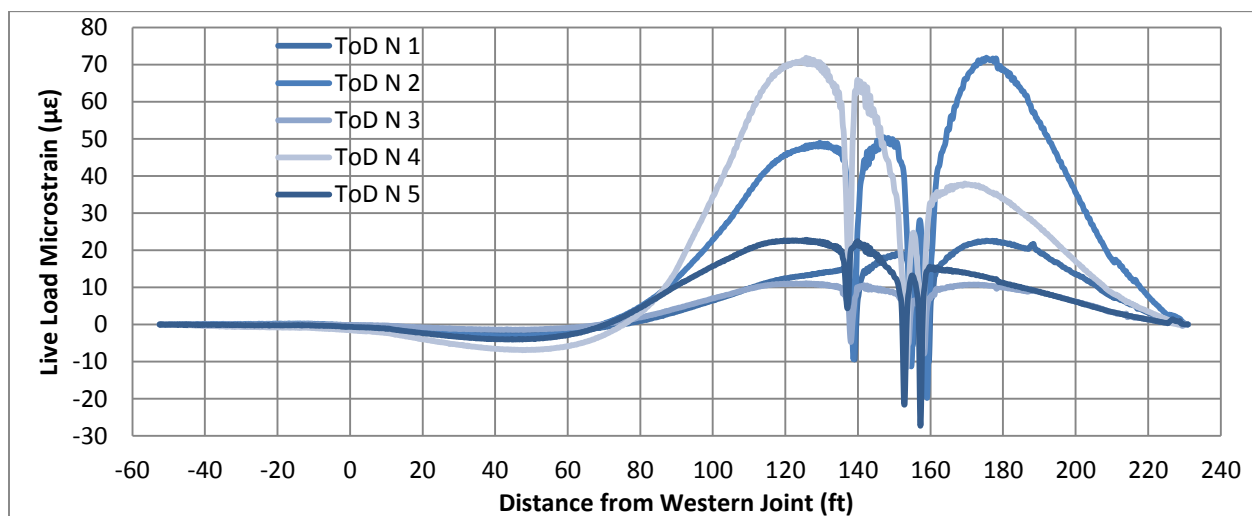
**Figure 4.8. Representative data from load path 3 of 2011 live load strains of top of deck gauges north line**

For the north line of gauges on the top of the deck, much greater maximum strain values were recorded consistently by the transducers spanning the interface between the HPC precast deck panels and the transverse UHPC joint. Figure 4.8 also shows that these interface gauges are reading significantly higher strains than adjacent gauges along the same north line.

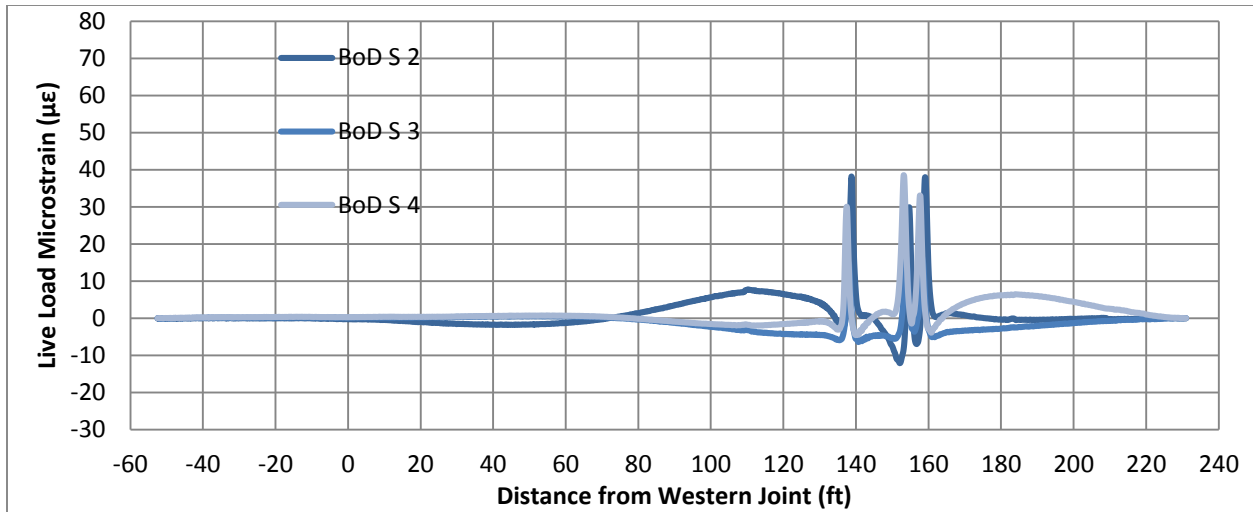
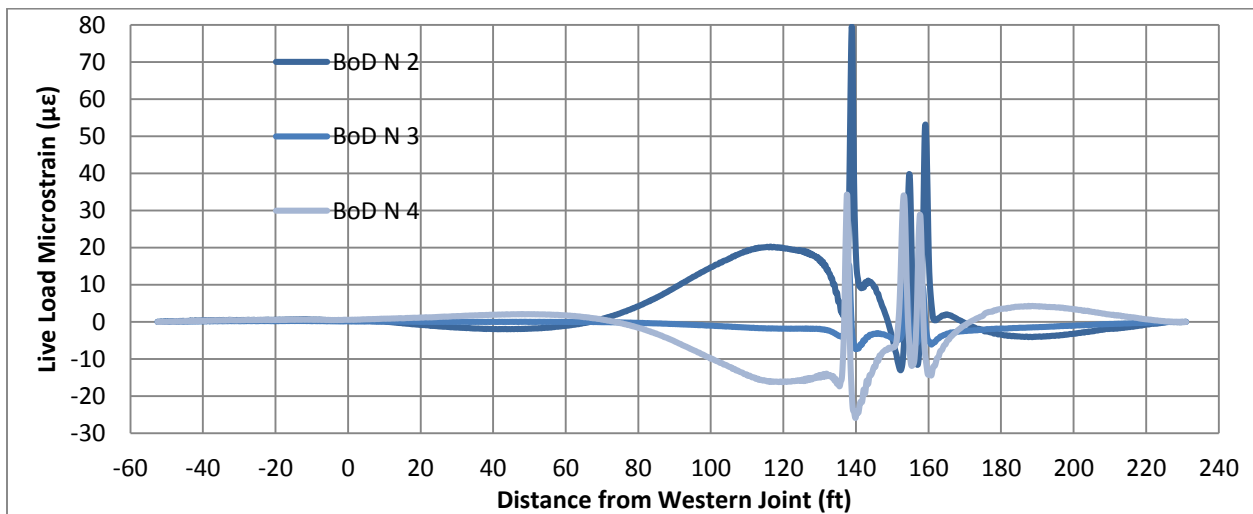
Similar behavior was found in the gauges attached to the bottom of the deck in that there are noticeably higher strains recorded in the north line of gauges as can be seen when comparing Figure 4.9 and Figure 4.10. This could imply failure to fully develop a bond between the UHPC and HPC consistently throughout the transverse joint as was seen in the laboratory testing.

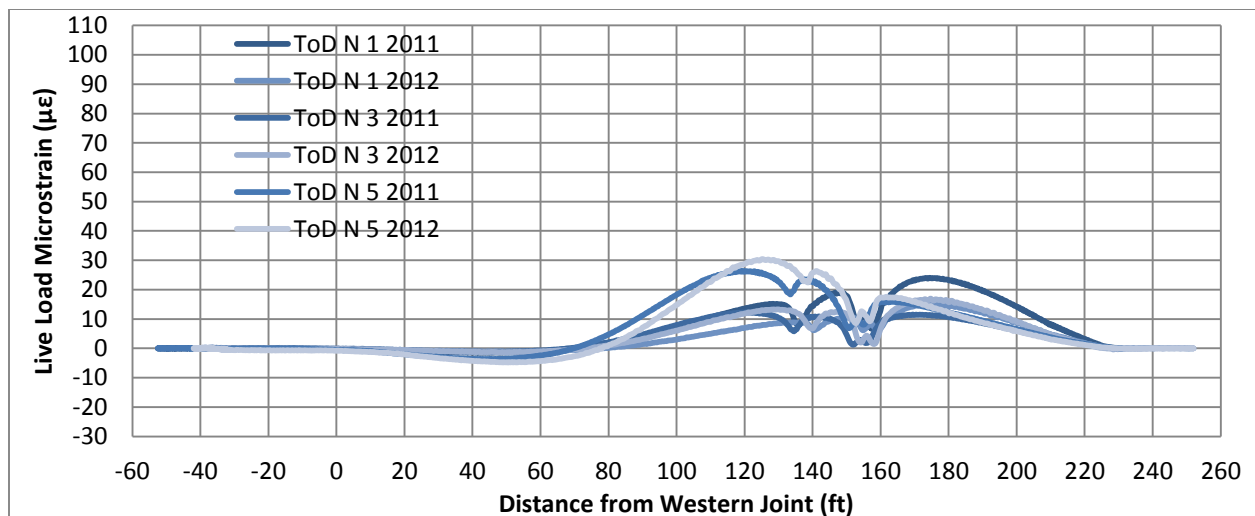
**Figure 4.12. Comparison of live load strains from 2011 to 2012 of surface-mounted transducers away from interface load path 2**

There also seems to be a consistent increase in maximum strain values between the 2011 and 2012 test with almost all maximum strains now being found at the HPC/UHPC interface locations. The most drastic increases in strains seem to be occurring at these interface locations

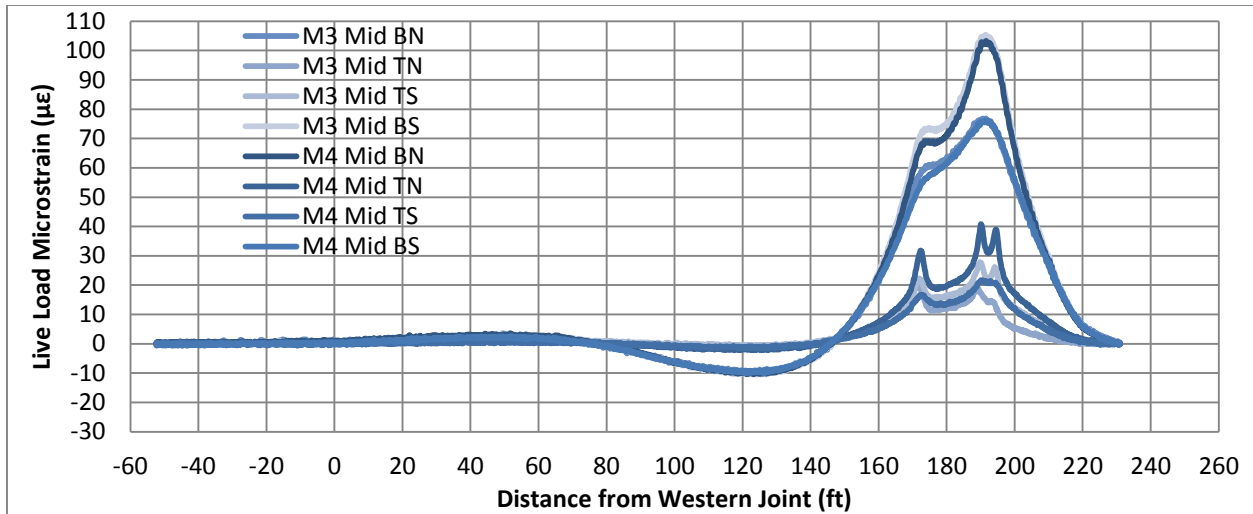
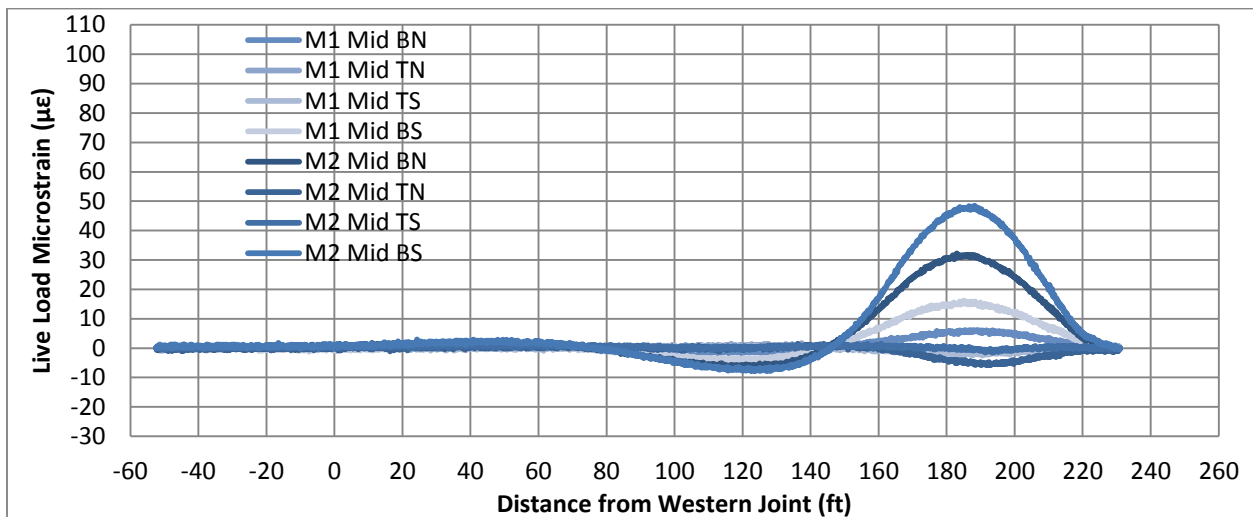
The results also show a difference in strain response between the more heavily loaded girders and the girders farther away from the load path, while the test truck is on the east end span. For girders farther away from the load path, strain values recorded in the bottom flange are tensile strains while strains in the top flange are recorded as compressive strains, indicating the neutral axis is located somewhere within the steel beam.

For modules 1 and 2 the neutral axis is typically calculated between 24 and 29 in. from the underside of the bottom flange of the steel girders which are W30X99 steel beams having a depth of 29.65 in. For the girders underneath the load path, transducers on both the bottom and top flange are recording tensile strains, indicating a neutral axis above the top flange.

These results are not necessarily unexpected due to the precast deck panels being compositely constructed with the steel girders, but the extent to which the neutral axis is above the steel girders is unexpected. At the extreme, the neutral axis is calculated to even exceed the height of the precast deck by as much as 10 in. (This is discussed further later in this report.)

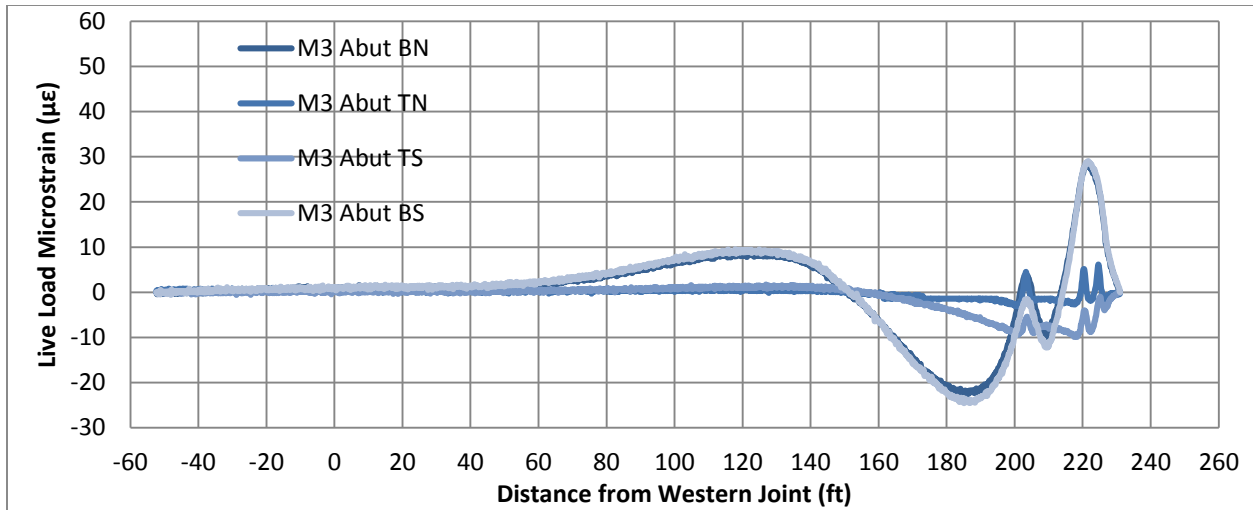
**Figure 4.19. Representative data from load path 3 of 2011 live load strains for steel girders of module 3 at abutment**

For gauges located at the abutment, maximum strains were recorded as tensile strains in the girders closest to the specified load path after the front axle of the truck had exited off of the bridge while the rear axle was still on the east end span. These maxima were seen in the bottom flange registering just over +30  $\mu\epsilon$ . Another local maximum occurs as the test truck is near the midspan of the east end span. When the test truck is located at this position, the bottom flange of the girders at the abutment registers compressive strains indicating a negative moment at the abutment as expected due to the semi-integral abutments. Strains recorded in the top flange of the girders at the abutment never registered above 10  $\mu\epsilon$ , tensile or compressive.

A representative data set is shown in Figure 4.19 for gauges mounted to the girders under module 3 at the abutment for load path 3 showing this behavior. Due to the stopping of data collection in the 2011 test immediately after the rear axle passed the east joint, full behavior of the semi-integral abutment was not able to be seen, but is discussed in greater detail in the subsequent section related to the 2012 test data.

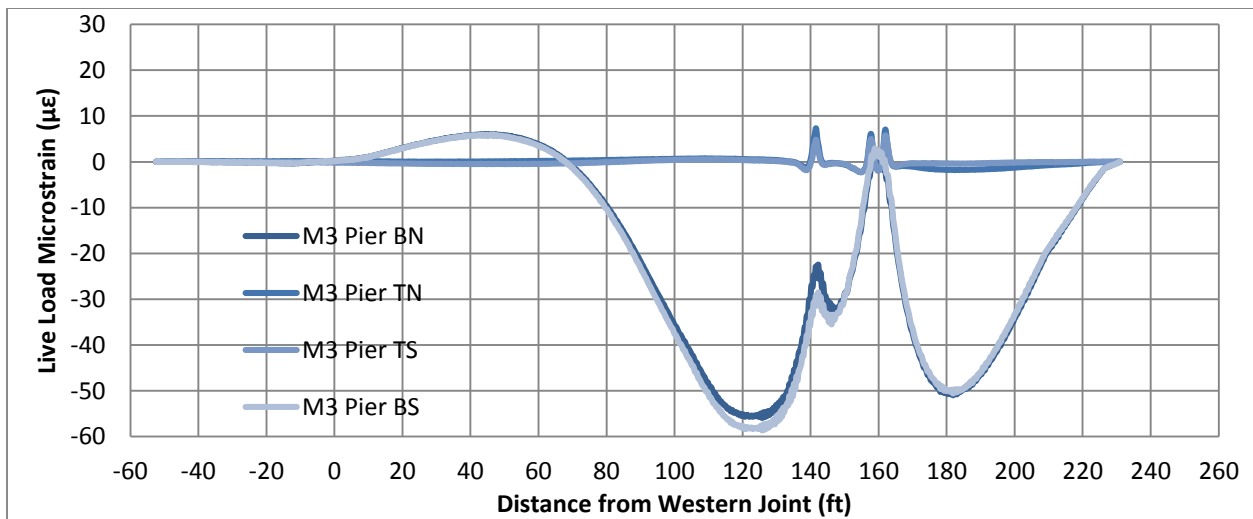
**Figure 4.20. Representative data from load path 3 of 2011 live load strains for steel girders of module 3 at pier**

For gauges located at the pier, maximum strains were recorded as compressive strains in the bottom flange of the girder closest to the specified load path as the truck approached the pier from the west. Compressive strains in the bottom flange imply a negative moment region at the pier. This is to be expected based on the fact that the bridge was designed to be continuous for live loads. The greatest strains recorded in the top flange of the girders at the pier location never registered above 10  $\mu\epsilon$ , tensile or compressive. A representative sample of these data from load path 3 is shown in Figure 4.20.

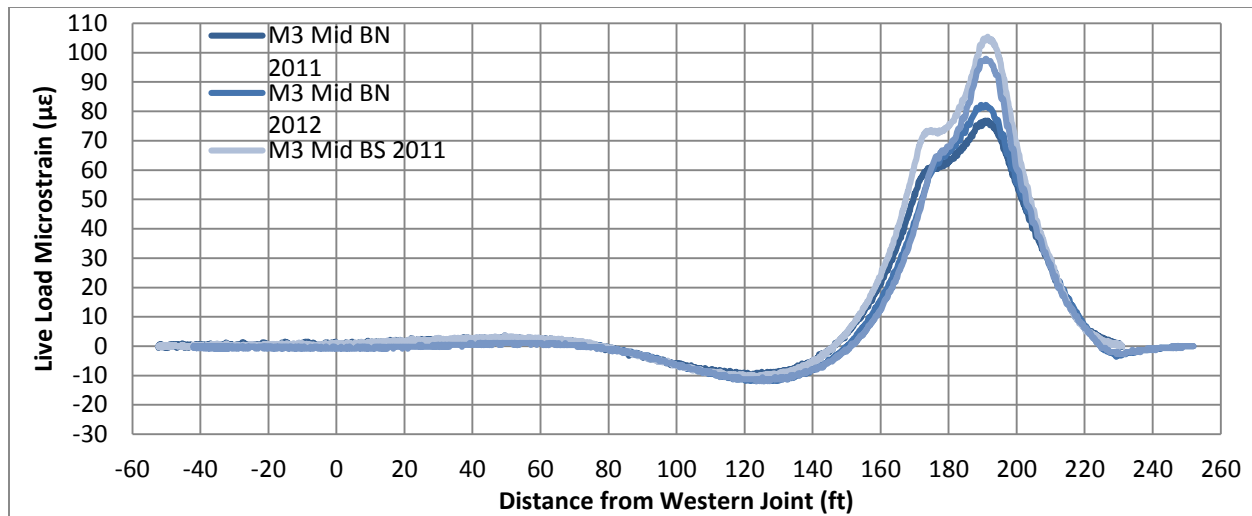
**Figure 4.21 Comparison of live load strains from 2011 to 2012 of transducers on bottom flange of girder at midspan for module 3 from load path 4**

Figure 4.21 and Figure 4.22 show comparisons of representative samples of data between the 2011 and 2012 test for module 3 strains recorded in the top and bottom flanges for load path 4.
