## Analysis of Existing Work-Zone Devices with MASH Safety Performance Criteria

Final Report February 2009

## MIDWEST ROADSIDE SAFETY FACILITY

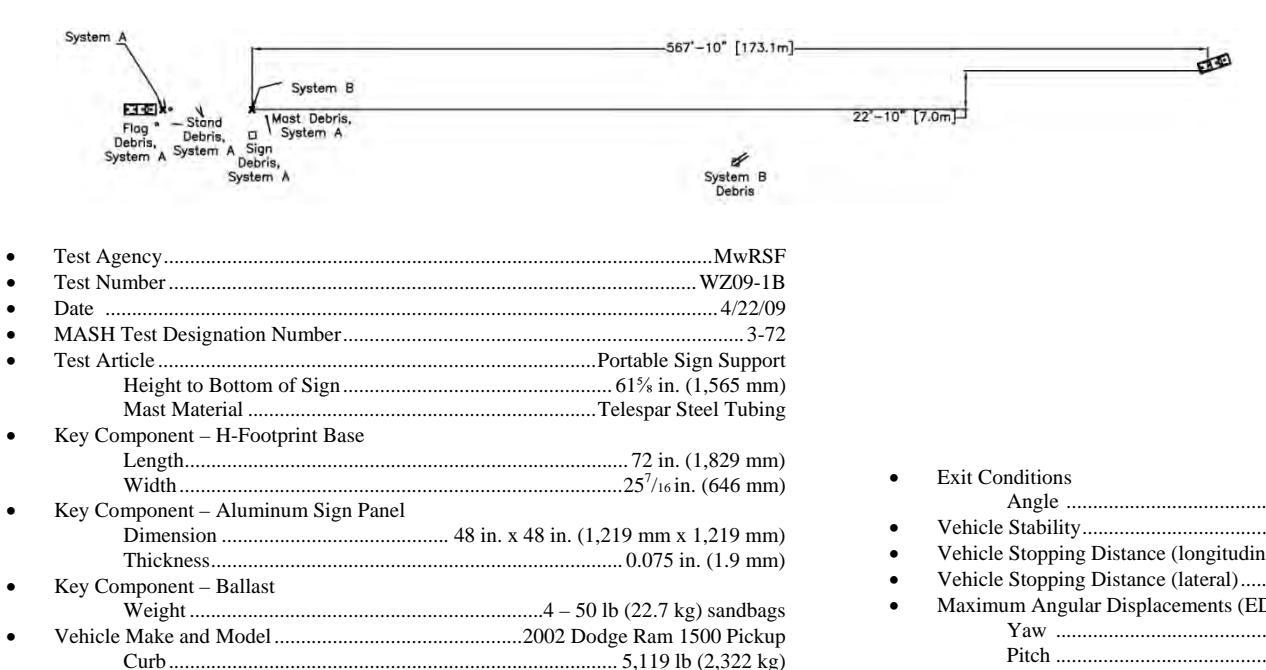
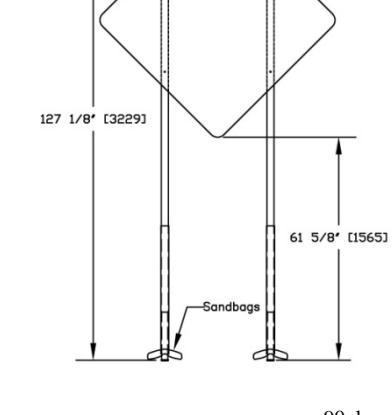
Figure 46. Summary of Test Results and Sequential Photographs, Test No. WZ09-1B

System No. 1B encountered moderate damage. The impact-side leg fractured at the vertical stub and was bent onto itself. The non-impact side leg fractured at the vertical stub and was bent moderately. The impact-side mast was dented above the outer sleeve. The bottom of the

non-impact side outer sleeve, mast, and vertical sleeve had a crease and were dented in. Tearing in the sign panel occurred at both bottom bolt locations. The sign panel was bent around the attached light. A slight bend occurred in the impact-side mast around the bottom bolt. Scratches were found on the warning light, and glass pieces were embedded in the plastic light box.

System No. 1B was also determined to be unacceptable according to the MASH criteria due to the light and mast penetrating the windshield, windshield indentation greater than 3 in. (76 mm), and significant windshield cracking, which caused the obstruction of driver visibility and the loss of structure in both glass layers in the windshield. Deformations of, and intrusion into, the occupant compartment did occur as System No. 1B penetrated into the occupant compartment near the upper-center region and upper-left corner of the windshield when the light, mast, and sign panel contacted the windshield. The vehicle's trajectory did not intrude into adjacent traffic lanes.

•	Exit Conditions
	Angle
•	Vehicle Stability Satisfactory
•	Vehicle Stopping Distance (longitudinal) 567 ft - 6 in. (173.0 m) from Impact B
•	Vehicle Stopping Distance (lateral)
•	Maximum Angular Displacements (EDR-4)
	Yaw1.51 deg
	Pitch0.34 deg
	Roll
•	Vehicle DamageSevere Windshield Damage
	VDS <sup>[33]</sup>
	CDC <sup>[34]</sup> 12FYAN1
	Maximum Interior DeformationNA
•	Test Article Damage Moderate

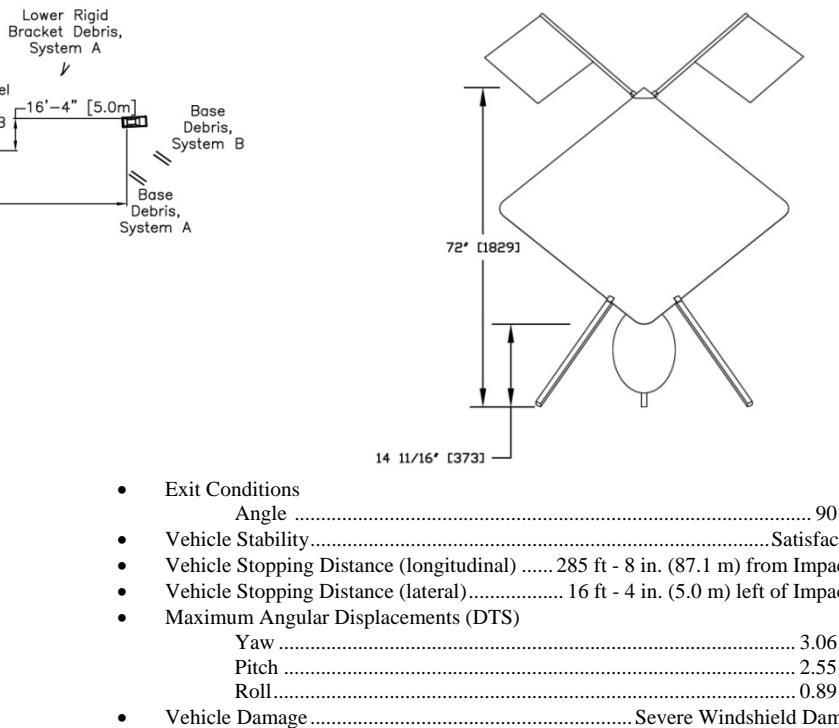
Figure 60. Summary of Test Results and Sequential Photographs, Test No. WZ09-2B

•	Exit Conditions	
	Angle	
•	Vehicle Stability	Satisfactory
•	Vehicle Stopping Distance (longitudinal) 28	85 ft - 8 in. (87.1 m) from Impact A
•	Vehicle Stopping Distance (lateral) 1	6 ft - 4 in. (5.0 m) left of Impact A
•	Maximum Angular Displacements (DTS)	
	Yaw	3.06 deg
	Pitch	
	Roll	
•	Vehicle Damage	Severe Windshield Damage
	VDS <sup>[33]</sup>	
	CDC <sup>[34]</sup>	
	Maximum Interior Deformation	NA
•	Test Article Damage	Moderate

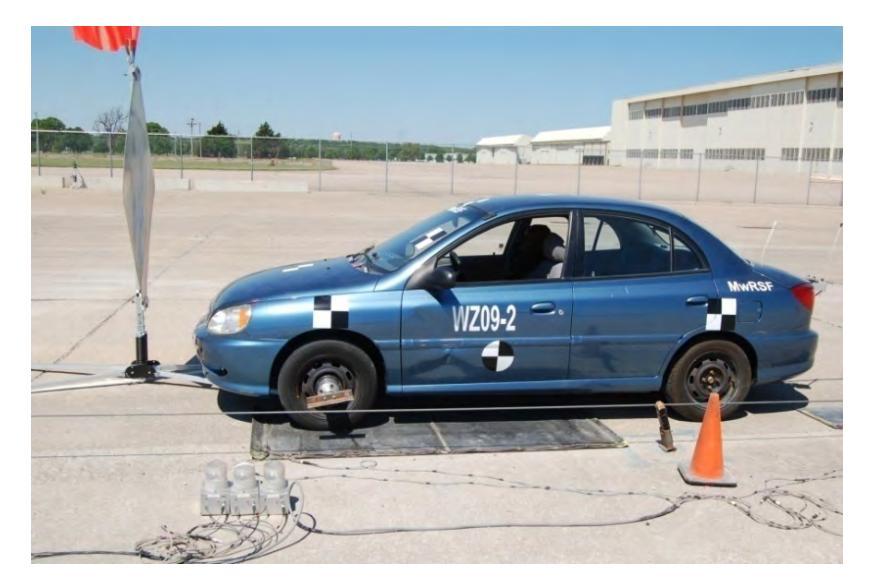
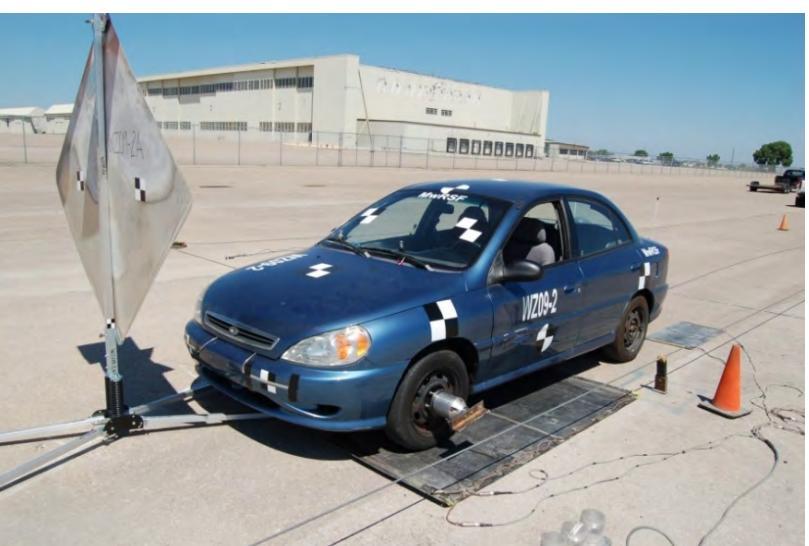
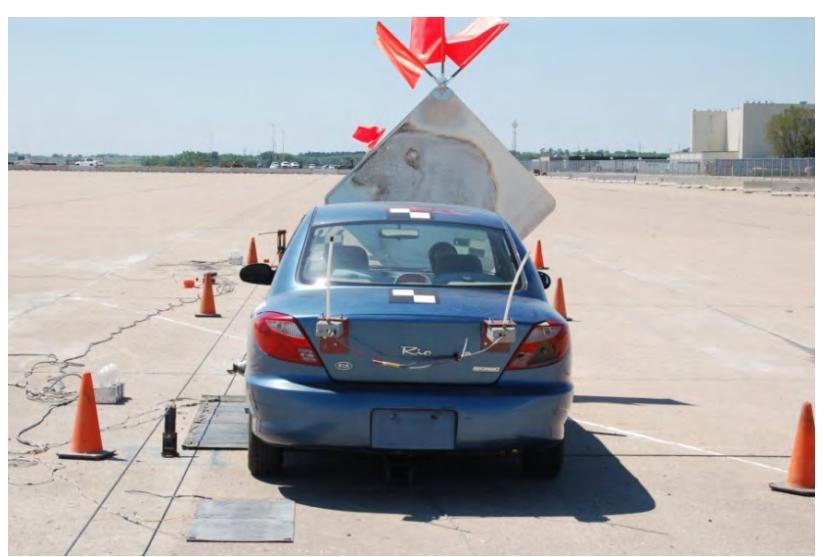
Figure 64. Impact Location, Test No. WZ09-2A

For System No. 2A, initial vehicle impact was to occur with the centerline of the mast at the right-side quarter point on the car's bumper, as shown in Figure 64. The actual point of impact was 3 in. (76 mm) to the left of the right-side quarter point. For System No. 2B, initial

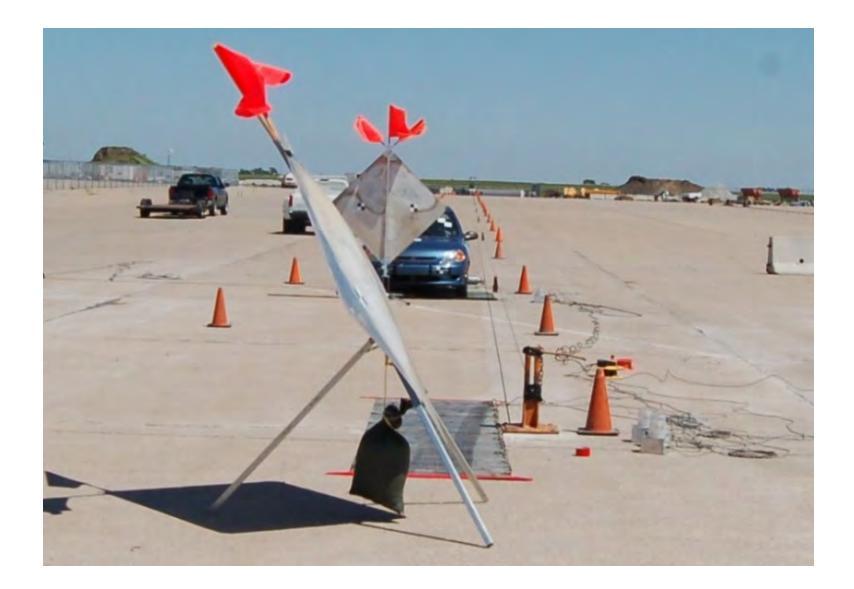
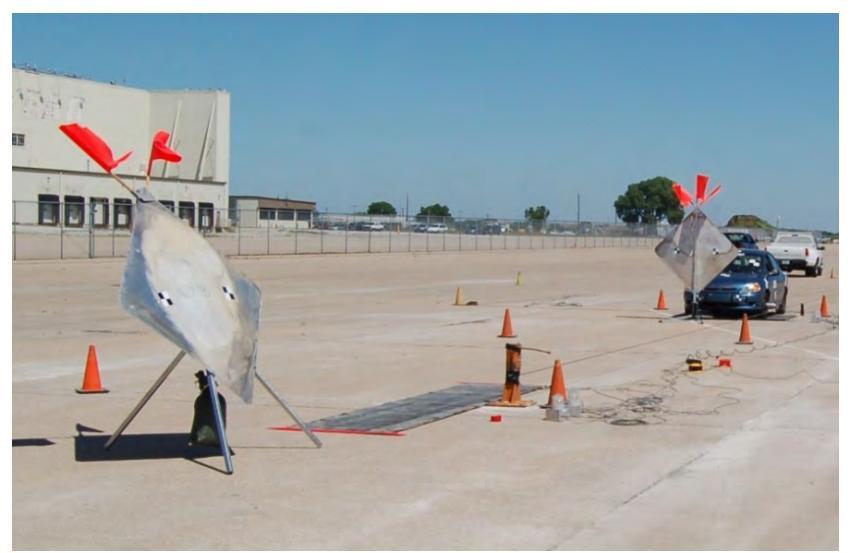
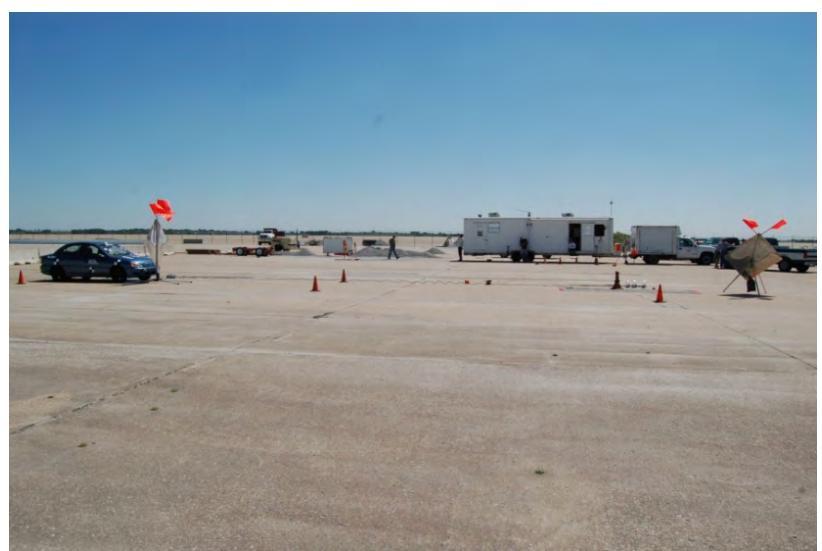
Figure 65. Impact Location, Test No. WZ09-2B

vehicle impact was to occur with the center of the sign panel at the left-side quarter point on the car's bumper, as shown in Figure 65. The actual point of impact was at the left-side quarter point. A sequential description of the impact events for test no. WZ09-2A is shown in Table 17. Approximately 0.678 seconds after the first impact, the second impact occurred. A sequential description of the impact events for test no. WZ09-2B is shown in Table 18. The vehicle came to rest 285 ft – 8 in. (87.1 m) downstream from the first impact and 16 ft – 4 in. (5.0 m) laterally towards the left of the first impact. The vehicle trajectory and final position are shown in Figures 59, 60, and 66.

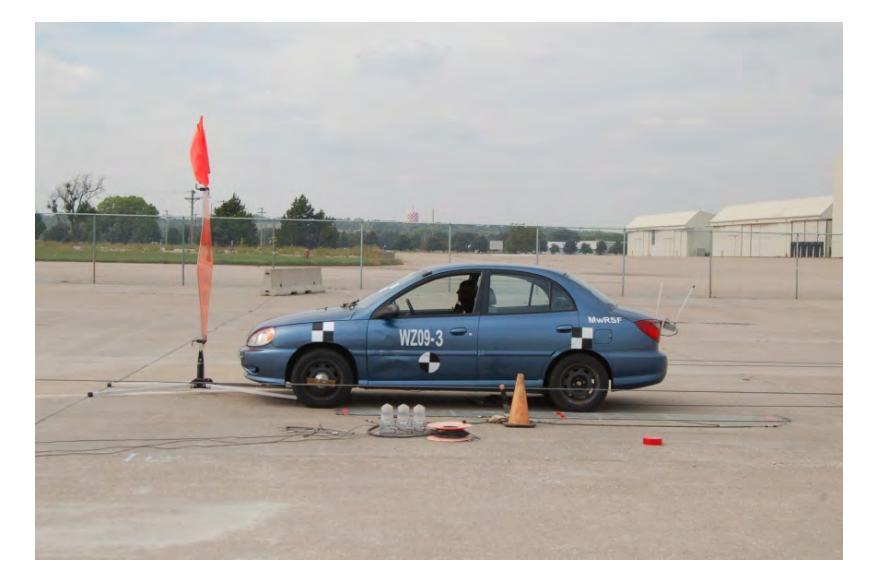
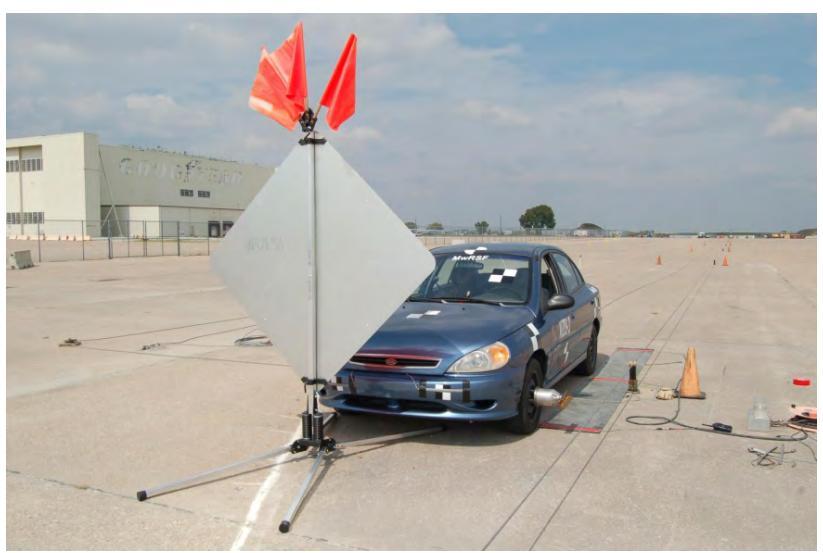
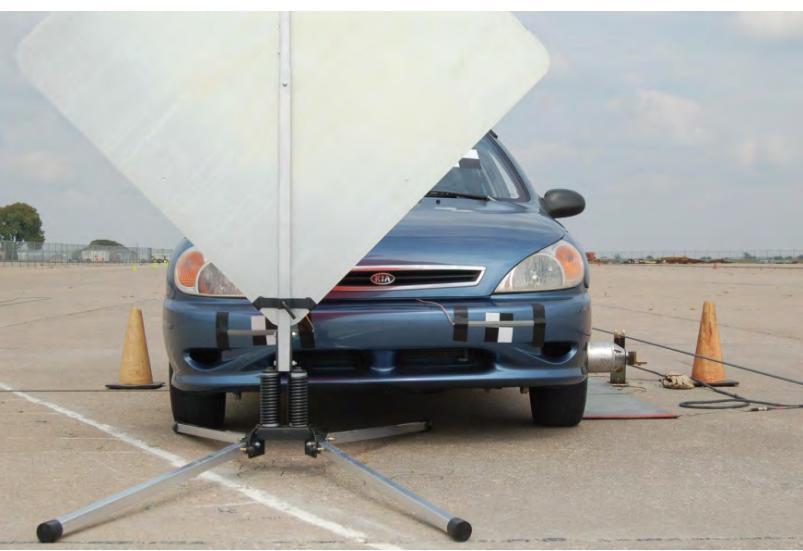
Figure 79. Impact Location, Test No. WZ09-3A

For System No. 3A, initial vehicle impact was to occur with the centerline of the mast at the right-side quarter point on the car's bumper, as shown in Figure 79. The actual point of impact was 1<sup>1</sup>/<sub>2</sub> in. (38 mm) to the left of the right-side quarter point. For System No. 3B, initial

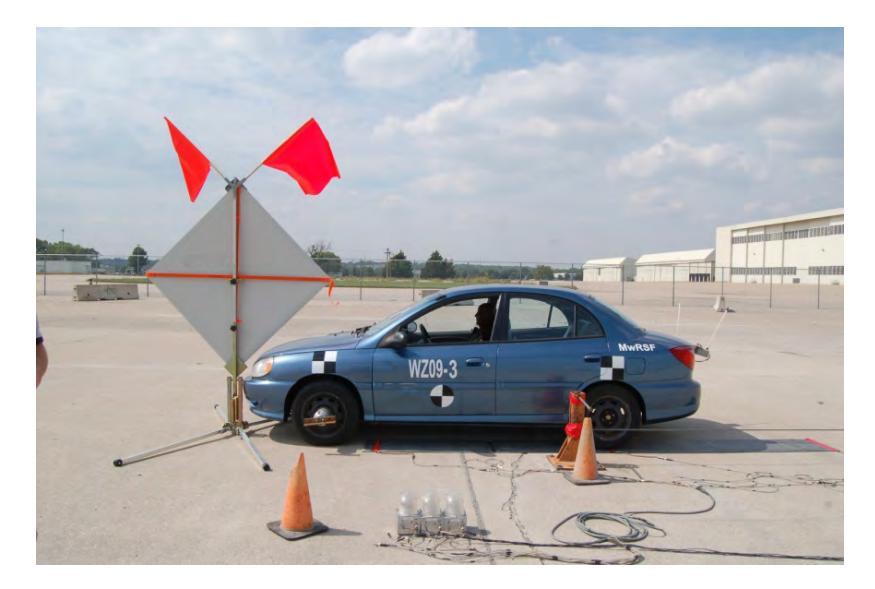
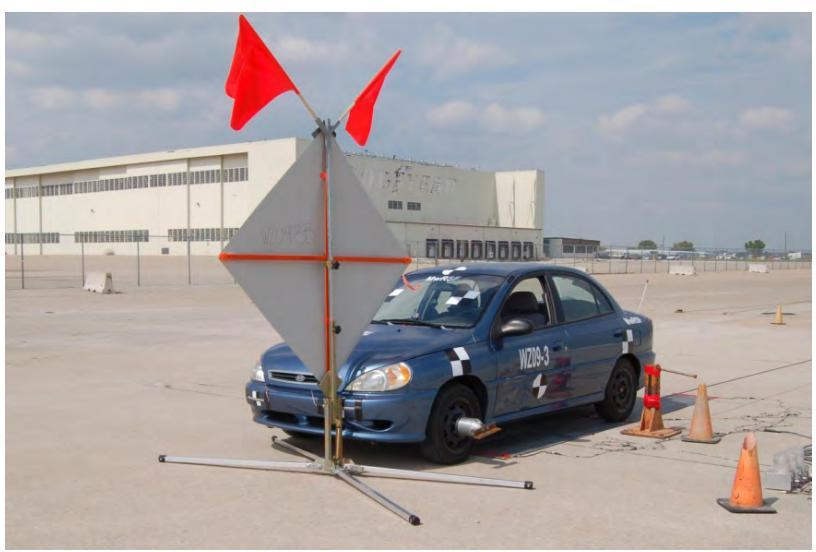
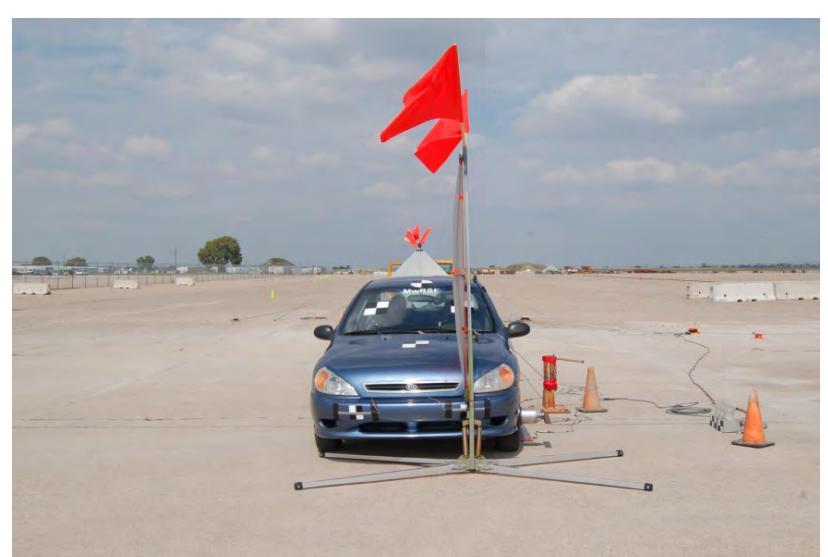
Figure 80. Impact Location, Test No. WZ09-3B

vehicle impact was to occur with the centerline of the mast at the left-side quarter point on the car's bumper, as shown in Figure 80. The actual point of impact was at the left-side quarter point.

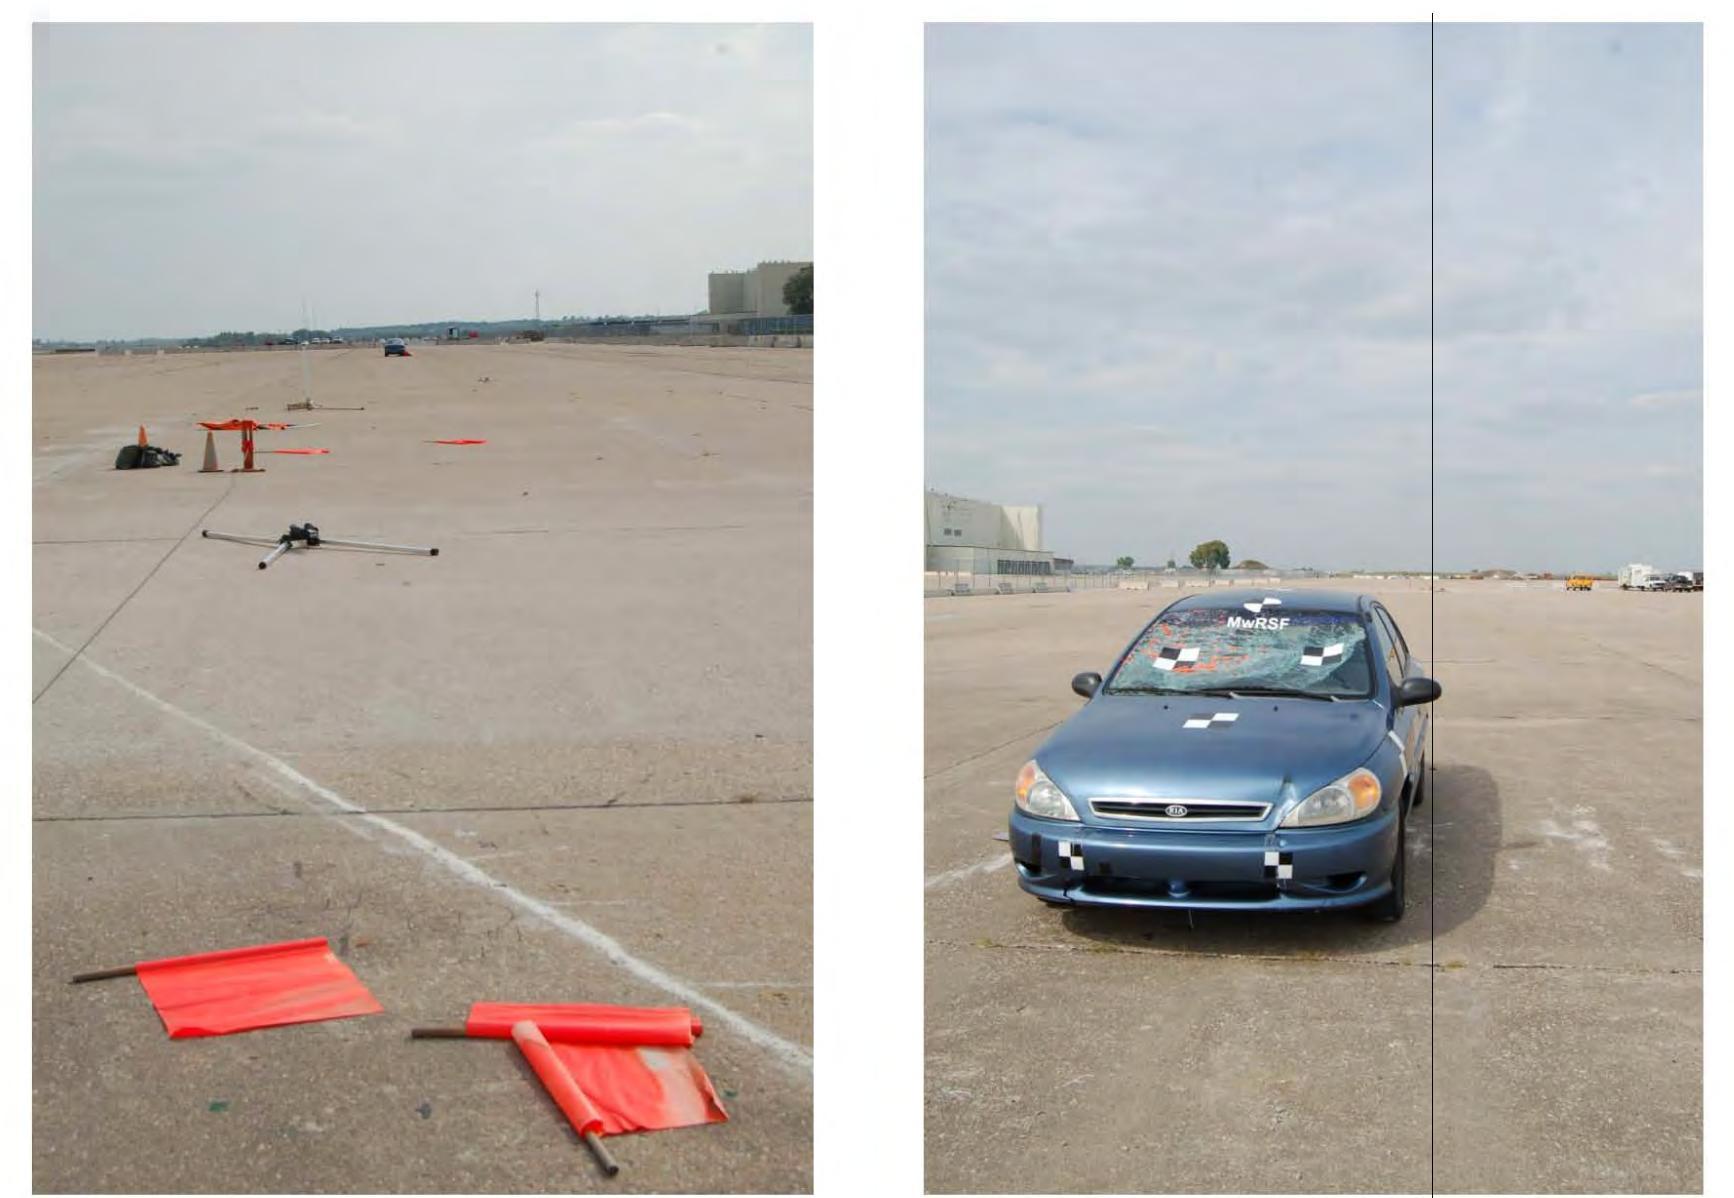
Figure 81. Vehicle Final Position and Trajectory Marks, Test No. WZ09-3

A sequential description of the impact events for test no. WZ09-3A is shown in Table 20. Approximately 0.640 seconds after the first impact, the second impact occurred. A sequential description of the impact events for test no. WZ09-3B is shown in Table 21. The vehicle came to rest 445 ft – 2 in. (135.7 m) downstream from the first impact and 5 ft – 8 in. (1.7 m) laterally towards the right of the first impact. The vehicle trajectory and final position are shown in Figures 73, 74, and 81.

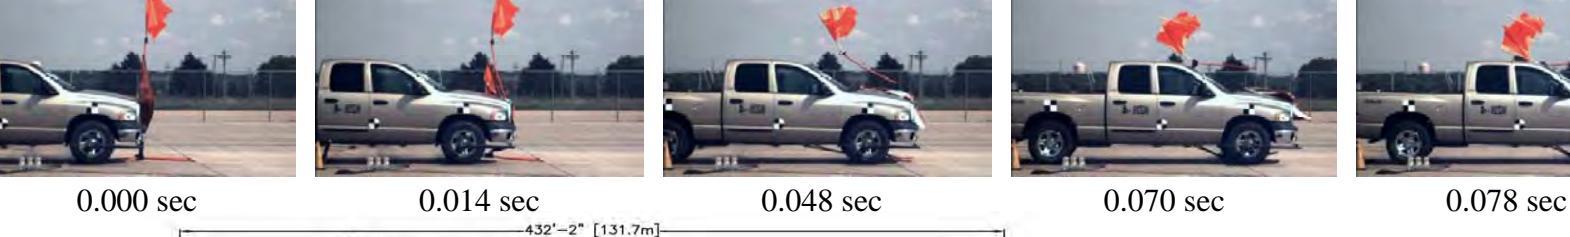
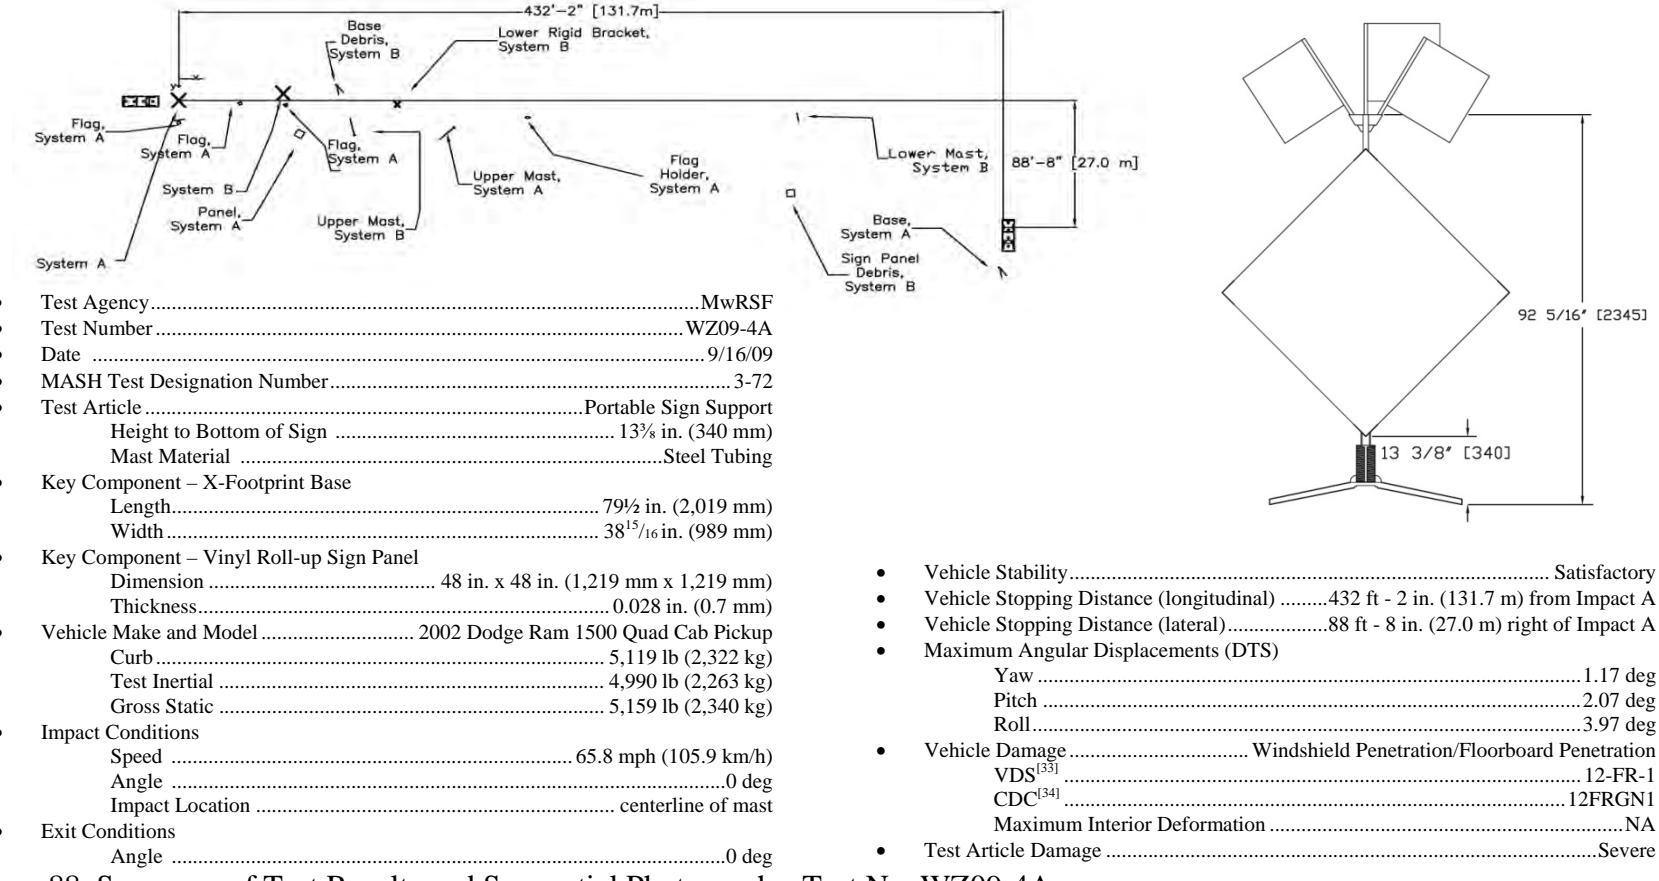
Figure 88. Summary of Test Results and Sequential Photographs, Test No. WZ09-4A

Following test no. WZ09-4, a safety performance evaluation was conducted, and the performance of System No. 4A was determined to be unacceptable according to the MASH criteria. It was deemed unacceptable due to the mast penetrating the windshield and a leg penetrating into the occupant compartment. Deformations of, and intrusion into, the occupant compartment did occur as System No. 4A penetrated into the upper-right corner of the windshield and the occupant compartment on the floorboard behind the left-front seat. Also, one of the legs on System No. 4A was wedged behind the right-front tire which inhibited the braking system on the pickup truck. This caused the pickup truck to veer to the right and impact a concrete barrier prior to stopping. This result could be considered a danger to workers in the work-zone area as well as to the occupants of vehicle depending on what objects would have been located to the right side of the roadway.

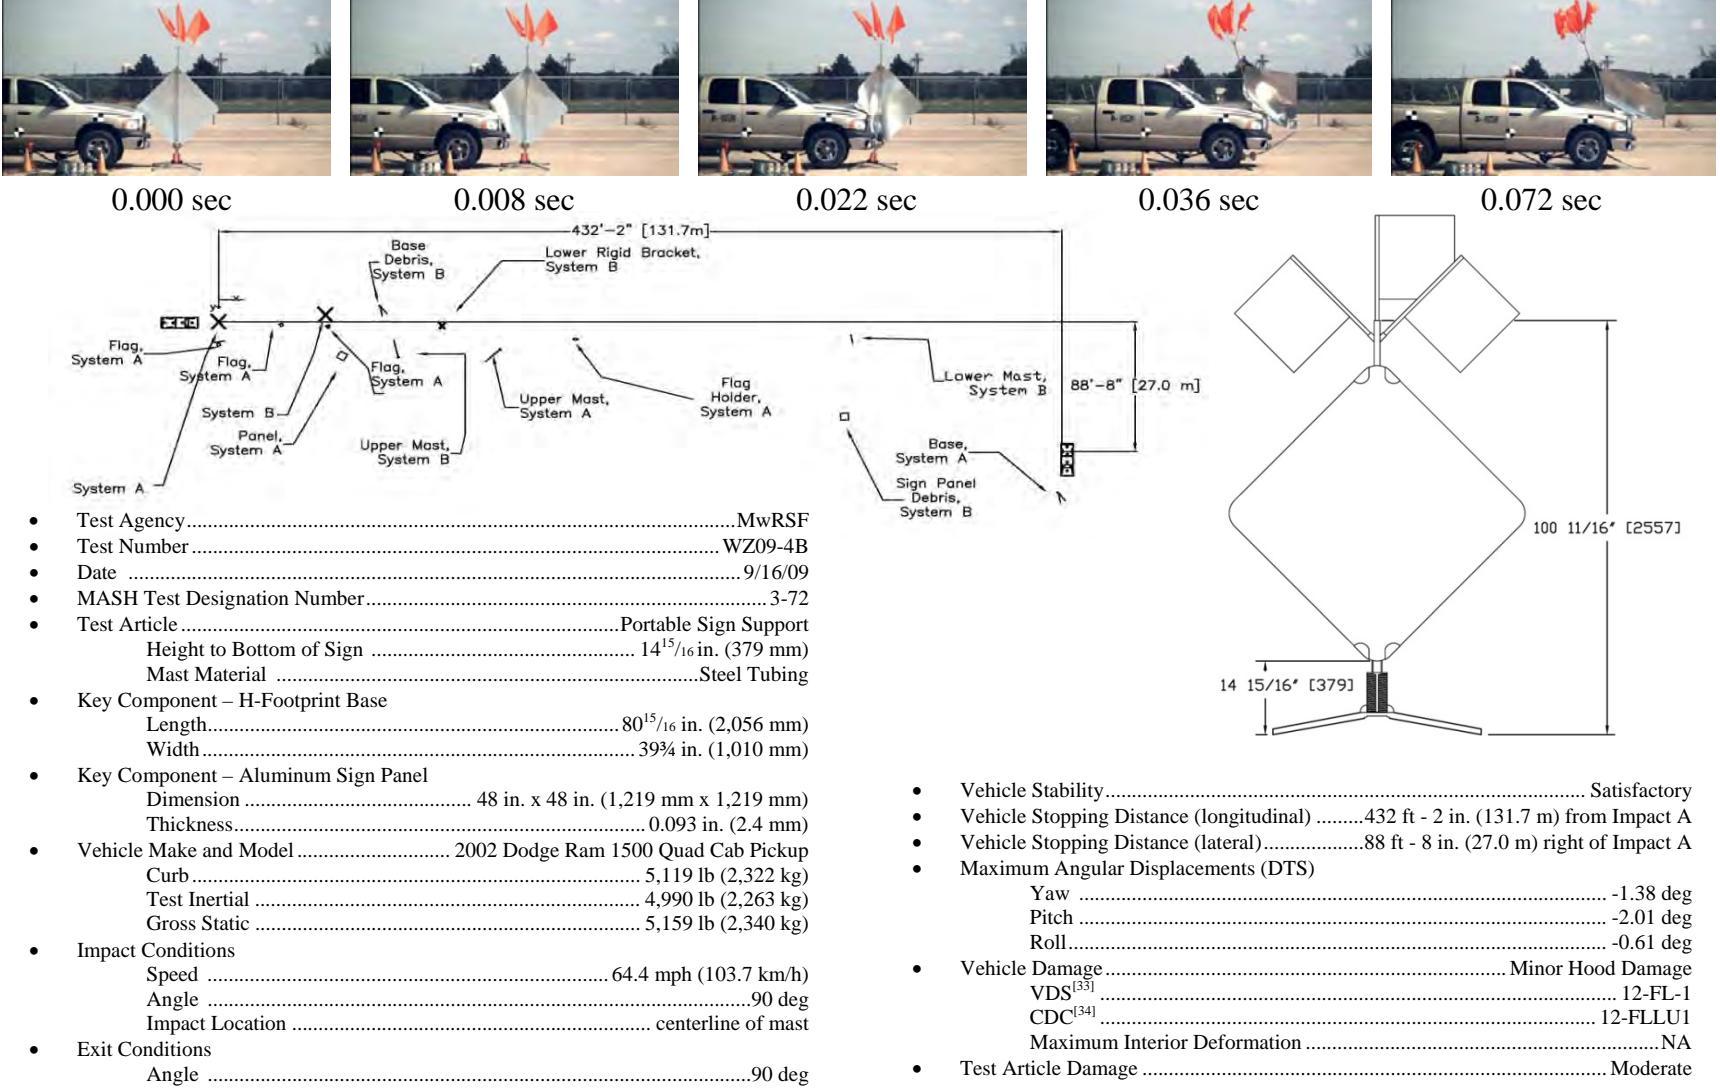
Figure 89. Summary of Test Results and Sequential Photographs, Test No. WZ09-4B

System No. 4B was determined to be acceptable according to the MASH criteria since the components of System No. 4B did not contact the pickup truck's windshield or roof. Deformations of, and intrusion into, the occupant compartment did not occur, and System No. 4B did not show any potential for occupant compartment penetration. The impact with System No. 4B did not affect the vehicle's trajectory.

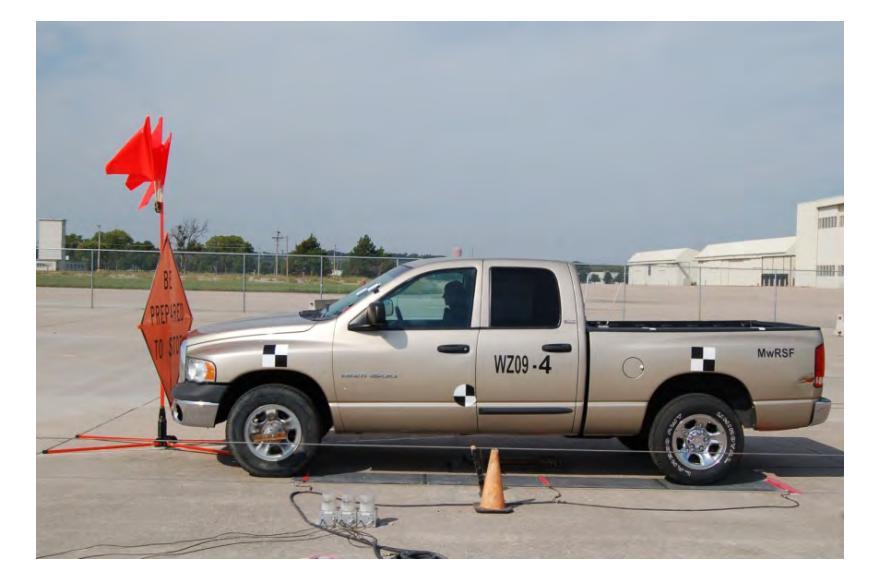
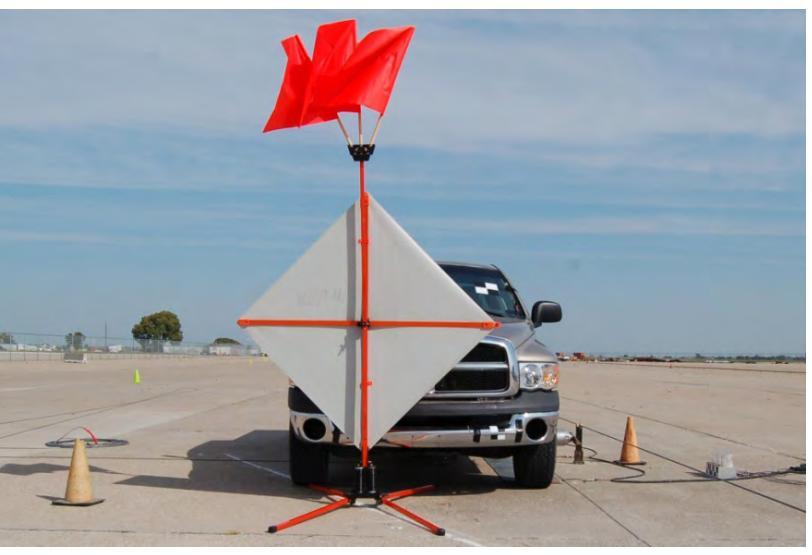
Figure 93. Impact Location, Test No. WZ09-4A

For System No. 4A, initial vehicle impact was to occur with the centerline of the mast at the right-side quarter point on the pickup truck's bumper, as shown in Figure 93. The actual point of impact was 1<sup>1</sup>/<sub>2</sub> in. (38 mm) to the left of the right-side quarter point. For System No. 4B,

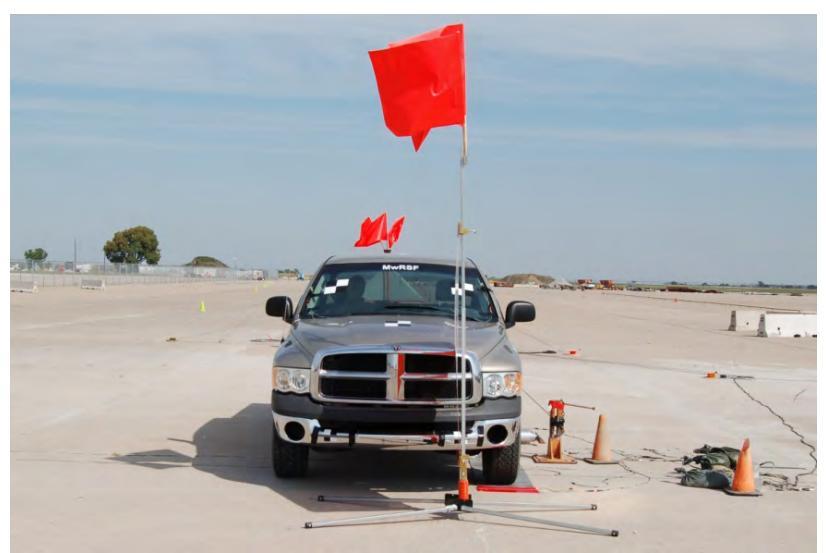
Figure 94. Impact Location, Test No. WZ09-4B

initial vehicle impact was to occur with the centerline of the mast to the right of the left-side quarter point on the pickup truck's bumper, as shown in Figure 94. The actual point of impact was 2 in. (51 mm) to the right of the left-side quarter point.

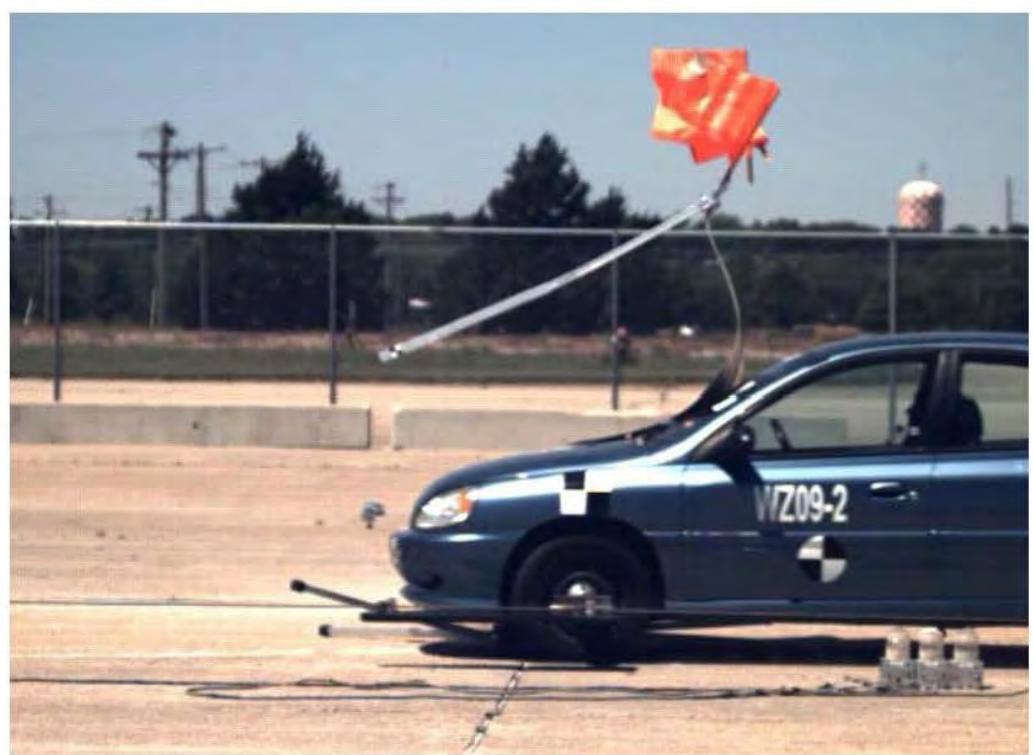
Figure 103. System No. 3A, Frangible Mast

A mast with a frangible base reduces the amount of flex that develops in the sign panel and mast (System Nos. 1A, 2A, 3A, and 4A). This relatively quick release of the mast from the stand allows the sign panel and mast to fall upon the vehicle with little additional force than what normally occurs through the impact event, as shown in Figure 103. However, this force can still be sufficient to cause indentation or penetration of the windshield. On the other hand, when base bending occurs, as shown in Figure 104, the sign panel and the top of mast are accelerated downward into the windshield (System No. 1B). When the mast was unloaded, the sign panel and mast have the tendency to "whip" downward onto the vehicle. In addition, a base-bending

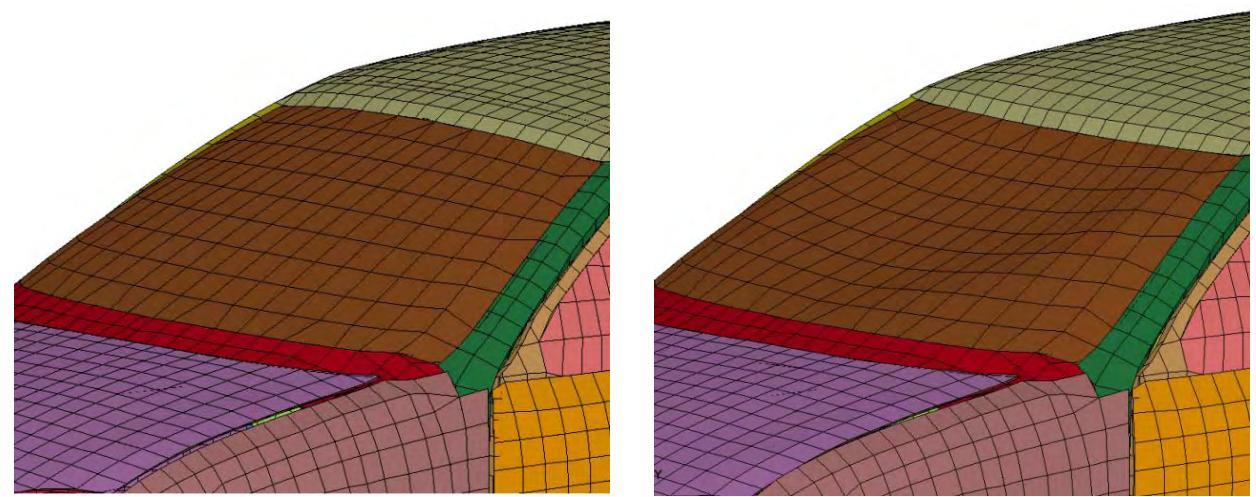
Figure 117. Windshield Deformation

Although the windshield material model was believed to be inaccurate in predicting deformations, the windshield deformed similar to what was found in test no. WZ09-2A. A comparison of the deformation in the simulation is shown in Figure 117. The vertical displacement of the windshield was compared over time, as shown in Figure 118. The maximum vertical deformation in the simulation was 2.24 in. (56.8 mm). The maximum windshield deformation in the full scale crash test was 2<sup>1</sup>/<sub>4</sub> in. (57 mm).

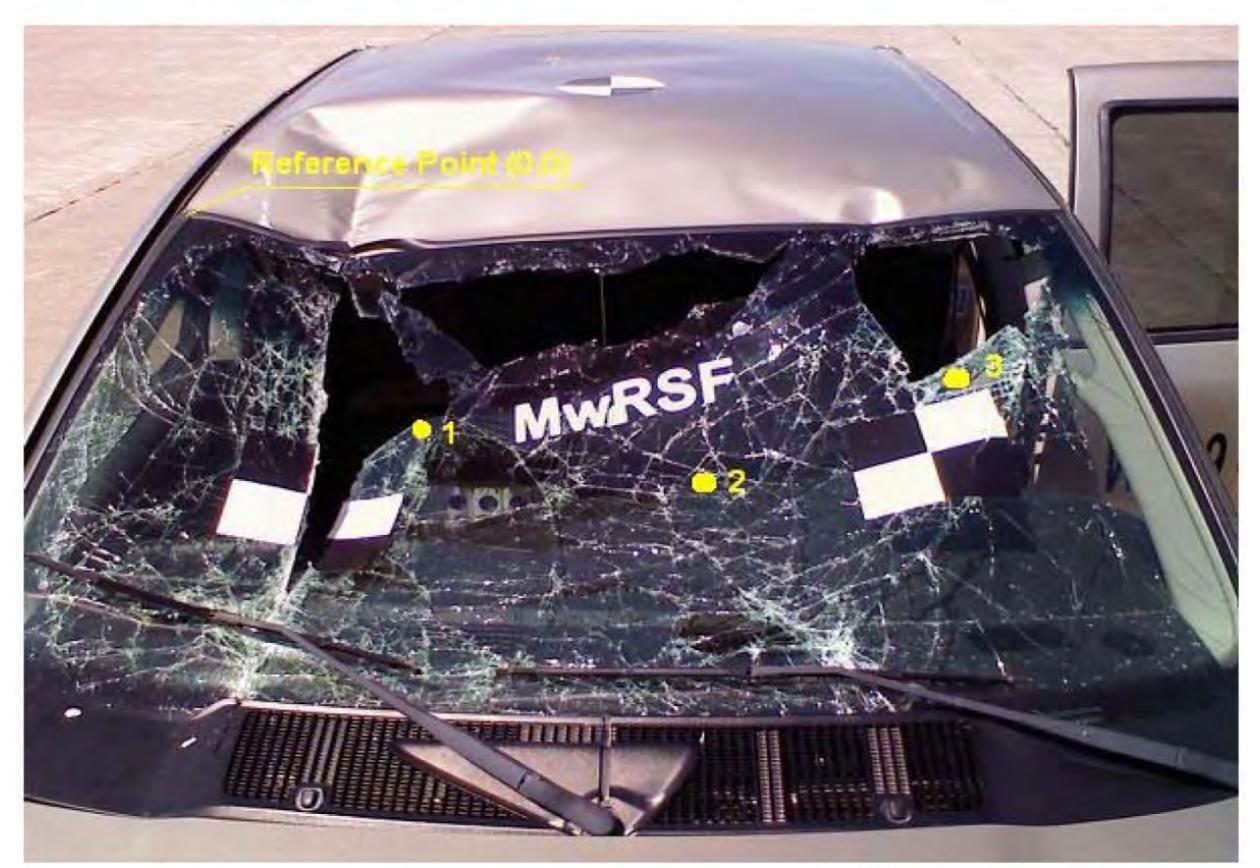
Figure E-2. Windshield Deformation Data, Test No. WZ09-1

Location from passenger side roof corner of windshield						
	Lateral (X)	Longitudinal (Y)	Pre test	Post test	Crush		
Point 1	12	7	4	17	13		
Point 2	28	14	2.25	11.25	9		
Point 3	44	9	4.25	8.5	4.25		
Max Crush	12	7	4	17	13

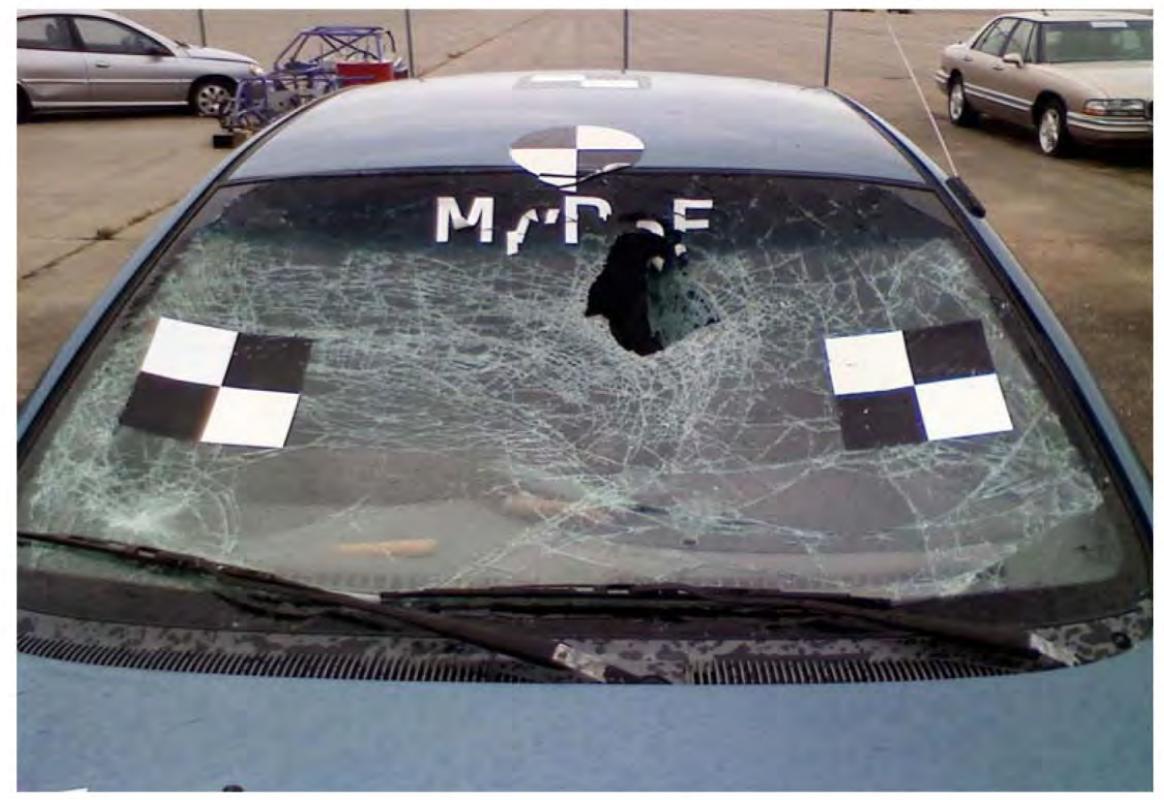
Figure E-4. Windshield Deformation Data, Test No. WZ09-2

Location from	Location from passenger side upper roof corner of windshield (0,0)						
	Lateral (X)	Longitudinal (Y)	Pre test	Post test	Crush			
Point 1	9	11	5.25	7.5	2.25			
Point 2	25	9	4.75	9.5	4.75			
Point 3	26	13	4.75	12.5	7.75			
Max Crush	12	13	4.75	12.5	7.75

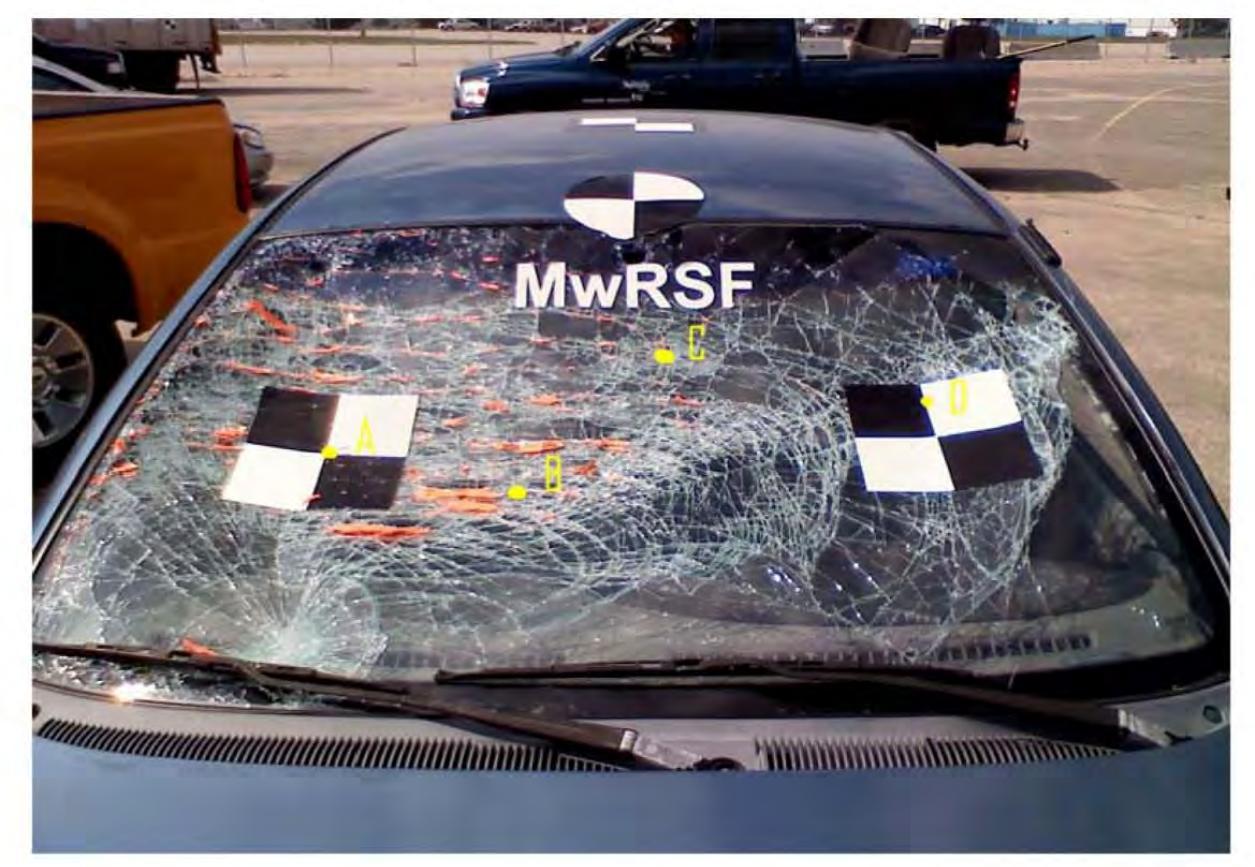
Figure E-7. Windshield Deformation Data, Test No. WZ09-3

Location from the top passenger side roof corner of windshield					
	Lateral (X)	Longitudinal (Y)	Pre test	Post test	Crush	
Point A	6.5	14.5	5.25	9.25	4	
Point B	15.5	17.75	4.5	8.25	3.75	
Point C	23.75	10.5	5	7.75	2.75	
Point D	34.75	12.25	5.5	7.75	2.25	
Max Crush	6.5	14.75	5.25	9.25	4
