Regional Approach to

Landslide Interpretation and Repair

March, 2001

lowa DOT Project TR 430

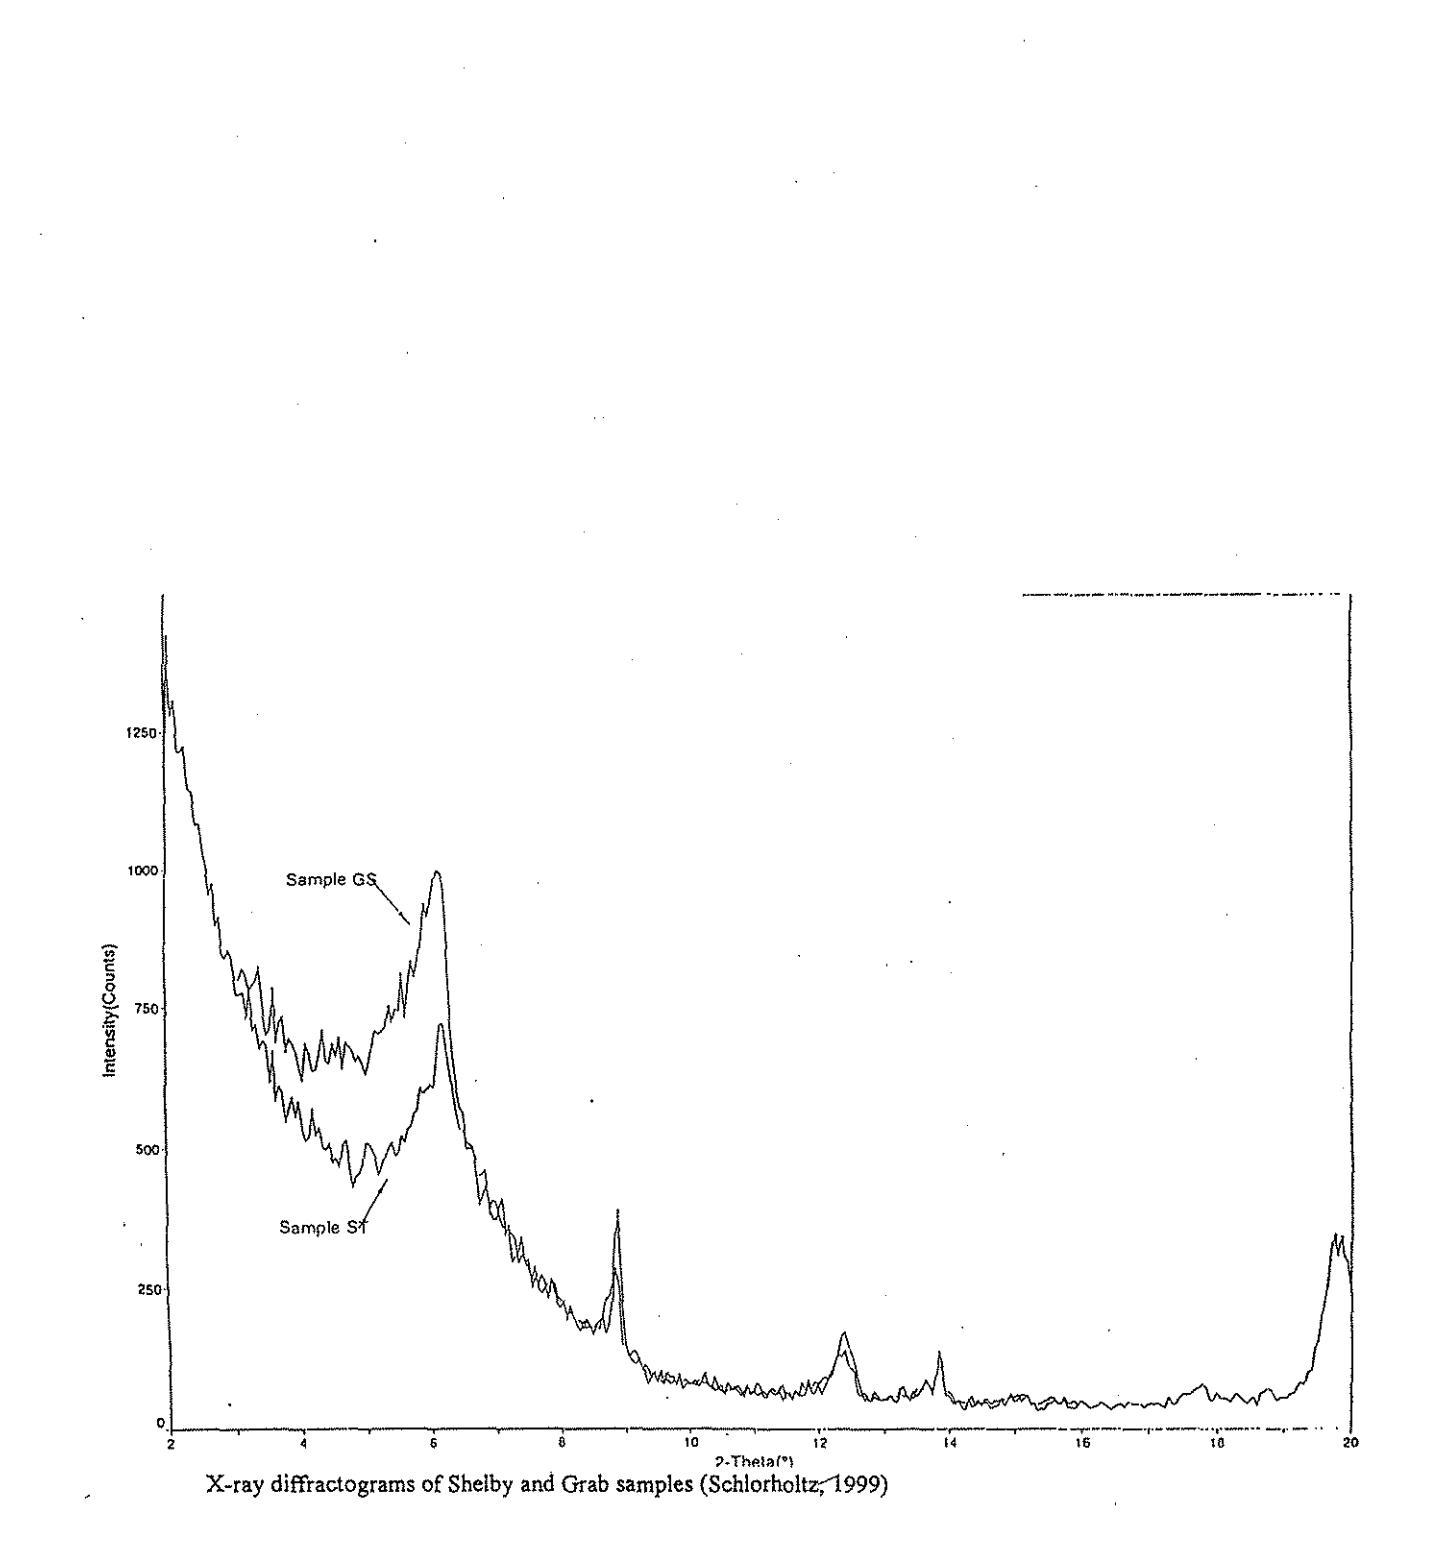
X-ray diffraction tests were carried out on both the grab and Shelby tube samples to determine their mineral composition. Figure 9.2 shows an overlay of the X-ray diffractograms from the grab and Shelby tube samples. The composite diffractograms show that both the soils are similar in mineralogy and composed of clay minerals, quartz and feldspar. The clay minerals were dominated by montmorillonite (Schlorholtz, 1999). This supports the description from the soil survey report (Oelmann, 1984) of the Gosport soil series having high shrink-swell potential on drying or wetting. The diffractogram from the grab sample shows a slightly broader montmorillonite peak, which may indicate the presence of intracrystalline moisture and perhaps a different exchangeable cation in the failure zone soil. This subtle difference could account for a lower shear strength in the soil at the surface of the embankment. Other studies have shown

Figure 9.2 X-ray diffractograms of tube samples and grab samples from Highway 34 slide.
that shear strength of clays and shales varies with adsorbed cations (Steward and Cripps, 1983; Moore, 1991, and Mitchell, 1993)

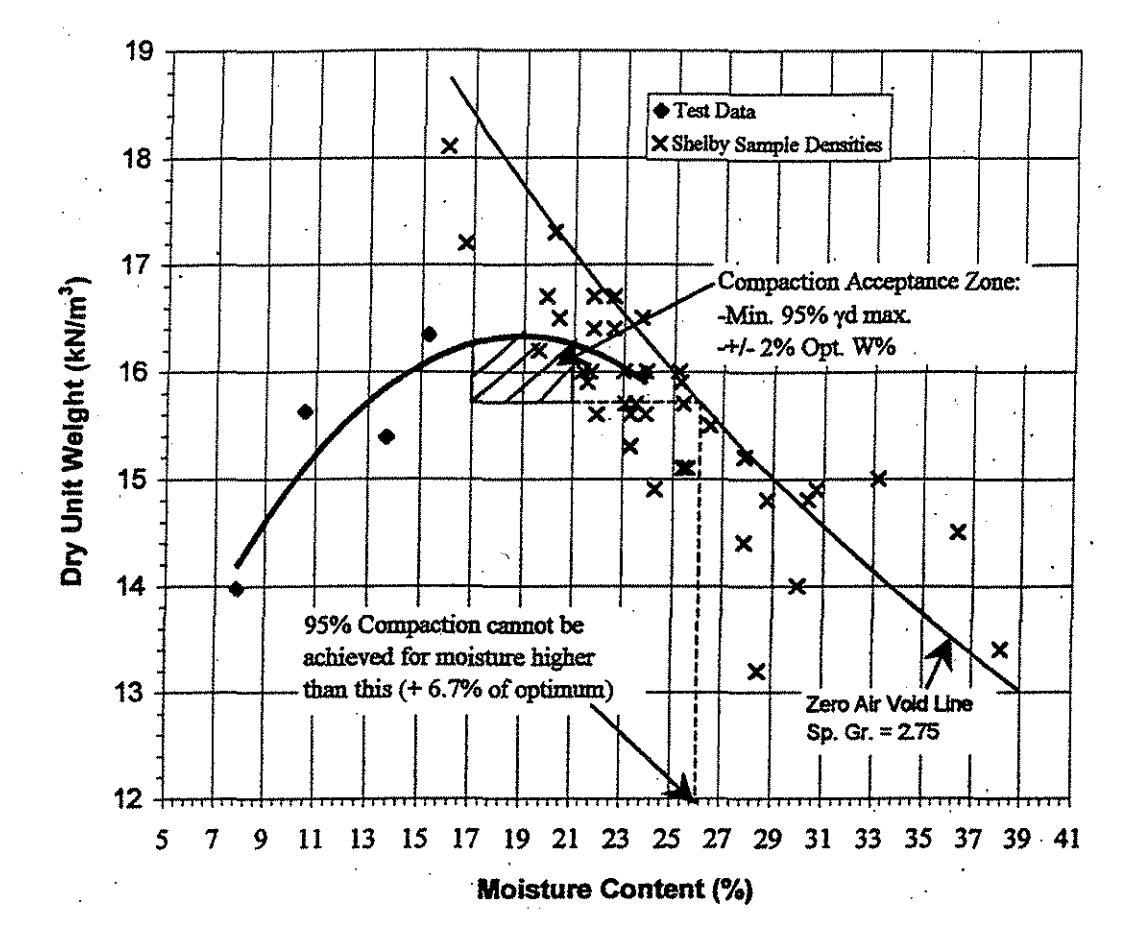
It has been observed that if embankment compaction is less than 95% the shear strength is likely to be lower (Bergesson et al, 1998). Of the eight samples tested, four samples had dry unit weights less than 95% of the maximum dry unit weight. The data from these samples were combined to obtain the shear strength parameters. The regression (Figure 9.4 (b)) shows the low density soil to have a "c" of 25psf (1.20kPa) and a " $_{\phi}$ " of 25 degrees with a correlation coefficient (R²) of 0.86.

Figure 9.3 Compaction curve and field densities of embankment soil at Highway 34 slide.

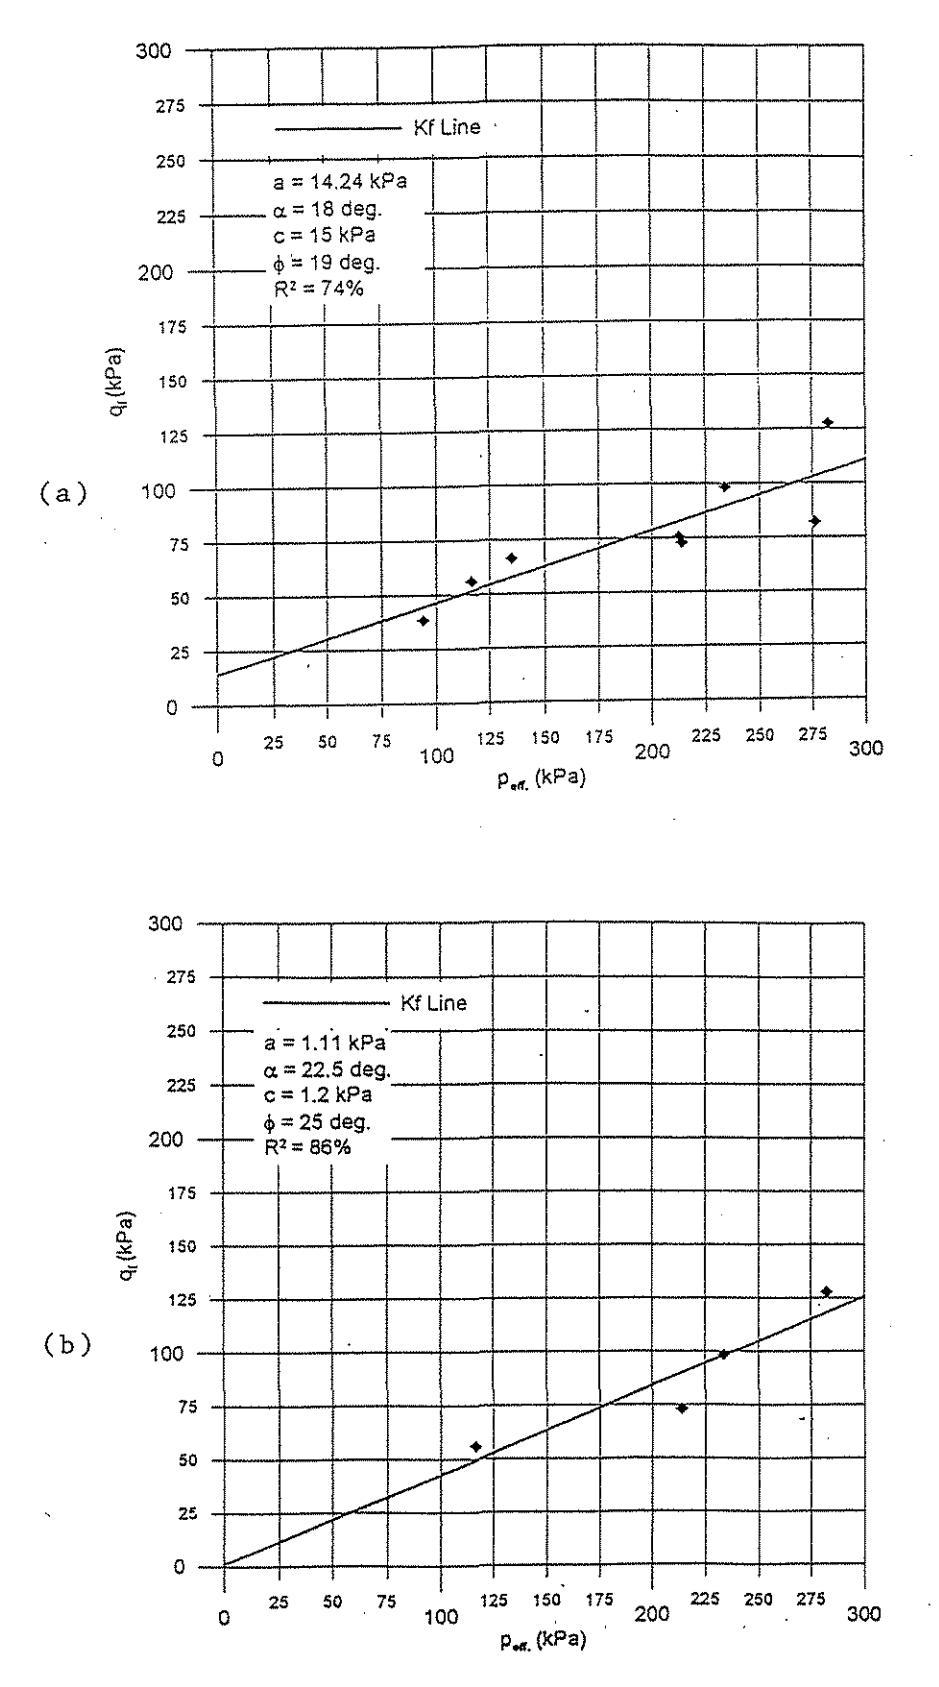
Consolidated undrained (CU) triaxial tests with pore pressure measurements were carried out on eight Shelby tube samples obtained from the interior of the embankment. The samples were backpressure saturated before testing and pore pressures measured. The results were used to plot the deviator stress versus strain curves. Maximum values from the stress-strain curves were interpreted as the shear strength and used to plot the effective stress K_f line and the "a" and " α " values were obtained by linear regression as shown in Figure 9.4 (a). The plot shows the soil to have a cohesion intercept "c" of 313psf (15kPa) and an angle of internal friction " ϕ " of 19 degrees with a R² value of 0.74.

Figure 9.4 a) Strength (effective p-q) graph for all tube samples. b)Strength (effective p-q) graph for soil samples less than 95% maximum dry density

Another regression was carried out on the remaining four samples with dry unit weights greater than 95% of maximum dry unit weight. The regression showed the soil to have a "c" of 587psf (28kPa) and a " $_{\phi}$ " of 12 degrees with a R² value of 0.80. Stability analyses for long-term stability were conducted for each set of strength parameters. It is not surprising that the soil strength varies with degree of compaction with higher relative compaction associated with higher strength.

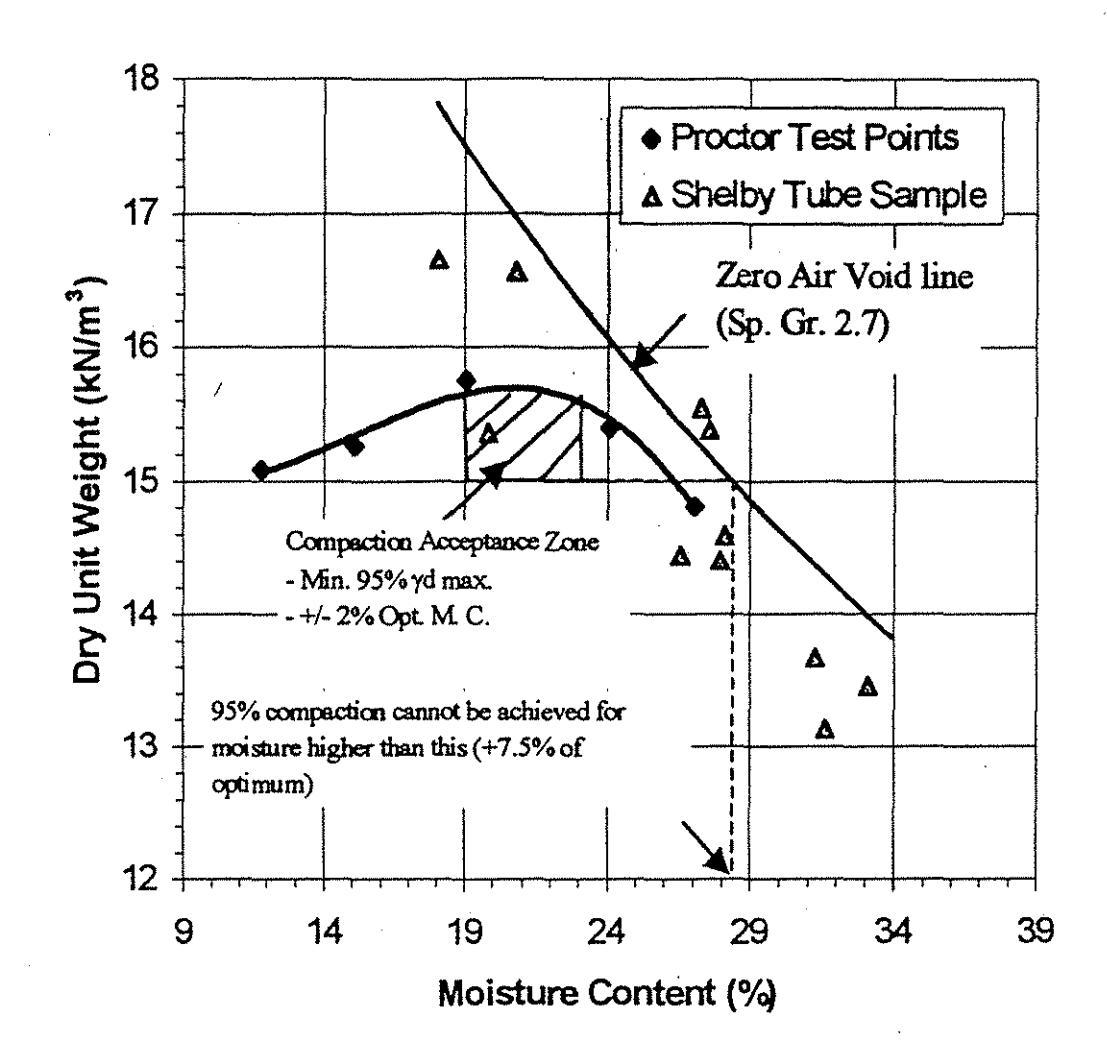
Standard Proctor tests were conducted on composite soil samples to determine the dry unit weight versus moisture content relationship, so that the density and moisture characteristics of the soil in the embankment could be compared with specifications. Standard Proctor Test results are in Figure 9.6. The optimum moisture content was about 21% and the maximum dry unit weight was 100pcf (15.75kN/m³). The moisture contents and dry unit weights determined from Shelby tube samples are also plotted with the Standard Proctor results in Figure 9.6.

A "compaction acceptance zone" of 95% maximum unit weight was marked on the Standard Proctor curve to demarcate the acceptable range of dry unit weights and corresponding moisture contents (Bergeson et al, 1998). Figure 9.6 shows that nearly 50% of the samples lie below the zone of 95% compaction. It is likely that the high moisture contents obtained are greater than those at the time of compaction.

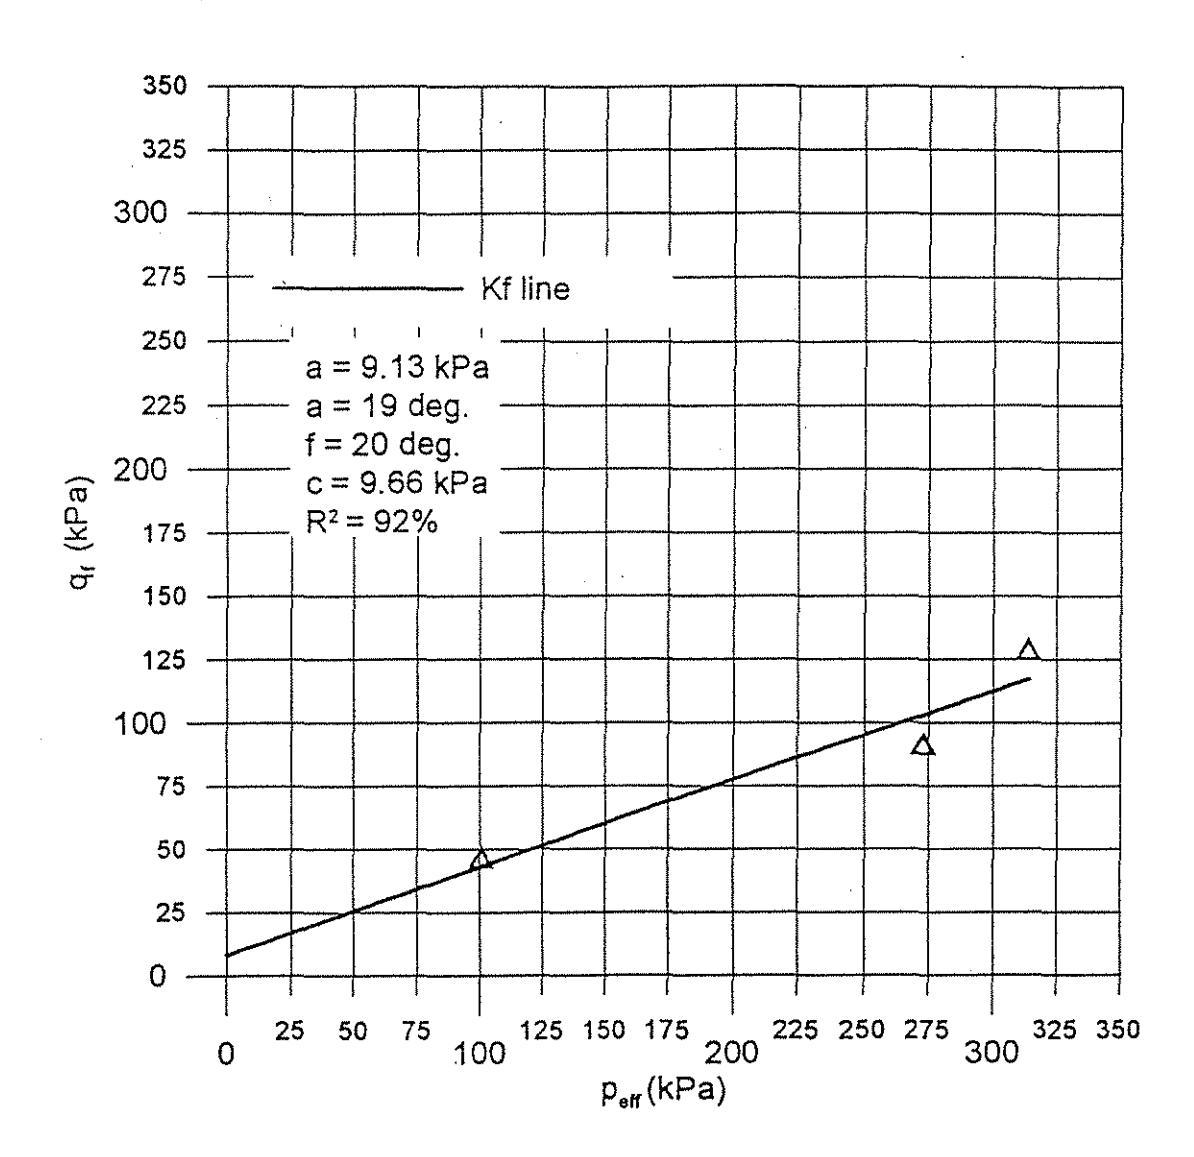
Figure 9.8 Strength (effective p-q) diagram for Shelby tube samples from K Street slide.

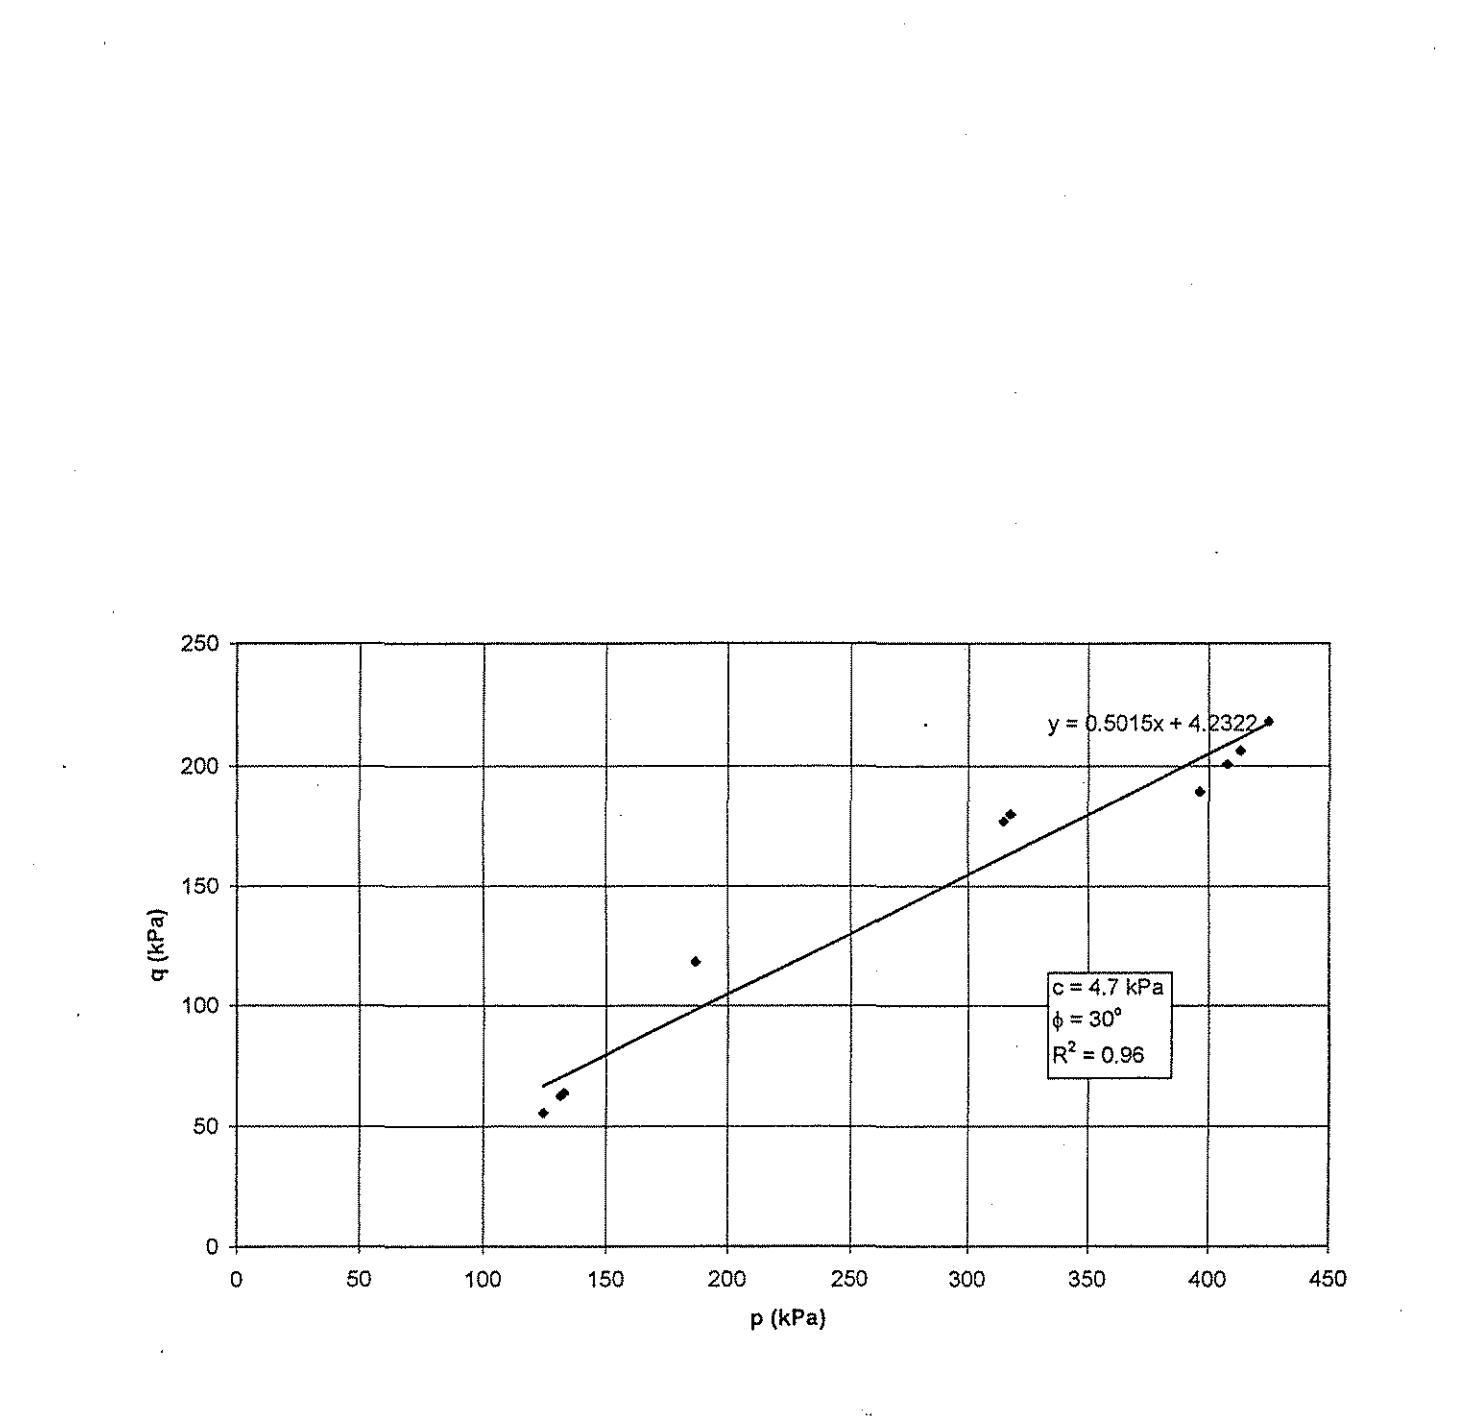
Figure 9.13 Strength diagram for loess at Murray Hill slide

Triaxial tests were performed on the Shelby tube samples to obtain the shear strength parameters of the soil. Consolidated drained (CD) triaxial tests were carried out on samples at natural moisture content. Deviator stress versus axial strain curves were plotted by using the test results. These stress-strain curves and stress paths are shown in Chu (2001). By using the maximum values from the stress-strain curves, the effective stress K_f line was plotted and the "a" and " α " values were obtained by linear regression as shown in Figure 9.13. These values were converted to "c" and " $_{\phi}$ " values where the cohesion "c" is 98.79 psf (4.73 kPa) and the internal friction angle " $_{\phi}$ " is 30.1°. These strengths are lower than similar studies of loess at natural moisture contents where cohesion intercepts averaged 259 psf (12.4 kPa) and $_{\phi}$ averaged 26° and are nearly equal to values for saturated loess (Akiyama, 1964, Olson, 1958). Table 9.4 shows the average shear strength parameters that were reported by Olson (1958), Akiyama (1964), and Benak (1967) for the Hamburg soil along with shear strength parameters obtained as part of this study.

From these data, it is apparent that the cohesion intercept "c" value will be lower if the tests are performed under saturated conditions. These results are similar to conclusions of Badger (1972) who observed that cohesion of friable loess is inversely proportional to the degree of saturation:

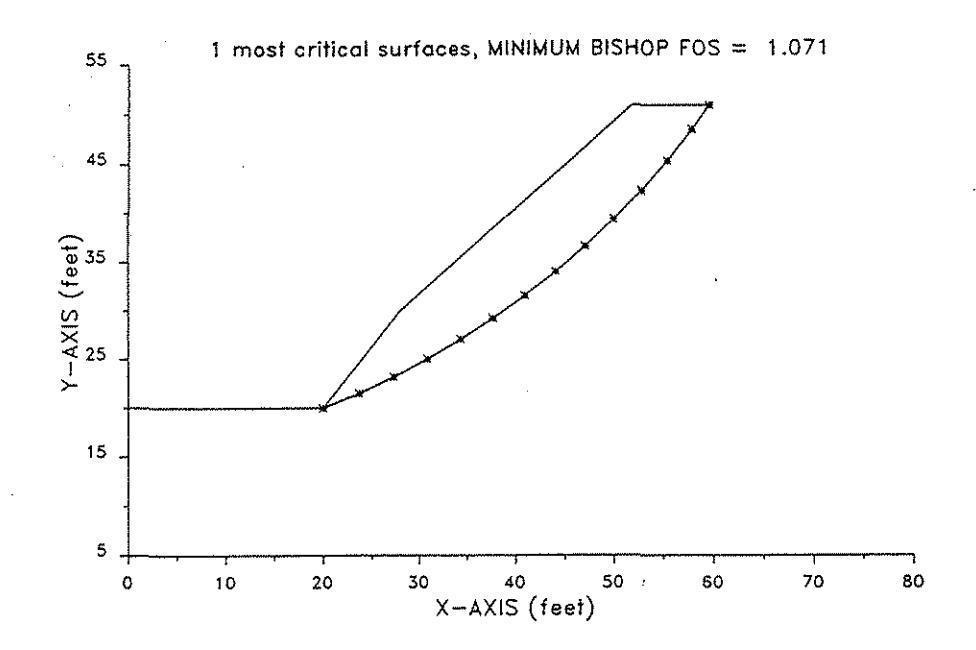
The slope was analyzed by using XSTABL computer software with the Simplified Bishop method using shear strength values obtained in this study and shear strength values reported in other studies. A typical analysis is shown in Figure 9.14. When the average strengths are used, the minimum safety factor is 1.5 for the soil at natural moisture content. For the shear strength values obtained in this study, the safety factor is 1.1 with a theoretical failure surface close to that observed in the field. Although the latter stability analysis indicates a marginal safety factor at Murray Hill, additional analyses were conducted to determine the influence of other possible factors.

During fieldwork, trucks were observed to pass close to the edge of the road with their tires tracking through the depression in the pavement. Therefore, XSTABL analyses with a surcharge load from the trucks were performed. The vehicle surcharge loading represented a tandem truck; a stress of 17000 psf (814 kPa) was applied on each tire in the location shown in Figure 9.15. The minimum factor of safety decreases to 0.8 when the surcharge is included with the load at the shoulder; the failure surface shown by the analysis, however, extends further back below the roadway than suggested by the cracks observed on the pavement. It is interpreted that the slope without surcharge is at a metastable condition; and instability results from the surcharge load of passing trucks.

As truck weight is a likely cause of failure, stability analyses for the surcharge at various locations were performed. Minimum safety factors under vehicle surcharge loading at different distances from the shoulder were conducted and show that if the truck loading is 20 feet (6.1 m) from the shoulder, the factor of safety increases to 1.1. Therefore, moving the road from its present location provides a marginal factor of safety and a partial solution to this slope stability problem. Because of the metastable condition of the natural slope, relocation of the roadway should be combined with a buttress for a more comfortable safety factor. Further analysis of the slope downslope of the proposed buttress should be carried out to insure that the buttress loading will not create stability problems downslope of this slide.
