**Longitudinal Grinding  
and Transverse Grooving  
to  
Improve Frictional  
and  
Profile Properties**

Project HR-1035

June 1983

**Iowa Department  
of Transportation**

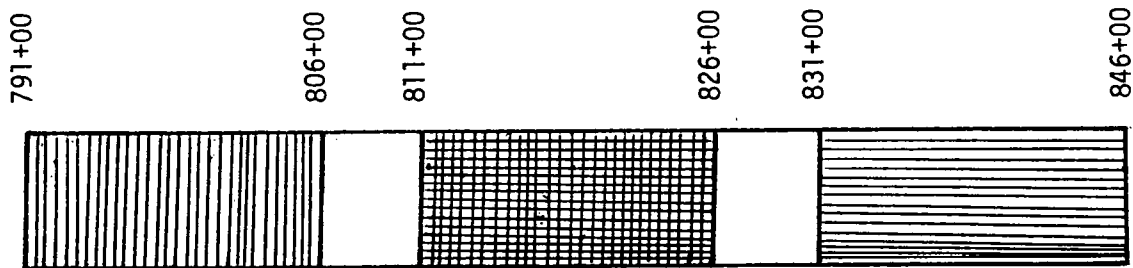
Test Section Layout

The eastbound lanes of I-80 in the vicinity of milepost 219 in Iowa County were textured by the three methods previously mentioned. The pavement between stations 791+00 and 806+00 was textured by transverse grooving only. The grooving was done with a MU Inc. Full Deck Groover which was developed for grooving the full width of a bridge deck. It has two cutting heads, each two feet long. Diamond impregnated blades are randomly spaced along the cutting heads from 3/4" to 1 1/8" apart, as randomly spaced grooves cause less tire noise than evenly spaced grooves. The grooves on this project are 1/4" deep.

Only longitudinal grinding was done between stations 831+00 and 846+00. This was done by the same Target Safe-T-Planer as the previous section. The texturing in this section was also 1/16" deep.

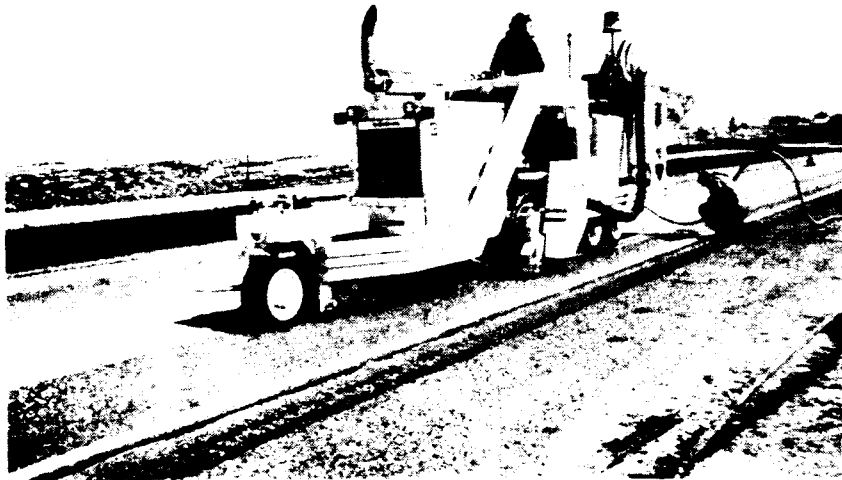
TARGET Safe-T-Planer

The machine has a 38" cutting head equipped with 187-14" diameter diamond impregnated blades. This machine also requires water to cool the blades. The water is pumped from a semi-trailer tanker and the waste water and cuttings are picked up by vacuum and pumped to the ditch or another tank truck if necessary. Four passes of the machine were required to texture each lane. The first pass in each lane was along centerline. The texture was 1/16" deep as measured with a tire tread-depth gauge and the grooves 1/4" deep.
