GALVANIZED BRIDGE DECK REINFORCING

FINAL REPORT FOR Iowa Department of Transportation Project HR-504

DECEMBER 1992

Iowa Department of Transportation

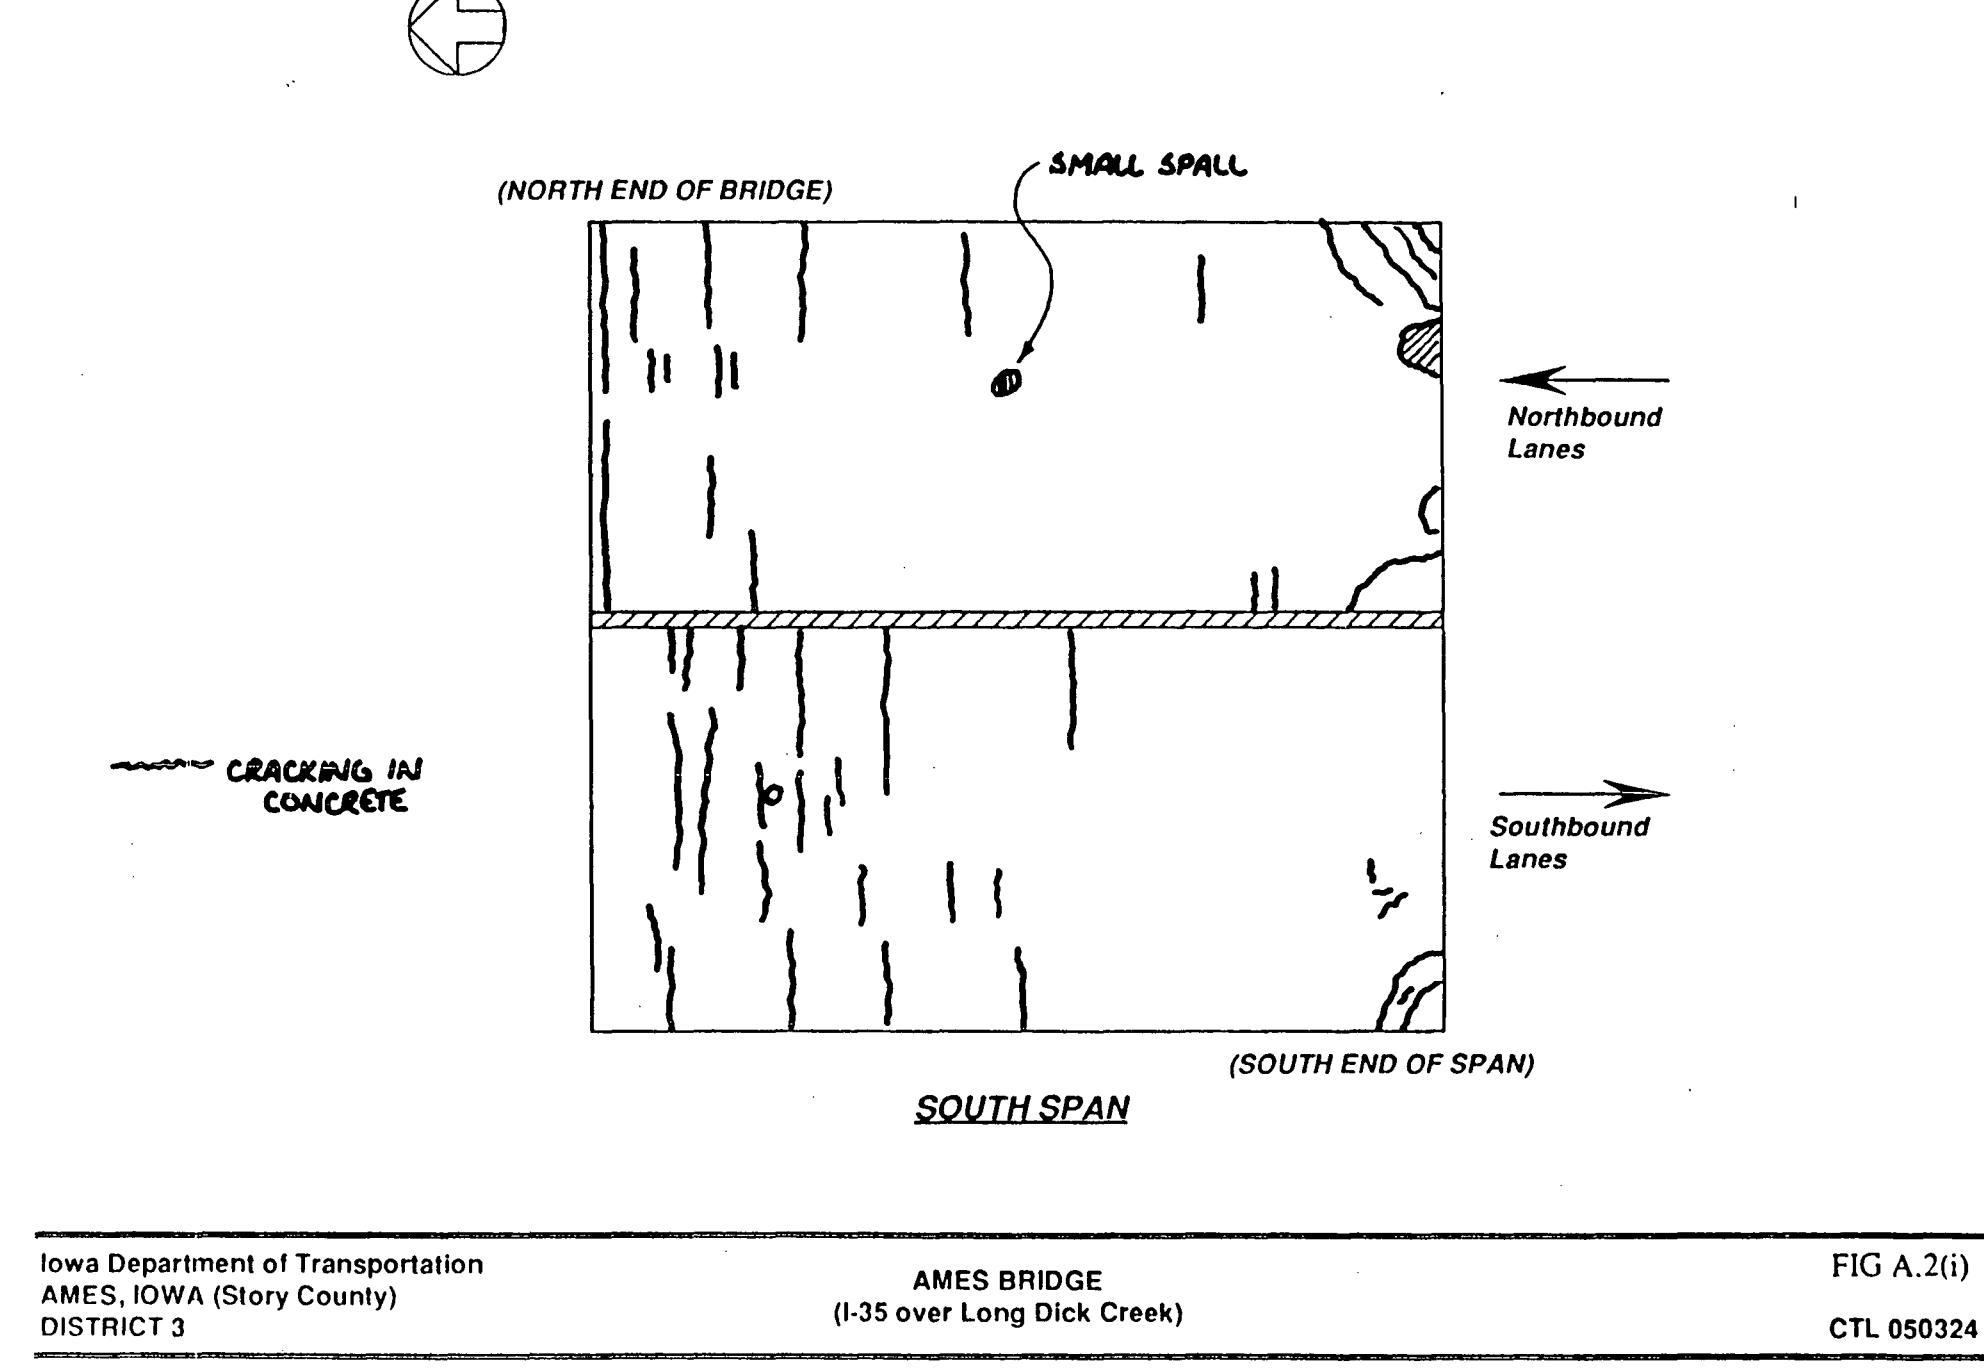
Concrete deterioration in the form of cracking was observed on exposed deck surfaces. Concrete cracking oriented in the transverse direction is shown in Figs. A.2.(g - i). In some instances, cracks occur over embedded steel reinforcement.

Representative Conditions of Bridge Deck Wearing Surface (Note areas of concrete deterioration and ashalt patch shown in Photo b)

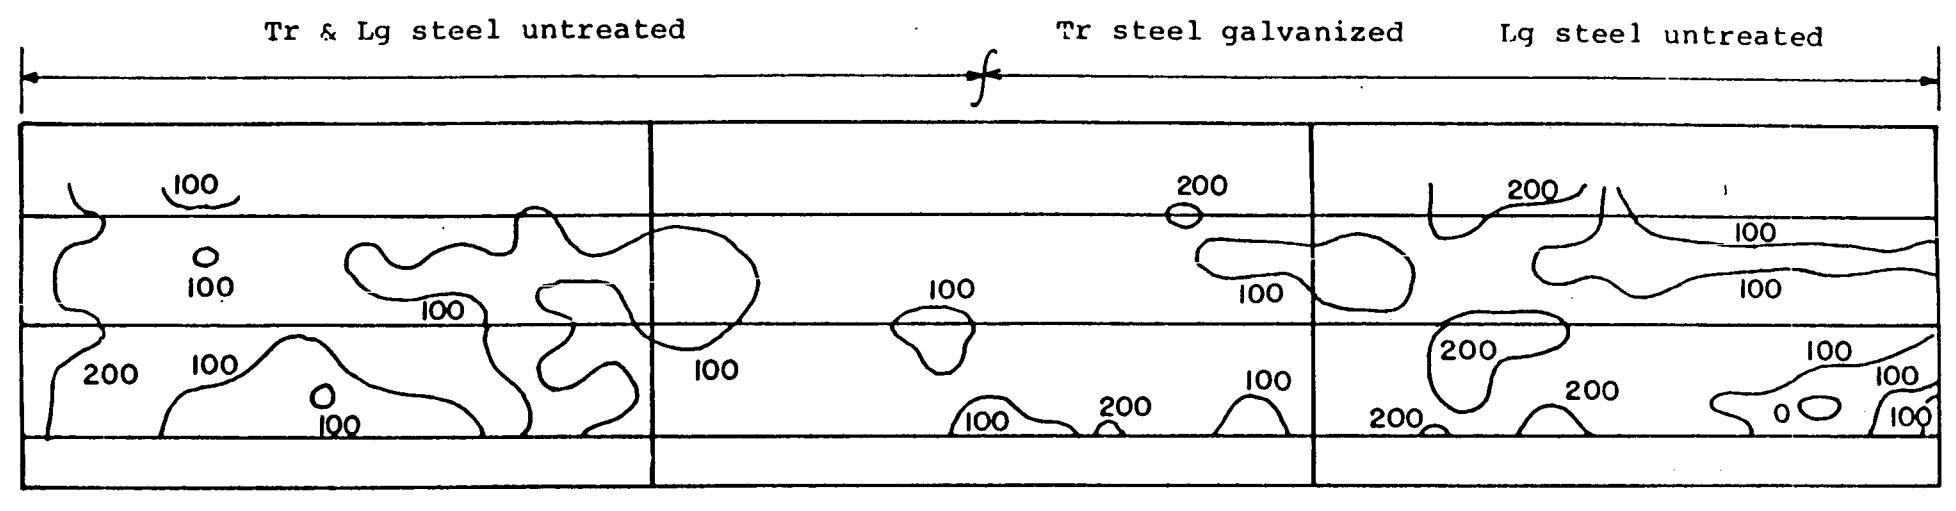
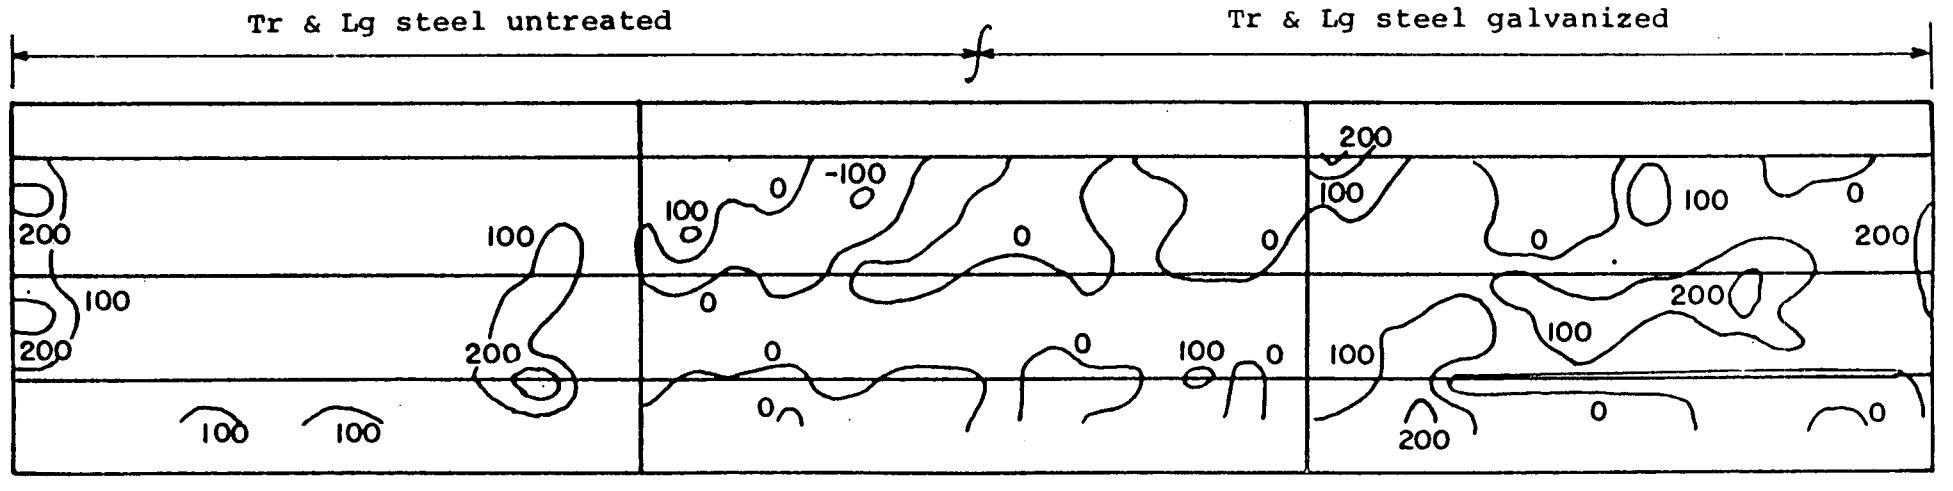
Fig. 22 - Diagram of distribution of electrical potentials in top mat of reinforcing steel.

Potentials are expressed in millivolts.
