**Final Report  
for  
Iowa Highway Research Board  
Project HR 203**

# **Transverse Joint Sealing with Various Sealants**

**Highway Division  
September 1983  
in cooperation with  
Dallas County  
Secondary Road Department**

BY  
VERNON J. MARKS  
RESEARCH ENGINEER

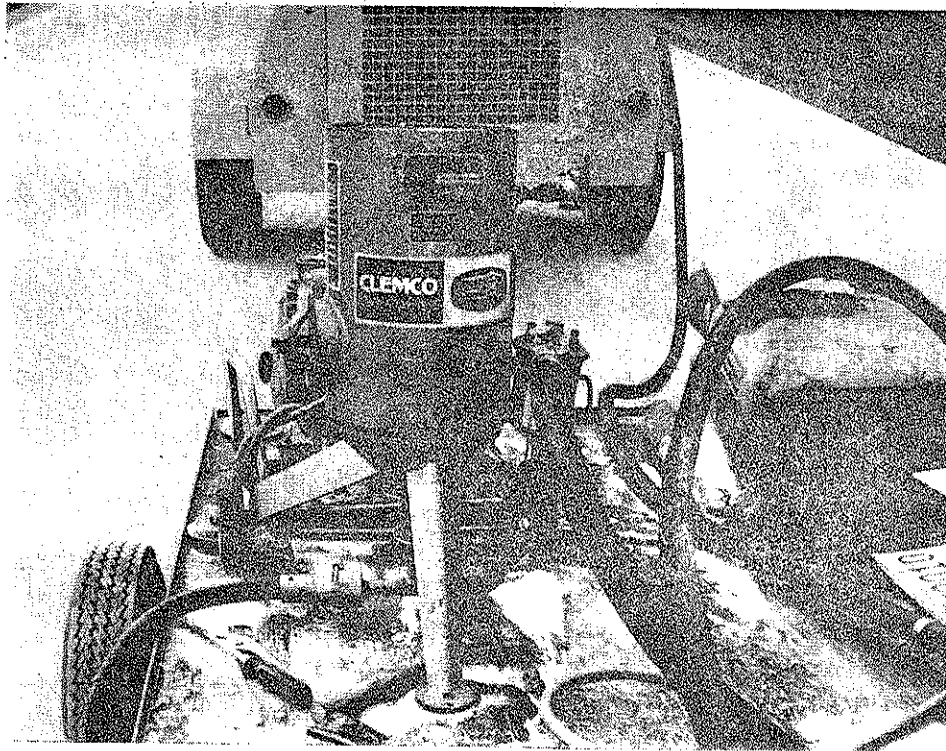
Figure 3 - Sand Blast Equipment

The second method of cleaning was sand blasting. For this operation, the contractor rented a small Clemco Mighty-mite Sandblaster (figure 3) and used bagged silica sand. A specially designed wand would have improved this operation. To effectively sand blast the joint, the operator had to hold the short metal section with the nozzle very close to the pavement.

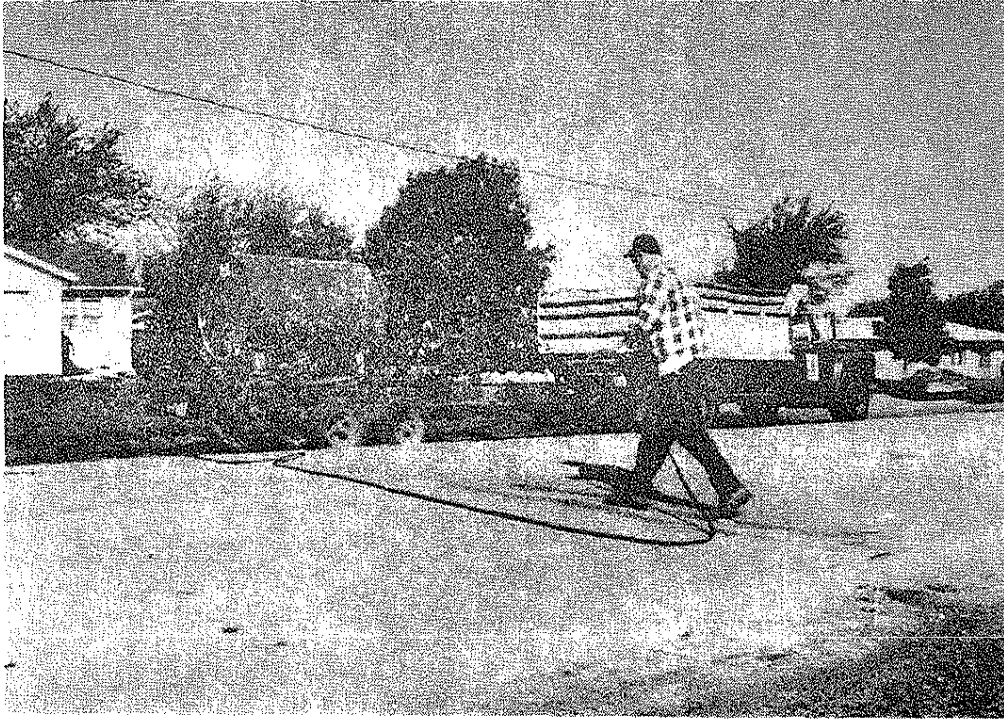
Figure 4 - Water Blast Equipment

A portable car wash unit (figure 4) that would supply about 500 psi of pressure was used for water blast removal of dust and dirt. This unit was operated from the roadway shoulder and, therefore, could not be used when the rainy weather produced impassible conditions.

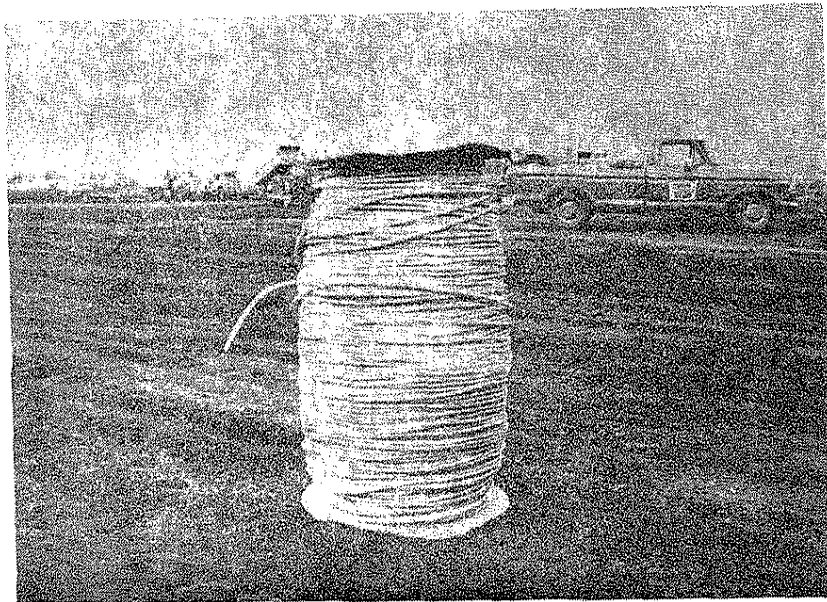
Figure 6 - Backer Rod Material

The backer rod material (figure 6) comes in three sizes ( $3/8$ ",  $1/2$ " and  $5/8$ " diameter) that are matched to joint widths. It must be properly centered over the joint and rolled to the proper depth with a special tool (figure 7). To obtain the desired  $1/2$ " reservoir for the sealant, the knife edge on the roller had to be  $5/8$ " deep for the  $1/2$ " and  $5/8$ " diameter backer rod while a  $1/2$ " knife edge depth was sufficient to place the  $3/8$ " diameter backer rod.

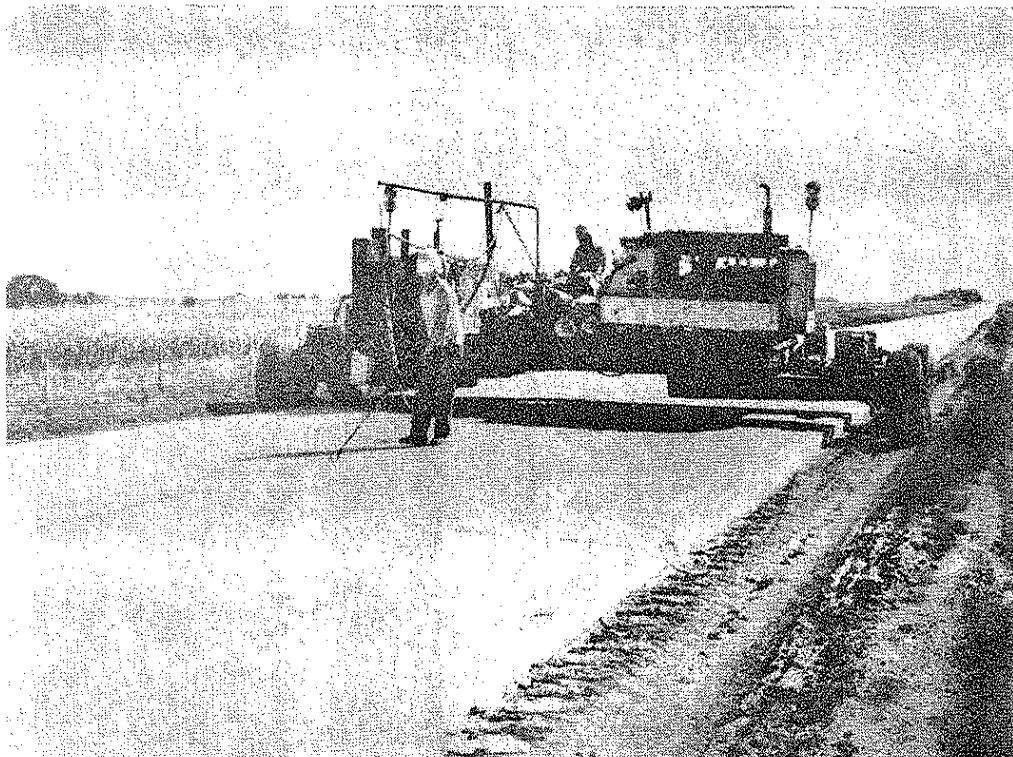
Figure 8 - Contractor's Joint Sealing Unit

The contractor's standard operation includes a specially constructed hydraulically driven joint sealing unit (figure 8) that spans the slab for ease in applying the standard sealant material. It was equipped to heat the sealant to the recommended pouring temperature of 390°F. The material was pumped through a wand with a special applicator tip.

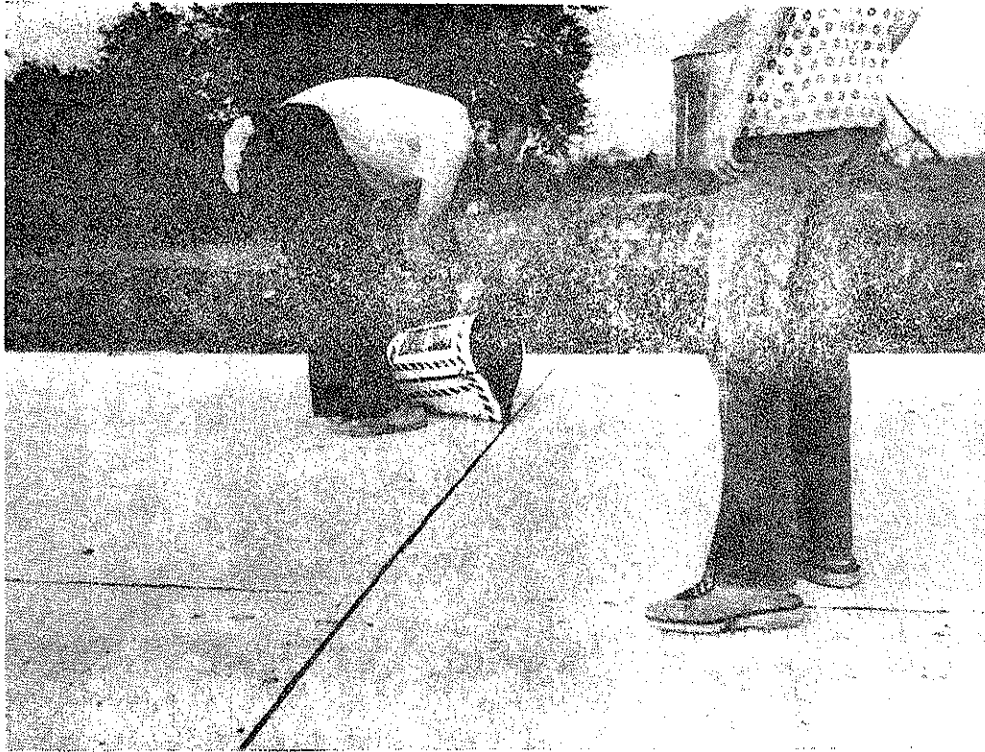
Figure 9 - Manual Pouring of Joint Sealant

The two component material was mixed per the manufacturer's instruction. The contractor made a mixing agitator by welding a 6" hinge onto 1/4" diameter round stock. After component two was poured into component one, the contractor's personnel mixed the material thoroughly for 3 to 5 minutes. The viscosity of this material would not allow it to flow through the small orifice of an Iowa DOT crack sealing pot. All joints were hand poured using a five gallon bucket with one side bent to form a pouring spout (figure 9).

Operator experience and technique are very important in obtaining properly filled joints. The pot life of this sealant was one to two hours. Better joints were obtained if the sealant was used soon after mixing while very fluid. If only the right amount of sealant was added to the pouring bucket to complete one joint at a time, a better sealing job was obtained. The operator must proceed at a speed that is coordinated with the viscosity of the sealant. With hand operation, it was very difficult and near impossible to under fill the joint  $1/8$ " as desired. With some operator experience, reasonably neat appearing joints were obtained. Production type equipment could be developed to improve this sealing procedure and make it compatible with the contractor's operation.

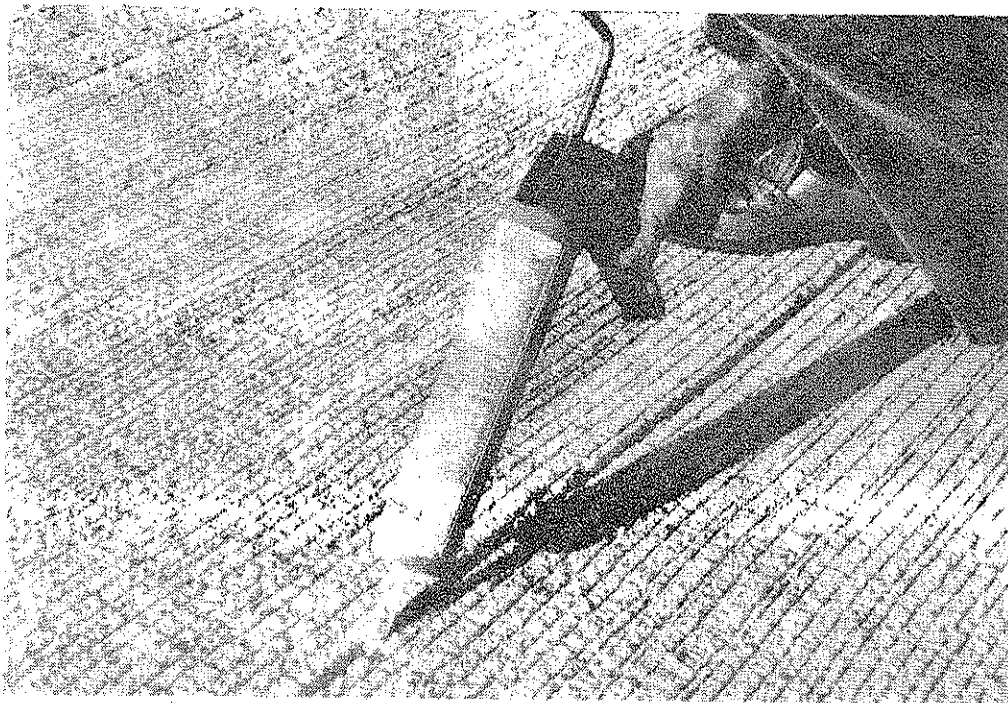
Figure 10 - Dow Corning 888 Sealing with a Caulking Gun

A representative of the Dow Corning Corporation supplied the sealant and application equipment in addition to supervising the installation. The sealant for this research was supplied in 4.5-gallon pails and 11-ounce caulking tube samples. The "888" sealant is to be tooled in and, therefore, the manufacturer recommends the use of backer materials. A few of the 1/4" wide joints were sealed using the caulking gun (figure 10). Most of the research joints were sealed using the air operated bucket pump supplied by Dow Corning (figure 11). The "888" sealant does not flow readily and must be "tooled" into the joint. This tooling was done immediately after depositing the sealant. Round steel rods compatible with the width of joints were used in much the same manner as one would "strike" the joints of a concrete block wall.

This was the first paving project where the Dow Corning personnel had assisted in the field application. It was a relatively slow process and the Dow Corning representative recognized that equipment modifications would improve the operation. A more efficient sealing system can be developed to increase the speed of application.

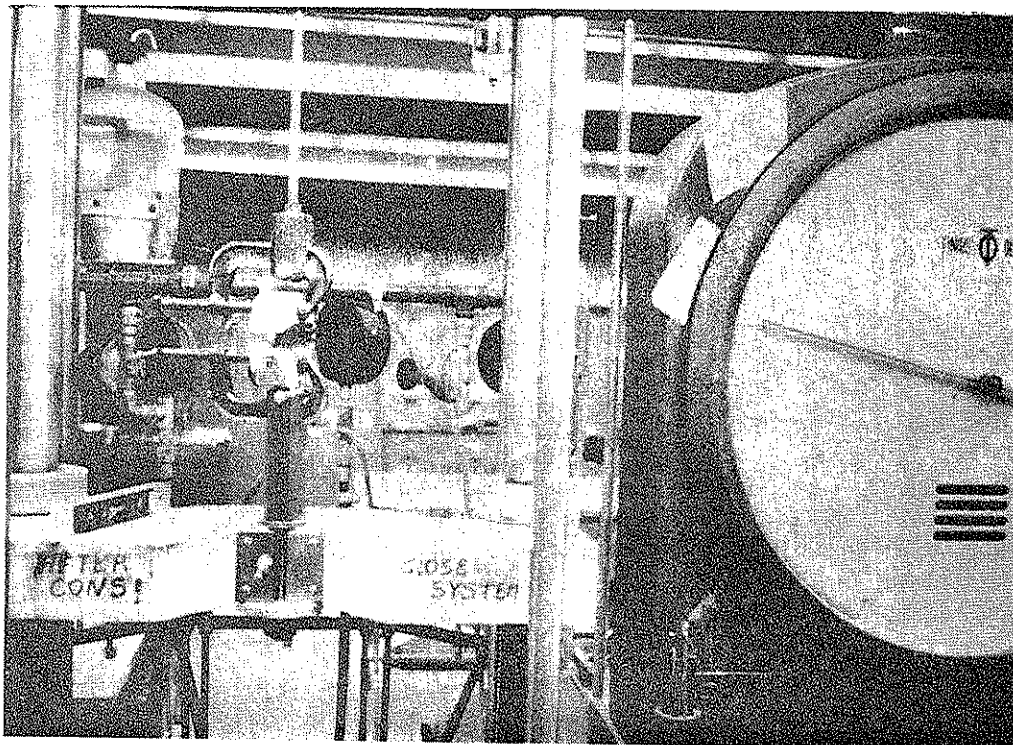
Figure 13 - Joint Seal Testing Apparatus

The top portion (approximately 2") of the cores, including the joint seal, was cut off for the final test of the cores. Two C clamps were fitted with pull rods to be used in a Tinius Ohlsen Testing Machine (figure 13). The C clamps were secured to the rods so they were not free to rotate. The rods were free to move for alignment. All cores that were bonded sufficiently to transmit load were tested. Even some that were rated partial seal failure yielded a significant maximum load at failure. The load was applied at the rate of 0.3" per minute. The maximum load, elongation at maximum load (not available for all cores) and elongation at failure are tabulated in Appendix B.
