# Deterioration of Iowa Highway Concrete Pavements: A Petrographic Study

FINAL REPORT  
HR-1065

Paul E. Stutzman

December, 1999

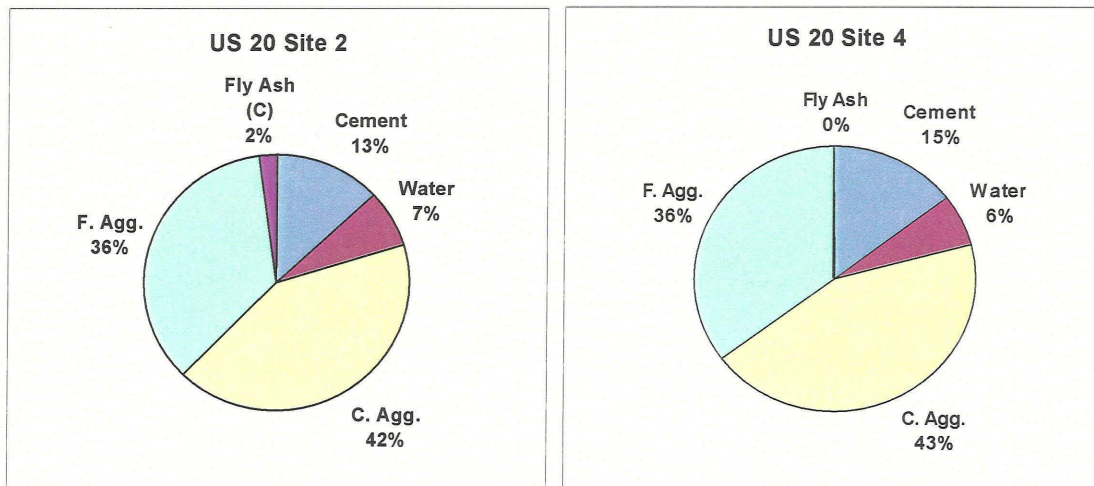
Figure 4 gives the concrete materials proportions from US 20 for mixes with and without fly ash while Figure 5 indicates the gap grading of the aggregates. Evaluation of the mix design by two separate internationally recognized engineers [18,19] found agreement in that the high sand content and gap-grading probably led to difficulties in workability and consolidation, and may have resulted in drying shrinkage problems. The aggregate distributions plotted on a Shilstone Coarseness Factor Chart [20] fall in a region reflecting gap-graded concrete and where workability difficulties may be present (Figure 6). The parallel blue lines on this chart define a region of optimum grading for low water demand and optimum response to vibration. While the potential difficulty in workability were not unexpected to the Iowa Department of Transportation staff [21], it is significant in that it may also affect the development of the entrained air void system during mixing. Failure to develop an adequate entrained air void system appears to be contributory to the deterioration of these pavements.

Figure 4. Concrete materials proportions, by mass, for selected sections of Iowa US 20.

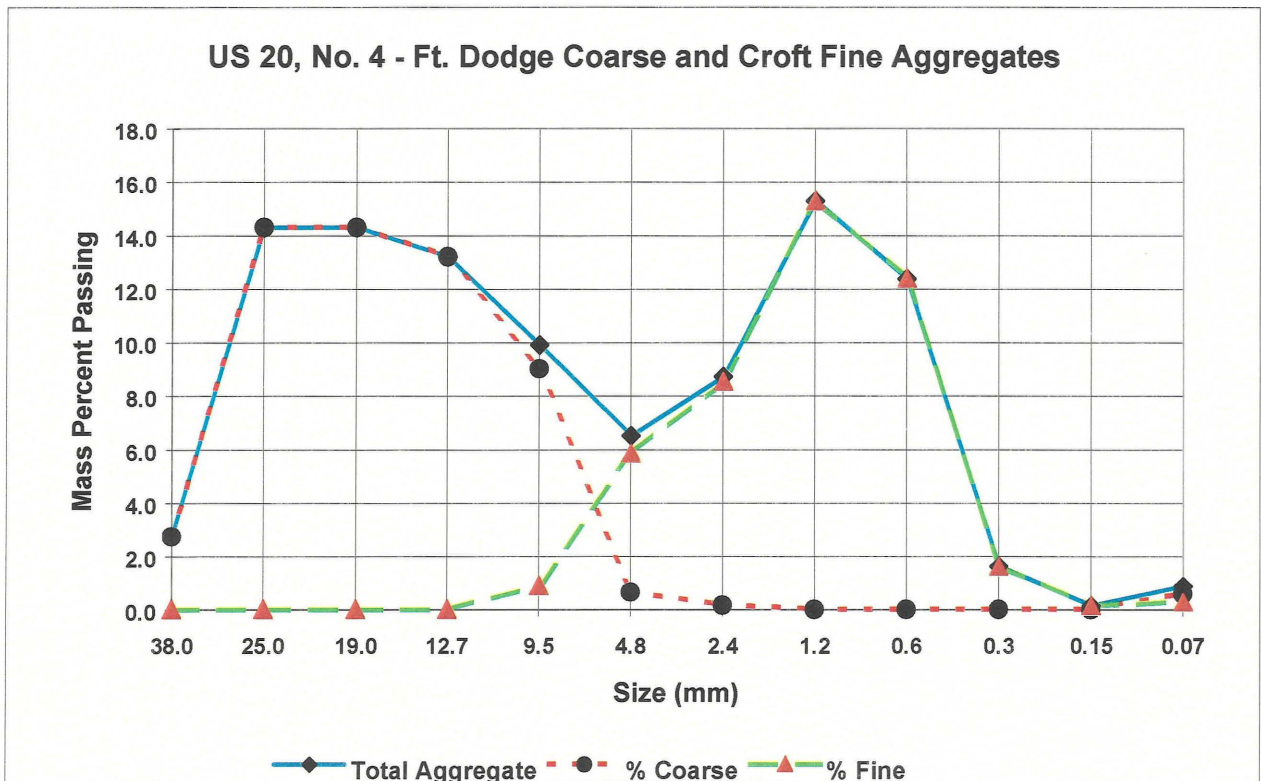
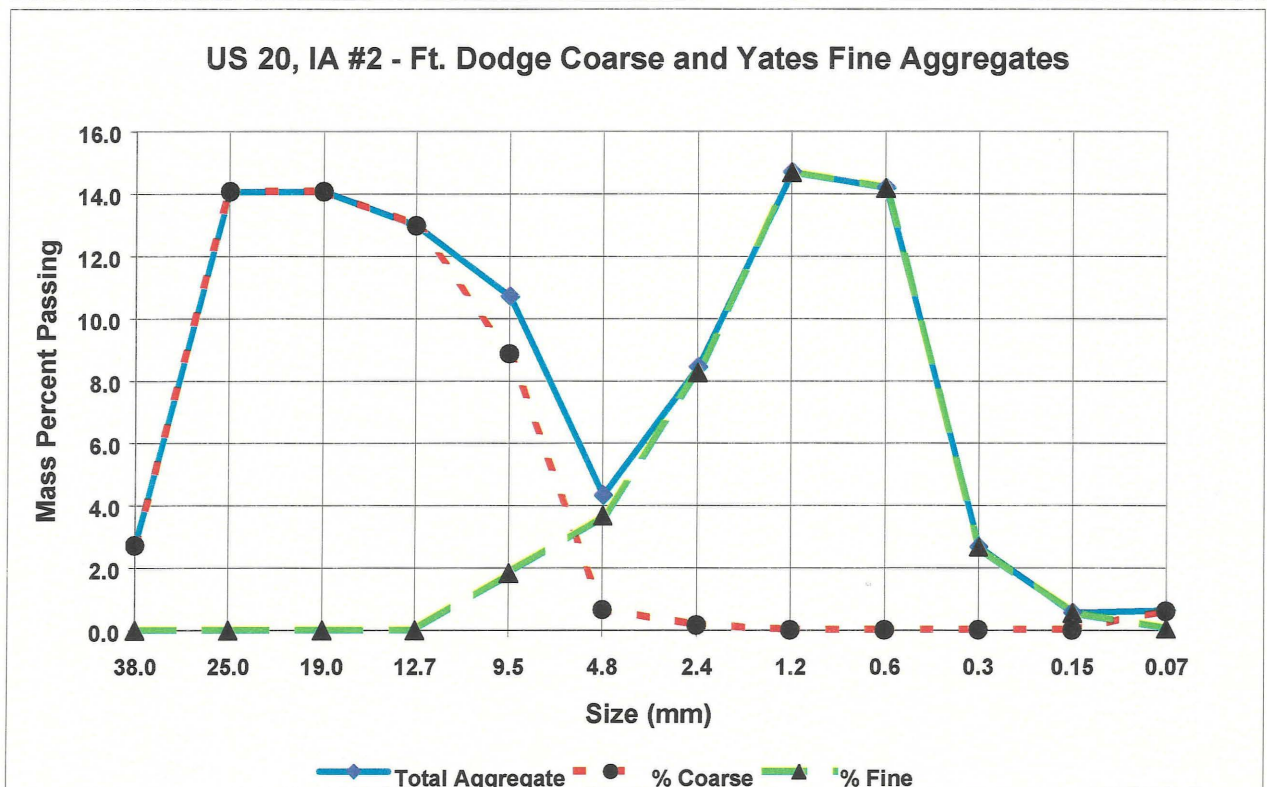
Figure 5. Aggregate gradation plots showing coarse, fine, and combined aggregate gradation and the lack of particles in the intermediate size range.

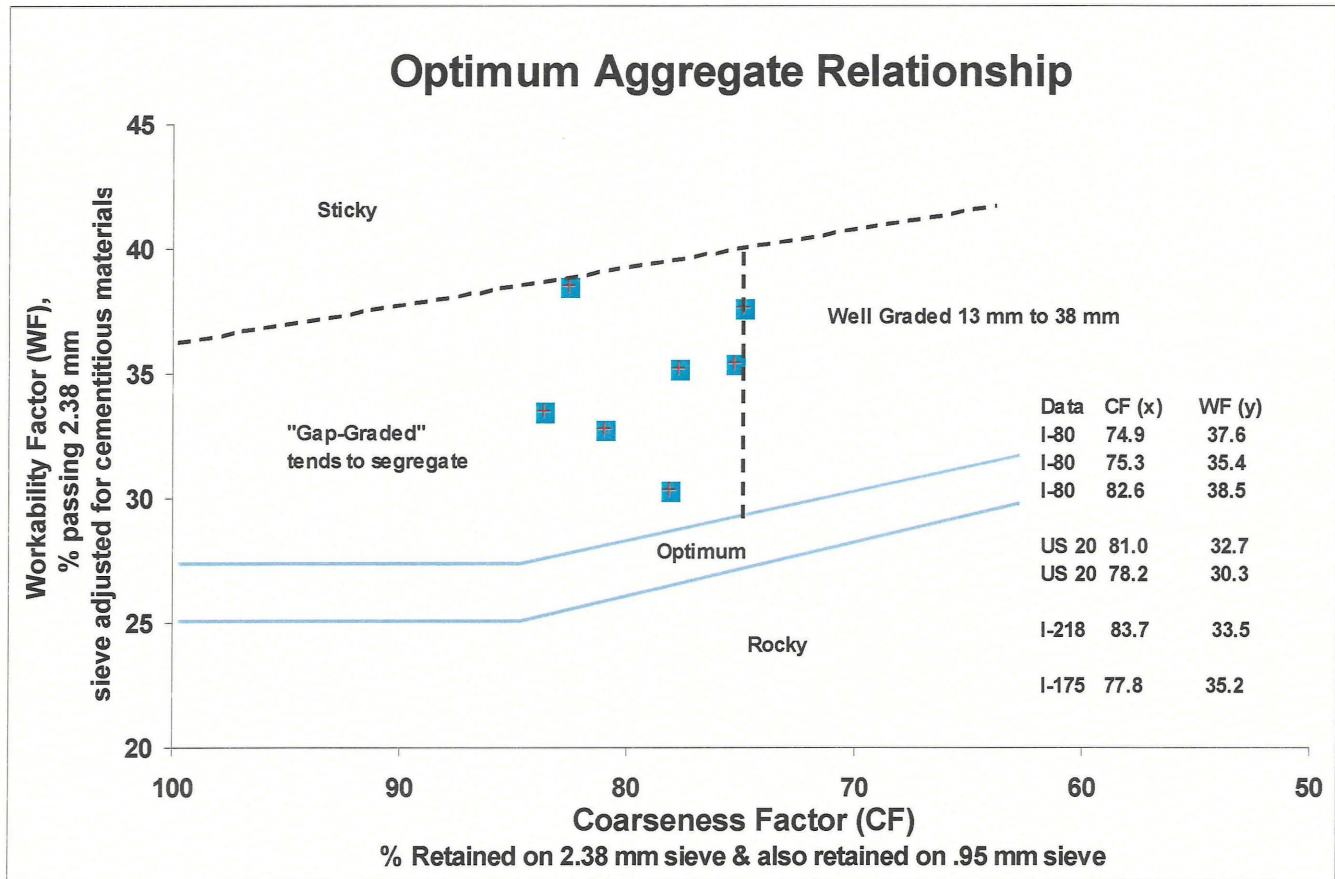
Figure 6. Optimum aggregate chart plots of Iowa pavement mix designs fall into the gap-graded region and indicate likely difficulties in workability [20].

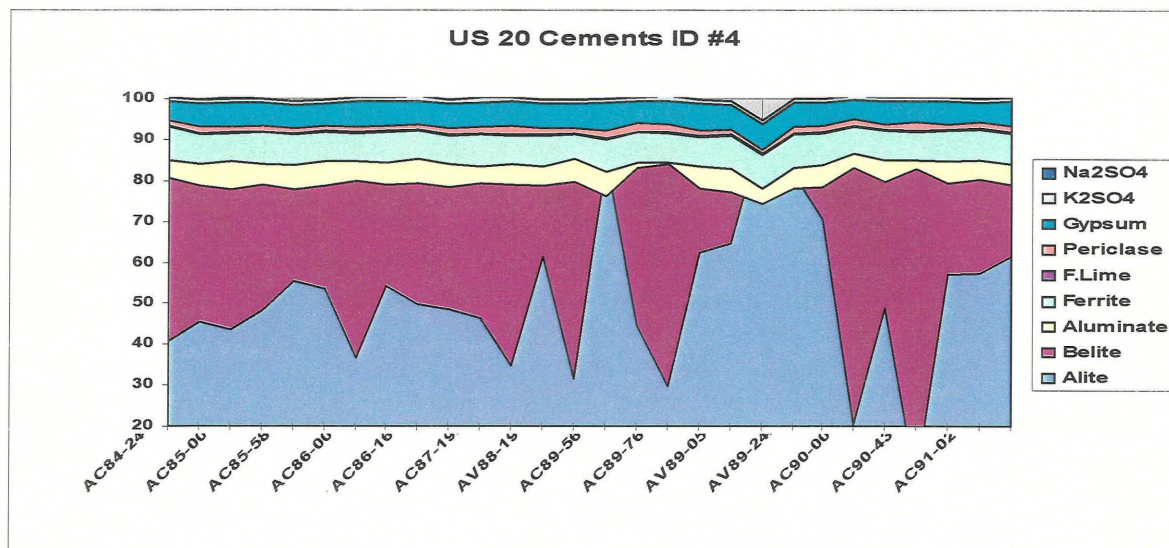
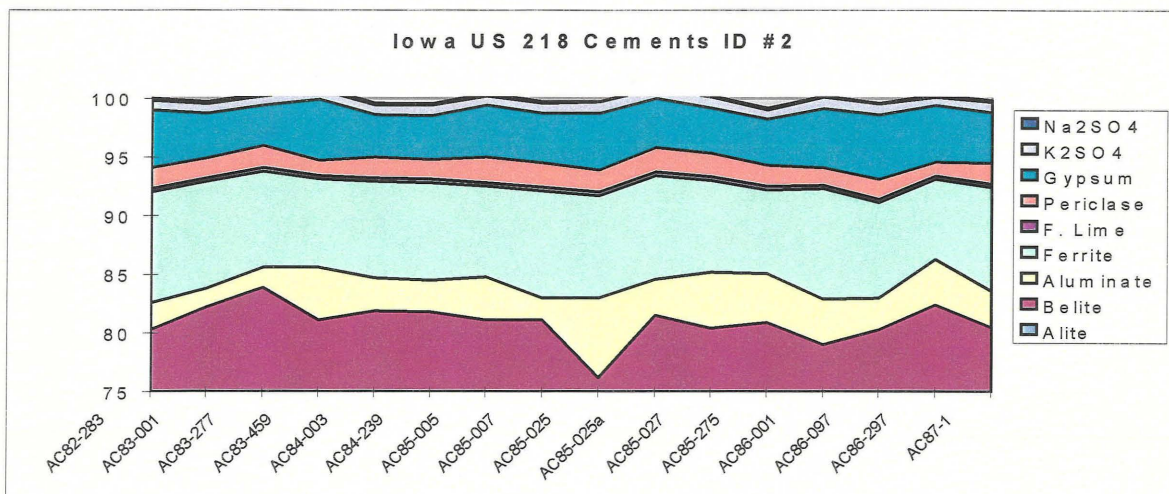
Figure 7. Cement compositions, expressed as mass percent, from chemical analyses from the Iowa DOT database and using a modified Bogue calculation described in Taylor [22]. The y-axis has been expanded to more clearly illustrate total silicates and other phases.

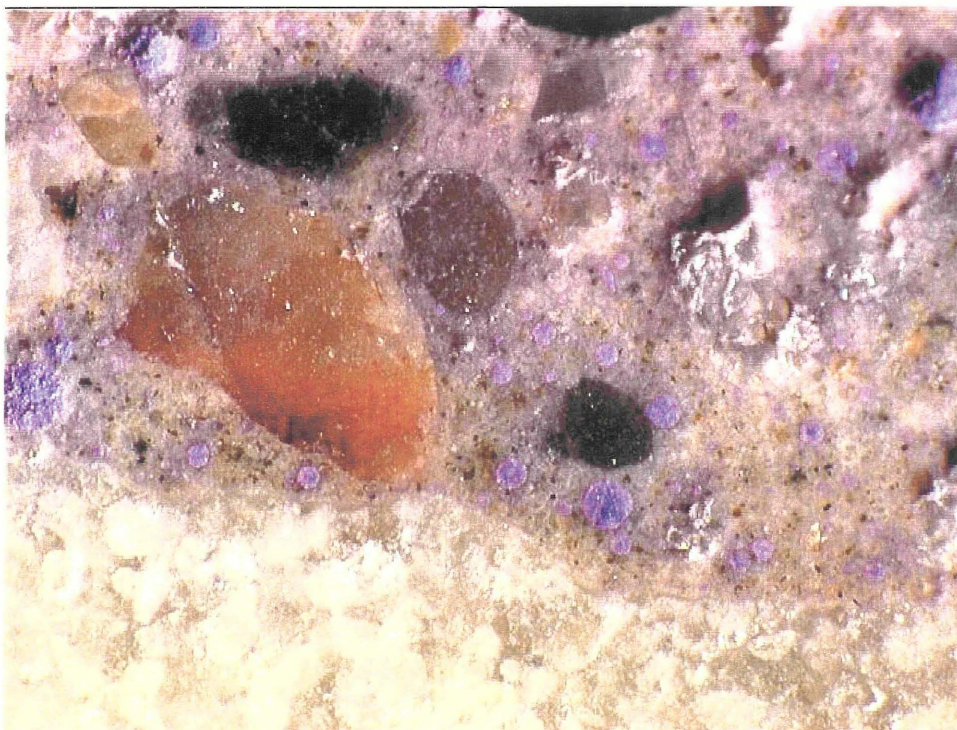
Figure 8. Potassium permanganate and barium chloride staining colors sulfate phases purple facilitating their identification. This allows discrimination of both the original and effective entrained air void systems.

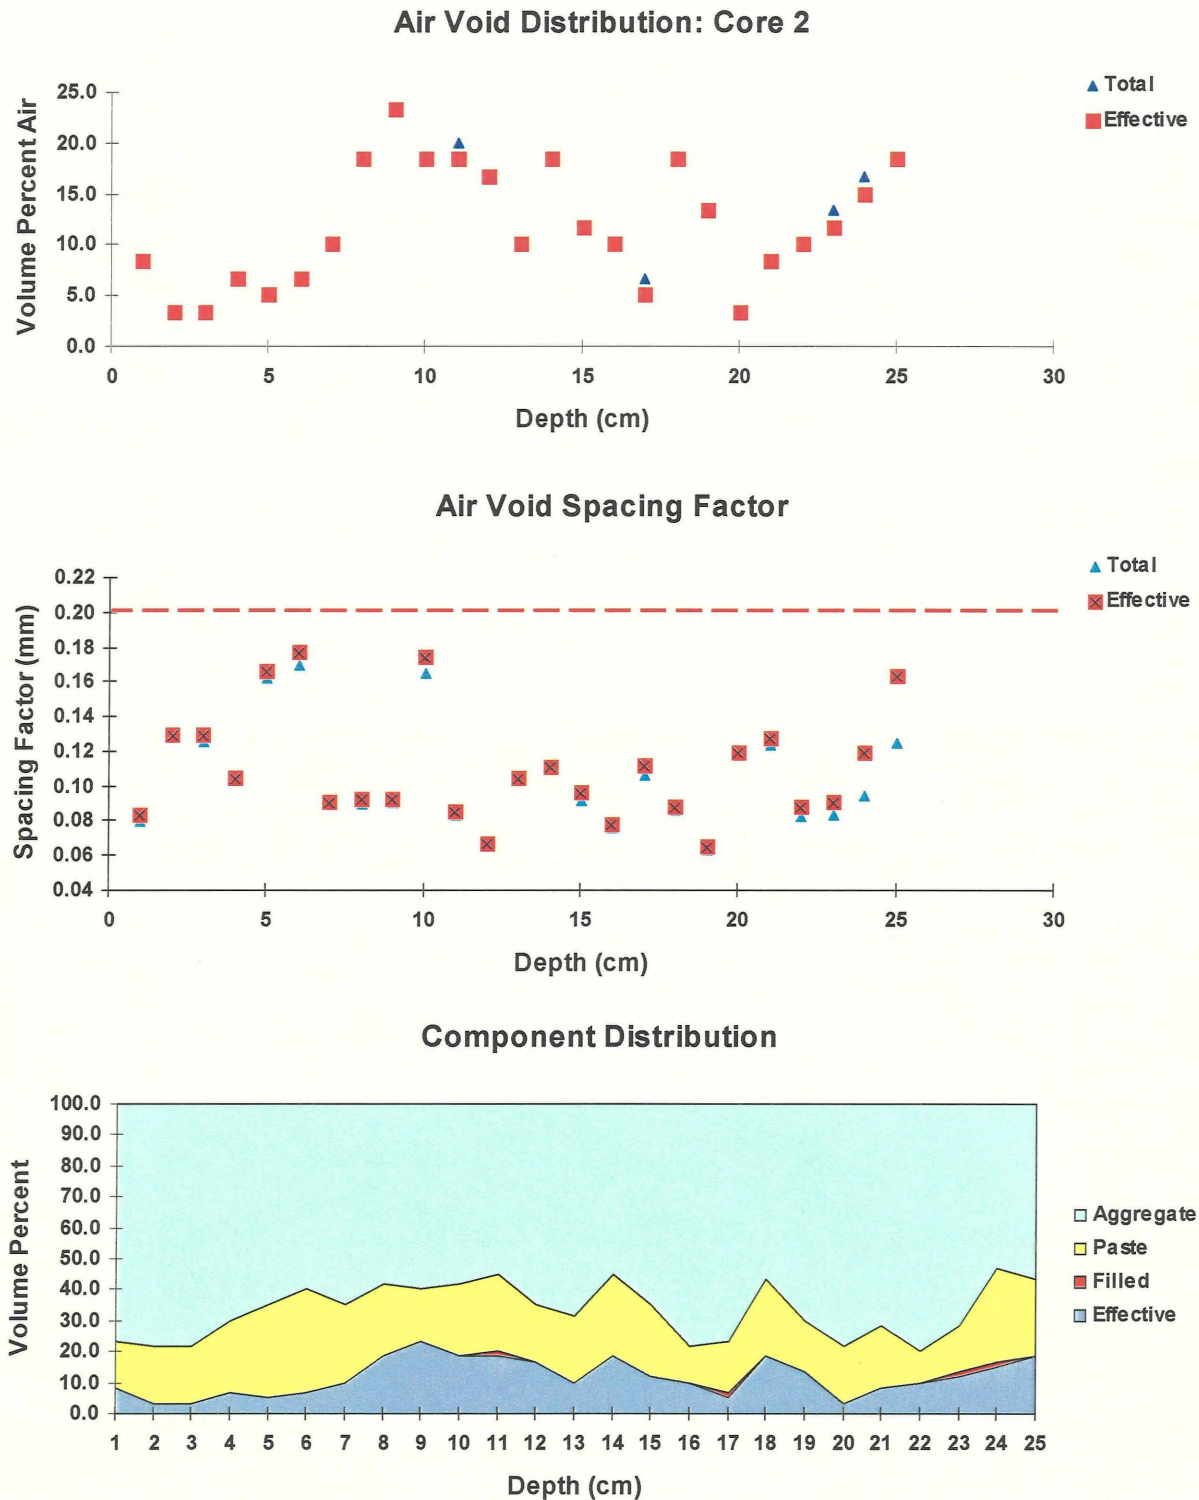
Figure 13. Iowa 175 Core 2 air void and materials distribution plots. A decrease in air near the surface may reflect the loss of entrapped air. The blue triangles represent an air void parameter estimate for the original concrete; the red box represents that value as affected by void filling, if present.

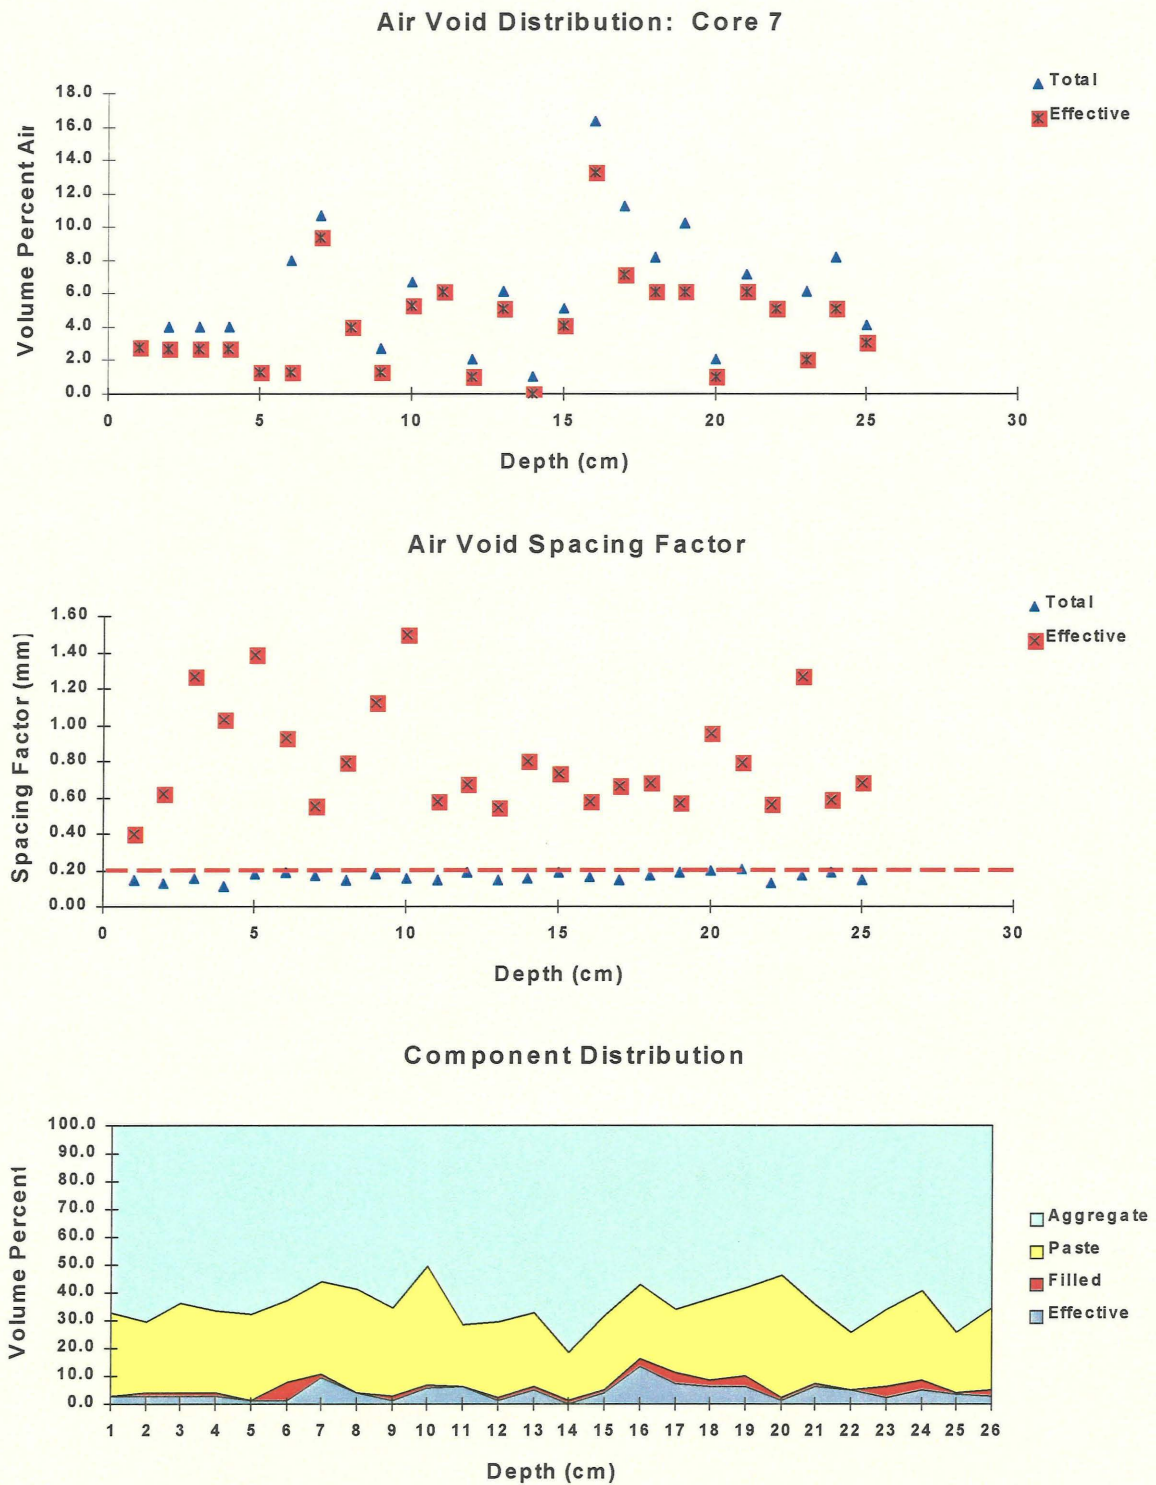
Graphical representation of the total air, spacing factors, and component distribution (Figure 18, Figure 19) illustrates the alteration of the air void system resulting from the ettringite filling. Air distribution, as measured by total air volume, appears uniform from the core top to base. Core 7 may show a slight decrease in air in the upper 50 mm, possibly reflecting the elimination of entrapped air in the upper-most portion of the concrete. This also indicates that, outside the immediate regions of the immersion vibrators, the air void spacing factors do not appear to be adversely affected. The decrease in ettringite precipitation near the surface (upper 5 mm) may reflect the influence of surface drying. At greater depths, filling of voids appears uniform from both a total air void volume and loss of spacing factor. Component distribution appears uniform indicating no apparent vertical segregation of materials due to vibration.

Figure 18: Air void distribution, spacing factors, and concrete component distribution versus depth for Core 7. The red boxes represent the current value, the blue triangle, the original value, and the red line in the spacing factor plot denotes the ASTM C 457 recommended limit for freeze-thaw protection.

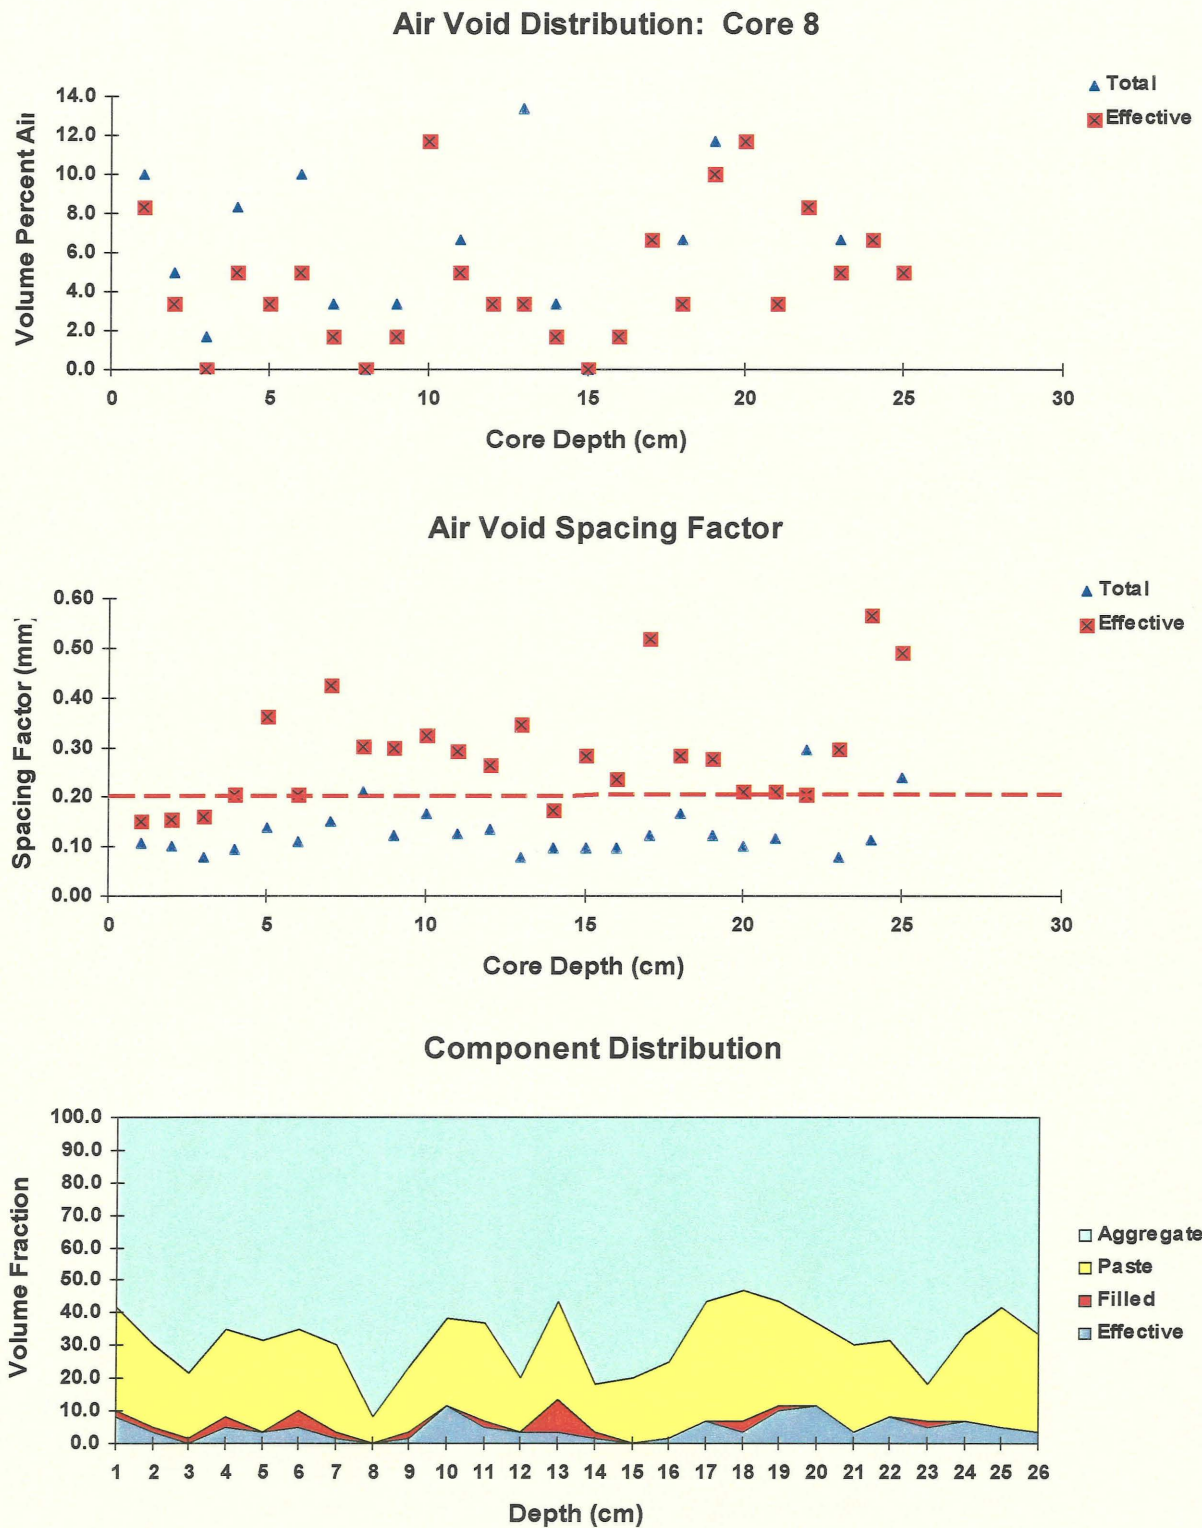
Figure 19: Air void distribution and spacing factors versus depth, and concrete component distribution for Core 8, mid-panel.

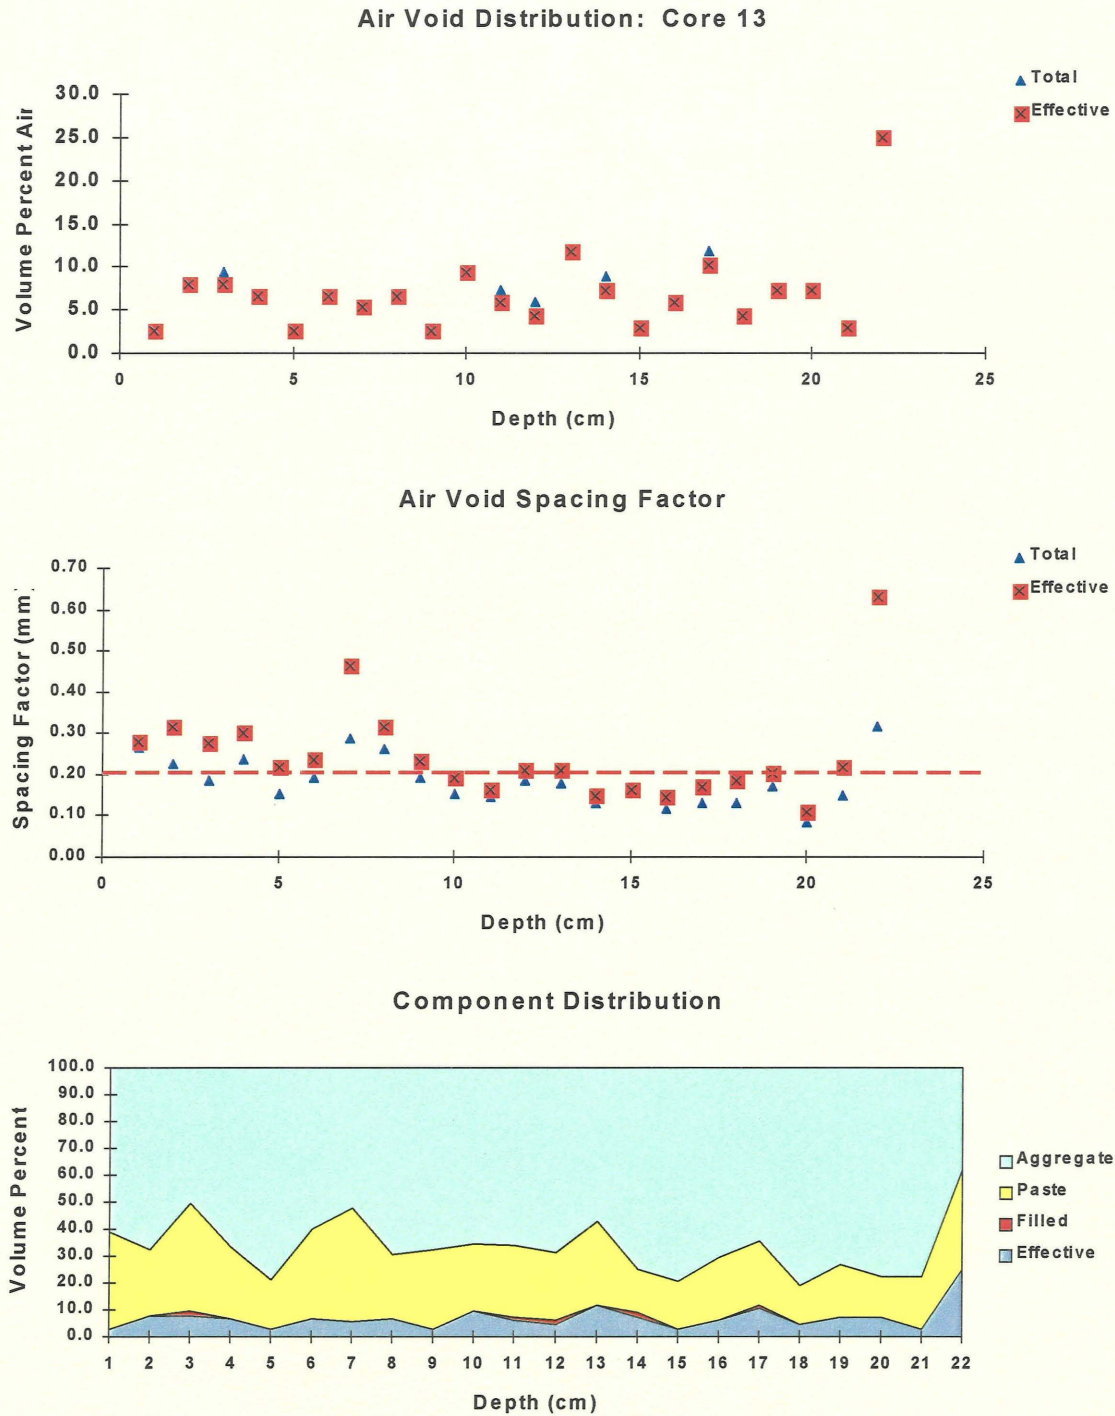
Figure 25. Air void distribution and spacing factors versus depth, and concrete component distribution for Core 13. The air volume appears uniform with depth while the spacing factor appears substandard in the upper 100 mm. Filling has resulted in a slight increase in the spacing factor.

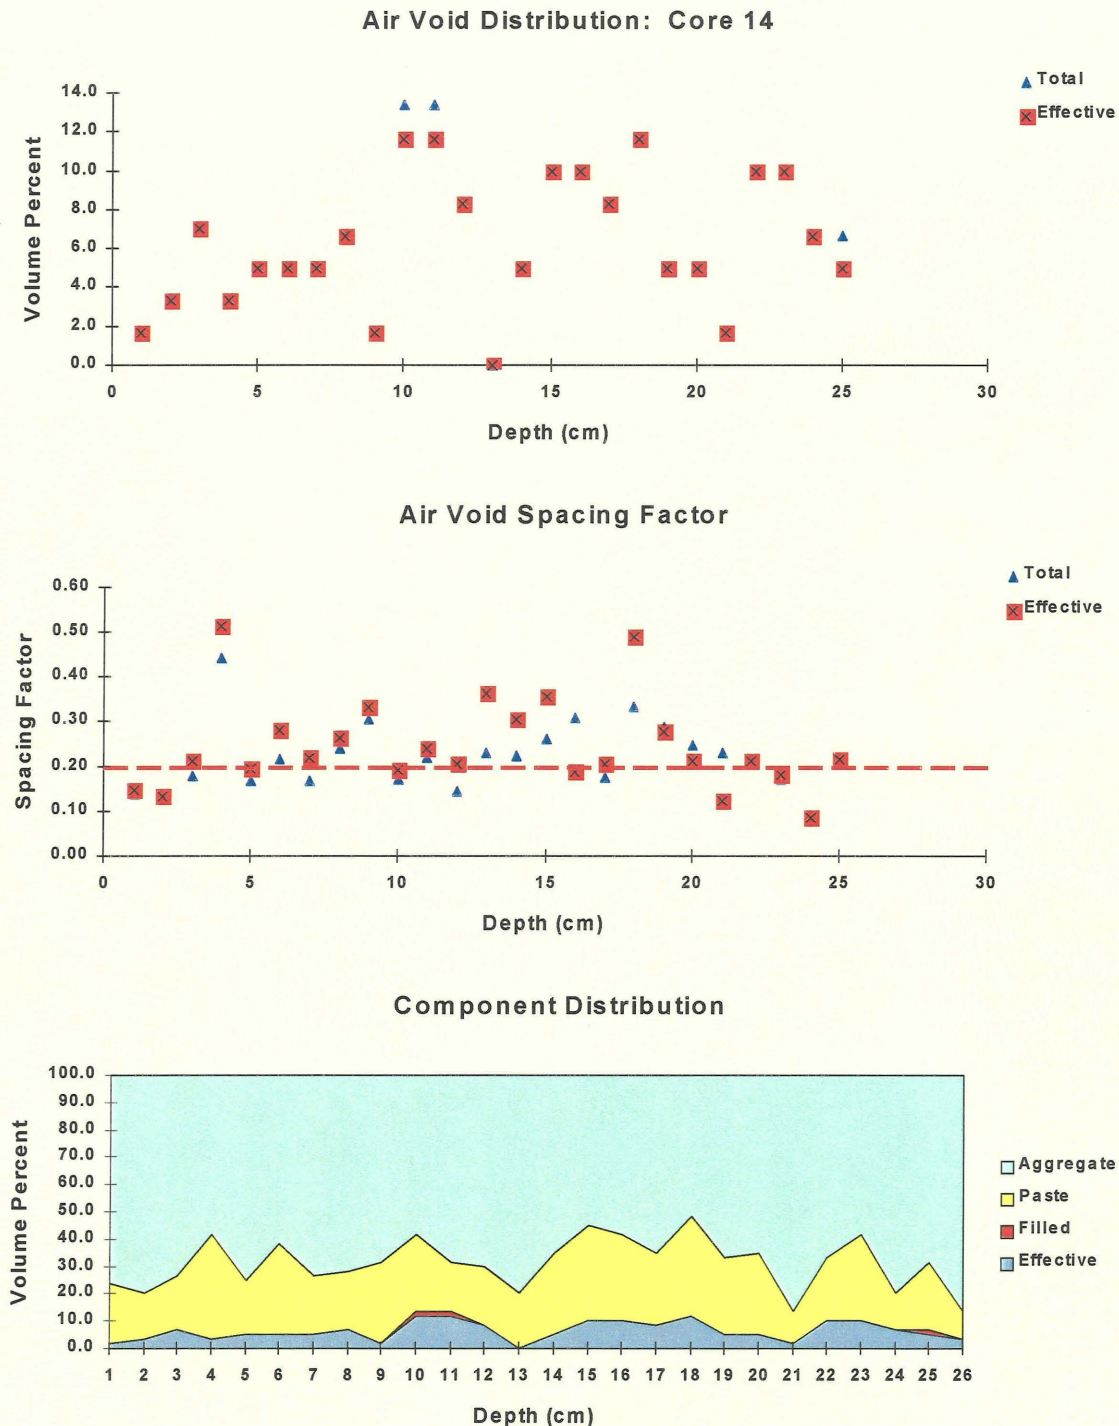
Figure 26. Air void distribution and spacing factors versus depth, and concrete component distribution for Core 14. The total air volume appears similar to that of Core 13 from the joint and appears uniform with depth (deviations from the median probably reflect entrapped air voids). The spacing factor appears marginal to sub-standard at depths below 6 cm, and filling of the smaller entrained air voids has resulted in an increase in void spacing factor.

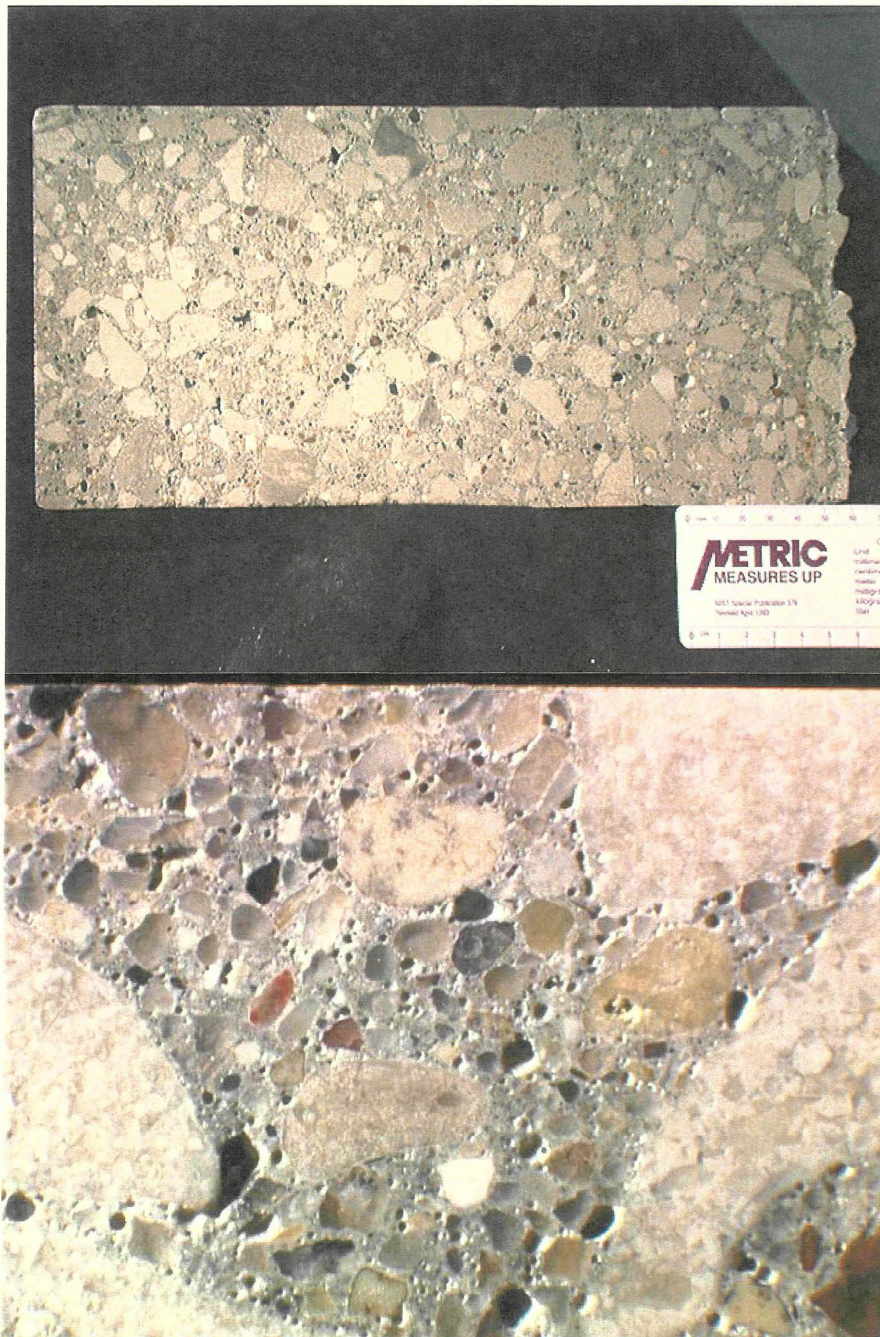
Core 18 (Figure 27), from a sound pavement at mile 124.4, is approximately 300 mm in length and appears different from Core 19 in that it seems to have a more uniform aggregate gradation, and a substantially better entrained air void system. The concrete appeared sound, though some microcracking was evident in the outer few millimeters under SEM examination. The concrete cut cleanly and exhibits good aggregate - paste bonding. Occasionally, a millimeter-sized void filled with alkali-silica reaction gel was seen, but little cracking was observed adjacent to the gel.

Figure 27. Core 18 contains about 12 % entrained air volume and a spacing factor of 0.08 mm. Aggregate gradation appears more uniform, and possibly smaller maximum size than the degraded pavement concretes. Low specific surface and common entrapped air voids are features common to other cores in this study.

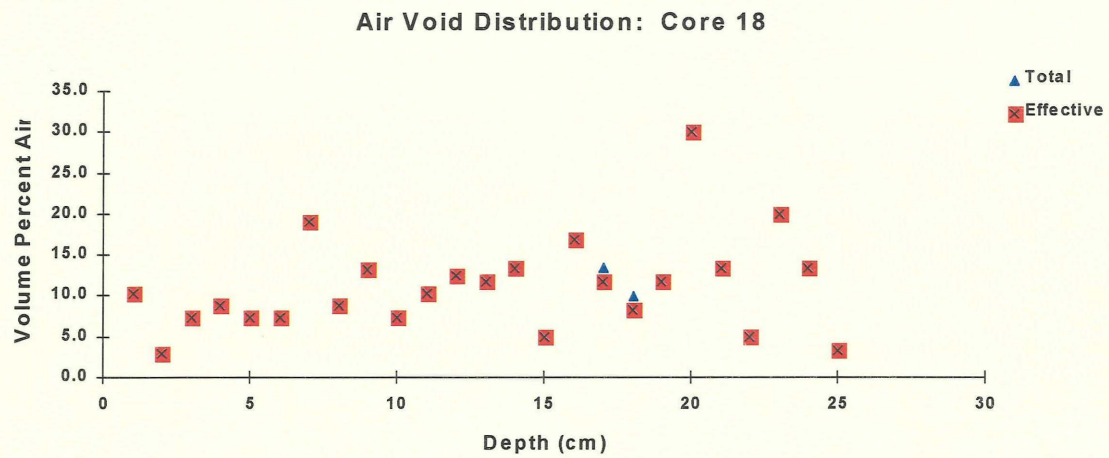
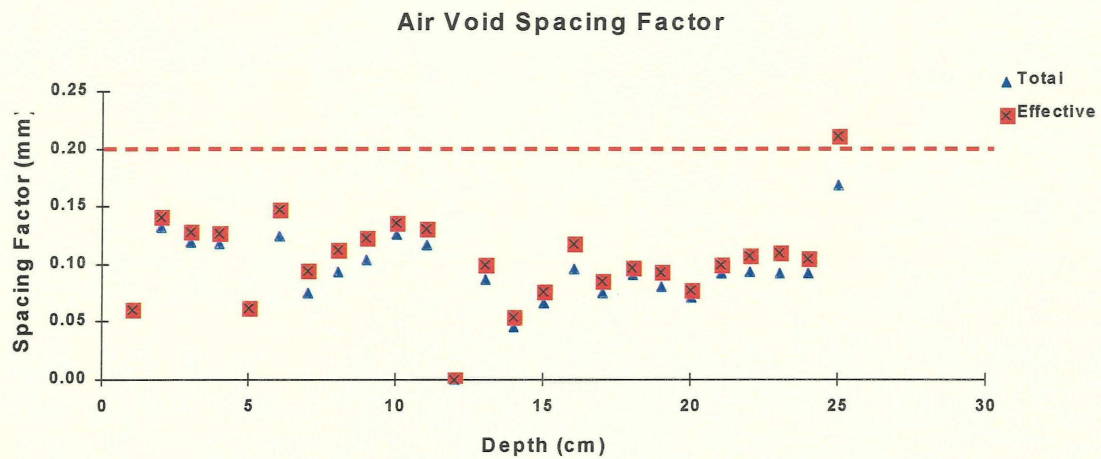
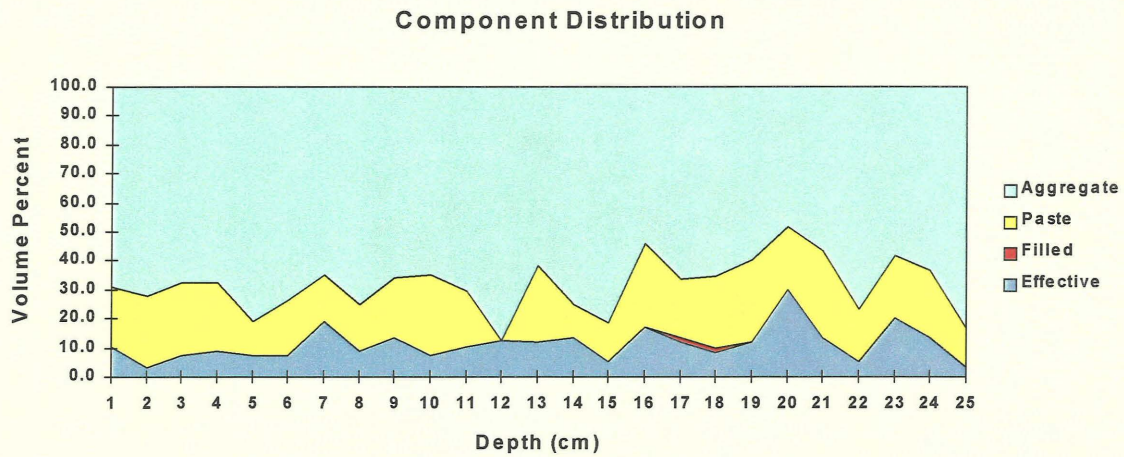
Figure 28. Air void and component distribution plots for core 18. Little loss of air void volume is evident with only a slight, uniform loss of air void spacing factor. Component distribution appears uniform from top to bottom.

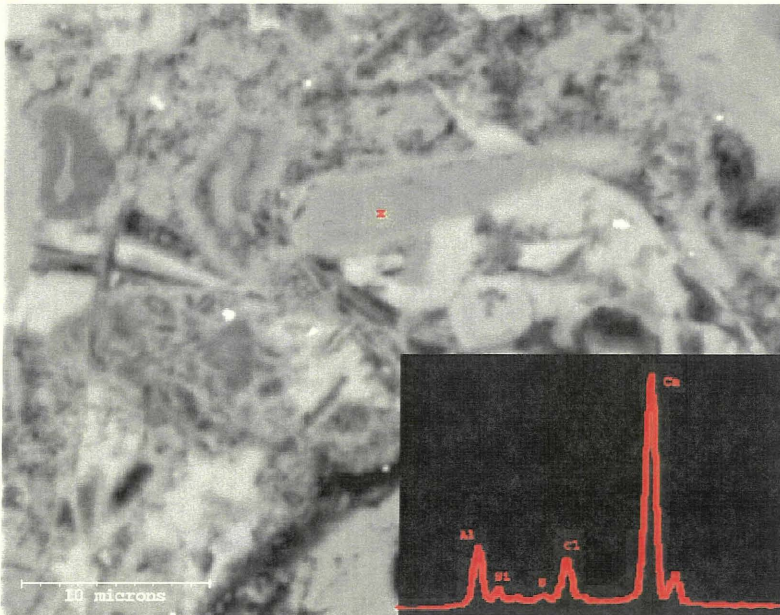
Figure 30. Friedel's salt in hardened paste is identified here using X-ray microanalysis. It appears to be a primary hydration product in the paste throughout the cores, suggesting that it may be a result of the presence of chlorides in the original mix as opposed to the infiltration of road salts.

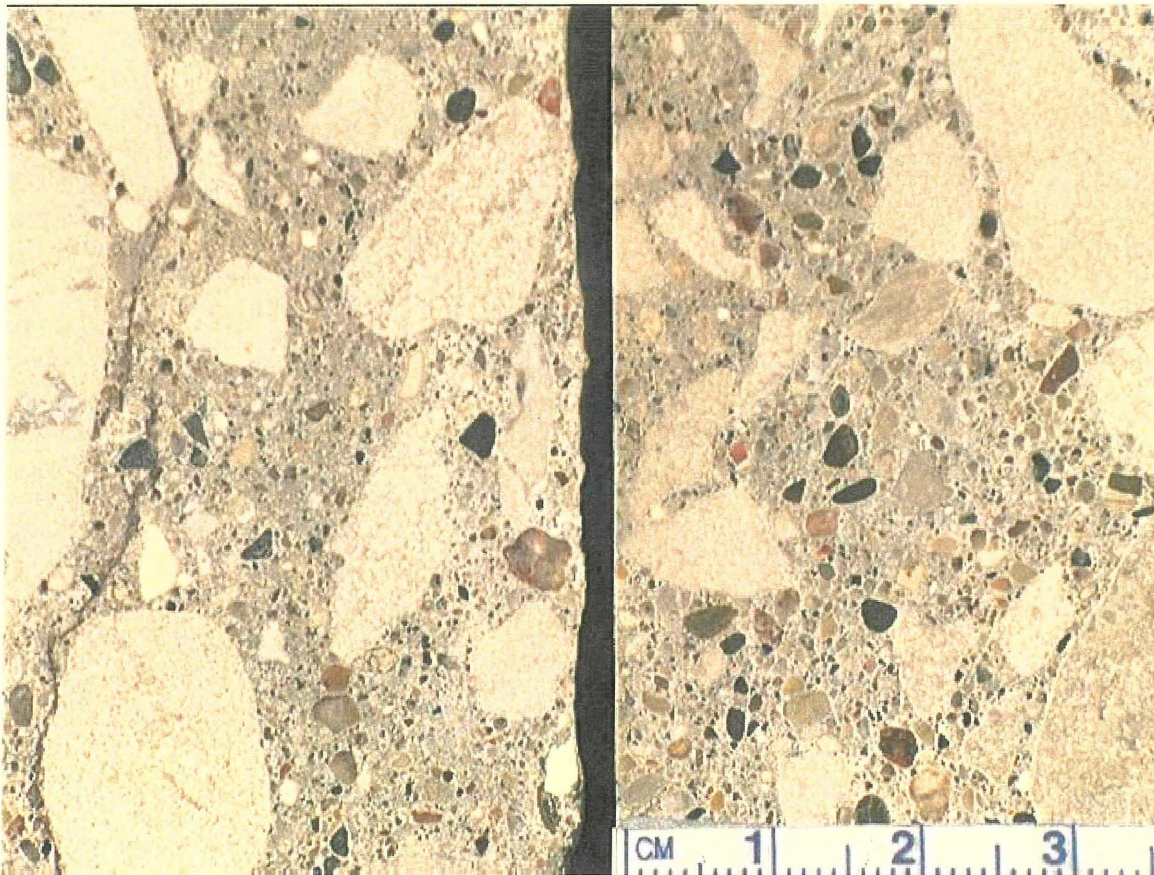
Visual examination of Cores 18 and 19 found a likely difference in aggregate grading (Figure 35) with Core 18 appearing to have a more uniform, and perhaps smaller, aggregate gradation. The apparent change in aggregate gradation may have affected the development of the higher-volume entrained air void system in Core 18. However, specific surface values indicate a coarse air void size distribution.

Figure 35. Core 19 (left) appears to have a finer-sized sand and possibly a larger maximum coarse aggregate size when compared to Core 18 (right).

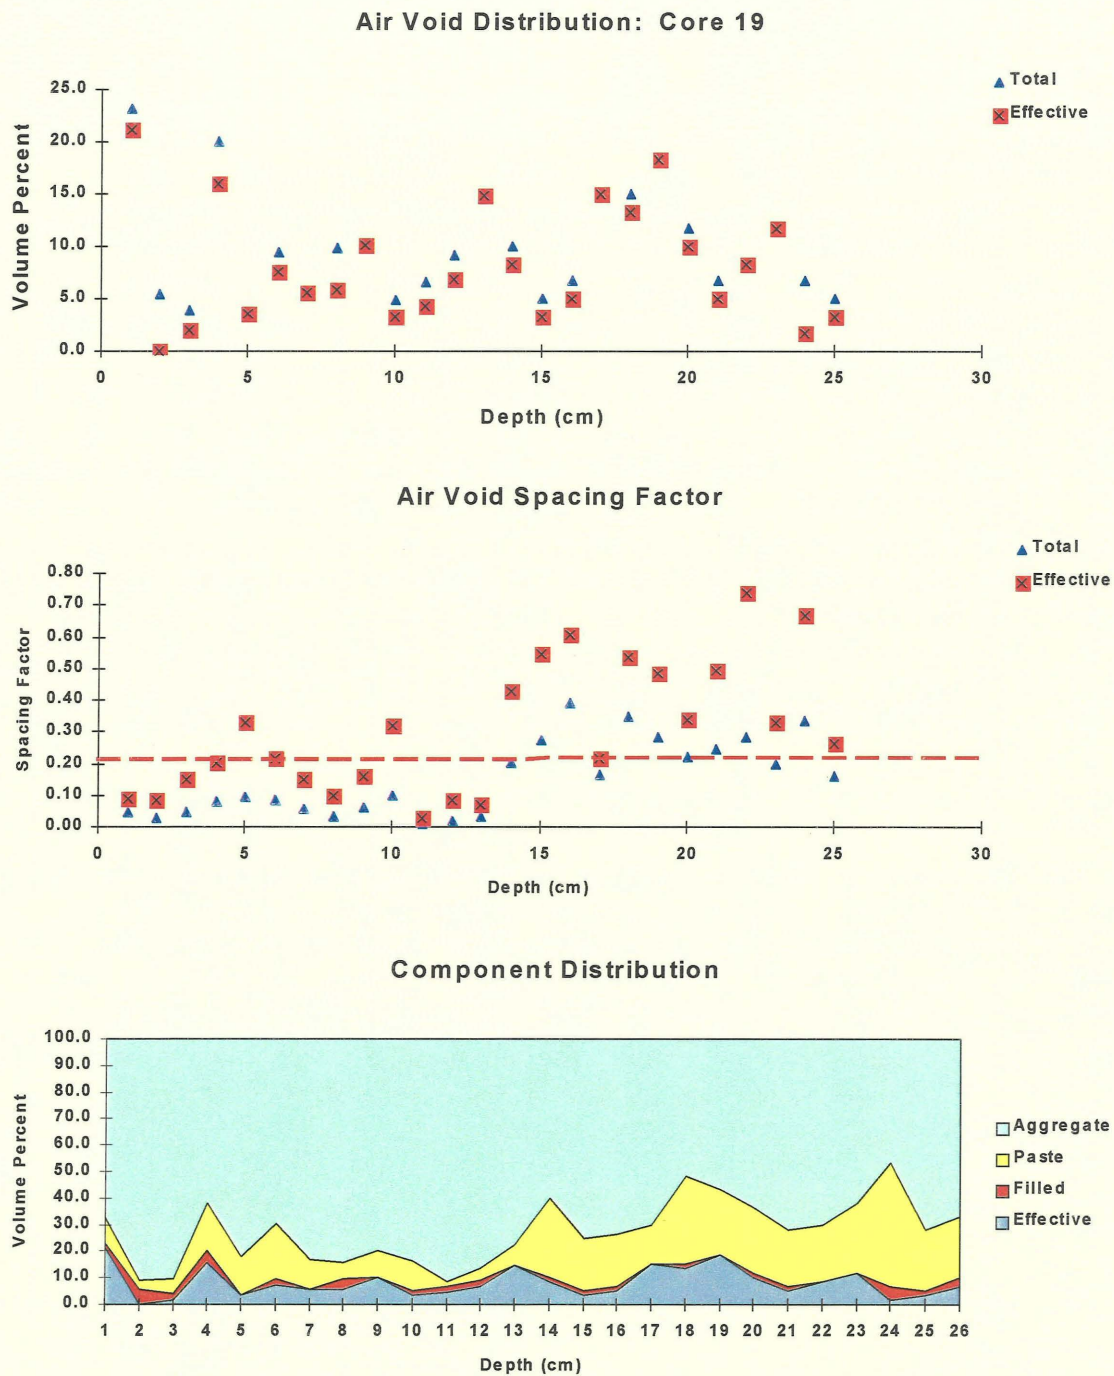
Graphical representation of the air void and component distributions indicates a decrease in spacing factor and an increase in cement paste content with depth (Figure 36). The spacing factors for both the total (original) and effective systems fall beyond that necessary for frost protection at depths greater than 150 mm.

Figure 36. Core 19 data show a decrease in spacing factor with depth and possibly a trend to an increased loss of spacing factor with depth. The component distribution plot shows a possible increase in aggregate and decrease in paste in the upper half of the core.
