# Deterioration of Iowa Highway Concrete Pavements: A Petrographic Study

FINAL REPORT  
HR-1065

Paul E. Stutzman

December, 1999

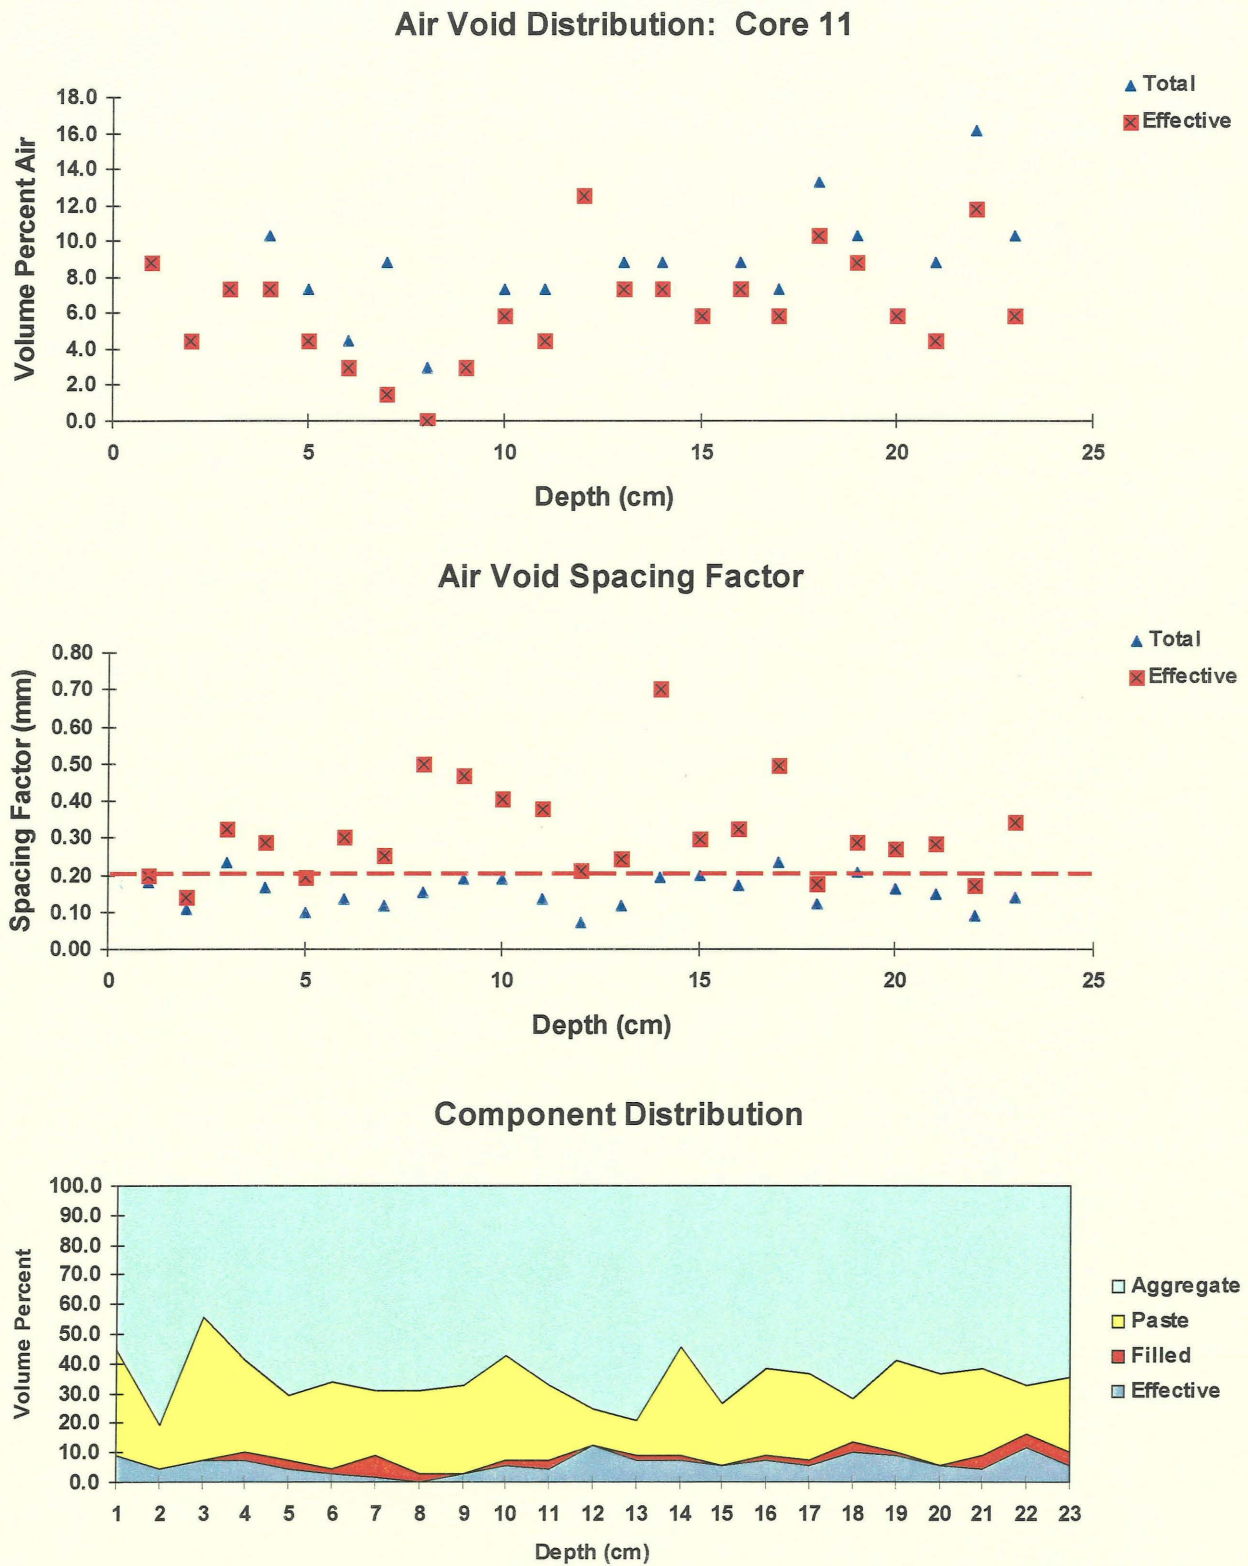
Figure 41: Core 11 air void parameters and component distribution show a loss of air void spacing yet relatively uniform air void volume and materials distribution.

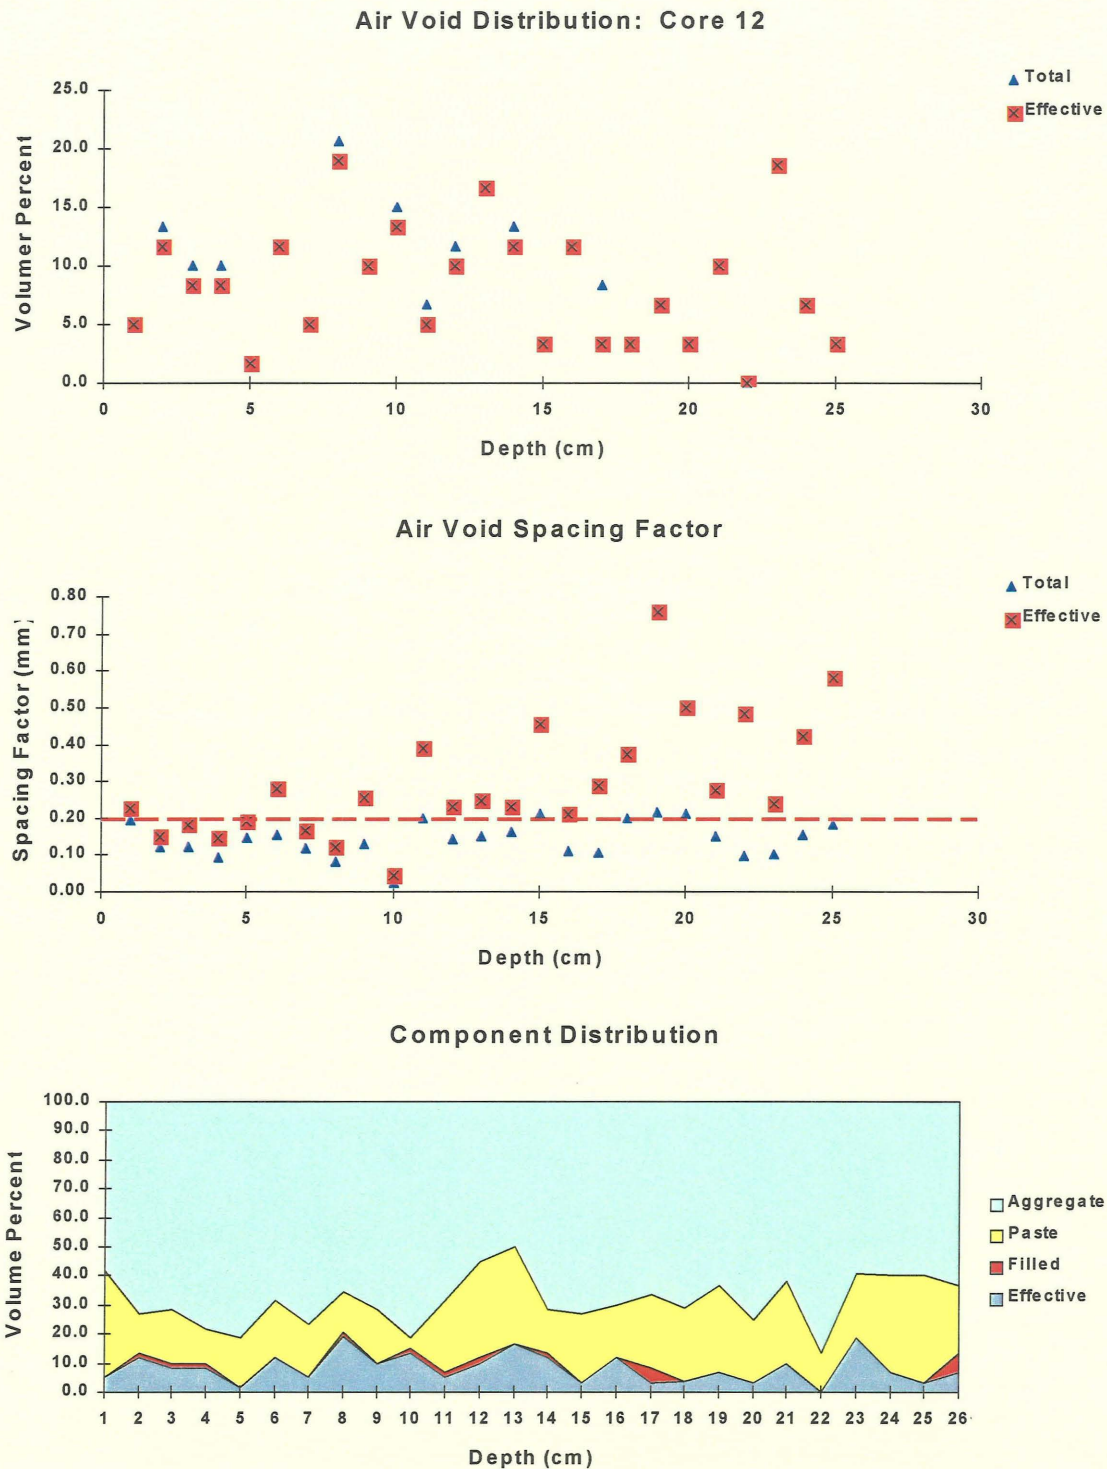
Figure 42. Core 12 air void volume and spacing parameters, and component distribution shows an increased degree of entrained air void filling with depth.

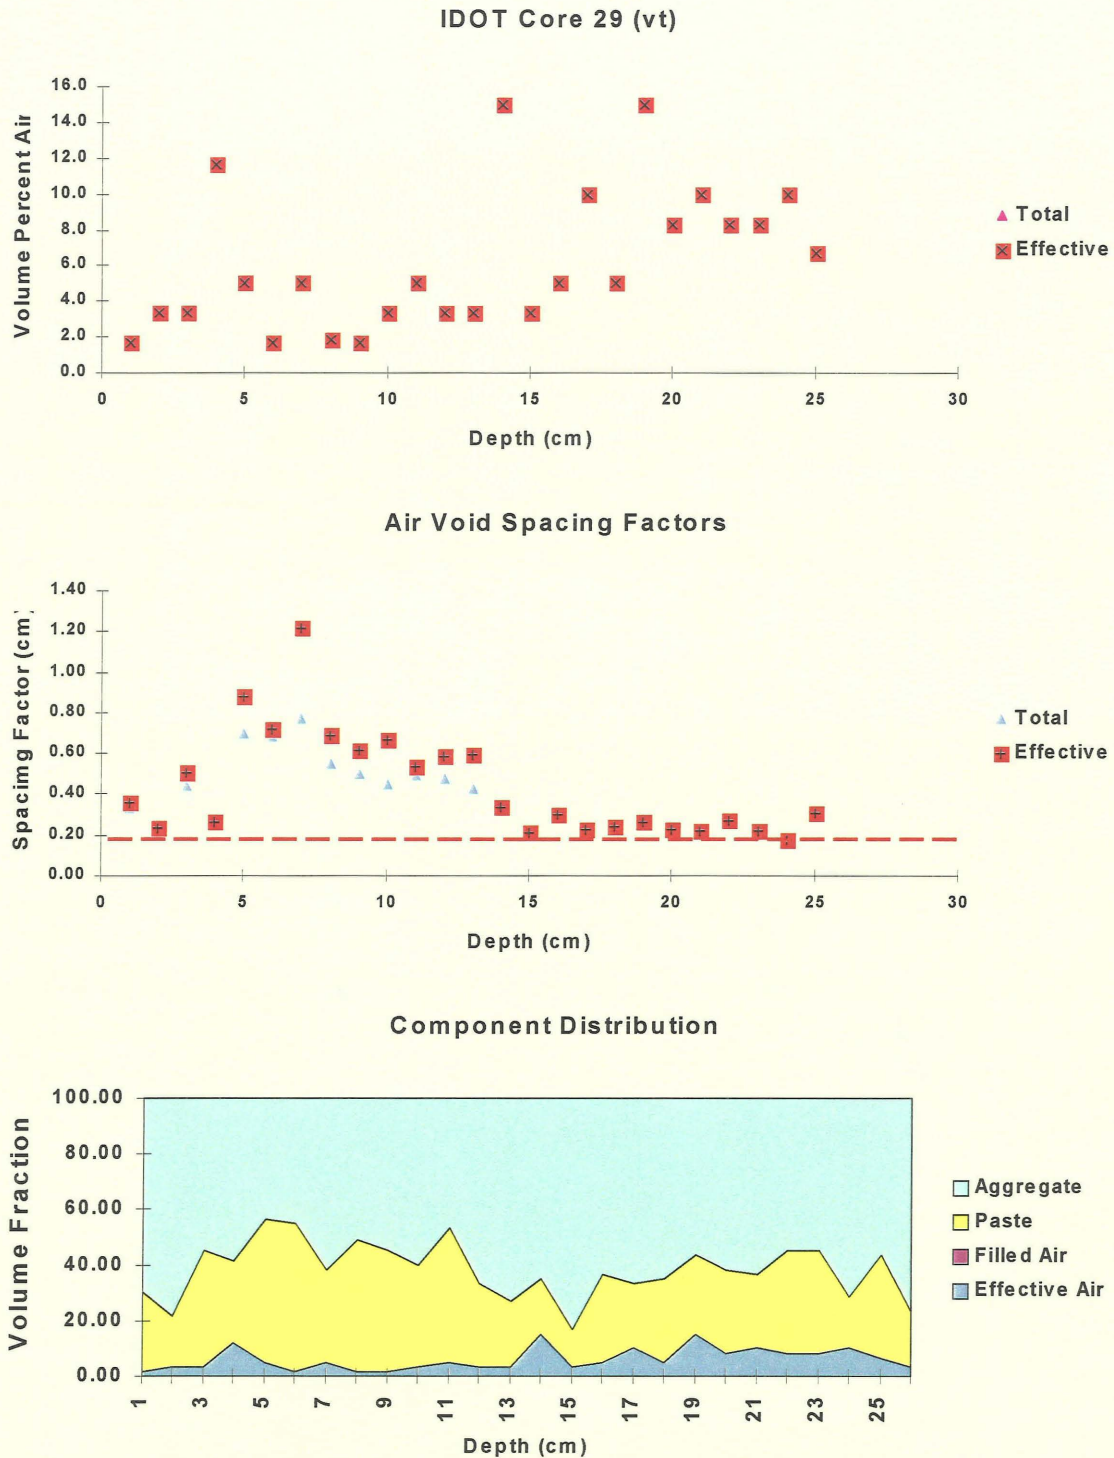
Figure 44. Core 29, centered on a well-defined vibration trail exhibits a significant increase in spacing factor in the upper half. This probably represents the zone of influence of the immersion vibrator probe. Note that the spacing factor is generally not satisfactory at any depth.
