Heavy Agricultural Loads on Pavements and Bridges

Sponsored by the
Iowa Department of Transportation and the
Iowa Highway Research Board

March 1999

Iowa DOT Project HR-1073

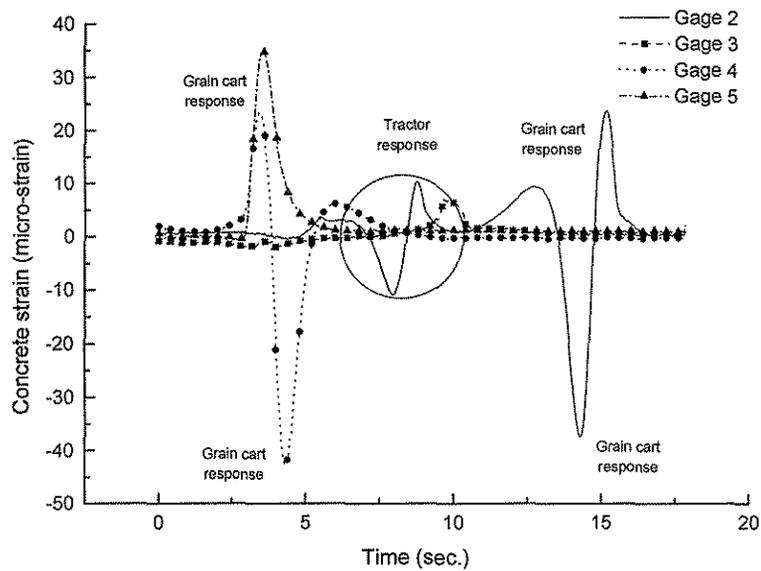
All of the tests performed indicated similar behavior of the pavement panel. Figure 5 shows a typical strain vs. time plot for one of the tests. There was little difference in the pavement behavior when the cart was pulled either north to south, or pushed south to north. The average maximum reading for Gage 2 was 25 micro-strains in tension and -39 micro-strains in compression. Gage 3 had maximum and minimum averages of 16 micro-strains in tension and -8 micro-strains in compression. Gage 4 average values were 24 micro-strains in tension and -44 micro-strains in compression. Gage 5 average maximum values were 64 micro-strains in tension and -6 micro-strains in compression. Table 1 tabulates these maximum and minimum values along with means and medians for all of the tests. Four of the tests resulted in some higher than normal tension values for Gage 5. The median value for all of the tests on Gage 5 was 44.5 micro-strains in tension. Gage 5 values in tension for, Tests 1, 3, 16, and 27 were 200, 125, 131, and 258 micro-strains. Test 1 plotted data are shown in Figure 6. Similar behavior was recorded in Tests 3, 16 and 27. Maximum stress values were calculated as 900, 562.5, 589.5, and 1,161 psi (6205, 3,878, 4,064, and 8,004 kPa). In general, the stress values in Gage 5 were in the range of 200 psi (1,379 kPa), with the other gage positions showing maximum ranges of 120 psi (827 kPa).

Figure 5. Test 12 strain vs. time plot with cart traveling north to south (left to right)

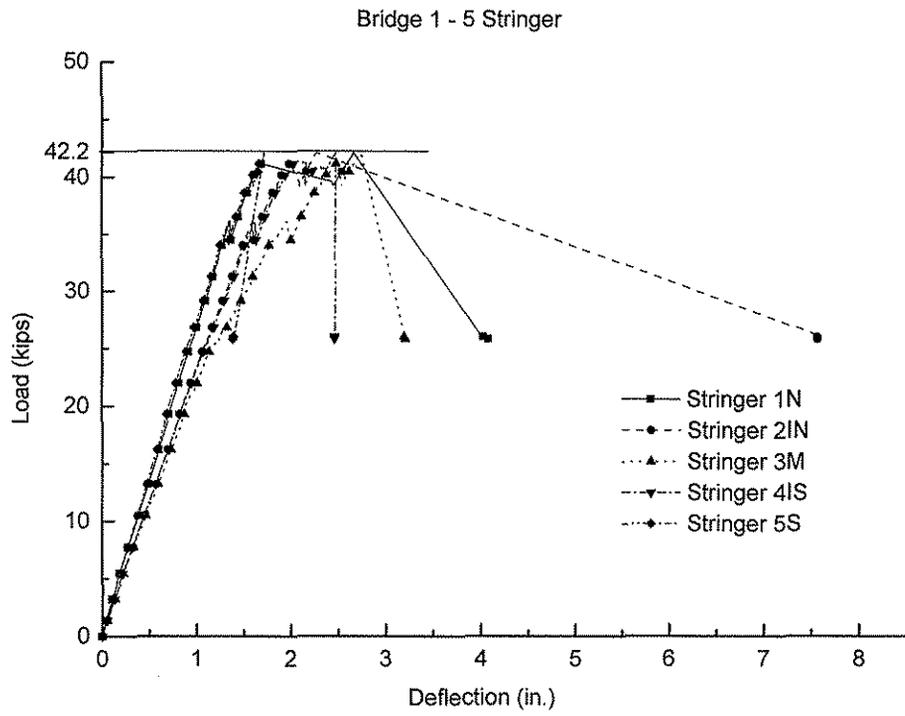
of the middle stringer at each end. The accompanying data plot, Figure 9, shows the five mid-span stringer deflections versus the load.

Figure 9. Load/deflection plot of Bridge 1.

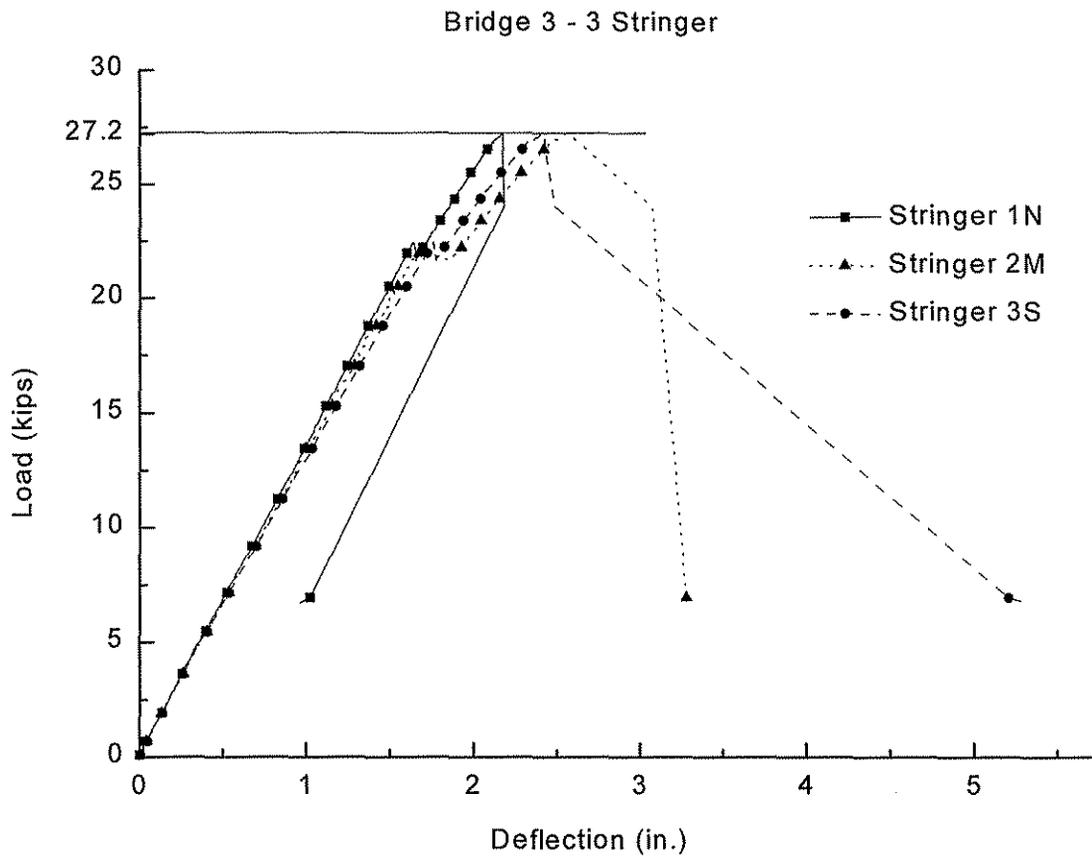
Figure 21 shows the load/deflection plot for the test. At a load of 3,000 to 5,000 lbs. (13.3 to 22.2 kN) noticeable bridge and/or fiber straining noises occurred. At 18,000 lbs. (80.1 kN), sounds of cracking could be heard and small clouds of dust could be seen coming off the bottom of the stringers. Referring to the plot, it appears as if stringer 2M, which contained the horizontal split, deflected less than stringer 3S but more than stringer 1N. At 23,000 lbs. (102.3 kN), the bottom of stringer 2M split significantly, resulting in a drop in the load of 1,000 lbs. (4.4 kN), and the deflection became greater than that of stringer 3S. Further loading resulted in an ultimate load of 27,200 lbs. (121 kN). At this point, stringer 3S suddenly failed near mid-span. Visual observation indicated that the failure initiated at a knot. A large piece at the east end of stringer 3S broke off and fell to the floor (see Figure 22). The split in the bottom of stringer 2M opened up considerably. There was no major damage noted to stringer 1N (see Figure 23). From the plot it appears that stringer 2M failed first and the sudden additional load to stringer 3S caused its failure. This may be supported by the fact that the load/deflection plots of these two stringers cross on Figure 21. The overall result of the bridge failure can be seen in Figure 24. Inspection of the deck planks indicated that there was no noticeable damage. Failure of the bridge was sudden and characterized by flexural failure of the stringers.

Figure 21. Load/deflection plot of Bridge 3.

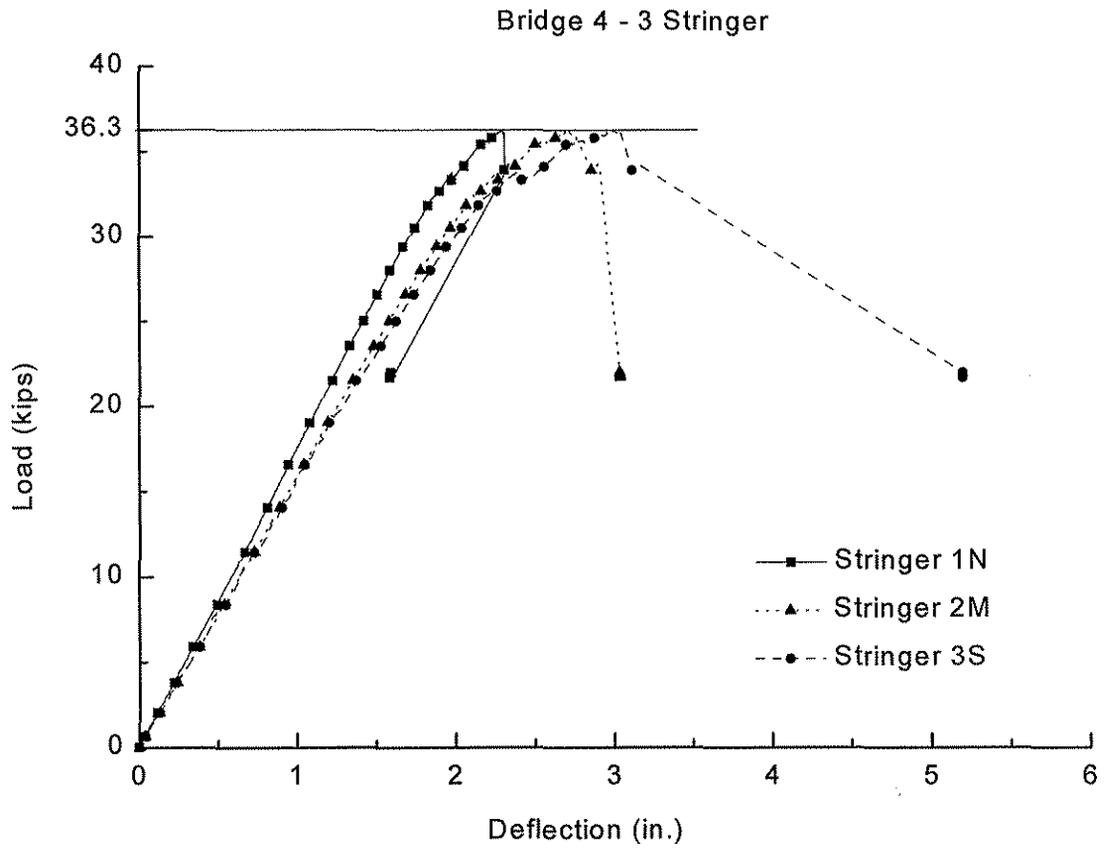
The load/deflection plot for this test is shown in Figure 27. At a load of 5,000 lbs. (22.2 kN), noticeable bridge and/or fiber straining noises occurred. From the beginning of the

Figure 27. Load/deflection plot of Bridge 4.
