Thin Maintenance Surfaces for Municipalities

Final Report
May 2007

Sponsored by
the Iowa Highway Research Board
(IHRB Project TR-507)
and
the Iowa Department of Transportation
(CTRE Project 03-161)

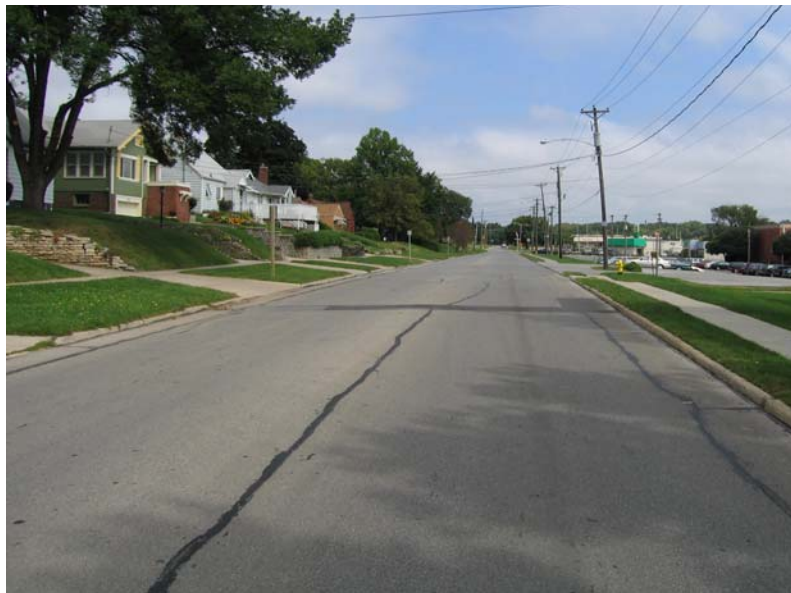
Figure 20. Fourth Street before construction

Fourth Street is a collector street located on the east side of West Des Moines (see Figure 15 and Figure 19). Before construction, Fourth Street was a PCC pavement with an ACC overlay of unknown thickness. Fourth Street and Vine Street both have concrete curbs, gutters, and storm sewers which provide excellent drainage. The major distresses previous to construction were low-severity reflective cracking and L&T cracking (see Figure 20). Many of the cracks had been sealed in 1993. The test section is located in a residential/commercial area. There is an industrial company on the north end of the test section, so there is a small amount of truck traffic delivering to that business. The estimated ADT is approximately 2,000 for Fourth Street.

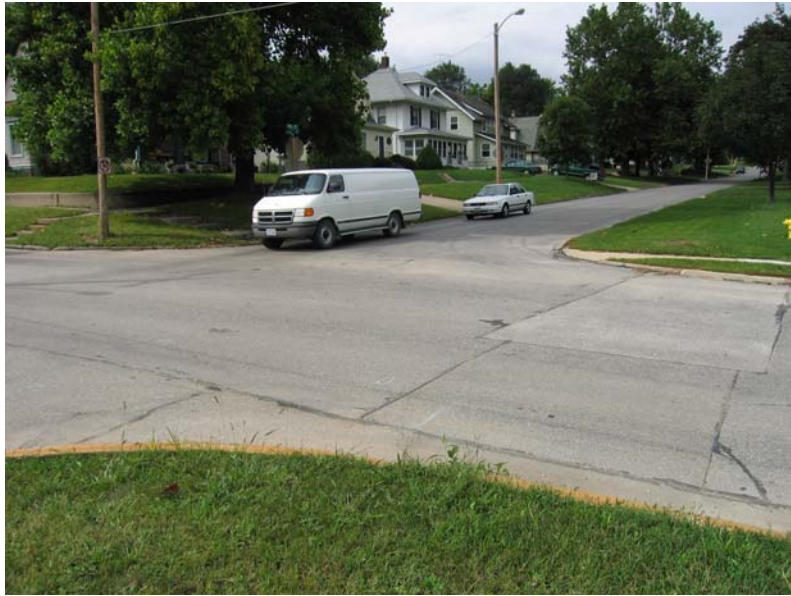
Figure 21. Vine Street before construction

Vine Street is a collector street located on the east side of West Des Moines. Before construction, Vine Street was a PCC pavement with an ACC overlay of unknown thickness. The major distresses previous to construction were low-severity reflective cracking and L&T cracking (see Figure 21). There was also a moderate amount of low-severity (1/4 in.–1/2 in.) to medium-severity (1/2 in.–1 in.) rutting. Many of the cracks had been sealed, and the seals were in good condition. The test section is located in a residential/commercial area and has a low amount of truck traffic, which services surrounding retail stores. The estimated ADT is approximately 5,000–6,000.

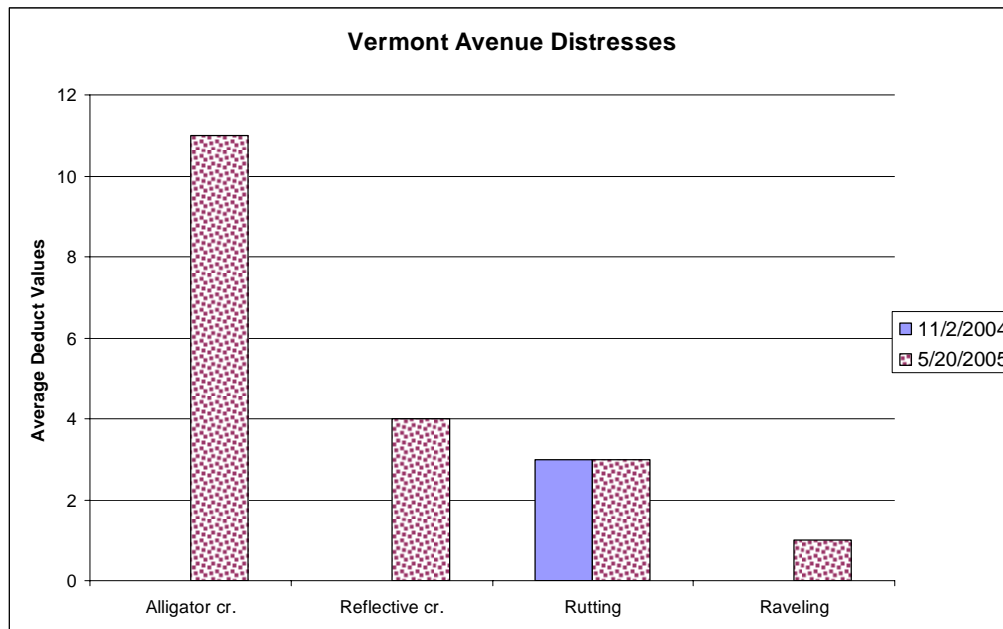
Figure 26. Vermont Avenue deduct values

The post-construction survey revealed that the pavement condition index (PCI) for Vermont Avenue was 72, which places it in the rating category of “very good.” A conservative estimate of the original PCI is 56, which falls in the rating category of “good.” (The estimate was based on a photo log and on estimated percentages of L&T cracking and alligator cracking.) This means that there was an estimated increase of 16 points for the PCI. At the time of the post-construction survey, the seal coat was in very good condition with no raveling or bleeding. The main distress was light-severity reflective cracking from the previous seal coat. The chipmat also performed very well. There was no reflective cracking in the areas where the chipmat was placed (see Figure 24). Researchers chose not to place fabric over some areas of alligator cracking in order to provide a comparison. In those places, the alligator cracking quickly reflected through to the new seal coat, even before the start of the subsequent winter (see Figure 25). The average deduct values for the test section are displayed in Figure 26.

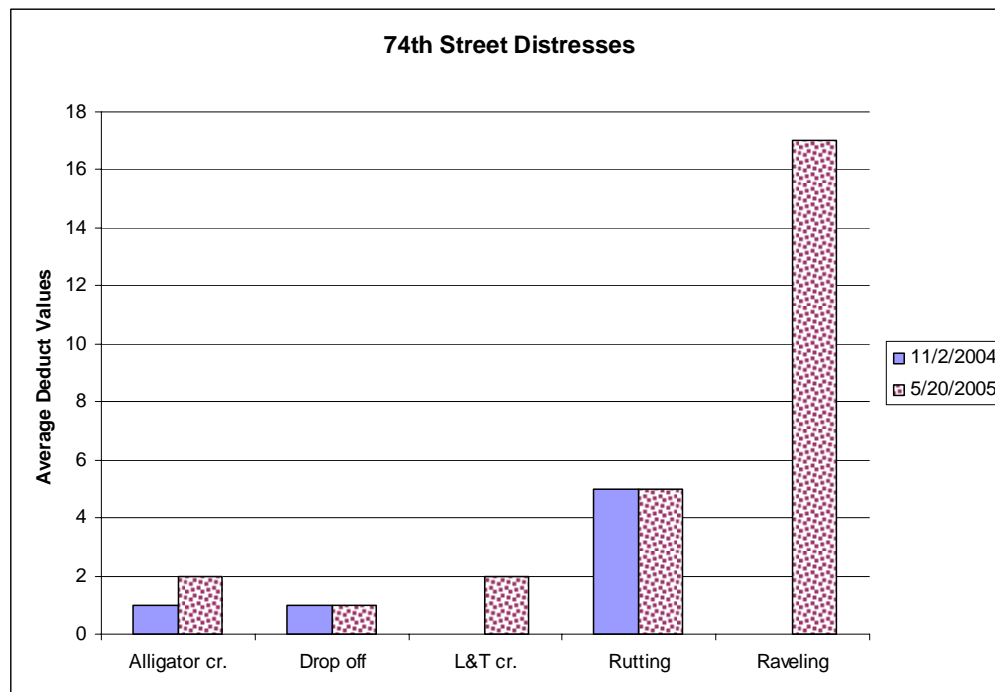
Figure 27. 74th Street deduct values

The post-construction survey revealed that the overall PCI for 74th Street was 72 (very good). A conservative estimate of the original PCI is 62 (good). This estimate was based on a photo log of the test section. The estimated increase in the PCI value is 10. As was expected, results

varied with each of the various types of aggregates. This “very good” rating is a strong indicator of a pavement with good structural stability. Examination of the actual distress deduct scores indicate very low amounts of cracking, rutting, and alligator cracking, which are all structural-related distresses. However, the test section appears to be in very poor condition because of surface distresses such as raveling and bleeding. These distresses are not weighted as heavily in the calculation of the PCI because they are only surface distresses and are not indicative of a pavement with poor structural stability. The average deduct values for the test section are shown in Figure 27.

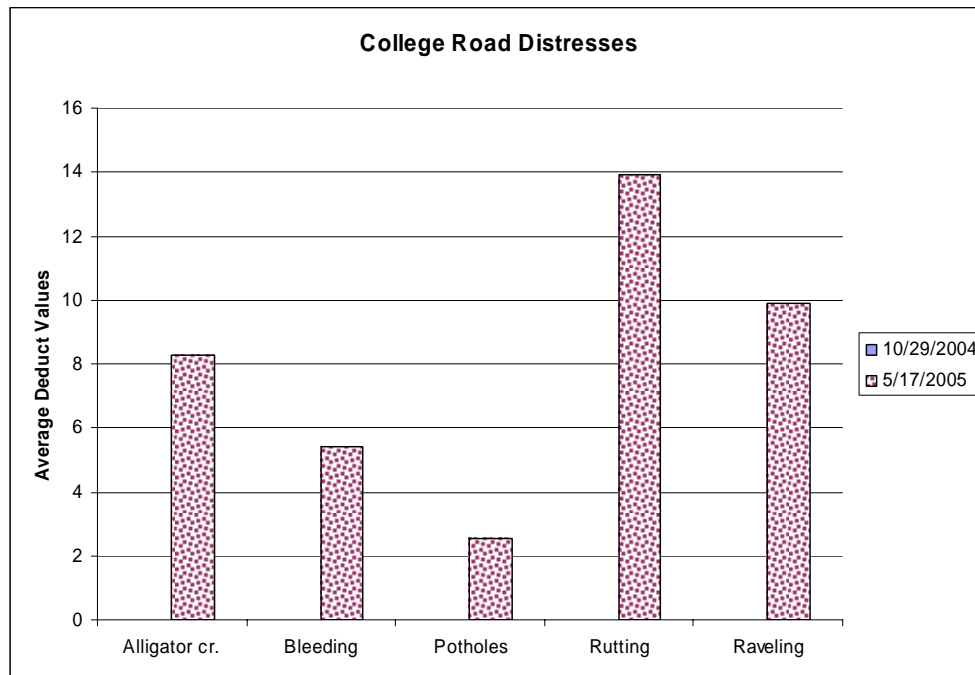
Figure 33. College Road deduct values
(The 10/29/2004 survey had zero deduct values.)

The fall 2004 post-construction survey indicated that the road was in “excellent” condition with a PCI near 100. However, by the time the spring 2005 survey was conducted, the road had deteriorated so that there was little to no improvement in comparison to the pre-construction condition of College Road. The new PCI of the road was 48, which is a “fair” condition rating, and the estimated previous PCI was approximately 30–50. The new PCI value does not include the portion of the test section adjacent to the north construction site (mentioned later) where earthwork was occurring and the resulting truck traffic caused a total failure of the pavement. This portion was left out because it did not represent the condition of the rest of the pavement. (The PCI values for these two sections were 29, which is

categorized as poor, and 11, which is categorized as very poor). The average deduct values for College Road, not including the failed sections, are found in Figure 33. It should be noted that, when performing PCI surveys on seal coat roads, the surveyor did not consider construction defects as distresses, because the investigation was attempting to focus on how structure and surface of a well-constructed road would perform. An example of a construction defect is a series of grooves left from a motor grader's ripper teeth before the application of the first seal coat; although the grooves could be considered rutting, they are not a sign of structural distress or of a surface distress and they were thus not included in the survey.

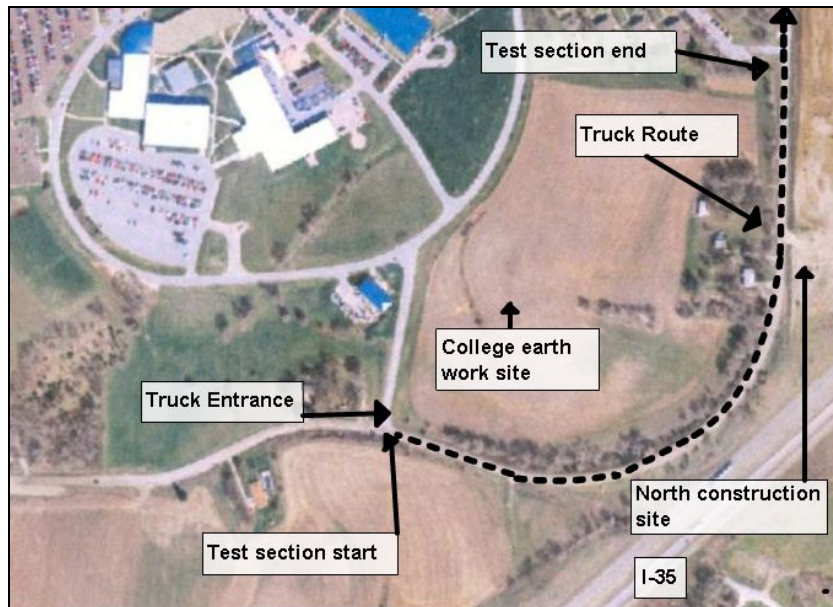
Figure 35. College Road construction map

The most probable cause for the various structural failures located throughout the test section was overloading of the pavement caused by the extra truck traffic. After discussions with the city engineer, the college adjacent to the test section removed approximately 350,000 cubic yards of earth, all of which was hauled by tandem-axle dump trucks that used the test section as a part of their haul route. Figure 35 shows the truck route (dashed line) that was used to access Interstate 35. The trucks entered the test section at its south end and drove north to the on-ramp for Interstate 35. The trucks used the test section as a return road as well. It can be reasonably assumed that each truck carried approximately 10–12 cubic yards of earth, which means that in the months after construction, the test section was traversed by approximately

35,000 fully loaded dump trucks. This number does not include traffic to and from the north construction site, which also included dump trucks removing an unknown amount of earth and using College Road to access Interstate 35. According to the city engineer, Iowa Western Community College plans to remove another one million cubic yards, and the test section will be traversed by all of this truck traffic as well.

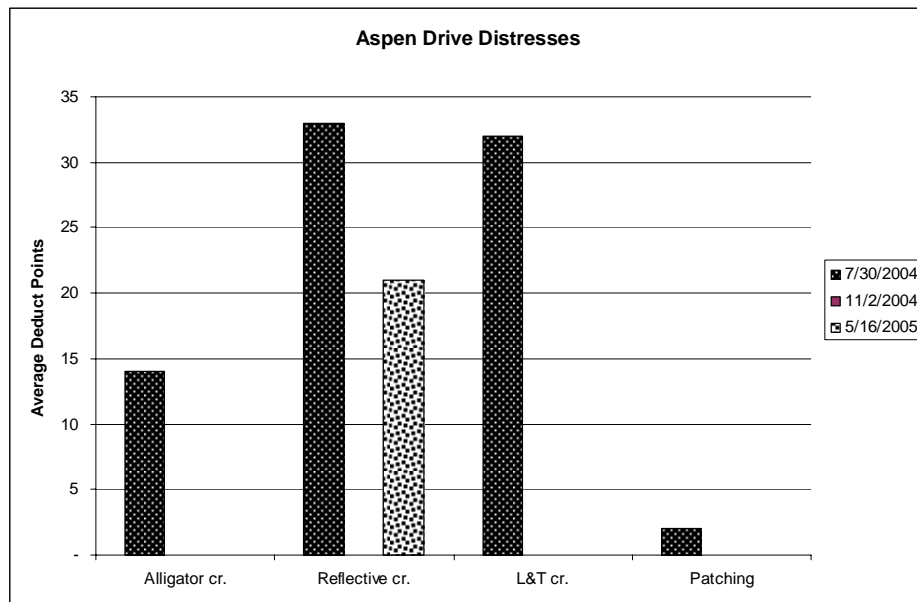
Figure 36. Aspen Drive deduct values

The post-construction survey revealed that there was considerable improvement in the condition of the road. The original PCI of the Aspen Drive was 49 and the new PCI was 82, an increase of 33 points to a “very good” rating. Figure 36 shows the average deduct values for the various surveys performed on Aspen Drive. Various reflected cracks were the only distresses present in the new micro-surfacing. Many of the original reflected cracks in the overlay also reflected through the new micro-surfacing treatment. This section was the only section for which researchers had the original surveys. (Recall that the others were lost in an auto theft). The original total for all of the cracks on six sample survey sections was 2,802 feet, which includes low-, medium-, and high-severity reflective and L&T cracking (see Figure 37). As of May 16, 2005, the total amount of cracking is 1,605 feet—a 43% decrease in cracking. This number only includes reflective cracking, because the PCC joint cracks as well as the L&T cracks in the overlay reflected through the micro-surfacing but no new L&T cracks will form in the micro-surfacing. This crack reflection is typical of micro-surfacing treatments. The only other distress in the original overlay was light-severity alligator cracking. As of May 16, 2005, none of the alligator cracking had reflected through the micro-surfacing. The micro-surfacing appears to be performing well (see Figure 38). In a few high spots, a snowplow sheared off the high parts of the limestone aggregate, but enough aggregate still remains to cover the original pavement.

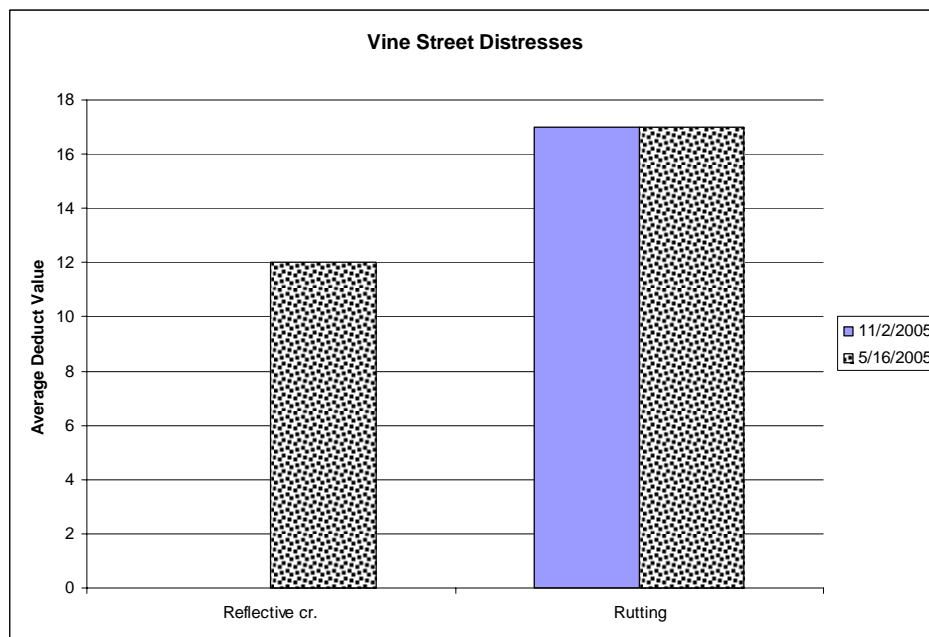
Figure 39. Vine Street deduct values

The post-construction survey revealed that the PCI for Fourth Street increased from an estimated pre-construction PCI of 81 (very good) to 86 (excellent). Because preconstruction survey data was lost in the previously mentioned auto theft, the pre-construction PCI was estimated by surveying Maple Street, a pavement with a condition similar to that of Fourth Street and Vine Street before the application of the micro-surfacing. However, unlike Fourth and Vine Streets, Maple Street not have any rutting, which makes comparison challenging. In order to adjust for rutting, the rutting deduct values from the Vine Street survey (see Figure 39) were included in the Maple Street survey (see Figure 40) to draw a more accurate estimate of the pre-construction condition of Vine Street. The PCI value for Maple Street with the Vine Street rutting adjustment was 70 (good). The final PCI for Vine Street was 80, with a rating of “very good” and a PCI increase of 10.

Similar to Aspen Drive, the primary distress for both Fourth Street and Vine Street was reflected cracking. Vine Street had experienced some light-severity rutting before construction, and the micro-surfacing did not fill in the ruts. (Rut filling was not specified in the contract.) The graphs do not include pre-construction data.

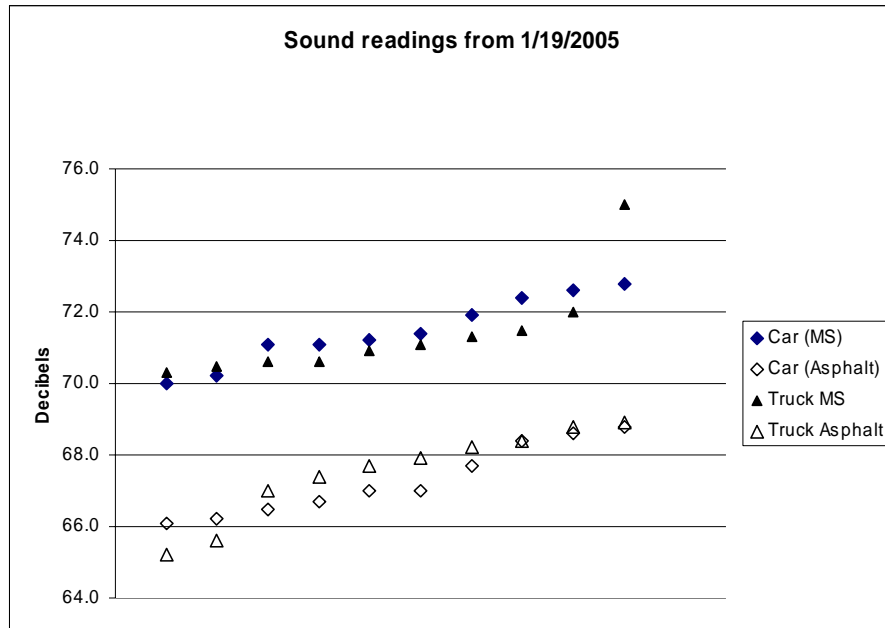
Figure 43. First sound readings (in order of intensity)

January 19, 2005			June 10, 2005		
	Car	Truck	Inside car	Car	Truck	Inside car
Asphalt	67.5	67.3	61.2	72.8	64.8	54.9
Micro-surfacing	71.4	71.5	66.0	73.2	66.0	62.1
Difference	3.9	4.2	4.8	0.4	1.3	7.2

The average sound intensity for the test vehicles during the test in March cannot be compared to the sound intensity during the test in June because the temperature was notably different—36°F for the January 19, 2005 test and 80°F for the June 10, 2005 test—and different vehicles were used for the testing. The reason that different test vehicles were used was that it was not possible to get the same exact vehicles from the Iowa State University Motor Pool. The difference in loudness for each of the test vehicles on each of the surfaces on one test day shows the difference in loudness (see Figure 43 and Figure 44). The chunk sampling of cars, trucks, and buses passing by also showed no difference in the decibel level, with the average decibel level of the micro-surfacing being 1.5 dB higher than that of the asphalt (see Figure 45).

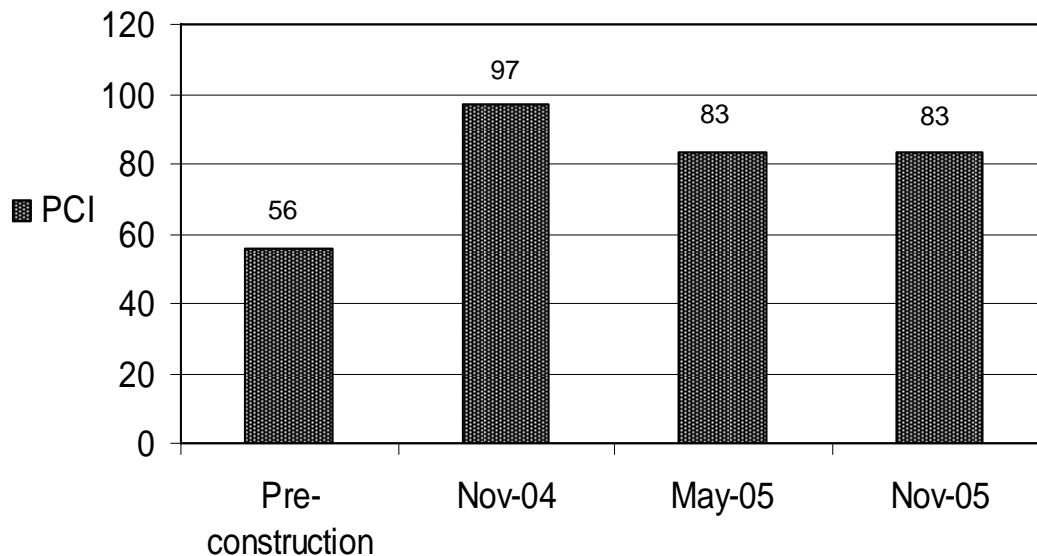
Figure F.1. Changes in PCI for Vermont Avenue

The PCI of Vermont Avenue in November of 2005 was 83, unchanged from that of May 2005. Figure F.1 summarizes how the PCI changed over the pre- through post-construction cycle. As the November 2005 survey was being conducted, the researchers noted the locations of the chipmat repairs and noted that alligator cracking had not yet reflected through in these locations. In contrast, the May 2005 survey had indicated that alligator cracks had reflected through in locations where chipmat was not applied (Figure F.2).

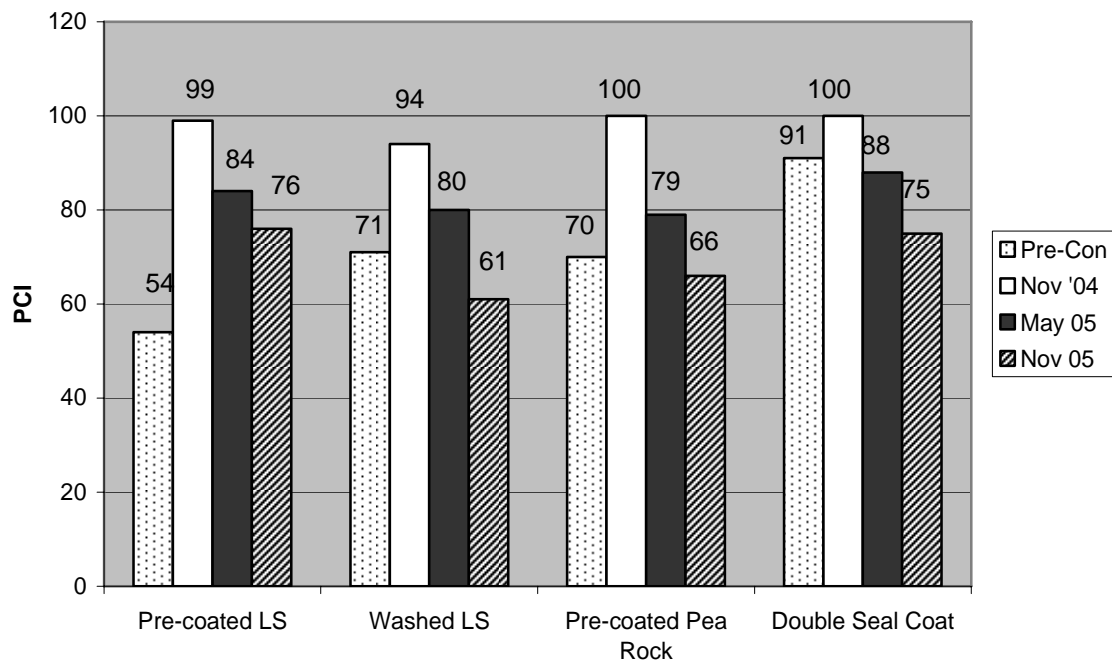
Figure F.3. Changes in PCI for 74th Street

By November of 2005, the PCI of all the demonstration sections on 74th Street had decreased from the values observed in May of 2005. The most prominent distress that increased was bleeding, which was heavy in places, especially in locations that withstood the forces of turning and stopping vehicles. In some cases, the bleeding occurred in places where the aggregate was stripped off by snow plows. For the purposes of PCI calculations, these areas were designated with a combination of raveling and bleeding. A few patches had been placed since the last survey.

The washed limestone and pre-coated pea rock had the lowest PCIs (61 and 68, respectively), while the single pre-coated limestone and the double seal coat had the highest (76 and 75 respectively). Figure F.3 summarizes how the PCIs changed over the pre- through post-construction cycle, while Figures F.4 through F.7 provide representative images of each of the sections. In comparing these sections, the effects that rutting had on the PCI calculation were not included. This is because a seal coat is not intended to improve road performance with regard to rutting and because there were noticeable differences in the amount of rutting from one road section to another, which would have made comparisons difficult.

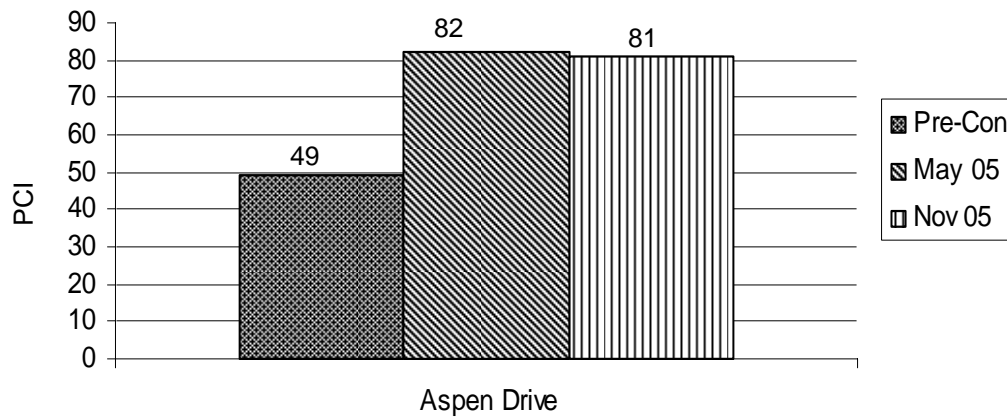
Figure F.8. Changes in PCI for Aspen Drive

The PCI for Aspen Drive essentially remained the same (changed from 82 to 81) during the period from May to November of 2005. Figure F.8 summarizes how the PCI changed over the pre- through post-construction cycle.

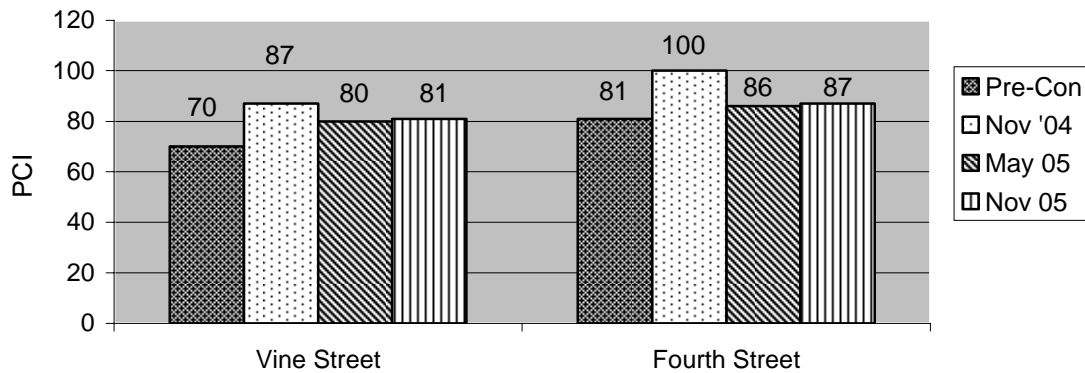
F.9. Changes in PCI for Vine Street and Fourth Street

As with Aspen Drive, Fourth Street and Vine Street only experienced slight changes in PCI during the period from May to November of 2005. Figure F.9 summarizes how the PCI changed over the pre- through post-construction cycle.
