Investigation of Improved Utility Cut Repair Techniques to Reduce Settlement in Repaired Areas, Phase II

Final Report
December 2010

Sponsored by
Iowa Highway Research Board
(IHRB Project TR-566)
Iowa Department of Transportation
(InTrans Project 06-282)

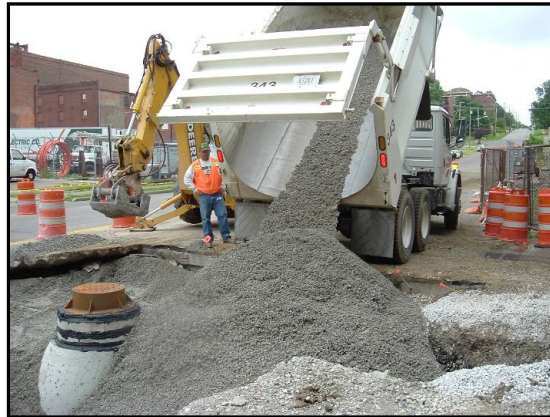
- Damage of pavement around the perimeter of the trench caused by large compaction equipment too near the edge of the utility cut (see Figure 2.1)
- The placement of backfill in lift thicknesses greater than 12 inches (in some cities lift thicknesses exceeded 3 feet), as shown in Figure 2.2

Figure 2.2. Large lift thickness used in utility cut trench backfilling

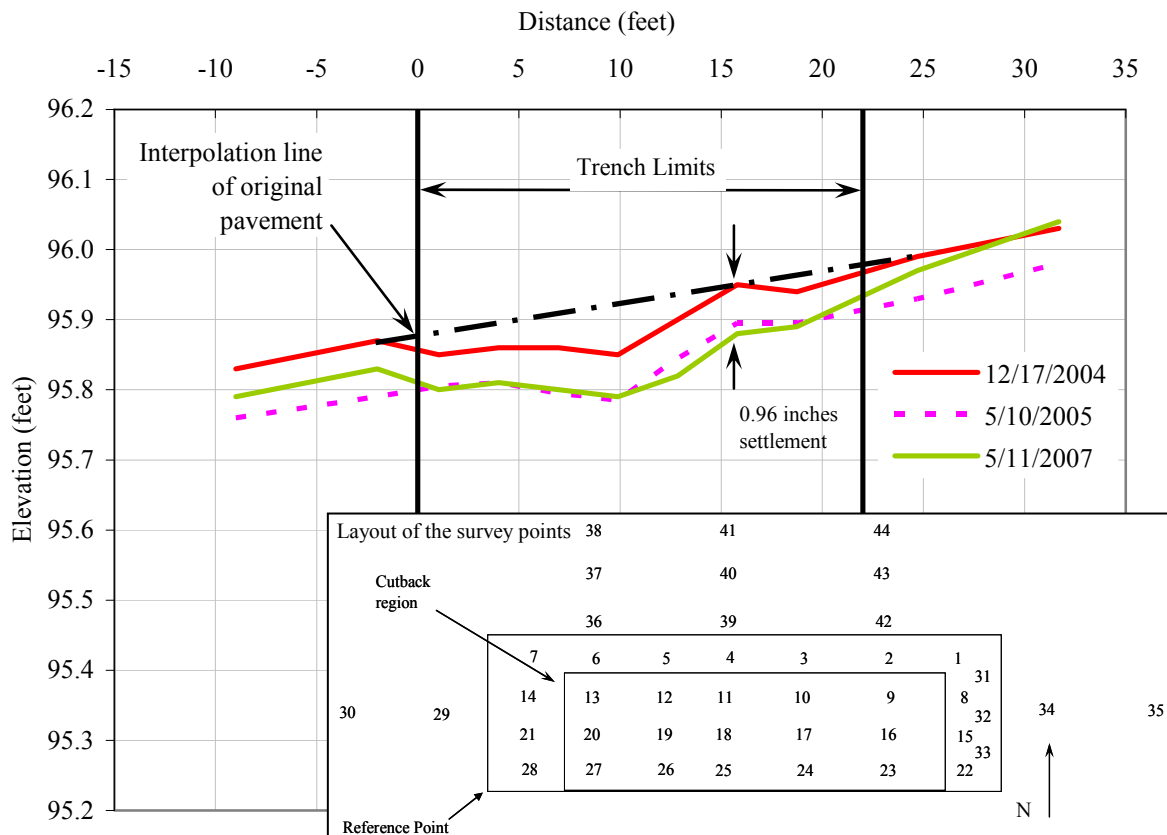
The trench was surveyed three times (December 17, 2004; May 10, 2005; and May 11, 2007). Figure 3.4 shows the centerline profiles for the trench on these dates. The maximum settlement along the centerline of the trench was 0.96 inches at survey point 17 (middle of the trench). The maximum settlement, which was along the edge of the trench, was 1.20 inches at survey points 24 and 26. The maximum settlement along the centerline of the trench occurred where the patch was initially placed at a higher elevation than the surrounding patch. A line was drawn between the two survey points located outside the perimeter of the trench. This line shows the elevation of the patch if it was initially installed level with the road. The west side of the patch was placed below the level patch line. The patch experienced the majority of the total settlement between the December 17, 2004, survey and the May 10, 2005, survey, approximately within six months after construction of the utility trench. Settlement of the surrounding pavement also occurred.

Figure 3.4. Profile of the Ames trench along the centerline of the trench

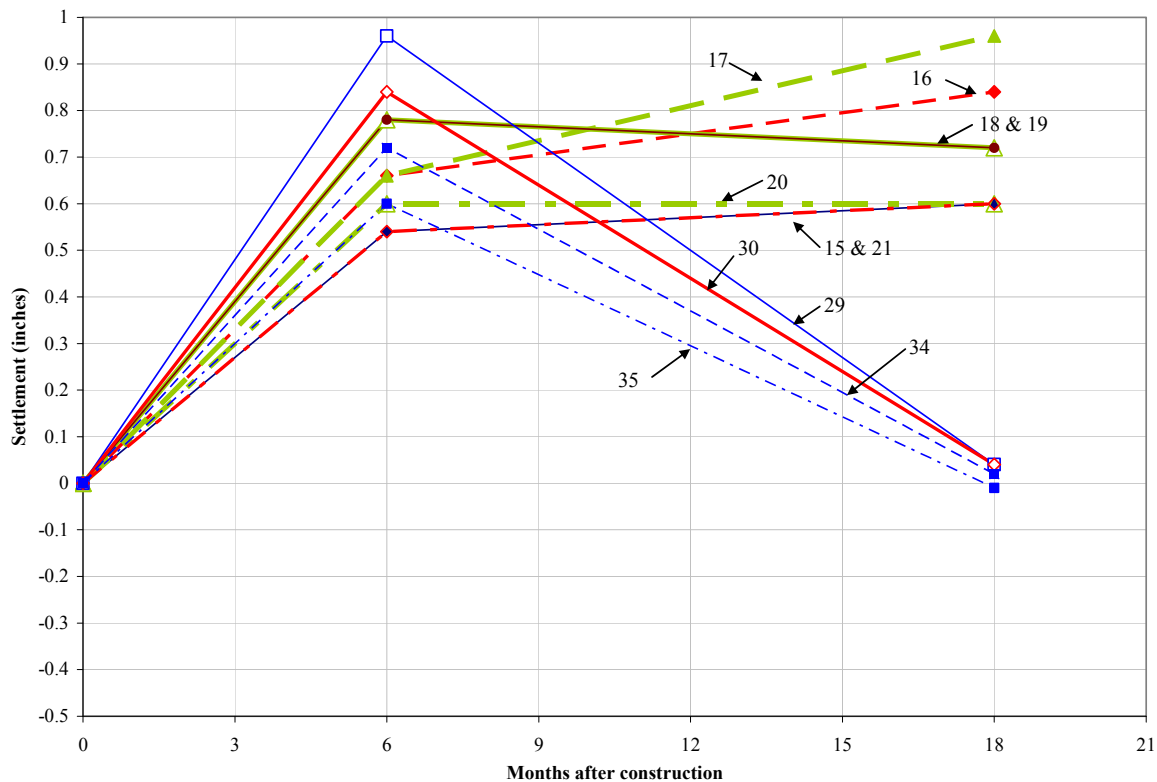
Settlements as a function of time are shown on Figure 3.5. This shows that survey points within the trench (15, 16, 17, 19, 20, and 21) have continued to settle with time. The rate of settlement, which is the slope of the line between two survey points, was greater in the first six months after construction (0.09 to 0.13 inches per month) than the rate of settlement (-0.005 [uplift] to 0.05 inches per month) 6 to 18 months after construction. Survey points 18 and 19 experienced uplift from 6 to 18 months.

For the survey points outside of the trench (29, 30, 34, and 35), the settlement in the first six months after construction was similar to settlements measured within the trench. The settlement rate for the first six months ranged from 0.10 to 0.16 inches per month. Six to 18 months after construction, the survey points outside the trench uplifted. The rate of uplift was 0.03 to 0.06 inches per month. Because of this uplift, the area outside the trench was at similar elevations to when the trench was first constructed. The uplift at the survey points outside the trench resulted in larger differential movements between the areas outside the trench and inside the trench.

Figure 3.5. Settlement as a function of time for survey points along the centerline of the trench

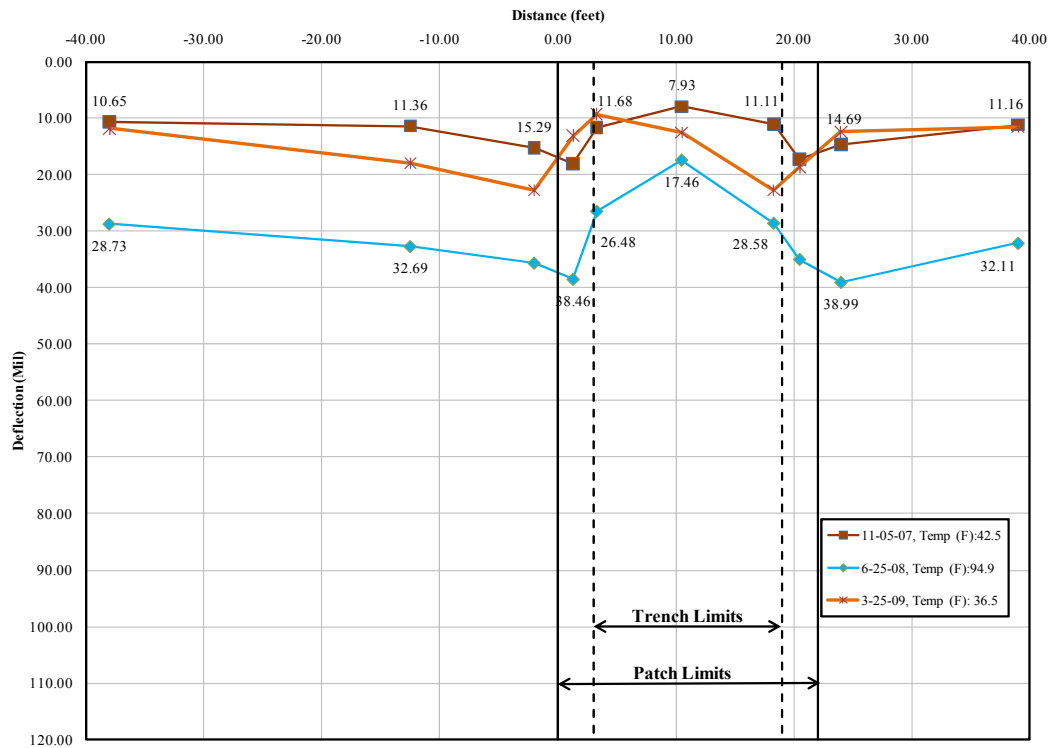
The results of FWD tests from November 5, 2007, and March 25, 2009, were similar in shape for the 15 kip load as shown in Figure 3.11. The results from FWD tests in November 2004 and 2007 were also similar in response. This was the result of high-moisture content in the subgrade. In the spring, the subgrade had a higher moisture content, causing the deflections to increase because of softer subgrade. Then in the fall, after the warm summer weather, the moisture under the patch decreased, and the stiffness of the subgrade increased.

Figure 3.11. Comparison of deflections from the 15 kip load for the trench in Ames conducted on test dates

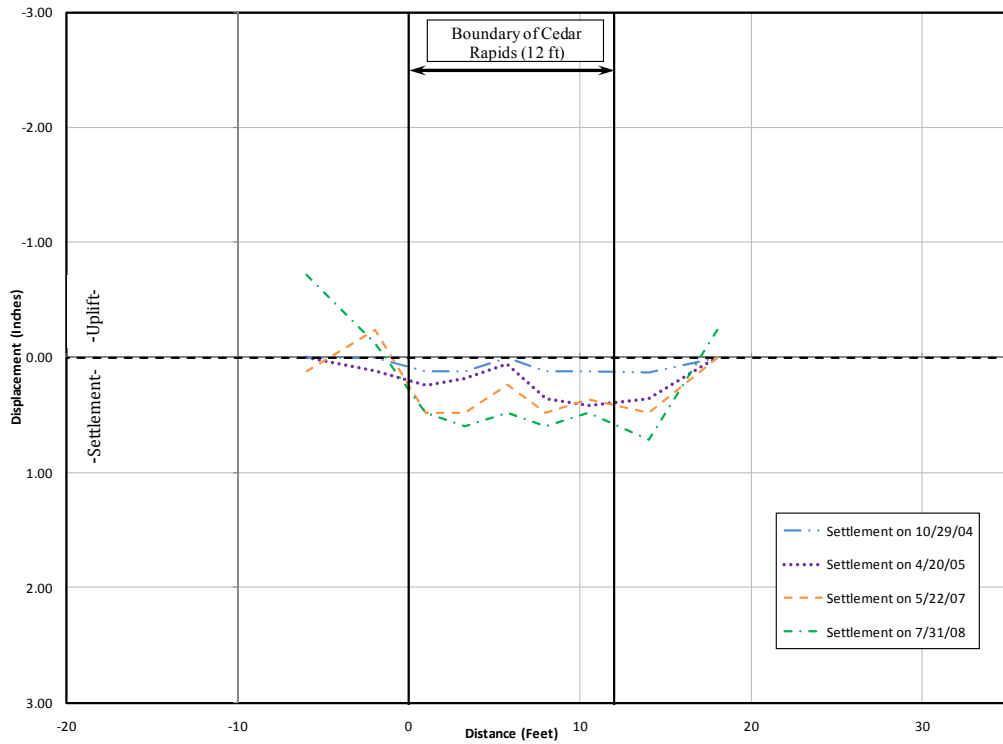
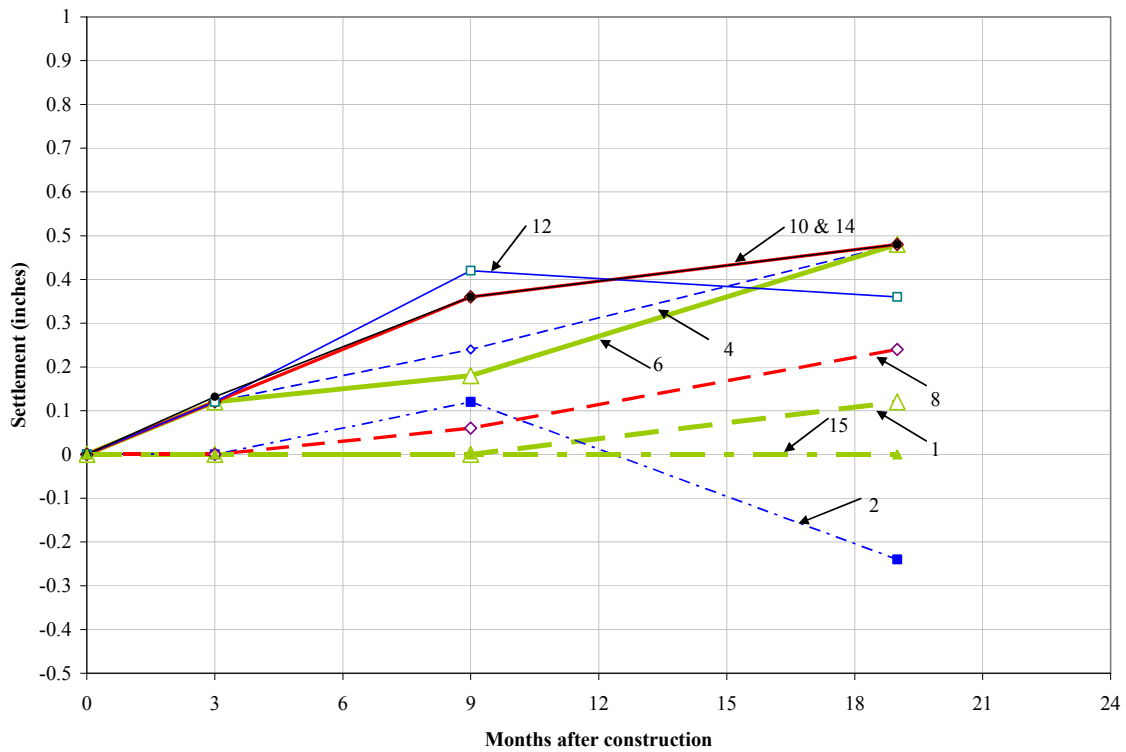
The trench was surveyed five times (July 21, 2004; October 29, 2004; April 20, 2005; May 22, 2007; and July 31, 2008). Figure 3.13 shows the points used for surveying and centerline profile. Figure 3.14(a) shows the centerline profiles for the trench on the various test dates. The maximum settlement along the centerline of the trench was 0.48 inches at survey points 4, 6, and 10, as well as survey point 14 outside the trench. This was also the maximum total settlement for the trench. Settlement of the surrounding pavement was observed up to a distance of 3 feet from the trench.

Settlement as a function of time is shown in Figure 3.14(b) for survey points along the center of the trench. The figure shows that the survey points within the trench (4, 6, 8, 10, and 12) have continued to settle based on the positive slope of the line between the survey points, except for survey point 12. The rate of settlement, which is the slope of the line, ranged from 0 to 0.04 inches per month for the first three months after construction. The rate of settlement increased for all the survey points within the trench during the time period from three to six months after construction. The rate of settlements ranged from 0.02 to 0.1 inches per month. The rates of settlement for 9 to 19 months after construction ranged from -0.004 to 0.02 inches per month. Survey point 12 uplifted during this time interval. The survey points outside of the trench (1, 2, 14, and 15) settled to differing degrees. Survey point 15 has shown no movement since

monitoring of the utility cut began, while survey point 14 (closer to the trench) has had the same settlements as survey point 10, which is within the trench. Survey points 1 and 2 have shown the opposite behavior. Survey point 1, which is furthest from the trench, has continued to settle, while survey point 2 has uplifted. The rate of settlement for the survey points outside the trench for the first three months ranged from 0 to 0.04 inches per month. From three to nine months after construction, the rate of settlement ranged from 0 to 0.10 inches per month. From 9 to 19 months after construction, the rate of settlement for the test points outside the trench ranged from -0.03 to 0.001 inches per month. The upper limit of these settlement rates was controlled by survey point 14.

Figure 3.14. Settlement of the trench and surrounding area (a) trench centerline, and (b) settlement as a function of time.

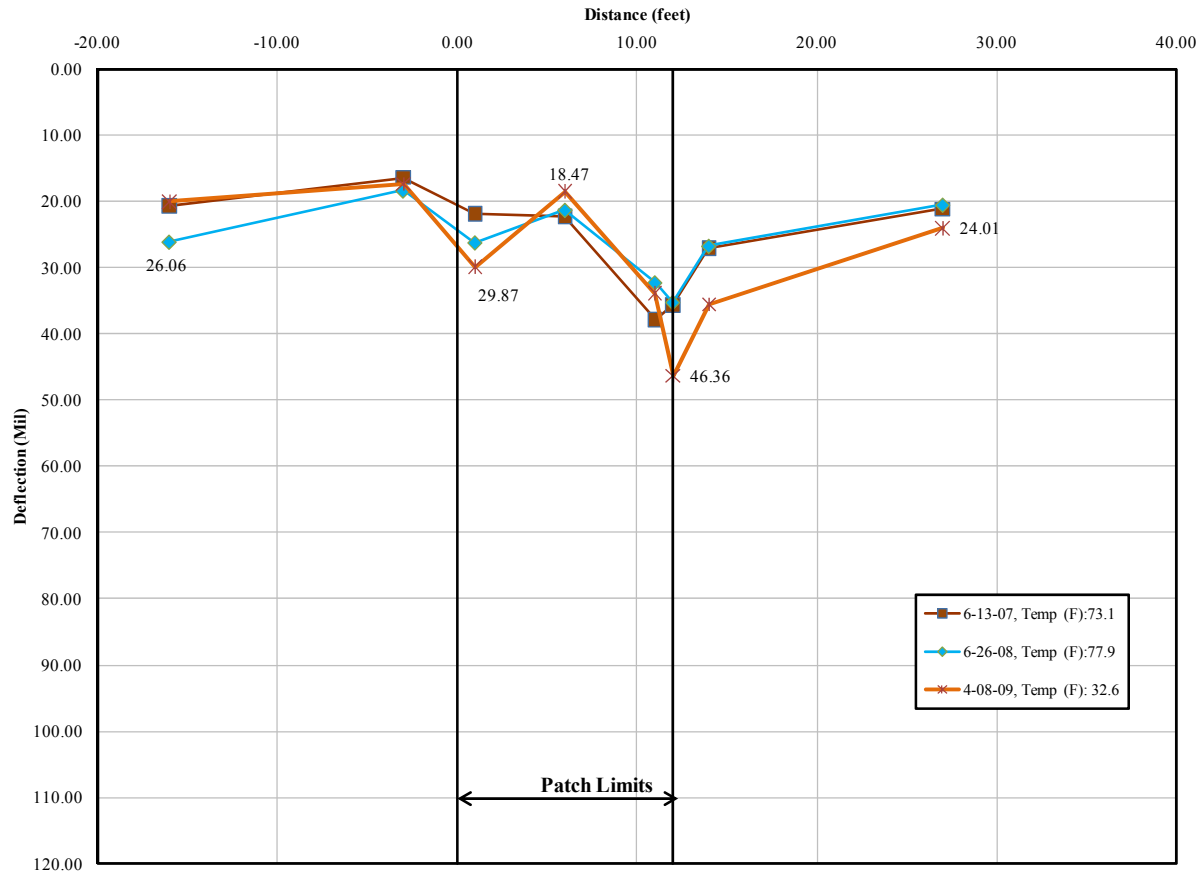
Figure 3.21. Comparison of deflections from the 15-kip load for the trench in Cedar Rapids conducted on three test dates

Figure 3.21 shows three dates at 15-kip load. This graph shows a weakened zone at the edge of the trench. This weakened zone was present in earlier testing and was the result of the construction equipment being near the edge of the trench.

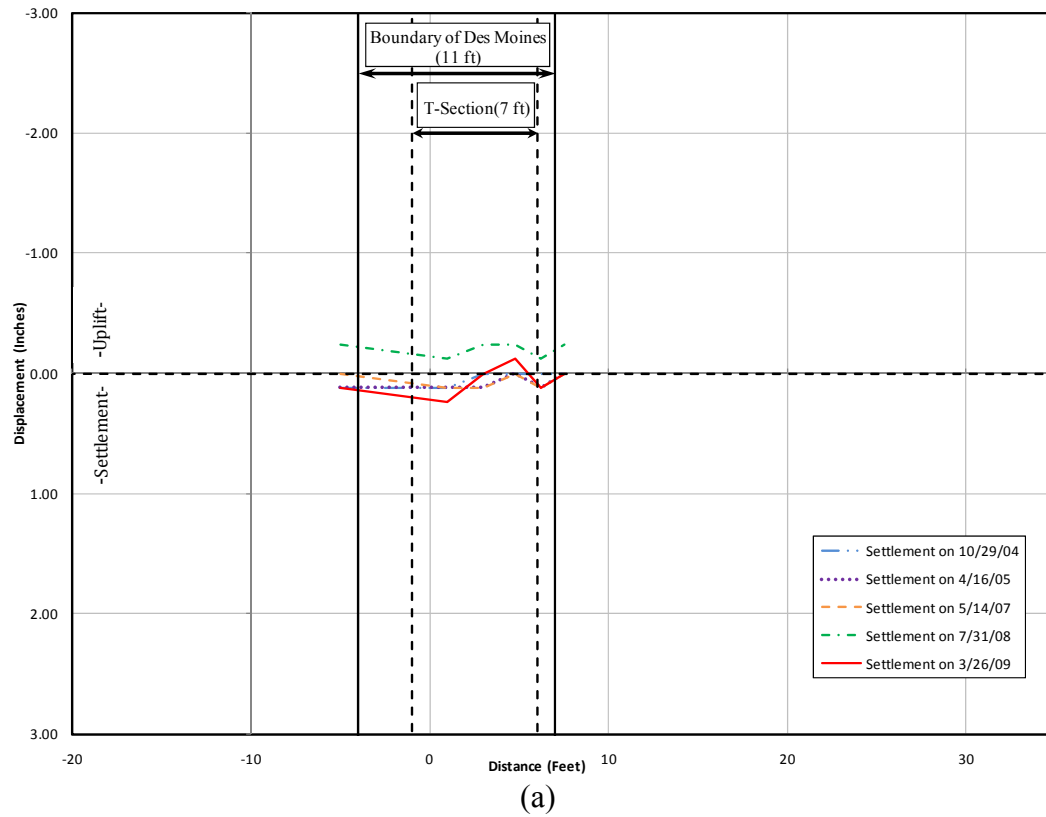
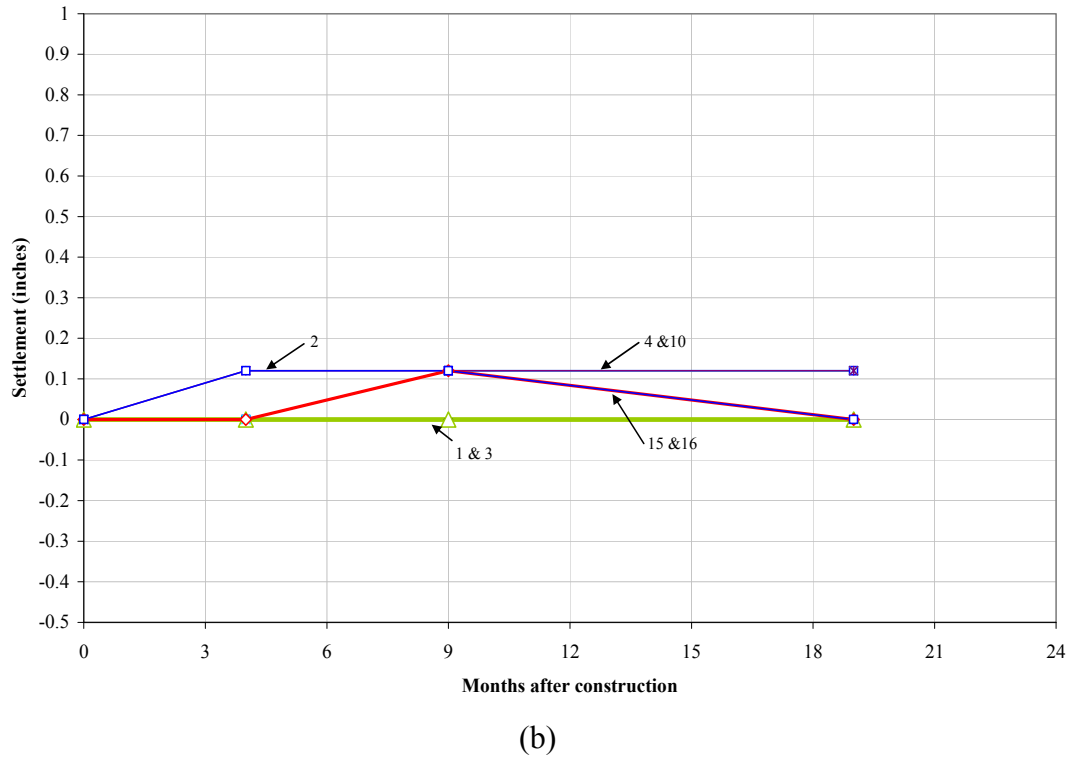
Figure 3.24. (a) Displacement for Des Moines trench, (b) Settlement versus time for Des Moines trench

of the trench was 0.2 inches at survey points 2, 4, and 10. The maximum settlement of the trench, which was at the edge of the trench, was 0.36 inches. When the patch was initially installed, the edge of the patch was higher than the center of the patch. As the trench settled over the last two years, the lowest point in the patch did not settle; however, the surrounding pavement in the patch settled to the same elevation.

Settlements versus time were plotted in Figure 3.24 (b). This figure shows that settlements as a function of time were less than in the other trenches. The maximum rate of settlement was 0.03 inches per month, occurring three to six months after construction for survey points 2, 4, 10, 15, and 16. The maximum rate of uplift movement was 0.01 inches per month.

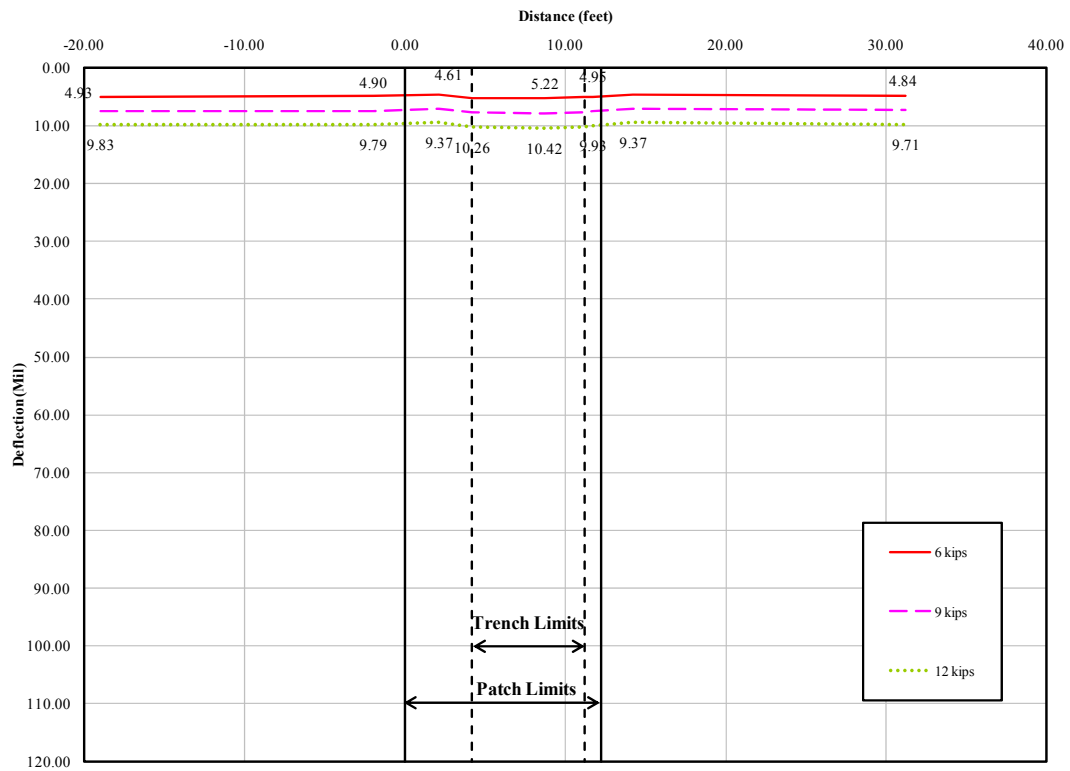
Figure 3.27. Falling weight deflectometer testing for the trench in Des Moines conducted on April 13, 2005

The FWD testing on this trench does not show the same seasonal effects as the other trenches, which had higher deflections in the spring and early summer and smaller deflections in the fall FWD tests. This was confirmed with plotting the test results from the 6-kip load in Figure 3.27 and the 15-kip load in Figure 3.28. The response of the trench did not vary with seasonal effects. These results may be attributed to being a concrete patch doweled with surrounding pavement.

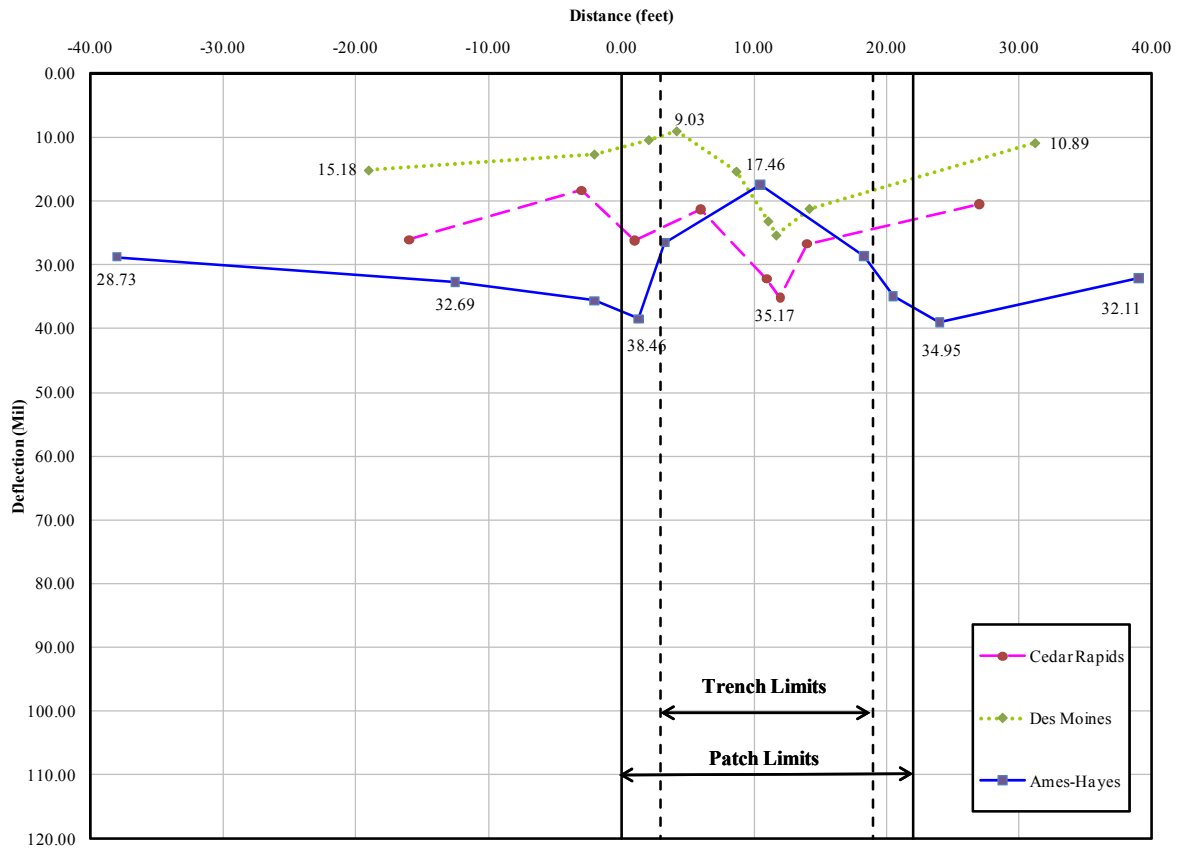
Figure 3.32. Comparison of the 15-kip FWD test results for summer 2008

To compare the performance of the three trenches monitored in Phase I, the 15-kip FWD test results from summer 2008 (Figure 3.32) were plotted and the spring 2009 test results were used (see Figure 3.33). These figures show that the Des Moines trench had the lowest deflections from FWD testing in June. The deflection patterns across the trenches were similar on both sides of

the trenches, showing that the loss of moisture over the summer resulted in the response of the trench becoming more uniform. This is important because when an area of the sub-base is softer than the surrounding area, it places additional stress on the surrounding pavement. This effect on load distribution is also seen with beams supporting continuous elastic foundations and pile design. The Cedar Rapids trench did not show improved performance on both sides of the trench as did the Des Moines and Ames trenches. The side of the highest deflections had equipment located on it during construction. The damage caused by the equipment to the sub-base during construction was not minimized over time.

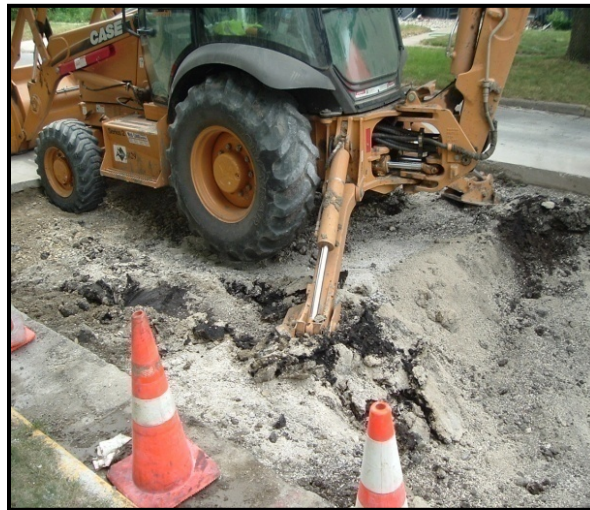
During compaction, the backhoe drove into the cut area because it could not access the entire area (see Figure 4.6). The truck also backed into the open cut to reach the excavated area as shown in Figure 4.7.

Figure 4.6. Backhoe operating where pavement was removed on the northeast side of Trench B

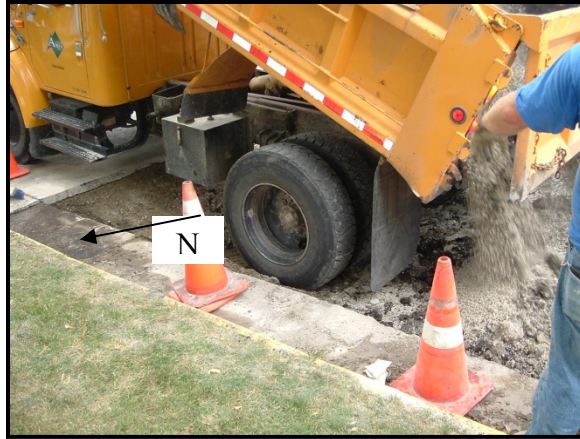
Figure 4.7. Truck operating where pavement was removed on the northeast edge of Trench B

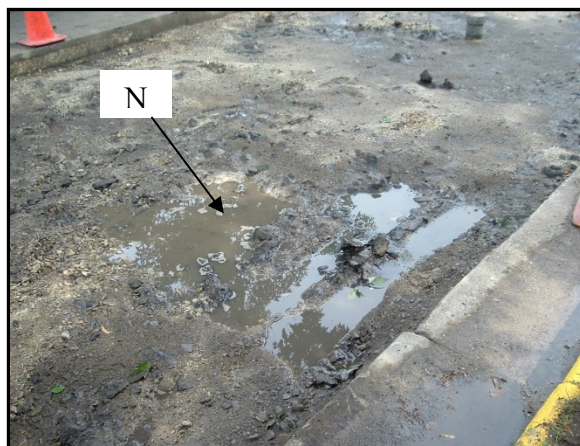
The trench was left open overnight. During the night, the City of Ames received 1½ inches of rain. The next day water was standing in the trench (see Figure 4.8). The trench was left open to dry for seven days. By July 25, 2007, the surface of the trench had mostly dried. The city then placed a thin lift of 3/8-inch minus limestone on the south side of the cut area where standing water remained. The 3/8-inch minus limestone was compacted using a small, hand vibratory compactor as shown in Figure 4.9. The trench was then patched with 6 inches of asphalt.

Figure 4.8. Standing water in Trench B after it rained

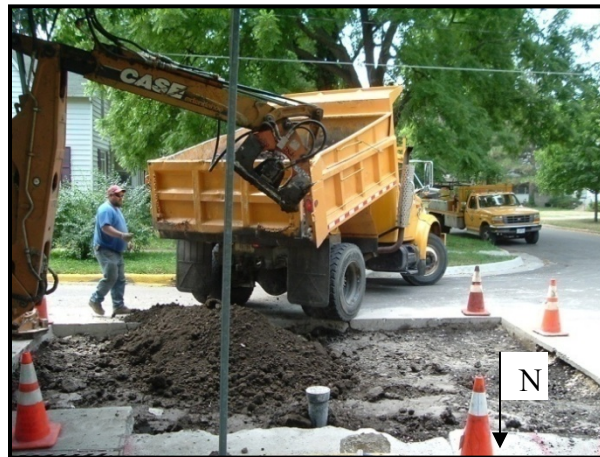
piles were used. Two bulk soil samples were collected of this backfill: Additional Backfill No. 1 and Additional Backfill No. 2. The origin of the soil in the supply piles was not known. During construction, the equipment was close to the edge of the trench (see Figures 4.18 and 4.19). The T-section was backfilled until it was at the elevation of the bottom of the existing pavement. A thin lift of 3/8-inch minus limestone was loosely placed as a base for the pavement patch. The asphalt patch was 6 inches thick.

Figure 4.18. Soil previously removed being placed back in Trench E by a truck to the south, while a backhoe operates on the east edge of the pavement

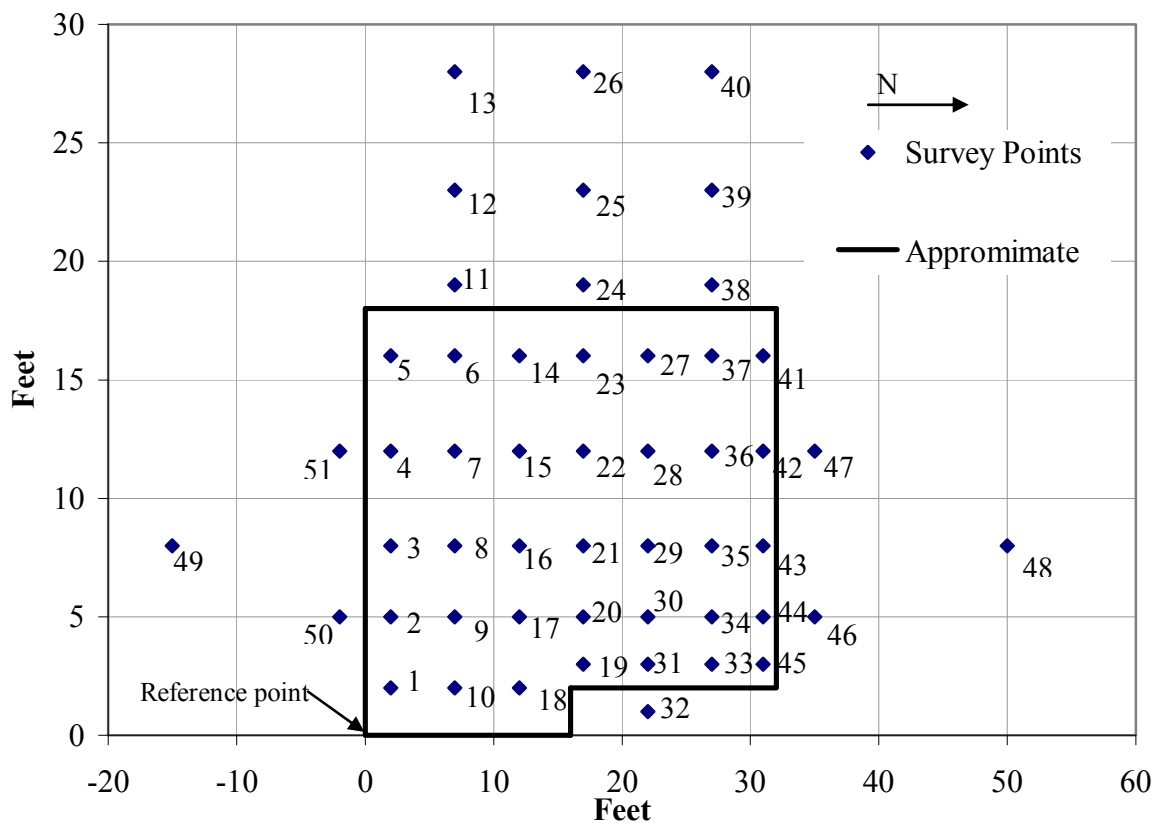
Figure 4.53. Survey locations for Trench B

Trench B was surveyed with 51 grid points (see Figure 4.53). The benchmark was located at the dome bolt on the fire hydrant northwest of the trench at the intersection of 9th Street and Carroll.

The average uplift at the site was 0.10 inches and the maximum settlement was 0.30 inches at survey point 34. The maximum settlement occurred on the north edge of the patch in the soil adjacent to the trench. Figure 4.54 shows the elevation profiles of the trench as well as the settlement profile of the trench. This figure shows the settlement occurred at the north edge of the trench.

The maximum settlement occurred on the north side of the trench (i.e., within the vicinity of test points 11 and 12 as shown in Figure 4.53). The dry unit weights at points 11 and 12 were 123.0 pcf and 116.3 pcf, respectively. The CBR values at the surface were 5% and 1% for points 11 and 12, respectively. The average CBR value for the depth of the test for both test points was 3%. These soils were extremely weak even though the densities for the soils were within the accepted range from NAVFAC. The CBR values from the DCP tests on the north edge of the trench at test point 11 showed a softening response, while depth and test point 12 showed the stiffness increasing with depth.

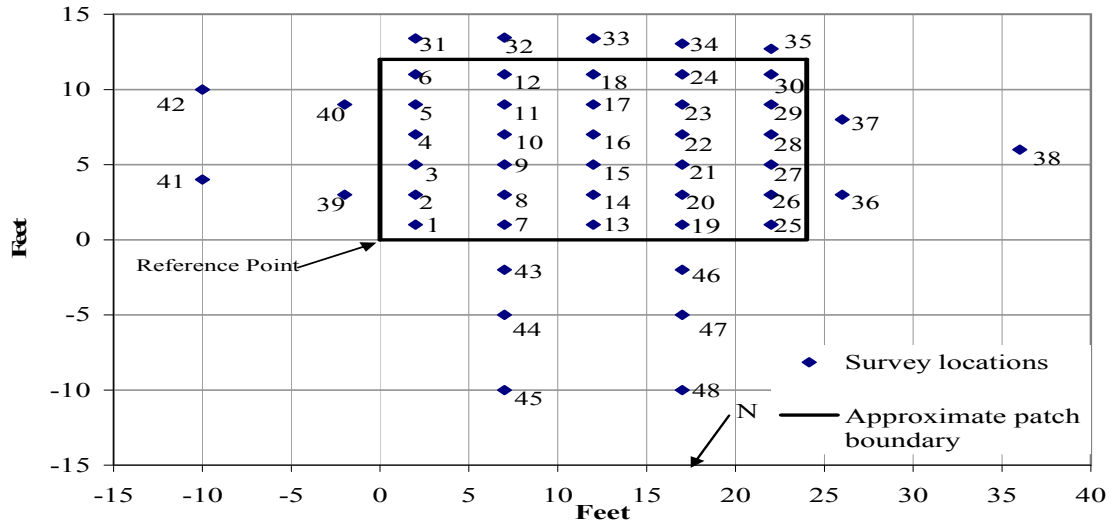
Figure 4.63. Survey locations for Trench C

Trench C was surveyed with 51 grid points (see Figure 4.63). The benchmark was the dome bolt (see Figure 4.40) on the hydrant northeast of the trench located at the intersection of McKinley Drive and Van Buren Avenue.

From the elevation survey on March 19, 2008, the average uplift of the trench was 2.05 inches and the maximum settlement was 1.7 inches (survey point 17). The maximum settlement occurred in the west corner of the patch. Figure 4.64 presents the elevation profiles and settlement profiles for Trench C. This figure shows that the middle of the trench did not experience the same magnitude of uplift during the winter as the area surrounding it. Because of this, the patch had a bump in it.

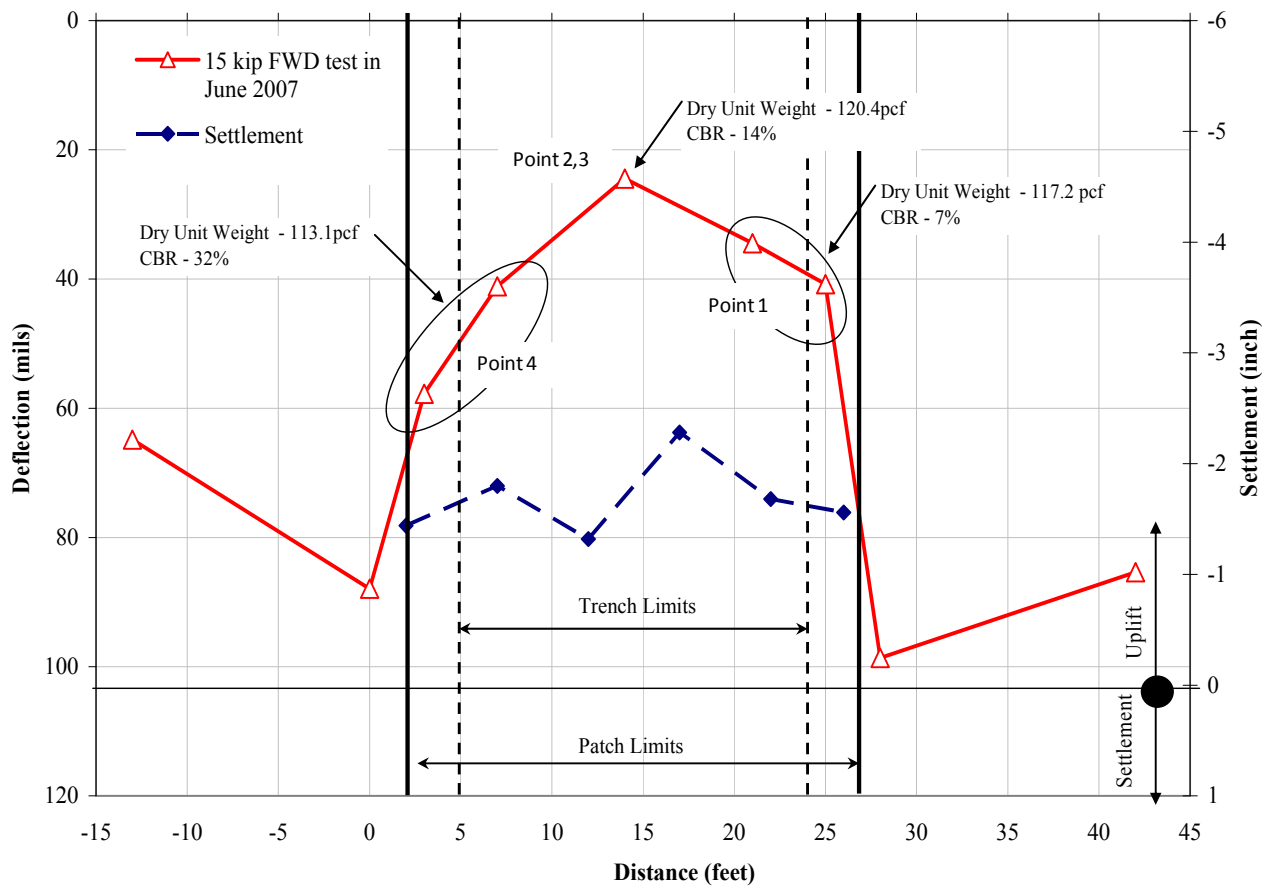
Figure 4.66. Falling weight deflectometer test (15 kip) and settlement for Trench C

Figure 4.66 shows a plot with FWD deflections and settlement. A load of 15 kip was used to accurately show the deflection of the subgrade. This shows the settlements are independent of the FWD deflections. On the chart, it can be seen that the higher dry unit weights measured within the trench occurred where there were lower deflections. It also shows the CBR values did not predict the FWD testing results.

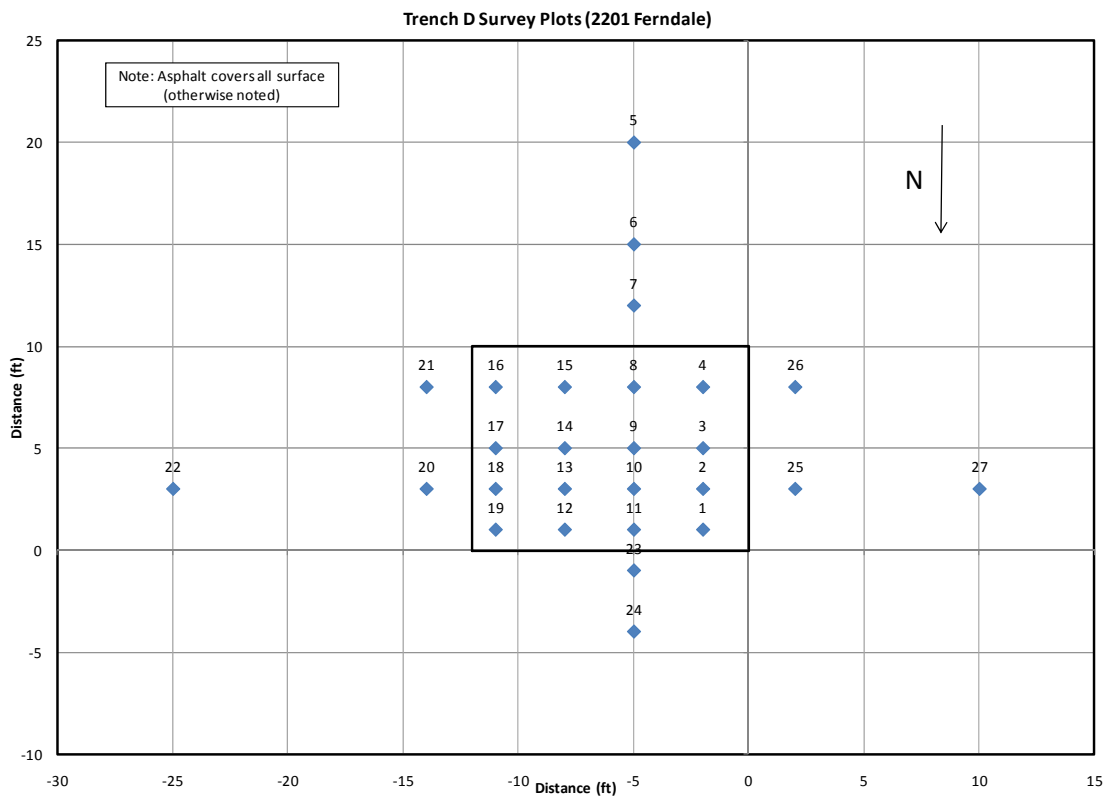
Figure 4.78. Survey locations for Trench D

The post-construction surfaces were constructed using survey data collected on July 30, 2007; March 19, 2008; June 10, 2008; August 20, 2008; November 18, 2008; and March 13, 2009. Figure 4.78 shows the location of the grid points.

Trench D was surveyed with 27 grid points. The benchmark was the dome bolt (see Figure 4.40) on a hydrant northeast of the trench. The difference between the maximum (point 1) and lowest (point 16) elevation was 1.44 inches on July 30, 2007. This was a reduction in the total difference between the highest and lowest level. The uplift was 0.96 inches and the maximum settlement was 0.24 inches at survey point 15 along the south edge of the trench in the adjacent soil.

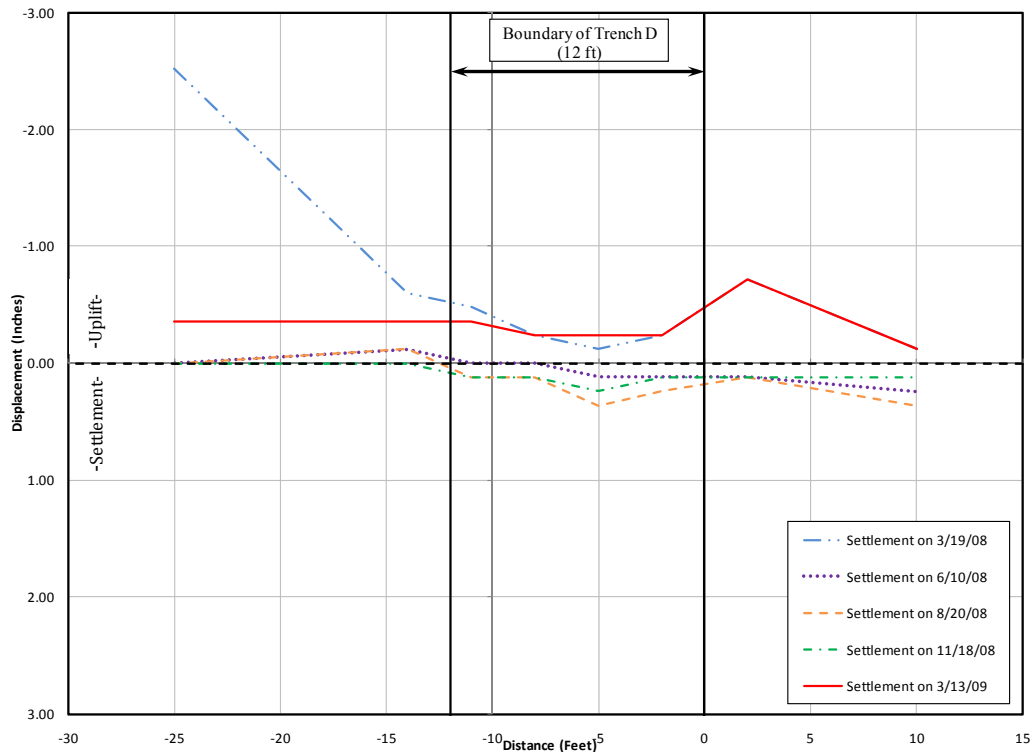
Figure 4.79. Settlement along center line of Trench D (points 22, 20, 18, 13, 10, 2, 25, 27)

Figure 4.79 shows the movement profiles for Trench D. This shows that the larger uplifts during the winter occurred outside the trench. This would result in the patch appearing like a dip in the road.

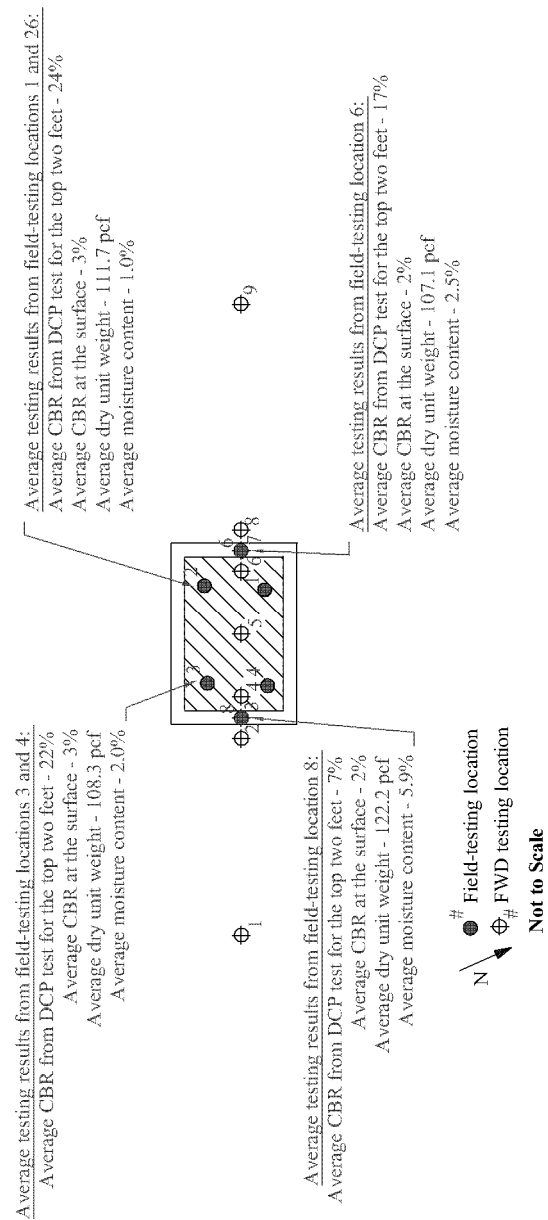
Figure 4.80. Comparison of CBR values, dry unit weights, and FWD testing results for Trench D

Falling weight deflectometer test point 7 (see Figure 4.80) was near the location of maximum settlement. The CBR value at the surface and over the depth of the trench at this point was 7%. Comparing this value to other places in the trench, the CBR value was below the CBR values at other test points in the soil adjacent to the trench.

The field-testing results during construction from the four test points within the trench were compared with the FWD testing. Figure 4.80 shows the FWD and field-testing locations superimposed. Also in the figure are the average field-testing results for field-testing points that correspond to FWD testing locations. The average dry unit weight was 110 pcf. The CBR value at the surface was 3%, and the average CBR value for the depth of the test was 23%. At the west edges of the trench, test points 3 and 4 were within the vicinity of FWD testing point 4 and had an average dry unit weight of 108.3 pcf. The CBR value at the surface was 3% and the average CBR value for the depth of the test was 22%. On the east side of the trench, test points 1 and 2 were in the vicinity of FWD test point 6. The dry unit weight was 111.7 pcf. The CBR value at the surface was 3% and the average CBR result was 24%.

The dry unit weight of the soil adjacent to the trench on the west side (FWD point 7) at test point 6 (see Figure 4.80) was 107.1 pcf at 2.5% moisture content. The average CBR value for the length of the test was 17%, and at the surface the CBR was 2%.

The dry unit weight of the soil adjacent to the trench on the east side (FWD point 3) at test point 8 (see Figure 4.80) was 122.2 pcf at 5.9% moisture content. The average CBR value for the length of the test was 7%, and at the surface the CBR was 2%.

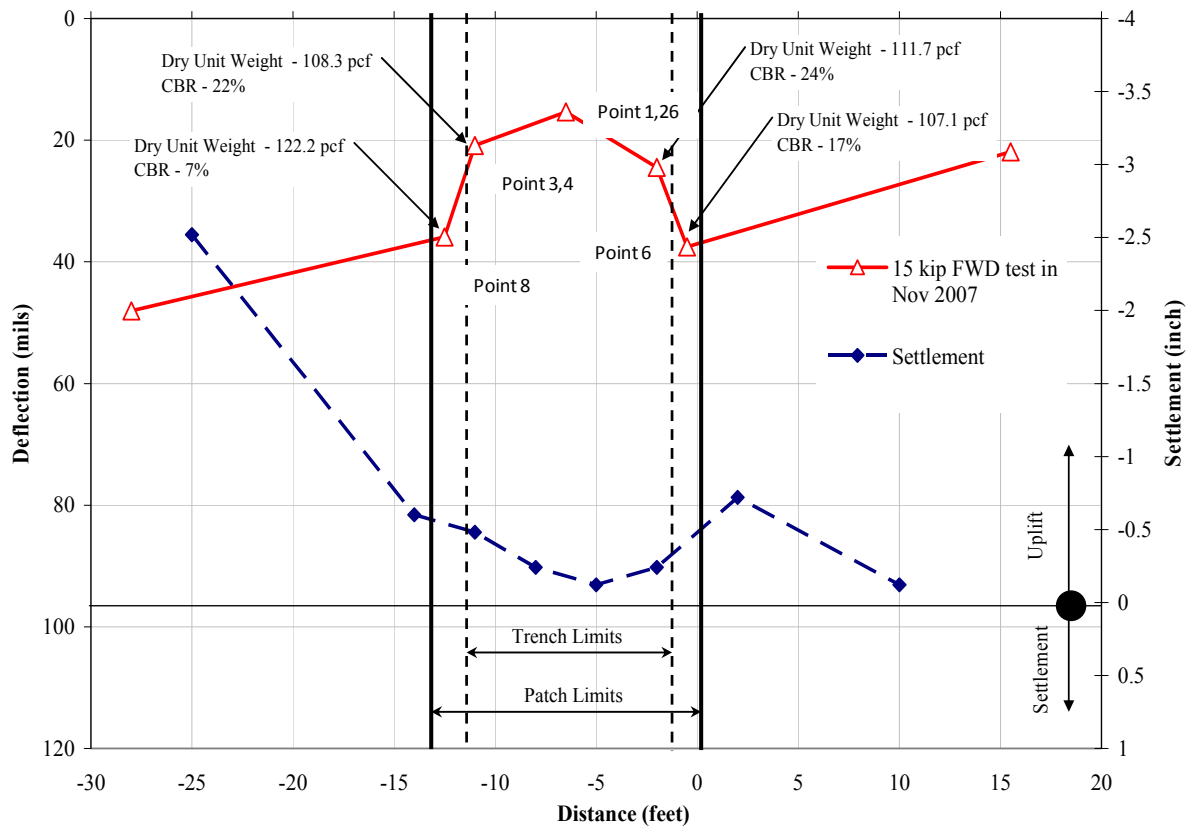
Figure 4.81. Falling weight deflectometer test (15 kip) and settlement for Trench D

Figure 4.81 shows an overlay of the pavement settlement between the summer and early spring surveys with the FWD testing results. A load of 15 kip was used to accurately show the deflection of the subgrade. Stiffer responses to FWD testing correlate to reduced movement during the freeze/thaw cycle. The higher deflections from the FWD testing were located where the backfill had lower CBR values.

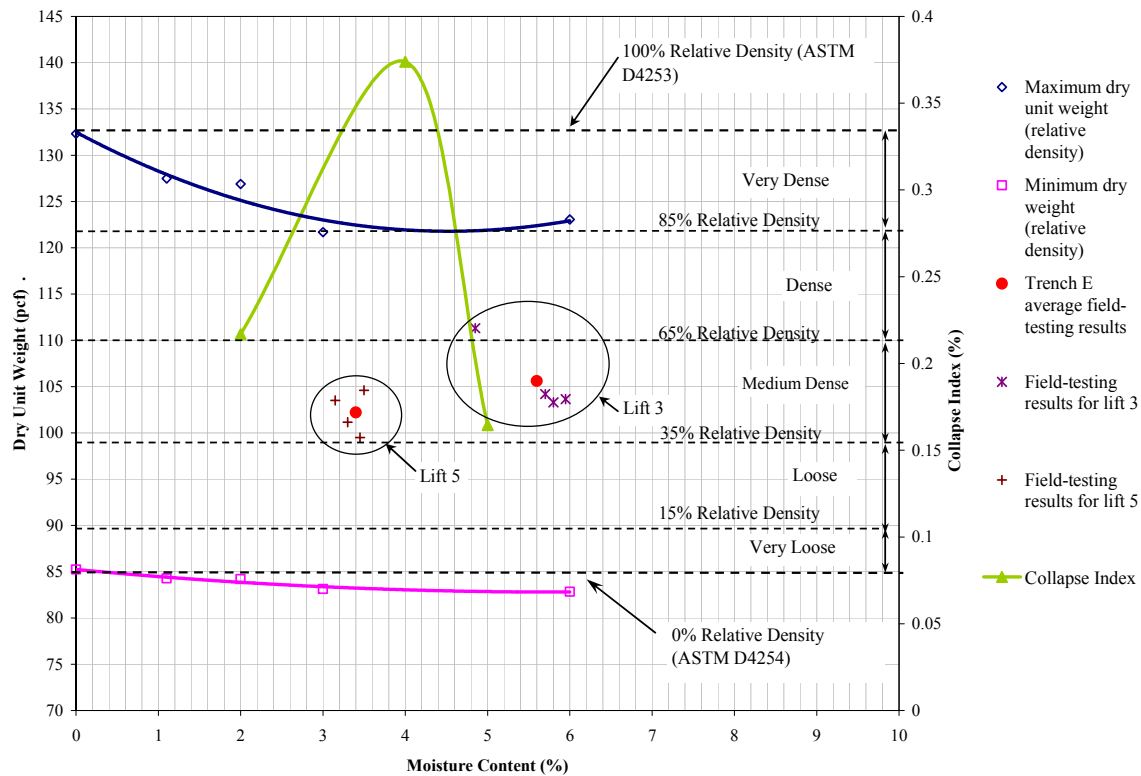
Figure 4.83 shows the average field-testing results for the third and fifth lifts. These lifts were placed at medium dense compaction. The field-testing results are circled and show the test points were uniform within the trench.

Figure 4.83. Relative density test results from Phase I with field-testing results from the third and fifth lifts of Trench E

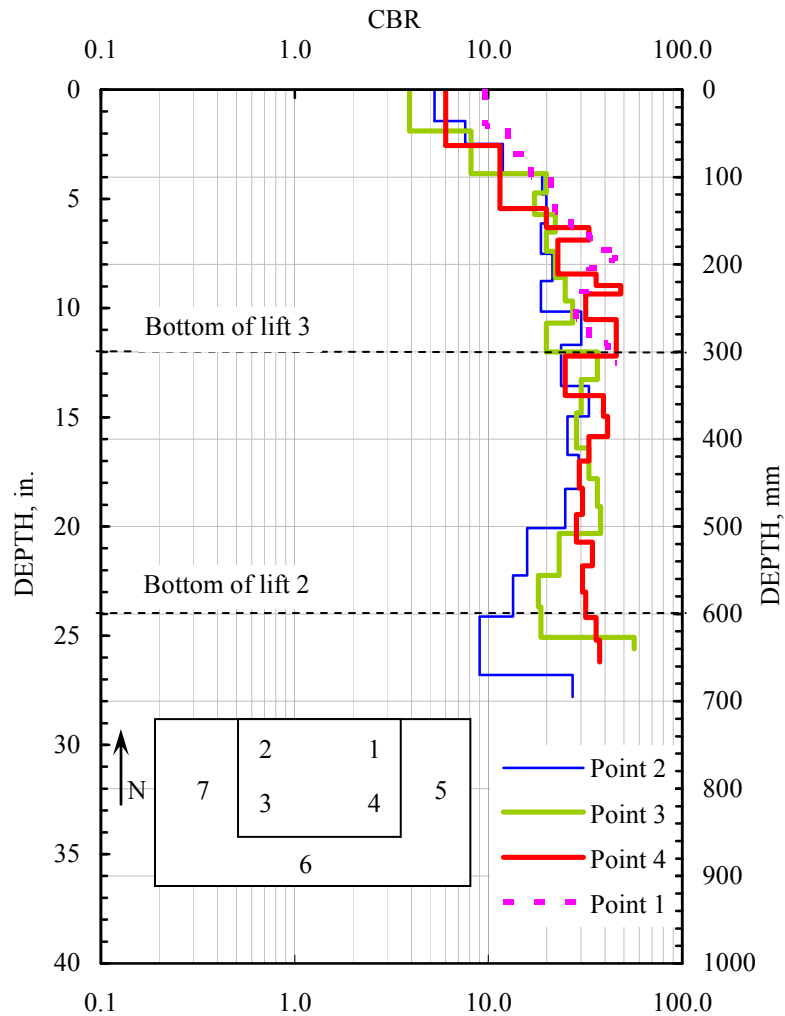
For the four test points in the third lift, the CBR values had an average of 28% for an average depth of 22.7 inches. It should be noted the DCP test at point 1 was terminated at 12.6 inches. At the surface of the lift, the CBR values ranged from 4% to 10%. At the termination of the DCP tests, the CBR values ranged from 12% to 56%. The average CBR value at the termination of the tests was 42%. The profile shows backfill follows the same generalized pattern through the depth of the profiles. This indicated the backfill was placed and compacted in a uniform manner. The profiles increased with depth, indicating the backfill increased in resistance with depth. Figure 4.84 plots profiles of the CBR values as a function of depth.

Figure 4.84. CBR results from the DCP test profiles for the third lift in Trench E
