Investigation of Improved Utility Cut Repair Techniques to Reduce Settlement in Repaired Areas, Phase II

Final Report
December 2010

Sponsored by
Iowa Highway Research Board
(IHRB Project TR-566)
Iowa Department of Transportation
(InTrans Project 06-282)

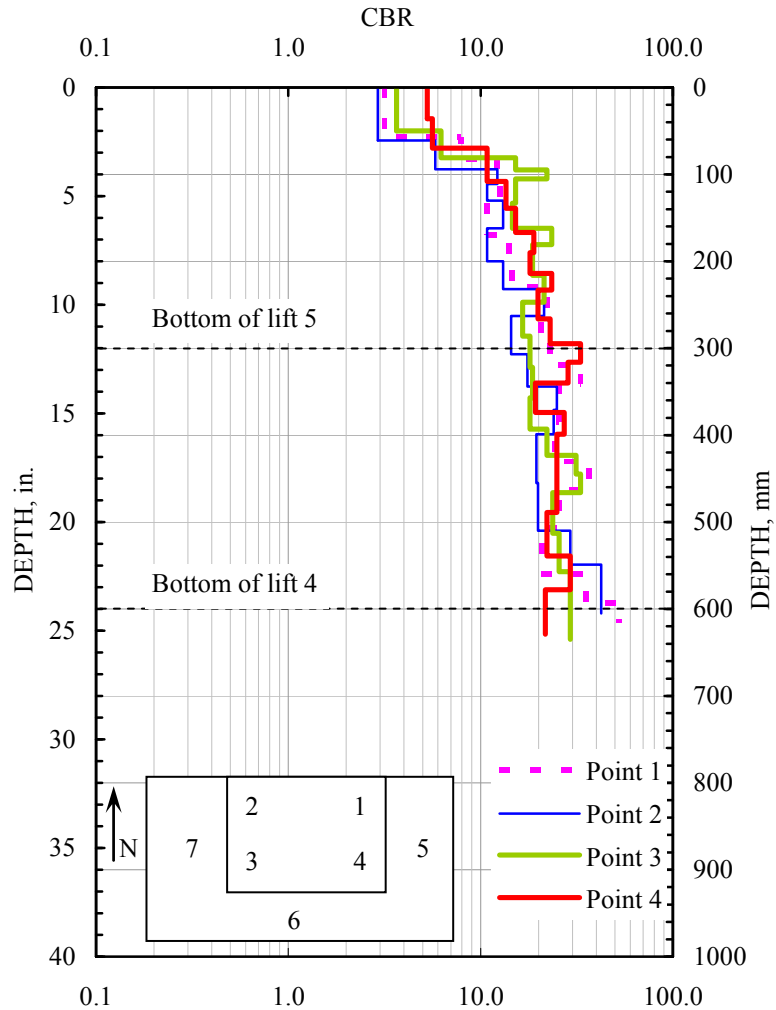
The fifth lift, tested on July 12, 2007, for the four test points within the trench, had an average CBR of 16% extending 24.5 inches (see Figure 4.85). At the surface of the lift, the CBR values ranged from 3% to 5%. The CBR values at the termination of the DCP tests ranged from 22% to 53%. The profiles all followed the same pattern with increasing CBR as a function of depth, suggesting the lifts were compacted in an even manner and indicating the increases in soil resistance and strength.

Figure 4.85. CBR profiles for test points within the fifth lift in Trench E on July 12, 2007

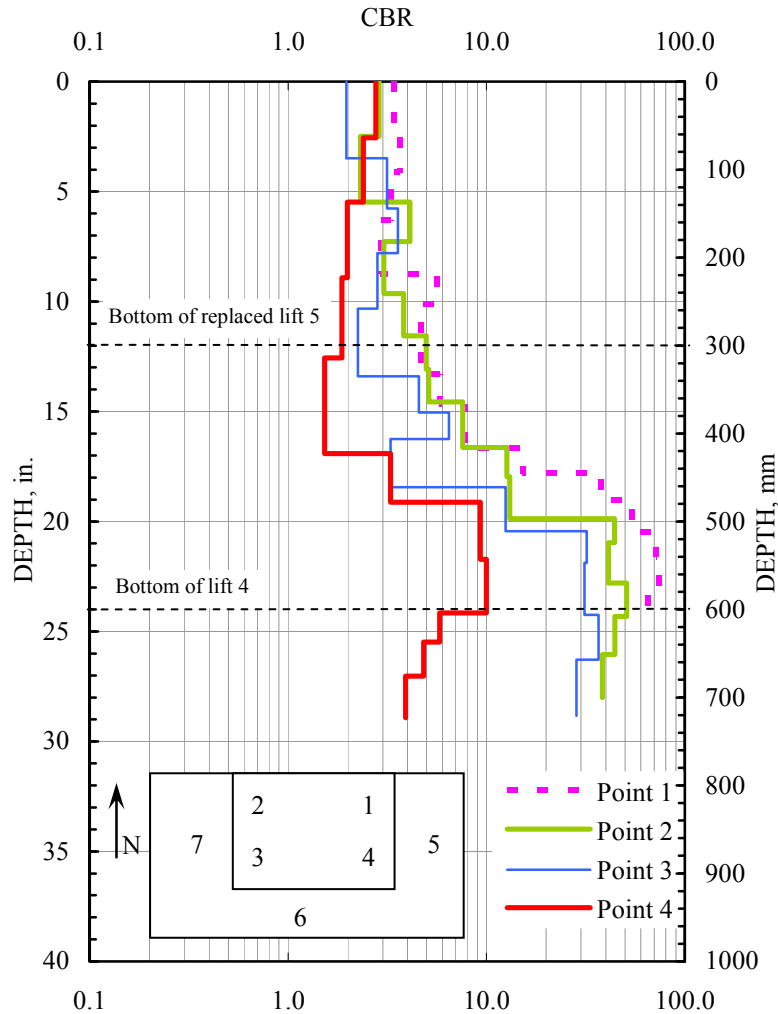
The replaced fifth lift, tested on July 18, 2007, for the four test points within the trench, had an average CBR of 13% extending 27.1 inches (see Figure 4.86). At the surface of the lift, the CBR values ranged from 2% to 3%. At the termination of the test, the CBR values ranged from 4% to 65%. At a depth between 17 and 20 inches for test points 2, 3, and 4, the CBR values increased from between 12% and 13% to a range of 32% to 54%. This indicated the DCP probe penetrated to the 1-inch clean limestone below.

Figure 4.86. CBR profiles for test points within the replaced fifth lift in Trench E on July 18, 2007

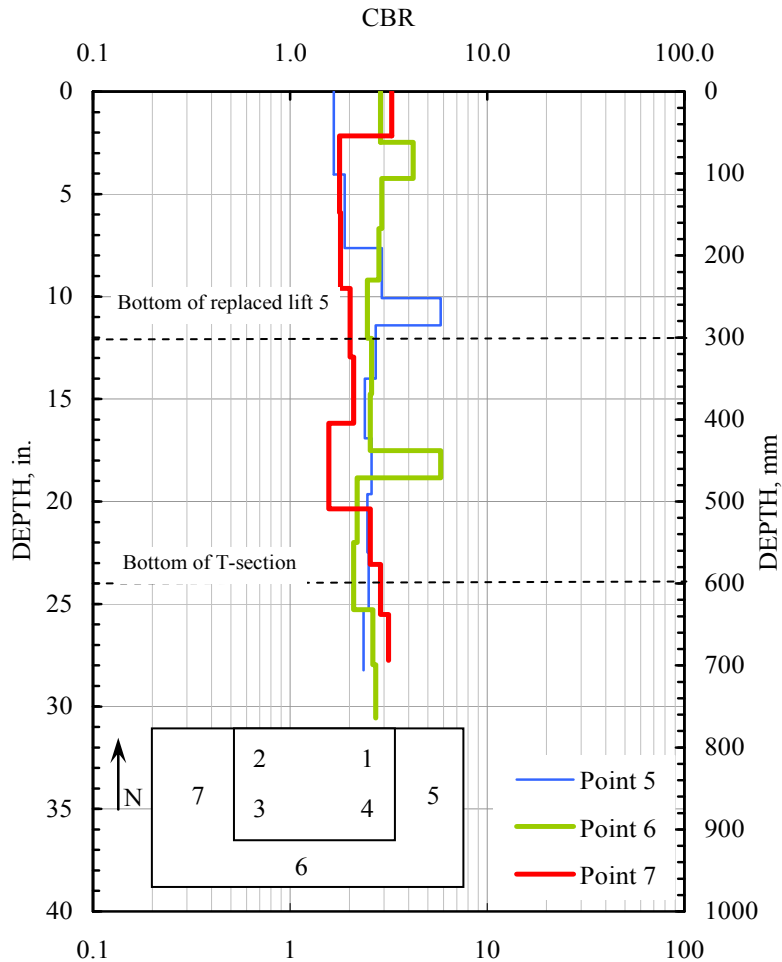
Figure 4.87 shows the CBR profiles for the three points in the T-section tested on July 18, 2007. The replaced fifth lift had an average CBR of 13% extending 28.5 inches. The average CBR values for the top 2 feet ranged from 2% to 3%. At the surface and termination of the lift, the CBR values ranged from 2% to 3%. This indicates the backfill within the T-section was not compacted sufficiently.

Figure 4.87. CBR profiles for test points within the T-section of the fifth lift on July 18, 2007

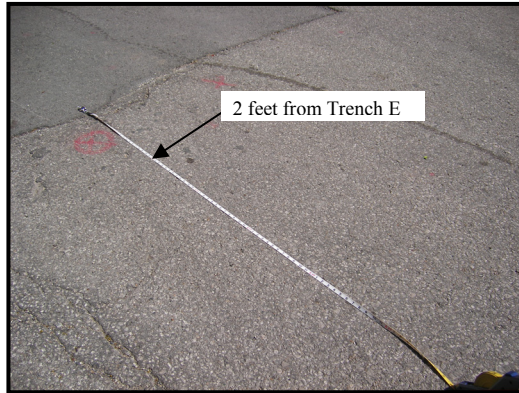
The FWD diagram shows, on the east side of the trench, the zone of influence is present. The zone of influence was beyond the outer limits of the T-section. On the west side of the trench, the deflections were high in comparison to other locations. Figure 4.93 shows there was no visible cracking in the pavement. Based on the photographs taken during construction of the trench, equipment was only located on the east side of the trench (see Figure 4.19). This does not account for the difference in the response to the FWD testing.

Figure 4.93. Condition of the pavement 2 feet west of Trench E at FWD testing location 10

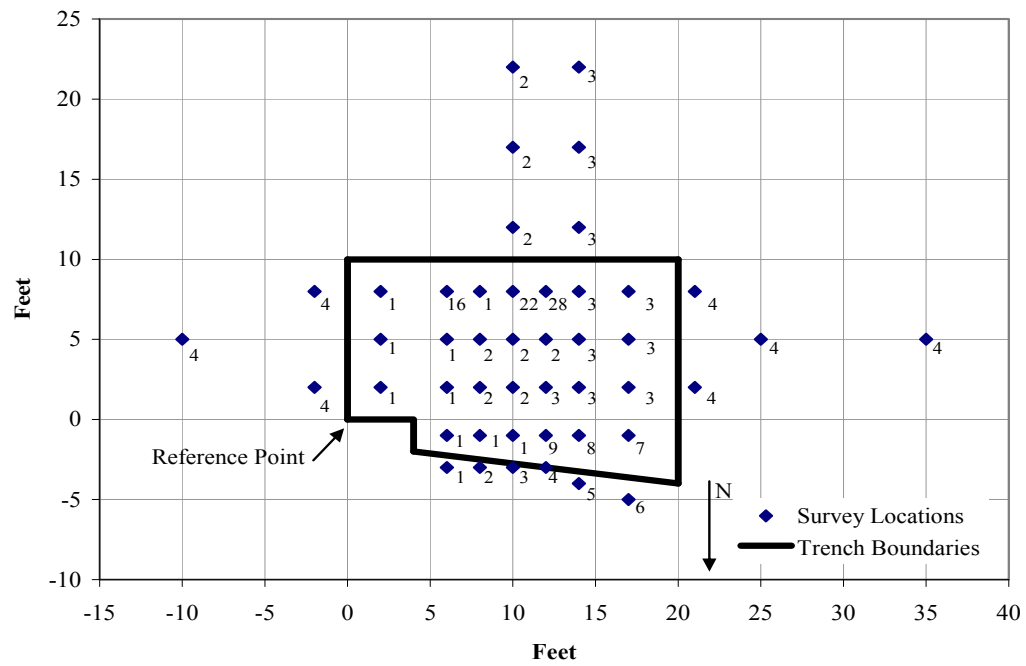
Trench E was surveyed at 46 grid points. The benchmark was the hydrant northwest of the trench at the intersection of 6th Street and Carroll Avenue. The average settlement was 0.36 inches, and the maximum settlement was 0.72 inches along the south edge of the trench at survey points 22 and 26. Figure 4.94 shows the location of the grid points.

Figure 4.94. Pavement surface elevations of Trench E

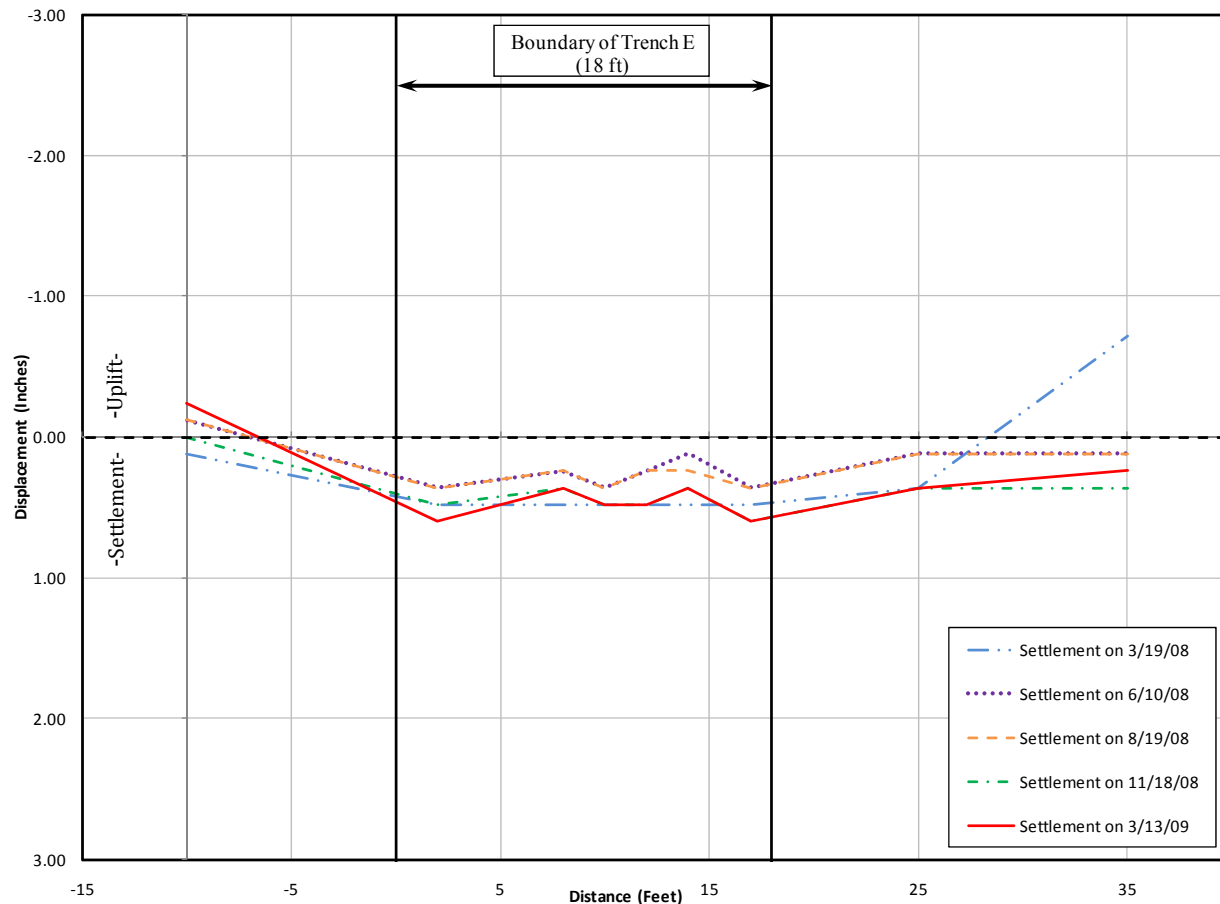
Figure 4.95 shows the settlement and elevation profiles for Trench E. This shows the trench settled since construction. Five feet west of the trench, the pavement was in a state of uplift. This caused the settlement of the patch to appear greater.

Figure 4.95. Settlement along the center line of Trench E (points 46, 14, 17, 20, 23, 19, 32, 38, 42, 43)

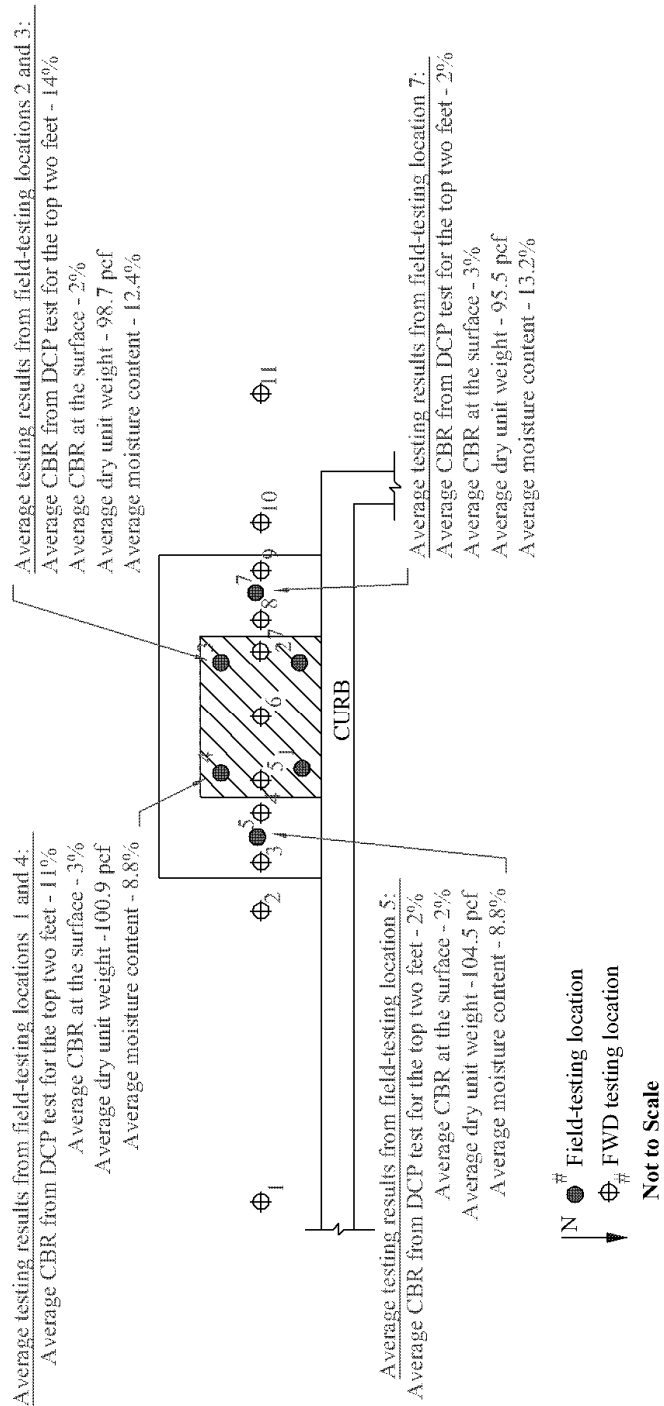
Figure 4.96 shows the FWD locations and the field-testing locations superimposed with field-testing results averaged. The dry unit weights at test points 5 and 7 were 104.5 pcf and 95.5 pcf, respectively. At the top of the fifth lift, the CBR value was 2% and 3% for test points 5 and 7, respectively. The higher deflection on the west side of the trench was the result of the backfill not being compacted to a dense state. Figure 4.97 shows the settlement of the trench with the FWD deflections and field-testing results. A load of 15 kip was used to accurately show the deflection of the subgrade. The maximum settlement of Trench E was 0.72 inches along the south edge of the trench. The dry unit weight at test point 6 on the south side of the trench was 96.1 pcf at a moisture content of 14.7%. The CBR values from the DCP tests were constant with depth. This figure shows that where the FWD deflections were lowest, the settlement was the highest. Outside the trench, the highest deflection on the FWD results occurred where the trench had uplifted during the winter.

Figure 4.96. Comparison of CBR values, dry unit weights, and FWD testing results for Trench E

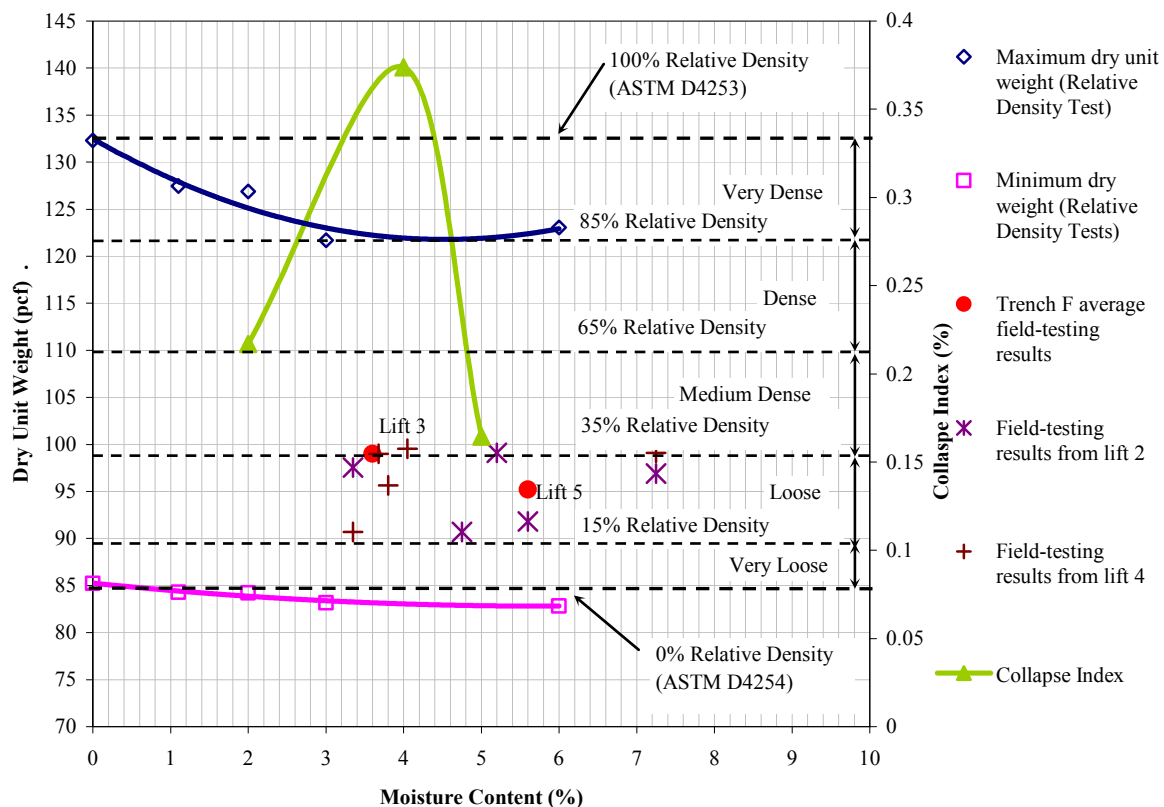
Figure 4.99 shows the field placement results for the second and fourth lifts for Trench F. The backfill was placed at loose density with nonuniform compaction.

Figure 4.99. Relative density test results with field-testing results for Trench F

The Standard Proctor test results for the backfill used in the top 2 feet of the trench show a maximum dry unit weight of 119.1 pcf at an optimum moisture content of 13.2%. The figure shows the field placement of the backfill was between 90% and 95%. The backfill within the T-section was placed at a higher dry unit weight than within the trench.

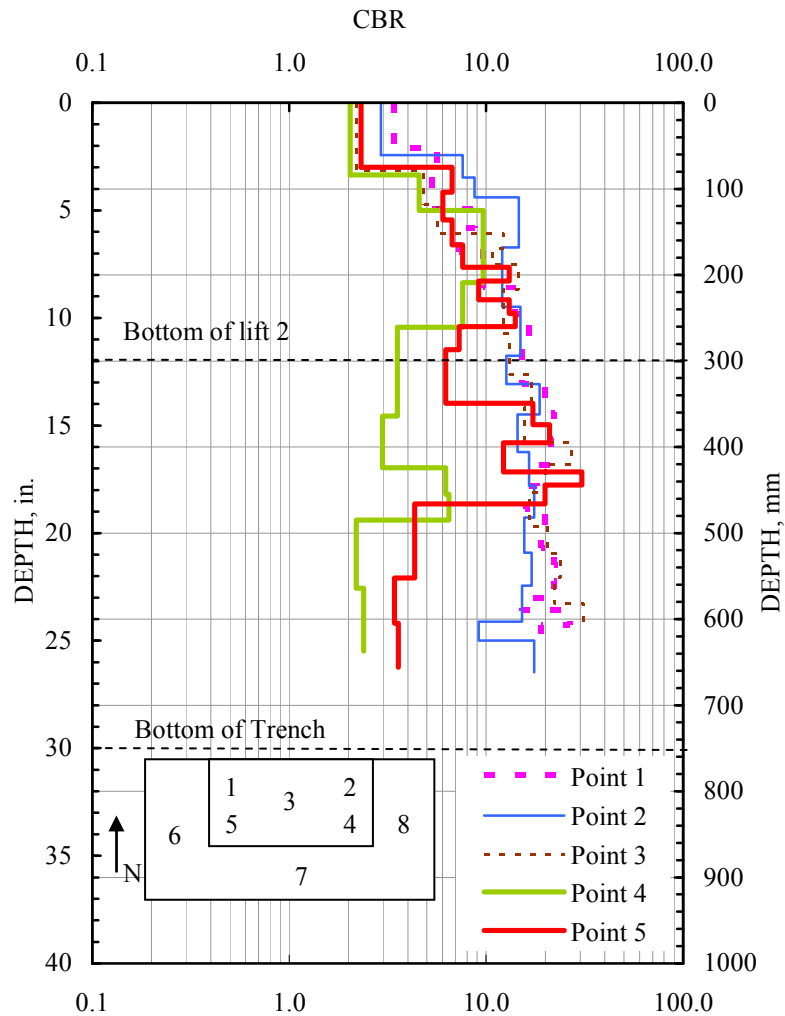
Figure 4.100 shows the CBR profiles for the five test points within the trench for the second lift. The second lift, tested on July 12, 2007, had an average CBR value of 11% extending 24.6 inches. At the surface of the lift, the CBR values ranged from 2% to 3%, and at the termination of the tests the CBR values ranged from 2% to 19%. At the start of the test, the CBR values were similar; however, at the termination of the test the CBR values were scattered. At a depth of 10 inches, the profiles diverge. This is the interface between the 1-inch and 1½-inch clean limestone, which was used as bedding for the pipe.

Figure 4.100. CBR results from the DCP test profiles for the second lift in Trench F

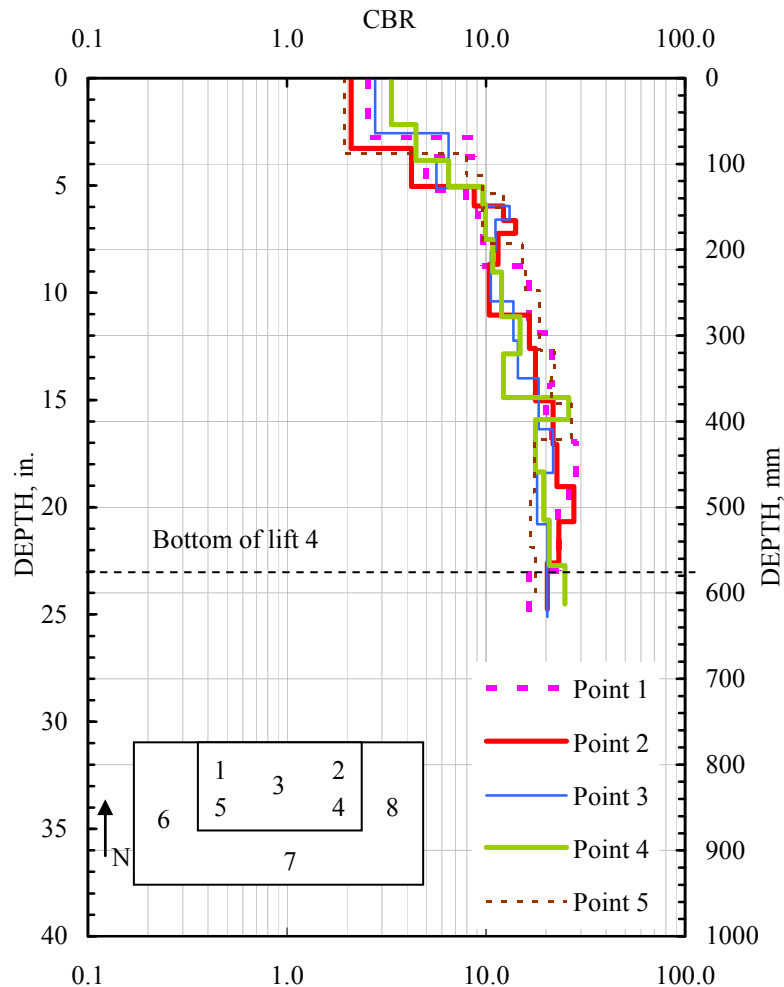
Figure 4.101 shows the CBR profiles for five test points tested on July 12, 2007, within the trench for the fourth lift. The fourth lift, tested on July 12, 2007, had an average CBR value of 15% extending 24.5 inches. At the surface of the lift the CBR values ranged from 2% to 3%, while at the termination of the test the CBR values ranged from 16% to 25%. The CBR profiles increased with depth. The profiles also followed the same pattern throughout the profile. This indicated the lift was evenly compacted.

Figure 4.101. CBR profiles for test points within the fourth lift in Trench F on July 12, 2007

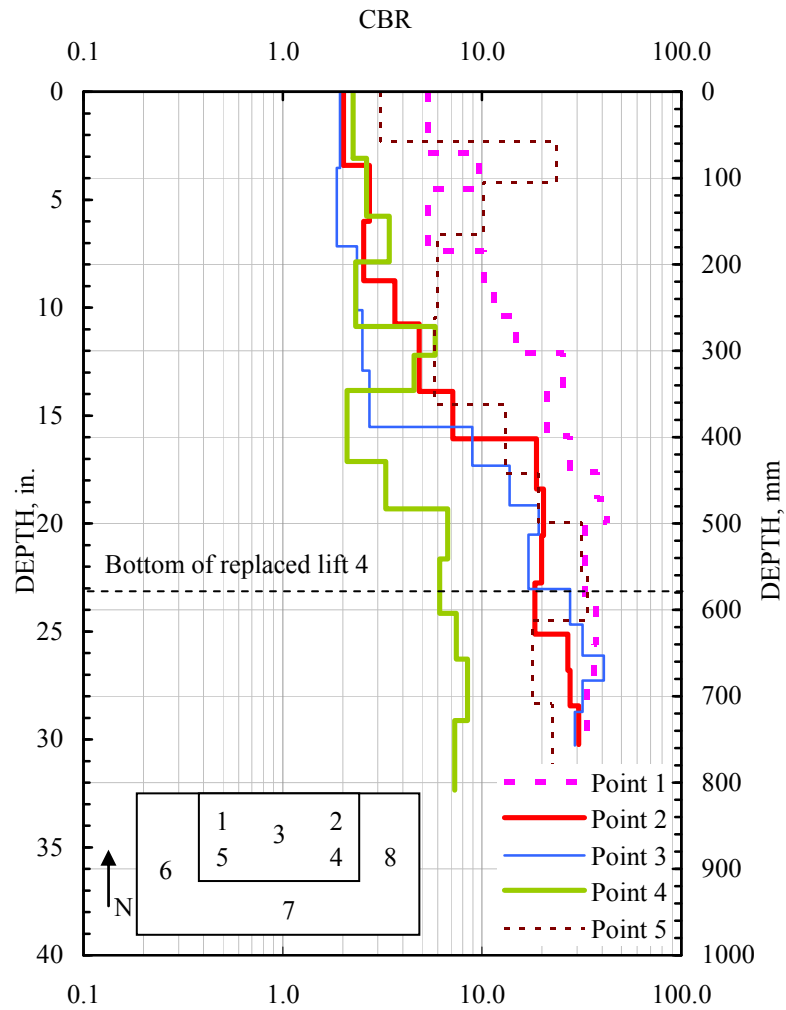
The replaced fourth lift, tested on July 18, 2007, at the five test points within the trench, had an average CBR value of 13% extending 30.5 inches (see Figure 4.102). At the surface of the lift, the CBR values ranged from 2% to 5%. At the termination of the DCP tests, CBR values ranged from 22% to 34%. However, as the depth increased, the CBR values increased. The CBR profiles had wide variation at the bottom of the lift, indicating compaction was not applied evenly across the trench.

Figure 4.102. CBR profiles for test points within the replaced fourth lift in Trench F, July 18, 2007

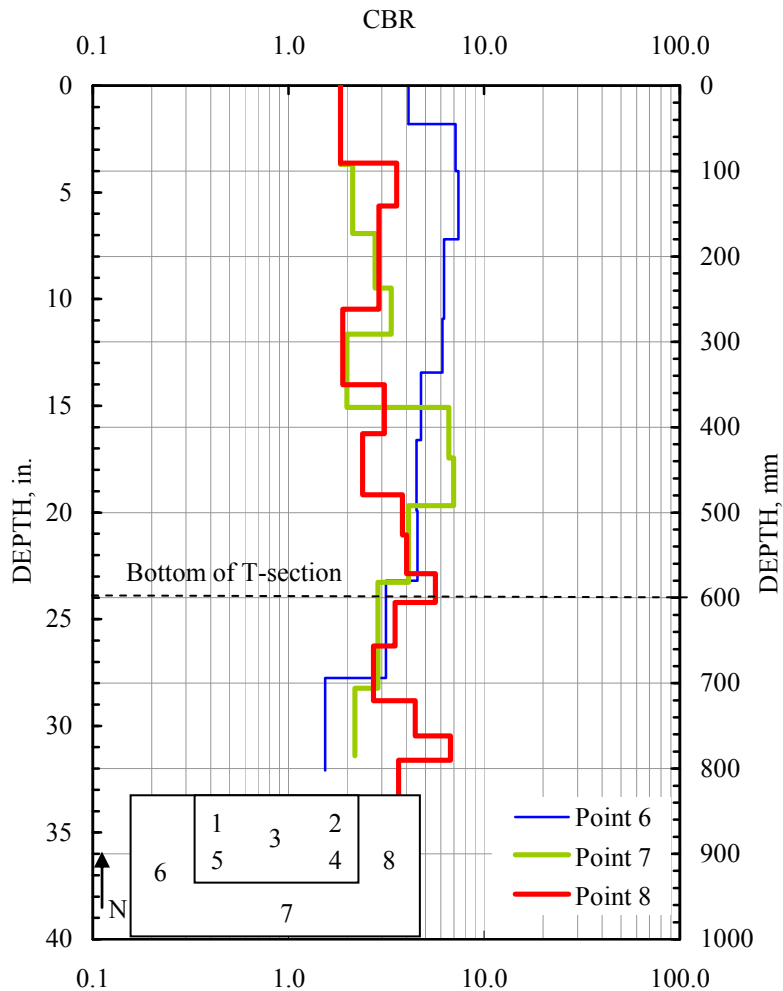
Figure 4.103 shows the CBR profile for the three points tested on July 18, 2007, in the T-section, which had an average CBR value of 3% extending 32.0 inches. At the start of the test, the CBR values ranged from 2% to 4%. At the termination of the test, the CBR values ranged from 1% to 4%. These values are low and indicate the T-section did not receive significant compaction.

Figure 4.103. CBR profiles for test points within the replaced fourth lift of the T-section in Trench F, July 18, 2007

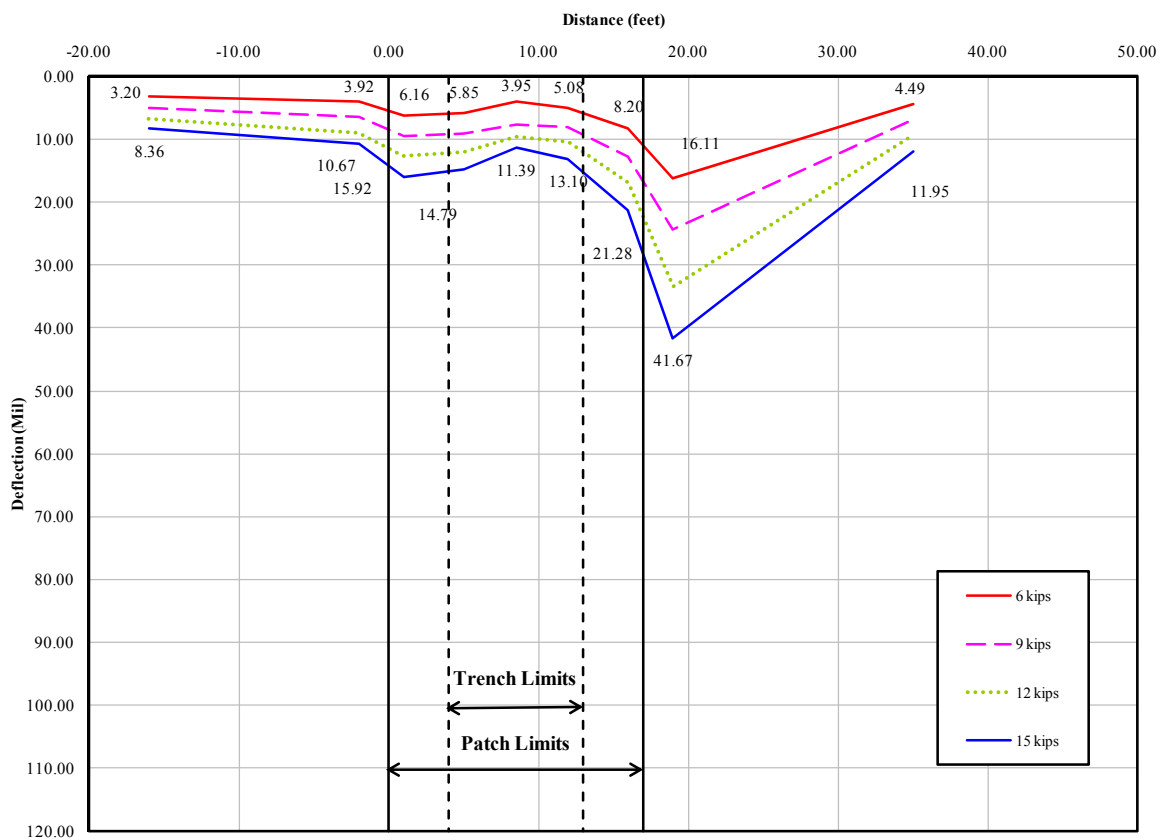
Figure 4.104 shows the FWD testing locations and Figure 4.105 shows the FWD testing results on November 5, 2007. The deflection from the 15-kip load in the center of the trench was 11.4 mils. The deflections at the edges of the trench were 15.9 mils and 21.3 mils. The zone of influence is reflected on both sides of the trench. To the west of the trench, there were no visible cracks in the pavement. Figure 4.106 shows the results from the June 28, 2008, FWD testing; Figure 4.107 shows the results from November 20, 2008; and Figure 4.108 shows results from the March 25, 2009, testing. Figure 4.109 shows overall comparison of the data sets with 15-kip load. Note a 15-kip drop was chosen since it gives a good estimation of the trench's subgrade. Figure 4.110 shows there was no visible cracking of the pavement where the high FWD deflections occurred. The construction equipment does not account for the difference in the FWD responses between the east and west sides of the trench. The pavement away from the trench deflected 8.5 mils. The backfill in the trench was not placed as stiff as the surrounding soil.

Figure 4.105. Falling weight deflectometer test results for Trench F on November 5, 2007, at a temperature of 44.4°F

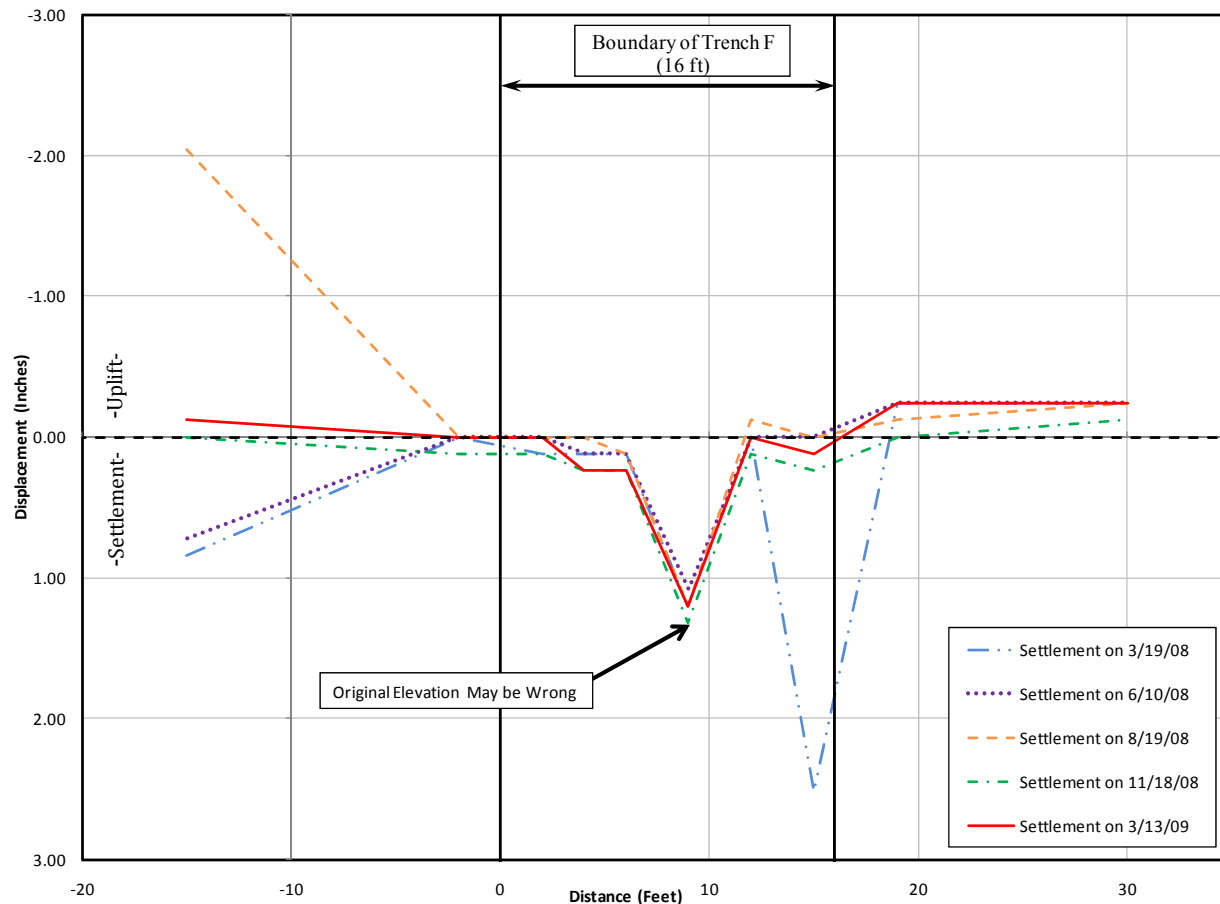
19, 2008, the average settlement was 0.24 inches and the maximum settlement was 2.51 inches, which occurred along the southwest corner of the patch. The difference between the highest elevation and the lowest elevation was 5.04 inches. Figure 4.112 shows the elevation profiles and settlement for Trench F. This shows the trench settled since its construction.

Figure 4.112. Settlement along center line of Trench F (points 36, 34, 2, 7, 10, 18, 21, 29, 31, 33)

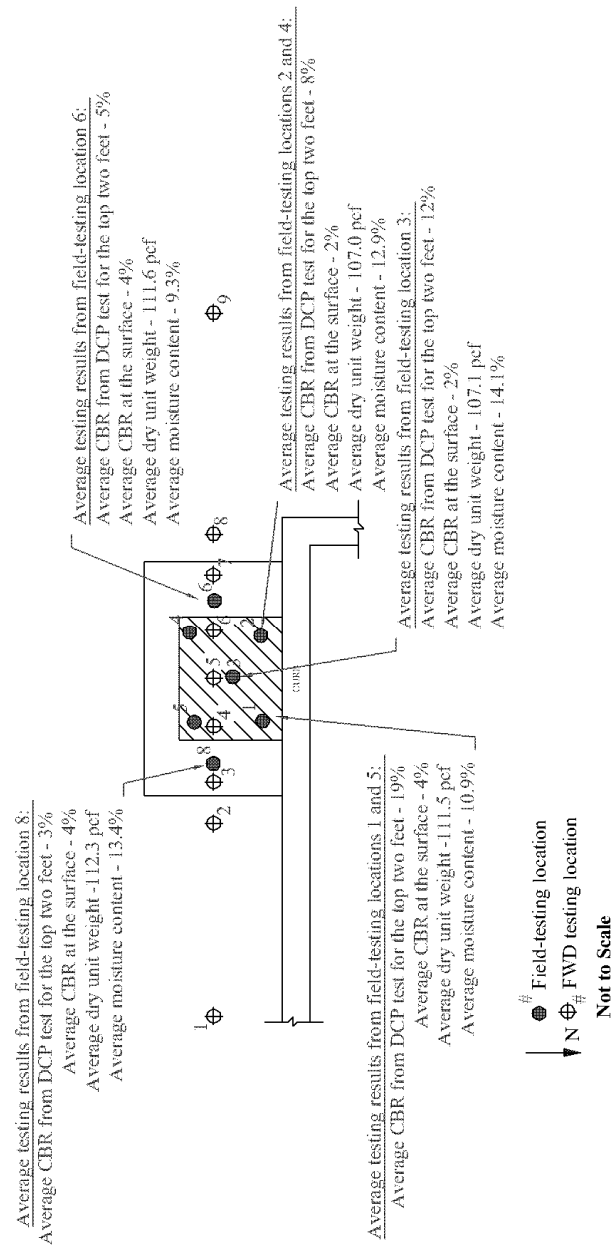
Figure 4.113 shows the FWD locations and the field-testing locations with the average field-testing results corresponding to the test points. On the east side of the trench, test point 8 (see Figure 4.113) corresponds to FWD location 3. According to the nuclear density test, at test point 8 the dry unit weight was 112.3 pcf at a moisture content of 13.4%. The DCP test at point 8 shows the soil stiffness increased with depth. The CBR value at the surface was 4%, and the average CBR value was 3%. In the center of the trench, test point 3 corresponded to FWD location 5. The nuclear density test measured a dry unit weight of 107.1 pcf. The CBR value at the surface was 2%, and the average CBR value was 12%. On the west side of the trench, test point 6 corresponded to FWD location 7. The dry unit weight was 111.6 pcf. The CBR value at the surface was 4%, and the average CBR value was 5%. This shows the higher measured FWD deflections occurred where there were lower CBR values. The dry unit weights did not correspond to the FWD deflections.

Figure 4.113. Comparison of CBR values, dry unit weights, and FWD testing results for Trench F

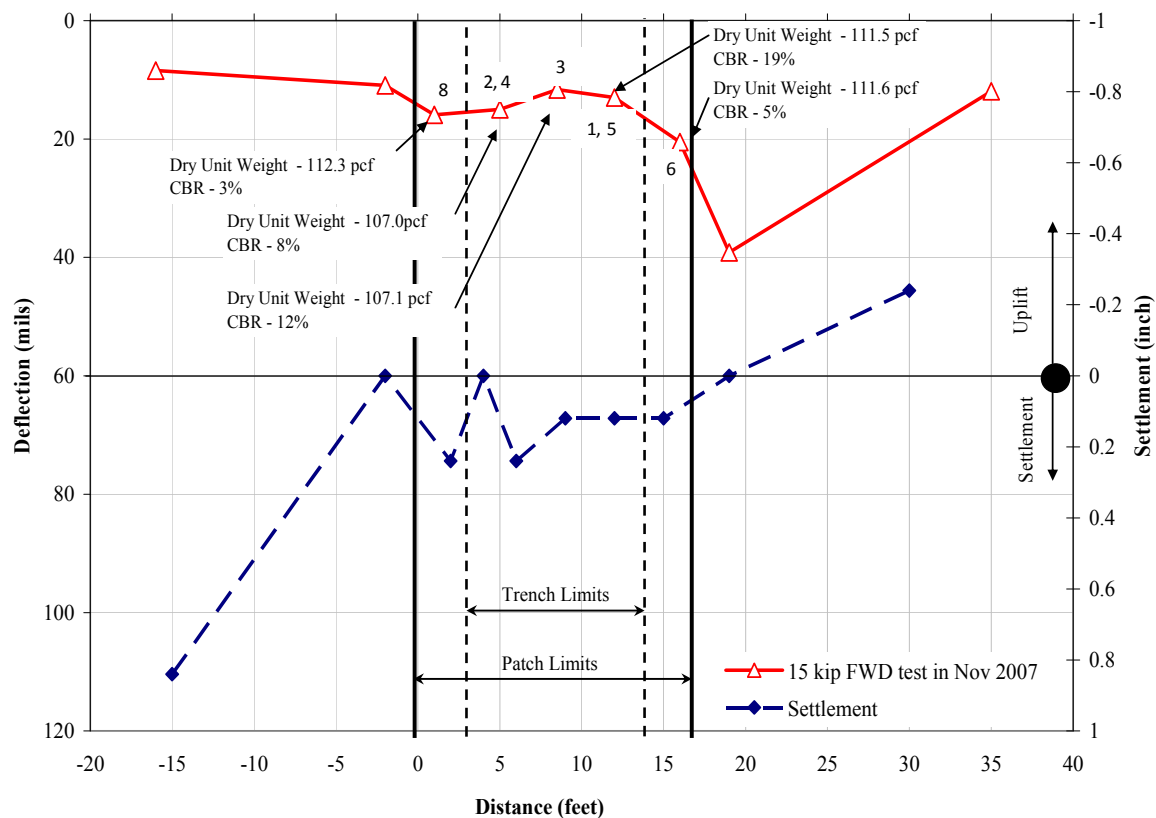
Figure 4.114. Falling weight deflectometer test (15 kip) and settlement for Trench F

Figure 4.114 shows the settlement profile of the trench with the FWD test results. A load of 15 kip was used to accurately show the deflection of the subgrade. The maximum settlement of the

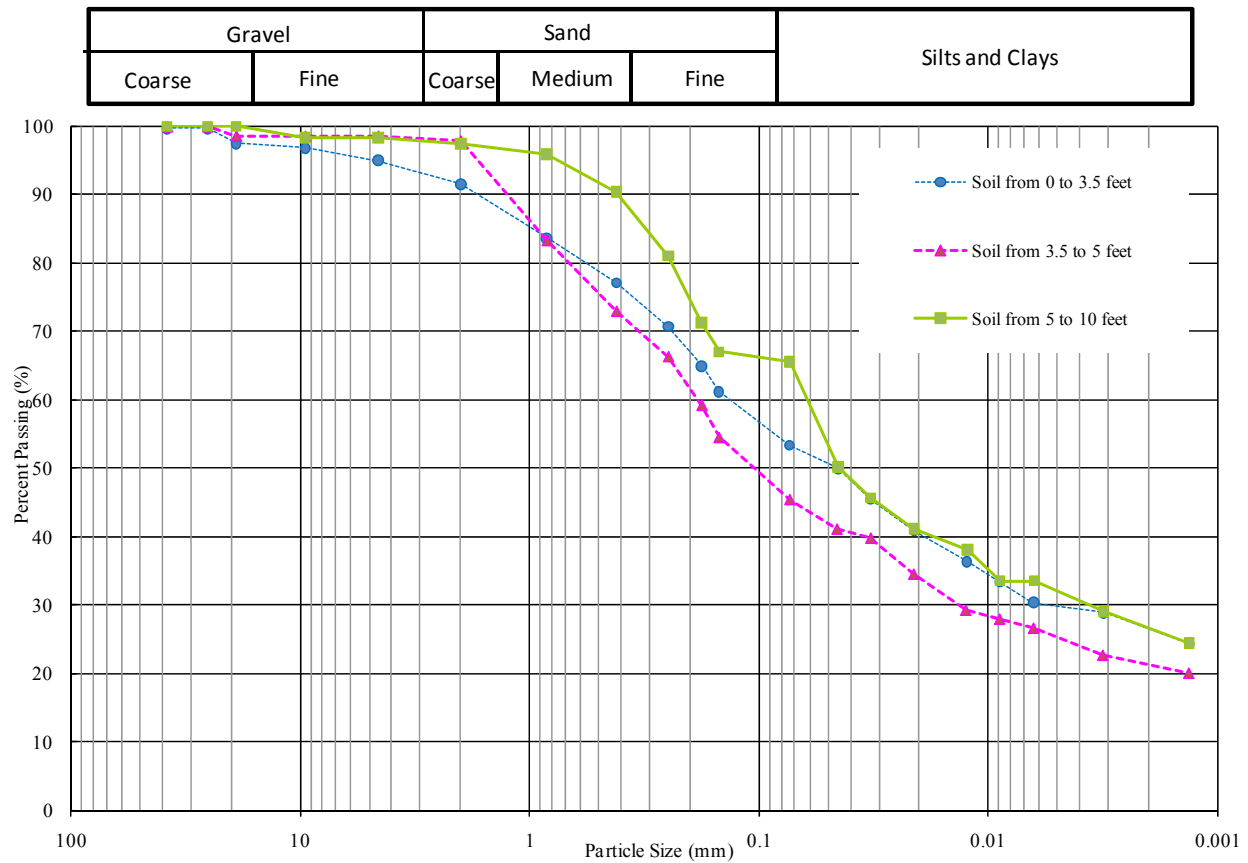
Table 5.1 and Figure 5.3 show the gradations of the soil on Kellogg Avenue. More than 30% of the soil particles were smaller than 0.02 mm (see Figure 5.3). This high percentage increased the soil's susceptibility to frost heave, which, along with the soil's classification of SC, allowed for a frost heave classification of F3, as determined by the Army Corps of Engineers (see Table 2.9). The Army Corps of Engineers also determined the frost heave suitability of the soil to be medium to high. This means the soil was expected to experience 2.0 to 8.0 mm per day heave when temperatures were below freezing. These soils were classified using the USCS and AASHTO standards (see Tables 2.2, 2.3, and 2.4).

Figure 5.3. Gradation of soils excavated from the Kellogg Avenue trenches

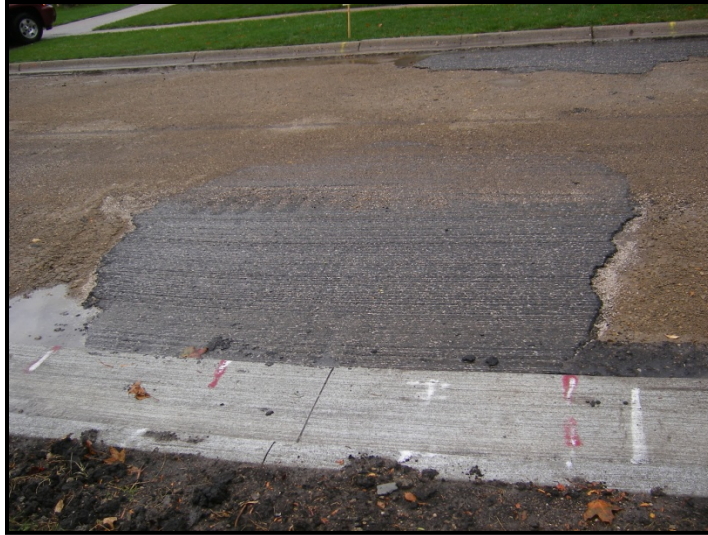
- measure the moisture content of the soil adjacent to the trench.
- Upon the completion of the trench, a temporary asphalt patch was placed over the trench (see Figure 5.20).
 - On September 30, 2007, the asphalt was stripped from the road for repaving. The trenches were left with only a partial patch. During that afternoon, the City of Ames experienced a large amount of rain (0.82 inches). The runoff flowed into the trenches (see Figure 5.21).
 - On October 1, 2007, the street was resurfaced with 6 inches of asphalt.

Figure 5.21. Runoff flowing into the trench around the temporary patch

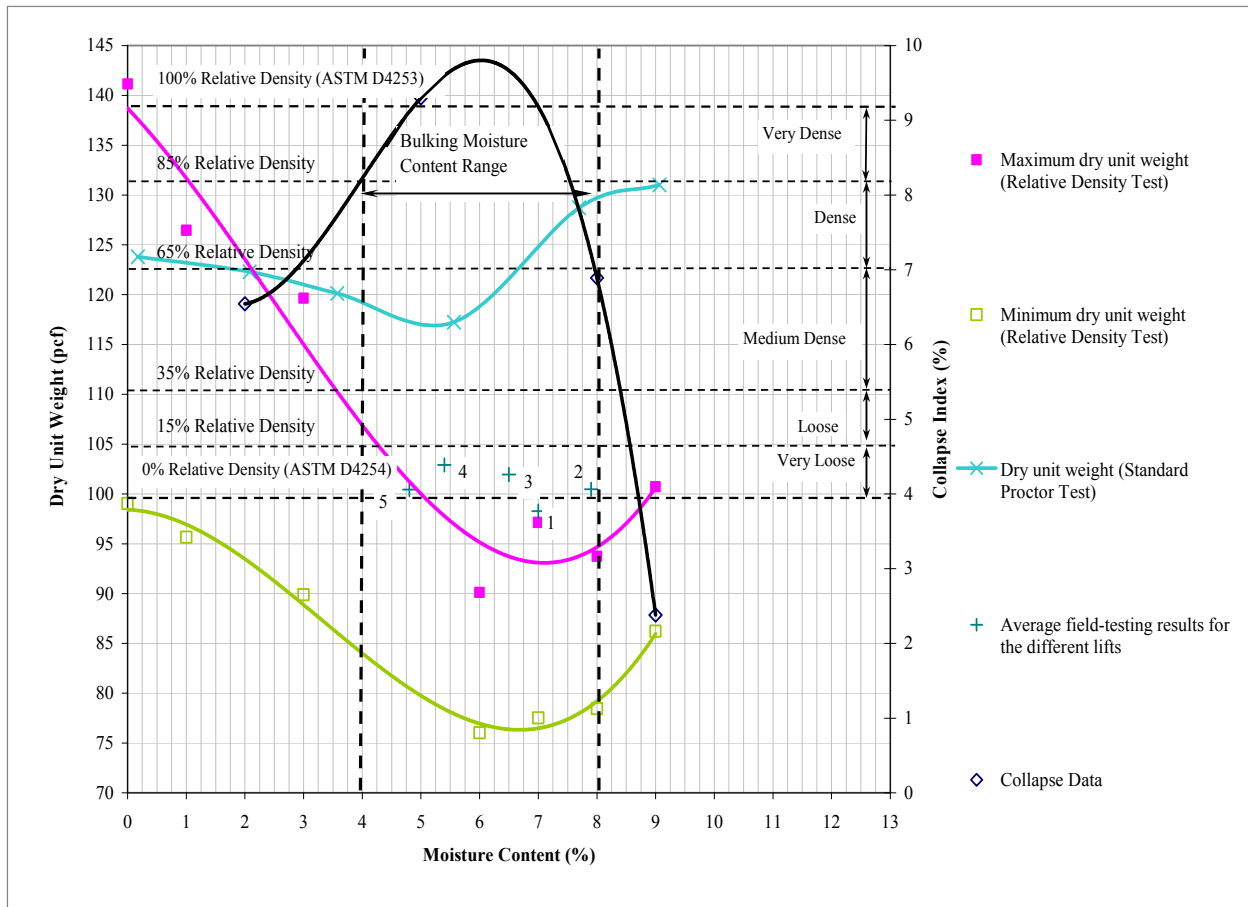
All measured dry unit weights corresponded to very loose compaction densities. The average moisture contents measured in the trench for all lifts were within the bulking moisture content range. The average dry unit weights and moisture contents for each lift are plotted in Figure 5.29. This figure illustrates that all the lifts were placed at very loose relative densities and within the bulking moisture content range of 4% to 8%.

Figure 5.29. Dry unit weights and moisture contents measured during the construction of Trench AI compared with the relative density and Standard Proctor test results with the collapse index

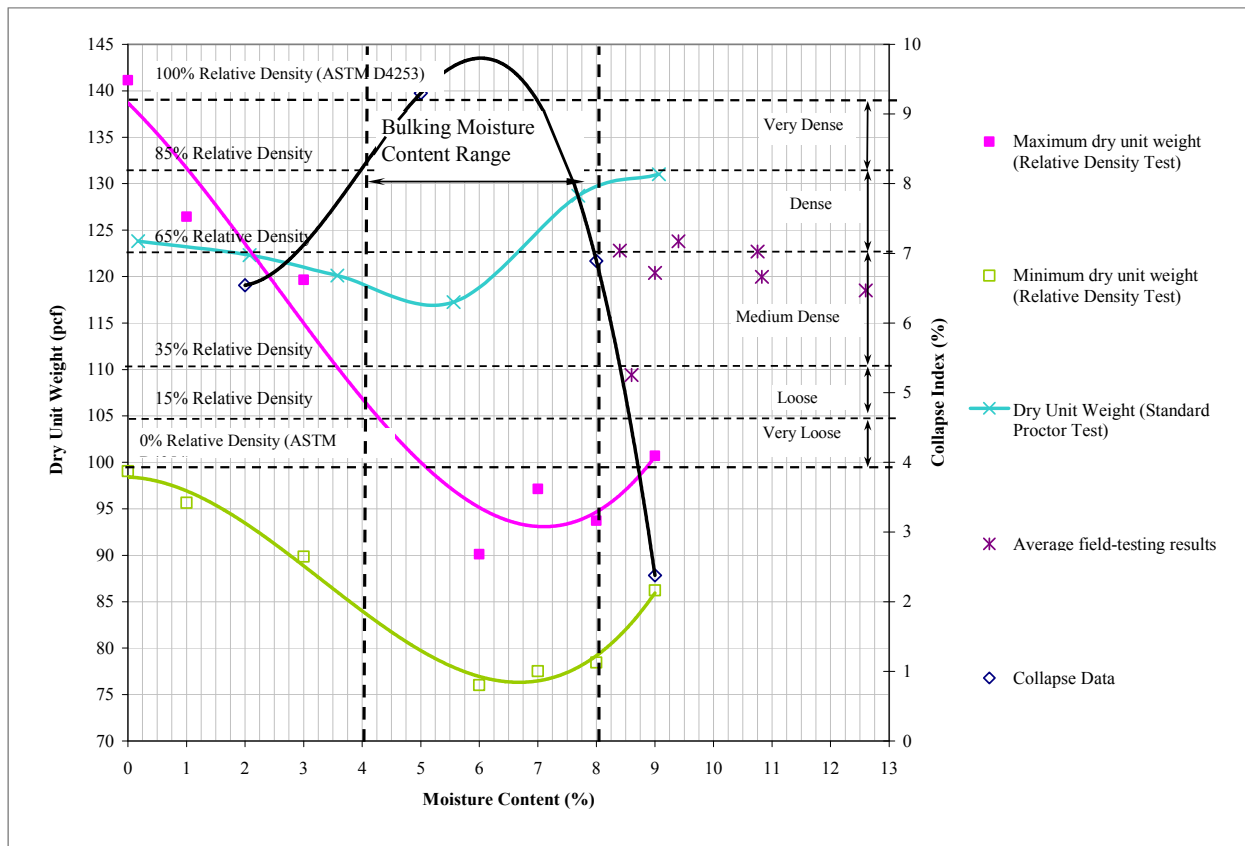
The lower lifts were compacted to medium dense to dense compactions. The upper lift was loose at 32% relative density. Figure 5.32 shows the average field-testing results for each lift compared to lab-test results. The average dry unit weight for all the lifts was 118.5 pcf. This is a 55% relative density or medium dense compaction. The average moisture content for all lifts was 9.7%. The moisture content was above the bulking moisture content.

Figure 5.32. Summary of average dry unit weights and moisture contents measured for different lifts during the construction of Trench BI compared with the relative density and Standard Proctor test results with the collapse index
