Stabilization Procedures to Mitigate Edge Rutting for Granular Shoulders – Phase II

Final Report
January 2011

Sponsored by
Iowa Highway Research Board
(IHRB Project TR-591)
Iowa Department of Transportation
(InTrans 08-319)

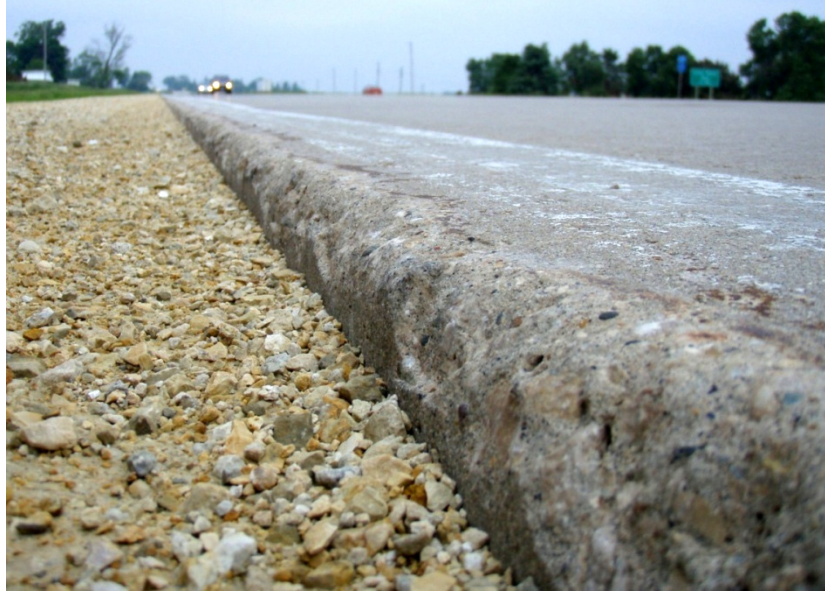
Figure 1. Shoulder drop-off near pavement edge Highway 18 milepost 195.95-196.2 westbound June 4, 2008

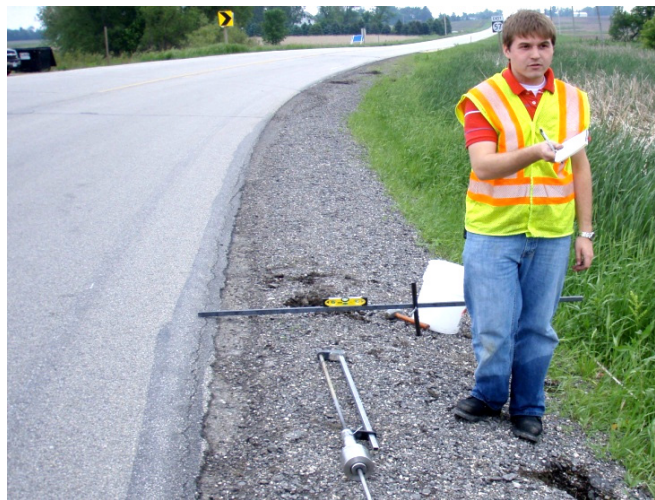
Figure 2. Shoulder drop-off Highway 63 milepost 172.5 northbound June 4, 2008

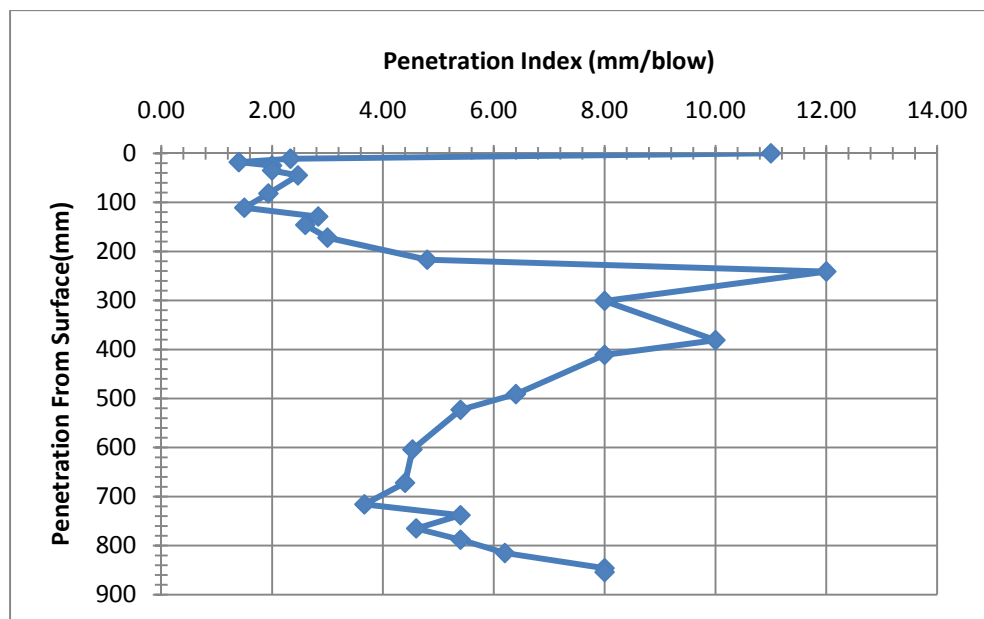
Figure 4. DCP test results Highway 3 milepost 215.16-215.63 June 4, 2008

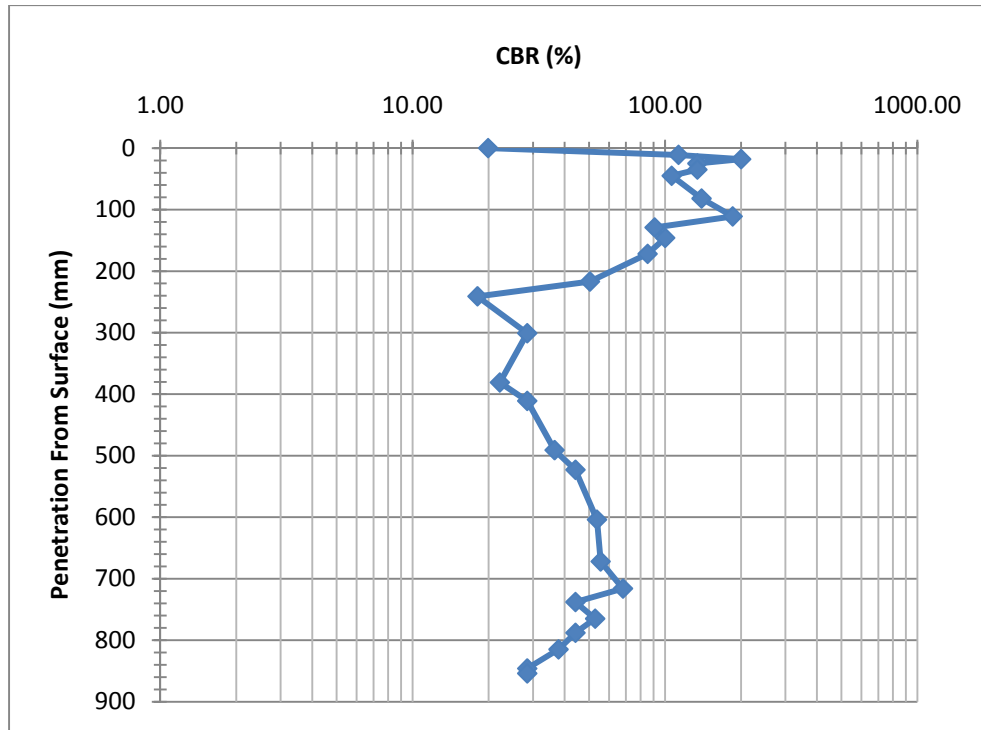
Figure 5. CBR measurements for Highway 3 milepost 215.16-215.63 June 4, 2008

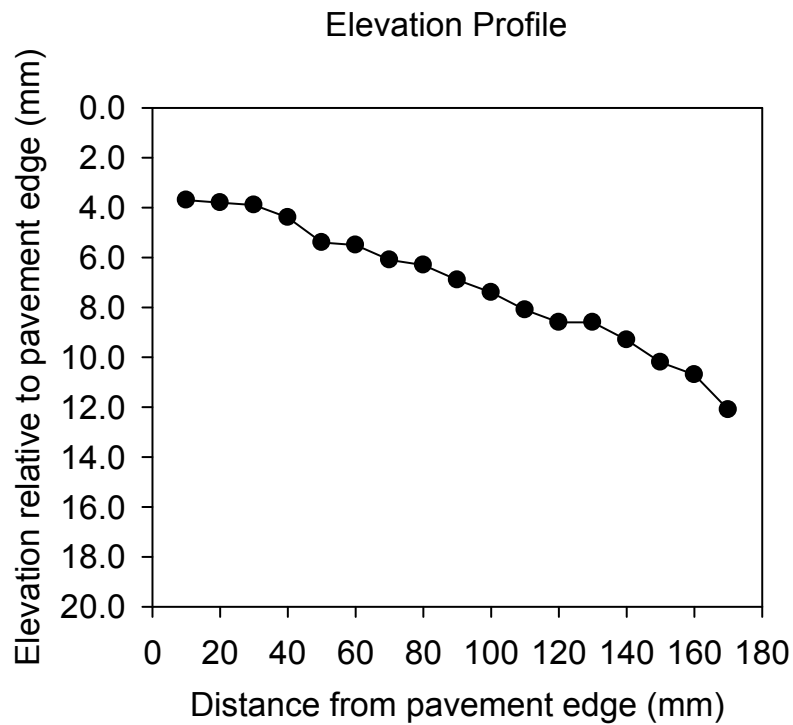
Figure 6. Elevation profile relative to the pavement edge for Highway 3 milepost 215.16-215.63

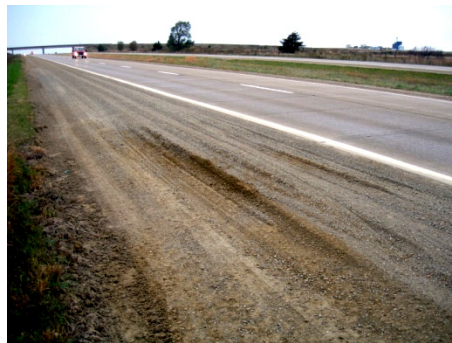
By the following week, much of the shoulder had stabilized, so it could support a 3/4 ton pickup truck (See Figure 17), but a few soft spots remained (See Figure 18).

Figure 18. No stabilizer, full-depth, still soft one week later

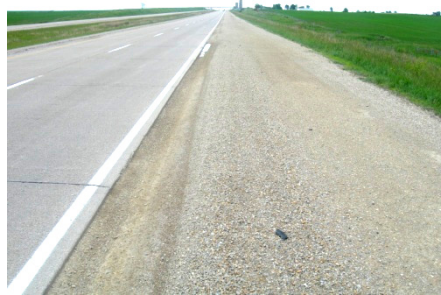
However, some research team members have performed some informal photo documentation after formal field reconnaissance ended. Conditions appeared to be little changed from those that were present before test section construction took place (See Figure 21). And, difficulties maintaining the shoulder near the pavement edge prevailed (See Figure 22).

Figure 22. Calcium chloride scarify twice June 2009

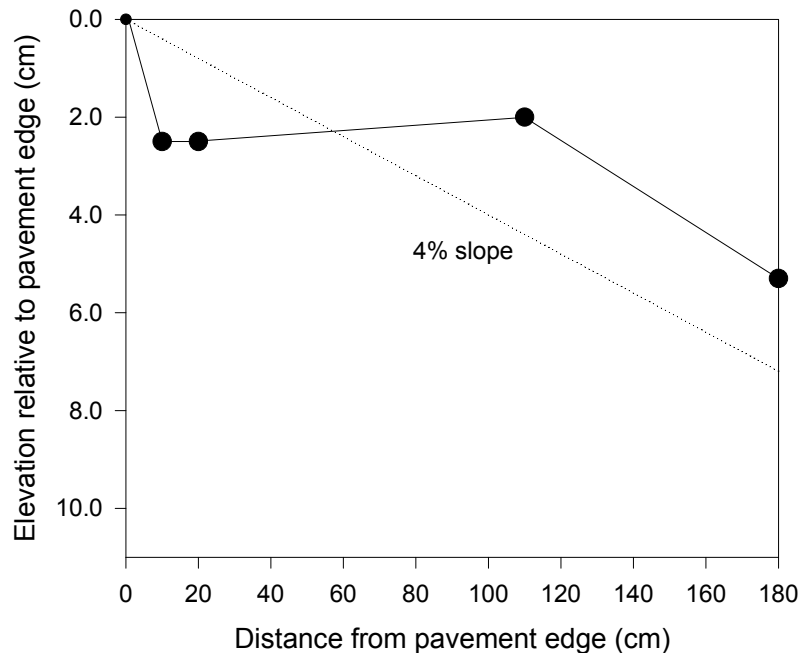
Cross sectional elevation profiles, DCP tests, and samples were taken from the shoulder before it was stabilized. The depth of pavement drop-off was measured as part of the process of obtaining the cross-sectional elevation profiles. Typical elevation profile of the shoulder before stabilization is shown in Figure 51.

Figure 51. Typical elevation profile of shoulder in Test Area I before stabilization

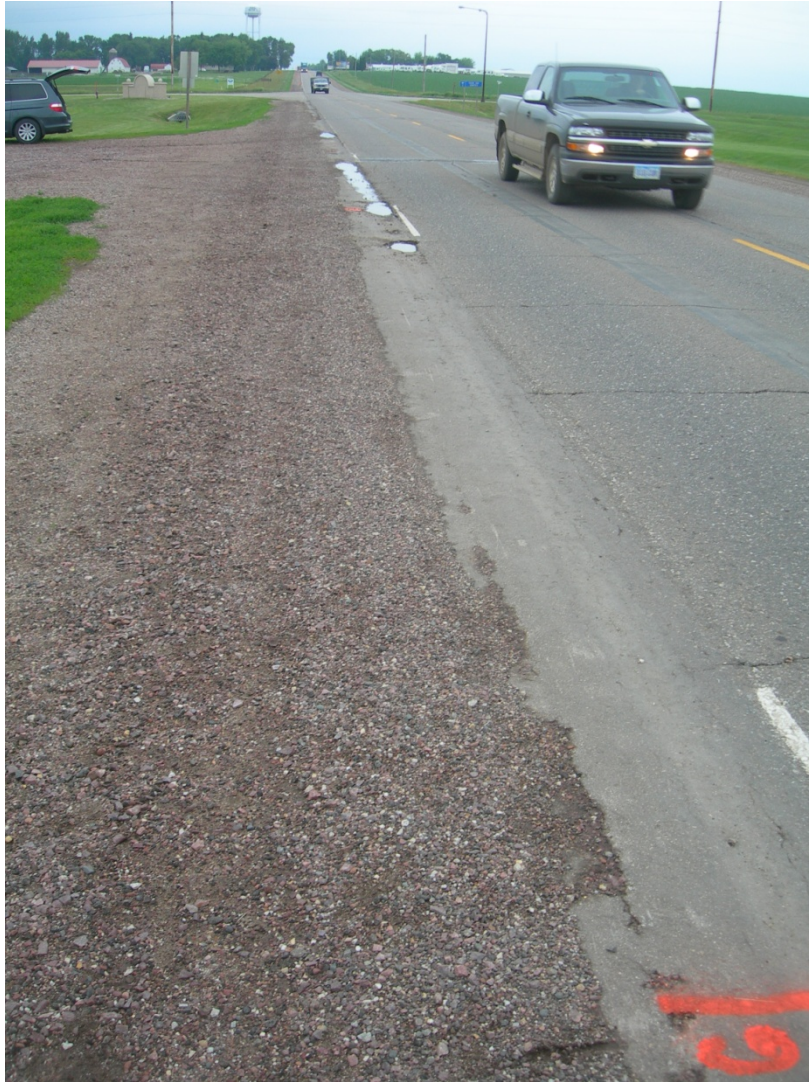
In the elevation profile, the solid line represents the elevation of the first measurement, the dashed red line with dots at the measurement points represents the second measurement, and the dashed blue line represents the third measurement. The profiles show that the shoulder generally lost elevation after two years in service and that the edge rut had returned in places after 10 months in service (See Figures 56 and 57). Repeated trafficking was considered as the likely cause. Despite the previously mentioned damage noted on many parts of the test section (especially away from the driveway area), the stabilized shoulder material remained completely intact.

Figure 56. Looking north from Point 9 at Test Area I on southbound shoulder of US 75 near Sioux Center, Iowa June 8, 2010.

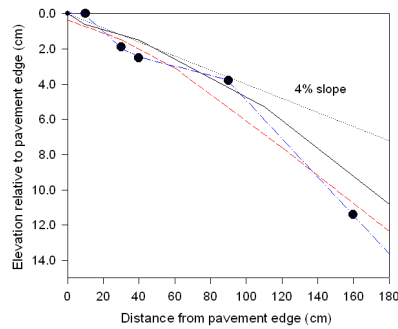
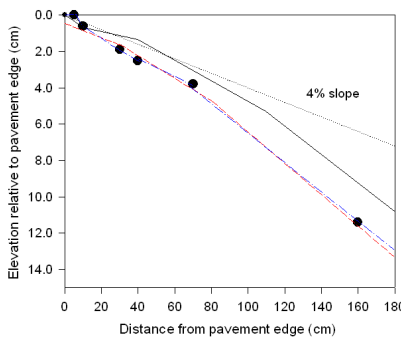
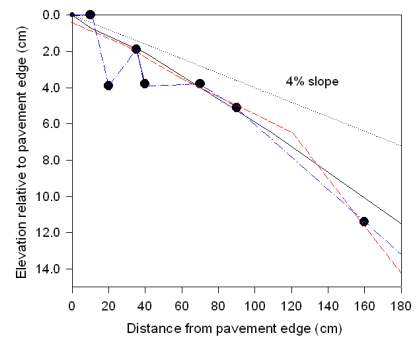
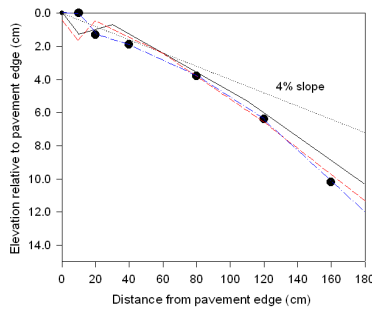
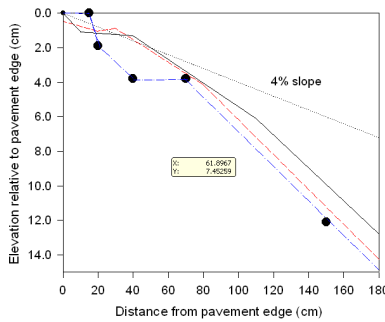
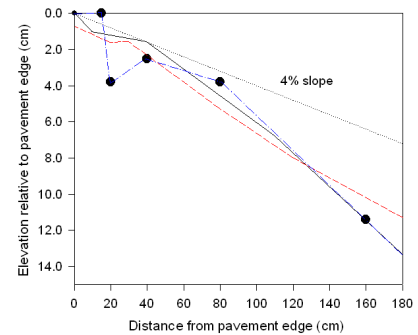
Figure 61. Elevation profiles of Test Area II on the southbound shoulder of US 75 near Sioux Center, Iowa

By October 27, 2009, some small areas of instability were evident (See Figure 62). The profiles show that shoulders generally lost elevation while in service and by June 2010 at some locations, the stabilized material had been removed from the edge of the road, resulting in small potholes (See Figure 63).

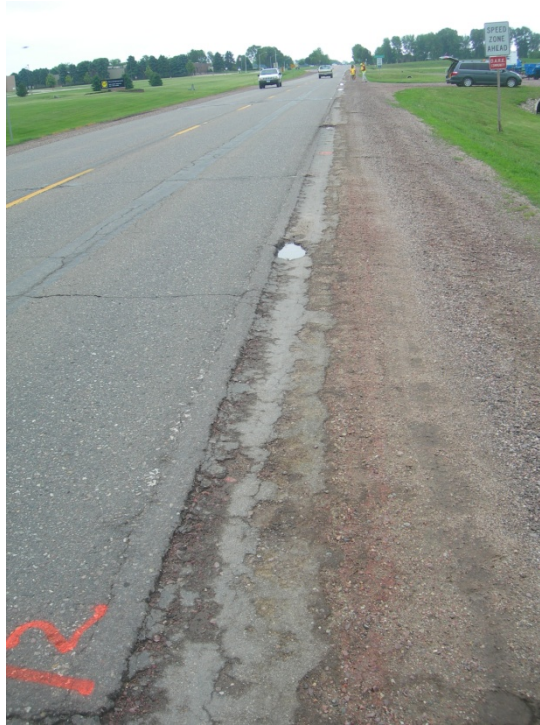
Figure 63. Looking south at Test Area II from Test Point 2 June 8, 2010

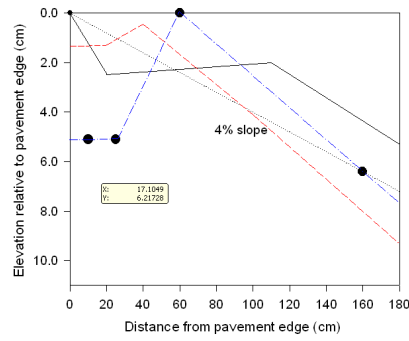
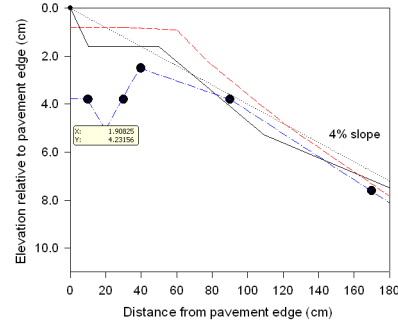
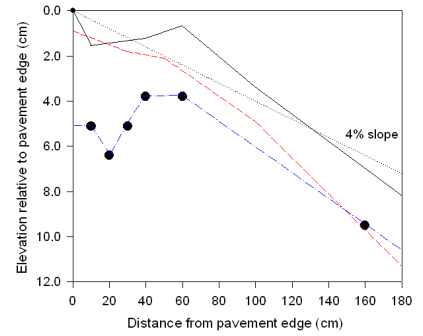
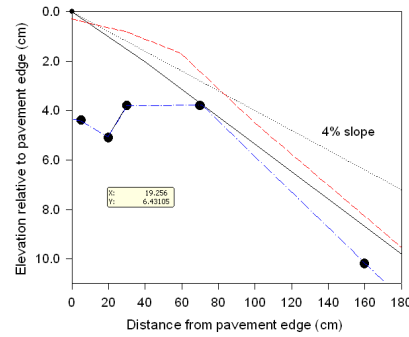
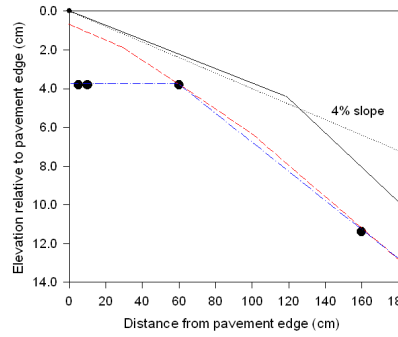
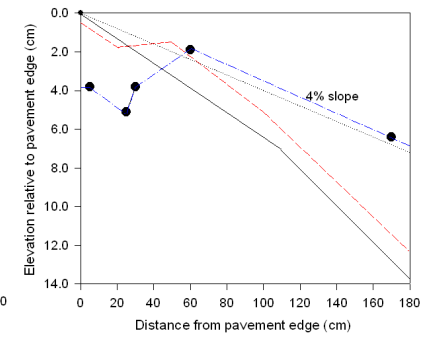
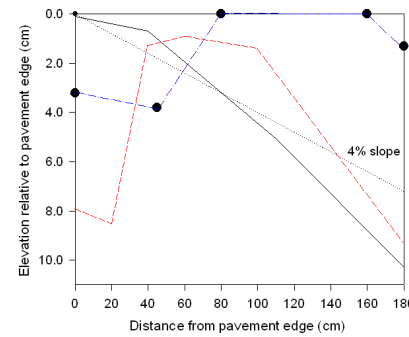
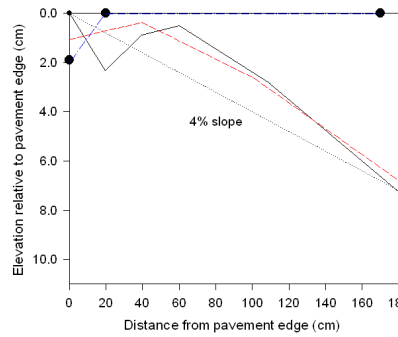
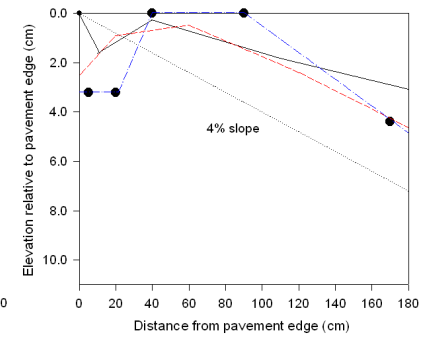
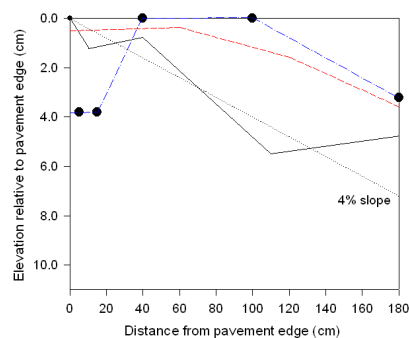
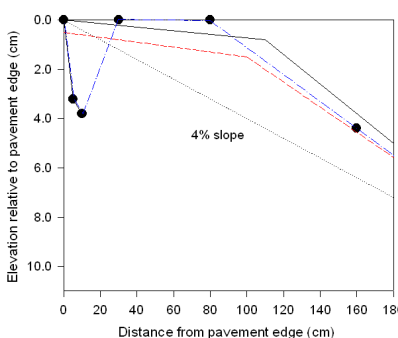
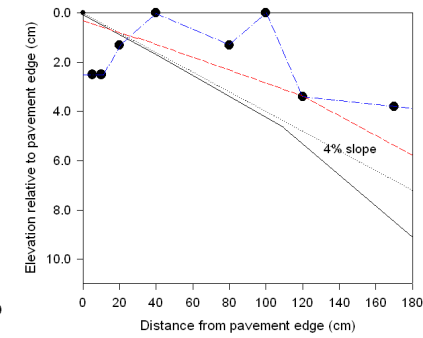
Figure 67. Elevation profiles of Test Area III on the southbound shoulder of US 75 near Sioux Center, Iowa

The elevation profiles showed that the elevation of the shoulder surface at the test points changed over several months. By October 2009, at some test points, the shoulder surface elevation had increased, while it decreased at the other points. The DUSTLOCK shoulder surface was observed to be damaged at several areas after about two months of construction.

The damage was observed in particular at Test Point 7 (See Figures 67 and 68). By June 2010, the stabilized material had mostly disappeared from the entire area (See Figure 69).

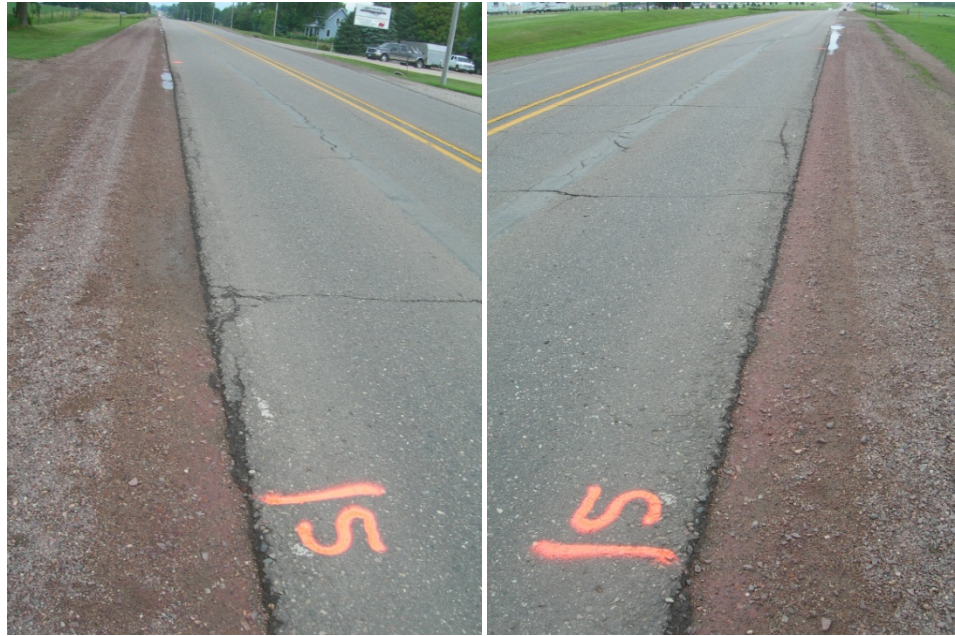
Figure 69. Looking north and south from Test Point 5 Area III on June 8, 2010 (approximately the same location as the photos in Figure 68)

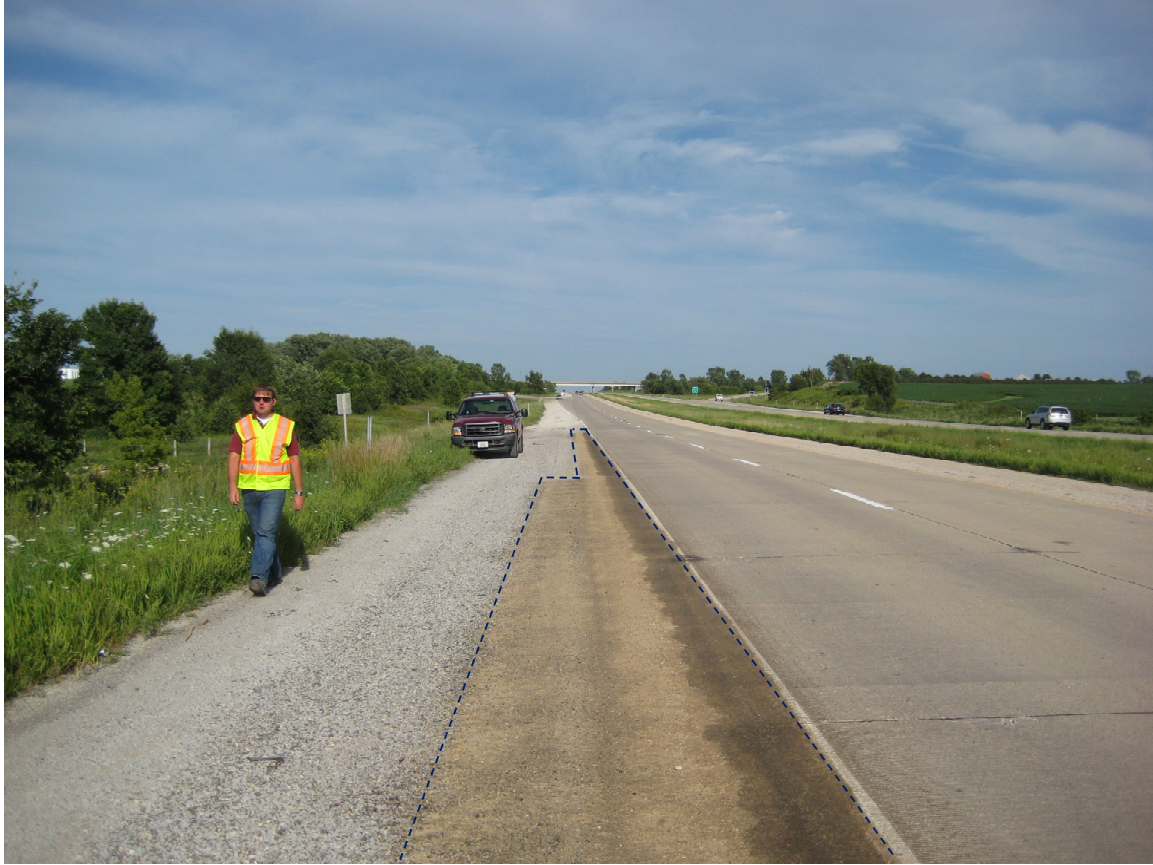
Figure 77. Section I after construction August 18, 2009

The shoulder surface was covered with sand provided by three passes of a dump truck with a sand spinner. The surface was then allowed to set for 15 minutes before being compacted by the roller. The construction period for this section, began at 9:34 a.m. and ended at 10:32 a.m., accounting for 58 minutes. The finished surface of the section is shown in Figure 77.

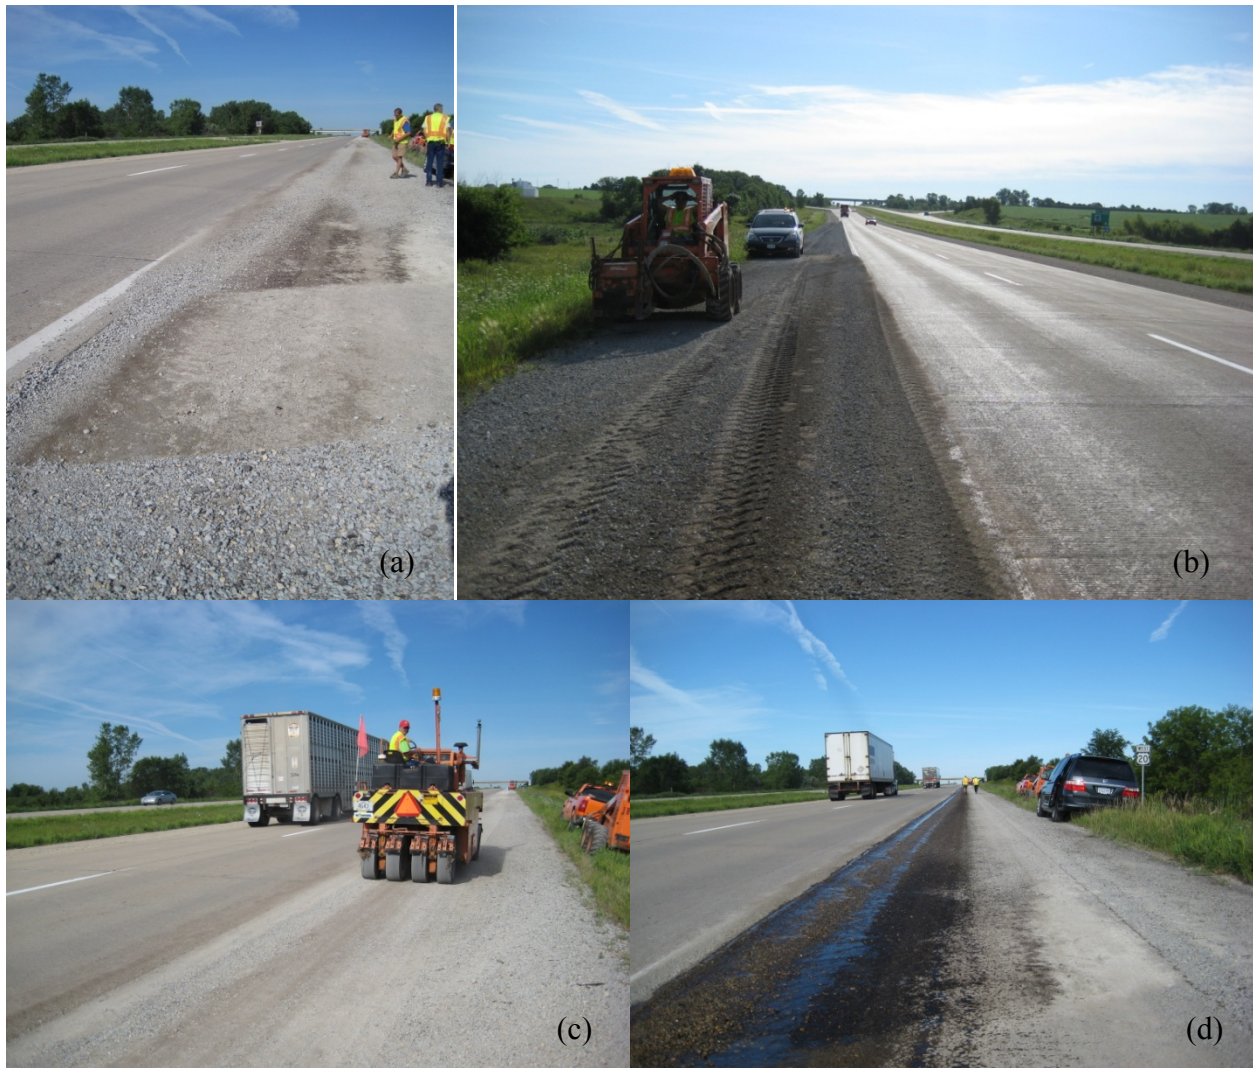
Figure 79. Section II: a) grading, b) filling and leveling, c) compaction, and d) application of DUSTLOCK August 18, 2009

The grain size distribution for the granular shoulder materials at Test Section II is shown in Figure 78. The deepest edge rutting mostly occurred in this section. The shoulder surface was heavily graded by a motor grader on August 18, 2009. Loose aggregate was leveled to fill the edge rut along the pavement edge. This filled layer was from 1/2 to 1 in. (1.2 to 2.5 cm) thick, resulting in a surface that appeared to the researchers to be equivalent to a scarified surface. The loose surface was compacted with a pneumatic roller and then DUSTLOCK was topically applied (See Figure 79). Three passes of sand was broadcast on the surface. The roller was then used to compact the section.

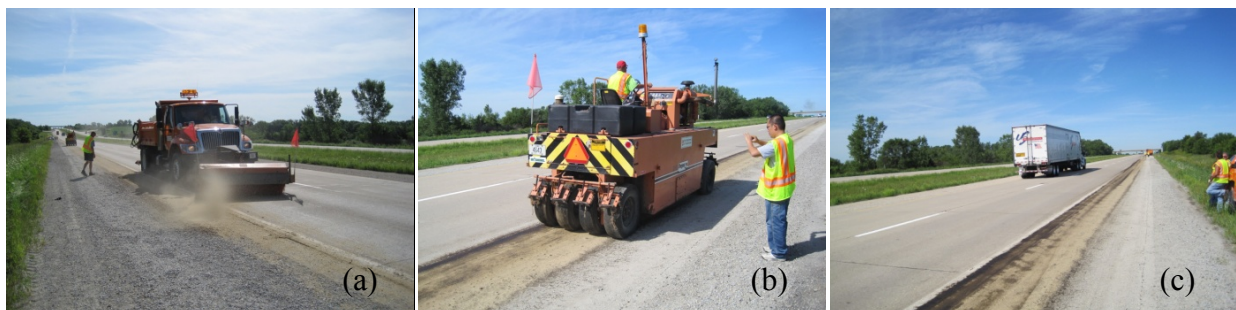
Figure 80. Section II: a) pavement cleaning, b) compaction, and c) finished surface August 18, 2009

The construction duration of the section was 1 hour 20 minutes, from 9:18 a.m. to 10:38 a.m. The completed section is shown in Figure 80 (c).

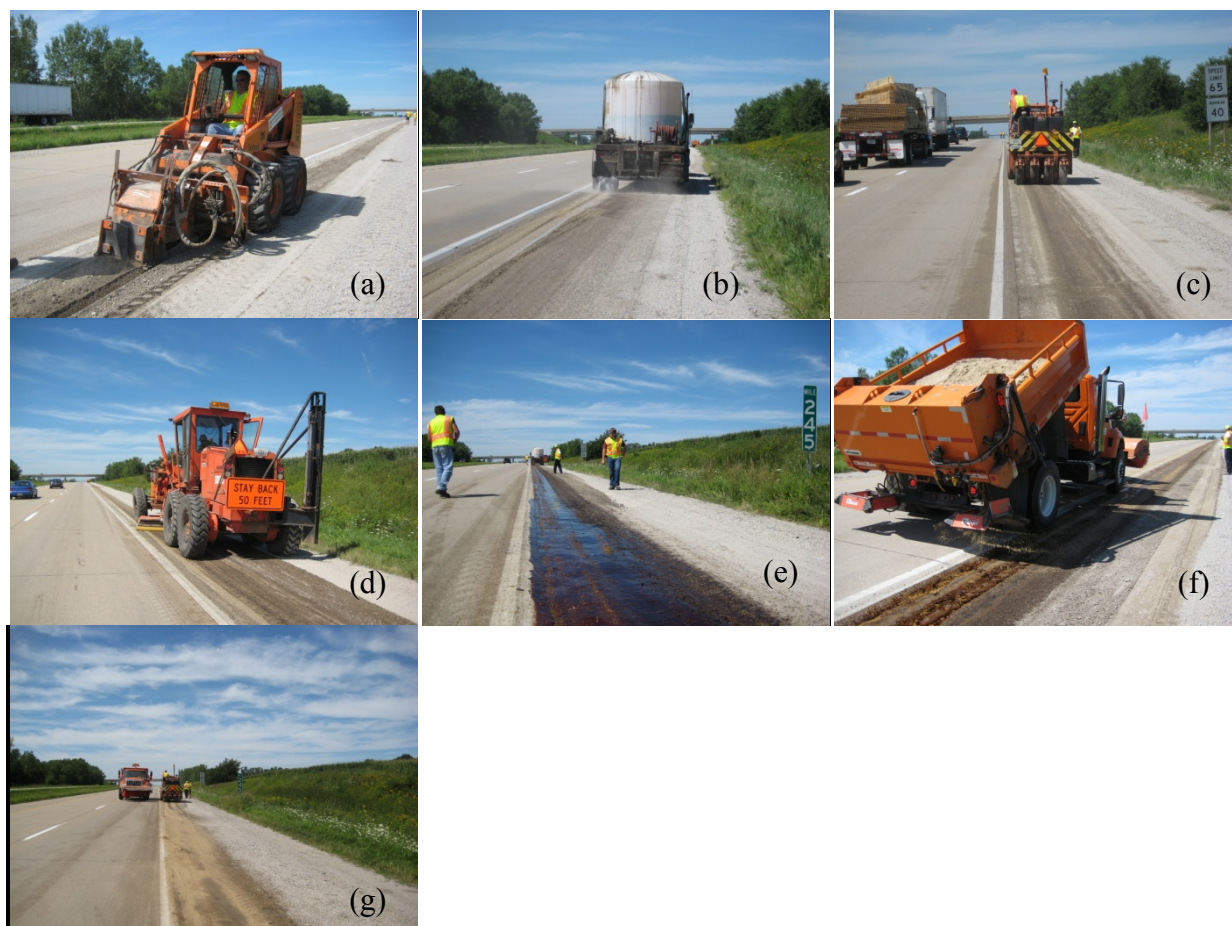
Figure 83. Section III: a) shoulder scarification, b) moisturizing, c) roller compaction, d) surface grading, e) DUSTLOCK application, f) sand spraying, and g) roller compaction August 18, 2009

Although the construction process included surface grading after the initial compaction, the shoulder surface after construction did not have a cross slope that was as constant as desired. The moist aggregate materials that were bound with the high-viscosity binder (DUSTLOCK) and the rubber wheels of the roller might have interacted to create an uneven surface. The shoulder surface along the pavement edge was still slightly lower than the surrounding area.

A skid steer mounted milling head was used to scarify the hardpan surface, creating a scarified strip of 4 ft (1.2 m) width and $\frac{1}{2}$ in. (1.2 cm) depth. Three passes of overlapping scarification were required to provide the 4 ft (1.2 m) test section width. The scarified layer was then sprayed with water and compacted with six passes of the pneumatic roller. The motor grader was then struck off the compacted shoulder surface, providing a surface with a constant cross slope. DUSTLOCK was then topically applied to the shoulder surface before the application of five passes of sand from the sand spinner of a dump truck. The DUSTLOCK and sand were allowed to set for 15 minutes before they were compacted by the pneumatic roller (See Figure 83). Section III was constructed from 10:44 a.m. to 1:04 p.m. for a duration of 2 hours 22 minutes.

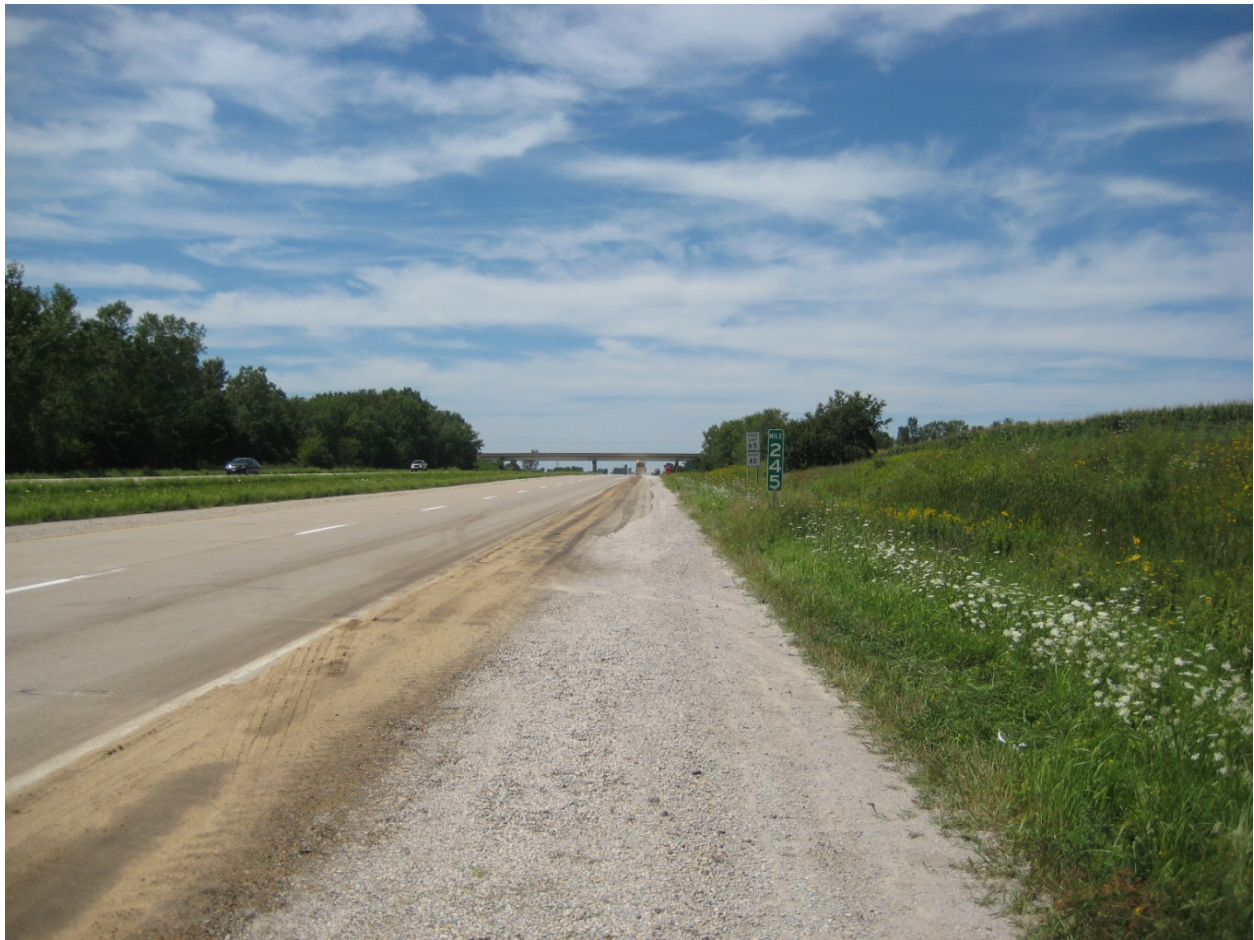
Figure 84. Stabilized shoulder surface of Sections II to IV (a) August 18, 2009

The original shoulder surface of Test Section IV was struck off to a constant cross slope with a motor grader, resulting in a pavement drop-off depth of 1.2 in. (3.0 cm) and a cross slope of 3% toward the ditch. Water and DUSTLOCK were then topically applied to the shoulder surface. Six passes of sand from the dump truck spinner were applied to the shoulder surface. The finished surface of the section is shown in Figure 84.

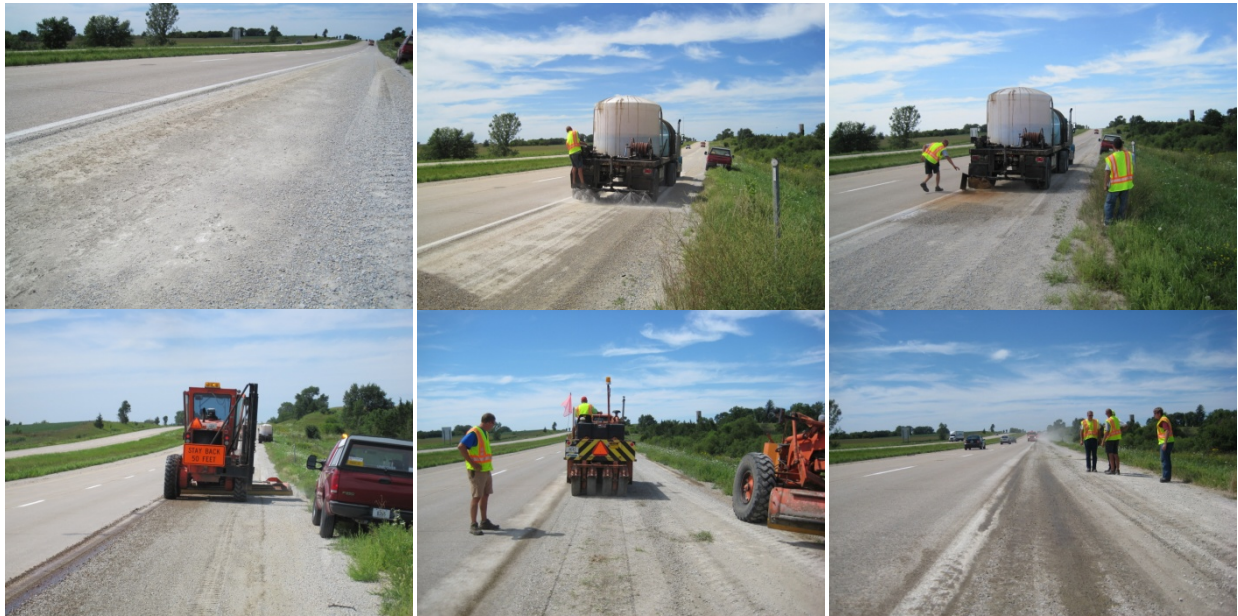
Figure 85. Construction process of Section V August 18, 2009

Redistribution of aggregate materials using the road grader reduced construction time and eliminated the use of sand. However, when the aggregate was cast back on top of the DUSTLOCK, the DUSTLOCK was rolled out of its original position. When the material was struck back away from the pavement, some of the mixture was unintentionally cast toward the ditch (See Figure 86). Nevertheless, this test section was constructed in a short period of time. The construction duration was only 34 minutes, starting at 1:15 p.m. and ending at 1:49 p.m..

Test Section V was located at the bottom of a sag from milepost 244.45 to 244.35. This area was considered to be problematic to the maintenance crews. Aggregate shoulder for this section was struck off to a 3% cross slope by the motor grader. The struck surface was sprayed with water and then DUSTLOCK. To eliminate the use of sand, the struck-off aggregate materials were cast back by the motor grader to cover the DUSTLOCK. The test section was then compacted by six passes of the pneumatic roller (See Figure 60).

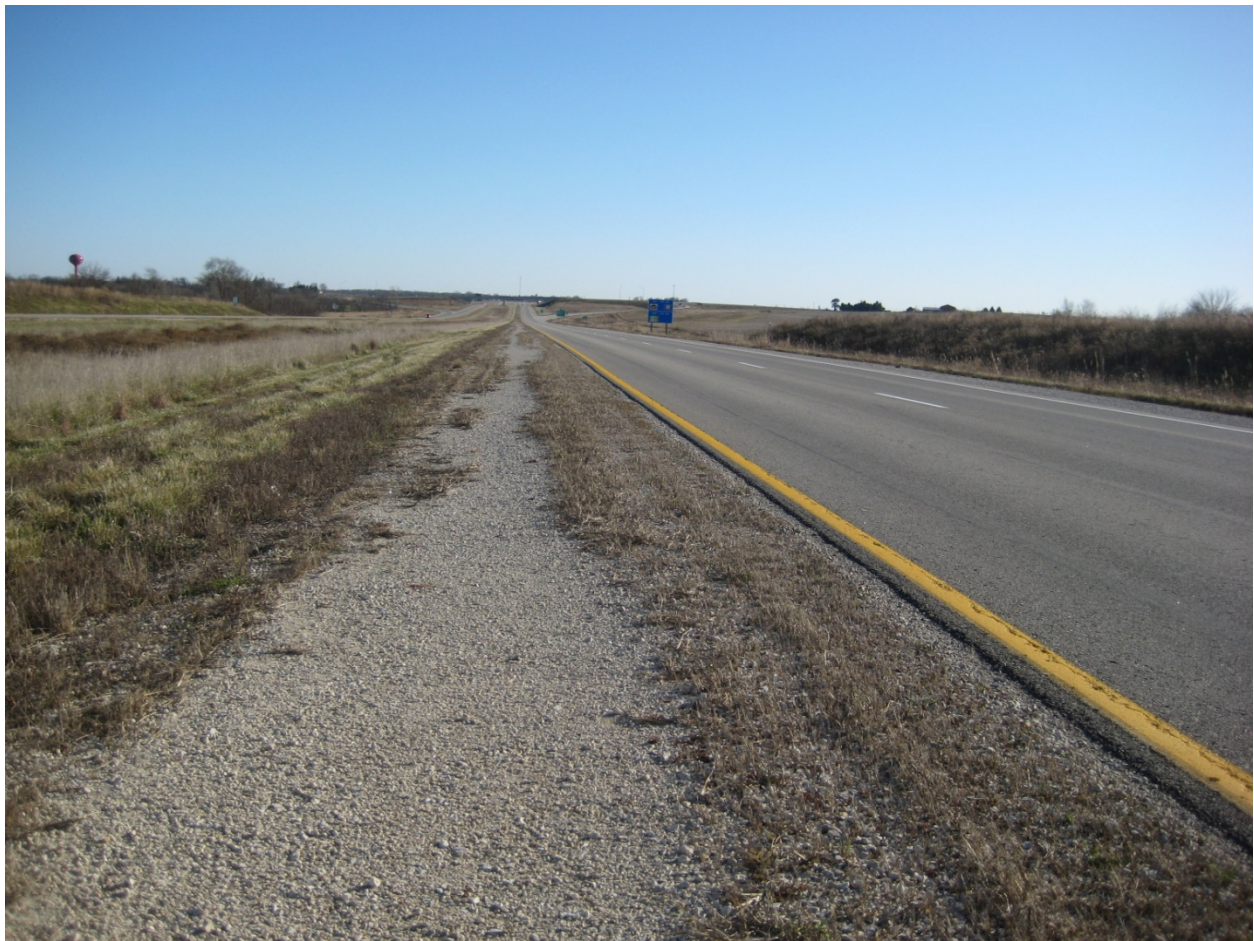
Figure 92. Test sections on November 7, 2009

The control section was 200 ft (61 m) long from mileposts 220.60 to 220.55. It was stable with no heavy rutting observed (See Figure 92). An edge rut was located within 8 in. (200 mm) of the pavement edge with an average depth of about 0.8 in. (20 mm). The elevation profiles showed that the maximum edge rut was about 1.8 in. (45 mm). The CIV values of the shoulder at various points 8 in. (200 mm) from the pavement edge ranged from 13.1 to 15.4 (See Table 31).

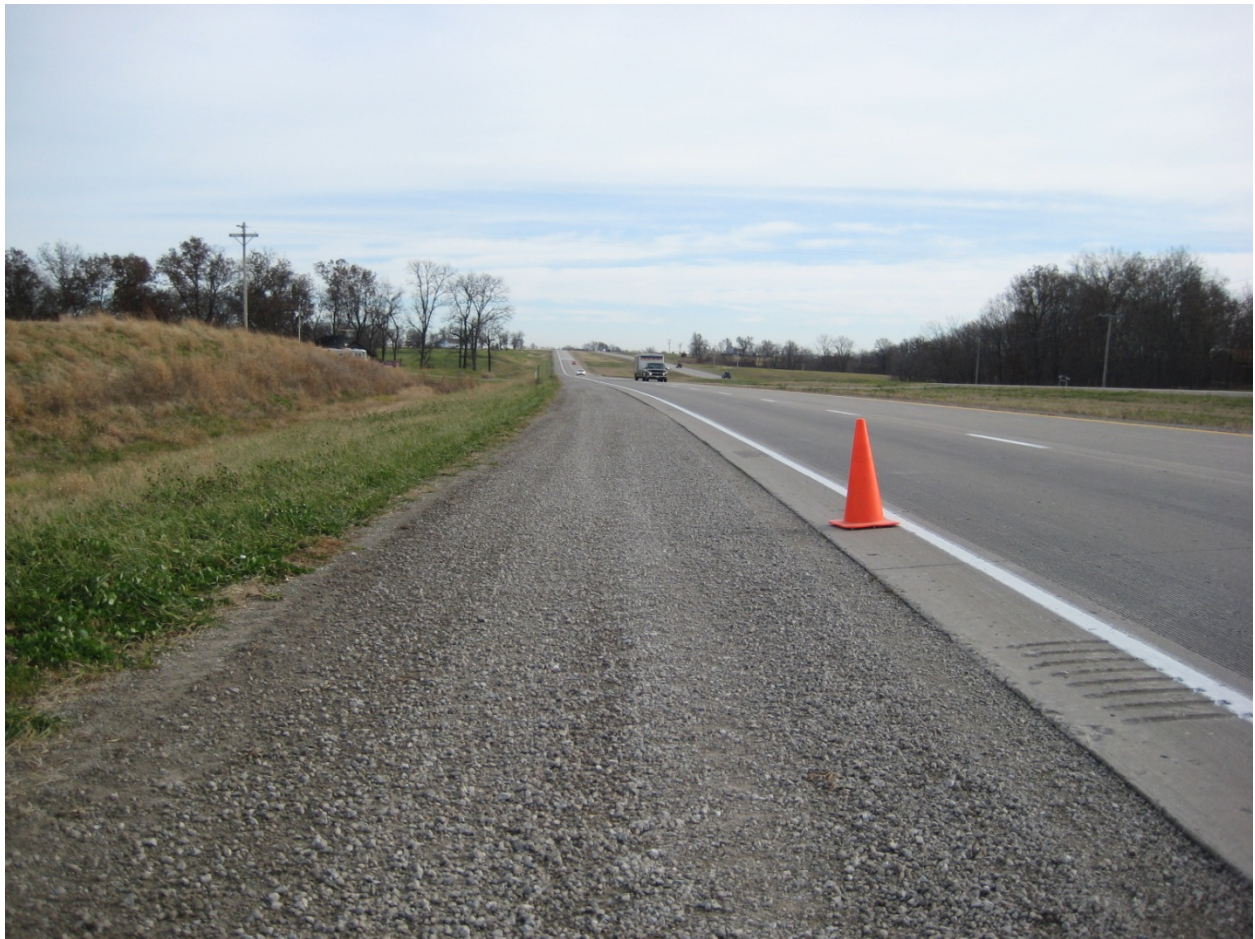
Figure 93. Test sections on November 12, 2009
