## Timber Abutment Piling and Back Wall Rehabilitation and Repair

### Final Report September 2012

Institute for Transportation

**Sponsored by** Iowa Highway Research Board (IHRB Project TR-616) Iowa Department of Transportation (InTrans Project 10-372)

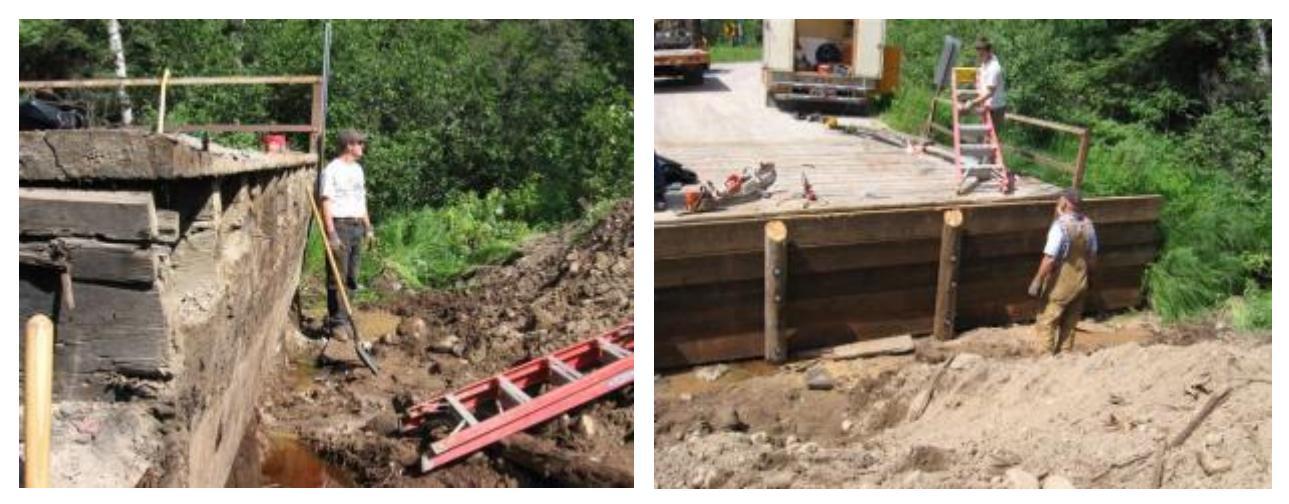
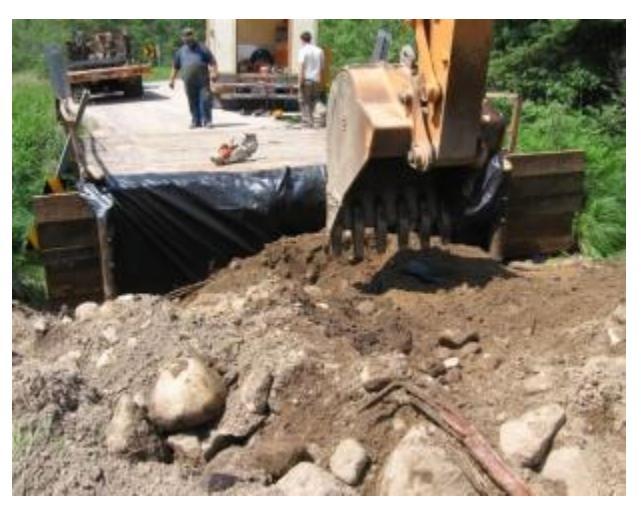
Figure 6-21 St. Louis County, Minnesota backwall repair by us of vertical pile stays

(a) Excavation of embankment

(b) Installation of new planks and pile stays

(c) Backfilling of fabric lined backwall

One of the backwall repair methods used by St Louis County, Minnesota is to place "pile stays" on the back side of the backwall. In order to place the pile stays, the embankment is excavated away from the existing backwall, as shown in Figure 6-21a. The deteriorated backwall planks are then replaced and vertical stays (e.g., round timbers) are bolted to the existing piles and cap beam, shown in Figure 6-21b. The wall is then covered with geotextile fabric and backfilled, seen in Figure 6-21c.

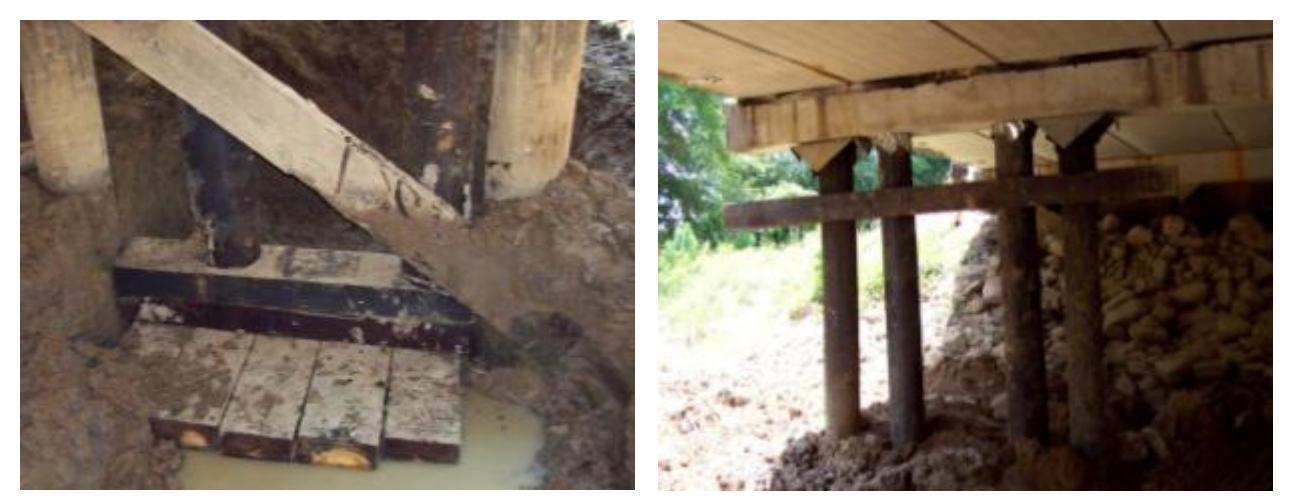
Figure 6-23 New piles placed on mudsill next to rotted existing columns and braced

(a) New piles placed on mudsill

(b) New piles backfilled and braced

The Parish of Caddo in Louisiana has had success with placing new piles on mudsills. The repair technique, shown in Figure 6-23, requires the soil around the existing pile to be removed a suitable distance to expose a firm sound bearing soil layer.

A network of thick planking (approximately 6 in. thick) are placed, as shown in Figure 6-23a, to provide a foundation for the new piles. If settlement has occurred, a jack is used to push the

bridge back up to finished grade. New treated timber piles are placed between the top of the mudsill and bottom of the cap beam. Bracing is then attached to the new piles and existing piles to provide stability. Lastly, the bases of the piles were backfilled up to existing grade. The Parish of Caddo has been performing the mudsill repairs for several years; however, improvements were made to the design approximately four years ago that have helped the performance of the repair. The two biggest improvements consisted of digging deeper to allow the mudsill to rest on a firm layer of soil and provide a larger network of planking and thusly a larger foundation below the piles. The new technique has been used on 10 to 15 bridges all showing very little settlement. The Parish of Caddo estimates the repair provides an additional 10 to 15 years of service life to the repaired substructure.

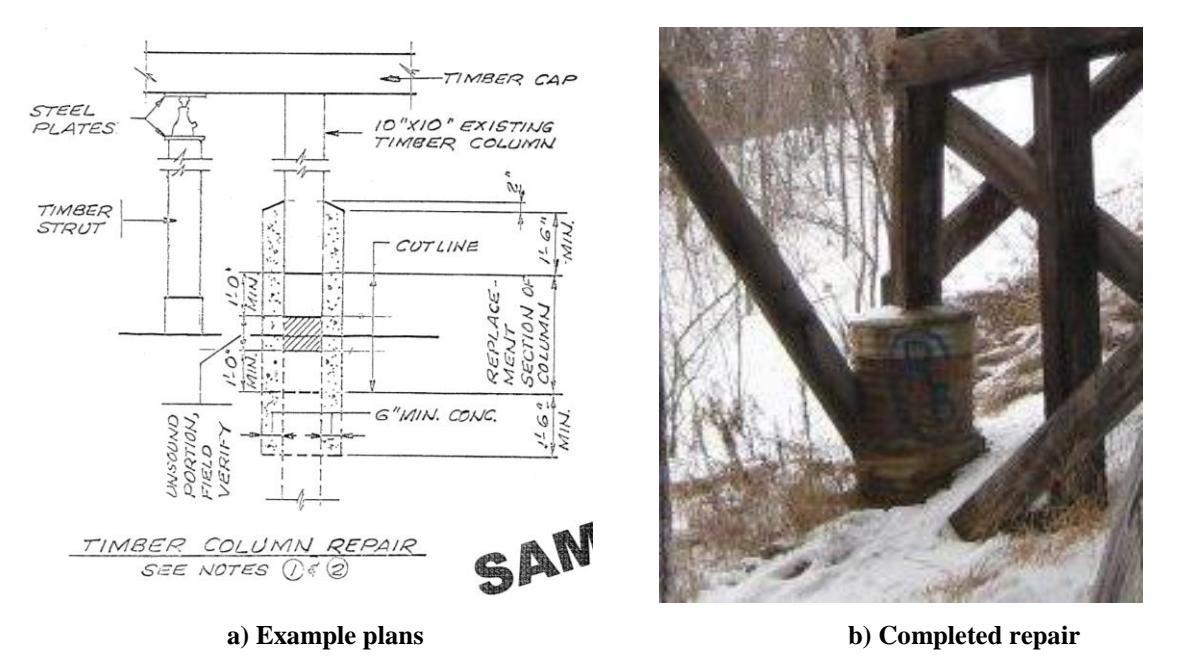
Figure 6-31 Minnesota DOT posting and concrete encasement repair for piles

The Minnesota DOT has installed two concrete encasements and explained that the repair is generally only worthwhile when only one bad pile is found on the bridge. In most cases, there are multiple bad piles in a bridge, which, for the Minnesota DOT, results in replacement of the bridge being a more feasible option. The first concrete encasement repair done by the Minnesota DOT was completed in 1993. According to Minnesota DOT personnel, the 1993 repair, although on dry ground, is in as good of condition as the day is was installed providing an extended service life thus far of 17 years.

The Minnesota Department of Transportation has used a combination of posting and concrete encasing to repair deteriorated piling. Shown in Figure 6-31 are example plans for repairing a timber piling and a photo of an existing repair. The repair is completed by excavating 2.5 ft below the unsound portion of the pile or to the base of the pile. Then the cap is jacked up to remove load from the pile. The deteriorated portion of the pile is cut off 1 ft above and below the deteriorated section. A new column section that is 1/4 in. longer than the removed section is placed in the same location as the section removed; after which the temporary jack is removed. The concrete jacket and reinforcing steel is placed; after which concrete is placed with 6 in. of minimum cover around the pile.

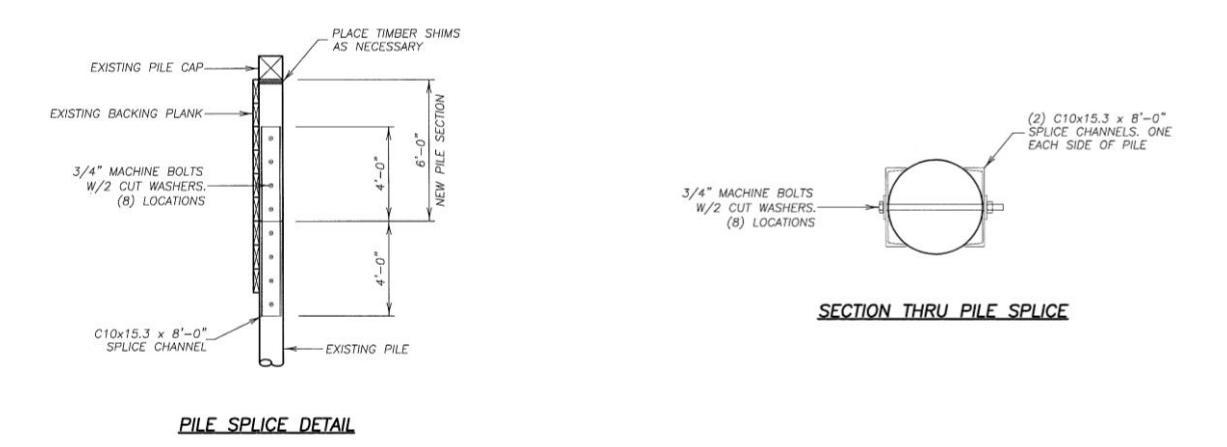
Figure 6-32 Minnesota DOT channel pile splice for piles next to backwall

The Minnesota DOT also provided information on repair for pilings next to a backwall or brace members. Since the complete circumference of the piling is not exposed, concrete encasement cannot be completed. Therefore, a combination of posting and splicing with channels is used. A similar process as described above is completed except a new section of pile is placed from the cut below the deteriorated location up to the cap beam. The new pile section is sandwiched between two splice channels as shown in Figure 6-32. The channels extend 4 ft above and below the joint between the new and old pile; through bolts are used to clamp the channels to the pile.

The channel pile splice repair is a relatively new detail for the Minnesota DOT that was designed by a local consultant. The repair is suited for rotted or damaged pile and can be placed next to a backwall or brace member. To-date the repair technique has not been used, but Minnesota DOT personnel feel that it will last at least as long as the remaining service life of the bridge.

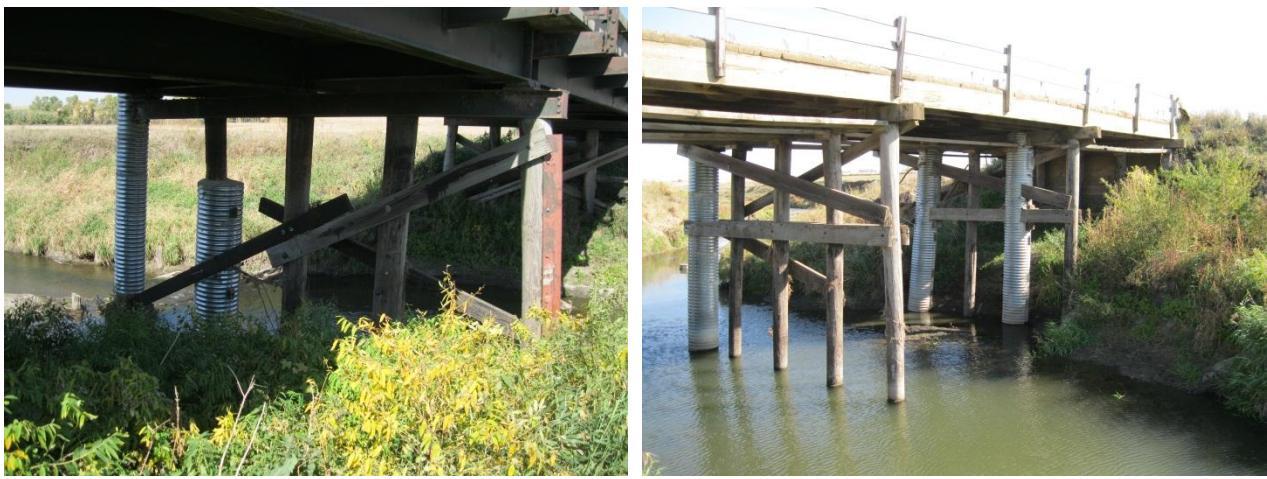
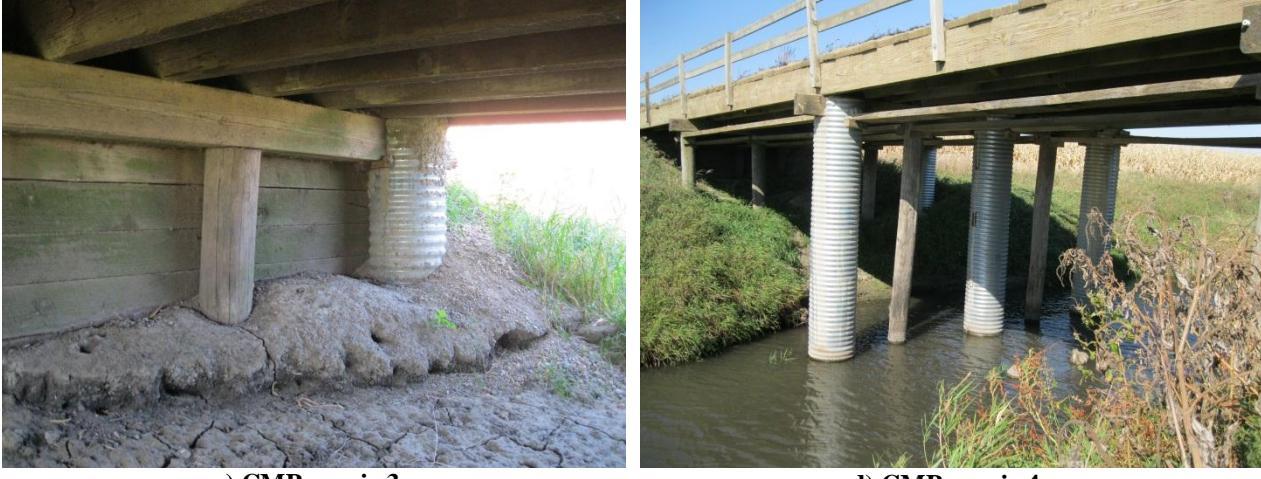
Figure 7-1 Example of timber piles and abutment repairs in Iowa

a) CMP repair 1

b) CMP repair 2

c) CMP repair 3

d) CMP repair 4

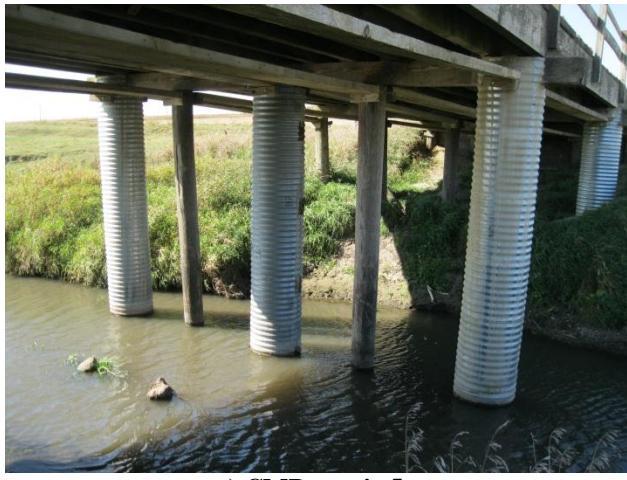
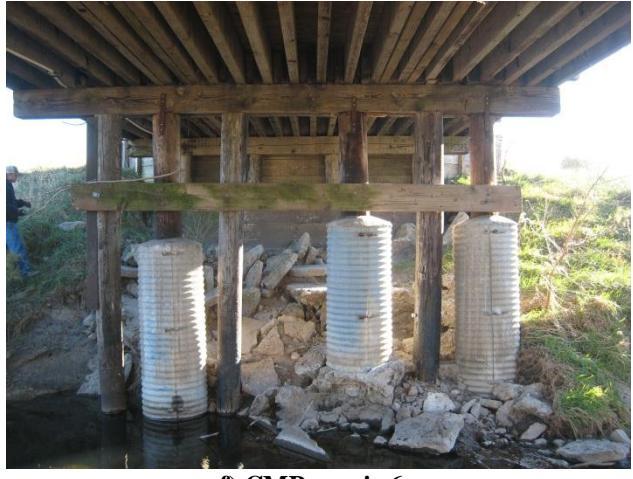
e) CMP repair 5

f) CMP repair 6

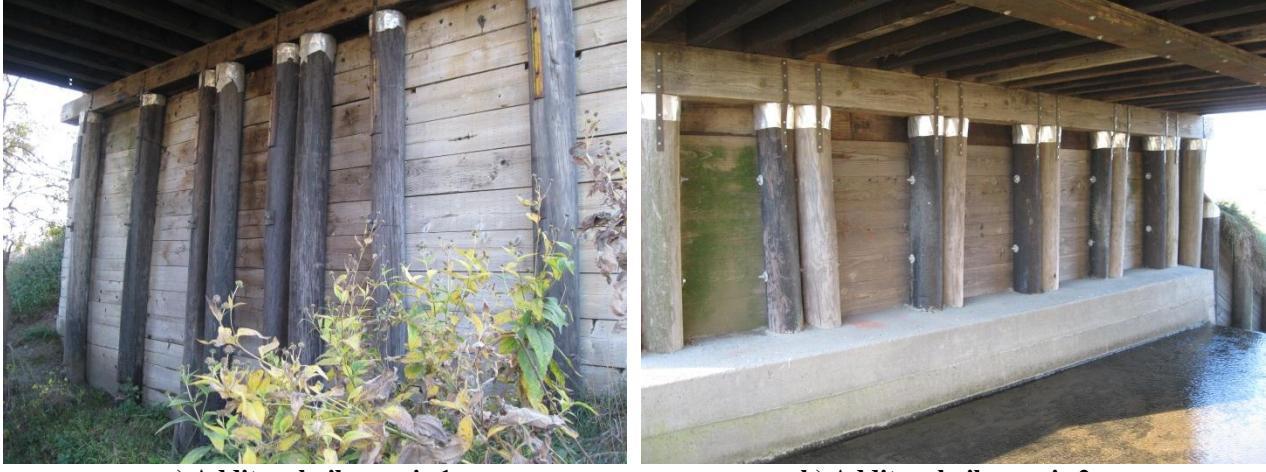
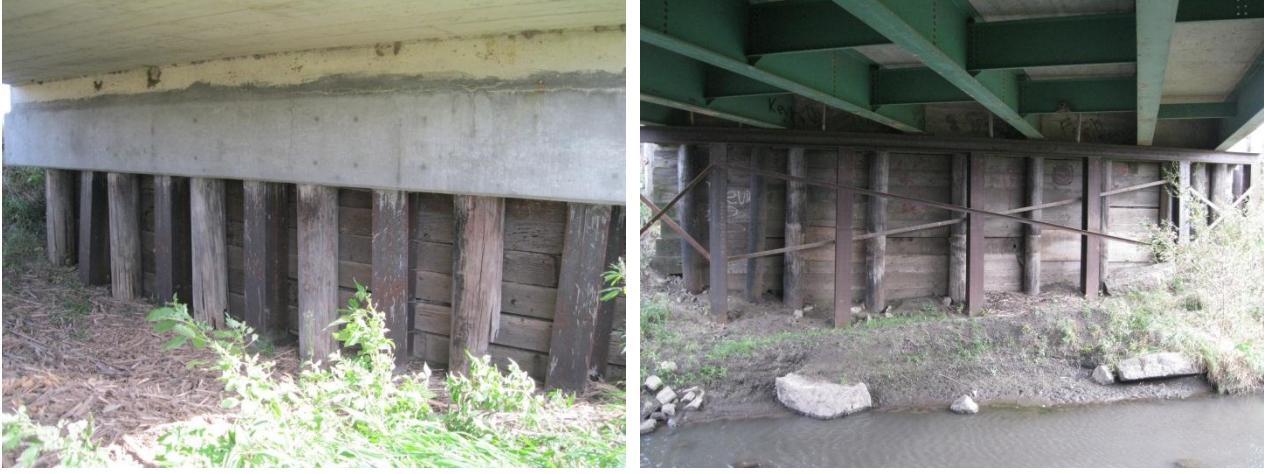
Figure 7-1 continued

g) Additonal pile repair 1

h) Additonal pile repair 2

i) Additonal pile repair 3

j) Added all-steel pier

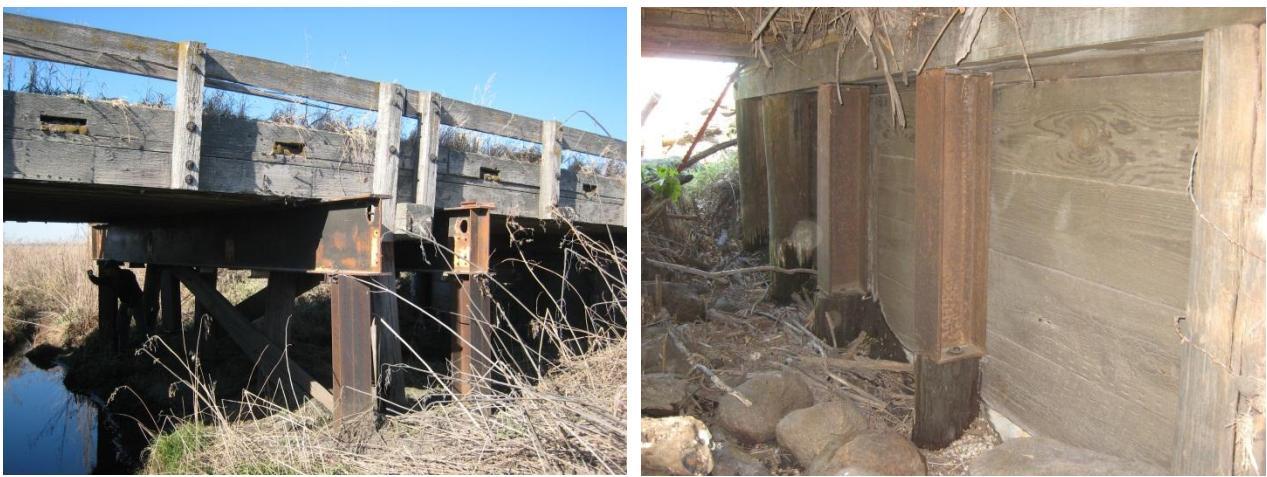
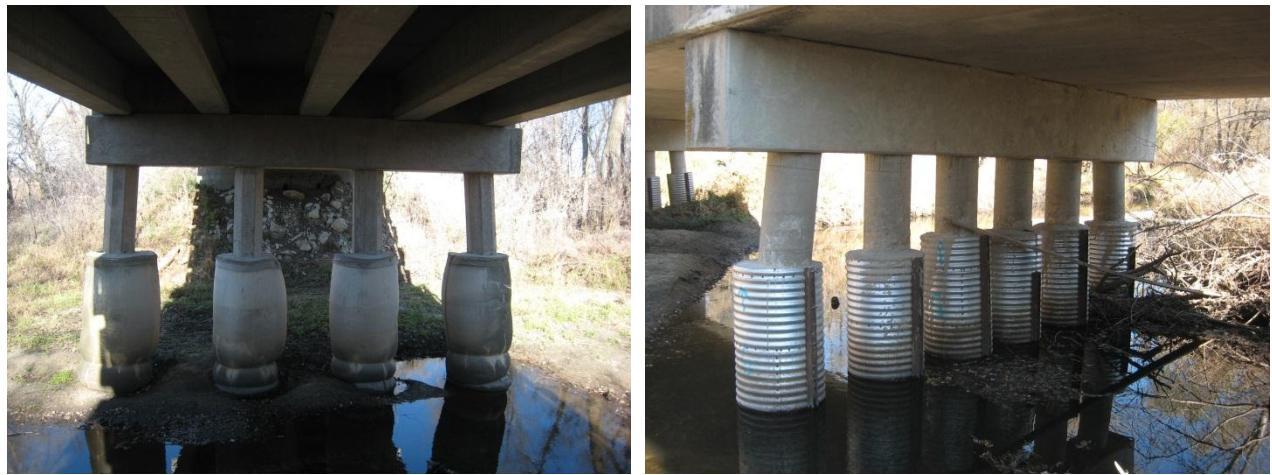
#### **Figure 7-1 continued**

k) Added all-steel pier

l) Steel posting

m) Doughboys

n) CMP repair on concrete

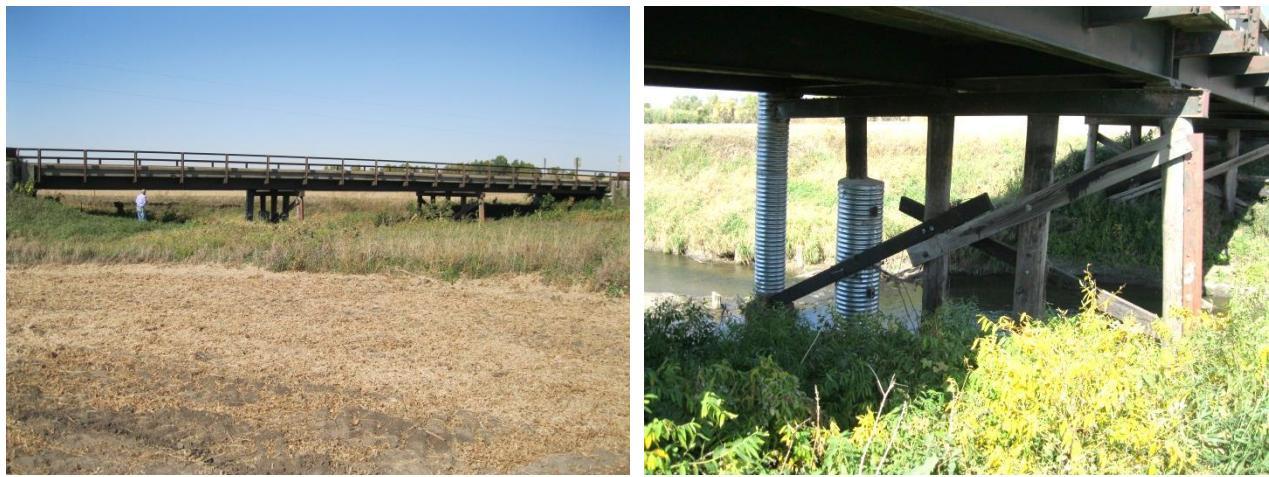
Figure 7-2 Bridge 1 side view and instrumented pier

Bridge 1 is a 126 ft long bridge with three equal spans. The continuous span superstructure consists of three steel girders and a concrete deck, while the substructure consists of timber piles, five at each abutment and pier. The only timber pile repairs were located at the southernmost pier; two of the five piles were repaired using the concrete encasement method. The

a) Side view

b) Corrugate metal pipe repairs

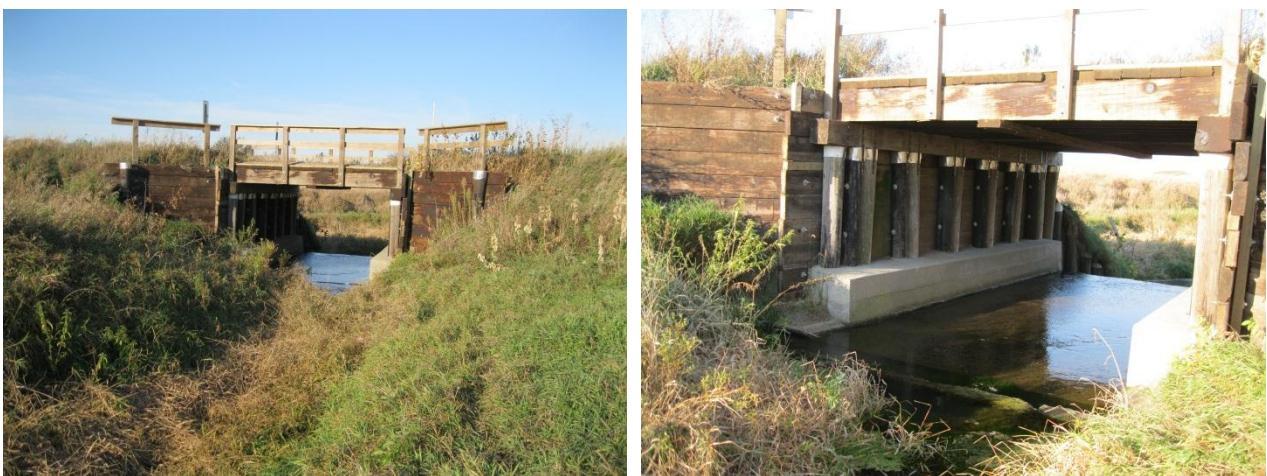
a) Side view

b) Abutment with original and new piles

The condition of the original piles was unknown prior to the addition of new piles and concrete footing. Nonetheless, the remaining visible portion of the original piles is in good condition. With that said, the strain data also gives evidence to the good condition of the visible portion and the effects of the concrete encasement at the base of all piles. With near equal strain values, the pile stiffness and, therefore, condition must be nearly equal. Additionally, the formed concrete footing that encapsulates the bases of each pile provides a solid base for which the load can be transferred from the piling.

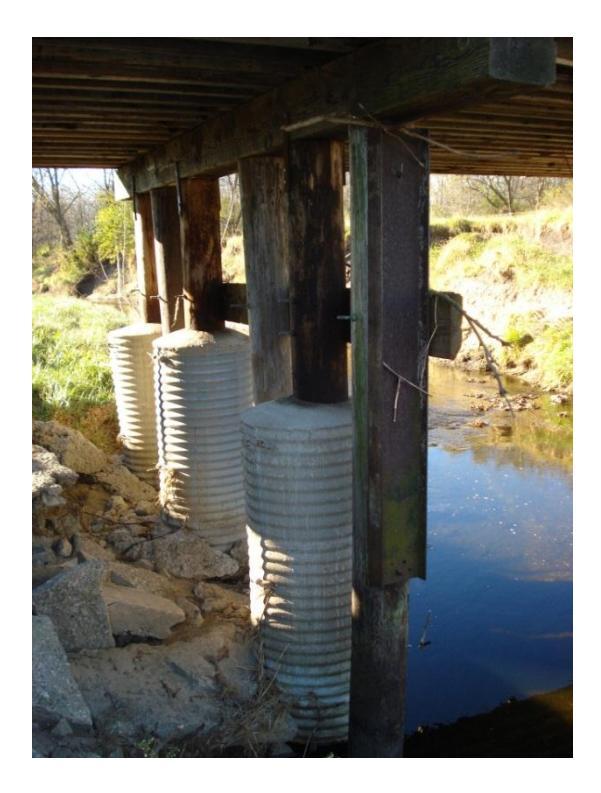
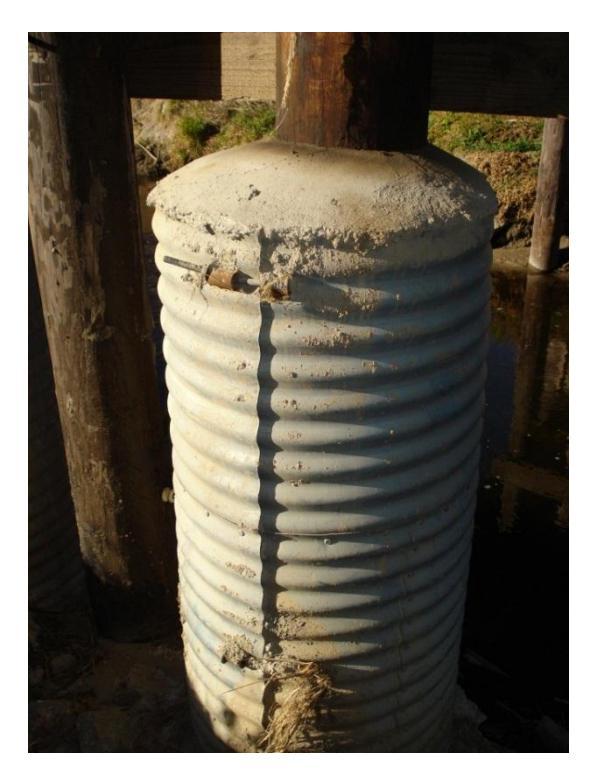
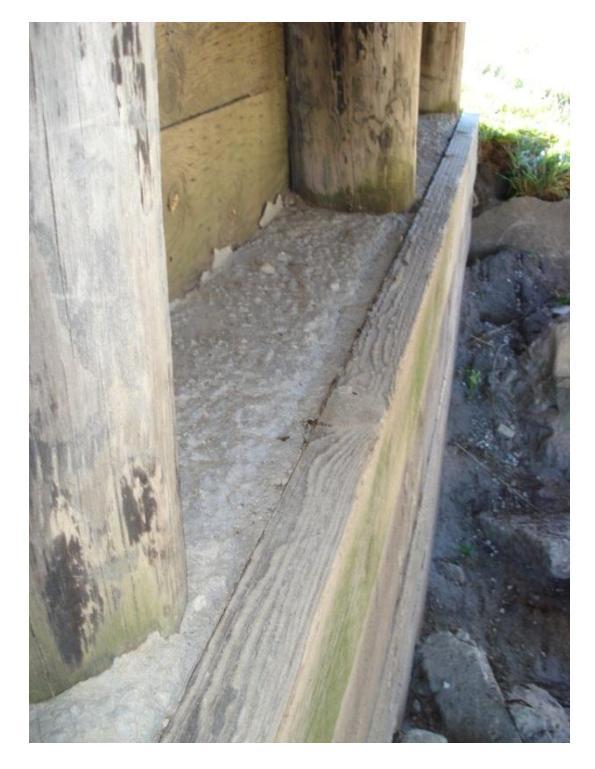
c) Close-up of repair d) Encapsulated abutment piles Figure 7-10 Bridge 3 repairs and reinforcement

At pier 2, the only repaired pile carried very little load in all load cases. It is possible the bearing condition between the pile cap and pile has separated enough to inhibit immediate load transfer. It may also be possible that the non-viewable portions of the pile below the ground line have deteriorated to a condition that prevents load transfer to the ground. Given the apparent load transfer within the casted portions of the piles in pier 1, it can be assumed the cast effectively strengthens and restores stiffness to the pile when the pile is in otherwise good condition beyond the casted portions.

a) Pier 1

b) Pier 2

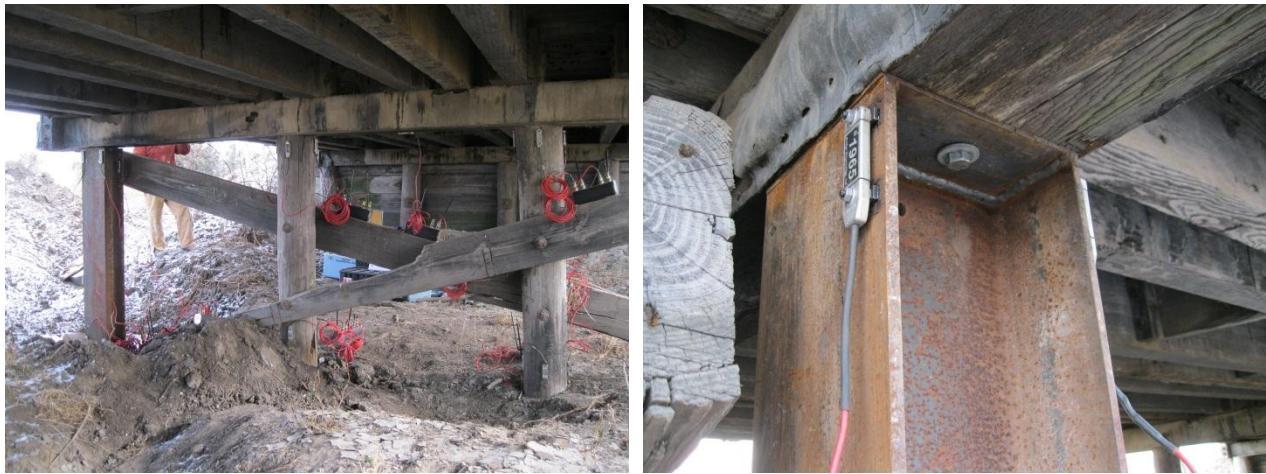
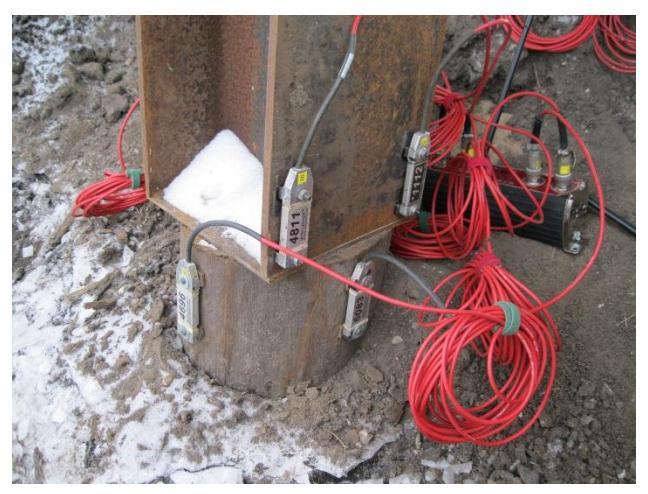
Figure 7-13 Bridge 4 posting repair

a) Pier with steel post

b) Steel post connection to pile cap

c) Steel post connection to existing pile

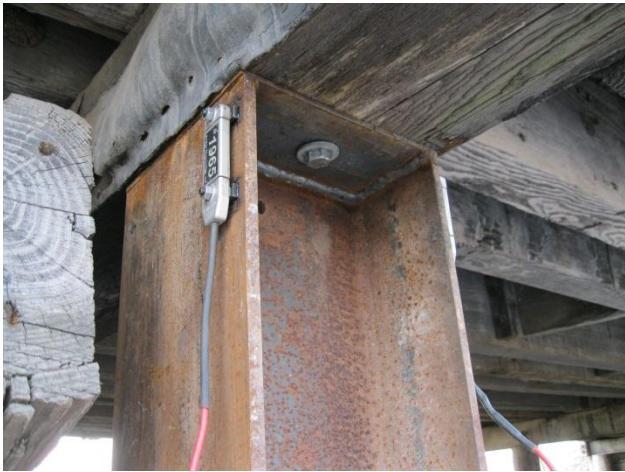
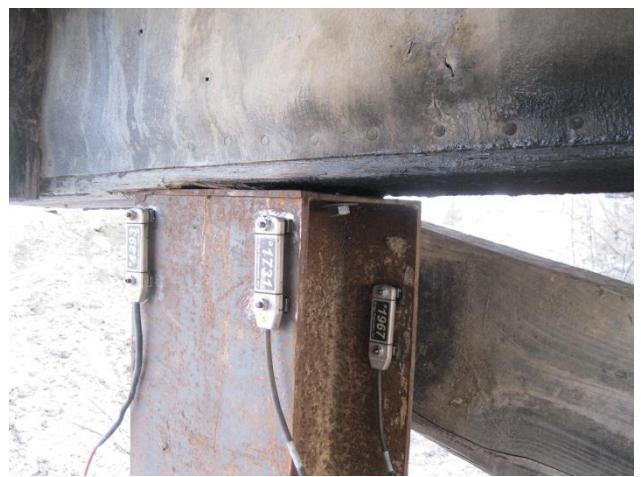
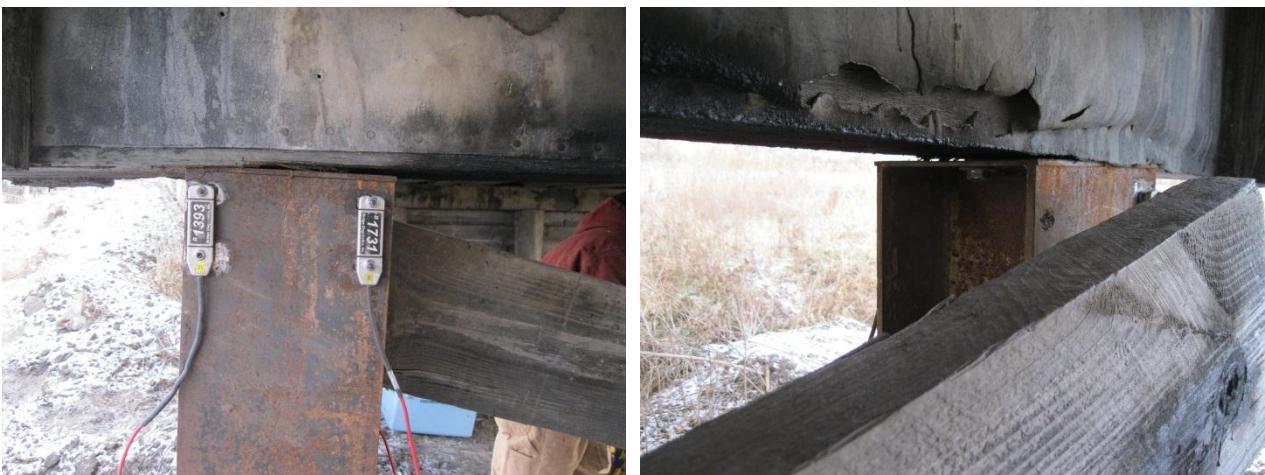
Figure 7-16 Bridge 4 steel pile to pile cap connection

Figure 7-15 Bridge 4 posted pile strain results
This incident may be attributable, at least in part, to the connections of the steel pile to the original pile and pile cap shown in Figure 7-16. The pile cap did not achieve full bearing on the post. Rather, the pile cap achieved bearing only on one edge of the post. Additionally, lag screws were used to connect each component. It is possible that when a load was introduced to this connection, the localized load path induced tension into the pile. Regardless of the unusual results, and possibly despite little structural assistance of the repaired pile, the bridge has been able to carry vehicular loads.

a) Steel post connection to pile cap – view 1

b) Steel post connection to pile cap - view 2

c) Steel post connection to pile cap - view 3

d) Steel post connection to pile cap – view 4

It is often difficult to achieve full bearing when retrofitting or repairing bridge piles in the field. As such, additional laboratory testing of a method to enable full bearing was completed and is presented in the next chapter.
