W.W. SANDERS, JR.
F.W. KLAIBER
H.A. ELLEBY
L.W. TIMM
APRIL 1975

Interim Report
ISU-ERI-Ames-75101

**ULTIMATE LOAD BEHAVIOR OF FULL-SCALE
HIGHWAY TRUSS BRIDGES: PHASE I—
ULTIMATE LOAD TESTS OF THE HUBBY BRIDGE—
BOONE COUNTY**

Iowa State Highway Commission
HR-169

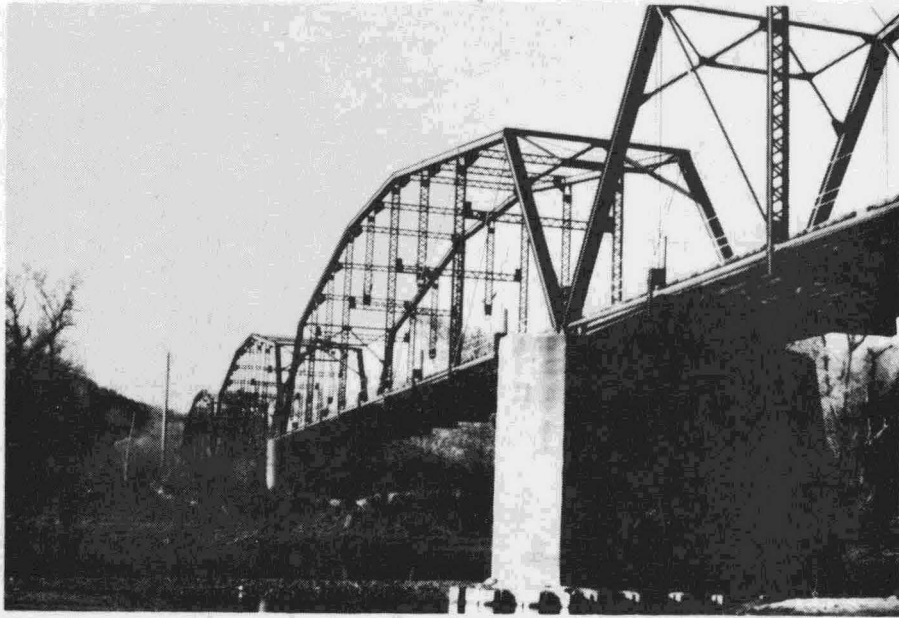
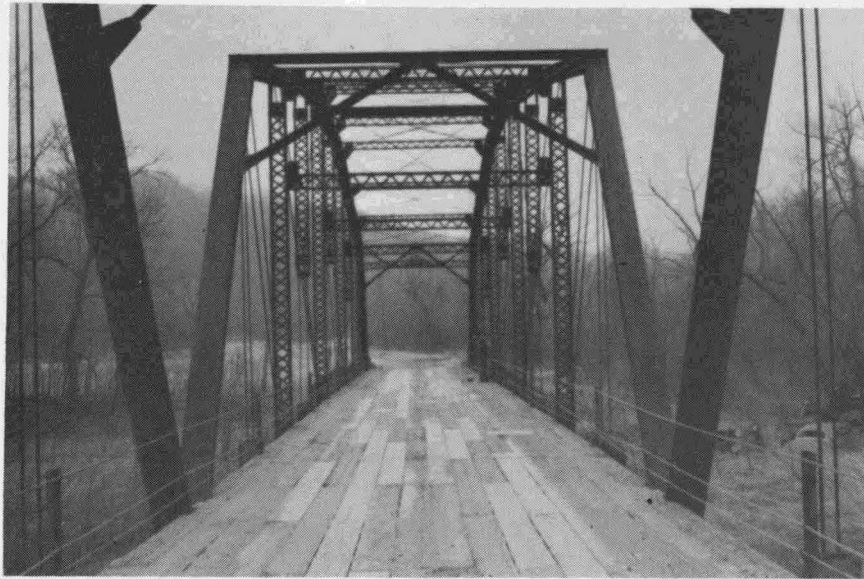
The highway bridge selected for testing was located on the Des Moines River northwest of Des Moines, Iowa, in an area which will be included in the Saylorville Reservoir. The high-truss bridge selected was the Hubby Bridge (Figs. 1 and 2), located in southern Boone County about 25 miles northwest of Des Moines and built in 1909. It was composed of four modified Parker type high-truss simple-spans, each 165 feet long.

Fig. 1. Photographs of the Hubby Bridge.

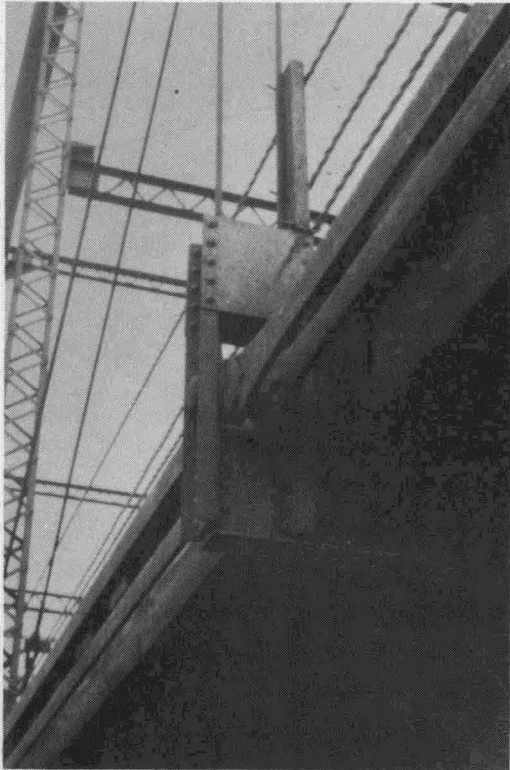
Figure 71 shows that the experimental deflections for the floorbeam test at L_4 do fall between limits of fixed and pinned end supports. The experimental deflection curve is closer to the theoretical curve based on fixed ends, thus indicating a fairly stiff end condition. At higher loads the experimental deflection does move closer to the theoretical deflection based on pinned ends, indicating a loss of stiffness at the ends at higher loads. Figure 73 indicates that the experimental deflections for the floorbeam test at L_5 also fall within the limits based on fixed and pinned end support. However, the experimental deflection curves for the floorbeam test at L_5 fall closer to the theoretical curve based on pinned ends, indicating an end condition that is not as stiff as that of the floorbeam at L_4 . This can easily be seen in Figs. 4 and 5. Figure 4 is typical of the connections at L_5 , and Fig. 5 is typical of the connections at L_4 .

Fig. 4. Photograph of typical connection of floorbeam to truss at hanger member.

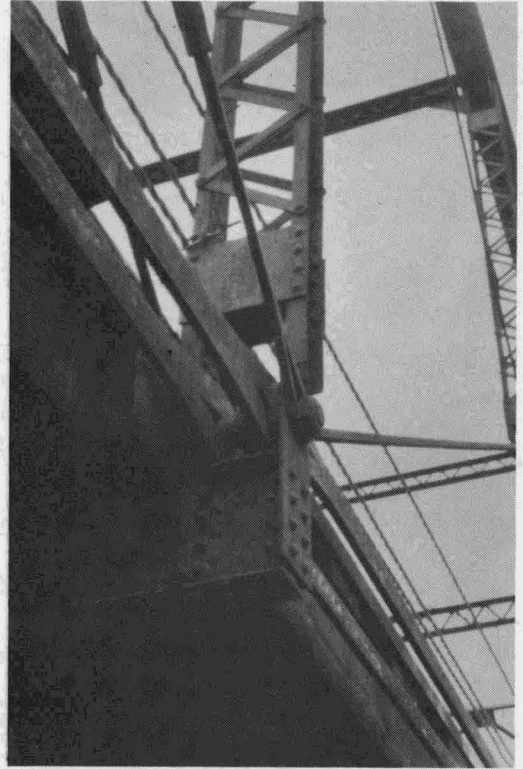
Fig. 5. Photograph of typical connection of floorbeam to truss at vertical laced channel member.

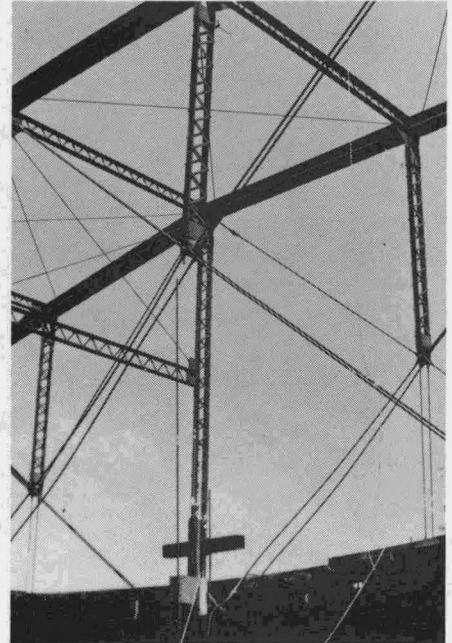
Fig. 37. Photograph of distortion of lower chord at L_5 .

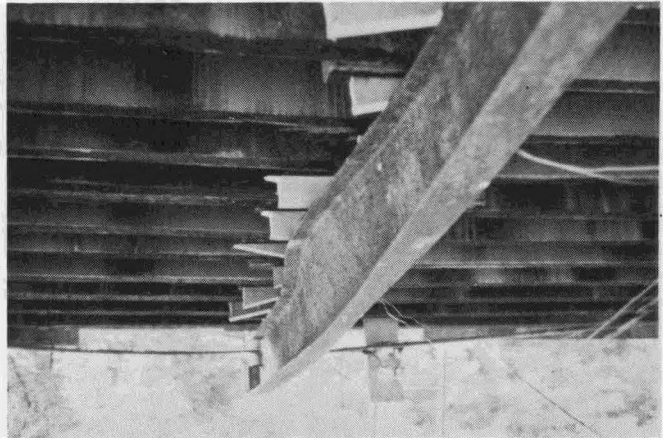
Fig. 49. Photograph of wedges inserted to assure deck continuity.

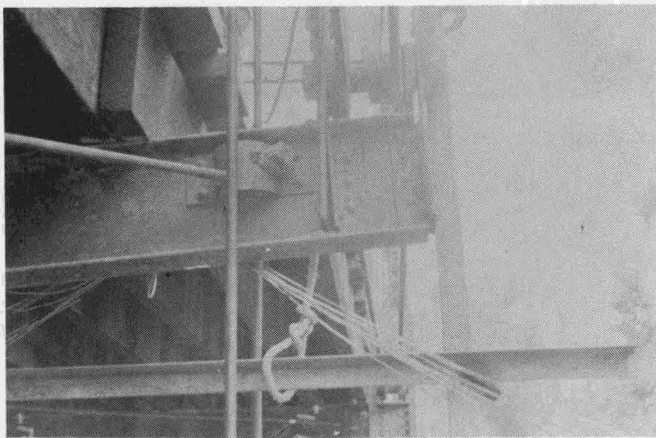
Fig. 50. Photograph showing where first three bolts broke.

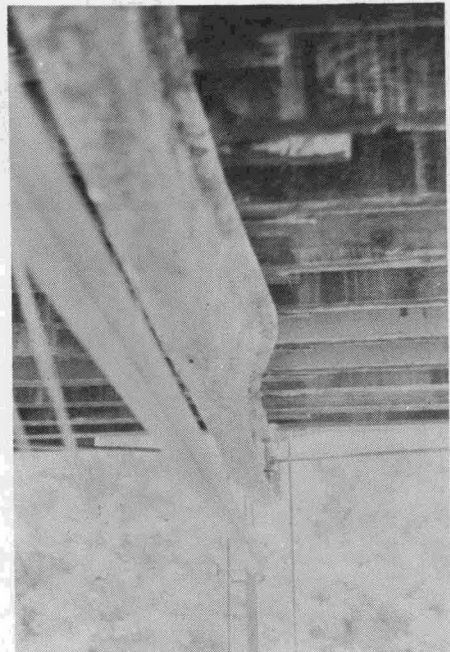
The final configuration of each of the floorbeams was evidenced by a large amount of lateral buckling of the floorbeam, as was anticipated. The compression flanges of each floorbeam were tilted and severely deformed (Figs. 48 and 51). The floorbeam had also pulled away from the timber stringers above it.

Fig. 51. Photograph of lateral buckling of floorbeam 4.

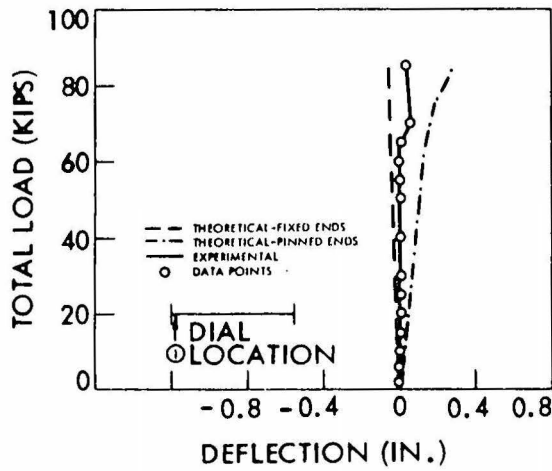
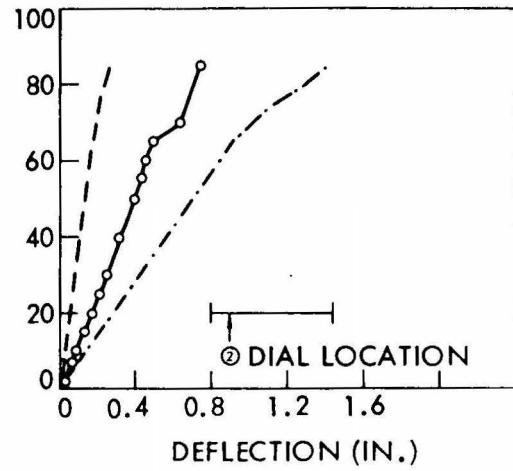
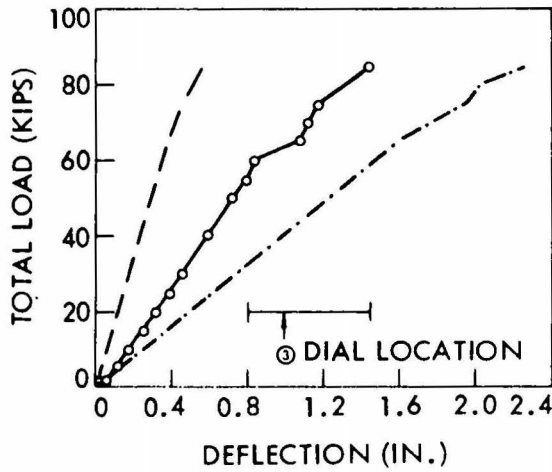
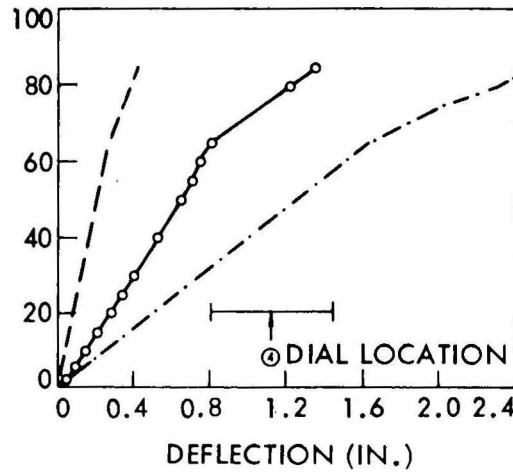
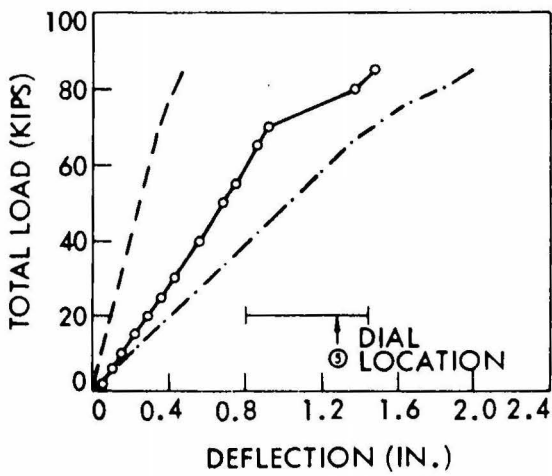
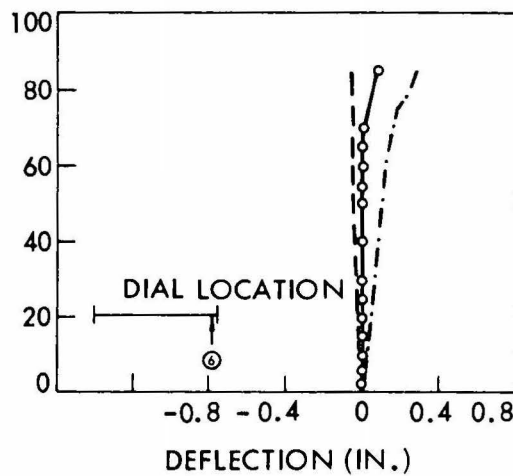
Another indication of behavior can be seen in Fig. 53b between 70 and 85 kips, in Fig. 53c between 65 and 75 kips and in Fig. 53e between 80 and 85 kips. In these instances the slope of the load-deflection curve increases, indicating that the unfailed portions of the deck are carrying a greater portion of the total load than they had previously carried. These unfailed portions of the deck must carry more load because the failed portions of the deck are unable to sustain the additional load.

Figures 53 and 54 show that the experimental deflection does, in most cases, fall about midway between the theoretical deflections based on simple and fixed ends. Deck test 1, in which the loads were applied symmetrically, exemplifies this behavior. In deck test 2 the loads were applied to one side of the panel, causing a departure from this behavior. This behavior can be seen most clearly in Figs. 54f and 54g. The main reason for this behavior is the fact that when a stringer was unable to continue carrying load the foundation stiffness contributed by that stringer was eliminated. The method in which the loss of stiffness was distributed allowed the side of the panel of deck on which the stringers had failed to have a greater stiffness than actually existed. Therefore, the theoretical deflection was less than the experimental deflection. Thus for general cases the more conservative simple support condition should be used in theoretical deflection calculations.

Fig. 53. Load-deflection for deck test 1.

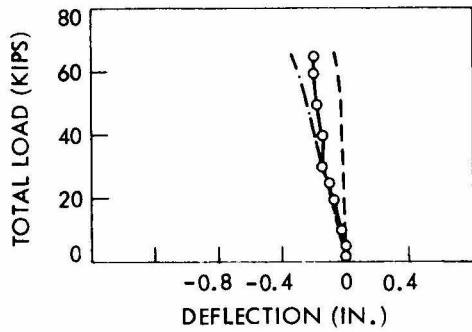
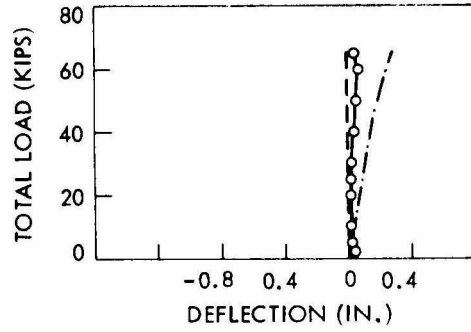
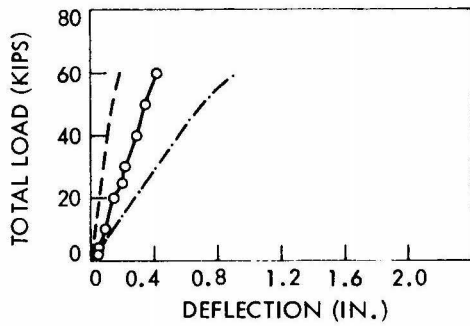
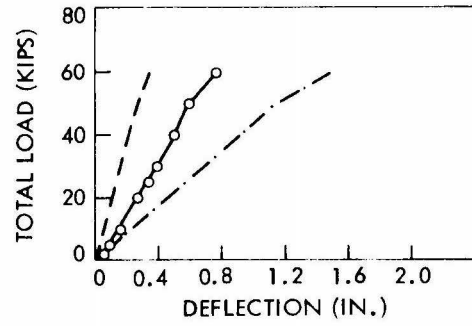
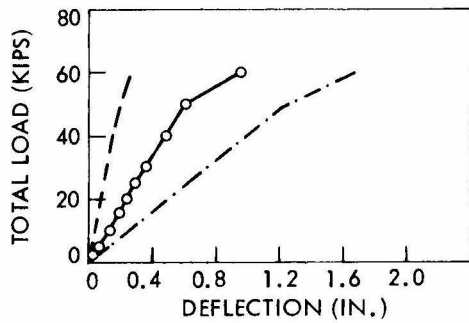
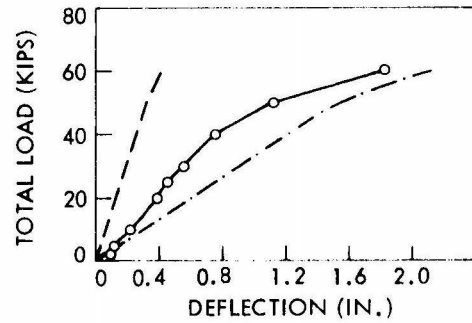
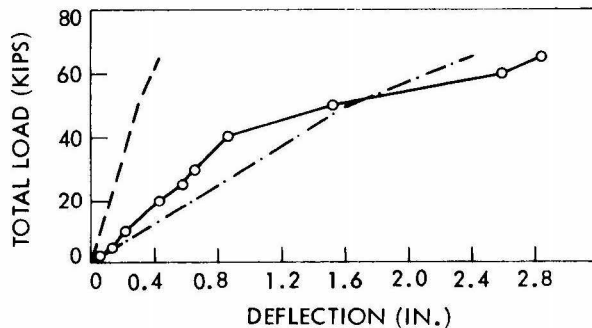
The behavior of deck test 2 was also typical of that expected. The load-deflection curves for that test (Fig. 54) indicate that the behavior of the deck was linear up to a total load of 40 kips (H 17 truck). The behavior of the deck shown by Figs. 54a and 54b is not really indicative of behavior of the entire deck because these

At loads greater than 40 kips the influence of high stress levels in the stringers and the failure of stringers can be seen in Figs. 54d-54g. Figures 54f and 54g indicate that a nonlinear increase in deflection occurred between 40 and 50 kips of load at these two deflection dial locations near the edge of the deck. This nonlinear increase in deflection was caused by the high stress levels in this portion of the deck. Figures 54d-54g indicate a similar behavior between 50 and 60 kips of load at these deflection dial locations. This increase in deflection can be attributed to the failure of stringers 13 and 15. A different type of behavior is shown in Fig. 54g between the loads of 60 and 65 kips. The slope of the load-deflection curve increases, indicating that other portions of the deck are taking a greater portion of the load than they had previously taken.

Fig. 54. Load-deflection for deck test 2.

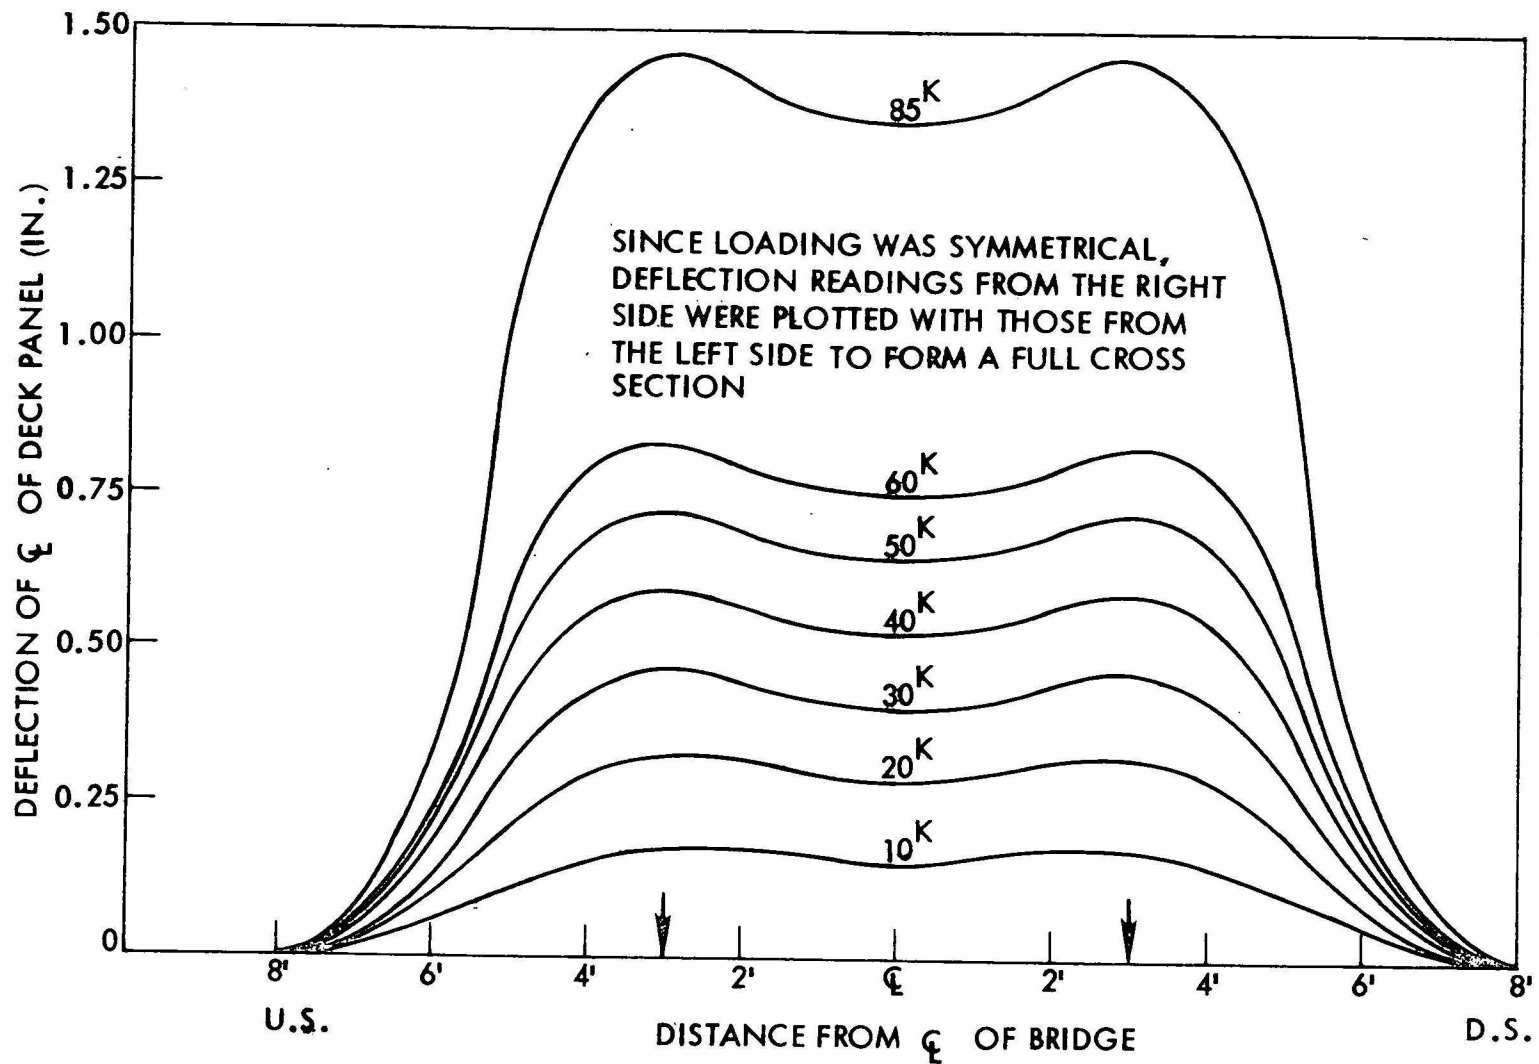
The deflection readings in Fig. 53 can be combined to form a deflection cross section at various load levels (Fig. 55). This figure gives an indication of the distribution of the load to each of the stringers. From these deflections, the amount of load distributed to each of the stringers can be calculated. The figure shows that

Fig. 55. Deflection cross section at mid-span of deck panel for deck test 1 at various loads.

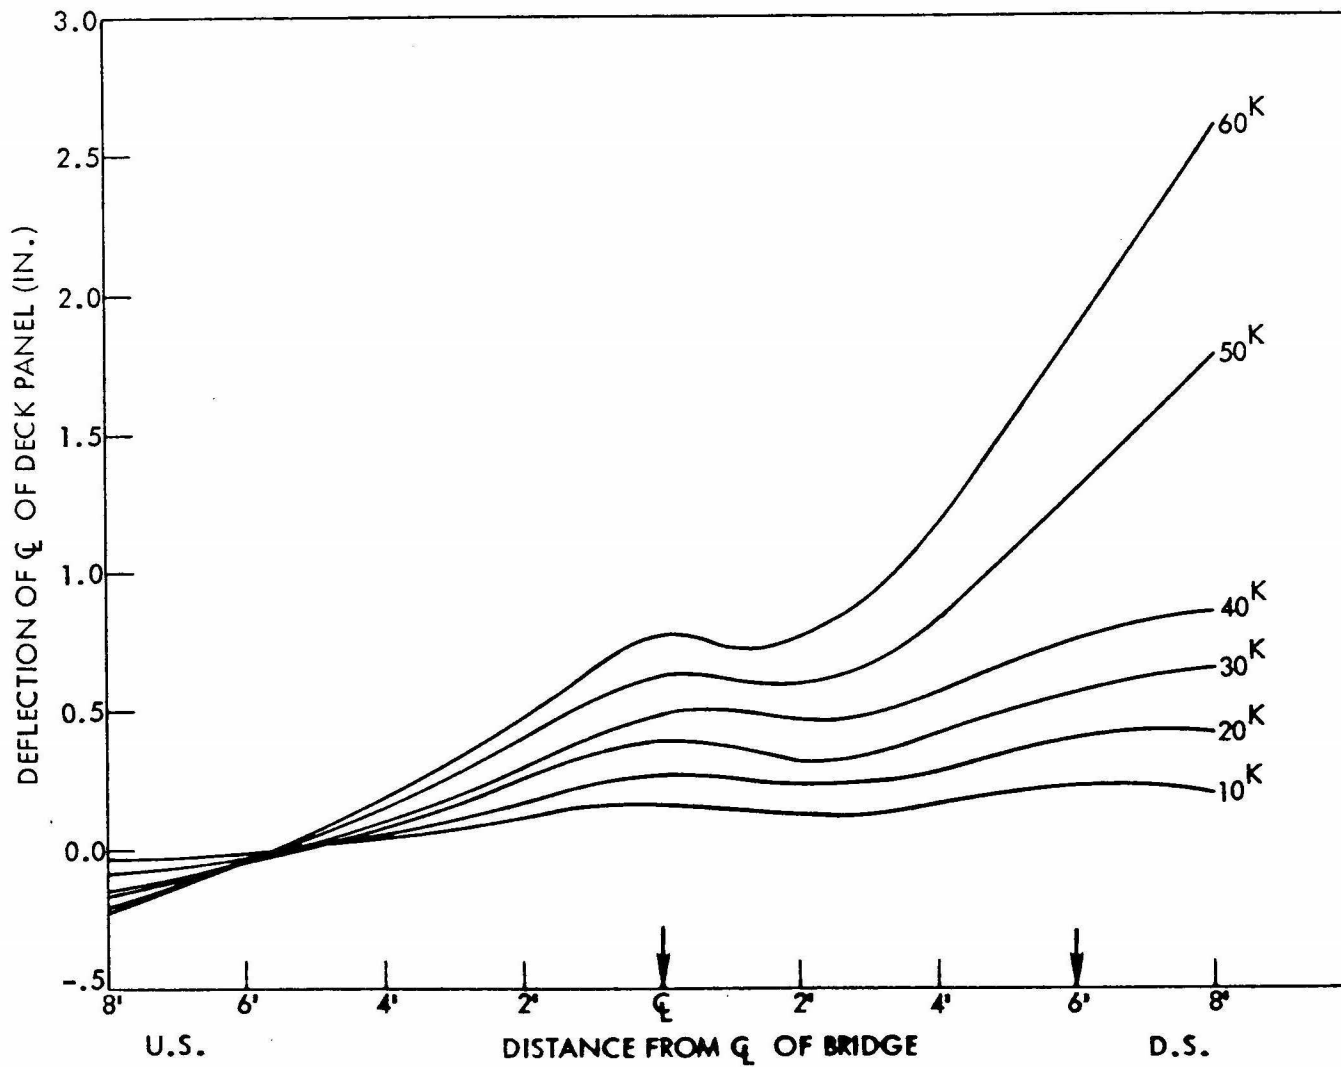
The deflection readings in Fig. 54 are combined in the same manner as Fig. 53 to form a deflection cross section at various loads (Fig. 56). Figure 56 gives an indication of the distribution of the load to each of the stringers. This figure also indicates that the major portion of the load is being carried by the stringers on the loaded side of the panel and that the deflection increases linearly up to a total load of 40 kips.

Fig. 56. Deflection cross section at mid-span of deck panel for deck test 2 at various loads.

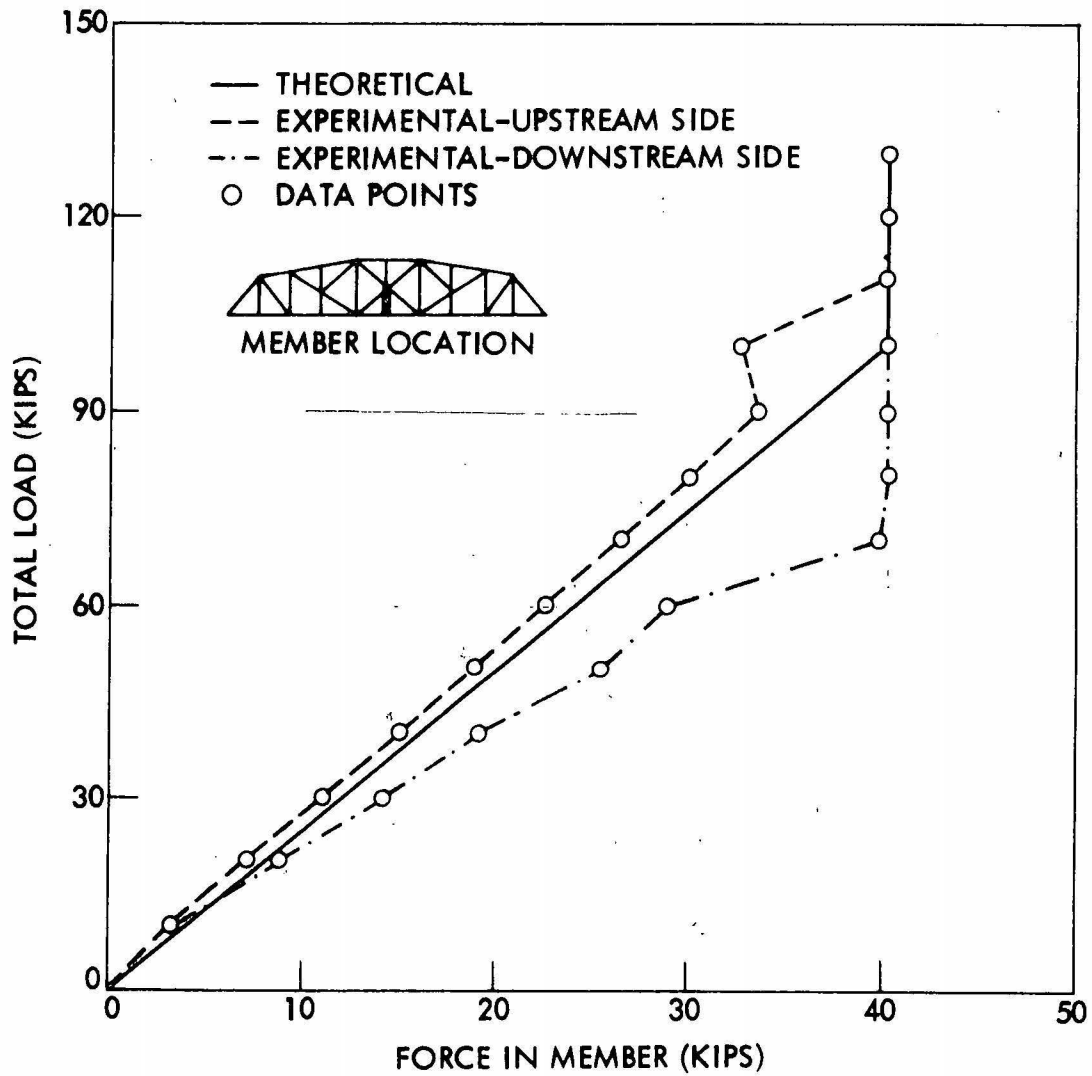
Figure 59, the total load-force in truss member L_5M_5 curve, indicates, for this truss, approximately the same behavior as the total load-vertical deflection curve at L_5 (Fig. 57). Figures 60-70, curves for other total load-force in truss member, indicate linear behavior up to the maximum load at which readings were taken.

Fig. 59. Total load-force in member L_5M_5 .

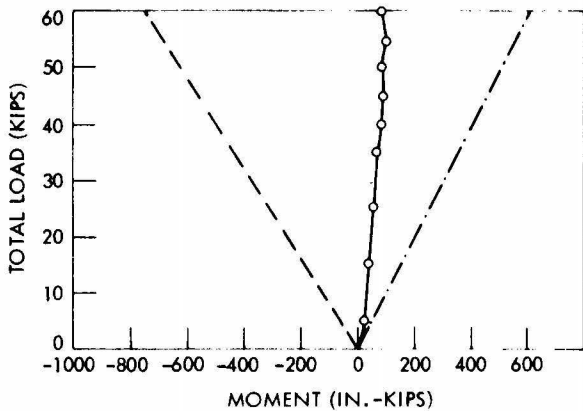
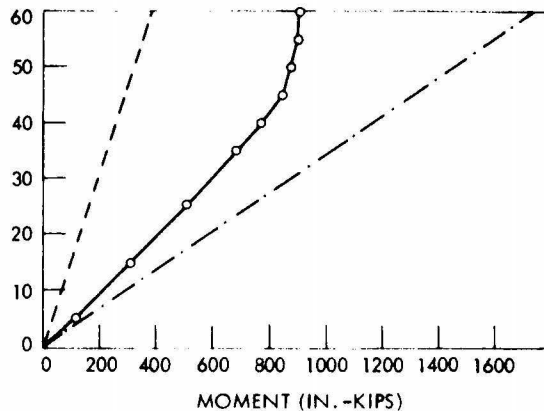
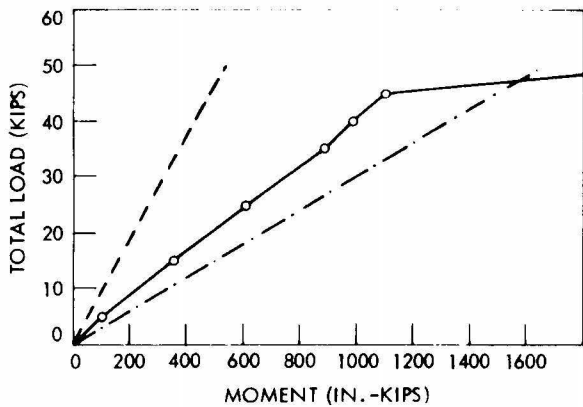
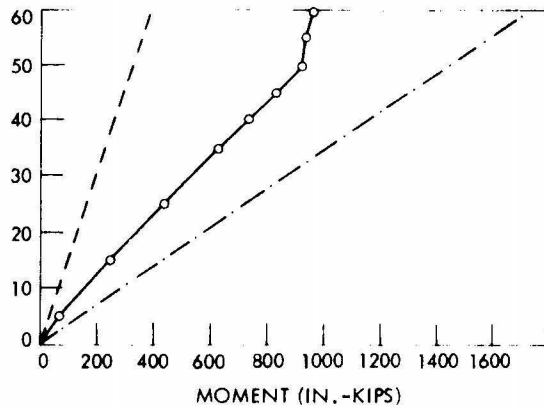
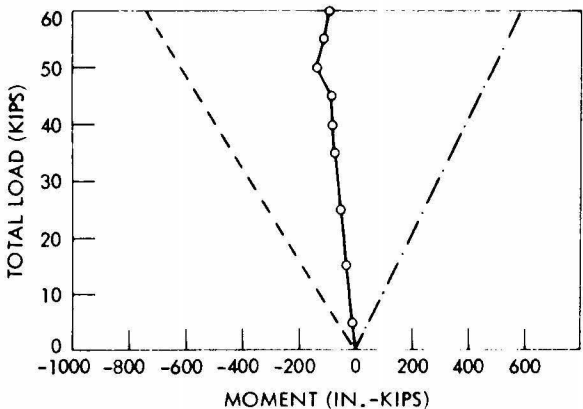
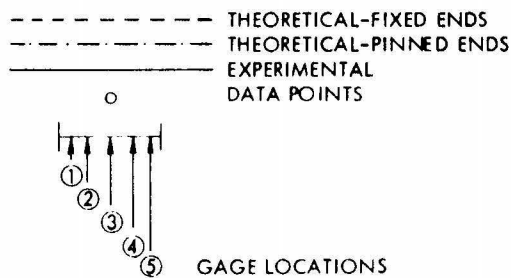
Fig. 72. Load-moment for floorbeam test at L_4 .

reduction in the load carrying capacity of the beam. Because the moments are so small in the end portions of the floorbeam, very little can be concluded from Figs. 72a and 72e. Figure 72c indicates a trend opposite to that shown in Figs. 72b and 72d. However, this trend is questionable because the strain gages near the center of floorbeam are beyond the yield stress for the steel beam.

Figure 72 indicates that the experimental moments calculated from the strain readings for the floorbeam test at L_4 do fall between

the limits of fixed and pinned end supports. The experimental moment curve falls closer to the theoretical curve based on pinned ends, indicating that the load-moment curves show a more flexible end condition than do the load-deflection curves for the floorbeam test at L_4 . Figure 74 indicates the same trend as Fig. 72. However, the trend is even more pronounced than in the earlier figure. The figure indicates that the load-moment curves show a more flexible end condition than do the load-deflection curves for the floorbeam test at L_5 . This is consistent with the actual end conditions.

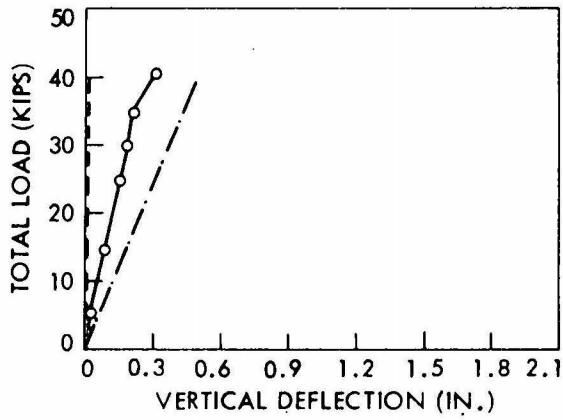
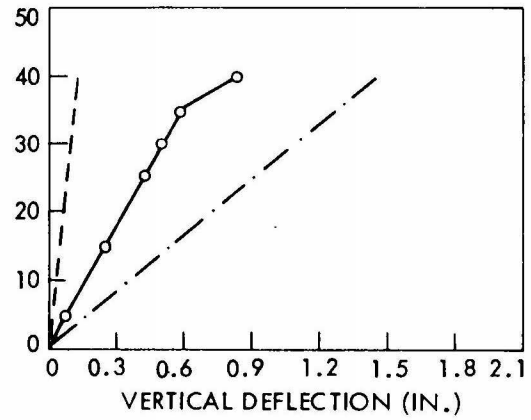
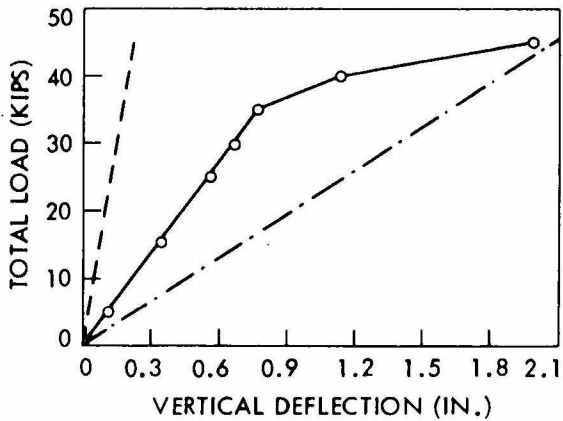
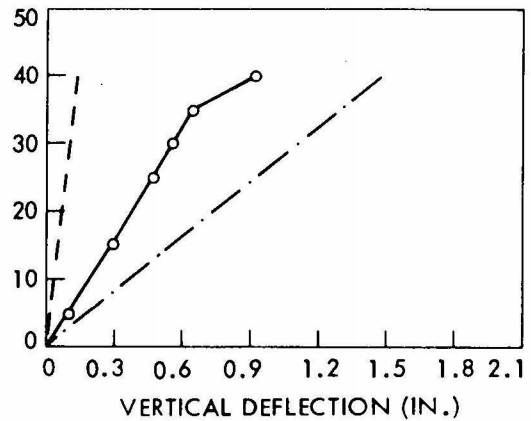
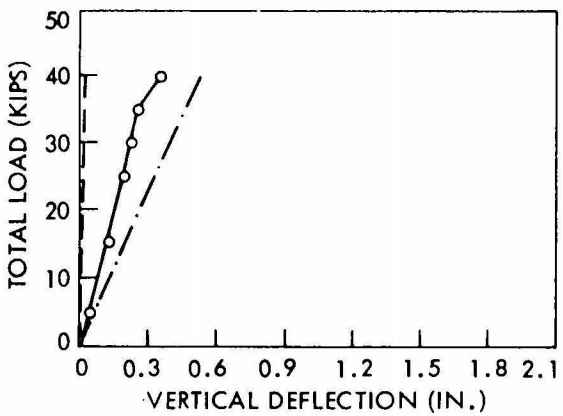
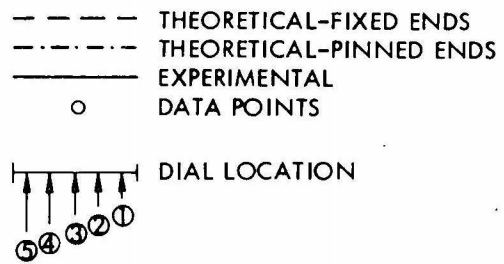
Fig. 73. Load-deflection for floorbeam test at L_5 .

The load-deflection curves for the floorbeam test at L_5 are shown in Fig. 73. This figure indicates a departure from linearity at a load of about 35 kips (H 21 truck). At about the same load the observation was made that the floorbeam was beginning to buckle laterally. This departure from linearity thus gave an indication of the initiation of lateral buckling in the floorbeam. This indicates that the natural dapping of the stringers provides sufficient lateral support of the floorbeam up to about 70 percent of the ultimate load. Beyond 70 percent of the ultimate load the floorbeam buckled laterally between the load points because there was no positive tie between the stringers and the floorbeam. Figure 73c shows that between 40 and 45 kips of load the curve again becomes linear, indicating that the lateral buckling proceeds at a constant rate between these two loads.

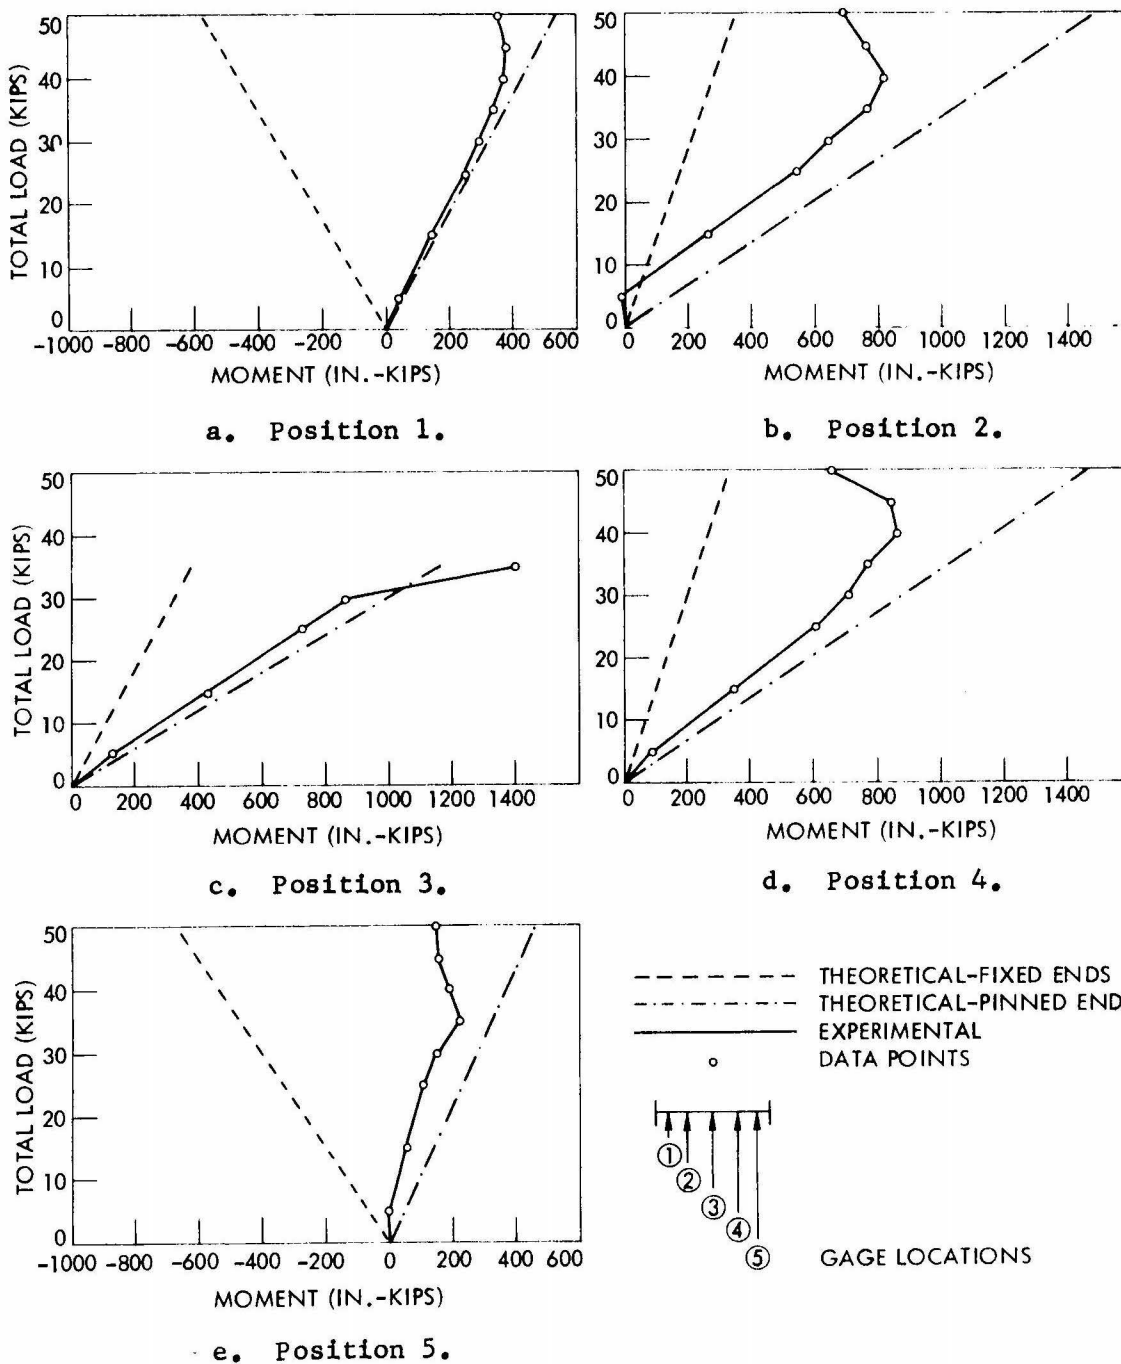
Fig. 74. Load-moment for floorbeam test at L_5 .

The load-moment curves for the floorbeam test at L_5 are shown in Fig. 74. Figures 74a, 74b and 74d indicate a departure from linearity at about 35 kips, indicating the lateral buckling of the beam and a corresponding reduction in the load carrying capacity of the beam. Figure 74e indicates a behavior contrary to that seen in Fig. 74a. This contrary behavior is due to the restraint of the

rotation of that end of the floorbeam by a vertical channel on that end of the floorbeam resting against one of the hangers. Figure 74c indicates a behavior similar to that in Fig. 72c and the same explanation covers this figure.

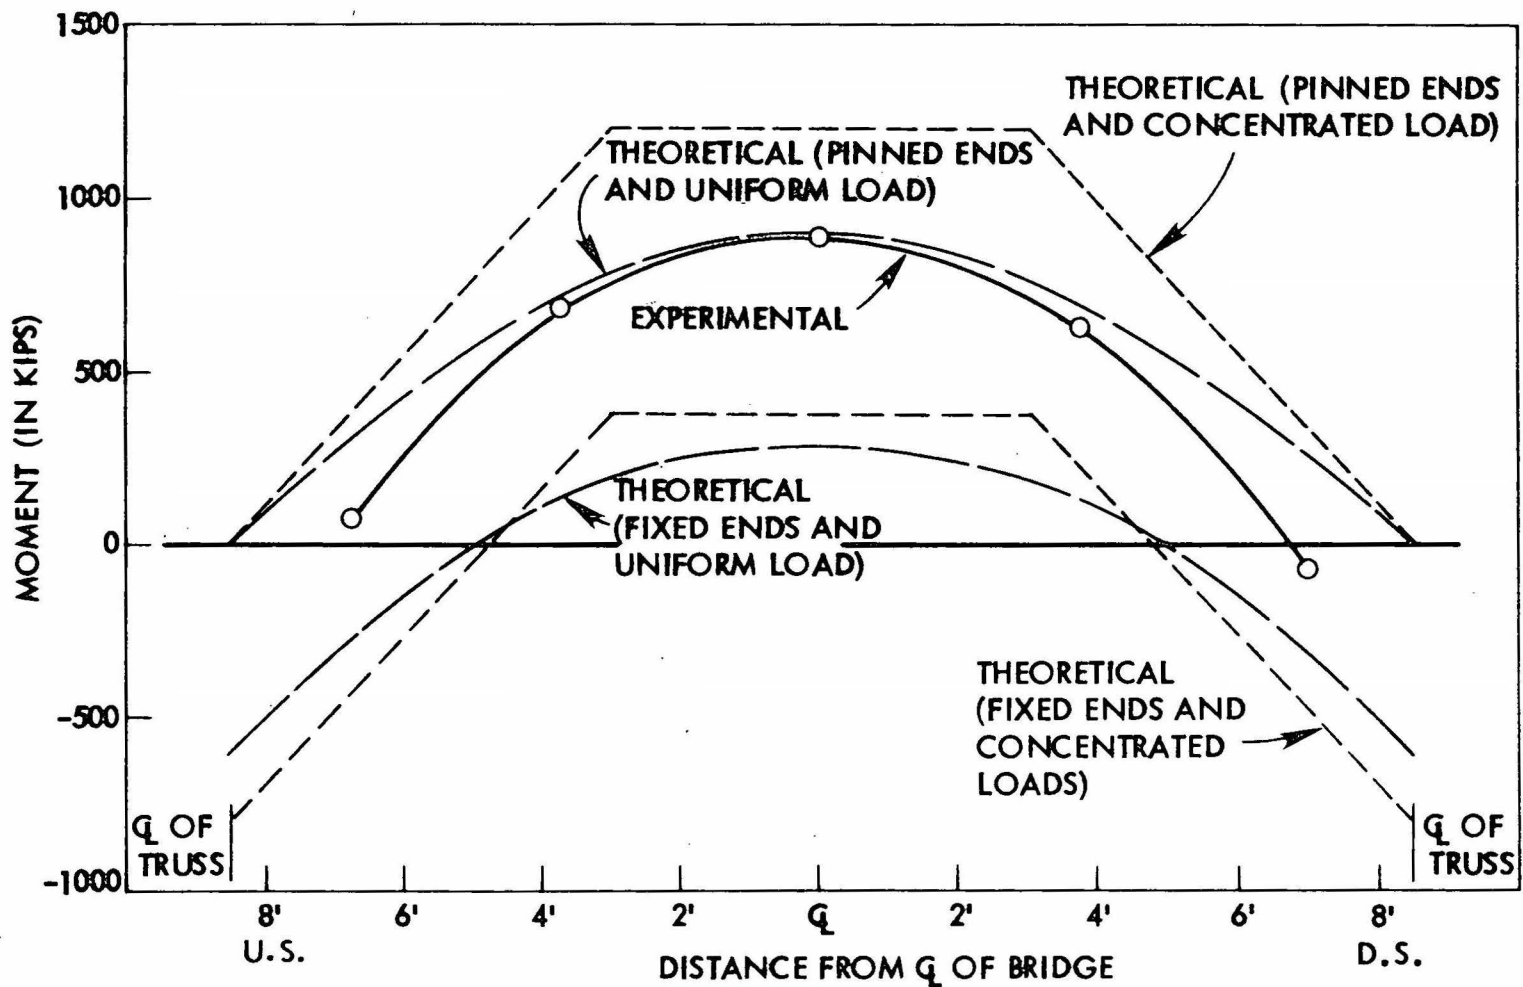
Fig. 75. Moment cross section for floorbeam test at L_4 for a load of 35 kips.

The load-moment curves for each floorbeam test (Figs. 72 and 74) can be combined to form moment cross-sections as shown in Figs. 75 and 76. This cross-section is drawn for a load of about one-half of the ultimate load to give an indication of the trend. These two figures show that the experimental moments fall within the bounds of fixed and pinned support for both concentrated loads and uniform loads. The experimental moment falls closest to the curve based on pinned end support and uniform load indicating that the deck had excellent distribution characteristics.
