EVALUATION OF BOND RETAINAGE

**PORTLAND CEMENT
CONCRETE OVERLAYS**

**INFRARED THERMOGRAPHY
AND
GROUND PENETRATING RADAR**

**IOWA DEPARTMENT
OF TRANSPORTATION**

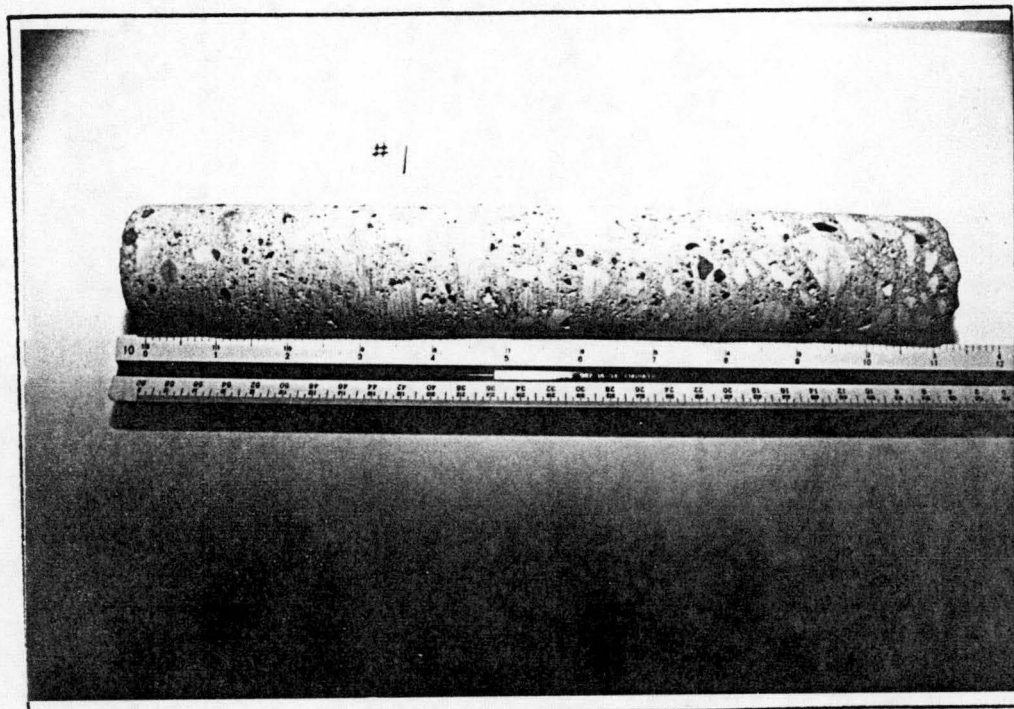
CONDITION OF ASPHALT: Good

DEFECTS IN CORE: None

QUALITY OF CONCRETE: Good

REMARKS: Good Bond - no defects

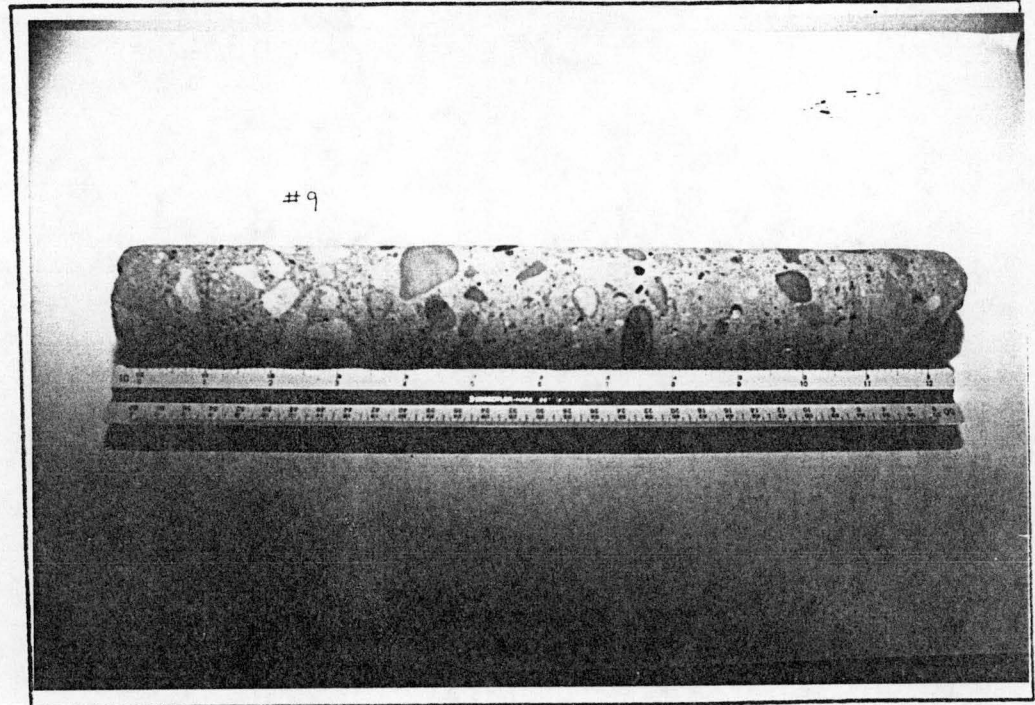
DATE: August 19, 1987
 PROJECT: Iowa D.O.T. - PCC Bond Evaluation
 CORE LOCATION: Iowa 141 - Milepost 134.0
 CORE: # 9
 DIAMETER: 2 inch
 OVERLAY THICKNESS: 3.5 inches
 CONCRETE THICKNESS: 12.25 inches
 FULL DEPTH Y/N: Yes
 CONDITION OF OVERLAY: Good
 DEFECTS IN CORE: None
 QUALITY OF CONCRETE: Good
 REMARKS: _____
