# Concrete Overlay Performance on Iowa's Roadways

**Field Data Report  
July 2017**

National Concrete Pavement  
Technology Center

**Sponsored by**  
Iowa Highway Research Board  
(IHRB Project TR-698)  
Iowa Department of Transportation  
(InTrans Project 15-559)

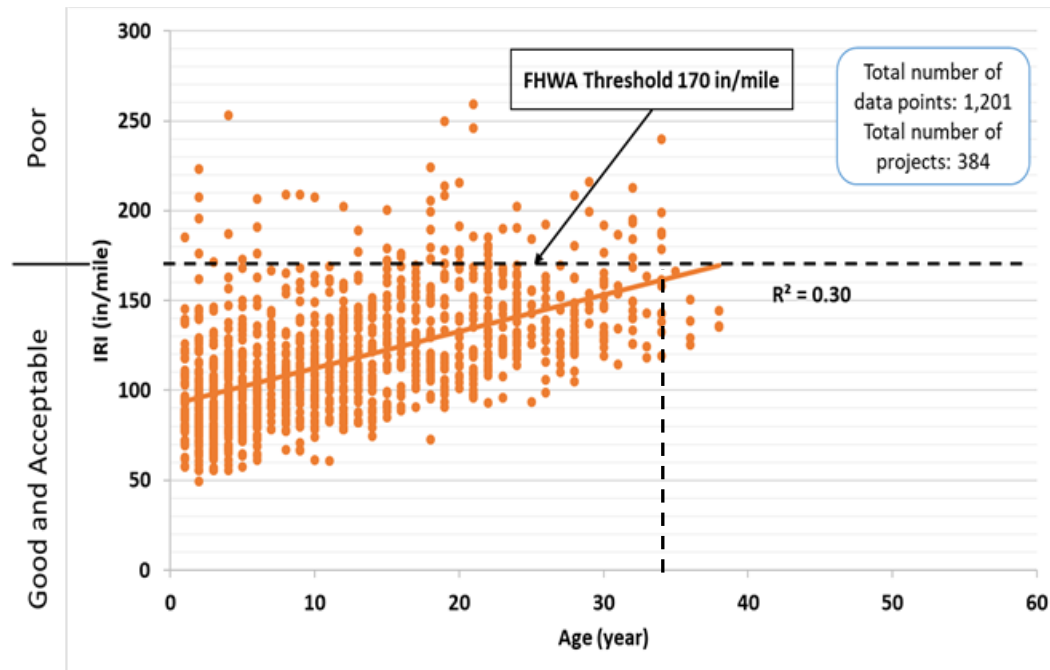
**Figure 39. Iowa concrete overlay IRI performance history for all projects**

As overlays age, the PCI data follows a downward linear trend, whereas the IRI data follows an upward linear trend. Linear trend lines were plotted in Figures 12 and 13, as well as the data plots in Figures 38 through 63. The trend lines serve as a guide to long-term performance and to relate pavement age to condition, but they may not fully capture long-term behavior. For example, the PCI will often begin to decline more rapidly with age rather than in a linear fashion. Because this data set encompasses comparatively fewer projects that have reached the absolute end of their service life compared to early- or intermediate-life, linear PCI trend lines generally provided the best fit. The key findings for the entire concrete overlay database are as follows:

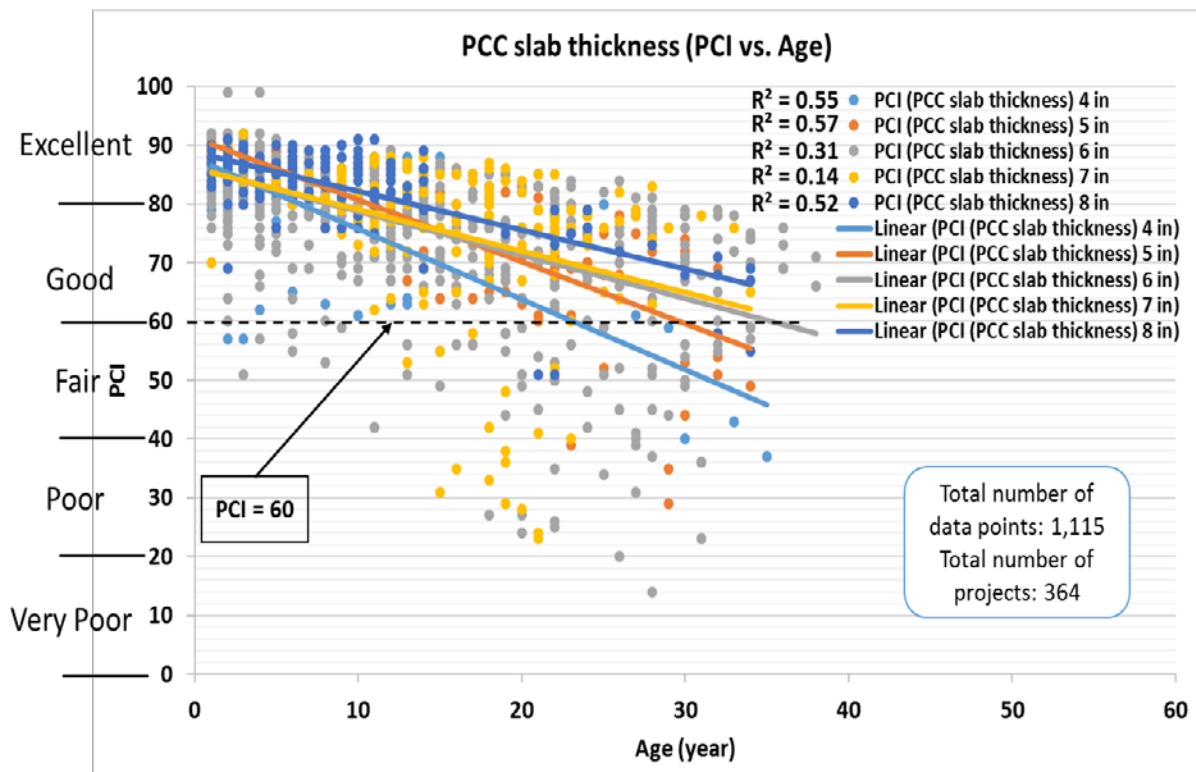
**Figure 40. Iowa concrete overlay PCI performance history for five different concrete overlay thickness projects**

- The PCI trend line for 4-in. thickness decreased gradually during the first 24 years of service life before dropping below 60.
- The PCI trend line for 5-in. thickness decreased gradually during the first 29 years of service life before dropping below 60.
- The PCI trend line for 6-in. thickness decreased gradually during the first 35 years of service life before dropping below 60.
- The PCI trend lines for 7-in. and 8-in. thicknesses decreased gradually but remained above 60 during the first 35 years of service life.
- Higher overlay thickness resulted in increased overlay service life.

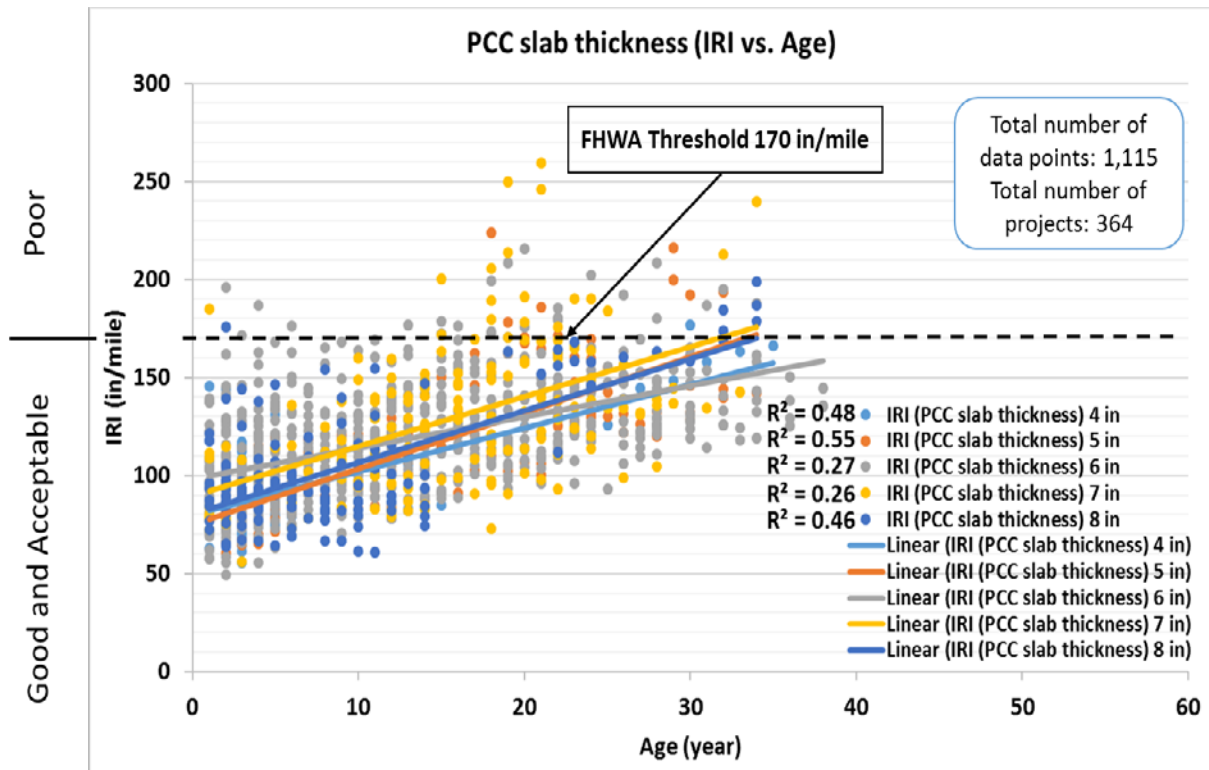
**Figure 41. Iowa concrete overlay IRI performance history for five different concrete overlay thickness projects**

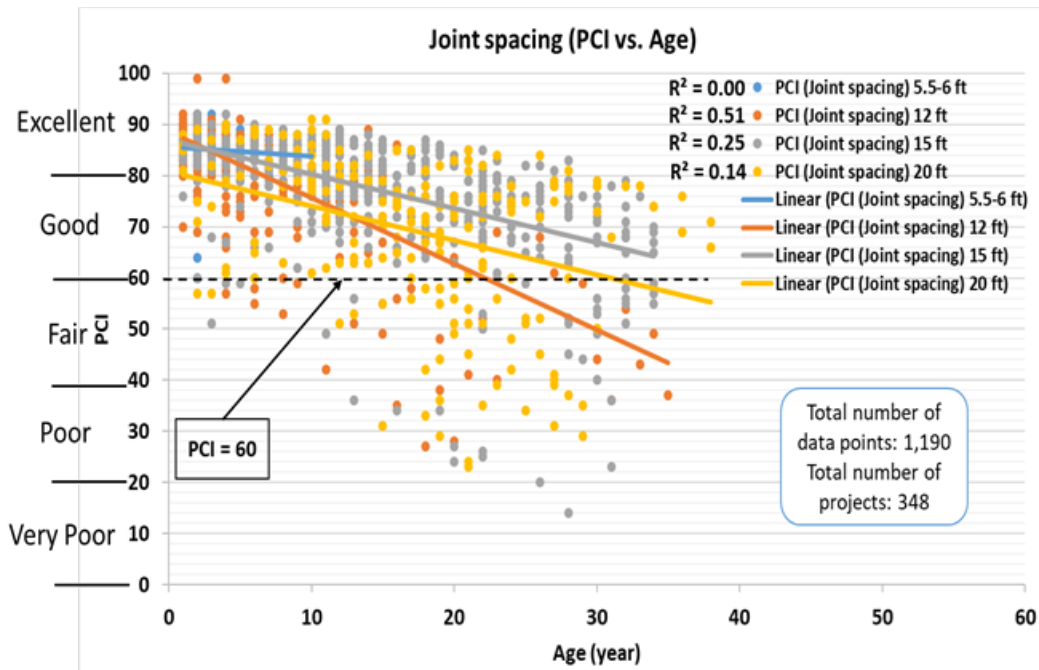
**Figure 42. Iowa concrete overlay PCI performance history for four different concrete overlay joint spacing projects**

- The PCI trend line for 5.5- to 6-ft transverse joint spacing decreased modestly and remained above 80 during the first 10 years of service life.
- The PCI trend line for 12-ft transverse joint spacing decreased rapidly during the first 22 years of service life before dropping below 60.
- The PCI trend line for 15-ft transverse joint spacing decreased gradually but remained above 60 during the first 33 years of service life.
- The PCI trend line for 20-ft transverse joint spacing decreased gradually during the first 33 years of service life before dropping below 60.
- Shorter slab sizes have only been used since roughly 2004 and have exhibited good performance.
- PCI values for older Iowa concrete overlays (i.e., those after 20 years of life) have shown that larger slab sizes can provide good long-term performance.

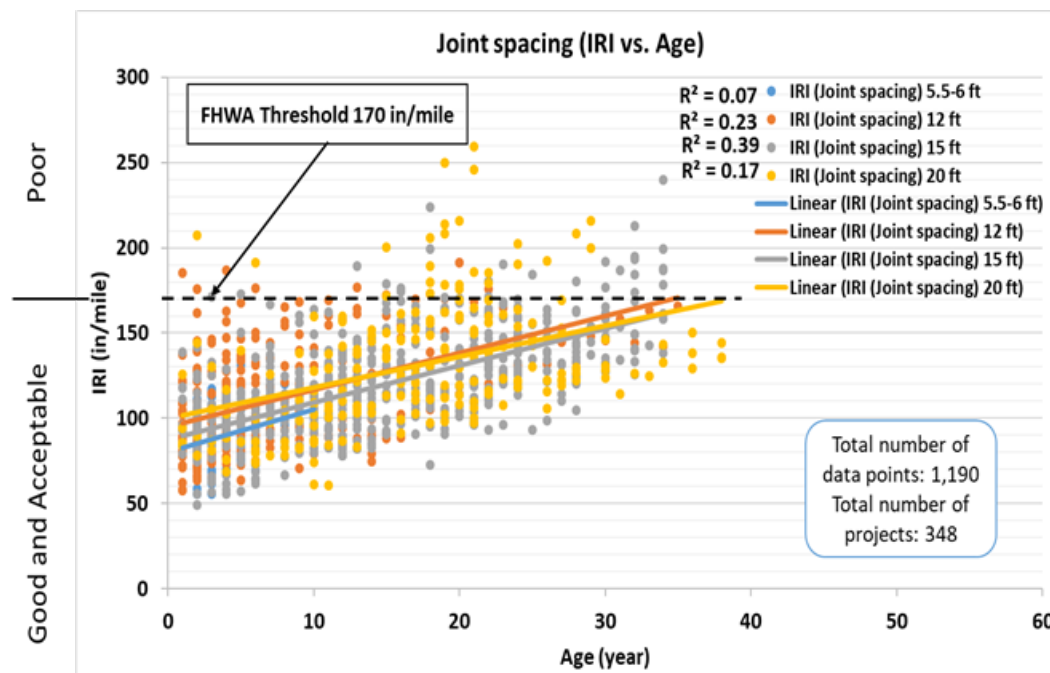
**Figure 43. Iowa concrete overlay IRI performance history for four different concrete overlay joint spacing projects**

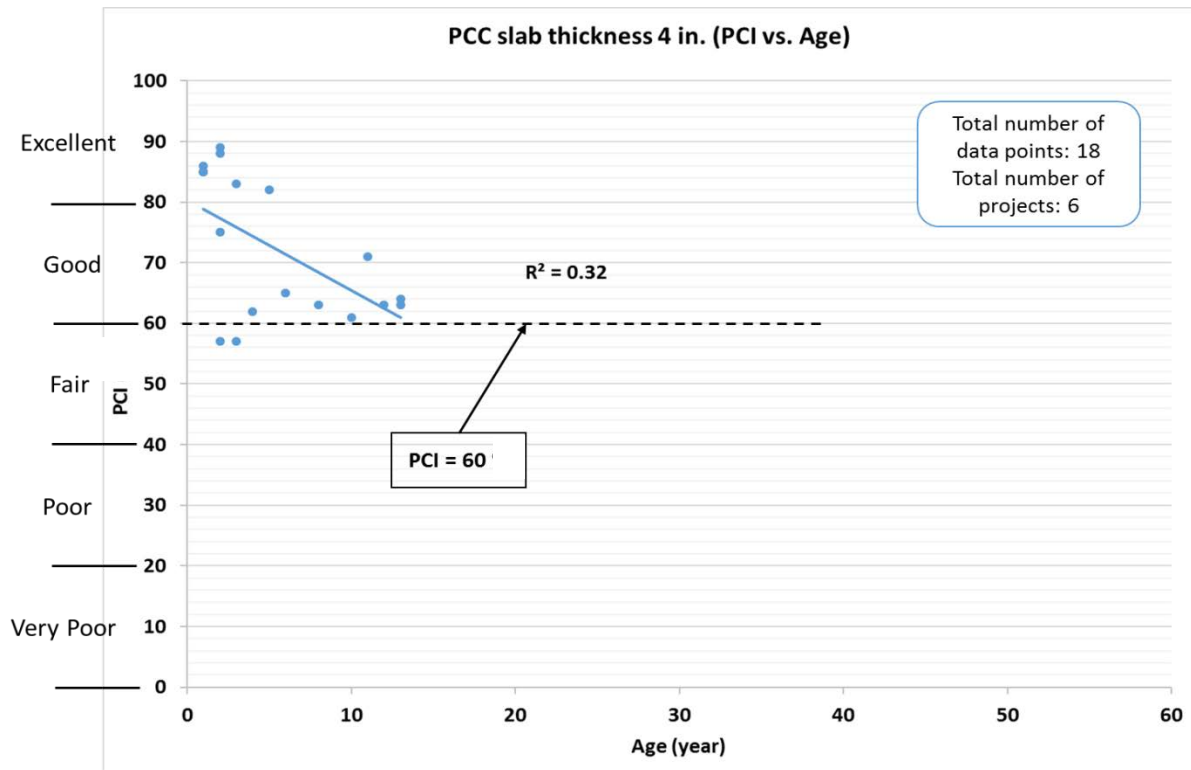
Figure 44 through Figure 47 show that the PCI data follows a downward linear trend with age, whereas the IRI data changed very little with age.

**Figure 44. BCOC PCI performance history categorized by concrete overlay thickness**

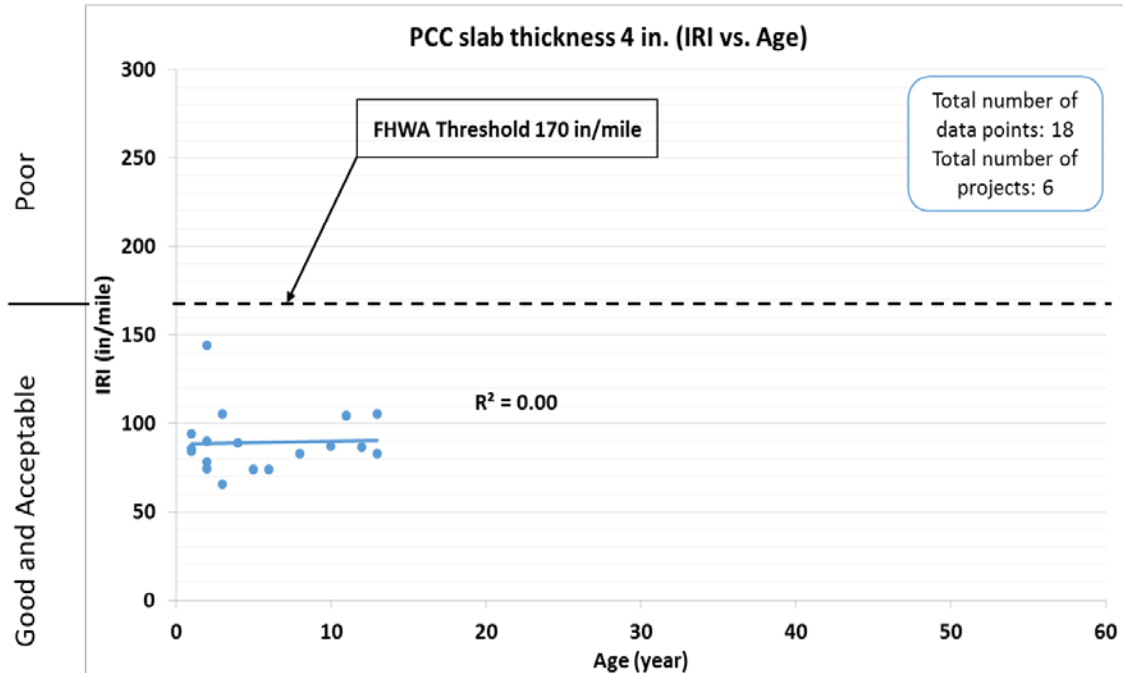
**Figure 45. BCOC IRI performance history categorized by concrete overlay thickness**

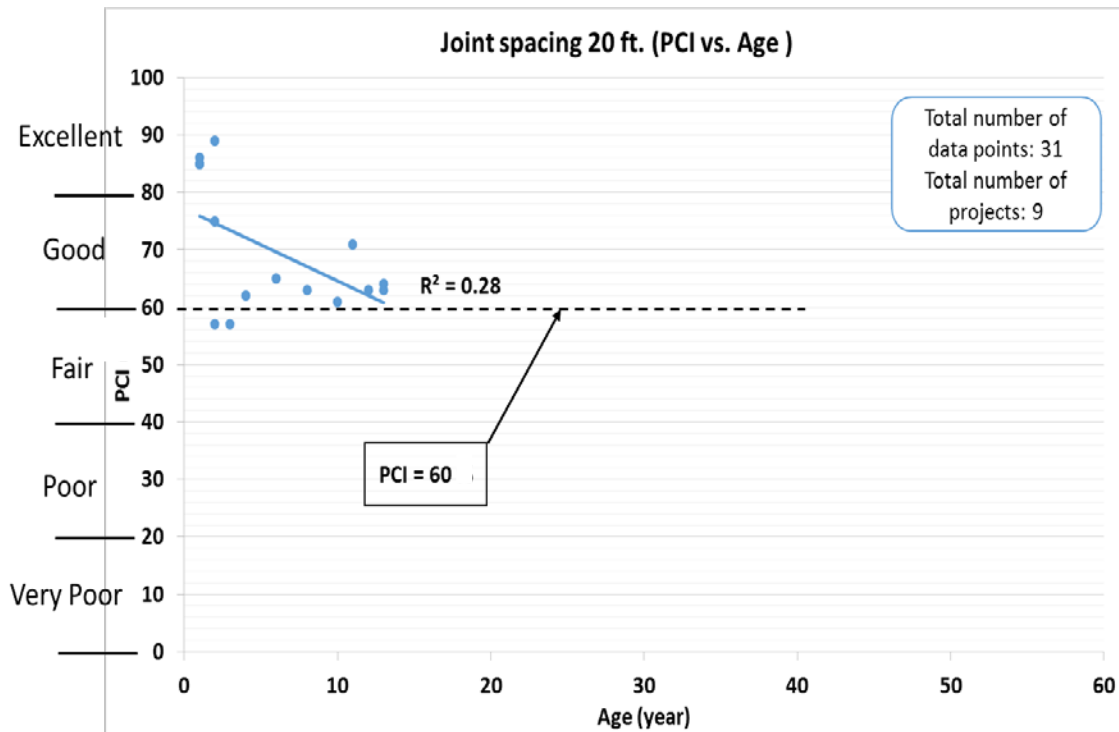
Figure 46. BCOC PCI performance history categorized by concrete overlay joint spacing

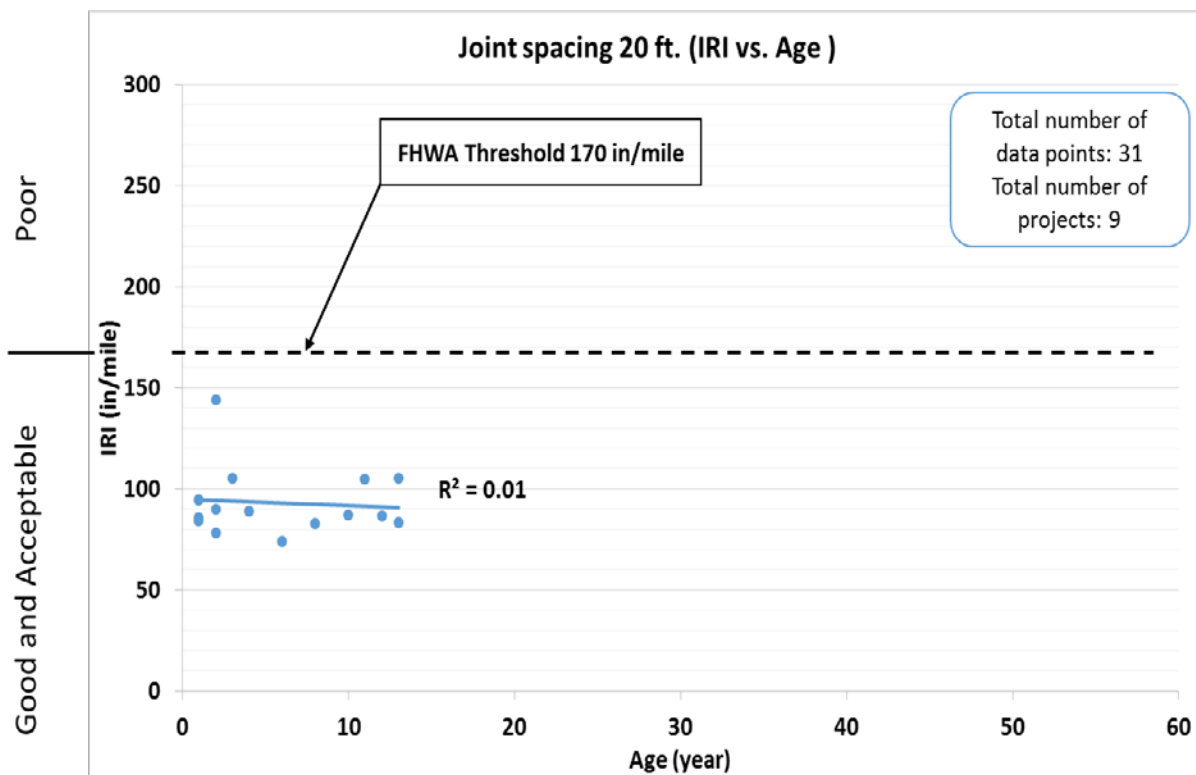
Figure 47. BCOC IRI performance history categorized by concrete overlay joint spacing

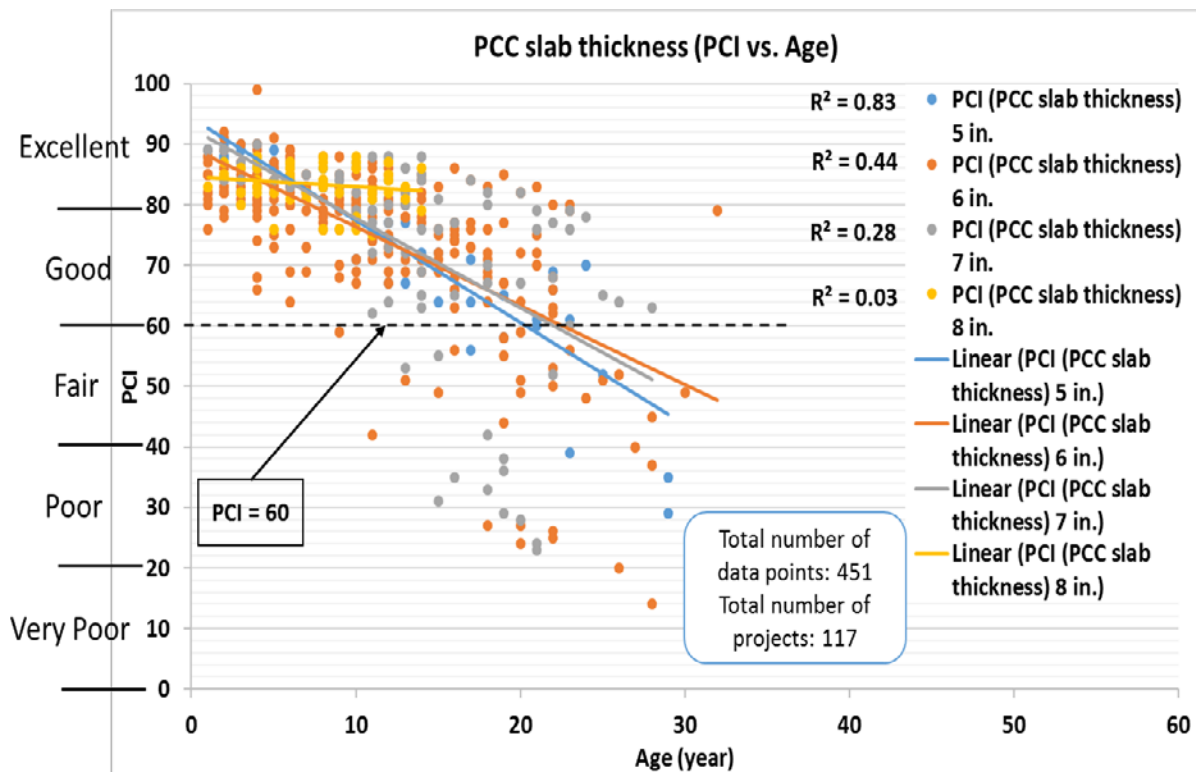
**Figure 48. UBCOC PCI performance history categorized by concrete overlay thickness**

- The PCI trend line for 5-in. thickness decreased gradually during the first 20 years of service life before dropping below 60.
- The PCI trend line for 6-in. thickness decreased gradually during the first 22 years of service life before dropping below 60.
- The PCI values trend line for 7-in. thickness decreased gradually during the first 22 years of service life before dropping below 60.
- The PCI values trend line for 8-in. thickness remained above 80 during the first 15 years of service life.
- Higher overlay thickness led to increased overlay service life.

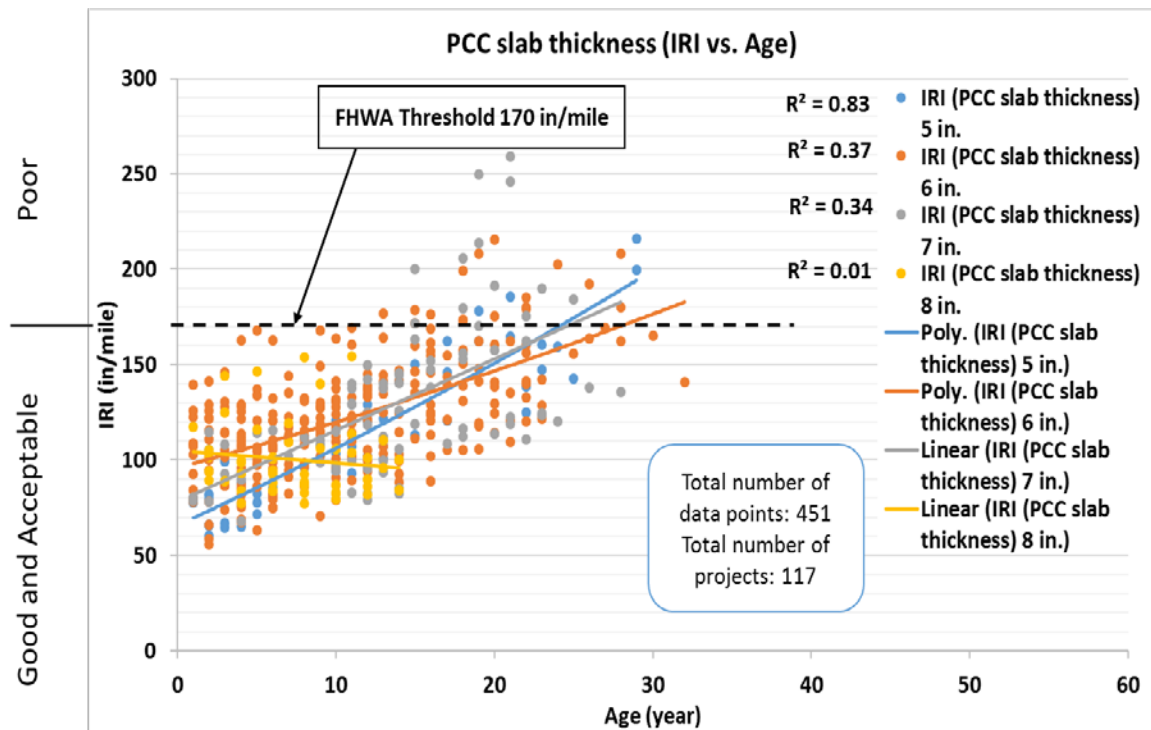
**Figure 49. UBCOC IRI performance history categorized by concrete overlay thickness**

- The IRI trend line for this data set appears to be trending in the opposite direction as expected—i.e., smoothness slightly increasing over time. The collection method changed from a point laser to band laser around 2010–2011. This resulted in a minimal decrease (5–10 in/mi) in IRI for many concrete pavements. With a small data set in which values were relatively constant, this change likely caused the data to trend in the opposite direction as expected.

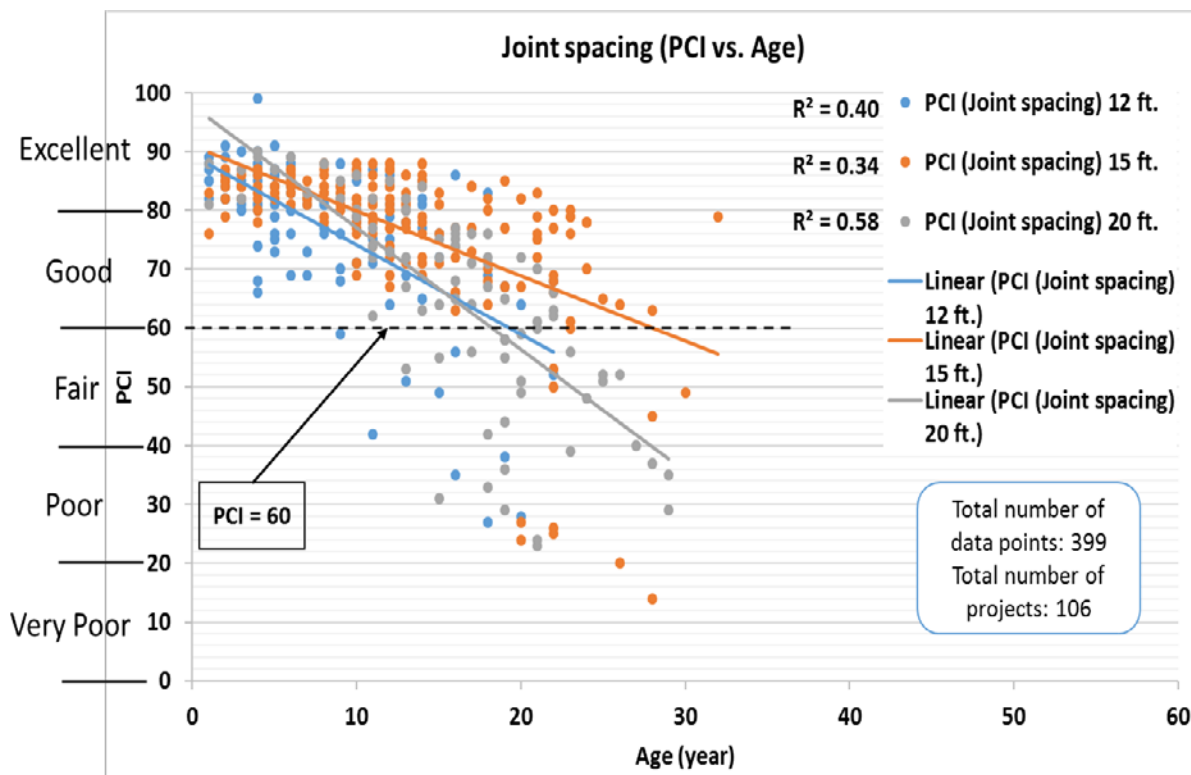
**Figure 50. UBCOC PCI performance history categorized by concrete overlay joint spacing**

- The PCI trend line for 12-ft transverse joint spacing decreased rapidly during the first 20 years of service life before dropping below 60.
- The PCI trend line for 15-ft transverse joint spacing decreased gradually during the first 28 years of service life before dropping below 60.
- The PCI trend line for 20-ft transverse joint spacing decreased rapidly during the first 19 years of service life before dropping below 60.

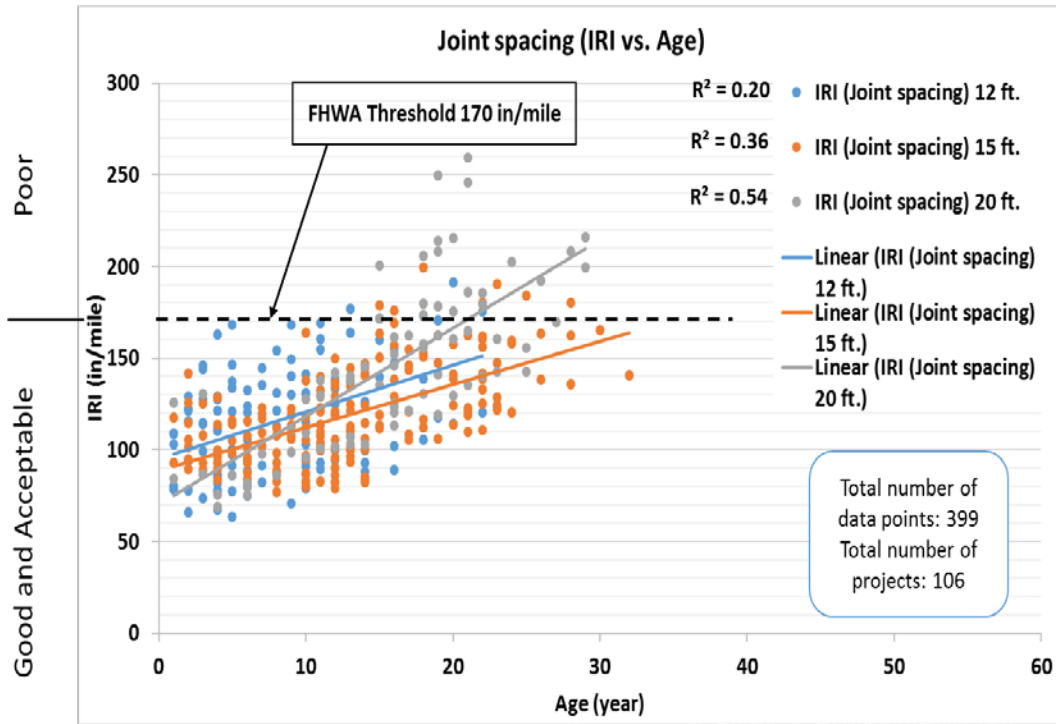
**Figure 51. UBCOC IRI performance history categorized by concrete overlay joint spacing**

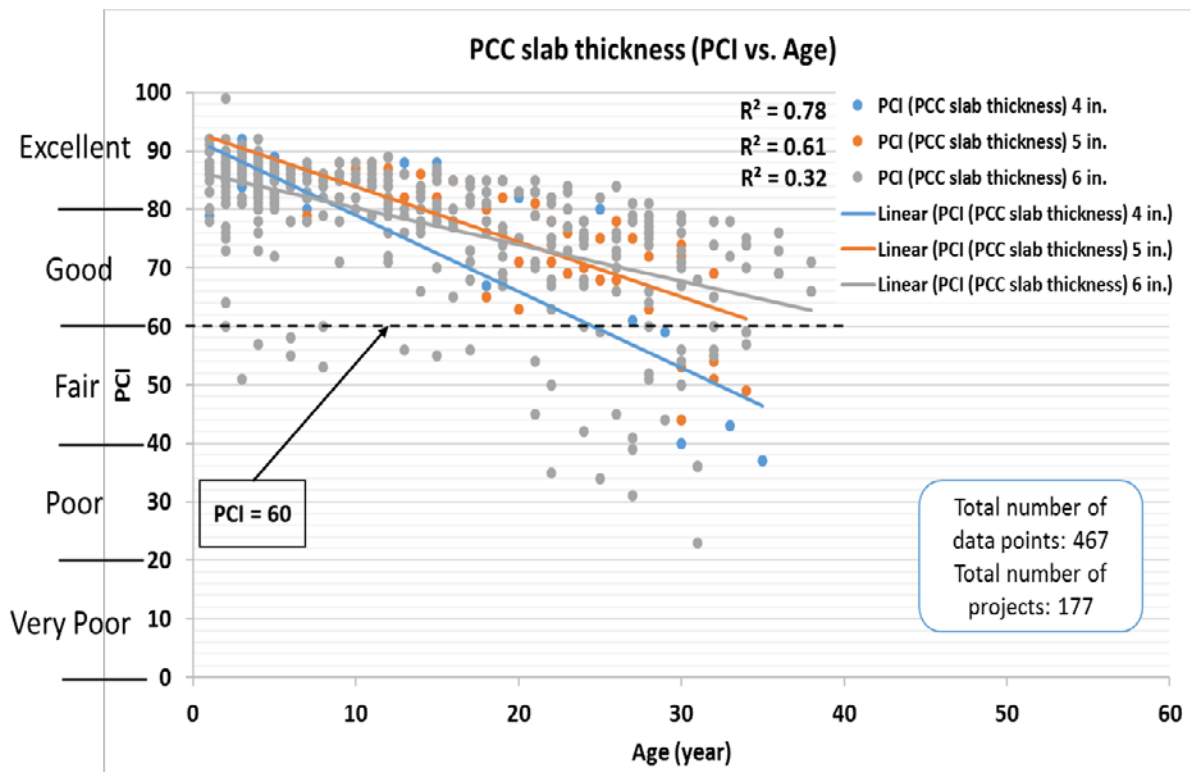
**Figure 52. BCOA PCI performance history categorized by concrete overlay thickness**

- The PCI trend line for 4-in. thickness decreased gradually during the first 25 years of service life before dropping below 60.
- The PCI trend line for 5-in. thickness decreased gradually but remained above 60 during the first 35 years of service life.
- The PCI trend line for 6-in. thickness decreased gradually but remained above 60 during the first 37 years of service life.
- Higher overlay thickness led to increased service life.

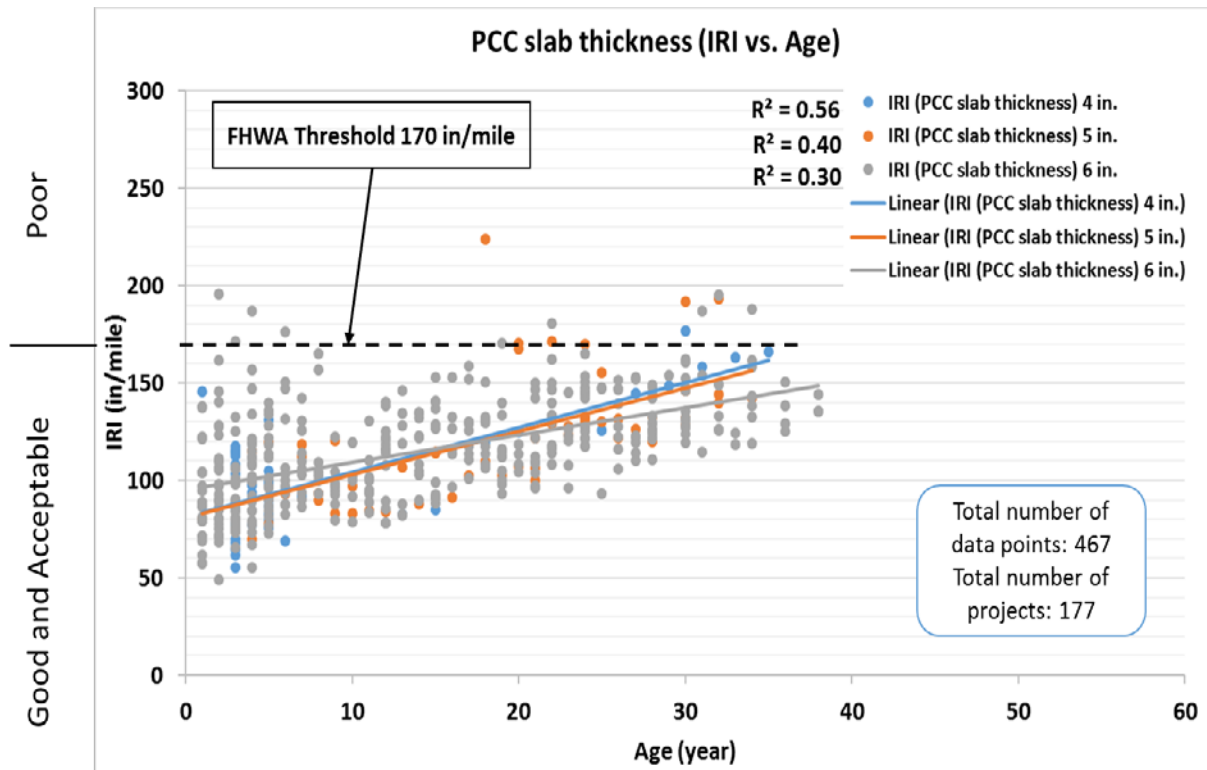
**Figure 53. BCOA IRI performance history categorized by concrete overlay thickness**

- The IRI trend line for 4-in. thickness increased gradually but remained below 170 in/mi during the first 35 years of service life.
- The IRI trend line for 5-in. thickness increased gradually but remained below 170 in/mi during the first 35 years of service life.
- The IRI values trend line for 6-in. thickness increased gradually but remained below 170 in/mi during the first 37 years of service life.

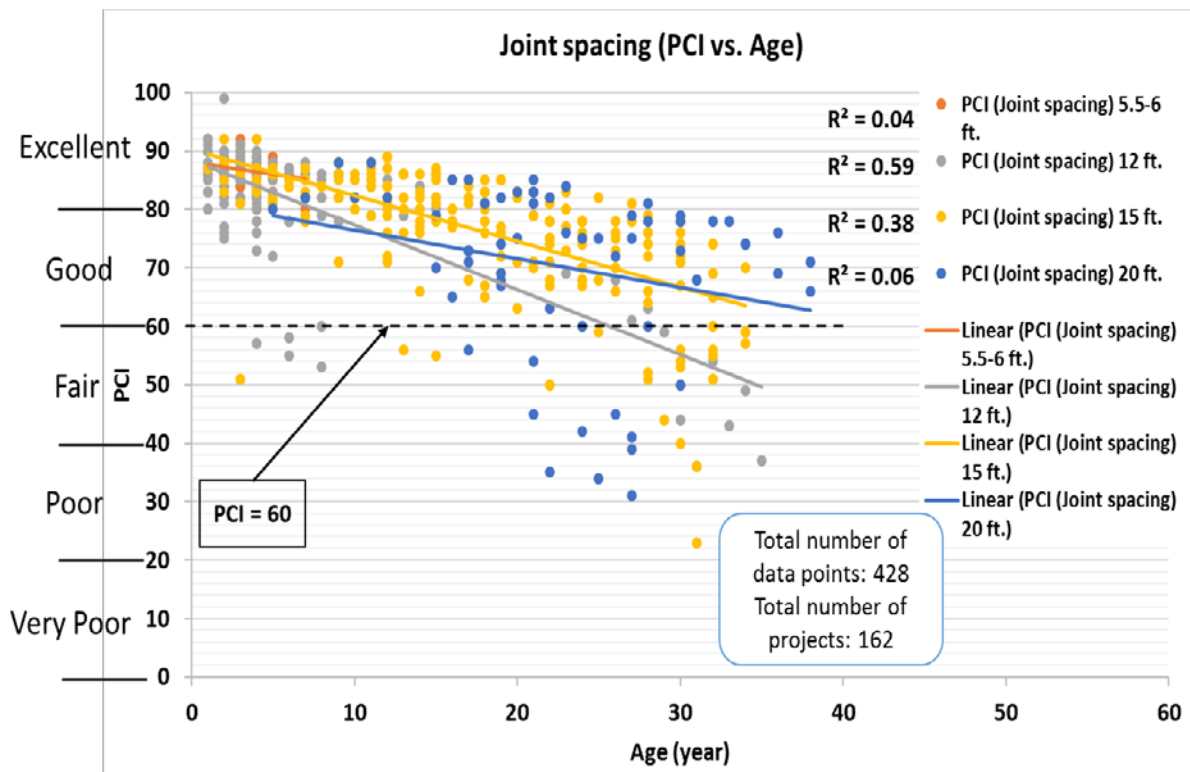
**Figure 54. BCOA PCI performance history categorized by concrete overlay joint spacing**

- The PCI trend line for 5.5- to 6-ft transverse joint spacing decreased modestly and remained above 80 during the first 10 years of service life.
- The PCI trend line for 12-ft transverse joint spacing decreased rapidly during the first 25 years of service life before dropping below 60.
- The PCI trend line for 15-ft transverse joint spacing decreased gradually during the first 35 years of service life before dropping below 60.
- The PCI values trend line for 20-ft transverse joint spacing decreased gradually but remained above 60 during the first 37 years of service life.

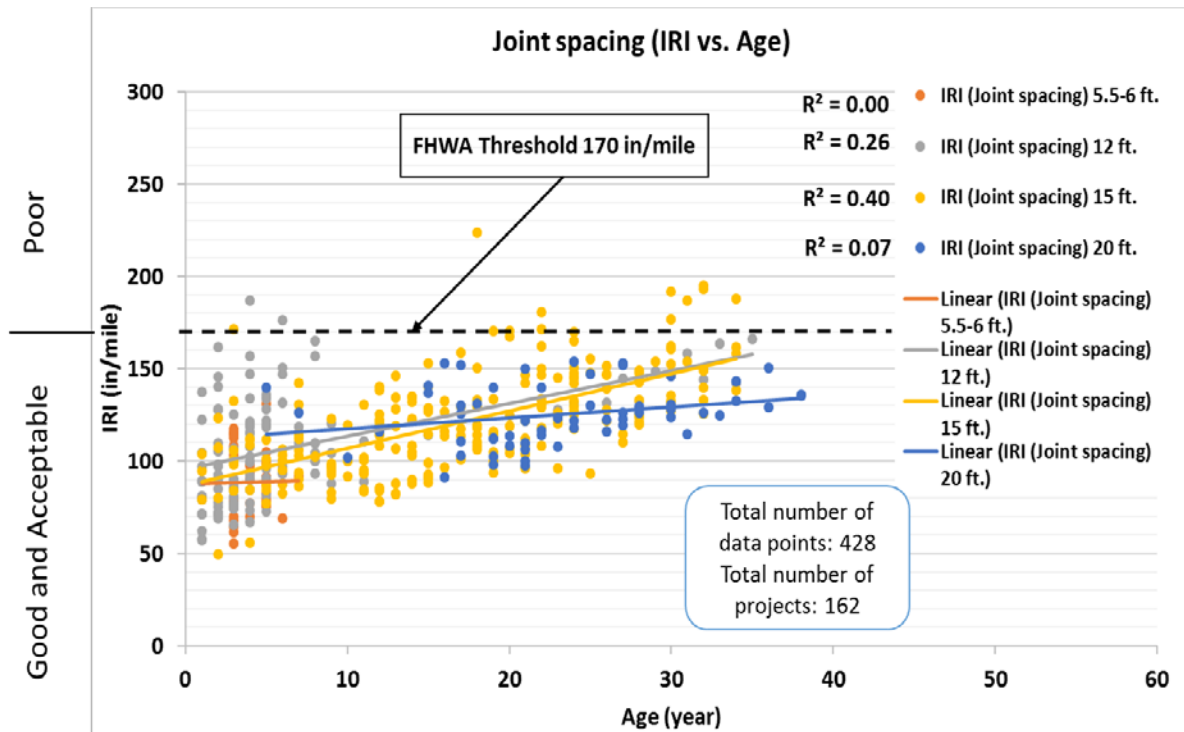
**Figure 55. BCOA IRI performance history categorized by concrete overlay joint spacing**

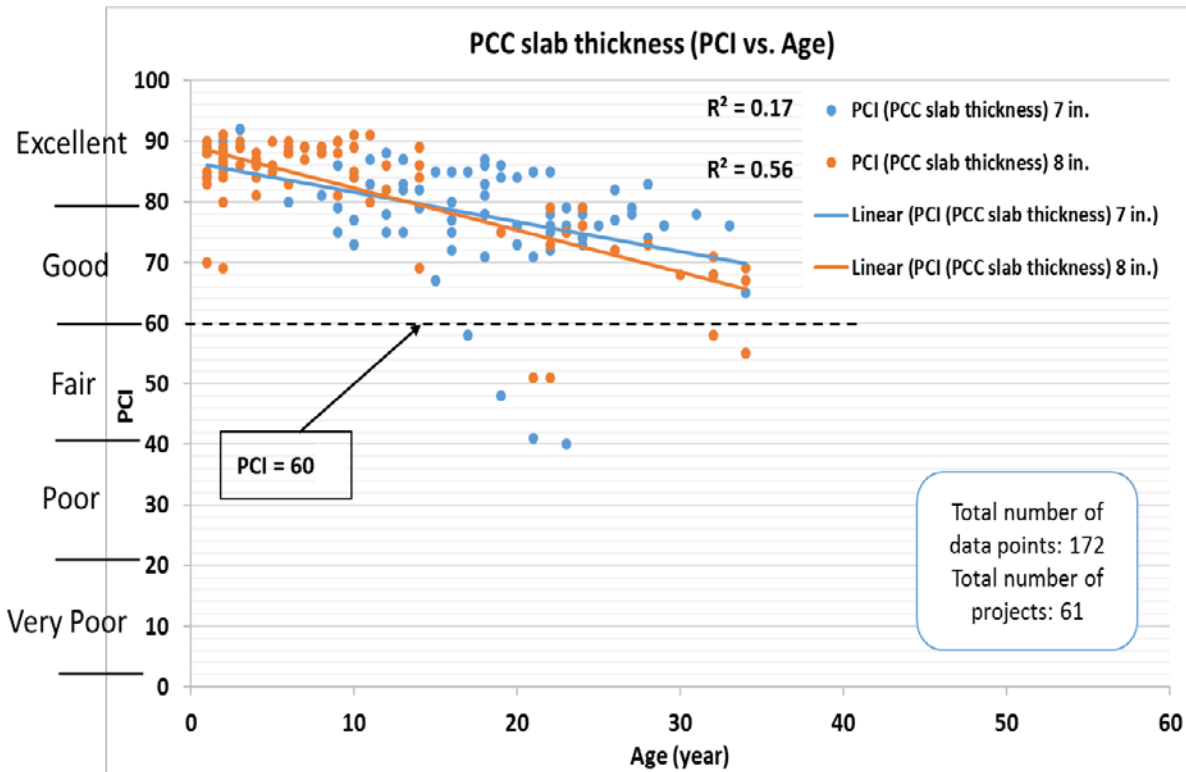
**Figure 56. UBCOA PCI performance history categorized by concrete overlay thickness**

- The PCI values trend line for 7-in. and 8-in. thicknesses decreased gradually but remained above 60 during the first 35 years of service life.

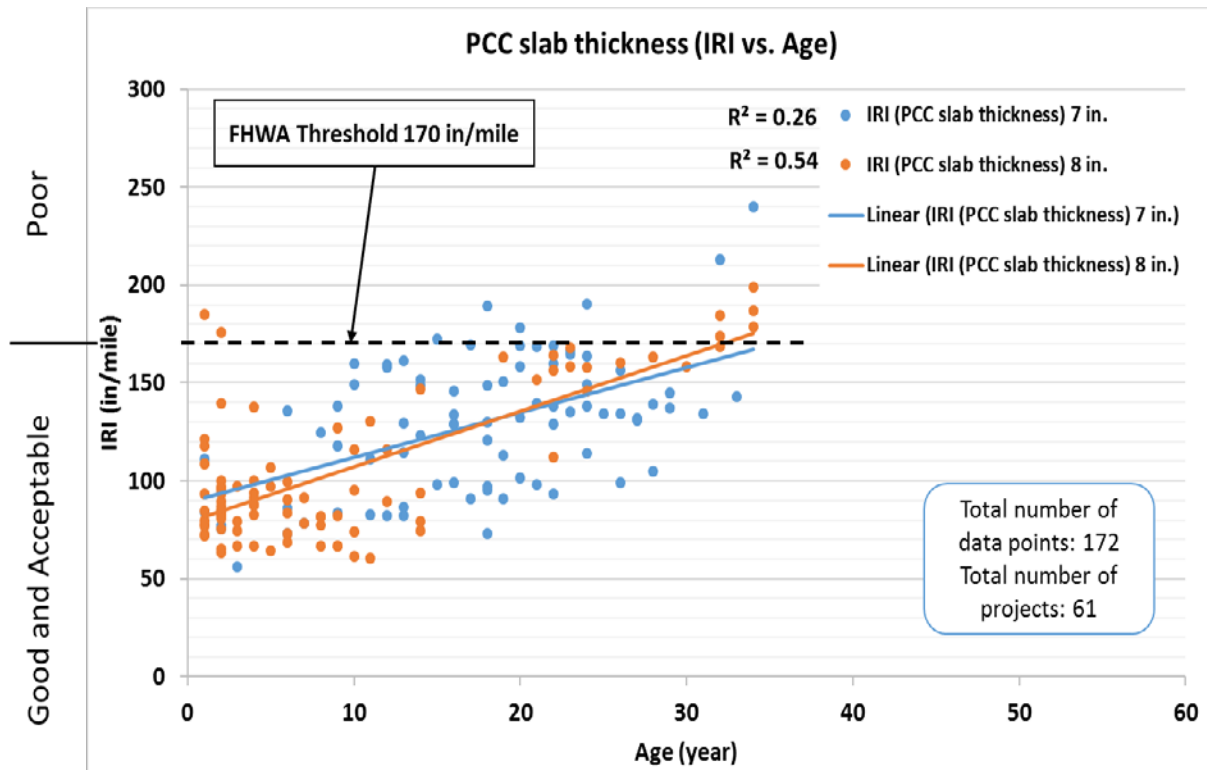
**Figure 57. UBCOA IRI performance history categorized by concrete overlay thickness**

- The IRI trend line for 7-in. thickness increased gradually but remained below 170 in/mi during the first 35 years of service life.
- The IRI trend line for 8-in. thickness increased gradually during the first 33 years of service life before exceeding 170 in/mi.

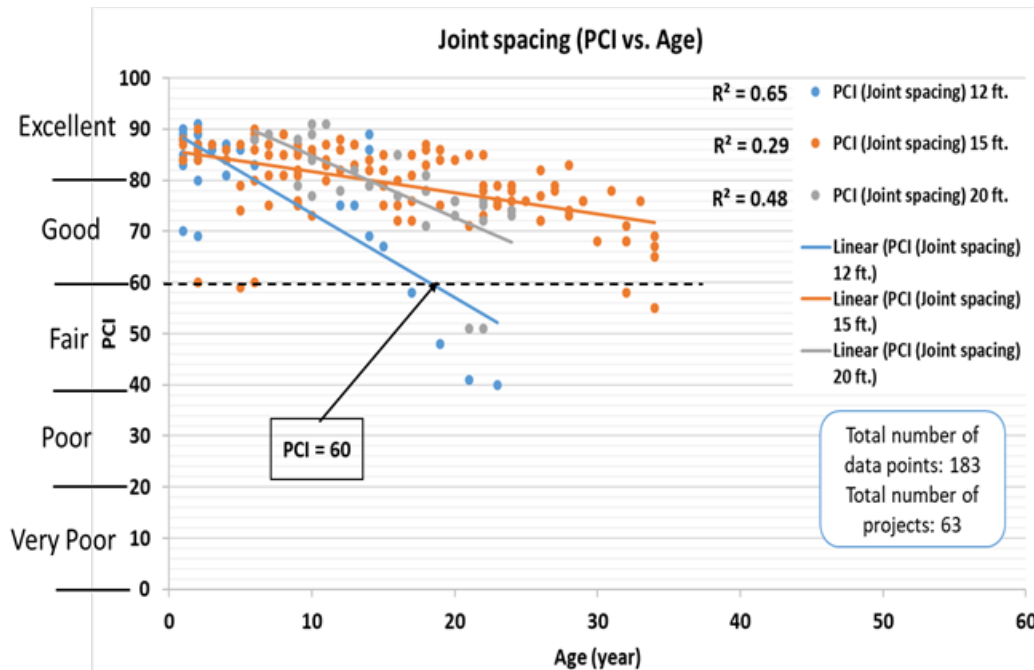
**Figure 58. UBCOA PCI performance history categorized by concrete overlay joint spacing**

- The PCI trend line for 12-ft transverse joint spacing decreased rapidly during the first 18 years of service life before dropping below 60.
- The PCI trend line for 15-ft transverse joint spacing decreased gradually but remained above 70 during the first 35 years of service life.
- The PCI trend line for 20-ft transverse joint spacing decreased gradually but remained above 70 during the first 22 years of service life.

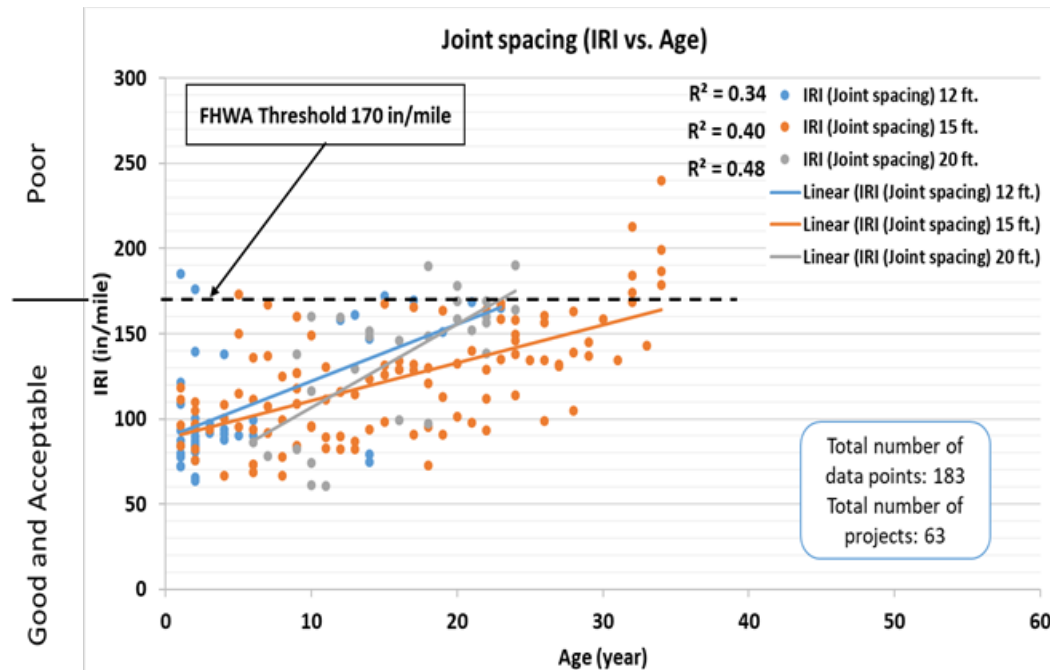
**Figure 59. UBCOA IRI performance history categorized by concrete overlay joint spacing**

- The IRI values trend line for 12-ft transverse joint spacing increased gradually and remained below 170 in/mi during the first 22 years of service life.
- The IRI values trend line for 15-ft transverse joint spacing increased gradually but remained below 170 in/mi during the first 35 years of service life.
- The IRI values trend line for 20-ft transverse joint spacing increased gradually but remained below 170 in/mi during the first 22 years of service life.

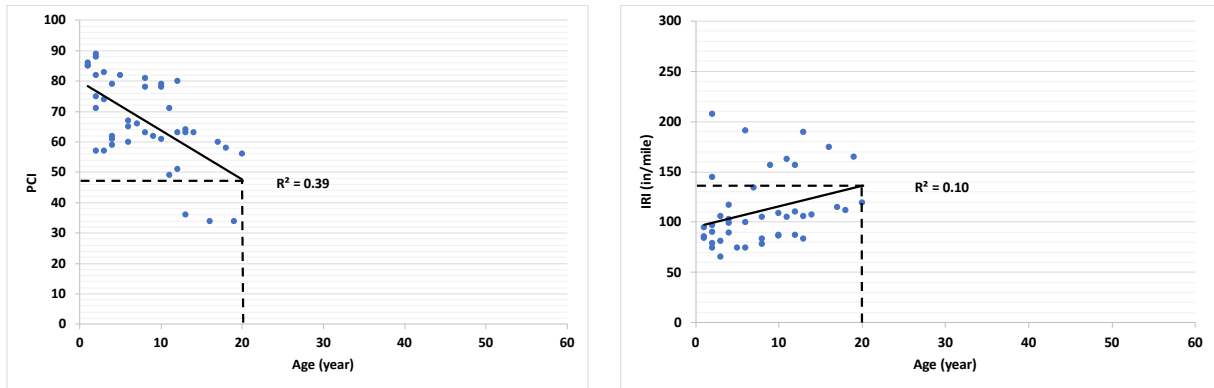
**Figure 60. BCOC performance at Year 20**

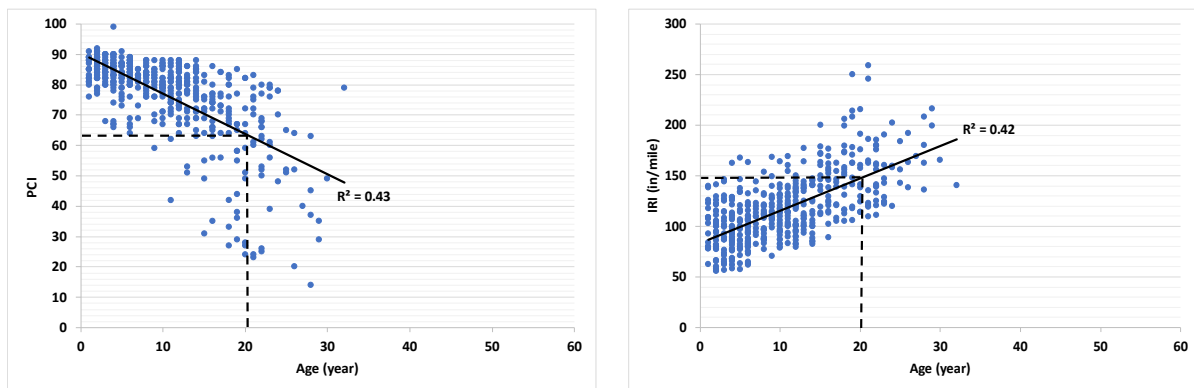
**Figure 61. UBCOC performance at Year 20**

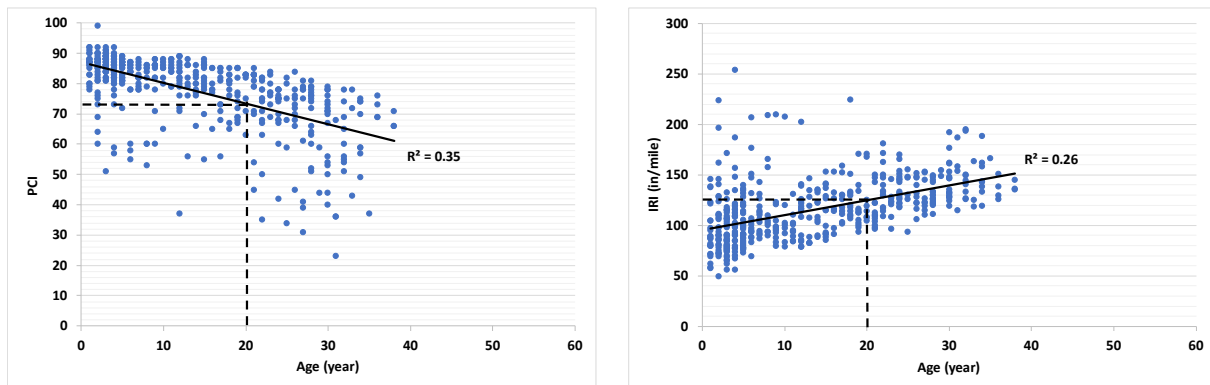
**Figure 62. BCOA performance at Year 20**

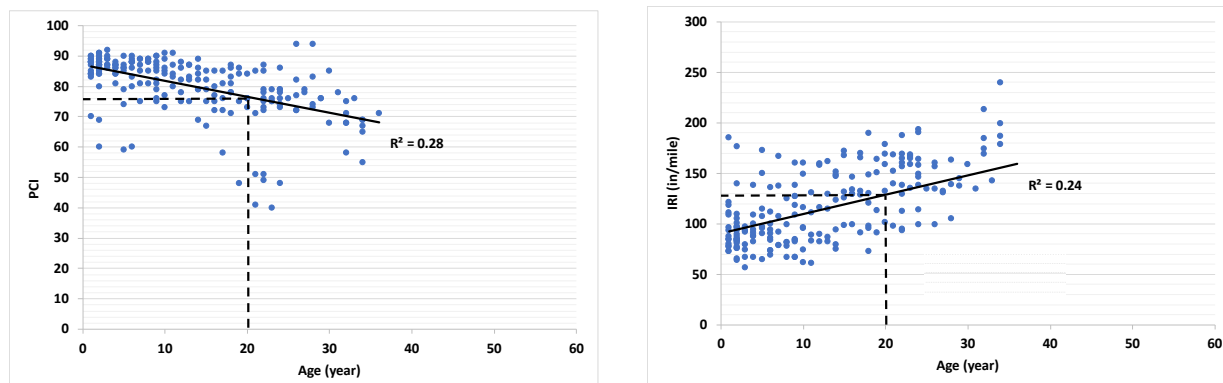
**Figure 63. UBCOA performance at Year 20**
