# Concrete Overlay Performance on Iowa's Roadways

**Field Data Report  
July 2017**

National Concrete Pavement  
Technology Center

**Sponsored by**  
Iowa Highway Research Board  
(IHRB Project TR-698)  
Iowa Department of Transportation  
(InTrans Project 15-559)

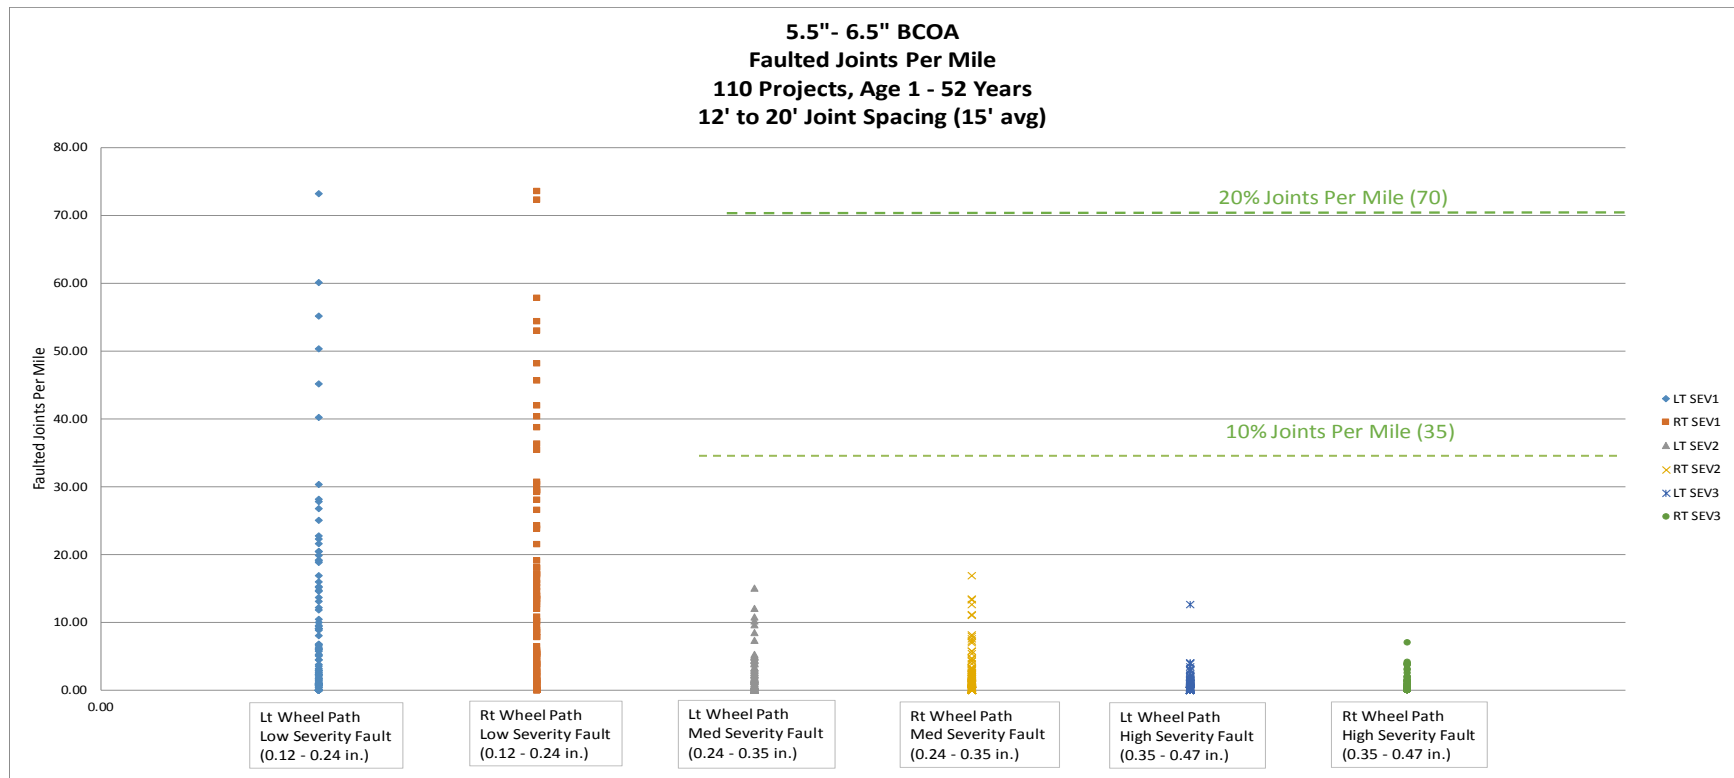
As seen in Figure 64, 8% (9 of 110) of the 5.5- to 6.5-in. BCOA projects have more than 40 faulted joints in the right wheel path in the low-severity category. Assuming an average joint spacing of 15 ft for these projects (352 joints per mile), 40 faulted joints per mile represent 11.3% of the total joints per mile.

**Figure 64. Faulted joints per mile (5.5- to 6.5-in. BCOA) based on severity levels 1–3**

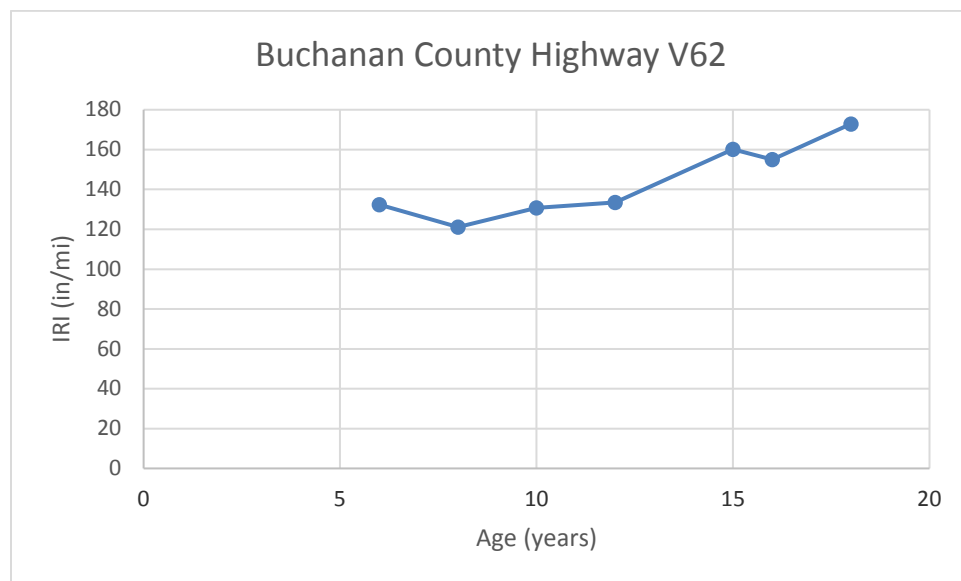
**Figure A.4. IRI performance of Buchanan County V-62**

This project was selected for review mainly because of its high IRI value, which measured 172 in/mi in 2014 at a pavement age of 18 years. Discussion with the county engineer confirmed that the overlay had a rough ride, which was attributed to roughness upon original construction and curling and warping (as opposed to faulting). As a result, the entirety of the project was rehabilitated with diamond grinding in 2015. A close-up of the ground surface of the overlay taken at the time of the field review in 2016 is shown in Figure A.5.

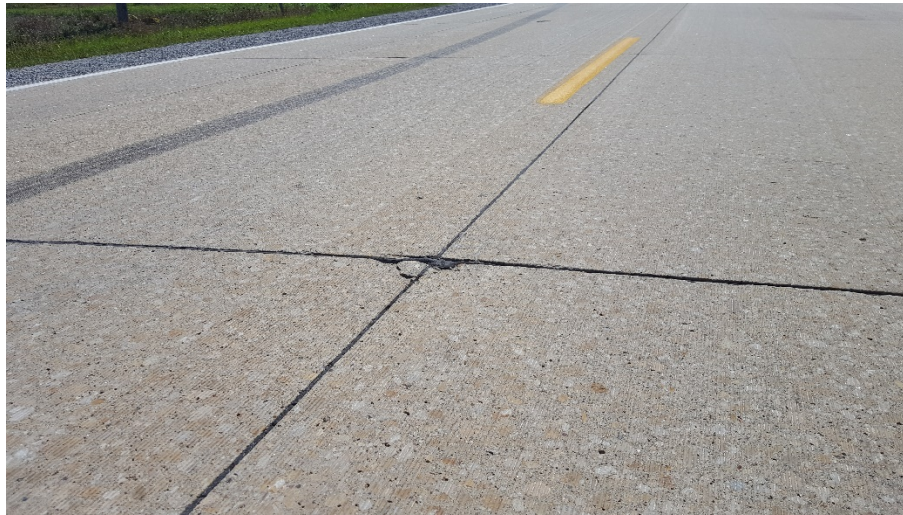
**Figure A.5. Surface post diamond grinding on Buchanan County V-62, September 2016**

Although the most recently collected performance data predates the diamond grind, as of 2016, considerable smoothness had been restored to the overlay.

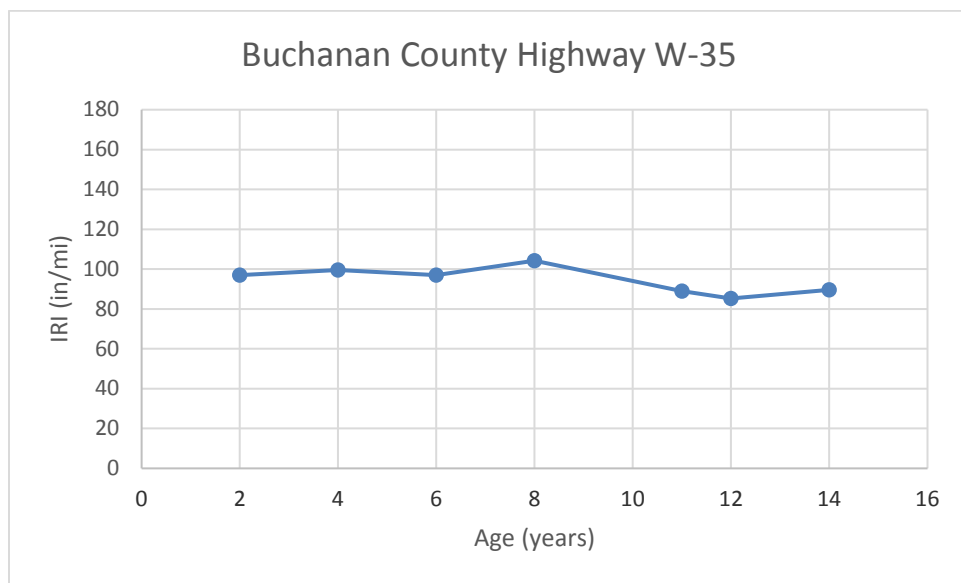
**Figure A.7. IRI performance of Buchanan County W-35**

No real physical distresses were observed on this project, but a relatively rough ride was noted during the review in September 2016. This roughness appeared to be related to curling and warping, as no significant faulting had developed. Given the most recent IRI reading in 2014 was 89.6 in/mi, this roughness may be a recent development that should be monitored over time. (A drop in IRI from a previous high of 104.2 in/mi recorded in 2008 likely resulted primarily from the change in how IRI was measured, as no rehabilitation activities had occurred on this overlay.)

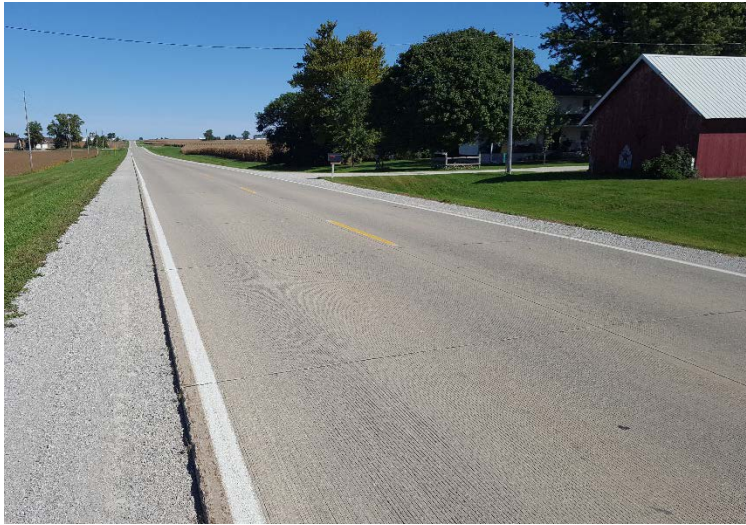
**Figure A.8. Overview of Buchanan County W-40**

Overall, Buchanan County W-40 was found to be in good condition and the performance metrics were in line with the overall trend of similarly designed overlays (PCI of 85 and IRI of 93.2 in/mi at an age of 8 years). However, some distresses had developed in areas along the southbound pavement edge as shown in Figure A.11.

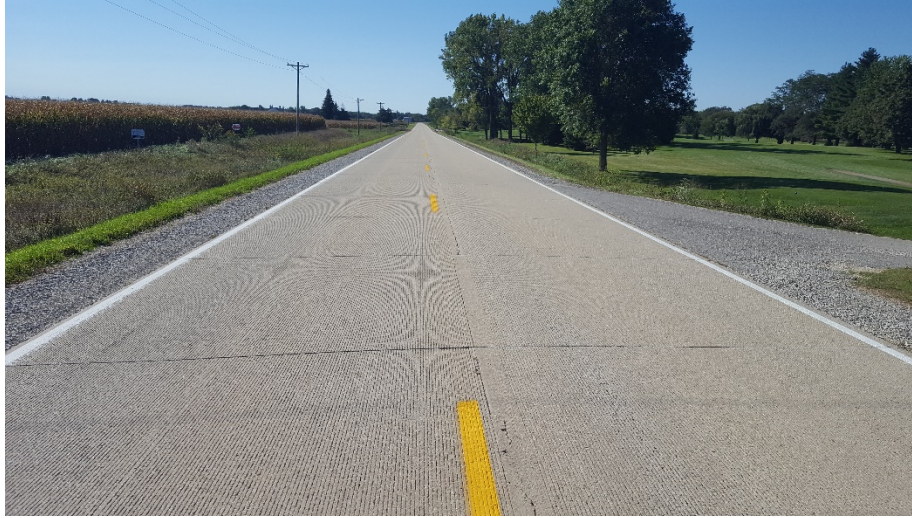
**Figure A.12. Overview of Buchanan County W-45, September 2016**

County W-45 was found to have performed well at 13 years of service, featuring a PCI of 79 in/mi when last measured in 2014. Some distress was associated with random longitudinal cracking caused by failure to establish the longitudinal joint during construction. This project was initially selected for field review to investigate why PCI and IRI appeared to have rebounded significantly; between 2008 and 2011, PCI increased from 72 to 79 and IRI fell by nearly 20 in/mi.

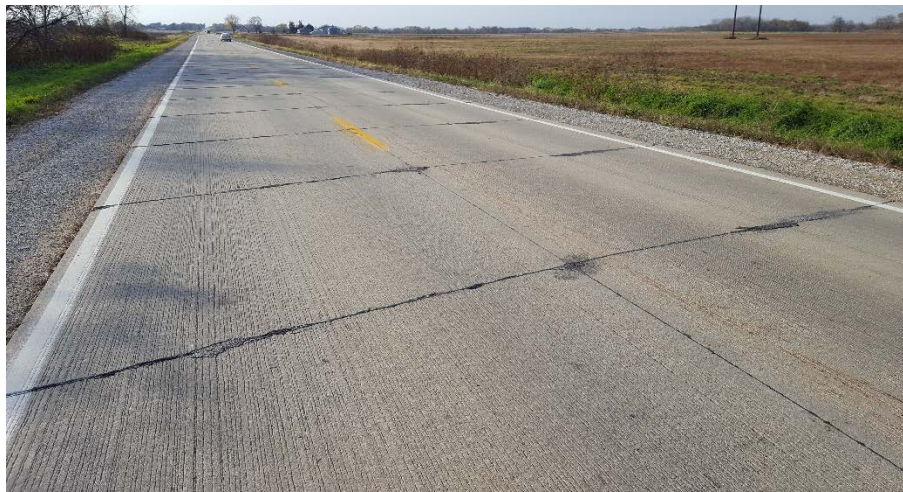
**Figure A.15. Overview of Dallas County F-31 west of Granger, November 2016**

In the section west of Granger, shown in Figure 76(b), transverse joint deterioration was concentrated primarily in areas near a creek crossing. In addition, joints and spalled areas were saturated with water.

These observations suggested that poor local drainage conditions were the primary factor driving the distresses. Some cracking associated with loss of support at the pavement edge was also observed near the creek crossing, which could also have been related to drainage issues causing erosion of the underlying soil.

As is evident in Figure A.15, transverse joint deterioration developed at certain locations along Dallas County F-31, particularly as the overlay approached a creek crossing. Despite sunny conditions on the afternoon of the field review, shadowing from moisture was observed at many of the deteriorated joints and water was found sitting within a spalled joint area, as shown in Figure A.18.

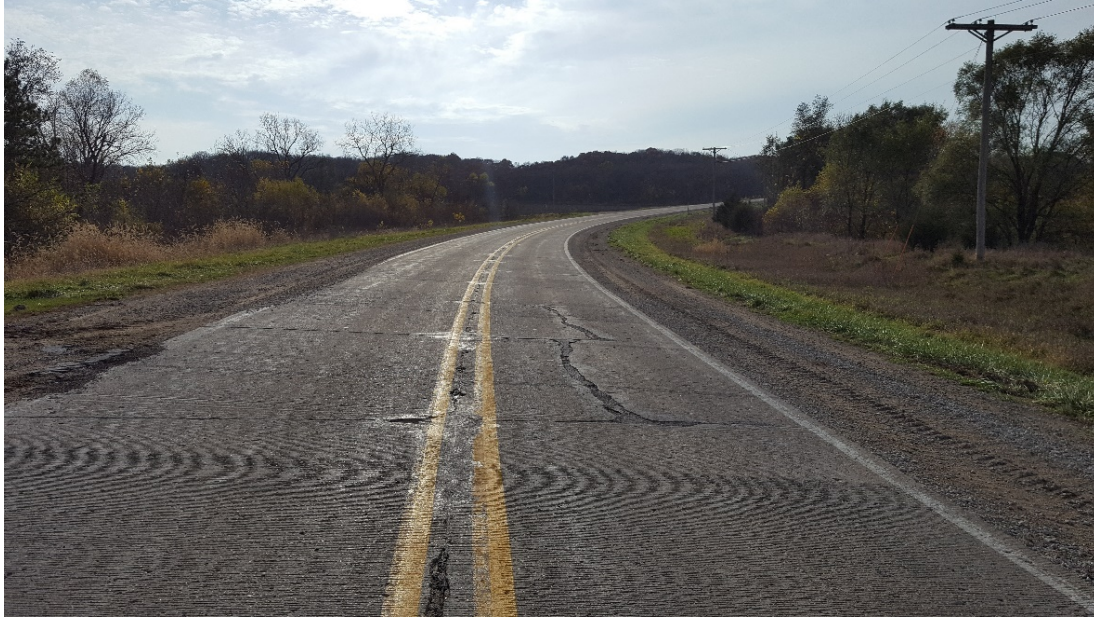
**Figure A.20. Overview of Dallas County F-31 west of Minburn, November 2016**

The section west of Minburn, shown in Figure 76(a), featured substantial longitudinal joint deterioration. This deterioration appeared to result from poor-durability concrete and poor drainage at the longitudinal joint.

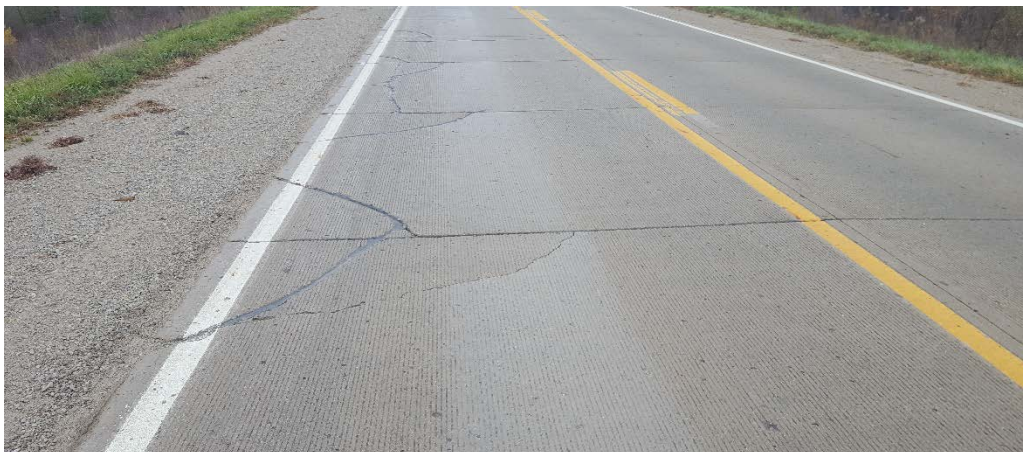
**Figure A.24. Overview of Dallas County F-90, November 2016**

Dallas County F-90 was observed to have a significant amount of corner and longitudinal cracking, which can be seen in Figure A.24, contributing to a quickly declining PCI of 68 at an age of 9 years. Faulting was also beginning to develop at the joints.

Discussion with county staff indicated that this section served a quarry and featured upwards of 30 to 40% truck traffic. Therefore, the cracking likely resulted from load failure.

The cracks appeared to start at the corners of the slab before developing into further longitudinal and diagonal cracking, which was an observation based on the fact that many more corner cracks had been sealed by maintenance crews compared to longitudinal and diagonal cracks. The engineer also noted that maintenance crews observed water sitting underneath the underlying concrete slab when performing patching activities, indicating a poorly draining subgrade.

Given the heavy truck traffic and poor drainage conditions, this overlay likely would have performed better if it was thicker or had shorter joint spacing. The predominance of corner cracking may suggest, in particular, that curling and warping stresses, caused by the combination of a large slab size (12-ft) and a skewed joint pattern, were significant contributors to the observed distresses. An increase in slab thickness or a reduction in joint spacing to about 6-ft would likely have helped mitigate the stresses from the heavy truck traffic.

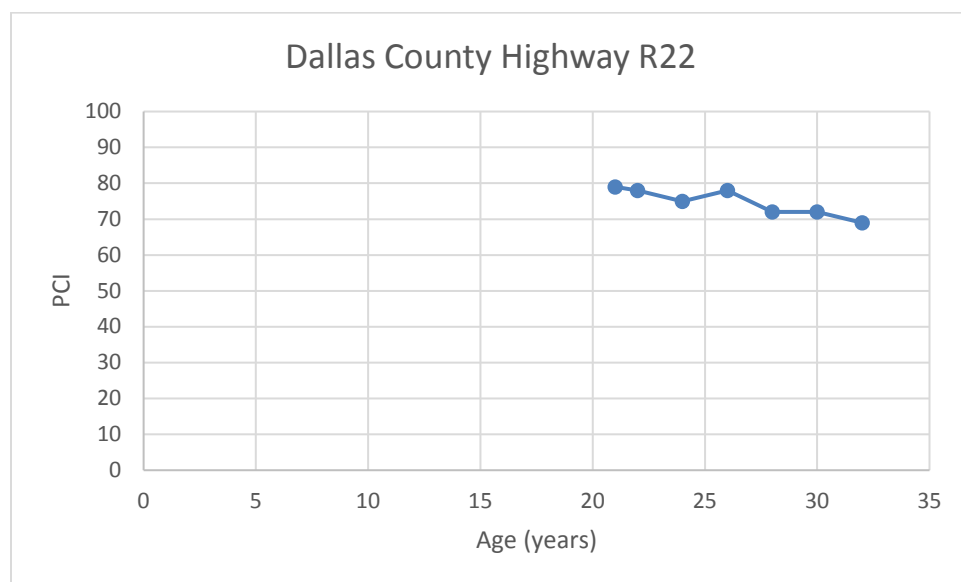
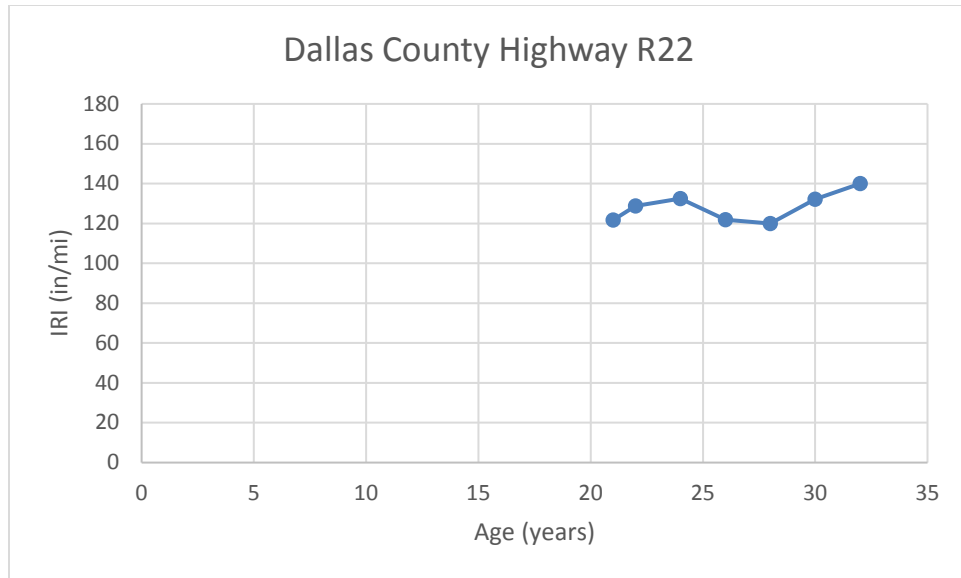
As seen in the performance plots in Figures A.28 and A.29, Dallas County R-22 has continued to exhibit excellent performance, while in service for more than 30 years, featuring a PCI of 69 at a pavement age of 32 years. The only notable distresses observed on this project were occasional instances of loss of support along the pavement edge, with one example shown in Figure A.30.

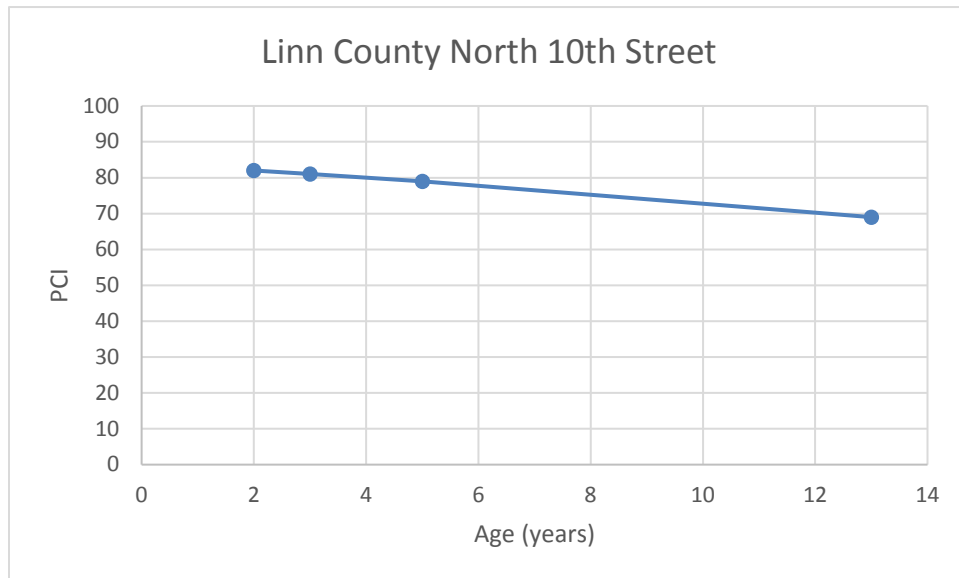
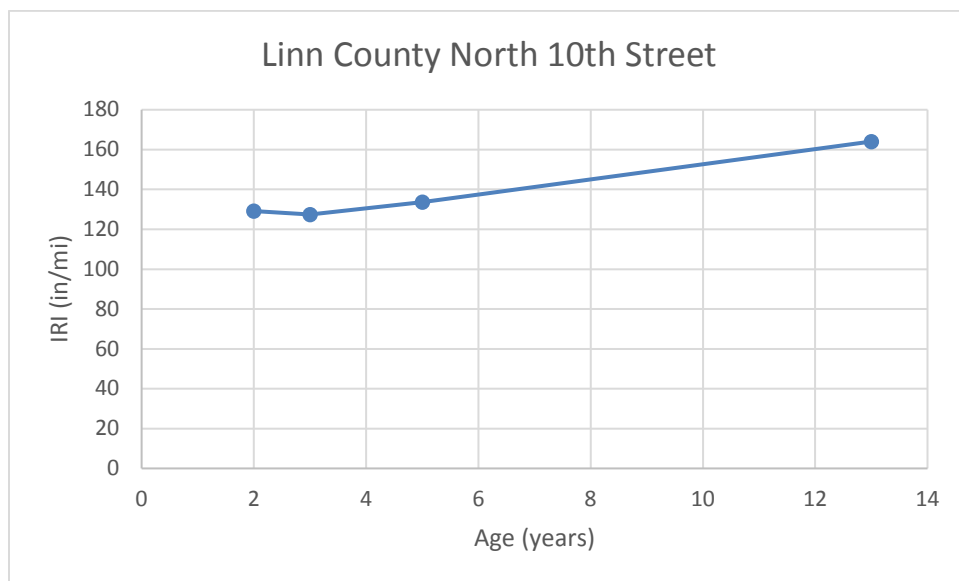
North 10th Street was observed to exhibit a rough ride at a young age (IRI of 164 in/mi at 13 years), and the review found that the roughness was primarily due to significant faults that occurred at a frequency of about every three transverse joints. In one area of study, this faulting resulted in considerable joint deterioration, as shown in Figure A.36.

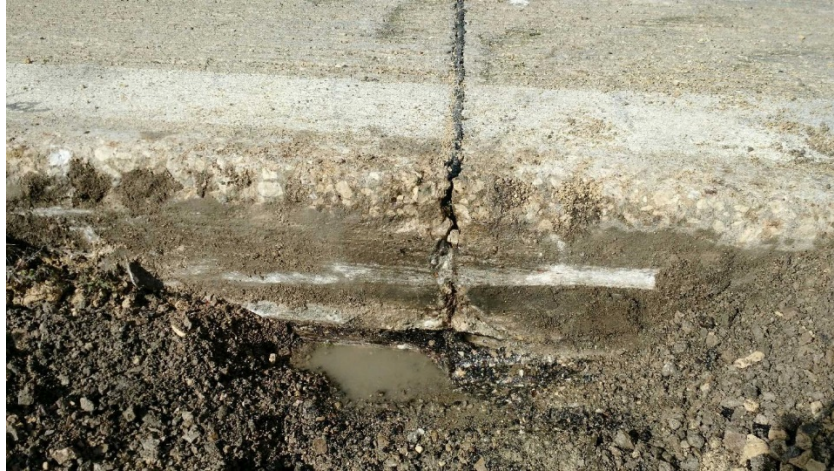
**Figure A.37. Activated transverse joint in slab adjacent to blow-up on Linn County North 10th Street**

One hypothesis for the development of these faults and accompanying distresses was that they may have occurred over areas of D-cracking in the original, underlying concrete pavement. Another hypothesis was that the faults may have developed because some or most transverse joints may never have activated, leading to wide working cracks where the joints did manage to activate. When repairing a joint distress area in late 2016, county crews dug along the shoulder at the transverse joints in the adjacent slabs and confirmed that the transverse joints in the adjacent slabs had indeed activated, as shown in Figure A.37.

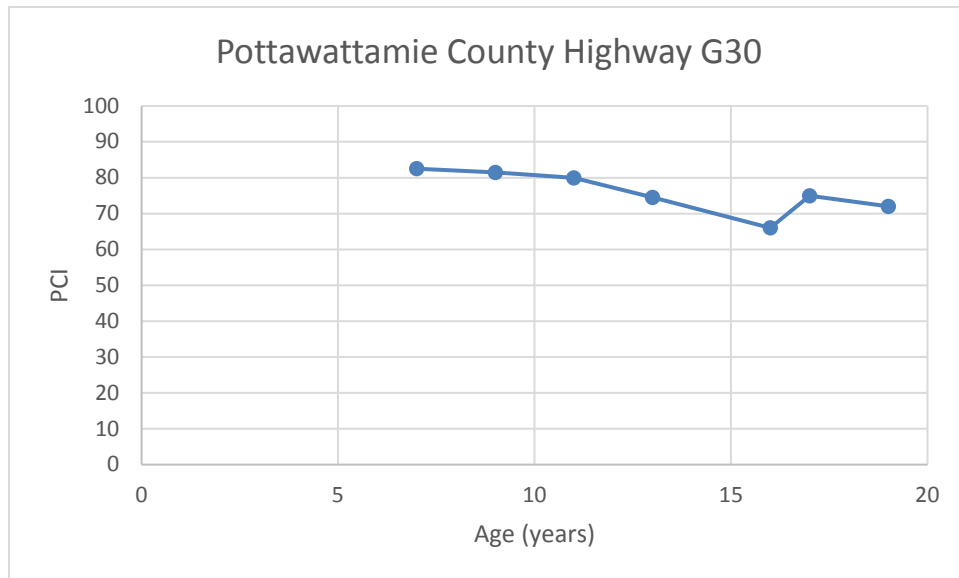
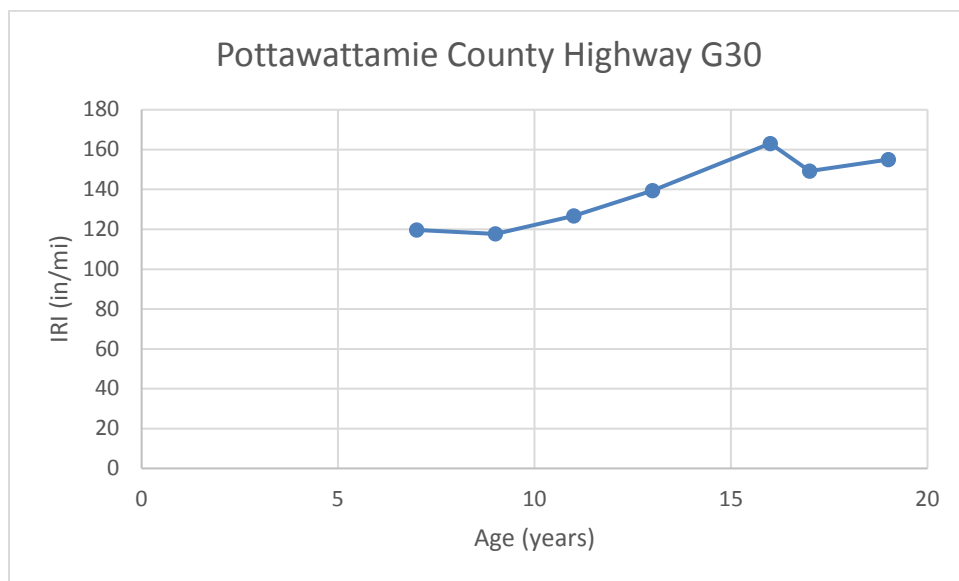
Pottawattamie County G-30 has performed well for more than 20 years of service. At the time of the most recent measurement in 2014, the project featured a PCI of 72. (The jump from a PCI of 66 in 2011 would appear to be a result of the change in how IRI was measured, accompanying a drop in IRI from 163 in/mi in 2011 to 149 in/mi in 2012.) With the exception of patches in a few areas and rare instances of random cracking along the longitudinal joint, few distresses were observed along the overlay.
