Performance Evaluation of Recent Improvements of Bridge Abutments and Approach Backfill

Sponsored by:
The Iowa Highway Research Board
TR-736

Final Report
November 19, 2018

Prepared by:
Mohamed K. ElBatanouny, Ph.D., S.E., P.E.
Kathleen A. Hawkins
Nathaniel S. Rende, S.E., P.E.
Paul D. Krauss, P.E.
Wiss, Janney, Elstner Associates, Inc.
Northbrook, Illinois 60062

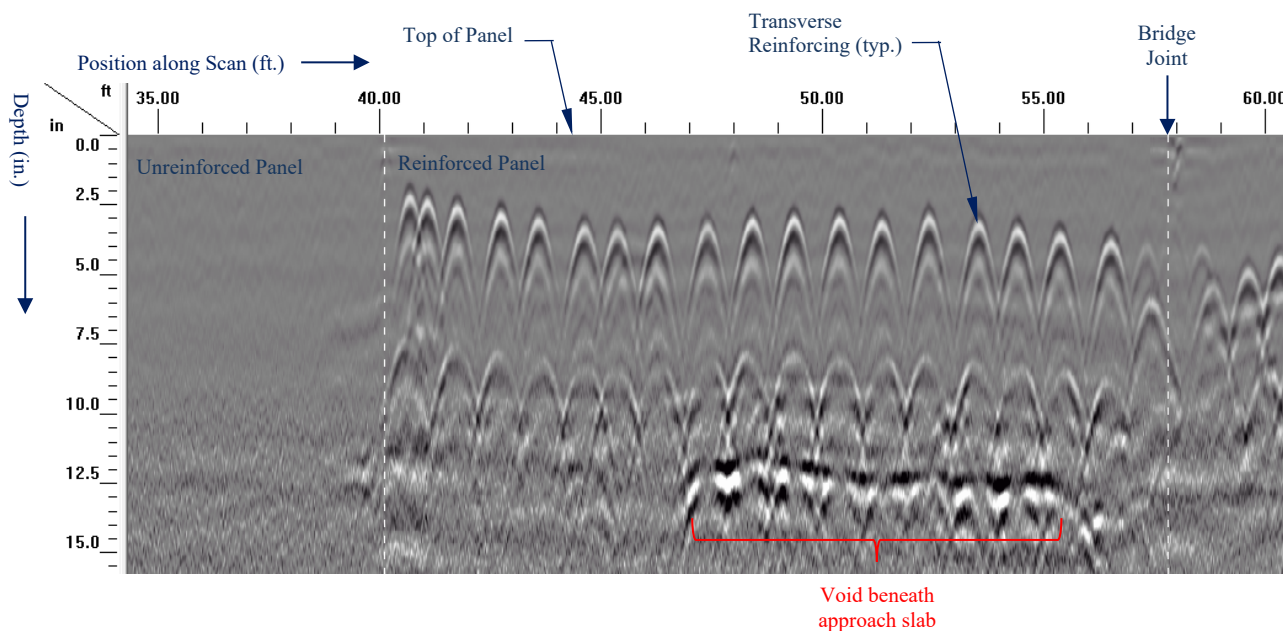
Figure 3.2. Typical processed and filtered GPR scan indicating presence of void under the approach slab adjacent to the bridge joint. Example represents portion of Scan 07 collected at Bridge 5622.50061, West approach; North shoulder.

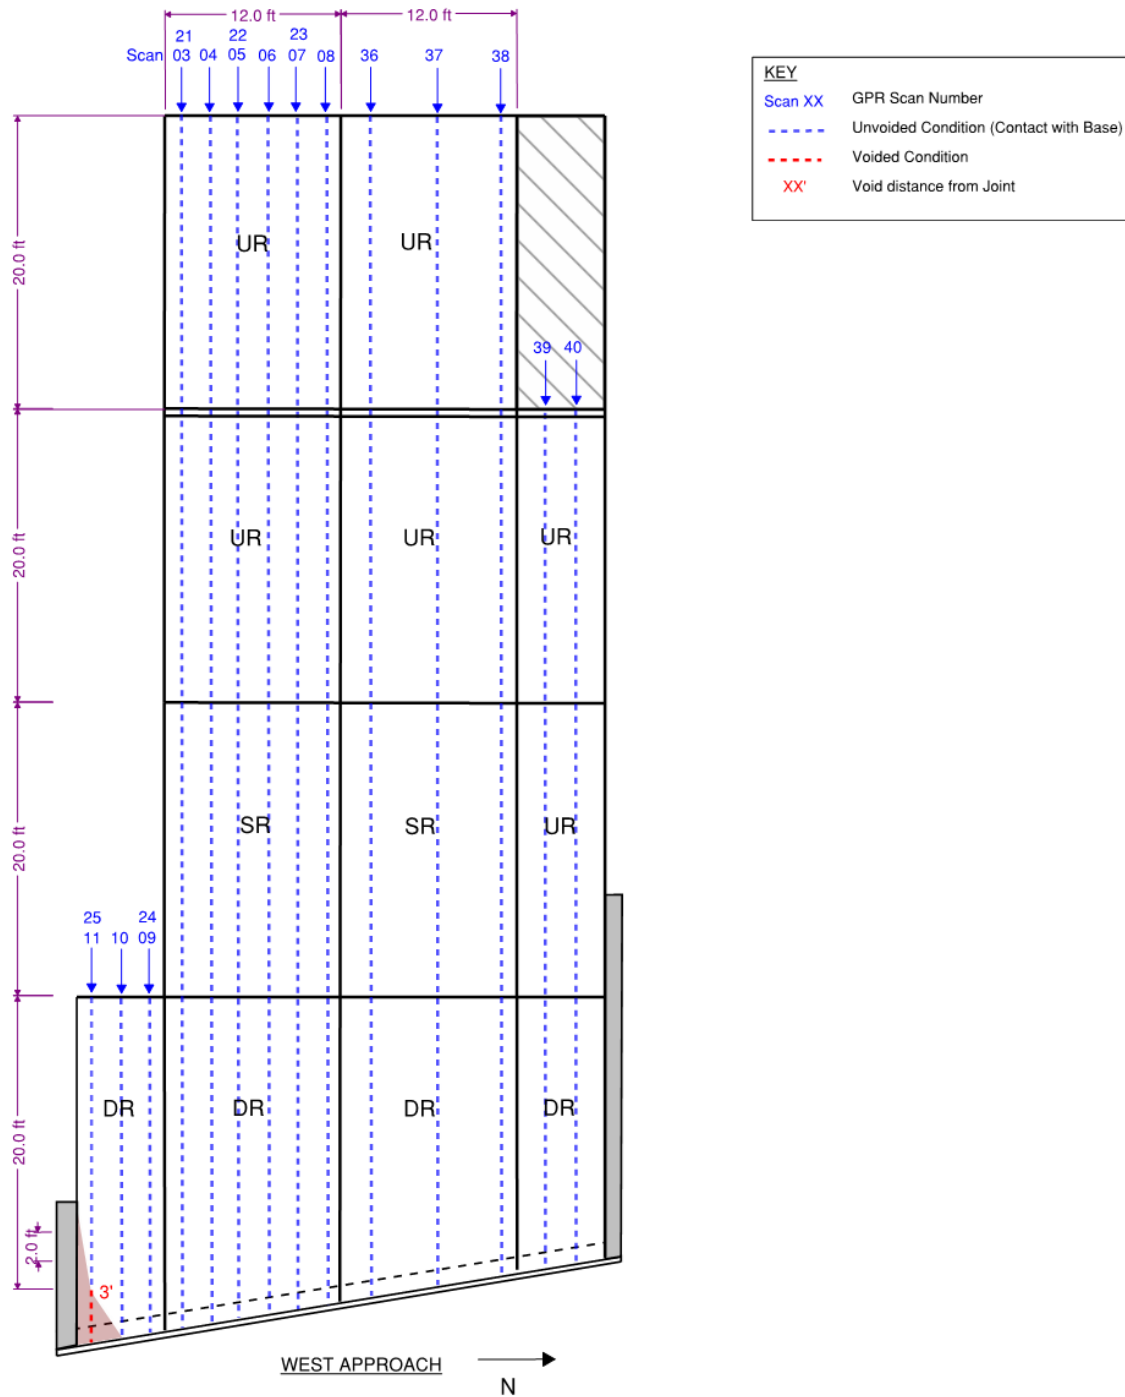
Figure 3.11. GPR results at west approach of Bridge 5111.50034.

GPR scanning results for the east and west approach are provided in Figure 3.10 and Figure 3.11, respectively. Each figure provides a plan view of the approach slab system. The dotted lines indicate the discrete GPR scans collected, generally in the direction toward the bridge. The scan lines have been color-coded to indicate either an unvoided condition (contact between bottom of slab and the base material, shown in blue) or a voided condition (shown in red). Additionally, the likely extent of voiding based on the discrete scan results is shown as a shaded red region. The results showed that voids beneath the slabs of this fixed abutment were relatively minor. The east approach had one void that extends 5 feet into the approach slab under the shoulder of the eastbound lane, and a narrow void that extends 9 feet into the approach slab on the shoulder side of the westbound lane. The west approach only had one void that extends 3 feet under the slab along the south barrier.

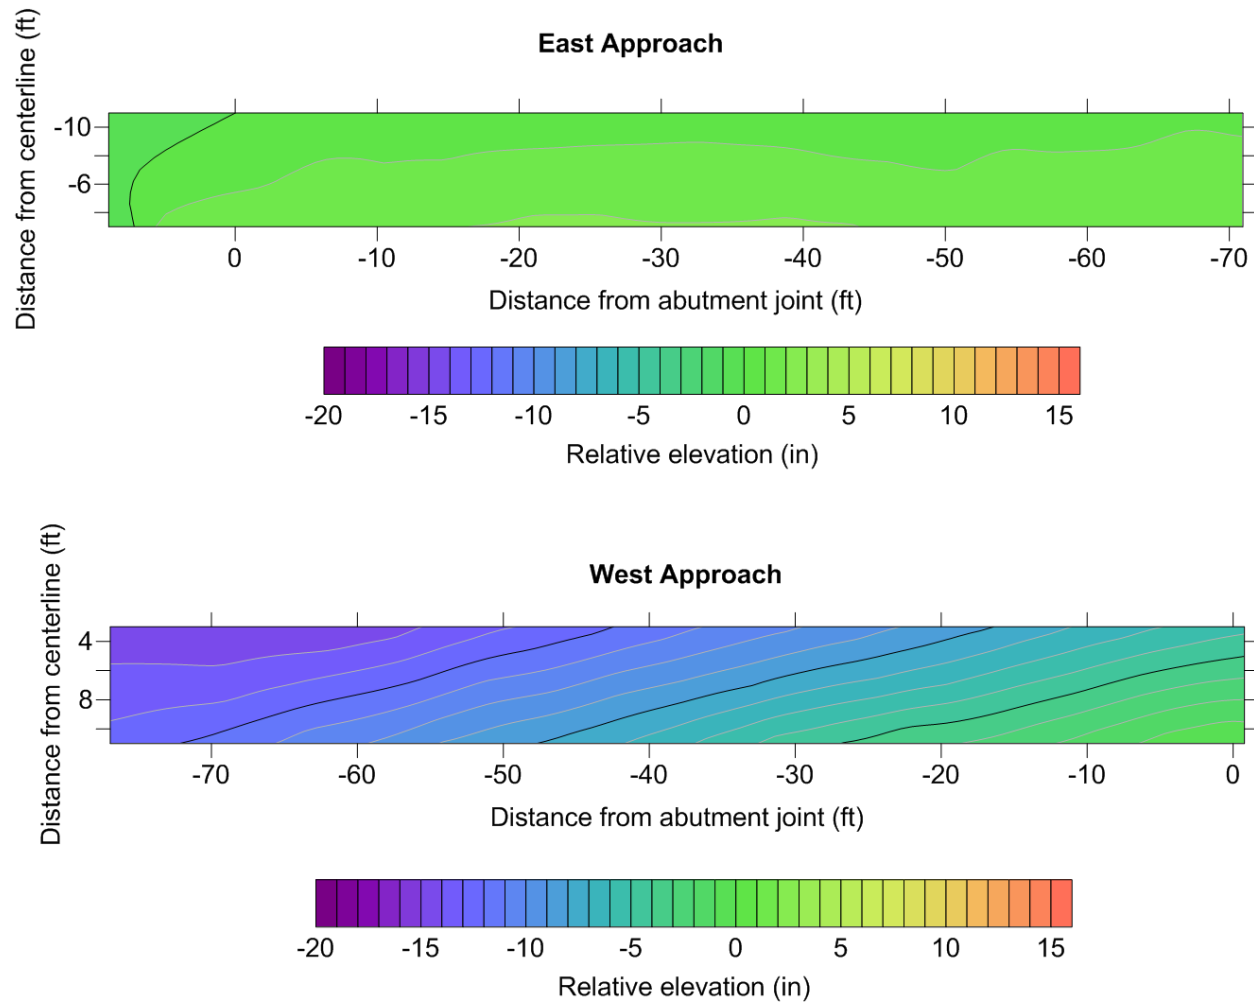
Figure 3.13. Contour maps of the elevations of the approaches of Bridge 5111.5O034.

The surface elevations of the bridge approaches were surveyed along three longitudinal lines in each lane, with only the approach lane surveyed per end. Figure 3.13 shows the contour maps for the approaches. All the elevations were measured relative to the elevation of the bridge joint. The depression of the slab was determined by assuming the intended profile was linear between the elevation of the bridge joint and the elevation of the roadway-end of the approach slab. Figure 3.14 shows the contour maps for the depression of the approaches. Figure 3.15 shows the depression visually in 3D surface maps. On the horizontal axes, the negative direction represents the distance away from the bridge. On the vertical axis of Figure 3.14, the negative direction represents north.

The depression maps show that negative depression (settlement) was present at the west approach while a slight positive depression was observed at the east approach. Note that this may be related to variation in the measurements. As shown in Figure 3.12, the pavement surface was grooved, which creates noise in the data and makes depressions and elevations smaller than the depth of the grooves insignificant. The survey data was used to calculate the BI value as 0.002 and 0.004 for the east and west approach, respectively. These values are small compared to values reported by White et al. (2005), which indicates that the bridge approaches are in good condition.

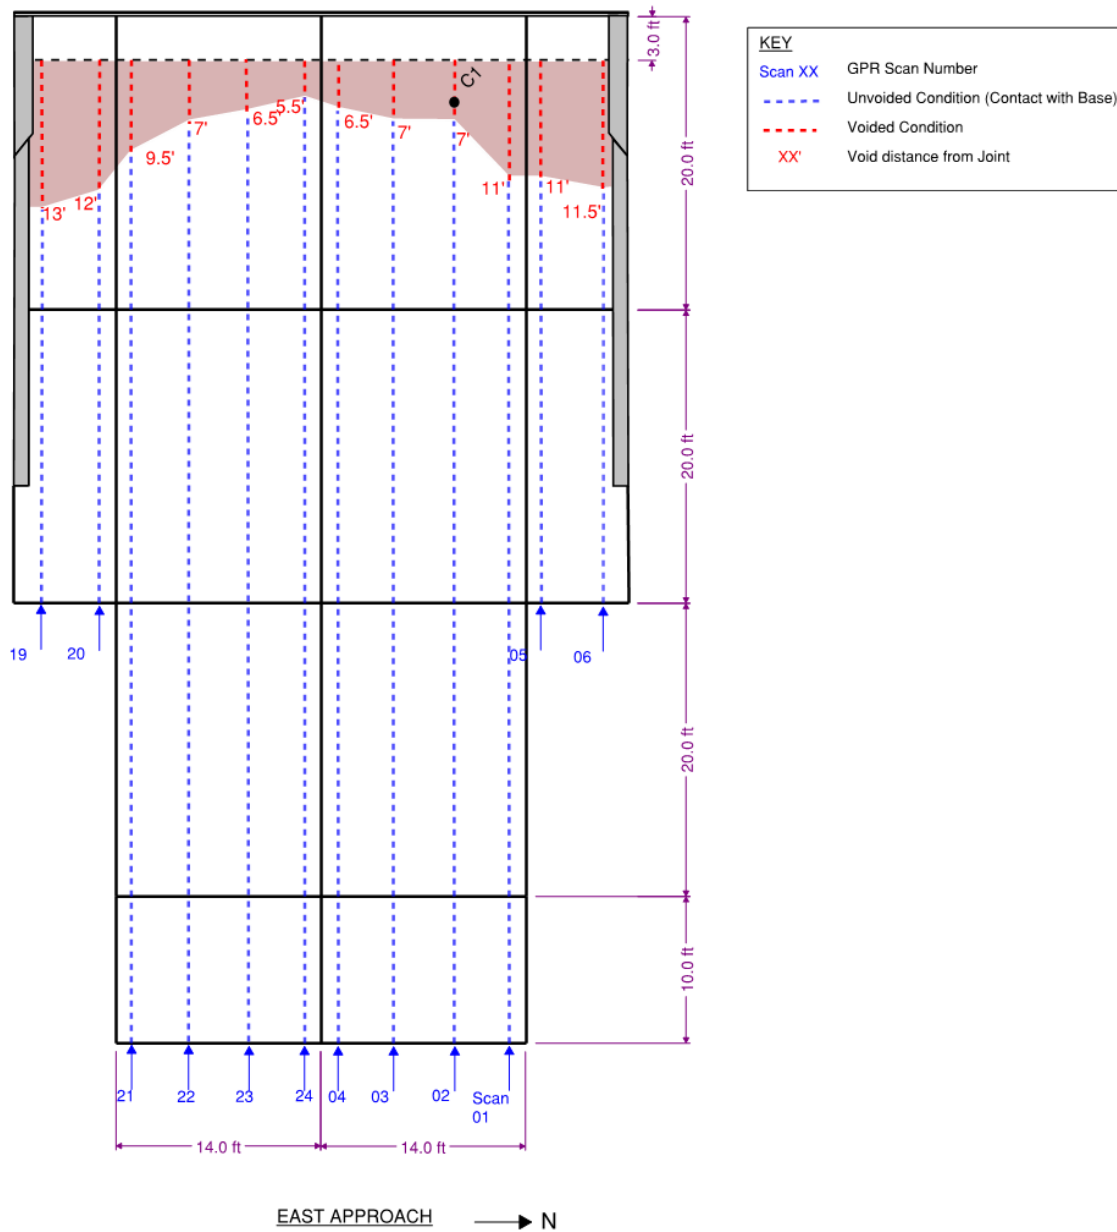
Figure 3.16. GPR results and core location at east approach of Bridge 5126.5S078.

Two cores were collected at this bridge, one core at each bridge approach. Core 1 is located in the westbound lane at the east approach (Figure 3.16). The pavement core measured approximately 13 inches in depth. The core dropped a distance of 3.5 inches confirming the presence of a large void at this location, as seen in Figure 3.18. Core 2 is located at the corner of the eastbound lane of the west approach, at the shoulder and the bridge deck. An epoxy-coated rebar was encountered during cutting of the core. A drill was used to reach the bottom of the slab where a void measuring 2.5 inches in depth was observed, as shown in Figure 3.19.

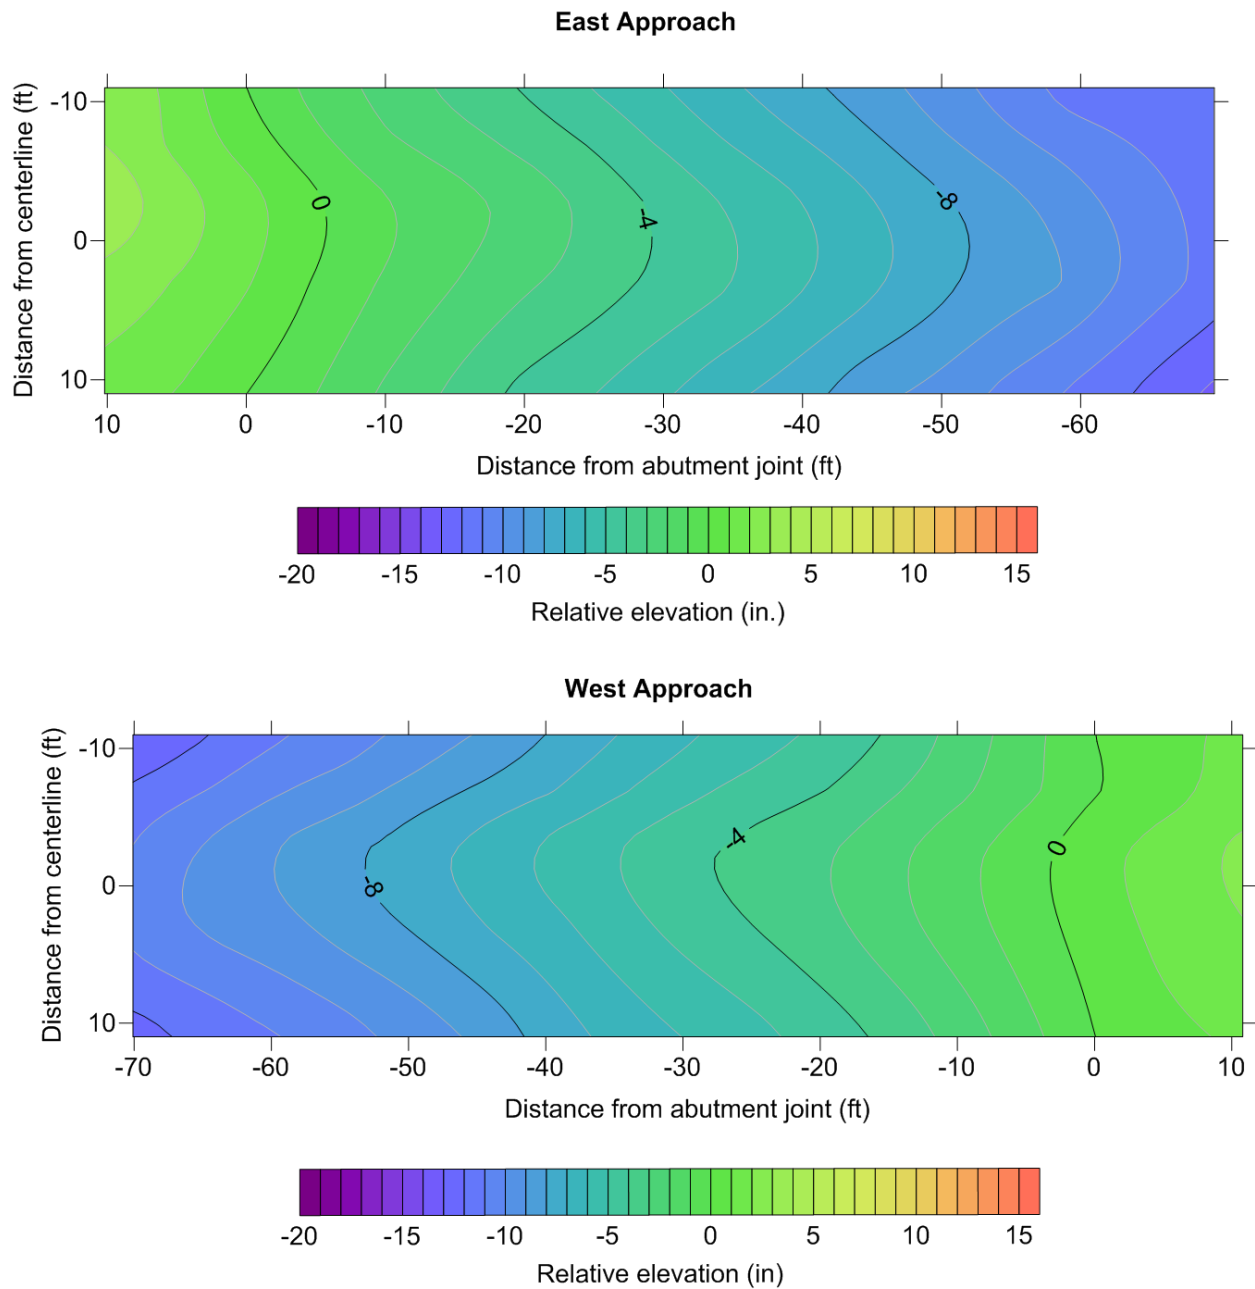
Figure 3.22. Contour maps of the elevations of the approaches to Bridge 5126.5S078.

The V-shaped patterns on the elevation maps show the drainage control. There is a slight deviation at the north sides of the bridge joints, but otherwise the pattern is predictable. The depression maps show that the maximum depression was 0.8 inches at the west approach and 0.35 inches at the east approach. The survey data was used to calculate the BI value as 0.016 to 0.030 for the east and west approach, respectively.

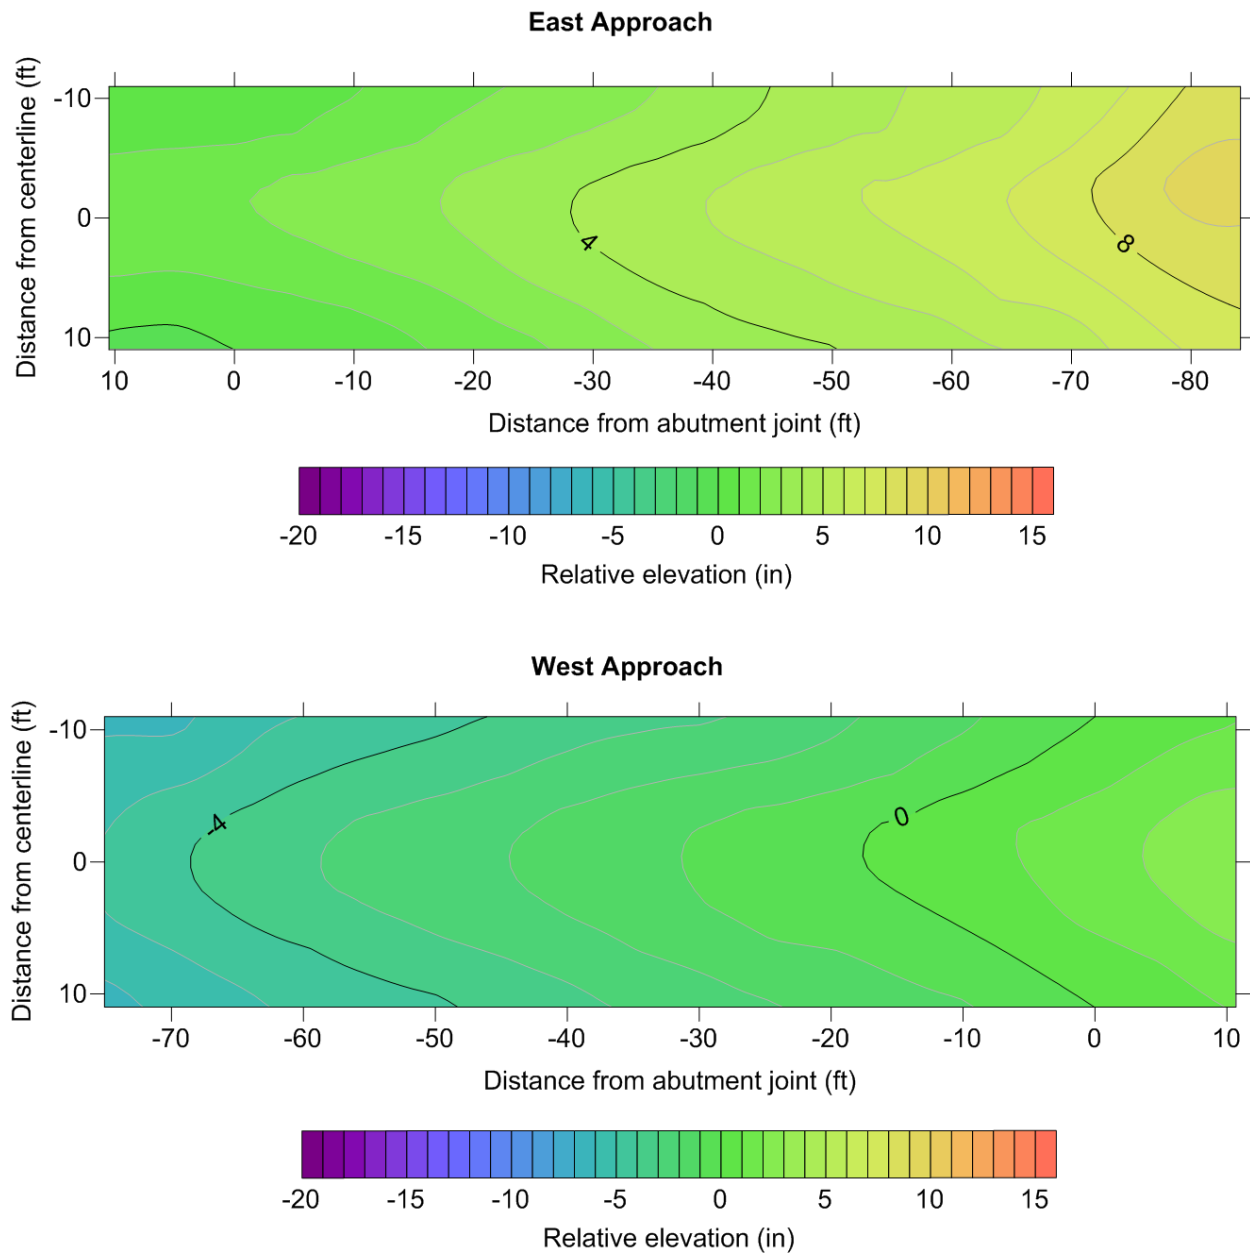
Figure 3.32. Contour maps of the elevations of the approaches to Bridge 5622.50061.

The V-shaped patterns on the elevation contour maps show the typical drainage pattern. For this bridge, the maximum amount of depression was 1.0 inches at the west approach and 0.6 inches at the east approach. The maps indicate that there are no areas with a bump at either approach. The BI value was calculated as zero and 0.014 for the east and west approaches, respectively. These values are small compared to values reported by White et al. (2005).

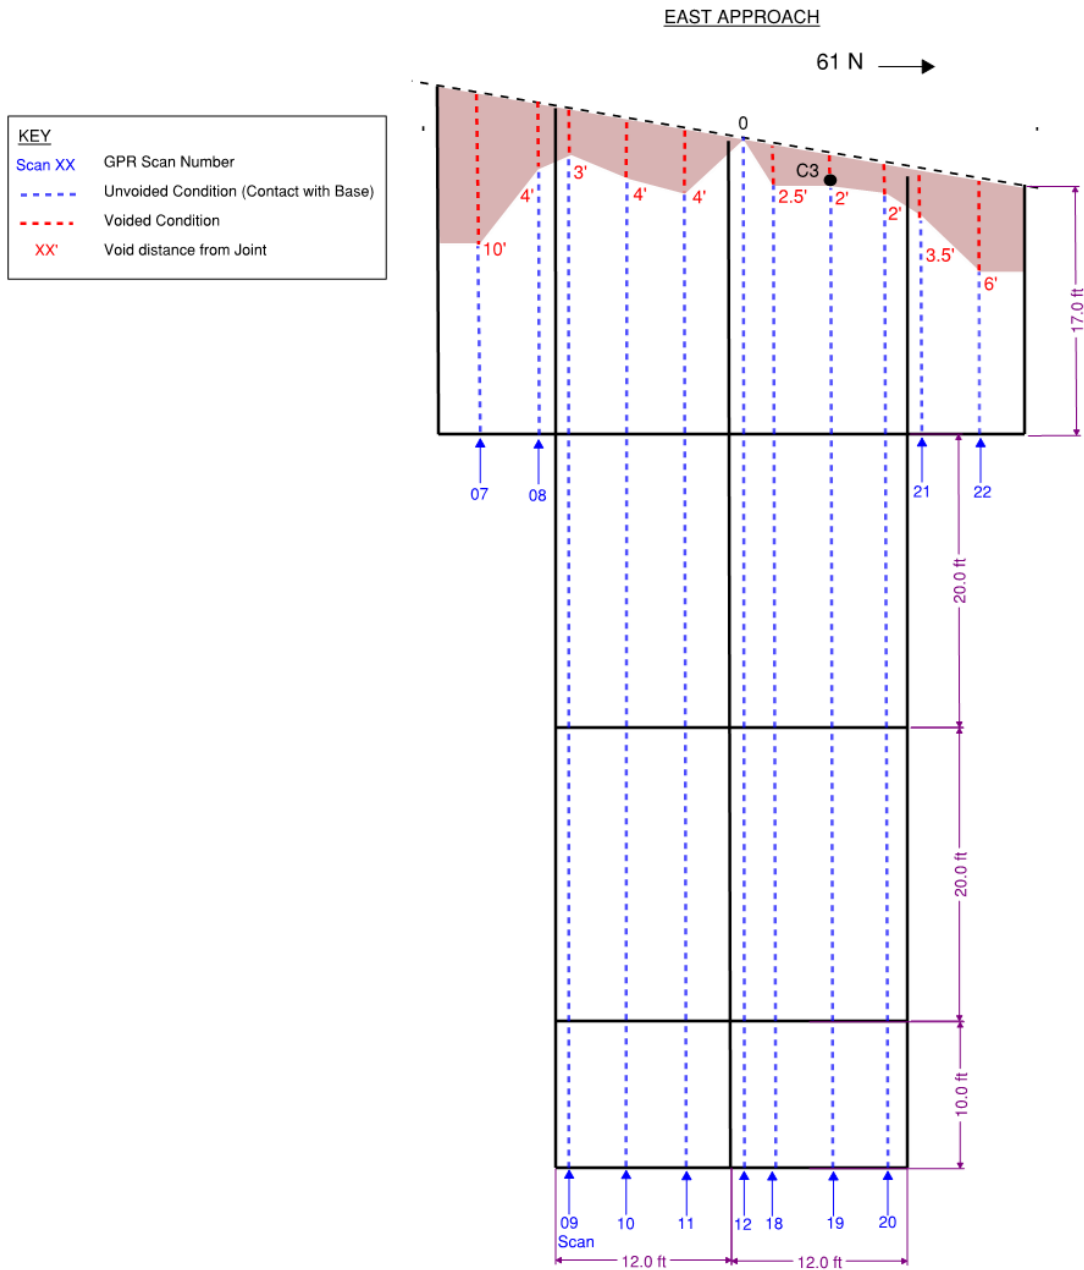
Figure 3.35. GPR results and core locations for east approach of Bridge 5624.20061.

GPR scanning results for the east and west approach are provided in Figure 3.35 and Figure 3.36, respectively. Similar to other bridges, the voids extend further into the slab at the barriers than under the traffic lanes. On the westbound side of the east approach, the void extends 6 feet on the shoulder and then only 2 to 3 feet in the lane. There is no void roughly at the centerline of the pavement. On the eastbound lane of the east approach, the void extends 10 feet at the barrier and 3 to 4 feet in the lane. On the eastbound lane of the west approach, the void extends about 11.5 feet along the barrier and 3 to 4 feet under the traffic lanes. On the westbound side of the west approach, the void extends 9 feet along the barrier and about 3 feet under the traffic lanes.

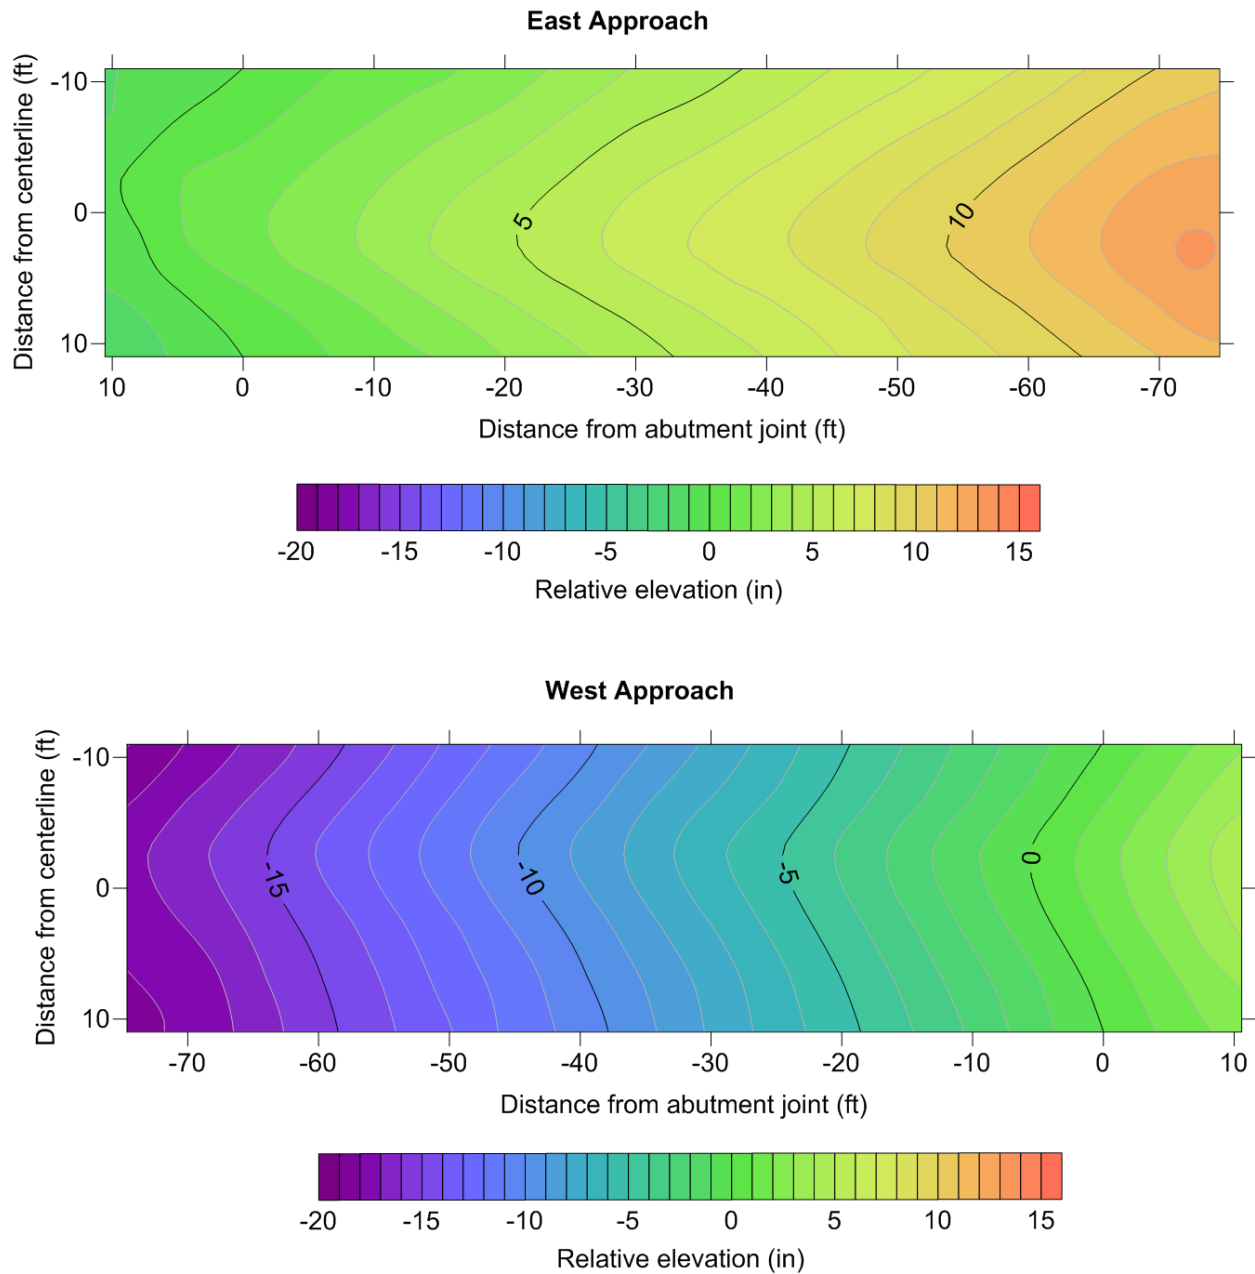
Figure 3.41. Contour maps of the elevations of the approaches to Bridge 5624.20061.

The elevation contour maps show the standard drainage elevation across the length of the approach slabs. There appears to be a peak in the pavement after the approach slab in the east approach. For this bridge, the maximum depression was 0.4 inches at the west approach and 0.3 inches at the east approach. There is a 0.5-inch peak at the westbound lane of the west approach. The BI value was calculated as 0.008 for each of the east and west approaches. This value is small compared to values reported by White et al. (2005) which indicates that the bridge approaches are in good condition.

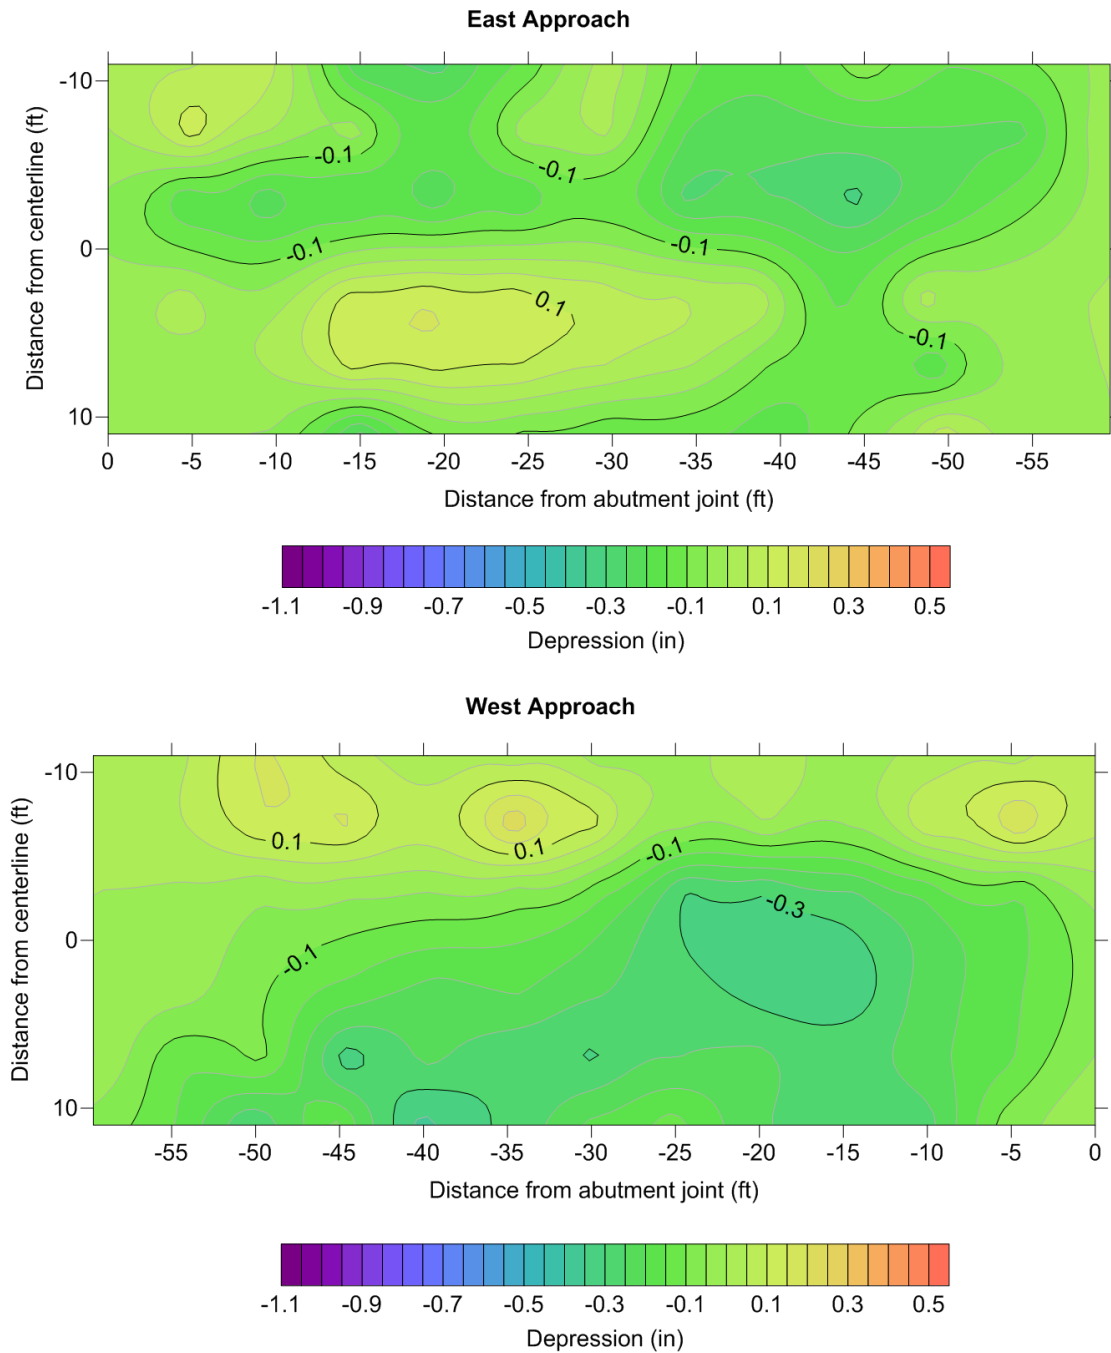
Figure 3.42. Contour maps of the depression experienced by the approaches to Bridge 5624.2O061.

The elevations of the approaches were surveyed and the net elevations were determined following the same procedure as for Bridges 5111.5O034. Figure 3.41 shows the contour maps for the approaches while Figure 3.42 and Figure 3.43 show the depression in contour maps and surface maps, respectively.
