IDENTIFICATION OF THE BEST PRACTICES FOR DESIGN, CONSTRUCTION, AND REPAIR OF BRIDGE APPROACHES

Iowa DOT Project TR-481
CTRE Project 02-118

Final Report

January 2005

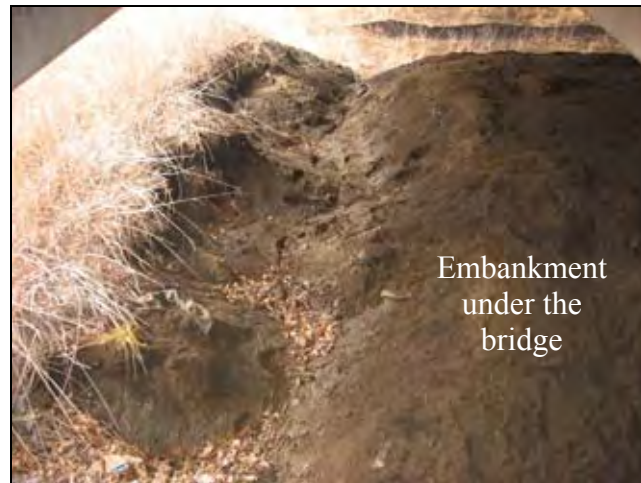
This bridge was constructed in 1999 with non-integral abutments. At the north end of the north bound approaches, significant settlement was observed. Soil erosion of the embankment under the bridge was also observed (Figure 17). Moreover, concrete spalling was noted at the ends of the bridge deck.

Figure 17. Soil erosion of the embankment under the bridge (South end of North bound)

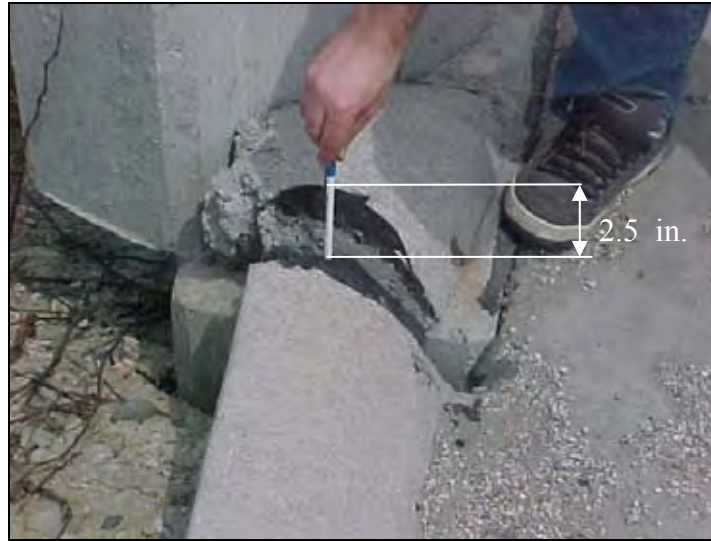
At the south end of the southbound lane (SBL), a 1 inch gap was measured between the abutment and embankment. The soil of the embankment under the bridge was very wet. The differential settlement of the approach slab at the end of the abutment wingwall was approximately 2.5 in., as shown in Figure 19. The width of the expansion joint was 5.0 and 5.3 inches at the north and south ends, respectively, and the width of the 'CF' joint was 4.1 and 4.4 inches at the north and south ends, respectively.

Figure 19. Differential settlement of 2.5 inches at the end of the abutment wingwall (South end SBL)

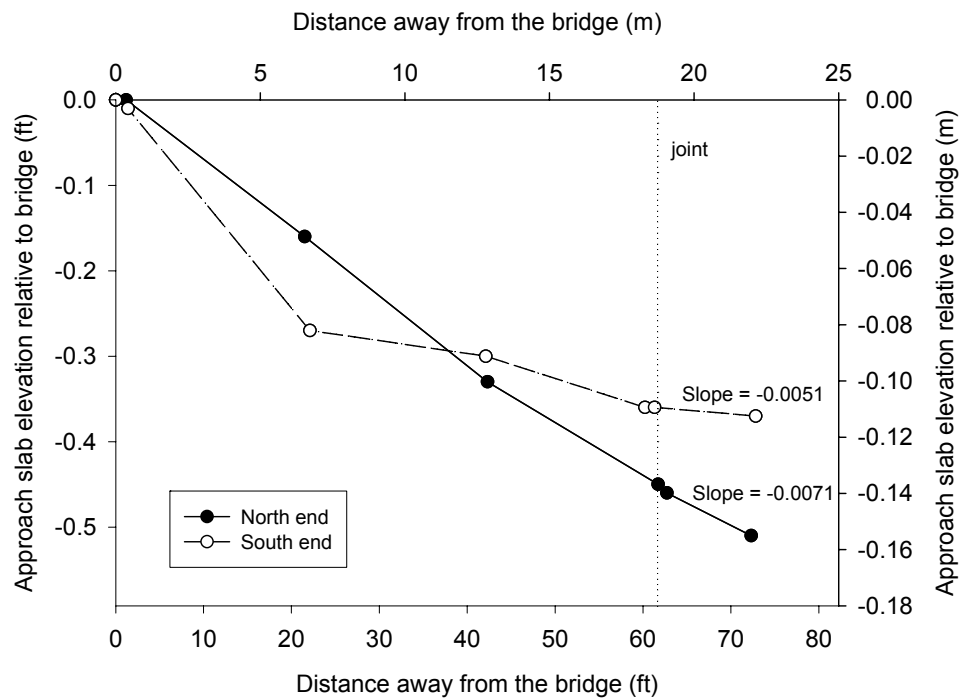
The bridge approach profiles for both ends of the northbound lane were obtained in spring 2003 and are shown in Figure 20. The profiles show that the south end approach slab has experienced more settlement compared to the north end. Further, the slope gradients of both the south and north ends are -0.0071 and -0.0051 (i.e., sloping away), which indicates either compression of the embankment fill material or settlement of the embankment foundation soil.

Figure 20. Elevation of bridge approaches relative to bridge slab

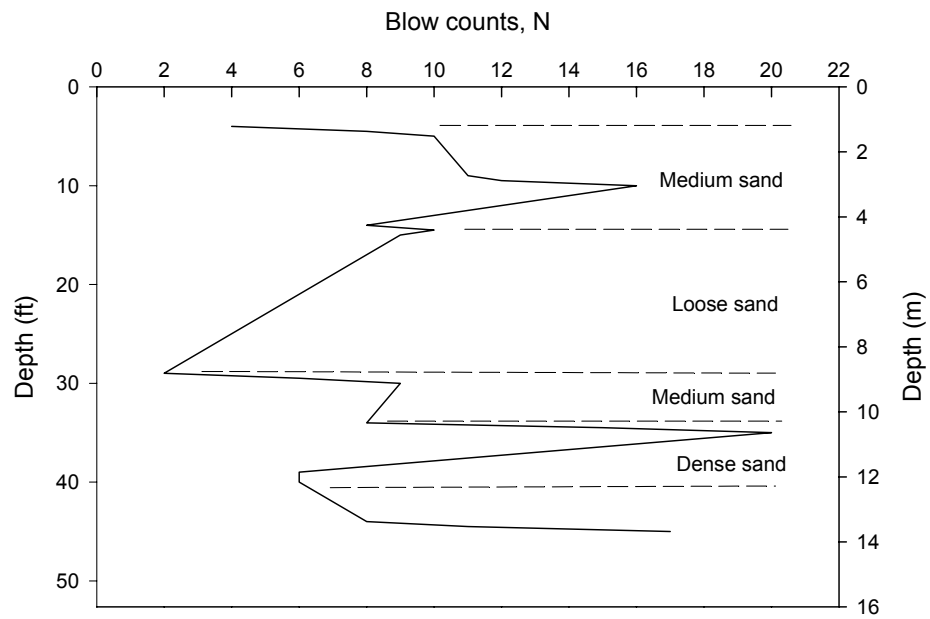
To investigate and characterize the embankment soils, Standard Penetration Tests (SPTs) were conducted at the north end of the northbound lane, as indicated in Figure 21. The soil was classified as loose to medium dense sand with a moisture content varying from 12% to 17%. The SPT blow counts provided in Figure 22 range from 5 at the surface to 20 at about 35 ft. According to the drillers, the water table was located at a depth of 25 ft immediately after completing the boring. The height of the embankment was approximately 20 ft.

Figure 22. Results of SPT and classification of the embankment soil

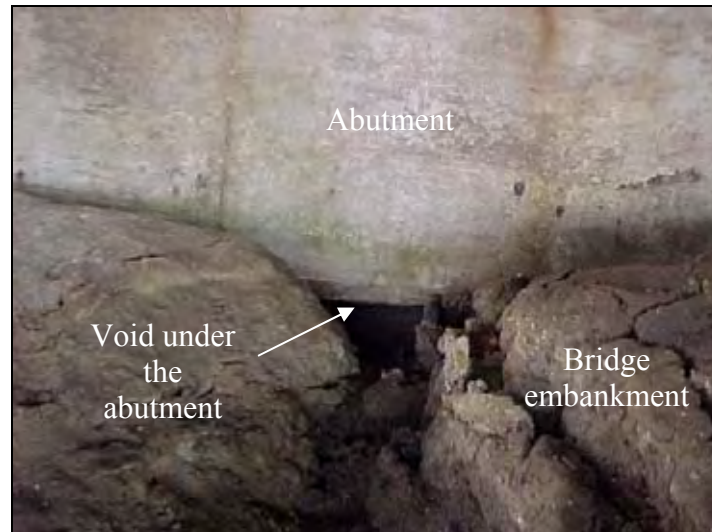
This bridge has non-integral abutments. Water was observed running through the expansion joints and under the bridge abutment. Soil erosion was severe at both ends of the bridge. Severe soil erosion shown in Figure 23 was observed at the north end of the northbound lane. At the south end of the northbound lane, the approach slab at the guardrail settled about 6 inches from its original elevation, as shown in Figure 24. At both the north and south ends of the southbound lane, severe erosion and settlement of the embankment was noted. The embankments were constructed using sandy soils which are considered highly erodible (Figures 25 to 27).

Figure 23. Erosion of soil under abutment (North end of NBL)

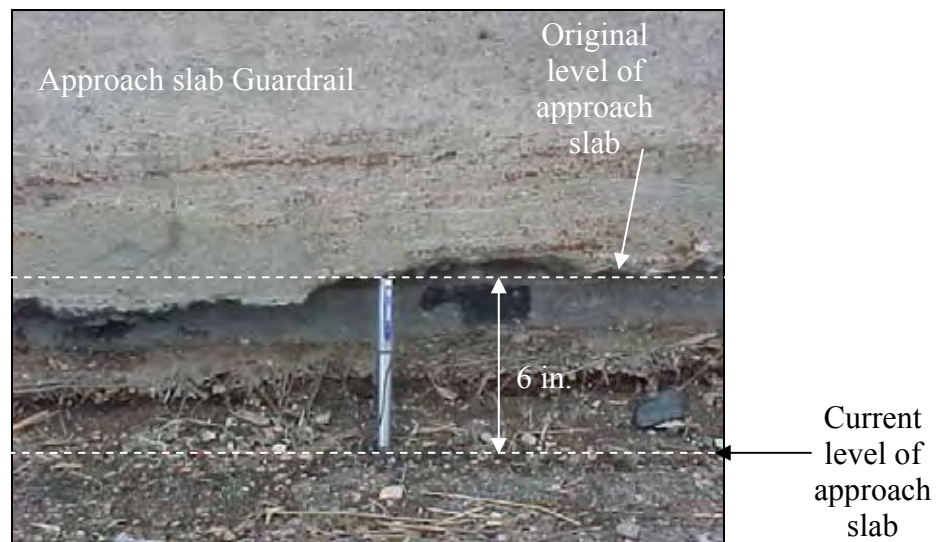
Figure 24. Settlement of bridge approach slab at the guardrail (South end of NBL)

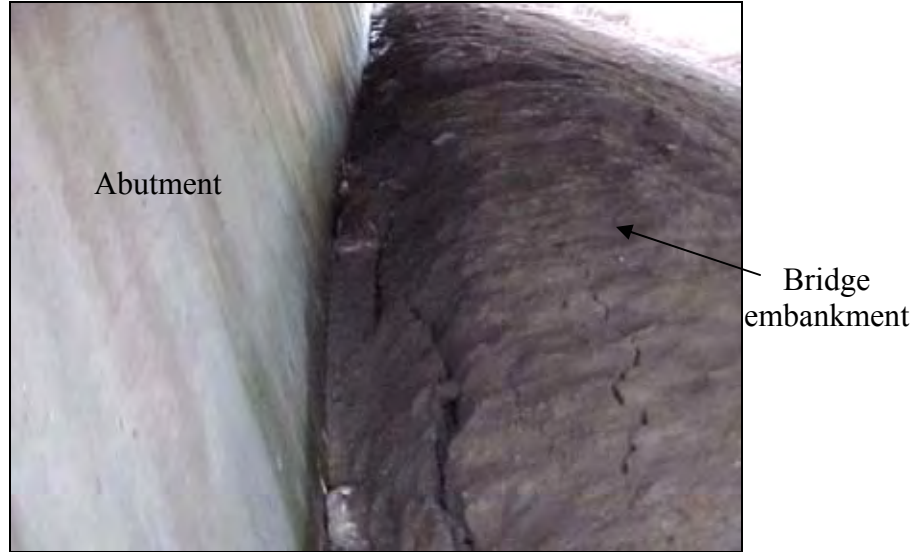
Figure 25. Erosion between abutment and embankment (North end of SBL)

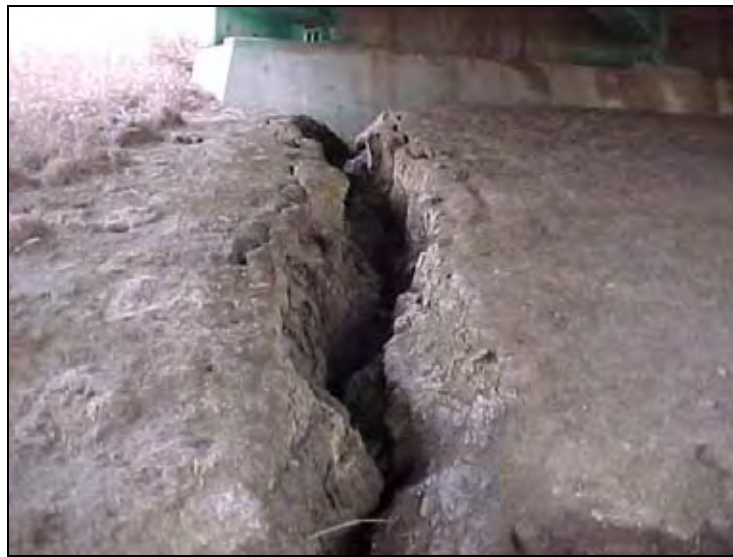
Figure 26. Erosion of the soil under the bridge (North end of SBL)

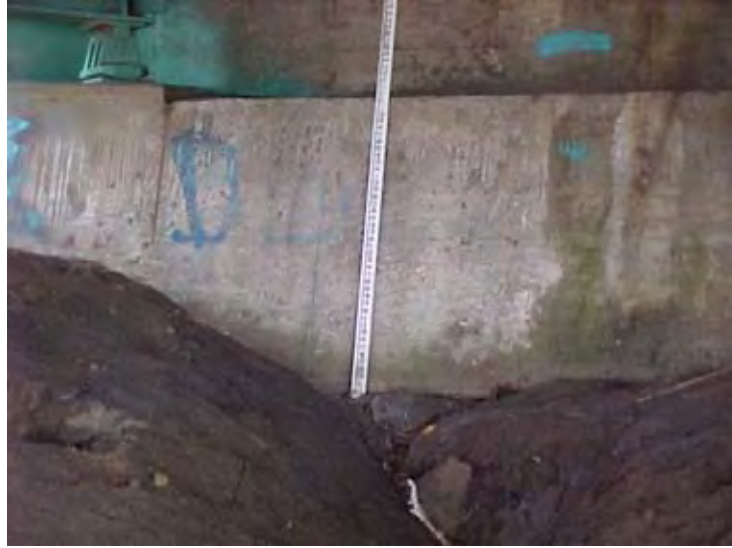
Figure 27. Erosion of the soil under the bridge (South end of SBL)

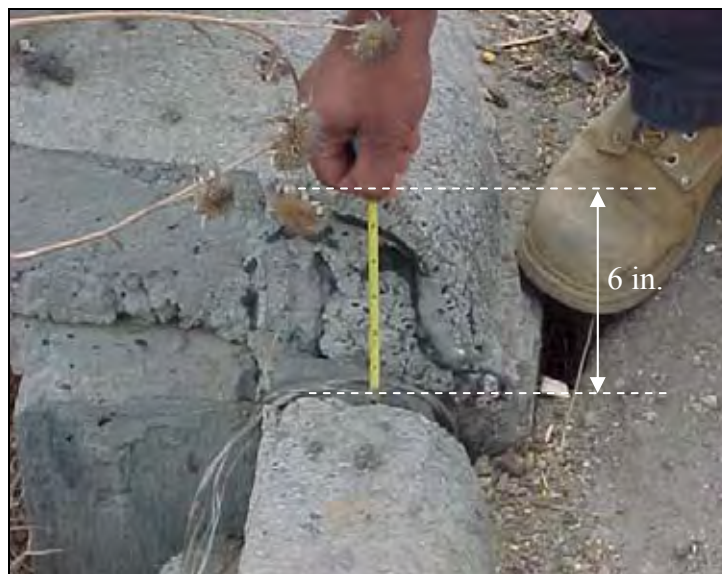
This bridge has integral abutments and concrete girders. The embankment under the bridge settled about 3.5 inches from its original level, as shown in Figure 28. Figure 29 shows the differential settlement at the end of the wingwall at the north end of the northbound lane, which is approximately 6 inches. Figure 30 shows cracks near both expansion joints at the northbound lane. Moreover, at the south end of the northbound lane, differential settlement of 2 inches was measured between the bridge deck and the end of the approach slab.

Figure 29. Differential settlement at the approach slab (North end of NBL)

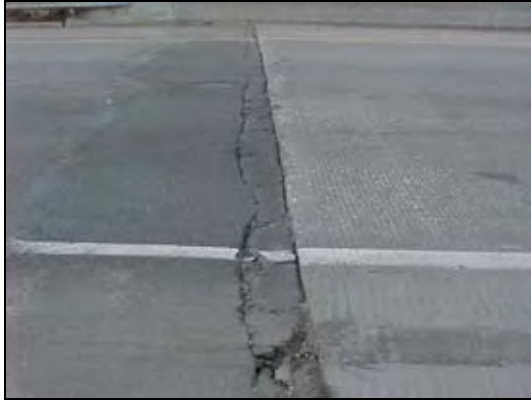
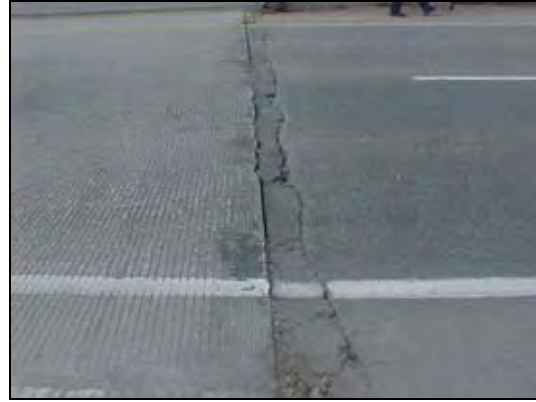
Differential settlement between bridge deck and the end of the approach slab was observed at the north end of the southbound lane. The width of the expansion joint was approximately 5 inches, which is wider than the designed joint width of 4 inches. This could be due to concrete deterioration or thermal contraction of the bridge. At the north end of the southbound lane, fewer cracks at the expansion joint were observed (Figure 31).

Figure 30. Cracks and concrete spalling at the expansion joints

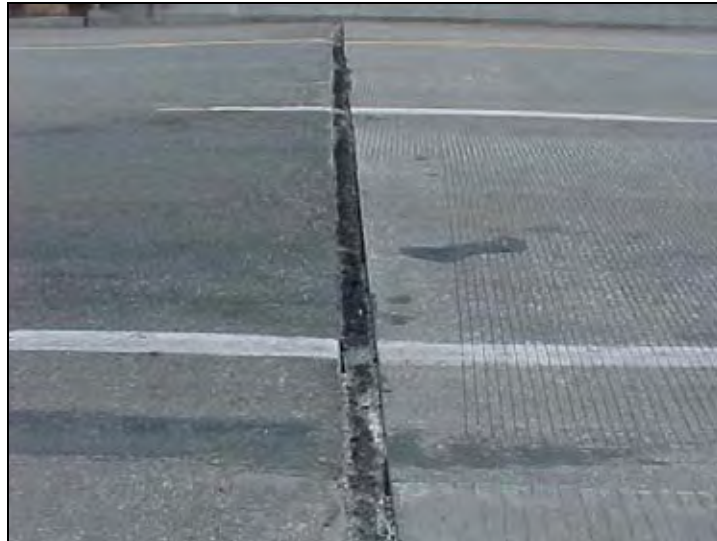
Figure 31. Poorly filled expansion joint with recycled tires used as a joint filler (North end SBL)

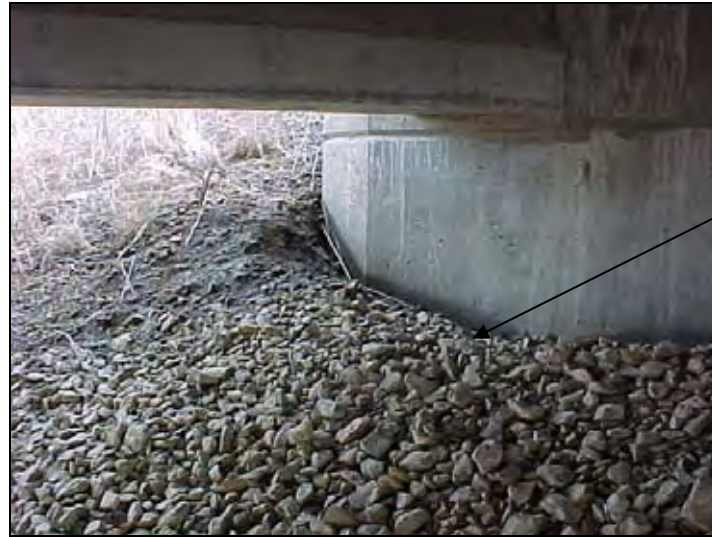
This bridge has an integral abutment and concrete girders. Aggregate was used under the bridge as slope protection, as shown in Figure 32. Significant soil erosion was observed between the embankment and the backwall at both the north and south bounds lanes. Figure 33 shows a 3-inch void that developed under the approach slab.

Erosion
between the
abutment and
the embankment

Figure 32. Aggregate used as slope protection at the embankment under the bridge

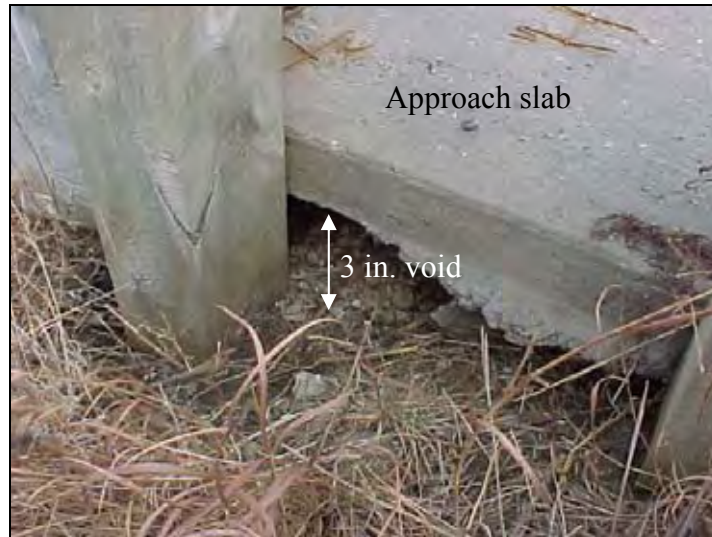
3 in. void

Figure 33. Void developed under the approach slab (South end of North bound bridge)

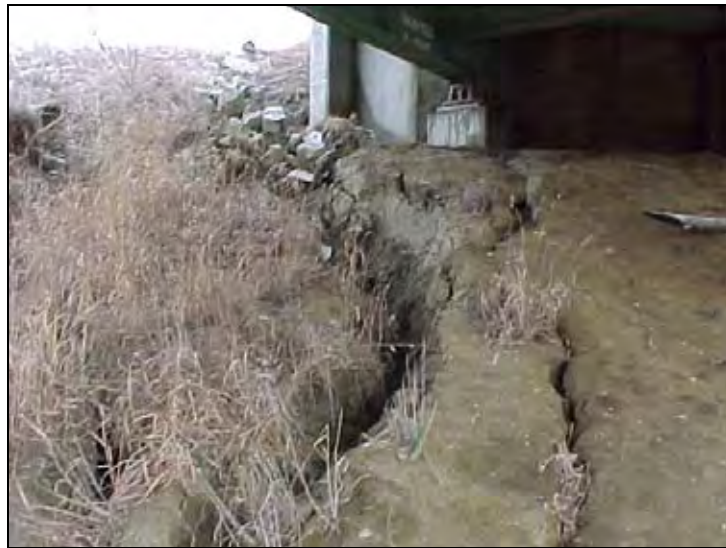
This bridge has non-integral abutments. The east bound bridge is supported on concrete girders, while the west bound bridge is supported on steel girders. Soil erosion was observed, as shown in Figure 35. No other major problems were noticed.

Figure 35. Soil erosion of the embankment under the bridge

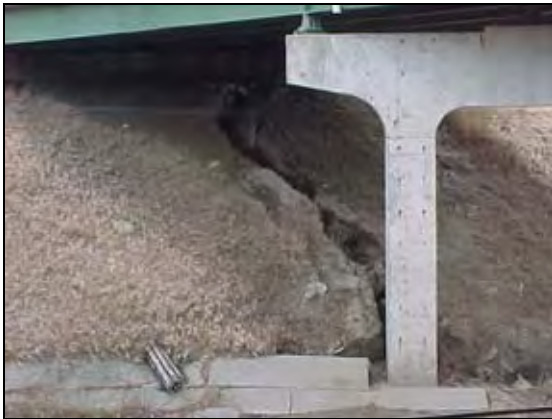
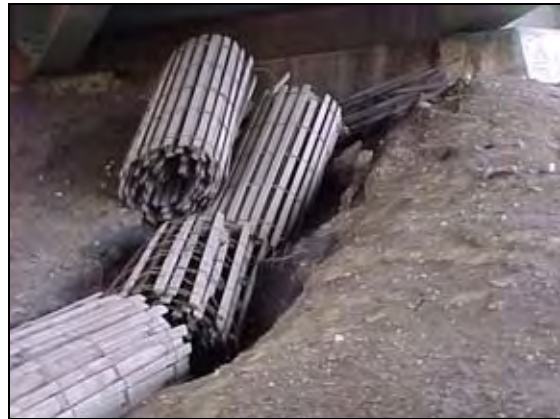
This bridge has non-integral abutments and steel girders. Significant erosion was observed under the bridge at both the east and the westbound lanes, as shown in Figure 36. However, the approach slab appeared to be in a good condition.

Figure 36. Soil erosion of the embankment under the bridge

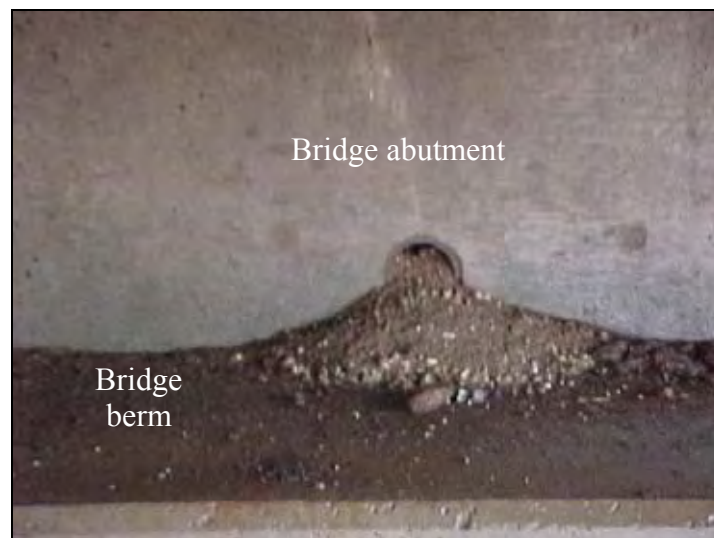
This bridge has steel girders and non-integral abutments. No significant settlement of the bridge approach was noted. Soil erosion of the embankments under the bridge was observed. The abutment weep holes were filled with eroded backfill material, as shown in Figure 37.

Figure 37. Weep holes filled with backfill material

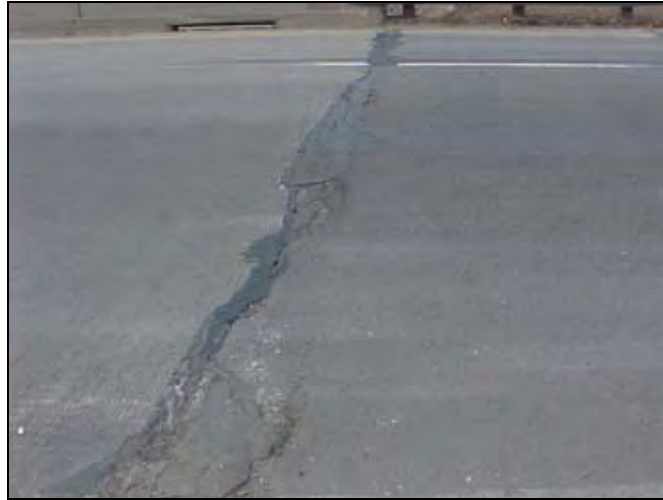
This bridge has non-integral abutments with concrete girders. Concrete spalling was observed at the girder ends. Figure 38 shows a damaged expansion joint that was paved over during a previous maintenance effort. A dip in the original approach slab of about 4 inches was observed between the approach slab and the wingwall.

Figure 38. Expansion joint covered after placing the approach slab overlay (EBL)

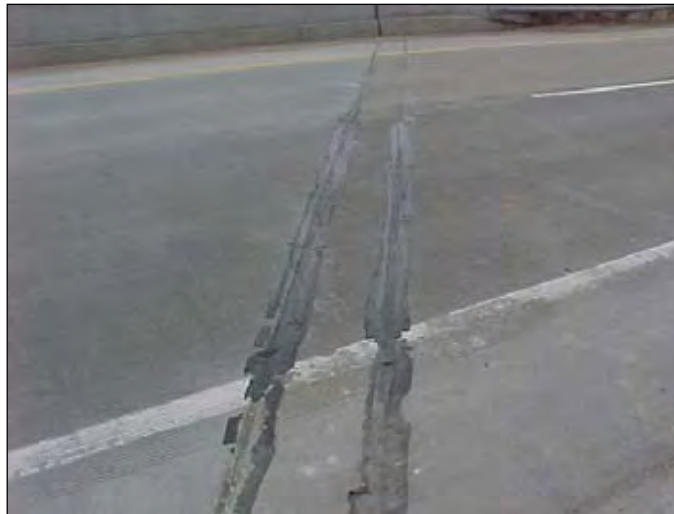
This bridge has non-integral abutments and steel girders. Differential settlement of 4 inches was measured at the end of the wingwall. No other major problems were observed. Figure 39 shows deterioration of the expansion joint sealer.

Figure 39. Deteriorated sealer at the expansion joint

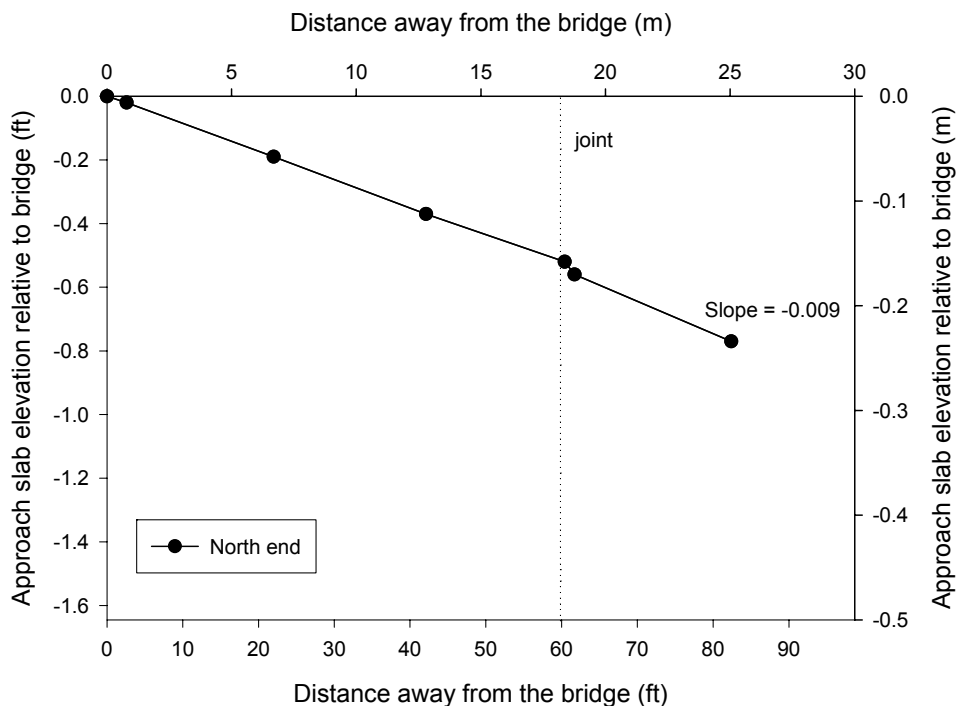
This bridge has integral abutments and concrete girders. Profiles of both ends of the northbound lane were measured in fall 2002. Figure 40 shows the profiles collected at the centerline for both approaches. About 0.5 in. of elevation difference was measured between the end of the approach slab and the pavement at the EF joint at the north end of the northbound lane. The north end approach slab appears to be in a good condition. The slope of the bridge approach is -0.009.

Figure 40. Profile of bridge approaches relative to bridge deck

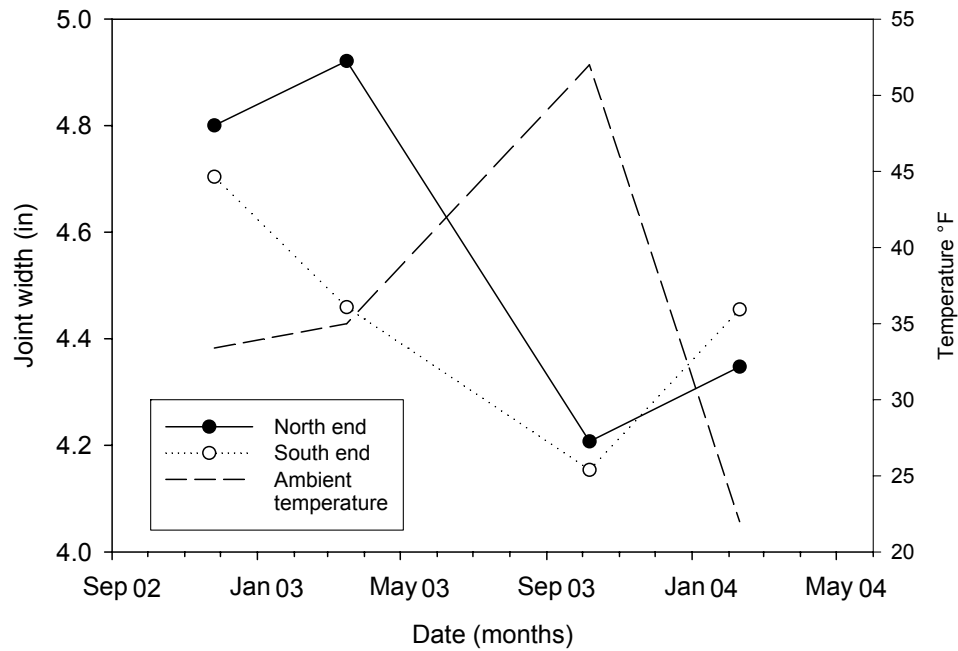
The width of the expansion joint at both ends of the bridge and the corresponding ambient temperature were measured over 15 months (Figure 41). As the air temperature increased, the joint width decreased. The largest variation in joint width was about 0.8 in. (2.0 cm) at temperatures ranging from 22 °F to 55 °F. Greater variation in temperatures could result in larger joint width changes.

Figure 41. Change in expansion joint width with respect to thermal variation

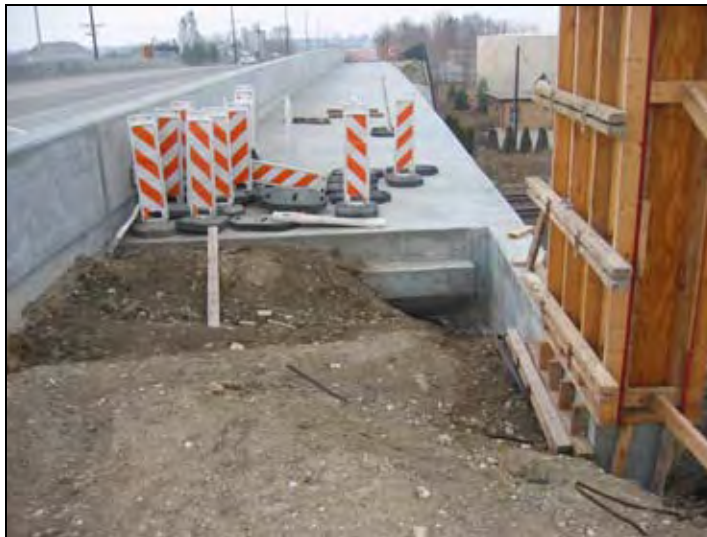
This bridge has integral abutments with concrete girders. Although the bridge is newly constructed, a dip in the approach slab could be seen. No measurement was made. Figure 42 shows non-compacted granular backfill behind the abutment.

Figure 42. Non-compacted granular backfill behind the bridge abutment

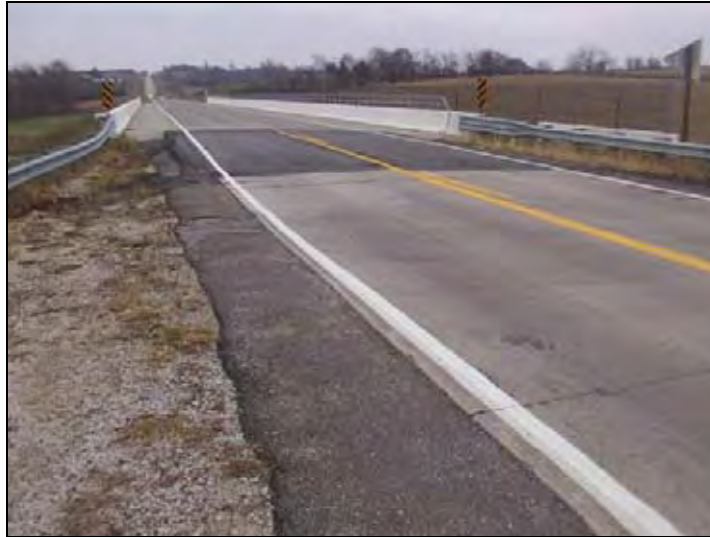
This bridge is a four-span bridge with integral abutments and concrete girders. Asphalt overlays were placed at both ends of the bridge (Figure 43). Figure 44 shows some cracks in the overlay. Differential settlement at the bridge approach of about 3 inches was measured at the approach slab shoulder. Minor erosion of the embankment under the bridge and the abutment sides was noted. Furthermore, the 4 inches expansion joints were poorly filled at the east end (Figure 45). As shown in Figure 46, aggregate was used as slope protection for the embankments under the bridge.

Figure 43. A view of the bridge showing recently placed asphalt overlay at the bridge approach (East end)

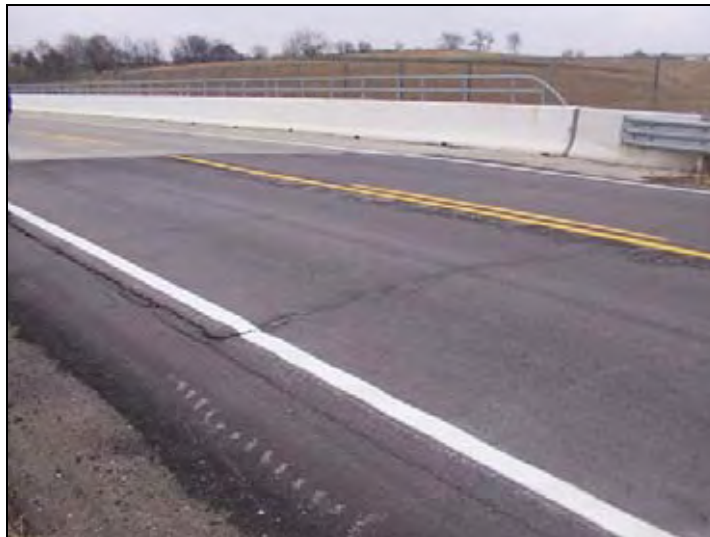
Figure 44. Cracking of the asphalt overlay (East end)

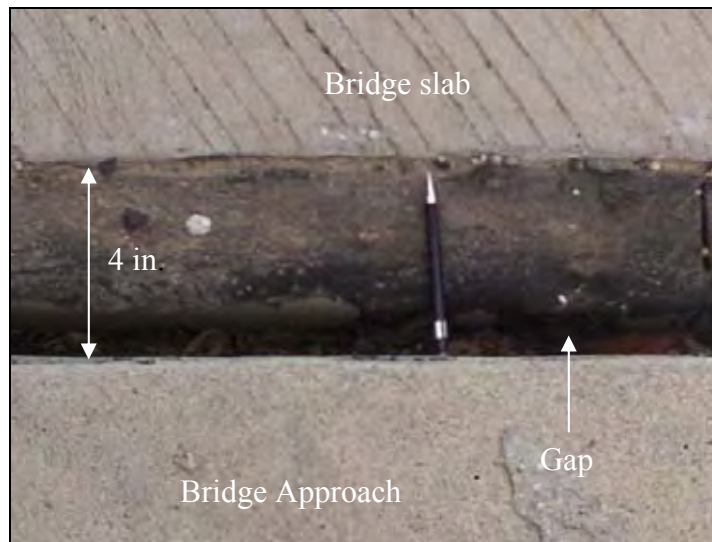
Figure 45. Poorly filled expansion joint (East end)

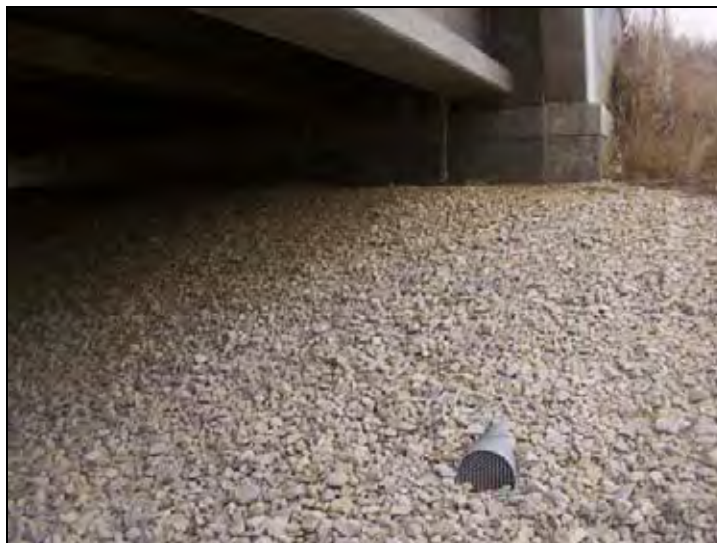
Figure 46. Aggregate used as a slope protection at the embankment under the bridge

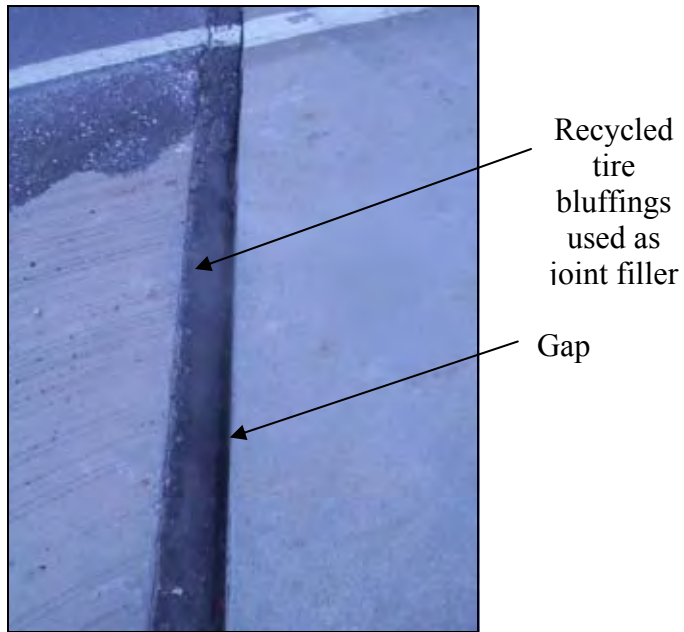
The bridge was visited again in summer 2004. At the east end, differential settlement of 6.5 inches at the guardrail at the approach slab and a void depth of 5.5 inches under the approach slab were observed. The width of the expansion joint was 5.5 inches (Figure 47). More transverse cracks were noted on the asphalt overlay, as shown in Figure 48.

Figure 47. Poorly sealed expansion joint (East end)

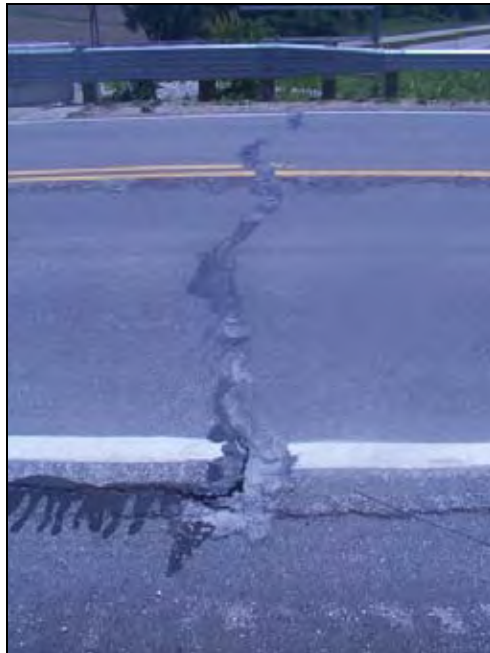
Figure 48. Transverse cracks of asphalt overlay (East end)

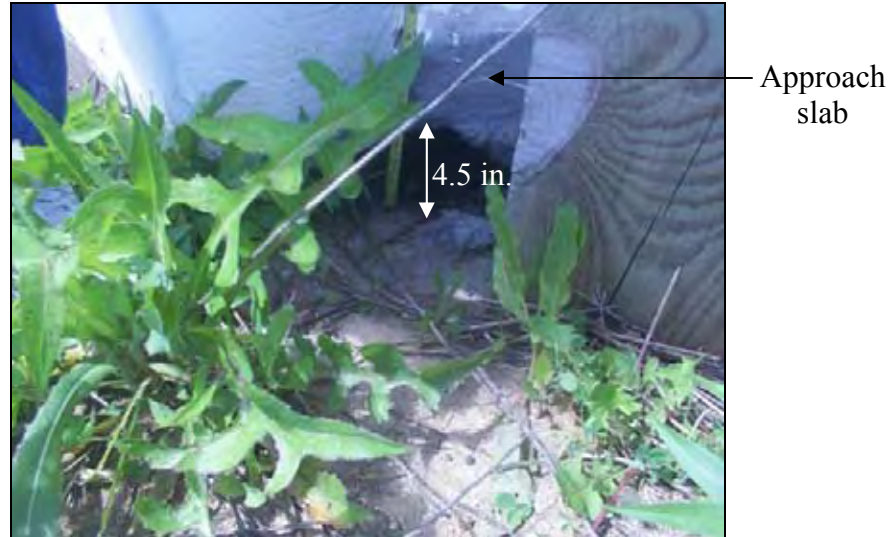
At the west end, a void has developed under the approach slab. The void was 5.5 inches at the expansion joint and 4.5 inches at the end of the wingwall (Figure 49). Furthermore, soil erosion at the abutment side was observed (Figure 50). Soil near the abutment sides is silty sand and is considered highly erodible. An aggregate slope protection cover was used at the embankment under the bridge and appeared to be in good condition.

Figure 49. 4.5 in. void developed under the approach slab (West end)

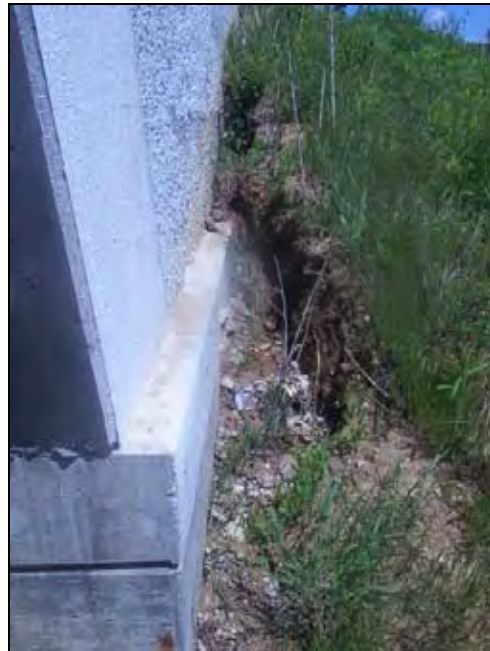
Figure 50. Soil erosion at the abutment side (West end)

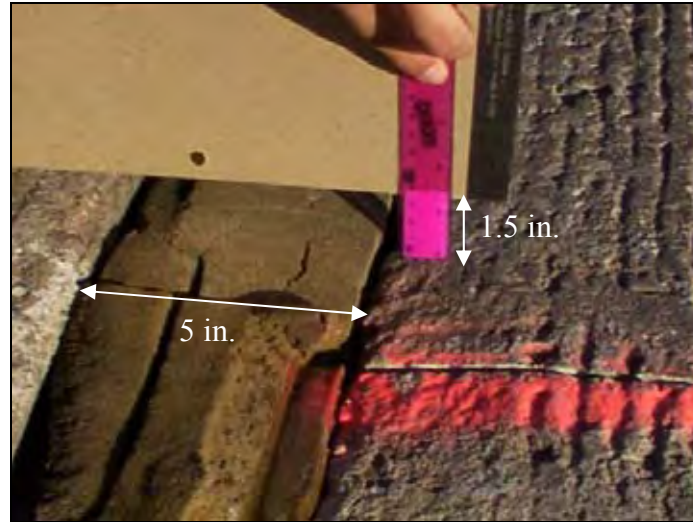
The bridge has integral abutments and concrete girders. Differential settlement between the bridge deck and the approach slab of 1.5 inches was measured at the east end (Figure 51). The embankment under the bridge has settled 3.5 inches and a gap of 3 inches was measured between the abutment and the embankment under the bridge (Figure 52). The width of the expansion joint, which has flexible foam filler, was approximately 5 inches.

Figure 51. Differential settlement of 1.5 in. at the bridge approach (East end of WBL)

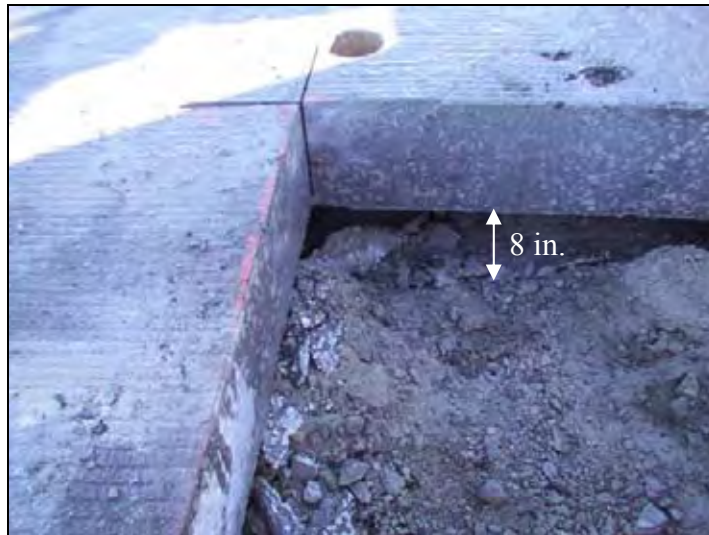
Figure 56. Eight-inch void observed under the approach slab

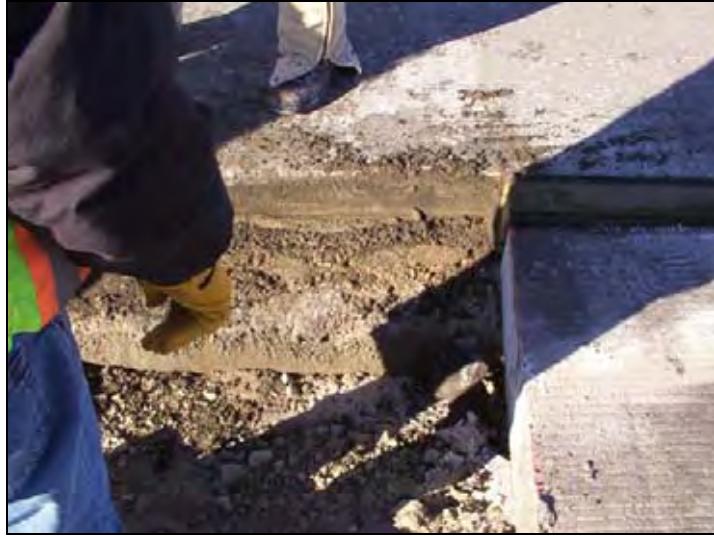
Figure 57. Layer of fine sand covering the paving notch

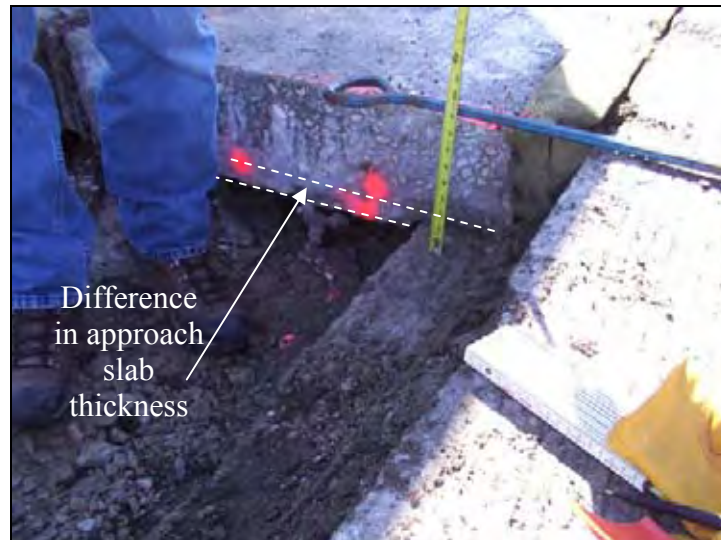
Figure 58. Non-uniform approach slab thickness with 1.5 in. increase over the backfill compared with the thickness over the paving notch

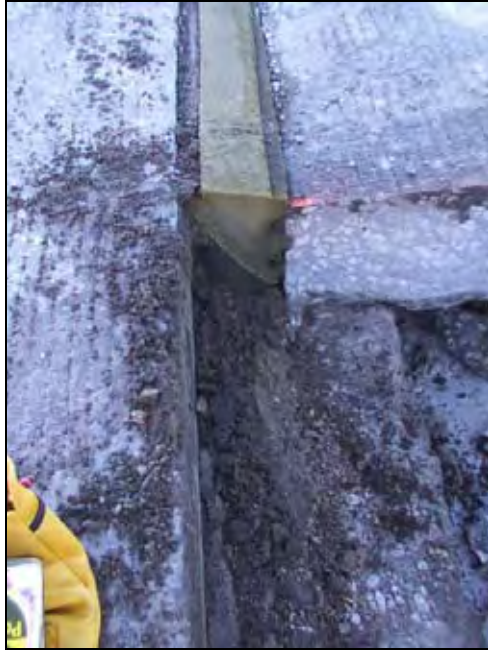
Part of the approach slab at the east end of the westbound lane was removed by Iowa DOT personnel as part of their endeavor to determine the cause of differential settlement between the end of approach slabs and bridge decks. A 3-foot-long by 15-foot-wide section extending from the centerline of the approach slab to the center of the shoulder was removed (Figures 53 to 55). After removing the approach slab segment, an 8-inch void was measured under the approach slab (Figure 56). Also, the base material appeared to be poorly placed and not compacted. Upon inspection of the paving notch, it was observed that about 1.5 inches of fine sand was under the joint filler (Figure 57). The thickness of the approach slab was 7 inches over the paving notch and 8.5 inches over the approach slab embankment (Figure 58). The difference in thickness is attributed to poorly cleaning the paving notch prior to placement of the approach slab. The width of the paving notch is 10 inches. As shown in Figure 59, flexible foam was used as a joint filler material.

Figure 59. Contaminated expansion joint

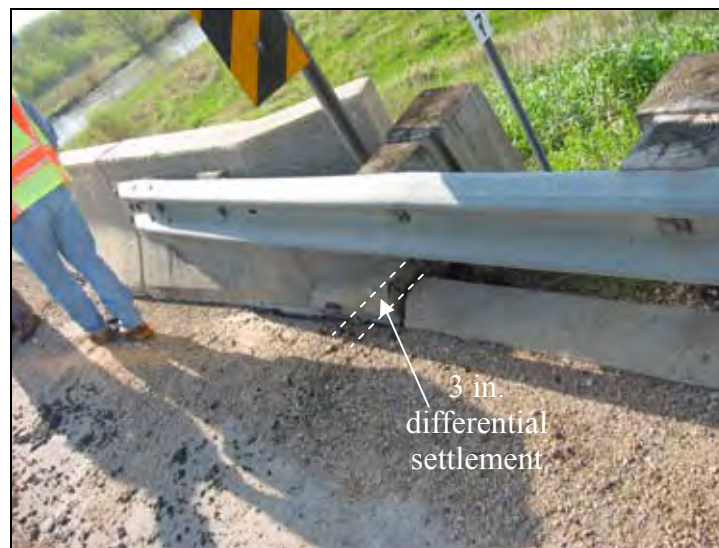
This bridge was constructed in 1984 and has three spans with integral abutments. Figure 60 shows 3 inches of differential settlement between the bridge slab and the bridge approach at the end of the south-west wingwall. Figure 61 shows concrete deterioration at the west end CF joint, as well as longitudinal cracks in the approach slab. A crack developed between the bridge approach and the wingwall due to the settlement of the approach relative to the wingwall. The width of the crack was 1.5 inches and extended to a length of 4.5 feet. No major erosion was observed at this bridge.

Figure 60. Differential settlement of 3 in. at the south-west corner

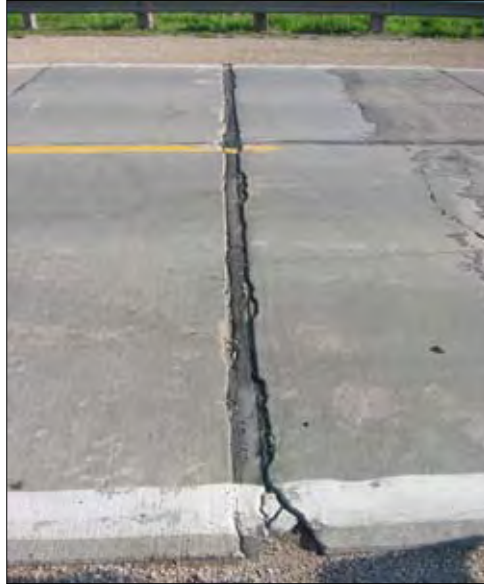
Figure 61. Concrete deterioration at the EF joint (West end)

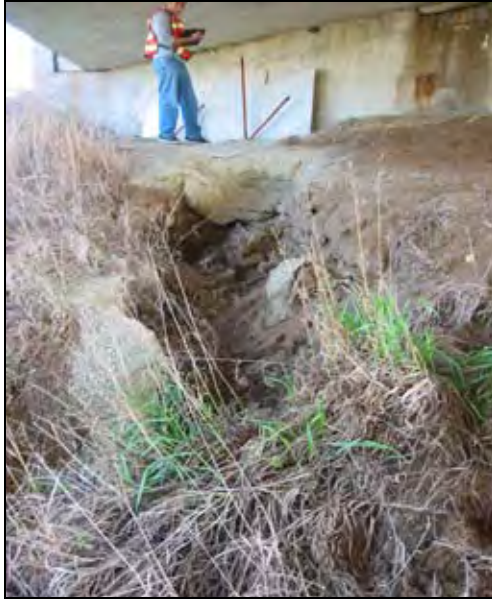
This bridge is a three-span concrete slab bridge (Figure 62). Figure 63 shows erosion of the embankment under the bridge. Cracks were observed in the asphalt overlay around the expansion joint (Figure 64).

Figure 63. Erosion of the embankment soil under the bridge

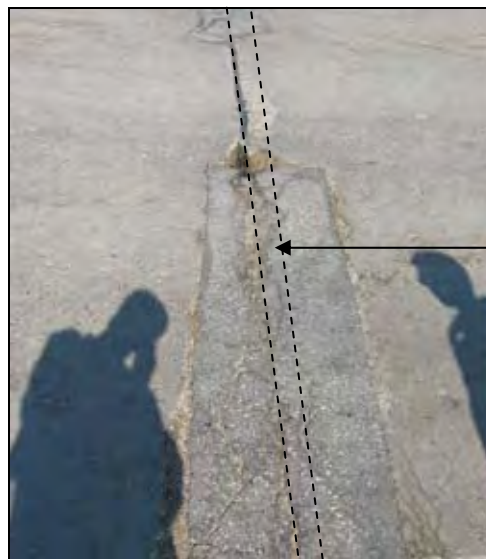
Figure 64. Cracked asphalt patch covering the expansion joint

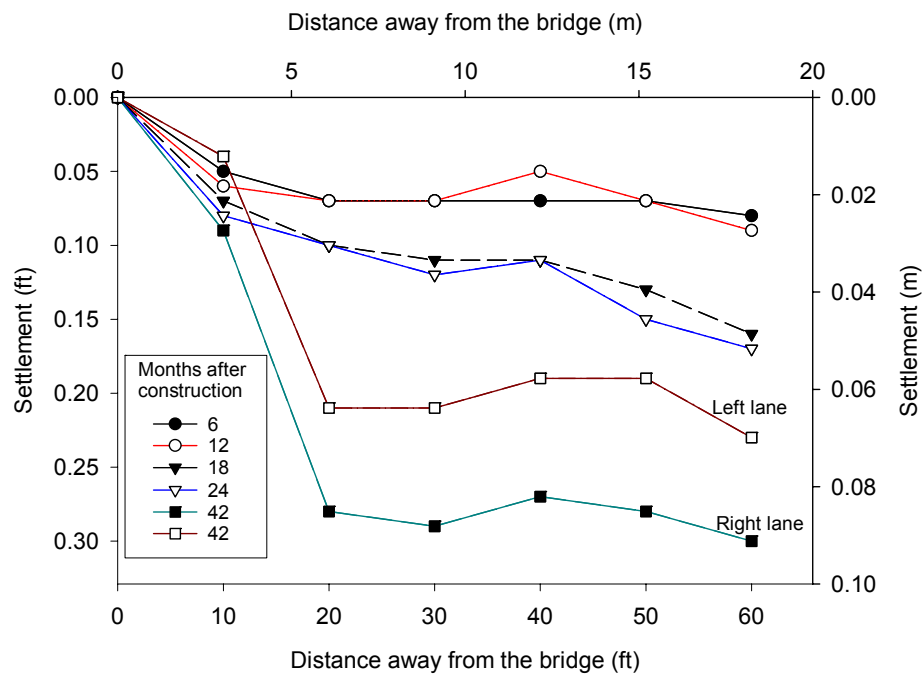
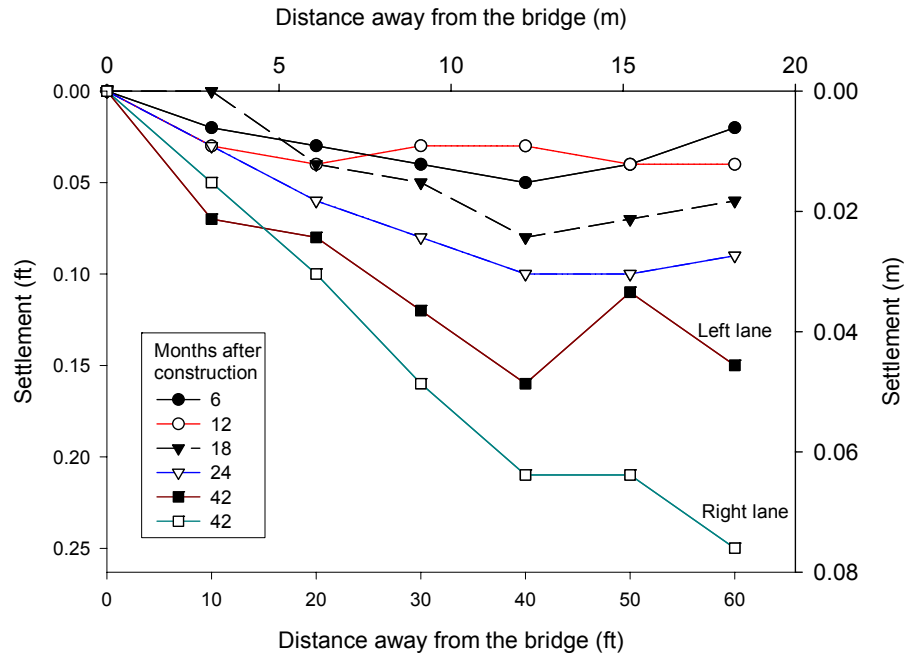
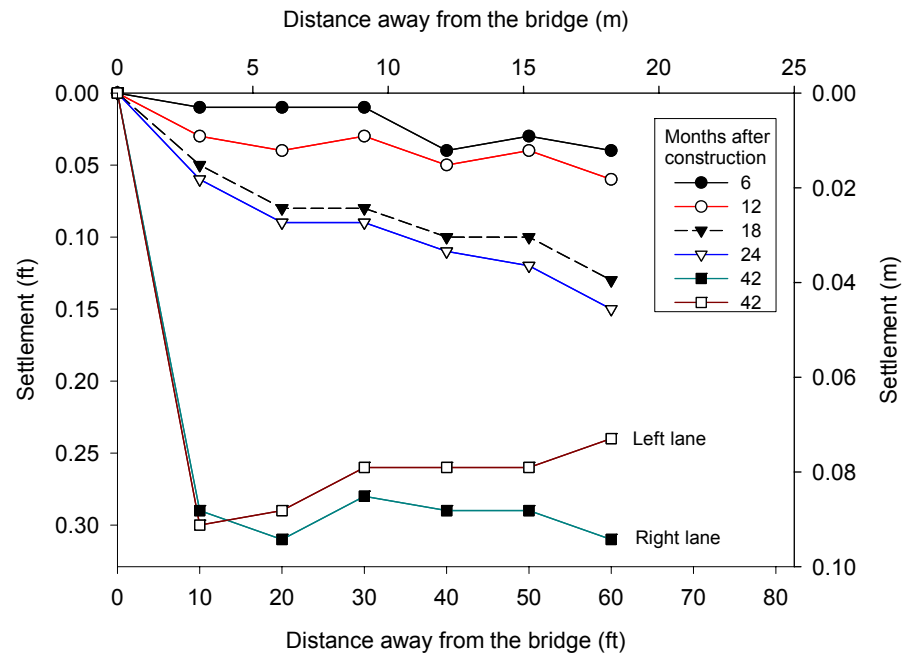
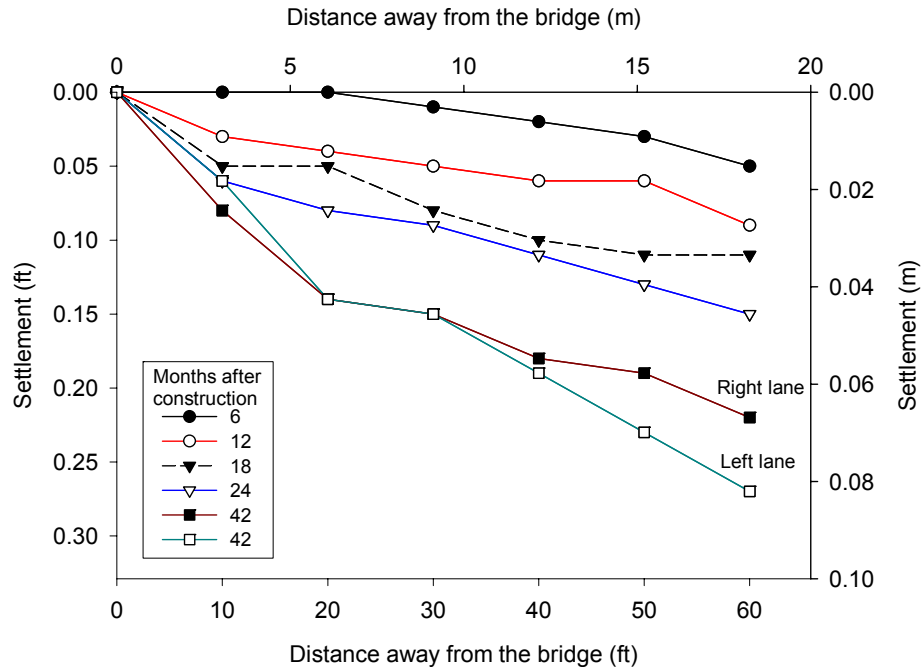
Figures 67 and 68 show the settlement for the bridge approaches at both the north and south ends of the northbound bridge, respectively. Settlement was measured in 10 ft. increments away from the bridge end. Settlement data for both approaches indicate that the approach slab settlement has been increasing with time.

Figures 69 and 70 show the settlement of the bridge approaches of the north and south ends of the southbound bridge, respectively. It is observed that approach slab settlement increases with time at both approaches. Figures 67 through 70 show no settlement difference between approach slabs supported on Geopier elements or embankment fill. This suggests that the embankment fill

is not the contributor to differential settlement and that perhaps settlement of the embankment foundation is the contributing factor.

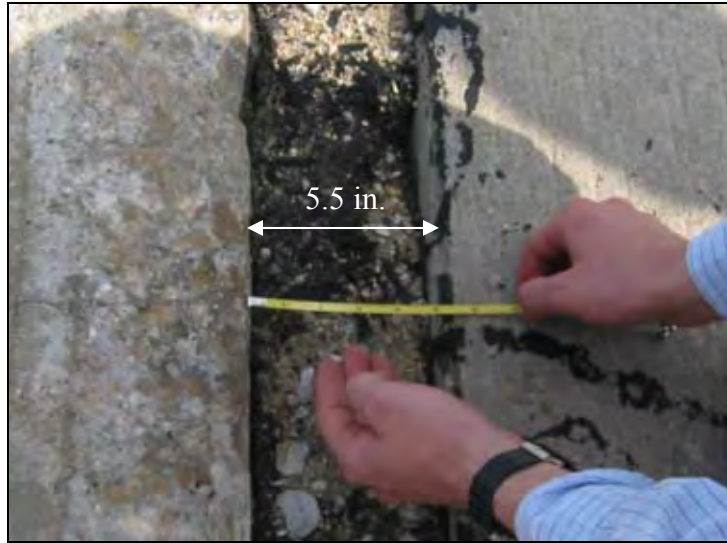
This bridge has integral abutments and concrete girders. Figure 71 shows that the width of the expansion joint is about 5.5 inches. Recycled tire chips were used as filler material at the expansion joint. Deterioration of the concrete at the expansion joint was also observed. Figure 72 shows about 1 inch differential settlement between the approach slab and the bridge deck. In the summer 2003, profiles of all approach slabs were measured and are shown in Figures 73 and 74. All four approach slabs show nonlinear profiles indicating settlement of the approach slab. Approximately 3.9 inches of differential settlement was measured at the west end of the eastbound bridge approach at the end of the wingwall. The slopes of the eastbound lane approach slabs are -0.009 and 0.017 for the east end and west end, respectively, and -0.009 and 0.02 for the east and west end approach slabs of the westbound lane, respectively.

Figure 71. Expansion joint with recycled tire filler and a width of 5.5 in. (top view)
