IDENTIFICATION OF THE BEST PRACTICES FOR DESIGN, CONSTRUCTION, AND REPAIR OF BRIDGE APPROACHES

Iowa DOT Project TR-481
CTRE Project 02-118

Final Report

January 2005

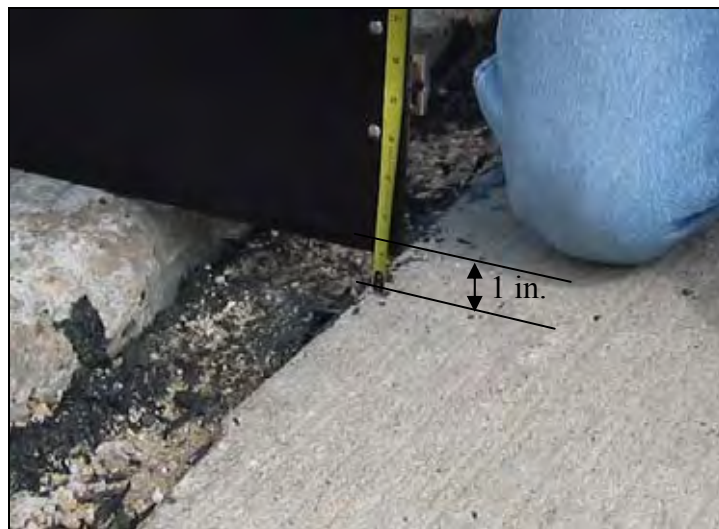
Figure 72. Differential settlement of 1 inch at the bridge approach

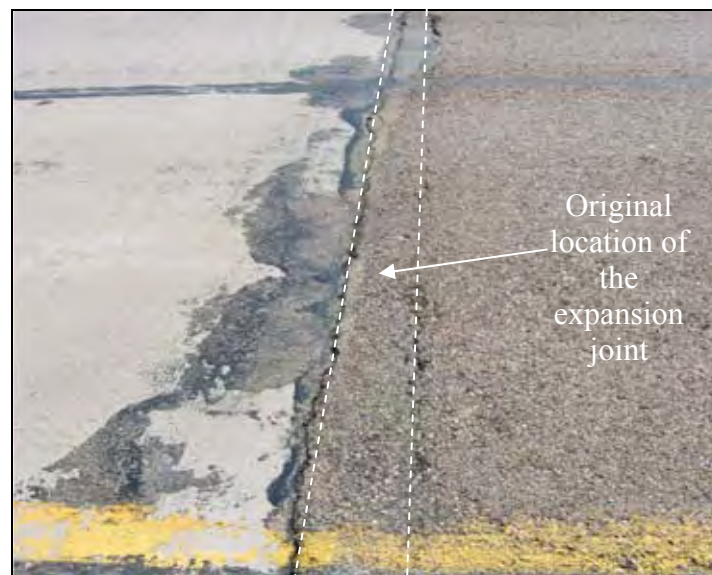
This bridge was constructed in 1976 with integral abutments. Currently, an asphalt resurfaced approach slab covers the expansion joint, as shown in Figure 75. According to the maintenance reports, the approach slab has been resurfaced more than once.

Figure 75. Asphalt overlay covering the expansion joint at the bridge approach

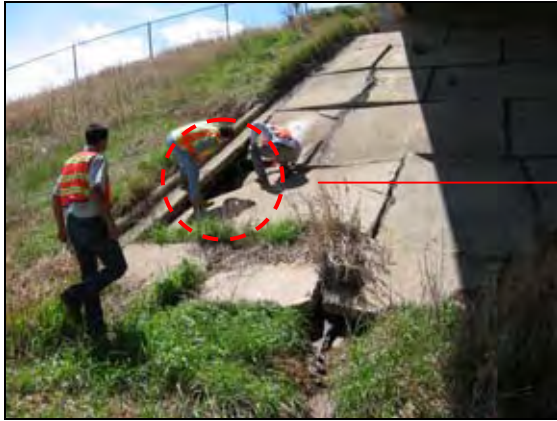
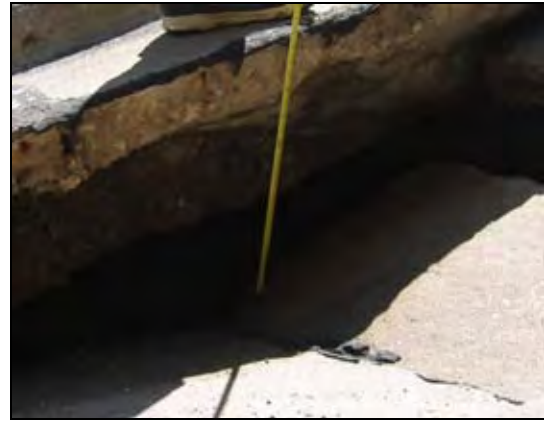
This bridge approach was also resurfaced with an asphalt overlay. The embankment has concrete slope protection. Figures 76 and 77 show damage of the concrete slope protection at the south

end of the northbound lane. The depth of the void under the concrete slope protection was approximately 1.6 feet. Figure 78 shows the settlement of the embankment under the bridge. A gap was also observed between the abutment and embankment. The width of the gap between the abutment and the embankment was 6.5 in. In addition, water was running over the concrete slope protection, indicating poor drainage.

(a) Damaged slope protection

(b) Closer image of the damaged concrete

Figure 76. Failure of slope protection due to loss of support (south end NBL)

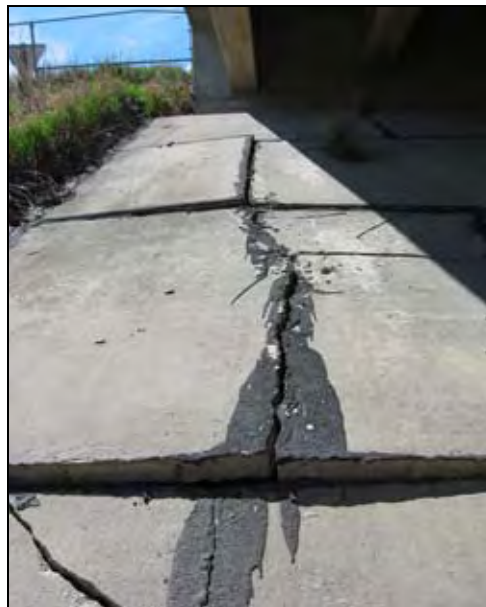
Figure 77. Fractured concrete slope protection

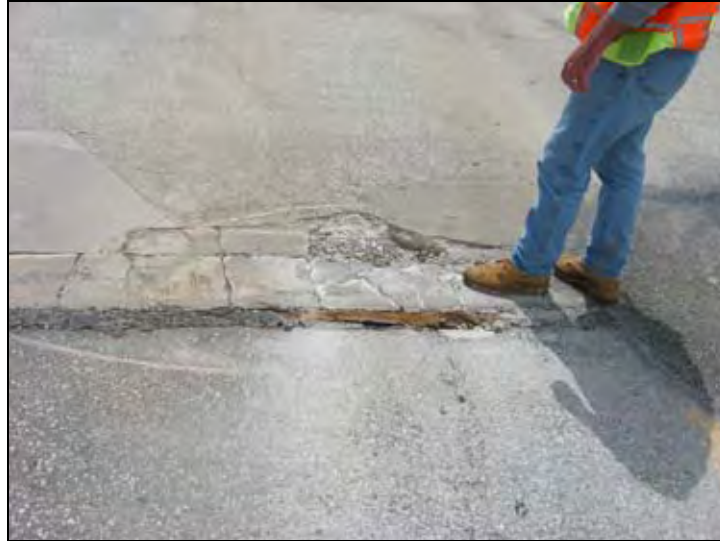
This bridge has integral abutments and concrete girders. Similar to the previous two bridges, cracks developed at the bridge slab (Figure 83). No soil erosion was observed at the embankment under the bridge; however, erosion along the abutment sides was visible.

Figure 83. Cracks in the bridge deck concrete

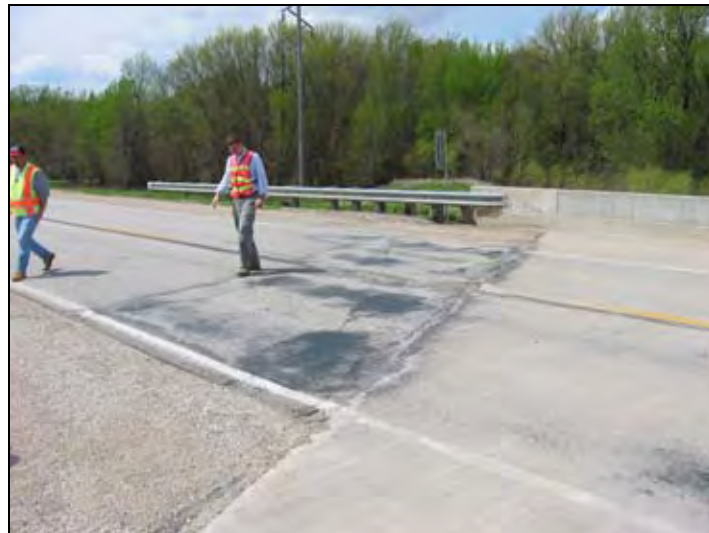
This bridge has integral abutments with concrete girders. No significant soil erosion was observed. Settlement of the embankment of 4.5 inches under the bridge was measured. Both approach slabs had been patched; however, deterioration and cracks were observed on both approach slabs (Figure 84).

Figure 84. Cracking of asphalt overlay (East end)

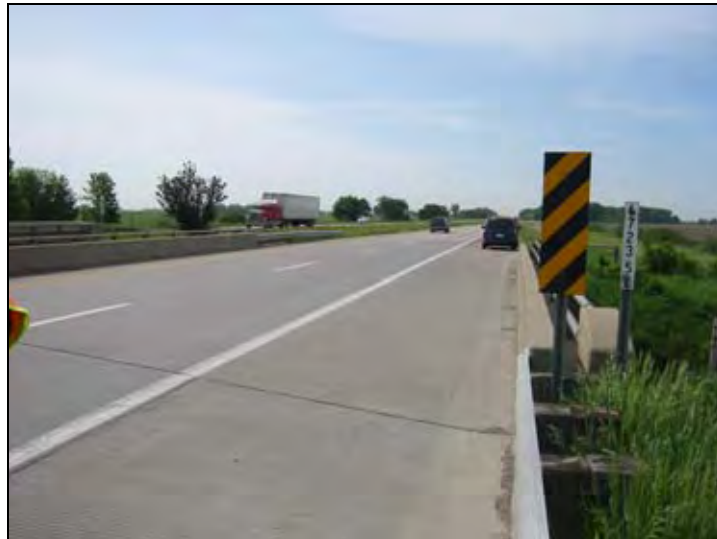
This bridge was constructed in 1960. The approach slab had been recently replaced for the south bound bridge lanes and no major problems were observed (Figure 85).

Figure 85. Recently replaced bridge approach slab (SBL)

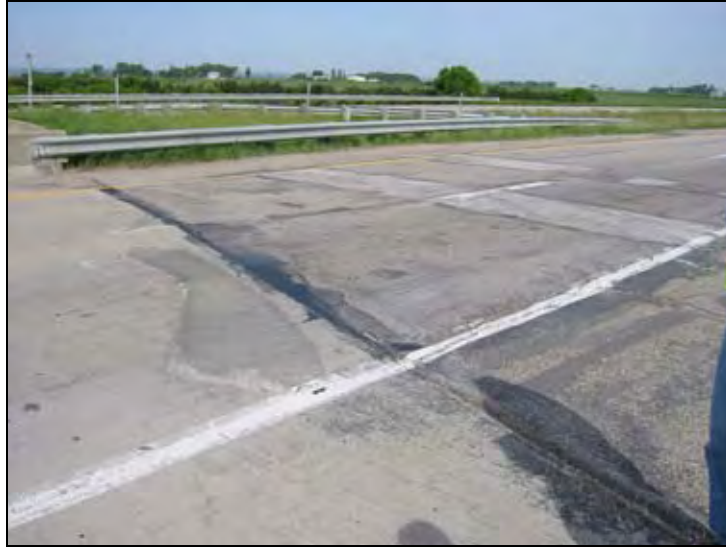
Approach slabs for the north bound bridge were resurfaced with asphalt overlays at both ends. However, wavy approach slabs, longitudinal cracks, and differential settlement of 4 inches relative to the wingwall were observed at both ends (Figures 86 to 88). Figure 88 shows differential settlement and cracks at the bridge slab. The cracks were similar to the ones observed at District 2 (See Bridge no. 5596S169). Figure 88 also shows an asphalt patch that was placed over the crack at the bridge slab while inspecting the bridge.

Figure 86. Significant damage of the asphalt overlay on the approach slab (NBL)

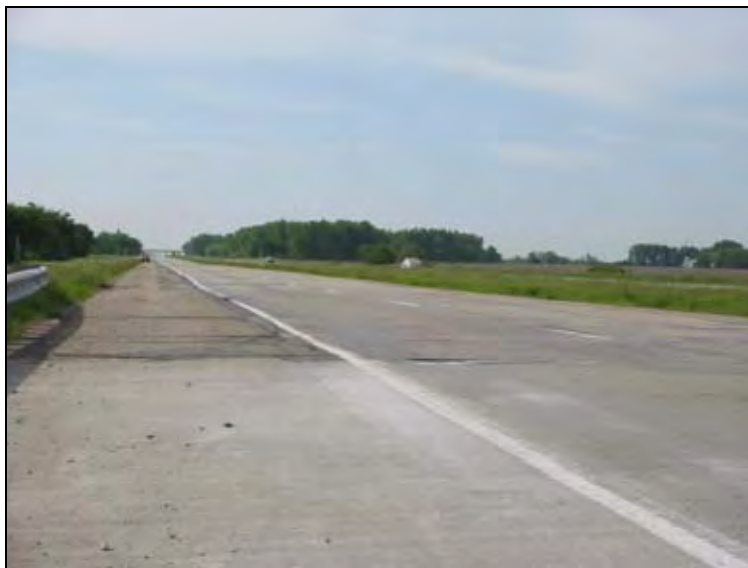
Figure 87. Wavy approach slab (NBL)

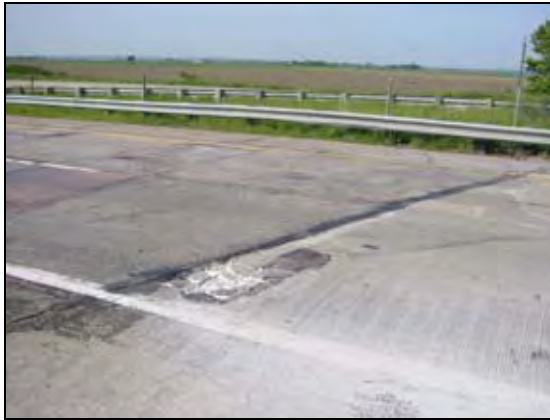
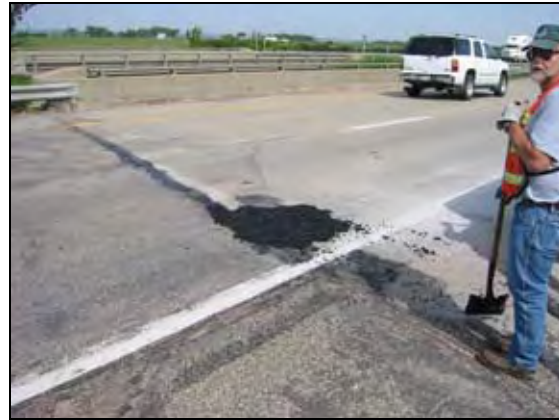
(a) Cracks on the bridge deck

(b) Asphalt patch covering the cracks

Figure 88. Asphalt patch placed over cracked bridge slab (NBL)

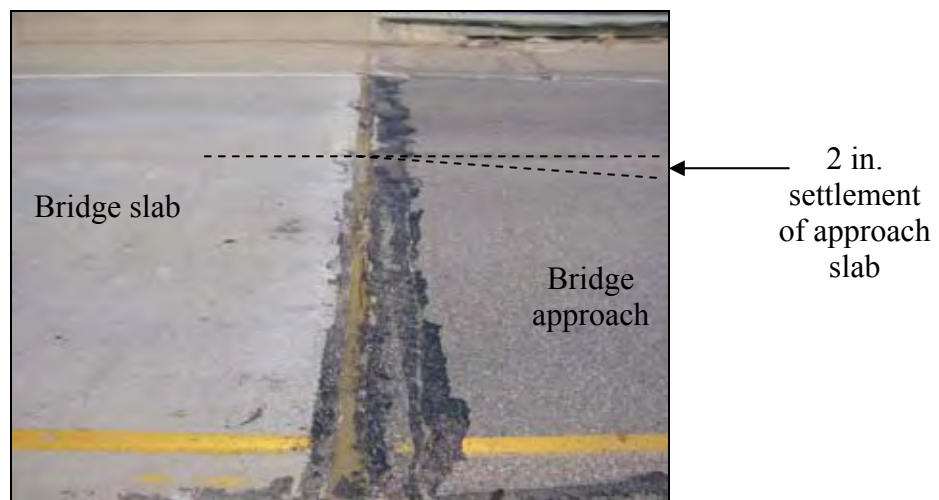
This bridge has an integral abutment and concrete girders. Damage to the expansion joint and 2-inch differential settlement, which was measured at the expansion joint, were observed (Figure 89). The bridge has an asphalt overlay. The slope protection at the embankment under the bridge settled about 3 inches relative to the abutment. Grout, which was pumped to fill the void developed under the approach slab, was observed seeping out between the concrete panels of the slope protection (Figure 90). This suggests that the void extended under the abutment.

Figure 89. Differential settlement between bridge slab and bridge approach

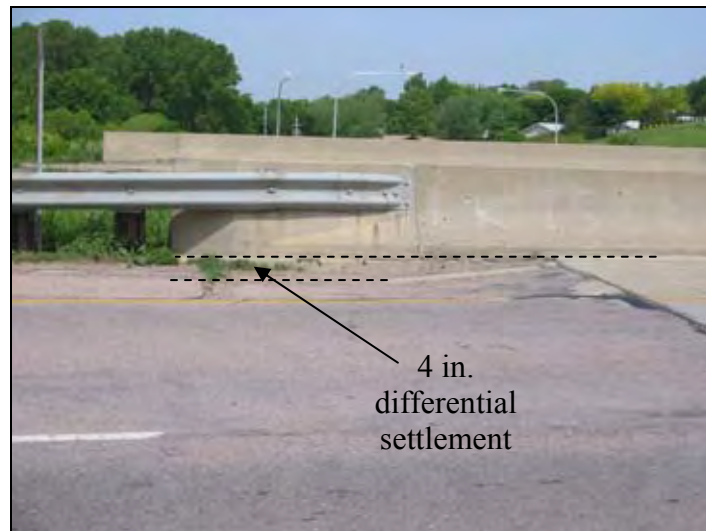
This bridge has integral abutments and concrete girders. The embankments under the bridge had a slope protection. The expansion joint at this bridge was 2 inches wide. Figure 91 shows the 4 inches of differential settlement measured between the bridge deck and the shoulder of the bridge approach. This figure also shows alligator cracking at the bridge shoulder. Grout was pumped behind the abutment at the west end of the eastbound lane and under the embankment slope protection cover. The concrete slope protection settled about 6.5 inches relative to the abutment (Figures 92 and 93).

Figure 91. Differential settlement between the bridge deck and the approach slab

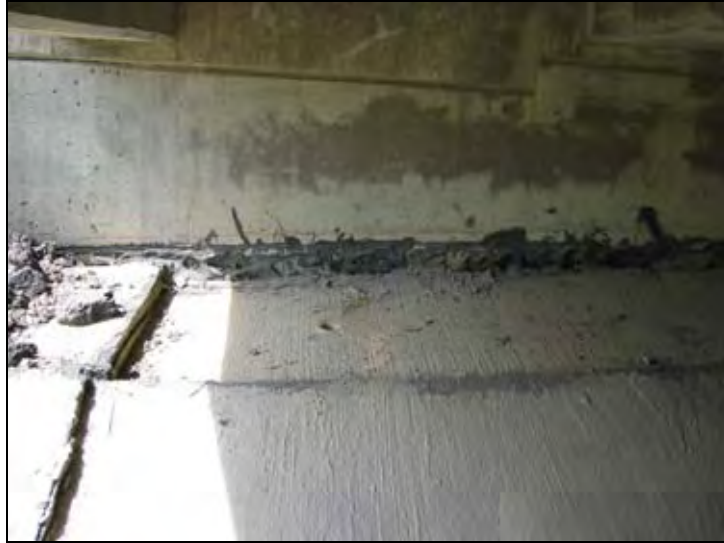
Figure 92. Uneven settlement of concrete slope protection

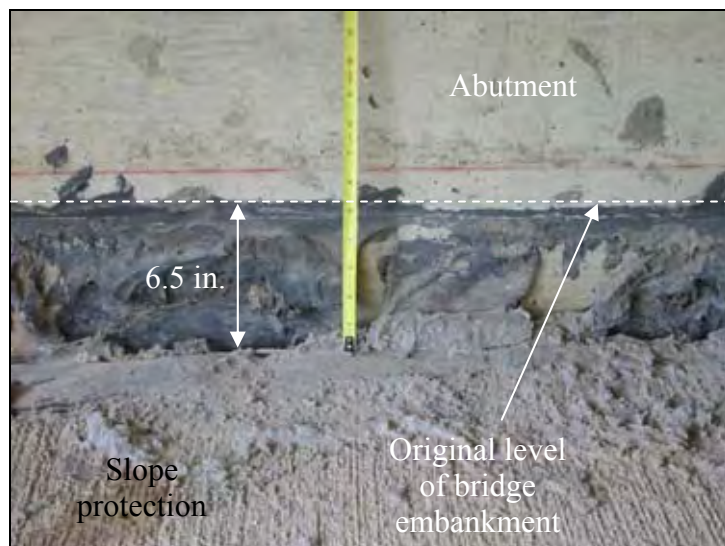
Figure 93. Settlement of the embankment slope protection of 6.5 inches

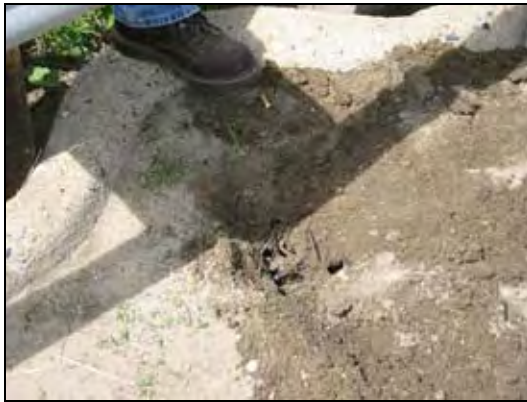
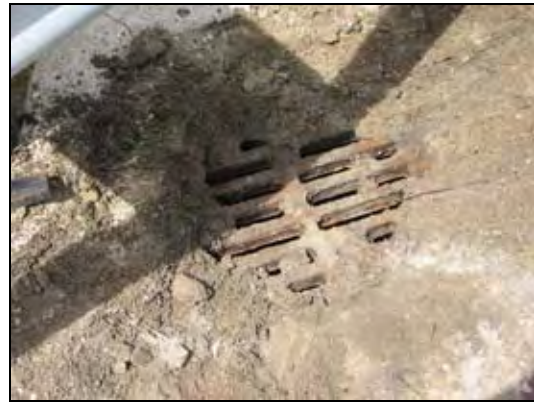
This bridge has non-integral abutments and concrete girders. The approach slab was grouted to prevent water infiltration. This caused water to run along the bridge shoulder to the other end of the bridge. Although surface drainage was used on the west side of the bridge, it was plugged (Figure 94). As a result, water eroded the approach slab shoulder, as shown in Figure 95. With no slope protection under the bridge and silty soil used for the embankment, severe erosion was also observed (Figure 96).

(a) Bridge approach surface drain blocked by debris

(b) Bridge approach surface drain after debris removal

Figure 94. Drainage intake before and after debris removal

- Some bridges do not have a surface drain. The current Iowa DOT surface drain detail shown in Figure 94 is not effective. The surface drain observed at 5596.2S169 bridge (Figure 81) is effective and is believed to have helped in reducing erosion around the bridge abutment.

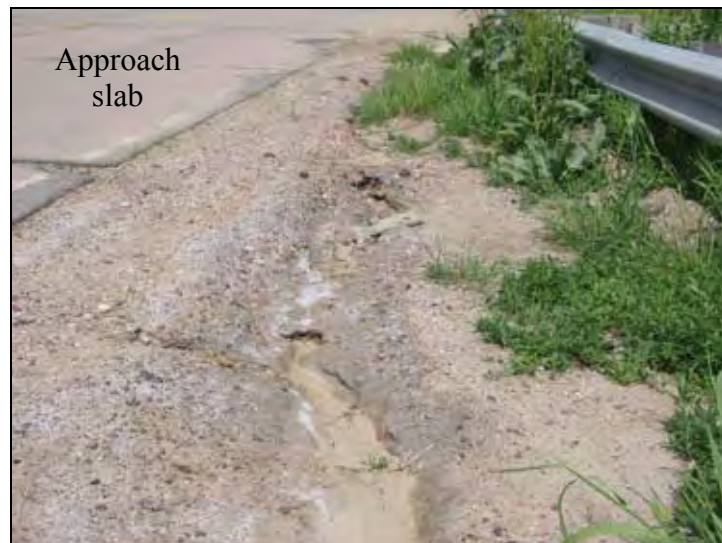
Figure 95. Erosion caused by runoff water at the approach slab shoulder

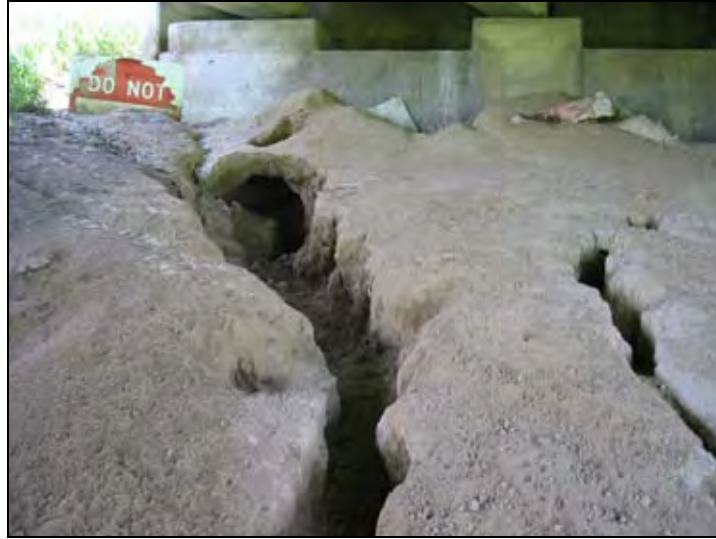
Figure 96. Severe erosion under the bridge

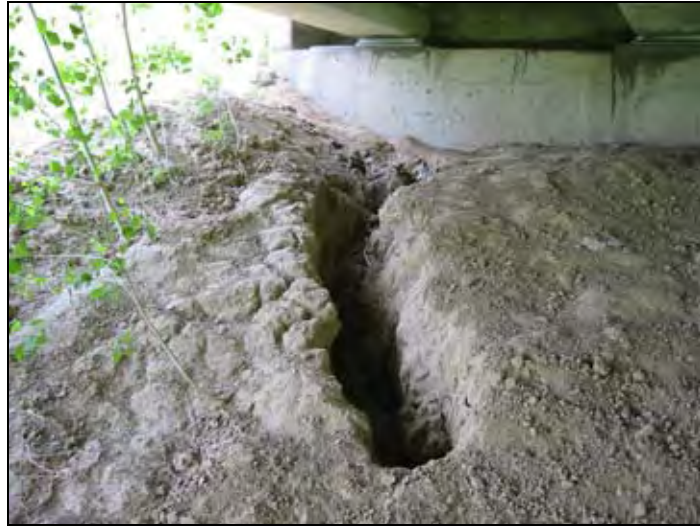
The bridge was constructed in 2000 with non-integral abutments. The foundation soils at this bridge were allowed to consolidate under the embankment weight for one year prior to construction. No differential settlement was observed at the approach slabs. Erosion of the soil under the bridge was observed because the strip seal of the expansion joint was cut short at both sides of the north bound lane, causing water to run down the sides of the bridge (Figures 98 and 99). At the opposite end of the bridge, the same strip seal problem was noticed and erosion of the embankment soil was observed.

Figure 98. Soil erosion of the embankment under the bridge

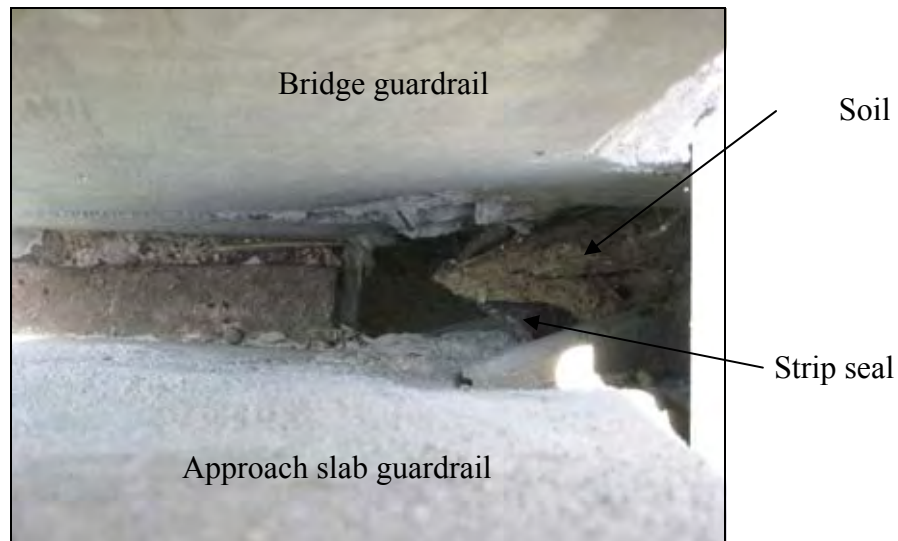
Figure 99. Top view of the strip seal cut short (North bound)

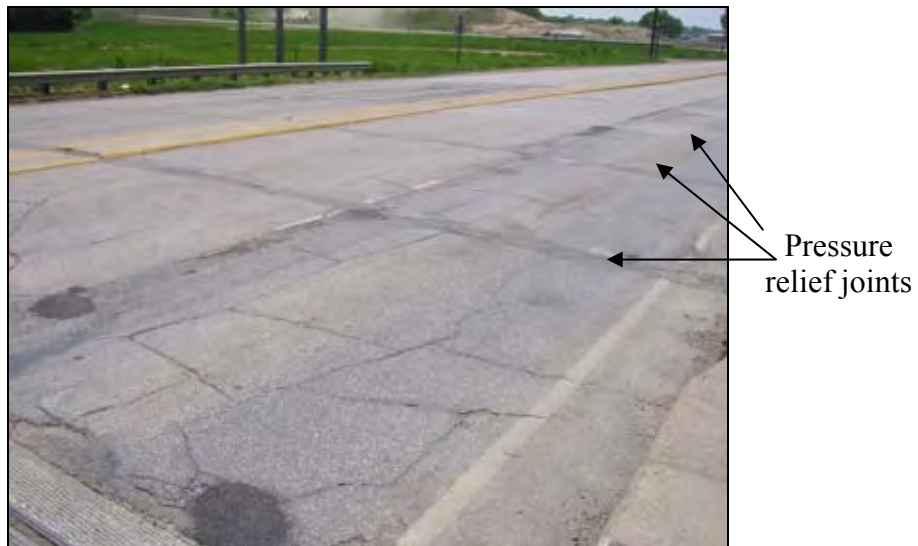
This bridge was constructed in the 1960s and has steel girders with non-integral abutments. Longitudinal and transverse cracks were visible on the approach slab. Figure 101 shows the aggregate that was used as a slope protection under the bridge. After overlaying the approach slab with asphalt, which also covered the expansion joint, a pressure relief joint was made by cutting the approach slab. More pressure relief joints were made as previous joints were deemed non-functional due to debris. The additional joints provide opportunity for water to infiltrate into the subgrade under the approach slab (Figure 102).

Figure 102. Pressure relief joints cut at the approach slab

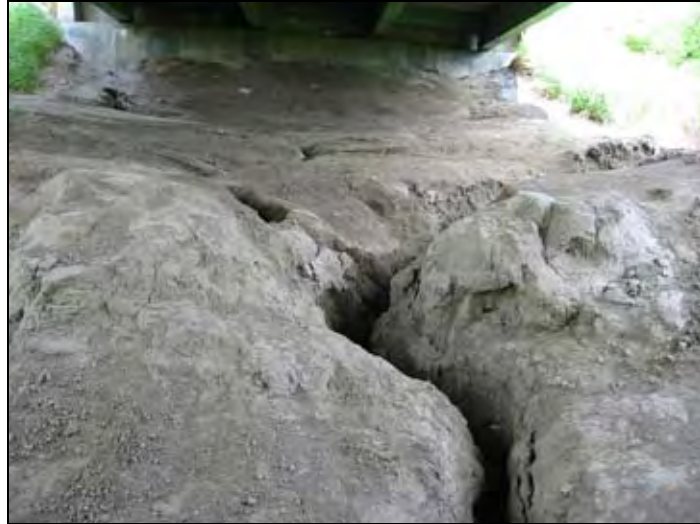
This bridge has steel girders with non-integral abutments. About 2 inches of settlement of the approach slab was measured at the wingwall. Although the soil of the embankment was silty, no embankment slope protection was used under the bridge. As a result, soil erosion was observed, as shown in Figure 103.

Figure 103. Soil erosion of the embankment under the bridge

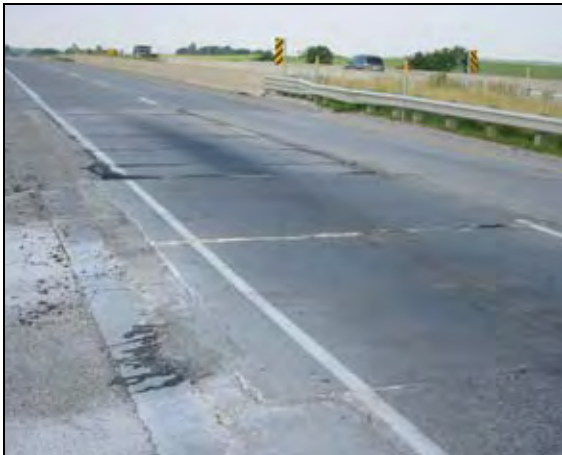
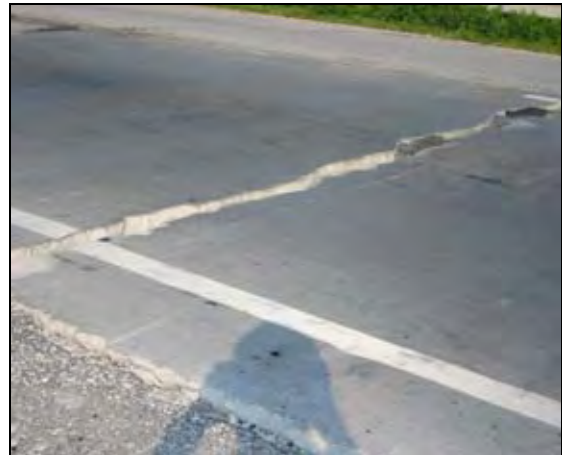
This bridge was constructed in 1968 and has four spans with non-integral abutments. Figure 109 shows severe faulting of the bridge approach panels. Maintenance records indicate that this approach slab had been previously repaired with the most recent patch places in spring 2003. The outlet of the end drain could not be located (Figure 110), which may be blocked with soil that caused the observed cracking and faulting of the approach slab. Cracked concrete slope protection of the embankment under the bridge was also observed (Figure 111).

(a) Cracked approach slab panels

(b) Closer image of faulted approach slab

Figure 109. Faulting of bridge approach panels

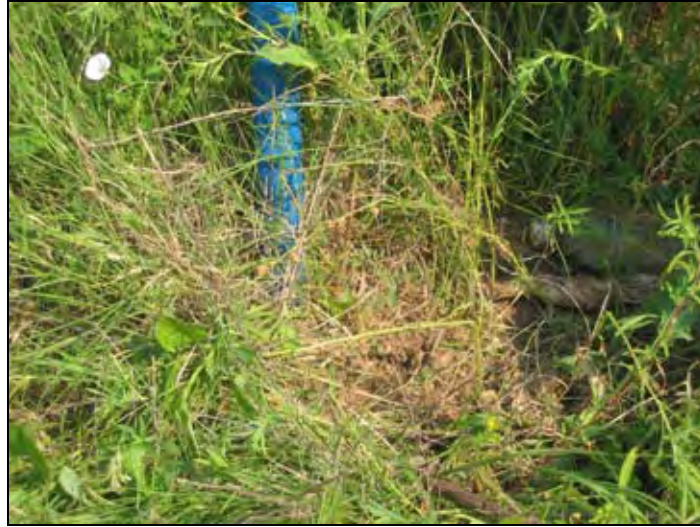
Figure 110. Drainage outlet could not be located

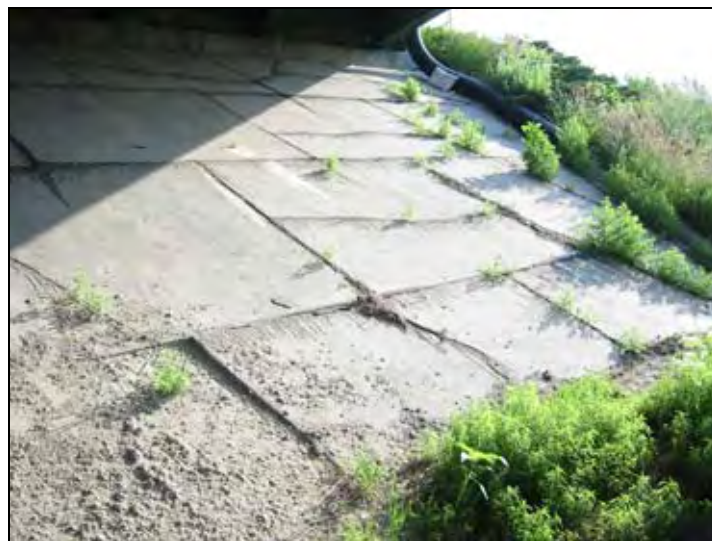
Figure 111. Cracking of concrete slope protection

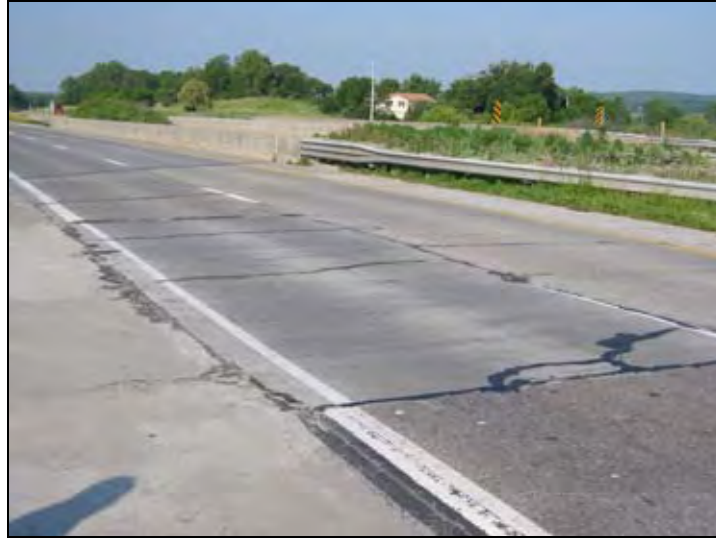
This bridge was constructed in the late 1960s and has three steel spans with non-integral abutments. According to interviews with Iowa DOT field personnel, the approach slab has been replaced 5 times in the last 13 years and, and although it was recently replaced, transverse cracks and settlement were observed (Figure 112). The outlet of the end drain was dry with no signs of water or fine soil particles at the time of the inspection (Figure 113). With no slope protection and loess soils used as embankment soil (Figure 114), erosion was observed around the bridge.

Figure 112. Cracking and settlement of recently replaced approach slab

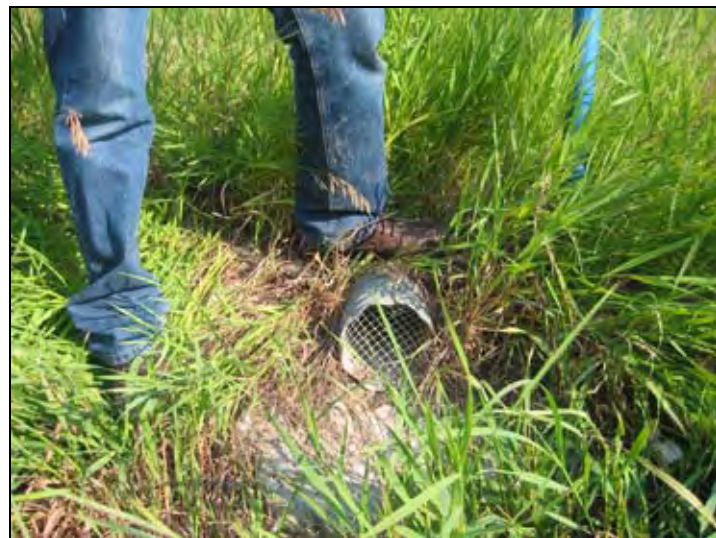
Figure 113. Dry end drain with no indication of water flowing out

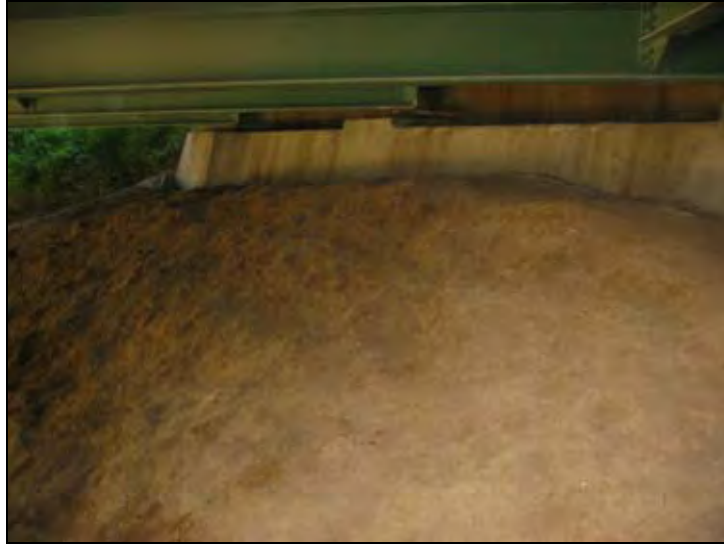
Figure 114. Loess soil used for the embankment

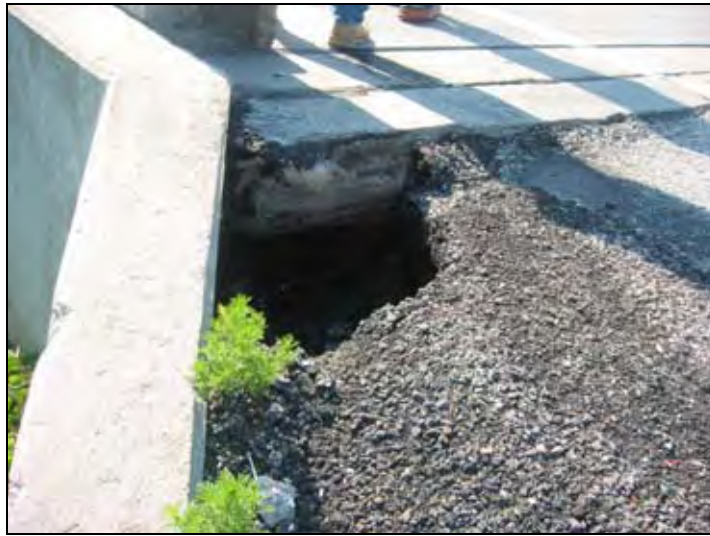
The bridge has three spans with non-integral abutments. At the westbound end, the expansion joint was poorly sealed and erosion at the shoulder of the approach slab (Figure 118) was observed. Figure 119 shows map and longitudinal cracks developed at the expansion joint. Differential settlement of 2 inches between the approach slab and the wingwall was also noted. There was no slope protection under the bridge. Soil erosion and settlement of the embankment were observed.

Figure 118. Failure at the shoulder of the approach slab (WBL)

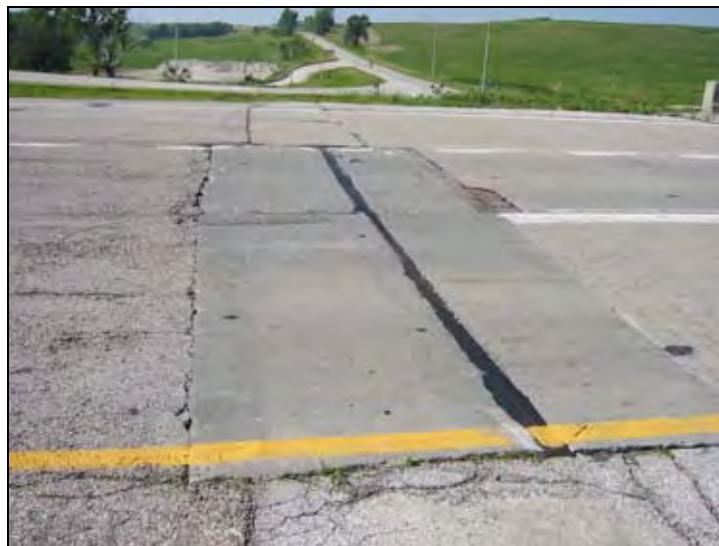
Figure 119. Various cracking at the bridge approach (EBL)

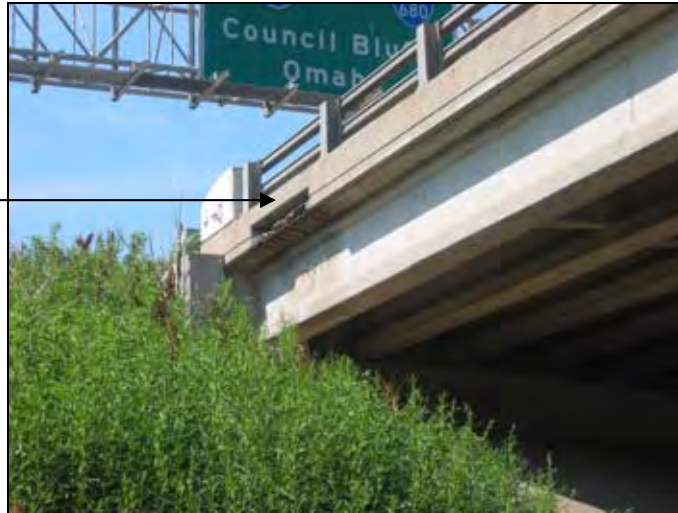
This bridge has integral abutments and concrete girders. Damage of the expansion joint was visible. Figure 120 shows the bridge surface drain at the northbound lane. This figure illustrates that no drainage pipe was used to direct the water collected on the bridge deck away from the embankment, which may have caused soil erosion under the concrete slope protection. Excessive erosion led to failure of the slope protection at both ends of the bridge and the exposure of H-piles supporting the abutments (Figures 121 and 122). Settlement of the embankment under the bridge at the southbound lane of 10.5 inches was measured (Figure 123). Ponding water was observed at the bottom of the bridge embankment (Figure 124).

Figure 120. Surface drain of the bridge deck allowing water to fall on the embankment

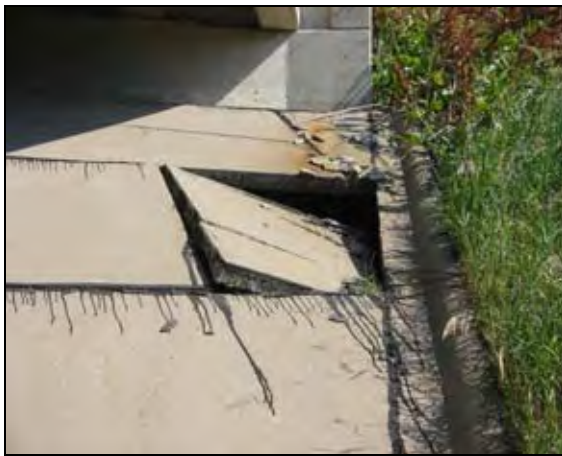
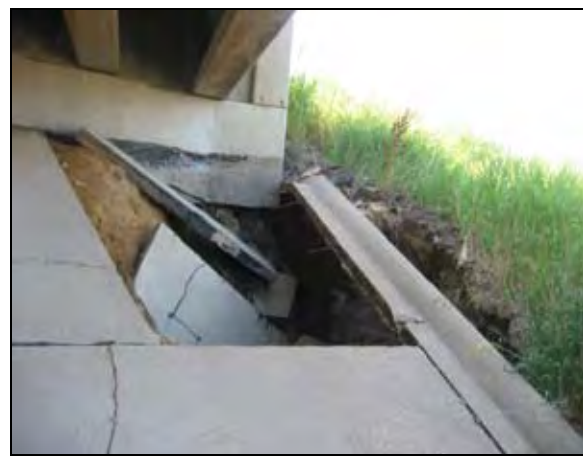
Figure 121. Failure of concrete slope protection

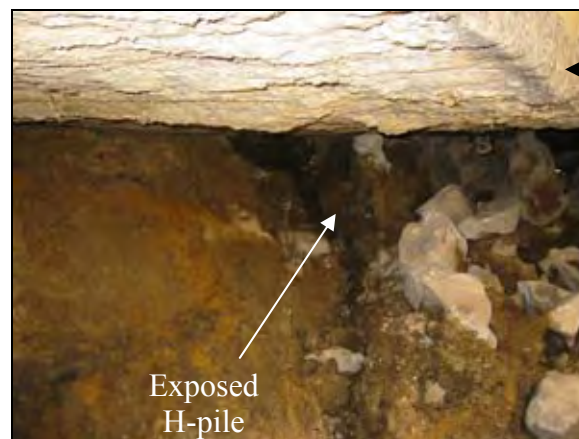
Exposed
H-pile

Figure 122. Exposed H-pile (side view)

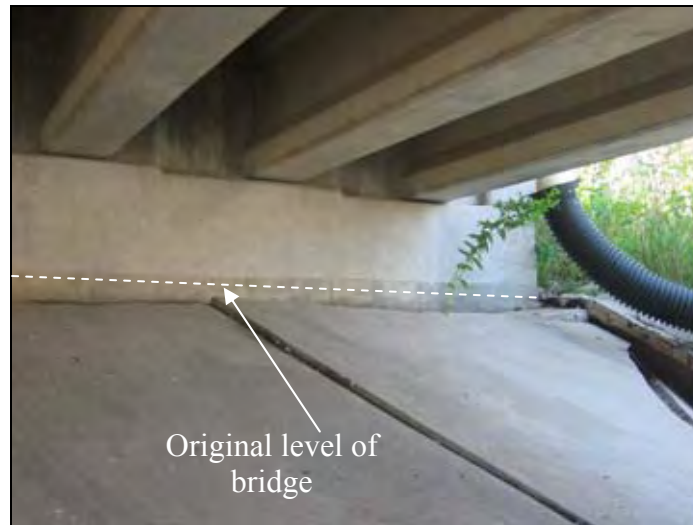
Figure 123. Concrete cover settlement of 10.5 in.

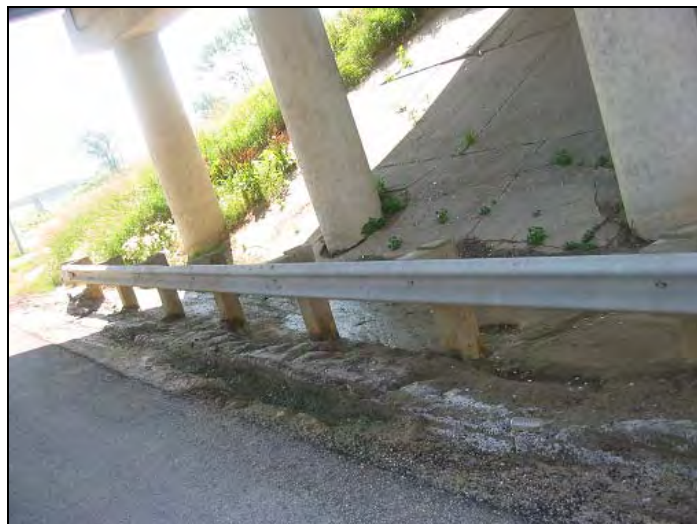
Figure 124. Ponding water and debris observed at the bottom of the embankment

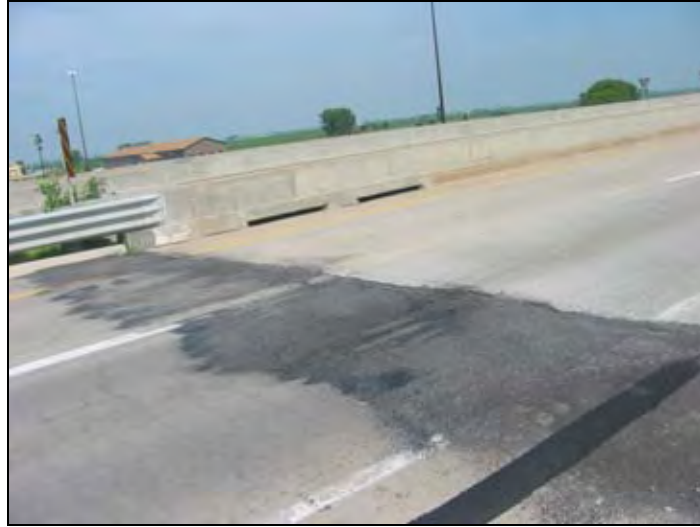
Figure 125. Asphalt patch placed at the approach slab

This bridge has four spans and non-integral abutments. Figure 125 shows the asphalt overlay placed at the bridge approach to compensate for the approach slab settlement relative to the bridge deck. In spite of the asphalt overlay, 3 inches of differential settlement was still observed at the end of the wingwall. The concrete slope protection on the embankment under the bridge had been replaced with aggregate. Where recycled tires were used as a filler material, the expansion joint was in a satisfactory condition (Figure 126).

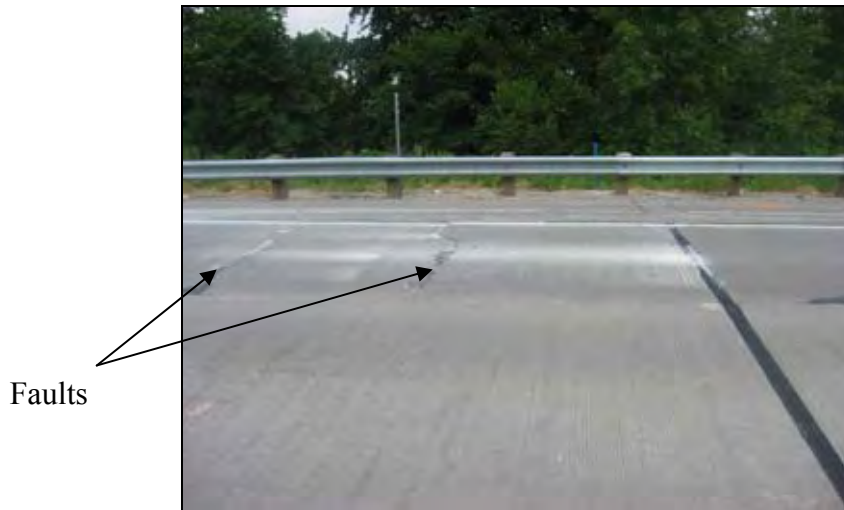
Figure 129. Faulting of approach slab panels

This is a three-span concrete bridge with non-integral abutments. Figure 127 shows settlement of the approach slab. Concrete spalling and cracking at the expansion joints were observed (Figure 128). Faulting of the bridge approach panels was also noted (Figure 129). The voids developed around the abutments were grouted. The embankments under the bridge had no slope protection and soil erosion was observed.

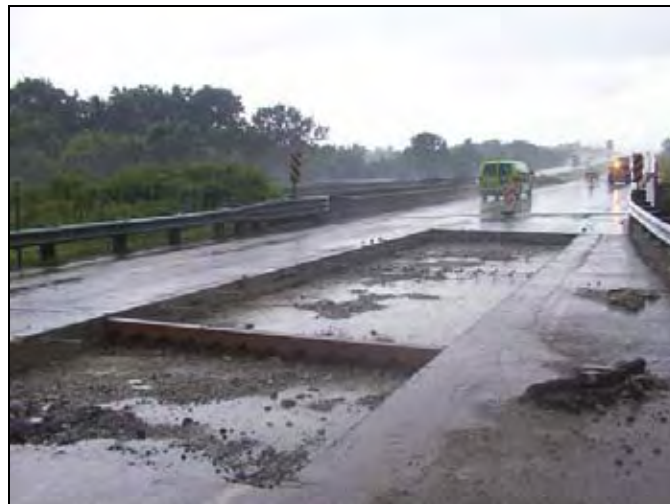
Figure 130. Bridge approach panel removed for replacement

Due to the significant damage of the approach slab, the approach slab panels were replaced in July 2003. Figure 130 shows the exposed subgrade after removing the old pavement. Two sections at both ends of the westbound lane were replaced. These sections were at the right lane starting 15 feet away from the bridge and extended over 40 feet. After removal, it rained and saturated the underlying subgrade. A subgrade sample was obtained from the exposed subgrade and was classified as well-graded gravel (GW) (see Appendix B for detailed results).

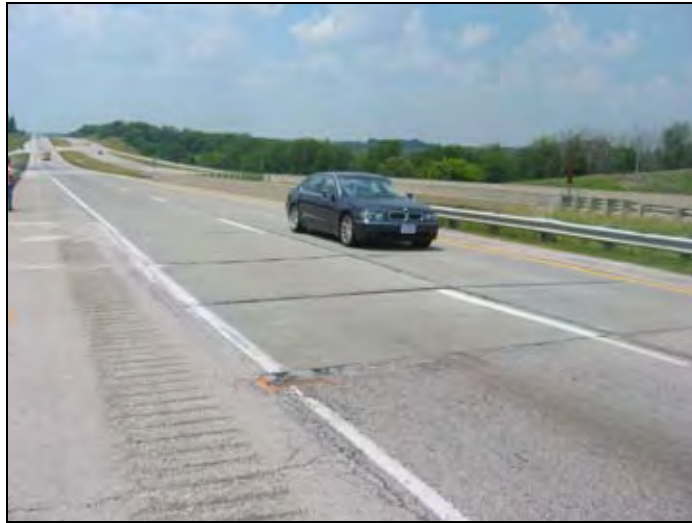
Figure 131. Damage of the approach slab section

This is a three-span concrete bridge with non-integral abutments. Settlement and damage of the approach slab and damage of the expansion joint were observed (Figure 131). The embankment under the bridge has concrete slope protection. In addition, the end of drain outlet was blocked with soil.

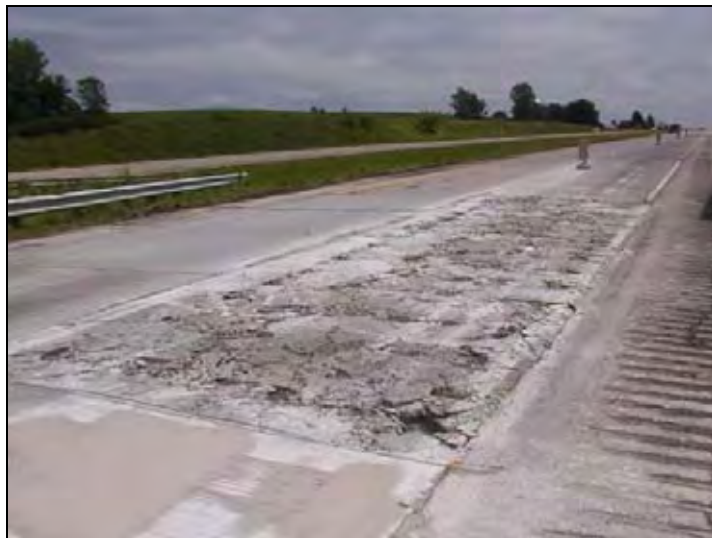
Figure 132. Approach pavement broken before replacement

The approach slab of this bridge was replaced in summer 2003. This section, which is on the right lane at the east end of the eastbound lane, was 30 feet long and approximately 15 feet away from the bridge. Figure 132 shows the broken approach slab pavement before removal and replacement. Figure 133 shows the approach slab section being replaced after removing the old pavement. A sample of the base material was tested in the laboratory and classified as well-graded gravel (GW) according to the Unified Classification System (See Appendix B for results).

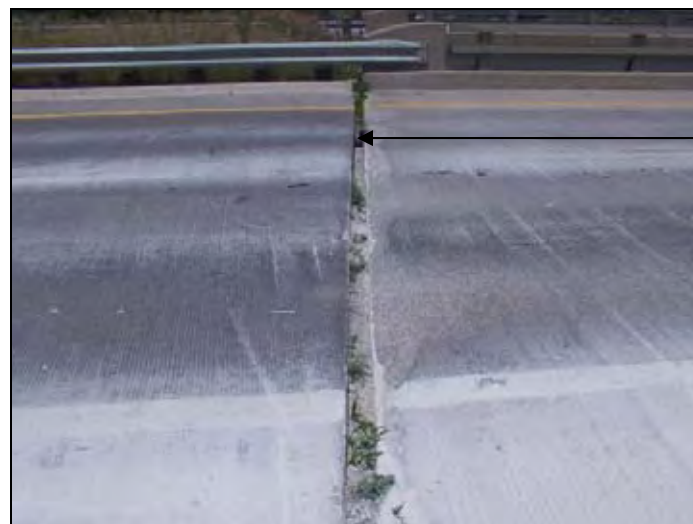
Figure 134. Expansion joint poorly sealed and filled with fines (West end of EBL)

This bridge has four spans with non-integral abutments. The expansion joint was not properly sealed and cracks around the joint were observed at both the east and westbound lanes (Figure 134). Faulting of the approach slab was noticed at the west end of the eastbound lane, as shown in Figure 135, and replaced in summer 2003 (Figure 136). The embankments of the bridge had an aggregate slope protection cover.

Gap caused
by missing
filler
material

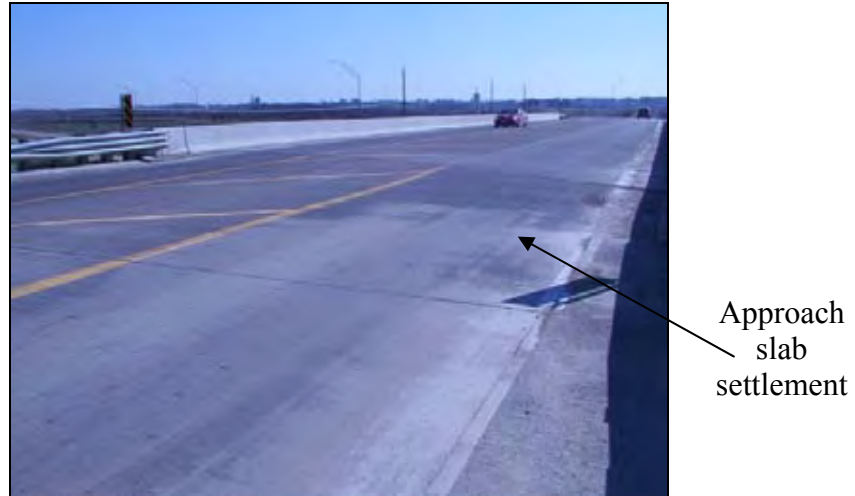
Figure 137. Settlement of approach slab

At the west end, differential settlement of 3 inches was observed between the approach slab and wingwall (Figures 137 and 138). The width of the expansion joint at the west end was 5.5 inches. Part of the joint filler material was missing (Figure 139), allowing water to flow behind the bridge abutment, which contributed to increasing soil erosion. As a result, a void developed under the approach slab was 11 inches deep at the abutment and extended to 6 feet away from the abutment (Figure 140). The end drain at the west end was observed to be in good working condition.

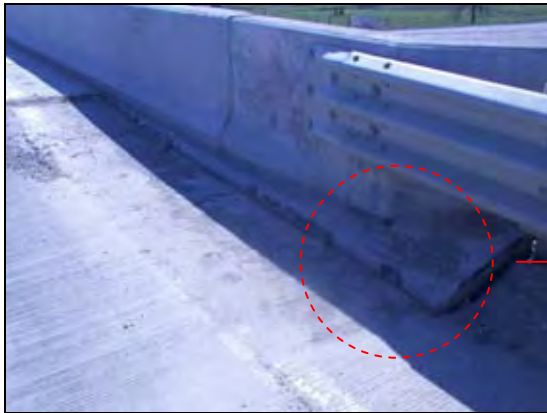
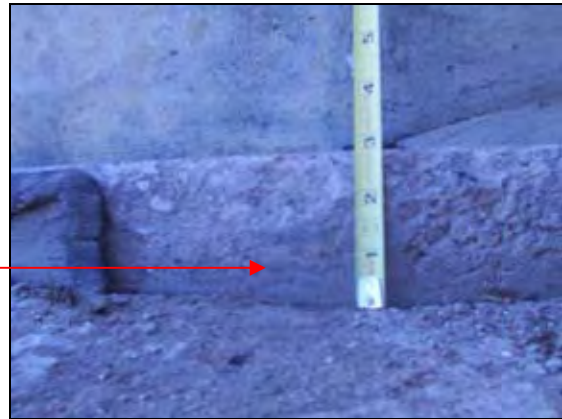
Figure 138. Settlement of approach slab relative to wingwall

(a) Settlement of approach slab

(b) Closer image of approach settlement

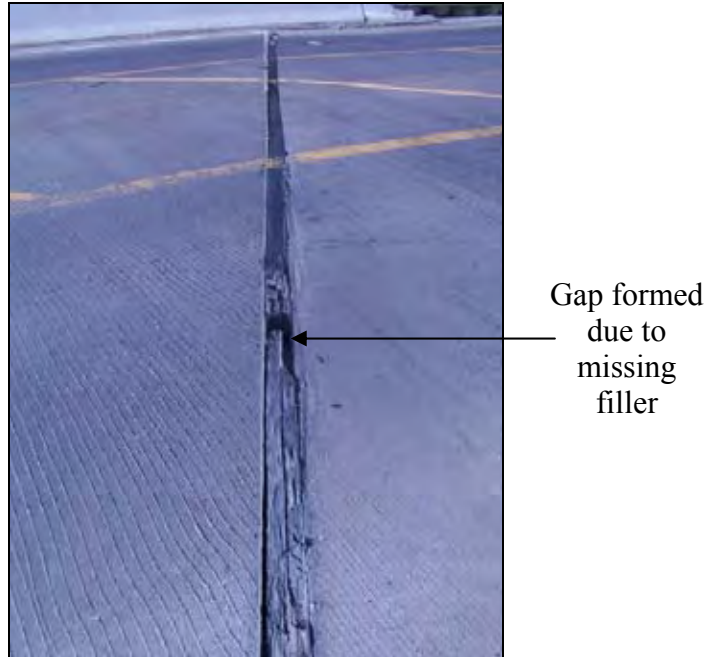
Figure 142. Missing and deteriorated filler material at the expansion joint (East end)

At the east end, differential settlement of about 1 inch between the approach slab and the bridge deck was measured (Figure 141). The expansion joint width was 5 inches. The sealer used to keep the joint filler in place deteriorated shortly after construction, and the forks used to hold the joint material in place were not found. As a result, the joint filler was missing leaving a large gap (Figure 142) allowing water to erode the backfill material under the approach slab. The void developed under the approach slab was about 4 inches deep (Figure 143). Another indication of poor water management was the observed erosion at the sides of the abutment (See Figure 144). Furthermore, concrete spalling was observed at the expansion joint.

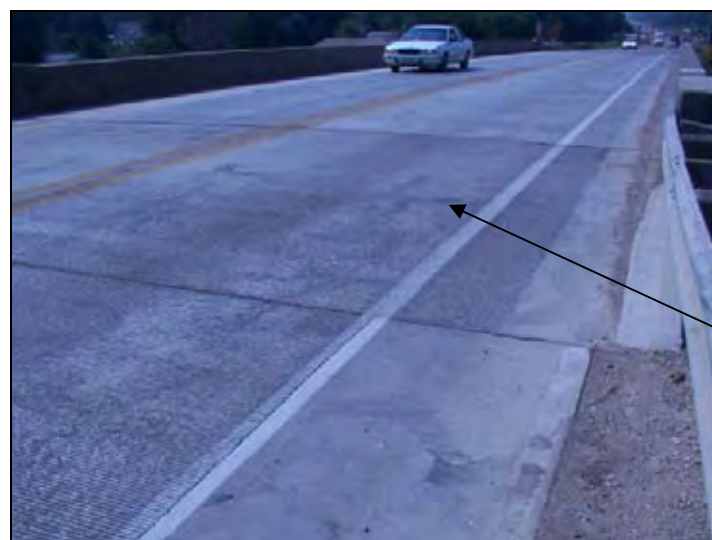
Figure 145. Differential settlement at recently replaced bridge approach

This is a three-span bridge with integral abutments. The approaches were replaced in May 2004 due to the failure of the paving notch. After replacing the approaches, the new expansion joints were 2.5 inches wide. Differential settlement between the bridge deck and the approach slab was observed (Figure 145). At the south end of the bridge, a gap 1 inch wide was observed between the abutment and slope cover (Figure 146), while the embankment settled 3 inches. At the north end of the bridge, concrete slope protection panels were removed for replacement due to uneven settlement, cracking, and failure. The soil used at the embankment under the bridge was silty clay. Aggregate were used at the sides of the abutment to minimize erosion. Similar to other bridges inspected in District 5, this bridge reportedly does not have a subdrain around the abutment.

Settlement
of approach
slab

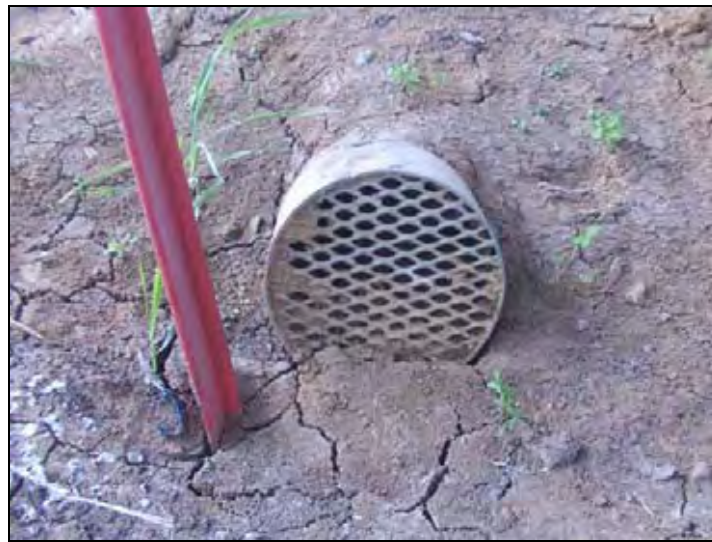
Figure 149. Perforated drain tile filled with soil (South end of SBL)

This is a five-span bridge with concrete girders at the south bound and steel girders at the north bound. The bridge has non-integral abutments. Glacial till soil was used to build the embankment with no slope protection under the bridge. At the south end of the south bound bridge, the approach slab was not yet constructed at the time of inspection. It was observed that the strip seal at the expansion joint was cut short which would allow water to flow downward to the embankment under the bridge (Figure 148). Perforated drain tile were used during embankment construction to allow for faster consolidation of the foundation soil. These drains were observed filled with soil (Figure 149). At the north end of the north bound, erosion of the embankment under the bridge was observed (Figure 150).
