IDENTIFICATION OF THE BEST PRACTICES FOR DESIGN, CONSTRUCTION, AND REPAIR OF BRIDGE APPROACHES

Iowa DOT Project TR-481
CTRE Project 02-118

Final Report

January 2005

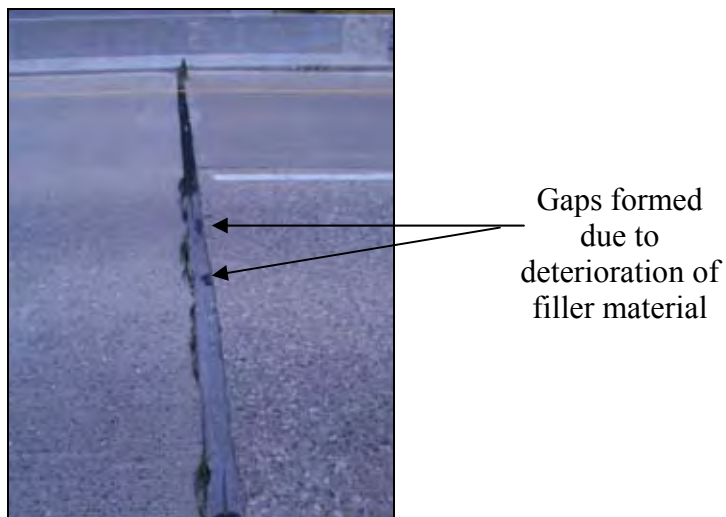
Figure 151. Deteriorated flexible foam which was used as joint filler (North end of NBL)

This is a two-span bridge with steel girders and integral abutments. Aggregate was used as slope protection for the embankment under the bridge. At the north end of the northbound bridge, a void under the approach slab that ranged from 3 to 8 inches developed and may have contributed to approach slab faulting. The void was grouted and the approach slab panels were replaced. After replacement, the expansion joint was 3 inches wide and flexible foam was used as joint filler. The joint was poorly sealed, as shown in Figure 151, and concrete spalling was still noticeable. No surface drain on the bridge was constructed; however, water was directed away from the bridge by sloping the shoulders away from the bridge. This led to erosion along the sides of the abutment. At the south end of the northbound bridge, differential settlement of 3 inches was measured. A 4-inch void developed under the approach that was grouted (Figure 152). Erosion at the sides of the abutment was also noted.

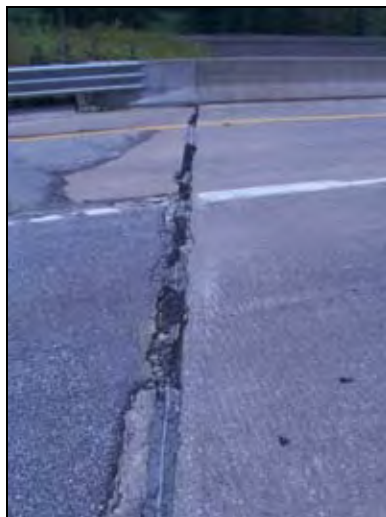
Figure 153. Poor performing resurfaced bridge approach (West end of WBL)

This is a three-span bridge with concrete girders and integral abutments. The bridge approach was resurfaced with an asphalt overlay at the west end of the west bound bridge, which was significantly deteriorated and cracked, as shown in Figures 153 and 154. The width of the expansion joint was 4 inches and consisted of flexible foam. Differential settlement between the approach slab and the bridge deck of 1 inch was measured. Grout was pumped under the approach slab due to void development. Glacial till was used as embankment material with no slope protection. Erosion between the embankment and abutment backwall was noticeable (See Figure 155). The subdrain outlet was blocked with soil (Figure 156).

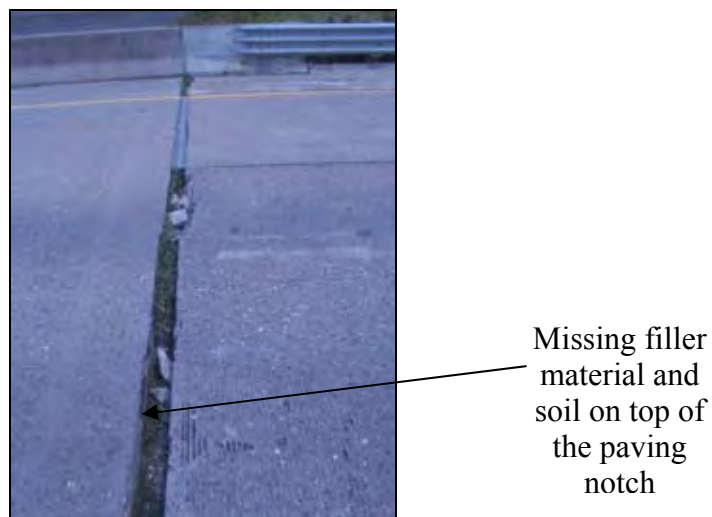
Figure 157. Missing filler material exposing the pavement notch (East end of WBL)

This is a three-span bridge with integral abutments. At the east end of the bridge, differential settlement between the approach slab and the wingwall of 1 inch was measured. The width of the expansion joint was 4.5 inches. Parts of the flexible foam joint filler completely came out exposing the paving notch (Figure 157), which was covered with about 3 inches of soil debris. Grout was pumped under the approach slab to fill a void developed behind the abutment. Furthermore, erosion between the embankment under the bridge and the backwall was observed (Figure 158a) where rip-rap was used to control erosion (Figure 158b).

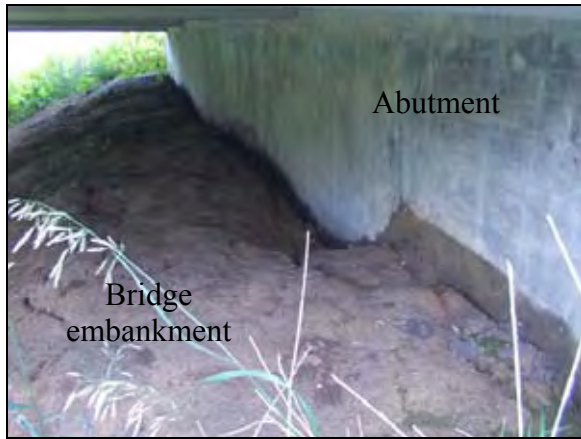
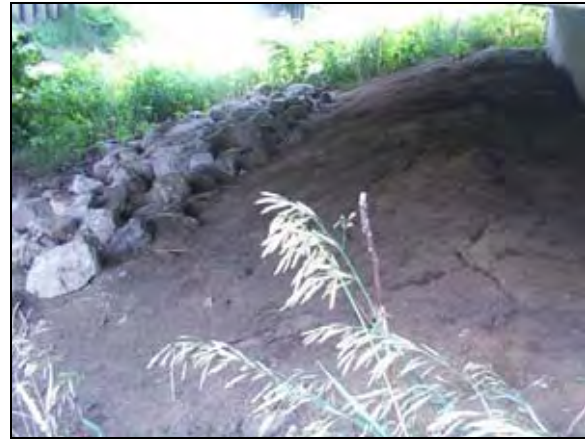
Figure 158. Erosion between the embankment under the bridge and the abutment, and the rocks used to control erosion (East end of WBL)

(a) Erosion at the abutment

(b) Rip-rap used to control erosion

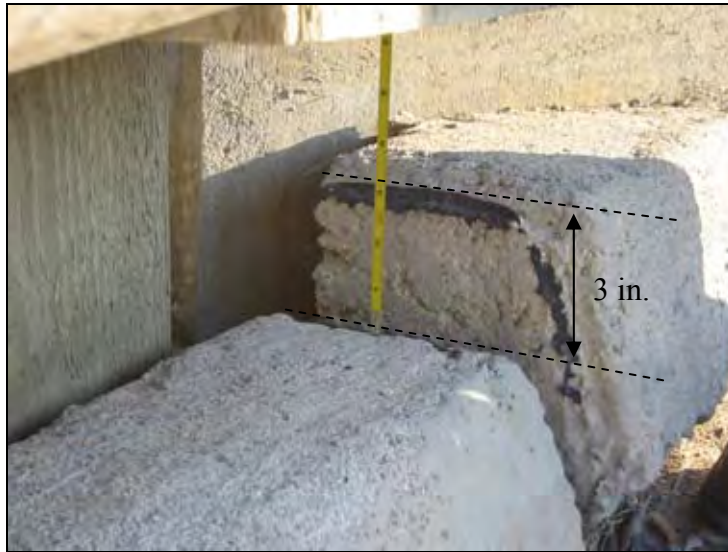
Figure 159. Differential settlement at the bridge approach (South bound)

This bridge was constructed in 1992 and has concrete girders with non-integral abutments. Three inches of differential settlement was observed at the bridge approach guardrails (Figures 159). The strip seal was cut short. The embankment under the bridge was built with loess soil with no slope protection (Figure 160). Water appeared to be flowing through the expansion joint to the embankment under the bridge. To fill the void developed behind the abutment, the bridge was grouted in 2003.

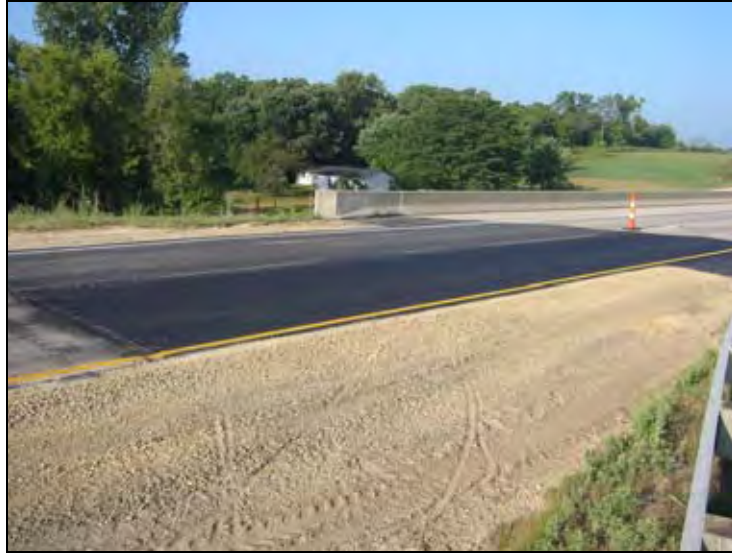
Figure 161. Approach slab asphalt overlay

This bridge was constructed in 1992 and has three spans with integral abutments. No slope protection was used under the bridge and wet embankment soil was observed. Erosion along the sides of the abutment was also observed. According to the maintenance reports, a void developed around the abutment and has been grouted twice in the last 10 years. The second grouting was performed in June 2003. The approach slabs were also overlaid with 2 inches of asphalt to alleviate the differential settlement at the bridge approach, as shown in Figure 161.

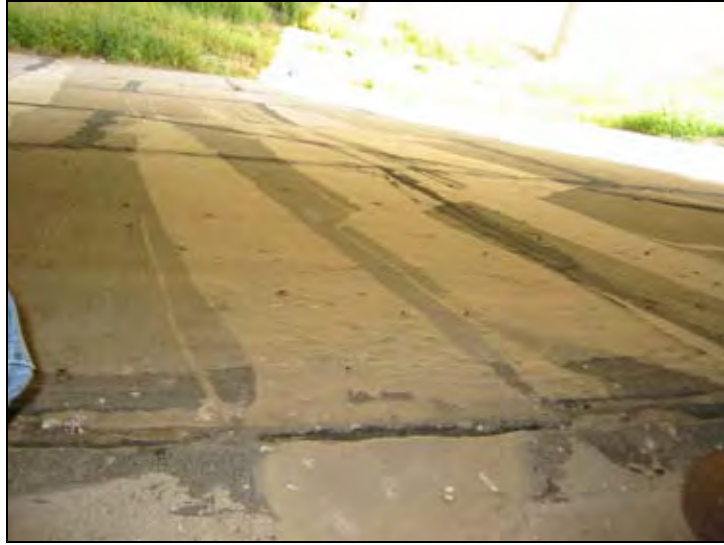
Figure 162. Grout seeping from under the concrete cover

This bridge was constructed in 1983 and has three spans with integral abutments. Although maintenance reports indicate that grouting was performed twice to fill the void developed under all approach slabs (Figures 162 and 163), additional settlement and loss of material lead to a void forming under the approach slab. Noticeable vibration occurred on the approach slab as vehicles passed. The approach slab shoulder was drilled by Iowa DOT personnel during inspection to measure the depth of the void. The three drilled holes indicated a 2-inch gap under the bridge approach. Figure 164 shows that the distance between the approach slab surface and the base material was about 14 inches. The void development may have accounted for about 2 in. differential settlement between the bridge deck and the bridge approach (Figure 165) and significant cracks and faulting of the approach slab (Figure 166). Flexible foam was used as expansion joint filler (Figure 167).

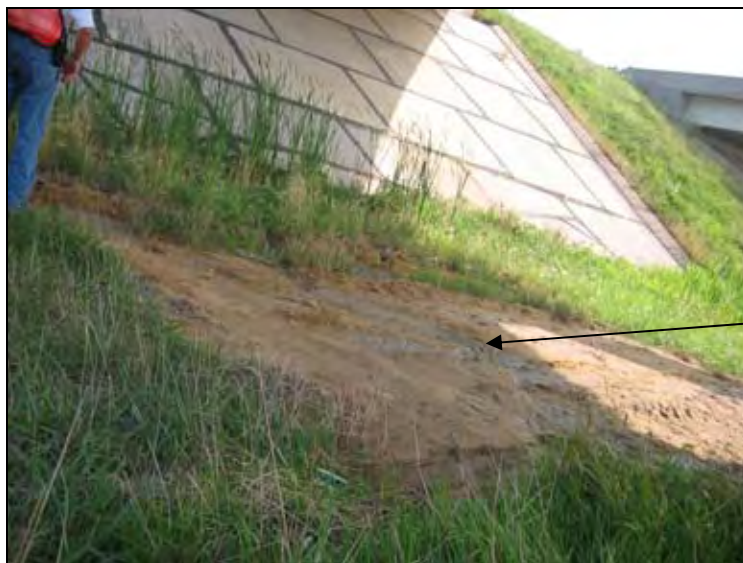
Figure 163. Grout seeping from the bottom of the embankment

Seepage of
grout

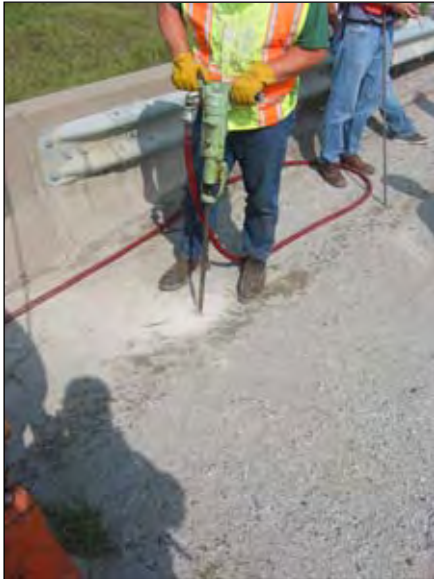
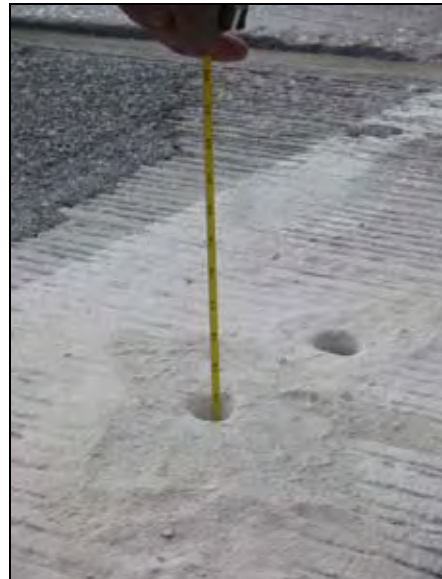
Figure 164. Drilling at the approach slab shoulder indicating 2 in. deep void

(a) Drilling at the approach slab

(b) Measuring the void

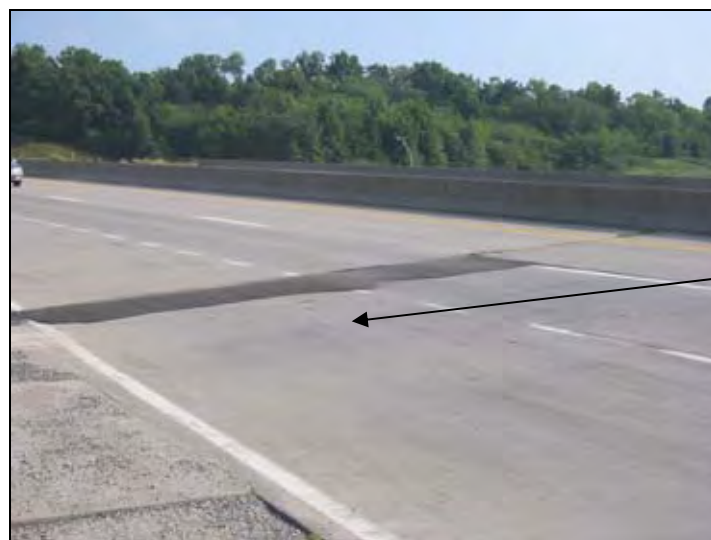
Figure 165. Differential settlement at approach slab

Settlement
of approach
slab

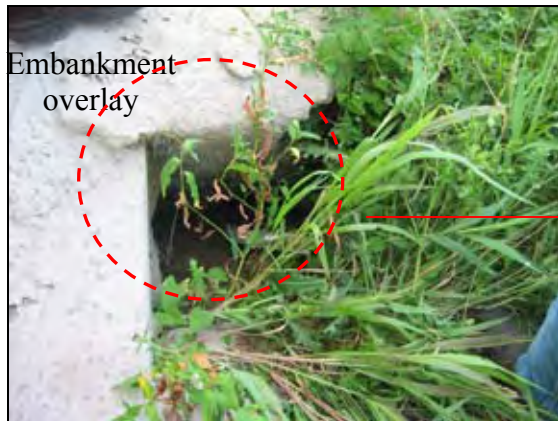
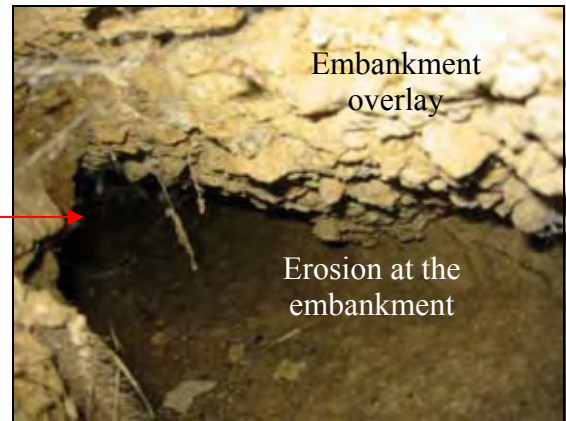
Figure 168. Void created by erosion and settlement after grouting

A void under the concrete slope protection (Figure 168) and uneven settlement and cracking of the concrete slope protection panels were observed (Figure 169). Furthermore, the embankment under the bridge settled 4.5 inches relative to the abutment. A 1.5 in. wide by 4.5 ft. deep void was observed on the downslope side of the abutment (Figure 170).

(a) Void under slope protection

(b) Closer image of the developed void

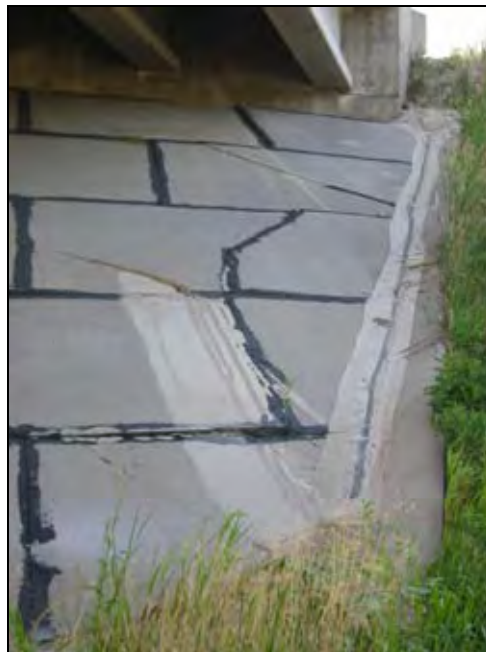
Figure 169. Cracking of the concrete slope protection overlay

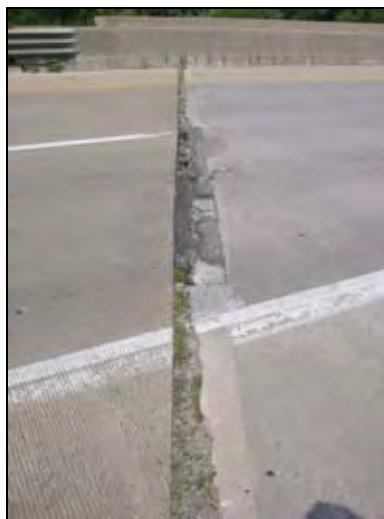
This bridge was constructed in 1971 and has three spans with integral abutments. Cracks and concrete spalling were observed around the expansion joint (Figure 171). Soil erosion and ponding of water were noted on the embankment under the bridge (Figures 172 and 173). Aggregate and an erosion blanket were used for slope stabilization, as shown in Figure 174. According to the maintenance records for this bridge, the near end of the right lane of the bridge approach was grouted using 5 cubic yards of flowable mortar in fall 2002.

Figure 171. Concrete spalling and cracking at the expansion joint

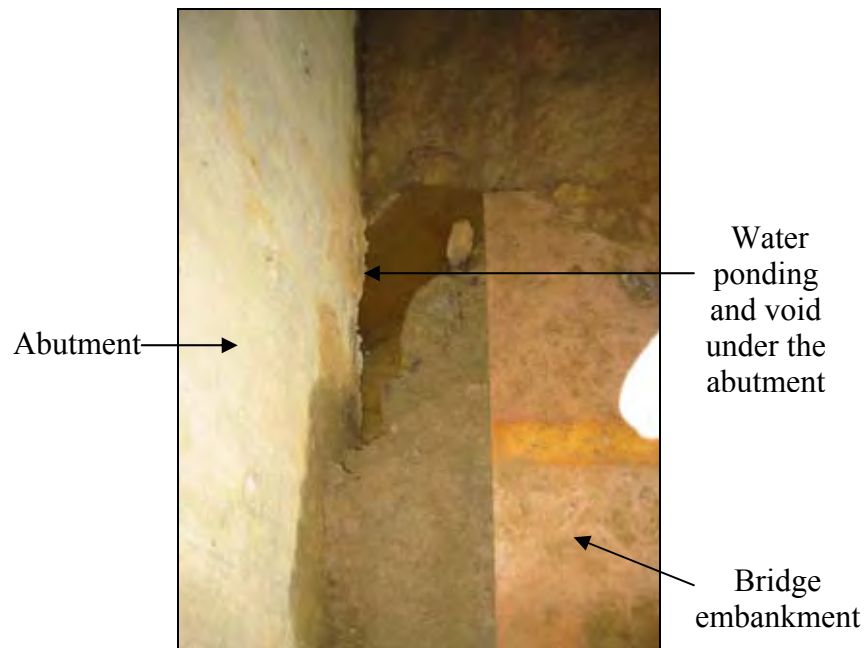
Figure 173. Water ponding at the embankment (Top view)

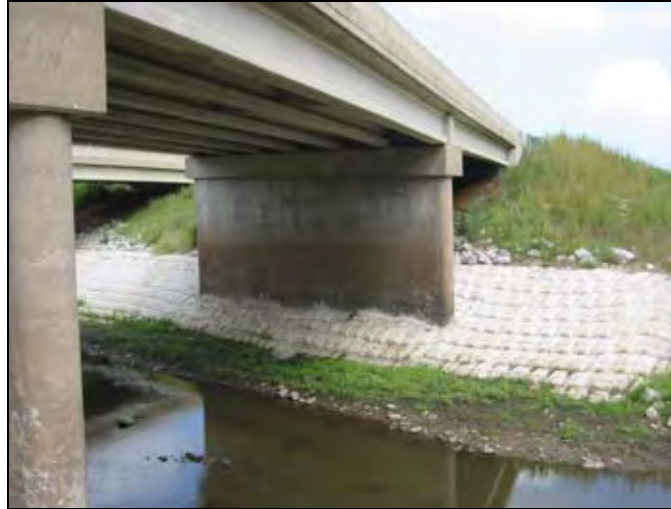
Figure 174. Rocks and pillows used for embankment stabilization

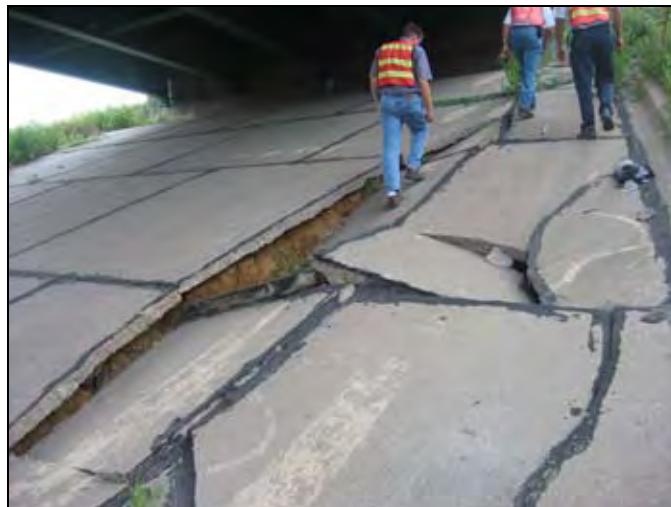
This bridge was constructed in 1970 and has three spans with steel girders and non-integral abutments. The concrete slope protection of the embankments at both ends of the bridge was significantly damaged, as shown in Figure 175, due to erosion. Furthermore, the embankment under the bridge experienced about 5 inches of settlement relative to the abutment. A 2 inches wide gap was measured between the abutment and embankment. No differential settlement was observed between the bridge slab and the bridge approach, and the expansion joints were in a satisfactory condition. Maintenance report for this bridge indicated that flowable mortar was used to fill a void developed at the far end of the left lane in fall 2002. Flowable fill was used again in July 2003 to fill an additional void developed at the same approach slab.

Figure 175. Severe damage of concrete slope protection due to erosion

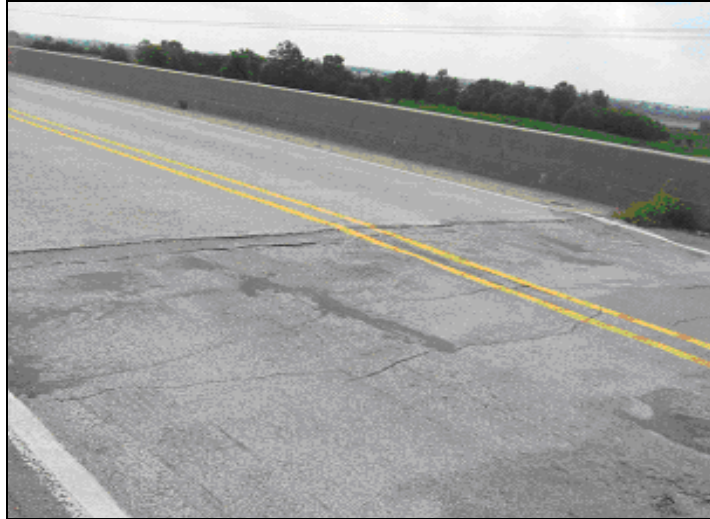
This bridge was constructed in 1972 and has four spans with integral abutments. Figure 176 shows the observed transverse and map cracks at the approach slab. The bridge approach slab had been grouted and overlaid. The asphalt overlay was deteriorated, as shown in Figure 177. Differential settlement between the approach slab and wingwall of about 3 inches was measured. Severe cracking near the expansion joint was also observed. A 3-inch wide gap was observed between the abutment and embankment.

Figure 176. Transverse and map cracking at the approach slab

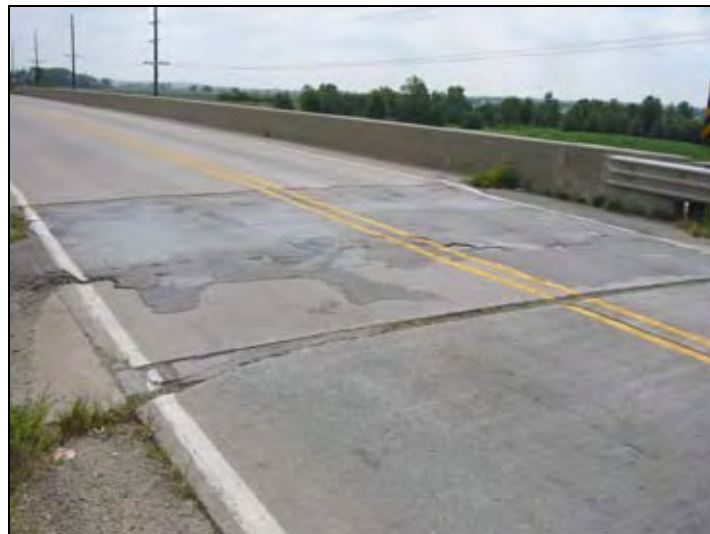
Figure 177. Deterioration of asphalt overlay at bridge approach

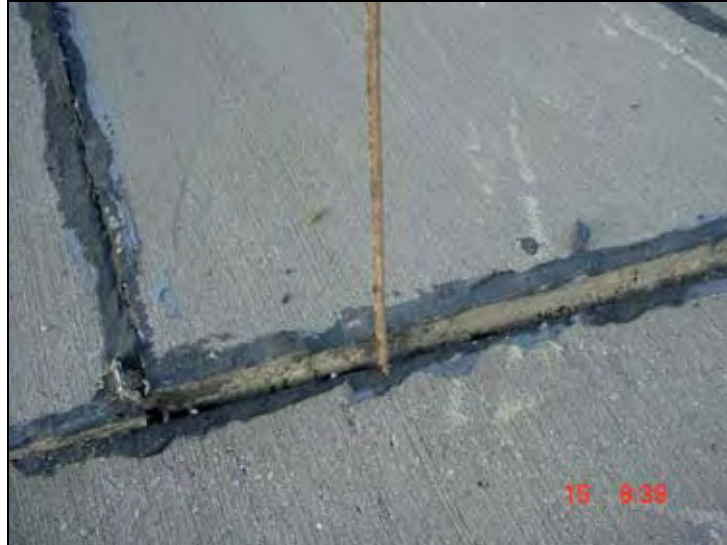
This bridge was not inspected during the field visit; however, some figures and maintenance reports were provided by Iowa DOT. This bridge has four spans with non-integral abutments. Figure 178 shows uneven settlement of the concrete slope protection of the embankment under the bridge. The near end of the right lane of the bridge was grouted in August 2003 to fill the void developed behind the abutment, which exposed the H-piles (Figures 179 to 182).

Figure 178. Uneven concrete slope protection

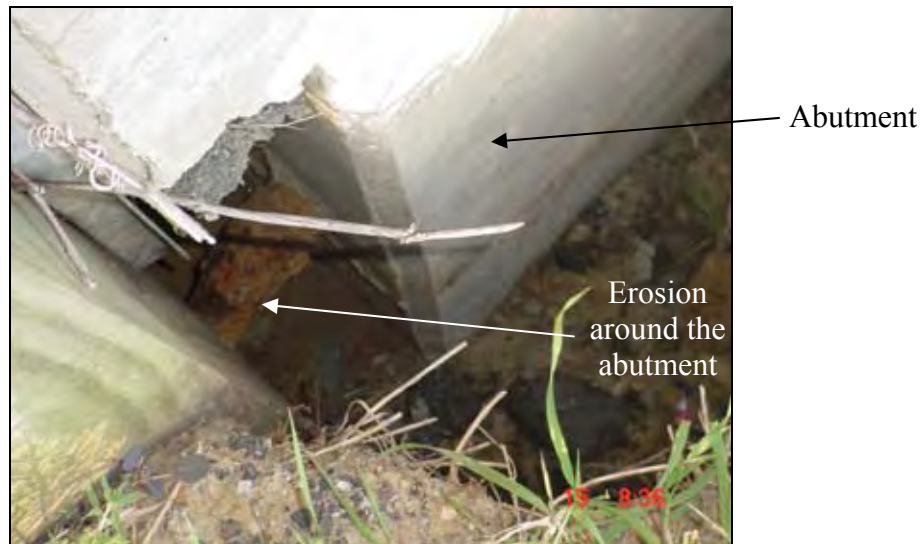
Figure 179. Soil erosion around the abutment

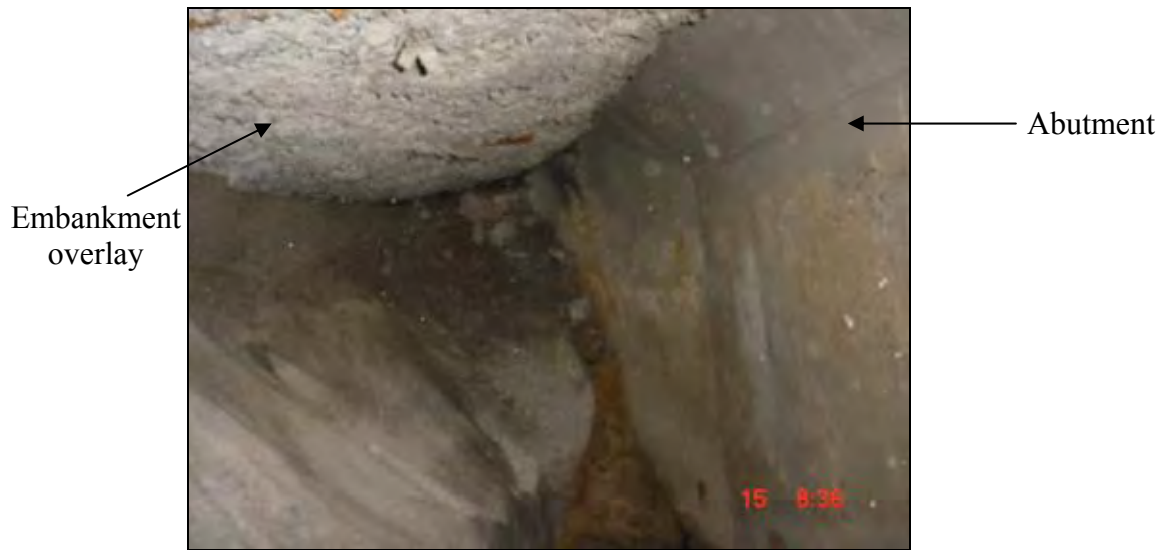
Figure 180. Erosion under the concrete slope protection (Side view)

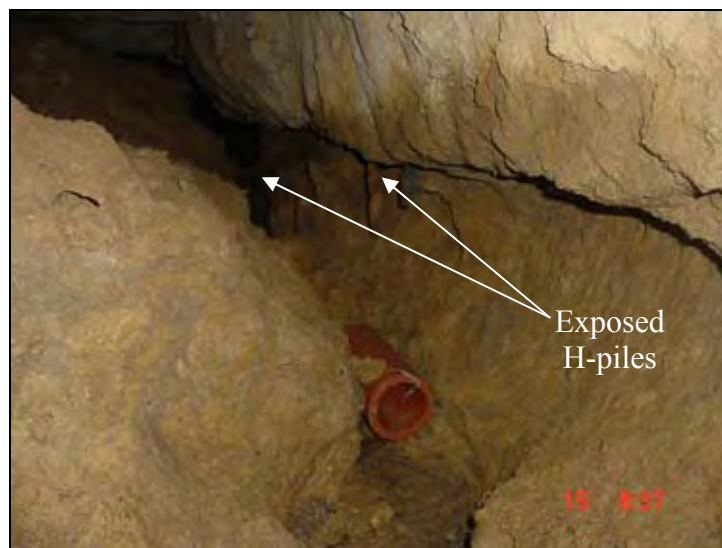
Figure 181. Void created under bridge approach exposing H-piles (Side view)

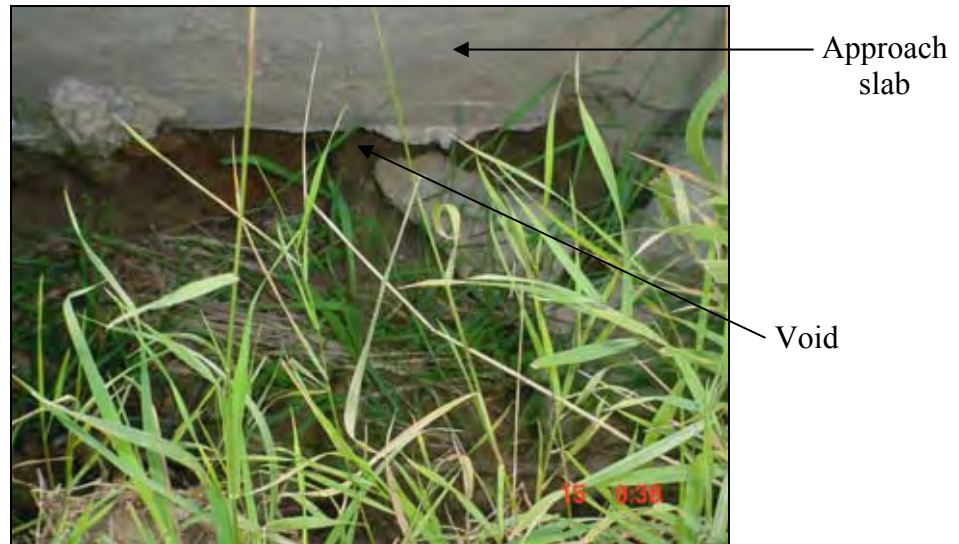
Figure 182. Void developed under the approach slab

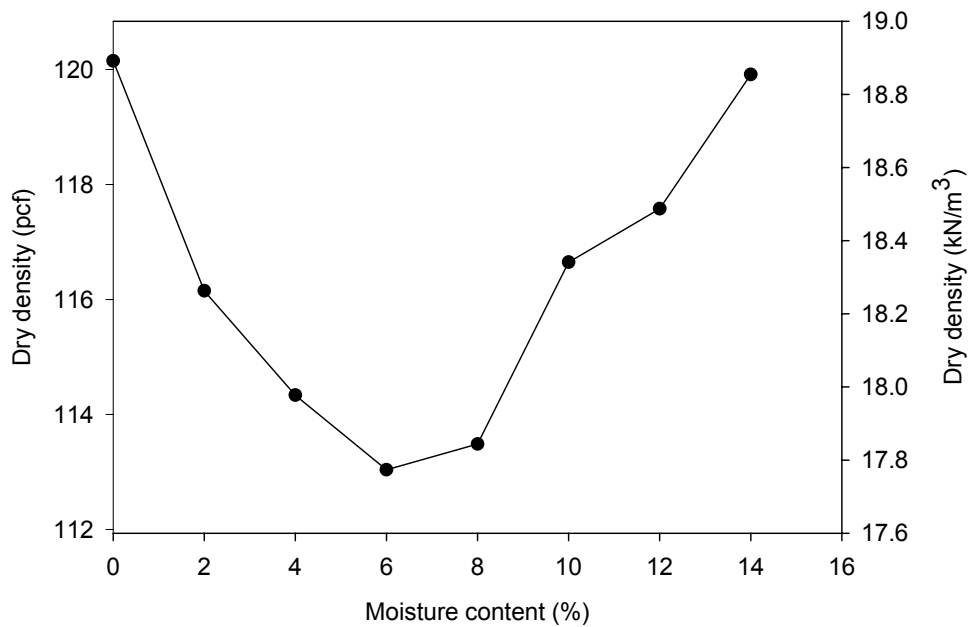
Table 15 summarizes the results of the laboratory tests performed on backfill materials. Figures 189 and 190 show the grain-size distribution of granular and porous backfill materials used at the north and south ends, respectively. According to Unified Soil Classification System (USCS), the granular backfill classifies as poorly graded sand (SP), while the porous backfill classifies as poorly graded gravel (GP). Relative density tests (ASTM D4253-00) were performed on the granular backfill material at several moisture contents to evaluate the minimum and maximum densities, material compactibility, and the bulking moisture content range (Figure 191). For the porous backfill, an oven dry sample was tested to evaluate the minimum and maximum density and material compactibility. Compactibilities of 1.052 and 0.157 were calculated for the granular and the porous backfill materials, respectively, which indicate relatively high compactibility for the granular backfill and low compactibility for the porous backfill (Hilf 1991). The natural moisture content for the granular and porous backfill materials were 3.9% and 4.2%, respectively. The natural moisture content of the granular backfill was within the bulking moisture content range ($\approx 3\%$ to 7%) where compaction requirements could not be achieved.

Figure 191. Dry density-moisture content relationship of granular backfill used at the North end. Vibrating table tests (ASTM D4253-00).

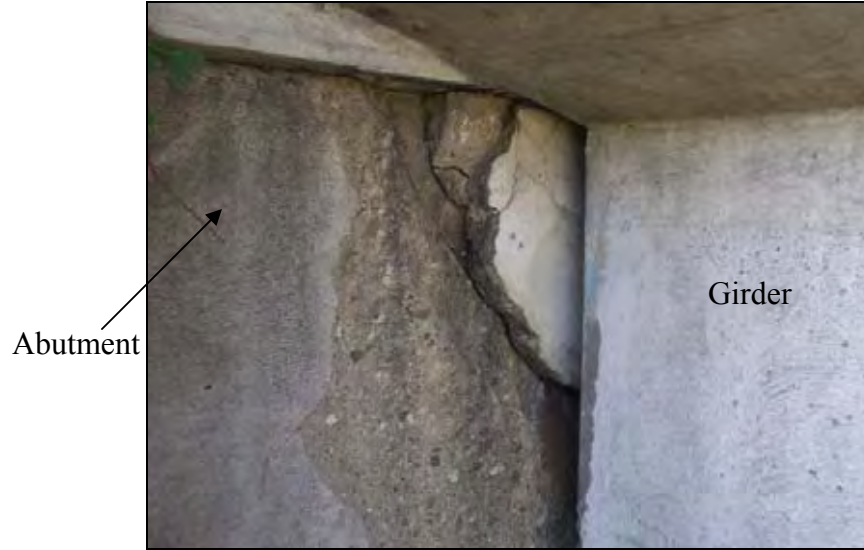
Figure 194. Concrete spalling at the abutment (SBL)

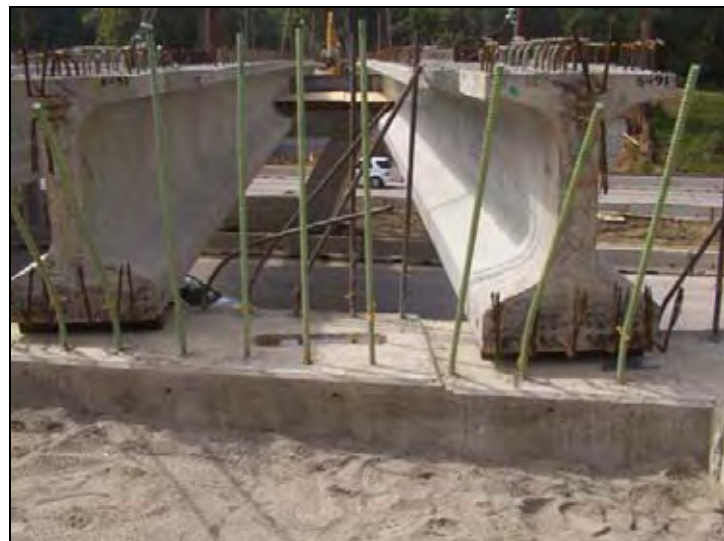
Figure 197. Sand used as granular backfill material

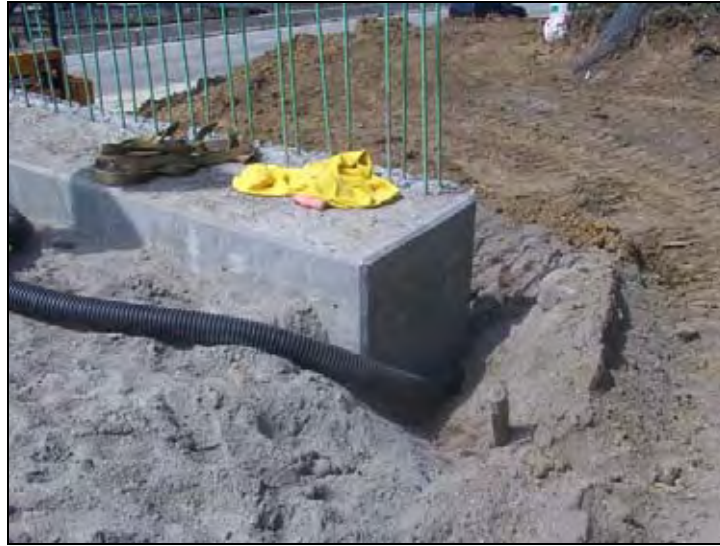
The bridge was inspected again in June 2003. During this field visit, the H-piles were being installed at the north end of the northbound lane, as shown in Figure 195. In July 2003, the bridge was visited again where retaining wall construction was taking place at the south end of the northbound lane (Figure 196). At the north end, the backwall was already constructed. Granular backfill material was used behind the abutment, as shown in Figure 197. No porous backfill was observed around the subdrain (Figure 198). When examined, the perforated drainage pipe was filled with sand particles.

Figure 198. No porous fill surrounding the subdrain (North end NBL)

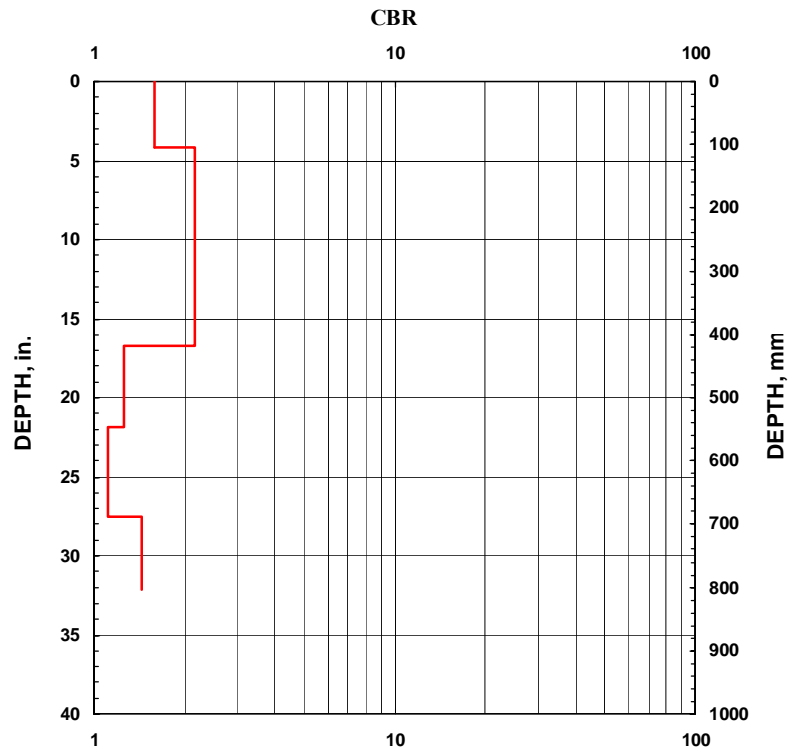
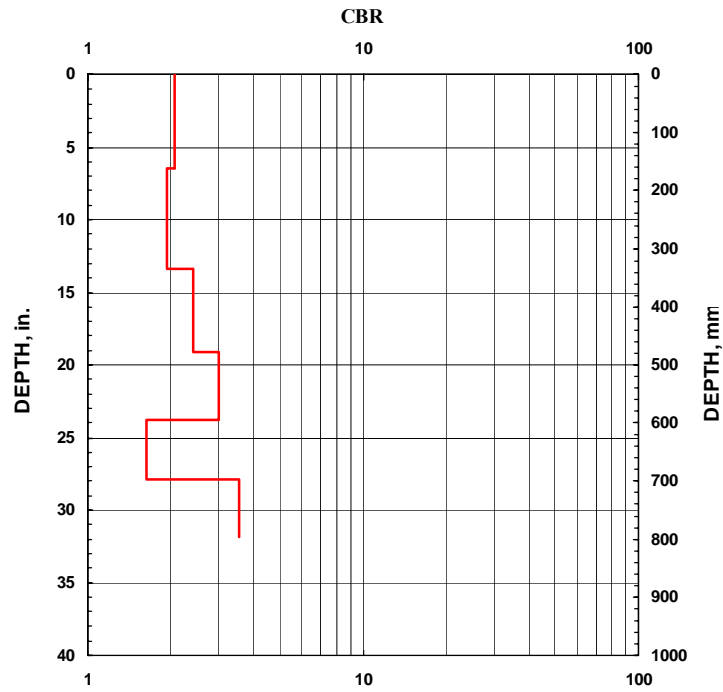
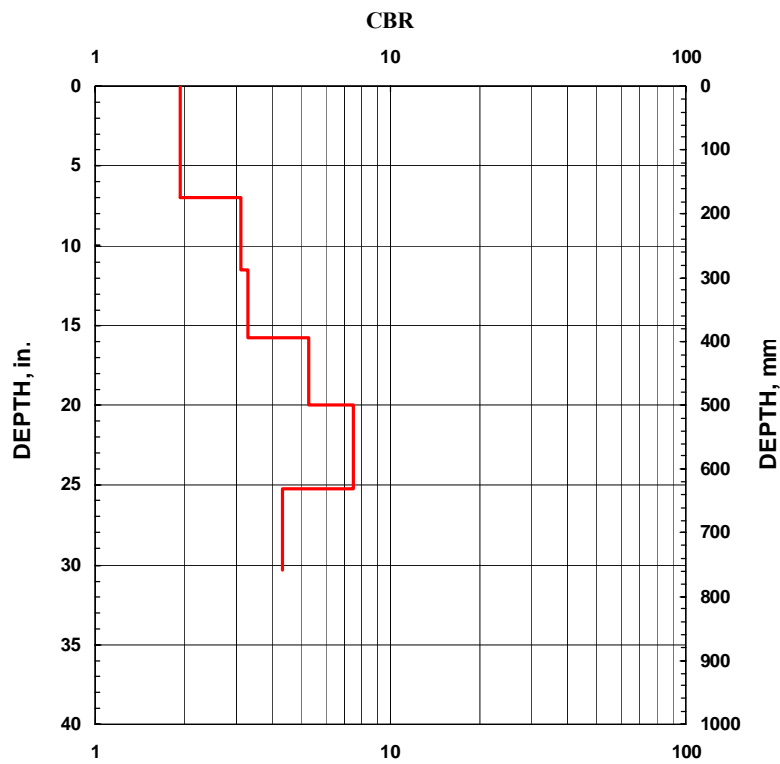
Dynamic Cone Penetration (DCP) tests were performed at three locations behind the backwall at the north end of the north bound. Estimated California Bearing Ratio (CBR) values ranged from 1 to 8 at all test locations (Figures 202 through 205) indicating a soft/loose backfill material. Nuclear gage tests were also conducted at two locations behind the north end backwall. The average measured dry density was 105 pcf and the moisture content was 4.7%.

Figure 203. DCP test results (Location 1 North end of NBL)

Figure 204. DCP test results (Location 2 North end of NBL)

Figure 205. DCP test results (Location 3 North end of NBL)

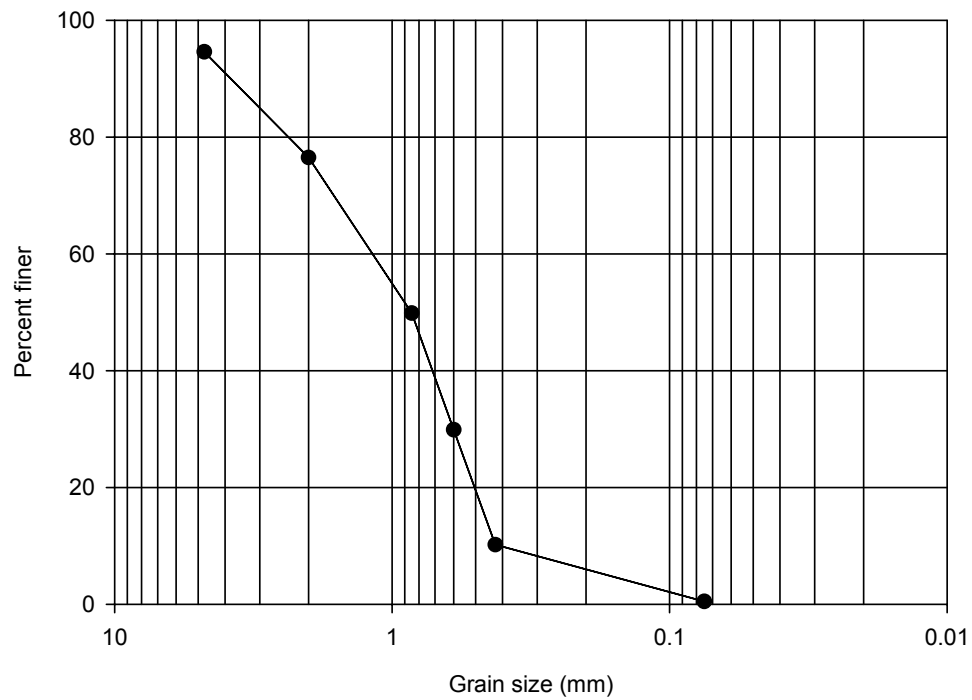
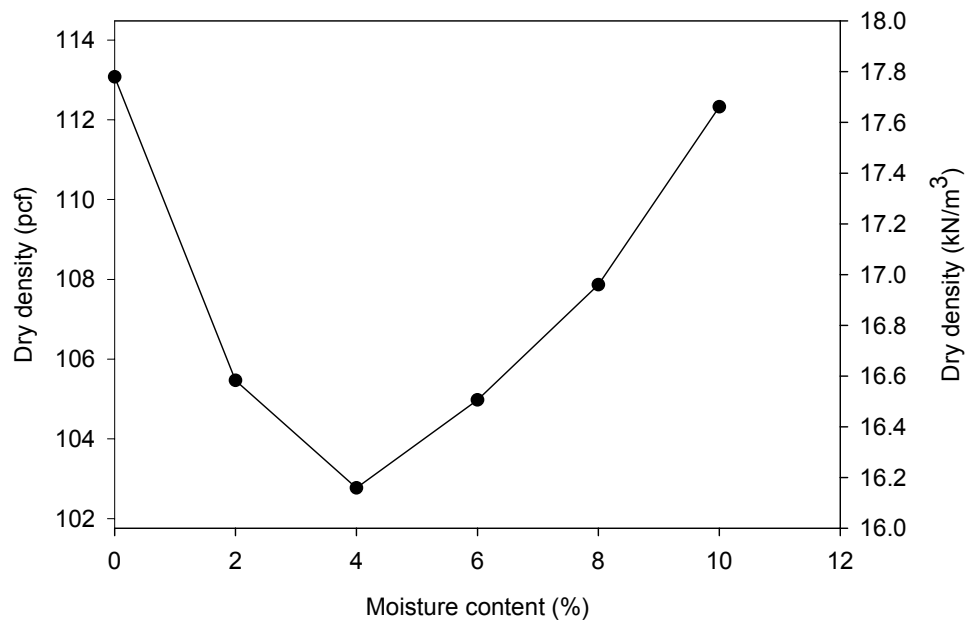
Figure 206 shows the grain-size distribution for the granular backfill material, which was classified as SP according to the USCS. Minimum and maximum density, compactibility, and bulking moisture content for granular backfill were estimated using the relative density test (ASTM D4253-00). The maximum dry density was 113 pcf, the minimum dry density was 96 pcf, and the bulking moisture content ranged from 3% to 5% (Figure 207). The measured moisture content of the backfill material at the site was within this bulking moisture content range. Using the measured dry density in the field, the calculated relative density is 56%, which is medium dense. Compactibility of the granular backfill of 0.54 was calculated, which indicates a low compactibility for the backfill material (see Appendix C for calculations).

Figure 206. Gradation of the granular backfill material classified as SP

Figure 207. Dry density – moisture relationship for backfill material. Vibrating table tests (ASTM D4253-00).

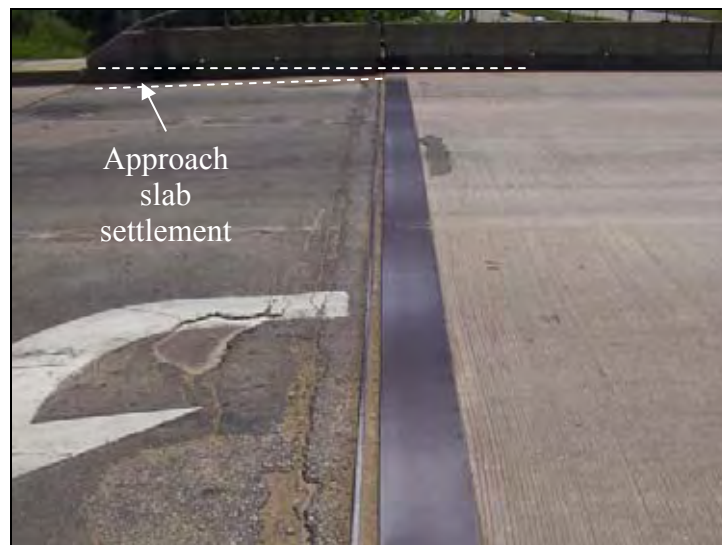
This bridge site was inspected in June 2003. When the bridge was inspected, the old bridge was still open for traffic. This bridge has three spans and concrete slope protection of the embankment. Two inches of differential settlement was observed at both ends of the bridge. Both ends of the bridge have an asphalt approach with visible longitudinal cracks (Figure 208). When the bridge was visited again in October 2003, the girders and the backwall of the southbound lane were constructed (Figure 209). Backfill material samples were collected to perform laboratory tests.

Figure 208. Cracks at asphalt approach with visible differential settlement

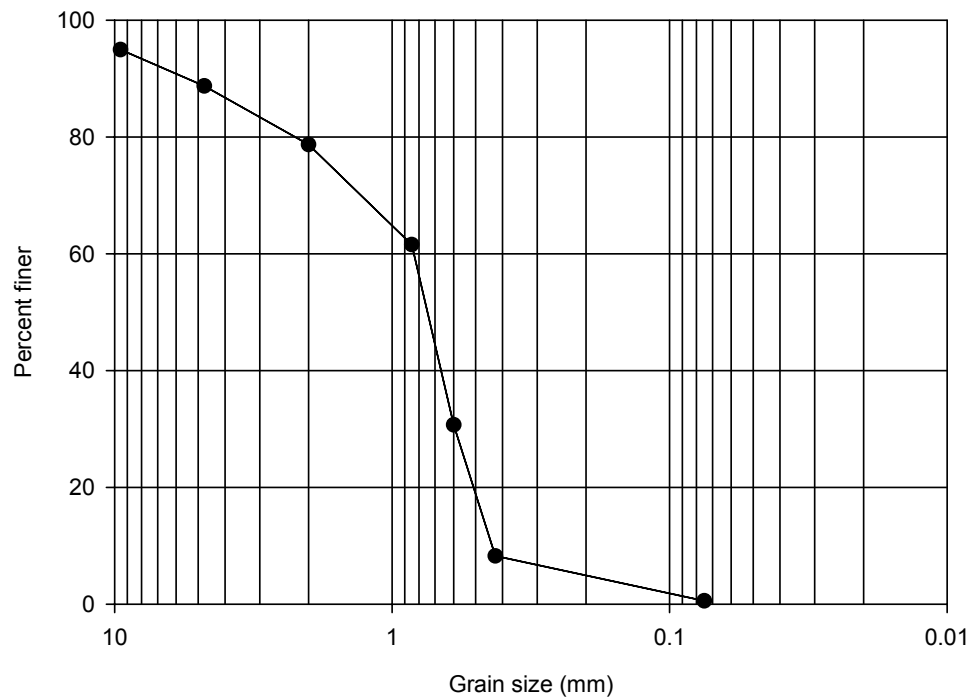
Figure 210 shows the grain-size distribution of the granular backfill material used behind the backwall. The backfill material classifies as SP according to the USCS. Minimum and maximum density tests were 91 pcf and 116 pcf, respectively, and the bulking moisture content ranged from 4% to 6% (Figure 211). Compactibility of 0.86 was calculated (see Appendix C for calculations), indicating good compactibility.

Figure 210. Gradation of granular backfill classified as SP

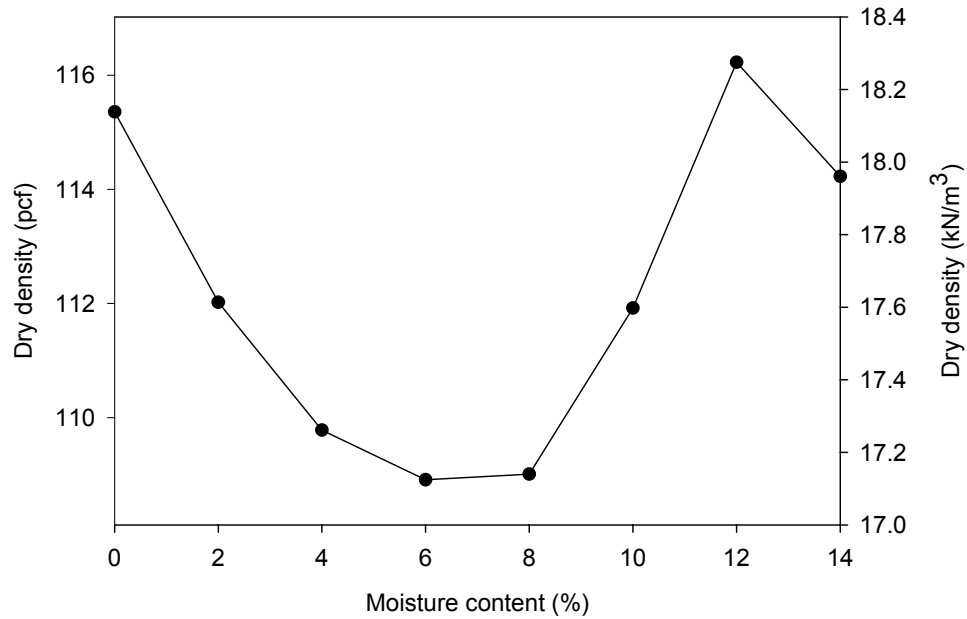
Figure 211. Density – moisture relationship for granular backfill. Vibrating table tests (ASTM D4253-00).

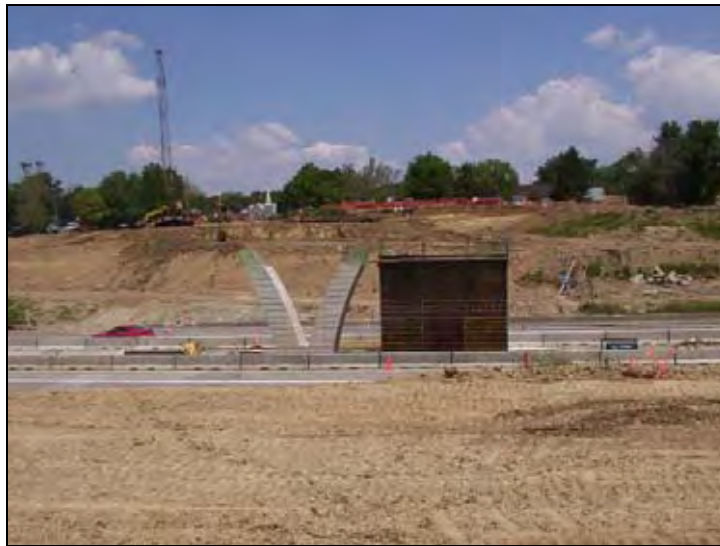
Figure 212. Construction of center pier

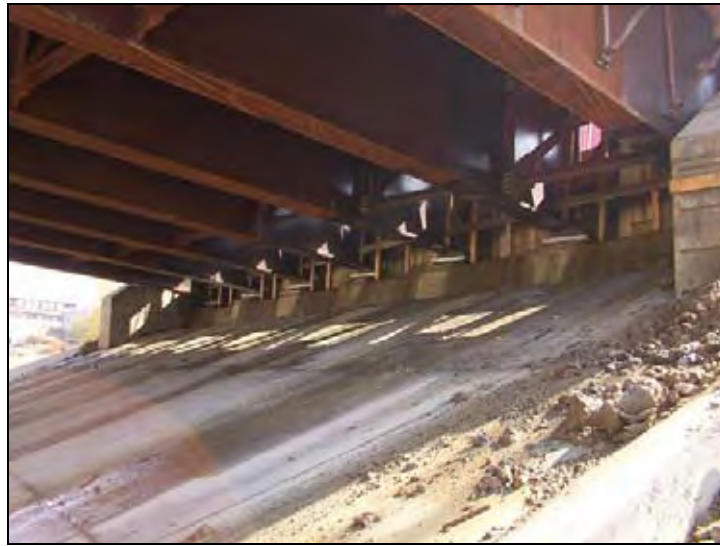
Figure 213. Embankment concrete slope protection

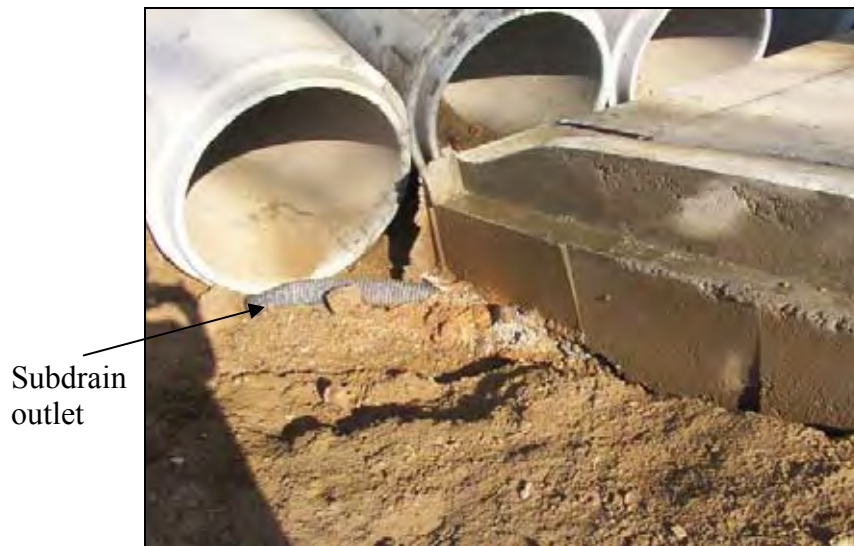
This bridge was inspected in June and October 2003. In June, the center piers were still under construction, as shown in Figure 212. In October, the concrete slope protection for the embankment under the bridge was constructed (Figure 213). No porous backfill was placed around the subdrain. Figure 214 shows the outlet of the subdrain at the bottom of the embankment surrounded by granular backfill. When inspected, the subdrain was filled with soil.

Figure 214. Subdrain outlet at the bottom of the embankment

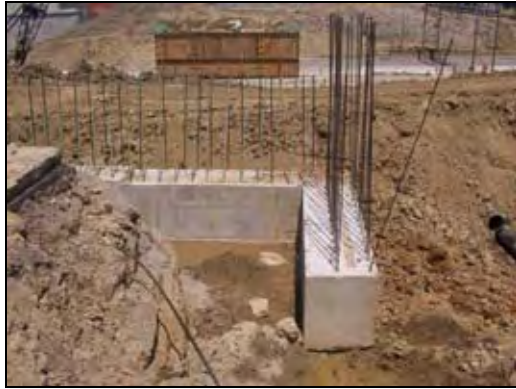
During the first inspection in June 2003, the center pier and the backwall of both ends were under construction (Figure 215). As shown in Figure 215a, the soil near the south end of the northbound abutment appeared to be wet sandy soil. When inspected in October 2003, the construction of the bridge slab was in progress (Figure 216). Figure 217 shows the reinforcement of the abutment which was at 1 ft. spacing. A sample of backfill material was tested in the laboratory to determine the classification and compactibility. Figure 218 shows the grain size distribution of the backfill material. The granular backfill

(a) Backwall construction

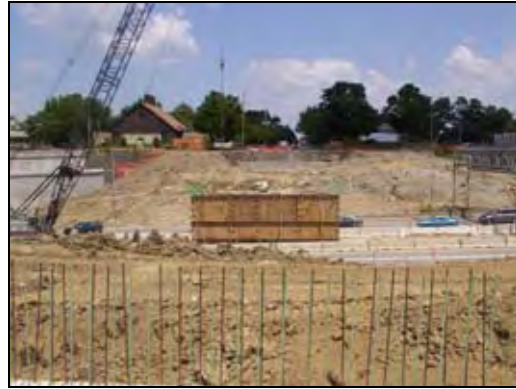
(b) Center pier construction

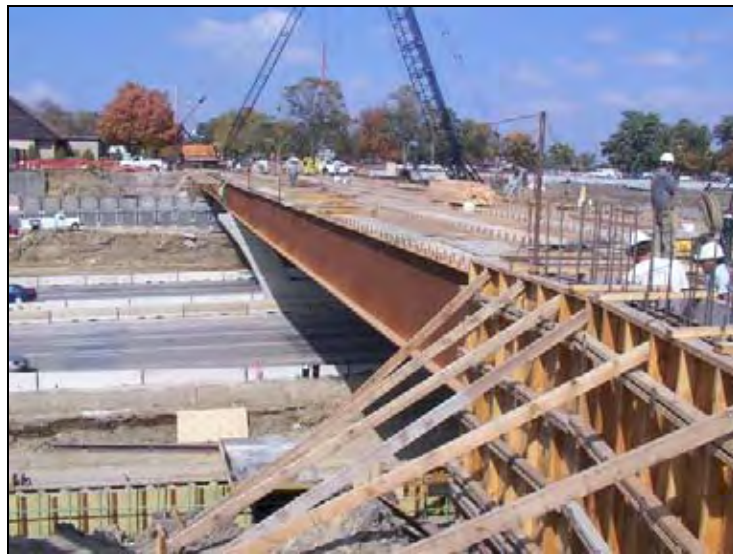
Figure 216. Construction of bridge slab (NBL)

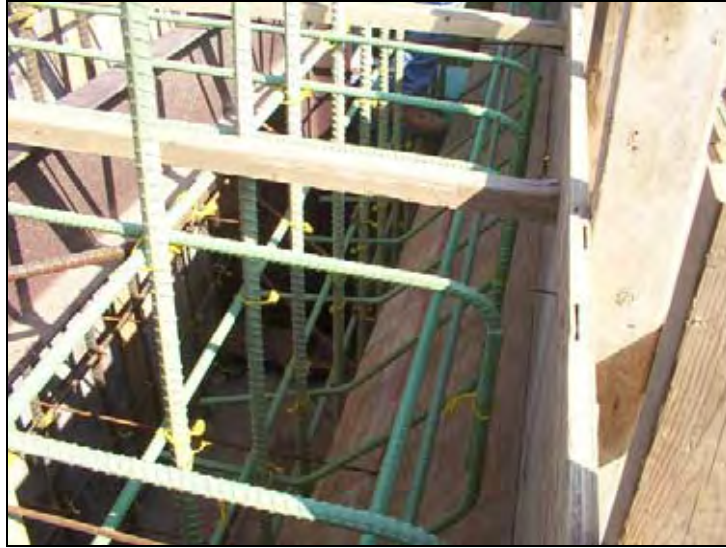
Figure 217. Abutment and paving notch rebar tied with reinforcement from the backwall
