IDENTIFICATION OF THE BEST PRACTICES FOR DESIGN, CONSTRUCTION, AND REPAIR OF BRIDGE APPROACHES

Iowa DOT Project TR-481
CTRE Project 02-118

Final Report

January 2005

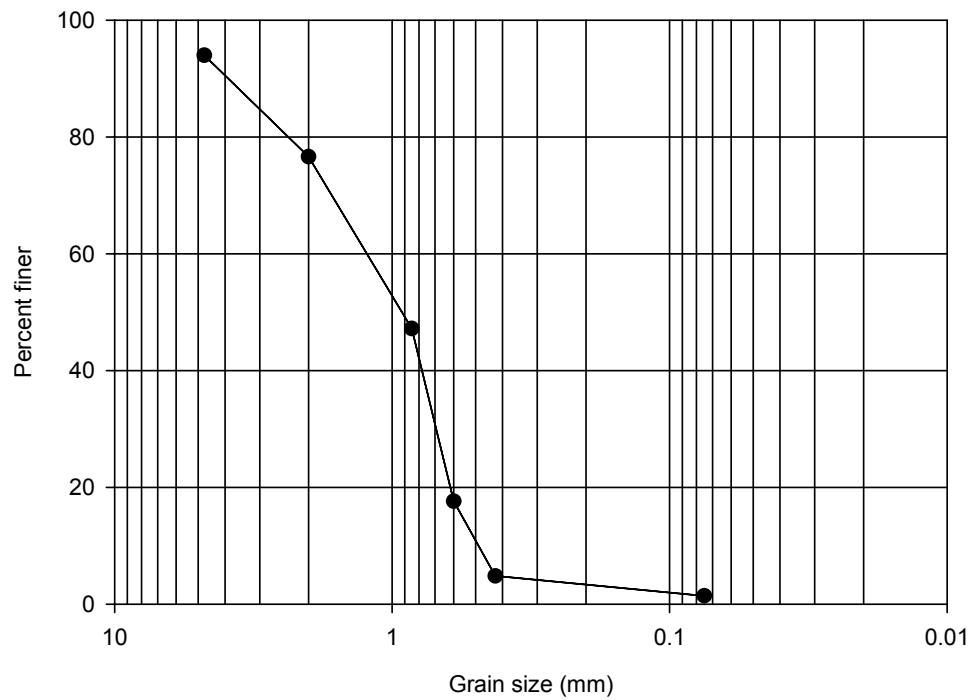
During the first inspection in June 2003, the center pier and the backwall of both ends were under construction (Figure 215). As shown in Figure 215a, the soil near the south end of the northbound abutment appeared to be wet sandy soil. When inspected in October 2003, the construction of the bridge slab was in progress (Figure 216). Figure 217 shows the reinforcement of the abutment which was at 1 ft. spacing. A sample of backfill material was tested in the laboratory to determine the classification and compactibility. Figure 218 shows the grain size distribution of the backfill material. The granular backfill

obtained at the backwall of the south bound was classified as SP according to the USCS. Relative density tests resulted in minimum and maximum dry densities of 96 pcf and 125 pcf and the bulking moisture content range of 3% to 5% (Figure 219). Compactibility of 1.227 was calculated indicating good compactibility of the backfill material (see Appendix C for calculations).

Figure 218. Gradation of granular backfill classified as SP

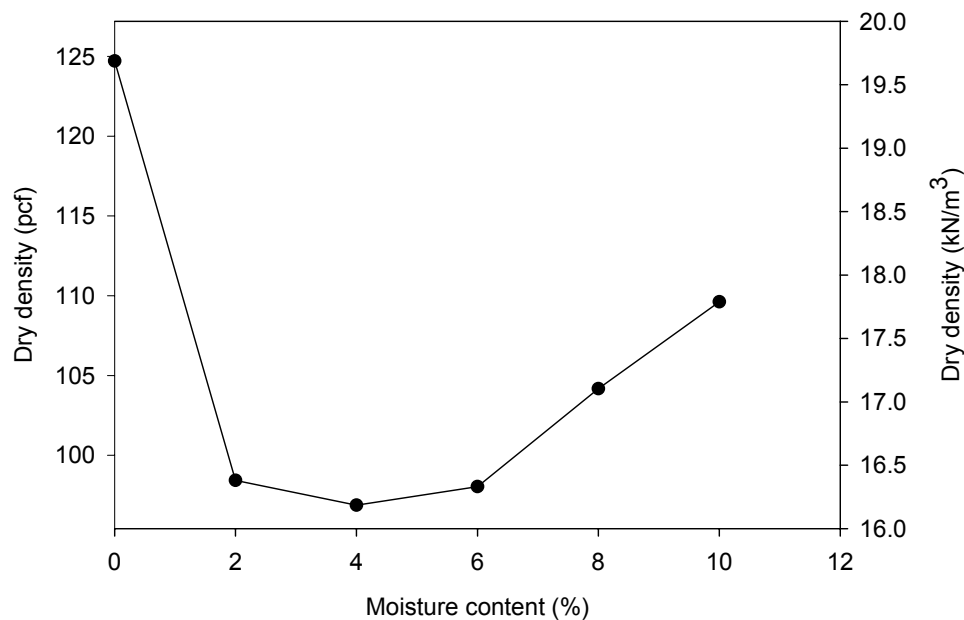
Figure 219. Relative density–moisture relationship for granular backfill. Vibrating table tests (ASTM D4253-00).

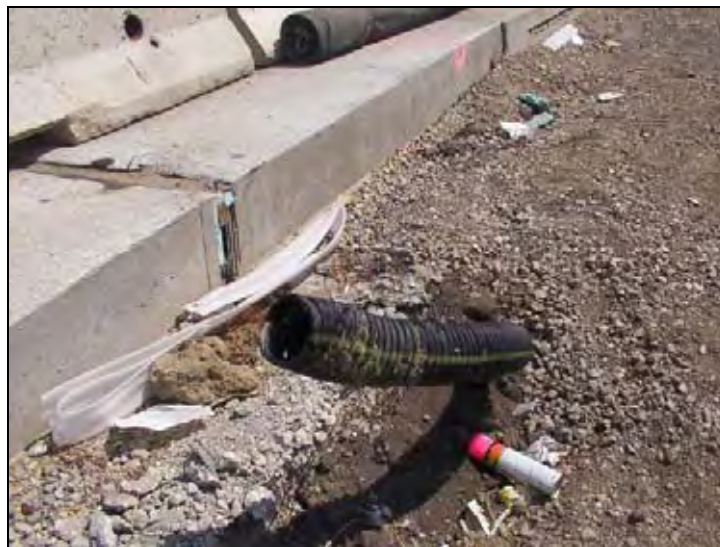
This bridge was also inspected twice in August 2003. During the first inspection, construction of the north bound was completed and construction of the south bound was taking place, as shown in Figure 222. Figure 223 shows the end drain filled with soil. Construction of the backwall was taking place, as shown in Figures 224 and 225. During the second inspection in August 2003, construction of the abutment was still underway. Poor construction of the approach slab at the north bound, which was recently completed and opened for traffic, was observed. When the south bound was removed for replacement, the loose backfill behind the northbound abutment collapsed as a result of removing the sheet piles supporting the backfill creating a void (Figures 226 and 227).

Figure 223. End drain outlet filled with soil

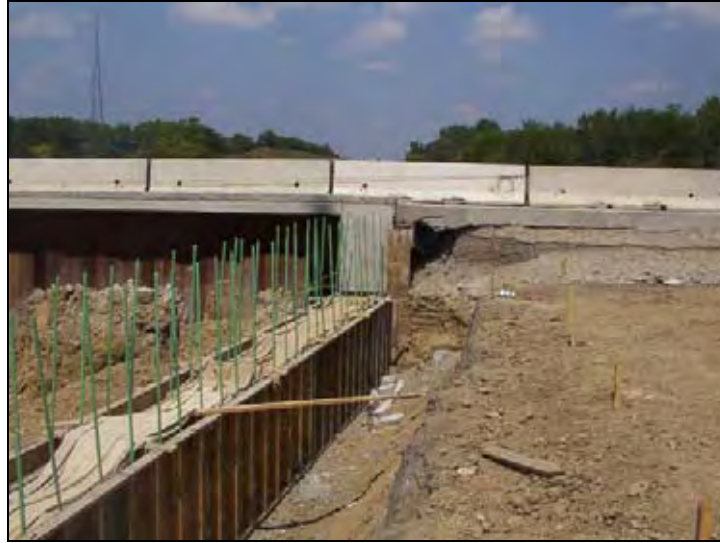
Figure 226. Abutment reinforcement and backfill placed at the northbound approach slab

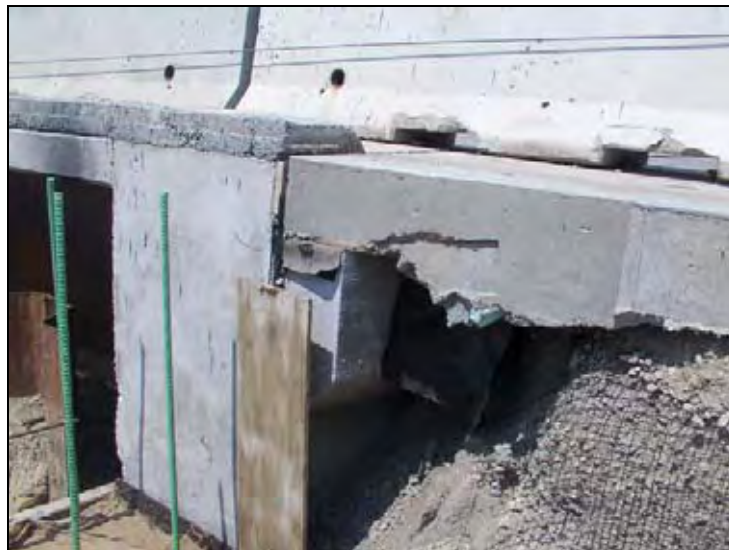
Figure 227. A closer image of the poorly-placed granular backfill (NBL)

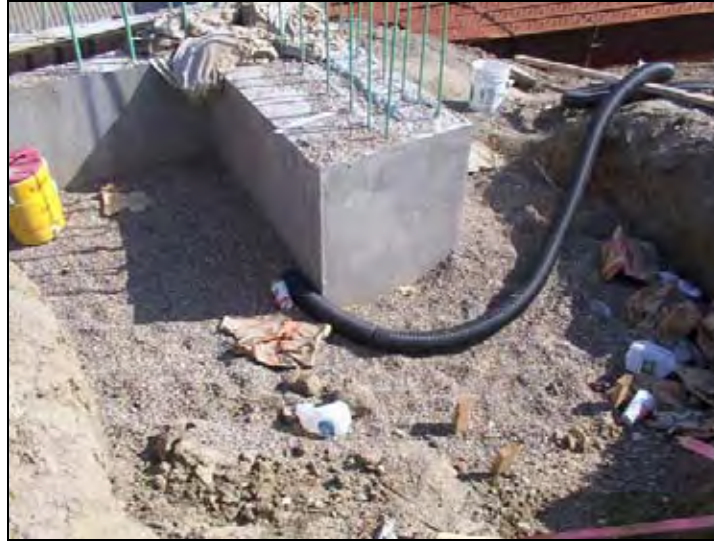
The bridge was visited again in October 2003. The old southbound bridge was removed and the new bridge was under construction. The center pier construction was taking place, while the embankments and backwalls were completed (Figure 229). Figure 228 shows that porous backfill was used around the subdrain. The bridge embankments were covered with concrete slope protection, as shown in Figure 229.

Figure 228. Constructed bridge backwall with visible subdrain surrounded by porous backfill

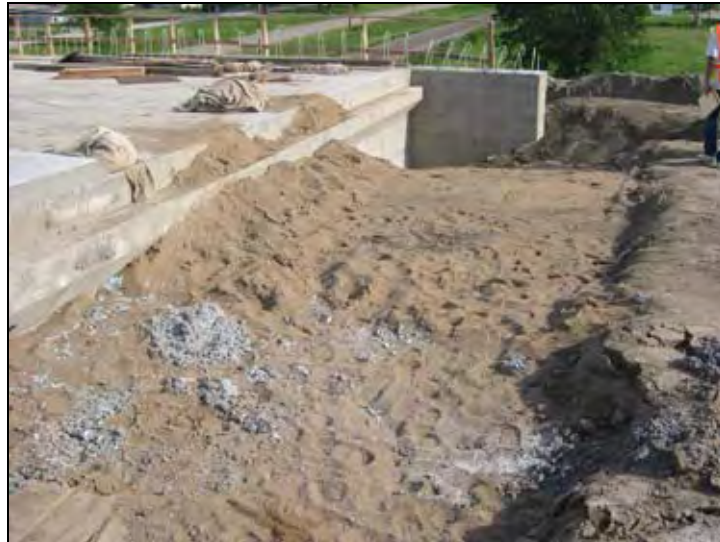
This bridge was constructed with integral abutments and concrete girders. Aggregate was used as slope protection on the embankment under the bridge. The foundation soil of this bridge was allowed to consolidate under the embankment weight for one year prior to construction of the bridge superstructure. Figure 230 shows the granular backfill poorly placed behind the abutment. As shown in Figure 231, no porous backfill was used around the subdrain. Figure 232 illustrates the poor construction of the paving notch with poorly consolidated concrete.

Figure 230. Poorly placed granular backfill

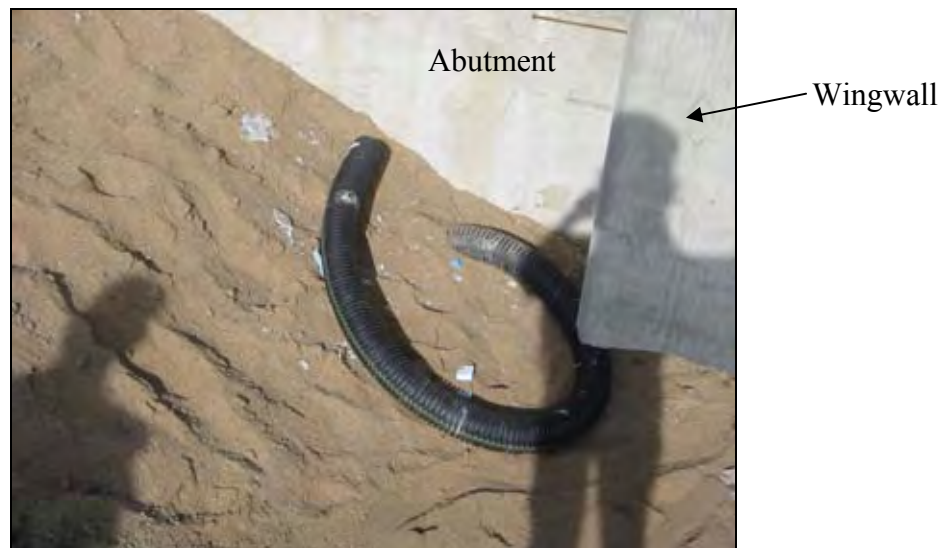
Figure 231. Granular backfill surrounding the subdrain

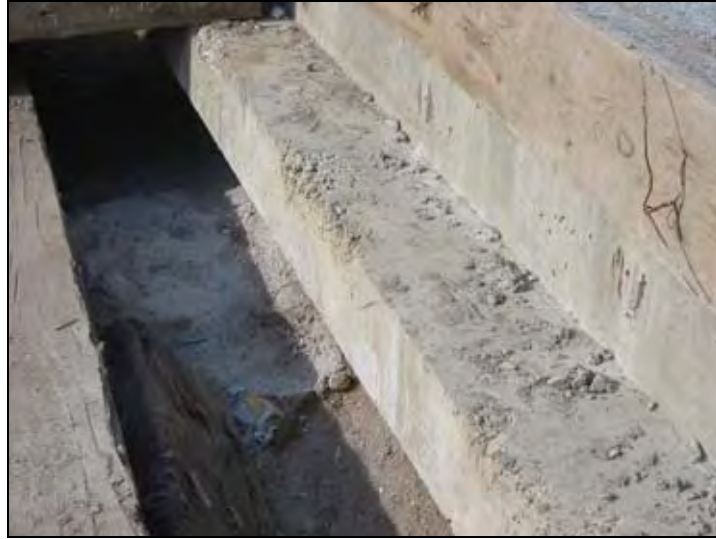
Figure 232. Poor construction of bridge paving notch

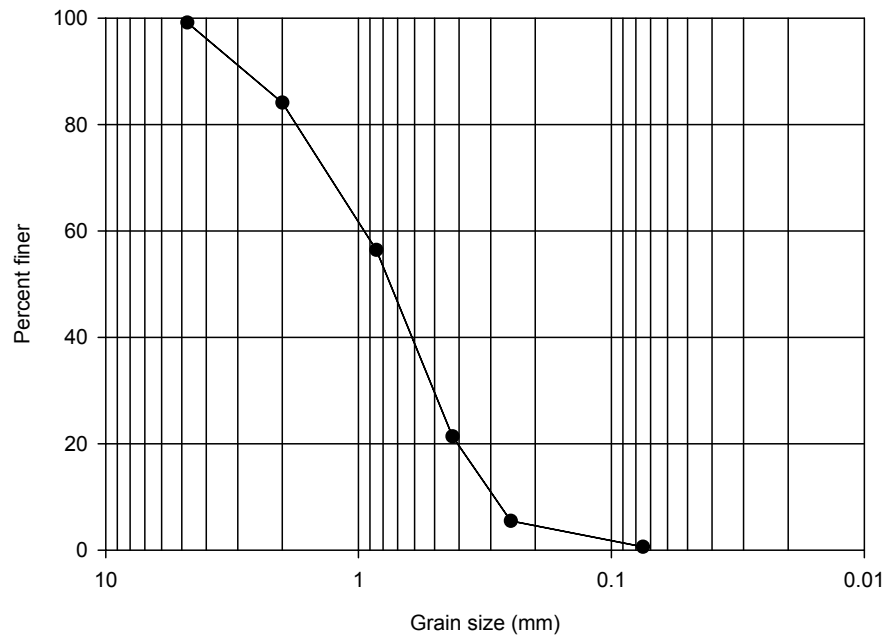
The backfill material sample obtained at the bridge site, which had a moisture content of 4.1%, classifies as SP according to the USCS. Figure 233 shows the grain-size distribution of the granular backfill material. A coefficient of permeability of 0.01 cm/s (see Appendix C for calculations) was measured following constant head permeability tests methods (ASTM D 2434).

Figure 233. Gradation of granular backfill classified as SP

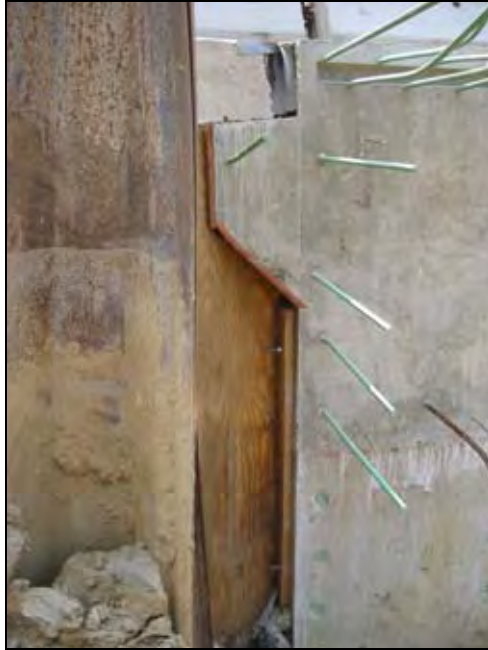
This bridge was still under construction when inspected in August 2003. The paving notch was observed to be declined in the direction of the approach slab (See Figure 234). Figure 235 shows the grain-size distribution of the granular backfill material used at this bridge. The granular backfill classifies as SP according to the USCS.

Figure 234. Declined paving notch

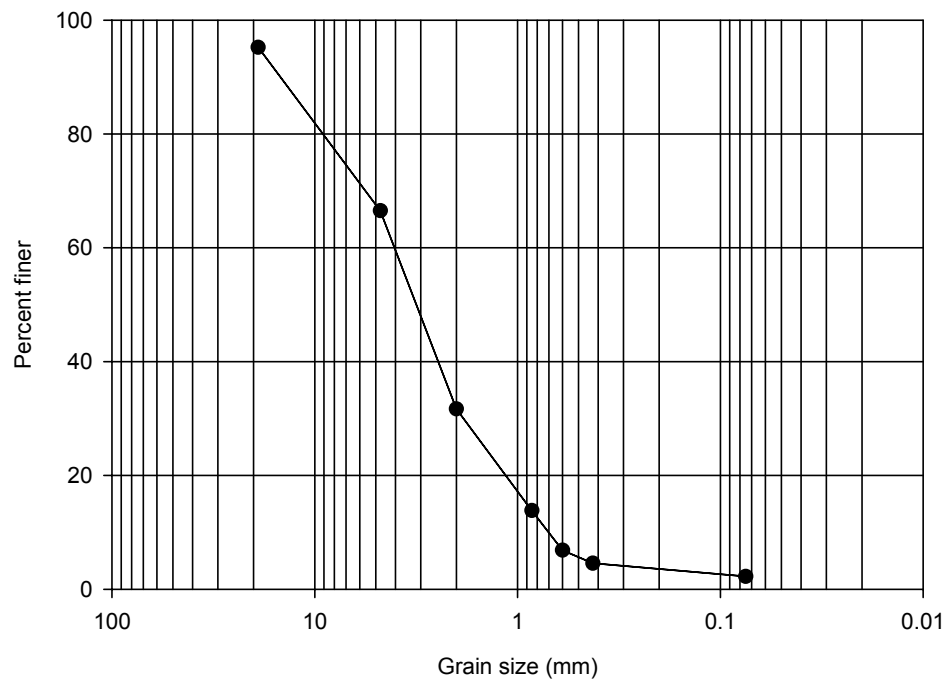
Figure 235. Gradation of granular backfill classified as SP

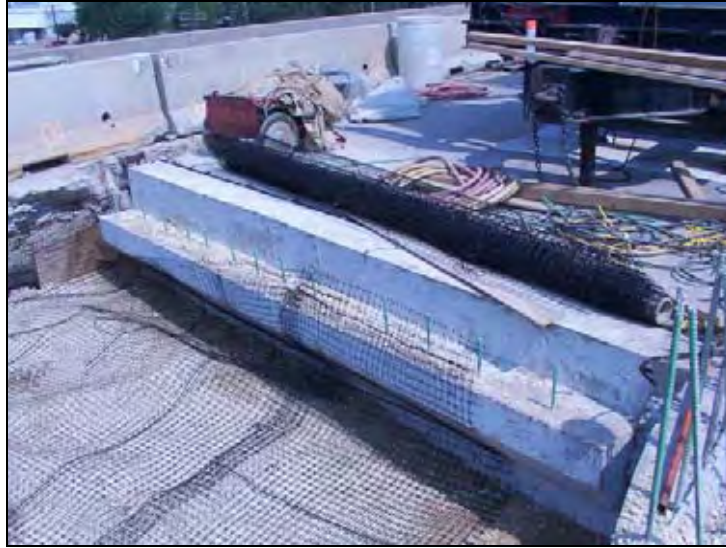
This bridge has three spans with steel girders and non-integral abutments. The bridge approach was grouted to fill a void (see Figure 236). During the field inspection, replacement of both approach slabs and the paving notch of the northbound lanes were in progress. The approach slabs were replaced due to excessive settlement and cracking, which is believed to be a result of severe erosion and subsequent void development. At the south end of the bridge, new granular backfill was placed and compacted in 8-inch-loose lifts using a vibratory base plate. The width of the newly constructed paving notch was 12 inches, with an expansion joint width of 2.5 inches (Figure 237). The bridge did not have subdrains and none were installed. The bridge embankment soil is mostly silty clay with no slope protection. At the north end of the bridge, reconstruction of the abutment was still in progress (Figure 238).

Figure 237. Construction of new bridge approach (South end of NBL)

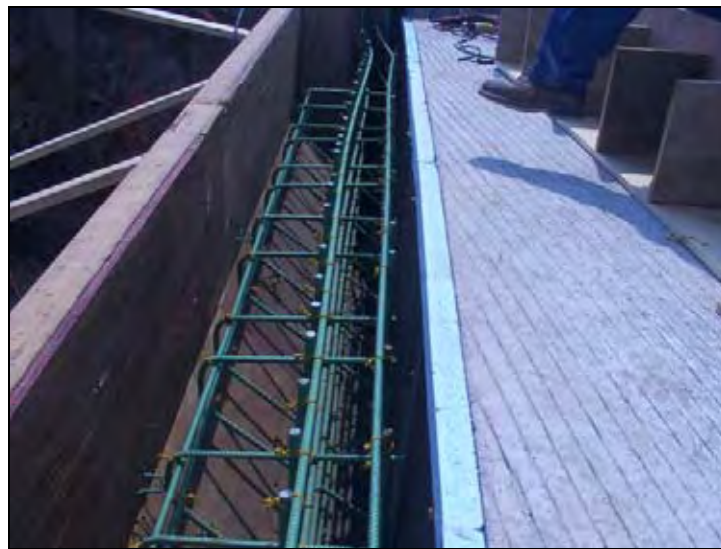
Figure 238. Abutment reinforcement (North end of NBL)

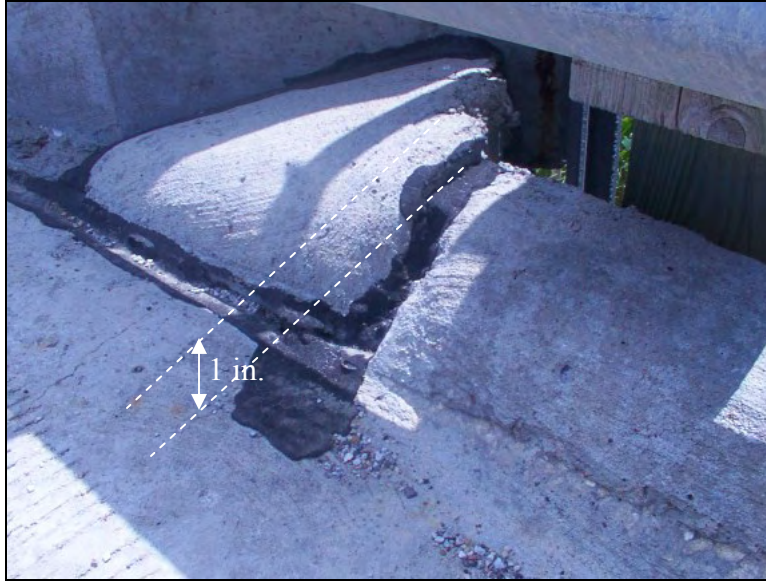
At the south end of the southbound bridge, differential settlement of 1 inch was measured relative to the wingwall (Figure 240), and a 2-inch void was observed under the approach slab. The embankment under the bridge was covered with aggregate and showed no signs of erosion or differential settlement. Aggregate cover was also used along the sides of the abutment to control erosion (Figure 241). The end drain was in a satisfactory condition, as shown in Figure 242.

Figure 240. Differential settlement of 1 inch between the bridge slab and the bridge approach (South end of SBL)

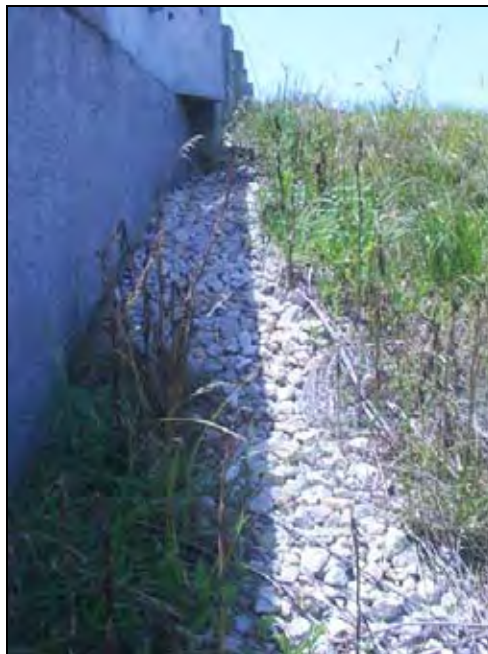
Figure 241. Aggregate placed at the sides of the abutment to control erosion (South end of SBL)

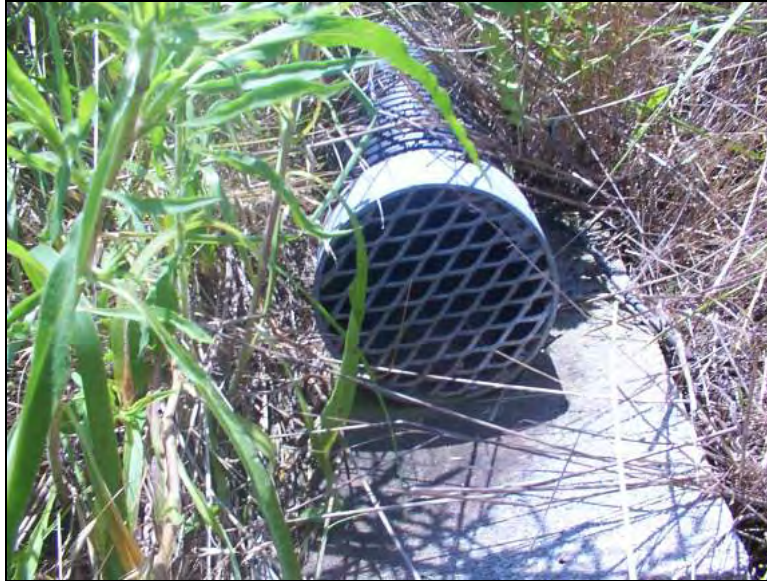
Figure 242. End drain in a satisfactory condition (South end of SBL)

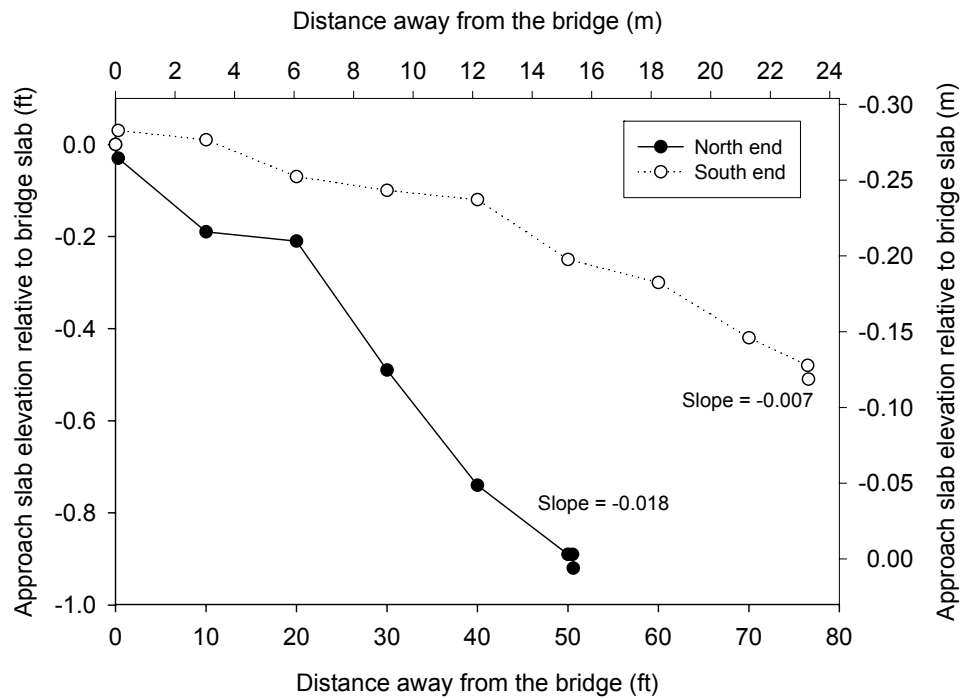
At this bridge, profiles of the north and south ends of the southbound lane are shown in Figure 243. Differential settlement of 0.5 inches was estimated between the approach slab and the roadway at both ends of the southbound lanes. The slopes for the north and south end approach slabs are -0.007 and -0.018. The approach slabs are sloping away from the bridge, which may indicate settlement of the foundation soil or compression of the embankment material. According to the Iowa DOT repair recommendation, only the approach slab at the north end was replaced.

Figure 243. Profiles of the approach slab relative to bridge slab (SBL)

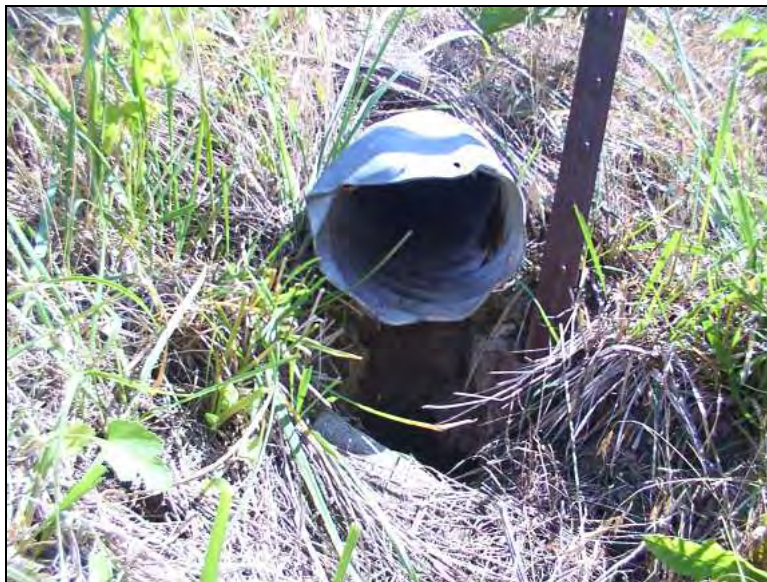
The subdrains of the northbound lanes were inspected using the Iowa DOT snake camera (Figures 244 and 245). At the north end, water and mud were observed within the first 9 ft. inside the subdrain (Figures 246 and 247). The snake camera was pulled out, cleaned, and

Figure 246. Subdrain prior to insertion of snake camera (North end of NBL)

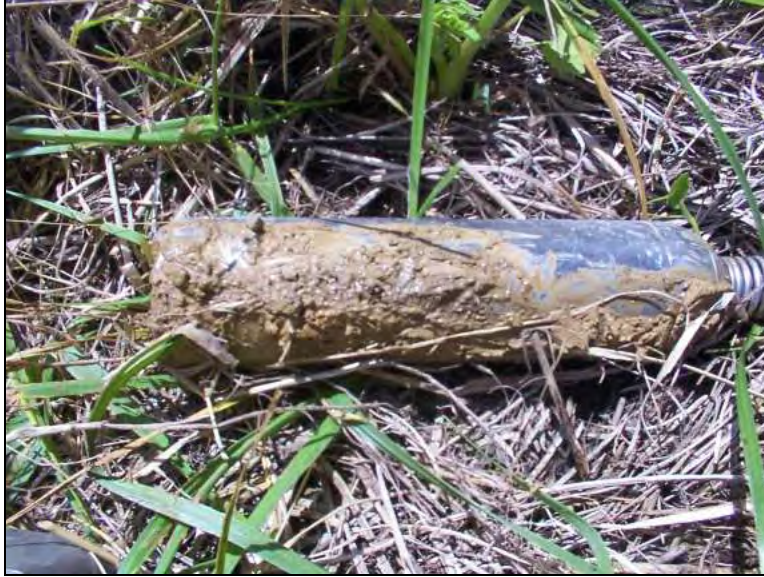
Figure 247. Snake camera covered with mud (North end of NBL)

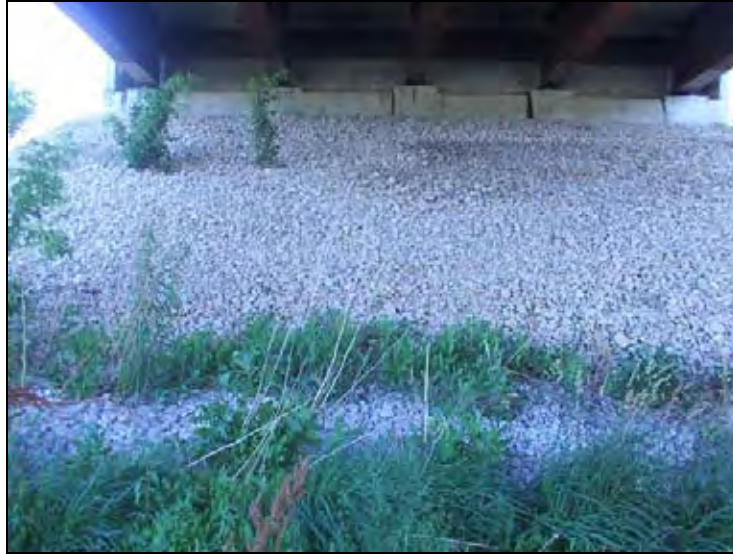
This bridge is a three-span bridge with steel girders and non-integral abutments. At the north end of the southbound lanes, bridge approach differential settlement of 1 inch was measured relative to the wingwall. No settlement of the embankment under the bridge, which was covered by aggregate, was observed (Figure 248). At the south end, differential settlement at the bridge approach was observed. In addition, water ponding at the bottom of the embankment under the bridge was noted. The inlet of the surface drain was in a satisfactory condition.

Figure 248. Aggregate slope protection at the bridge embankment (North end of NBL)

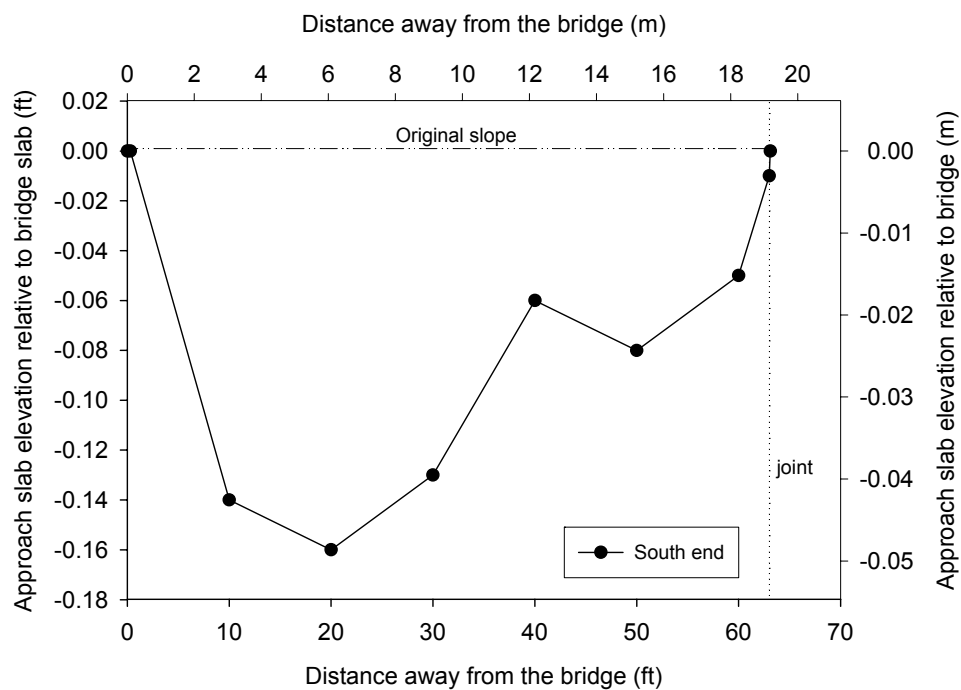
Approach slab coring at the south end of the south bound indicated a 0.5-inch void at both the center line and the edge line of the right lane. The profile of the south end approach slab revealed a non-uniform pavement elevation. The profile shows a maximum settlement of 1.9 inch at 20 feet from the bridge abutment. The original slope of the approach slab is horizontal (Figure 249).

Figure 249. Profile of the bridge approach relative to the bridge slab (South end of SBL)

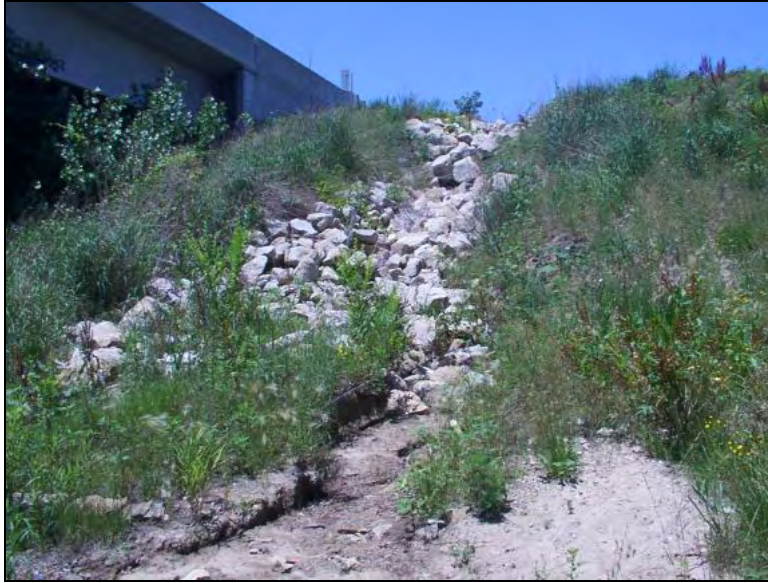
This bridge is a seven-span bridge with concrete girders and non-integral abutments. At the north end of the northbound lanes, the embankment consists of silty sand and has no slope protection. Some erosion of the bridge embankment was observed. At the sides of the abutment, large rip-rap had been placed to reduce erosion, as shown in Figure 250.

Figure 250. Rocks placed at the abutment side to prevent erosion (North end of NBL)

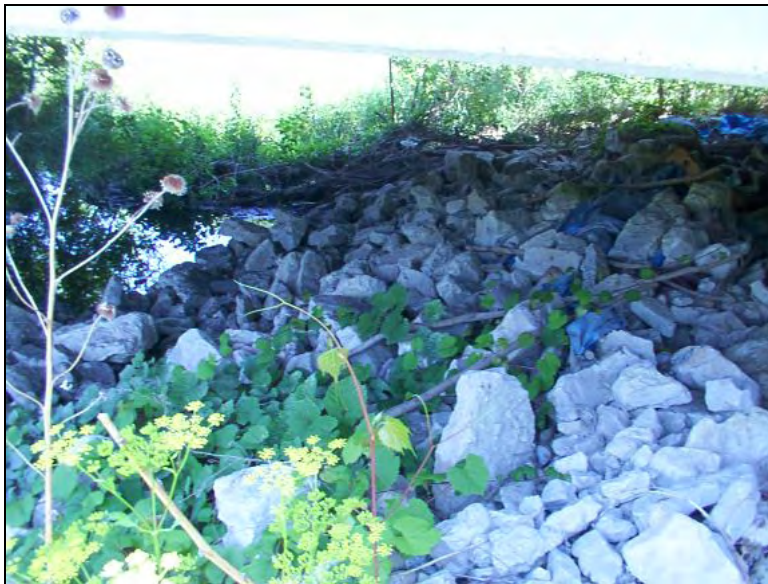
At the south end of the northbound lanes, differential settlement of 1.5 inches was measured at the end of the wingwall. The expansion joint was in satisfactory condition. Large rip-rap covered the embankment under the bridge as shown in Figure 251. Some erosion was observed along the side of the abutment.

Figure 251. Rocks placed at the embankment under the bridge to prevent further erosion (South end of NBL)

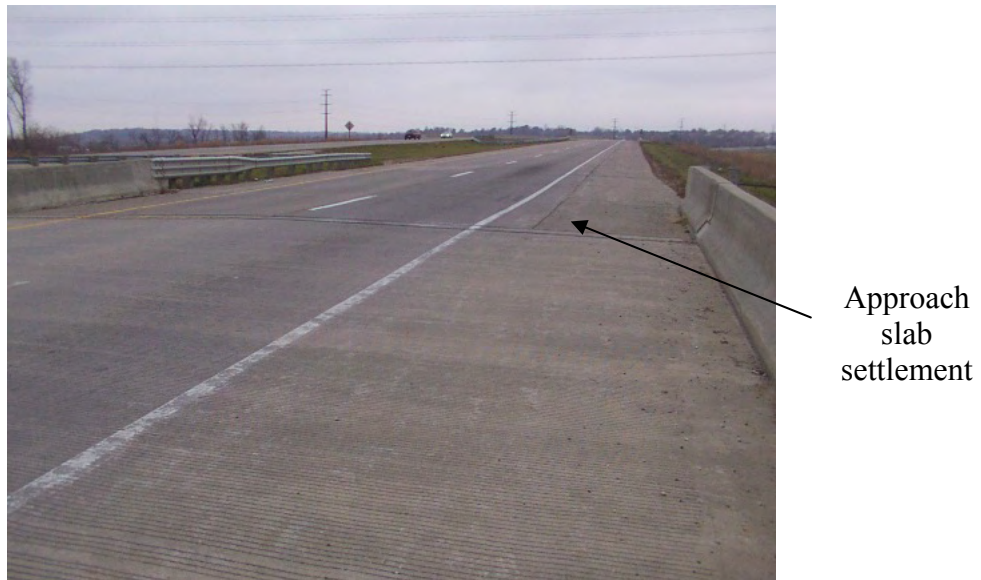
At the south end of the southbound lanes, the strip seal was cut short causing erosion at side of the abutment. Settlement and erosion of the bridge embankment was also observed. At the north end of the southbound lanes, 3.5 inches of differential settlement was measured (Figure 252). No slope protection was used and erosion of the embankment was observed.

Figure 252. Settlement of approach slab (North end NBL)

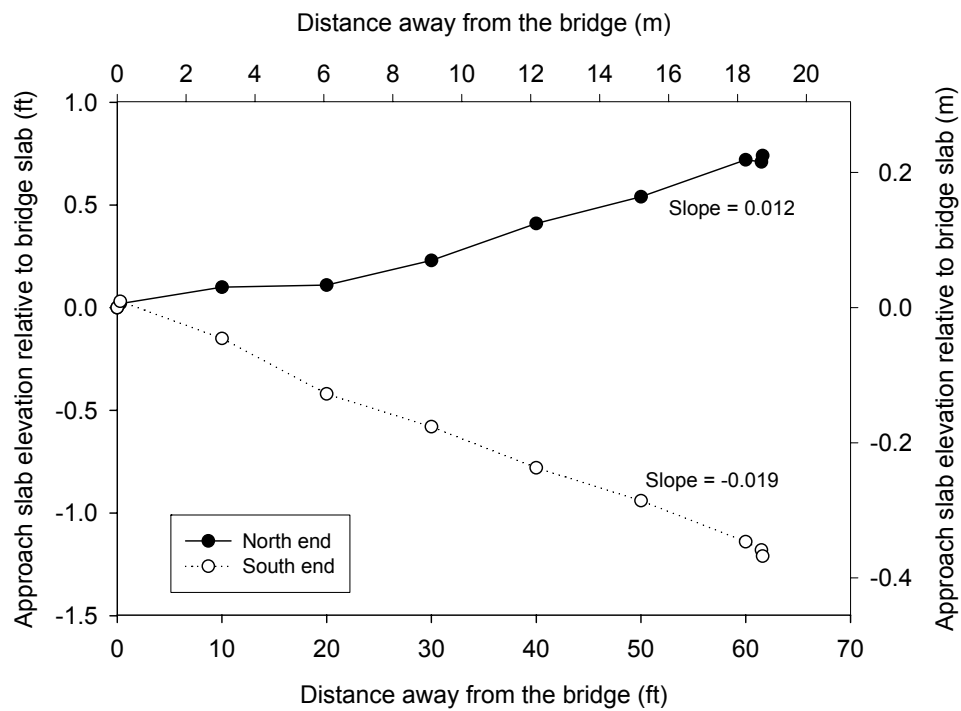
The approach slab elevation profiles for north and southbound lanes are shown in Figures 253 and 254. Differential settlement of the approach slab at the north end of the southbound lanes was about 1.2 inches at 5 ft. from the bridge abutment, while the south end approach slab settled about 3.5 inches at 50 ft. away from the bridge abutment. The slopes of the north and south end approach slabs of the southbound lane are 0.01 and -0.019. Differential settlement between the approach slab and the roadway of both ends of the northbound lanes was about 0.5 inches. The slopes of the north and south end approach slabs of the northbound lane are 0.012 and -0.019, respectively.

Figure 253. Profiles of the approach slab relative to bridge slab (NBL)

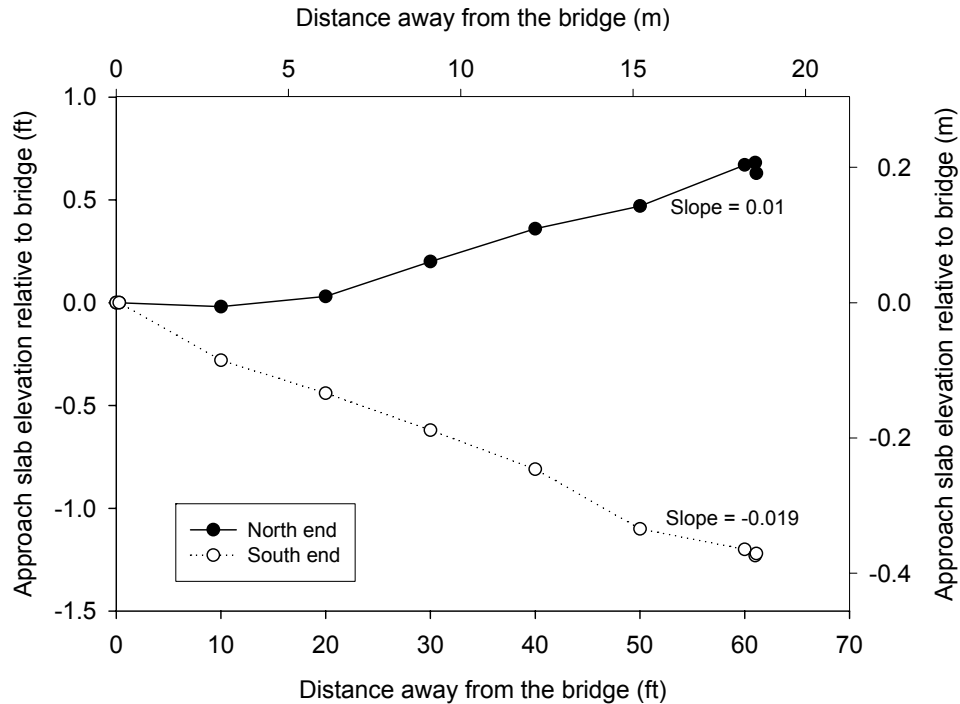
Figure 254. Elevation of the bridge approach relative to the bridge slab (SBL)

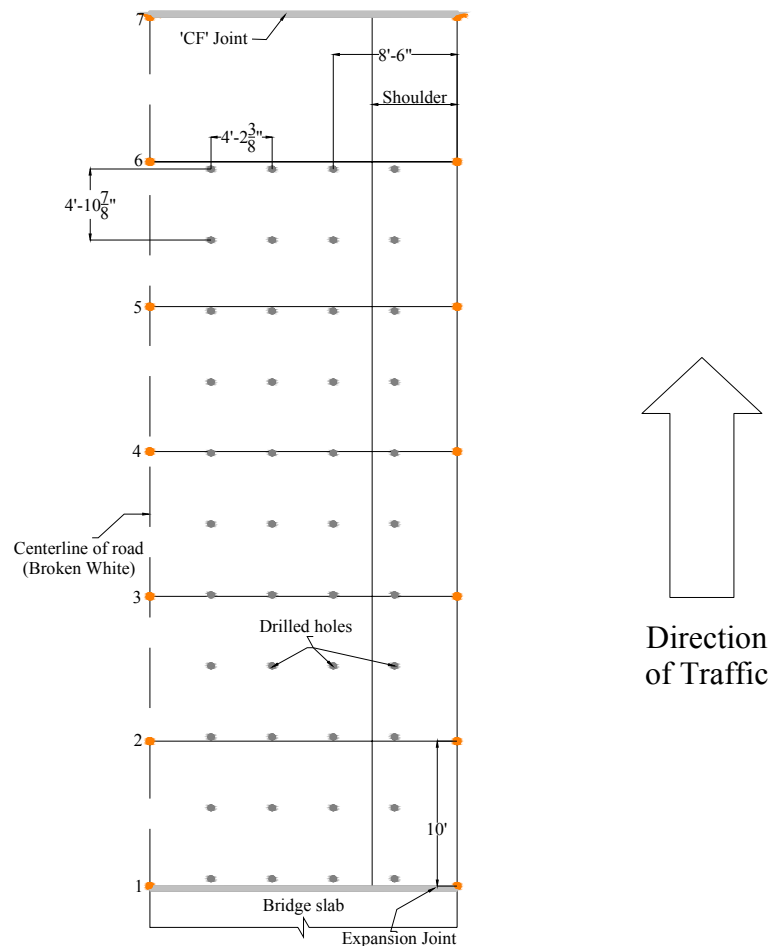
Figure 255. Location of holes drilled on the bridge approach slab

As a demonstration at this bridge site, URETEK, Inc., repaired the right lane of the north end of the northbound lanes. Figure 255 shows the locations where the URETEK expanding foam was injected through 5/8 inch drill holes in the slab. The drill holes were spaced about 4 to 5 feet apart (Figures 256 and 257). A dial gauge was placed just past the 'CF' joint, located 60 feet from the abutment, to monitor elevation changes in the approach slab pavement (Figure 258). After drilling was completed, pumping of the high density polyurethane was performed. Some holes were re-drilled after the material had hardened to inject additional material as needed (Figures 259 and 260).

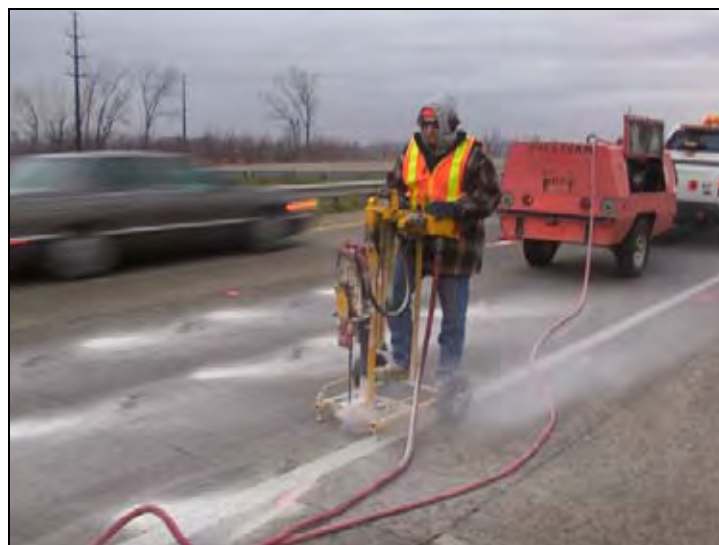
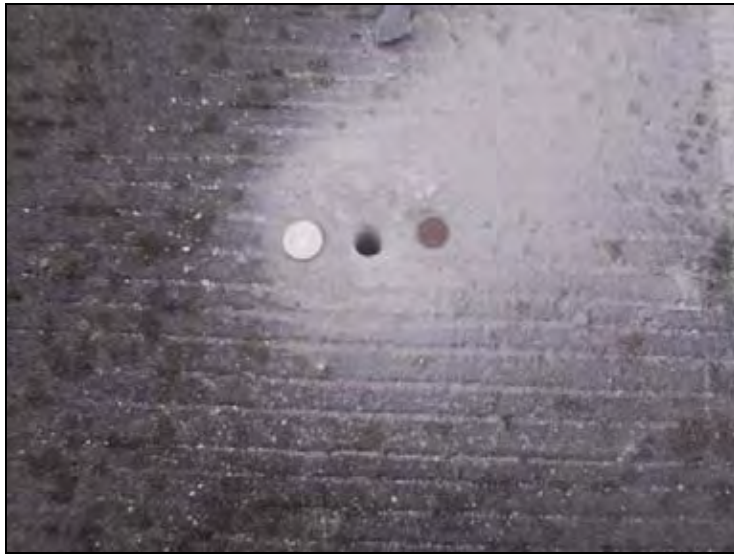
Figure 256. Holes drilled on the approach slab

Figure 257. Holes drilled for injecting expansive material under the approach

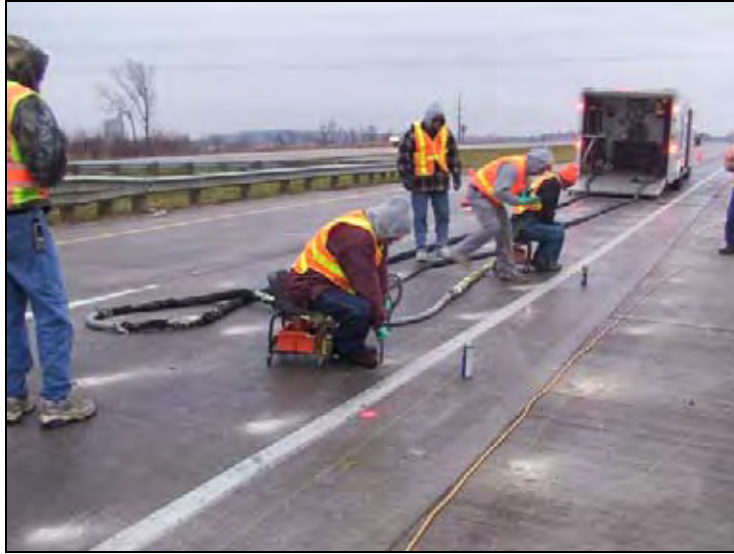
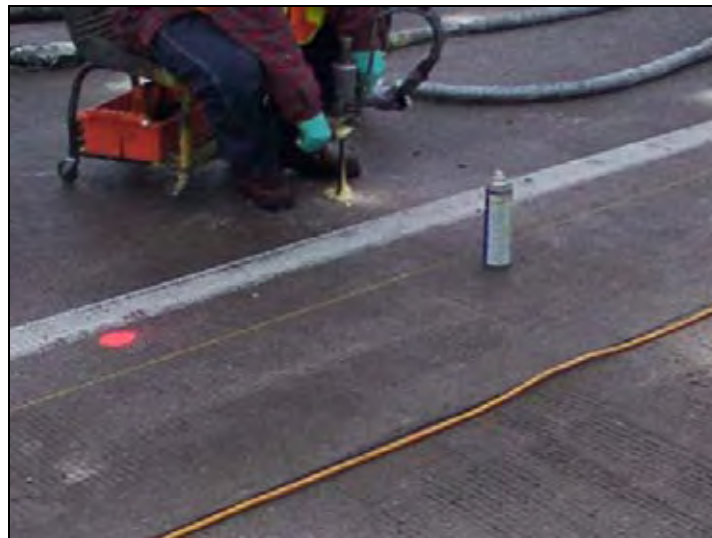
Figure 259. Injecting high-density polyurethane under the approach slab

Figure 260. Steady injection until material leaks out of hole

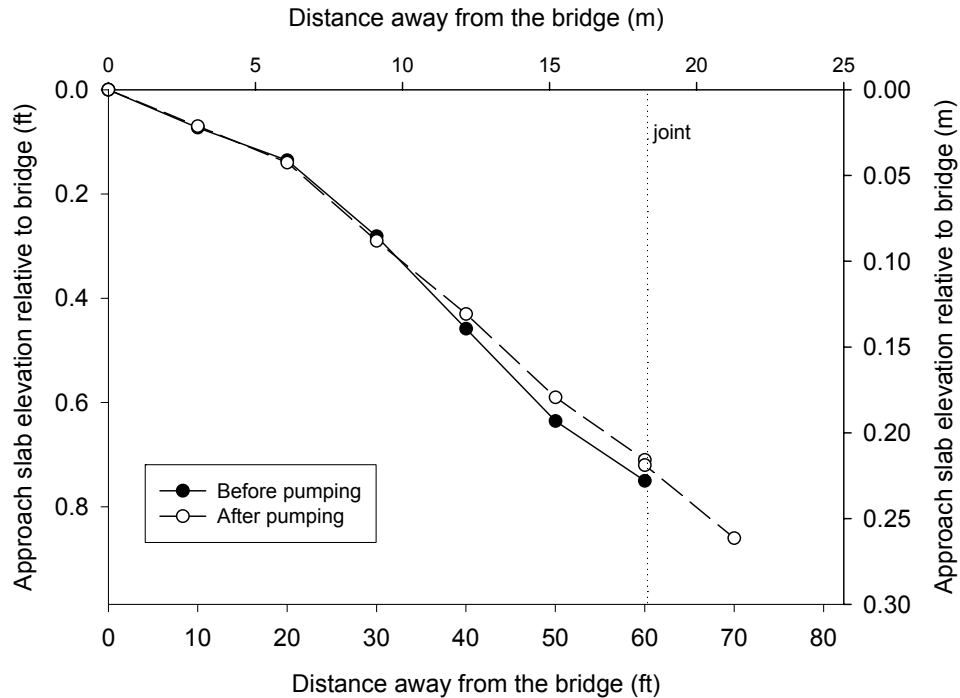
The research team measured the profile of the approach at 10 ft. intervals before and after injecting the expanding foam. The approach slab was raised approximately 0.25 inches at 40 to 60 ft. from the abutment. Unfortunately, due to bad weather, the URETEK crew was not able to inject the material from 0 to 30 ft (Figure 261).

Figure 261. Elevation of approach relative to expansion joint before and after pumping

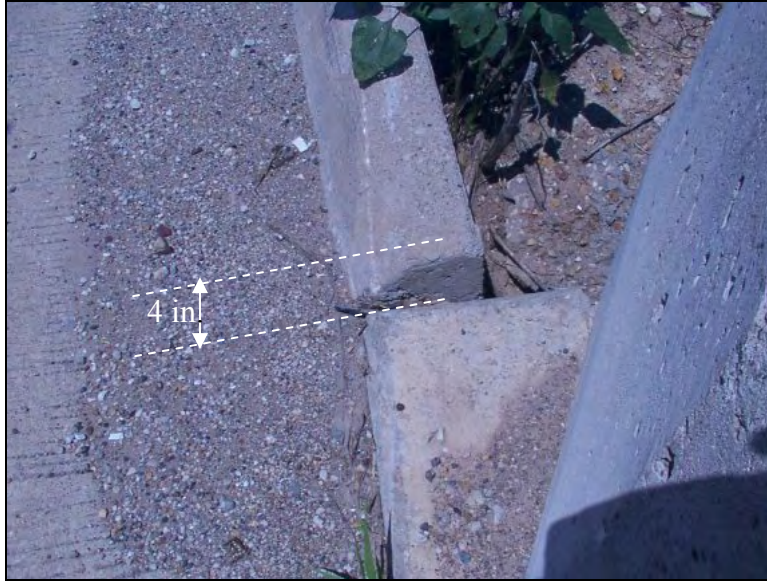
This bridge is a five-span bridge with integral abutments and concrete girders. At the north end of the northbound lanes, about 4 inches of differential settlement was measured at the end of the wingwall (Figure 262). A 6-inch void developed under the approach slab, as shown in Figure 263. Flexible foam was used as filler of the expansion joint—gaps were observed and concrete deterioration was observed at the expansion joint. Although the embankment under the bridge had an aggregate cover, erosion was observed between the abutment and the bridge embankment.

Figure 262. Differential settlement at the bridge approach (North end of NBL)

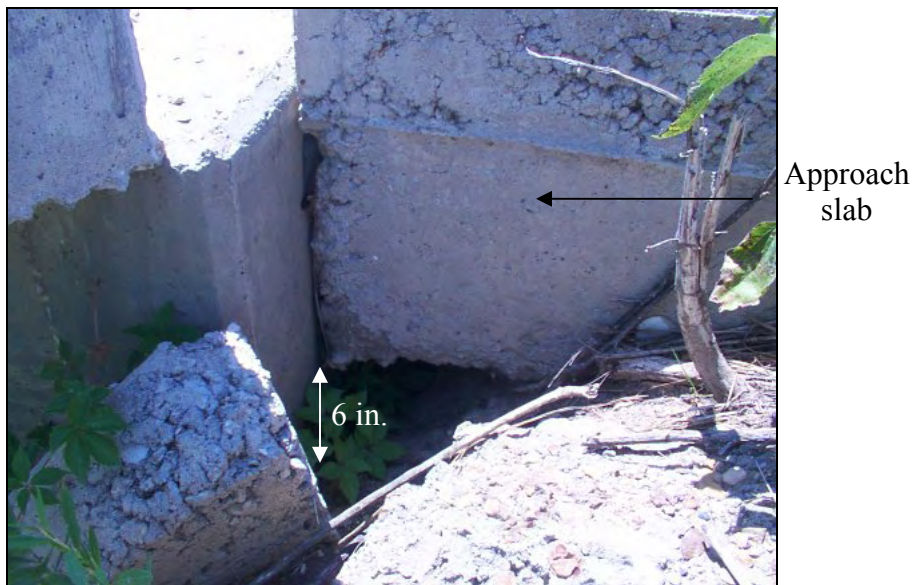
Figure 263. A 6 in. void developed under the approach slab (North end of NBL)

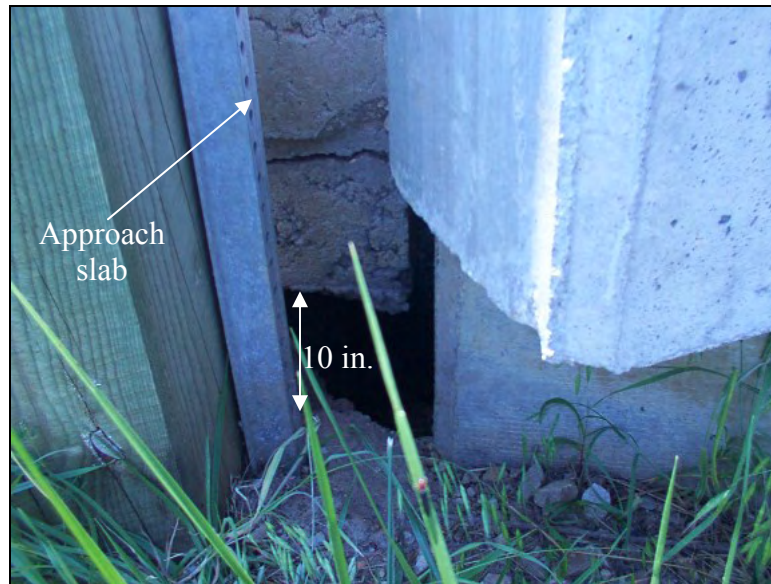
At the south end of the northbound lanes, a 10-inch void was observed under the approach slab (Figure 264). Figure 265 shows 1.5 inches of differential settlement between the approach slab and wingwall. The expansion joint was deteriorated, as shown in Figure 266. Furthermore, erosion along the abutment sides was observed (Figure 267). The embankment has concrete slope protection which appeared to be in relatively good condition. The embankment, however, had settled about 7 inches (Figure 268), and a 1-inch horizontal gap was measured between the embankment and abutment face (Figure 269).

Figure 264. A 10 in. void developed under the approach slab (South end of NBL)

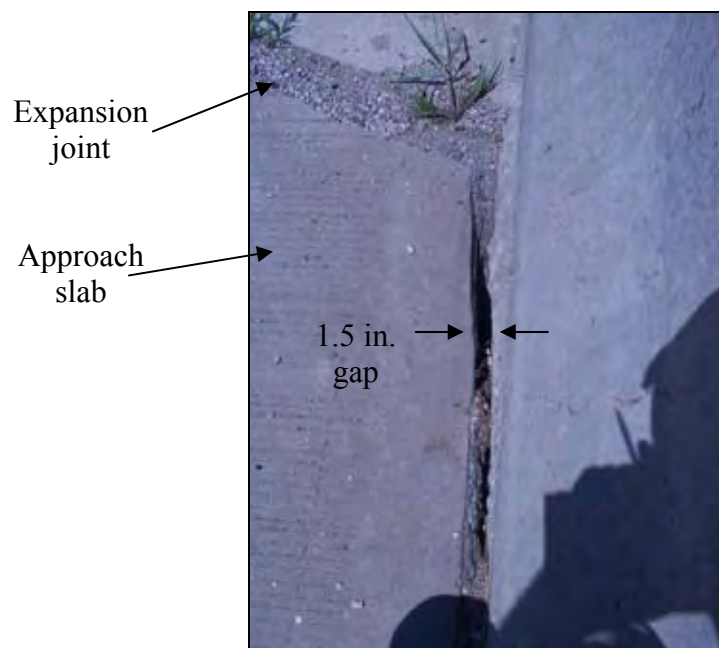
Figure 265. Gap between the approach slab and the wingwall (South end of NBL)

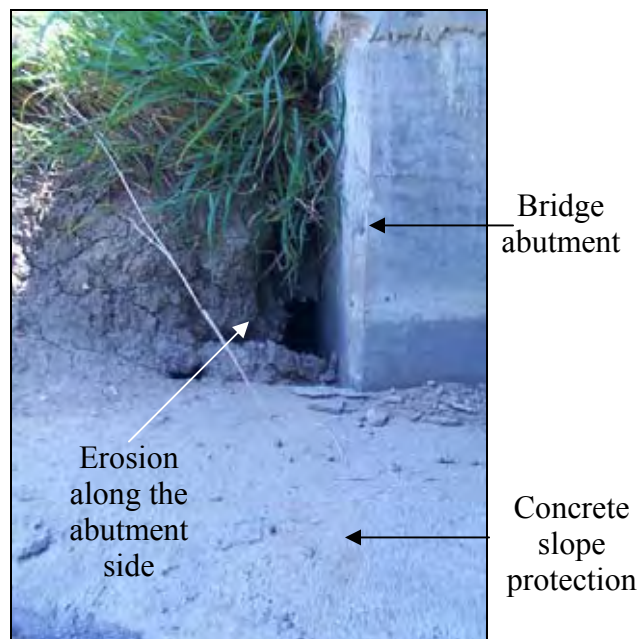
Figure 267. Erosion along the abutment sides (South end of NBL)

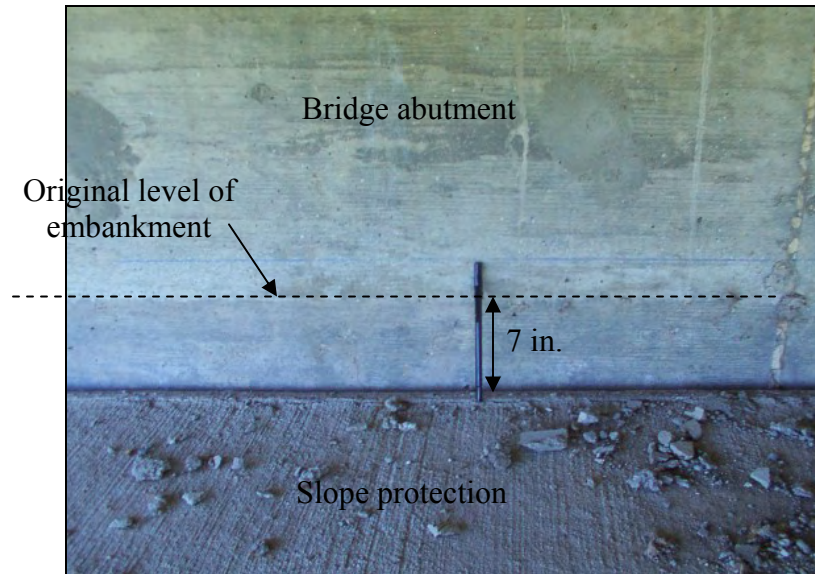
Figure 268. Settlement of the embankment under the bridge (South end of NBL)
