IDENTIFICATION OF THE BEST PRACTICES FOR DESIGN, CONSTRUCTION, AND REPAIR OF BRIDGE APPROACHES

Iowa DOT Project TR-481
CTRE Project 02-118

Final Report

January 2005

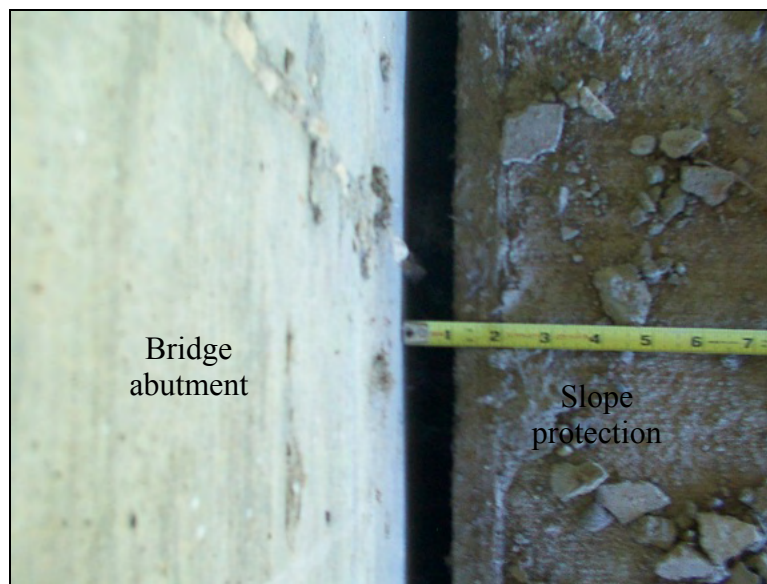
At the south end of the northbound lanes, a 10-inch void was observed under the approach slab (Figure 264). Figure 265 shows 1.5 inches of differential settlement between the approach slab and wingwall. The expansion joint was deteriorated, as shown in Figure 266. Furthermore, erosion along the abutment sides was observed (Figure 267). The embankment has concrete slope protection which appeared to be in relatively good condition. The embankment, however, had settled about 7 inches (Figure 268), and a 1-inch horizontal gap was measured between the embankment and abutment face (Figure 269).

Figure 269. Top view showing the 1 in. gap between the abutment and concrete slope cover (South end of NBL)

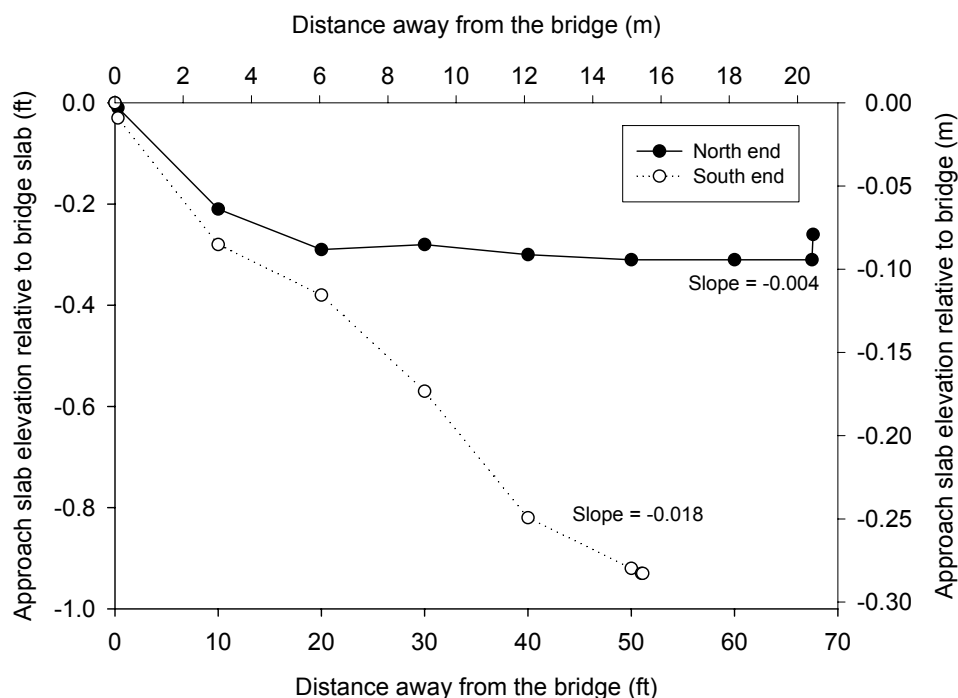
Bridge approach profiles were obtained for both ends of the northbound bridge, as shown in Figure 270. When compared with the assumed original profiles, differential settlement at the north end was about 1.5 inches at 20 feet from the bridge abutment and 0.6 inches between the approach slabs at 68 feet. The maximum settlement of the south end approach slab was 1.3 inches at 40 feet away from the bridge. The slopes of the north and south end approach slabs are -0.004 and -0.018, respectively. Both approach slabs are sloping away from the bridge, which may indicate settlement of the foundation soil or compression of the embankment material.

Figure 270. Profile of the bridge approach relative to bridge slab (NBL)

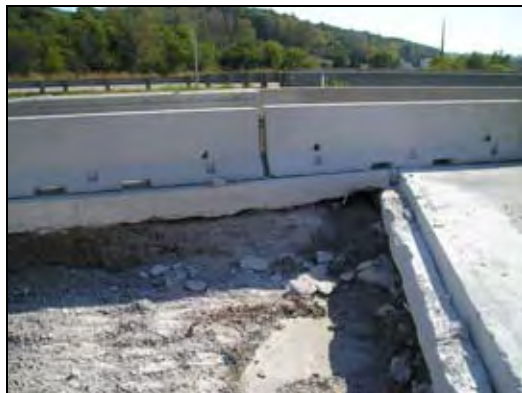
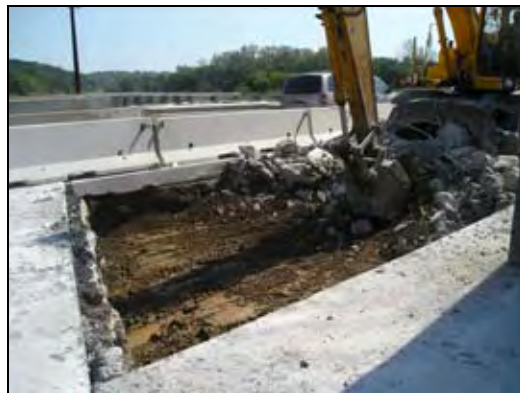
inspection, replacement of the right lane approach slabs at the south bound bridge was in progress (Figure 271). The left lane was still opened to traffic. The north end approach slab was removed while the south end approach slab was torn down and being removed.

Figure 271. Replacement of approach slabs at the south bound

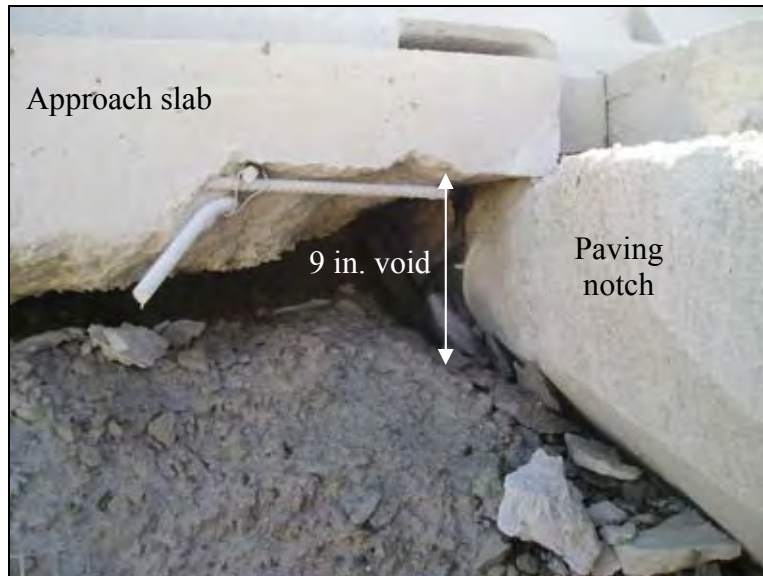
A void was observed under the left lane of the north end, as shown in Figure 272. The void was 9 inches deep at the abutment and about 1 inch at 4 feet away. Figure 273 shows that shear failure of portions of the paving notch of the left lane occurred such that the approach slab was only resting on about 0.5 inches of the paving notch (Figure 274).

Figure 272. A 9 in. void developed under the left lane approach slab (North end of SBL)

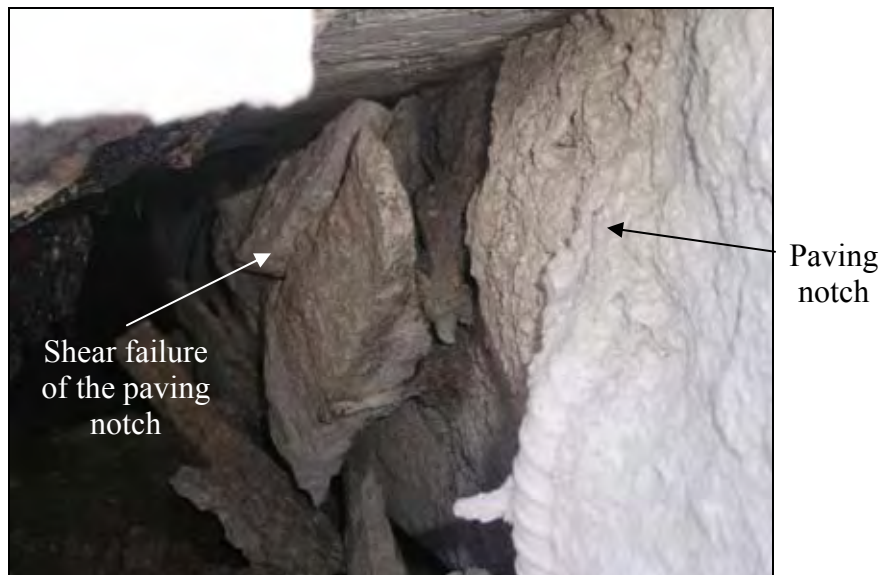
Figure 273. Shearing of paving notch (North end of SBL)

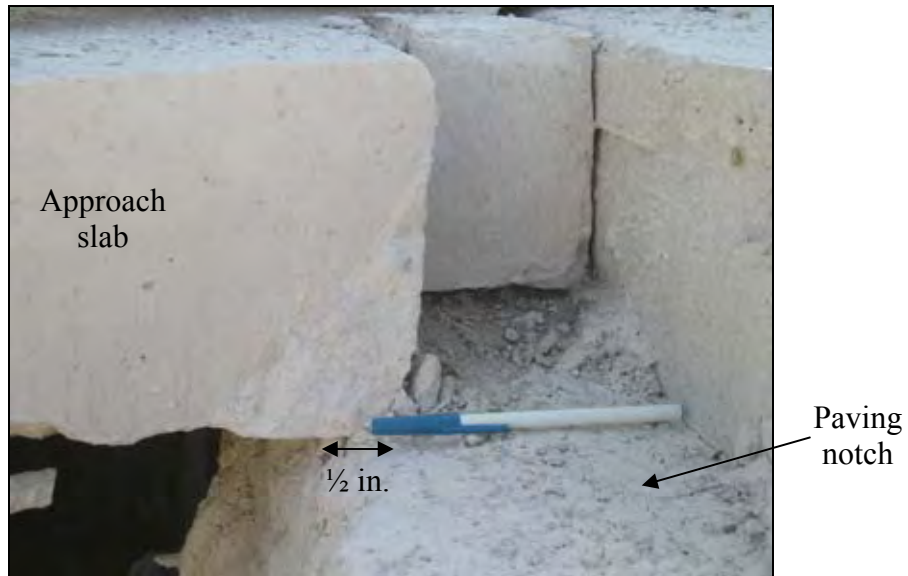
Figure 274. The approach slab resting on 0.5 in. of the paving notch (north end of SBL)

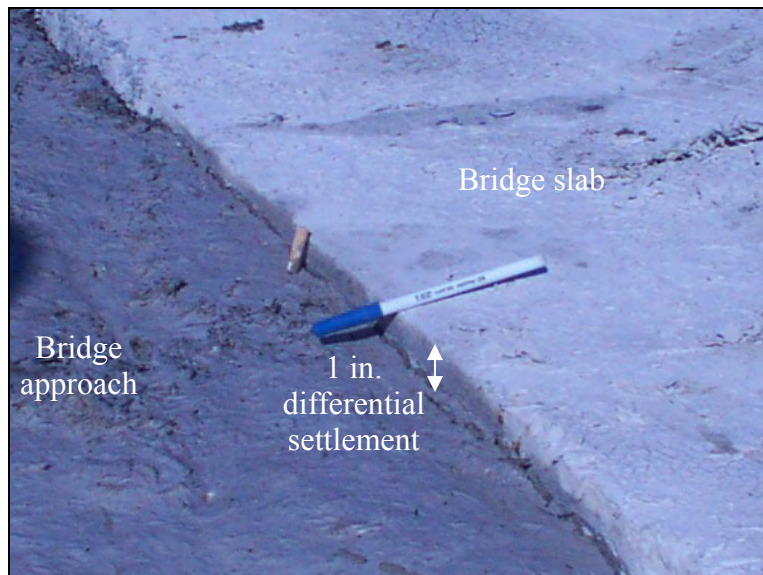
At the south end approach slab, about 1 inch of slab drop at the bridge deck was observed (Figure 275). Recycled tire chips were used as a joint filler material at the expansion joint. Similar to the north end, the approach slab at the south end was resting on only 1 inch of the paving notch, as shown in Figure 276. Under the approach slab, a 10-inch-deep void was measured at the abutment and extended 5 feet away from the bridge.

Figure 275. Differential settlement between the bridge slab and the bridge approach (South end of SBL)

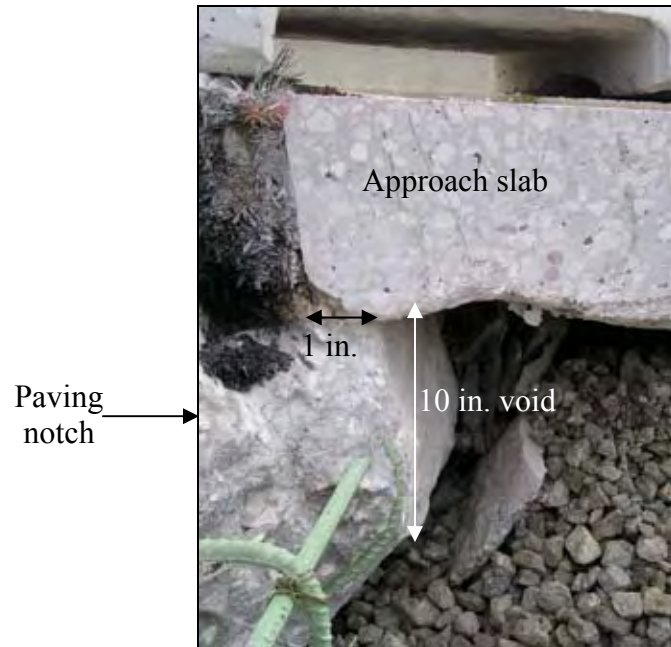
Figure 276. Approach slab resting on 1 inch of the paving notch, and a 10-inch-void developed under the approach slab (South end of SBL)

The study also examined the potential failure of an unreinforced concrete segment in the pavement notch and the approach slab independently as a result of transferring loads through this segment. The unreinforced segments may be found at the end of an approach slab and/or in the end region of a pavement notch. This condition occurs mainly due to inaccurate placement of the reinforcing steel during construction (e.g., see Figures 276 and 413).

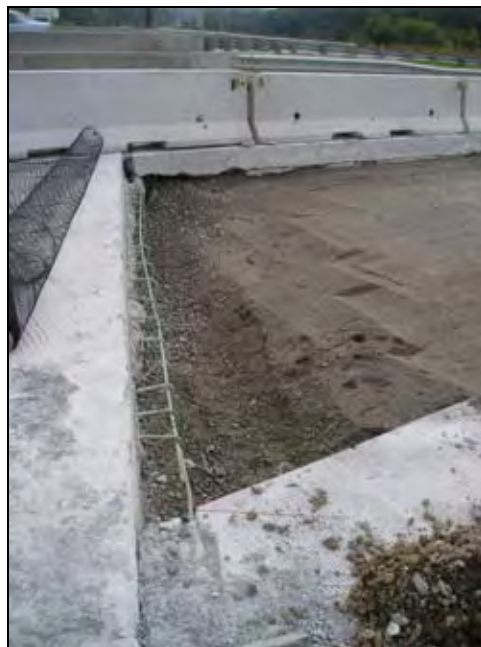
To evaluate subgrade strength, DCP tests were performed at the north and south ends of the southbound bridge at 2 feet from the abutment. At the north end, the DCP test was conducted on the old special backfill material. At the south end, the DCP test was conducted on the new compacted special backfill (Figure 277). The results of the DCP testing conducted on the old backfill material showed that the CBR values ranged from 2 to 15, as shown in Figure 278. DCP test results conducted on the new compacted special backfill shows that the CBR values range from 1.5 to 15. No significant difference was measured between the CBR values of both the old and the new compacted special backfill (Figure 279).

Figure 277. Compacted special backfill (South end of SBL)

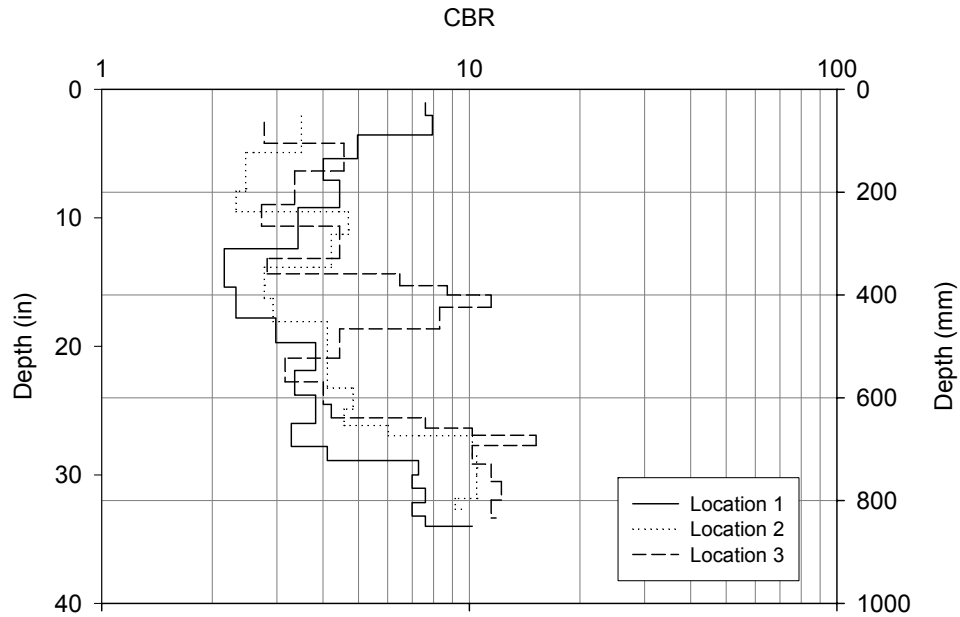
Figure 278. Results of DCP tests conducted on the old backfill material (North end of SBL)

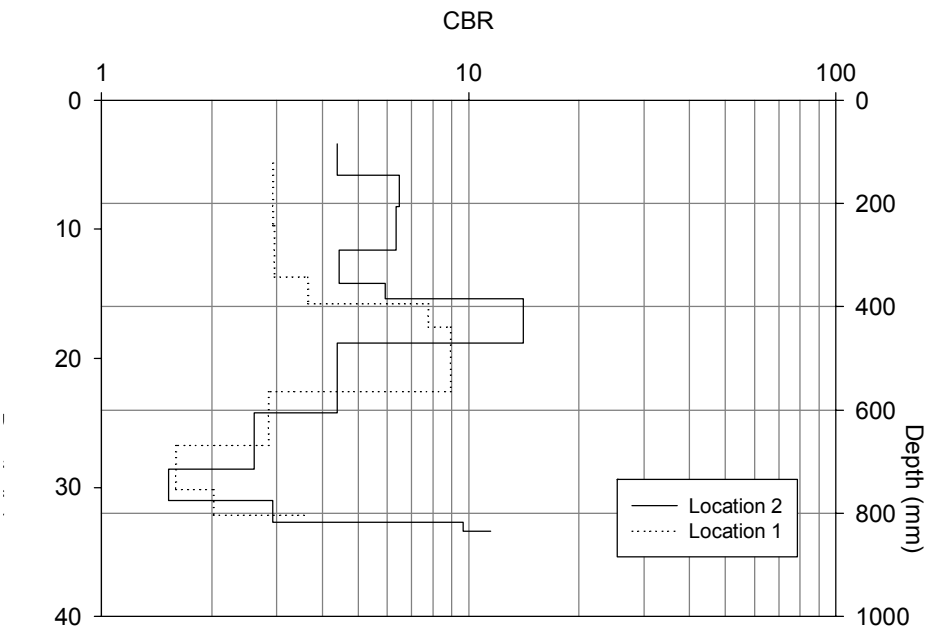
Figure 279. DCP test conducted on the replaced special backfill (South end of SBL)

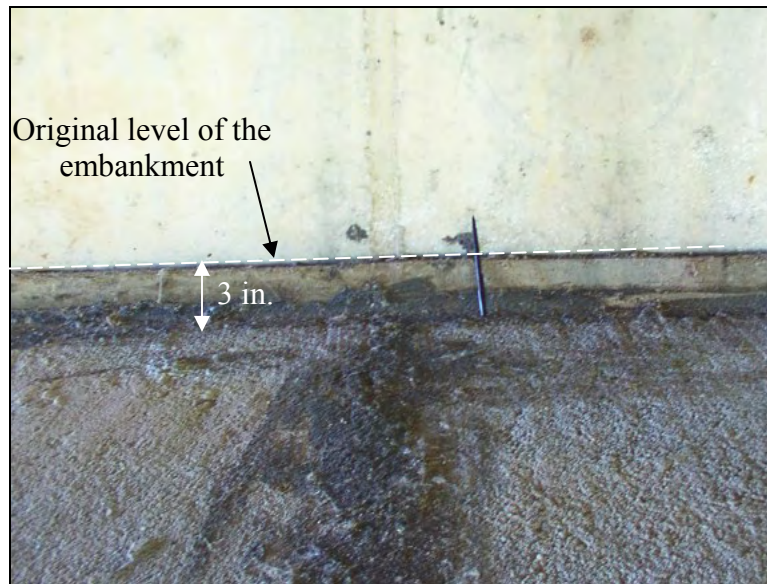
erosion along the sides of the abutment. The embankment has a slope protection which appeared to be in good condition with no settlement. At the north end of the northbound bridge, erosion along the abutment sides was also observed. The embankment had settled about 3 inches, as shown in Figure 280. The embankment has a slope protection that appeared to be in good condition.

Figure 280. Settlement of the embankment under the bridge (North end of NBL)

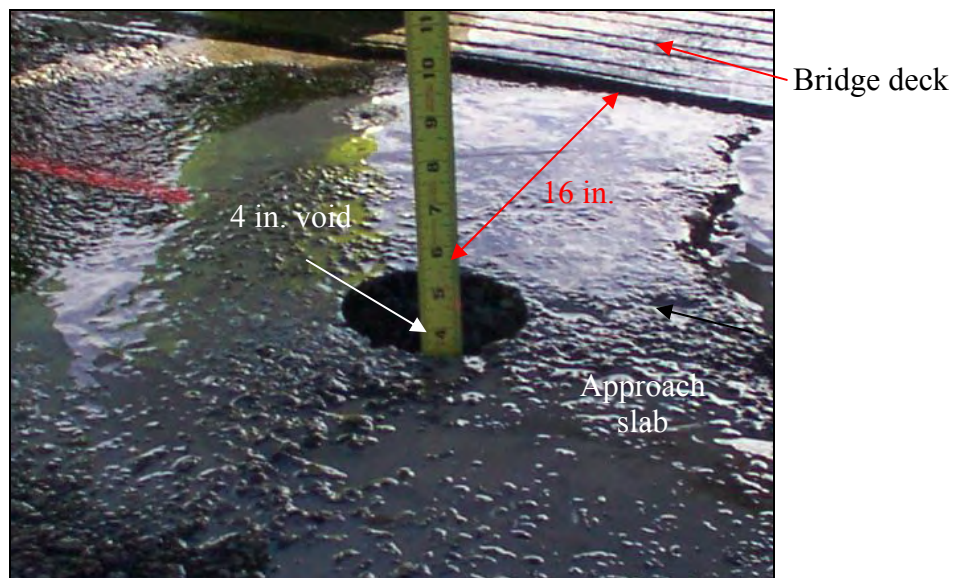
Figures 282 and 283 show how coring by the Iowa DOT was used to determine void size at the north end of the southbound bridge. The pavement thickness was 15.5 inches, which was determined by measuring the length of the core obtained at the white line (Figure 284). Table 17 summarizes the void sizes. The south end of the southbound lanes was not cored because no significant bridge approach pavement distress was observed.

Figure 282. A 4-inch-void under the approach slab estimated by measuring the distance the core dropped (North end of SBL, center line)

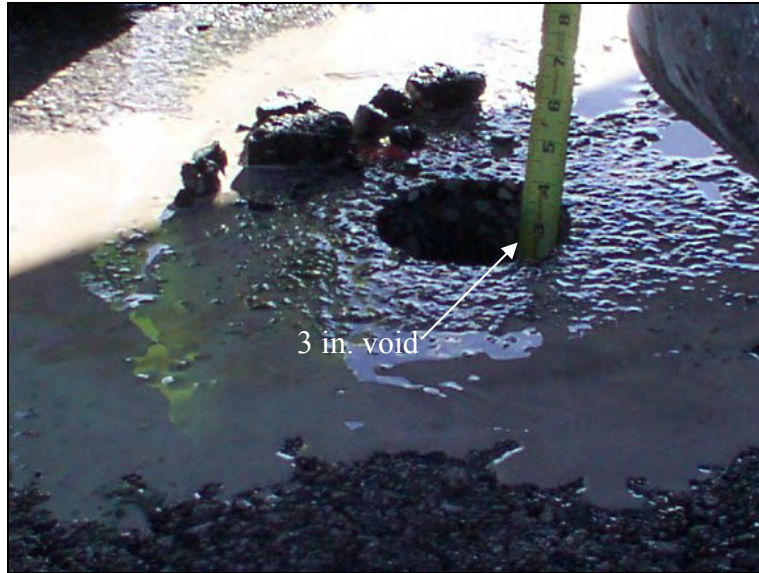
Figure 283. A 3-inch-void under the approach slab estimated by measuring the distance the core dropped (North end of SBL, edge line)

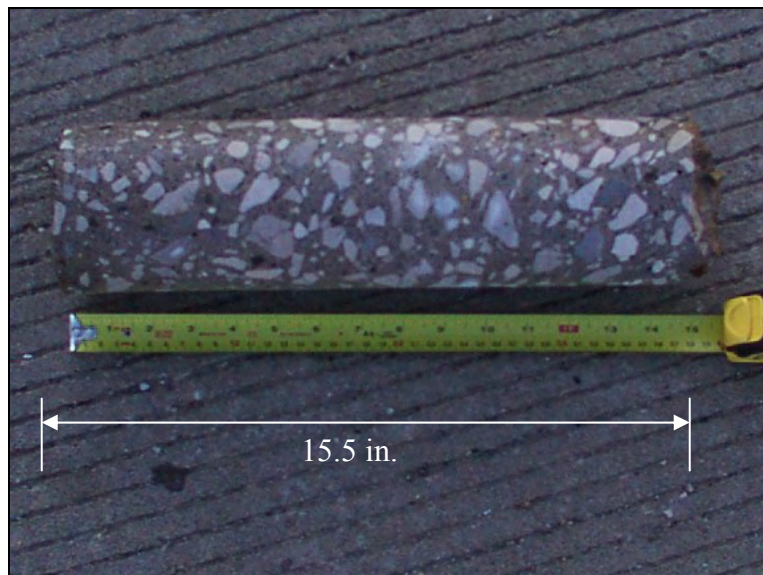
Figure 284. Pavement thickness determined from measuring the length of the core (North end of SBL, edge line)

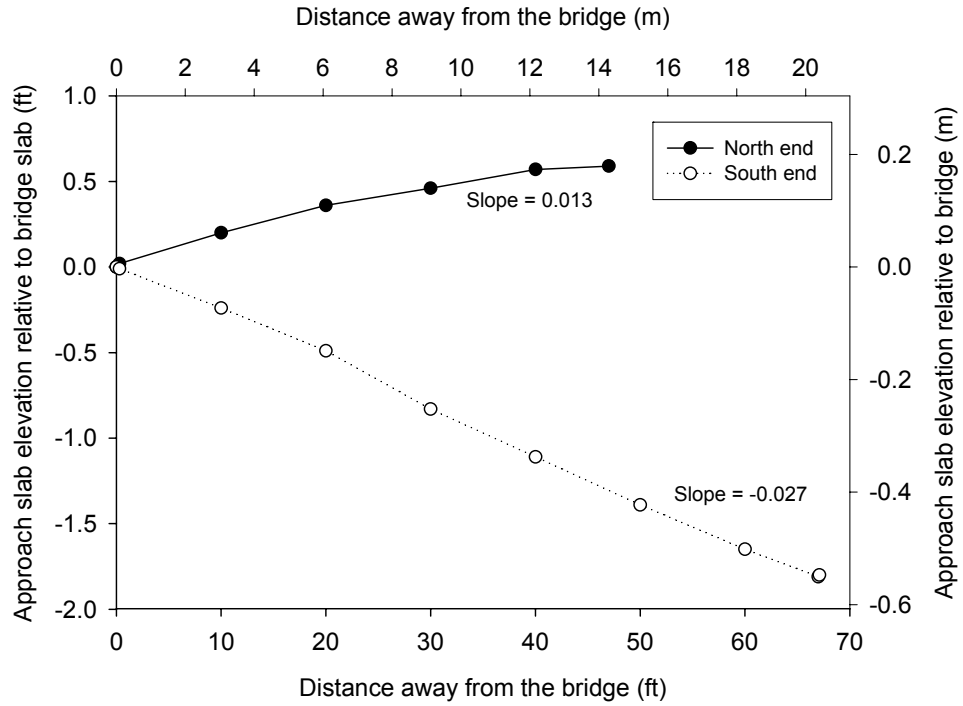
Elevation profiles of the bridge approaches are shown in Figures 285 and 286. Both the north and south approaches of the northbound lanes settled about 2.5 inches relative to the original slope at distances of 50 feet and 60 feet away from the bridge abutment. The slopes of the north and south end approach slabs are 0.012 and -0.027, respectively (Figure 285). The approach slab settled about 1.5 inches relative to the pavement past the CF joint. Settlement along the approach slab varied from 1 to 1.5 inches relative to the original slope. The slope of the north end approach slab is 0.017 (Figure 286).

Figure 285. Profile of the bridge approach relative to bridge slab (NBL)

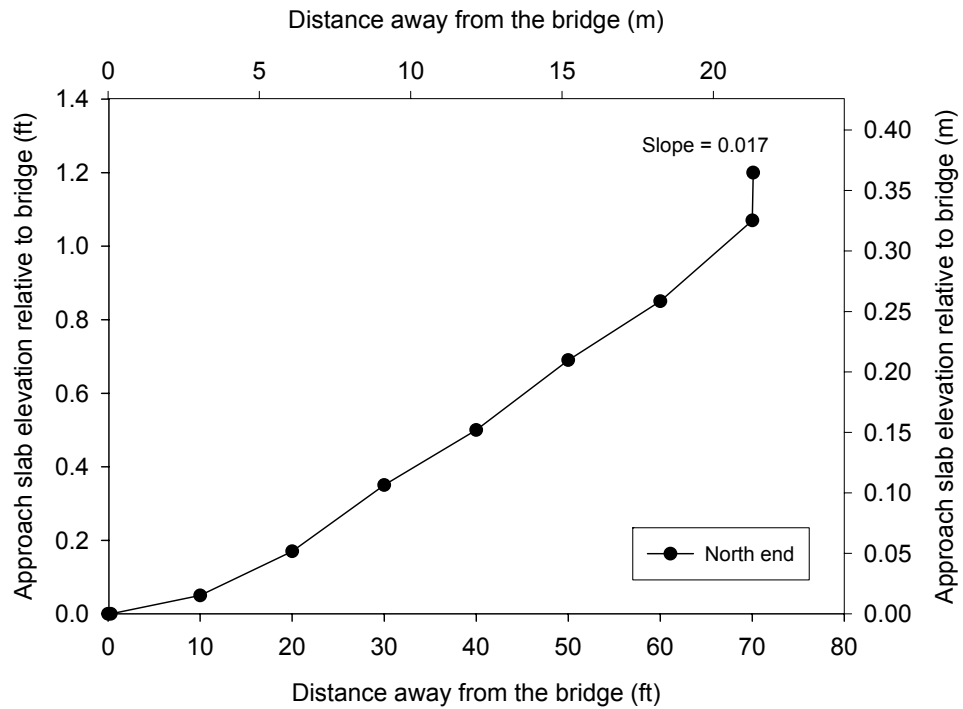
Figure 286. Profile of the bridge approach relative to bridge slab (SBL)

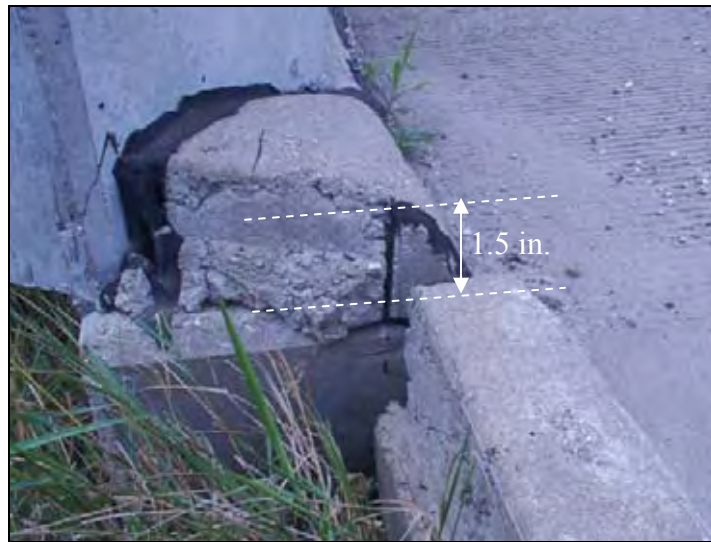
This bridge is a three-span bridge with concrete girders and integral abutments. At the north end of the northbound lanes, 1.5 inches of differential settlement was observed at the end of the wingwall (Figure 287). The width of the expansion joint was about 5.5 inches and poorly filled. The concrete slope protection of the embankment under the bridge was in good condition; however, the embankment had settled about 2 inches relative to the abutment (Figure 288).

Figure 287. Differential settlement between the bridge slab and the bridge approach (North end of NBL)

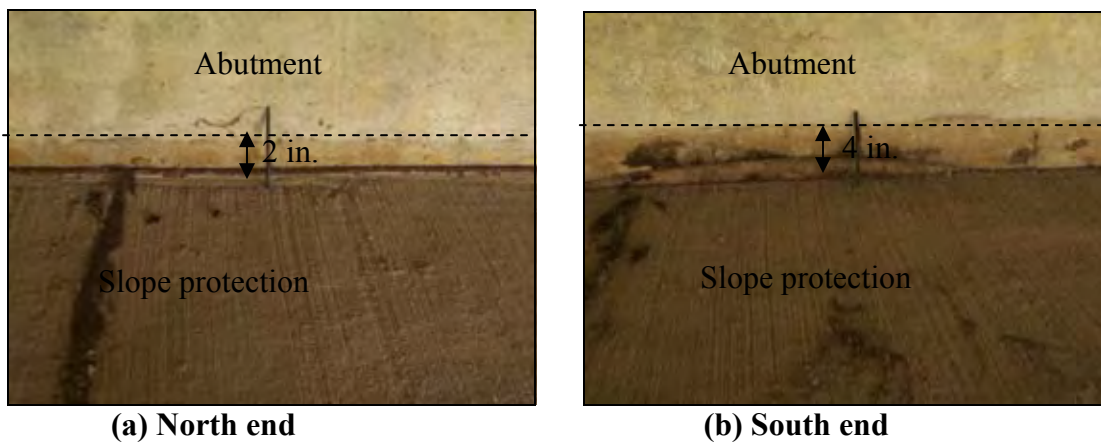
At the south end of the northbound lanes, erosion along the sides of the abutment was observed. Furthermore, the embankment under the bridge had settled about 4 inches relative to the abutment and a 1.5-inch horizontal gap existed between the abutment face and slope protection (Figures 288 and 289).

Figure 288. Settlement of the embankment under the bridge (NBL)

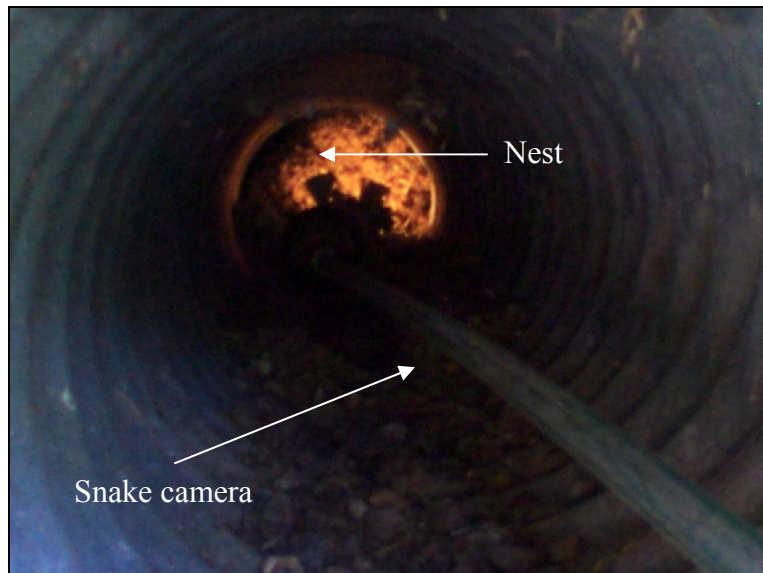
The snake camera was used to inspect the subdrains of both ends of the north bound. At the north end, the subdrain was dry. At 5 feet inside the subdrain, a rodent nest was observed blocking the subdrain (Figure 290). At the south end, the subdrain was completely dry with some fines at the bottom of the drain (Figure 291).

Figure 290. Rodent nest blocking the subdrain at 5 feet from the outlet

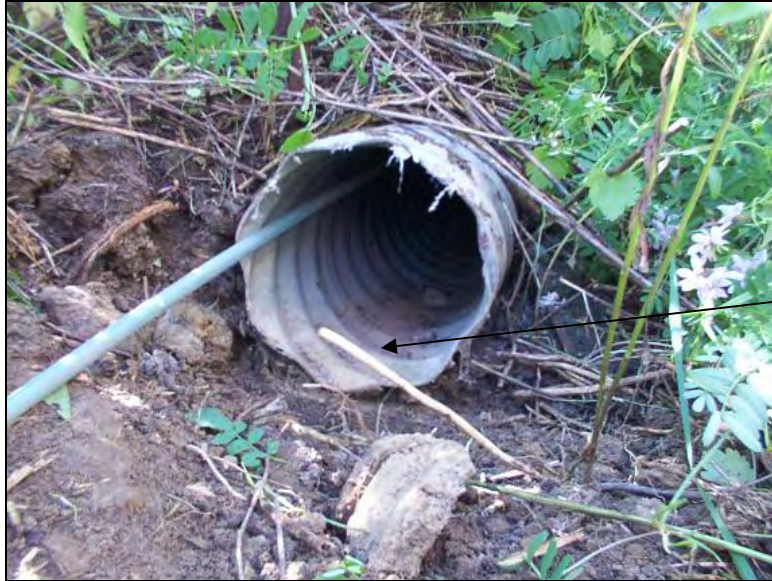
Fine soil
particles at
the bottom
of the
subdrain

Figure 291. Iowa DOT snake camera inserted inside the subdrain

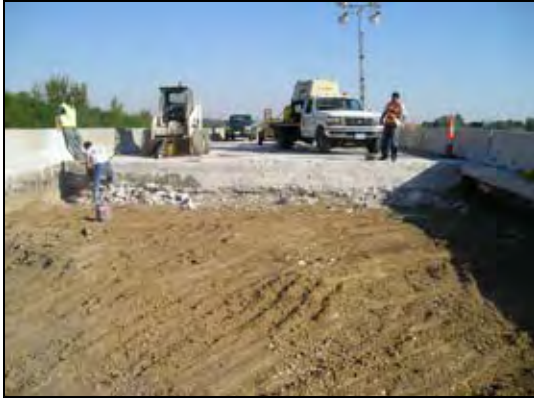
(a) Replaced approach slab

Figure 292. Replacement of the right lane approach slab (South end of SBL)

This bridge was also inspected in September 2004 while major maintenance operations were underway. During inspection, replacement of the approach slab at the south end of the southbound lanes was in progress. The replaced section was on the right lane, while the left lane approach slab was still open to traffic (Figure 292). Figure 293 shows removal of the existing 10-inch-wide paving notch. The void under the existing approach (left lane) was approximately 18 inches deep at the abutment and 6 inches deep at 3 feet from the abutment (Figure 294). A new subdrain pipe was installed behind the bridge abutment. The subdrain was connected to the end drain. Figure 295 shows the trench excavation to place the subdrain and end drain. Porous backfill was placed around the new drains.

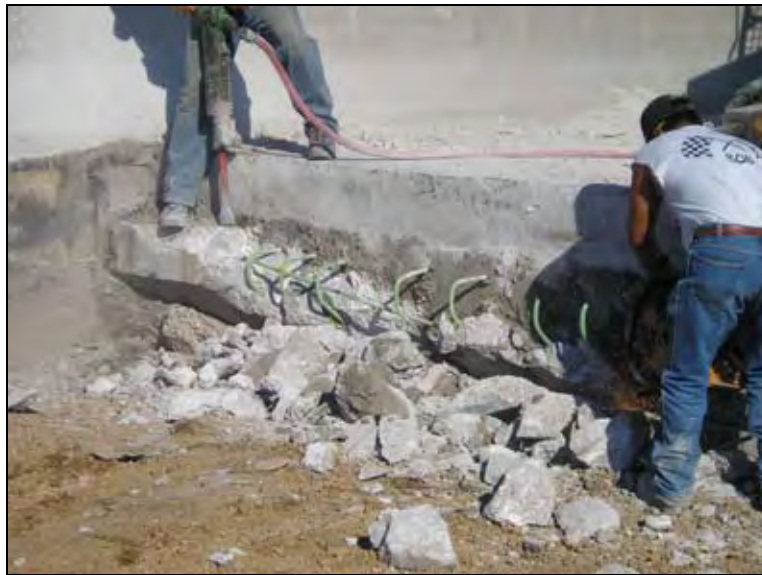
Figure 293. Tearing down the old pavement notch (South end of SBL)

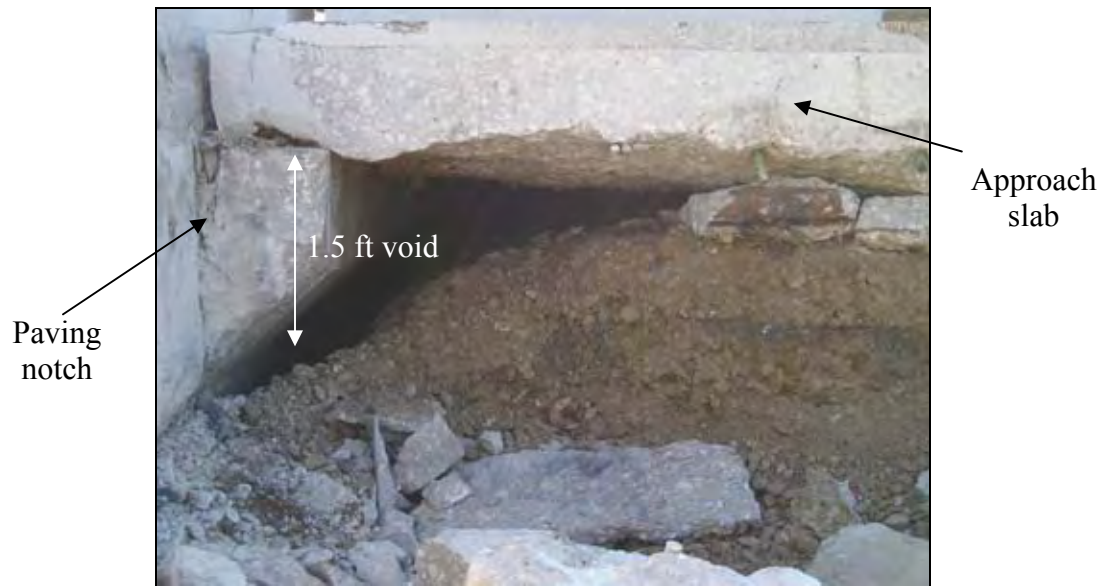
Figure 294. A void developed under the left lane approach slab which was 1.5-feet-deep at the bridge abutment (South end of SBL)

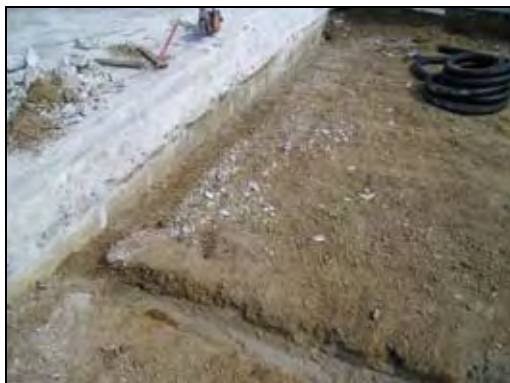
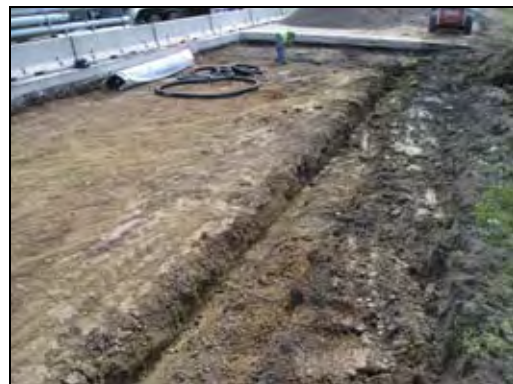
Figure 295. Installing a drainage system under the right lane approach slab

(a) Trench excavated to install subdrain

(b) Trench excavated to connect the subdrain to the end drain

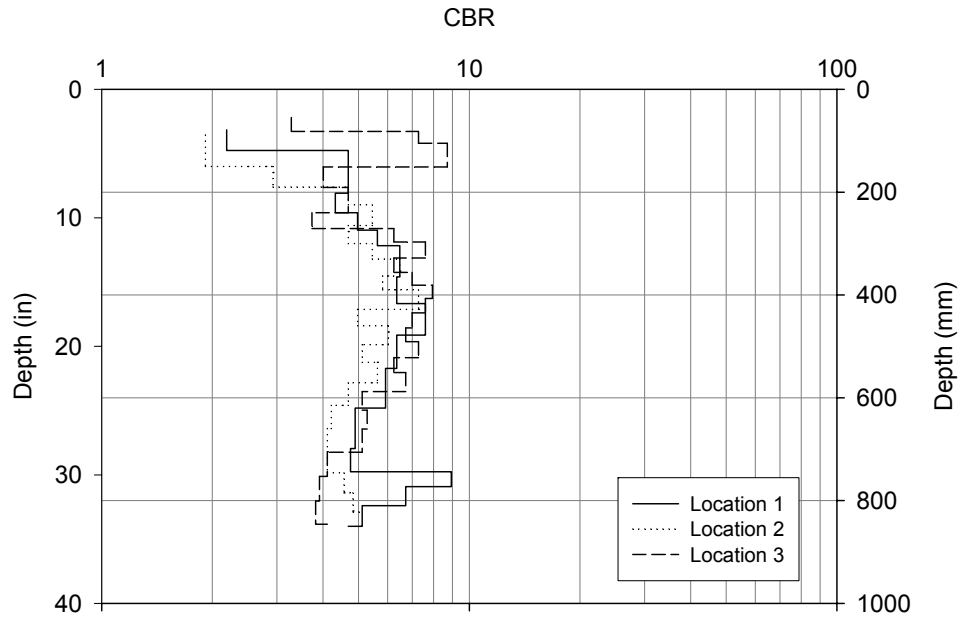
To measure subgrade strength, DCP tests were conducted at three locations about 2 feet from the abutment. Tests were performed before excavating the old special backfill and after placing the new special backfill. DCP test results presented in Figures 296 and 297 show that the old special backfill CBR values ranged from 2 to 9. The new special backfill CBR values ranged from 3 to 18. It did not appear that the new special backfill had been compacted.

Figure 296. Results of DCP test conducted on special backfill material before excavation (South end of SBL)

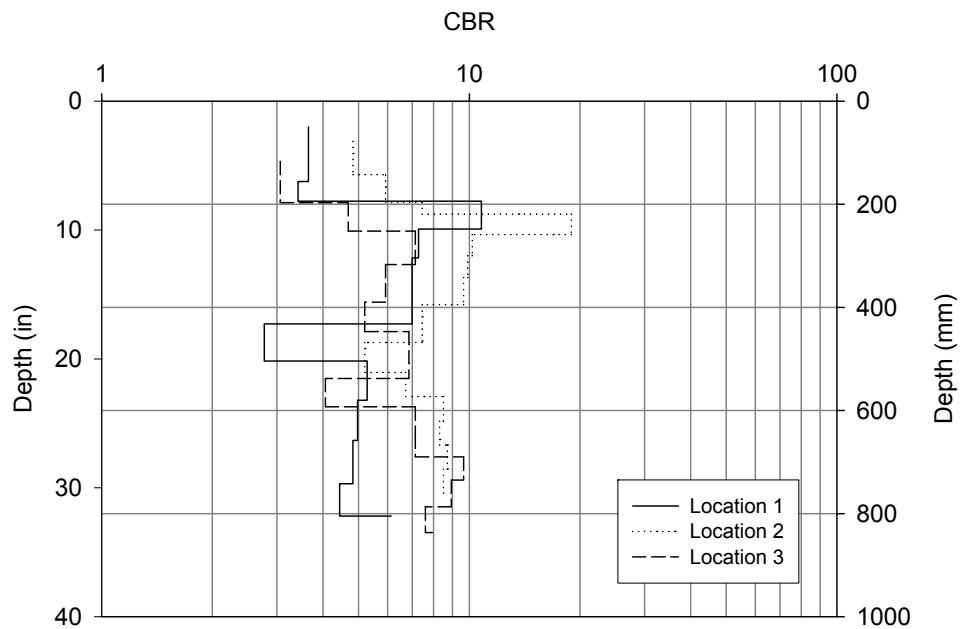
Figure 297. Results of DCP test conducted on special backfill material after replacement (South end of SBL)

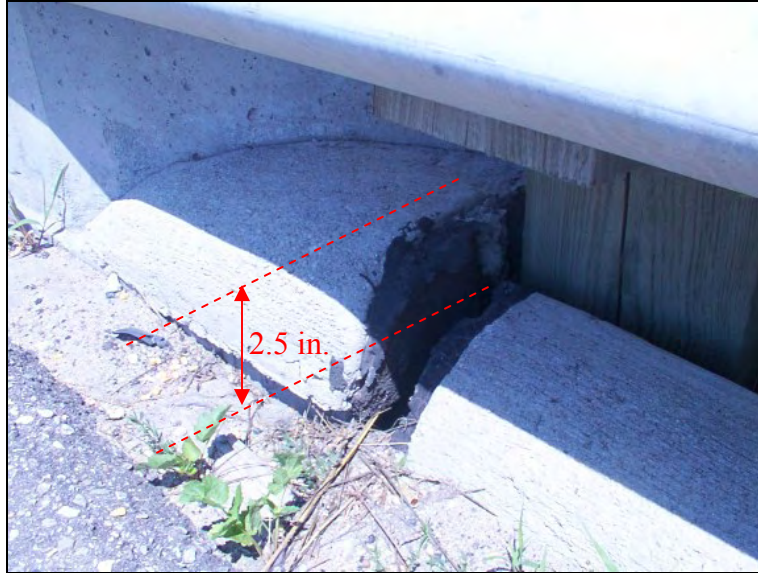
At the south end of the northbound lanes, differential settlement of 2.5 inches was measured at the end of the wingwall (Figure 298). Concrete spalling and cracking of the asphalt overlay were observed at the expansion joint (Figure 299). Concrete slope protection of the embankment under the bridge was in good condition; however, it settled about 3.5 inches relative to the abutment (Figure 300) and had a 0.5-inch gap at the abutment face.

Figure 298. Differential settlement at the bridge approach (South end of NBL)

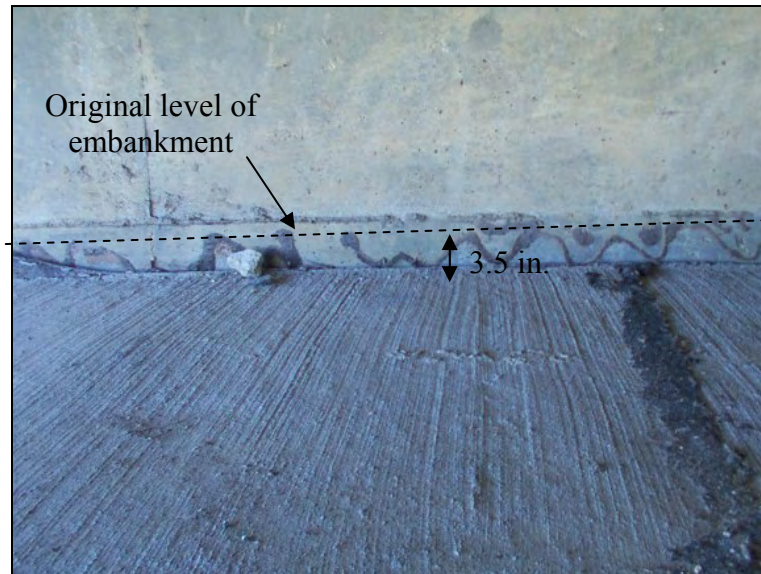
Figure 300. Settlement of the embankment at distance of 3.5 in. (South end of NBL)

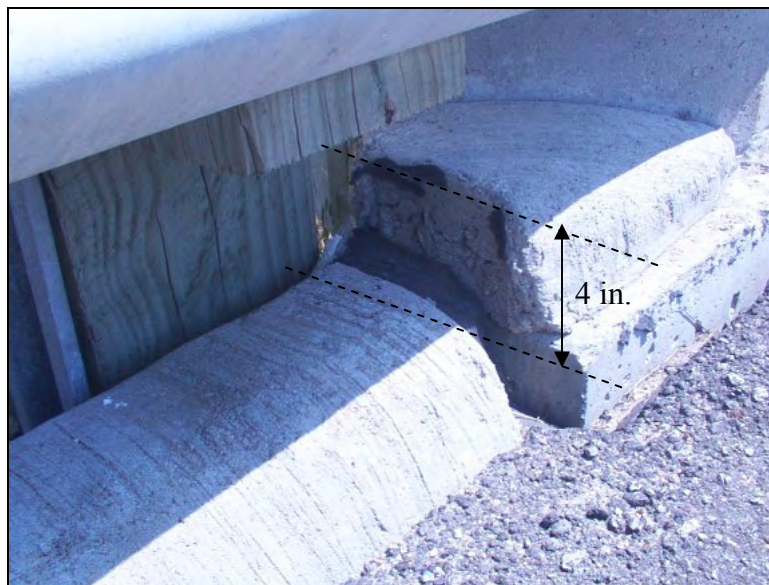
At the north end of the southbound lanes, 4 inches of differential settlement at the bridge approach was measured at the end of the wingwall (Figure 301). Recycled tire chips were used as joint filler for the expansion joint, as shown in Figure 302. The width of the expansion joint was about 5 inches. The concrete slope protection was in good condition.

Figure 301. A 4 in. differential settlement at the bridge approach (North end of SBL)

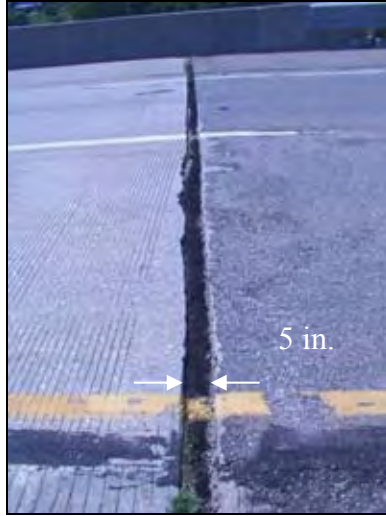
Figure 302. Recycled tires used as joint filler

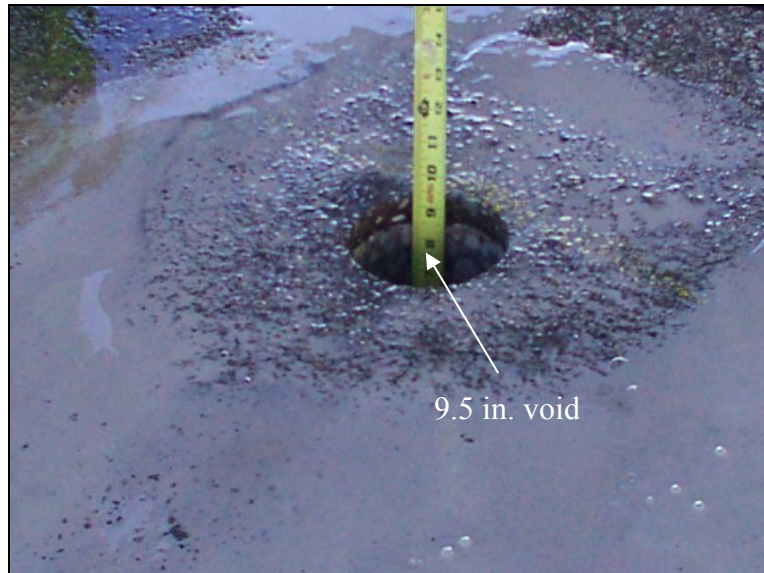
Approach slabs at both ends of the southbound lane were cored. Table 18 summarizes the measured void size, pavement thickness, and paving notch dimensions at the approach slabs. The void under the approach slab was about 9.5 inches at the edge line of the north end approach slab (Figure 303).

Figure 303. A 9.5 in. void under the approach slab estimated by measuring the distance the core dropped (North end of SBL)

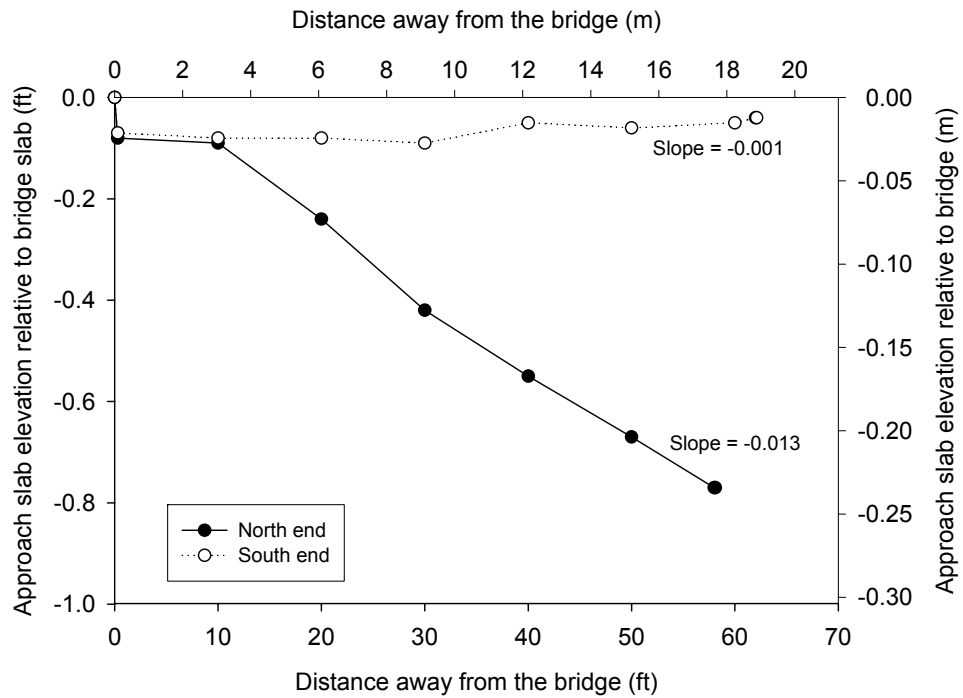
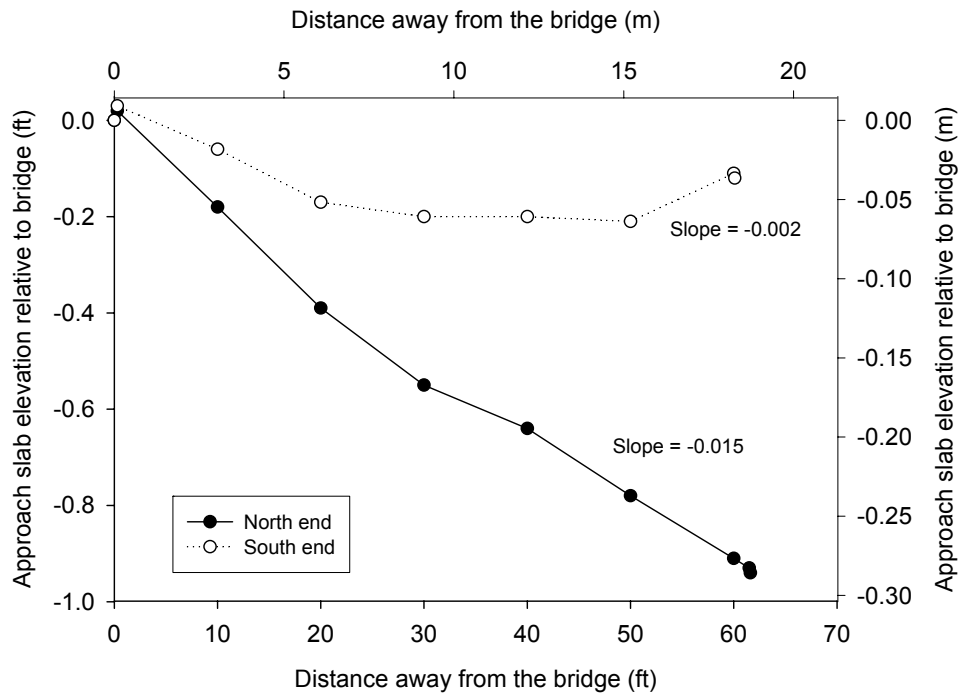
Profiles were obtained for all four ends of the bridge approach pavements (Figures 304 and 305). Differential settlement of the approach slab relative to the bridge slab for both ends of the northbound lane was about 1 inch. The slopes are -0.013 and -0.001 for the north and south end approach slabs, respectively. For the southbound lanes, the maximum settlement relative to the original profile was about 2 inches and 1.8 inches for the north and south end approaches, respectively. The slopes for the north and south ends approach slabs of the southbound lane are -0.015 and -0.002, respectively. Both approach slabs are sloping away from the bridge, which may indicate settlement of foundation soil or compression of the embankment material.

Figure 304. Profile of the bridge approach relative to bridge slab (NBL)

Figure 305. Profile of the bridge approach relative to bridge slab (SBL)

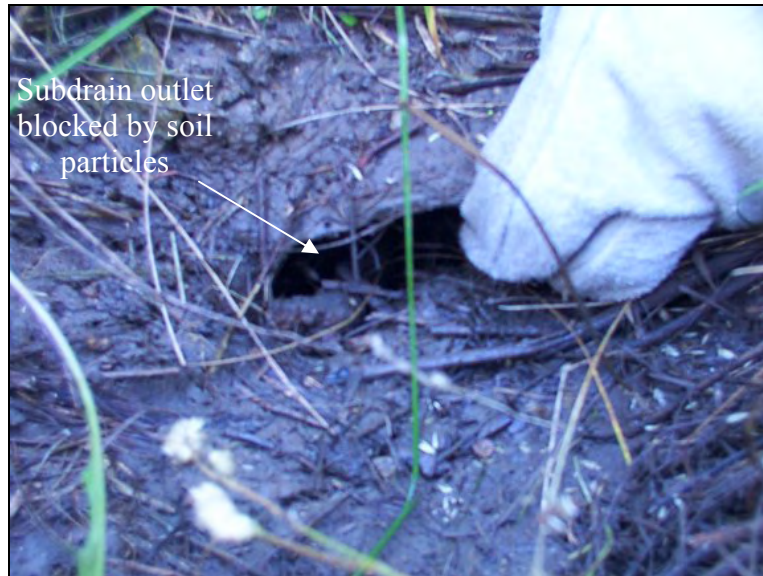
By using the snake camera at the north end of the northbound subdrain outlet, it was revealed that the subdrain was blocked with soil debris (Figure 306). Unlike other bridges where the subdrain outlet was day-lighted horizontally away from the abutment, this outlet was located at the bottom of the downslope embankment.

Figure 306. Subdrain outlet, located at the bottom of the embankment, blocked by soil debris

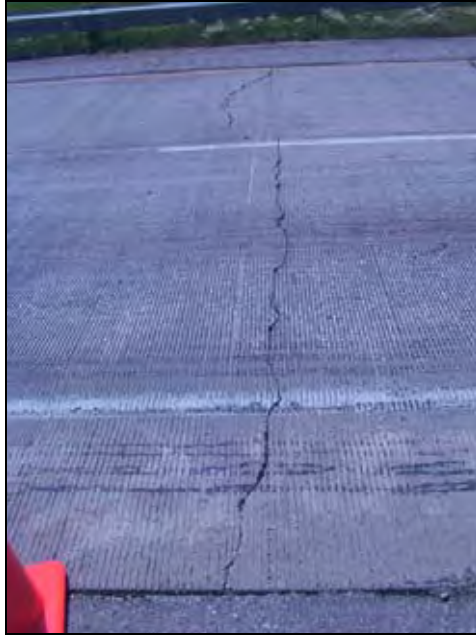
This bridge is a three-span bridge with concrete girders and integral abutments. At the north end of the northbound lanes, differential settlement of 2.5 inches was measured relative to the wingwall. Transverse cracks at the approach slab were visible (Figure 307). The expansion joint was 3.25 inches wide and filled with flexible foam filler, but not sealed. No settlement was observed at the embankment under the bridge, and the concrete slope protection appeared to be in a good condition. The outlet of the subdrain was in a satisfactory condition but was dry.

Figure 307. Transverse cracks at the bridge approach

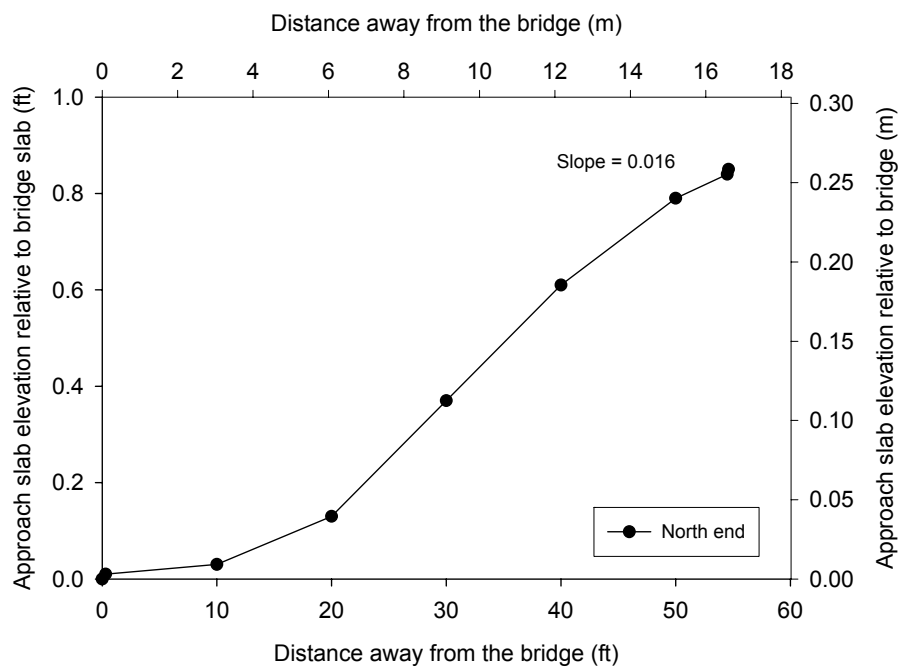
Elevation profile measurements are shown in Figure 308. The maximum settlement relative to the original profile was about 2 inches at 20 feet from the bridge abutment. The slope of the approach slab is 0.016.

Figure 308. Profile of the bridge approach relative to bridge slab (North end of NBL)

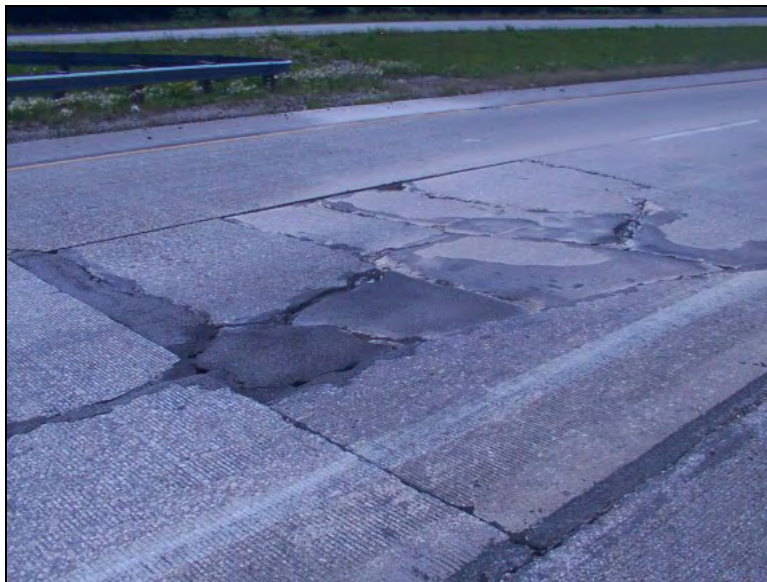
Significant damage to the approach pavement was observed (Figure 309). Although, the expansion joint condition was satisfactory, the strip seal was cut short allowing water to erode soil from around the abutment. At the embankment under the bridge, the unprotected slope was moderately eroded. The outlet of the end drain was damaged and appeared to be dry and not functioning (Figure 310).

Figure 309. Severe cracking at the bridge approach pavement (North end of NBL)

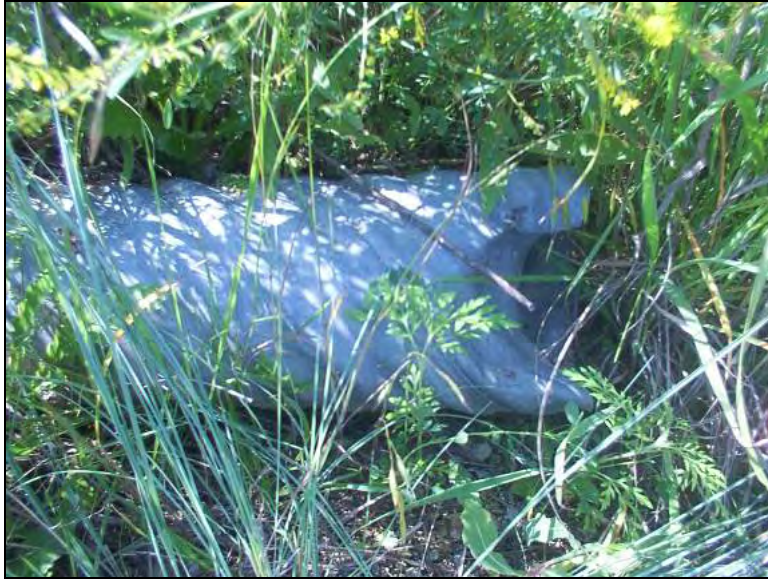
Figure 310. Damaged end drain (North end of NBL)
