IDENTIFICATION OF THE BEST PRACTICES FOR DESIGN, CONSTRUCTION, AND REPAIR OF BRIDGE APPROACHES

Iowa DOT Project TR-481
CTRE Project 02-118

Final Report

January 2005

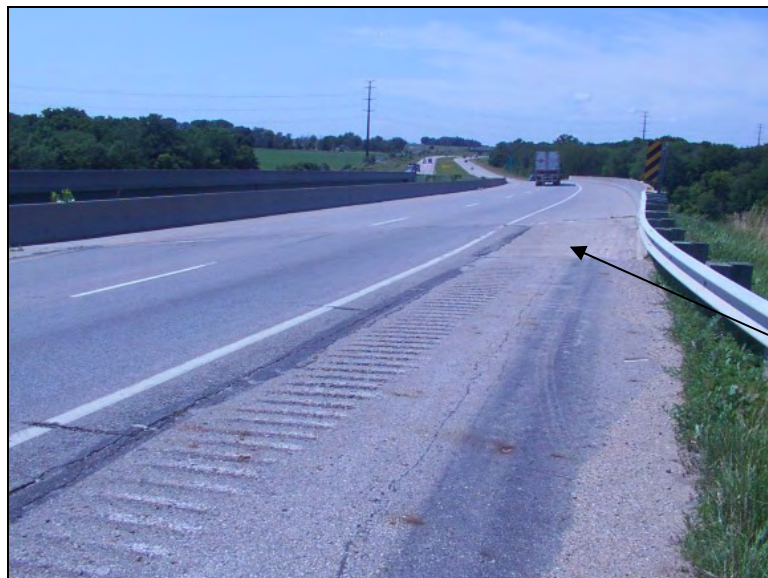
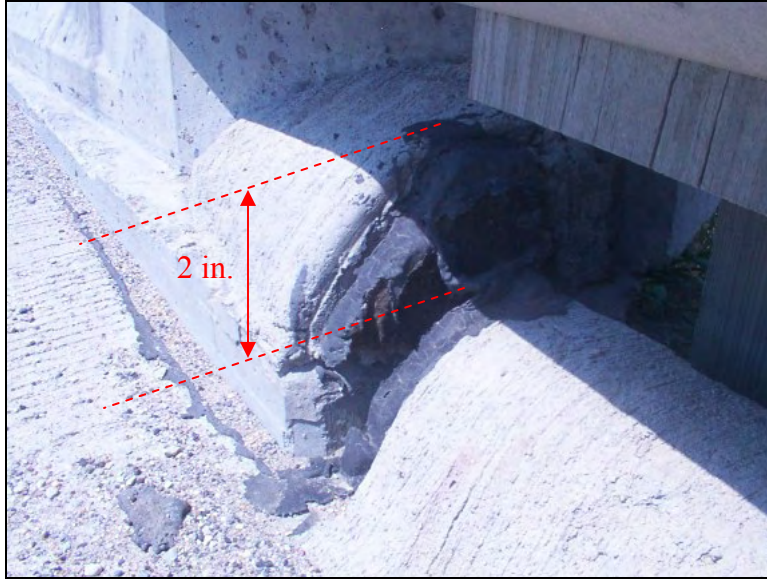
At the south end, an asphalt overlay had been previously placed because of differential settlement at the bridge approach. Nonetheless, differential settlement of 2 inches was observed relative to the wingwall (Figures 311 and 312). The end drain appeared to be in good condition.

Figure 311. Settlement of bridge approach (South end of NBL)

Figure 312. Differential settlement at the bridge approach (South end of NBL)

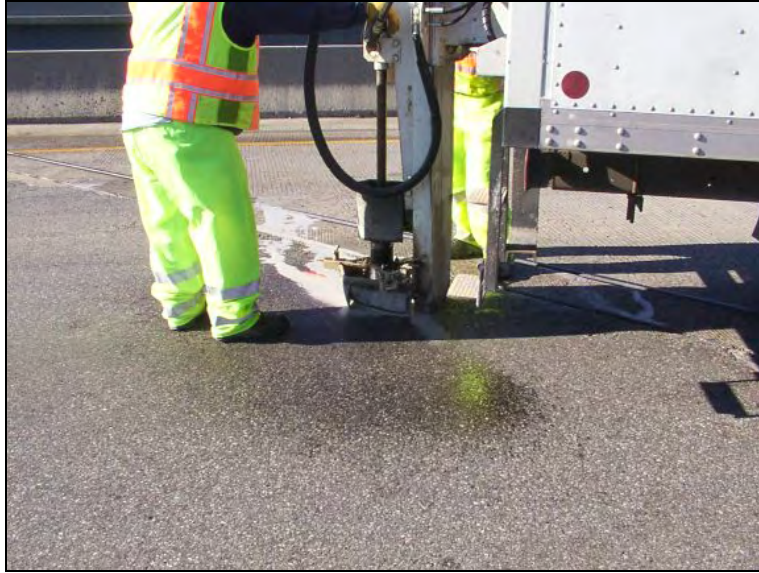
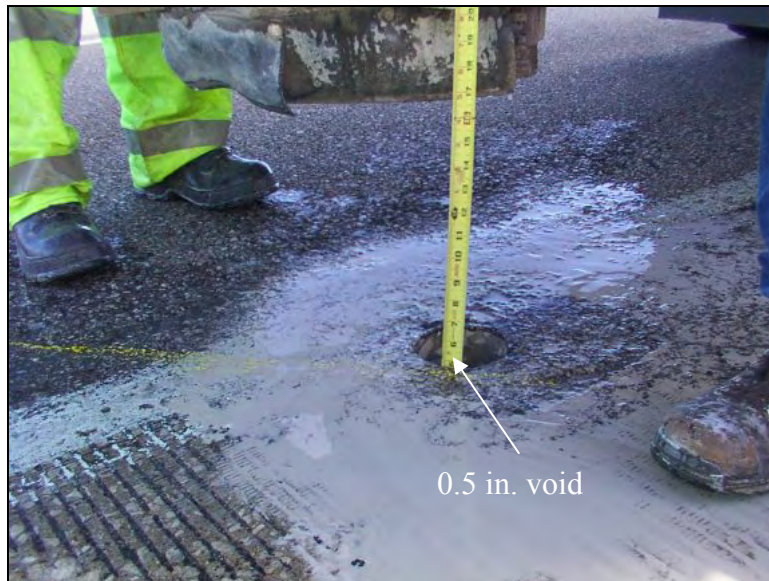
Figure 313 shows the approach slab cores at both bounds. Table 19 presents the void sizes measured under each approach slab. The maximum voids measured at the north and south end approach slabs were 4.5 and 5 inches at the edge line, respectively. The void under the north end of the southbound approach slab was about 0.5 inches, as shown in Figure 314. As performed at other bridges, expanding foam was placed after obtaining cores to plug the core hole, as shown in Figure 315.

Figure 313. Coring at bridge approach (NBL)

Figure 314. Measuring the void under the approach slab (North end of SBL)

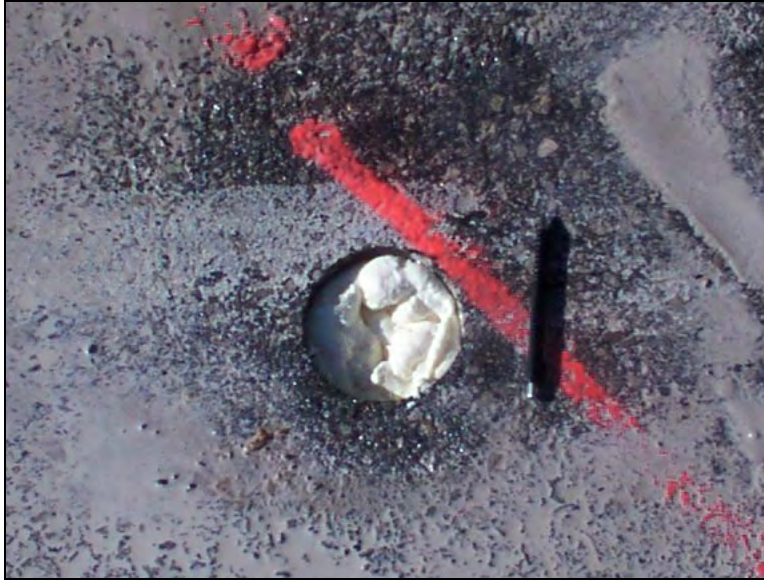
Figure 315. Expanding foam placed in the core hole of the approach slab (NBL)

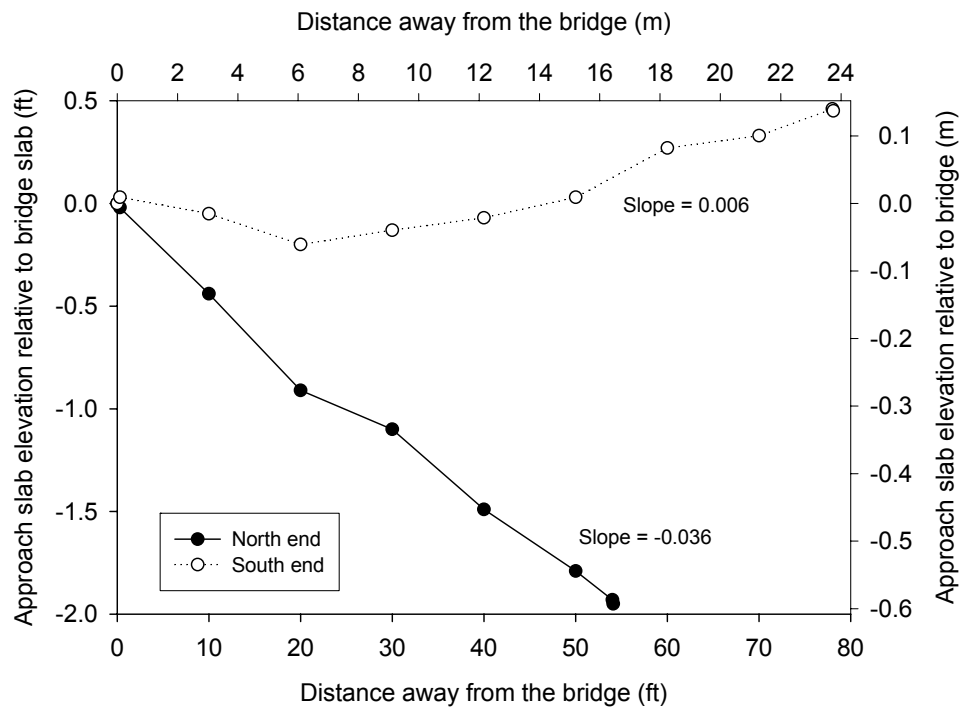
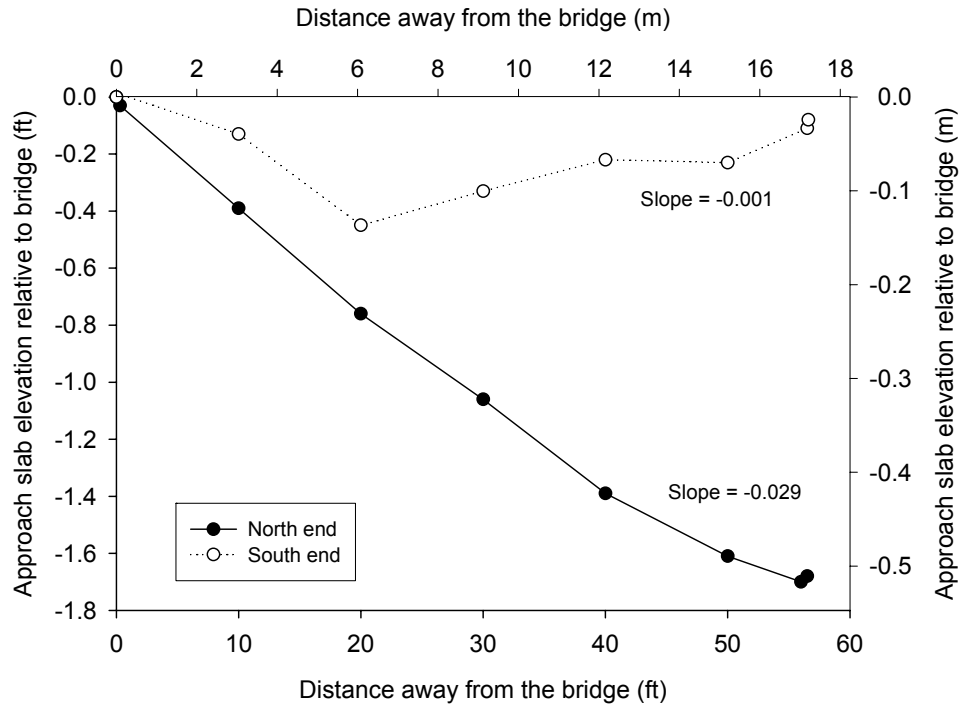
Figures 316 and 317 show the bridge approach profiles at all four ends. The approach slab at the north end of the north bound settled about 2 inches at 20 feet from the bridge abutment. The south end approach slab settled about 4 inches at 20 feet from the bridge abutment. The slopes for the north and south end approach slabs are -0.036 and 0.006, respectively. At the southbound lanes, the north end approach slab settled about 1 inch at 40 feet away from the bridge relative to the original profile, and the south end settled about 5 inches at 20 feet from the bridge abutment. The slopes for the north and south ends approach slabs are -0.029 and -0.001, respectively.

Figure 316. Profile of the bridge approach relative to bridge slab (NBL)

Figure 317. Profile of the bridge approach relative to bridge slab (SBL)

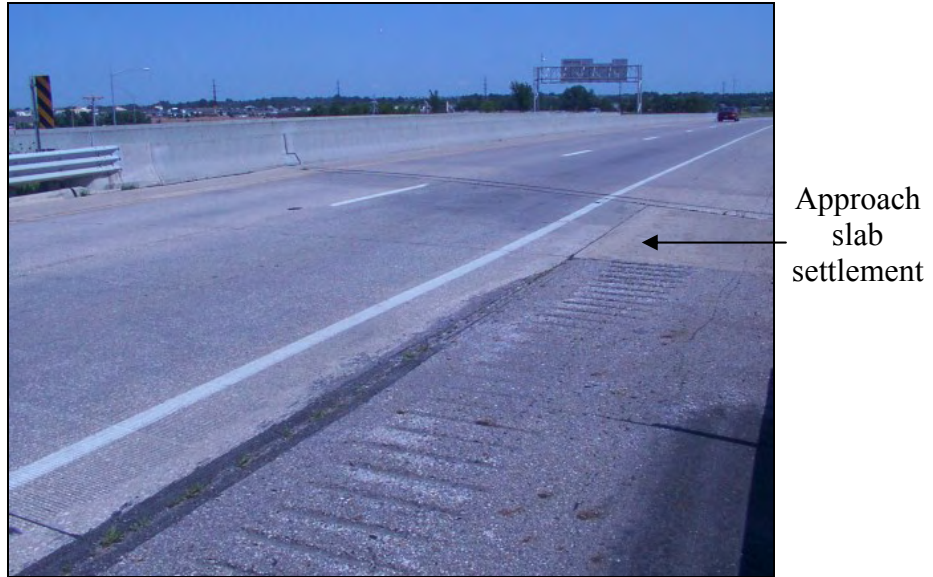
This bridge is a three-span bridge with steel girders and non-integral abutments. At the north end of the southbound lanes, differential settlement at the approach slab was observed (Figure 318). Transverse cracking across the approach slab was also noted (Figure 319). The expansion joint was not sealed. The strip seal was also observed filled with soil particles and cut short. Concrete slope protection of the embankment was in good condition.

Figure 318. Settlement of bridge approach (North end of SBL)

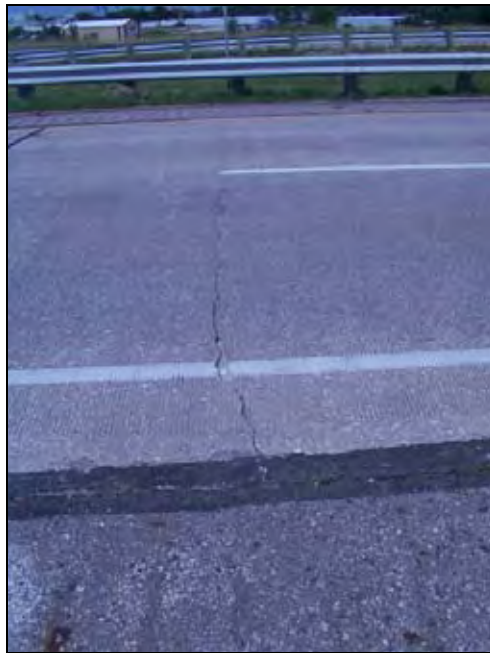
Figure 319. Transverse cracking at the bridge approach (North end of SBL)

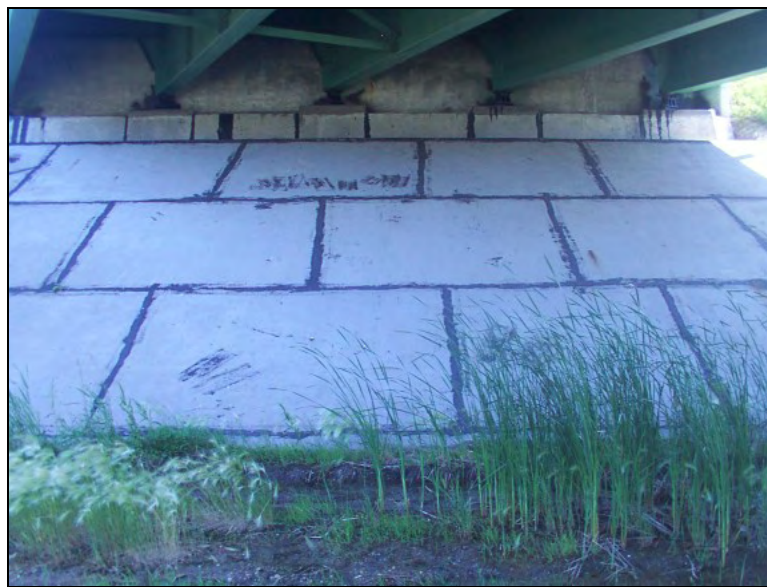
At the south end of the southbound lanes approach slab settlement was observed as shown in Figure 320. The strip seal was filled with soil particles, but the overall condition of the expansion joint was satisfactory. The concrete slope protection was in good condition with no observed settlement (Figure 321).

Figure 321. Bridge embankment in a satisfactory condition

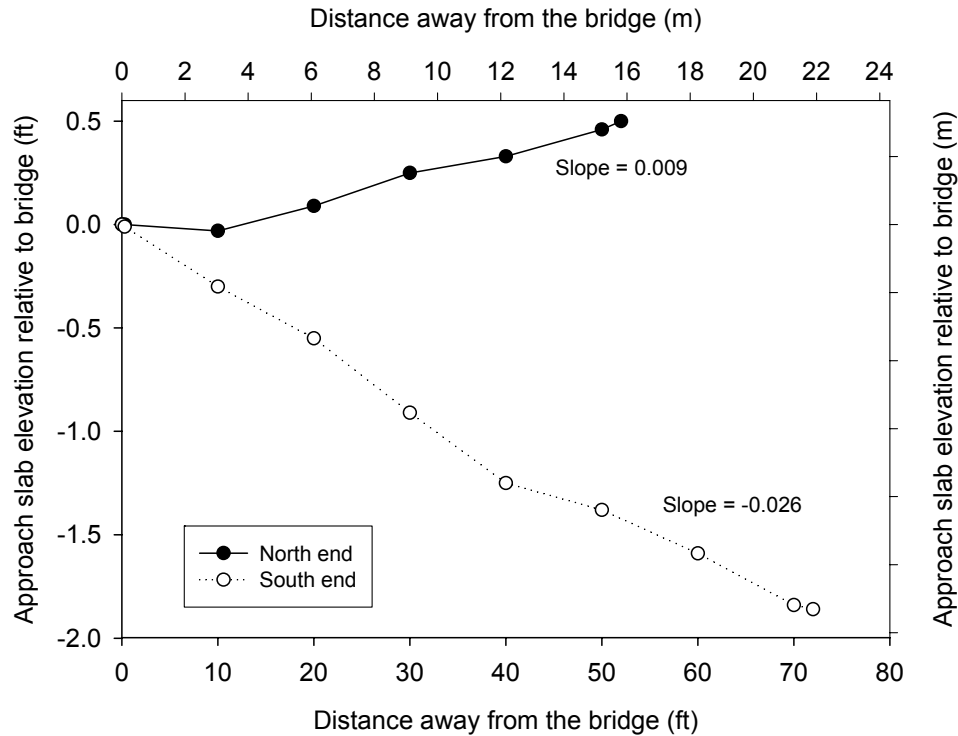
Profiles of both approaches at the edge line of southbound lane are shown in Figure 322. The maximum settlement of the north end approach slab relative to the original profile was 1.2 inches at 10 feet from the bridge abutment. The maximum settlement of the south end approach slab relative to the original profile was about 3 inches at 40 feet from the bridge abutment. The slope of the north and south end approach slabs are 0.009 and -0.026, respectively.

Figure 322. Profile of the bridge approach relative to bridge slab (SBL)

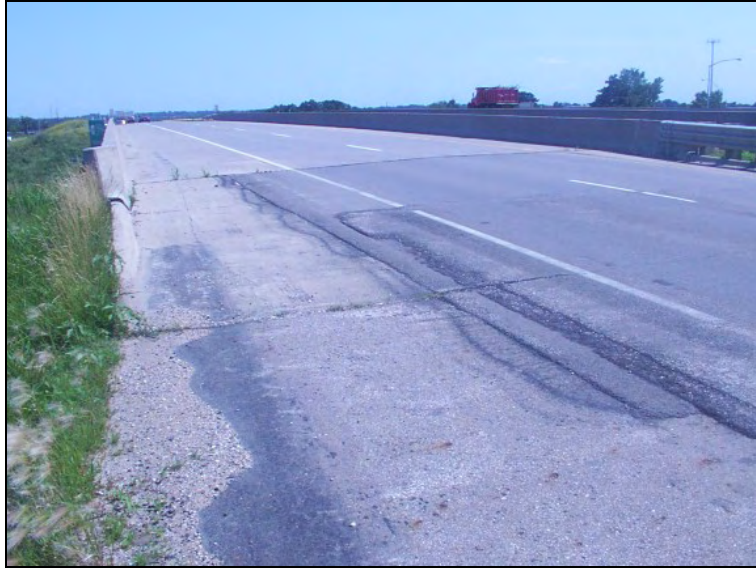
This bridge is a four-span bridge with concrete girders and integral abutments. Although the north end of the northbound lane was overlaid with asphalt, differential settlement of 2 inches was measured at the end of the wingwall (Figure 323). A 2-inch gap between the bridge approach and the wingwall developed due to settlement of the approach slab relative to the wingwall (Figure 324). Recycled tire chips were used as joint filler in the expansion joint. The embankment had settled about 4 inches and a 2-inch horizontal gap had formed between the abutment and embankment, as shown in Figure 325. The slope protection, however, was still in a satisfactory condition.

Figure 323. Asphalt overlay placed to compensate for the differential settlement (North of end NBL)

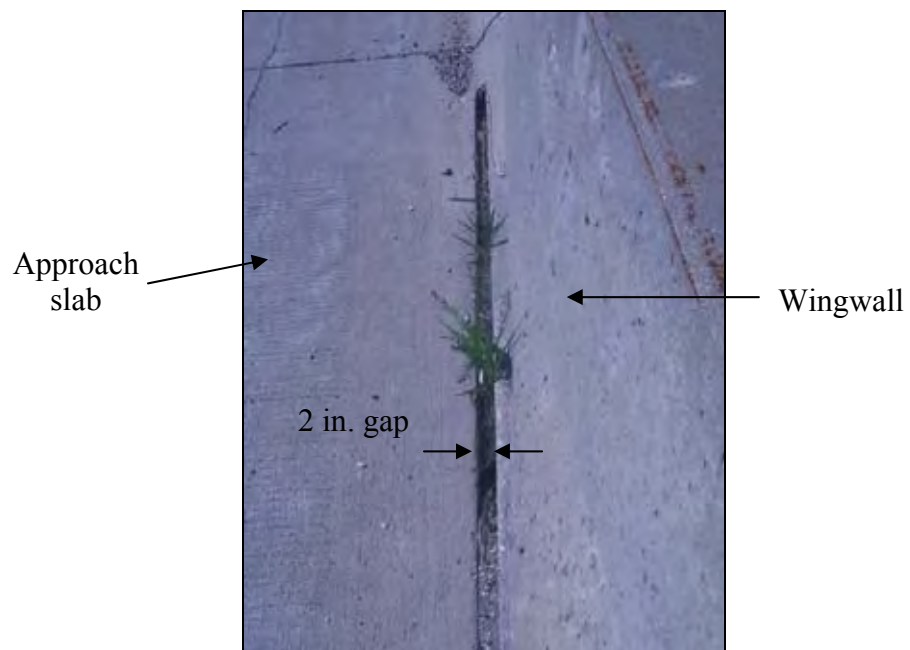
Figure 324. A 2-inch gap formed between the approach slab and the wingwall due to settlement of the approach slab (North end of NBL)

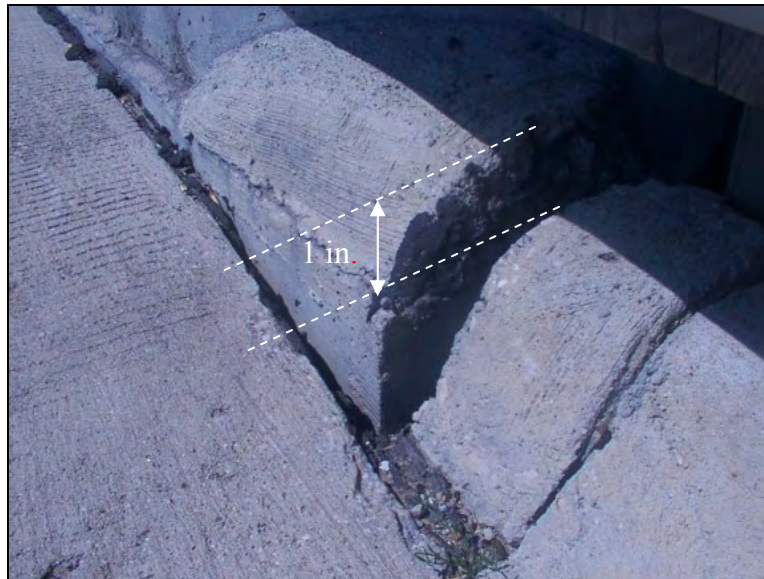
At the south end of the northbound lanes, differential settlement of 1 inch was measured at the end of the wingwall (Figure 326). The width of the expansion joint was about 5 inches. Recycled tire chips were used as joint filler and did not seal the joint. Settlement of the embankment was 4 inches. The end drain was observed to be damaged and not functioning.

Figure 326. Differential settlement at the bridge approach (South end of NBL)

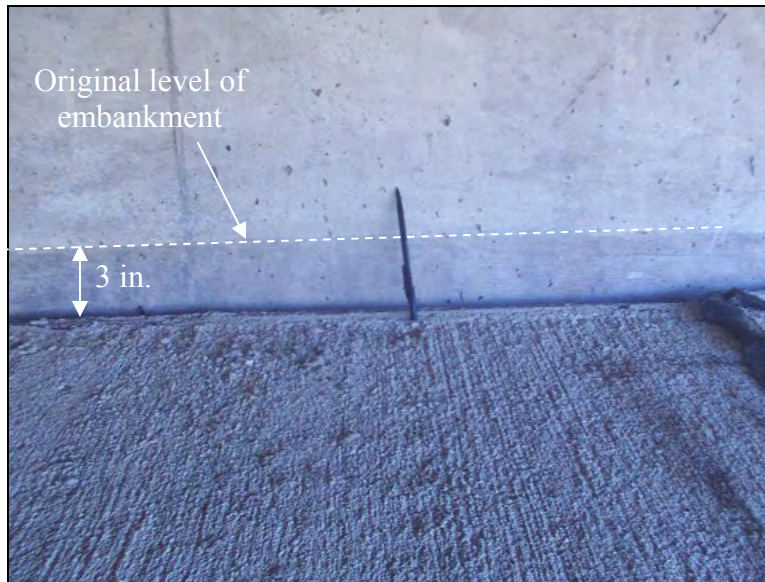
At the north end of the southbound lanes, differential settlement was about 2 inches. Moderate erosion along the sides of the abutment was observed. The concrete slope protection of the embankment under the bridge was in a good condition; however, the embankment settled 3 inches, and a 2-inch gap had developed between the embankment and the abutment (Figure 327).

Figure 327. Settlement of embankment at distance of 3 inches

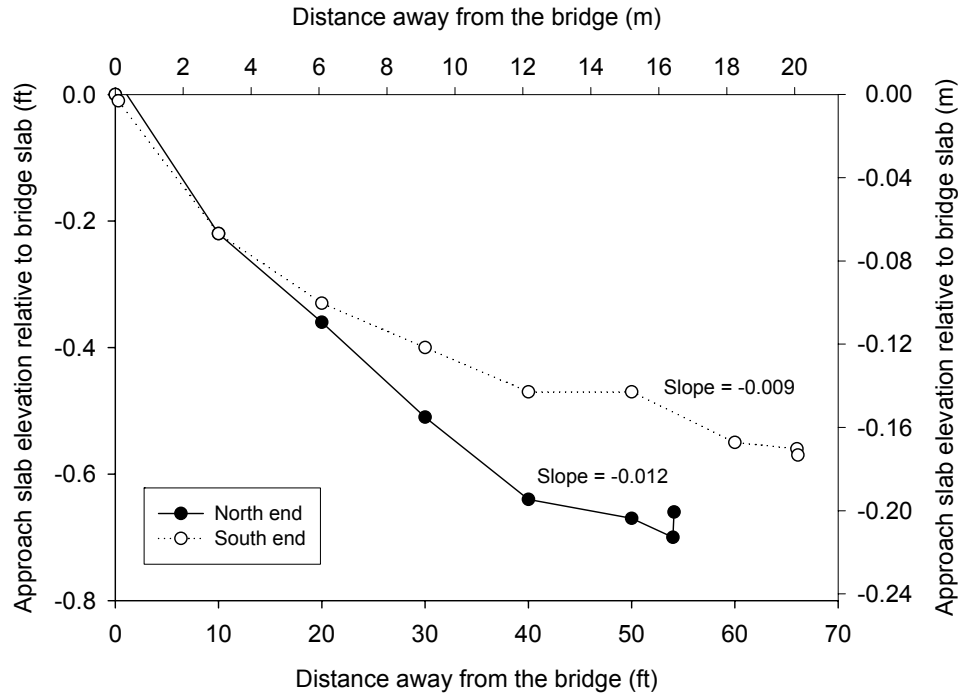
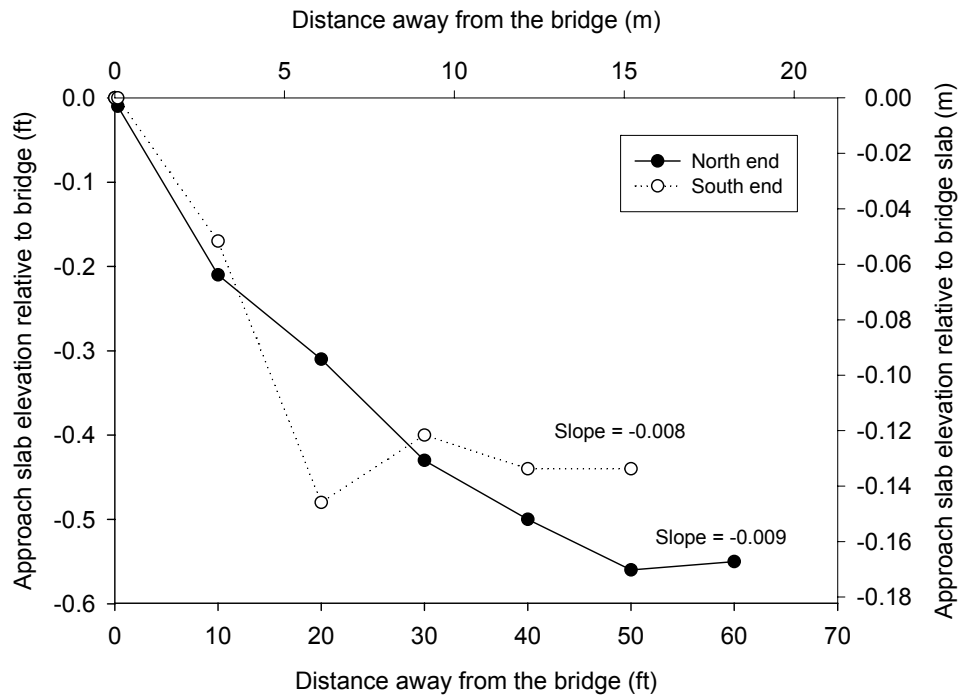
Elevation profiles for all four approaches were obtained from the edge line of the right lane and are shown in Figures 328 and 329. At the northbound lanes, differential settlement between the north end approach slab and the roadway was approximately 0.5 inches and the maximum settlement relative to the original profile was 1.5 inches at 40 feet from the bridge abutment. At the south end, the maximum settlement relative to the original profile was about 1 inch at 40 feet from the bridge abutment. The slopes of the north and south end approach slabs are -0.012 and -0.009, respectively.

At the south bound, the maximum differential settlement at the north end approach slab relative to the original profile was 1.5 inches at 30 feet from the bridge, while at the south end approach slab, the maximum settlement was 3 inches at 20 feet from the bridge abutment. The slopes of the north and south end approach slabs are -0.009 and -0.008, respectively. All four approach slabs at this bridge slope away from the bridge, which may indicate compression of the embankment soil or settlement of the foundation soil.

Figure 328. Elevation of the bridge approach relative to the bridge slab (NBL)

Figure 329. Elevation of the bridge approach relative to the bridge slab (SBL)

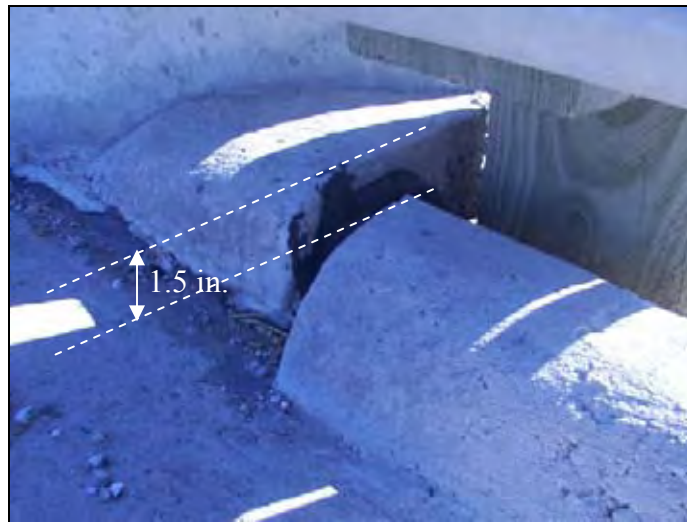
At the west end of the eastbound lane, differential settlement between the bridge approach and the bridge deck at the wingwall was approximately 1.5 inches (Figure 330). Furthermore, the expansion joint sealer was deteriorated exposing the flexible foam filler material, which was poorly sealing the expansion joint leaving a gap for water to flow around the bridge, as shown in Figure 331. The bridge embankment has a slope protection, which was in good condition; however, the embankment settled 3.5 inches, as shown in Figure 332. A 1-inch gap between the bridge embankment and the bridge abutment was measured (Figure 333).

**Figure 330. Differential settlement between the bridge approach and the approach slab
(West end of EBL)**

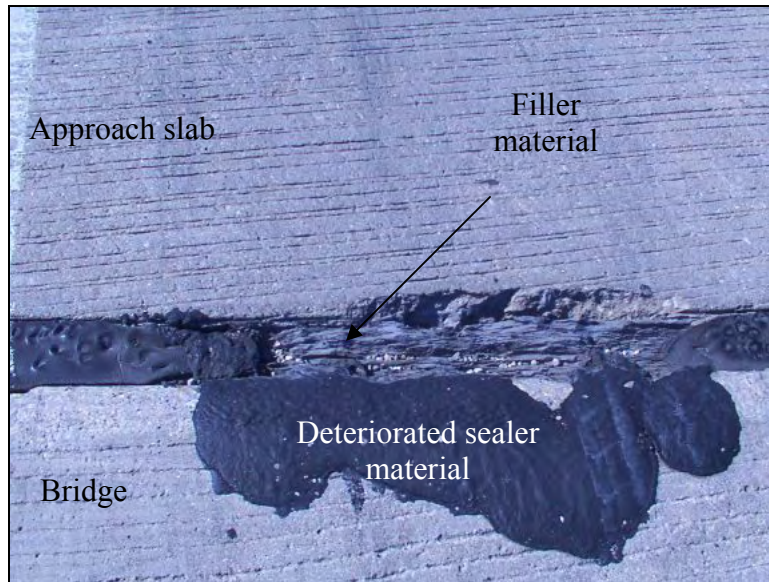
Figure 331. Deterioration of the expansion joint sealer (West end of EBL)

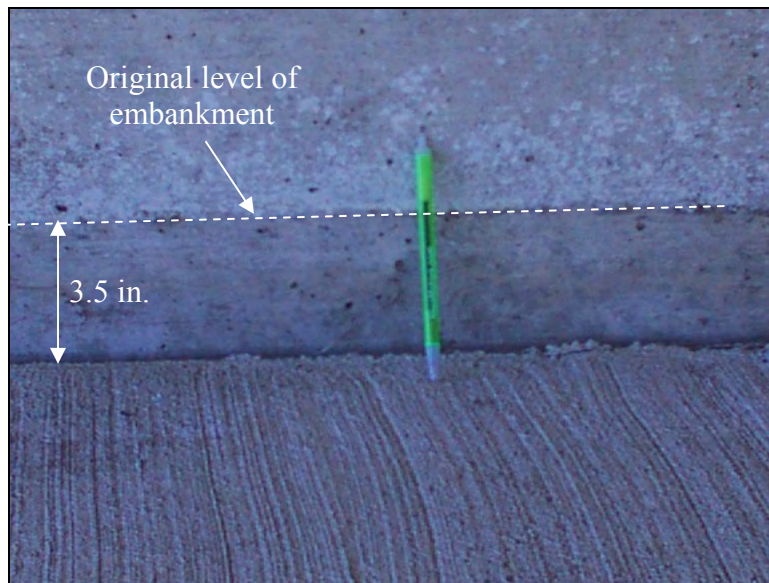
Figure 332. Settlement of the bridge embankment (West end of EBL)

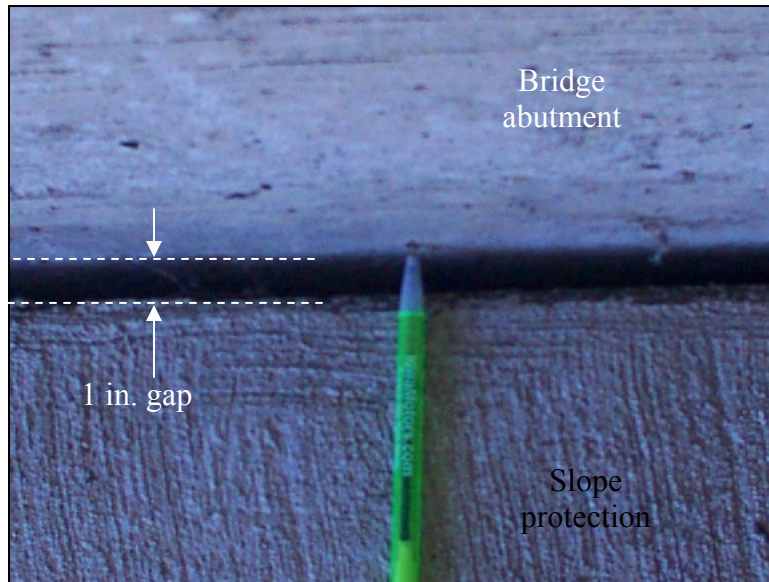
Figure 333. Top view showing a gap between the bridge embankment and the bridge abutment (West end of EBL)

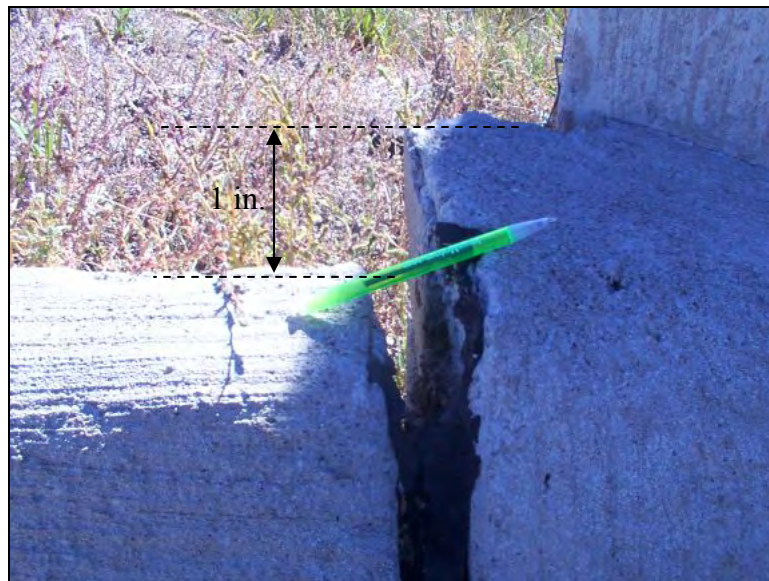
At the east end of the eastbound lane, differential settlement at the wingwall was 1 inch (Figure 334). Similar to the west end, the sealer material at the expansion joint was deteriorated exposing the flexible foam material, which poorly sealed the expansion joint. In addition, concrete spalling near the expansion joint was observed (See Figure 335).

Figure 334. Differential settlement between the bridge approach and the approach slab (East end of EBL)

URETEK, Inc., injected polyurethane material under both approach slabs at the eastbound lane to alleviate the bump caused by excessive settlement. The profiles of the approach slabs before and after injecting the expansive polyurethane were measured. Both approaches were lifted approximately 1.8 inches at 20 feet away from the bridge; however, both approach slabs were lifted approximately 0.5 inch higher than the bridge deck level, creating a bump.

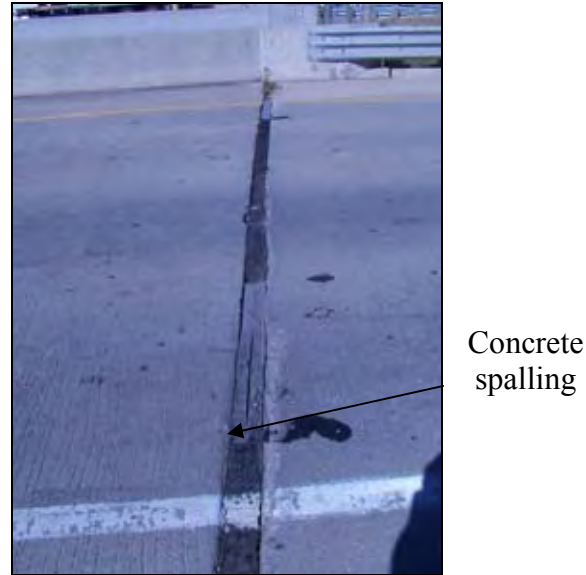
Figure 335. Poorly sealed expansion joint with concrete spalling (East end of EBL)

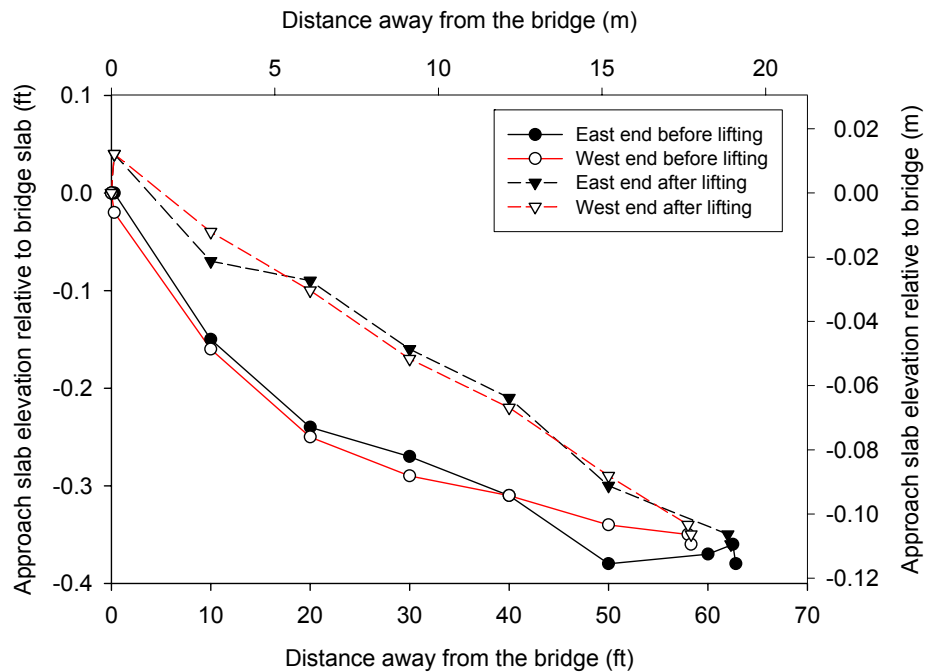
Figure 336. Approach slabs elevations before and after injecting the expansive polyurethane (EBL)

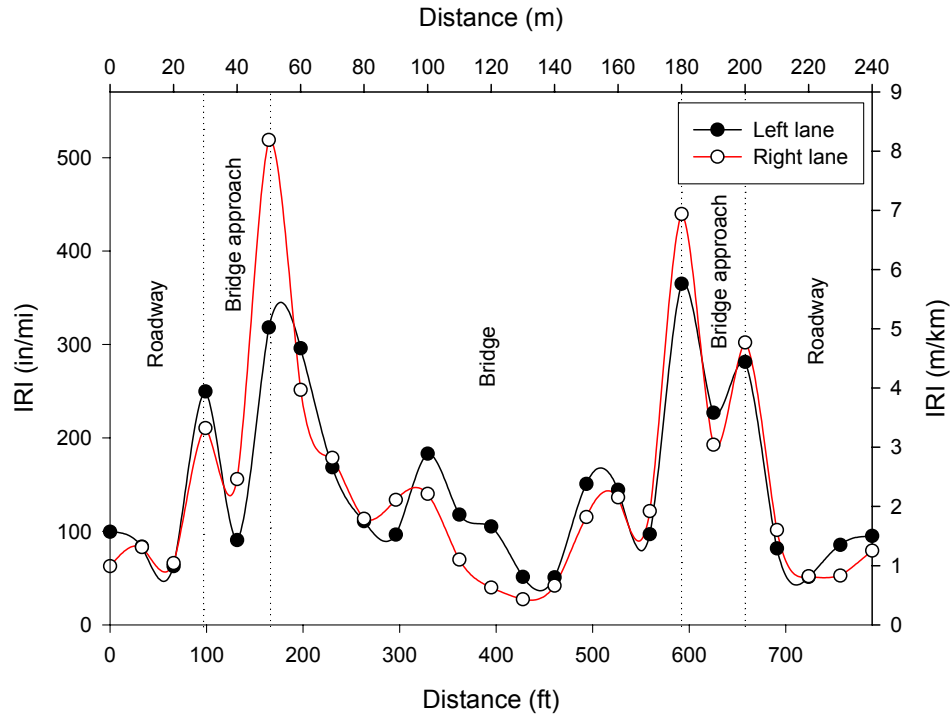
IRI results obtained from the Center for Transportation Research and Education (CTRE) at Iowa State University were from measurements made between 2001 and 2003. The IRI data was provided for 10 bridges and 27 bridge approaches (see Appendix D for all profiles). A sample of IRI profiles is shown in Figure 337. The transition between the roadway and the approach slab, and the transition between the approach slab and the bridge have significantly higher IRI values. These values ranged from 3.9 to 11.8 m/km.

Figure 337. IRI graph; Bridge no. 7777.0065 SBL

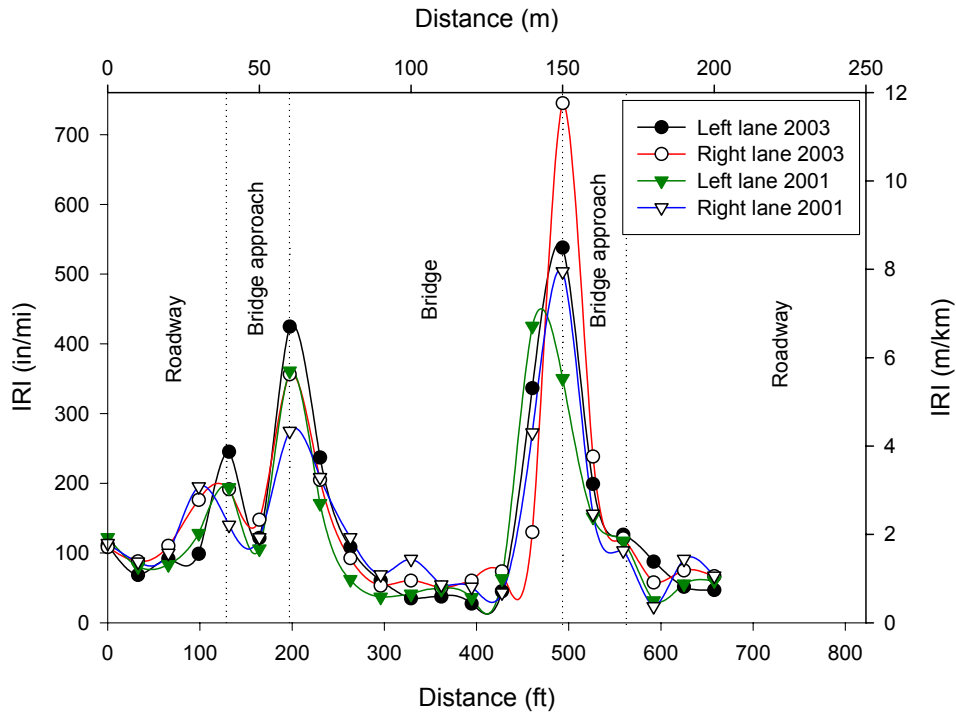
The 2001 IRI values of the bridges on U.S. 65 were compared to the 2003 data. A sample of this comparison is shown in Figure 338. Results show that the high IRI values at the two transition locations (i.e., the transition between the road and the approach slab and the transition between the approach slab and the bridge) increase with time, which indicates approach slab deterioration with time. It was determined that IRI values could provide useful information for characterizing bridge approach performance.

Figure 338. Increase of International Roughness Index with time; Bridge no. 7773.0065 NBL

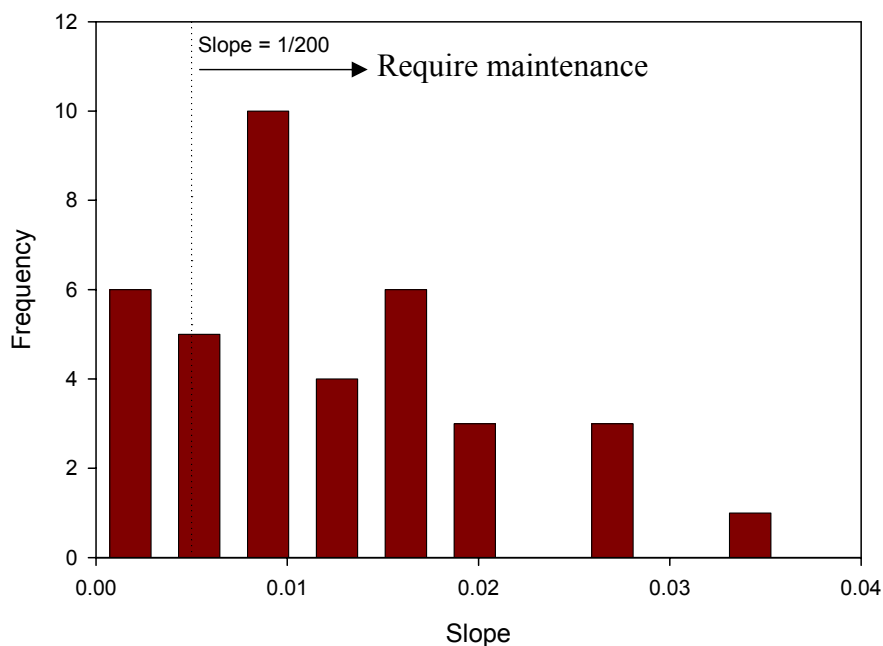
The elevation profiles of 38 bridge approaches were measured relative to the bridge deck. All profiles were measured at the edge line of the right lane. The slopes of the bridge approach slabs were calculated using the elevations of the first and last points on the bridge approach profile. Figure 339 shows that the majority of the slopes are higher than $1/200$ suggested by Wahls (1990) as a maximum slope for bridge approaches. According to this criterion, bridge approaches with slopes higher than $1/200$ require maintenance. To further characterize the performance of bridge approaches, the Bridge Approach Index (BI) was developed. The BI is calculated as the area between the original profile and the existing profile of the approach slab divided by its length. The area is determined by subtracting the integration of the original profile, which is assumed to be a straight line connecting the bridge slab to the pavement elevation just past the CF joint, and the existing profile over the length of the approach slab. In general, the higher the calculated BI, the worse the approach slab condition.

Figure 339. A frequency plot for slopes calculated from approach slab profiles

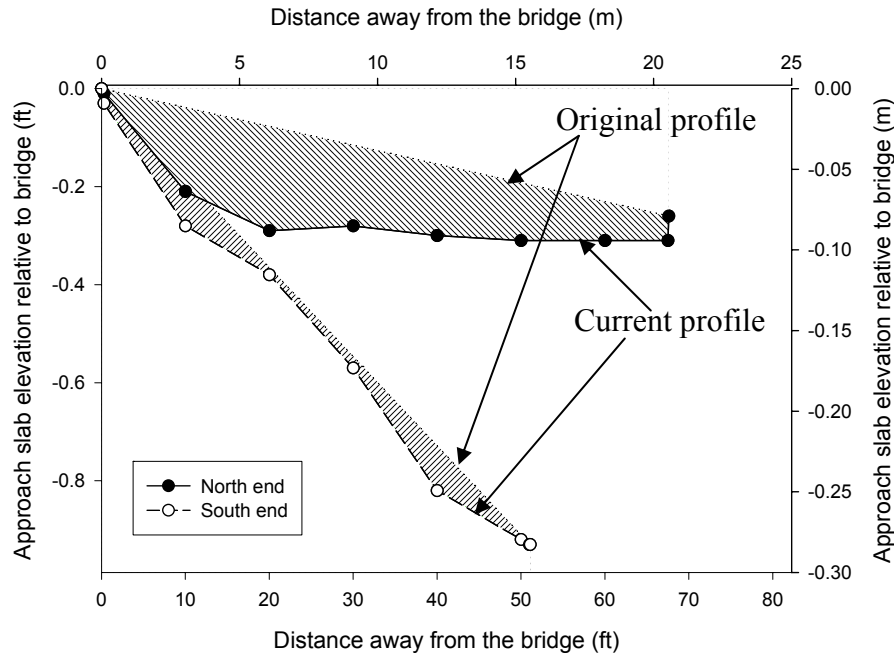
Figure 340 shows the profiles of two approach slabs relative to the original profile. As shown, the north end settled more than the south end, which is reflected in the higher area calculation between the original and existing profile. The area calculated for the north end was 50.2 ft^2 (4.7 m^2), while the area calculated for the south end was 28.4 ft^2 (2.6 m^2). After dividing by the length, the BI values for these two approaches were 0.822 and 0.557, respectively.

Figure 340. Elevation of two approach slabs relative to bridge; Bridge no. 7777.0065 NBL

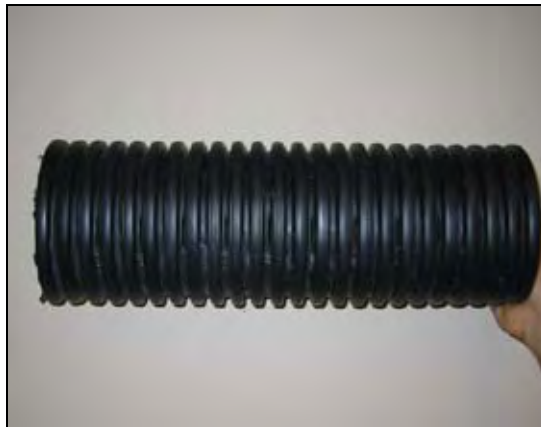
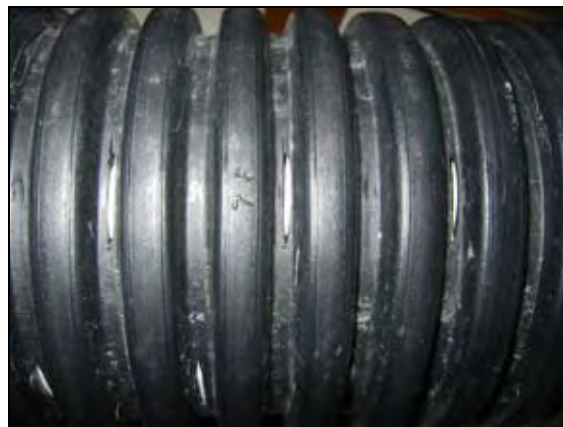
Even though it was specified, at many bridge sites it was observed that no porous backfill was placed around the subdrain. Generally, granular backfill was used in lieu of porous backfill. Iowa DOT specifies that granular backfill material must have 20% to 100% passing the No. 8 sieve and up to 10 % passing the No. 200 sieve. Figure 342 shows a typical perforated drainage pipe used for subdrain construction. The width of ten random pipe perforations was measured to compare to the size of granular backfill particles. The largest measured pipe opening was 0.09 in. (2.3 mm) and the average pipe opening was 0.07 in. (2.0 mm), which is similar to the No. 8 sieve opening (2.36 mm). Further, it was found that the majority of granular backfill soil particles are smaller than the subdrain perforation size, which possibly lead to plugged drains. Table 24 shows that the percentage of granular backfill soil particles smaller than the average subdrain perforation is about 80%.

Figure 342. Perforated drainage pipe used around Iowa bridges

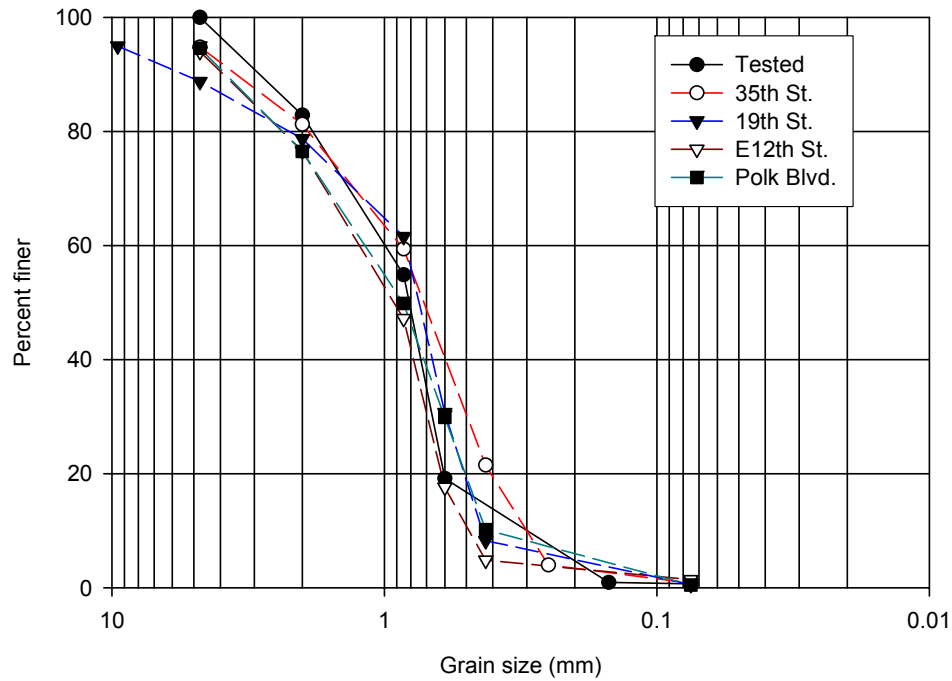
Granular backfill material was obtained from Hallett Materials Quarry in Ames, Iowa. Figure 344 shows the gradation curve with comparisons to granular backfill materials used at four bridge sites evaluated during this study. The granular backfill used in this experiment classifies as poorly graded sand (SP) according to the USCS. Results provided in Figure 345 show that the highest measured collapse index value is 6% at initial moisture content ranging from 4% to 6% (see Appendix C for detailed calculations). This was not unexpected given that bulking water content typically ranges from 3% to 7% for this type of materials. At a 6% collapse value, 0.5 ft. of settlement would be expected for every 10 ft. of fill.

Figure 344. Gradation of tested granular backfill materials compared with the gradation of samples collected at four under-construction bridges

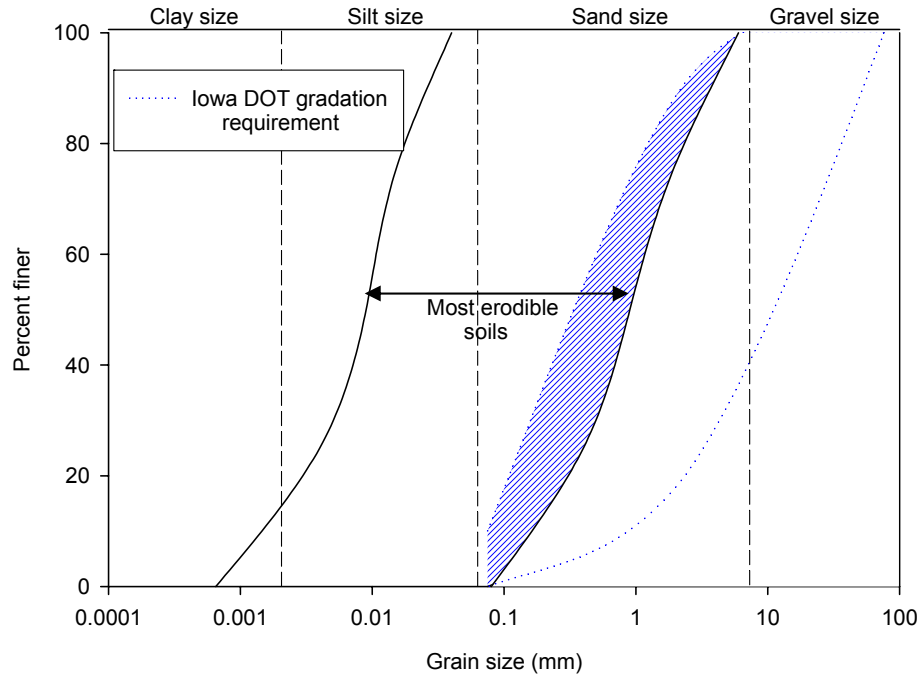
Erosion was one of the major problems observed at the inspected bridge site in Iowa. Briaud et al. (1997) reported that soils with silt and fine sand are more erodible than other soil types and provided a range of most erodible soils (Figure 347). This erodible soil range was compared with the Iowa DOT granular backfill gradation requirement (Figure 348) and backfill materials collected at four bridge sites (Figure 349). Both gradations have a common region with the range of most erodible soils. Changing Iowa DOT specification of granular backfill material from 20% to 100% to 20% to 60% passing sieve number 8 (2.36 mm) would shift the backfill material gradation out of the most erodible soil region.

Figure 348. Iowa DOT granular backfill gradation requirement compared with the range of most erodible soils

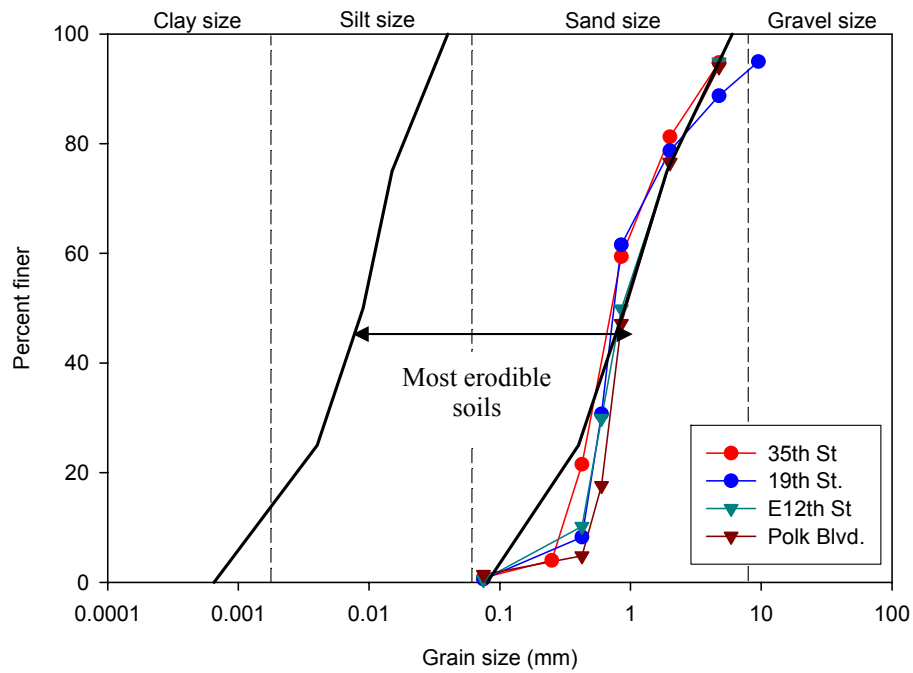
Figure 349. Granular backfill obtained from bridge sites compared to the range of most erodible soils

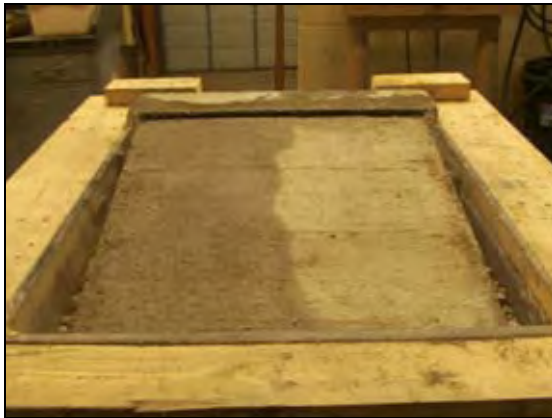
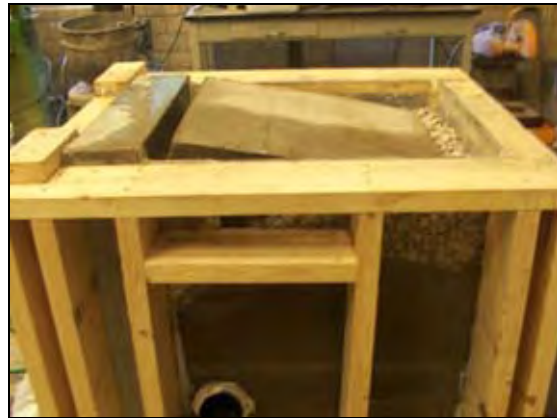
Water began to flow out of the subdrain after 10 minutes of introducing water through the expansion joint. Initially, fine soil particles were observed in the water. After 15 minutes, the water became clear. Table 25 summarizes the results of this test. The maximum achieved steady state flow was 32cm³/sec. A void developed at the abutment that measured 4.5 inches deep and extended through the full width of the approach slab. The maximum differential settlement was 2 inches (Figures 360 and 361). An interesting observation is that water only entered the drain tile from the bottom perforations. One might expect water to enter from the top and bottom perforations. A possible explanation of why water only entered from the bottom is that the soil particles plugged the voids of the porous backfill and/or the pipe openings.

Backfill type	Granular backfill with porous fill around subdrain and special backfill under the approach slab
Moisture content	3.0 %
Compaction	By tamper every 2 in. lift
Settlement (in)	Left side: 2.0 in.
	Right side: 1.5 in.
Void (in)	Left side: 4.5 in. deep at the abutment face and extending 8.5 in. under the approach slab
	Right side: 3.5 in. deep at the abutment face and extending 9.0 in. under the approach slab
Maximum steady state flow (cm ³ /sec)	32.0
Time for water to drain (min)	10

Figure 361. Level of approach after the test

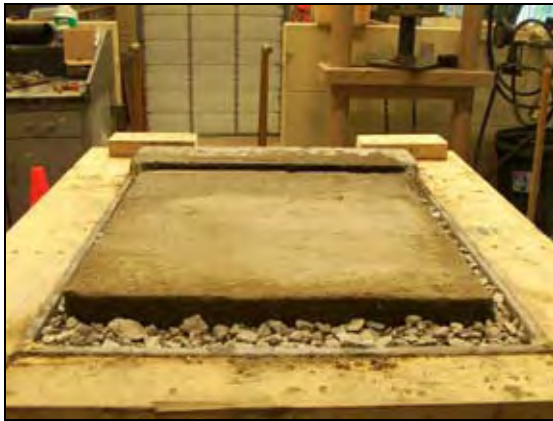
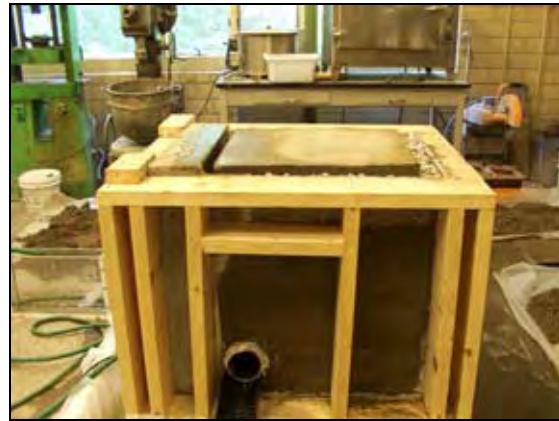
Water began to drain after 12 minutes from initiating the test. Initially, fine soil particles were washed out with water. After 17 minutes, the water became clear. Table 26 summarizes the results from this test. Compaction of the granular backfill at high water content significantly reduced the bridge approach settlement and void formation (Figures 363 and 364). However, the maximum achieved steady state flow did not change at 31 cm³/sec. Water was again observed seeping into the subdrain from the bottom perforation and not the top.

Figure 364. Level of approach slab after the test
