SHENANDOAH

TRAFFIC SAFETY STUDY

SHENANDOAH, IOWA

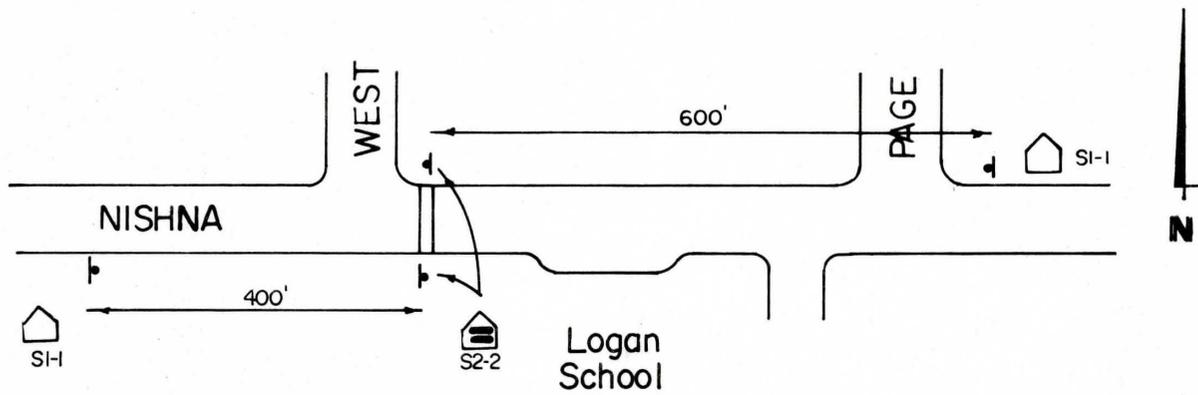
SCHOOL CROSSING AT
WEST & NISHNA
FIGURE 14

Logan School. Two crossings are associated with this elementary school. The first is nearly opposite the school on Nishna Road. It is marked with "Slow - School" signs on the approaches to the crossing. For conformance, it is recommended these be removed and replaced as shown in FIGURE 14.

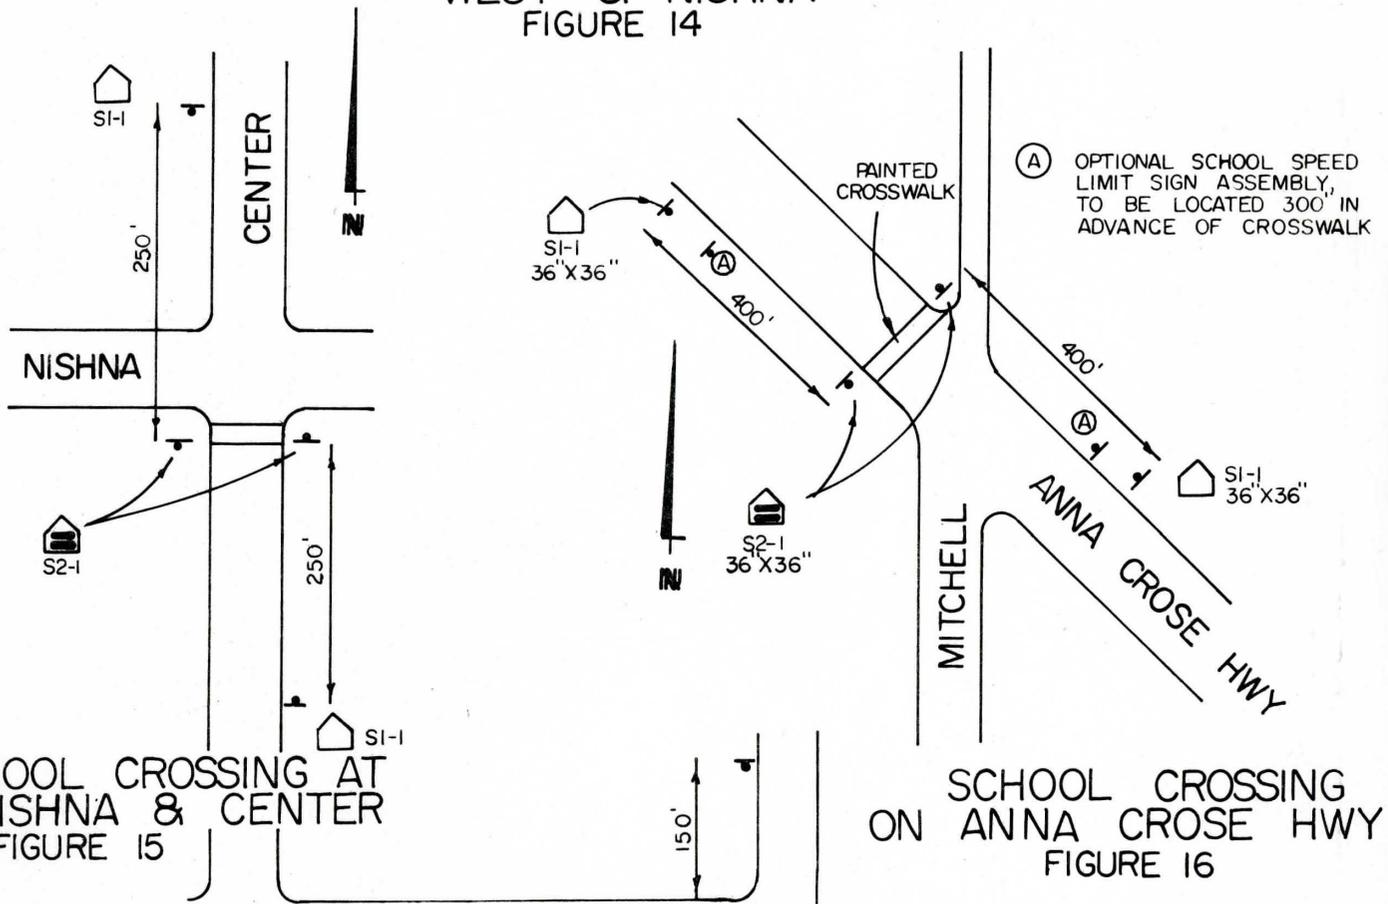
SCHOOL CROSSING AT
NISHNA & CENTER
FIGURE 15

The crossing on the south leg of Center Street and Nishna Road has no advance signing. A portable stop sign is placed in the crosswalk at the appropriate times. The recommendation is made that this crossing be signed as shown in FIGURE 15, and that use of the portable stop sign unit be discontinued.

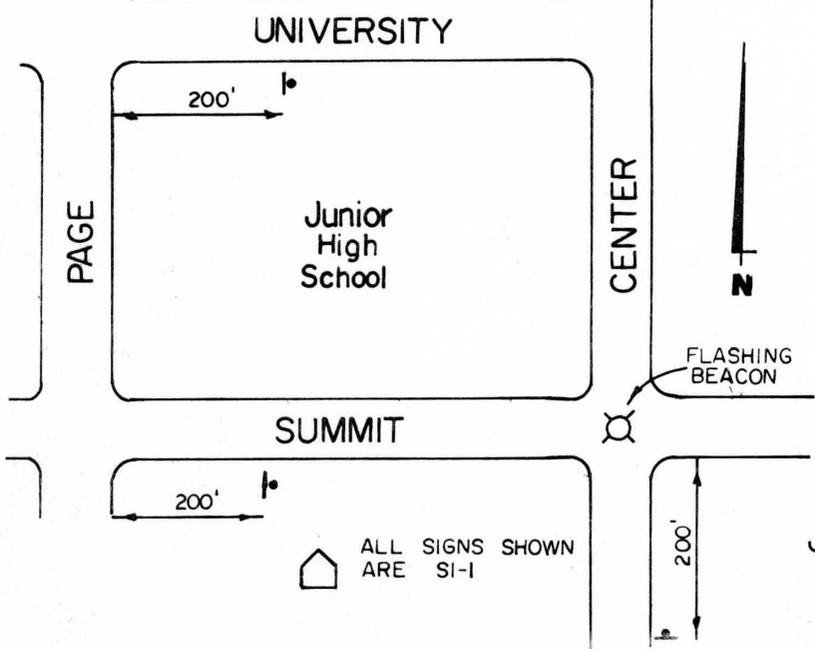
JUNIOR HIGH AREA
FIGURE 17

Junior High School. Two "Slow - School" signs are located in advance of the junior high. In addition, a flashing beacon is located at Center and Summit, presumably to warn motorists of children in the area. As the children are older, and traffic on Center Street is not heavy, a marked crosswalk does not seem necessary.

It is recommended that the two signs mentioned above be removed and the area be signed as shown in FIGURE 17.

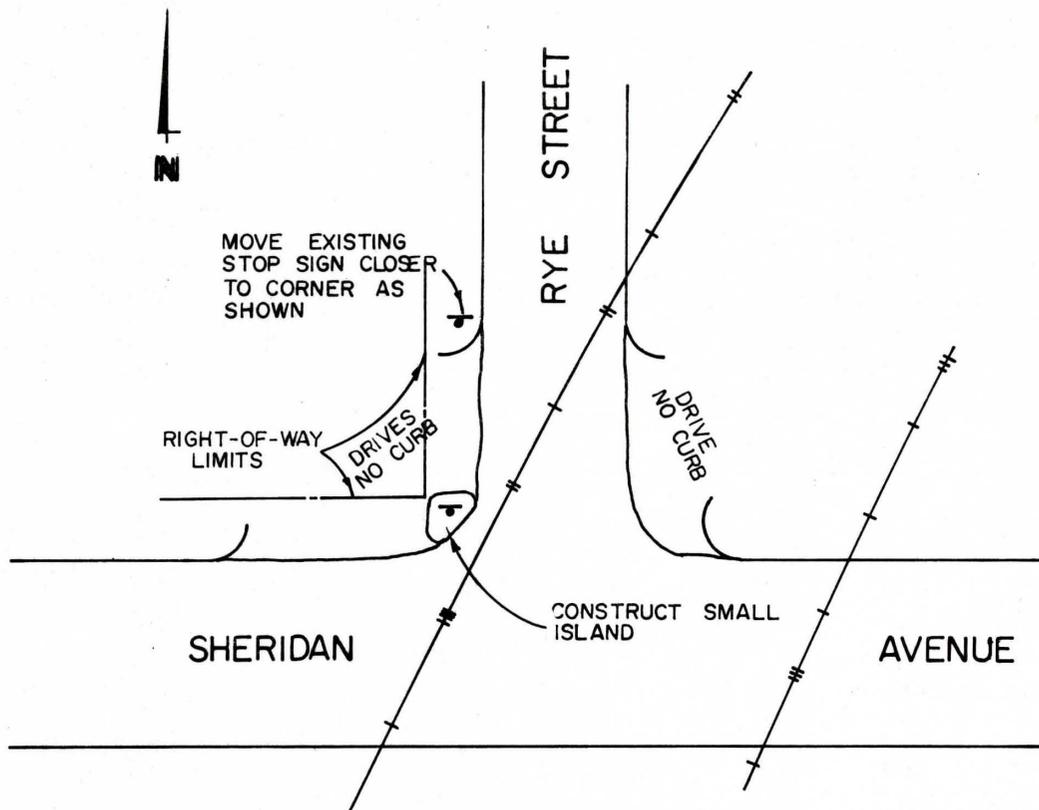
IMPROVEMENTS AT
SHERIDAN & RYE
FIGURE 20

Neither intersection has a significant accident history, nor is side street traffic heavy in either case. For these locations, it is recommended a small island be constructed, with asphalt curbing or preferably concrete curbing and that the portions facing streets be painted yellow for good visibility. These islands will better define the actual intersection and provide a protected area for proper placement of the stop sign. These recommended improvements are summarized in FIGURES 20 and 21.

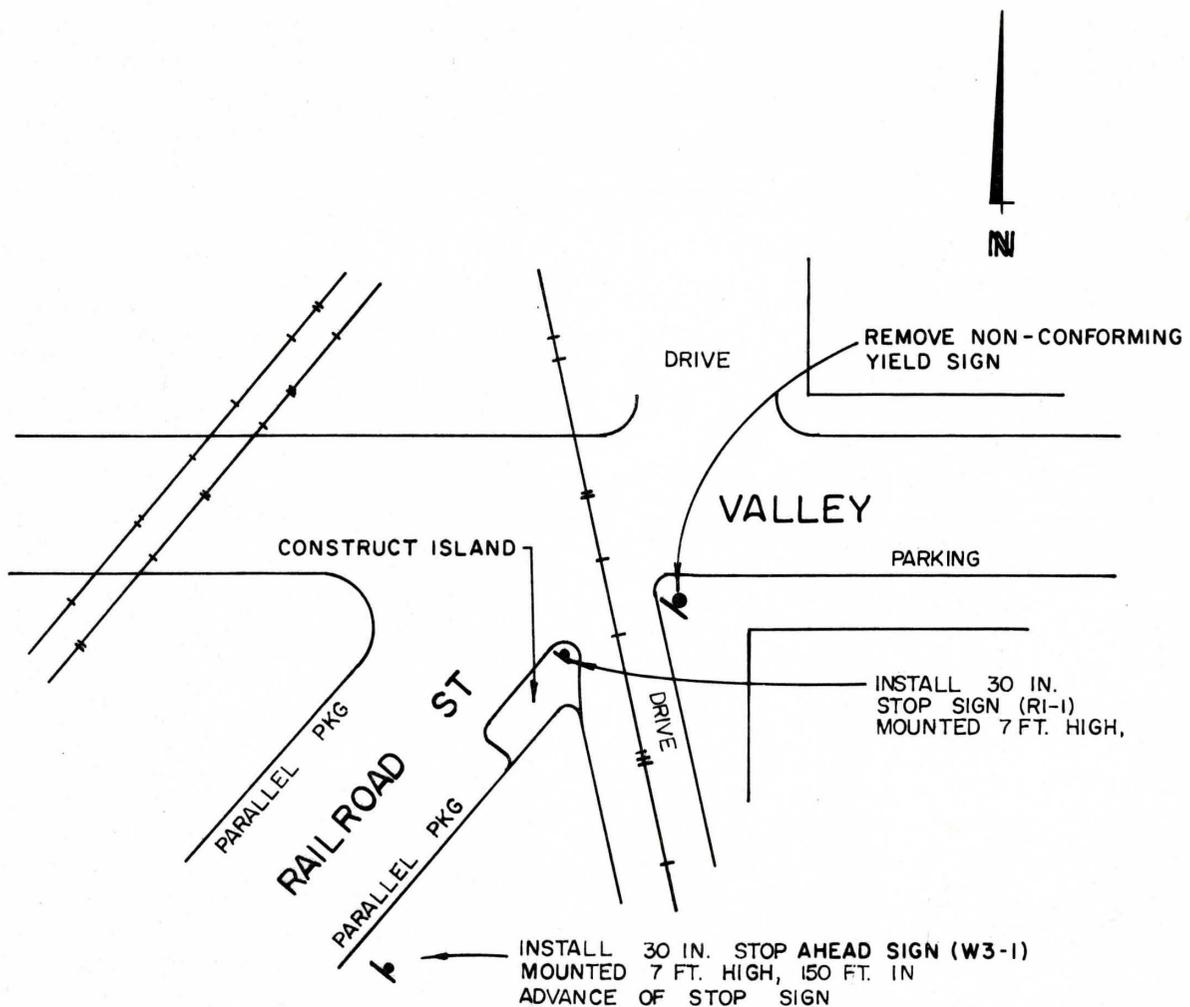
IMPROVEMENTS AT
RAILROAD & VALLEY
FIGURE 22

Railroad Street and Valley Avenue. This intersection is complicated by a rail spur, parked cars, an adjacent railroad crossing, two drives, and somewhat restricted sight distances. The geometrics and signing should be modified as shown in FIGURE 22. No additional measures are warranted as no accidents were recorded in the study period.

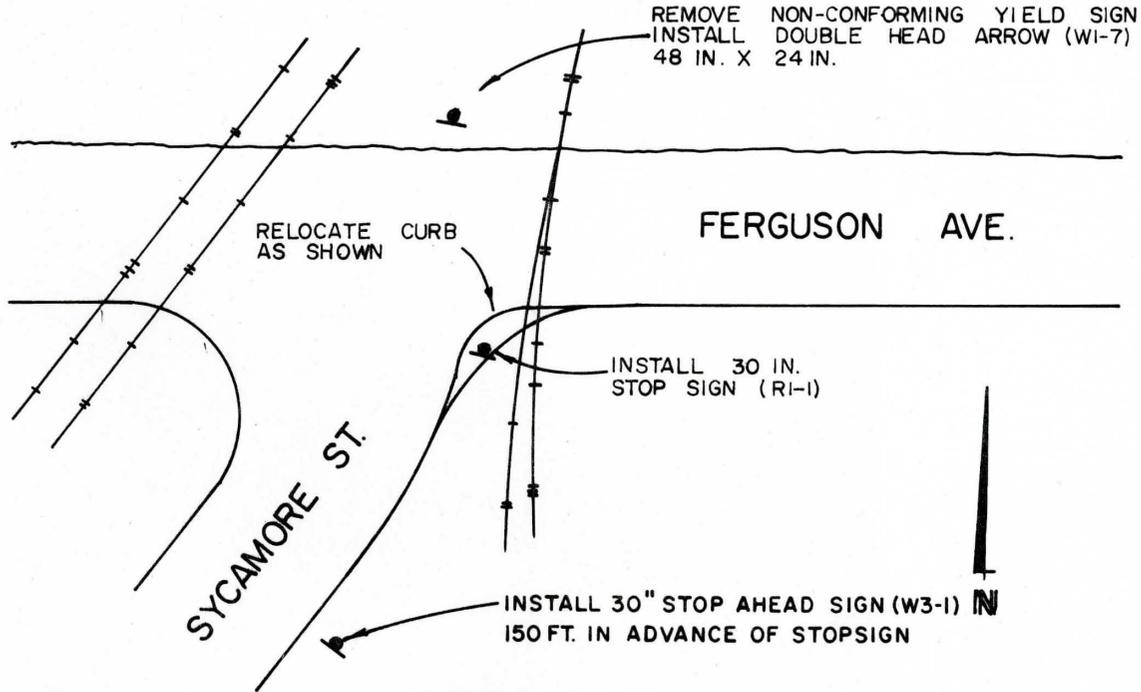
IMPROVEMENTS AT
SYCAMORE & FERGUSON
FIGURE 23

Sycamore Street and Ferguson Avenue. This skewed intersection is currently controlled by a non-conforming yield sign on the far side of the intersection. Ferguson Ave. is not curbed, and heading north on Sycamore, the upcoming T-intersection is not readily apparent. It is recommended the intersection signing be modified as in FIGURE 23. It is suggested that the southeast curb be modified to better define the intersection and provide a better placement of the recommended stop sign. Also, a double-head arrow is recommended to clearly indicate the end of Sycamore Street.

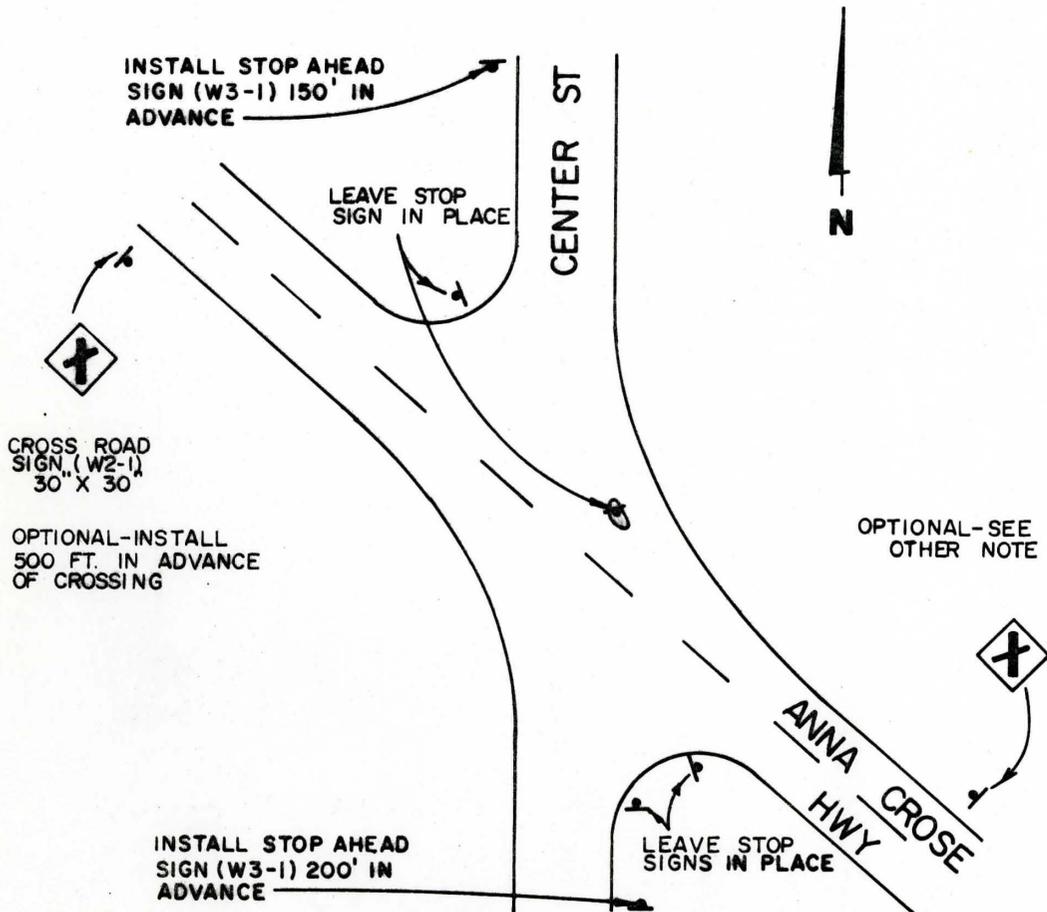
IMPROVEMENTS AT CENTER ST. & ANNA CROSE HWY
FIGURE 25

It is recommended that the intersection be modified as shown in FIGURE 25. Stop Ahead signs should be placed as shown. It is doubtful that painted stop lines are practical due to the surfacing of the approaches. However, due to the minimal accident experience at this location, more extensive modifications are not warranted at this time.

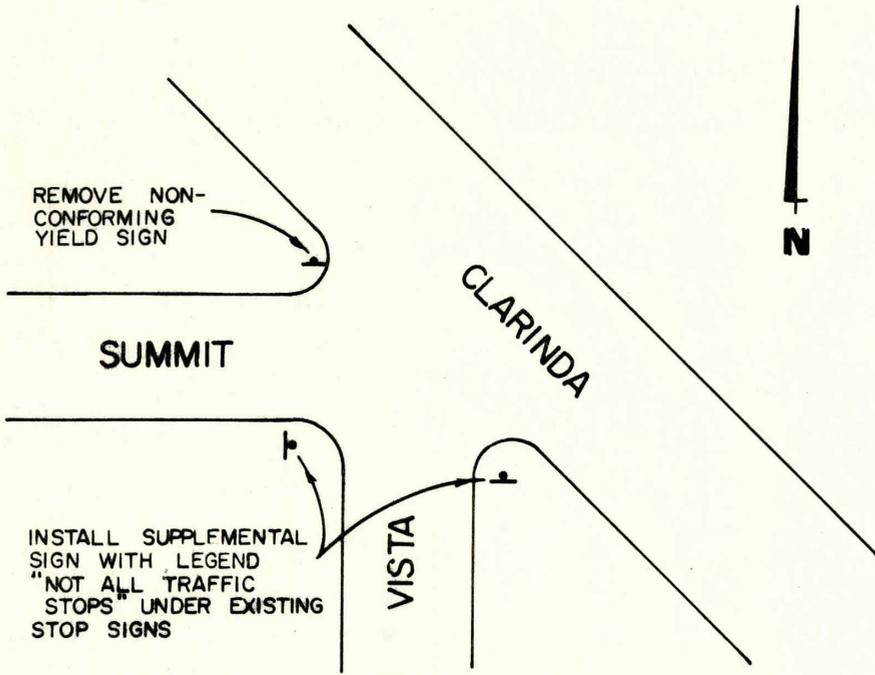
IMPROVEMENTS AT CLARINDA, VISTA & SUMMIT
FIGURE 26

Clarinda, Vista, and Summit Avenues. The only recommended improvement is removal of the yield sign on the northwest corner, whose placement and legend are non-conforming. In addition, a supplemental sign reading "Not All Traffic Stops" (See FIGURE 9) should be installed below the stop signs on Vista and Summit (FIGURE 26).

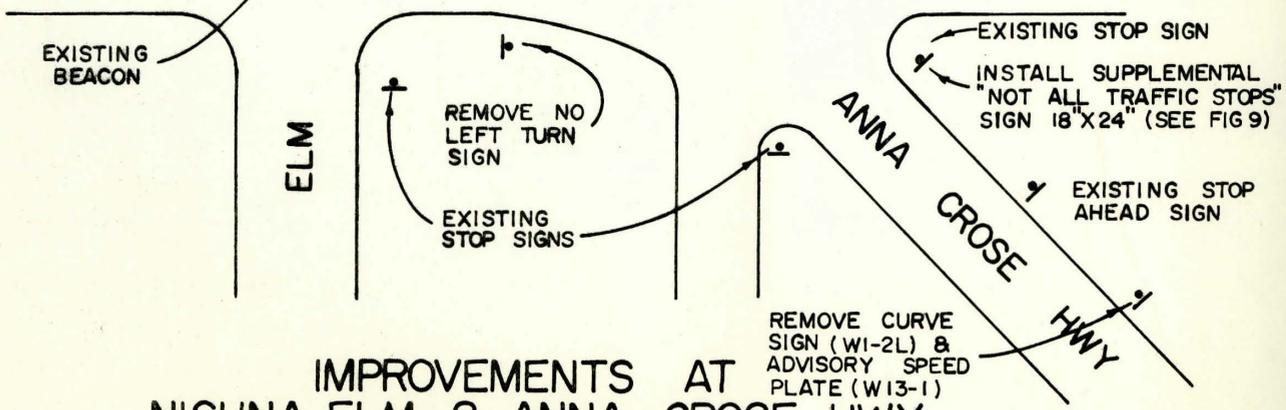
IMPROVEMENTS AT NISHNA, ELM, & ANNA CROSE HWY
FIGURE 27

slight physical modification are required. As shown in FIGURE 27, it is recommended that signing changes be made as indicated, and that the one-way turning lane be narrowed and delineated. The flashing beacon can be retained, but should be painted yellow with flat black visors the next time painting is needed. Existing right-of-way designations have not been changed, as the accident history is minimal and traffic demands are adequately served.

One other modification which should be considered is the moving of the hospital drive entrance further east on Anna Crose Highway, or the provision of a different access point off of Elm Street, so as to reduce the intersection conflicts. Also, the curve signs with 25 mph speed plates located in advance of the intersection on Nishna Rd. and Anna Crose Hwy. should be removed.

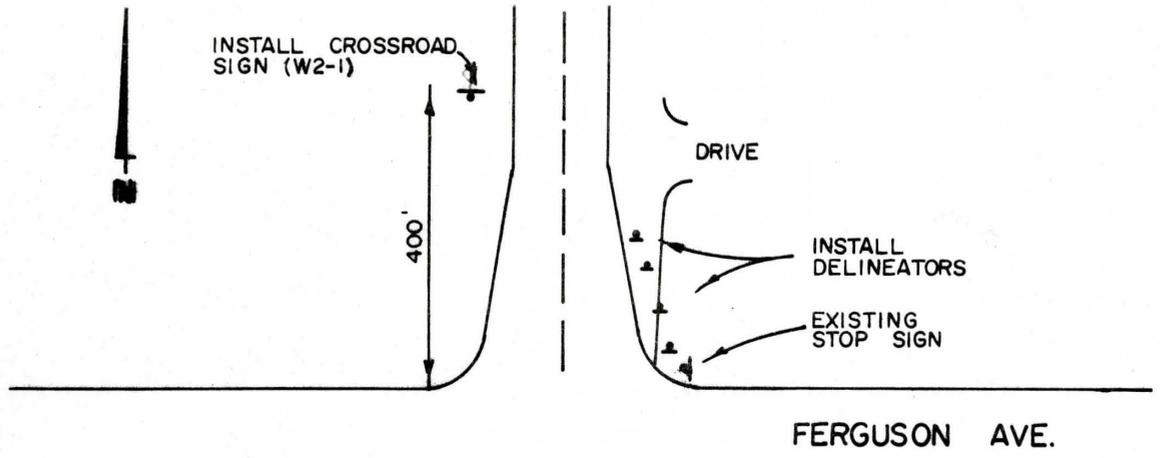
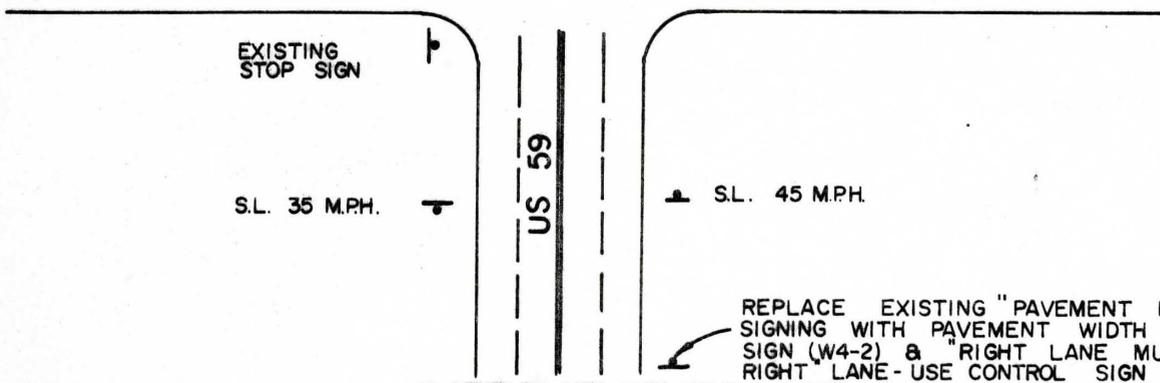
IMPROVEMENTS AT US 59 & FERGUSON
FIGURE 30

The recommended changes are shown in FIGURE 30. If accident involvement increases, it would be desirable to continue the 35 mph speed zone to the north of Ferguson Avenue.

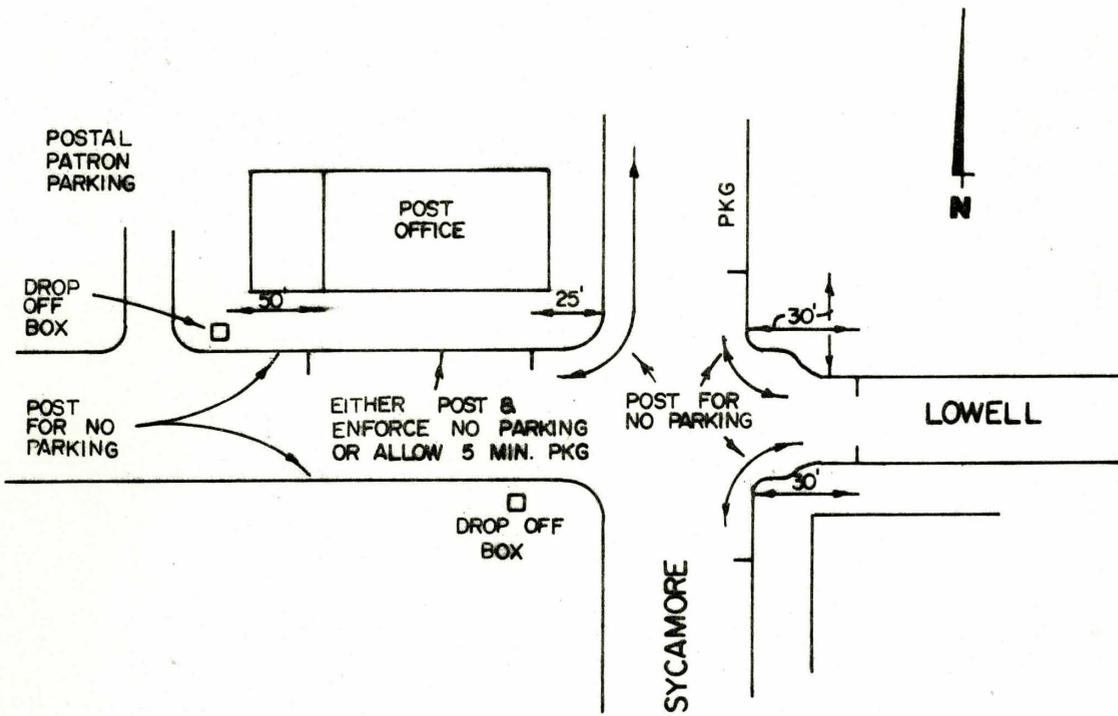
IMPROVEMENTS AT
SYCAMORE & LOWELL
FIGURE 34

These traffic volumes and the accident history do not appear to warrant any change in controls at this time. However it is recommended that special no parking zones be instituted as shown in FIGURE 34, and enforced. The no parking in front of the Post Office should either be supplemented with signing and be enforced, or 5 minute parking should be permitted. The existing no parking on the east curb of the south leg should be enforced and additional no parking zones be instituted as shown.
