EVALUATION OF BOND RETAINAGE

PORTLAND CEMENT CONCRETE OVERLAYS

INFRARED THERMOGRAPHY AND GROUND PENETRATING RADAR

IOWA DEPARTMENT OF TRANSPORTATION

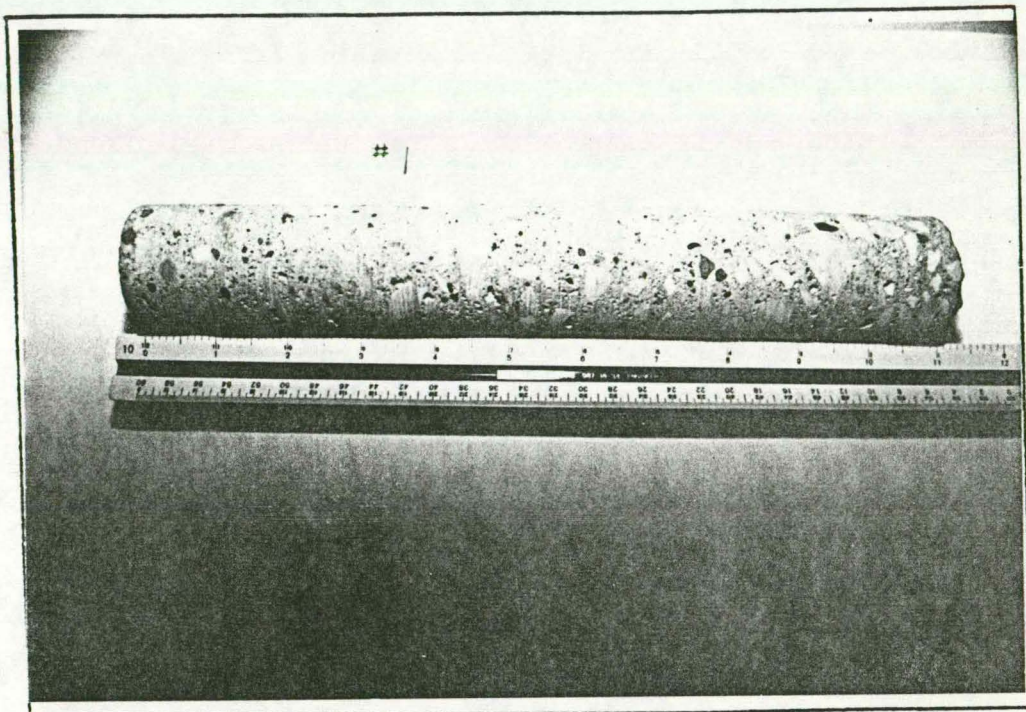
CONDITION OF ASPHALT: Good

DEFECTS IN CORE: None

QUALITY OF CONCRETE: Good

REMARKS: Good Bond - no defects

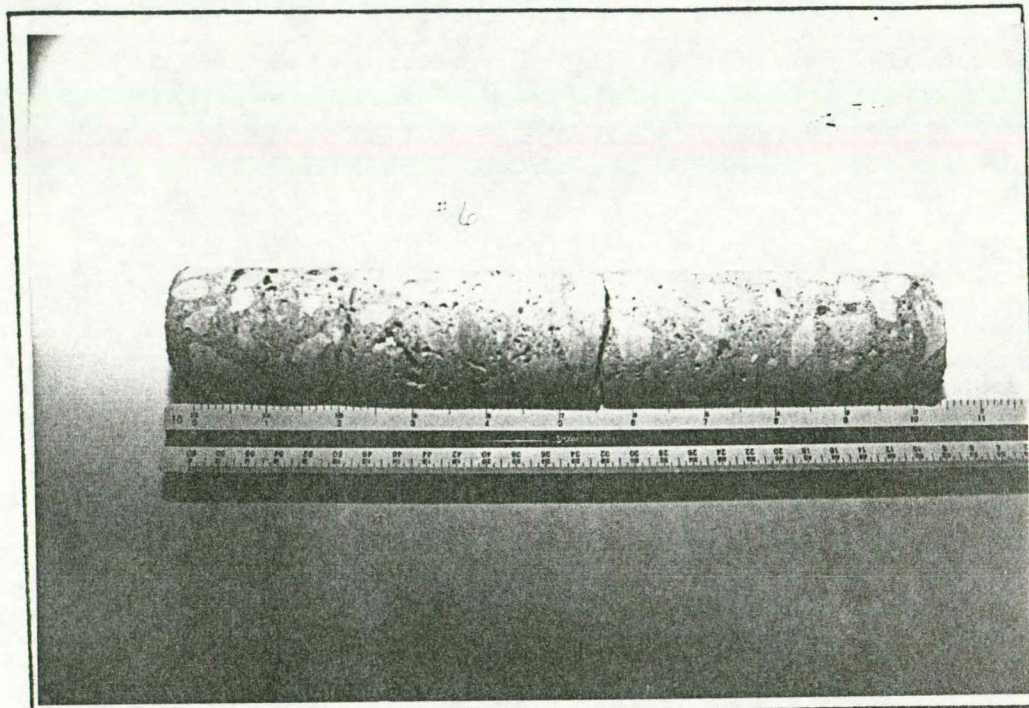
CONDITION OF OVERLAY: Good

DEFECTS IN CORE: None

REMARKS: Full Depth Repair Area

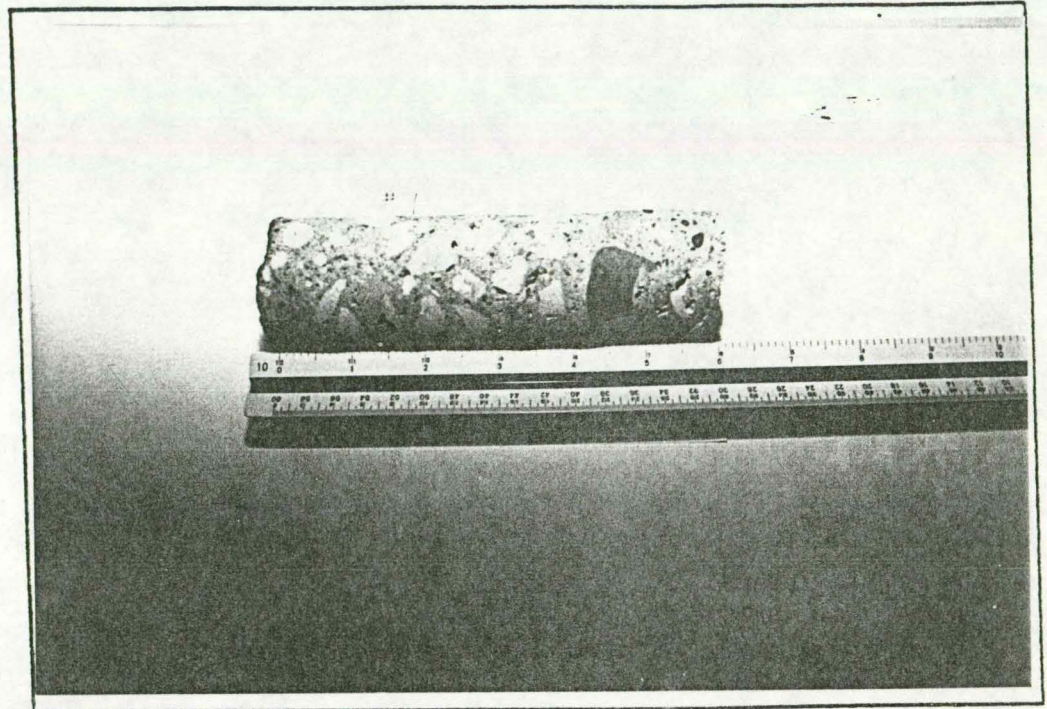
CONDITION OF OVERLAY: Good

DEFECTS IN CORE: None

QUALITY OF CONCRETE: Good

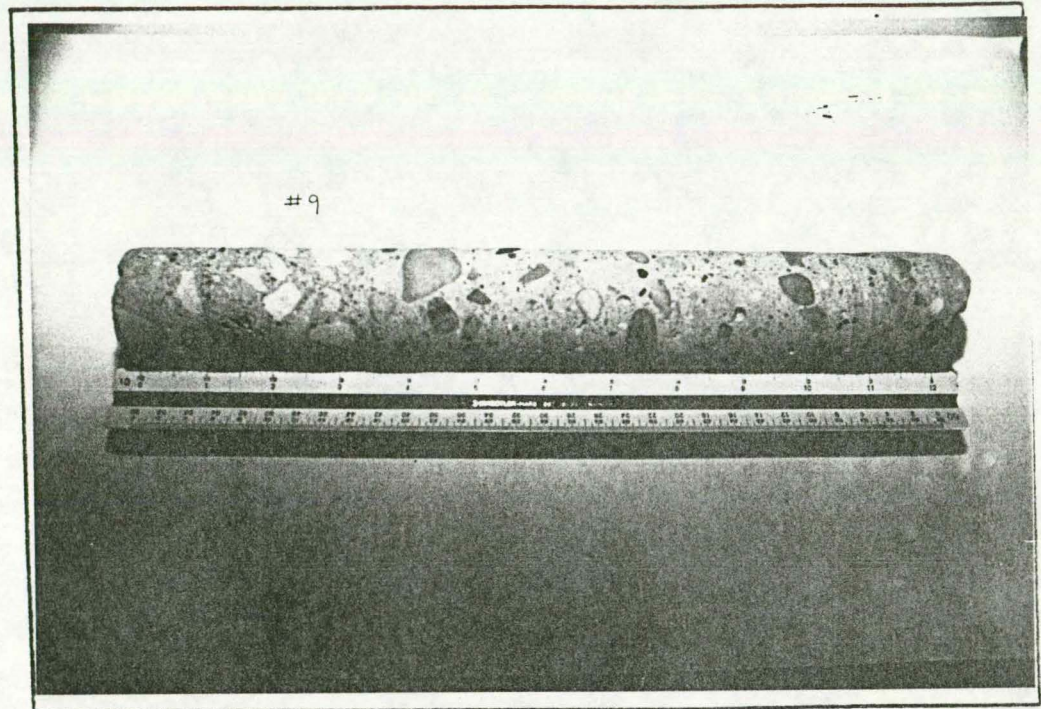
CONDITION OF OVERLAY: Good

DEFECTS IN CORE: None

QUALITY OF CONCRETE: Good

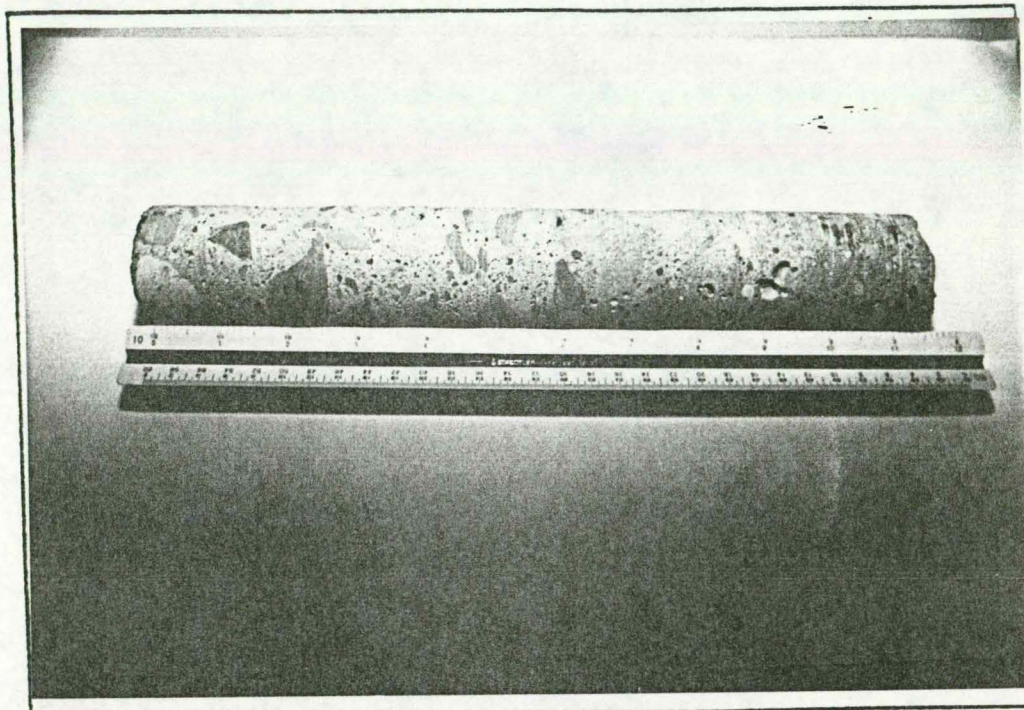
CONDITION OF OVERLAY: Good

DEFECTS IN CORE: None

QUALITY OF CONCRETE: Good

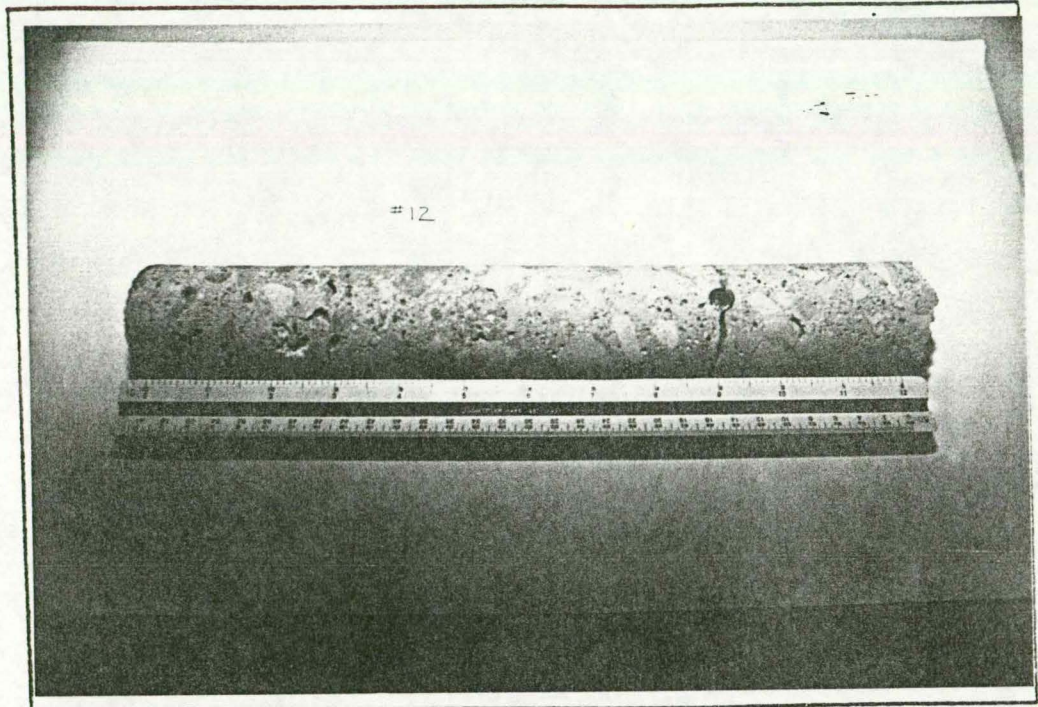
CONDITION OF OVERLAY: Good

DEFECTS IN CORE: None

QUALITY OF CONCRETE: Good

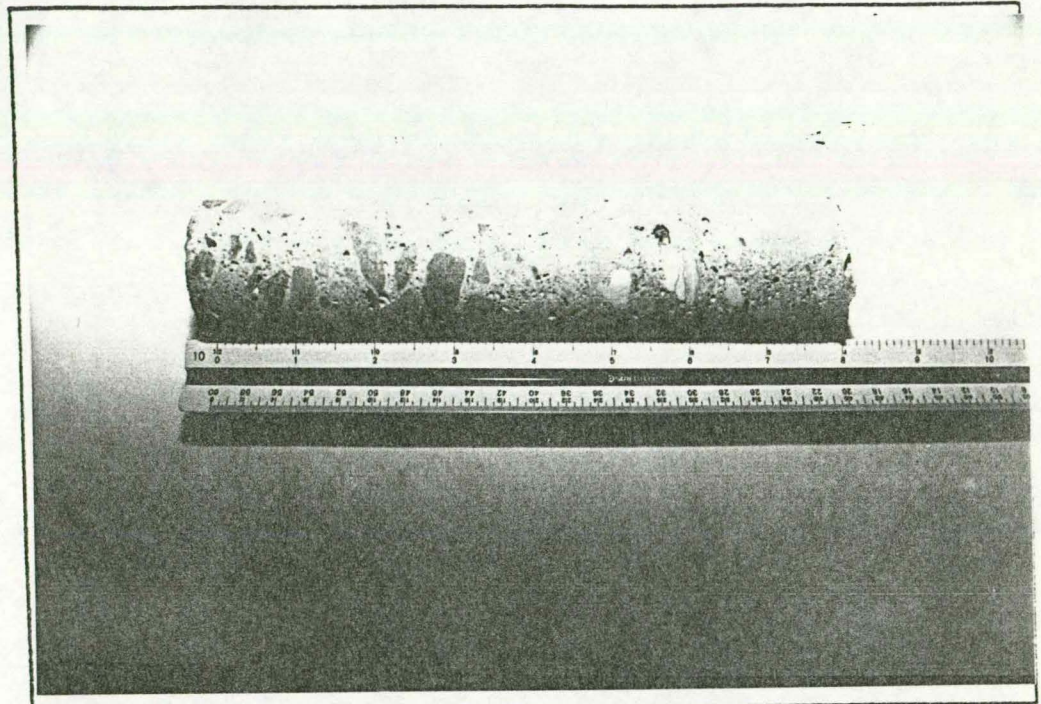
DATE: August 20, 1987
 PROJECT: Iowa D.O.T. - PCC Bond Evaluation
 CORE LOCATION: Interstate 80 - Milepost 185.1
 CORE: # 13
 DIAMETER: 2 inch
 OVERLAY THICKNESS: 4.5 inches
 CONCRETE THICKNESS: --
 FULL DEPTH Y/N: No
 CONDITION OF OVERLAY: Good
 DEFECTS IN CORE: None
 QUALITY OF CONCRETE: Good
 REMARKS: _____
