FULL-SCALE VEHICLE CRASH TESTS ON THE IOWA RETROFIT CONCRETE BARRIER RAIL

TRANSPORTATION RESEARCH REPORT TRP-03-015-88

January, 1989

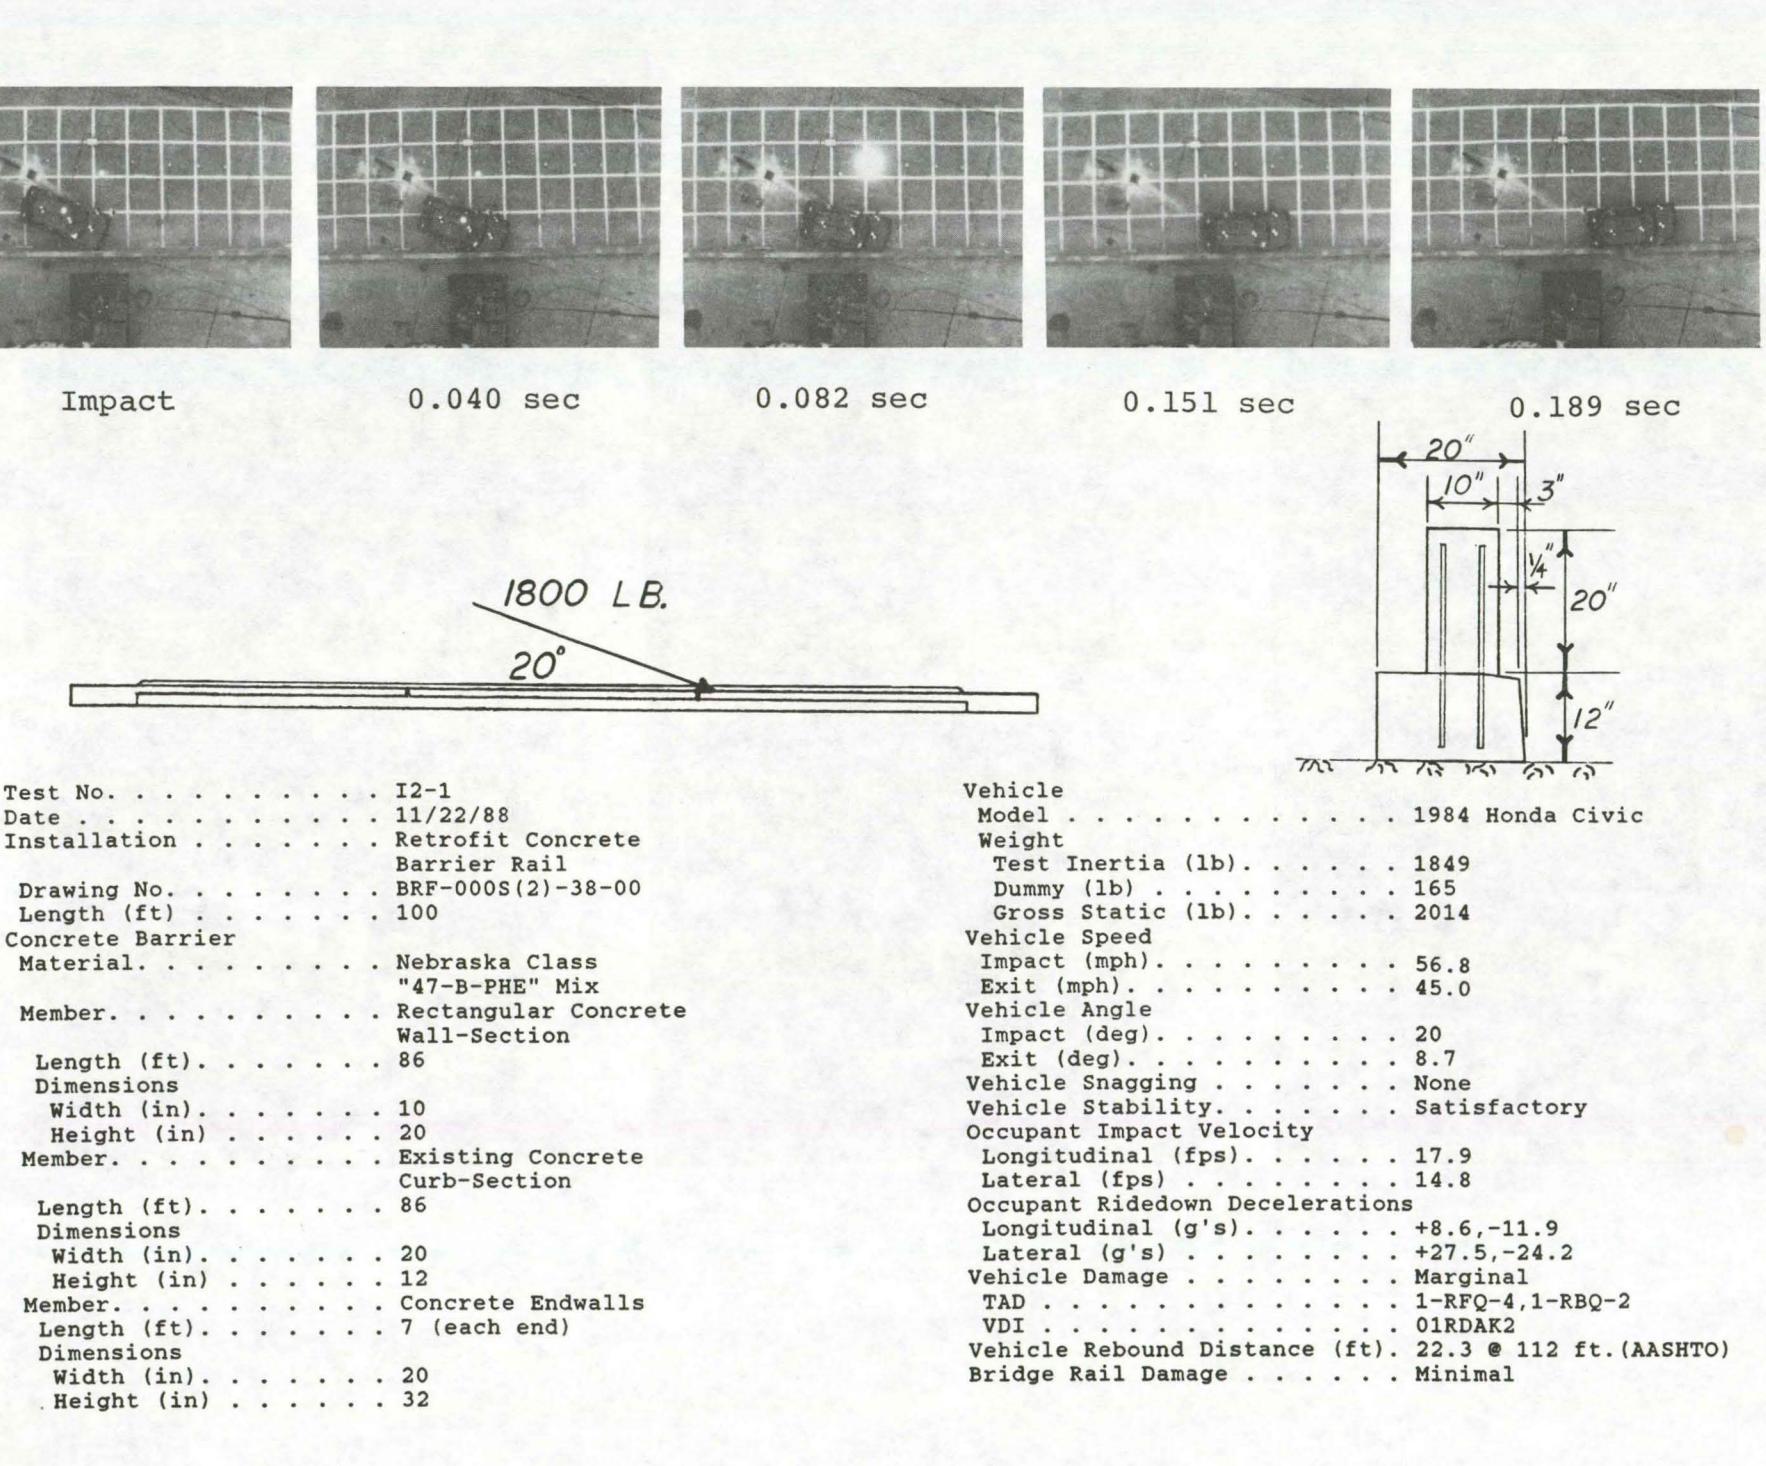
Test I2-1 was conducted with an 1,849 lb. Honda Civic under the impact conditions of 56.8 mph and 20 degrees. A summary of the test results is shown in Figure 17. The sequential photographs are also shown in Figure 17.

Upon impact with the retrofit concrete barrier rail, the frght front corner of the vehicle began to crush inward at approximately 0.040 sec. At 0.082 sec, the passenger-side window began to break due to the impact of the dummy's head. The vehicle was parallel to the barrier at approximately 0.151 sec. At this time, the dummy's head was protruding out of the window. As the vehicle became parallel to the barrier, the vehicle began to roll clockwise toward the barrier until contact was made between the upper portion of the vehicle and the top portion of the concrete wall. At this time, the left-side tires of the vehicle began to lose contact with the concrete ground surface. The rear right-side of the vehicle impacted the concrete barrier between 0.189 and 0.212 sec. The vehicle exited the concrete barrier at approximately 0.294 sec. The vehicle was in contact with the barrier rail for approximately 8 ft.

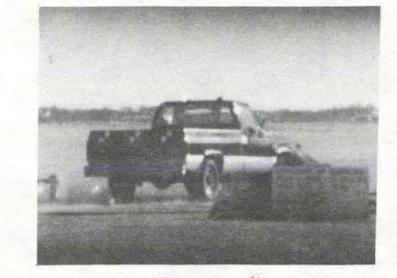
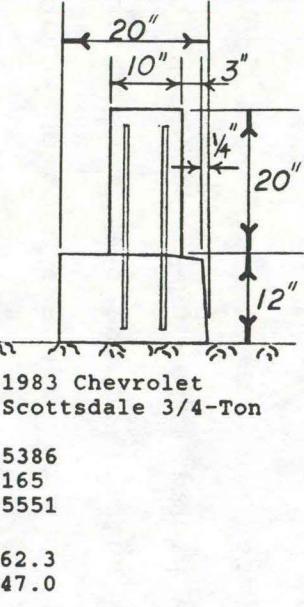
Test I2-2 was conducted with a 5,386 lb. Chevrolet Scottsdale 3/4-ton pickup under the impact conditions of 62.3 mph and 20 degrees. A summary of the test results is shown in Figure 20. The sequential photographs are also shown in Figure 20.

Photographs of the vehicle damage are shown in Figure 21. As evident, the vehicle damage was marginal. The TAD and VDI damage classifications are shown in Figure 20. Photographs of the minimal damage to the retrofit concrete barrier rail are shown in Figure 22. Minor concrete spalling and paint and tire marks were evident.

rest No									12-2
Date									12/01/88
Installati	on								Retrofit Concrete
									Barrier Rail
Drawing N	ю.								BRF-000S(2)-38-00
Length (f	t)								100
Concrete B	Barr	ie	r						
Material.	•	•	•	•	•	•	•	•	Nebraska Class "47-B-PHE" Mix
Member	•	•	•	•	•	•	•	•	Rectangular Concrete Wall-Section
Length (ft)								86
Dimensio	ns								
Width (in)								10
Height	(in)							20
Member	•	•	•	•	•	•	•	•	Existing Concrete Curb-Section
Length (ft)								86
Dimensio	ns								
Width (in)		1						20
Height	(in)							12
Member.									Concrete Endwalls
Length (ft)								7 (each end)
Dimensio	ns	•	•	•					, (outer one)
Width (in)		-						20
Height	(in	i	•	•		-	-		32
	1		•		-	-	-

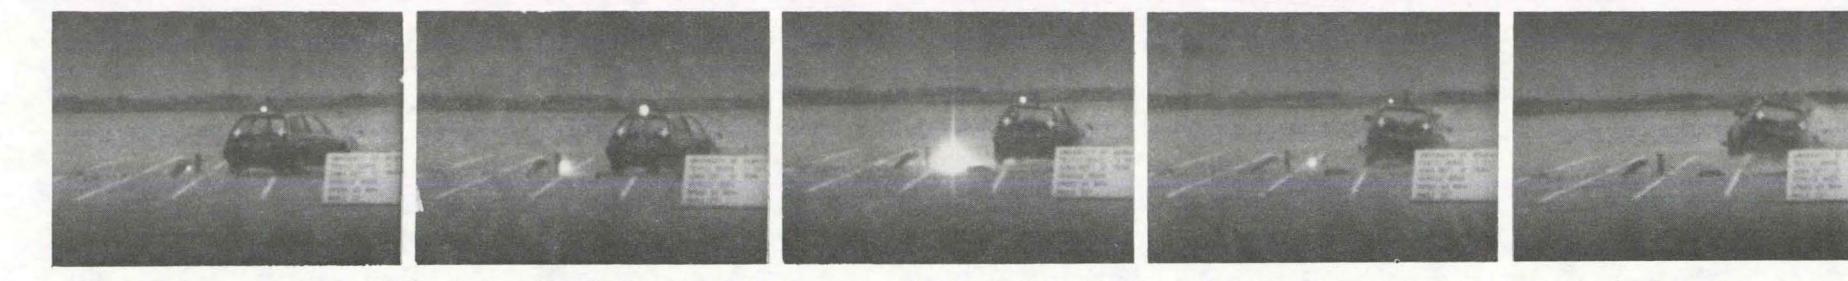
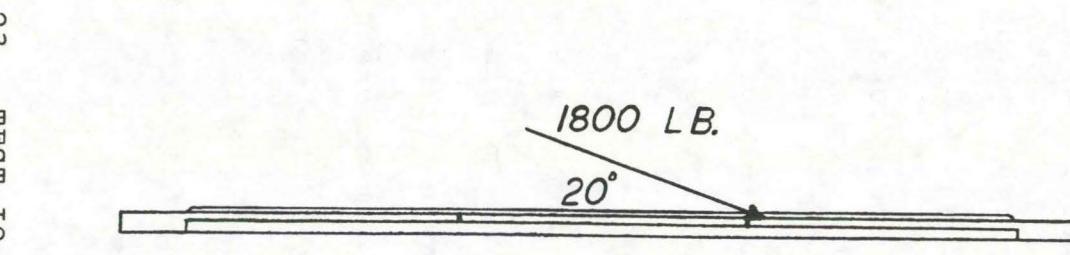
Test I2-3 was conducted with an 1,849 lb. Honda Civic under the impact conditions of 62.5 mph and 20 degrees. A summary of the test results is shown in Figure 23. The sequential photographs are also shown in Figure 23.

Photographs of the vehicle damage are shown in Figure 24. As evident, the vehicle damage was marginal. The TAD and VDI damage classifications are shown in Figure 23. Photographs of the minimal damage to the retrofit concrete barrier rail are shown in Figure 25. Only paint and tire marks were evident.

12"
Vehicle 7/12 /12 /22	1 51 67
Model 1984 Hond	a Civic
Weight	
Test Inertia (1b) 1849	
Dummy (1b) 165	
Gross Static (1b) 2014	
Vehicle Speed	
Impact (mph) 62.5	
Exit (mph) 45.6	
Vehicle Angle	
Impact (deg) 20	
Exit (deg) 6.3	
Vehicle Snagging None	
Vehicle Stability Satisfact	ory
Occupant Impact Velocity	
Longitudinal (fps) 20.9	
Lateral (fps) Not Avail	able
Occupant Ridedown Decelerations	
Longitudinal (g's) 5.9	
Lateral (g's) Not Availa	able
Vehicle Damage Marginal	
TAD 1-RFQ-4,1-	-RBQ-2
VDI 01RDAK2	
Vehicle Rebound Distance (ft). 15.3 @ 11:	2 ft. (AASHTO)
Bridge Rail Damage Minimal

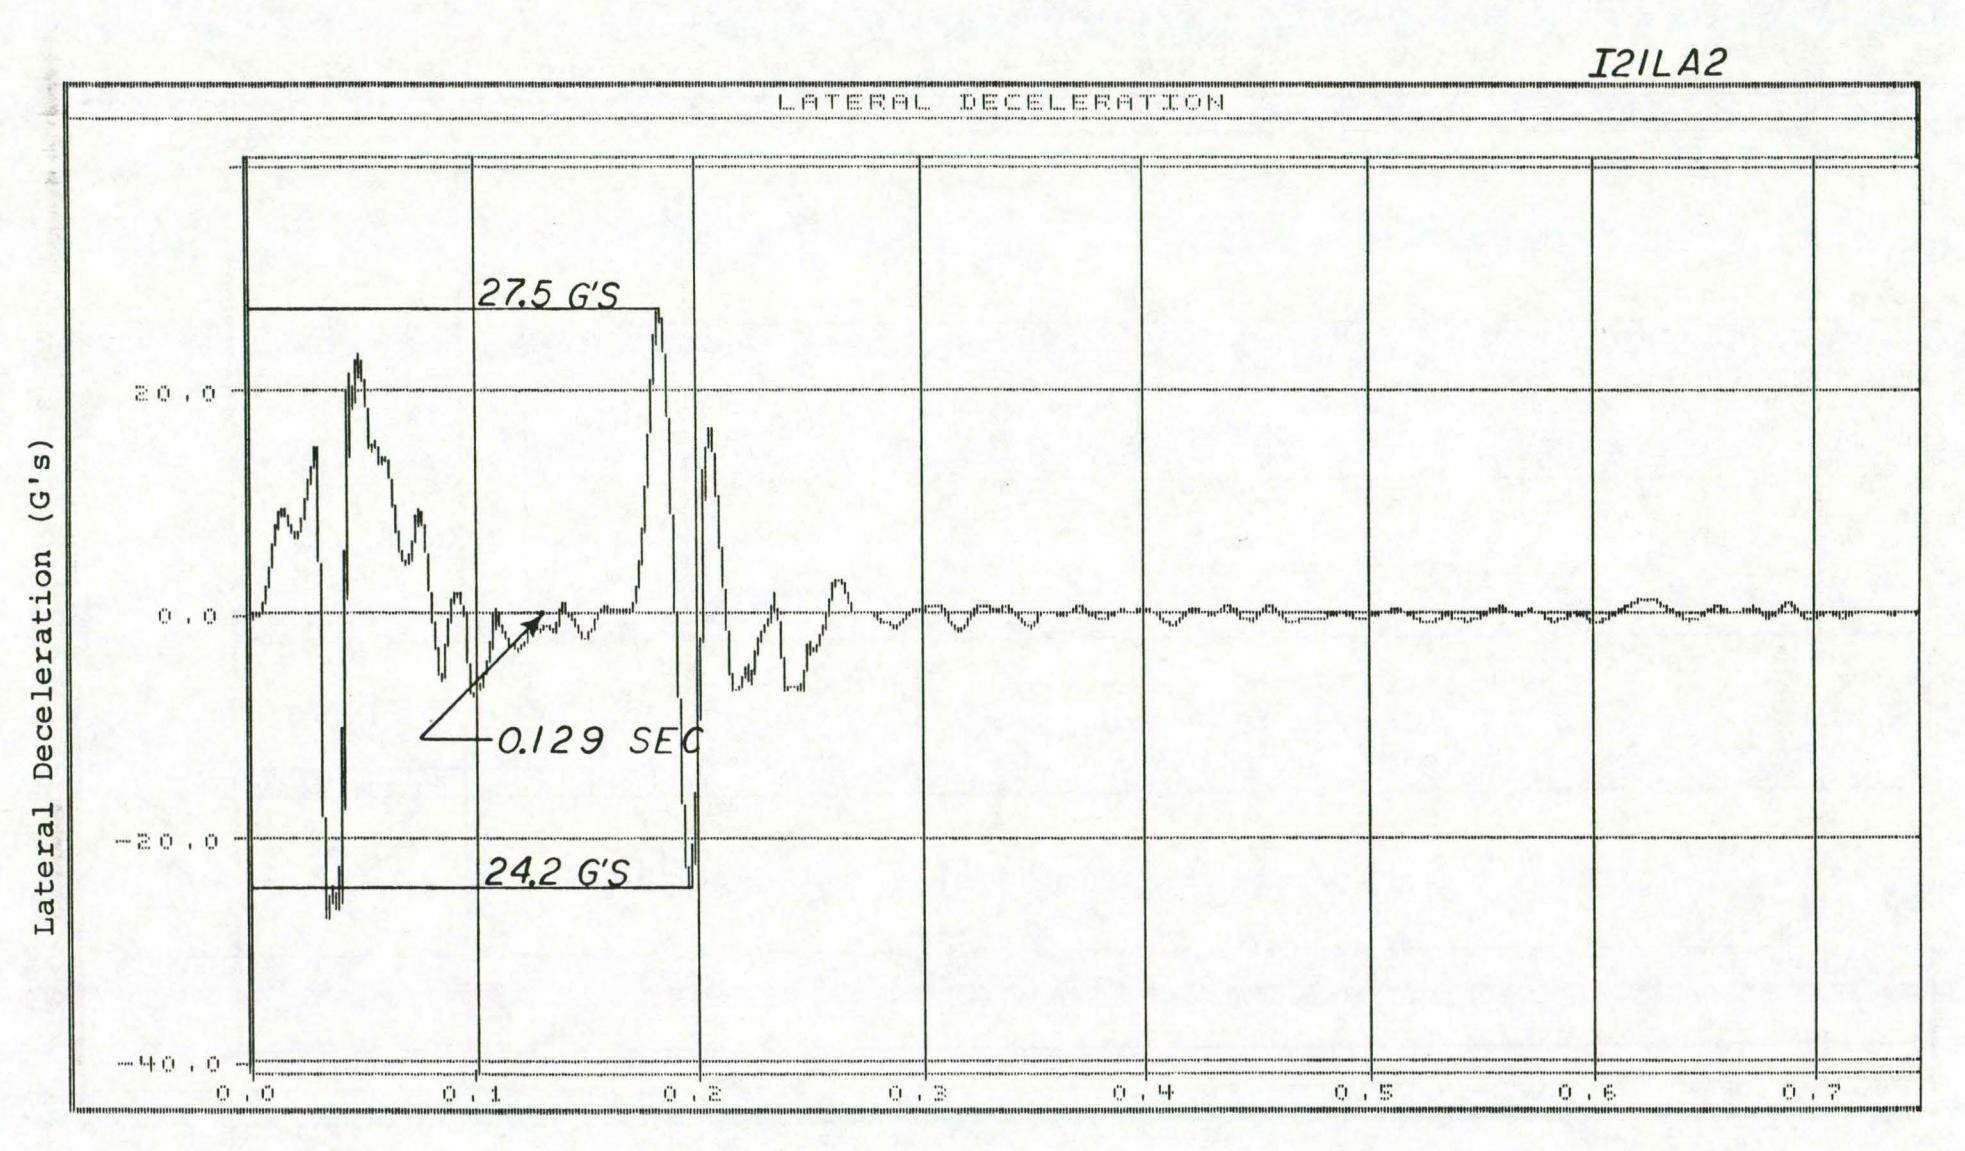
FIGURE C-4. GRAPH OF LATERAL DECELERATION, TEST 12-1

It was noted that high occupant values occurred for the lateral 0.010 sec. average ridedown deceleration. This occurred from a second impact between the rear portion of the vehicle and the concrete barrier. After discussions with both Mr. Charles F. McDevitt with the Federal Highway Administration and Mr. Jarvis D. Michie with Dynatech Engineering (formerly with Southwest Research Institute and developer of the flail space model), the high lateral ridedown decelerations should not be of great concern. This was due to the fact that the flail space model was not developed to handle the case of a second impact. The model would not be accurate, because it does not take into consideration the location of the occupant due to bouncing around when the second impact occurred.
