PROTECTION OF STRUCTURAL CONCRETE SUBSTRUCTURES

IOWA HIGHWAY RESEARCH BOARD

PROJECT HR-220

CONSTRUCTION REPORT

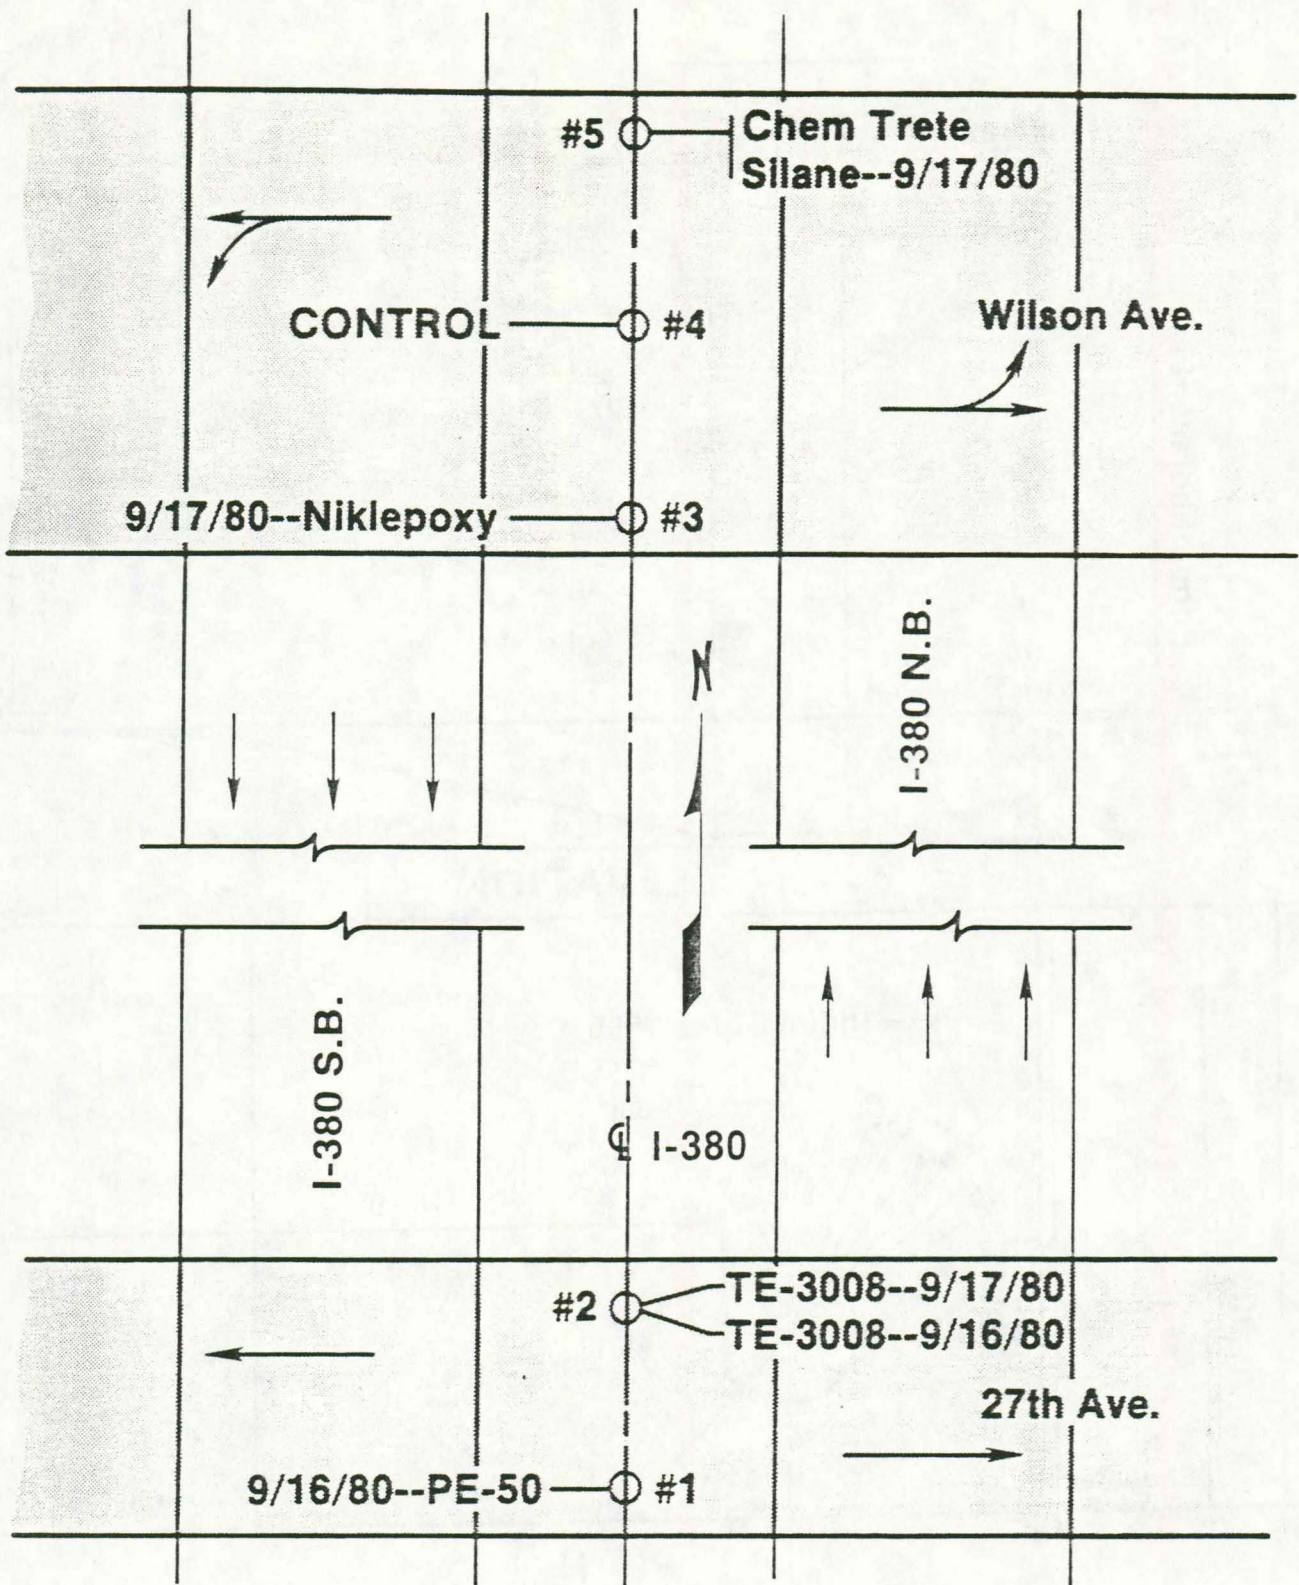
**FIGURE 2 - SITE LOCATION  
COLUMN IDENTIFICATION**

Concrete cores were obtained June 17 and 18, 1980 from the candidate pier columns in the I-380 corridor. The location and identification of the columns involved in this project are shown in the sketch "Site Location" (Figure 2, Appendix B). The "Core Sampling Plan" (Figure 3, Appendix B) indicates the locations from which cores were extracted from each pier column and the planned locations for core extractions in subsequent years.

Candidate pier columns were assigned numbers 1 through 5 from south to north ie: Numbers 1 and 2 at 27th Avenue Southwest, Numbers 3, 4 and 5 at Wilson Avenue Southwest (Figure 2, Appendix B).
