EVALUATION OF BOND RETAINAGE
IN
PORTLAND CEMENT
CONCRETE OVERLAYS
USING
— INFRARED THERMOGRAPHY
AND
GROUND PENETRATING RADAR

BRICE PETRIDES-DONOHUE
ENGINEERS & ARCHITECTS

PROJECT NO. 50389
COPYRIGHT, DONOHUE 1989

June 28, 1989

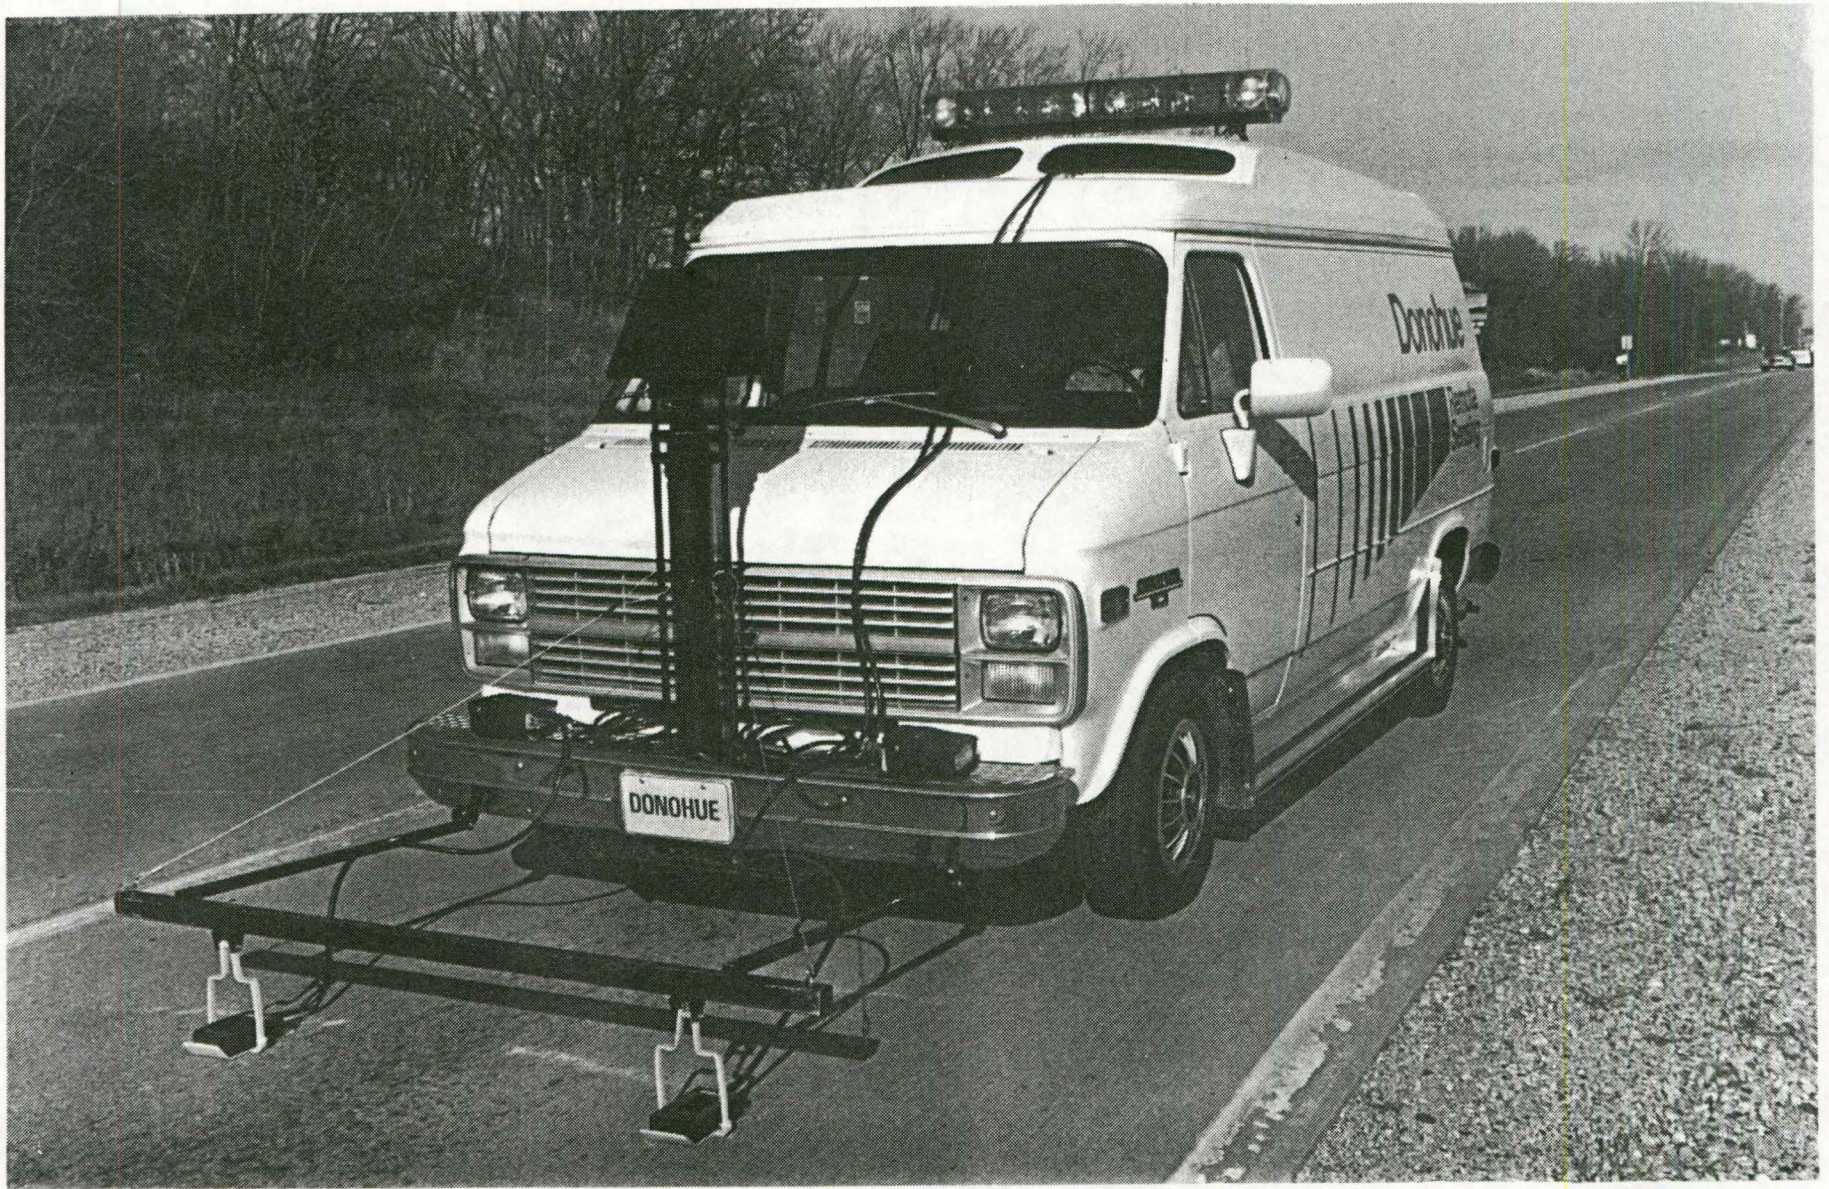
FIGURE 1

The GPR transducers were mounted on a bar extending from the front of the data collection van, Figure 1. The oscillographic reproduction of the radar wave form and the graphic representation produced by the strip chart recorder were continuously monitored and optimized by the operator in the van, Figure 2. The speed of the data collection van was held to approximately 2 miles per hour along the path selected.

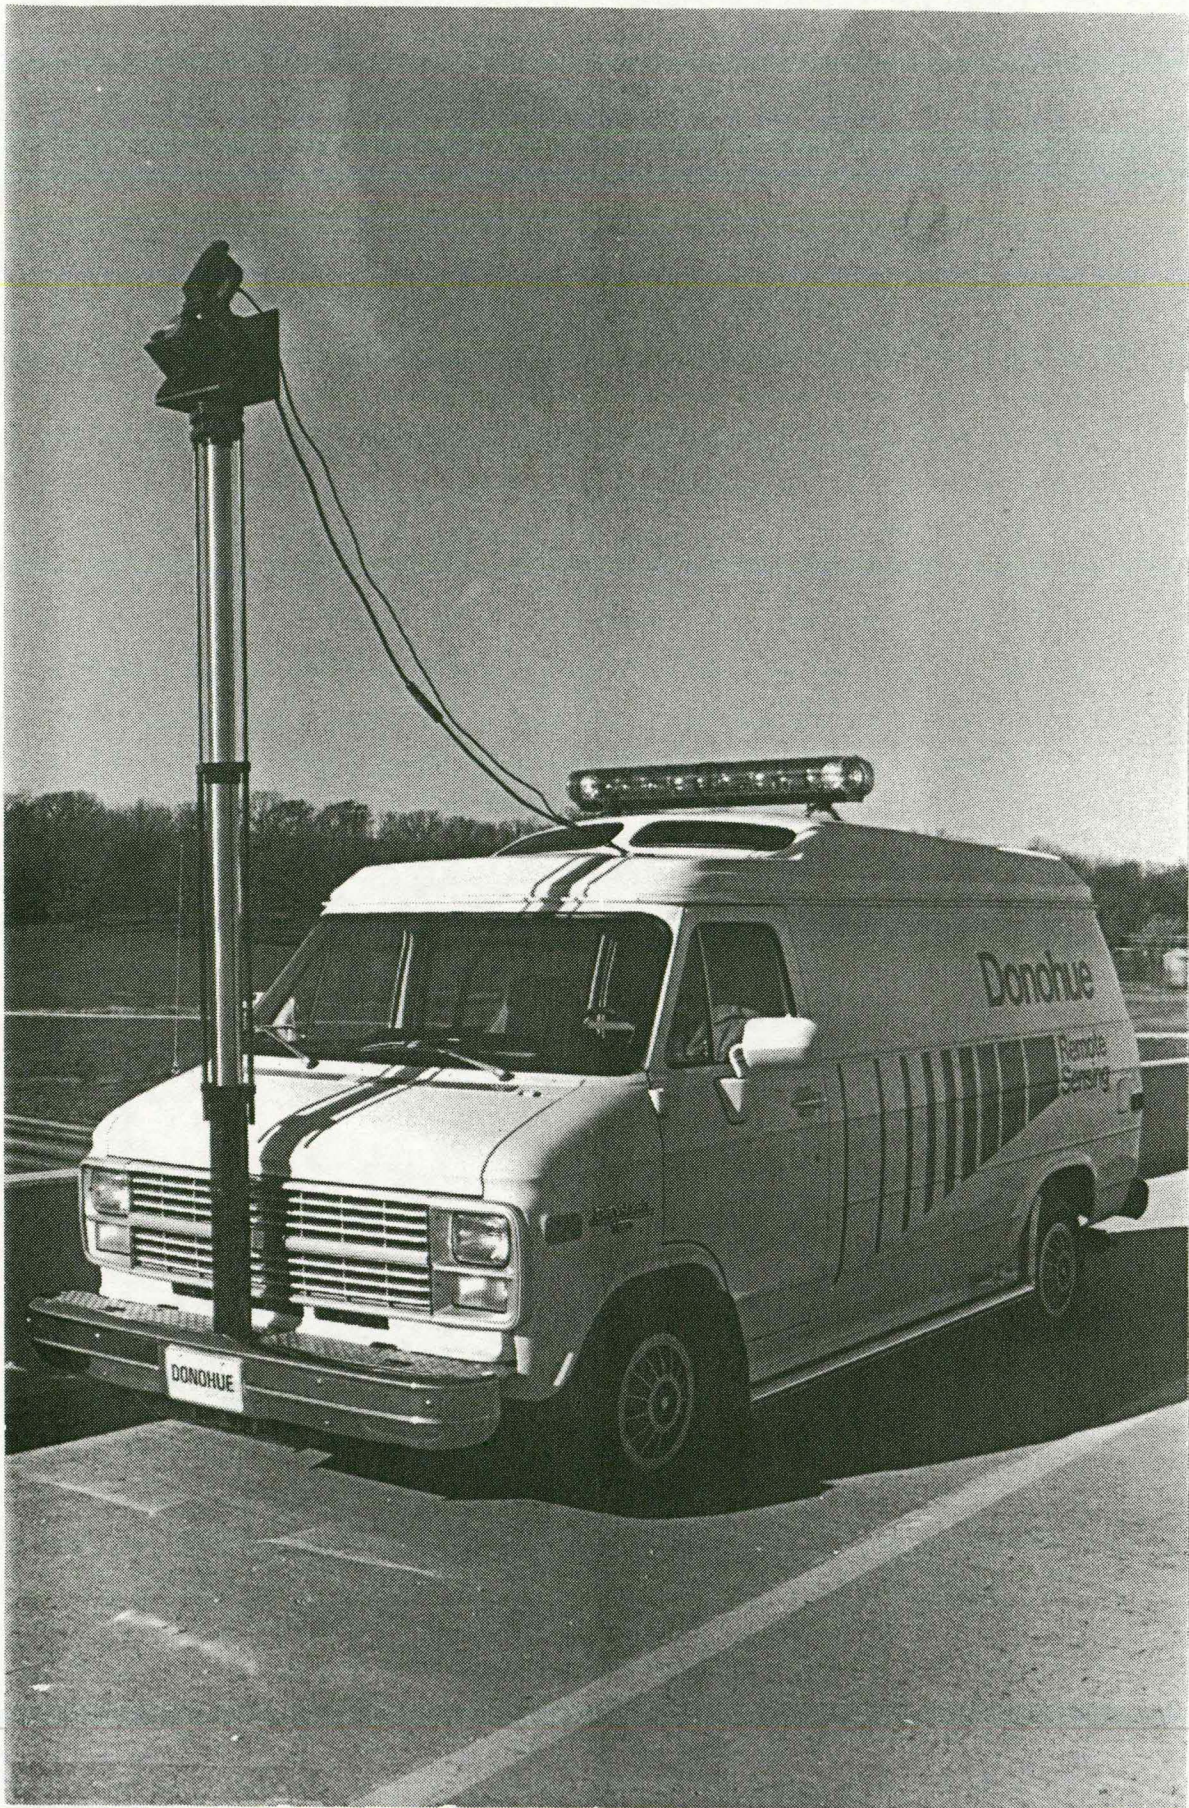
The infrared scanner and video camera were mounted on a hydraulic mast attached to the front of the inspection van and raised to approximately 14 feet above the bridge deck, as shown in Figure 6. Black and white video produced by the infrared scanner and color video produced by the control camera were displayed on monitors in the van, shown in Figure 7. The operator controlled the quality of the thermographic data being produced. The speed of the scanning van was held to approximately two miles per hour along the center of each traffic lane. A single pass was made for each selected lane of pavement.

Figure 6 Infrared data collection van

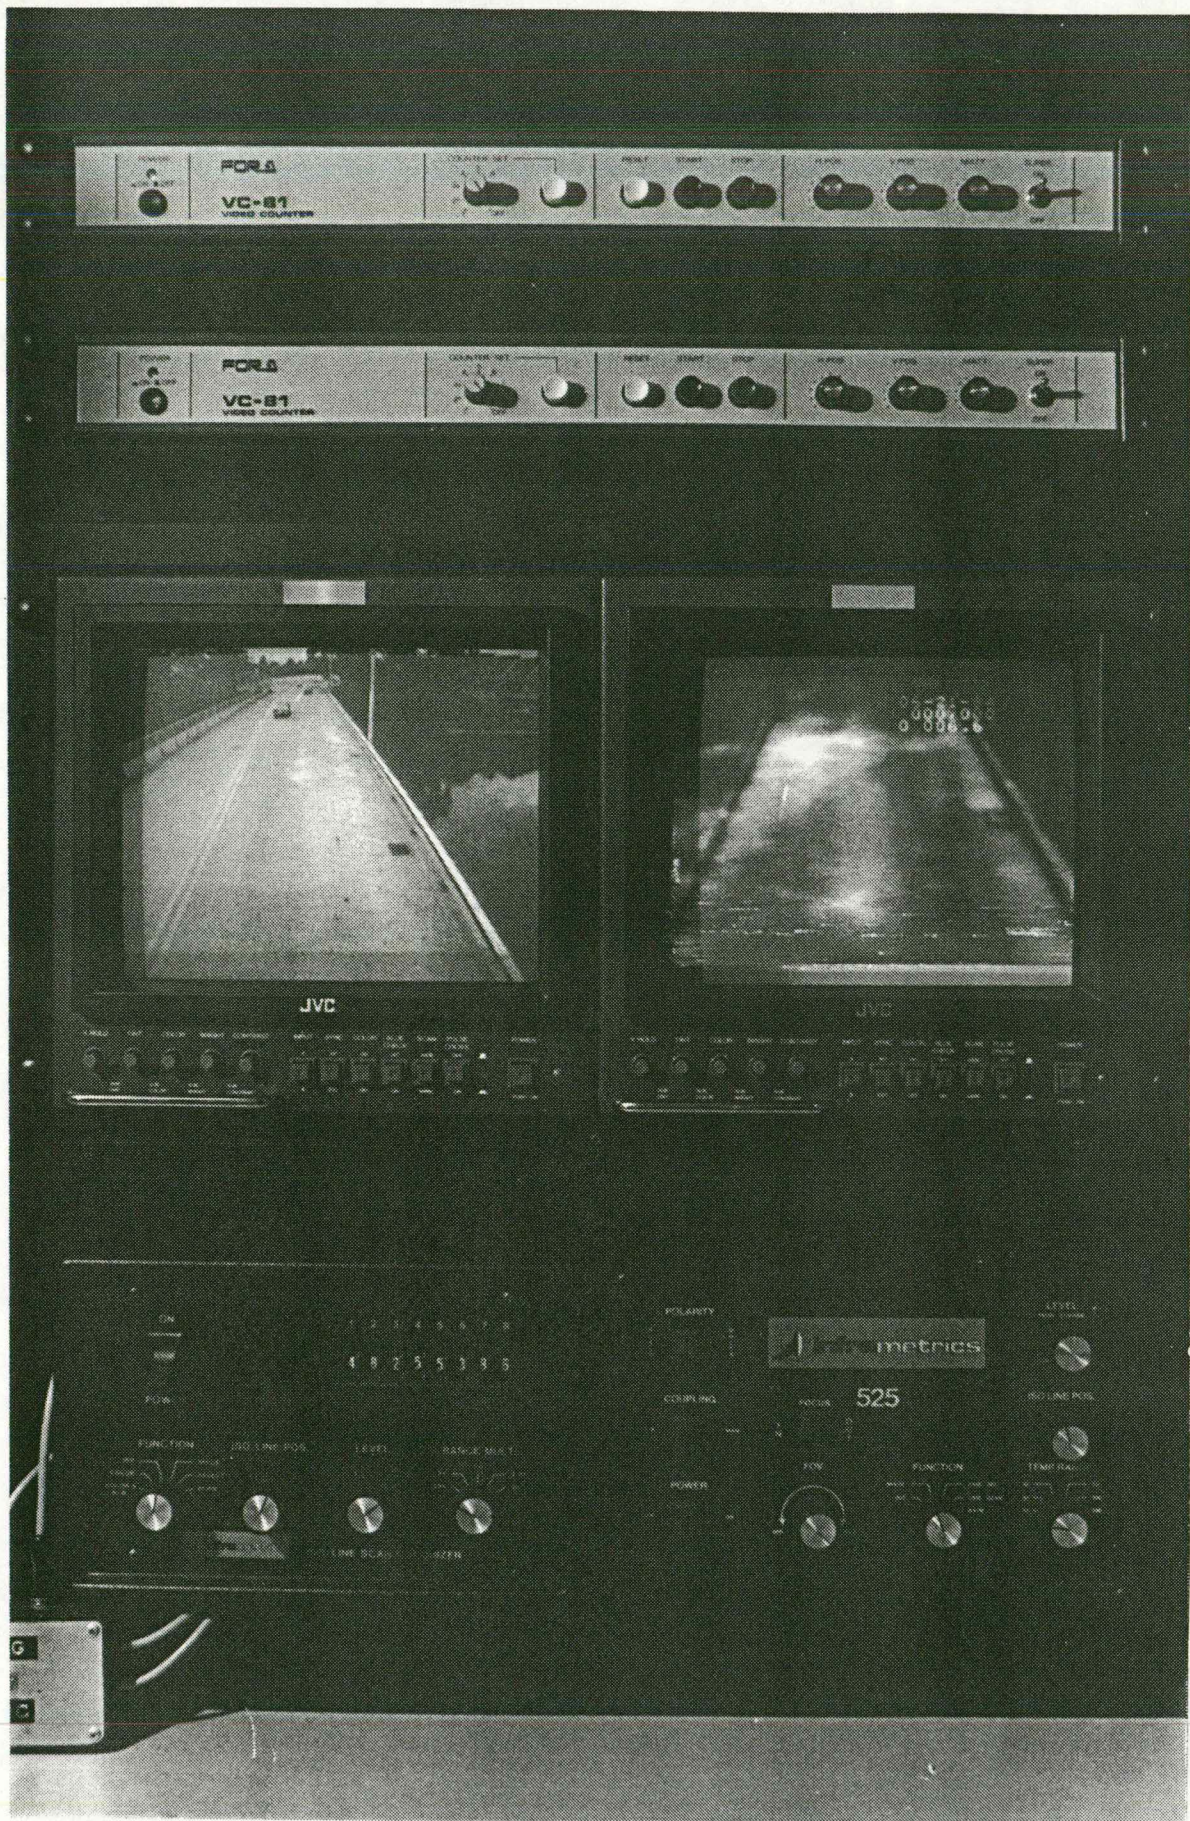
Figure 7 Interior of remote sensing van
