Vibration Monitoring of Luminaires on the Burlington Cable-Stayed Bridge

The Iowa Department of Transportation

Iowa DOT
Kenneth F. Dunker

August 5, 2002

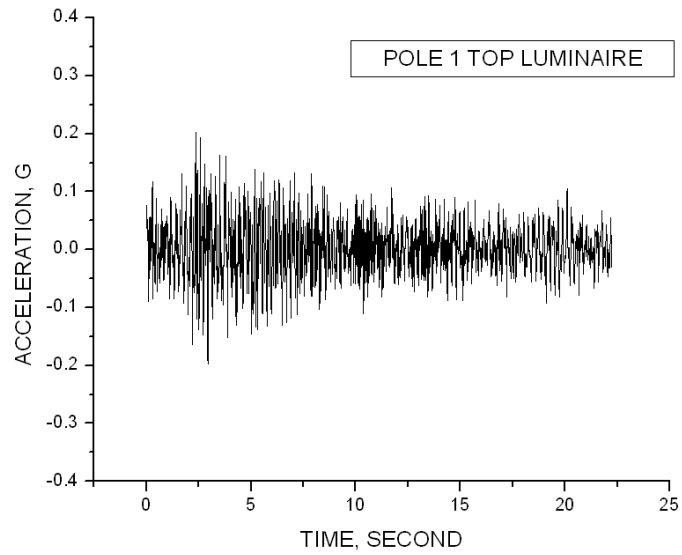
(a) Mainline Test 1, Pole 1 Top Luminaire

The data collected from these tests indicates that installing a damper on the exit ramp light pole tended to reduce the acceleration level. However, it was found that installing dampers on main span pole had no impact on acceleration levels. It should also be pointed out that it was also qualitatively noted during testing that vibration of the bridge, and also in the light poles, tended to continue for a relatively long duration after the test load had passed. Unfortunately, the testing procedure used, specifically the fact that the bridge was continuously open to traffic, did not allow for quantification of the length of these vibrations. Several general observations can be made from the data taken during the testing as follows:
