Report on
Evaluation of Interstate 80 Sign Truss

**Office of Bridges and Structures
The Iowa Department of Transportation**

Terry J. Wipf
Brent M. Phares

September 25, 2002

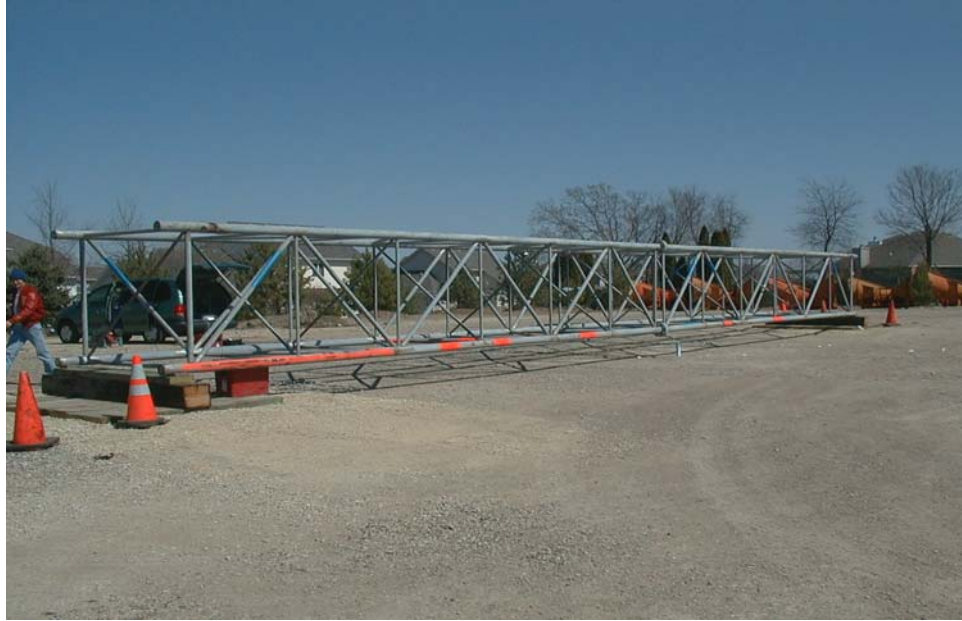
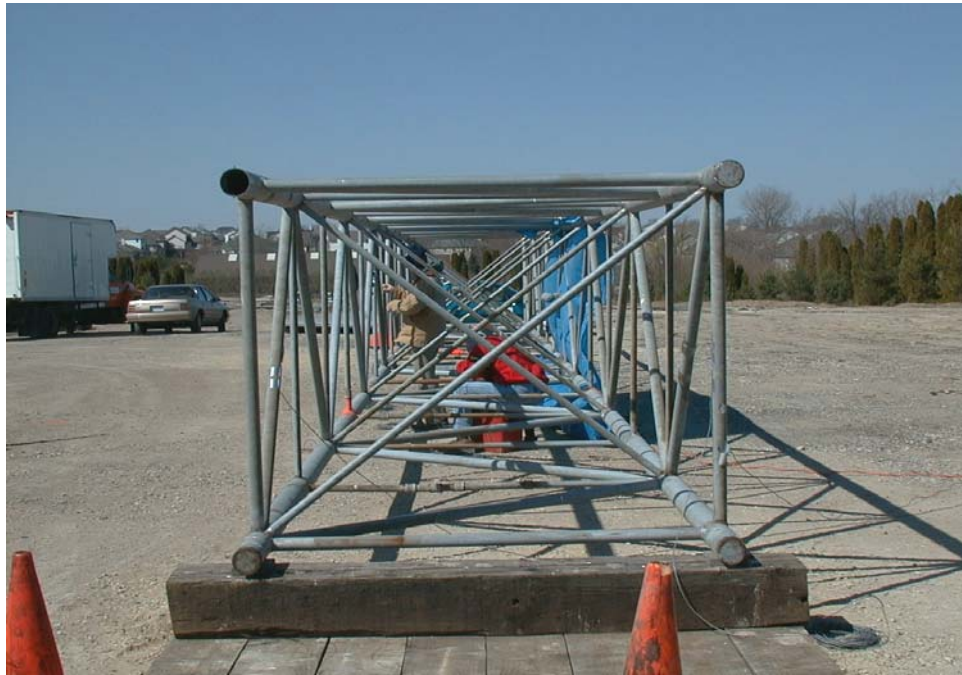
b. Side View of the Sign Truss
Figure 3. Experimental Setup.

Two load tests were conducted in March and April of 2000. Both tests were performed at the Iowa DOT maintenance garage facility after removing the damaged truss from service. Figure 3 shows photos of the test set-up. Note that the truss was rotated 90 degrees from its normal orientation so that the effect of wind loads could be simulated by applying vertical loads.

a. 3D View of the Sign Support Truss Before Testing

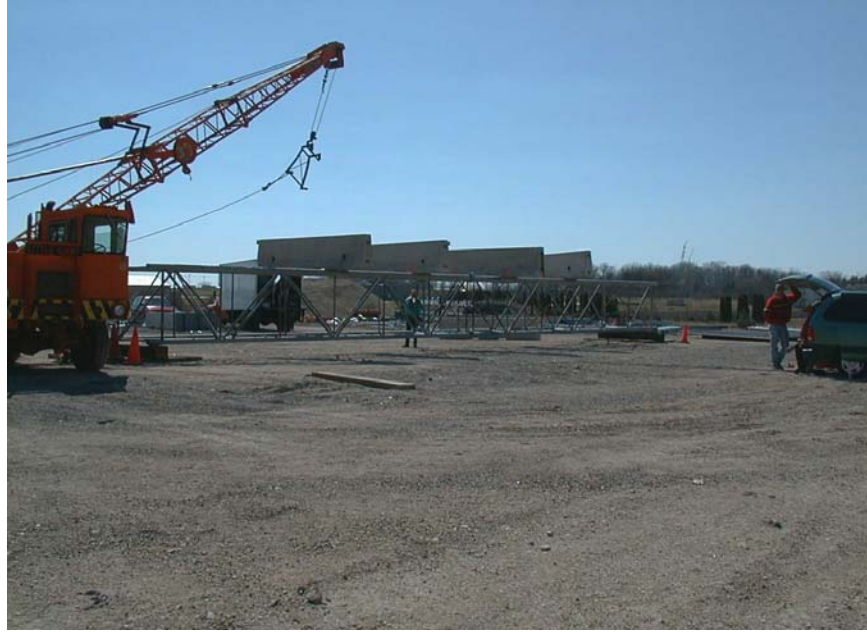
Figure 6: Sign Truss Loaded with Four Concrete Blocks

The tests were conducted by applying four concrete blocks weighing 5.0 kips each to the top of the truss (simulating horizontal wind load). Figure 6 shows a photo of the loaded truss. During the test, strain readings were taken after each concrete block was added.
