EVALUATION OF THE BETTENDORF BRIDGE, IOWA

**Final Report
July 2006**

A report from
Center for Transportation Research and Education

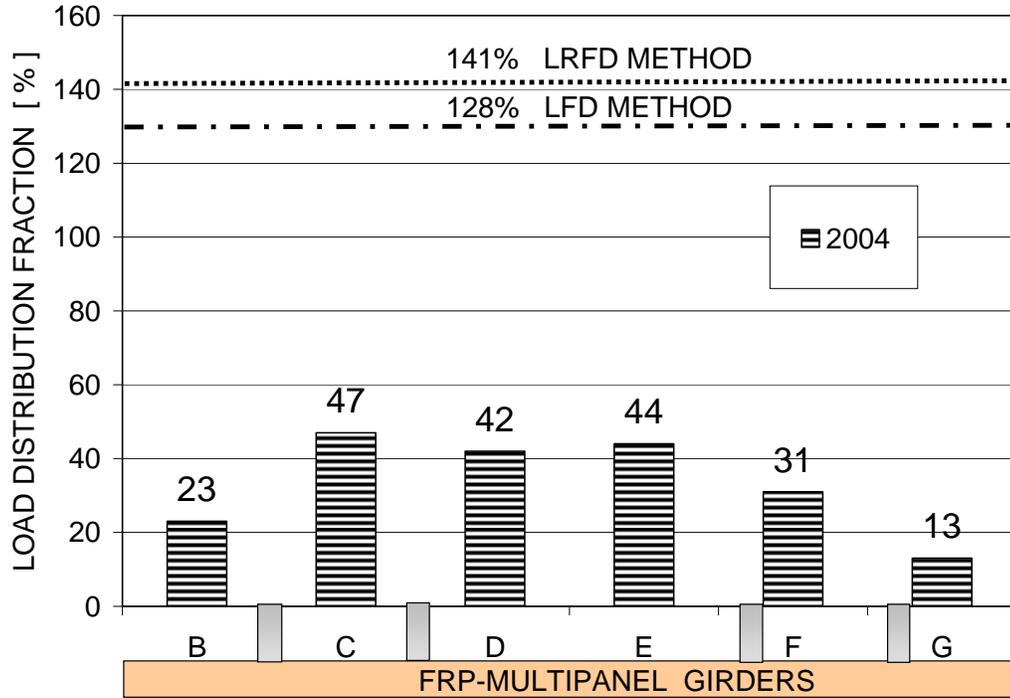
Figure 43. LDF Superposition of Paths Y1 and Y4

The LDF is defined as the fraction of the live load on each girder (AASHTO Standards, 1996). Since this bridge consists of five lanes, the design LDF was calculated as $S/5.5$ for two or more traffic lanes where S is the girder spacing in feet. The AASHTO Standard Specification provides distribution factors in terms of truck percentage. In the absence of code specifications for FRP panel decks, it was assumed by the designer that all decks behaved like an RC deck. Thus, for both spans and a girder spacing of 7 ft – 1 in., the LDF was 64.4% per wheel line (1.28 trucks). According to the AASHTO LRFD Specifications (1998), the LDFs are calculated based on the mechanical and materialistic properties of the composite section. Thus, the LDF was calculated to be 70.7% (1.41 trucks) for the FRP panel span and 62.7% (1.26 trucks) for the RC deck span. In the case of the FRP deck span, Figure 42 and Figure 43 show the LDF for three and two lanes, respectively computed by superimposing multiple passes of the test truck. The LDF per girder was calculated as a percentage of the superposition of bottom strains and assuming the linear elastic response of the bridge superstructure. As can be seen, the field results for Girders E and F were slightly lower than LFD and LRFD values. Figure 44 shows the LDF for the two tests over Path Y5 and Y6. Also, the test LDF were below the AASHTO values and no significant change was observed.

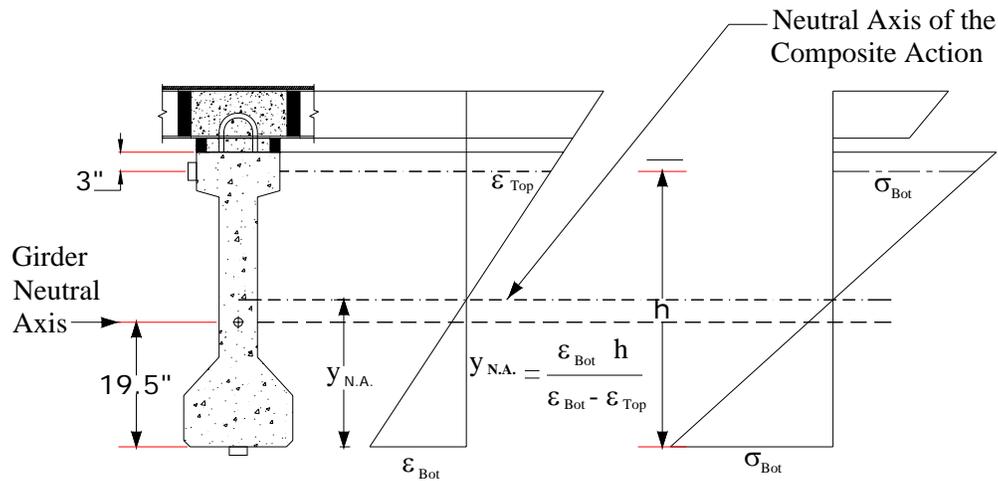
Figure 45. Evaluation of the Neutral Axis Location

To evaluate the deck-girder interaction, the neutral axis of the composite section was computed based on the gage locations and strain readings obtained from the field test (Figure 45). As reference, the neutral axis location of the bare prestressed girder was calculated as 19.4 in. from the bottom flange, based on its geometry. Calculations provided by the designer of record, with assumed material properties, indicated that the neutral axis for each span, with full composite action, was calculated to be 23.5 in. and 38 in. from the bottom flange for the FRP-deck span and the RC deck span, respectively.

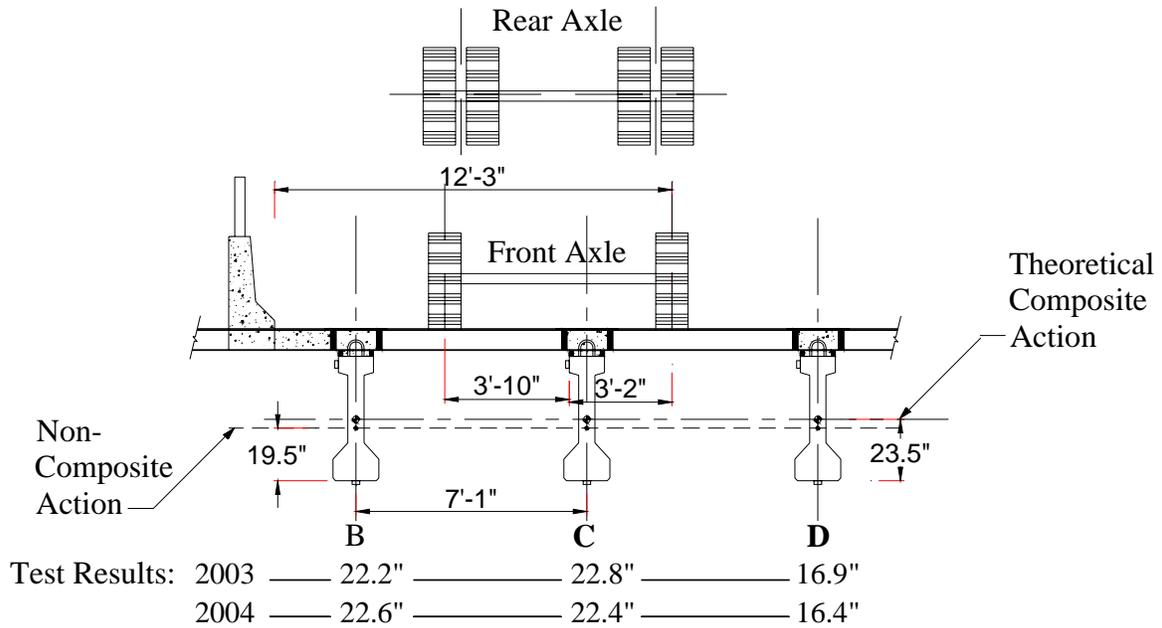
Figure 46. Neutral Axis: 2003 and 2004 Tests - FRP-deck span – Path Y1

The experimental neutral axis locations were determined for all transverse load positions. Figure 46 shows the neutral axis results for Path Y1 measured from the bottom flange over the most heavily loaded girders. As can be observed, the neutral axis locations did not significantly change over time. For Girders B and C, the values obtained show that composite action was likely achieved. For Girder D, the measured neutral axis location was below even the non-composite action (girder's neutral axis location, 19.4 in.). This can likely be attributed to a weak shear connection and the possibility of torsion effects of the truck loading typically ignored during design. This observation is validated later.

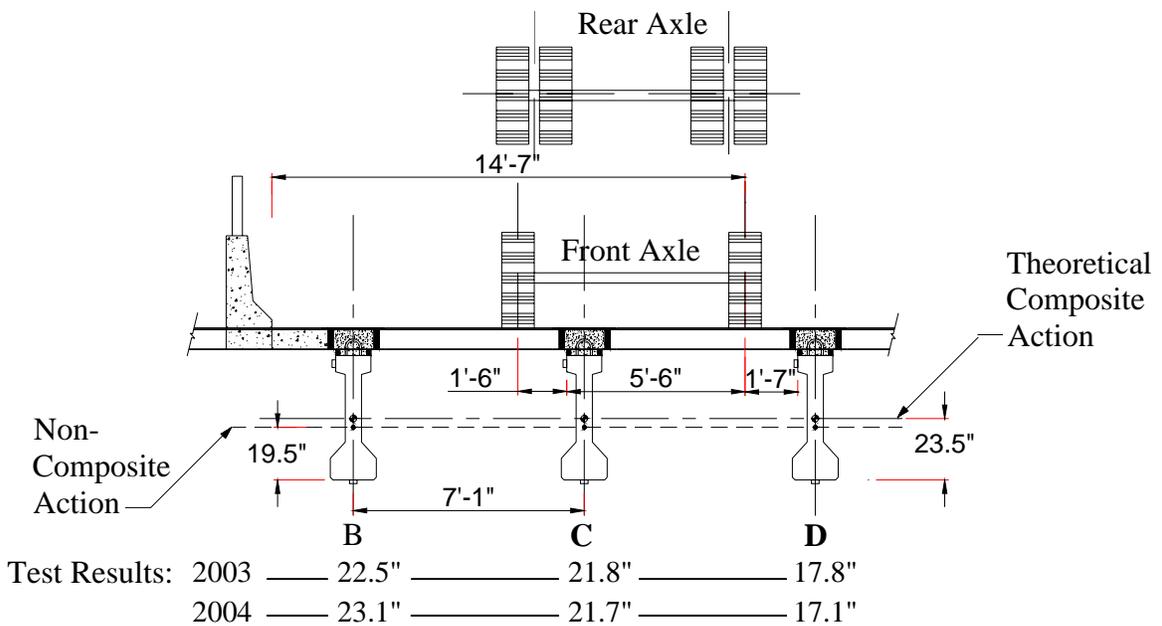
Figure 47. Neutral Axis: 2003 and 2004 Tests - FRP-deck span – Path Y2

For Path Y2, Girders B, C and D were the most heavily loaded. Figure 47 shows the wheel positions relative to Girders C and D and the resulting neutral axis locations for both tests. Girder D's measurements again indicated a neutral axis position below the neutral axis of the girder alone.

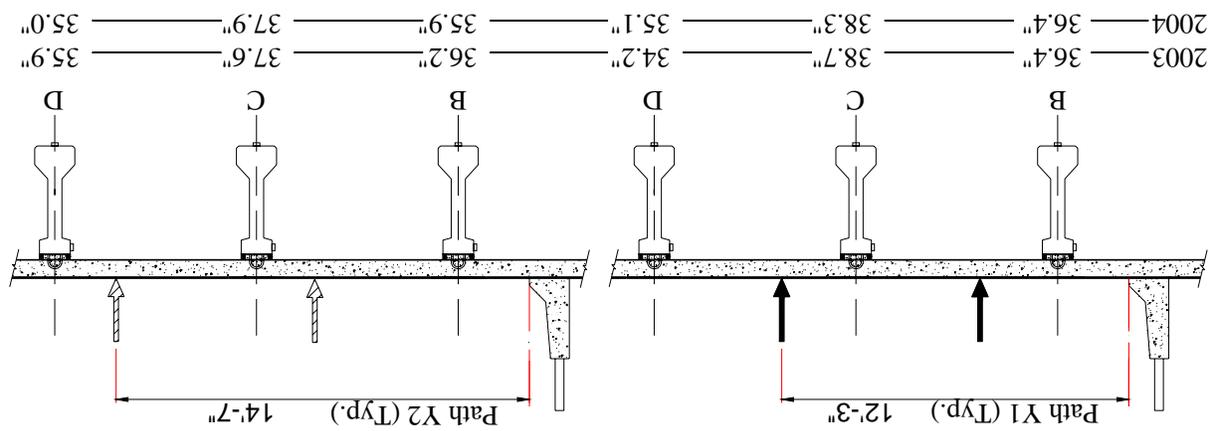
Figure 48. Neutral Axis: 2003 and 2004 Tests - RC Deck Span Comparison

Figure 48 shows the location of the neutral axis in the RC deck span for the two tests. The values were similar between the two tests and indicated that a high degree of composite action was likely achieved (design neutral axis of 38.0 in.).

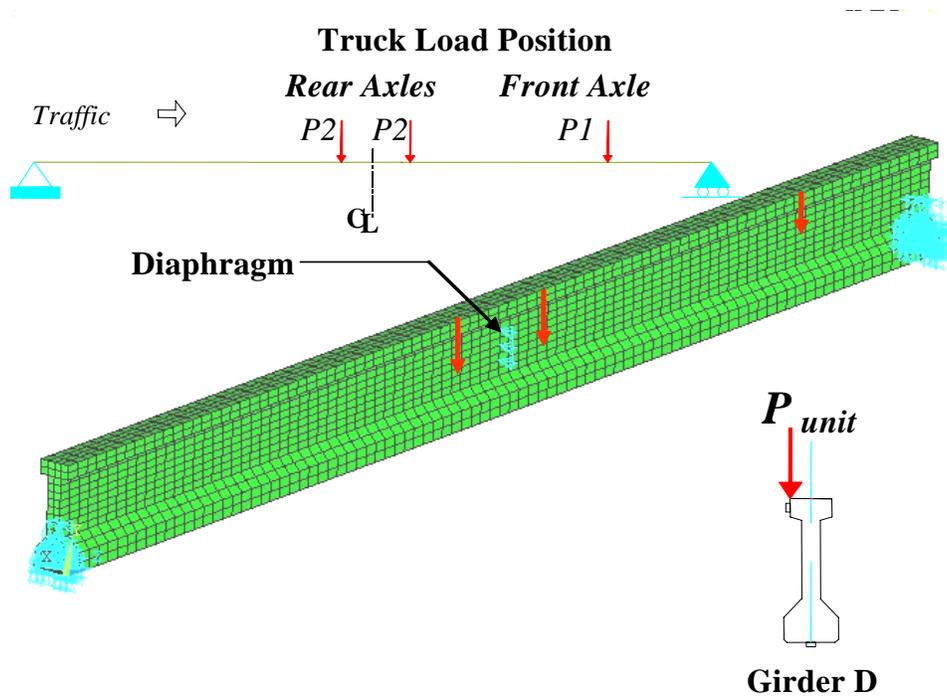
Figure 49. Analysis of Eccentric Load on Interior Girder D

To evaluate the impact of torsion in either Girder D or E, a single prestressed girder was modeled using a commercial finite element program. In this modeling, a three-dimensional element with simply supported ends and an intermediate diaphragm was used. The specific geometric and material properties used in the Bettendorf bridge were modeled. As shown in Figure 49, loads were placed at a position causing high load bearing stresses. Two specific cases were studied. In one case, the loading consisted of applying eccentric unit loads to cause torsion and bending in the girder. The other case considered centered loads applied on the girder which only caused bending.

The results of the torsional loading analysis showed that the absolute strains on the top flange were larger than the strains on the bottom flange, contrary to the results found for the flexural only loading analysis. It should be noted that for both loading cases, the same strain levels were obtained on the bottom flange. This can be explained as follows: without restraint (mid-span condition) the flange can warp and bend about the minor axis of the girder (Figure 50). Thus, the gage on the top flange captured two effects: pure bending and warping due to torsion. For the bottom flange, warping stresses are zero at the location when the strain transducers were placed. Thereby, when the neutral axis location was computed based on the gage positions and strains, similar to the field neutral axis computation, the increased top strain shifted the neutral axis down. For the torsional loading analysis, the obtained neutral axis was approximately 17 in., measured from the bottom flange, and was approximately 20 in. for the flexural loading analysis.

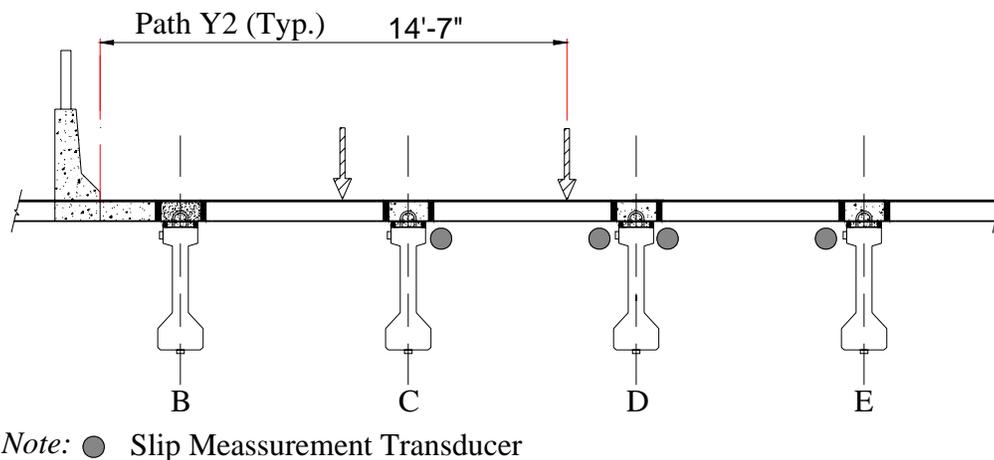
Figure 51. Location of Slip Instrumentation with Respect Path Y2

Figure 51 shows the location of four slip-measurement transducers installed underneath the FRP panel on the top flange of Girders C, D and E. As expected, the differential horizontal displacement (slip) between the concrete girder and the FRP deck was found to be greatest when the truck was in the immediate vicinity of the instrumentation locations. The most critical case for these specific girders corresponded to Path Y2.

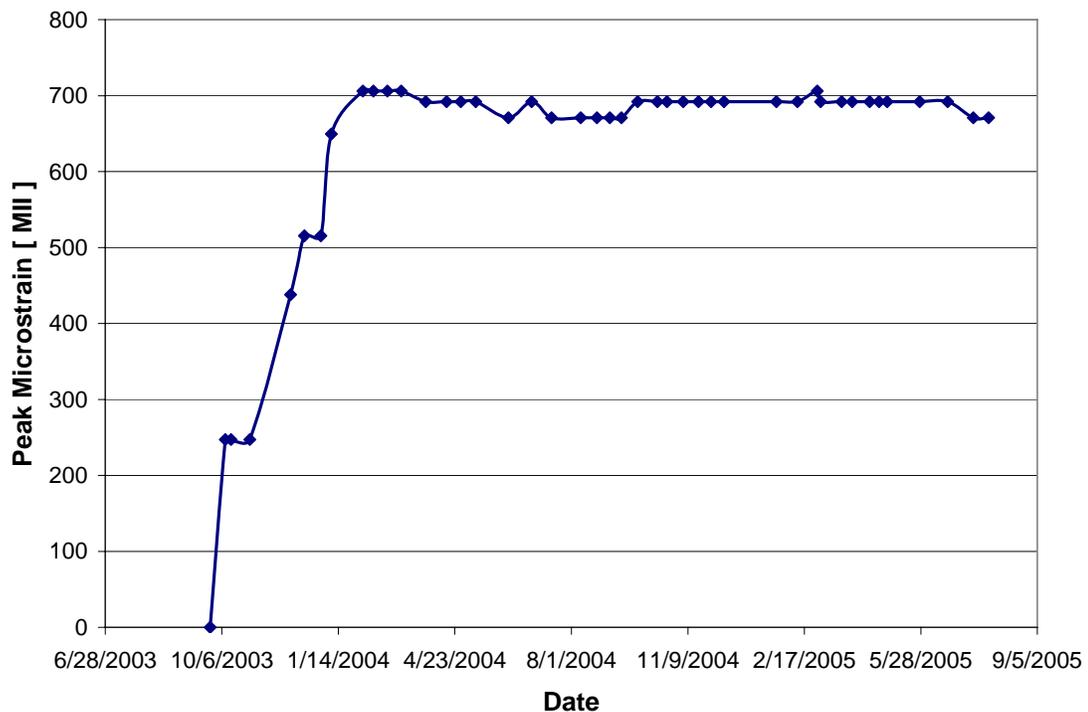
Figure 56. Girder B: Peak Strain Results

Figure 56, Figure 57 and Figure 58 illustrate three representative graphs of peak strain versus time. As can be seen in these graphs, the girders each reached peak strains that were between 650 and 750 MII. The consistency between the peak strains for the various girders indicates that there were very small differences in the response of the girders. It should be pointed out that 650

to 750 MII assuming an modulus of elasticity of 4 ksi corresponds to stress levels in the range of 2.6 to 3.0 ksi and are significantly higher than the strain levels measured during short-term testing. It was found, to the surprise of the research team, that the peak strain gages used in this work were not temperature corrected as the manufacturer had claimed. Therefore, the peak strain recorded by the sensors was the peak of temperature strains plus live load strains. In this case, the strains induced by temperature effects are several times greater than those one would expect under live load. Thus, the research team used a different approach to assess whether damage had occurred. To accomplish this, the research team analyzed the air temperature and active strain data (which when the bridge is unloaded represents temperature strain only) to identify changes in bridge stiffness. Although not a direct assessment of the likelihood of overload, when combined with the visual inspection results presented herein, the research team believes that the observed deterioration was the result of an overload event. Shown in Figure 59, Figure 60 and Figure 61 are examples of the temperature and active strain data for select girders. As can be seen, there is good correlation between the active strain levels and the ambient air temperature. This indicates that the girders were consistently responding to changes in temperature and that there was not likely any damage that would have occurred from an overloaded truck.
