Testing and Evaluation of the Iowa DOT FRP Temporary Bypass Bridge

Bridge Engineering Center

Final Report • March 2008

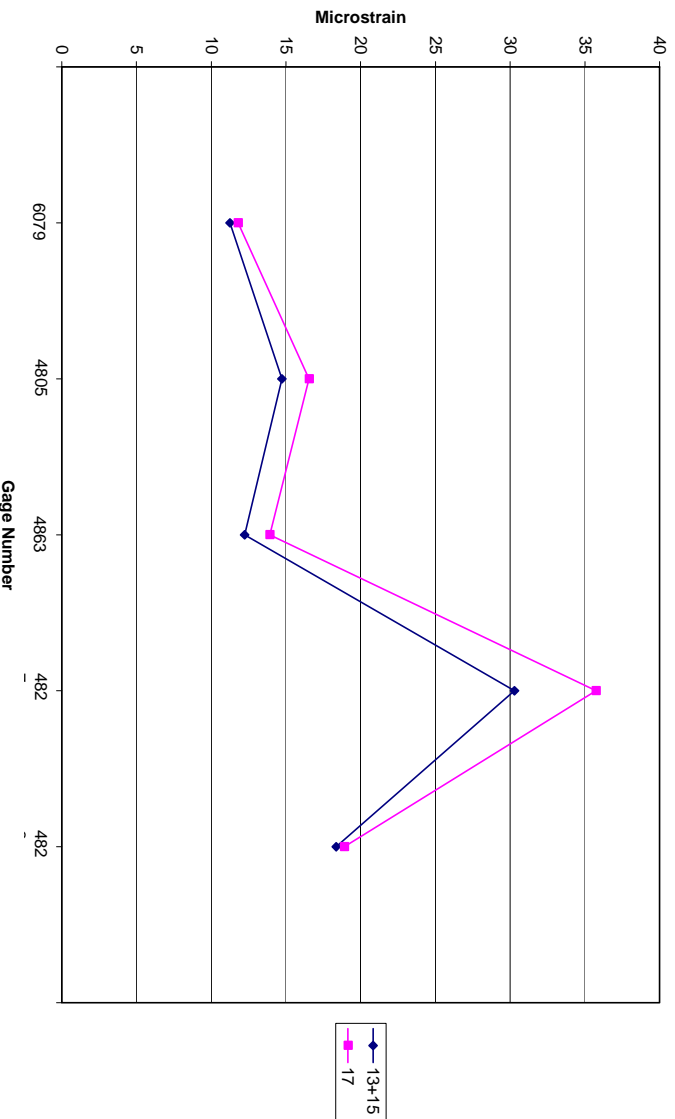
This preliminary testing was helpful in establishing a level of confidence in the performance of the bridge and test set-up. Illustrated in Fig. 19 are the midspan strains profiles for an individual deck panel loaded with two point loads simultaneously (load case 17) as well as the same two point loads loaded individually and then superimposed (load cases 13 and 15). Figure 19, and other data, confirms that the principle of superposition is applicable. Preliminary testing also confirmed that calculated maximum mid-span strains correlated well with maximum measured mid-span strain for a legal load truck.

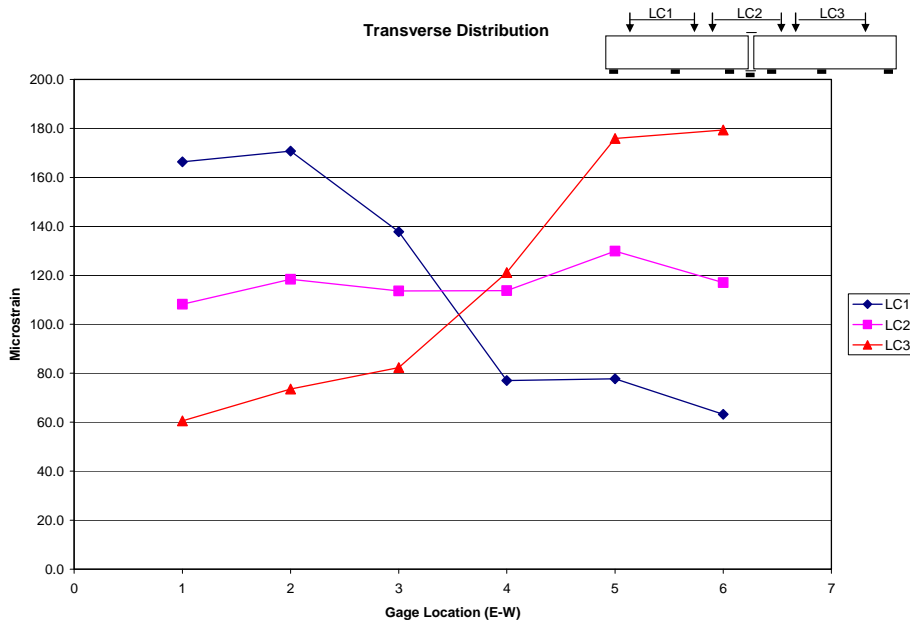
Figures 27 and 28 illustrate the transverse distribution of strain at mid-span for a single lane loaded and two lanes loaded, respectively (similar transverse distribution was calculated at quarter-span but is not shown here). The two lanes loaded case was approximated by superposition of LC 1 and 3. As shown, it is evident that the distribution of strain is relatively symmetric about the longitudinal centerline of the bridge, which suggests adequate load transfer from panel to panel by the steel connection plates. Note that SG7 strain data are not shown in Fig. 27 or 28; these data represent the strain on the steel connection plates. Generally, the strains measured in the steel connection plates were smaller in magnitude than those in the FRP, possibly the result of slip occurring between the connection plate and the panels as well as other factors.

Figure 27. Transverse load distribution at mid-span for all three load cases.

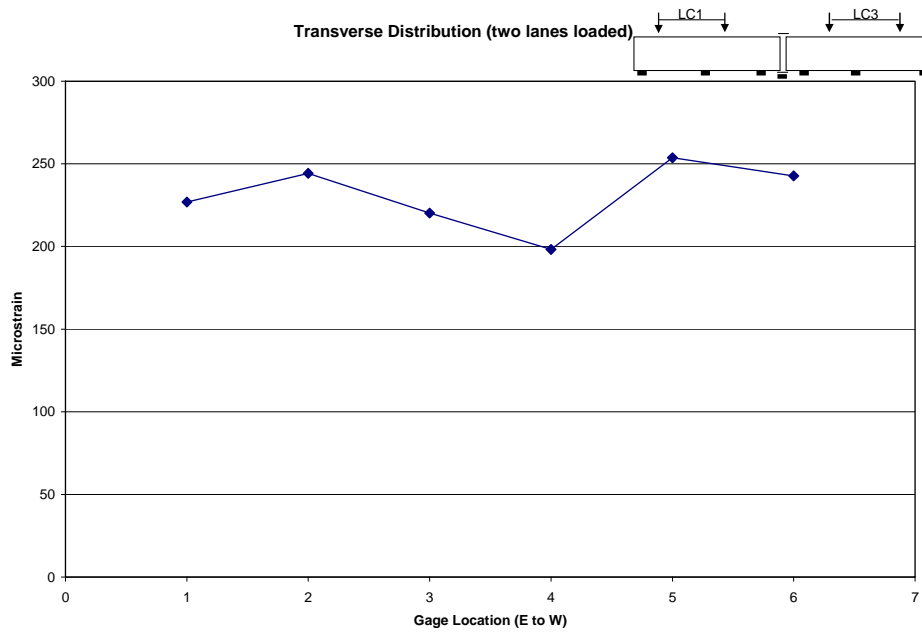
Figure 28. Transverse load distribution at mid-span, two lanes loaded.

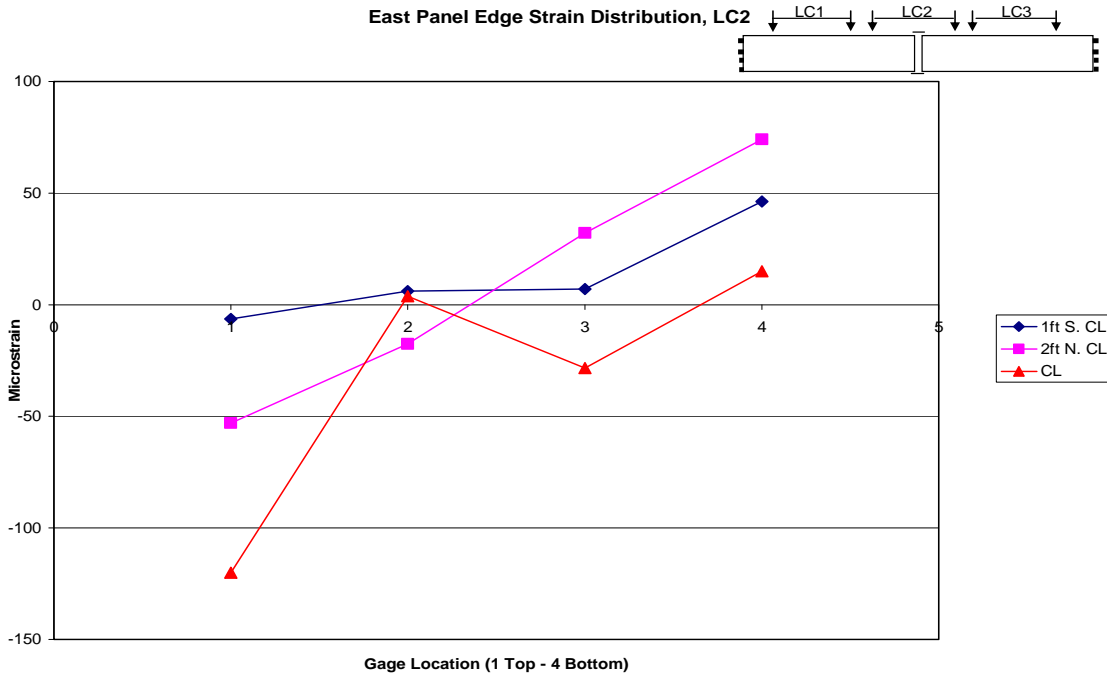
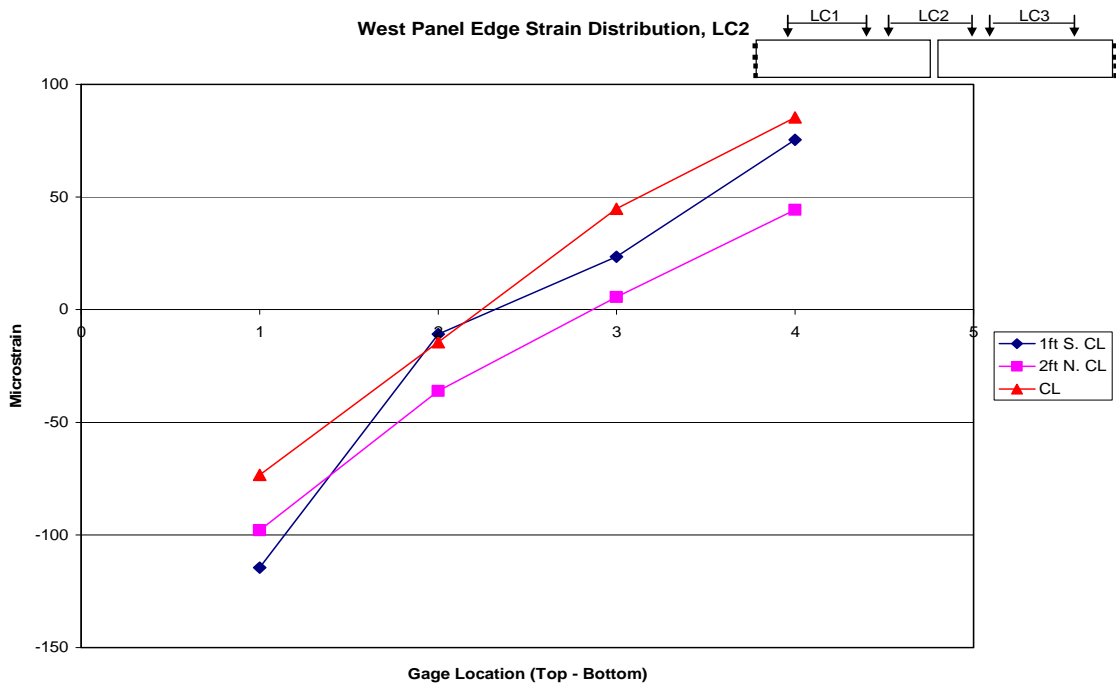
For testing, three vertical cross-sections were instrumented on both the East and West side of the bridge (1ft south of centerline, centerline, and 2 ft north of centerline, see Fig. 29), with four gages placed throughout each cross-section. Figures 30 and 31 illustrate the vertical strain distribution at each location for the East and West sides, respectively, for LC2 which is representative of all load cases. Figures 30 and 31 suggest that there are differences in the neutral axis location from cross section to cross section on the sides of the panels; additionally, Figure 24 also illustrates that the neutral axis may vary across the width of the panel. The reasons for the variability in neutral axis from cross section to cross section are unknown.

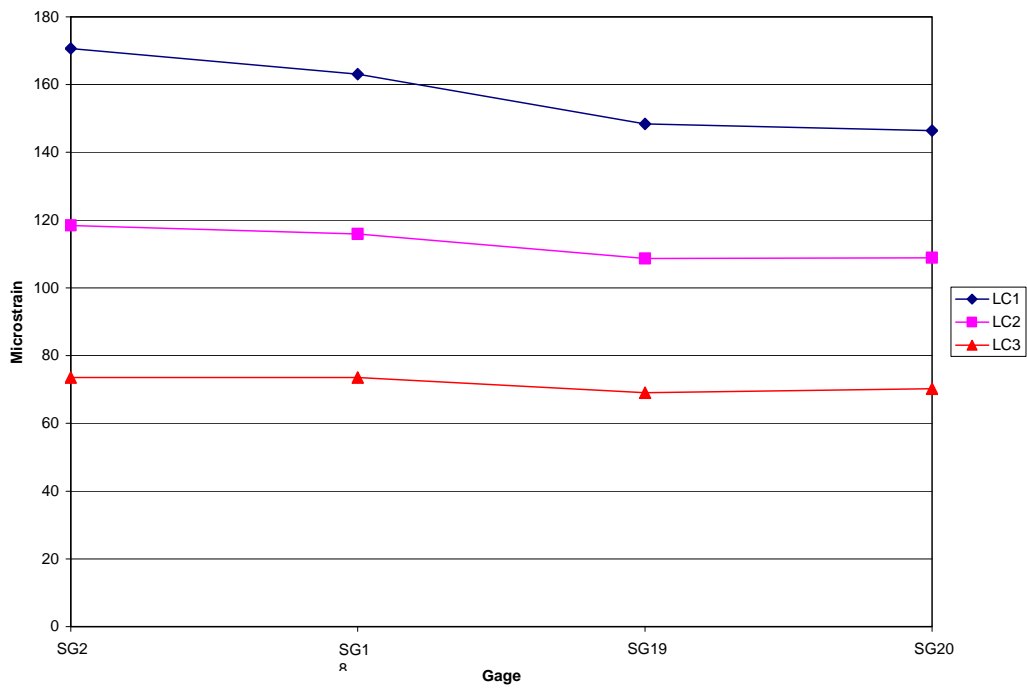
Figure 32 illustrates the strain profile for gages SG2, SG18, SG19 and SG20, on the bottom of the deck for all three load cases. It is evident from Fig. 32, that transverse distribution of load from bottle to bottle is adequate and relatively constant regardless of load position.

Figure 32. Transverse strain distribution from bottle to bottle.

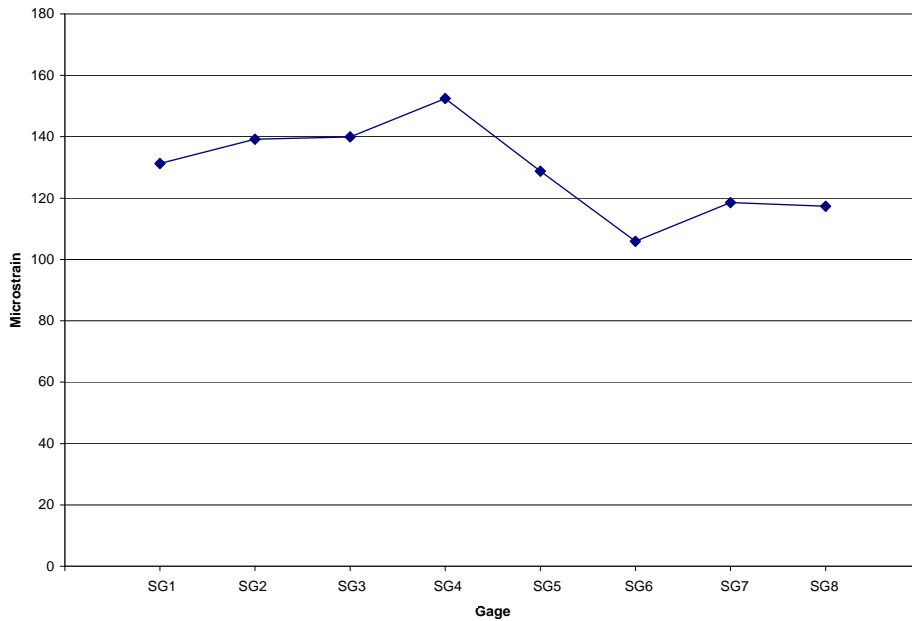
Figure 37. Transverse strain distribution at midspan, on site load test, 8/15/07.
