# ***EPOXY PAVEMENT MARKING SYSTEM***

IOWA HIGHWAY RESEARCH BOARD  
FINAL REPORT HR-180

EVALUATION OF AN  
EPOXY PAVEMENT MARKING SYSTEM

FINAL REPORT  
IOWA HIGHWAY RESEARCH BOARD  
PROJECT HR-180

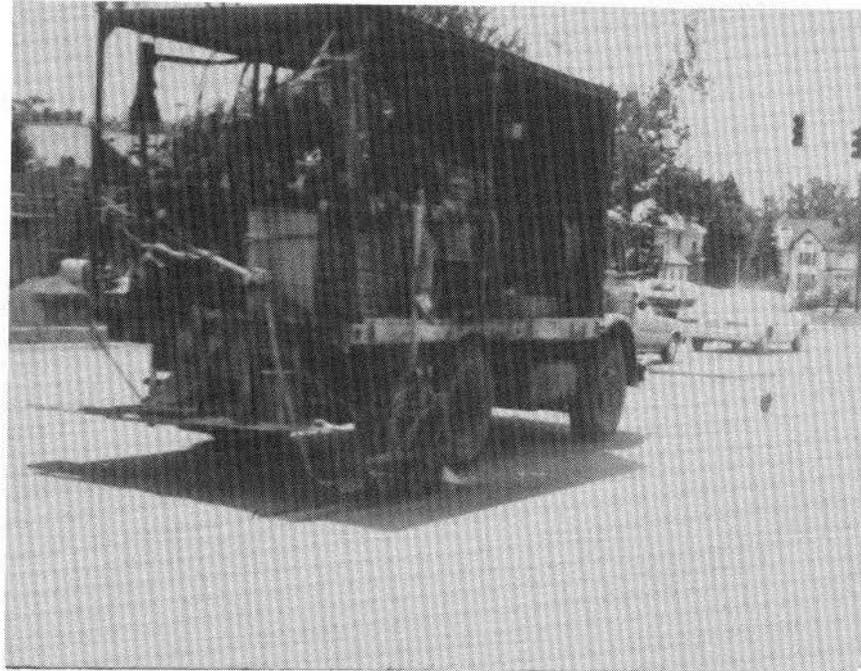
Figure 2: Truck and equipment for applying epoxy paint lines

The epoxy paint was applied by equipment mounted on a standard truck body (Figure 2). Again the operation was carried out at night and DOT maintenance personnel provided traffic control.
