C E N T E R F O R
**PORTLAND CEMENT CONCRETE
PAVEMENT TECHNOLOGY**

Measuring Pavement Profile at the Slip-Form Paver

May 2005

Sponsored by
Federal Highway Administration (Project 12)
and the Iowa Highway Research Board (Project TR-512)

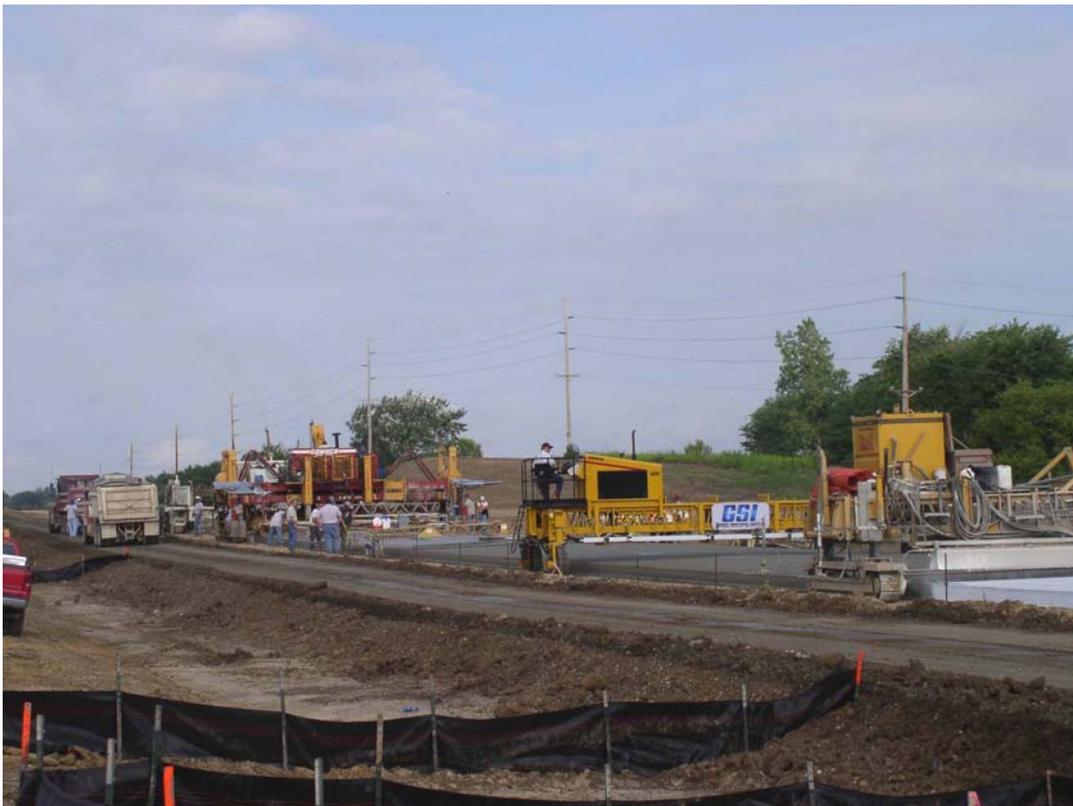
Data were collected using the GOMACO Smoothness Indicator (GSI) on U.S. Highway 30. A total of six wheel path sensors and two computers were used to collect the data. One computer was mounted to Manatt's GOMACO Model 3000 slip-form paver along with four traces, one located in each wheel path. The other computer was mounted to a GSI vehicle along with two traces. See Figure 1.

Figure 1. GSI testing on U.S. Hwy 30 westbound from Tama to Le Grand, Iowa

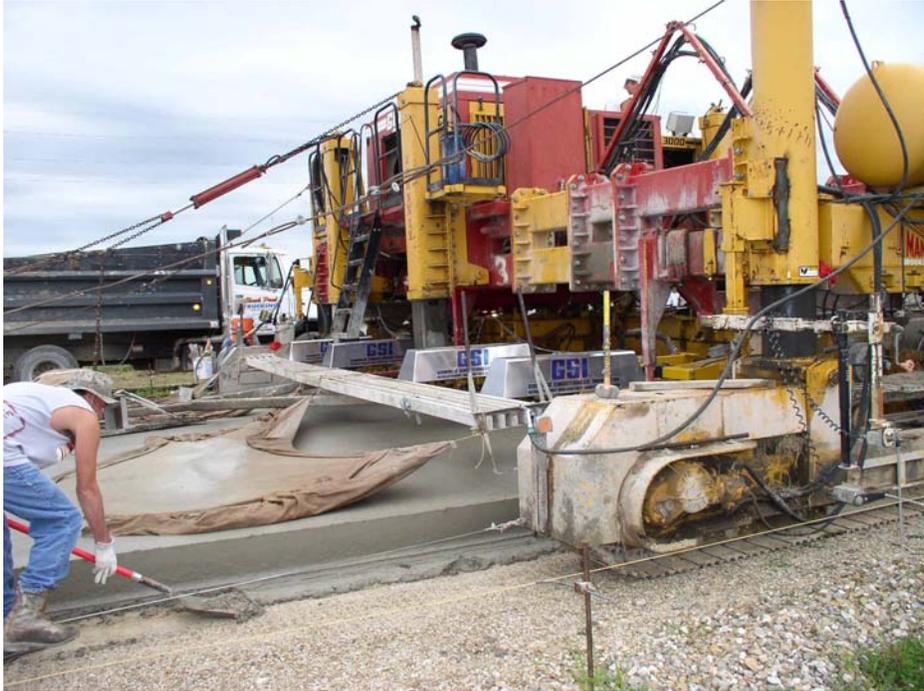
The arrangement of sensors changed throughout the study. For the first three days, the four traces were located behind the paver pan, and two additional traces were tested after the cure/texture machine. For the final three days of testing, three traces were attached to the paver pan, and an additional trace was placed on the v-float in-line with a trace on the paver pan. The GSI vehicle was located behind hand finishers but in front of the cure/texture machine, which also had two traces, one that was in-line with the paver pan and the v-float traces. See Figure 2.

Figure 2. GSI arrangement over each wheel path (Arrangement 1)

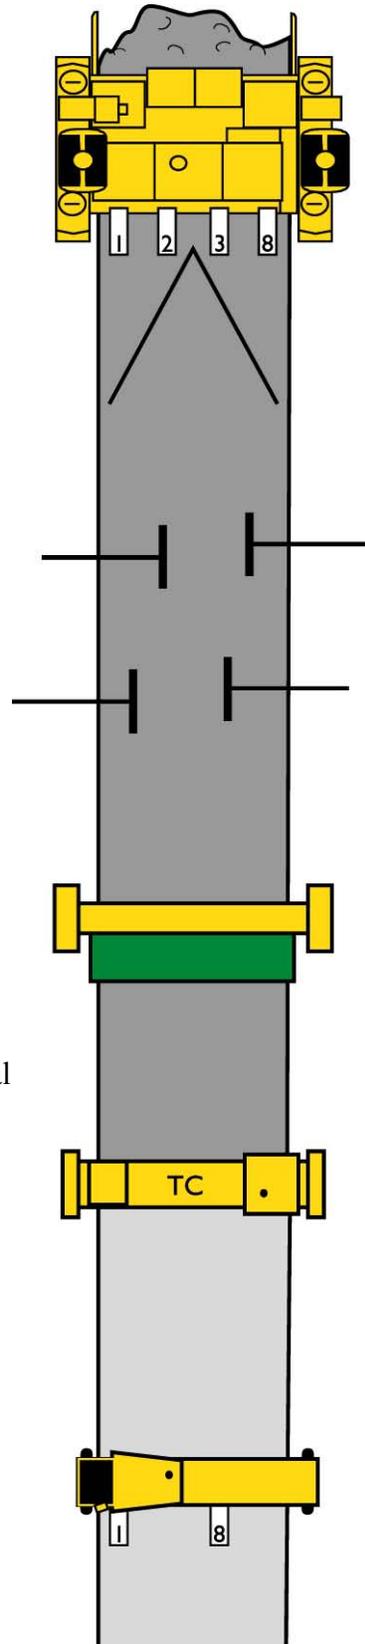
Arrangement 1

Four traces mounted to paver:

- Trace 1 Inside Lane – Outside Wheelpath
- Trace 2 Inside Lane – Inside Wheelpath
- Trace 3 Outside Lane – Inside Wheelpath
- Trace 8 Outside Lane – Outside Wheelpath

Two traces mounted to GSI vehicle,
located after cure/texture machine:

- Trace 1 Inside Lane – Outside Wheelpath
- Trace 8 Outside Lane – Inside Wheelpath

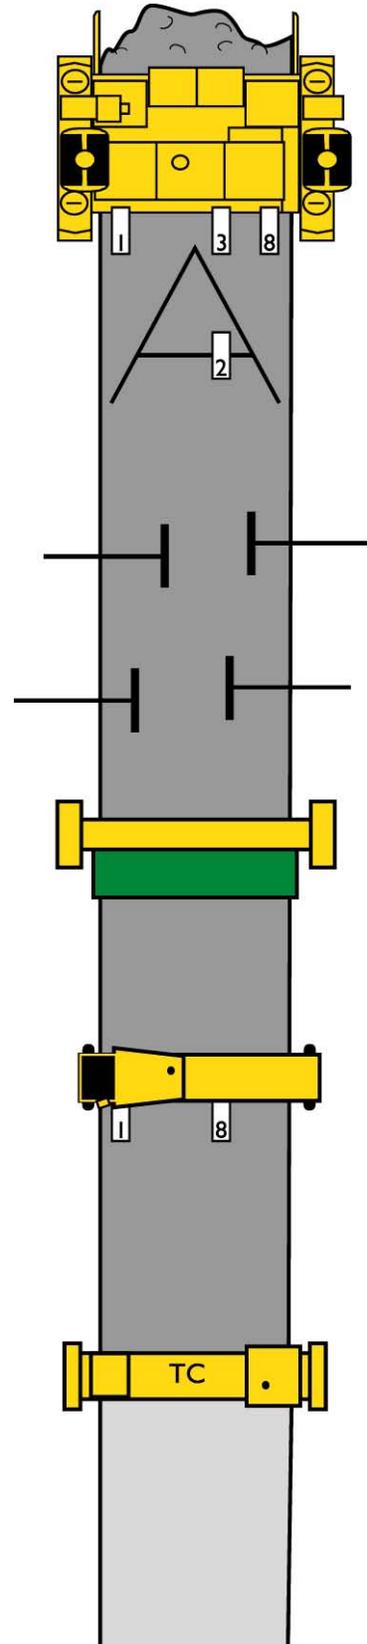
Arrangement 2

Four traces mounted to paver:

Trace 2 is located on V-Screed 30 ft behind trace 3 on paver.

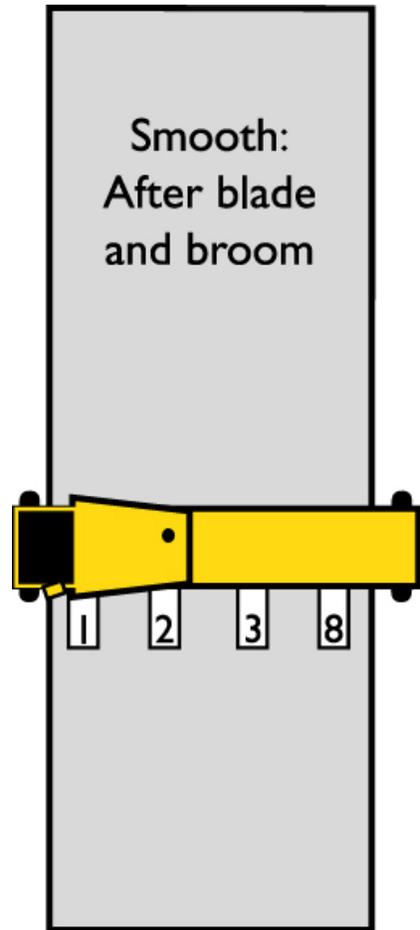
Arrangement 3

Four traces mounted to GSI vehicle:

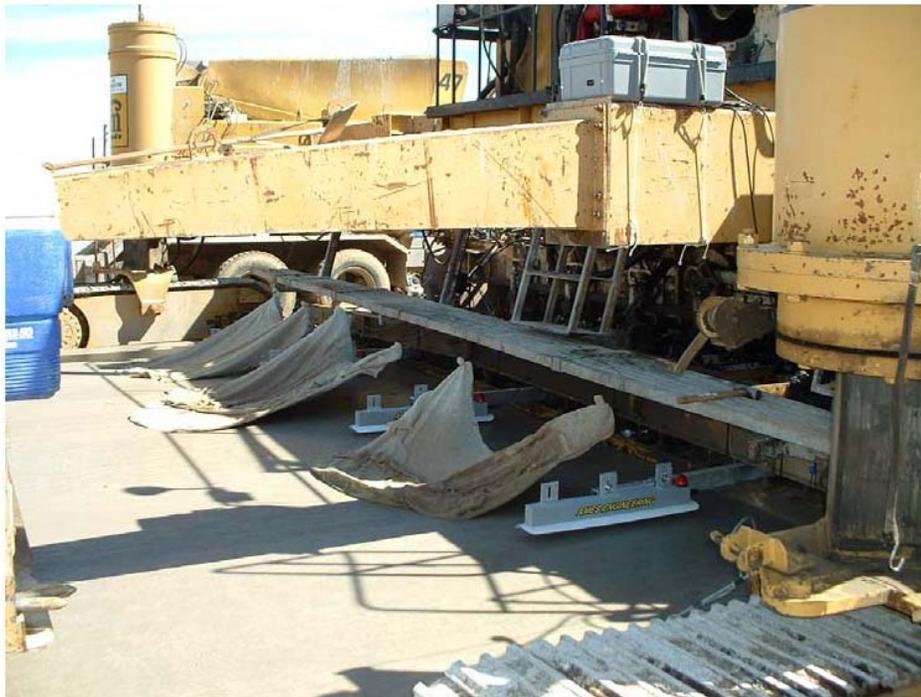
The first configuration used four sensors attached across the concrete slab; sensor one was located in the outside wheel track of the passing lane and the three additional sensors were placed consecutively across the slab in each wheel track. See Figure 3.

Figure 3. RTP beams attached in each wheel track

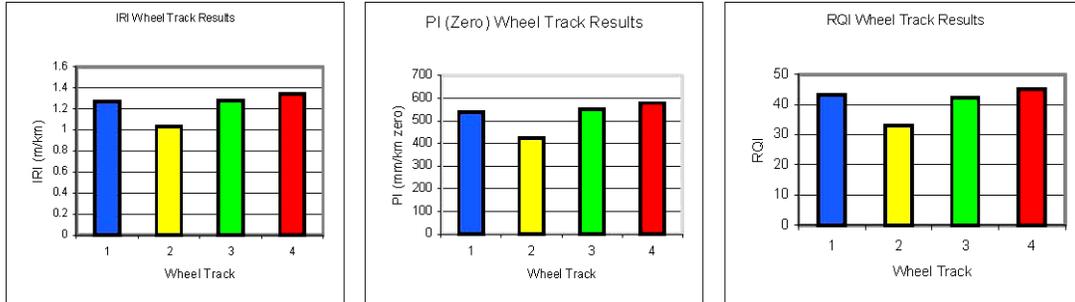
The three indexes compared were the international roughness index (IRI), the Profilograph index with a zero blanking band, and the Michigan ride quality index (RQI). Figure 4 shows bar plots of the RTP results of the three indexes compared for section one of the four sections tested. The 300-meter section was broken into 3 sections of 100 meters each. The average of the three sections is shown in the table and plots in Figure 4 below. The results in Figure 4 indicate that track four was the roughest wheel track. Wheel track one is slightly rougher than section three, and track two is the smoothest track. Figure 5 shows the results for the identical section tested by the LISA TriODS profiler. The results for each section tested followed this pattern. The index measurements for the RTP compared quite well to the LISA TriODS data. Both devices also show the same pattern of the inside wheel track data being smoother than the outside wheel track data. Wheel track two was almost always the smoothest of the four wheel tracks measured. Appendix A contains a table presenting the entire data set from RTP analysis, and Appendix B contains the entire data set for the LISA TriODS analysis.

Figure 4. RTP section 1 index results

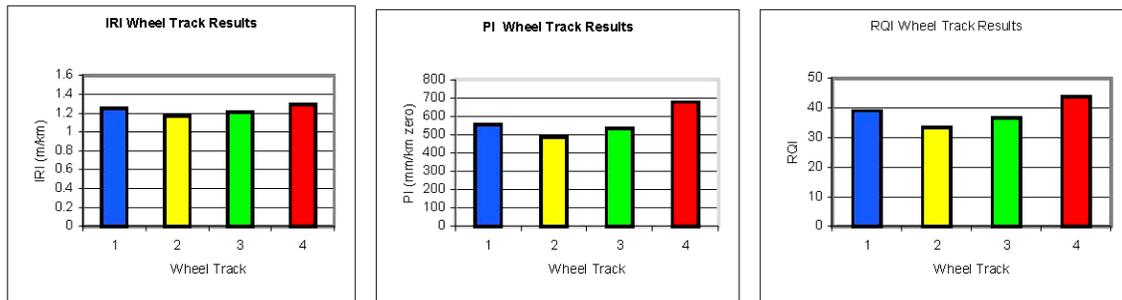
Figure 5. LISA TriODS section 1 index results

To help understand how the roughness is distributed across all four wheel tracks, four sections of 300 meters each were examined from data collected from the RTP and data collected later from the LISA TriODS system. For each section, the data were broken into 100-meter segments and the average for the 3 sections was recorded. The LISA data were high-pass filtered with a third order Butterworth filter set to 15.24 meters, which is identical to the filter setting used on the RTP during data collection.

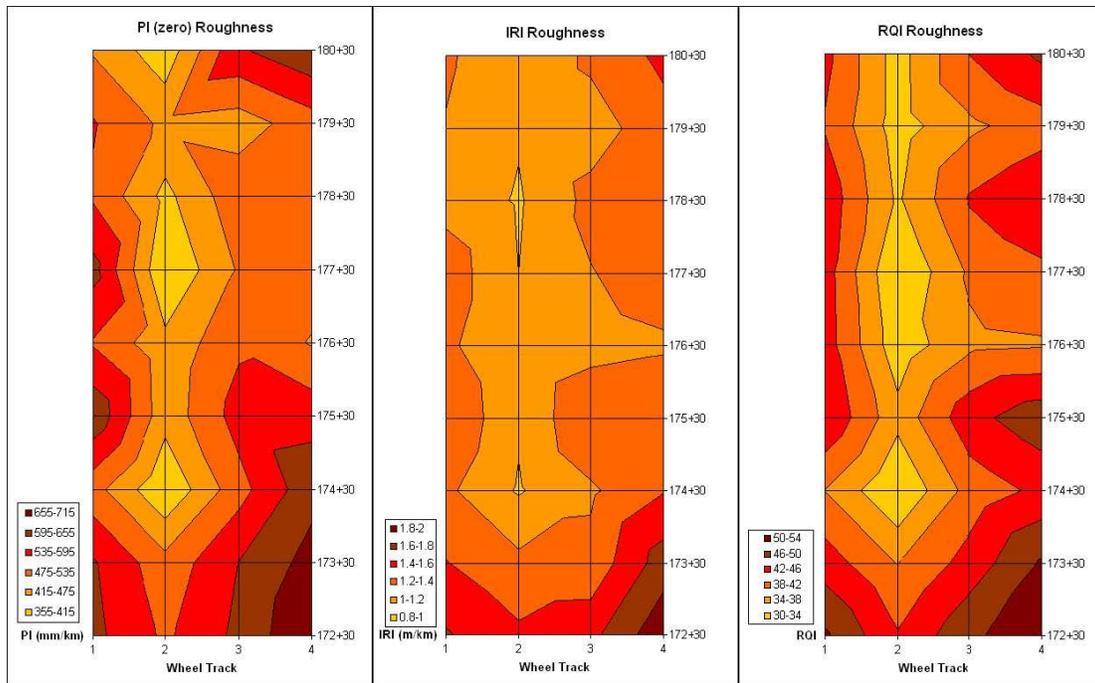
Figure 6 shows a low-resolution surface plot of roughness measured by the RTP across all four wheel tracks for nine contiguous 100-meter sections starting at station 172+30. Rougher sections are represented by darker colors, and smoother sections are represented by lighter colors. This plot gives a better representation of the roughness distribution across four pavement wheel tracks than Figure 4. Figure 7 shows the corresponding surface plot of the roughness measured by the LISA TriODS profiler.

Figure 6. RTP surface roughness plots for nine 100-meter sections

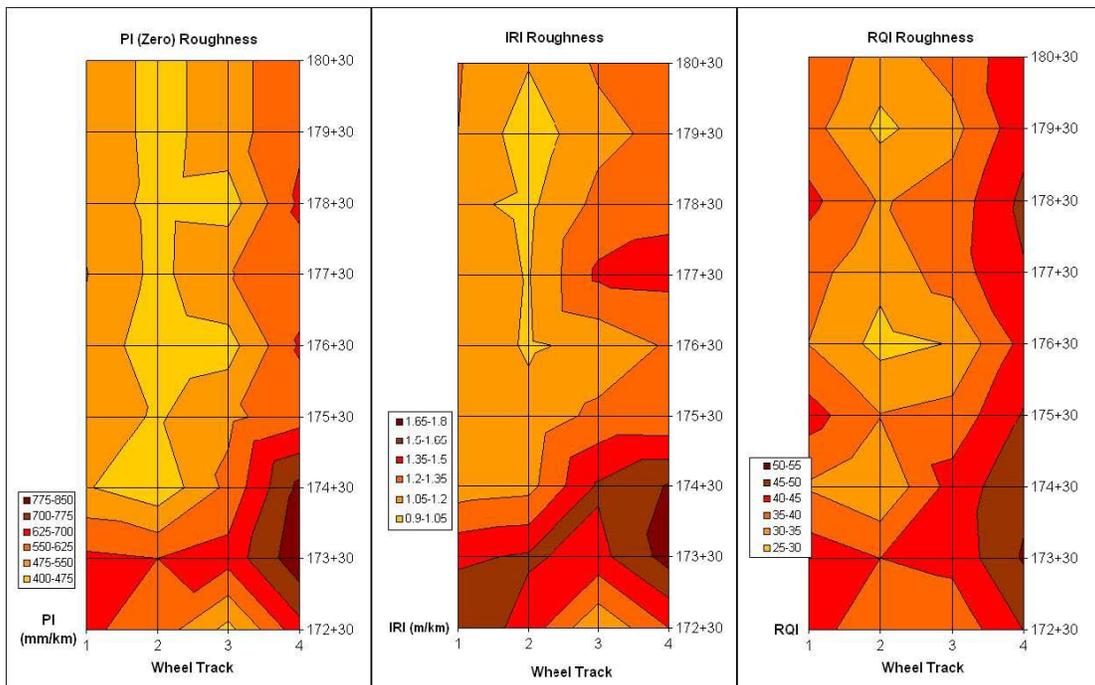
Figure 7. LISA surface roughness plots for nine 100-meter sections

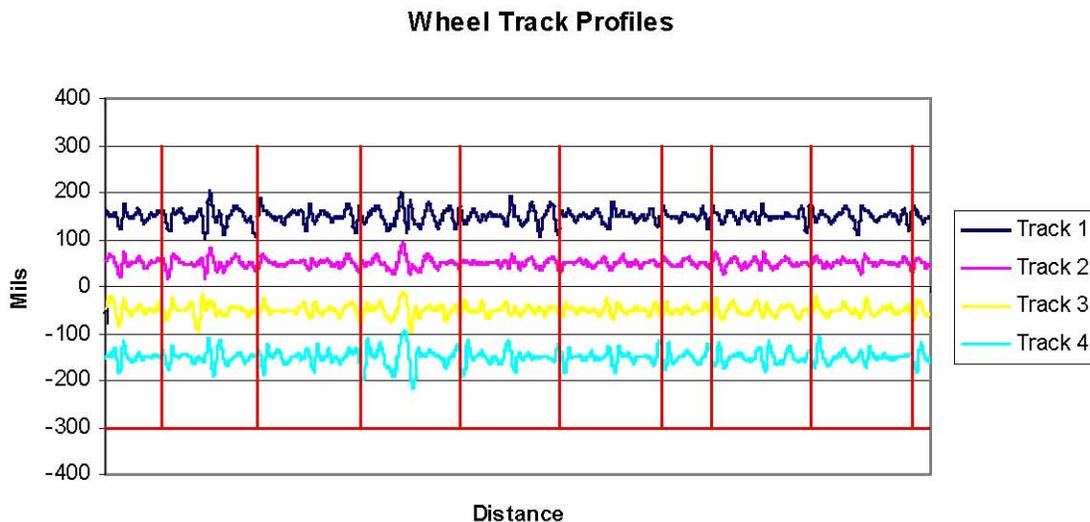
The plot in Figure 8 shows the profiles of four wheel tracks over a 100-meter section. These plots have been filtered to remove features longer than three meters to highlight the dowel bar ripple contribution to the surface roughness. The red line indicates the event marker cones that were typically placed in-line with the dowel bar baskets at an interval of every other basket, except in one case in this example where one cone was placed at an adjacent basket. The event marker cones were used to help locate the ripple in the profile caused by the dowel bar baskets. One would expect to see dowel bar ripple, if it existed, in-line with each event marker and halfway between each event marker. This effect is certainly evident in these profiles, and it could be argued that a majority of the roughness difference across the four wheel tracks is caused by the effects of the dowel bar ripple. When the ripple has a large amplitude in the outside wheel tracks one and four, the inside wheel tracks three and, to a greater extent, two usually show the same feature, but with less amplitude.

Figure 8. Dowel bar ripple plots across four wheel tracks

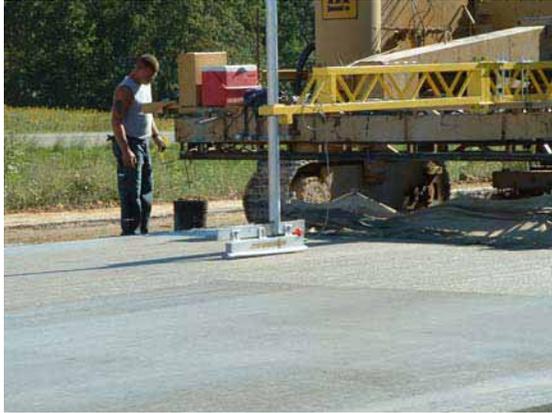
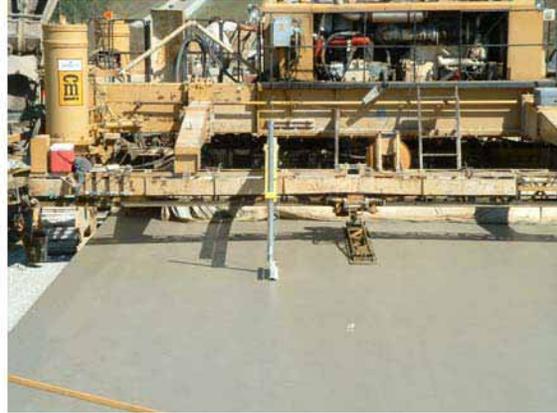
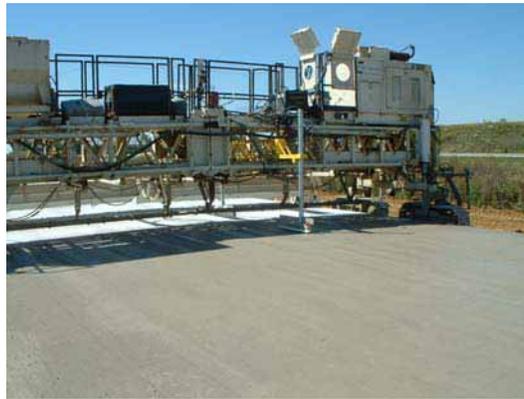
The three pictures in Figure 9 show the data collected in the train configuration for the sensors mounted on the paving machine and on the curing and tining machines. Two sensors were placed on the paving machine in the passing lane inside wheel track. One sensor remained mounted to the float pan, and the other was mounted on a truss hanging out behind the paving machine to avoid the auto-float. The auto-float was not working for the first part of the testing, so burlap was attached and dragged behind the auto-float bridge. Later the auto-float was repaired and data were collected in this configuration as well. The two other sensors were mounted on the curing and tining machine in an attempt to see whether the hand finishers were making the surface any smoother.

Sensors before and after burlap drag

Sensors before and after auto-float

Sensors mounted to texture and curing machine

Figure 9. Train configuration for the sensors mounted on the paving machine and on the curing and tining machines

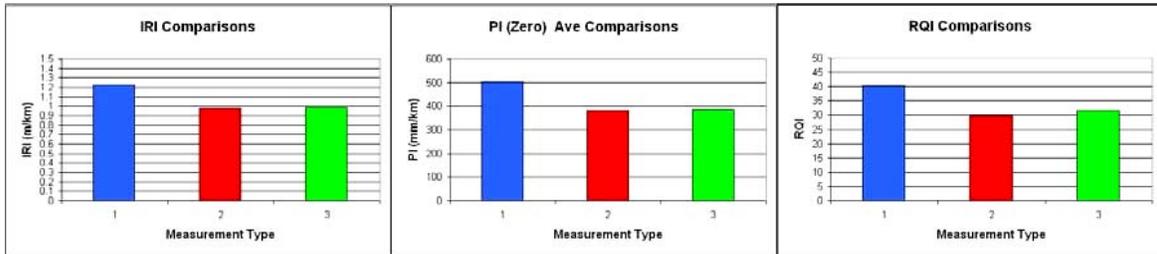
Examining the data collected before and after the auto-float made it easy to see that the auto-float was improving the smoothness of the road. Four sections of 100 meters were analyzed. Data from the sensor before the auto-float was compared to data from the sensor after the auto-float and to the LISA TriODS data collected days later. Figure 10 shows the results of the average of the four sections. These results indicate not only that the sensor data collected after the auto-float matches very well with the LISA TriODS data, but also that the sensor data show similar improvement when compared to the float pan sensor in all three index calculations. In particular, it appears that the auto-float is removing some of the dowel bar basket ripple from the profile. This is apparent when the slope power spectral density (PSD) plots in Figures 11, 12, and 13 are examined. The dowel bar basket ripple is clearly shown by the sharp spikes that appear in the slope PSD plots at harmonics of the 20-foot spacing of the dowel bar baskets. The graph in Figure 11 shows a considerable reduction of the spikes after the auto-float is used. Figure 12 shows the PSD of the TriODS profile in red overlaid with the PSD of the auto-float sensor in blue.

Figure 10. Auto-float improvements to smoothness

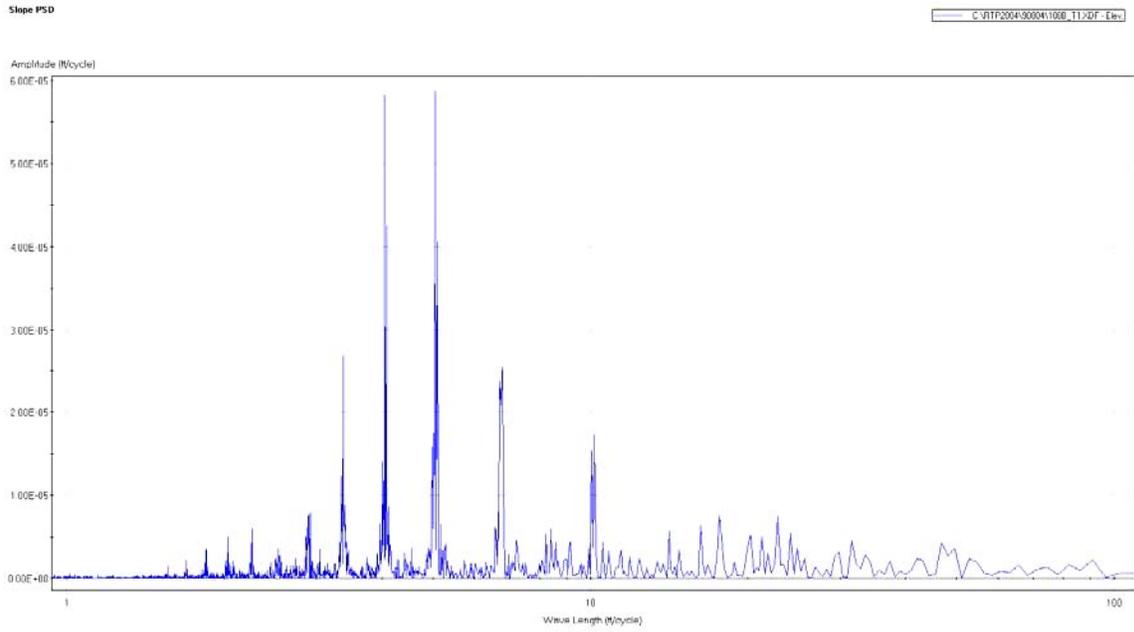
Figure 11. Slope PSD plot from float pan sensor

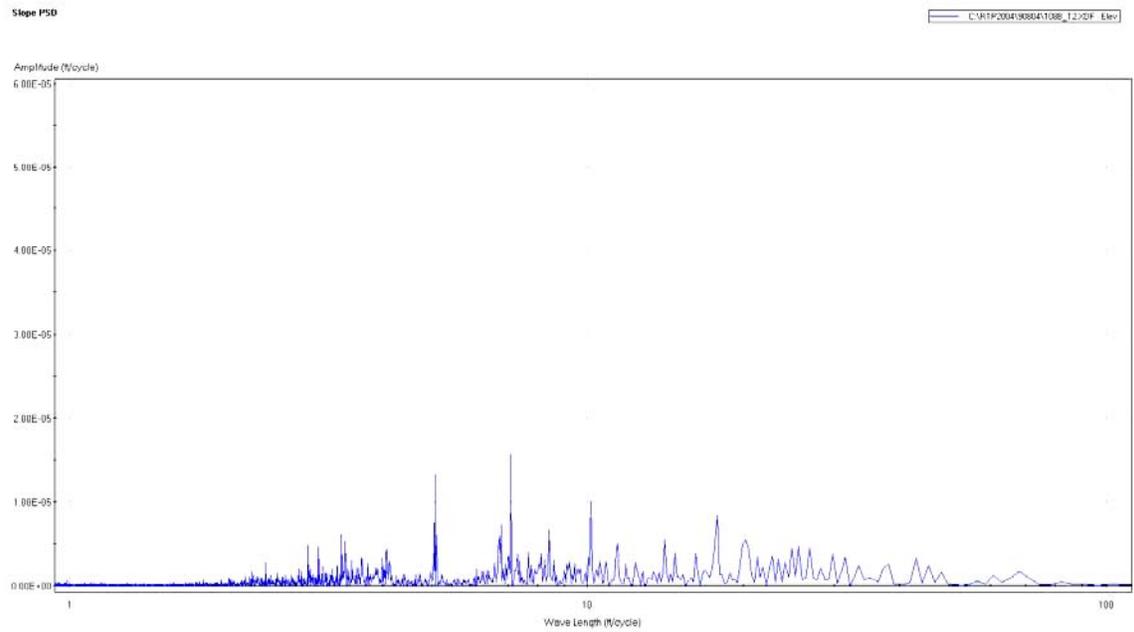
Figure 12. Slope PSD plot from auto-float sensor

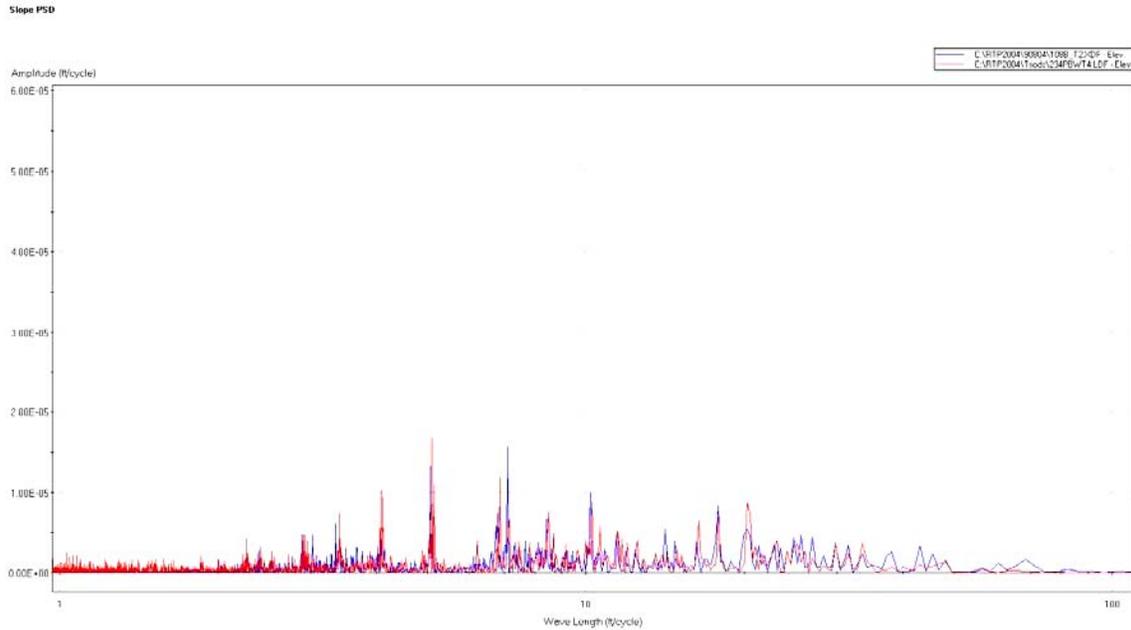
Figure 13. LISA TriODS PSD and RTP auto-float sensor PSD overlaid

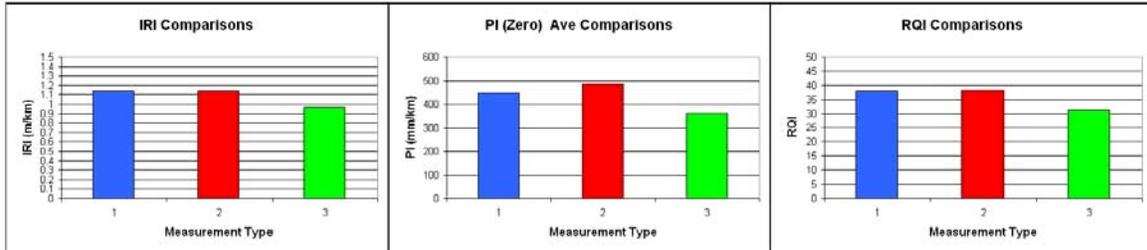
The auto-float was not used during the first day of profiling performed in the train configuration, and this proved to be advantageous for reasons of comparison. By looking at the data collected while the auto-float was not in use and comparing these data to the results from the LISA TriODS data collected days later, we can conclude that any improvement in the smoothness measured by the LISA TriODS is the result of the manual float operators. Instead of the auto-float, the paving machine operators had attached a burlap drag to the auto-float structure. Figure 14 shows the results of the average of the four sections. When the data after the burlap drag is examined, a slight increase is apparent in the penetration index (PI) and RQI indexes and no change in the IRI index is noted. In comparing these data to the LISA TriODS data for this same section, a considerable increase in the smoothness is evident, but not as much as was found by the use of the auto-float. On examining all the individual sections as listed in Appendices C and D, the auto-float seems to improve results more consistently over all the sections tested.

Figure 14. Average of index calculations without auto-float

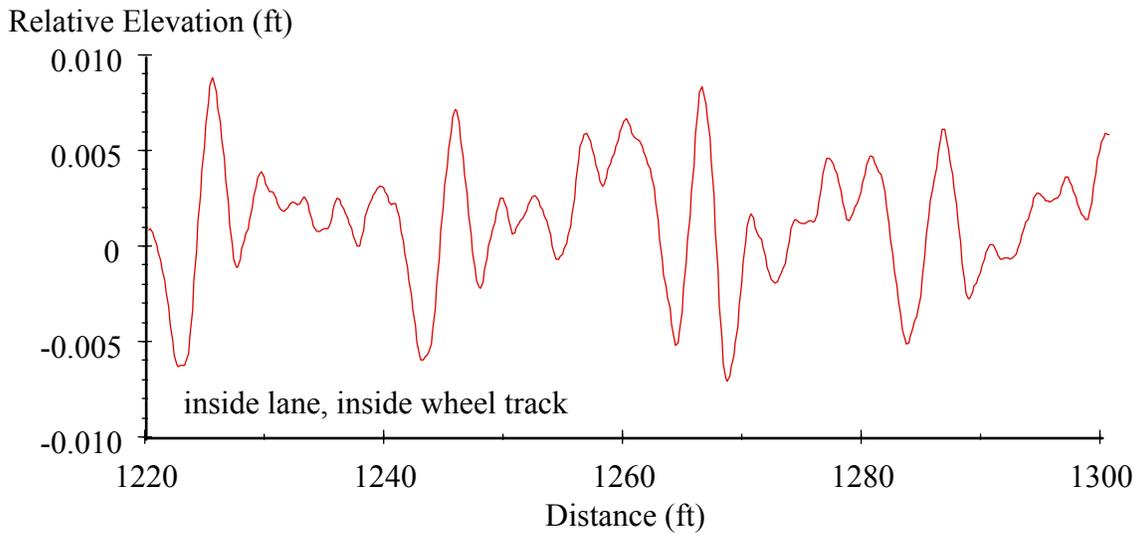
Figure 15. Disturbances spaced 20 feet apart

During the first three days of paving, the trace from the inside lane, inside wheel path that was collected at the paver appeared to be much rougher than the traces in the other three wheel paths. Tables E1 through E3 in Appendix E show that the IRI values were much higher in the inside lane, inside wheel path than in the other wheel paths and were often significantly higher than 100 in./mi. (Values much higher than 100 in./mi often prompt a requirement of corrective action or a penalty to the contractor.) The elevated roughness is caused by disturbances covering about 5 feet of pavement that appear every 20 feet. The peak-to-trough elevation difference across these disturbances is typically about 0.25 inches. Figure 15 shows an example of three of these bumps. The same features appear in the traces from the other three wheel paths, but with less than half the severity.

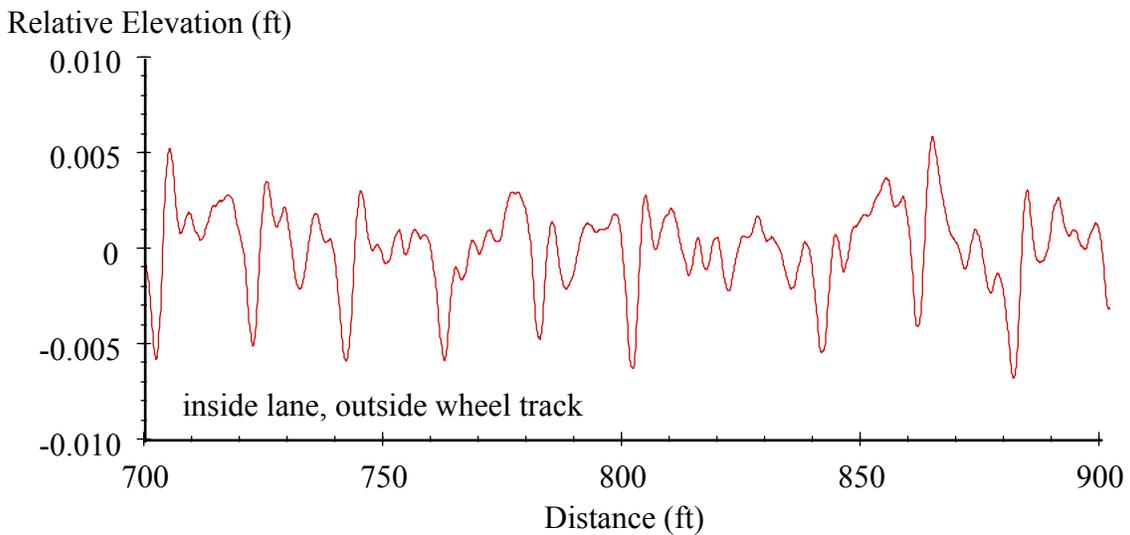
Data collected on the hardened concrete by an inertial profiler also include disturbances at a regular spacing of 20 feet. Figure 16 shows an example from the inside lane, outside wheel path. It is suspected that these dips actually appear at the joints as a result of dowel basket ripple.

Figure 16. Dowel basket ripple

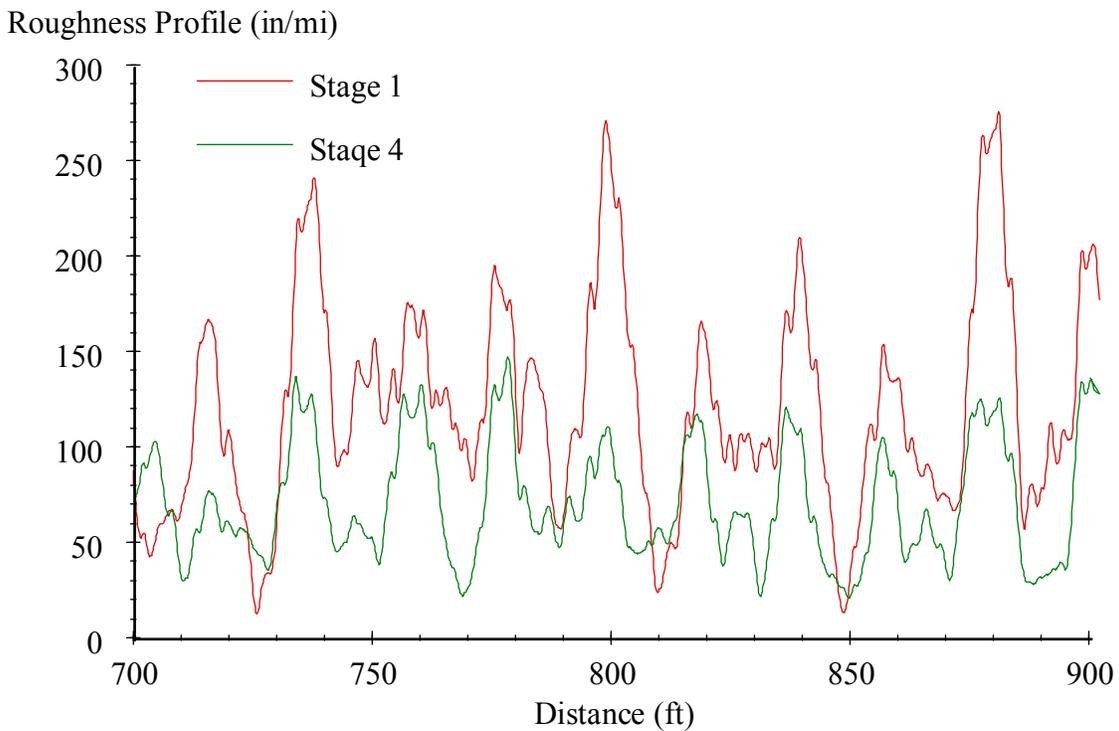
To characterize the first three days of paving, pairs of profiles were available from behind the pan (stage one) and after the tining and curing machine (stage four) for the inside lane, outside wheel path and the outside lane, inside wheel path. On day one and day three of paving, the roughness at stage four was lower than the roughness at stage one in a great majority of the lots tested. (See Tables E1 and E3 in Appendix E.) Inspection of filtered profile plots and continuous roughness plots showed that the improvement on day one came almost exclusively from the elimination of localized rough features that appeared with a regular spacing of 20 feet. Figure 17 shows a continuous report of roughness with a base length of 5.28 feet. In the plot, each point represents the portion of the IRI that was accumulated within a 5.28-foot-long segment of road, centered at that location. The trace for stage one includes concentrated roughness every 20 feet, but the trace for stage four does not. If the source of the roughness was dowel bar ripple, it was eliminated between these two stages. Note that the hand finishing operation was performed between stage one and stage four.

Figure 17. Reduction in roughness by hand finishing

Day two presents a contrasting case, in which many of the lots became rougher between stage one and stage four. Although the roughness with a characteristic wavelength was improved significantly between stage one and stage four on day two as well as on day one, the extraneous content with a wavelength of three feet became much worse. This extraneous content overwhelmed the improvement of the IRI.

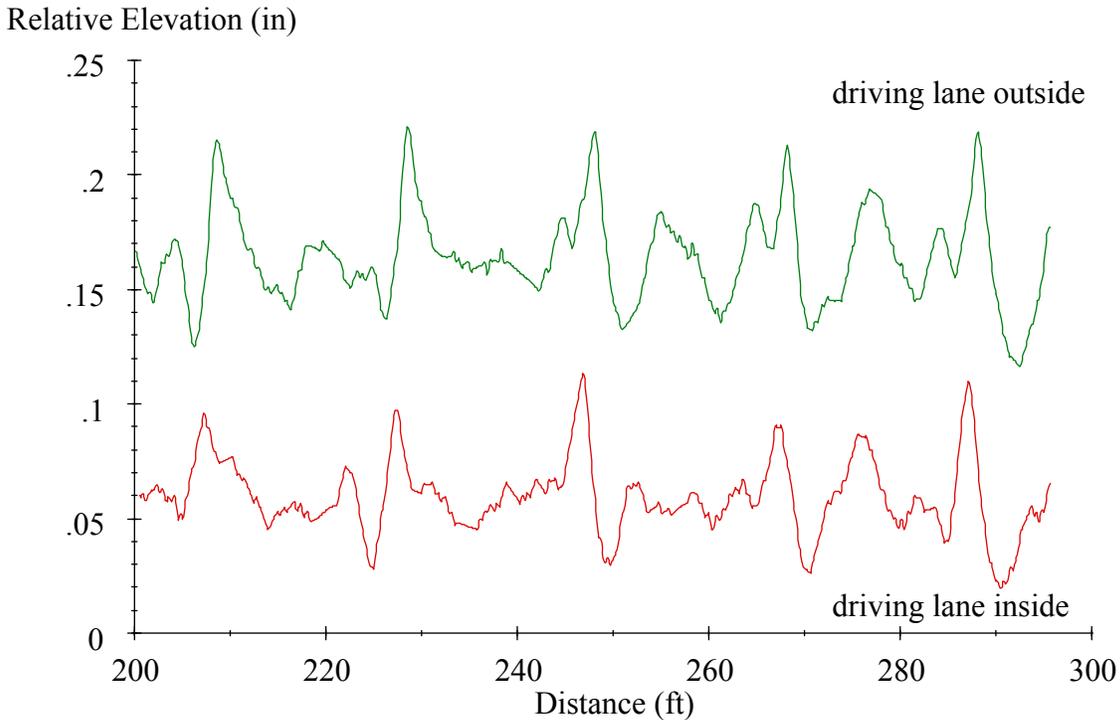
The RTP detected dowel bar ripple consistently over the entire paving job. Figure 18 shows the effect that dowel bar ripple has on the surface profile. The figure shows profiles from both wheel tracks of the driving lane, measured on August 23. The traces were conditioned with a moving average anti-smoothing filter with a base length of ten feet to help make short deviations more visible. Note that the distance axis simply

provides the distance from the start of the measurement. Roughly, the plot covers station 165+26 through 165+87.

Every 20 feet, a disturbance appears in both profiles. Since this pavement includes joints that are skewed by a ratio of 6:1, the bumps from the outside wheel path lag those of the inside wheel path by about one foot. In fact, the bumps from the driving lane outside wheel path consistently lag those of the passing lane outside wheel path by about three feet as well. On September 7, the measurements included event markers placed at the longitudinal location of every other dowel basket beside the passing lane. These markers helped verify that the bumps were indeed near the dowel baskets.

Figure 18. Dowel bar ripple

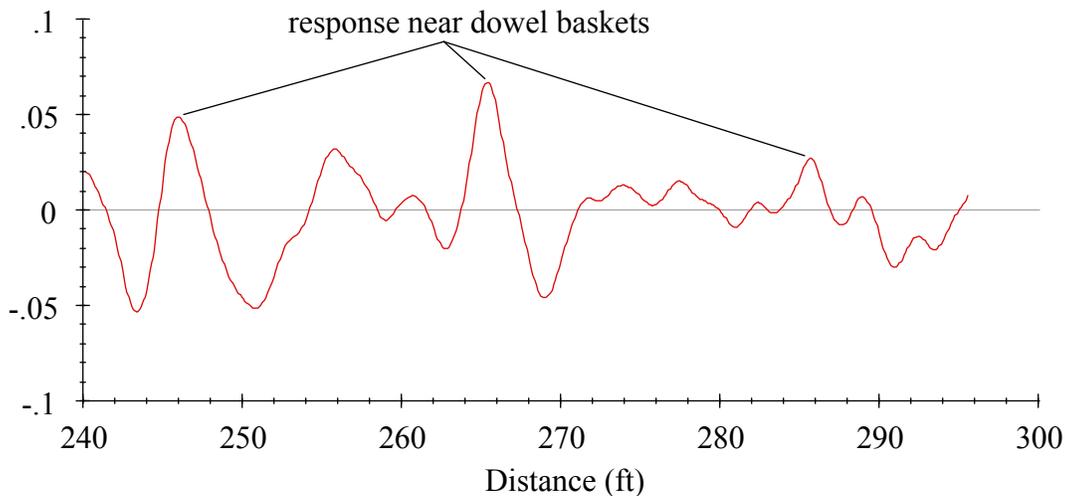
These ripples certainly increase the PI significantly when no blanking band is applied. Figure 19 shows a simulated profilograph trace in the passing lane, outside wheel path over three of the joints with clear dowel basket ripple. The approximate dowel basket locations are marked. Under a zero blanking band, the ripple causes an upward scallop at the dowel basket, and exacerbates downward scallops on either side. (Keep in mind that some of these downward scallops will not increase the PI, because typical counting schemes require scallops to be at least two feet wide before they are counted.) The upward scallops at the first two dowel baskets in Figure 19 are 0.050 inches and 0.067 inches high. These alone penalize the overall PI for a one-tenth of a mile lot by 0.50 and 0.67 inches/mile, respectively. The overall PI for this wheel path, under a zero blanking band, was about 38 inches/mile. More than a third of this can be attributed directly to the ripple.

Alone, dowel bar ripple does not cause bumps or dips high enough to penalize the PI with a 0.2-inch blanking band. For example, none of the simulated profilograph traces in Figure 19 exceeds an absolute value of 0.1 inches. However, when the bumps are superimposed on other sources of roughness, they increase the size of scallops.

Figure 19. Simulated profilograph trace, passing lane outside trace

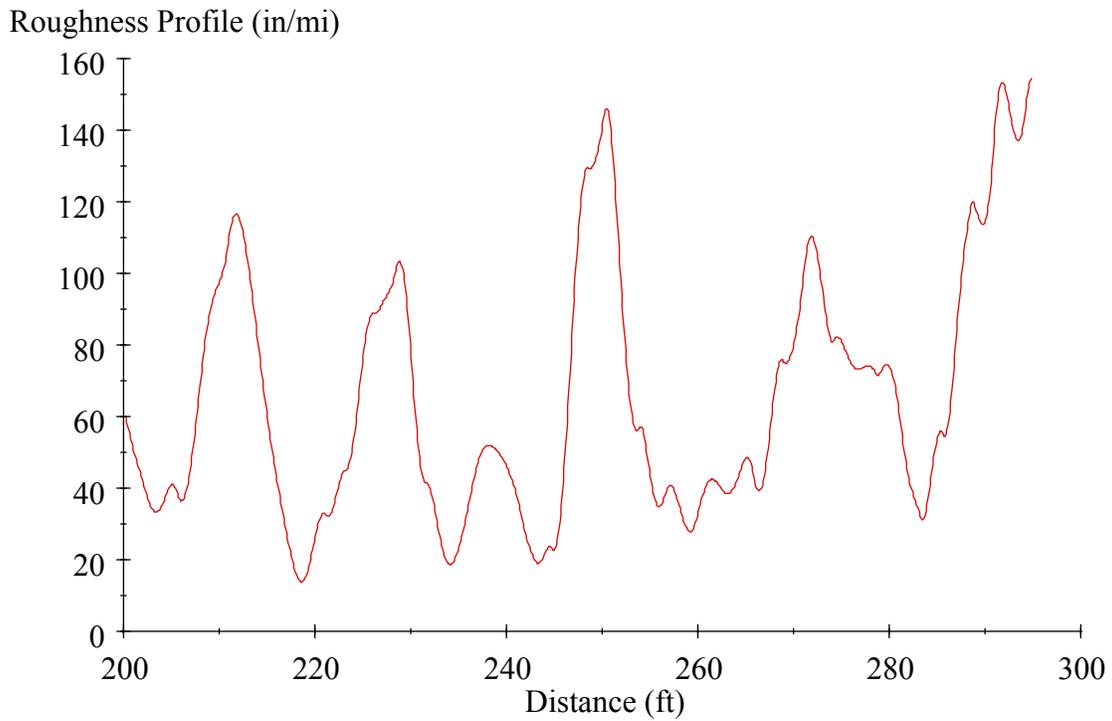
Dowel bar ripple also increases the IRI of the pavement. Figure 20 shows a continuous report of roughness for the driving lane outside wheel path with a base length of 5.28 feet (Michael W. Sayers, 1990). In the plot, each point represents the portion of the IRI that was accumulated within a 5.28-foot long segment of road, centered at that location. The plot is scaled so that the average of all of the values is the IRI for the overall length of the plot. This technique is used to search the pavement for hot spots and to help get an idea of the contribution of a given disturbance to the overall IRI. Figure 20 shows a local peak in roughness near each joint. This indicates that the IRI judges the bumps caused by dowel bar ripple to be concentrated roughness. The continuous report of roughness shows peak values from 106 to 158 inches/mile at the dowel baskets. The values are the average over 1% of a one-tenth of a mile-long segment. That means that the roughness in the vicinity of the dowel baskets contributed from 1.06 to 1.58 inches/mile per joint.

Figure 20. Continuous roughness report, driving lane inside track

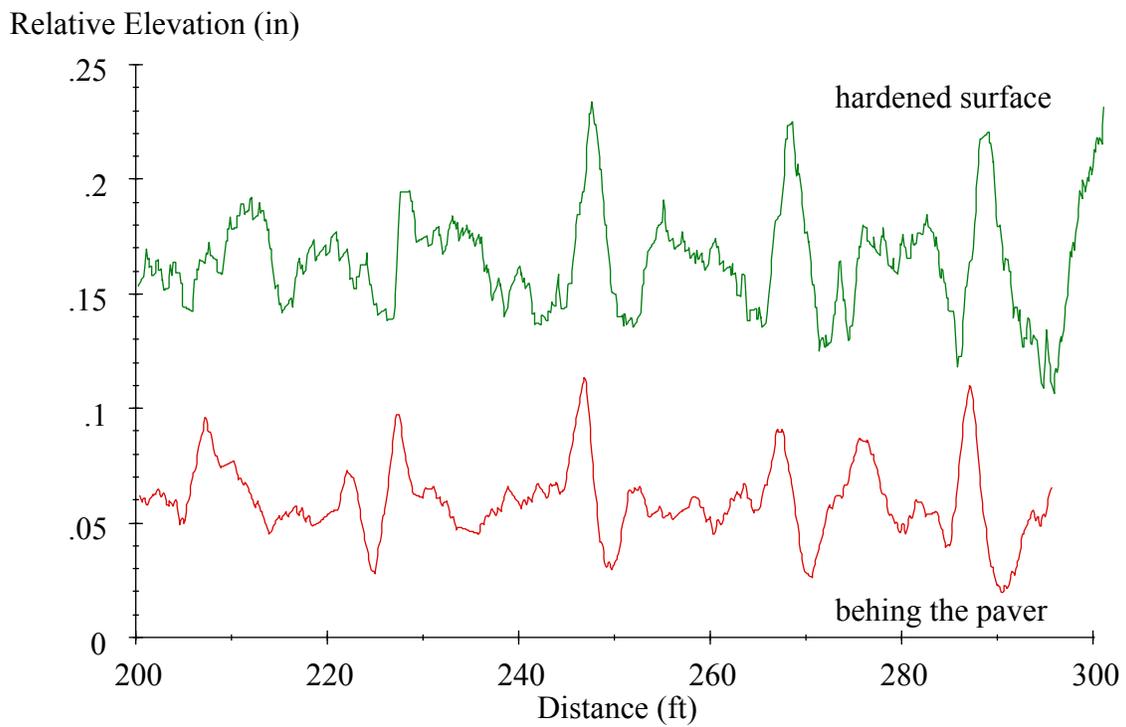
The penalty to smoothness caused by dowel basket ripple is only important if it appears on the finished pavement. Figure 21 compares the profile of the driving lane outside wheel path measured by the RTP to a profile measurement taken on the hardened surface with a lightweight inertial profiler. Again, the traces have been filtered to show only short wavelength roughness. The traces are very similar. This similarity verifies that dowel basket ripple does indeed appear on the finished pavement. Further, it confirms the credibility of the RTP's measurement of this type of feature. (Note that the RTP does not measure wavelengths greater than 50 feet. As a result, the raw output from the RTP and the lightweight inertial profiler would not have the same visual agreement as the traces in Figure 21.)

Figure 21. Change in the profile with time

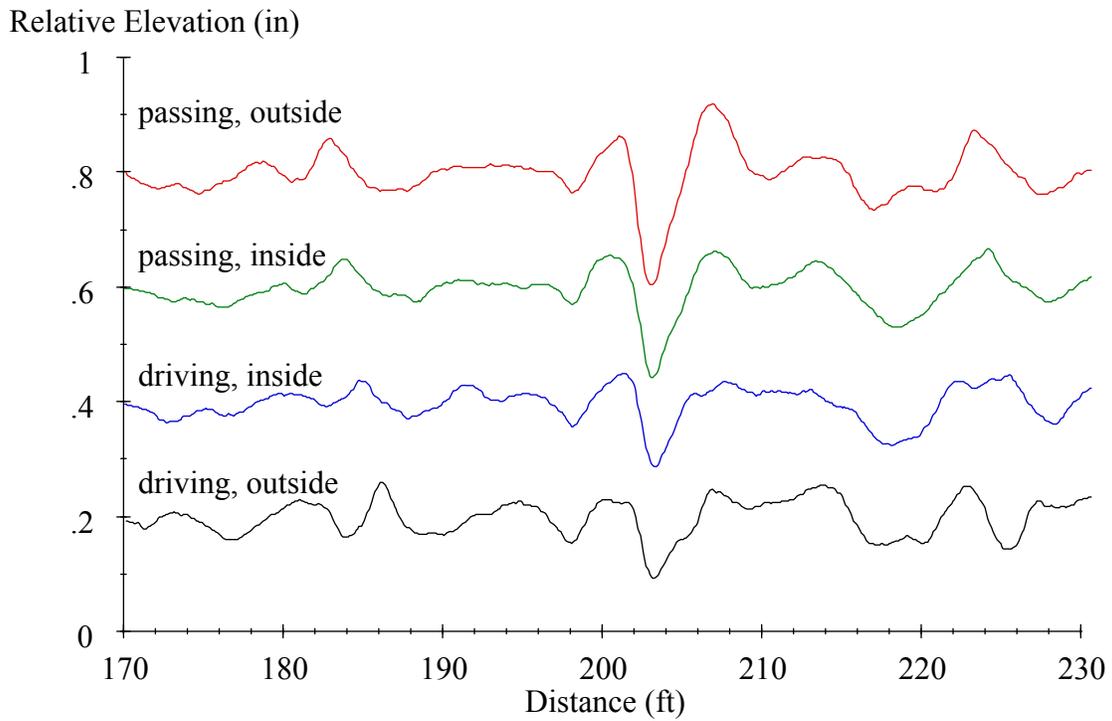
The field notes from August 31 reported that about 200 feet into the run, the string line broke on the passing lane side. Figure 22 shows the profile from all four wheel paths around this location. The traces were conditioned with a moving average anti-smoothing filter with a base length of 25 feet to remove the trend. They were also offset vertically from each other to help make a clearer comparison among them. Near the 200-foot mark, a deep narrow dip appears. Since the string line was broken on the passing lane side, the dip is most severe in the passing lane outside wheel path. In all of the wheel paths, the dip is followed by a broad area of pavement that is elevated above the overall trend. The field notes did not describe what method was used to deal with the broken line, or how quickly it was addressed.

The roughness added to the pavement by the broken string line is sure to degrade the ride quality. Ironically, however, the dip is so narrow that it may be ignored by a profilograph if a 0.2-inch blanking band is applied. This is because scallops in a profilograph trace are typically not counted unless they violate the blanking band limits for a distance of more than two feet. Figure 22 shows that the dips are narrower than two feet through about half of their depth.

Figure 22. Dips caused by a broken string line

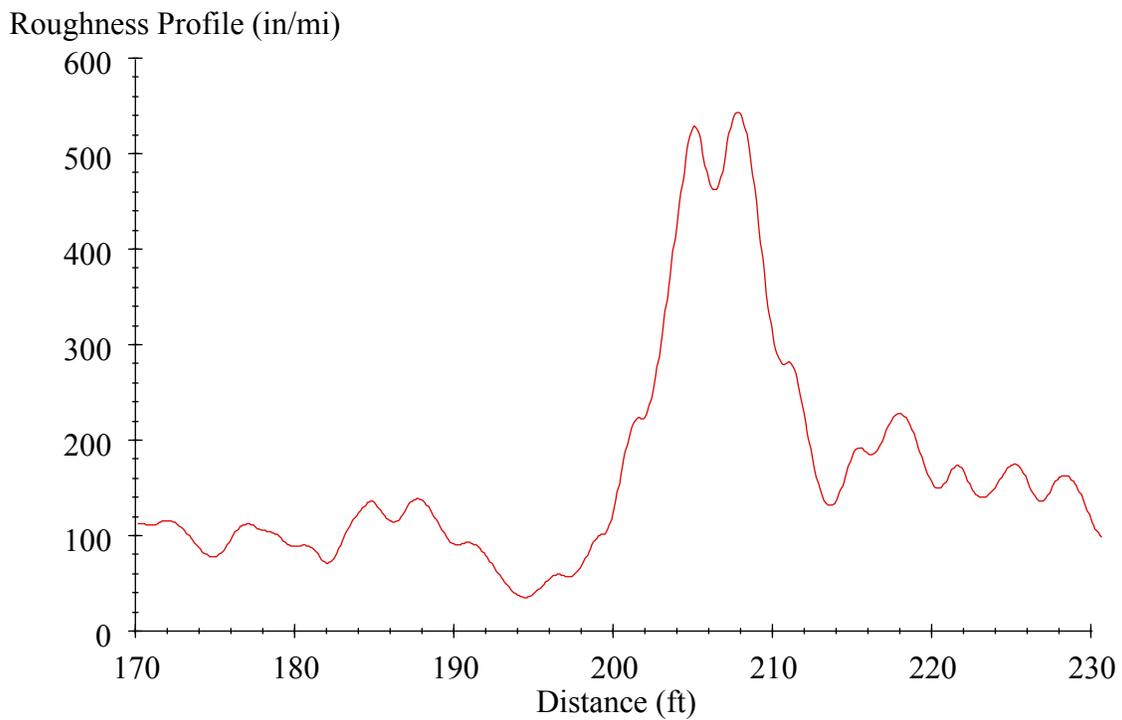
Figure 23 shows a continuous roughness report for the vicinity of the rough area in the passing lane outside wheel path. The plot was developed with a base length of 5.28 feet. The peak roughness near the broken string line is about 400 inches/mile higher than the prevailing trend. This suggests that the broken string line increased the roughness of a one-tenth of a mile lot by four in./mi. Inspection of the profile measured after the concrete hardened also included elevated roughness at this location, but not as severe.

Figure 23. Roughness caused by a broken string line

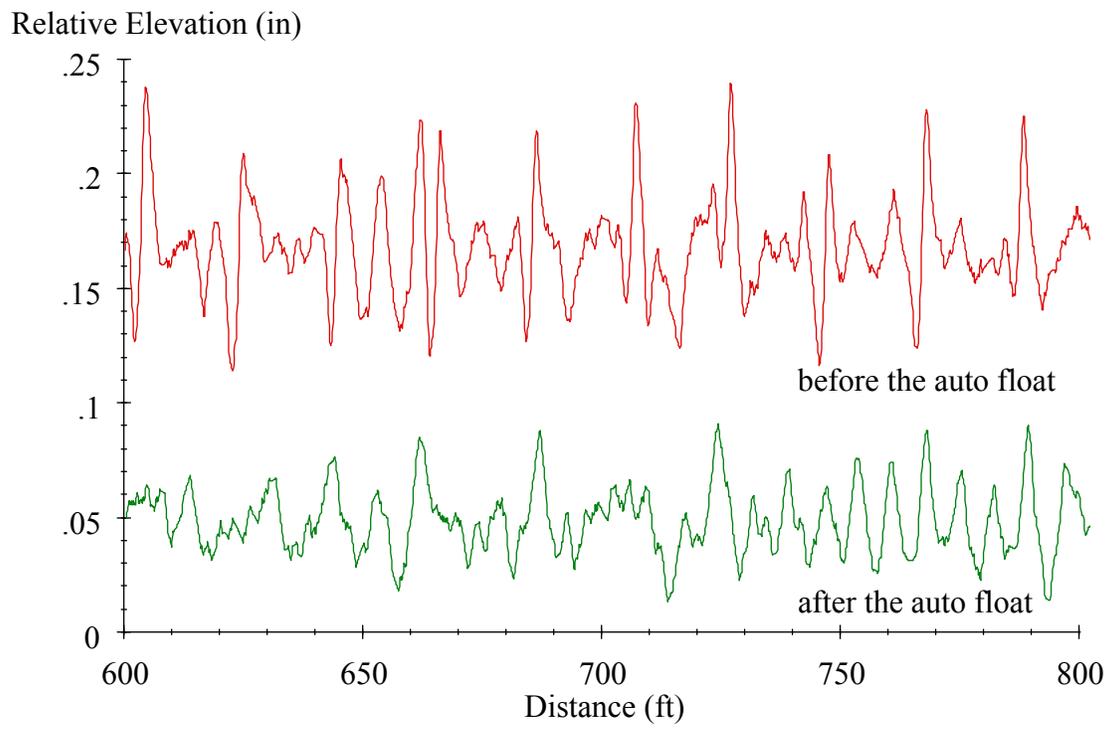
On September 9, profile data were collected in a train configuration along the inside wheel path of the passing lane. These data included a measurement of the profile directly behind the paving machine and another measurement just after application of an auto-float. The auto-float diminished the roughness caused by dowel bar ripple significantly. Figure 24 shows a portion of the profile before and after the auto-float. Before application of the auto-float, severe instances of dowel bar ripple appear in a regular pattern (every 20 feet). Afterward, the roughness near most of the dowel baskets is reduced or eliminated. Over the 2,980 feet of pavement measured on that day, the auto-float reduced the IRI by 11 inches/mile. The PI, with no blanking band applied, was reduced by 6.5 inches/mile.

Figure 24. Change in profile caused by the auto-float
