TRAFFIC ENGINEERING STUDY OSKALOOSA, IOWA

alan m. voorhees & associates, inc.

November, 1977

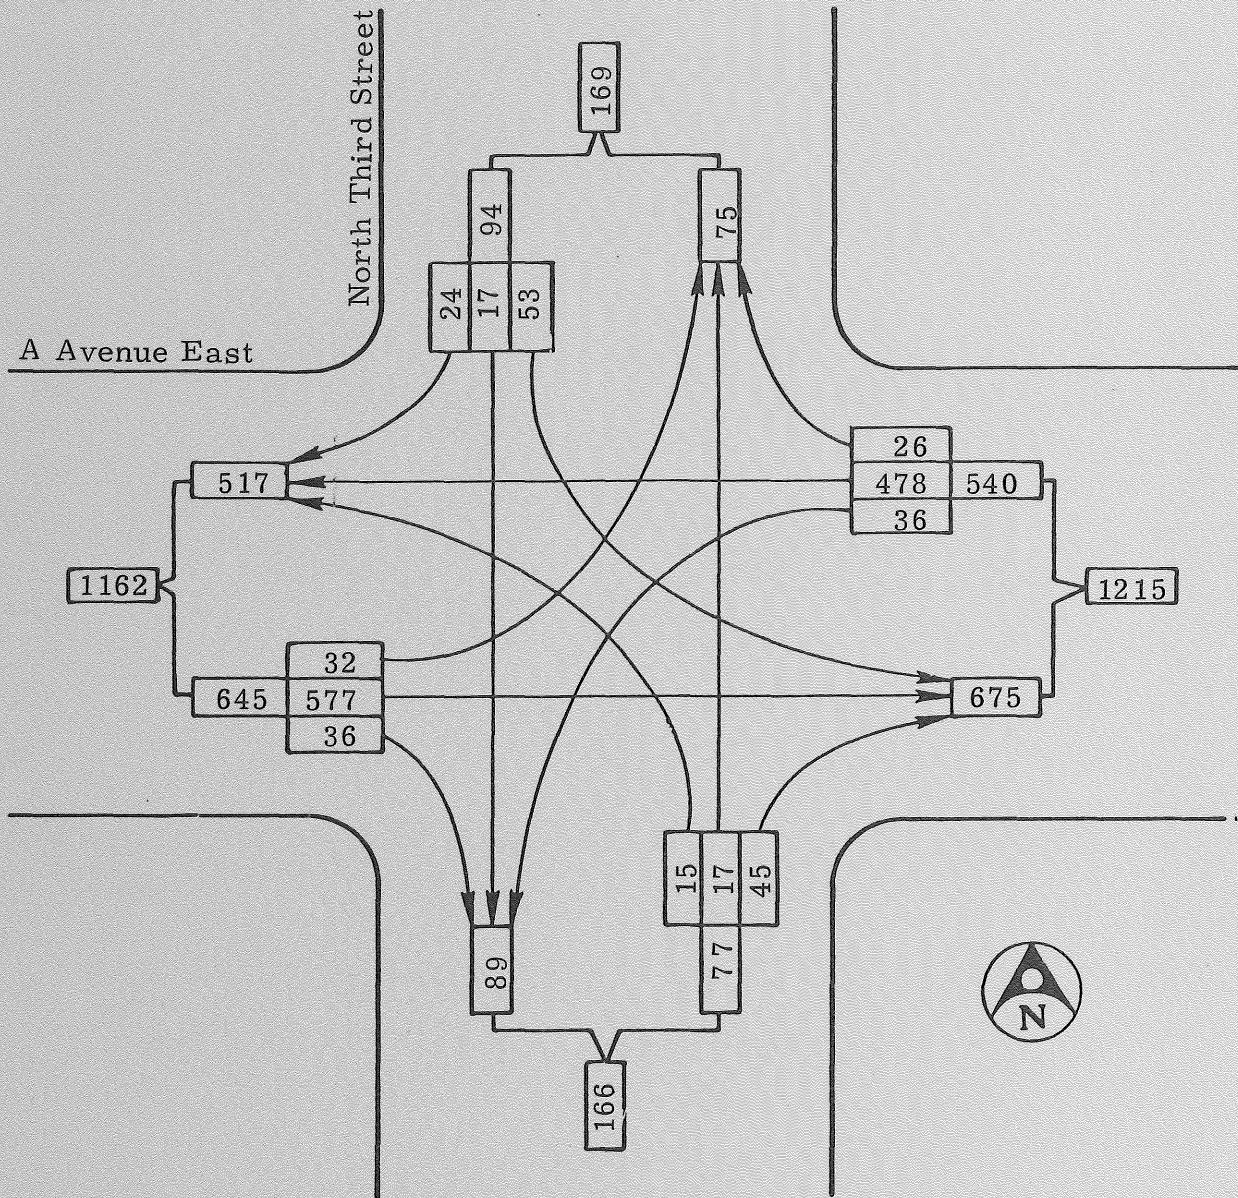
Location A Avenue East & North 3rd Street Time 4:15 to 5:15 p.m.

PEAK HOUR TRAFFIC FLOW DIAGRAM

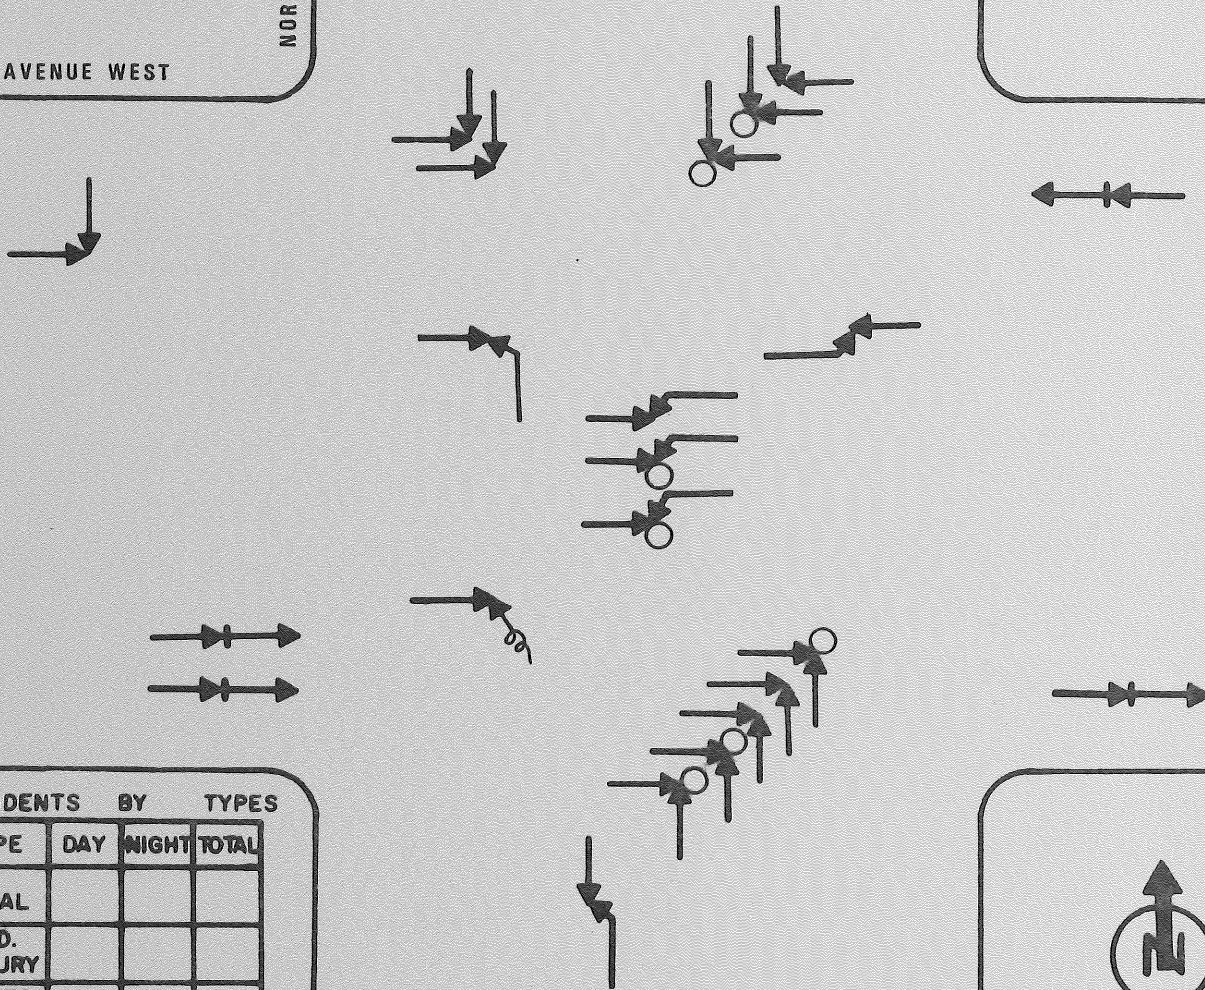
A AVENUE WEST

NORTH D STREET

ACCIDENTS BY TYPES

TYPE	DAY	NIGHT	TOTAL
FATAL			
PED. INJURY			
OTHER INJURY	5	2	7
PROP. DAMAGE	15		15
TOTAL	20	2	22
