**Bentonite Treatment For Economical
Dust Reduction on Limestone Surfaced
Secondary Roads**

January 1995

Sponsored by the Highway Division of the Iowa Department of Transportation
and the Iowa Highway Research Advisory Board
Iowa DOT Project HR-351

ERI Project 3643

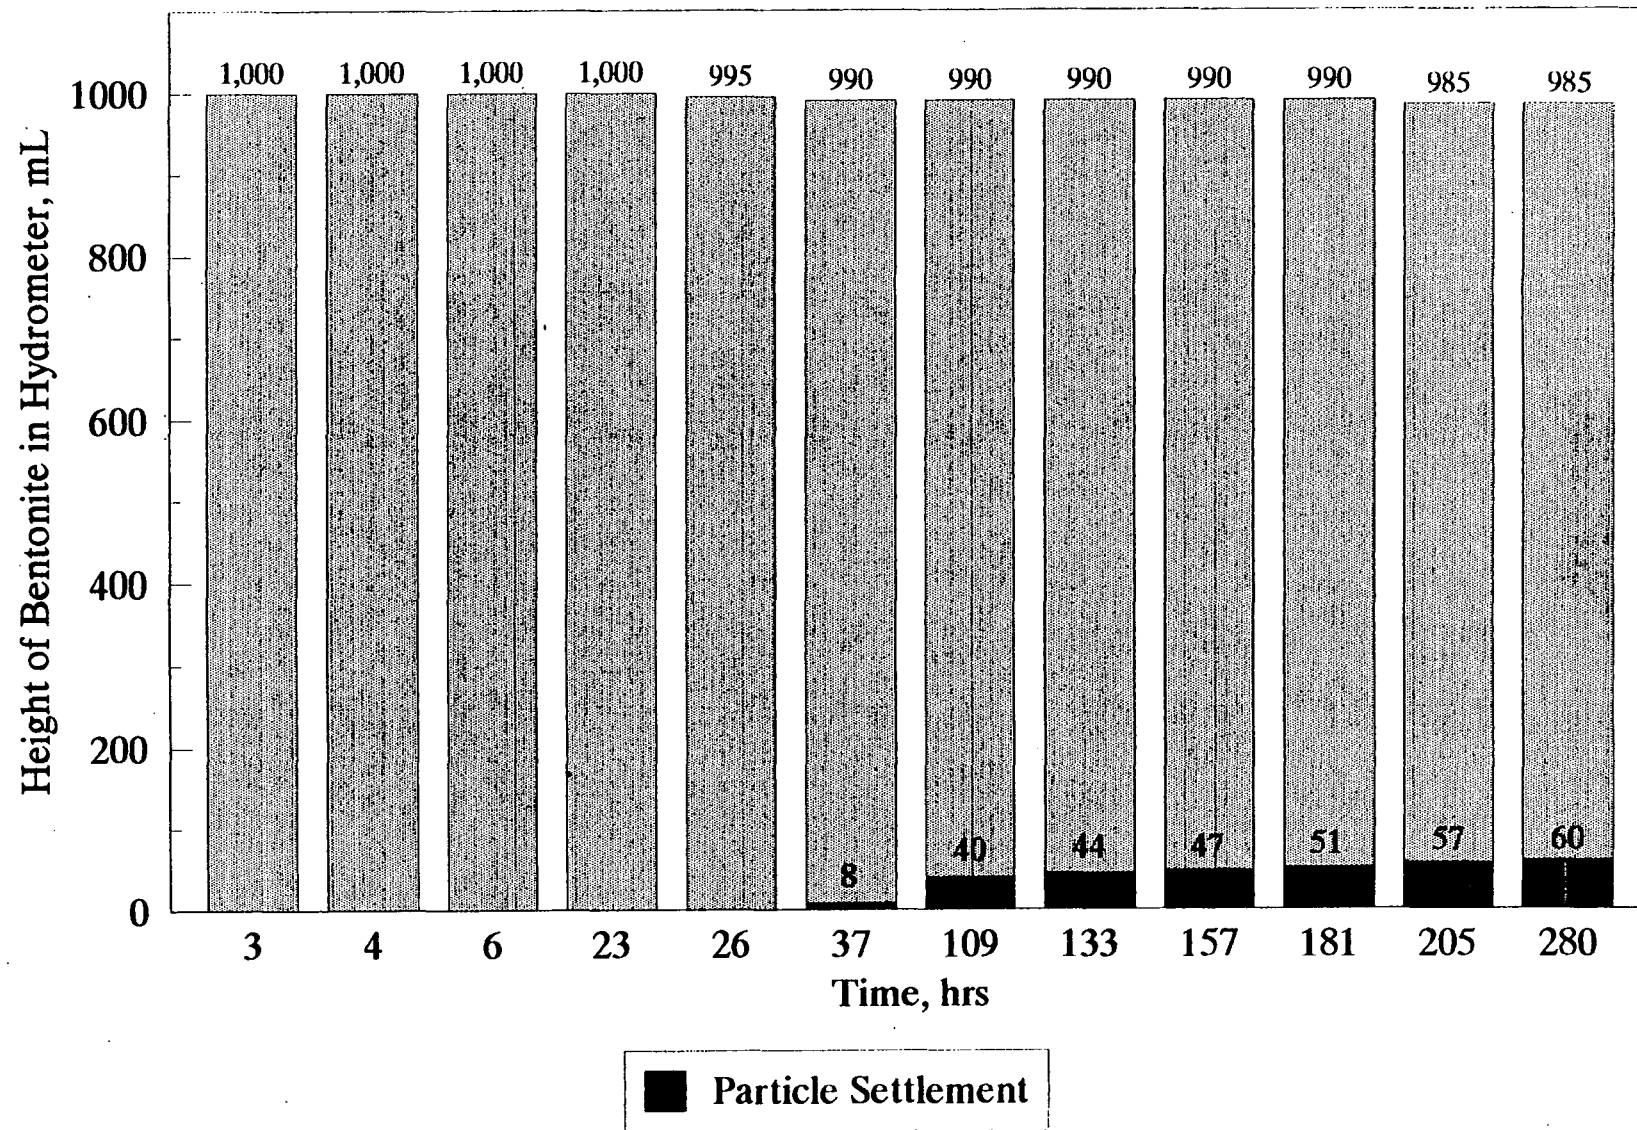
Figure 1. Settlement of Bentonite in A Sodium Hexametaphosphate (Calgon) Solution

Figure 1 presents the results of settlement observations of the standard Calgon solution as a function of time. After 280 hours, the Calgon was acting to maintain most of the small particles in suspension with only 15 ml of clear water observed in the hydrometer (1000 ml - 985 ml). However, particle flocculation began to occur at 37 hours and continued to increase over time as indicated by the dark bands at the bottom of the bars on Figure 1.

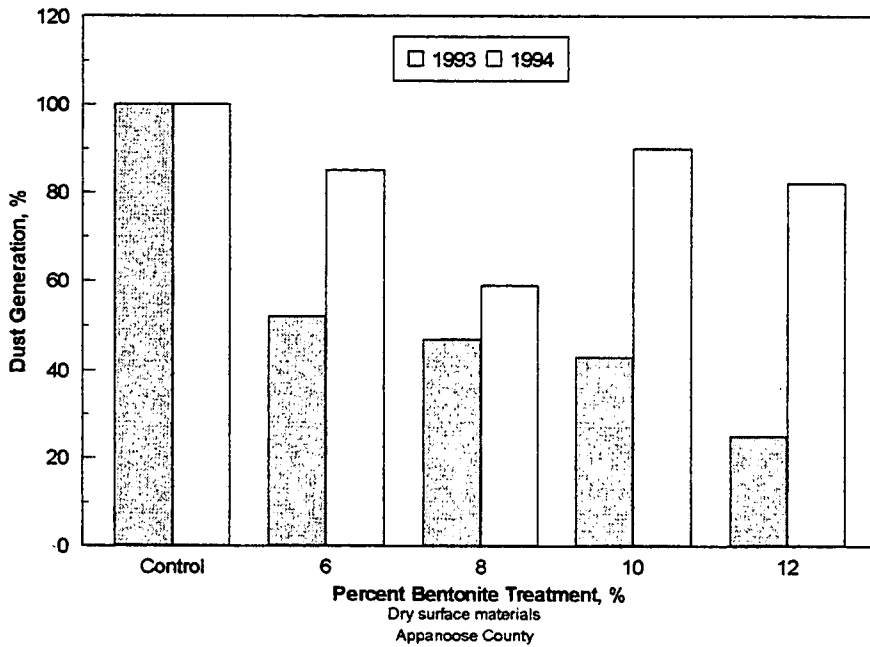
Figure 13. Dust generation for Appanoose County test road.

The 1993 and 1994 results tabulated in Table 3 for Appanoose County are also shown on Figure 13. Figure 13 shows a similar trend as the Tama County test road showed for the first year.

The control section had the most dust generated with the Bentonite treated sections having less dust generated. As the Bentonite treatment level increased for 1993 the dust generated decreased. The trend was the same, but the Bentonite treatment at Appanoose County was not as effective as the Tama County treatment. The Tama County location had reductions greater than 60 percent for the 7 percent and 9 percent section where the Appanoose County Test road had reductions only slightly greater than 50 percent. In 1994, the Appanoose County location showed a much greater increase in the dust generated in the treated sections. This increase may be due to the high fines content in the Appanoose County surfacing materials and the higher amount of truck traffic on the test road. Even though there was a greater increase in the dust generated on the Appanoose County test road the treated sections all showed reductions in dust generated after two testing seasons as compared to the control section.

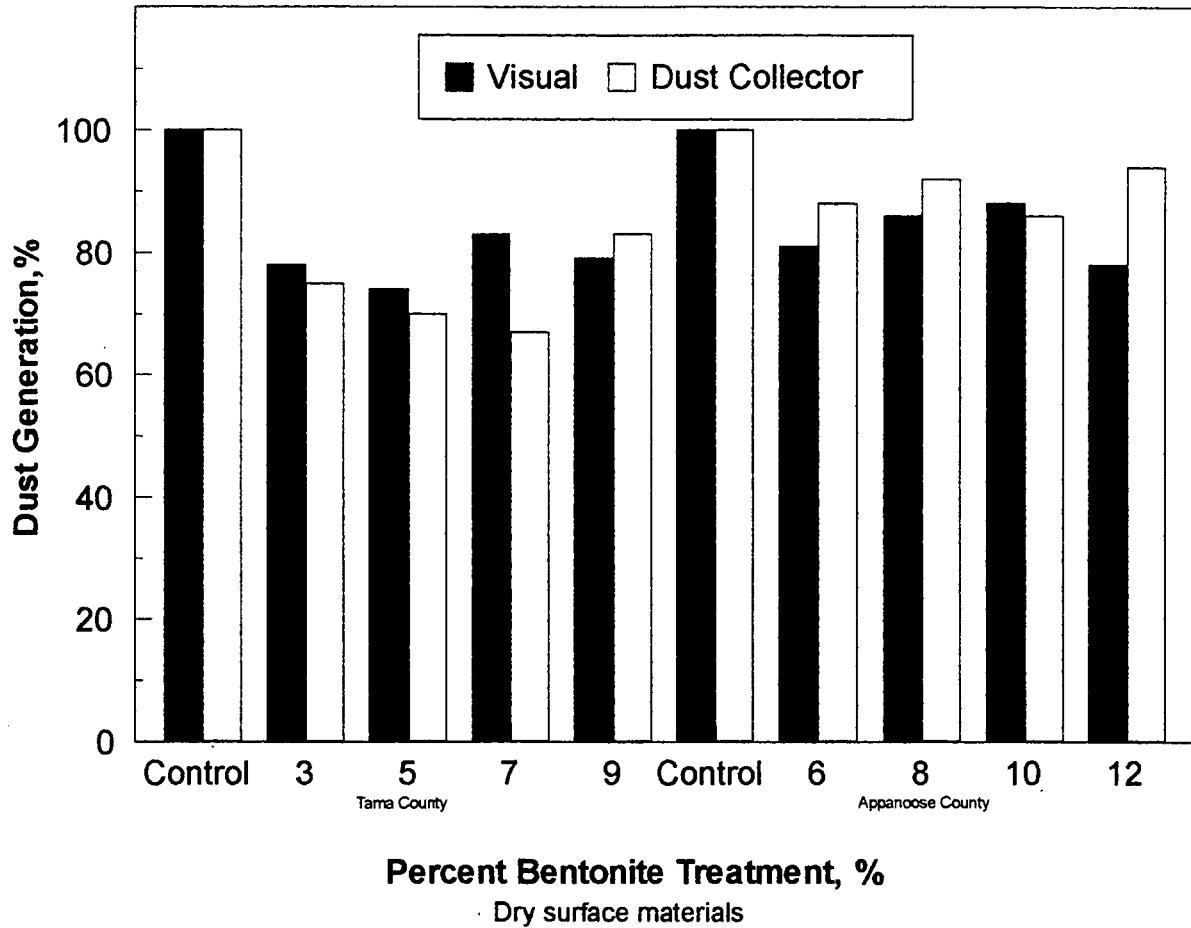
Figure 14. 1994 dust collector and visual evaluation comparison.

Shown on Figure 14, are the results of the 1994 visual evaluations and the dust collector data. Both Tama and Appanoose Counties results are shown. The data is also presented in Table B9 of Appendix B. The visual evaluation of dust generated displayed on Figure 14 are the average values for the days the dust collector was used. This shows that most of the differences of the two evaluation techniques are within the range of the error of the dust collector. The results of this testing validates the use of the visual method as an evaluation tool.

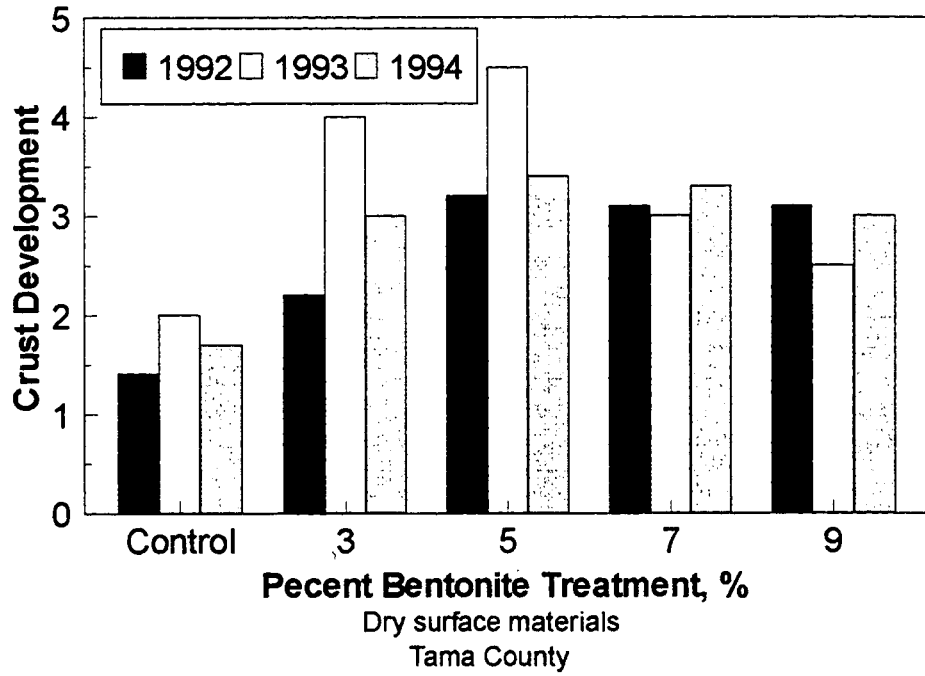
Figure 15. Crust development for Tama County.

The Tama County average results of the 1992, 1993, and 1994 testing seasons for crust development which were tabulated in Table 2 are shown on Figure 15. The control section exhibits less crust development than the Bentonite treated sections. In 1992, the 3 percent section had approximately one and a half times more crust development than the control and the 5 percent, 7 percent, and 9 percent sections had approximately twice the crust development as the control. In 1993, the 3 percent and 5 percent exhibited increased crust development and the 7 percent and 9 percent exhibited less crust development possibly due to the Bentonite being washed down the hill by rain or addition of surface material in the 7 percent and 9 percent sections. In 1994, a reduction in crust development was observed in the 3 percent and 5 percent treatment sections. This maybe attributed to the addition of surfacing material to the road. Each year showed a crust

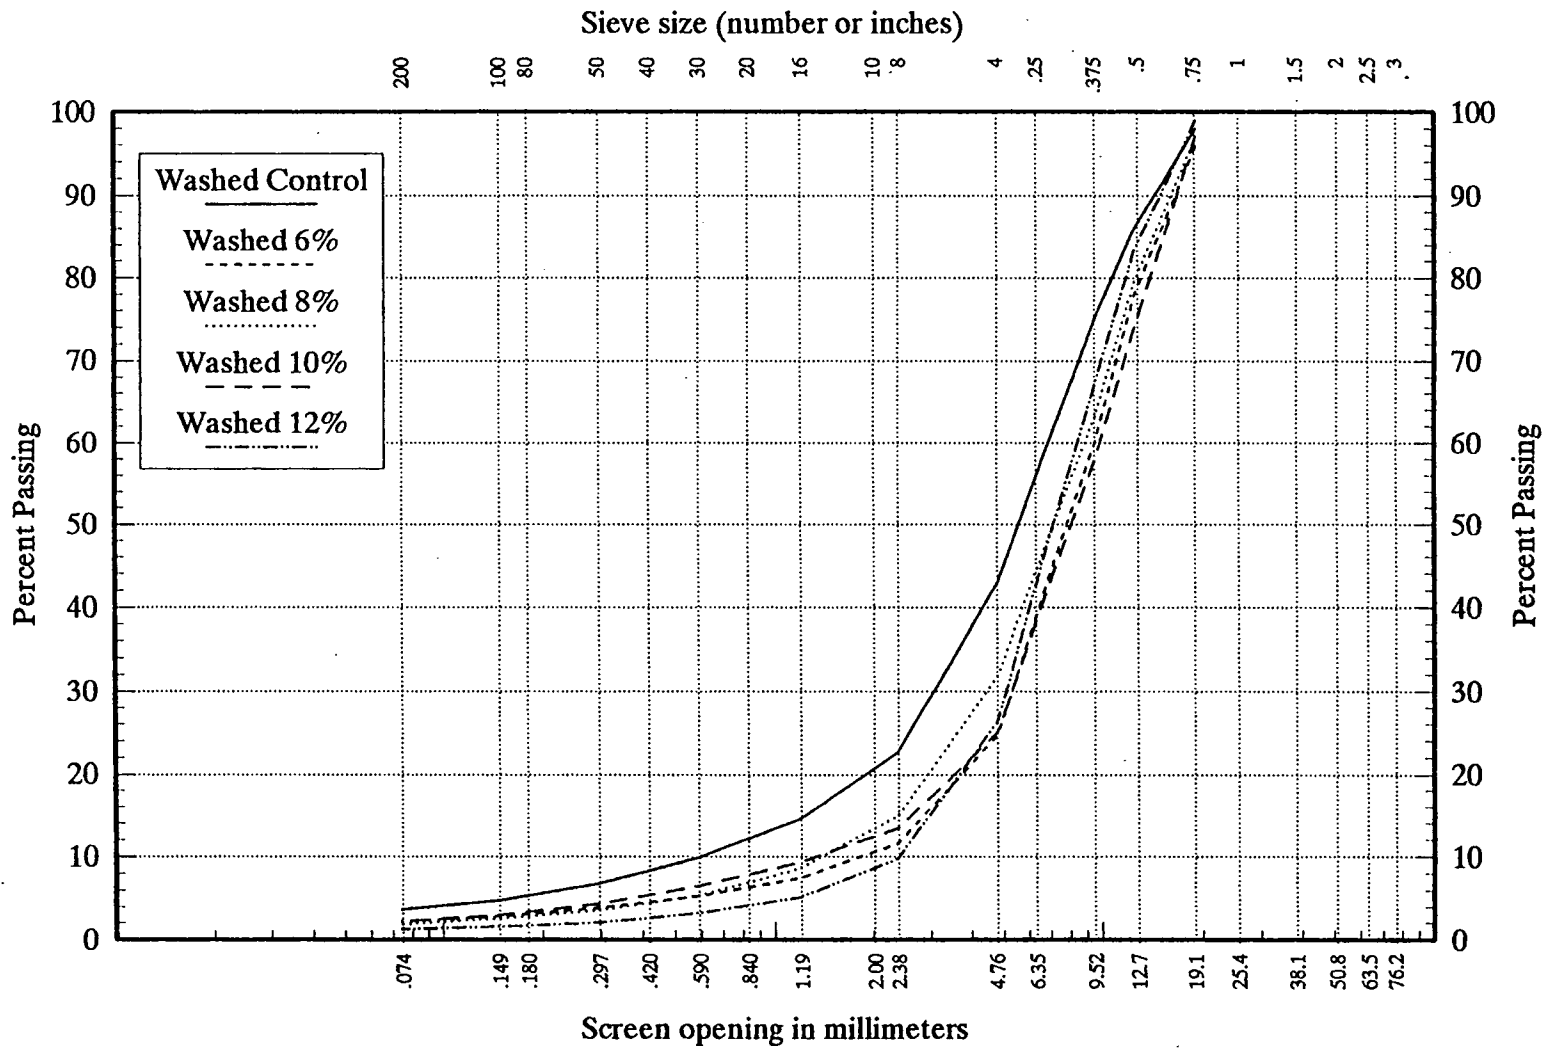
Figure 21. Appanoose County washed gradation from 08/15/93.

The washed gradation trends are shown on Figure 21. This shows the treated sections having less fines than the control section for a washed gradation on the Appanoose County test road. The trend was also evidenced by numerous other gradation tests. Some of the washed gradations showed some of the sections having a higher percentage of fines than the control. The higher amount of fines only occurs in the 6 percent and 10 percent sections. In the 6 percent section there are several residences where cars would be turning often which may grind up particles finer and loosen them from the crust. In the 10 percent section there is a reasonably sharp curve which the trucks and cars must maneuver around also churning up the surface crust and loosening materials on the surface. Also, in the 10 percent section there is a steep valley where the Bentonite could have washed down
