EXPERIMENTAL PROJECT

THIN BONDED CONCRETE RESURFACING

US 34 WEST BURLINGTON, IOWA

By A. A. Anderson, Chief Highway Consultant
Portland Cement Association

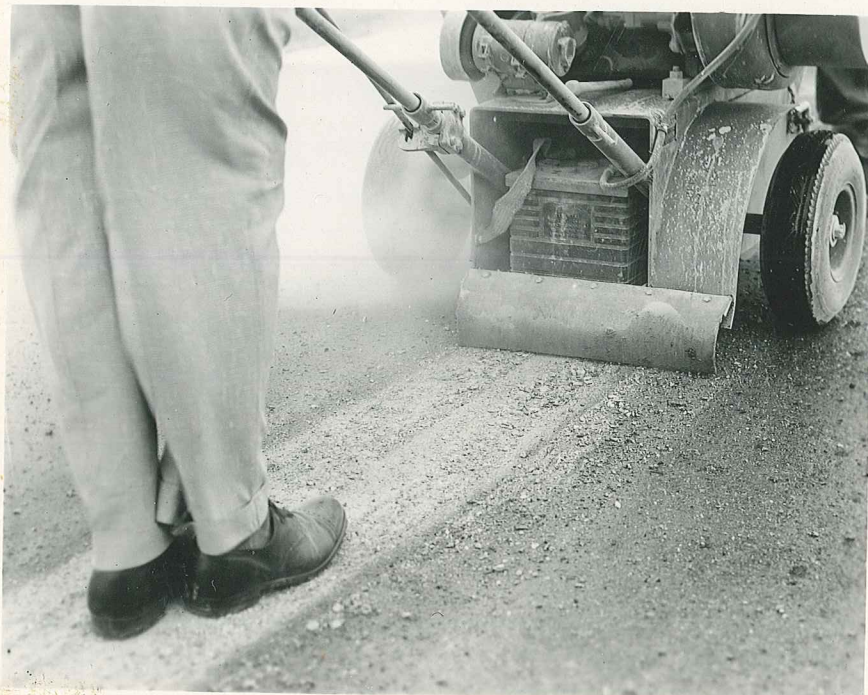
Picture 1 - Close up of G.H. Tennant surface scarifying machine removing bituminous material.

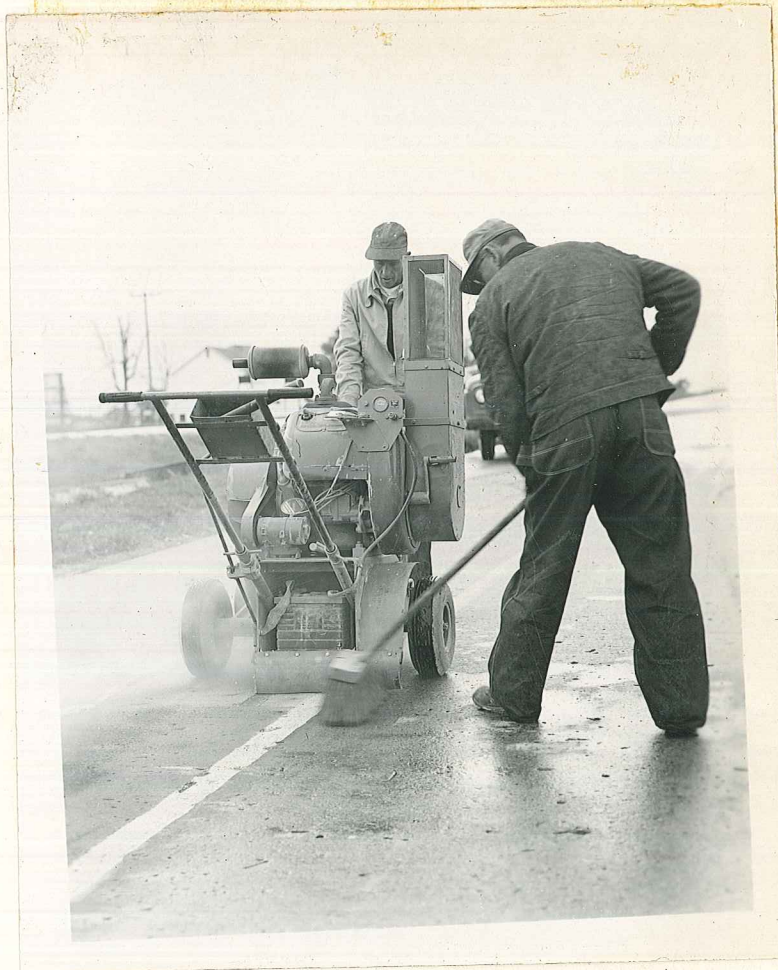
Picture 2 - Removing center line paint stripe from old pavement surface.

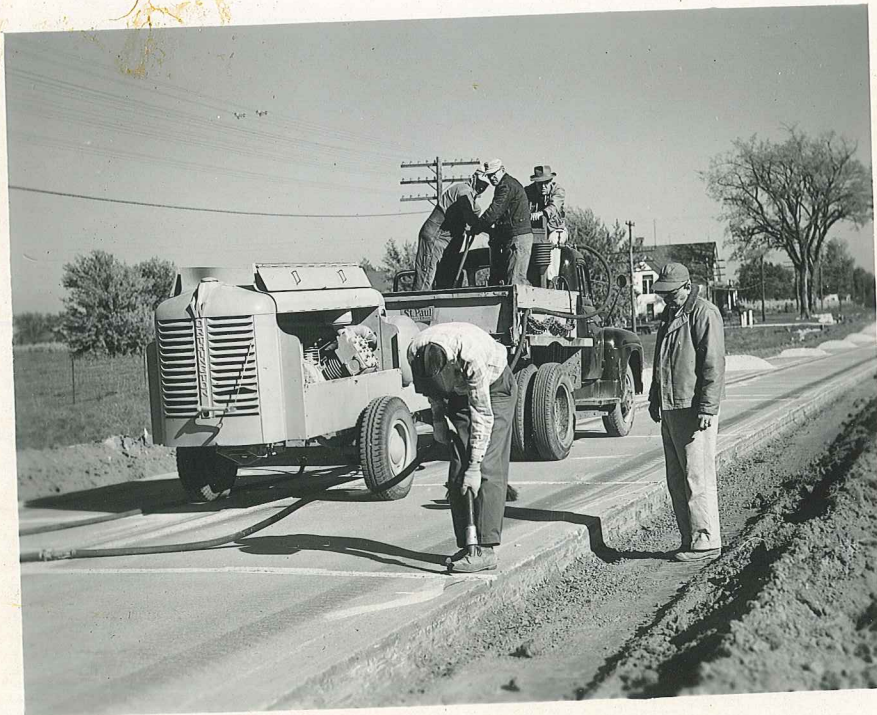
Picture 3 - Sand blasting bituminous material from routed out joints and cracks.

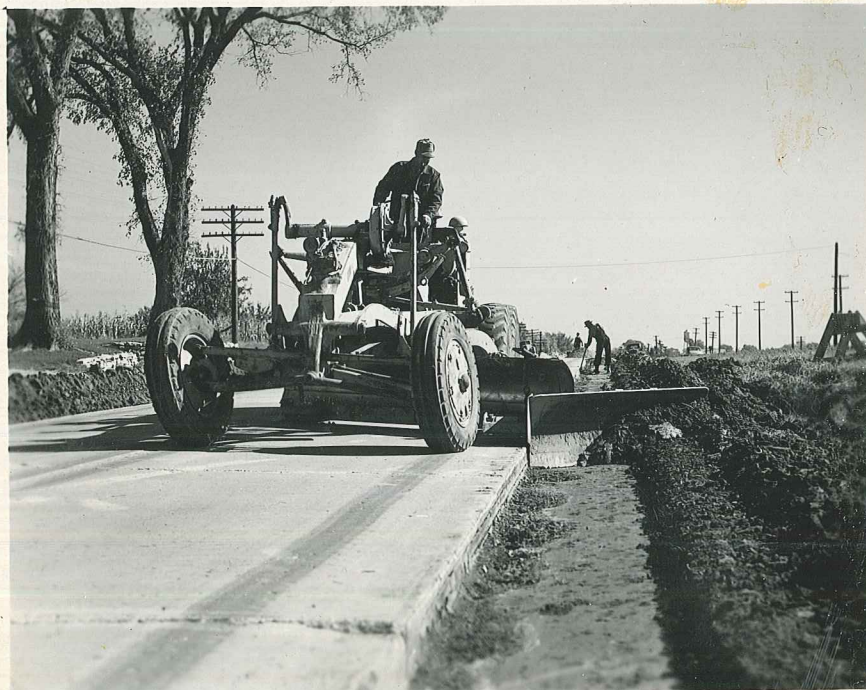
Picture 4 - Excavating trench, for widening using blade grader with trenching attachment.

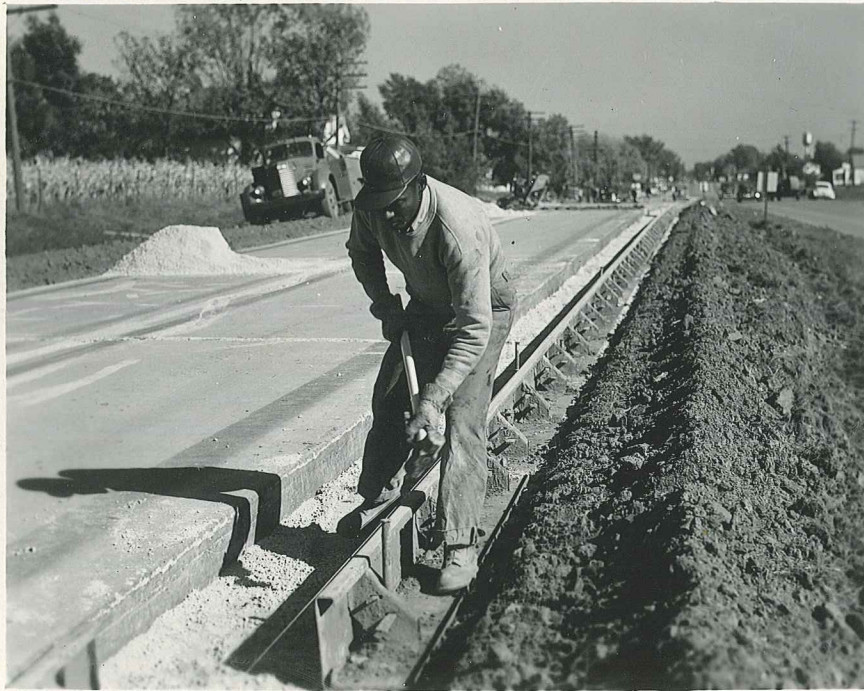
Picture 5 - Forms being set for 10x24 inch widening strip and the resurfacing.

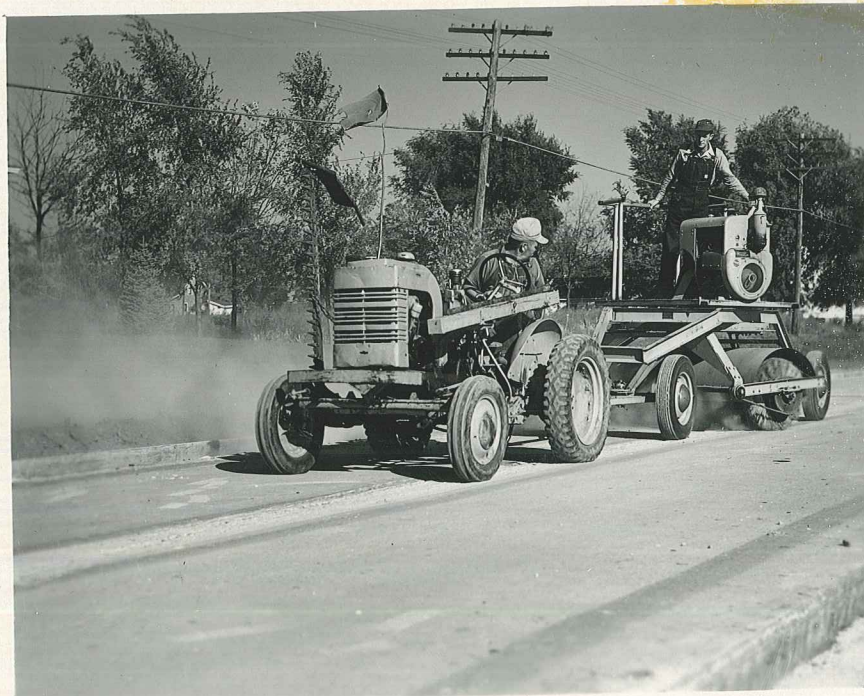
Picture 6 - Old pavement surface being dry swept with powered broom towed by light tractor.

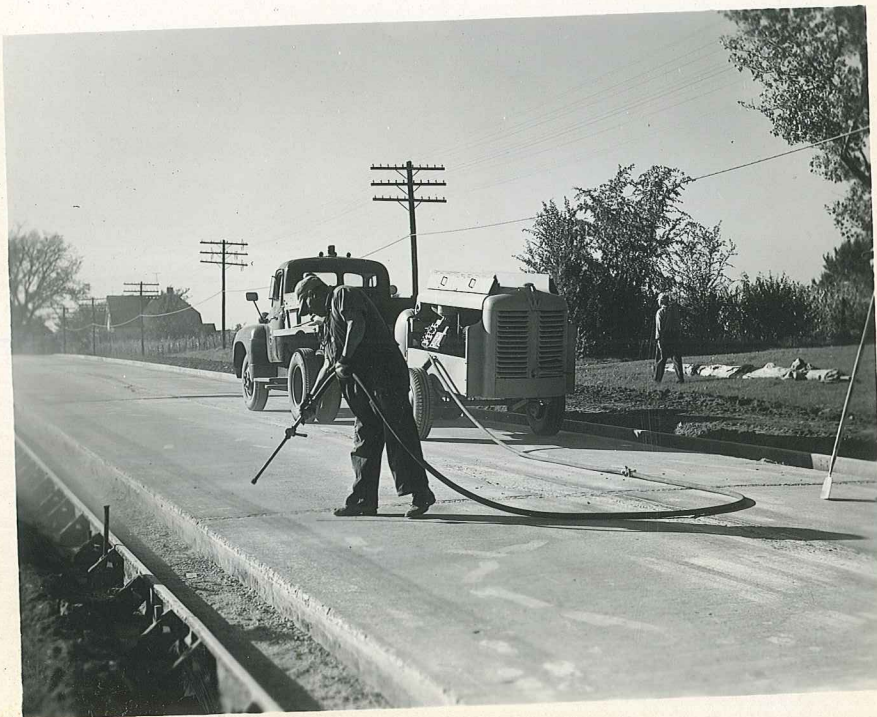
Picture 7 - Loose material being blown from crack crevices with air jet.

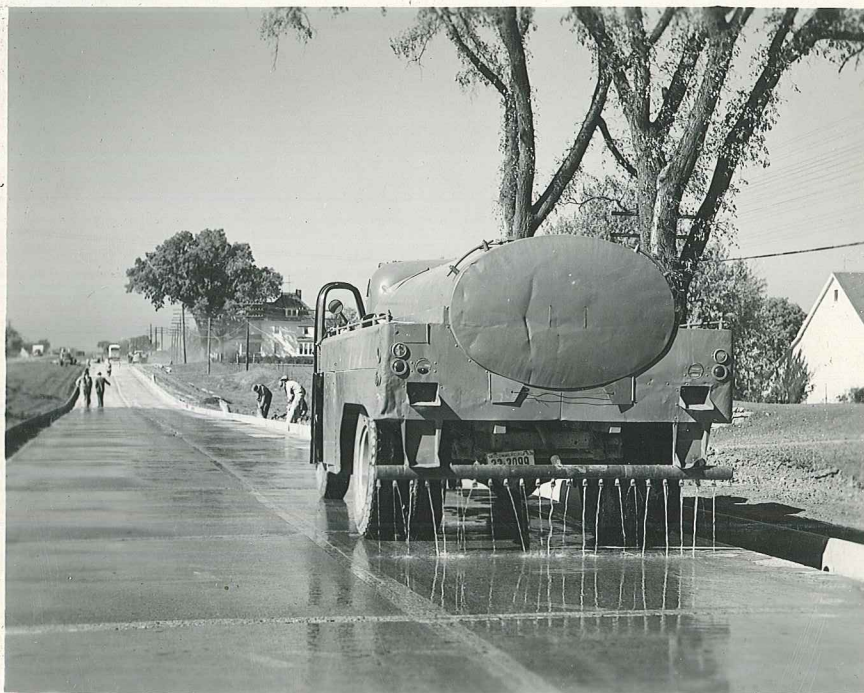
Picture 8 - Old pavement surface being wetted by tank truck equipped with spray bar. Surface was sprinkled ahead of applying detergent and acid.

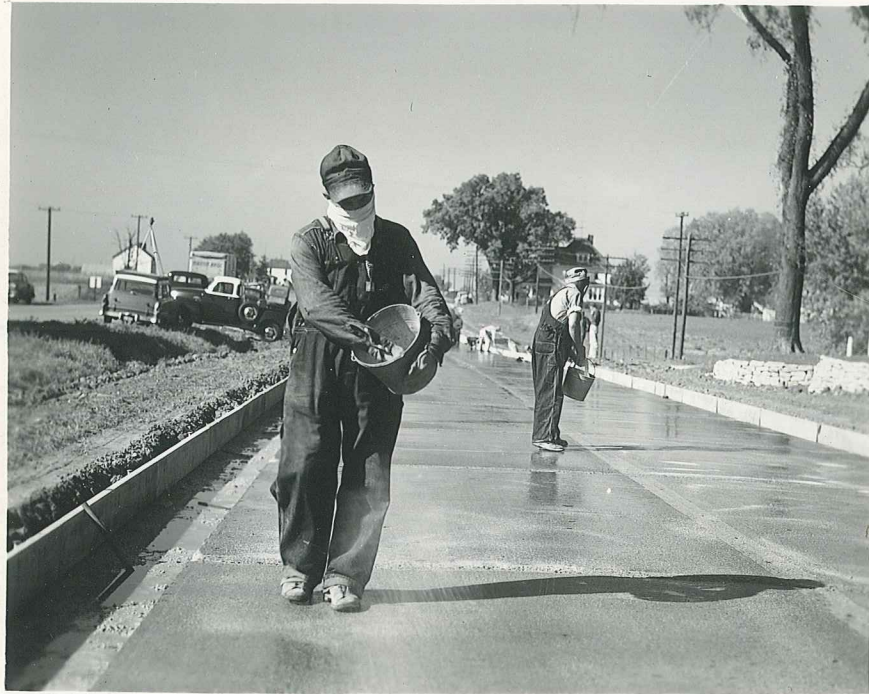
Picture 9 - Metzo 66 detergent was spread by hand at rate of 2 lb. per 100 sq. ft.

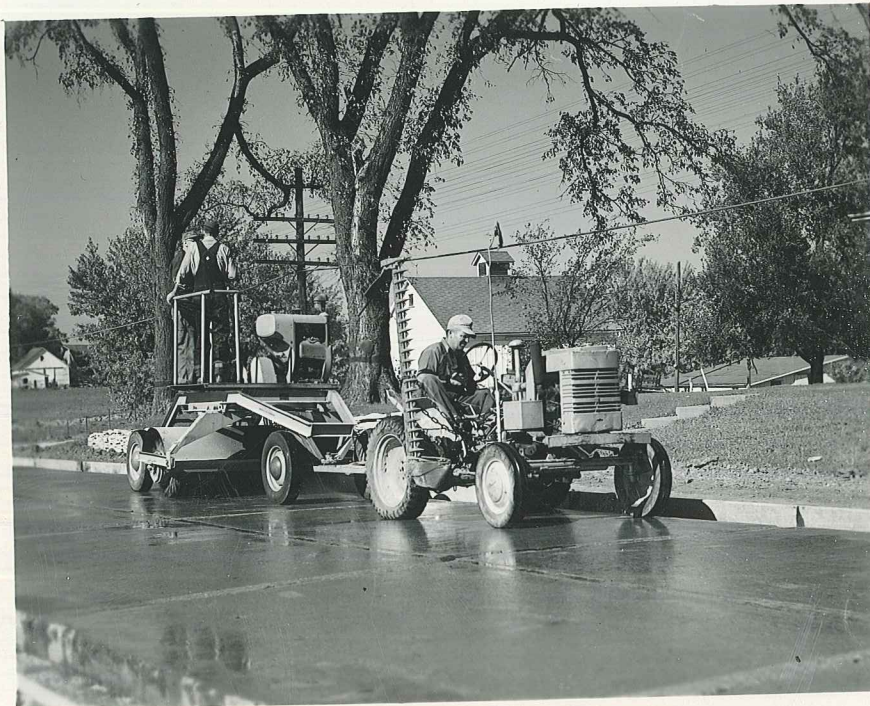
Picture 10 - When detergent became moist, it was thoroughly scrubbed into surface with powered rotary broom.

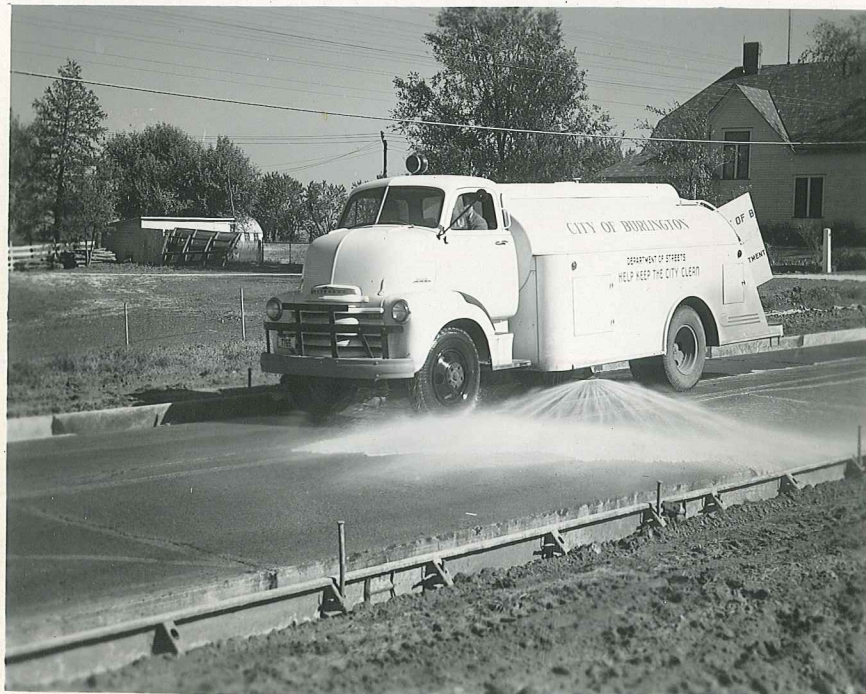
Picture 11 - Detergent residue was flushed from pavement until it showed neutral with pH paper. Same equipment used to flush surface after etching with acid.

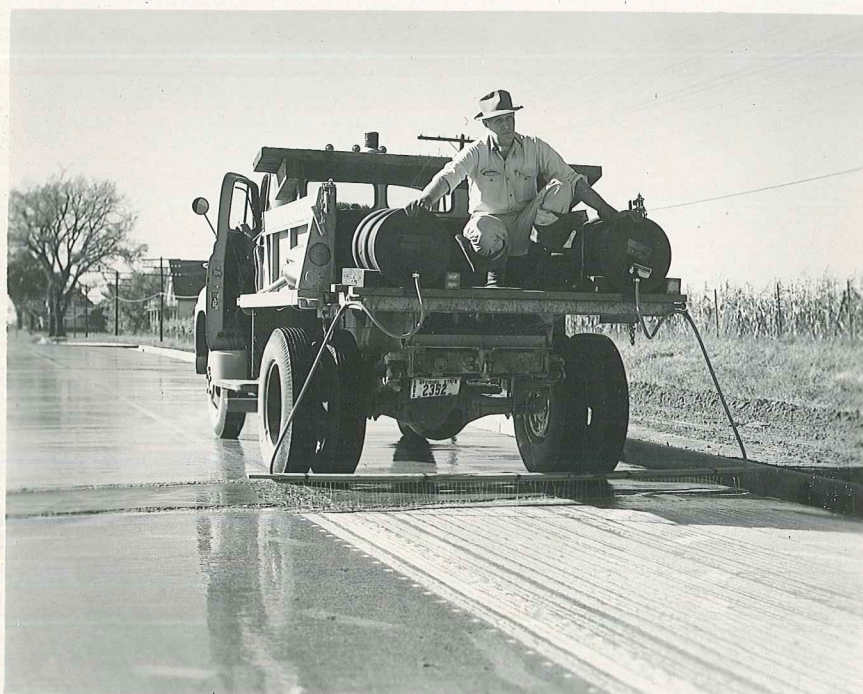
Picture 12 - Muratic acid was applied to wetted surface from rubber drums through home made Koroseal spray bar.

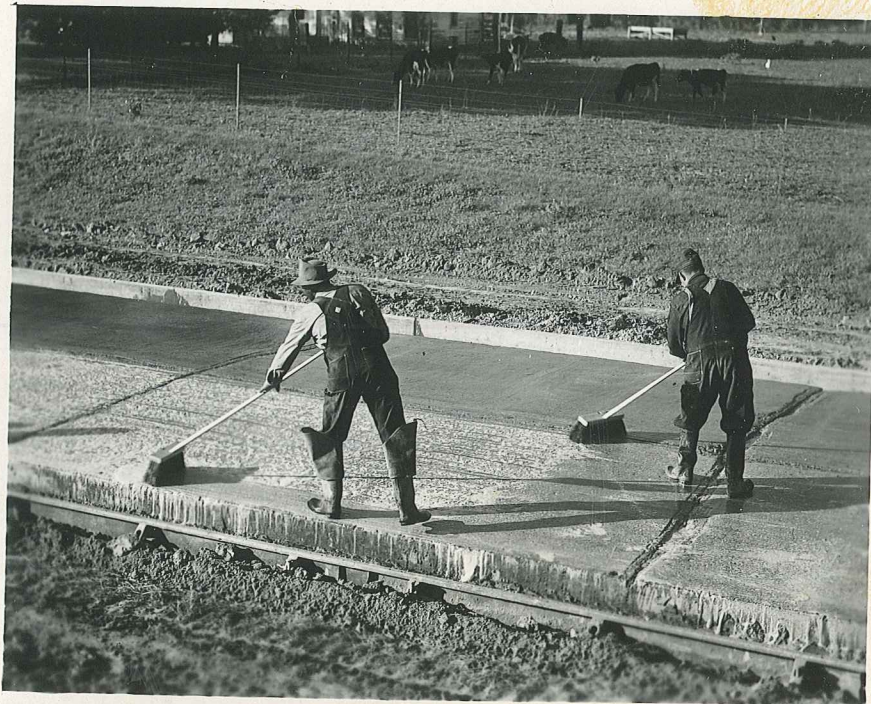
Picture 13 - Acid was further distributed by hand with rattan brooms.

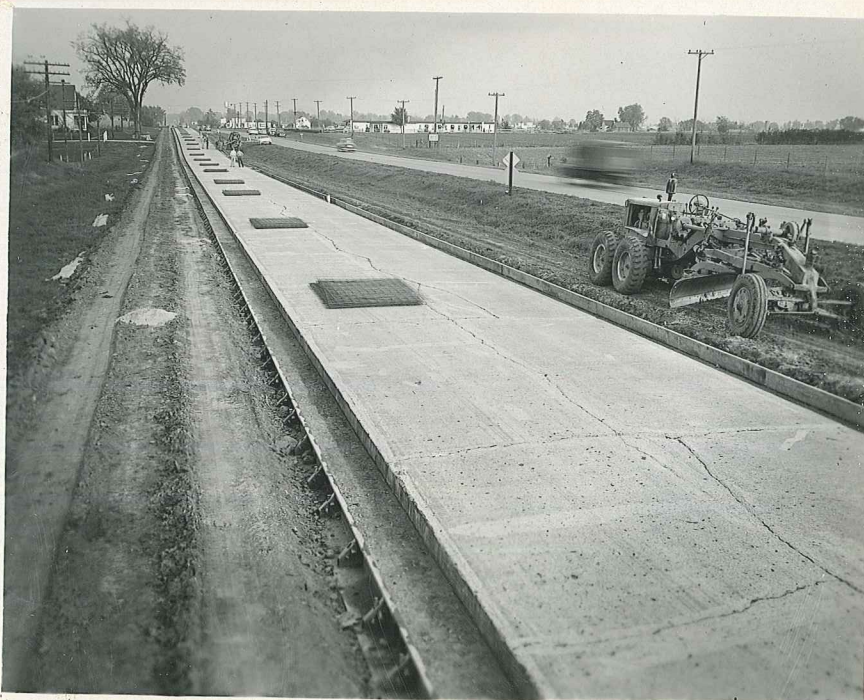
Picture 14 - Forms set and old pavement surface ready for widening and resurfacing. Note random cracking in old pavement.

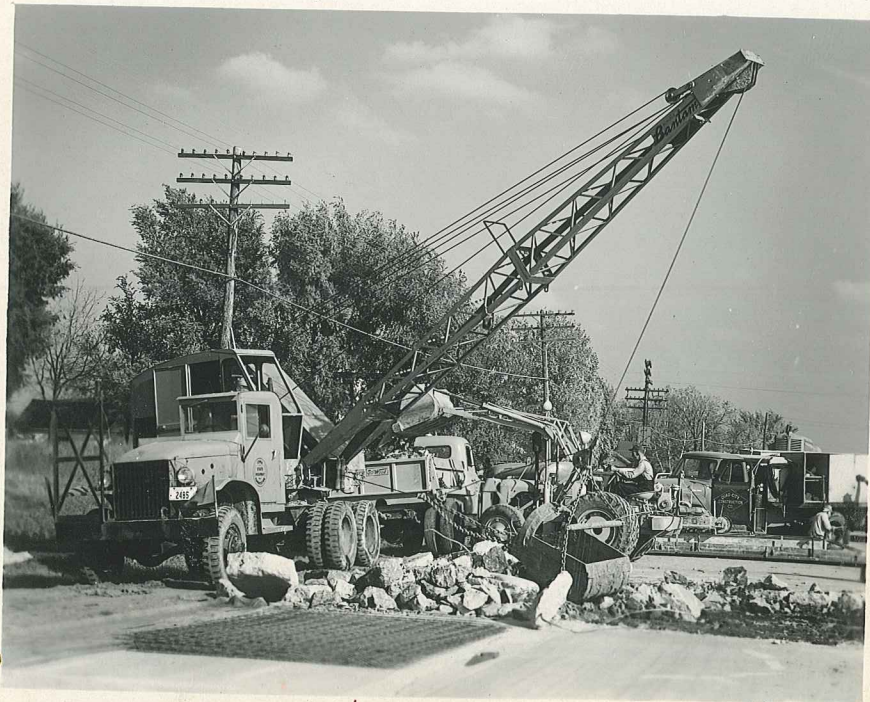
Picture 15 - Concrete being removed for 32 foot ramps placed at both ends of project.

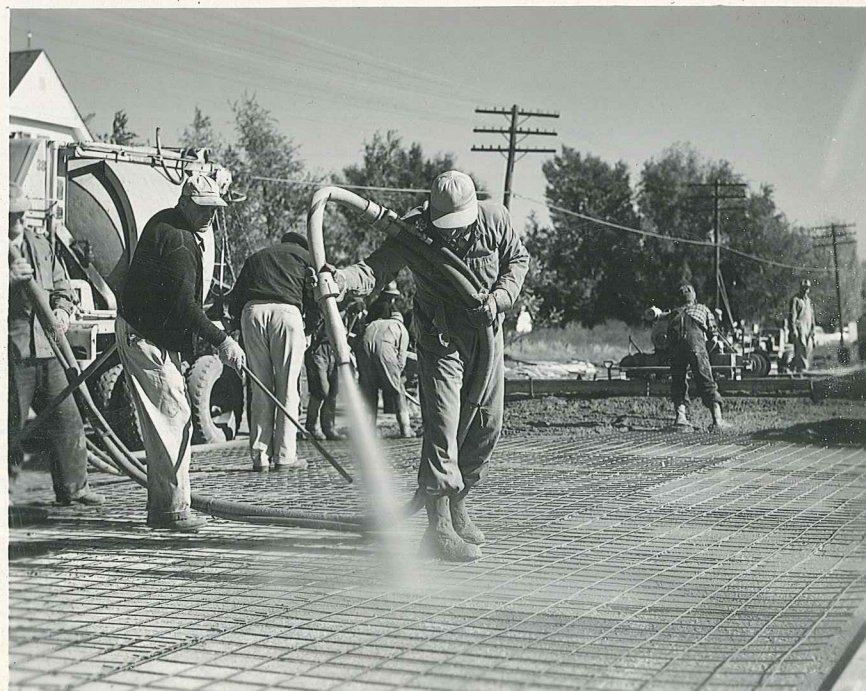
Picture 16 - Jete-crete bonding course being shot on surface.

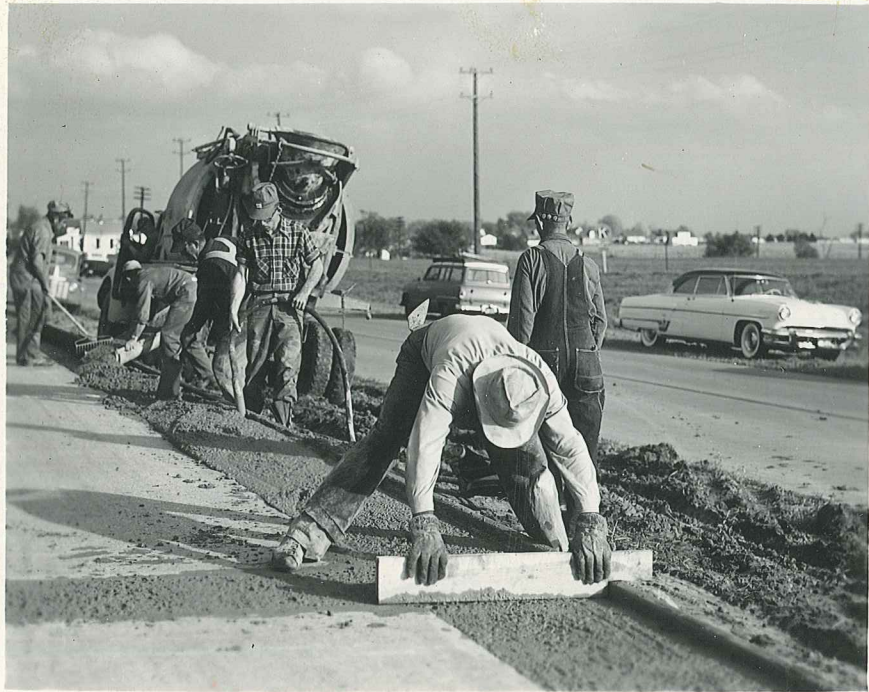
Picture 17 - Concrete for widening was placed from transit mixers, vibrated into place and struck to grade by hand.

purposely omitted in order to maintain a rough surface which would give the best possible mechanical bond with the resurfacing. Picture 17 shows how the concrete for the widening was placed and struck to grade.

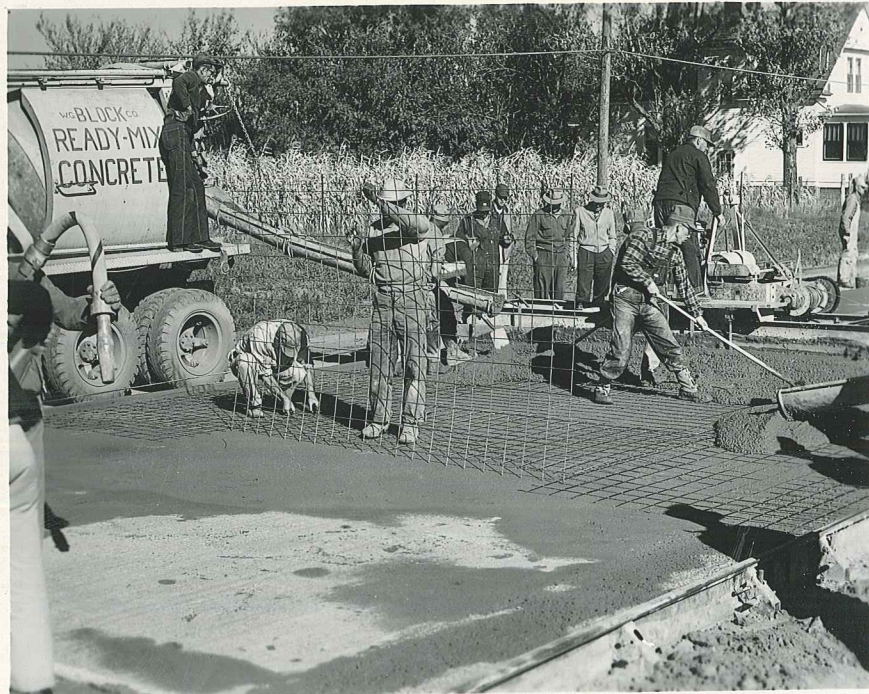
Picture 18 - Concrete for the resurfacing was placed from transit mixers, traveling on both shoulders, each of the two depositing concrete at the same time.

The concrete for the resurfacing was delivered to the contractor by W. G. Block Ready Mix Company in transit mixers which traveled on both shoulders, each of two mixers spouting concrete for the resurfacing simultaneously from both edges of the pavement. This is illustrated in Picture 18. After partially spreading by hand the concrete was further spread, consolidated, struck to grade and cross-section and finished by means of machine developed by the contractor. As can be seen in Picture 19, the machine consists of a trussed boiler plate, about $\frac{1}{2} \times 30$ in. which spans the pavement width and slides forward on the side forms. The machine is propelled forward by winches and cable anchored in a forward

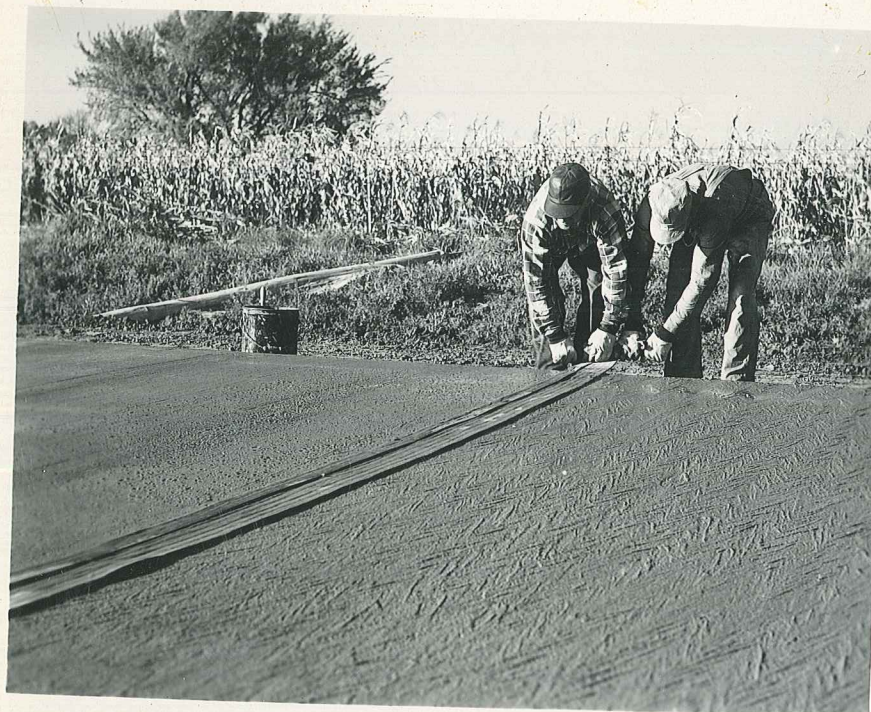
Picture 20 - Final surface finish was by hand operated transverse belt.

To comply with surface tolerances and for a good riding surface, the pavement was checked with scraping straight edges and smoothed with long handled floats. Final surface finishing was done with a hand operated transverse belt as shown in Picture 20. Curing of the resurfacing was accomplished with wet burlap strips followed with paper mats. See Pictures 21 and 22.

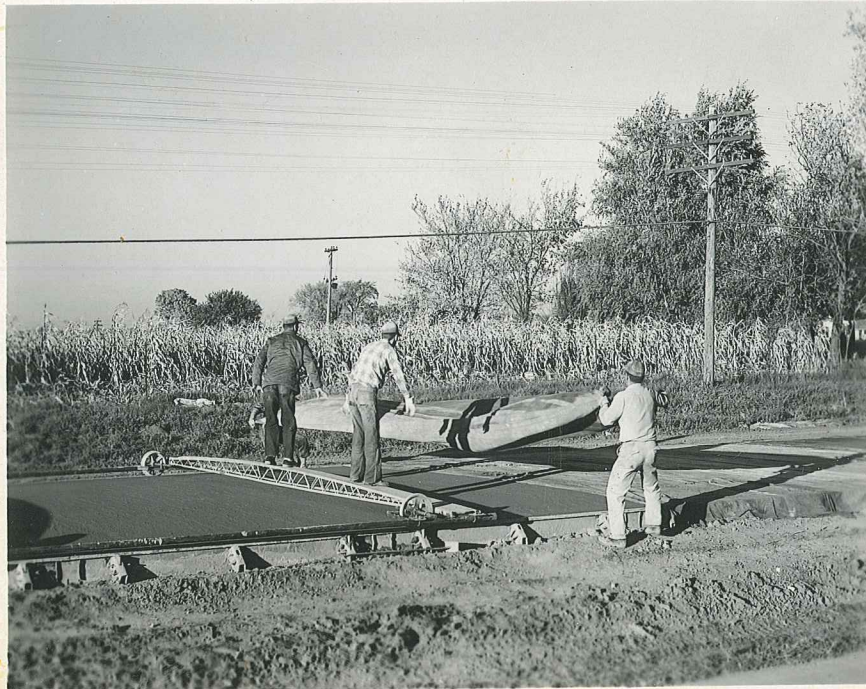
Picture 21 - Initial curing was accomplished with wetted burlap strips.

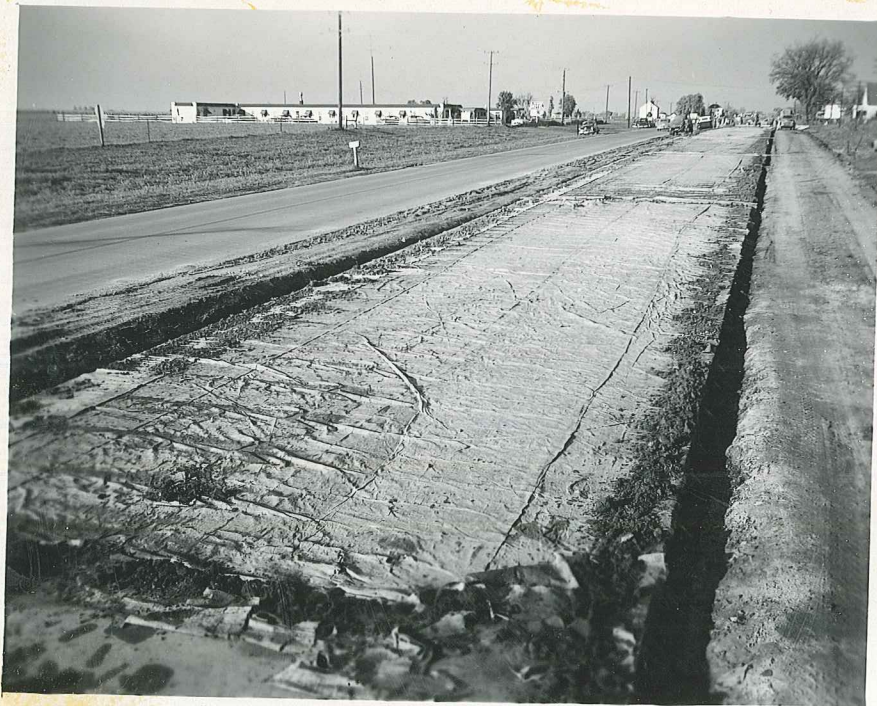
Picture 22 - After 24 hours, final curing was with paper blankets.

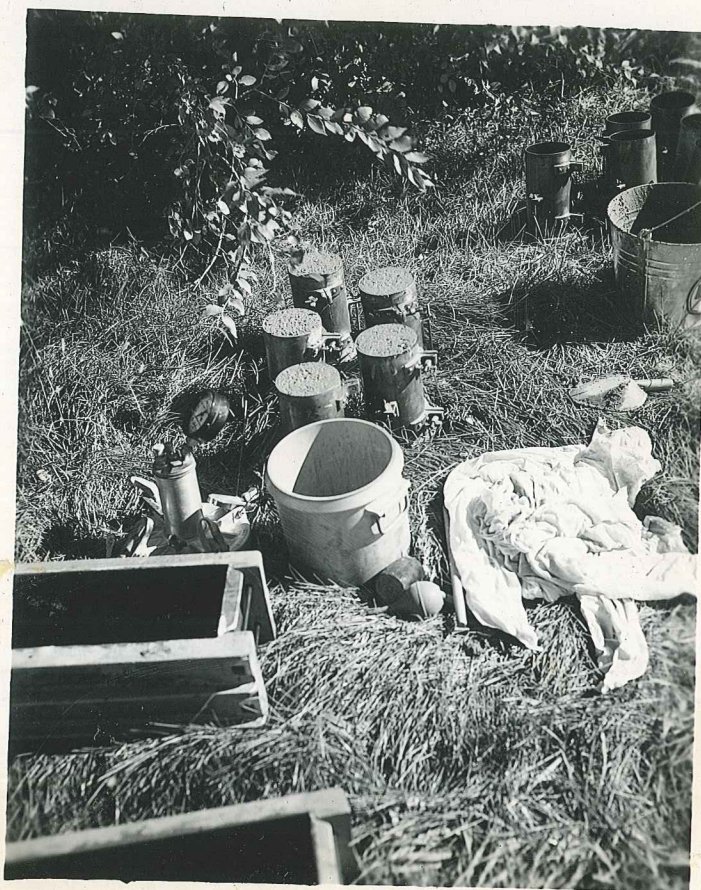
Picture 23 - Equipment used by Iowa Highway Commission Engineers in making concrete field tests and specimens for laboratory tests.

Field tests and the making of specimens for strength tests were done by Representatives of the Department of Materials. Field tests included slump and air content. Beams 6x6x33 in. were cast for flexural strength tests and $4\frac{1}{2}$ x9 in. cylinders were cast for compressive tests. Testing equipment used is shown in Picture 23. Test results (non-assembled) are included in the appendix. (Note: it is possible Bert Meyers would like to make a summary of all these test data with locations, etc. and include such a summary in the appendix, rather than the apparent incomplete material here-with appended.)
