Feasibility Investigation of Segmentally Precast Bridge Piers for Accelerated Construction

Final Report
March 2009

Sponsored by
the Iowa Department of Transportation (Project 06-257)
and
the Iowa Highway Research Board (Project TR-556)

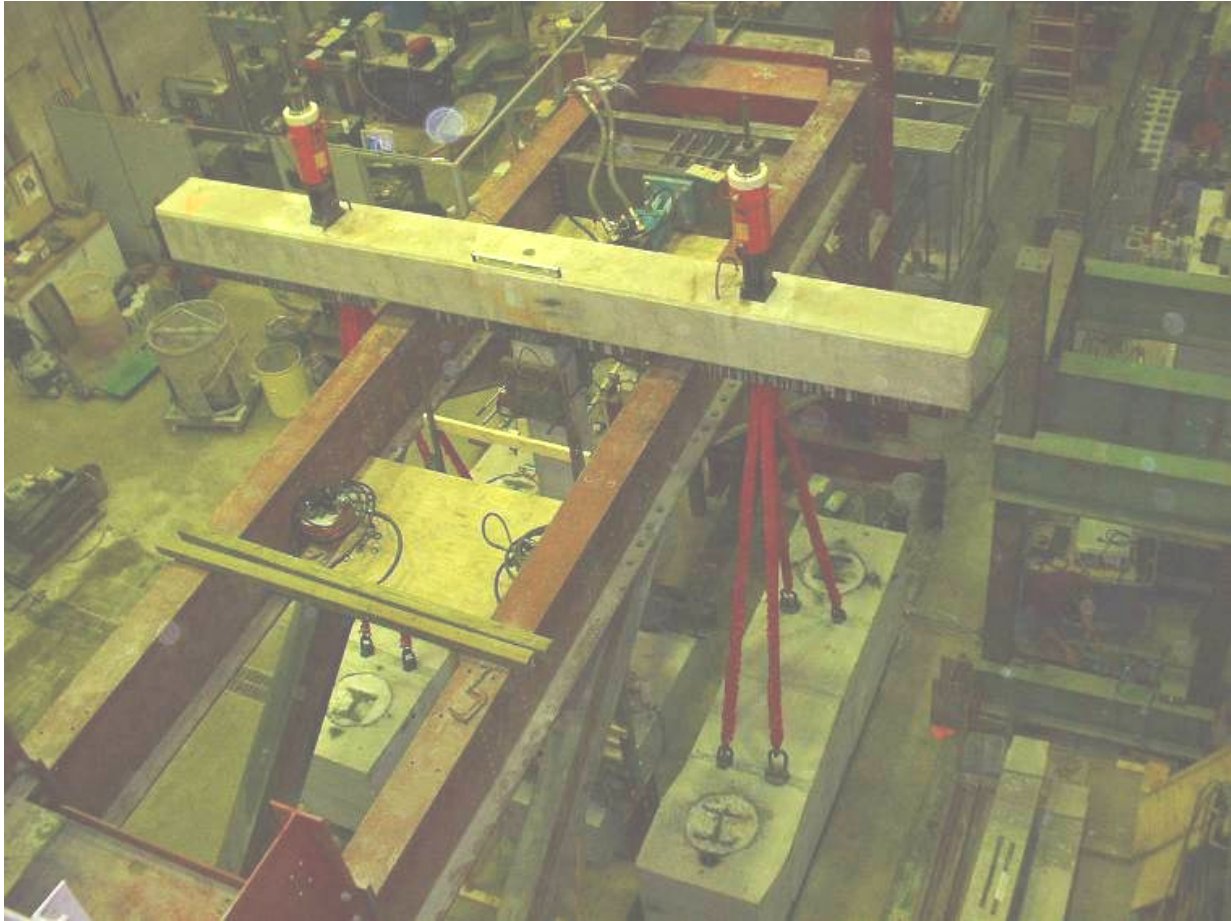
Figure 8. Photograph of load beam from above.

The load beam used to apply the dead load to the top of each test column was a doubly-reinforced concrete beam that was composite with a structural steel W-shape. Three holes were bored vertically through the load beam to accommodate the post-tensioning bar of the column specimen as well as the two rods that supported the concrete dead weights. The load beam was oriented perpendicular to the direction of lateral loading and applied its own weight of 7 kips as well as the weight two large concrete blocks weighing 18.5 kips each to the top of the column. This arrangement provided 44 kips of total dead load at the top of each column.

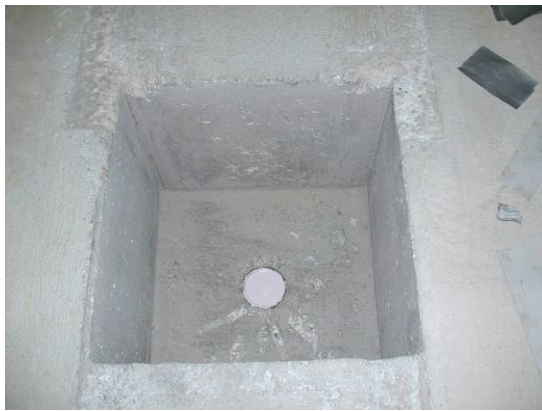
Figure 9. Photographs of Column 1 socket and column placement.

The foundation blocks for each column specimen were placed inside the load frame; two ducts in the blocks, that were six feet apart, were aligned with holes in the strong floor holes for post-tensioning the blocks to the floor. Each foundation block was post-tensioned to the floor with 120 kips (60 kips/rod) providing approximately 24 kips of frictional sliding resistance. Each foundation block had been cast with a centered 15 in. x 15 in. x 13 in. deep socket to accommodate a column specimen. These details are shown in Figure 9.

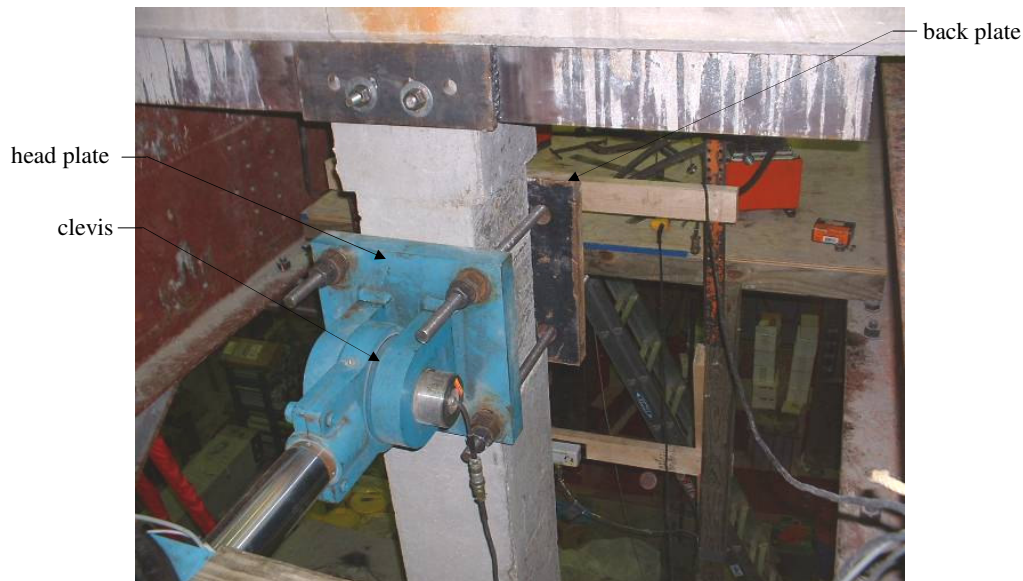
Figure 10. Photograph of actuator connection to column.

The base of each column was placed into the socket at the center of the foundation with the overhead crane. A flowable, two-part structural epoxy (Sikadur 32) mixed in equal proportion with Grade 37 silica sand was used to grout the column segment to the foundation. The epoxy reached initial set after about four hours, at which time the bearing plate was placed on the bottom column segment. The top column segment was then lowered onto the bearing plate using the overhead crane, after which the external fuse plates were bolted to each segment. Nuts were tightened to a snug-tight fit at this stage. By connecting the column segments with fuse plates, the column was stabilized until post-tensioning could be applied. The actuator was then connected to the column using a clevis and two bolted plates as shown in Figure 10. The actuator was fitted with clevises (i.e. hinges) at both of its ends to ensure that no concentrated moment was applied to the column through the actuator.

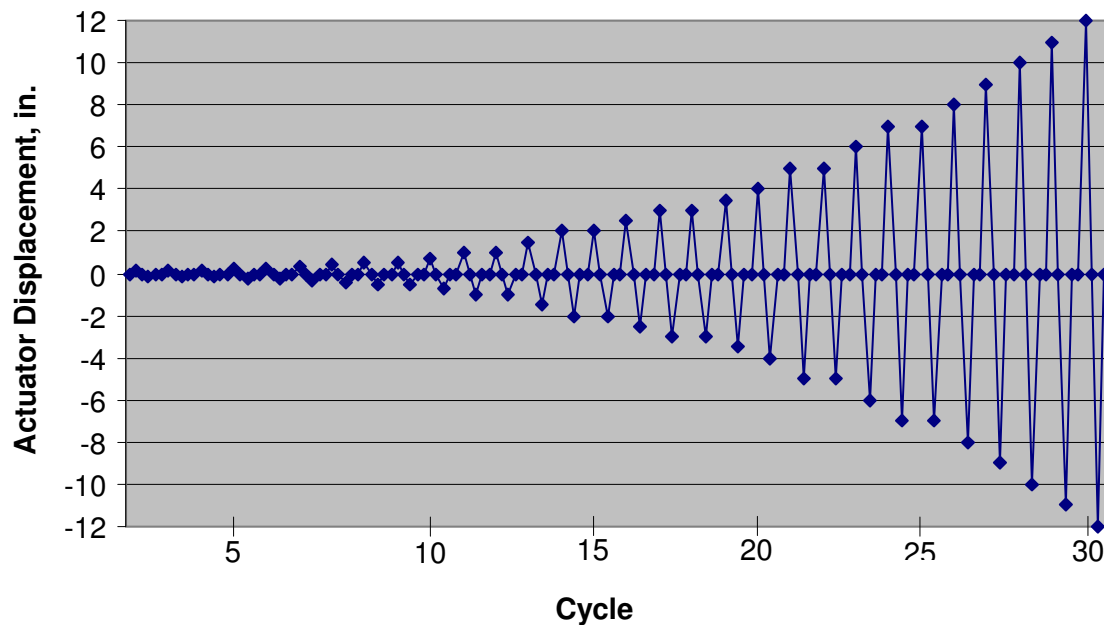
Figure 14. Displacement regimen.

Cyclic, quasi-static lateral loads were applied to the column specimens using displacement control. Displacement cycles increased incrementally until the column failed. Each cycle began by inducing the desired positive displacement that was desired and returning to zero displacement. The cycle was completed by inducing the same displacement in the opposite direction, and returning to zero displacement (e.g., 0 in., +1 in., -1 in., 0 in.). The specimen was examined for damage at peak displacements of each cycle, and photographs were taken every few cycles. The displacement regimen used in the tests is shown in Figure 14 and Table 1.

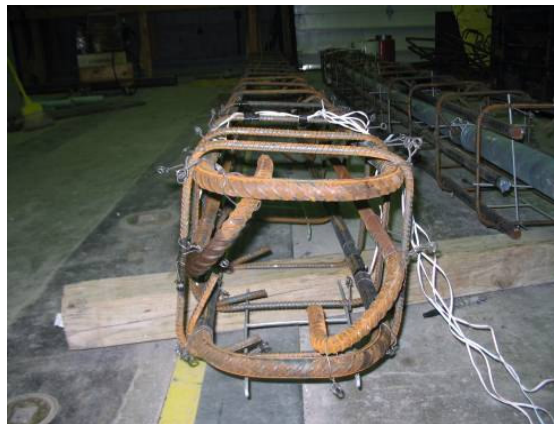
Figure 15. Base end of control column reinforcement cage.

For the longitudinal reinforcement in the control column (Column 1), the corner bars on the bottom end of the column embedded into the foundation socket consisted of two U-shaped bars. One-hundred-eighty degree hooks were used on this end for the interior two bars to achieve anchorage.

Transverse ties were spaced every foot along the height of the two column segments. On the bottom end of the column, the first stirrup was placed 5 in. from the end of the column to help confine the hooks and hoops; column reinforcement is shown in Figure 15.

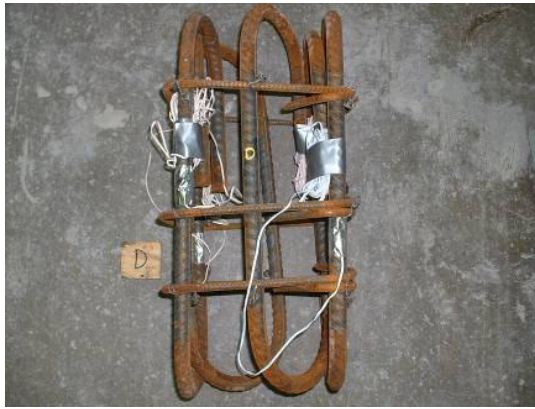
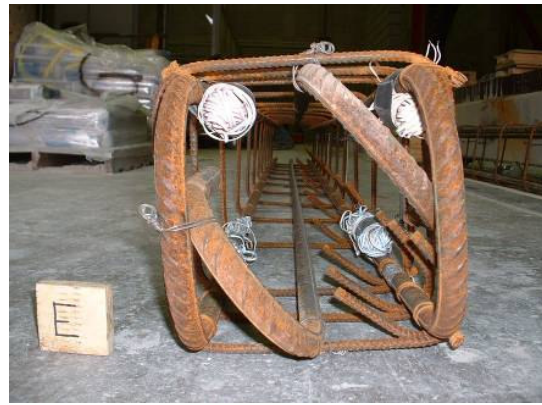
Figure 17. Photographs of column 2-4 reinforcement.

The first three segmented columns (Columns 2-4) had reinforcement details similar to those used in the unjointed control column (Column 1). U-bars were used on the construction-joint ends of the column segments for the corner bars as they were for the control column (Column 1).

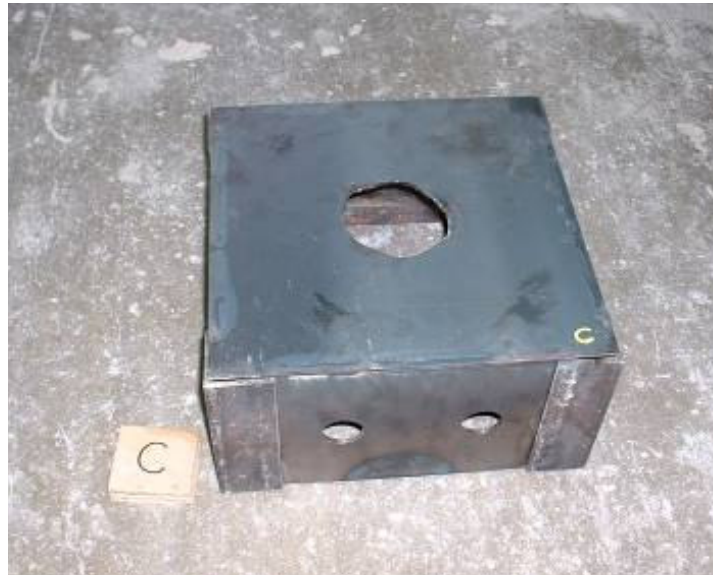
Figure 18. Collar for Columns 2-4.

For the first three segmented columns (Columns 2-4), the collars were fabricated from 3/16 in. thick plate and angles welded together. Holes were drilled in the plates to accommodate 1.1 in. outside diameter steel ducts for through-bolts spaced 4 in. apart on the tension and compression faces of the collar. For these three columns, fuse plates were only used on the tension and compression faces of the column.

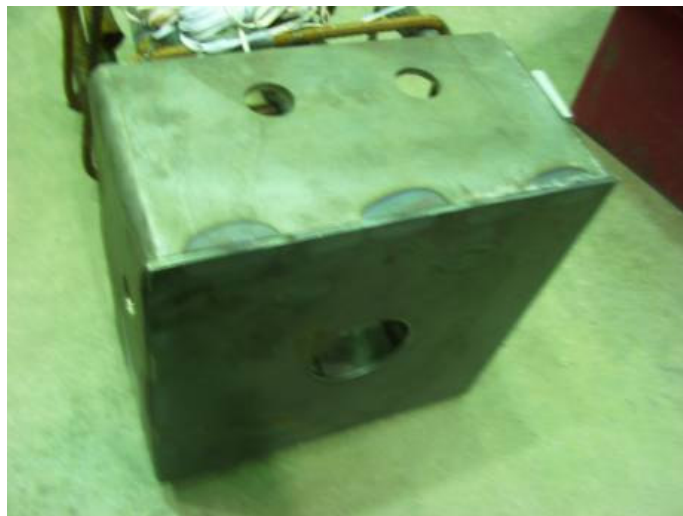
Figure 22. Column 6 collar.

As in Column 5, a structural steel tube (HSS 12 in. x 12 in. x 1/4 in.) was used for the collars of Column 6. The only alteration from Column 5 for these collars was the vertical spacing of the through-ducts. In these collars, a 1 in. gap was provided between the pairs of ducts perpendicular to each other. The ducts for the lateral faces of the column were spaced 1 in. closer to the construction joint. The ducts on the tension and compression faces of the collars were spaced 1 in. farther away from the construction joint. This was done to provide room for additional concrete between the ducts, as well as to avoid consolidation issues in this relatively congested region. The collar used for Column 6 is shown in Figure 22, and additional details for Column 6 are presented in Figure 23.

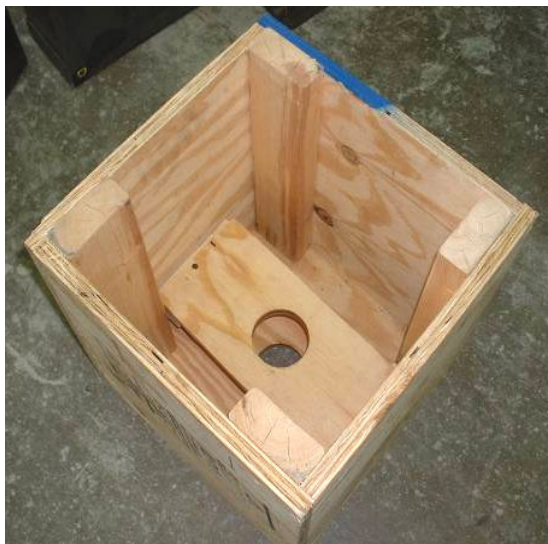
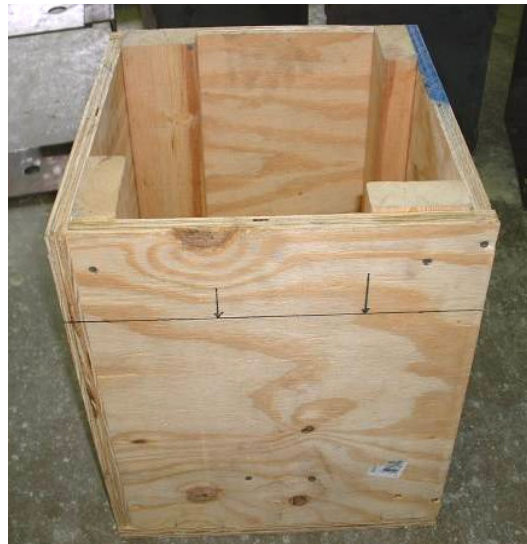
Figure 27. Photographs of center socket boxout.

After construction of the reinforcement cage, the boxout for the center socket (shown in Figure 27) was tied in place. As previously mentioned, this socket allowed the bottom column segment to be epoxy grouted in the foundation block. A 2.5 in. diameter hole was drilled in the center of the socket boxout to allow for the center post-tensioning duct. Two additional 2.5 in. ducts (shown in Figure 24) were spaced 3 ft. on either side of center to align with the holes in the strong floor, permitting two post-tensioned tie-down bars to secure the foundations to the lab floor. A photograph of these ducts can be seen in Figures 28.

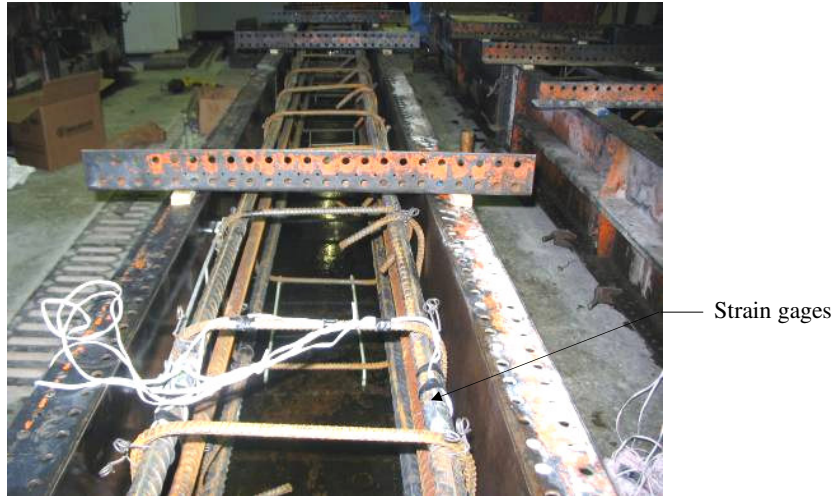
Figure 30. Photograph of Column 1 reinforcement.

For Column 1, the reinforcement cage was first tied and positioned in standard steel forms. Strain gages were placed on the longitudinal reinforcement; four gages were located one foot from the bottom of the column on the exterior four longitudinal bars. The column's reinforcement cage positioned in the steel forms can be seen in Figures 30-32.

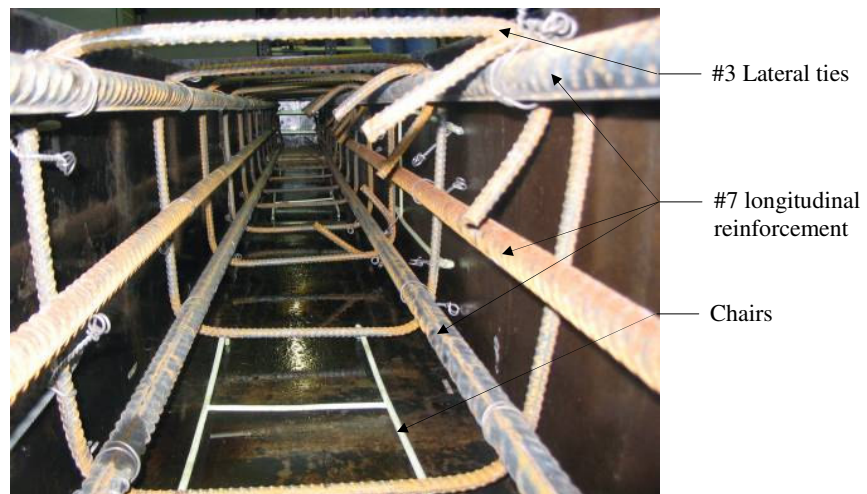
Figure 31. Photograph of chairs and reinforcement in Column 1.

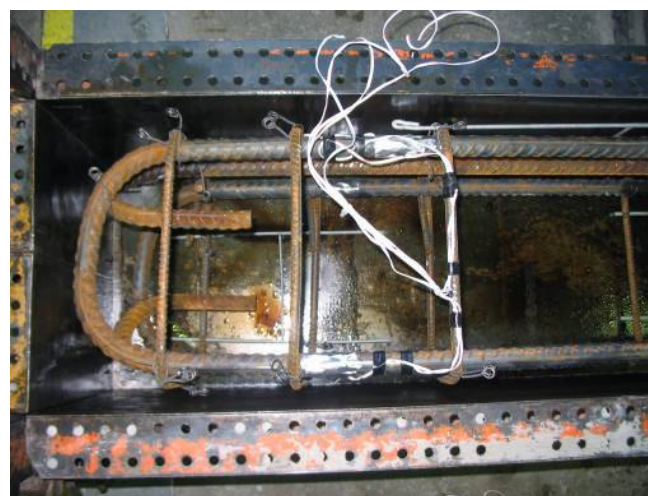
Figure 32. Photograph of base end of Column 1.

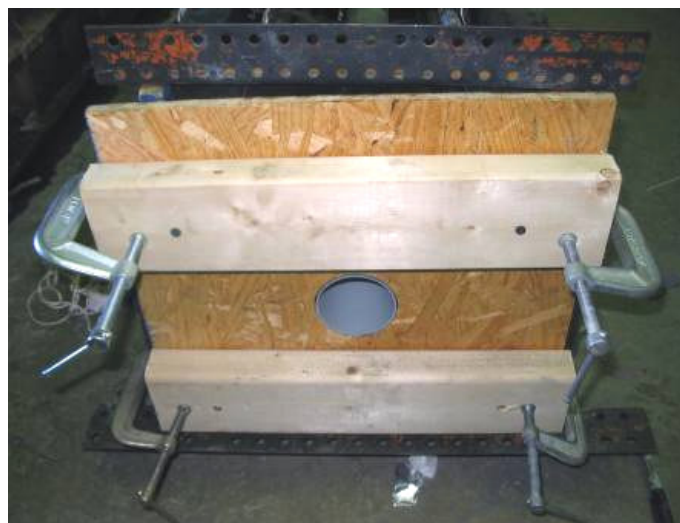
Figure 34. Photograph of Column 2 bulkhead.

The 12 ft. column segment for Column 2 was constructed in a similar manner as the control column. However, several alterations were made to allow for segmented construction. As with the control column (Column 1), four internal strain gages were used in this column. They were placed 12 in. from the bottom of the column on the four corner longitudinal bars. A central duct for the unbonded post-tensioning bar was included in this segment. The steel collar was placed in the forms on the base end of the 12 ft. column. Plywood bulkheads, as seen in Figure 34, were used to cap the end of the forms and securely position the post-tensioning duct. Details of the 12 ft. Column 2 segment in the forms are shown in Figures 34-37.

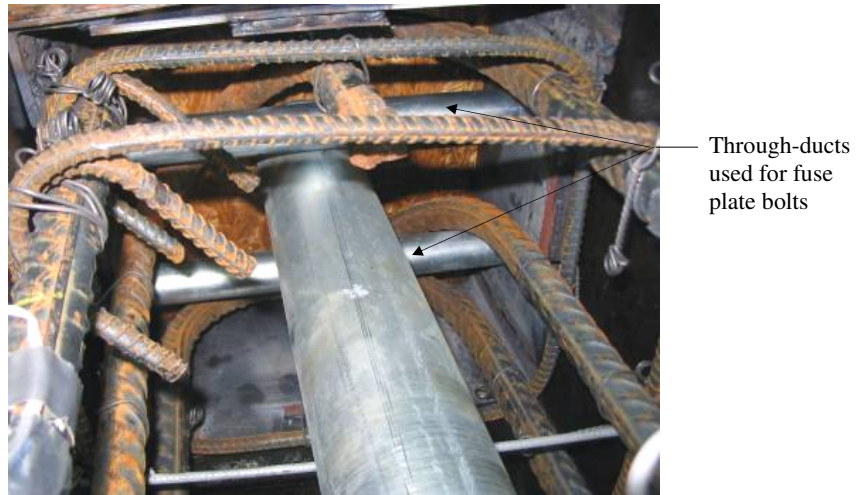
Figure 35. Photograph of Column 2 collar end.

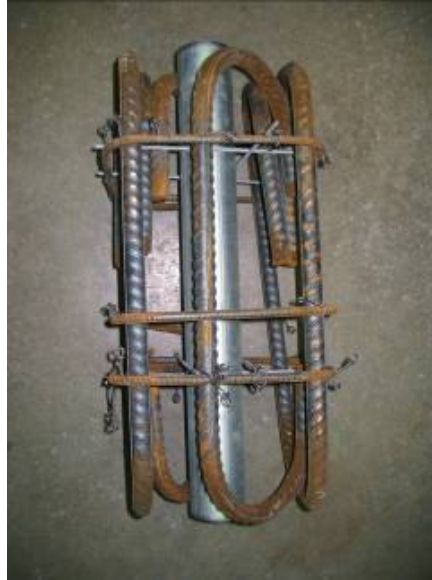
Figure 38. Photograph of reinforcement of Column 2 (2 ft. column segment).

The 2 ft. column segment shown in Figures 38 and 39 was constructed in a similar manner as the 12 ft. column segment. Strain gages were placed in the longitudinal direction at midheight of all four corner bars. Additionally, a steel collar identical to the one used on the 12 ft. column segment was placed on the top end of the segment.

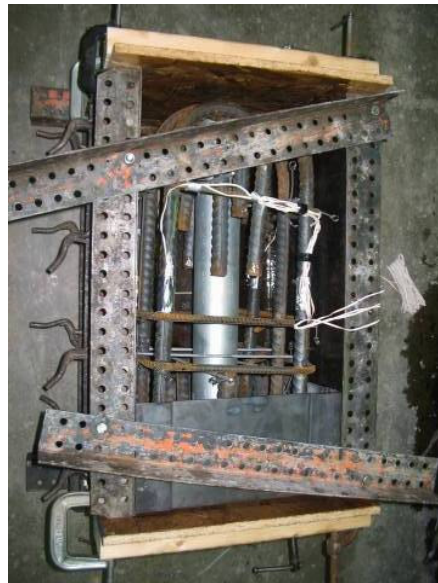
Figure 39. Photograph of Column 2 reinforcement in forms.

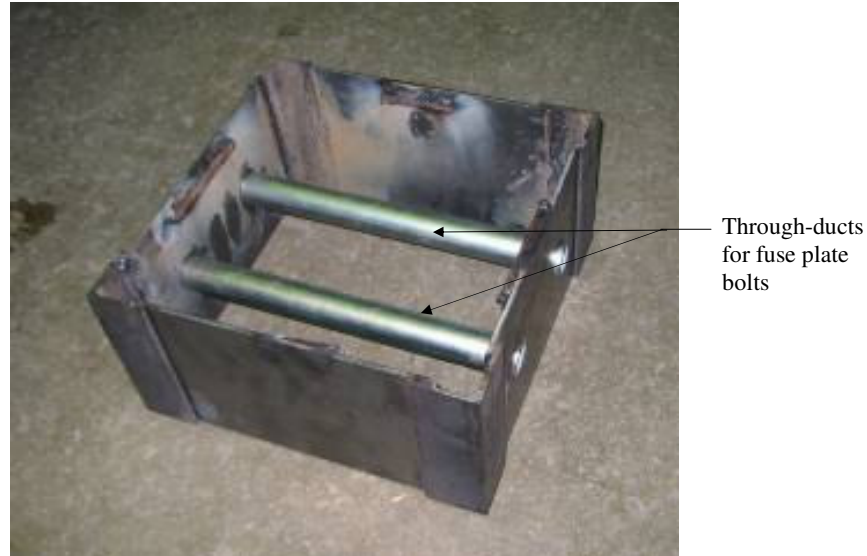
A typical collar used for Columns 2–4, shown in Figure 40, was constructed by welding 3/16 in. angles with 3/16 in. plates. Holes for the ducts were drilled in two of the side plates to secure bolt ducts that connected the fuse plates to each column segment. Additional information about the collars and reinforcement details was presented in Chapter 3.

Figure 40. Photograph of Column 2 steel collar with bolt through-ducts.

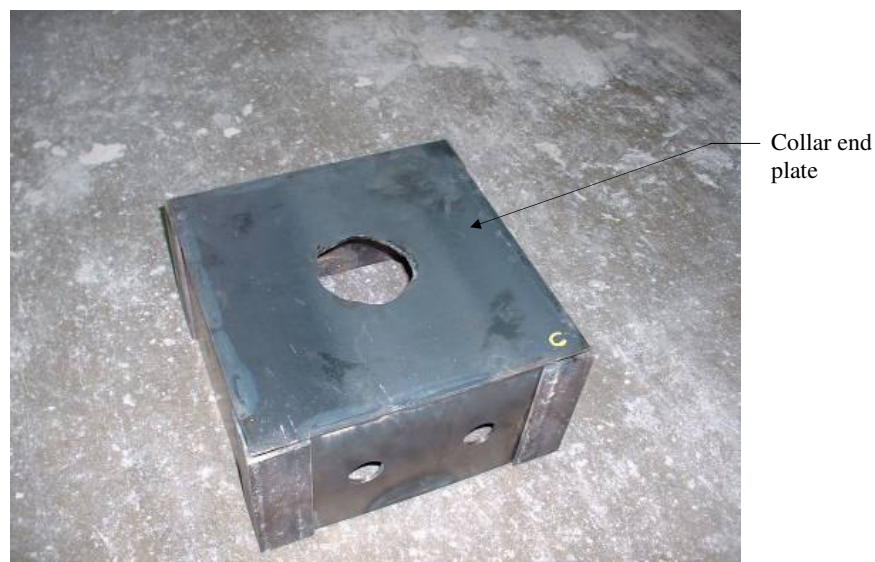
Figure 41. Photograph of Column 3 collar and end plate.

The third and fourth segmented columns (Columns 3 and 4) had a similar construction process as the first segmented column with one major difference. A steel plate was welded to the end of the collars for Column 3 to assist in confining the concrete near the construction joint. A 2.5 in. hole was cut in the center of this plate to accommodate the post-tensioning duct. Due to the experimental nature of this plate, it was not included for the Column 4 collars at the time of casting. The collar used for Column 3 is shown in Figure 41; construction details of the column segments used for Columns 3 and 4 are shown in Figures 42-50.

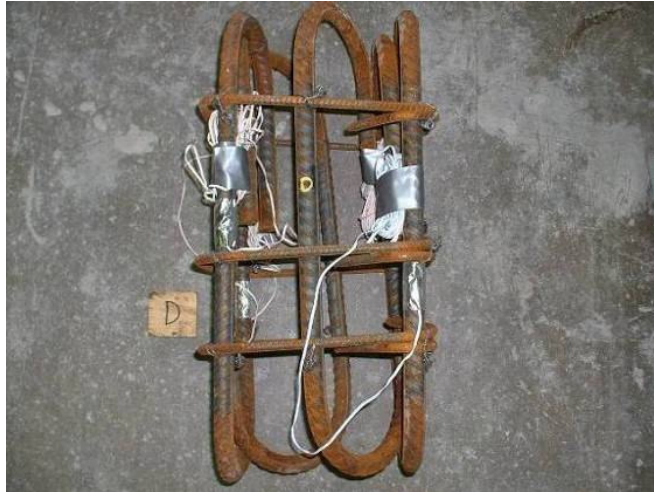
Figure 42. Photograph of Column 3, 2 ft. segment reinforcement.

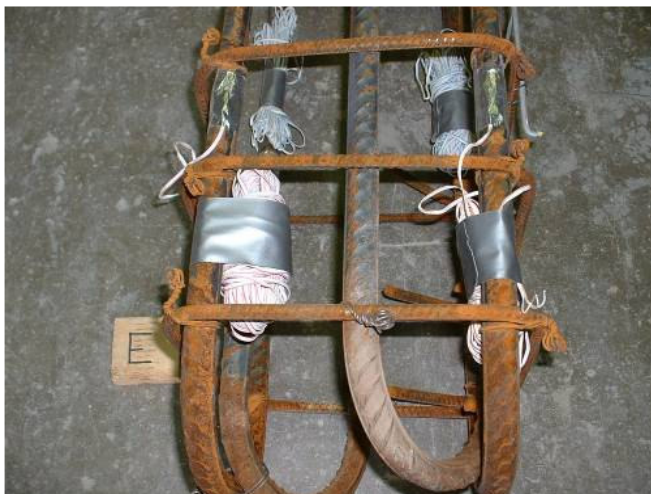
Figure 44. Photograph of Column 3 strain gages.

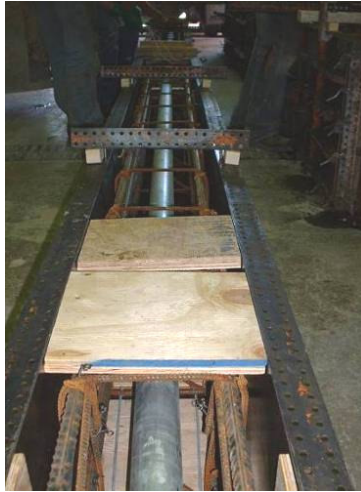
Figure 45. Photograph of Column 3 reinforcement and inserts.

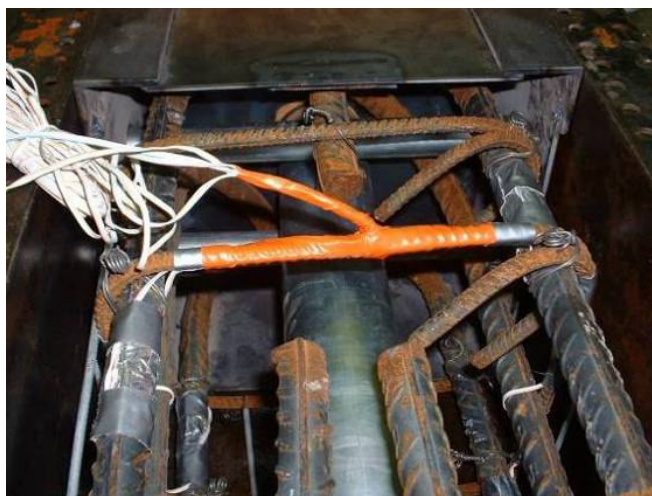
Figure 47. Photograph of Column 4 collar region congestion.

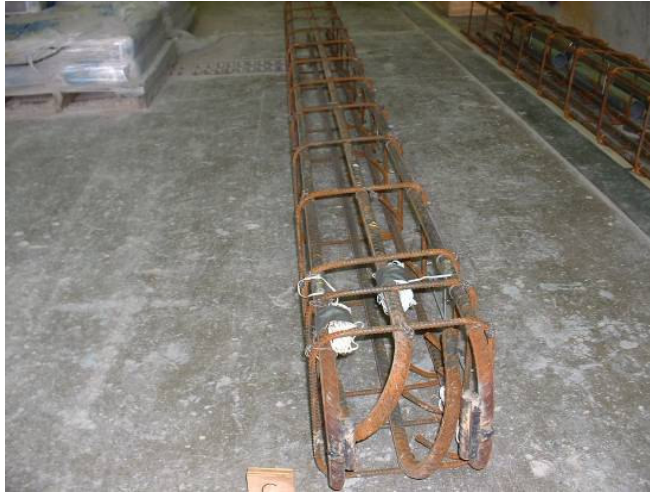
Figure 48. Photograph of Column 4, 12 ft. segment reinforcement.

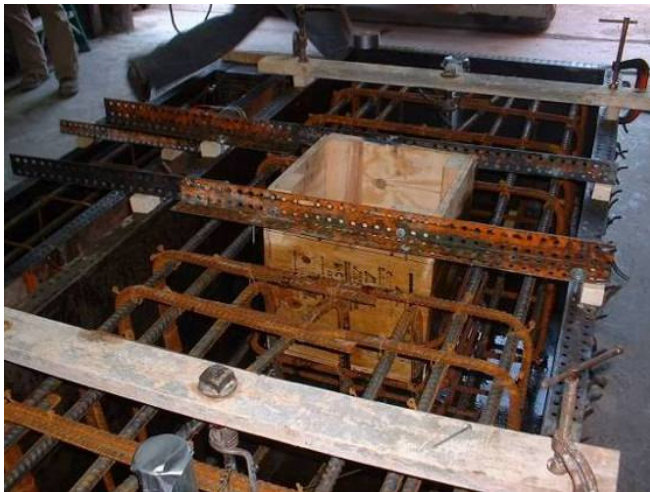
Figure 49. Photograph of Column 3 foundation reinforcement in forms.

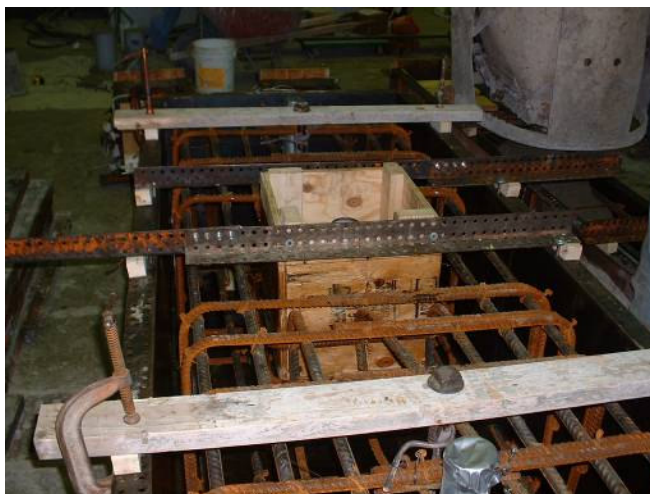
Figure 50. Photograph of Column 4 foundation reinforcement in forms.

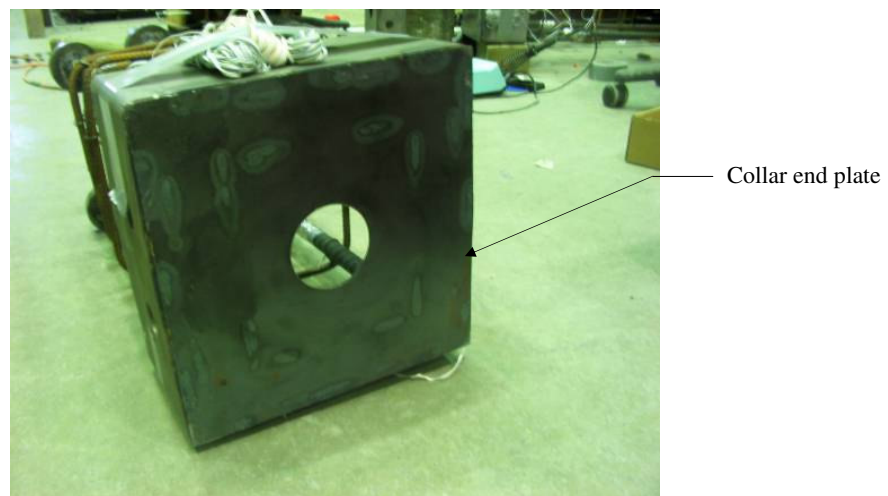
Figure 54. Photograph of Column 5 collar end plate.

As discussed in Chapter 3, the through-bolt holes on the extreme tension and compression faces of the column were offset $\frac{1}{2}$ in. farther from the ends of the columns, while the holes on the lateral faces of the collars were spaced $\frac{1}{2}$ in. closer to the ends of the columns. The collared ends of Column 5 are shown in Figures 52-55. In Figures 52 and 53, the 2 ft. column segment with straight bar reinforcement and end anchors is shown. The end plate welded to the Column 5 collars is shown in Figure 54, and the collared end in the forms prior to casting is shown in Figure 55.

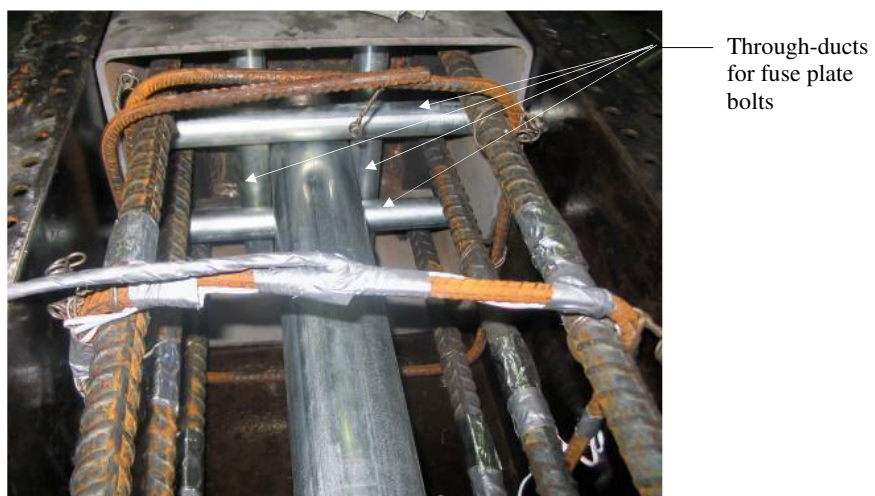
Figure 55. Photograph of Column 5, 12 ft. segment collared end.

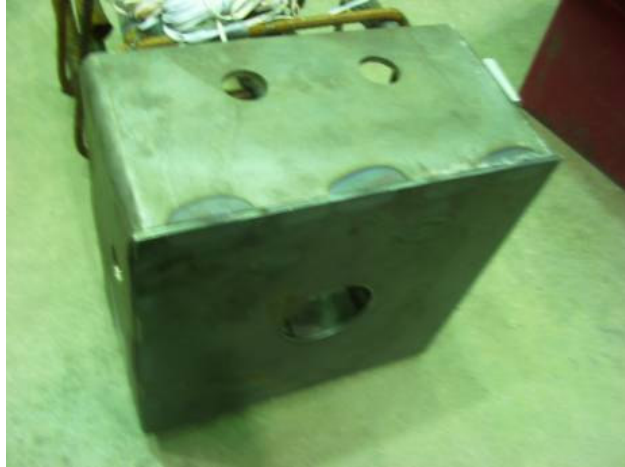
Figure 58 Photograph of Column 6 collar and end plate.

As discussed in Chapter 3, the through-bolt duct spacing was also altered for Column 6. Holes on the tension and compression faces of the column were offset 1 in. farther from the ends of the columns, while the holes on the sides of the collars were spaced 1 in. closer to the ends of the columns. The reinforcement end details, along with the collar details are shown in Figures 56-58, while the upper portion of the Column 6 12-ft. segment is shown in Figures 59 and 60.

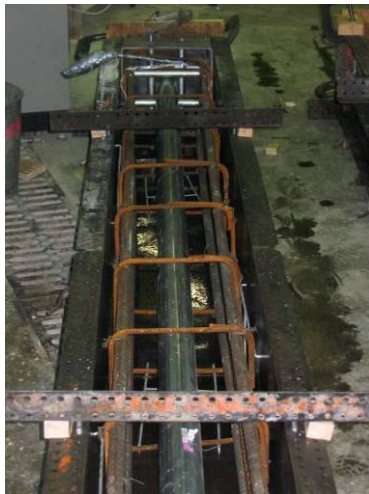
Figure 59. Photograph of Column 6 in forms.

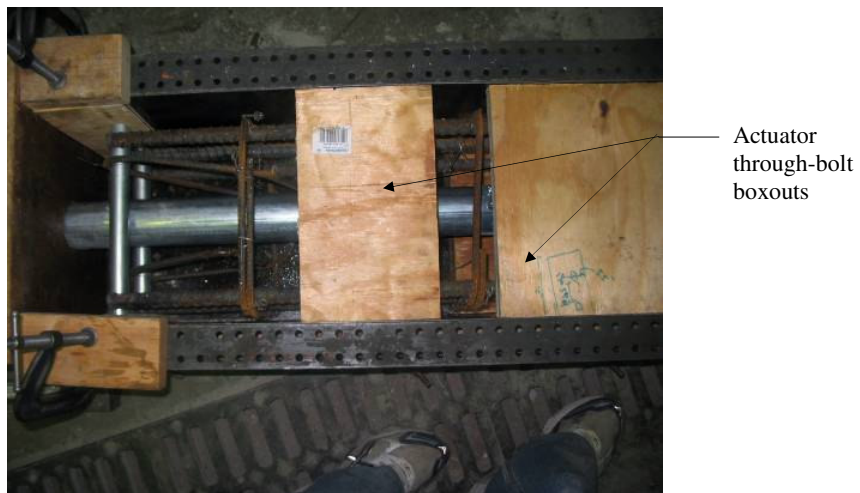
Figure 60. Photograph of Column 6 boxouts and lifting inserts.

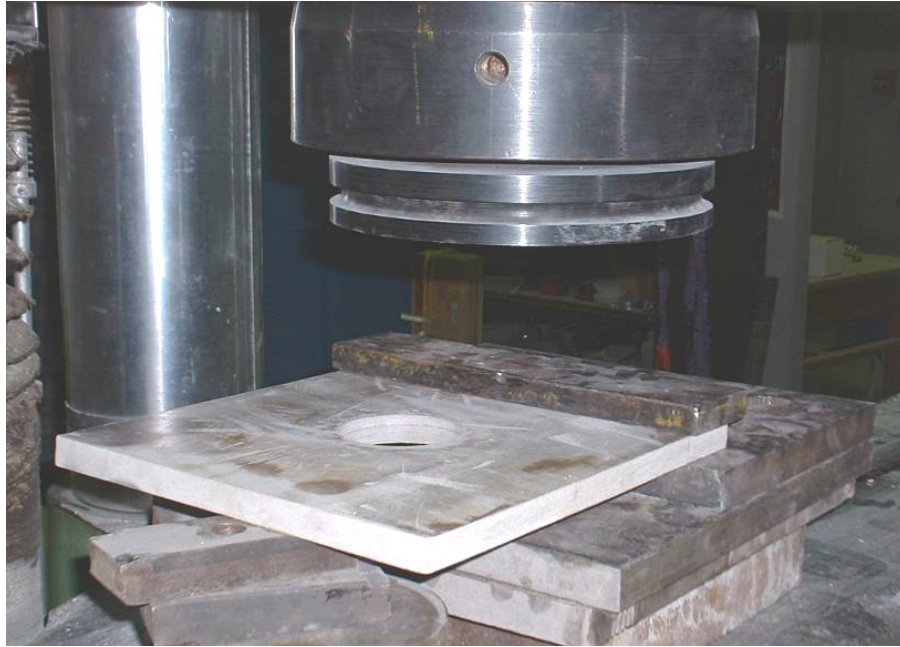
Figure 61. Photograph of edge compression test.

In addition to the cylinder breaks, an edge compression test was performed on each type of plate to obtain a realistic stress-strain relationship. To simulate the loading applied during column tests, a 2 in. wide strip on the edge of the plates was tested in compression. From these tests, an estimate of the elastic modulus of each plate was calculated by measuring the slope of the stress-strain relationship. The GFRP plate exhibited the highest modulus during the edge compression test, while the epoxy grout plate saw the lowest modulus. While the modulus of the GFRP plate was 20% higher than the epoxy grout plate modulus, the effect of the different modulus of the three plates during column testing could not be determined, because each plate performed satisfactorily during the tests. The edge compression test is shown in Figure 61 and the results from the tests are shown in Figure 62.

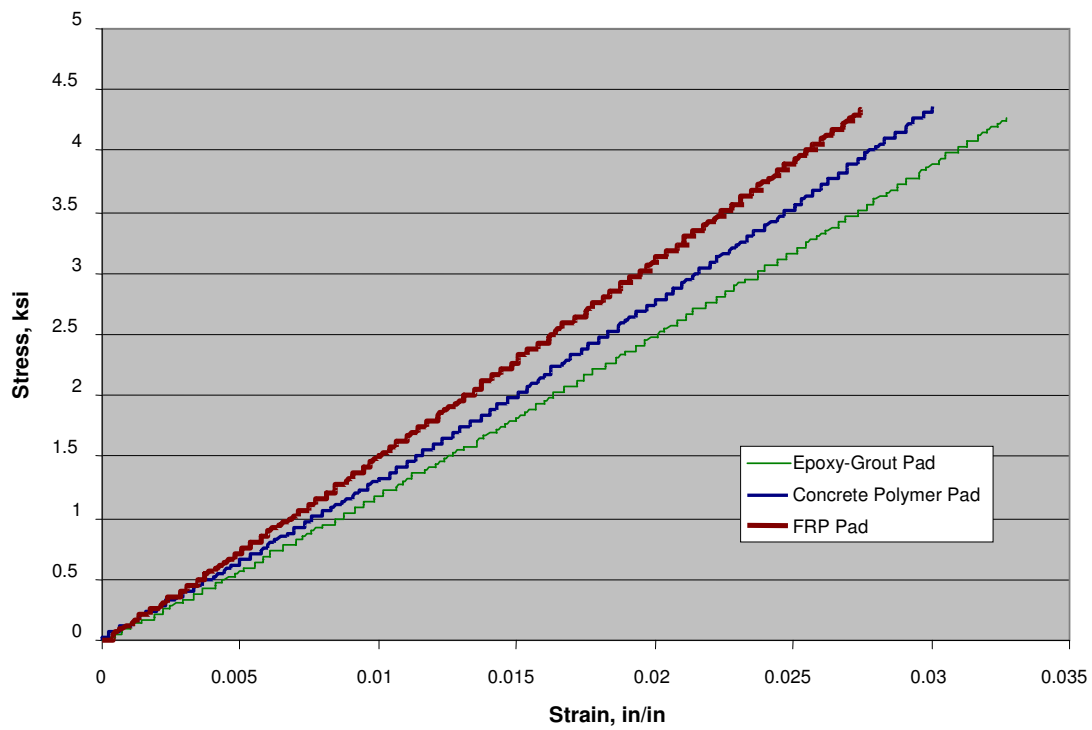
Figure 62. Bearing plate compression test results.

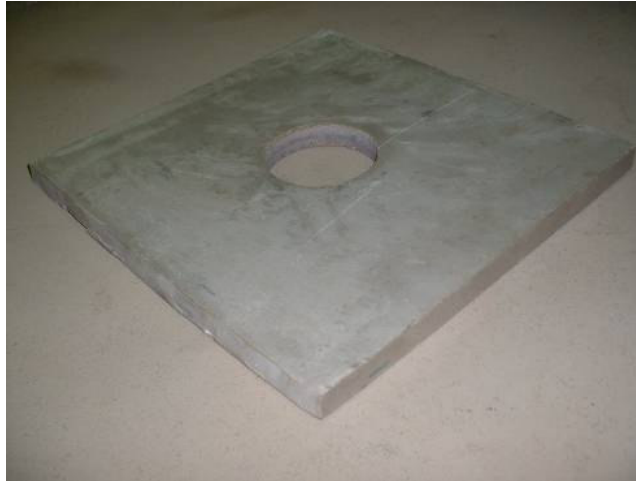
To form the epoxy grout bearing plate, Sikadur 32, a high modulus, flowable epoxy, was mixed with Grade 37 silica sand in a 1:1 ratio. This mixture was also used to grout each column base into its foundation socket. The average compressive strength of the epoxy grout used was 12 ksi in fifteen 3 in. diameter by 6 in. long cylinder breaks, while the elastic modulus of the epoxy grout plate was 1,300 ksi. It should be noted that the elastic modulus for this material can easily be adjusted by altering the sand-to-epoxy ratio. When tested in compression, this material exhibited large plastic strains without cracking. A prefabricated epoxy grout bearing plate, shown in Figure 63, was used for Columns 2 and 3.

Figure 63. Photograph of epoxy grout plate.

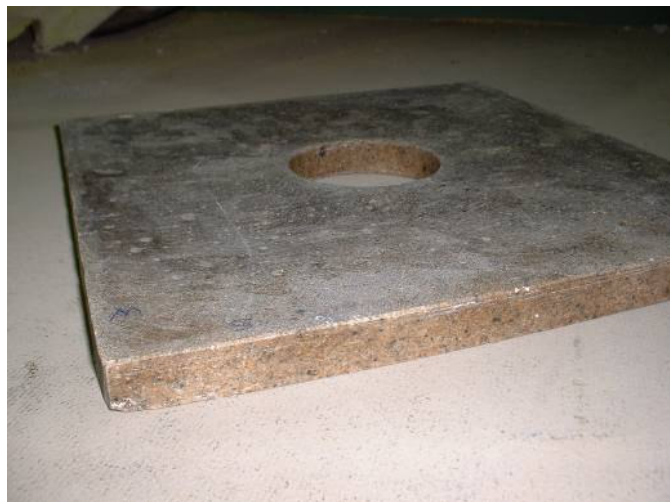
A steel-reinforced polymer concrete bearing plate was used in Column 4. In polymer concrete, a high strength, corrosion resistant, thermosetting resin acts as the binding agent. Three-eighths in. aggregate was used in the bearing plate, and a 2 in. square welded wire grid was cast into the plate to reinforce against splitting. The modulus of elasticity of the polymer concrete was approximately 1,500 ksi, while its compressive strength averaged 9.85 ksi in four cylinder breaks. The Column 4 plate is shown in Figure 64.

Figure 64. Polymer concrete bearing plate.

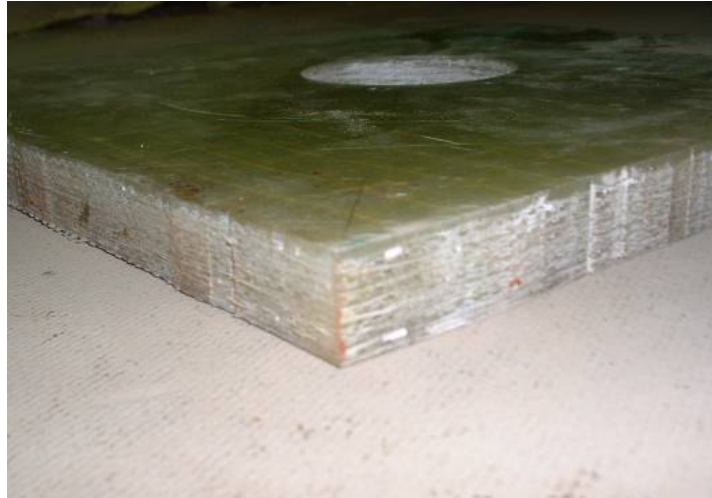
A GFRP bearing plate was used in Columns 5 and 6; an epoxy resin served as the matrix for GFRP, while glass fiber layers provided tensile reinforcement against lateral splitting. Seventeen layers of woven fiber fabric were laid up in alternating 90° orientations to construct the 0.75 in. thick plate. The elastic modulus for the GFRP bearing plate perpendicular to the fibers was

approximately 1,600 ksi, and the average compressive strength of the epoxy matrix determined from 3 cylinder breaks was 13 ksi. The GFRP bearing plate is shown in Figure 65.

Figure 65. GFRP plate.

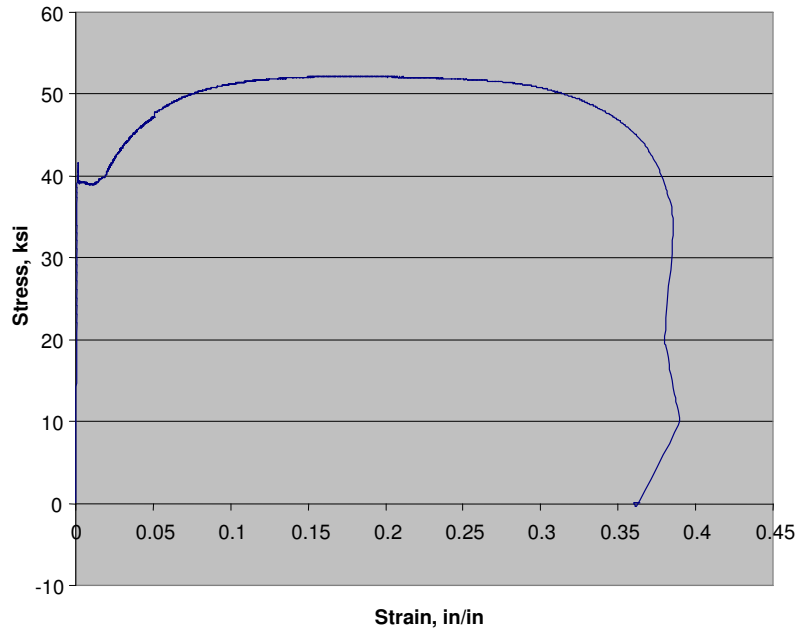
A36 steel plates were used for the fuse plates of Columns 2, 4, and 5. From three direct tension tests, the plates were determined to have an average yield stress of 38 ksi, an ultimate stress of 52 ksi, an ultimate elongation greater than 30%, and an elastic modulus of approximately 31,000 ksi. A representative stress versus strain relationship for the A36 plates is presented in Figure 66.

Figure 66. Typical stress vs. strain relationship for A36 steel used in fuse plates.

As shown by Figures 66-68, the properties of the three tested materials varied significantly. The yield stress of the A36 steel was tested to be 6-7 ksi higher than the 1018 carbon steel, while the yield stress of the SMA was higher than both but not well defined. Ultimate elongations in the 1018 carbon steel and the A36 steel were found to be above 30%, which will allow the pier system to sustain large displacements by permitting more rotation at each segment joint before plate fracture. The ultimate elongation of the SMA was found to be only 10%, but its high ultimate strength (~105-110 ksi) will resist larger loads before fuse plate fracture occurs. This gain in strength of the construction joint will cause the column segments to take additional rotation and subsequent damage caused by larger displacements.

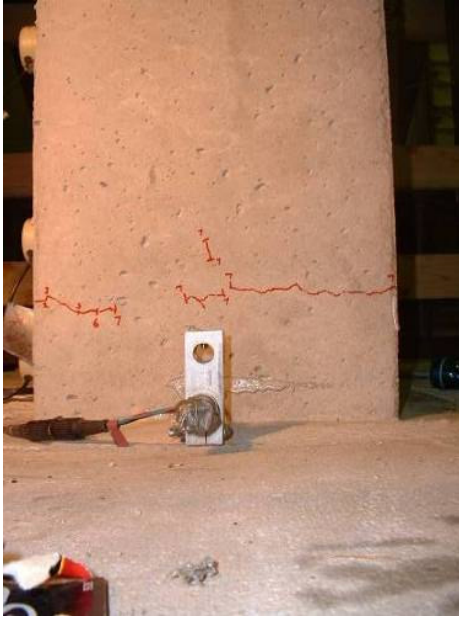
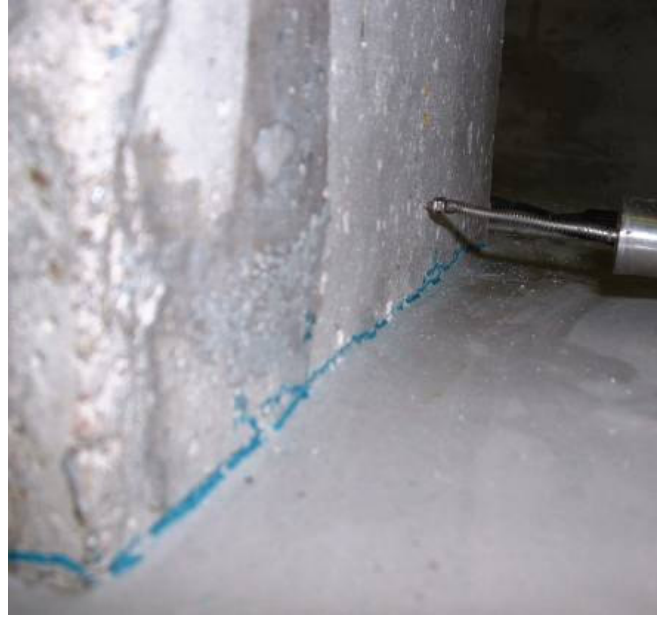
a.) East face initial cracking

b.) West face initial cracking

Figure 71. Photographs of Column 1 - Cycle 8.

Testing of Column 1 commenced and continued to a ± 9.0 in. lateral displacement. No post-tensioning was applied to this column to replicate the behavior of a conventional, cast-in-place column. Incremental damage accrued over the imposed displacement regimen is presented in Figures 71-84. Cracking across the east and west column faces was first observed on Cycle 7 (displacement = ± 0.40 in.). On the positive (push) half-cycle, cracking was observed 3 in. above the base on the east face; on the negative (pull) half-cycle, three full cracks across the column face were noted 3 in., 16 in., and 24 in. above the base on the west face. These initial cracks are shown during Cycles 8 and 11 in Figures 71 and 72, respectively.

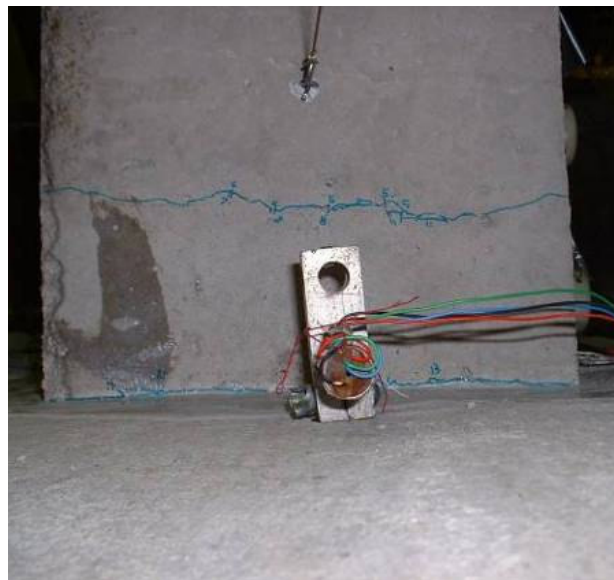
a.) East face

b.) West face

Figure 72. Photographs of Column 1 - Cycle 11 base cracking.

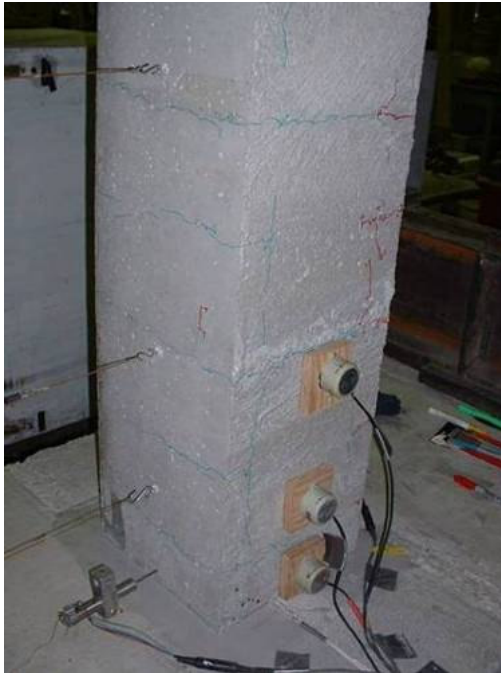
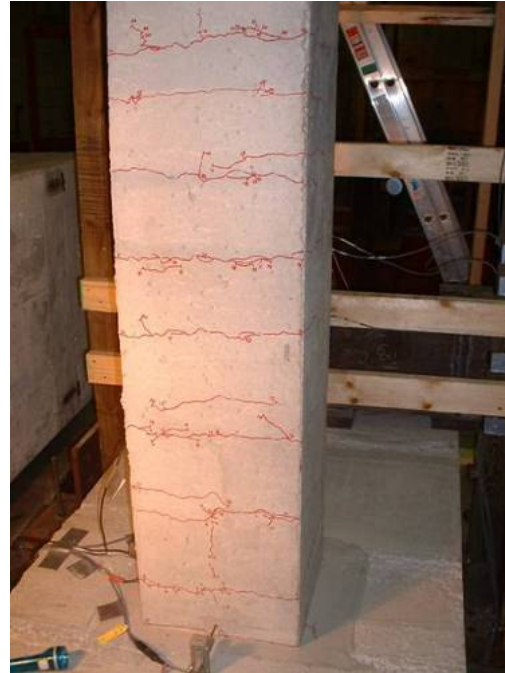
a.) Southwest corner view of progressive cracking

b.) Progressive cracking on the east face

Figure 73. Photographs of Column 1 - Cycle 11 progressive cracking.

Cracks continued to expand and develop further up the column as cycles continued and lateral loads increased (see Figures 73 and 74). From Cycles 20 to 22, several areas on the compression face of the column began to exhibit localized compression damage and are denoted by hatched areas drawn on the column faces (see Figures 75 and 76). Major compression damage that localized in the southwest corner of the column was observed on Cycle 20 (displacement = ± 5.0 in.) (see Figures 77a and 78). As the previously observed damage increased on subsequent cycles, the column began to tilt to the south, perpendicular to the axis of loading. On Cycle 21 (displacement = ± 5.0 in.), Column 1 attained its maximum lateral load of + 9.7 kips.

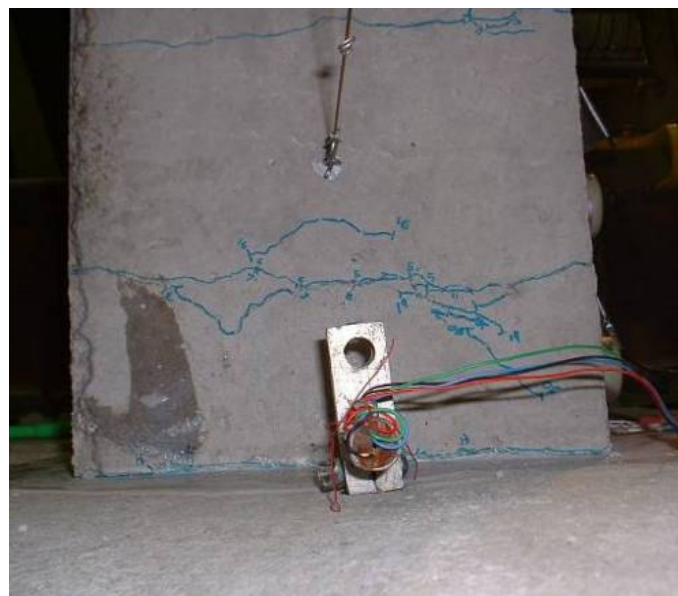
a.) East face cracking

b.) West face cracking

Figure 74. Photographs of Column 1 - Cycle 14.

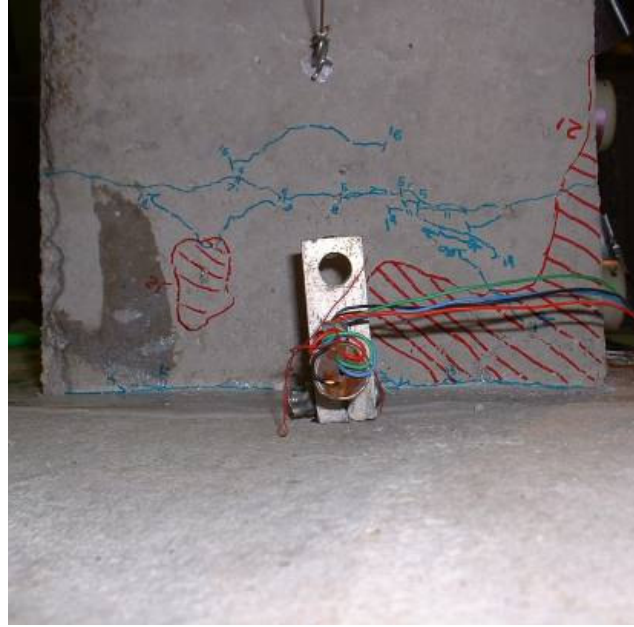
a.) West face initial compression damage

b.) Localization of compression damage on southwest corner

Figure 75. Photographs of Column 1 - Cycle 20.
